June 3, 2024 2023-005.07

Re: Devil's Gate Reservoir Restoration Project – Phase 1 Restoration Qualitative Monitoring Conducted on February 8, 2024

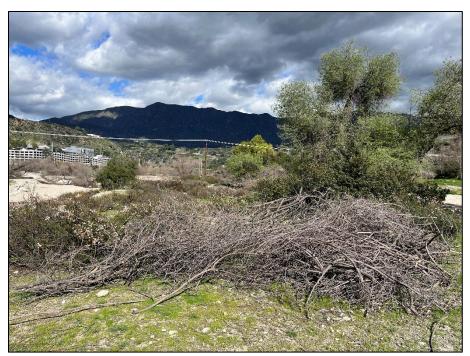
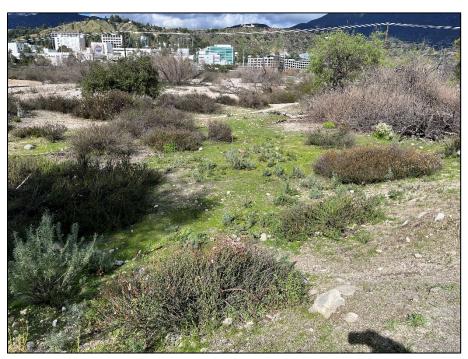
Photo 1: Overview Mitigation Area DG-1

Container plants were not installed in the DG-1 or DG-1 WOUS mitigation areas, but these areas were seeded with native plant species. Native plant growth, including perennials and annuals, was noted throughout the DG-1 and DG-1 WOUS mitigation areas, likely both from natural recruitment and from seeding. The majority of DG-1 WOUS was noted as being scoured during the 2020, 2021, 2022, 2023, and 2024 wet seasons and had minimal plant growth. Native plants such as California sagebrush (*Artemisia californica*), mulefat (*Baccharis salicifolia*), Spencer primrose (*Camissoniopsis micrantha*), common sandaster (*Corethrogyne filaginifolia*), California buckwheat (*Eriogonum fasciculatum*), common phacelia (*Phacelia distans*), and ladies' tobacco (*Pseudognaphalium californica*) were observed sprouting in the DG-1 and DG-1 WOUS mitigation areas. Native cover for the DG-1 and DG-1 WOUS mitigation areas was estimated to be approximately 60 to 65 percent with some areas having relatively dense cover and other areas being scoured and/or having minimal cover. Photos 1 and 2 in Attachment B document the status of the mitigation areas during the monitoring visit.

Nonnative weed cover in DG-1 and DG-1 WOUS was estimated to be approximately 3 to 5 percent, which is approximately 2 to 4 percent higher than the level of weed cover that was observed during the previous qualitative monitoring event. Nonnative species observed in DG-1 and DG-1 WOUS during the monitoring visit included black mustard (*Brassica nigra*), red-stemmed filaree (*Erodium cicutarium*), and nonnative grasses. Most nonnative weeds were just starting to germinate and had not gone to flower or seed.

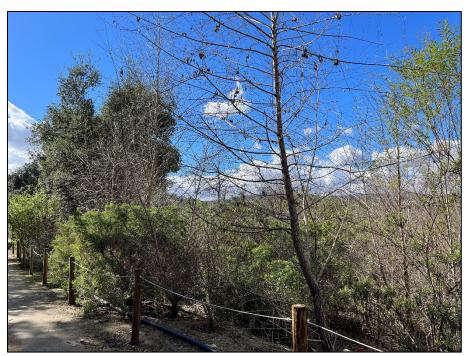
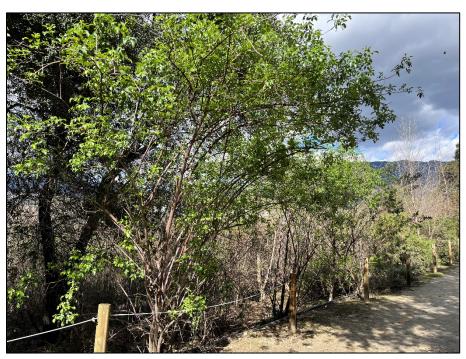
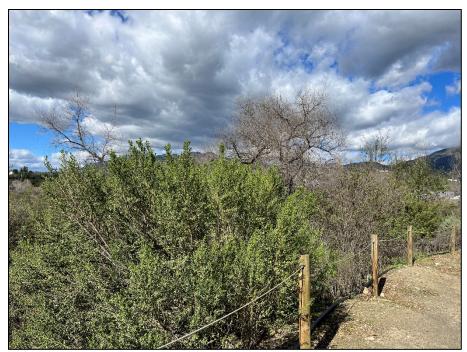
Photo 3: Overview Mitigation Area DG-2A

The overall health of the container plants in DG-2A was noted as being good. Approximately less than five percent of the container plants in DG-2A were noted as showing varied levels of stress, which is approximately the same as the percentage of container plants that were showing stress during the previous qualitative monitoring event. Stress may be occurring as a result of 1) competition from

nonnative and invasive weeds, 2) misplaced emitters, or 3) recreational traffic through the mitigation areas. There were no additional container plants noted as being missing or dead. Formal mortality counts were taken for DG-2A during the 2020, 2021, 2022, and 2023 quantitative monitoring events. The willows (*Salix* sp.) and Fremont's cottonwoods (*Populus fremontii*) were starting to show signs of seasonal dieback. The installation of plants in the DG-2A mitigation area appears to have been completed successfully. The current issues identified during the monitoring visit are not expected to have an effect on the continued growth of the plants in the mitigation area. Photos 3 through 5 in Attachment B document the status of the mitigation area during the monitoring visit.

Native plant growth was noted throughout the DG-2A mitigation area, likely both from natural recruitment and from seeding. Native plants such as mugwort (*Artemisia douglasiana*), tall flatsedge (*Cyperus eragrostis*), telegraph weed (*Heterotheca grandiflora*), common phacelia, ladies' tobacco, and stinging nettle (*Urtica dioca*) were observed sprouting in the DG-2A mitigation area. Native cover for the DG-2A mitigation area was estimated to be 80 percent. The minor drop in cover is likely due to seasonal dieback.

Nonnative weed cover in DG-2A was estimated at approximately 1 percent, which is approximately the same level of weed cover that was observed during the previous qualitative monitoring event. Nonnative species observed in DG-2A during the monitoring visit included black mustard and perennial pepperweed (*Lepidium latifolia*). Most nonnative weeds were just starting to germinate and had not gone to flower or seed.

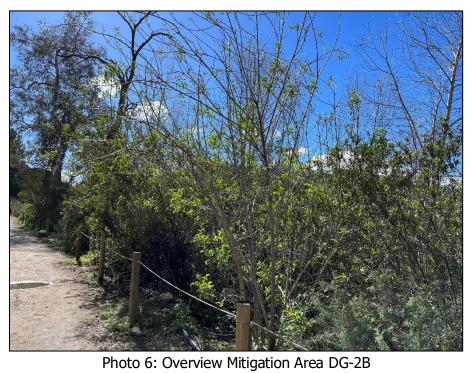
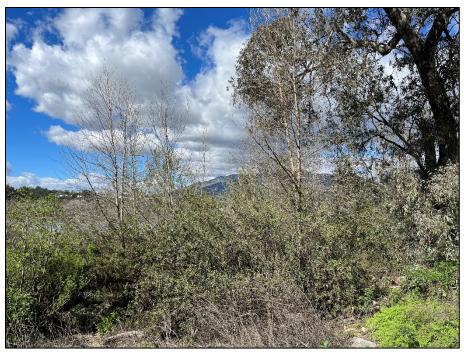
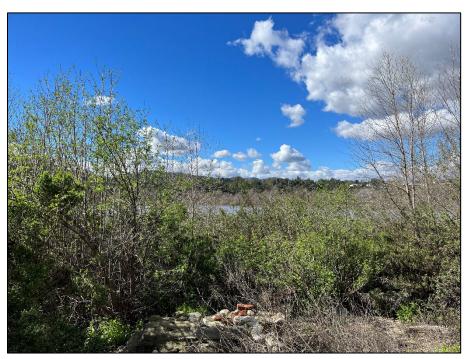
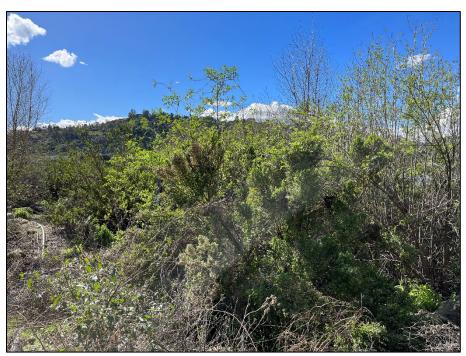
Photo 7: Overview Mitigation Area DG-2B

The overall health of the container plants in DG-2B was noted as being good. Approximately less than five percent of the container plants in DG-2B were noted as showing varied levels of stress, which is approximately the same percentage of container plants that were showing stress during the previous qualitative monitoring event. Stress was likely due to the same reasons as those described for DG-2A. In addition, insect galls were observed on several of the willow species. Formal mortality counts were taken for DG-2B during the 2020, 2021, 2022, and 2023 quantitative monitoring events. Similar to DG-2A, the willows and Fremont's cottonwoods were starting to show signs of seasonal dieback. The installation of the plants in the DG-2B mitigation area appears to have been successfully completed. The current issues identified during the monitoring visit are not expected to have an effect on the continued growth of plants in the mitigation area. Photos 6 through 9 in Attachment B document the status of the mitigation area during the monitoring visit.

Native plant growth was noted throughout the DG-2B mitigation area, likely both from natural recruitment and from seeding. Native plants such as mugwort, mulefat, coyote brush (*Baccharis pilularis*), common phacelia, Douglas' nightshade (*Solanum douglasii*), and stinging nettle were observed sprouting in the DG-2B mitigation area. Native cover for the DG-2B mitigation area was estimated to be 85 percent.

Nonnative weed cover in DG-2B was estimated at approximately 1 percent, which is approximately 1 percent lower than the level of nonnative cover that was observed during the previous qualitative monitoring event. Nonnative species observed in DG-2B during the monitoring visit included black

mustard, red-stemmed filaree, and perennial pepperweed. Most nonnative weeds were just starting to germinate and had not gone to flower or seed.

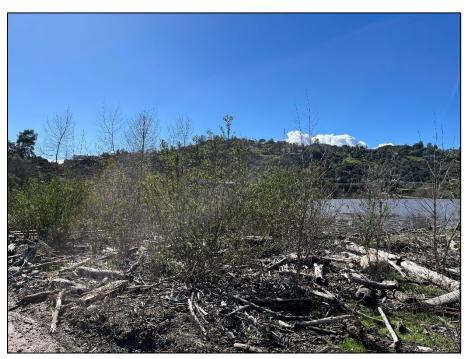
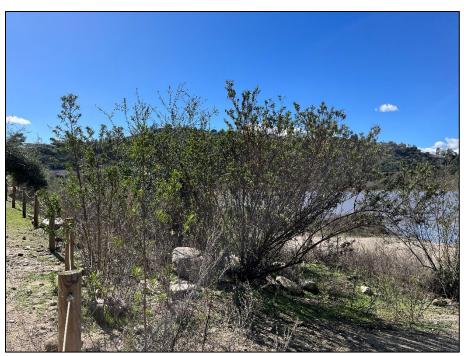
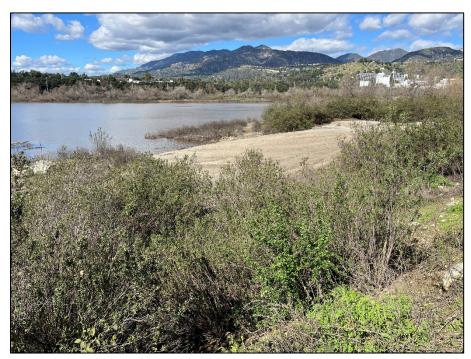
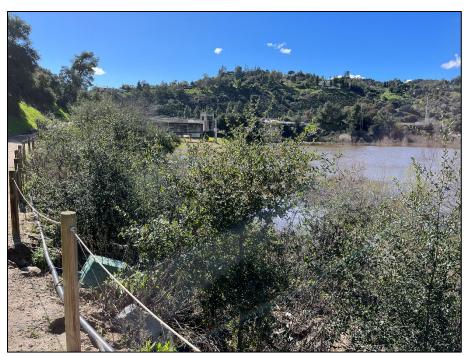
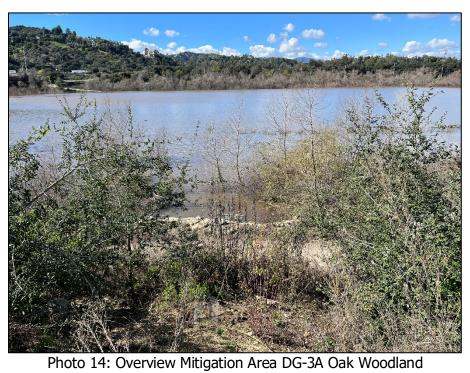
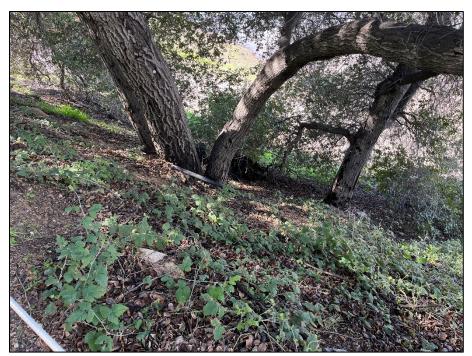
Photo 10: Overview Mitigation Area DG-3A Altadena Drain

The overall health of the container plants in DG-3A was noted as being good. Approximately 5 percent of the container plants in the coast live oak woodland portions of DG-3A were noted as showing varied levels of stress, which is approximately the same percentage of container plants that were showing stress during the previous qualitative monitoring event. During the monitoring visit, the planted coast live oak (*Quercus agrifolia*) acorns were inspected for survivorship and health. Approximately 20 germinated coast live oak acorns appear to still be present in DG-3A. The majority of the germinated acorns appear to be in good health. During the monitoring, it was noted that an existing coast live oak tree (Tree Tag #39) is continuing to experience branch failure for multiple branches. The cause of the branch failure was unclear.

During the monitoring visit, the mulefat thickets portions of DG-3A were noted as being mostly inundated under water and therefore the level of stress could not be determined. These areas will be assessed during the next qualitative monitoring event. Formal mortality counts were taken for DG-3A during the 2020, 2021, 2022, and 2023 quantitative monitoring events. The types of stress the plants were exhibiting are the same as those described for the plants in DG-2A. However, erosion is also a problem in some areas of DG-3A. Some of the planting basins were observed to have varied levels of erosion and should be repaired. The willow and mulefat stakes were observed to be thriving in this mitigation area during the last monitoring visit and are likely to survive the inundation. The installation of the plants in the DG-3A mitigation area appears to have been completed successfully. The current issues noted during the monitoring are not expected to have an effect on the continued growth of the plants in the mitigation area. Photos 10 through 15 in Attachment B document the status of the mitigation area during the monitoring visit.

Native plant growth was noted throughout the DG-3A mitigation area, likely both from natural recruitment and from seeding. Native plants such as California sagebrush, mugwort, mulefat, common phacelia, ladies' tobacco, coast live oak, and stinging nettle were observed sprouting in the DG-3A mitigation area. Native cover for the DG-3A mitigation area was estimated to be approximately 60 percent in the coast live oak woodland portion of the mitigation area and 70 percent in the mulefat thickets portion of the mitigation area.

Nonnative weed cover in DG-3A was estimated at approximately 1 percent, which is approximately 4 percent lower than the level of nonnative cover that was observed during the previous qualitative monitoring event. Nonnative species observed in DG-3A included black mustard and perennial pepperweed. Most nonnative weeds were just starting to germinate and had not gone to flower or seed.

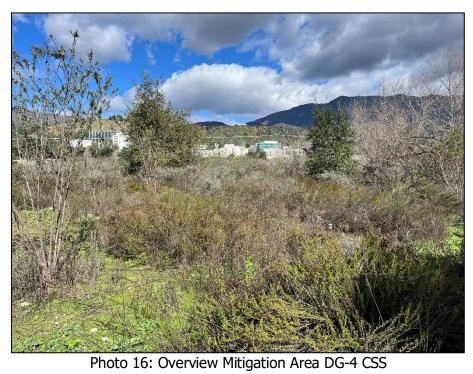
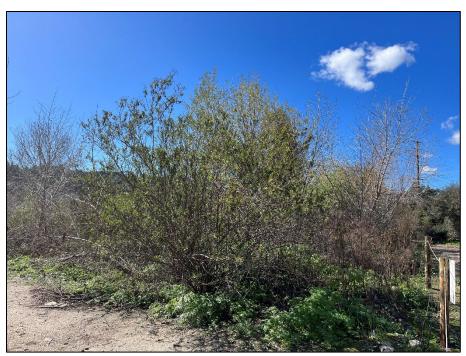
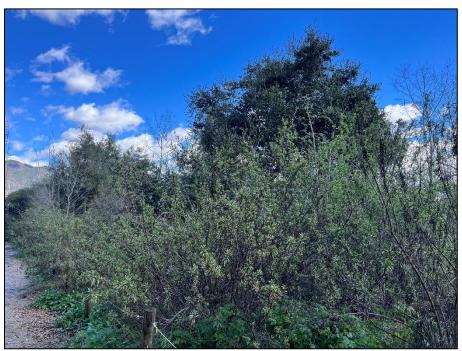
Photo 17: Overview Mitigation Area DG-4 Riparian

The overall health of the container plants in mitigation area DG-4 was noted as being good. Approximately 5 percent of container plants in the coastal sage scrub portions of DG-4 were showing varied levels of stress which is approximately the same percentage of plants showing stress during the previous qualitative monitoring event. Approximately 5 percent of container plants in most of the riparian

portions of DG-4 were showing varied levels of stress, which is the same percentage of plants showing stress during the previous qualitative monitoring event. The causes of stress appear to be mostly due to the same reasons described in DG-2A. In addition, the southern portions of DG-4 have experienced periods of inundation during the wet season and these areas were observed to be inundated during the February monitoring visit. For most portions of DG-4 that have not experienced inundation, only a negligible number of container plants were noted as missing or dead. Formal mortality counts were taken for DG-4 during the 2020, 2021, 2022, and 2023 quantitative monitoring events. Similar to DG-2A, the willows and Fremont's cottonwoods were starting to show signs of seasonal dieback. Some of the planting basins were observed to have minor erosion and should be repaired. The installation of plants in the DG-4 mitigation area appears to have been completed successfully and the issues noted during the monitoring are not expected to have an impact on the continued growth of the plants. Photos 16 through 18 in Attachment B document the status of the mitigation area during the monitoring visit.

Native plant growth was noted throughout the DG-4 mitigation area, likely both from natural recruitment and from seeding. Native plants such as California sagebrush, mugwort, mulefat, tall flatsedge, Jimson weed (*Datura wrightii*), telegraph weed, Hooker's evening primrose (*Oenothera elata*), ladies' tobacco, and stinging nettle were observed sprouting in the DG-4 mitigation area. Native cover for the DG-4 mitigation area was estimated to be approximately 75 percent in the riparian portion of the mitigation area and 70 percent in the coastal sage scrub portion.

Nonnative weed cover in DG-4 was estimated at approximately 20 to 30 percent, which is approximately 10 to 15 percent higher than the percentage of nonnative cover that was observed during the previous qualitative monitoring event. Nonnative species observed in DG-4 included black mustard, poison hemlock (*Conium maculatum*), red-stemmed filaree, perennial pepperweed, white horehound (*Marrubium vulgare*), and German chamomile (*Matricaria chamomilla*). Nonnative weed cover, especially perennial pepperweed, is a significant problem in portions of the DG-4 mitigation area. Because perennial pepperweed can produce dense colonies through seed germination and underground rhizomes (rhizomatous roots), removal of this species without the use of systemic herbicide is very difficult. Some of the nonnative weeds in this mitigation area were starting to produce flowers and or seed and should be removed as soon as possible.

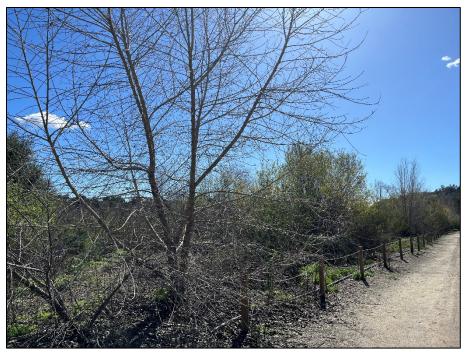
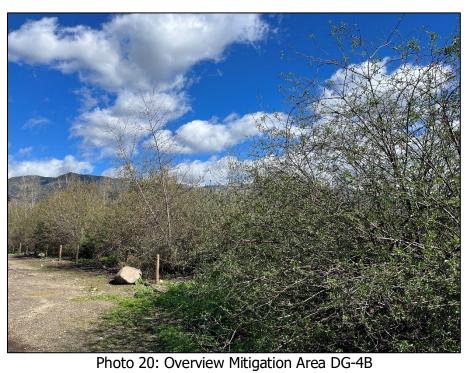
Photo 19: Overview Mitigation Area DG-4B

The overall health of the container plants in mitigation area DG-4B was noted as being good and this mitigation area is becoming well established. Approximately less than five percent of container plants were showing varied levels stress which is approximately the same percentage of plants that were stressed during the previous qualitative monitoring event. The types of stress the plants were exhibiting are the same as those described for the plants in DG-2A. A negligible number of container plants were noted as being missing or dead. Formal mortality counts were taken for DG-4B during the 2020, 2021, 2022, and 2023 quantitative monitoring events. Similar to DG-2A, the willows and Fremont's cottonwoods were starting to show signs of seasonal dieback. Some of the planting basins were observed to have minor erosion and should be repaired. The installation of plants in the DG-4B mitigation area appears to have been completed successfully and the issues noted during the monitoring are not expected to have an

impact on the continued growth of the plants. Photos 19 and 20 in Attachment B document the current status of the mitigation area during the monitoring visit.

Native plant growth was noted throughout the DG-4B mitigation area, likely both from natural recruitment and from seeding. Native plants such as mugwort, tarragon (*Artemisia dracunculus*), common phacelia, and stinging nettle were observed sprouting in the DG-4B mitigation area. Native cover for the DG-4B mitigation area was estimated to be approximately 80 percent.

Nonnative weed cover in DG-4B was estimated to be approximately 20 to 25 percent, which is approximately 10 to 15 percent higher than the level of nonnative cover that was observed during the previous qualitative monitoring event. Nonnative species observed in DG-4B included black mustard, poison hemlock, and perennial pepperweed. Most nonnative weeds were just starting to germinate and had not gone to flower or seed.

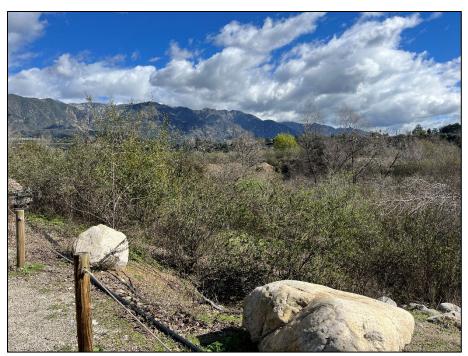
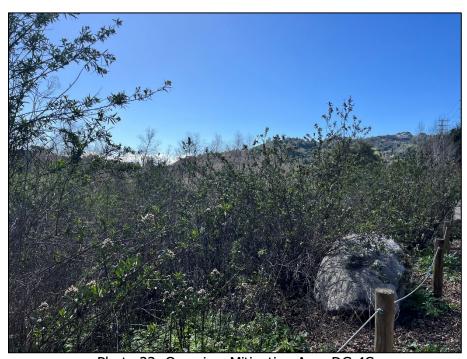
Photo 21: Overview Mitigation Area DG-4C

The overall health of the container plants in mitigation area DG-4C was noted as being good. Approximately five percent of all container plants were noted as showing minor levels of stress, which is approximately the same percentage of plants that were showing stress during the previous qualitative monitoring event. The types of stress the plants were exhibiting are the same as those described for the plants in DG-2A. A negligible number of container plants were noted as being missing or dead. Formal mortality counts were taken for DG-4C during the 2020, 2021, 2022, 2023 quantitative monitoring events. Similar to DG-2A, the willows and Fremont's cottonwoods were starting to show signs of seasonal dieback. Some of the planting basins were observed to have minor erosion and should be repaired. The installation of plants in the DG-4C mitigation area appears to have been completed successfully and the issues noted during the monitoring are not expected to have an impact on the continued growth of the plants. Photos 21 and 22 in Attachment B document the status of the mitigation area during the monitoring visit.

Native plant growth was noted throughout the DG-4C mitigation area, likely both from natural recruitment and from seeding. Native plants such as mugwort, tarragon, common phacelia, and Douglas' nightshade were observed sprouting in the DG-4C mitigation area. Native cover for the DG-4C mitigation area was estimated to be approximately 70 percent.

Nonnative weed cover in DG-4C was estimated at approximately less than 10 to 15 percent, which is approximately 5 to 10 percent higher than the percentage of nonnative cover that was observed during the previous qualitative monitoring event. Nonnative species observed in DG-4C during the monitoring visit included black mustard, poison hemlock, and white horehound. Most nonnative weeds were just starting to germinate and had not gone to flower or seed.

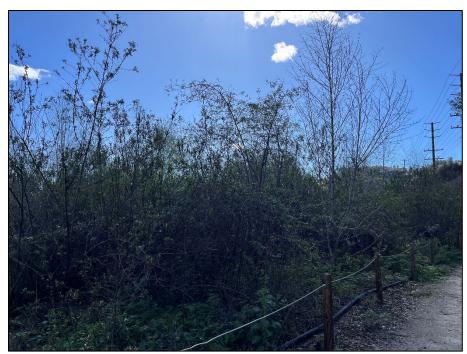
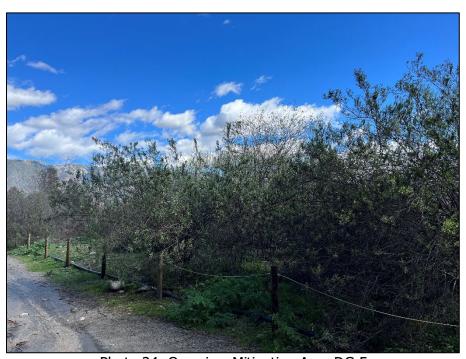
Photo 23: Overview Mitigation Area DG-5

The overall health of the container plants in the DG-5 mitigation area was noted as being good. Approximately less than five percent of all container plants were noted as showing varied levels of stress, which is approximately the same as the percentage of plants that were showing stress during the previous

qualitative monitoring event. Formal mortality counts were taken for DG-5 during the 2020, 2021, 2022 and 2023 quantitative monitoring events. Similar to DG-2A, the willows and Fremont's cottonwoods were starting to show signs of seasonal dieback. Some of the planting basins were observed to have minor erosion and should be repaired. The installation of plants in the DG-5 mitigation area appears to have been completed successfully and the issues noted during the monitoring are not expected to have a negative impact on the continued growth of the plants. Photos 23 and 24 in Attachment B document the status of the mitigation area during the monitoring visit.

Native plant growth was noted throughout the DG-5 mitigation area, likely both from natural recruitment and from seeding. Native plants such as mugwort, mulefat, and stinging nettle were observed sprouting in the DG-5 mitigation area. Native cover for the DG-5 mitigation area was estimated to be approximately 80 percent and the site is thriving.

Nonnative weed cover in DG-5 was estimated at approximately 20 to 25 percent, which is approximately 15 to 20 percent higher than the percentage of nonnative weed cover that was observed during the previous qualitative monitoring event. Nonnative species observed in DG-5 included black mustard, soft brome (*Bromus hordaceous*), poison hemlock, petty spurge (*Euphorbia peplus*), and perennial pepperweed. Most nonnative weeds were just starting to germinate and had not gone to flower or seed.
