June 3, 2024  
2023-005.07

**Re: *Devil's Gate Reservoir Restoration Project – Phase 2 Restoration Qualitative Monitoring Conducted on February 8, 2024***

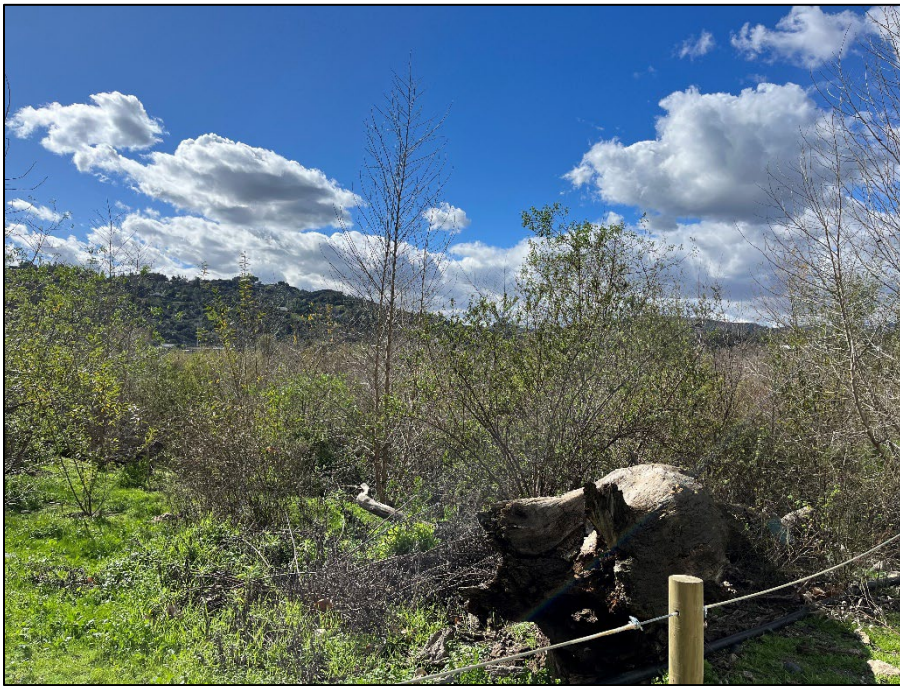
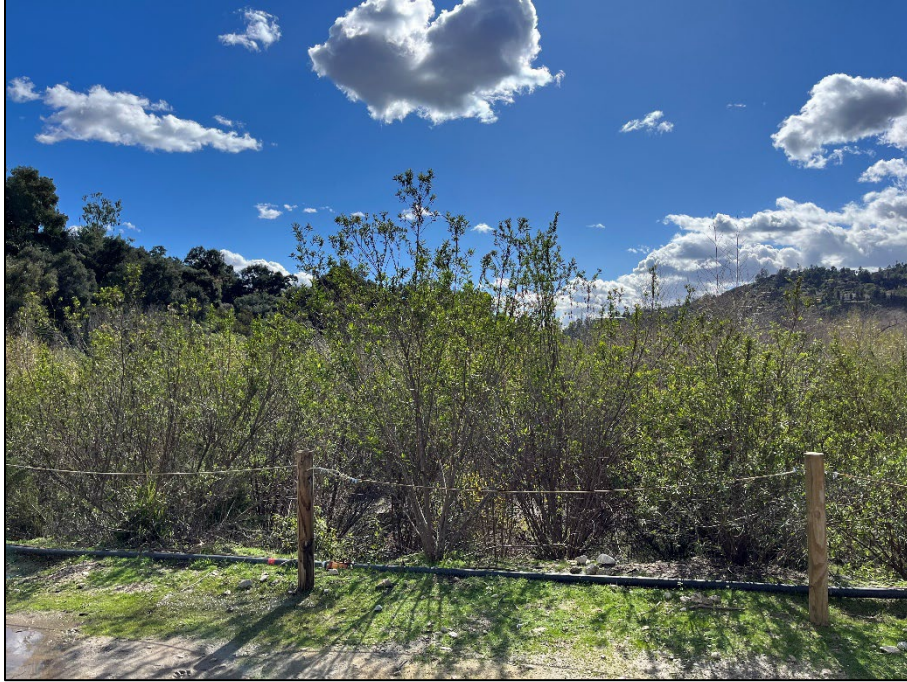
The overall health of the container plants in DG-W-1 was noted as being good. Approximately less than 5 percent of the container plants in DG-W-1 were noted as showing varied levels of stress and a negligible number were noted as being dead or missing. This is approximately the same percentage of plants that were showing stress during the last monitoring event. Stress may be occurring as a result of 1) competition from nonnative and invasive weeds, 2) misplaced emitters, or 3) recreational traffic through the mitigation areas. In addition, some of the Fremont's cottonwoods (*Populus fremontii*) and willows were starting to show signs of seasonal dieback. Evidence of dieback from *Phytophthora cactorum*, including wilting, stunted growth, leaf spotting, and/or browning along leaf margins and tips, was typically not observed on the container plants; however, leaf spotting was observed on some of the Fremont's cottonwoods and these trees should be monitored closely during the growing season to determine if the dieback was seasonal. Formal mortality counts were taken for DG-W-1 during the 2021, 2022, and 2023 quantitative monitoring events. Some of the container plants were noted as lacking well defined basins and should have their basins properly constructed and/or repaired. The irrigation line appeared to be functioning properly for the mitigation area during the monitoring visit. The installation of plants in the DG-W-1 mitigation area appears to have been completed successfully. The current issues identified during the monitoring visit are not expected to have an effect on the continued growth of the plants in the mitigation area. Photos 1 through 3 in Attachment B document the mitigation area during the monitoring visit.

Nonnative weed cover in DG-W-1 was estimated at approximately less than 5 percent, which is approximately 4 percent higher than the level of weed cover that was observed during the previous monitoring visit. Black mustard (*Brassica nigra*) and poison hemlock (*Conium maculatum*) were the only nonnative species observed in DG-W-1. Most of the nonnative weeds observed in this mitigation area were still vegetative and just beginning to germinate.

Photo 1: Overview Mitigation Area DG-W-1 (Johnson Field)

Photo 2: Overview Mitigation Area DG-W-1 (Johnson Field)

Photo 3: Overview Mitigation Area DG-W-1 (Johnson Field)

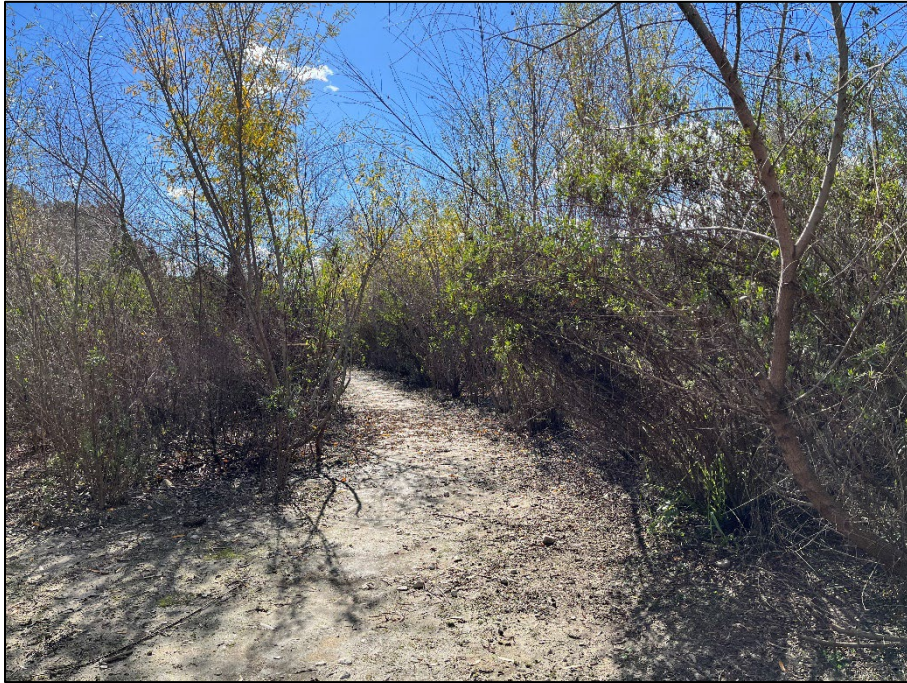
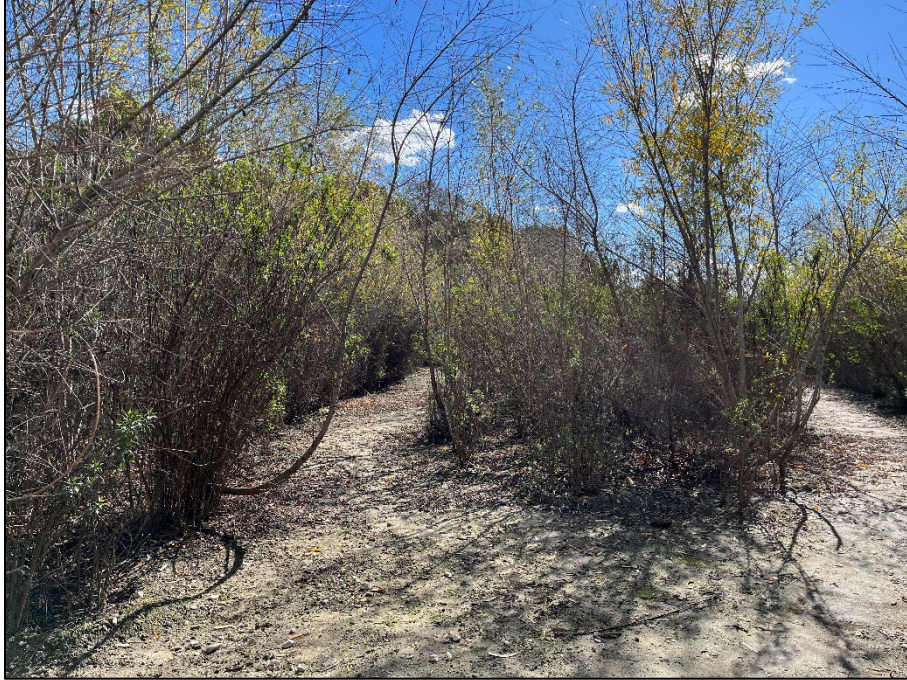
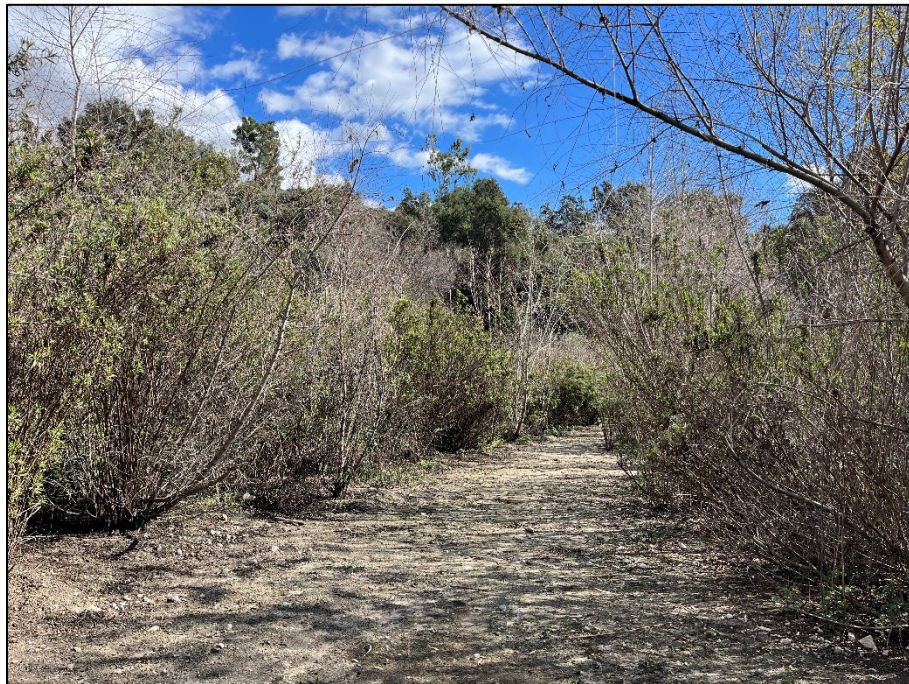
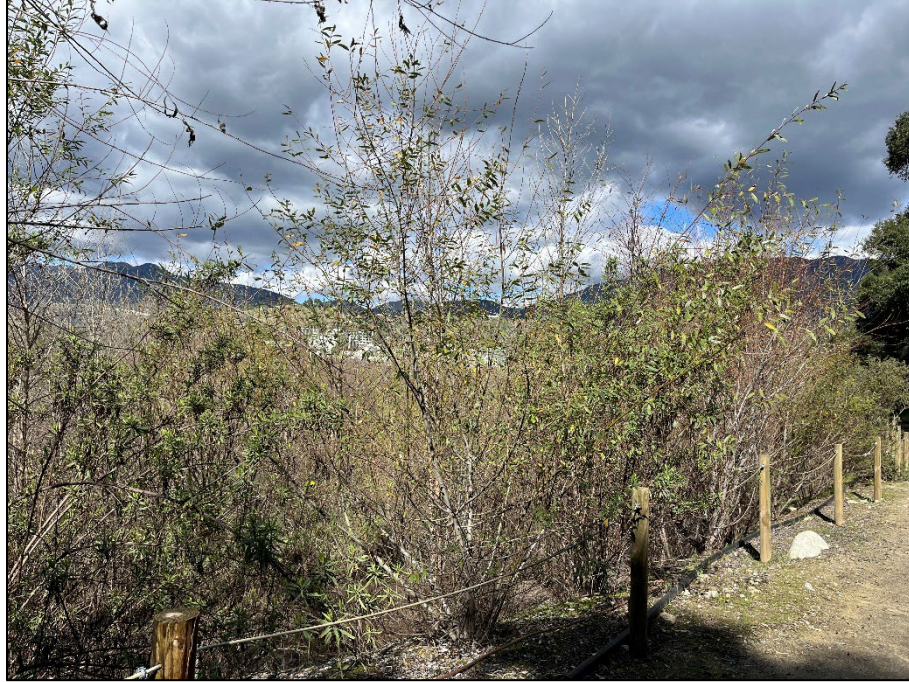
The overall health of the container plants in DG-2, DG-2 New Channels, and DG-2 WOUS was noted as being good. Approximately less than 5 percent of the container plants were noted as showing varied levels of stress and a negligible number were noted as being dead or missing. This is approximately the same percentage of plants that were showing stress during the last monitoring event. Stress may be occurring due to similar reasons described for DG-W-1. In addition, some of the Fremont's cottonwoods and willows were starting to show signs of seasonal dieback. Evidence of dieback from *Phytophthora cactorum*, including wilting, stunted growth, leaf spotting, and/or browning along leaf margins and tips, was typically not observed on the container plants; however, leaf spotting was observed on some of the Fremont's cottonwoods and these trees should be monitored closely during the growing season to determine if the dieback was seasonal. Formal mortality counts were taken for DG-2, DG-2 New Channels, and DG-2 WOUS during the 2021, 2022, and 2023 quantitative monitoring events. Some of the container plants were noted as lacking well defined basins and should have their basins properly constructed and/or repaired. The irrigation line appeared to be functioning properly during the monitoring visit. During the monitoring visit, the grade control structure that was installed at the northern end of DG-2 New Channels where the channels connect to DG-W-1 was inspected for erosion. Minor erosion was observed, mostly towards the western end of the structure; however, no major erosion issues were observed, and the structure appears to be functioning properly. In addition, erosion to the western-most portion of DG-2 that was previously noted was observed to have been repaired following the recontouring of the side slope on the west side of the reservoir. The installation of plants in the DG-2, DG-2 New Channels, and DG-2 WOUS mitigation areas appears to have been completed successfully. The current issues identified during the monitoring visit are not expected to have an effect on the continued growth of the plants in the mitigation area. Photos 4 through 7 in Attachment B document the mitigation areas during the monitoring visit.

Nonnative weed cover in the DG-2, DG-2 New Channels, and DG-2 WOUS mitigation areas was estimated at approximately 3 to 5 percent, which is approximately 2 to 4 percent higher than the percentage that was observed during the last monitoring visit. Poison hemlock and perennial pepperweed (*Lepidium*

Photo 4: Overview Mitigation Area DG-2 & DG-2 New Channels

Photo 5: Overview Mitigation Area DG-2 & DG-2 New Channels

Photo 6: Overview Mitigation Area DG-2 & DG-2 WOUS

Photo 7: Overview Mitigation Area DG-2 & DG-2 WOUS

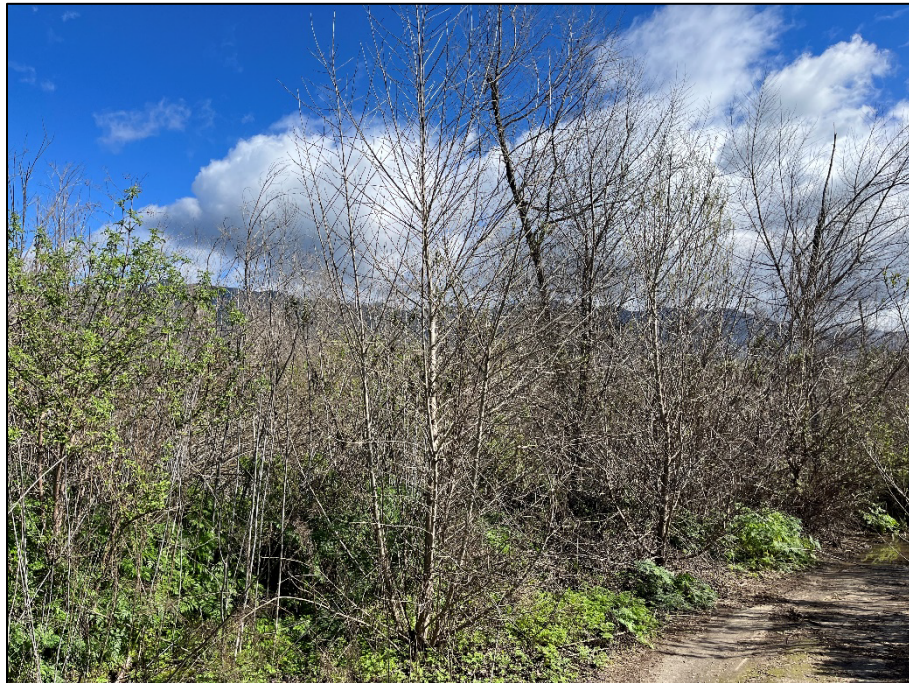
The overall health of the container plants in mitigation area DG-W-2 was noted as being good. Approximately less than five percent of the container plants were noted as showing varied levels of stress and a negligible number were noted as being dead or missing. This is approximately the same percentage of plants that were showing stress during the last monitoring event. Stress may be occurring due to similar reasons described for DG-W-1. In addition, some of the Fremont's cottonwoods and willows were starting to show signs of seasonal dieback. Evidence of dieback from *Phytophthora cactorum*, including wilting, stunted growth, leaf spotting, and/or browning along leaf margins and tips, was typically not observed on the container plants; however, leaf spotting was observed on some of the Fremont's cottonwoods and these trees should be monitored closely during the growing season to determine if the dieback was seasonal. Formal mortality counts were taken for DG-W-2 during the 2021, 2022, and 2023 quantitative monitoring events. Some of the container plants were noted as lacking well defined basins and should have their basins properly constructed and/or repaired. The irrigation line appeared to be functioning properly during the monitoring visit. The installation of plants in the DG-W-2 mitigation area appears to have been completed successfully and the issues noted during the monitoring are not expected to have an impact on the continued growth of the plants. Photos 8 and 9 in Attachment B document the mitigation area during the monitoring visit.

During the monitoring visit, it was noted that many of the remaining mature black willows (*Salix gooddingii*) in this mitigation area were continuing to show signs of recovery, such as sprouting vigorously from the base, from the polyphagous shot-hole borer (PSHB) infestation that was confirmed by the Los Angeles County Department of Agricultural Commissioner/Weights & Measures in December of 2021. The majority of the dead and hazardous black willows in this mitigation area were removed in October of 2022. Black willows that were determined to have the potential to recover were left in place and will continue to be monitored during the qualitative monitoring visits.

Nonnative weed cover in DG-W-2 was estimated at approximately 25 to 30 percent in the mitigation area, which is approximately 10 percent more than the level of nonnative cover that was observed during the last monitoring event. Nonnative species observed in DG-W-2 included black mustard, poison hemlock, and perennial pepperweed. Most of the nonnative weeds observed in this mitigation area were vegetative and just starting to germinate; however, some were going to flower and seed and should be removed as soon as possible.

Photo 8: Overview Mitigation Area DG-W-2 (Mining Pit)

Photo 9: Overview Mitigation Area DG-W-2 (Mining Pit)

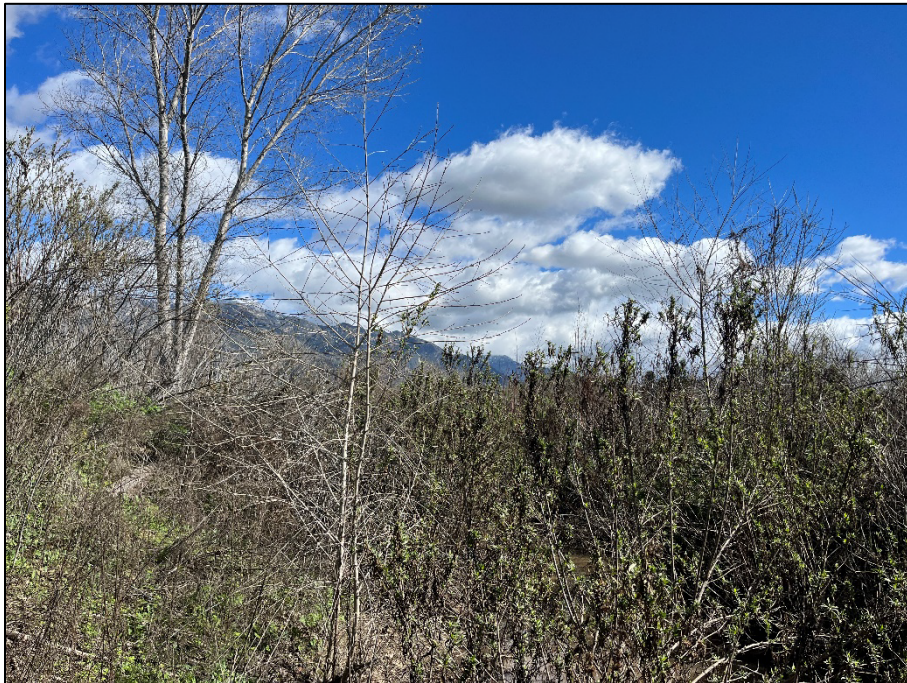
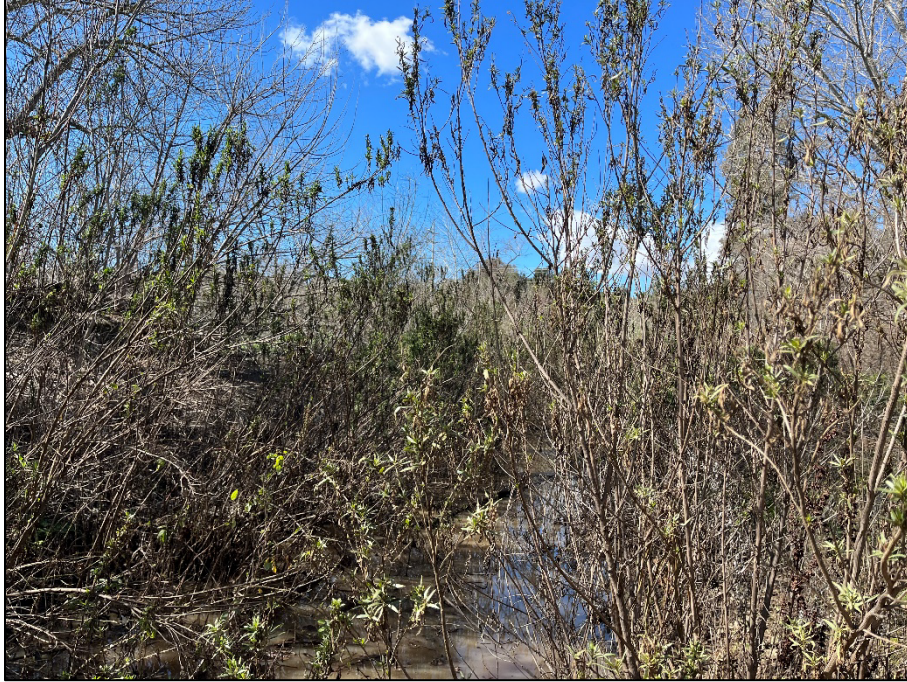
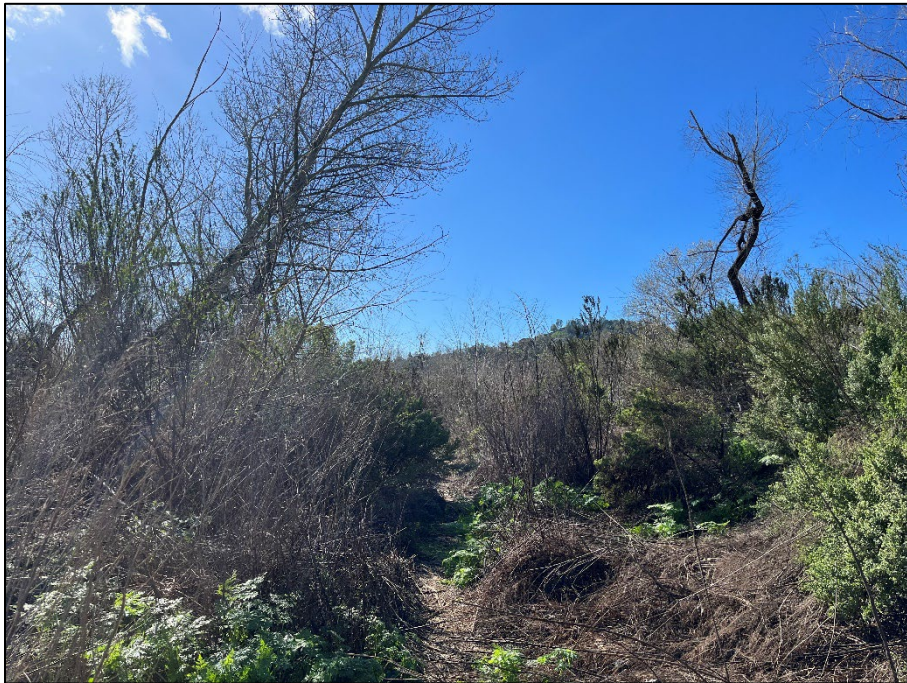
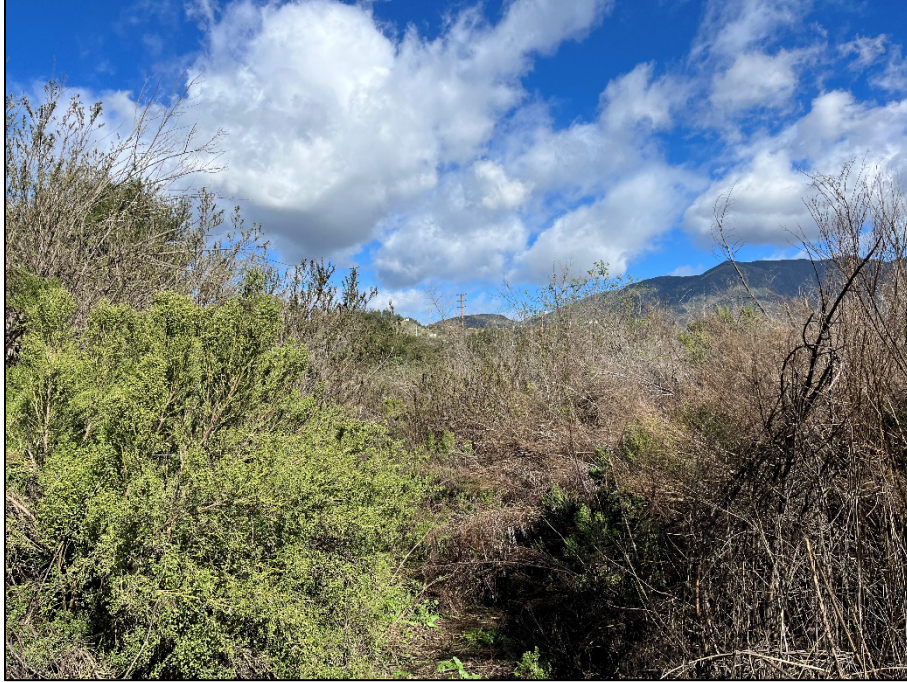
The overall health of the container plants in mitigation area DG-W-2 Outlet was noted as being good. Approximately 5 percent of the container plants were noted as showing varied levels of stress and a negligible number were noted as being dead or missing. This is approximately 5 percent less than the percentage of plants that were showing stress during the last monitoring event. Stress may be occurring due to similar reasons described for DG-W-1. In addition, some of the Fremont's cottonwoods and willows were starting to show signs of seasonal dieback. Evidence of dieback from *Phytophthora cactorum*, including wilting, stunted growth, leaf spotting, and/or browning along leaf margins and tips, was typically not observed on the container plants; however, leaf spotting was observed on some of the Fremont's cottonwoods and these trees should be monitored closely during the growing season to determine if the dieback was seasonal. Formal mortality counts were taken for DG-W-2 Outlet during the 2021, 2022, and 2023 quantitative monitoring events. Some of the container plants were noted as lacking well defined basins and should have their basins properly constructed and/or repaired. The irrigation line appeared to be functioning properly for most areas of the mitigation area during the monitoring visit. The installation of plants in the DG-W-2 Outlet mitigation area appears to have been completed successfully and the issues noted during the monitoring are not expected to have an impact on the continued growth of the plants. Photos 10 through 13 in Attachment B document the mitigation area during the monitoring visit.

Nonnative weed cover in DG-W-2 Outlet was estimated to be approximately 15 to 20 percent, which is approximately 5 percent more than the percentage of weed cover that was observed during the previous monitoring visit. Nonnative species observed in DG-W-2 included black mustard, poison hemlock, and perennial pepperweed. Most of the nonnative weeds observed in this mitigation area were vegetative and just starting to germinate.

Photo 10: Overview Mitigation Area DG-W-2 Outlet

Photo 11: Overview Mitigation Area DG-W-2 Outlet

Photo 12: Overview Mitigation Area DG-W-2 Outlet

Photo 13: Overview Mitigation Area DG-W-2 Outlet

be dry and the irrigation in this area should be checked for functionality. This is especially important during periods of drought and high temperatures. Some of the emitters were observed to be outside of the container plant basins, likely due to erosion, water flow, and/or public interference. Once per week watering events should be conducted for the container plants unless adequate rainfall occurs. After watering, the container plant basins should have at least 0.5 inch of saturation depth. Continual maintenance of the irrigation system should be conducted to ensure all plants are evenly watered and the tube emitters are placed at the base of the container plants. Watering of the seeded only areas is not recommended.

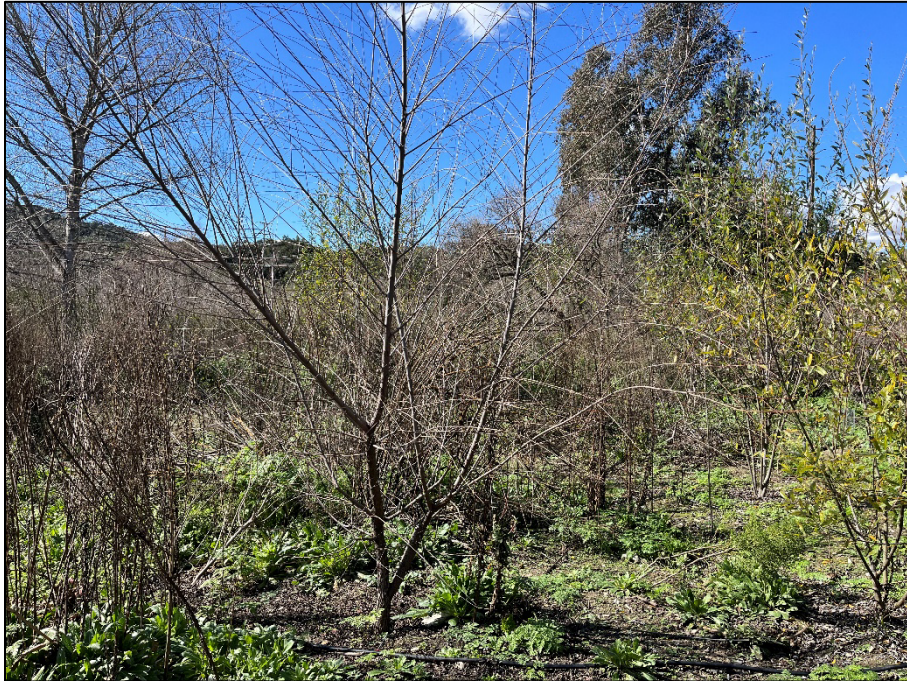
The overall health of the container plants in mitigation areas DG-4 Sheet Flow (northern) and DG-SF-1 was noted as being good. Approximately less than 5 percent of container plants were showing varied levels of stress which is approximately the same percentage of container plants that were showing stress during the previous monitoring event. Stress may be occurring due to similar reasons described for DG-W-1. Evidence of dieback from *Phytophthora cactorum*, including wilting, stunted growth, leaf spotting, and/or browning along leaf margins and tips, was not observed on any of the container plants. Similar to the other mitigation areas, the willows and Fremont's cottonwoods in this mitigation area were starting to show signs of seasonal dieback. Formal mortality counts were taken during the 2021, 2022, and 2023 quantitative monitoring events. Some of the container plants were noted as lacking well defined basins and should have their basins properly constructed and/or repaired. The irrigation line appeared to be functioning properly during the monitoring visit. The installation of plants in the DG-4 Sheet Flow and

DG-SF-1 mitigation areas appears to have been completed successfully and the issues noted during the monitoring are not expected to have an impact on the continued growth of the plants. Photo 14 in Attachment B document the mitigation area during the monitoring visit.

Nonnative weed cover in DG-4 Sheet Flow and DG-SF-1 was estimated at approximately 15 to 20 percent, which is approximately 5 to 10 percent more than the level of weed cover that was observed during the previous monitoring visit. Nonnative species observed in DG-4 Sheet Flow and DG-SF-1 included black mustard, poison hemlock, and perennial pepperweed. Most of the nonnative weeds observed in this mitigation area were vegetative and just starting to germinate.

Photo 14: Overview Mitigation Area DG-SF-1
