Fourth Annual Monitoring Report

Oak Woodland Habitat Revegetation/Mitigation Program for the Santa Anita Dam Riser Modification and Reservoir Sediment Removal Project

**California Department of Fish and Wildlife
Streambed Alteration Agreement
No. 1600-2008-0173-R5**

May 2020

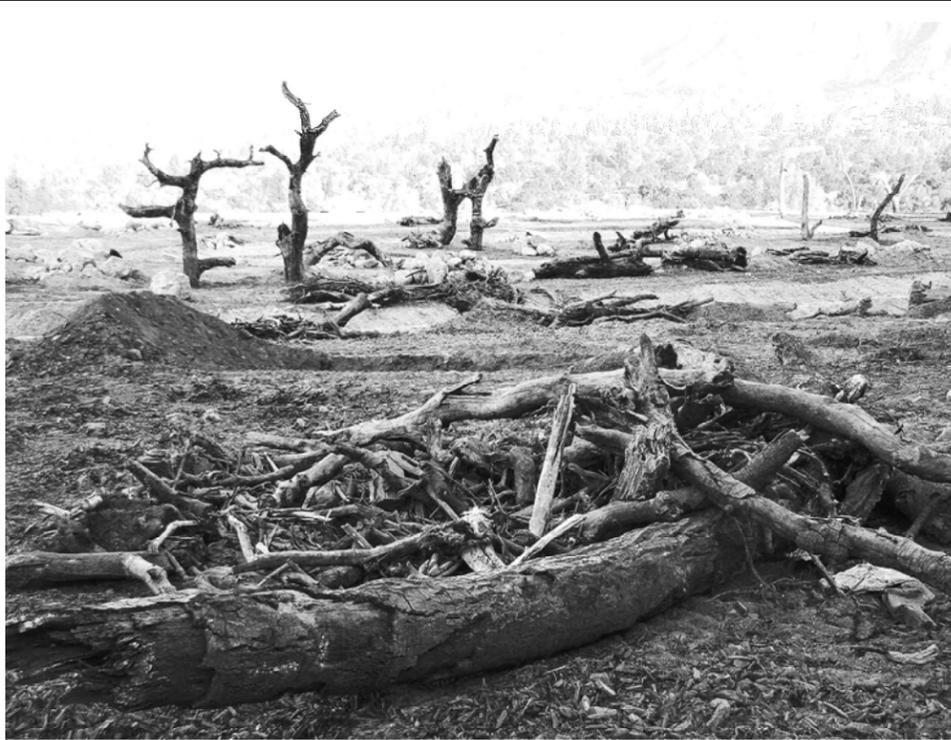
October 2013. The Lower Sediment Placement Site (SPS) following soil improvements (decompaction and incorporation of large volume of salvaged mulch) and the placement of salvaged natural snags, boulders, and coarse woody debris.

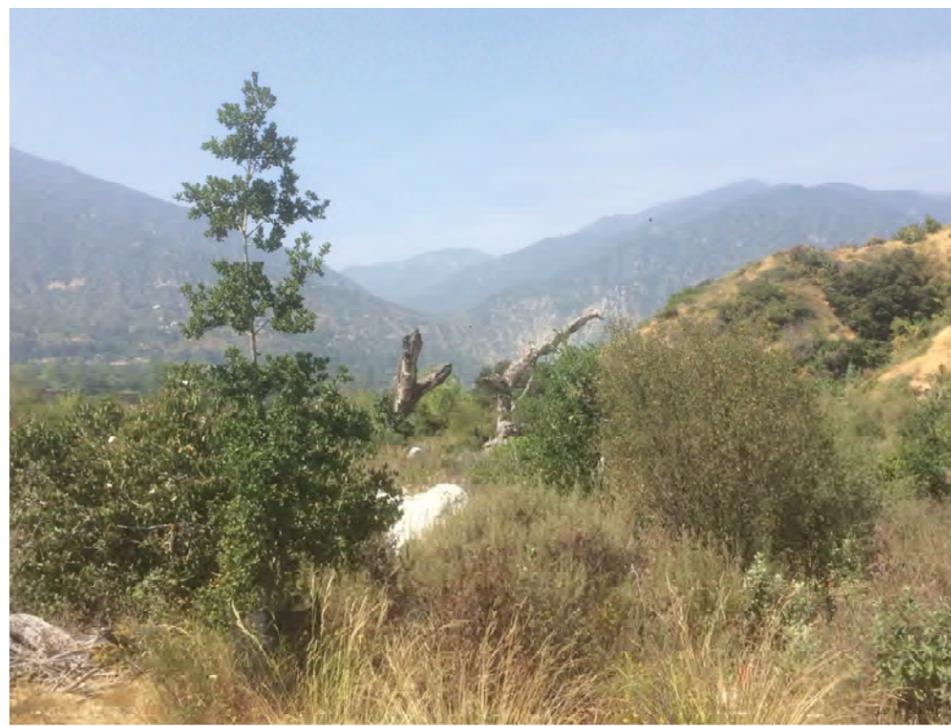
May 2019. A healthy planted coast live oak sapling amid shrubby native understory vegetation.

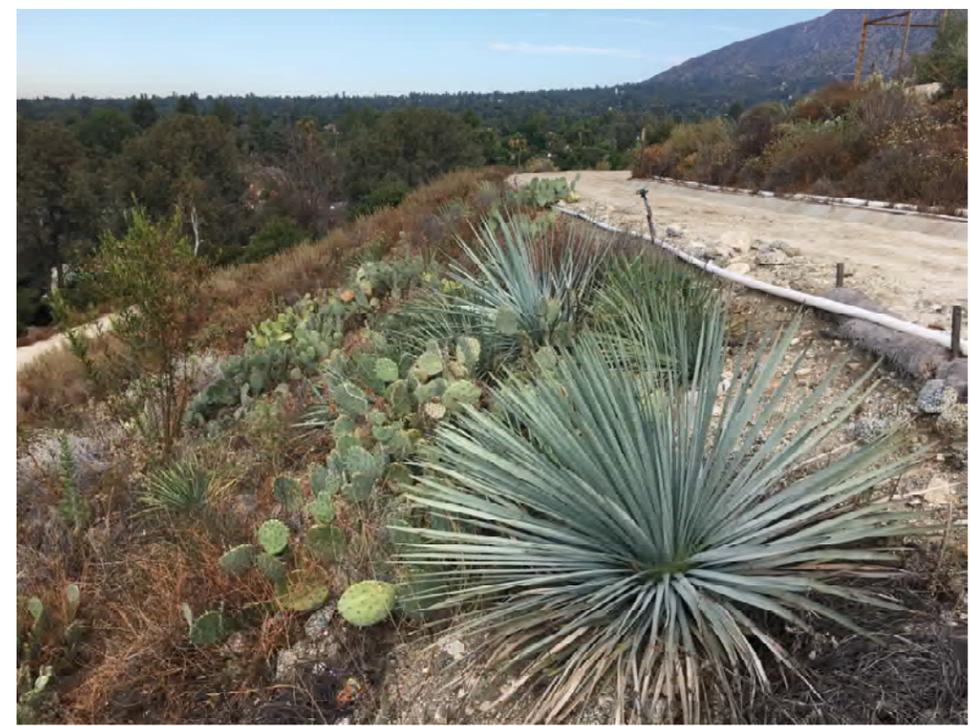
August 2019. The coastal sage scrub (CSS) mitigation site (slopes) was installed as a mosaic of woody scrub and native spiniferous species (cacti, yucca). The cactus/yucca areas were seeded with a diverse mix of native herbs/grasses and are maintained to exclude woody shrubs to retain vegetative diversity.

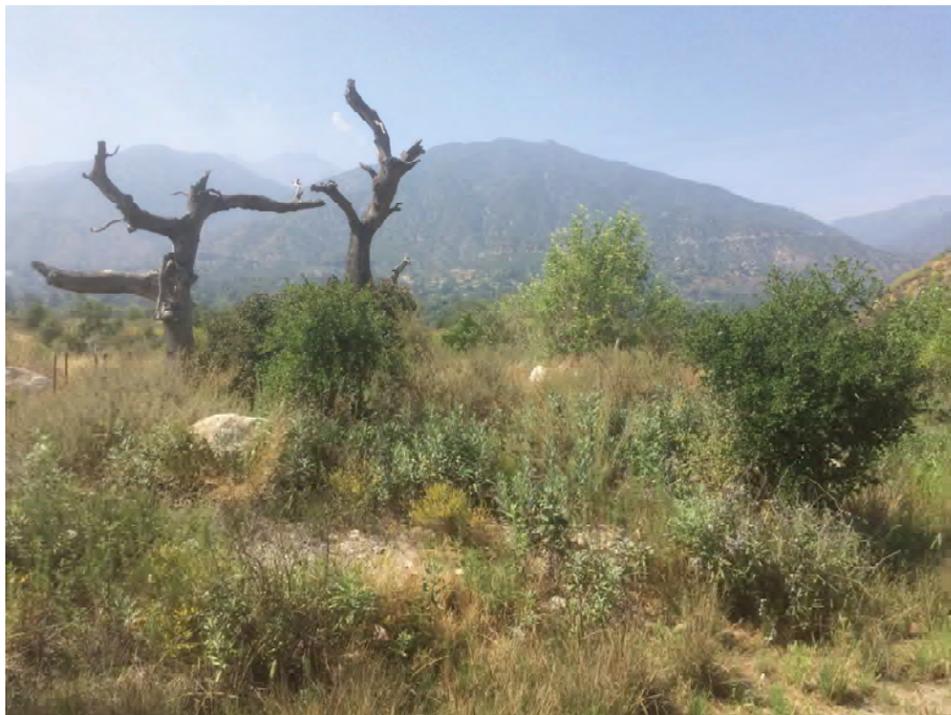
May 2019. Weathering (placed) natural snags occur amid developing oak trees, native shrubs, patches of designated spiniferous or herbaceous understory habitat, and placed boulder and coarse woody debris assemblages, all of which contribute to high biological diversity on the site.

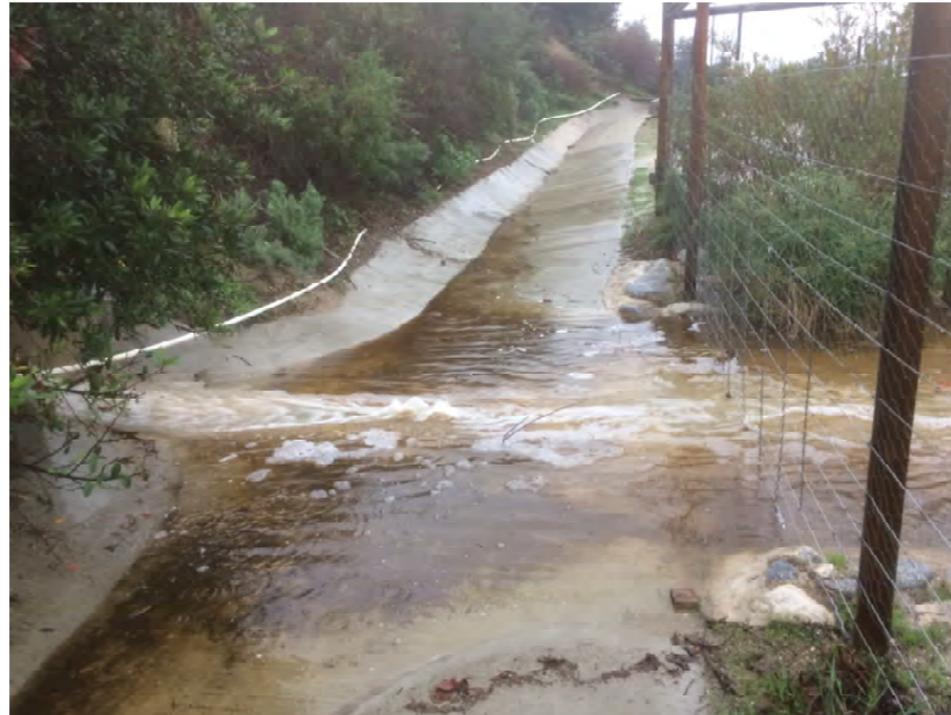
January 2019. Storm flows enter the mitigation site from manufactured slopes to the east of the SPS.

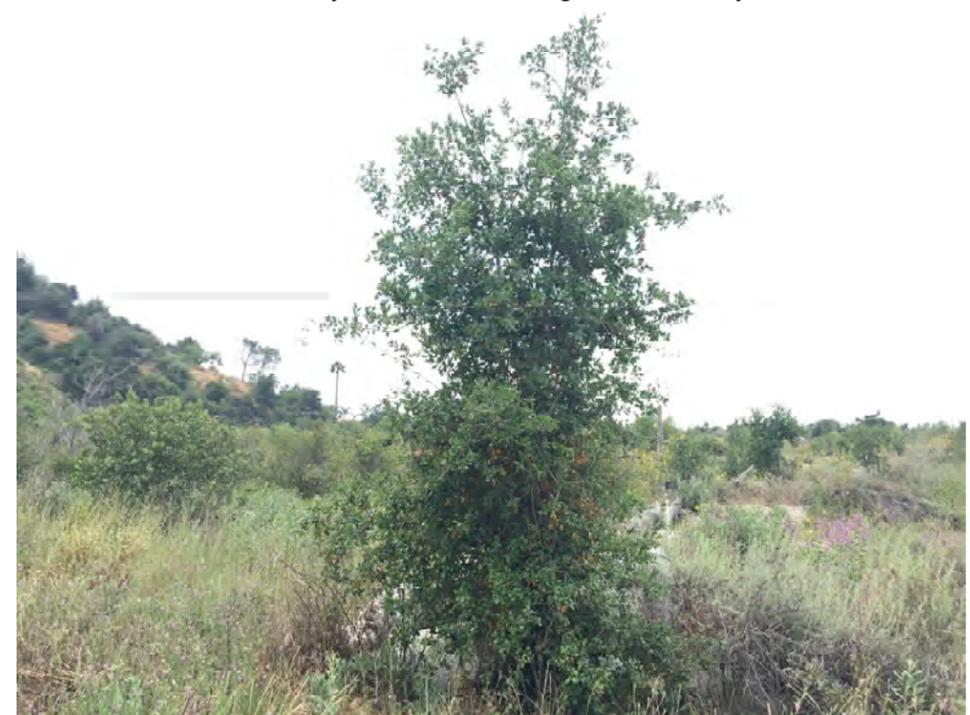
May 2019. Robust growth of a planted coast live oak tree surrounded by a native meadow of planted/seeded native herbs such as mugwort, four-spot, and short-fruited willowherb.

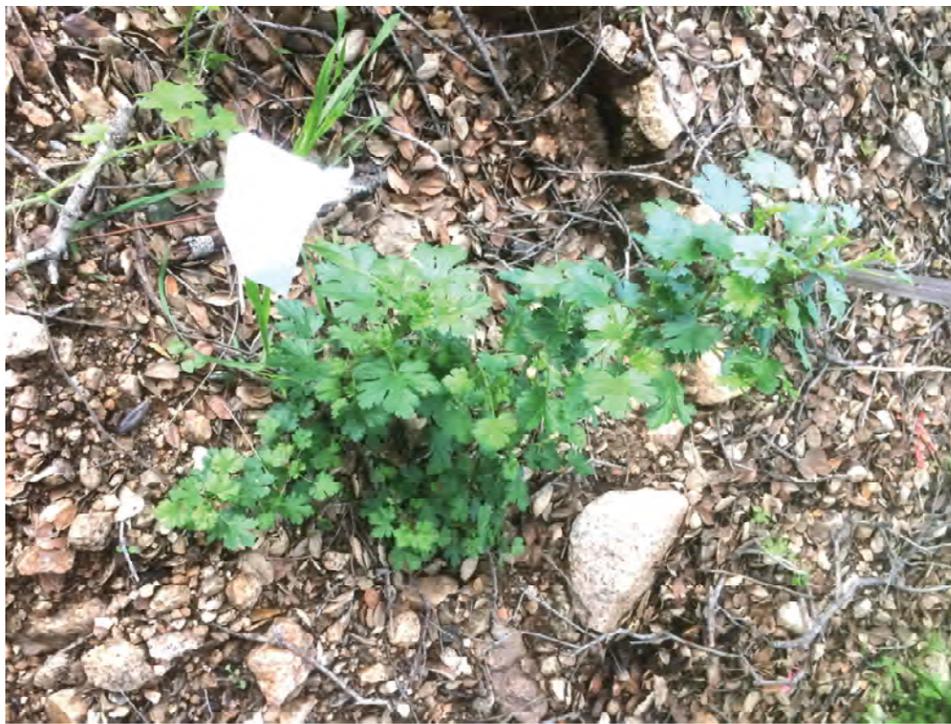
February 2019. The Restoration Contractor (Nakae and Associates) performed supplemental planting in February 2019, including this hillside gooseberry plant that was propagated by Rancho Santa Ana Botanic Garden from locally harvested cuttings.

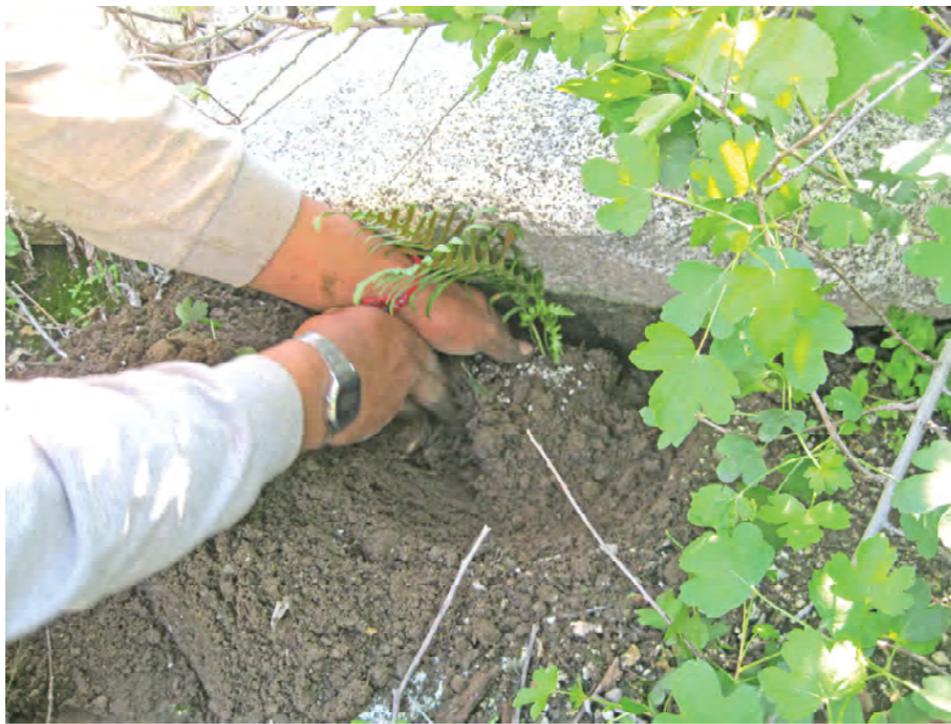
February 2019. The Restoration Contractor (Nakae & Associates, Inc.) is installing supplemental fern plants in carefully selected niches (tucked beneath the northern exposures of placed boulders and coarse woody debris) under the direction of Psomas' Restoration Ecologist.

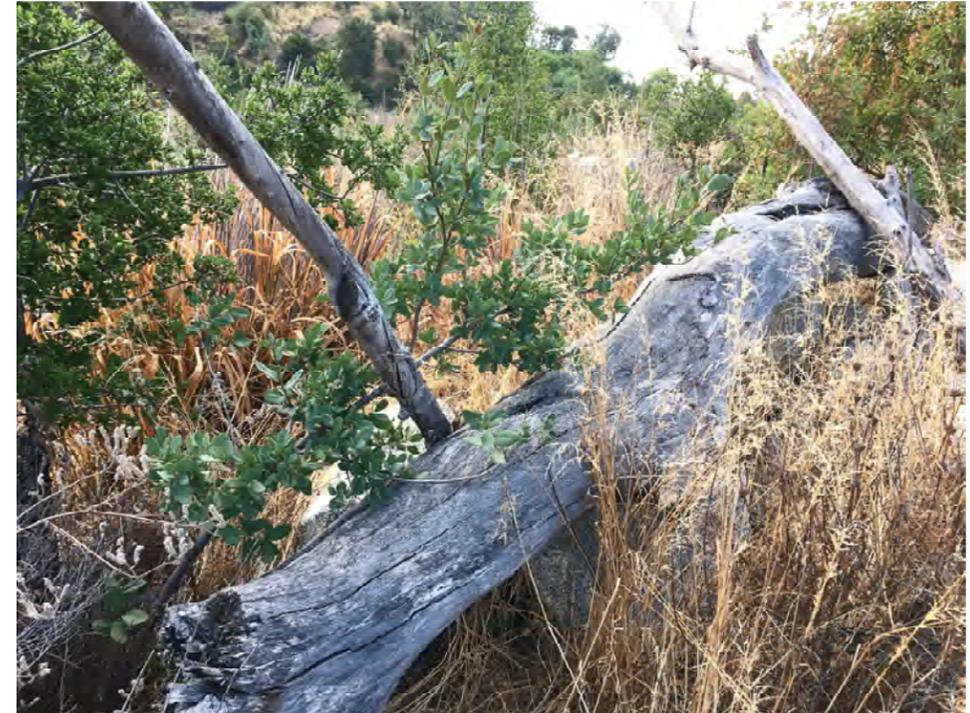
August 2019. An Engelmann oak sapling is growing alongside placed coarse woody debris amid an understory of multiple species of native perennial bunchgrasses and native broadleaf herbs. The large volume of placed coarse woody debris immediately provided some of important habitat functions of an old-growth oak woodland.

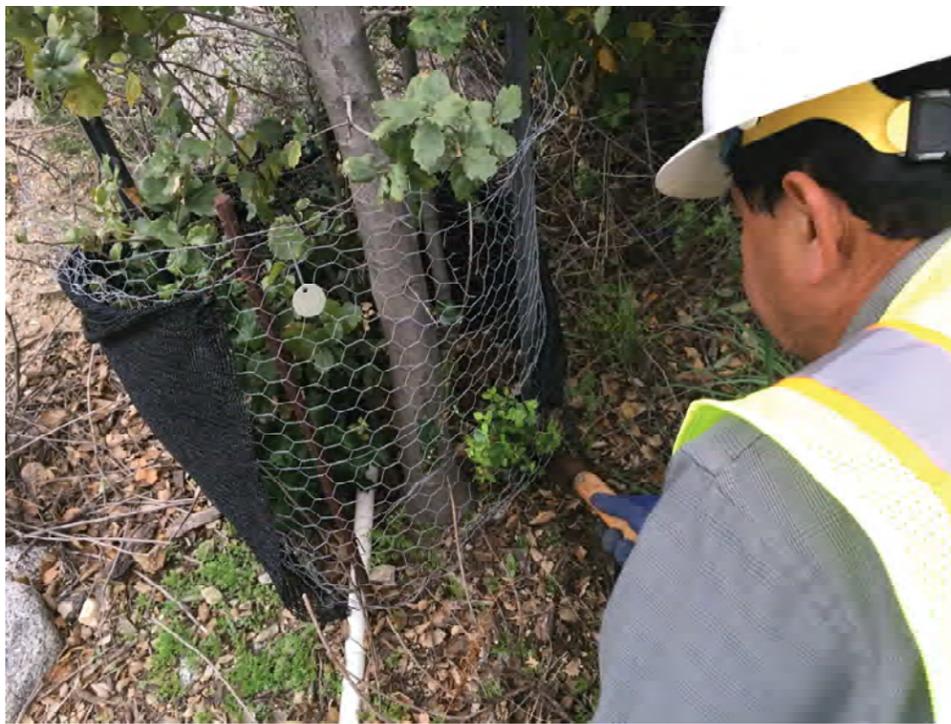
January 2019. The Restoration Contractor (Nakae and Associates) is removing a native volunteer shrub seedling that is growing within the temporary caging protecting this planted coast live oak sapling.

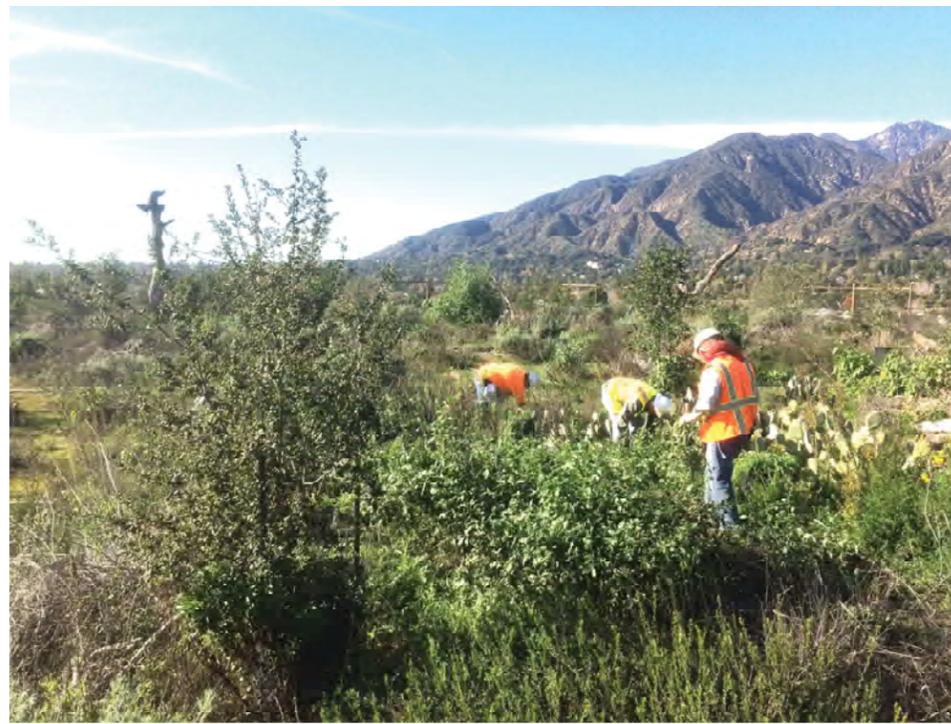
January 2019. The Restoration Contractor performs ongoing weed removal and other maintenance tasks under the supervision of Psomas' Restoration Ecologist. Starting in April 2019, all weed control has been performed manually (no herbicide use) in accordance with Los Angeles County Public Works' requirements.

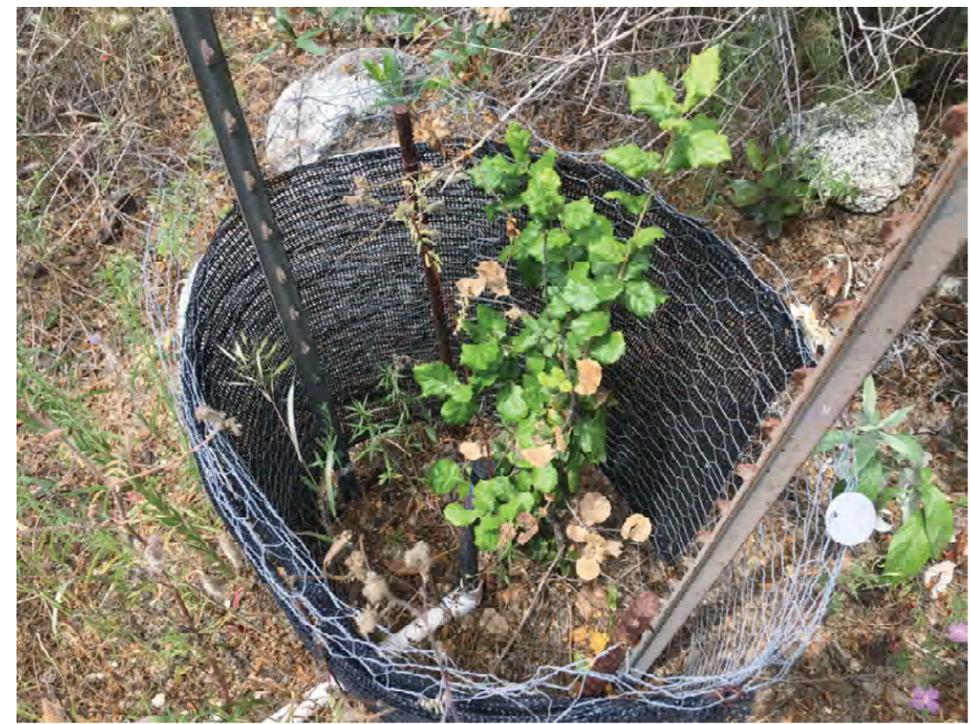
May 2019. A small number of the initially established oaks on the site have died. However, locally collected acorns were planted in these locations over several years, resulting in replacement plants such as this coast live oak seedling.

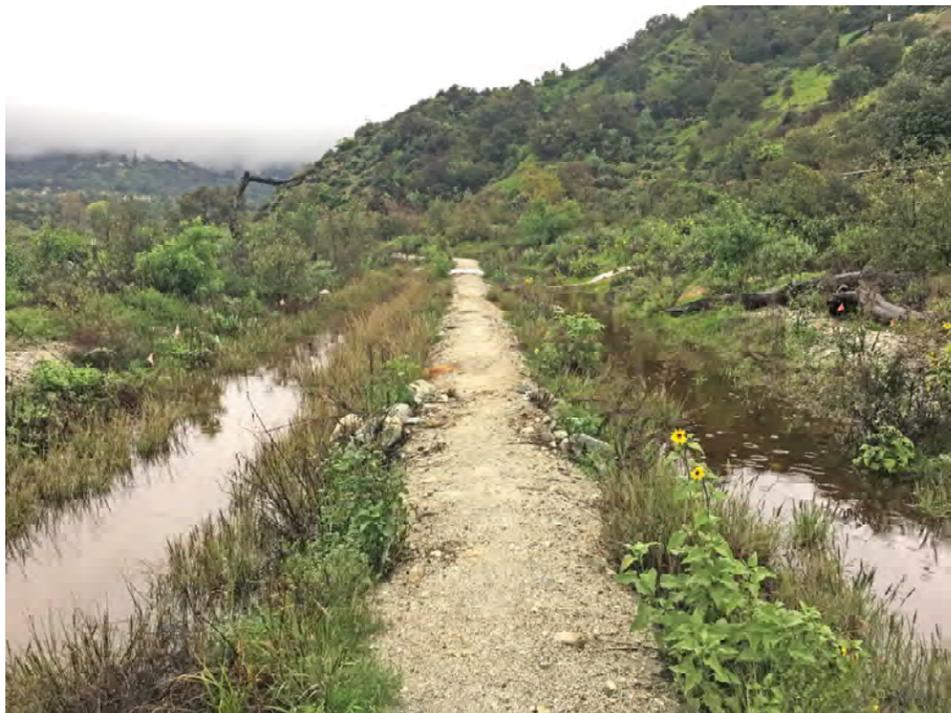
February 2019. Ephemeral flows occur in the designed spiraling drainages that convey off-site/on-site flows to an outlet tower in the center of the Lower Sediment Placement Site (SPS). Vegetation in the drainages is managed to facilitate the inspection/treatment activities of the San Gabriel Valley Vector Control District.

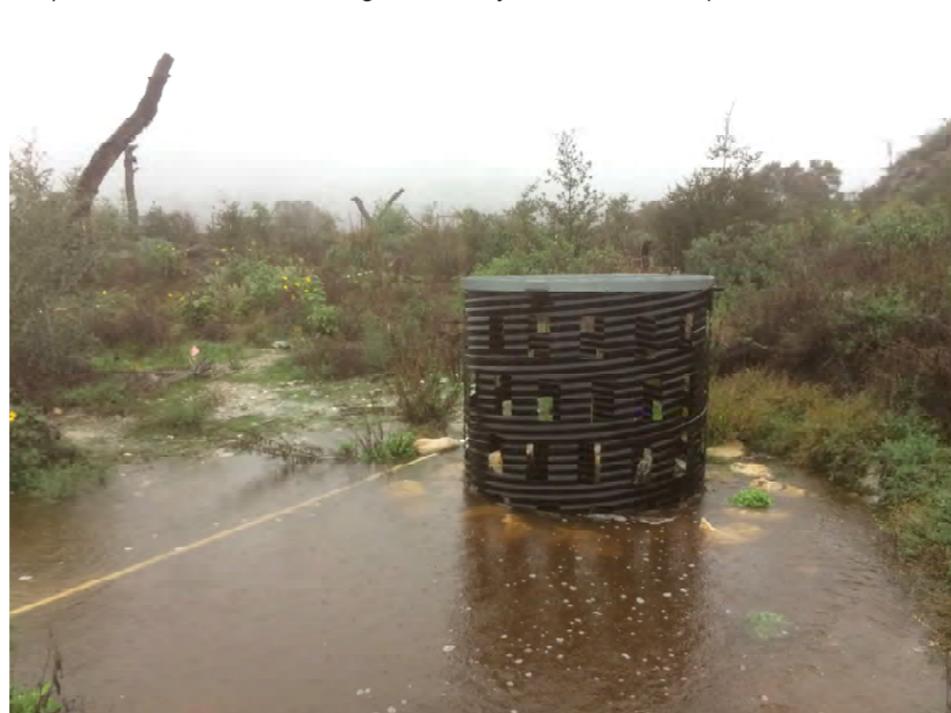
January 2019. An outlet tower at the center of the spiraling drainages conveys storm flows from the deck of the SPS into the Santa Anita Channel (to the west) via an underground pipe. This photograph was taken during a heavy rain event, and it shows the proper/unobstructed flows into the outlet tower.

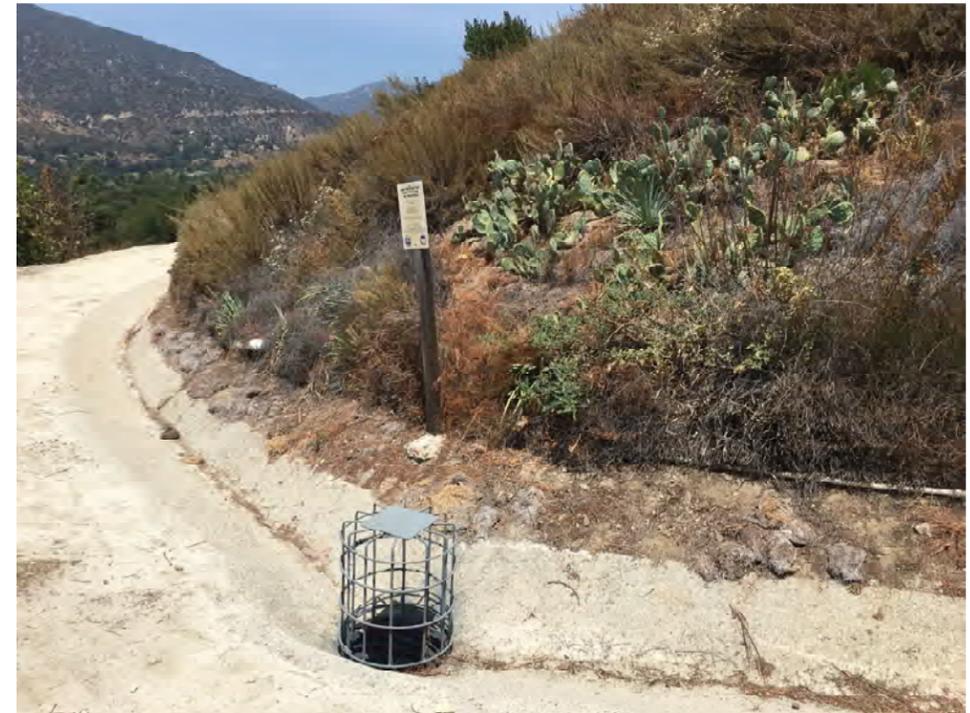
August 2019. In addition to providing project mitigation, the Lower SPS is part of a flood control facility; therefore, Public Works regularly monitors the SPS to ensure the integrity of the created landform. The Restoration Contractor periodically removes sediment and vegetative debris from the various v-ditches and inlets.

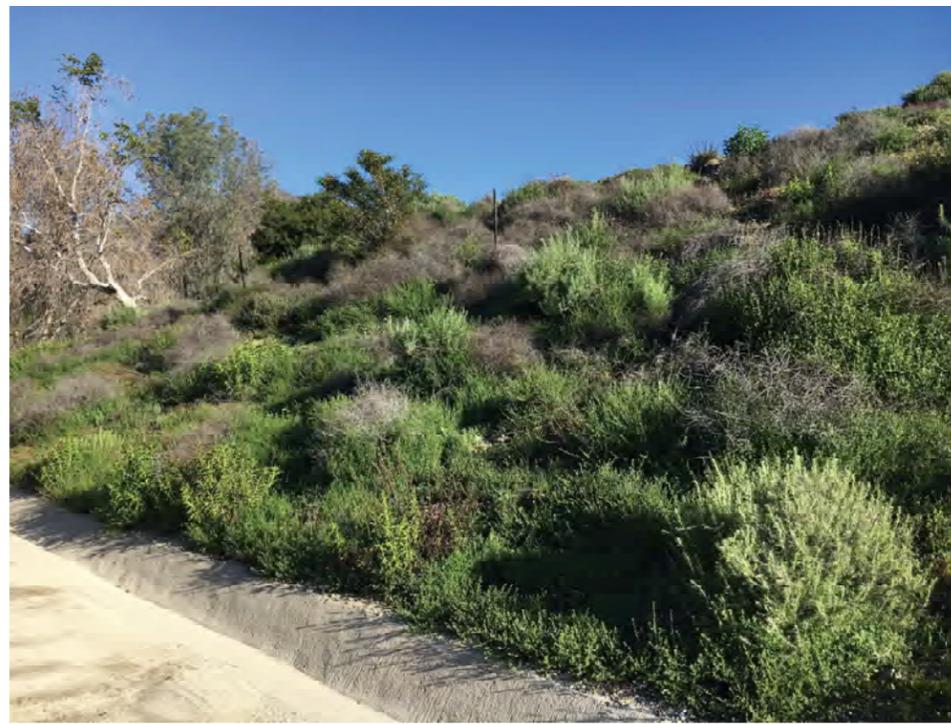
March 2019. Excellent native vegetation is being established in the Buffer Areas, providing ancillary habitat value for the mitigation site. Some of these Buffer Areas were nearly barren prior to mitigation implementation but now support a variety of native trees, shrubs, succulents, vines, and herbaceous species.

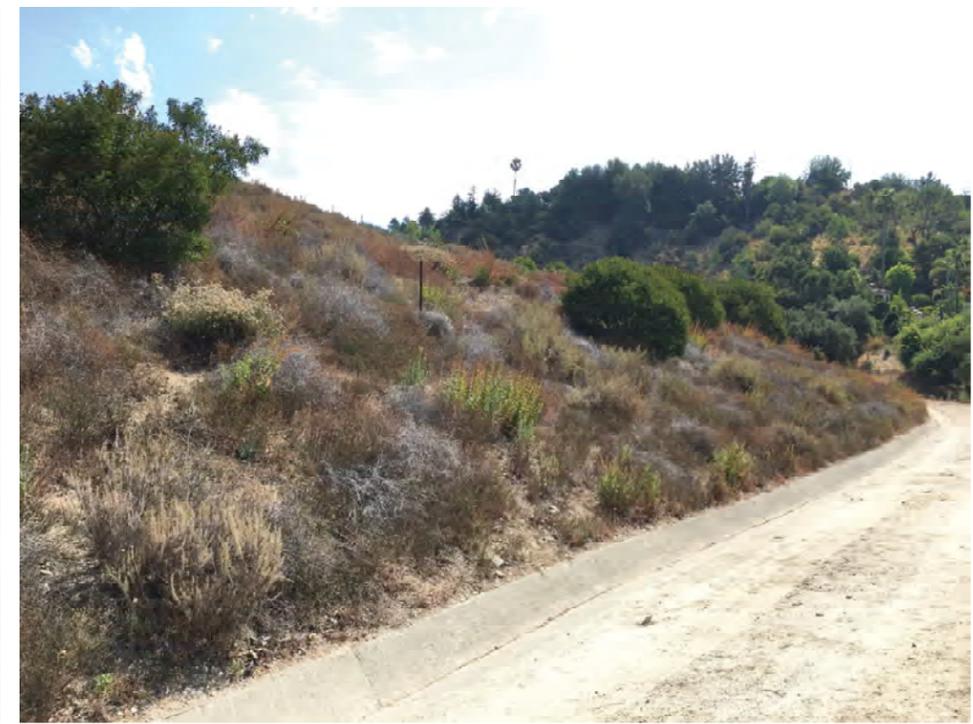
August 2019. The Buffer Areas are non-irrigated. This south-facing slope of the Lower Sediment Placement Site exhibits increasing coverage of native vegetation. This photograph was taken in August, and the native vegetation exhibits normal drought dormancy.

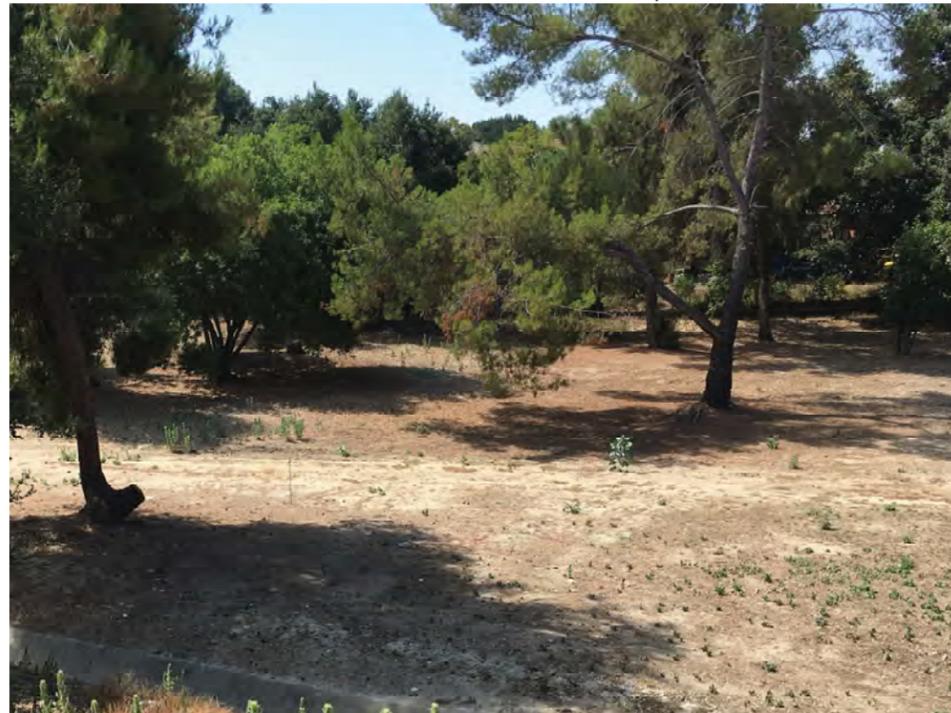
August 2019. The southernmost Buffer Area occurs between the SPS and the residential areas to the south of the Public Works facility. A portion of this Buffer Area is within the City of Arcadia's Defensible Space Vegetation Requirement zone. The Restoration Contractor (Nakae and Associates) periodically removes all herbaceous vegetation from this area.

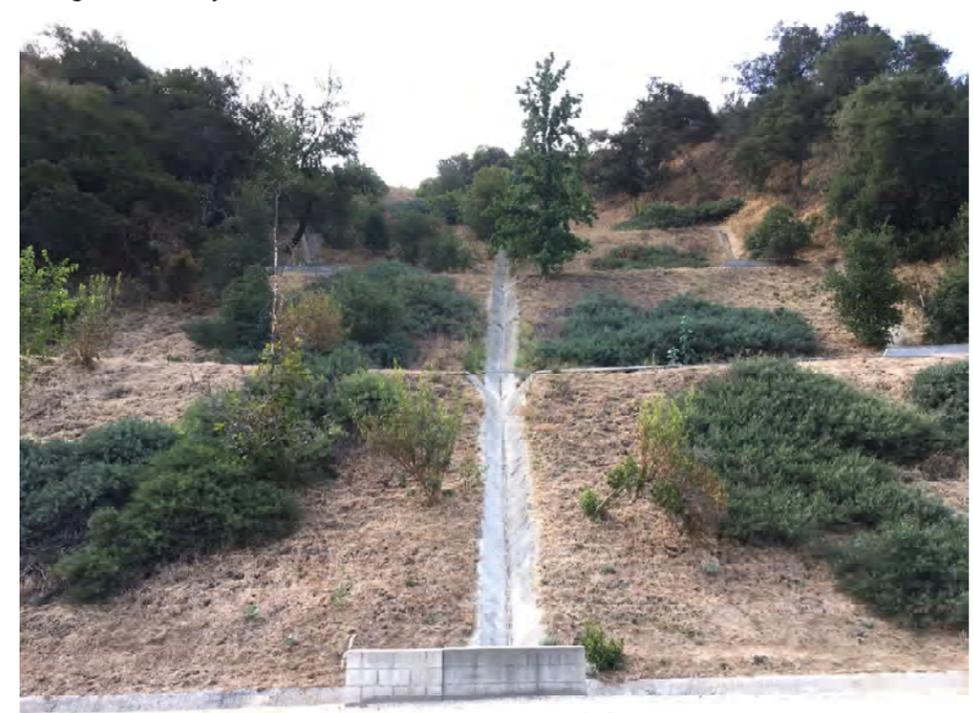
August 2019. Public Works recently initiated voluntary weed abatement in an additional Buffer Area to the north of the Lower SPS to reduce fire fuel and to eliminate a source of weed seeds adjacent to the mitigation site.

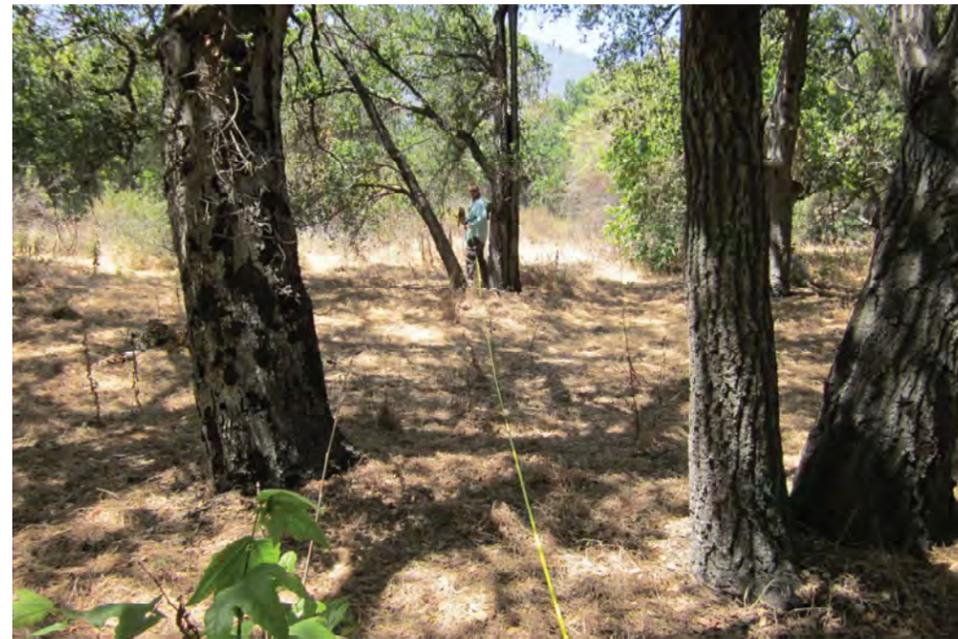
July 2013. The oak woodland reference site (Middle Sediment Placement Site [SPS]). Although the reference site contains numerous mature coast live oak and western sycamore trees, the understory vegetation is predominantly weedy (e.g., ripgut brome [grass]).

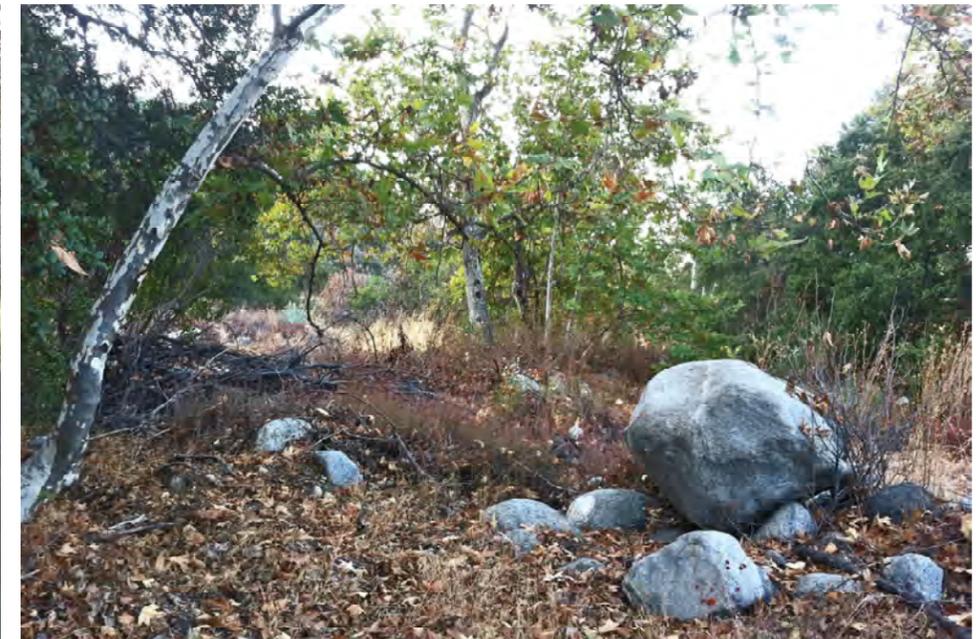
October 2012. The Middle SPS reference site contains some natural boulders and coarse woody debris, which are beneficial habitat features that are being recreated on the Lower SPS mitigation site.
