**Subject:** Status Report for the Oak Woodland Habitat Revegetation/Mitigation Program for the Santa Anita Dam Riser Modification and Reservoir Sediment Removal Project, Los Angeles County, California

Status Report: Oak Woodland Habitat Revegetation/Mitigation Program;  
 Santa Anita Dam Riser Modification and Reservoir Sediment Removal Project

## Site Photographs

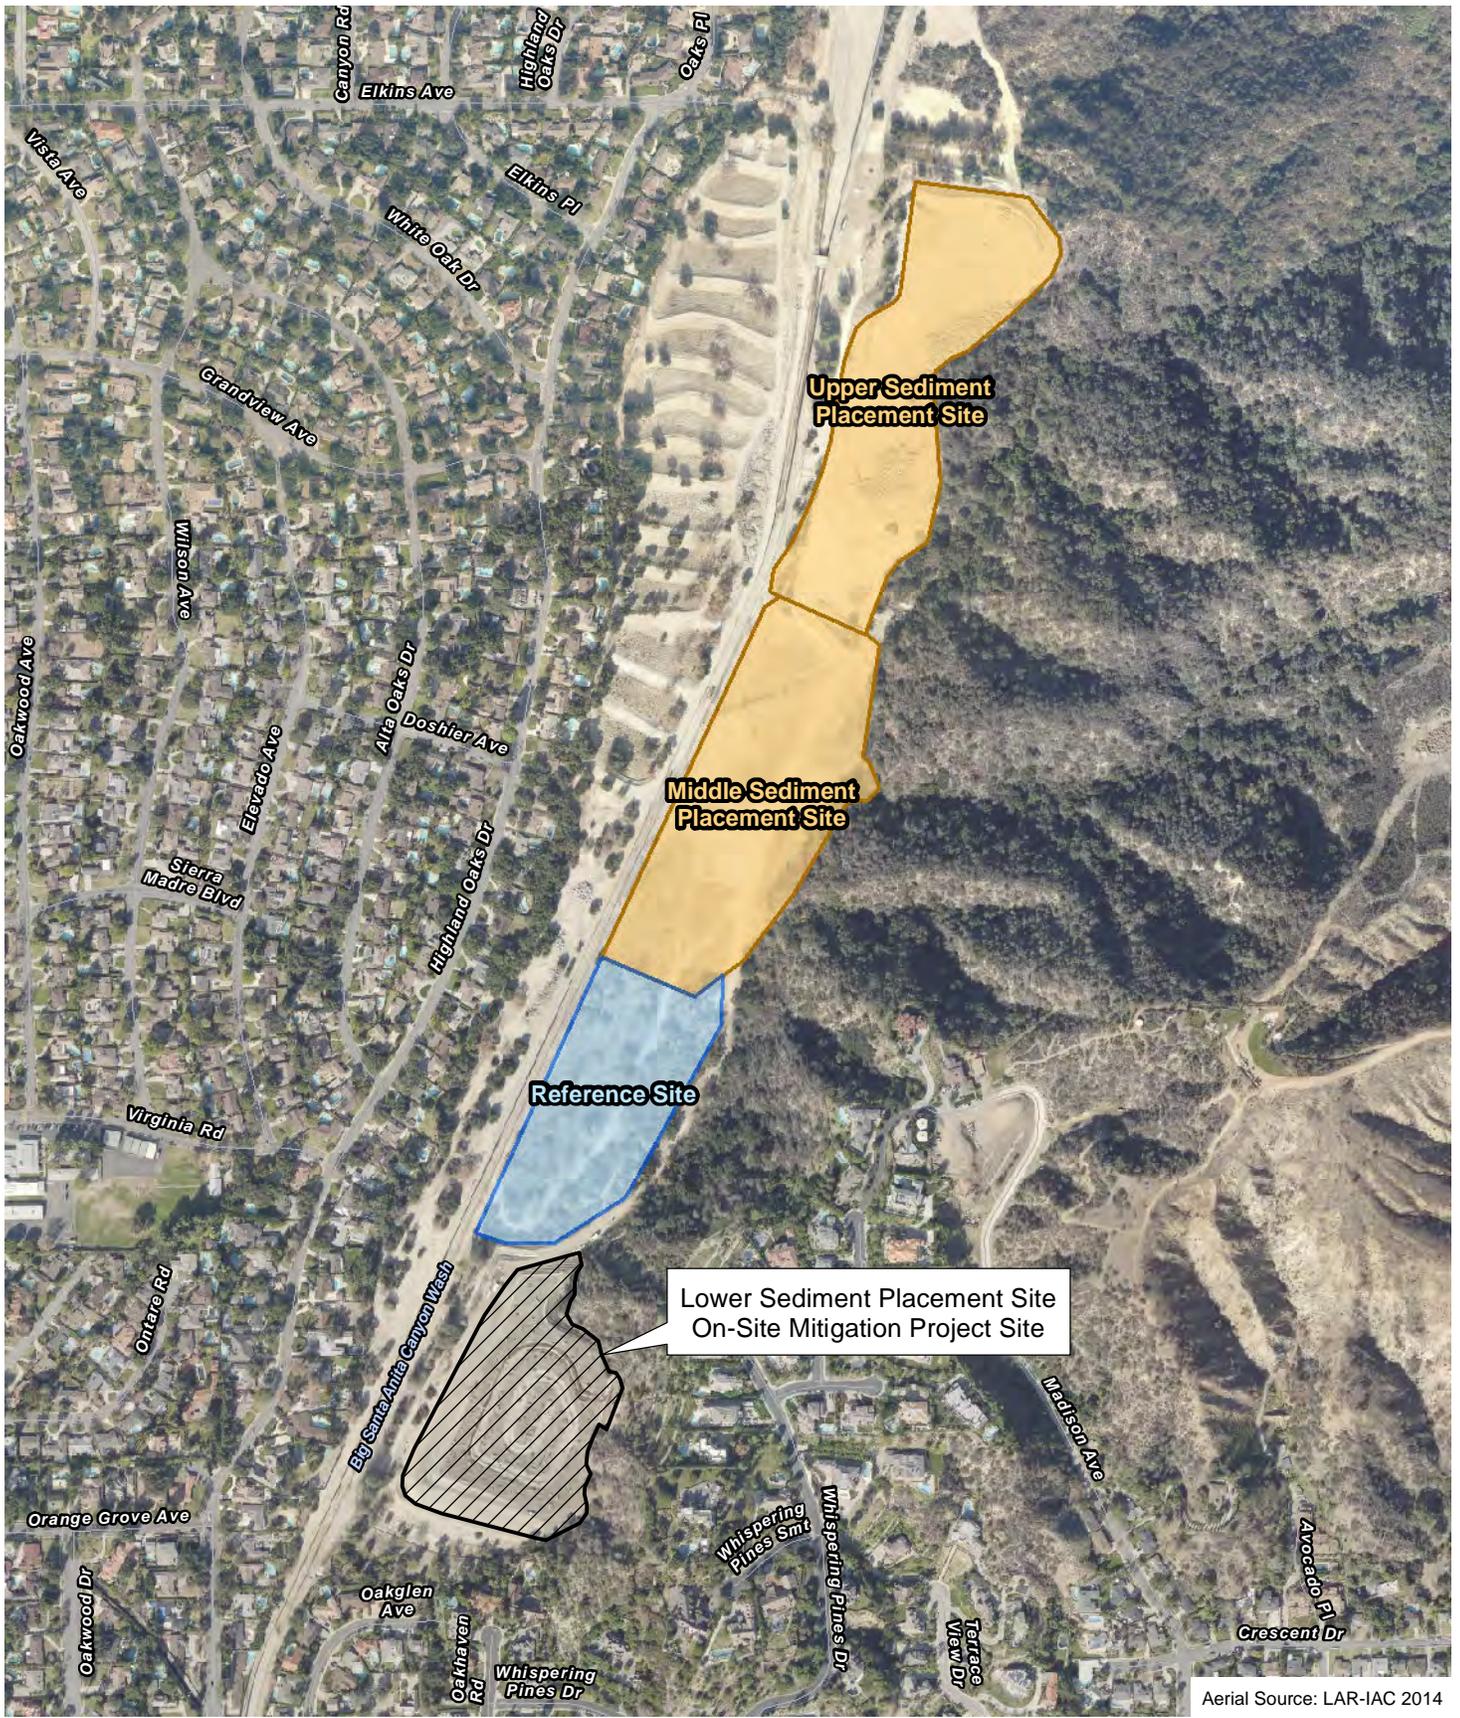
## Exhibit 2

## Sediment Placement Site Locations

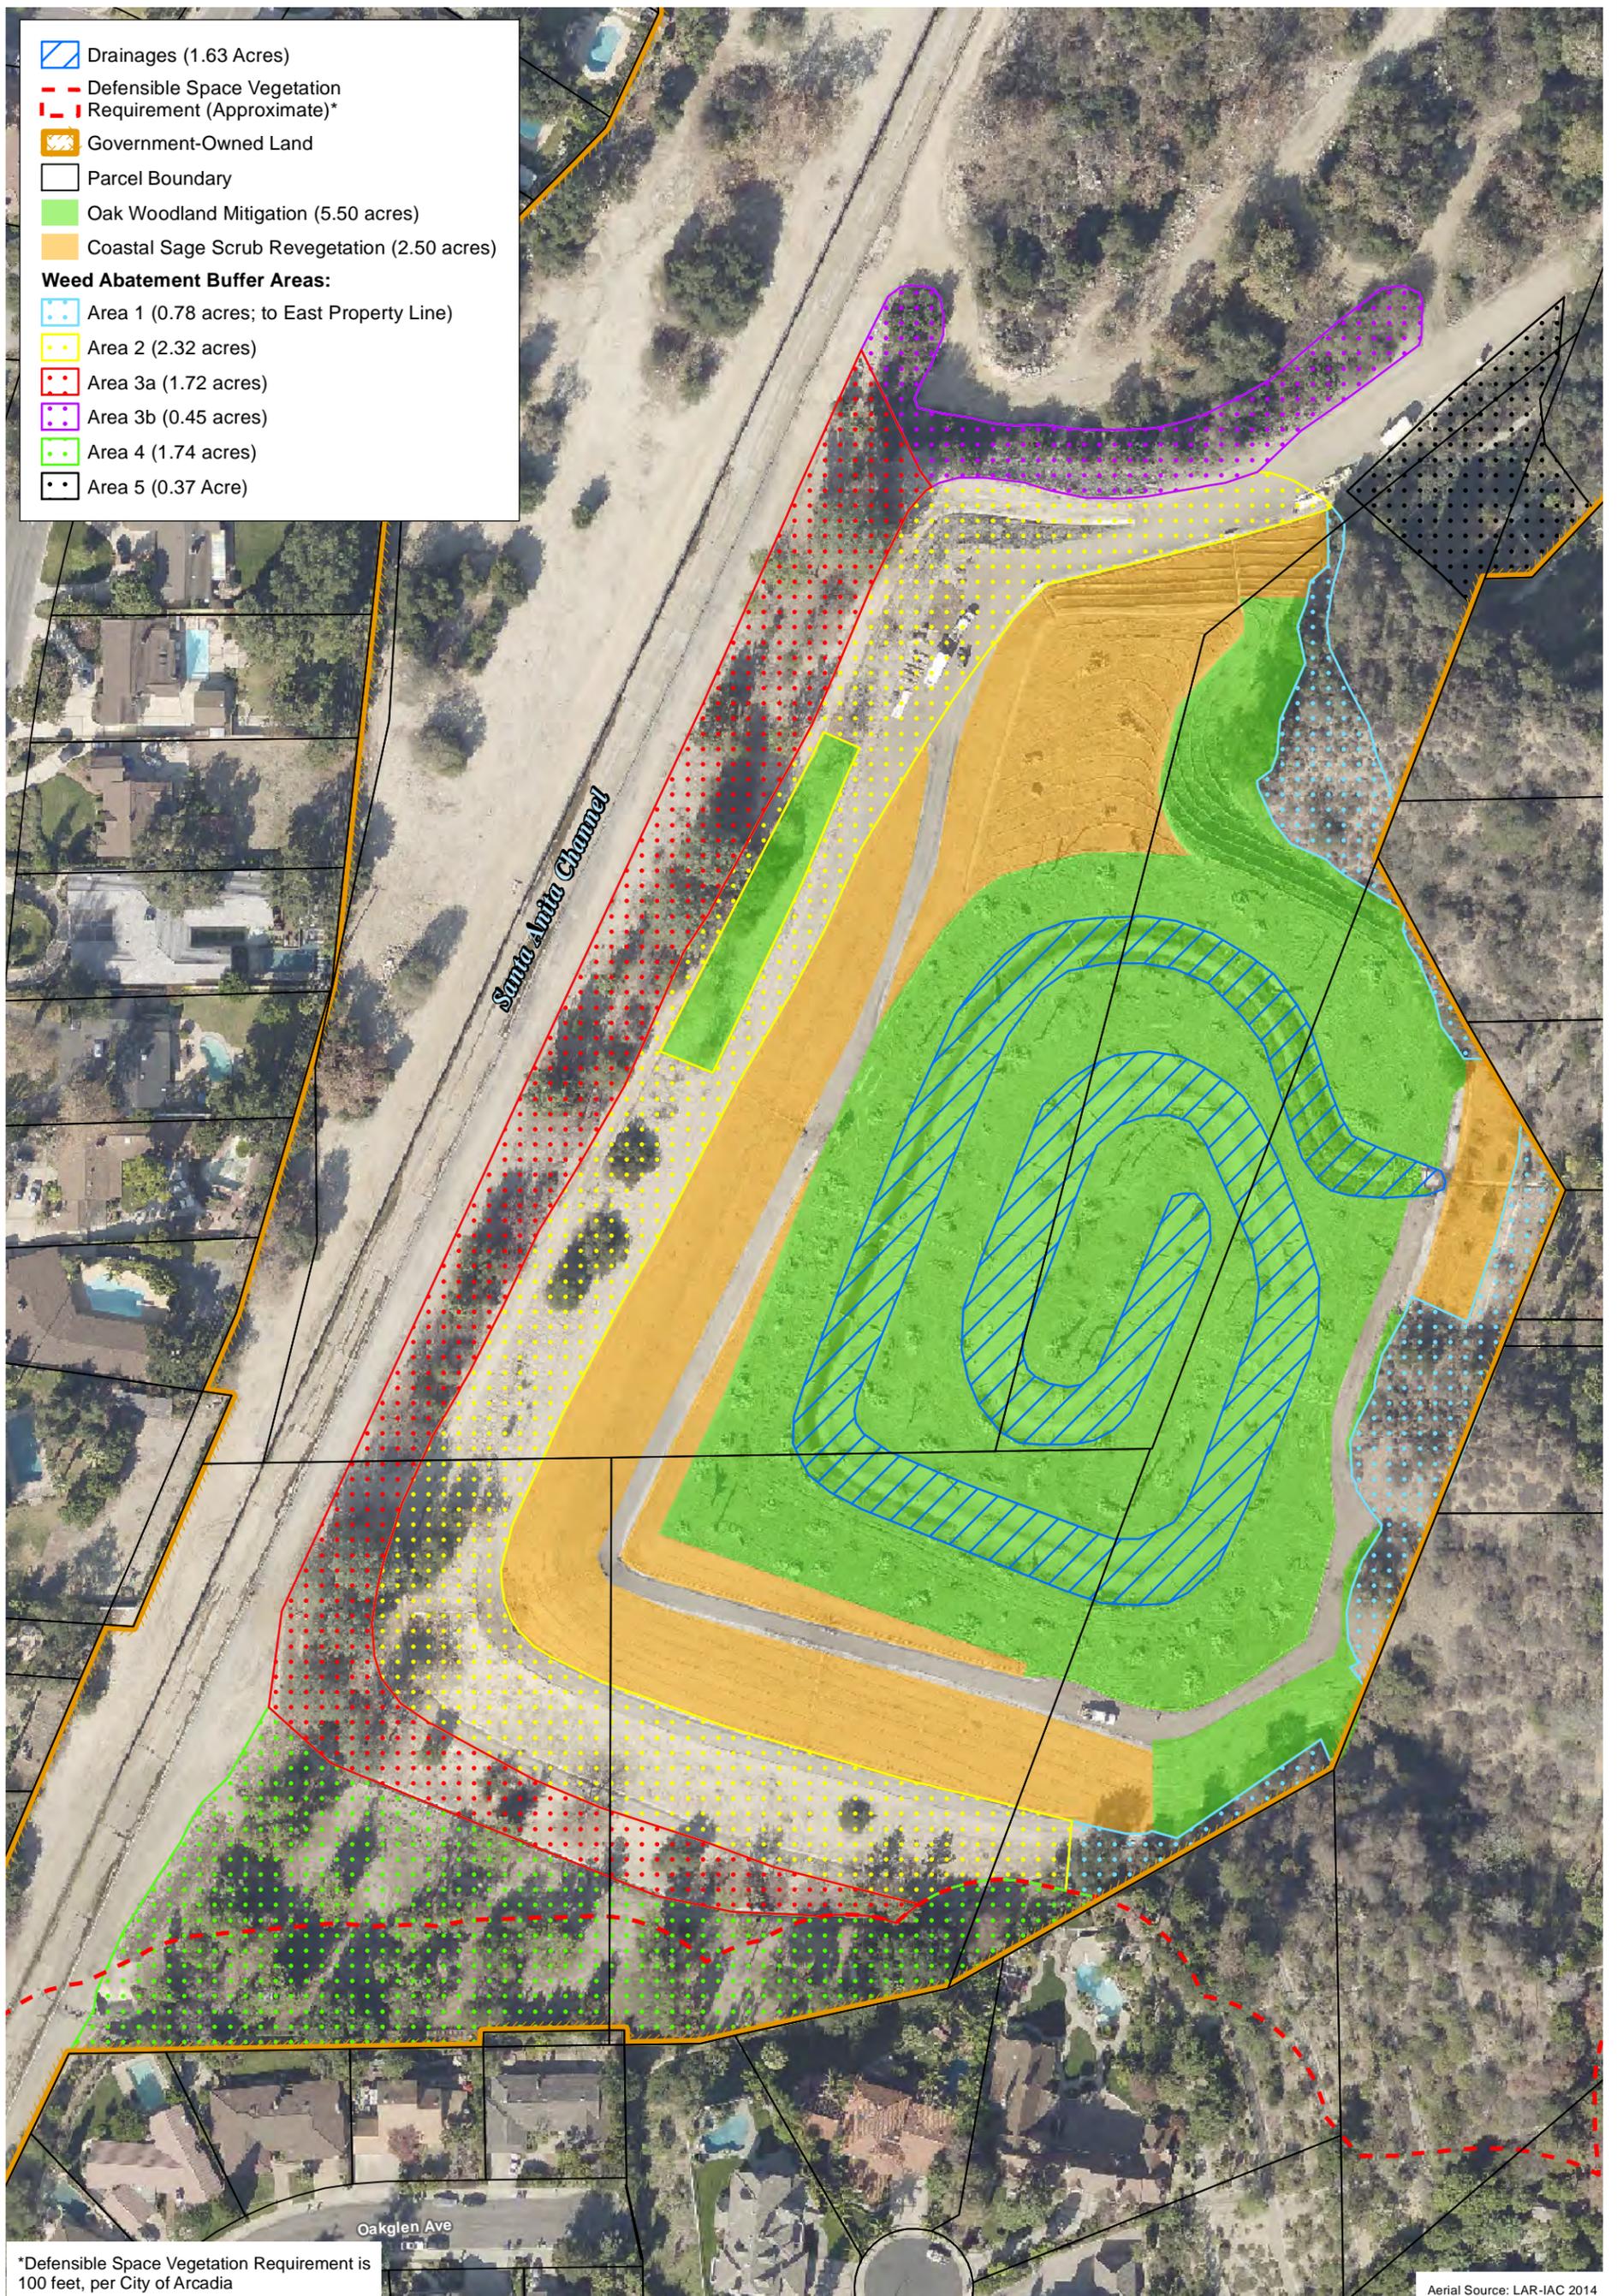
Exhibit 3

### Mitigation Site Location (Lower Sediment Placement Site)

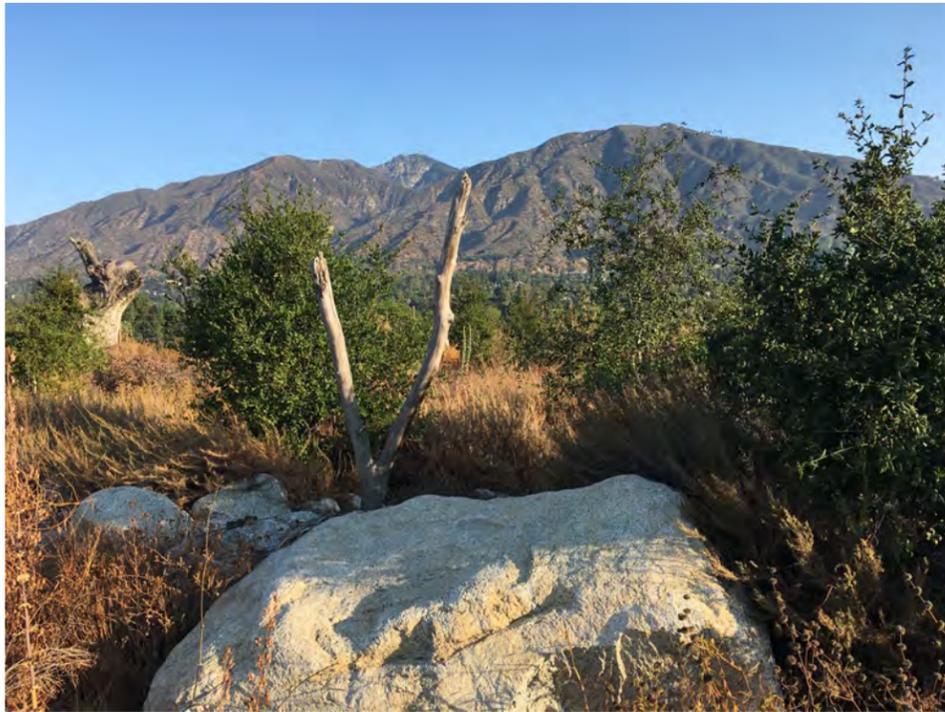
**August 2020.** Maturing planted oaks occur among understory shrubs and herbs, placed natural snags, boulders, and woody debris.

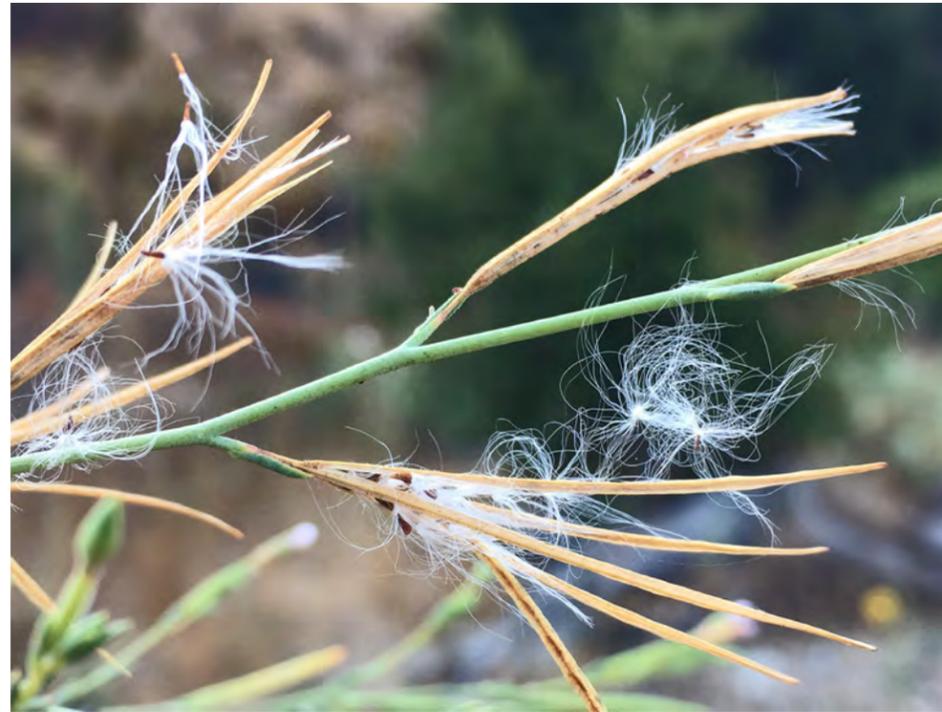
**July 2020.** Ripe seeds are dispersing from short-fruited willow herb—a late-blooming native volunteer wildflower that occurs on the mitigation site.

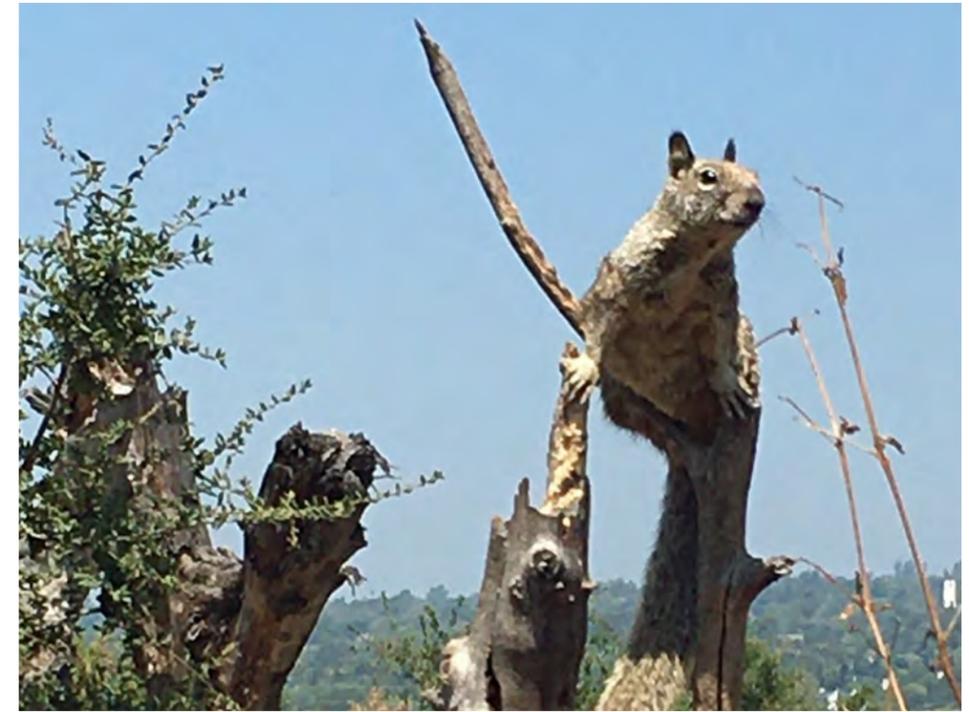
**July 2020.** A California ground squirrel is perching in placed woody debris near a planted oak. A placed natural snag is shown in the background.

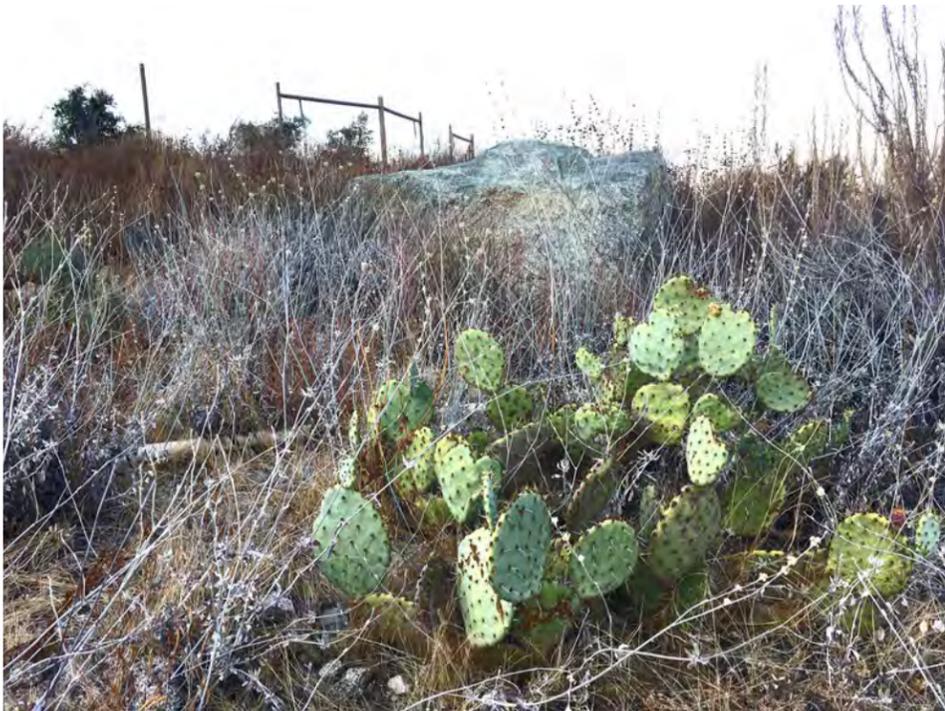
**August 2020.** A planted Vasey's prickly pear cactus is surrounded by long-stemmed buckwheat—a native perennial herb that was seeded onto the site.

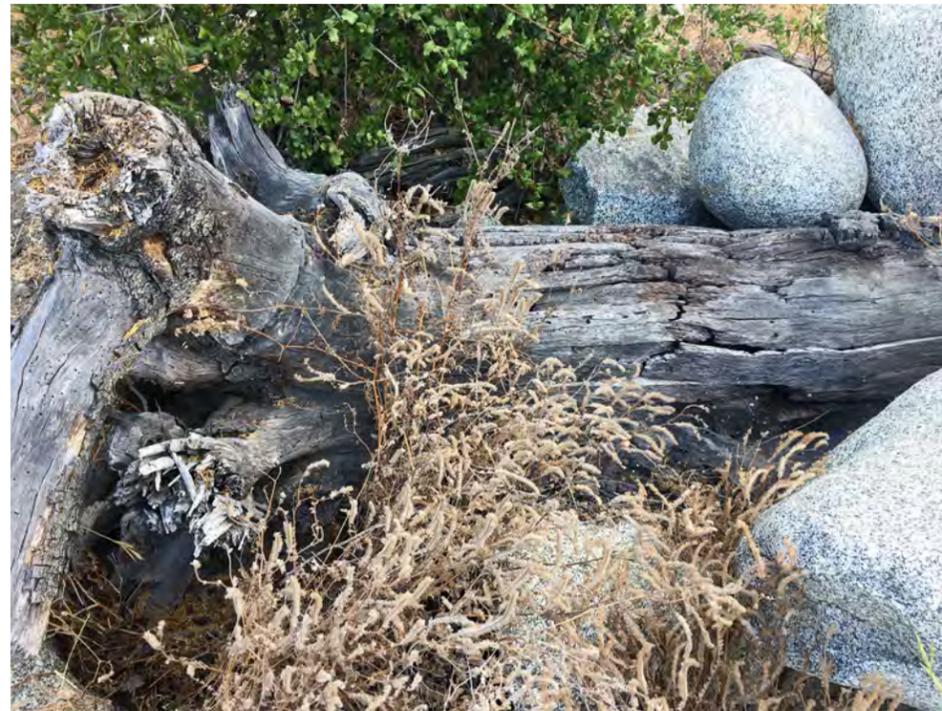
**August 2020.** Placed woody debris and boulders are seen beneath a planted oak, with desiccated distant phacelia—an annual wildflower that was seeded onto the site.

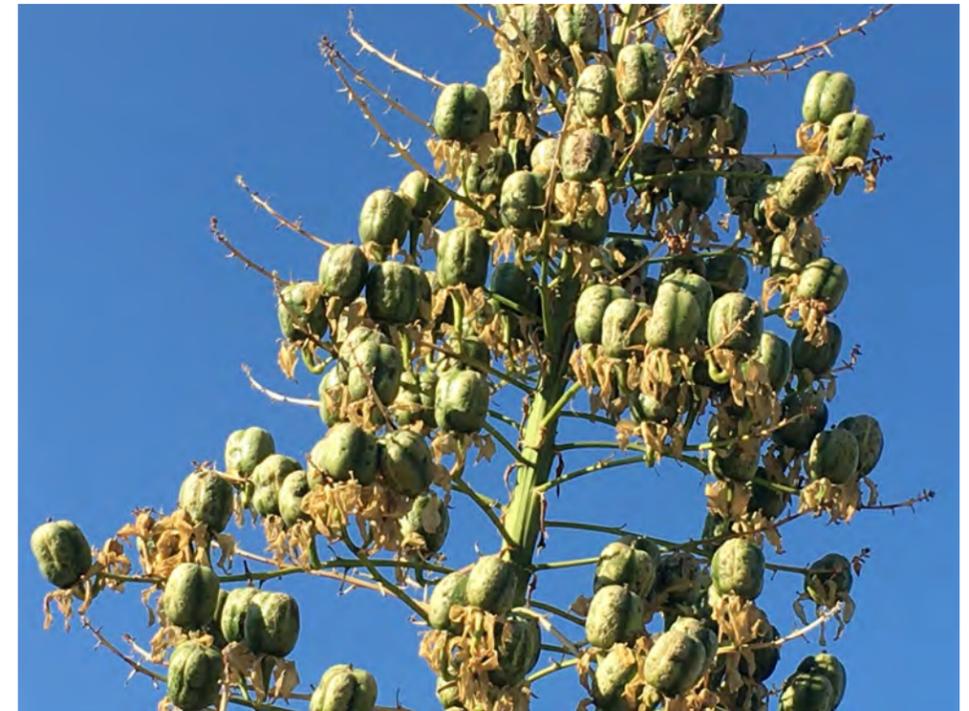
**August 2020.** The capsule fruits are ripening on chaparral yucca—a planted fibrous shrub that bloomed on the coastal sage scrub mitigation site for the first time in 2020.
