BIOLOGICAL TECHNICAL ASSESSMENT REPORT

LOS ANGELES RIVER WATERSHED FEASIBILITY STUDY

May 2013

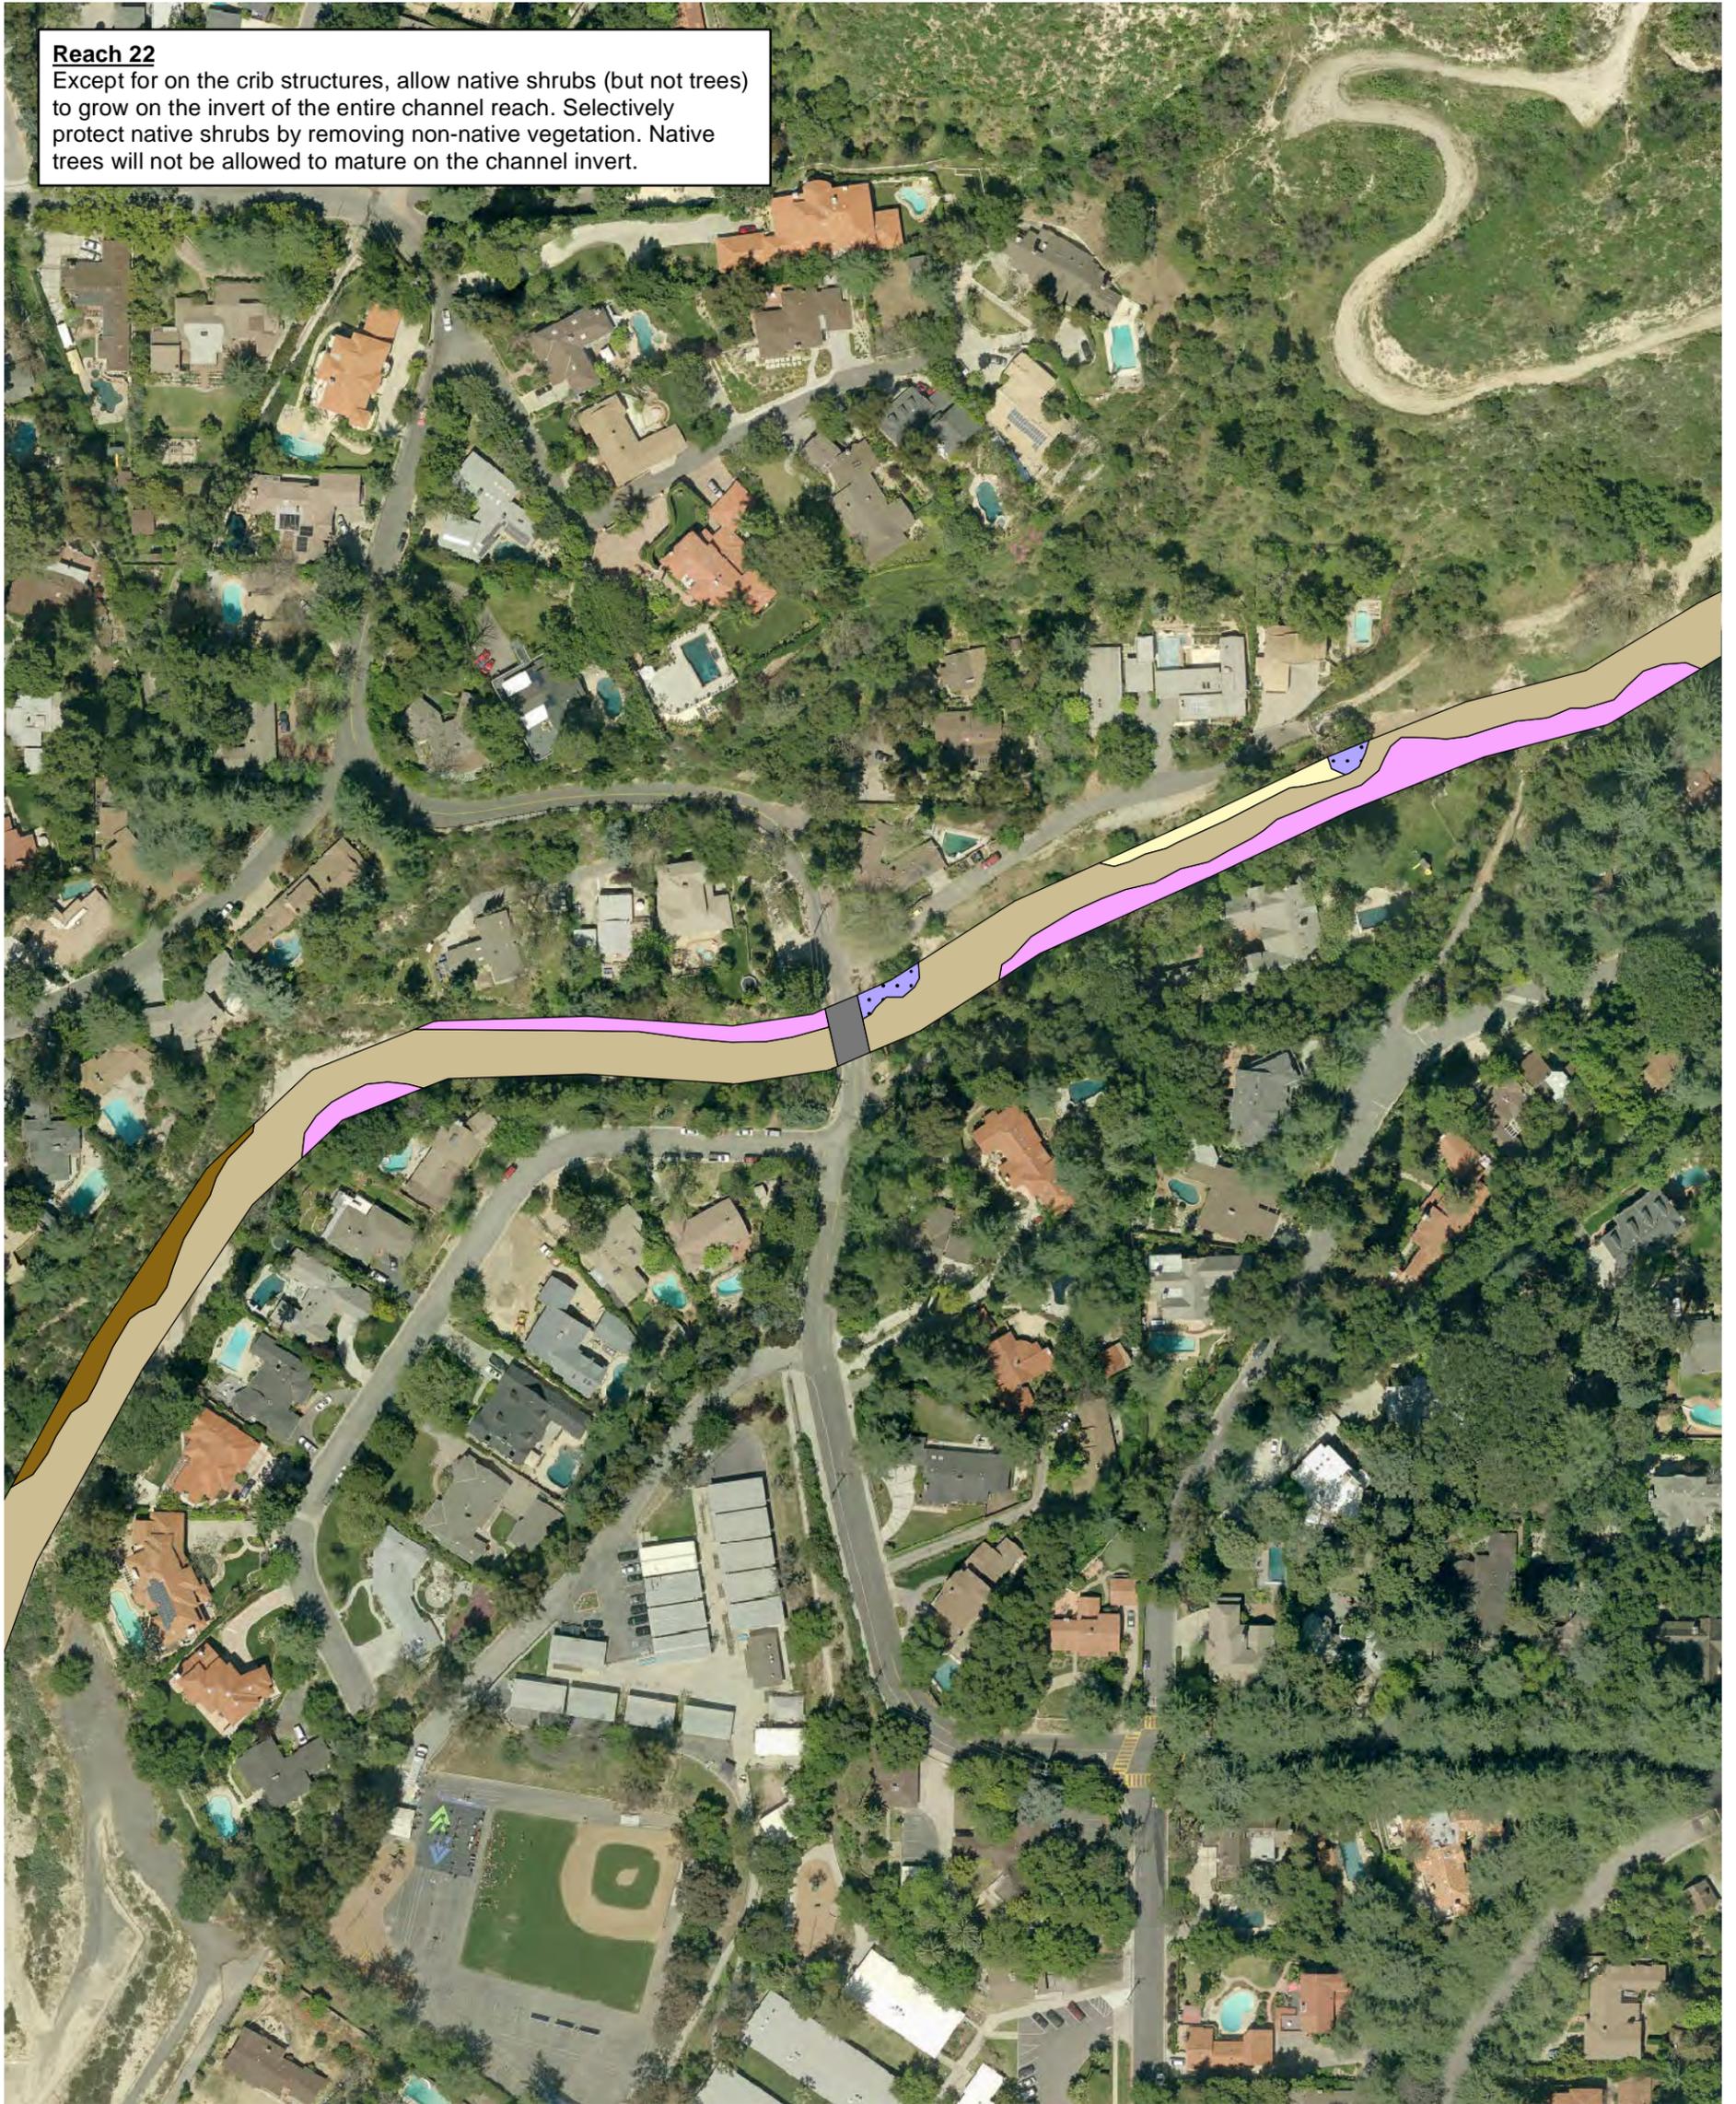
Recommendations - Reach 22

Reach 22

Except for on the crib structures, allow native shrubs (but not trees) to grow on the invert of the entire channel reach. Selectively protect native shrubs by removing non-native vegetation. Native trees will not be allowed to mature on the channel invert.

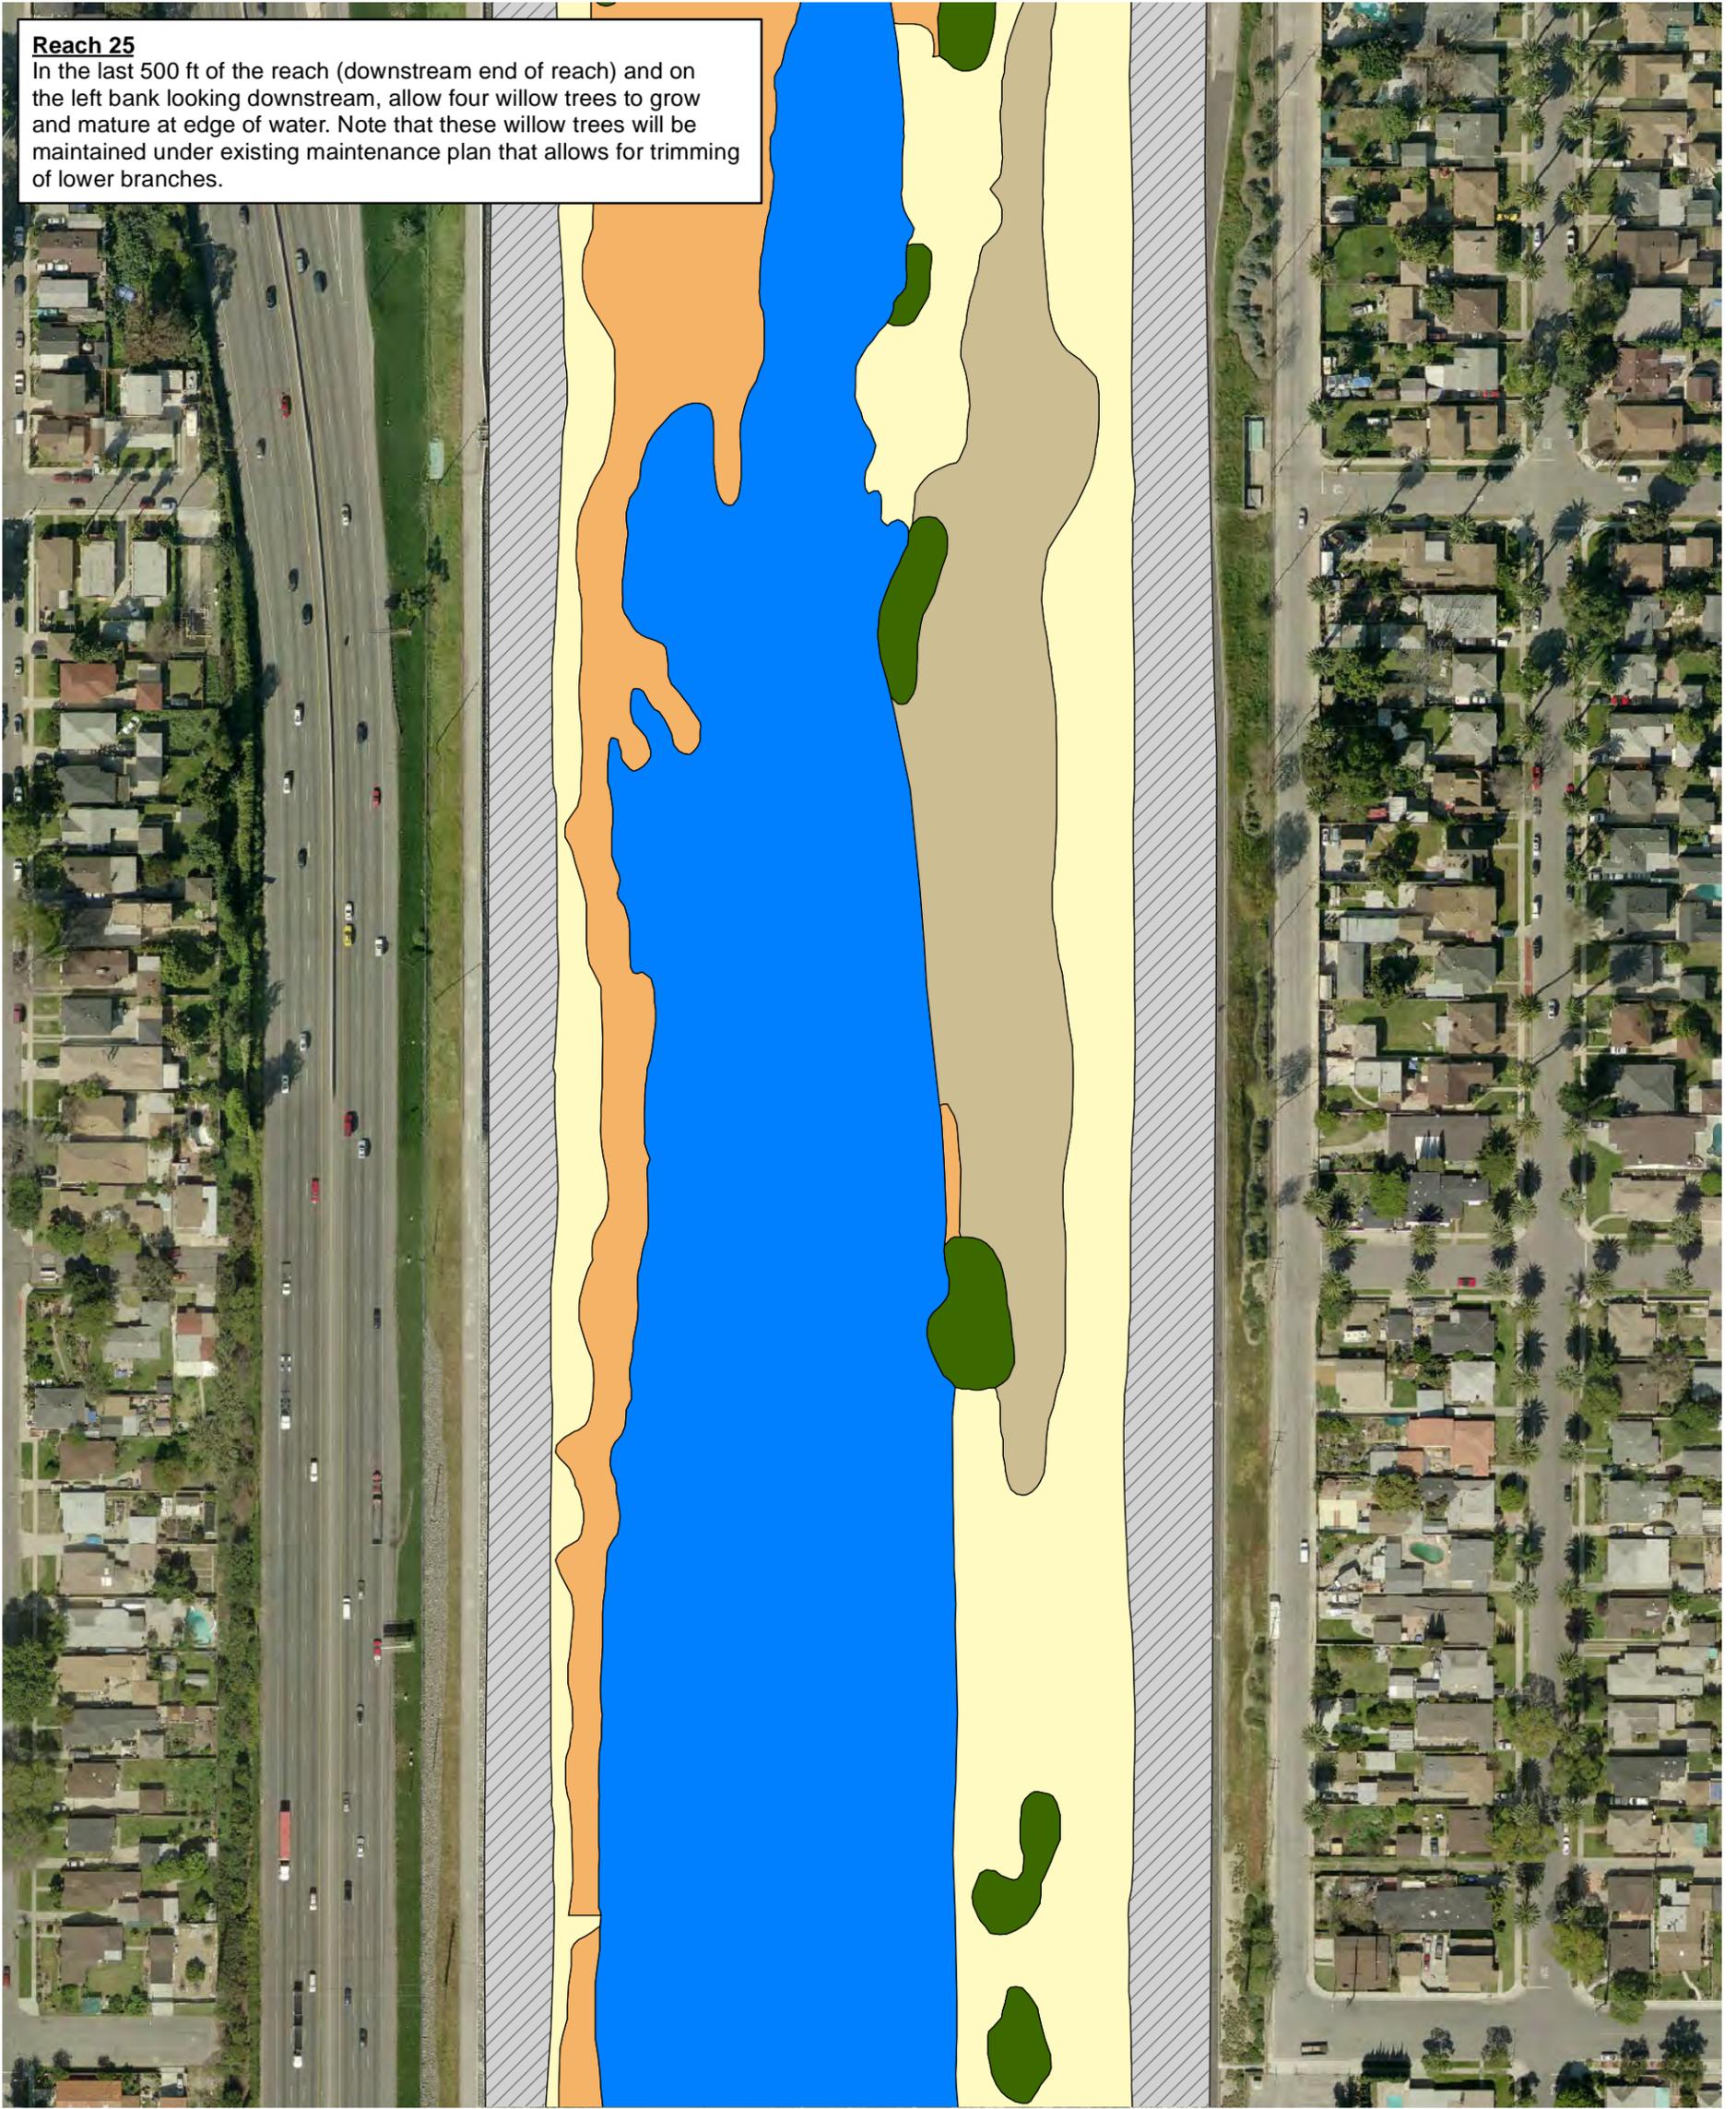
In the last 500 ft of the reach (downstream end of reach) and on the left bank looking downstream, allow four willow trees to grow and mature at edge of water. Note that these willow trees will be maintained under existing maintenance plan that allows for trimming of lower branches.

- scale broom scrub
- disturbed scale broom scrub
- southern coast live oak riparian forest
- disturbed southern coast live oak riparian forest
- willow riparian forest

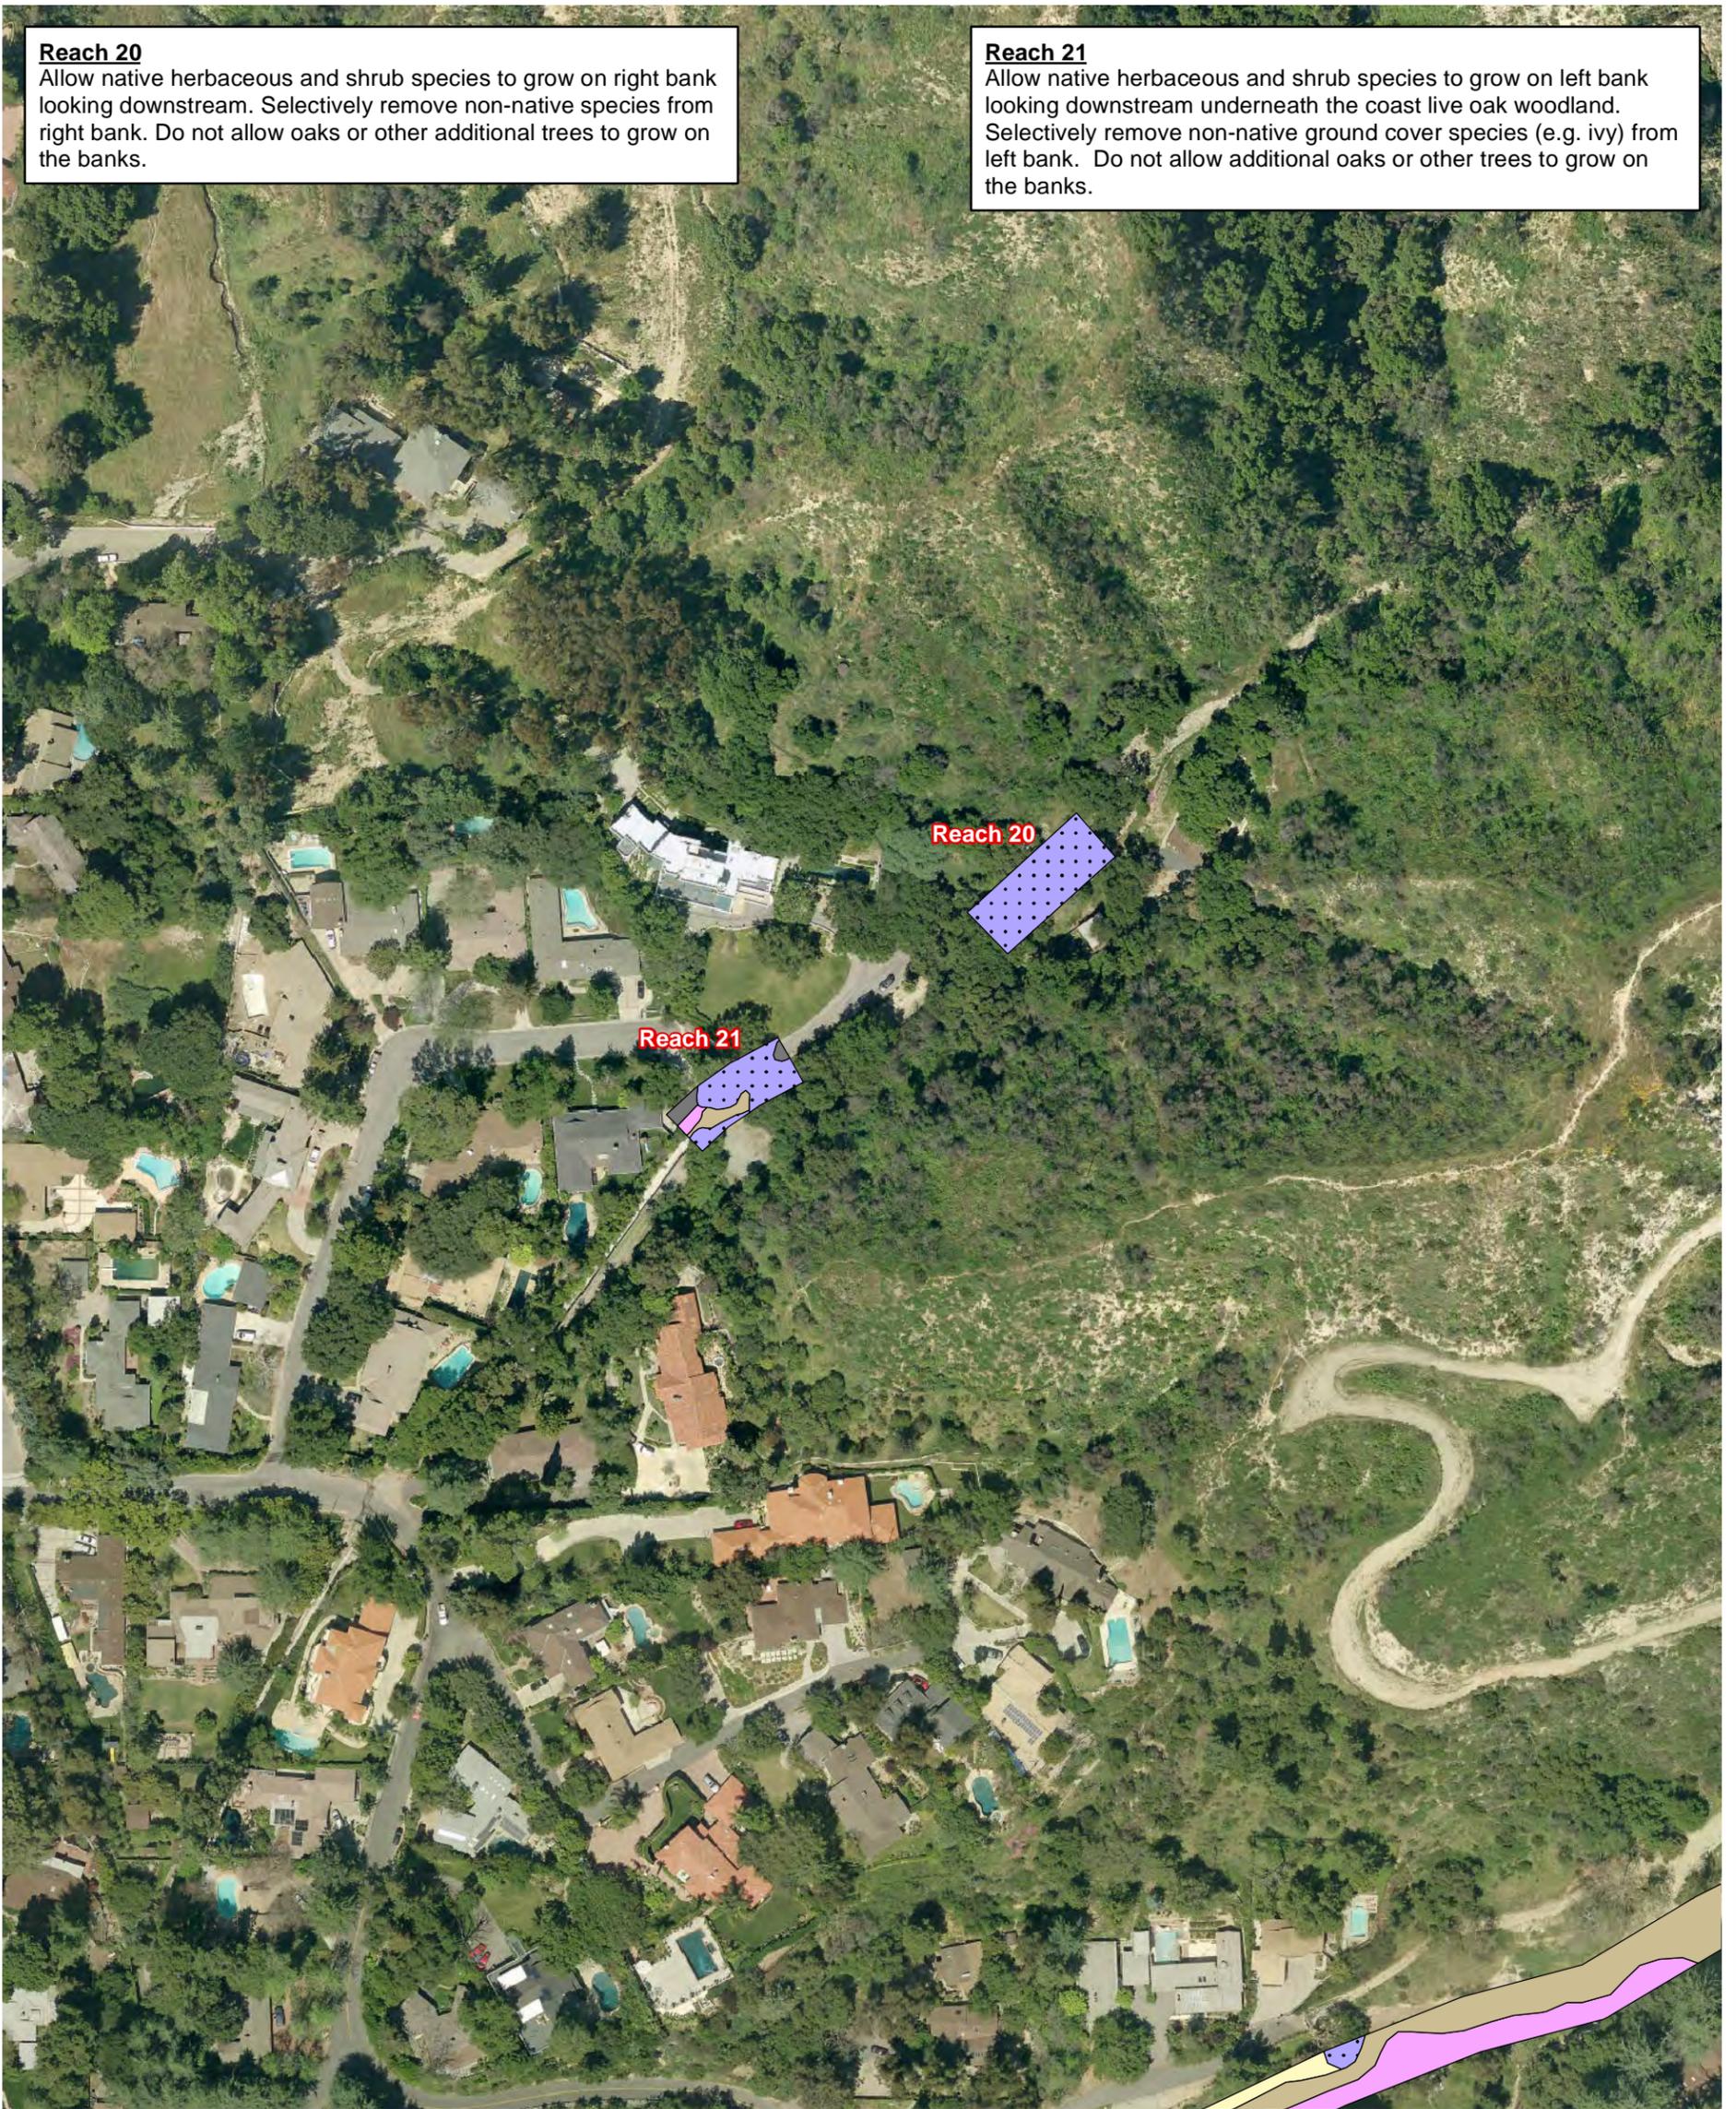
Recommendations – Reaches 20 and 21

Reach 21

Allow native herbaceous and shrub species to grow on left bank looking downstream underneath the coast live oak woodland. Selectively remove non-native ground cover species (e.g. ivy) from left bank. Do not allow additional oaks or other trees to grow on the banks.

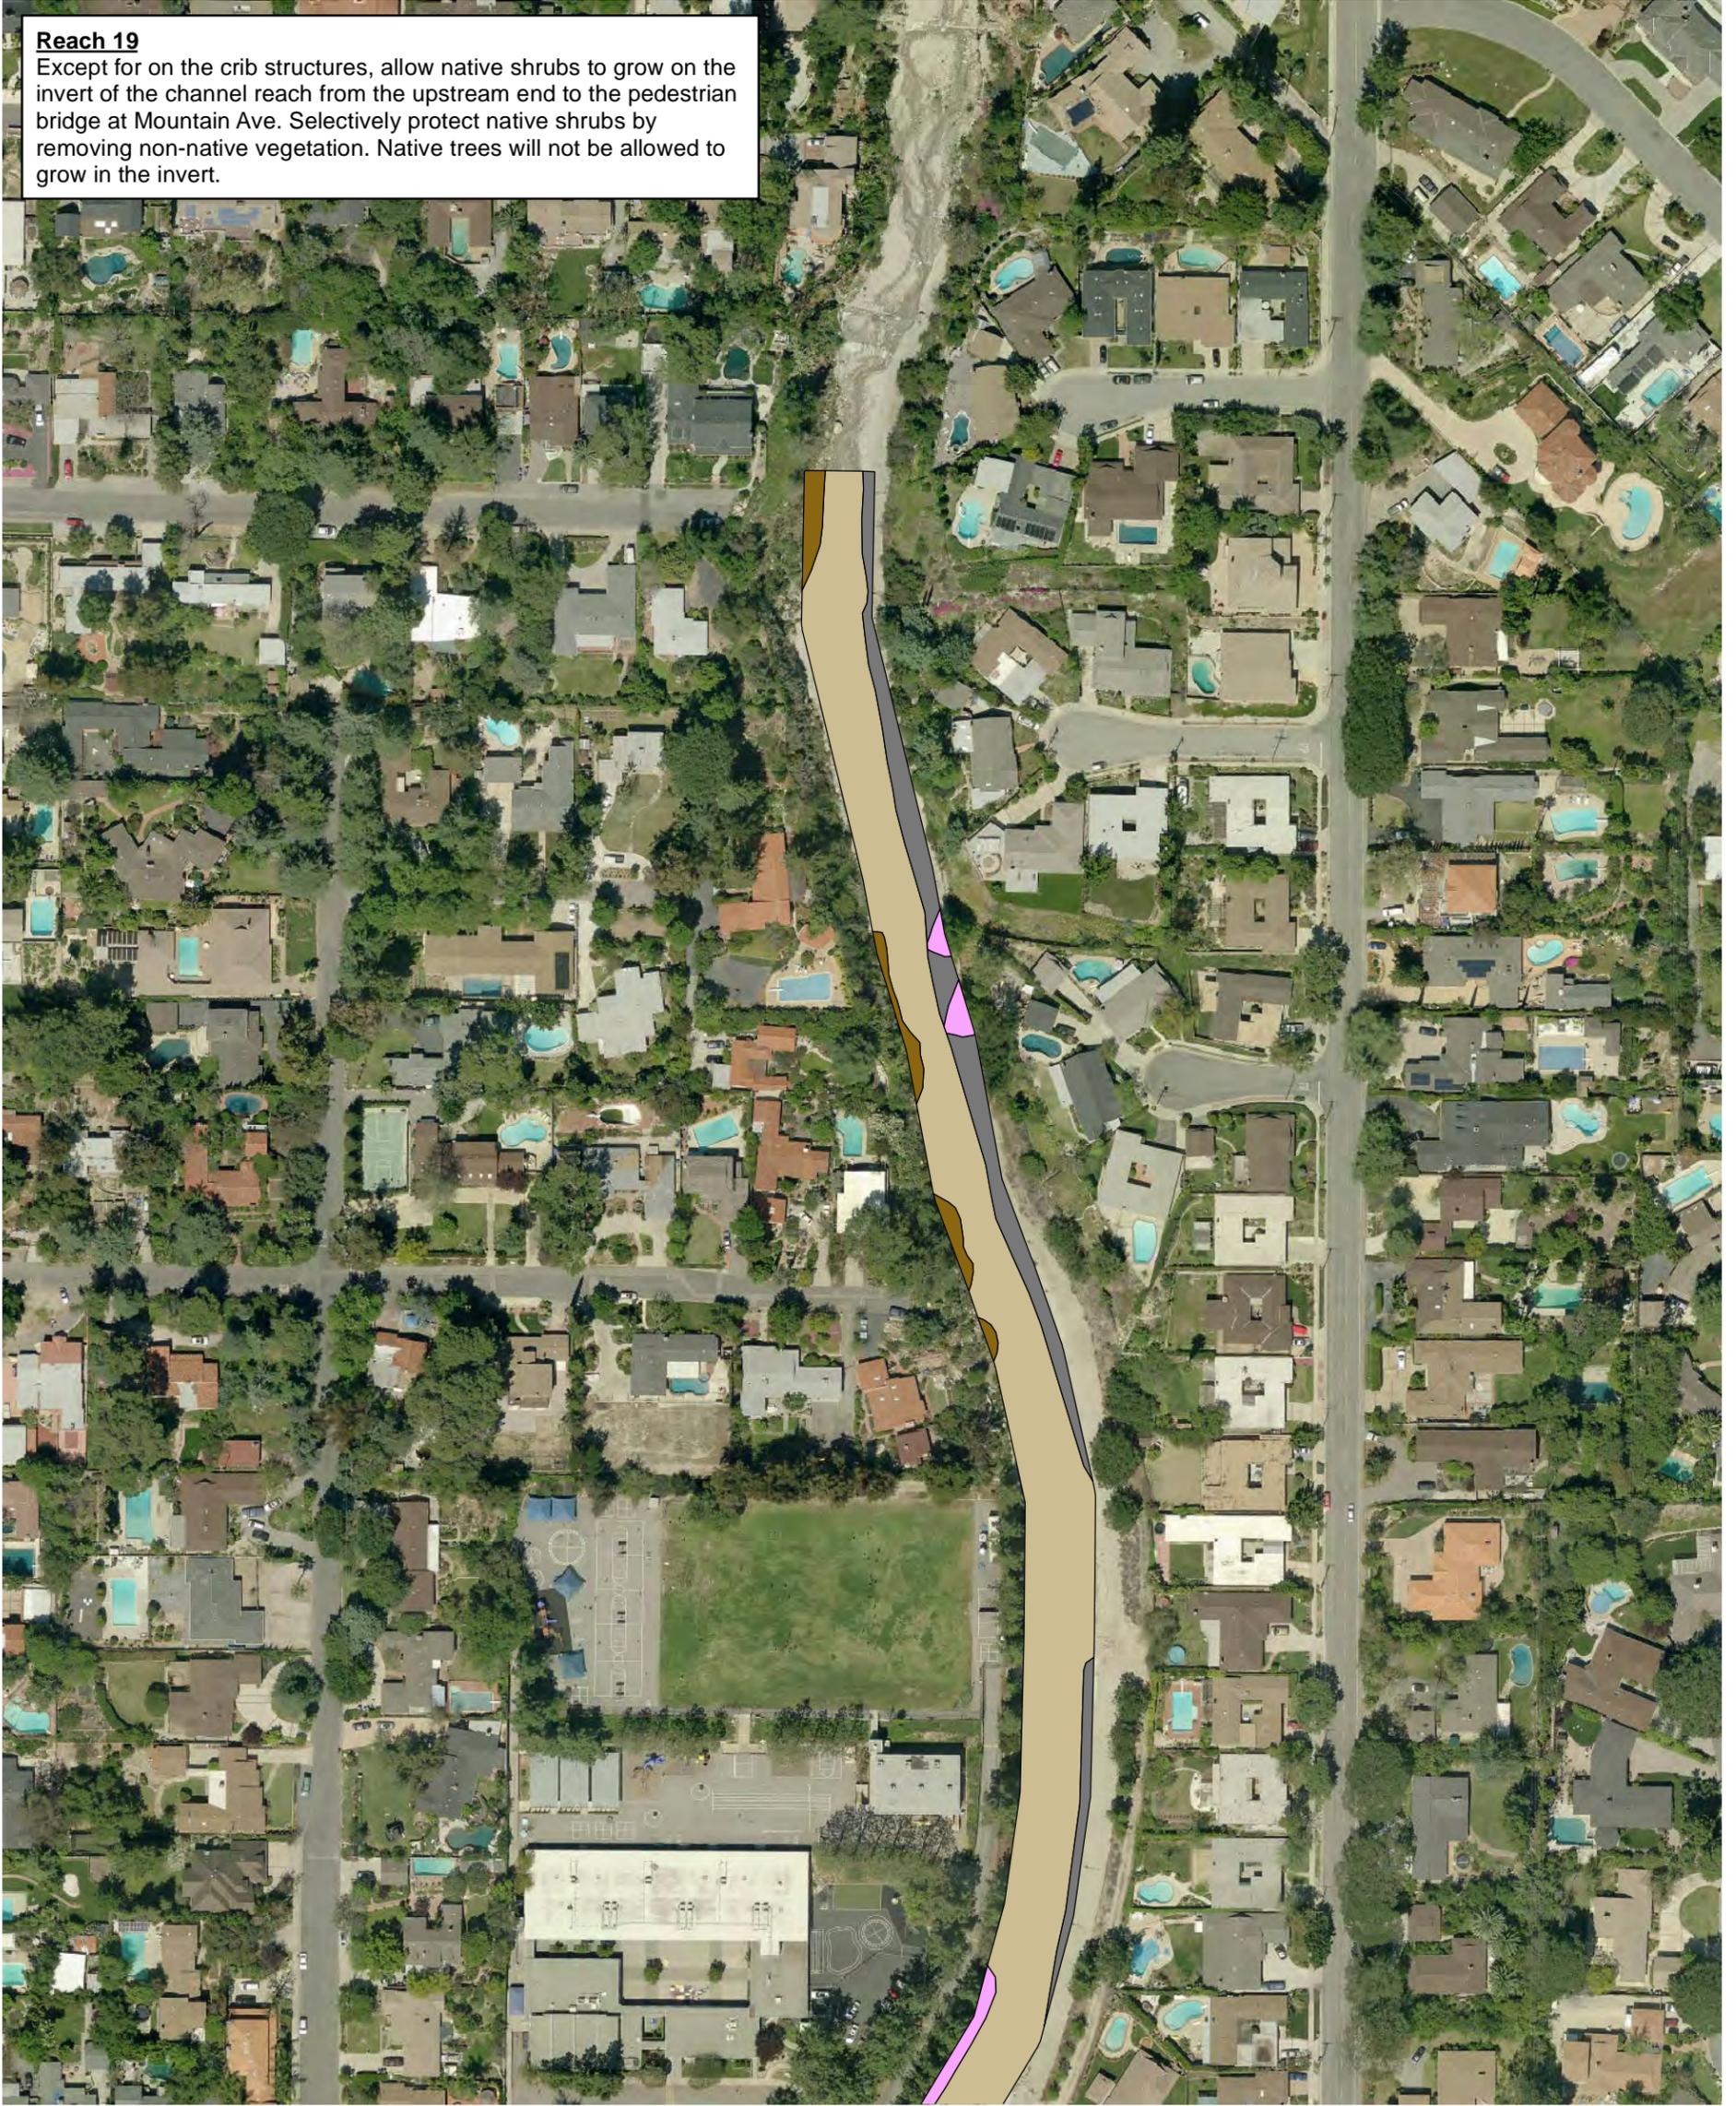
Recommendations - Reach 19

Reach 19

Except for on the crib structures, allow native shrubs to grow on the invert of the channel reach from the upstream end to the pedestrian bridge at Mountain Ave. Selectively protect native shrubs by removing non-native vegetation. Native trees will not be allowed to grow in the invert.

Remove non-native ash trees at top of both banks and replace with native trees. Sycamore trees are the preferred native trees to be planted per the maintenance plan that will be prepared for this task at a later date.

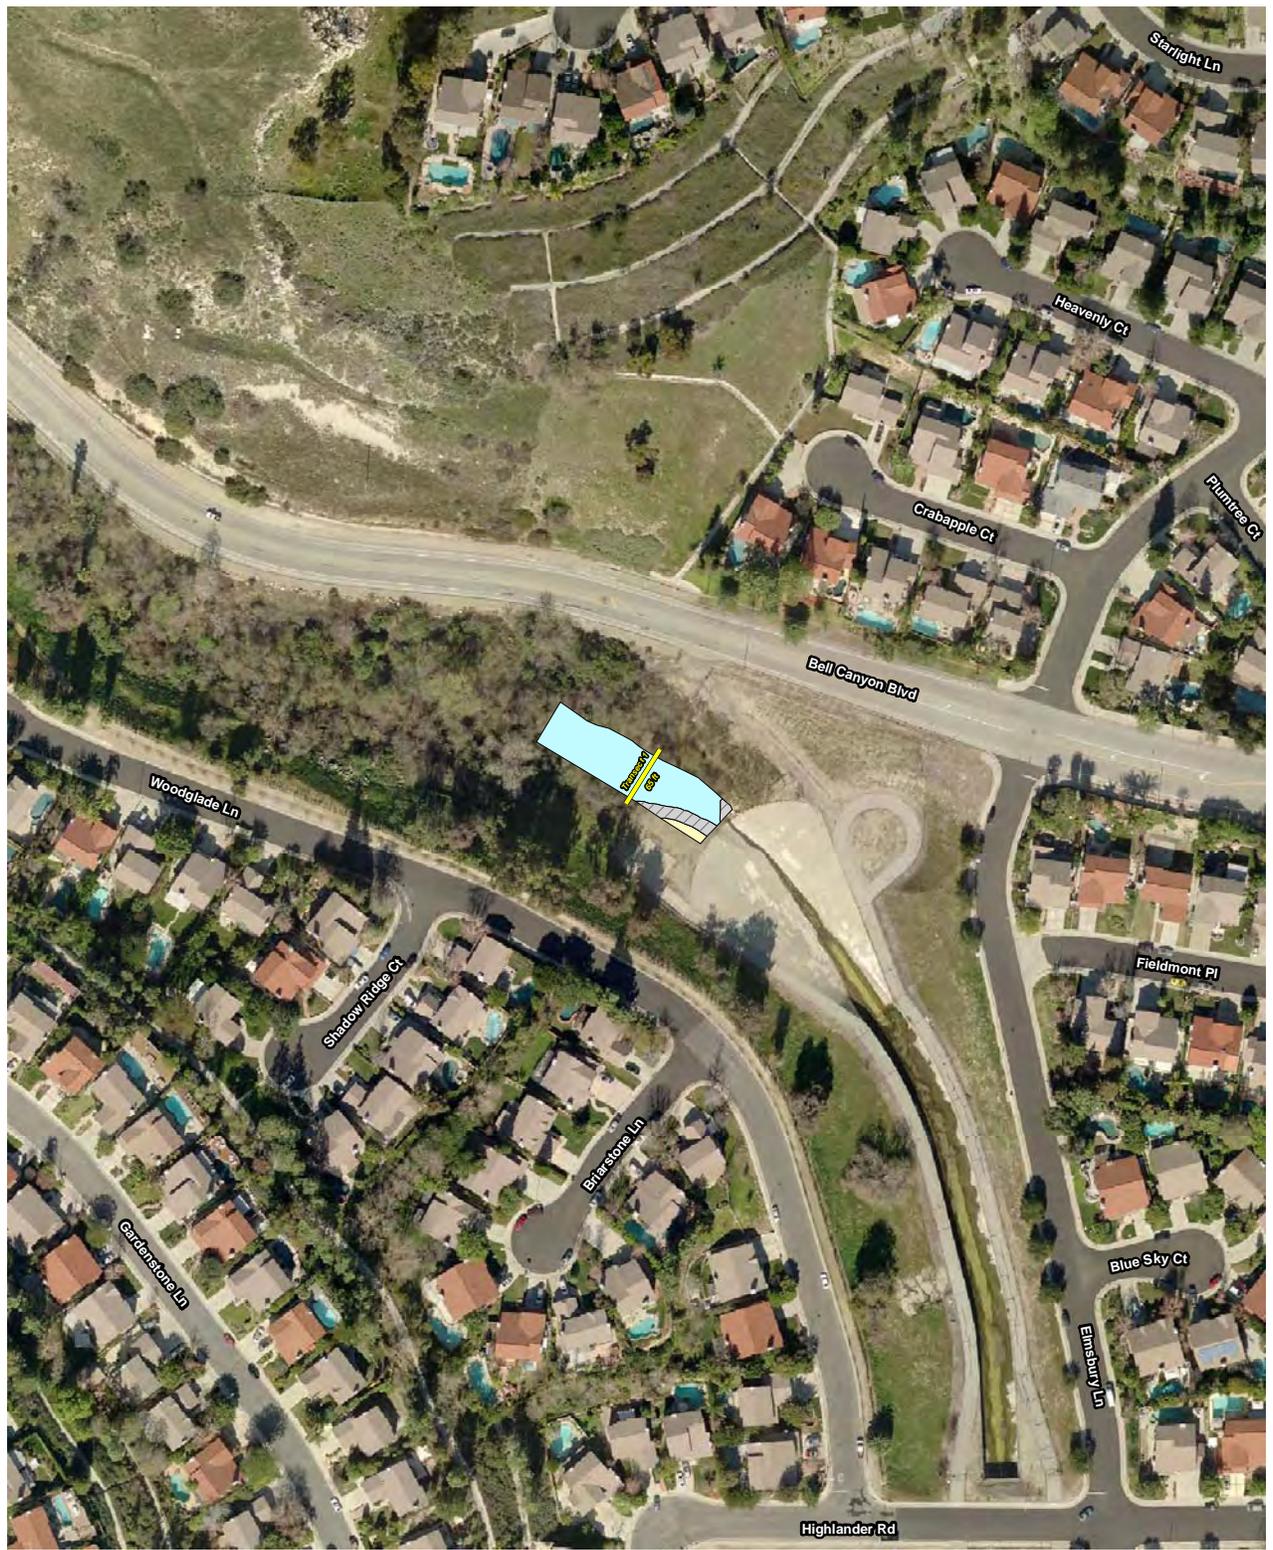
Vegetation Types - Reach 1

—	Transects	■	southern willow scrub	■	unvegetated wash
■	Vegetation Types	■	cattail wetland	■	open water
■	scale broom scrub	■	cattail wetland/open water	■	disturbed
■	disturbed scale broom scrub	■	disturbed cattail wetland	■	ungrouted riprap
■	southern coast live oak riparian forest	■	riparian herb	■	developed
■	disturbed southern coast live oak riparian forest	■	ruderal		
■	willow riparian forest	■	ornamental

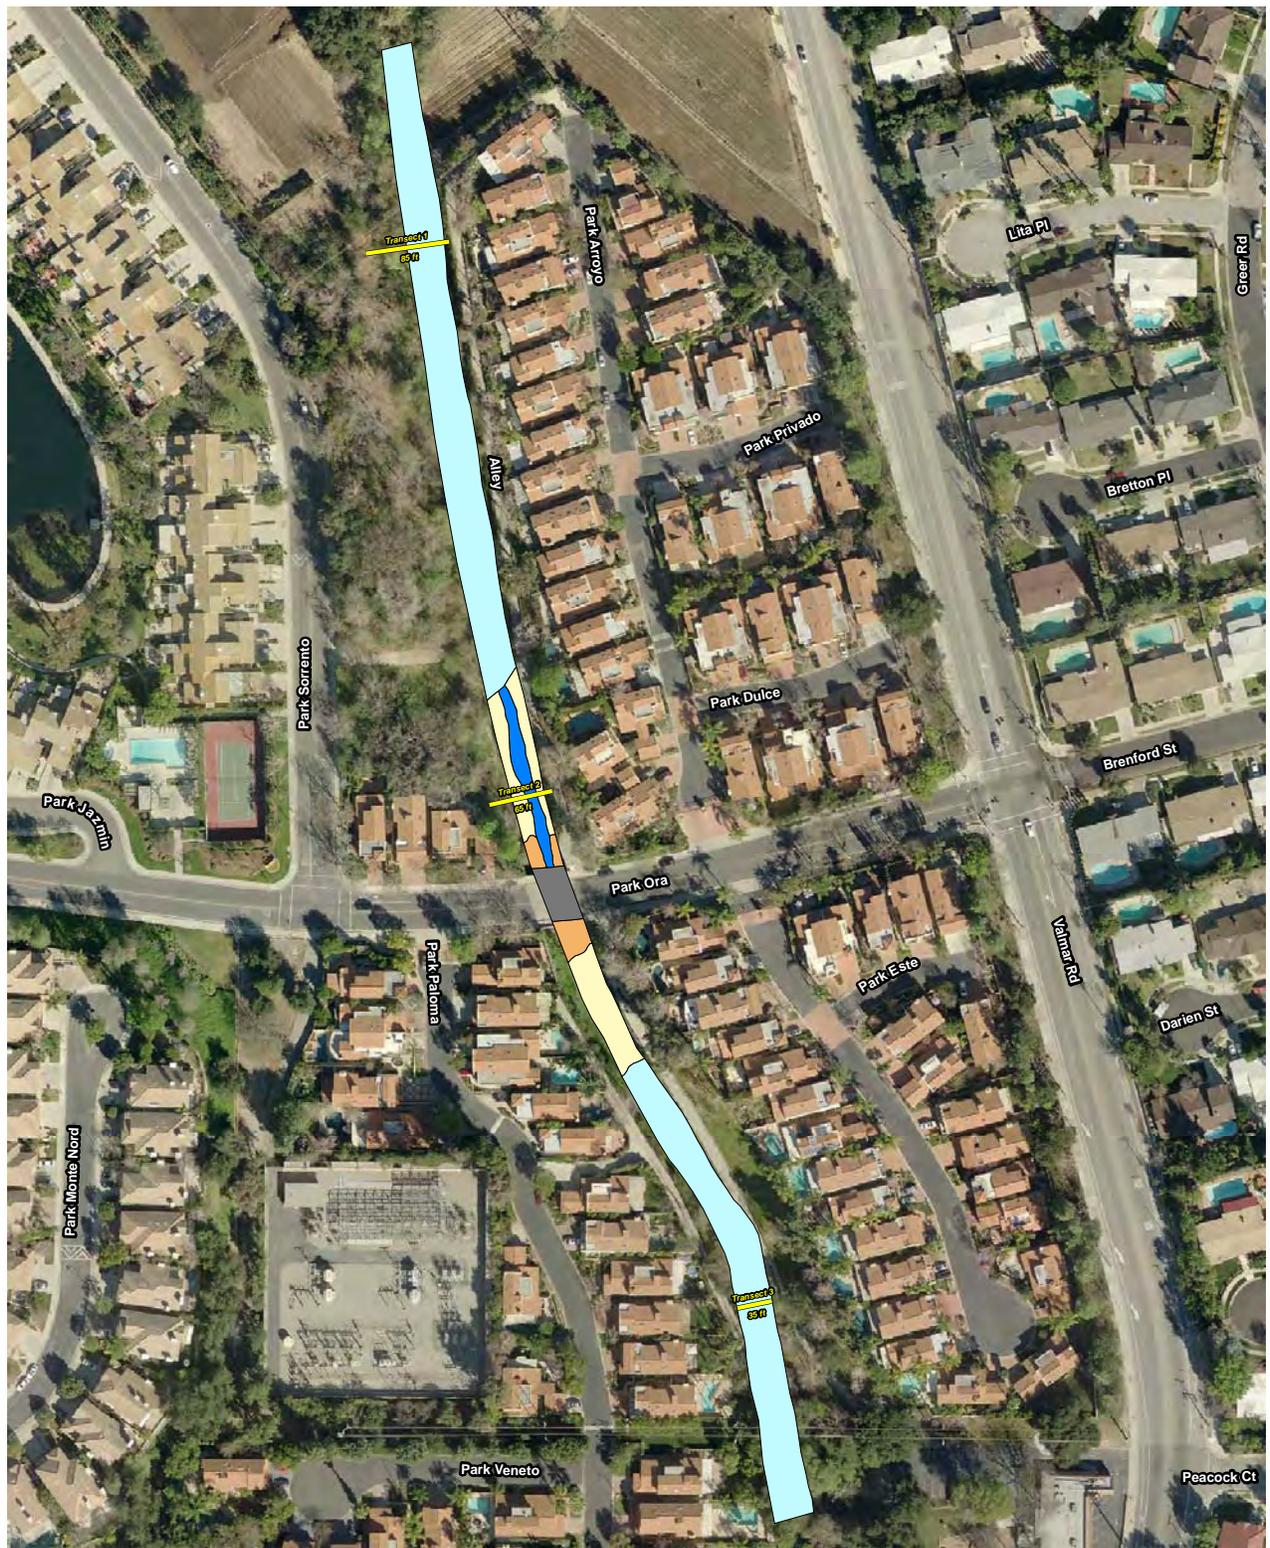
Vegetation Types - Reach 2

—	Transects	■	southern willow scrub	■	unvegetated wash
■	Vegetation Types	■	cattail wetland	■	open water
■	scale broom scrub	■	cattail wetland/open water	■	disturbed
■	disturbed scale broom scrub	■	disturbed cattail wetland	■	ungrouted riprap
■	southern coast live oak riparian forest	■	riparian herb	■	developed
■	disturbed southern coast live oak riparian forest	■	ruderal		
■	willow riparian forest	■	ornamental

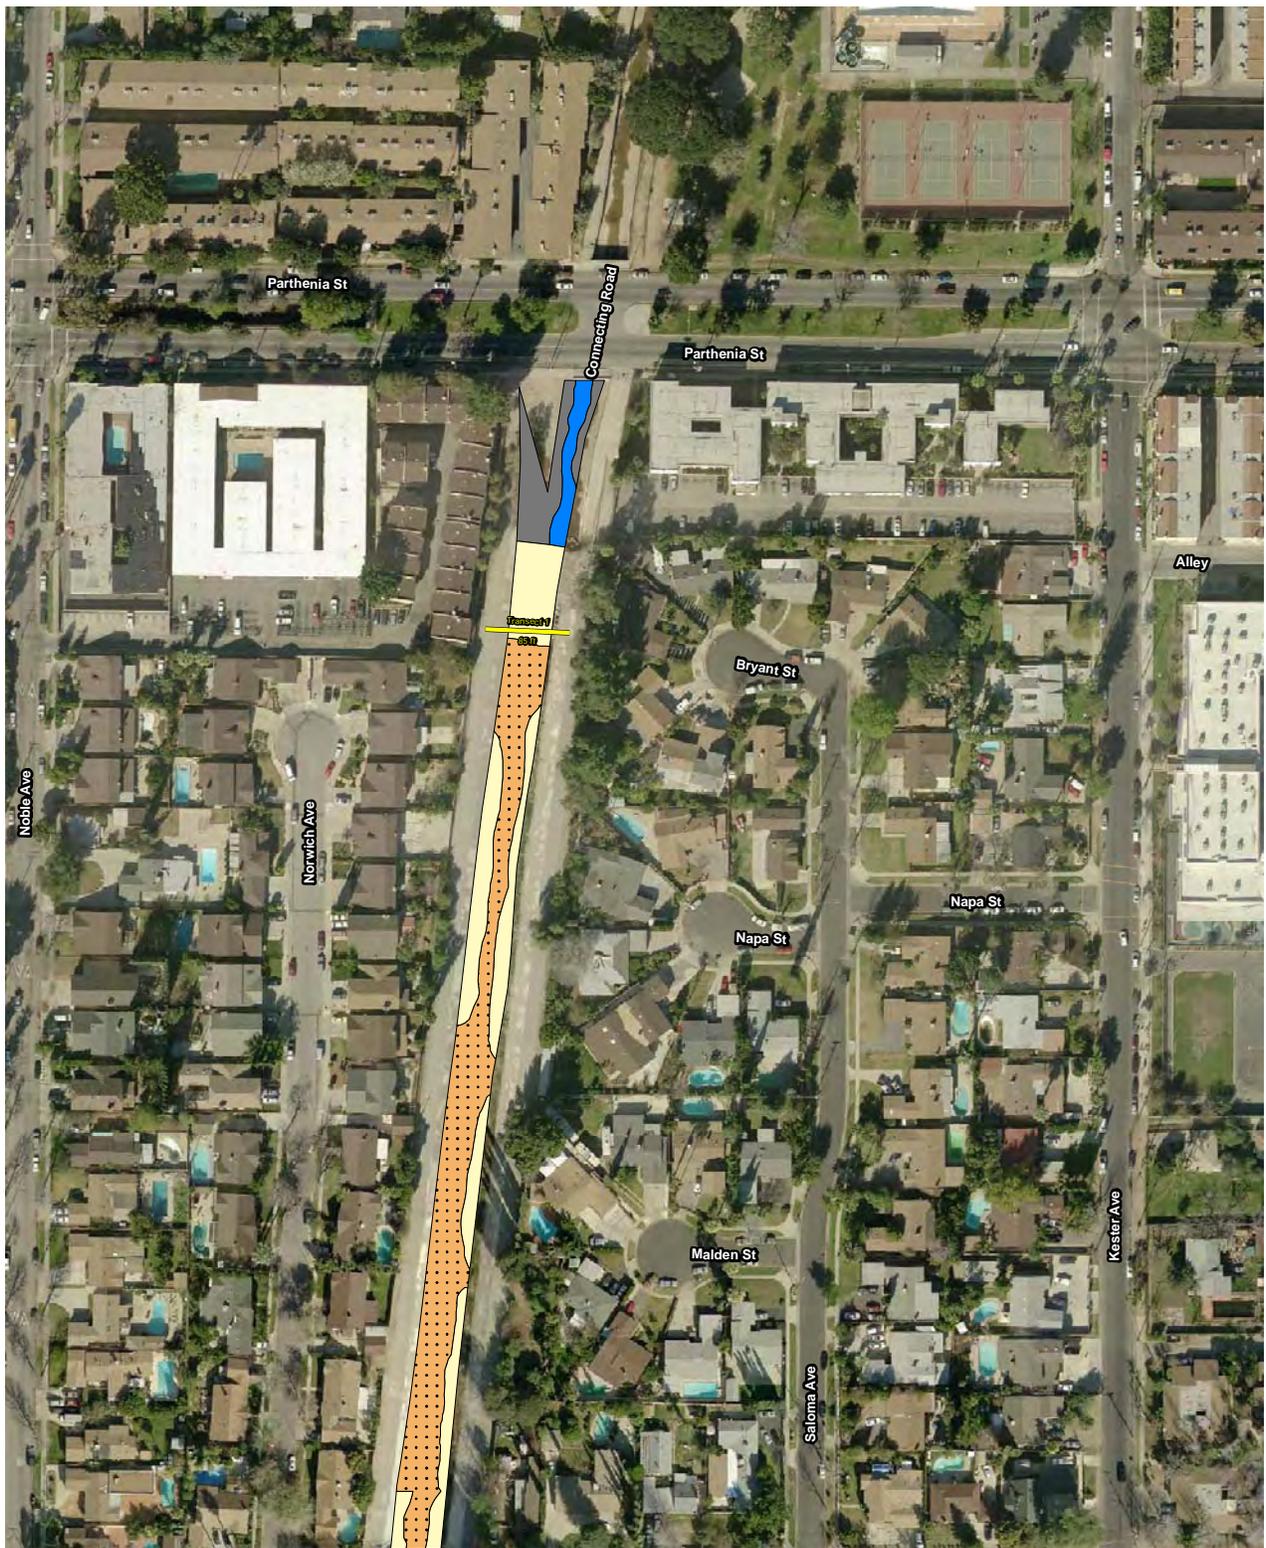
Vegetation Types - Reach 15

—	Transects	■	southern willow scrub	■	unvegetated wash
■	Vegetation Types	■	cattail wetland	■	open water
■	scale broom scrub	■	cattail wetland/open water	■	disturbed
■	disturbed scale broom scrub	■	disturbed cattail wetland	■	ungrouted riprap
■	southern coast live oak riparian forest	■	riparian herb	■	developed
■	disturbed southern coast live oak riparian forest	■	ruderal		
■	willow riparian forest	■	ornamental
