BIOLOGICAL TECHNICAL ASSESSMENT REPORT

LOS ANGELES RIVER WATERSHED FEASIBILITY STUDY

May 2013

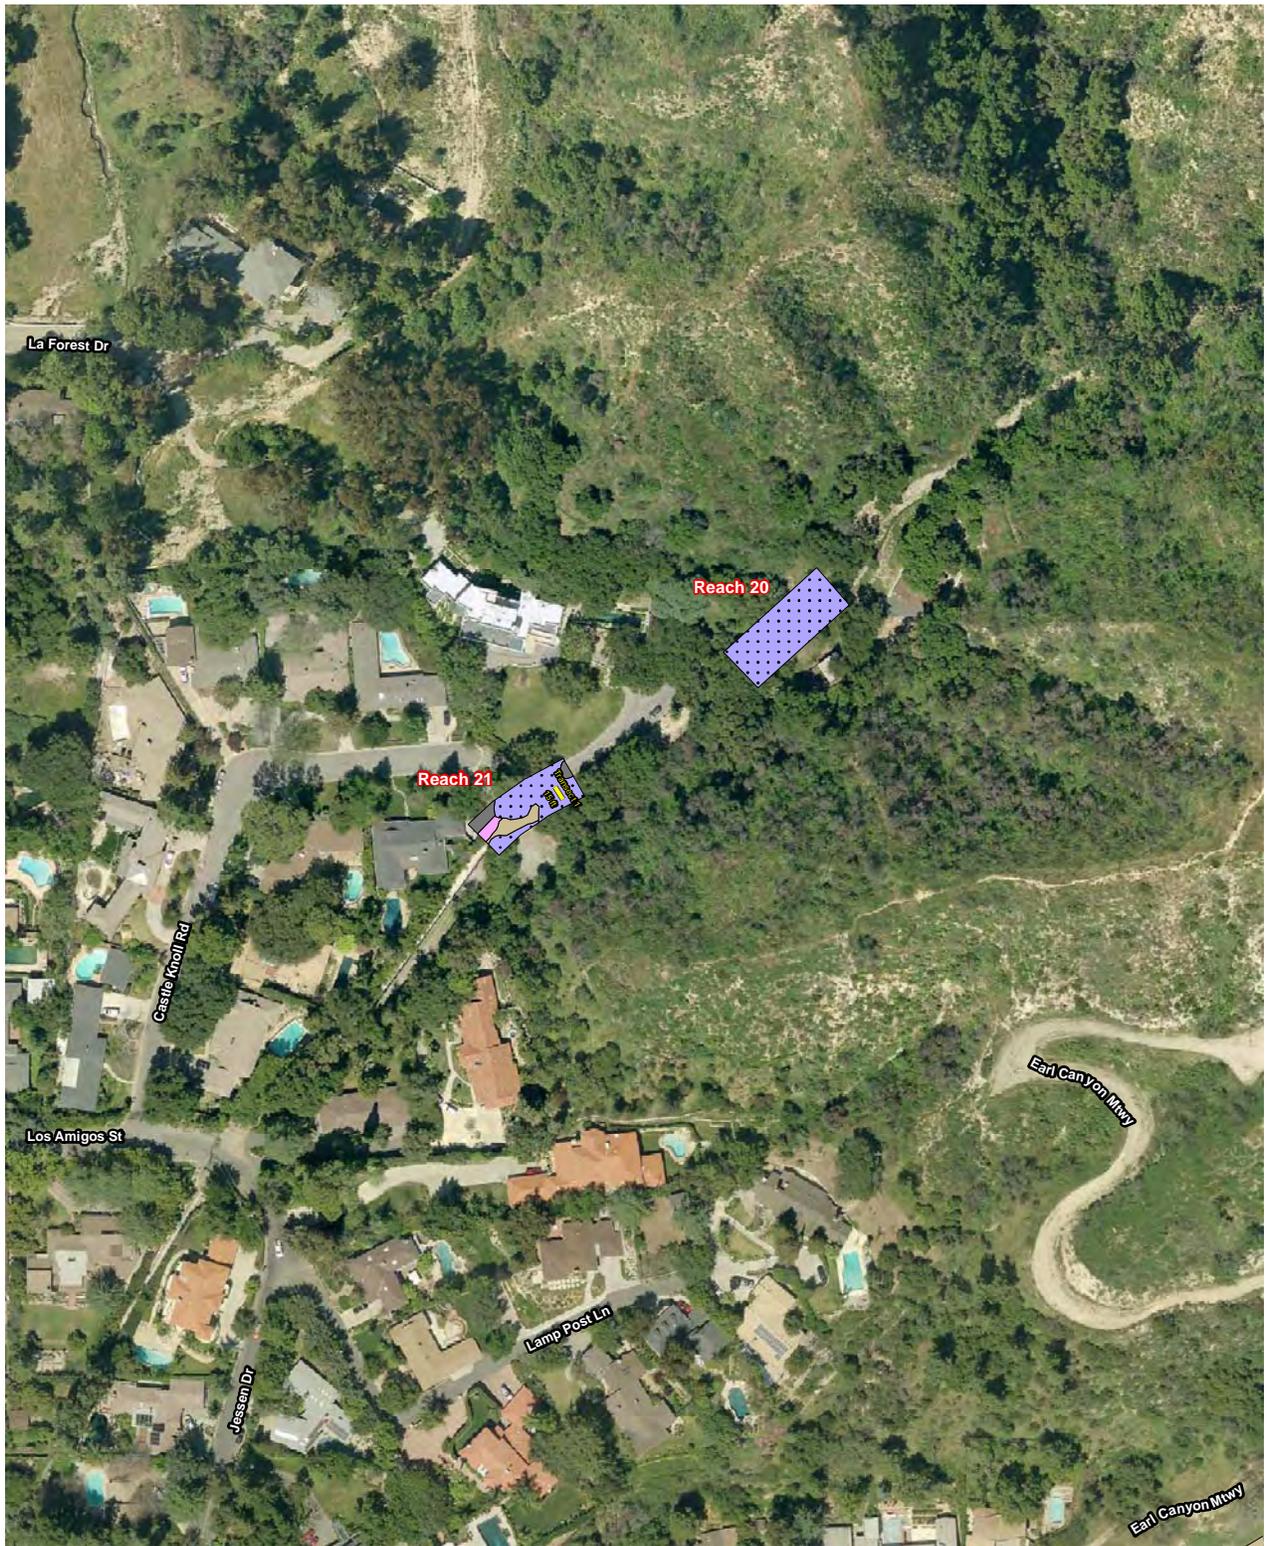
Vegetation Types - Reaches 20 and 21

—	Transects	■	southern willow scrub	■	unvegetated wash
■	Vegetation Types	■	cattail wetland	■	open water
■	scale broom scrub	■	cattail wetland/open water	■	disturbed
■	disturbed scale broom scrub	■	disturbed cattail wetland	■	ungrouted riprap
■	southern coast live oak riparian forest	■	riparian herb	■	developed
■	disturbed southern coast live oak riparian forest	■	ruderal		
■	willow riparian forest	■	ornamental

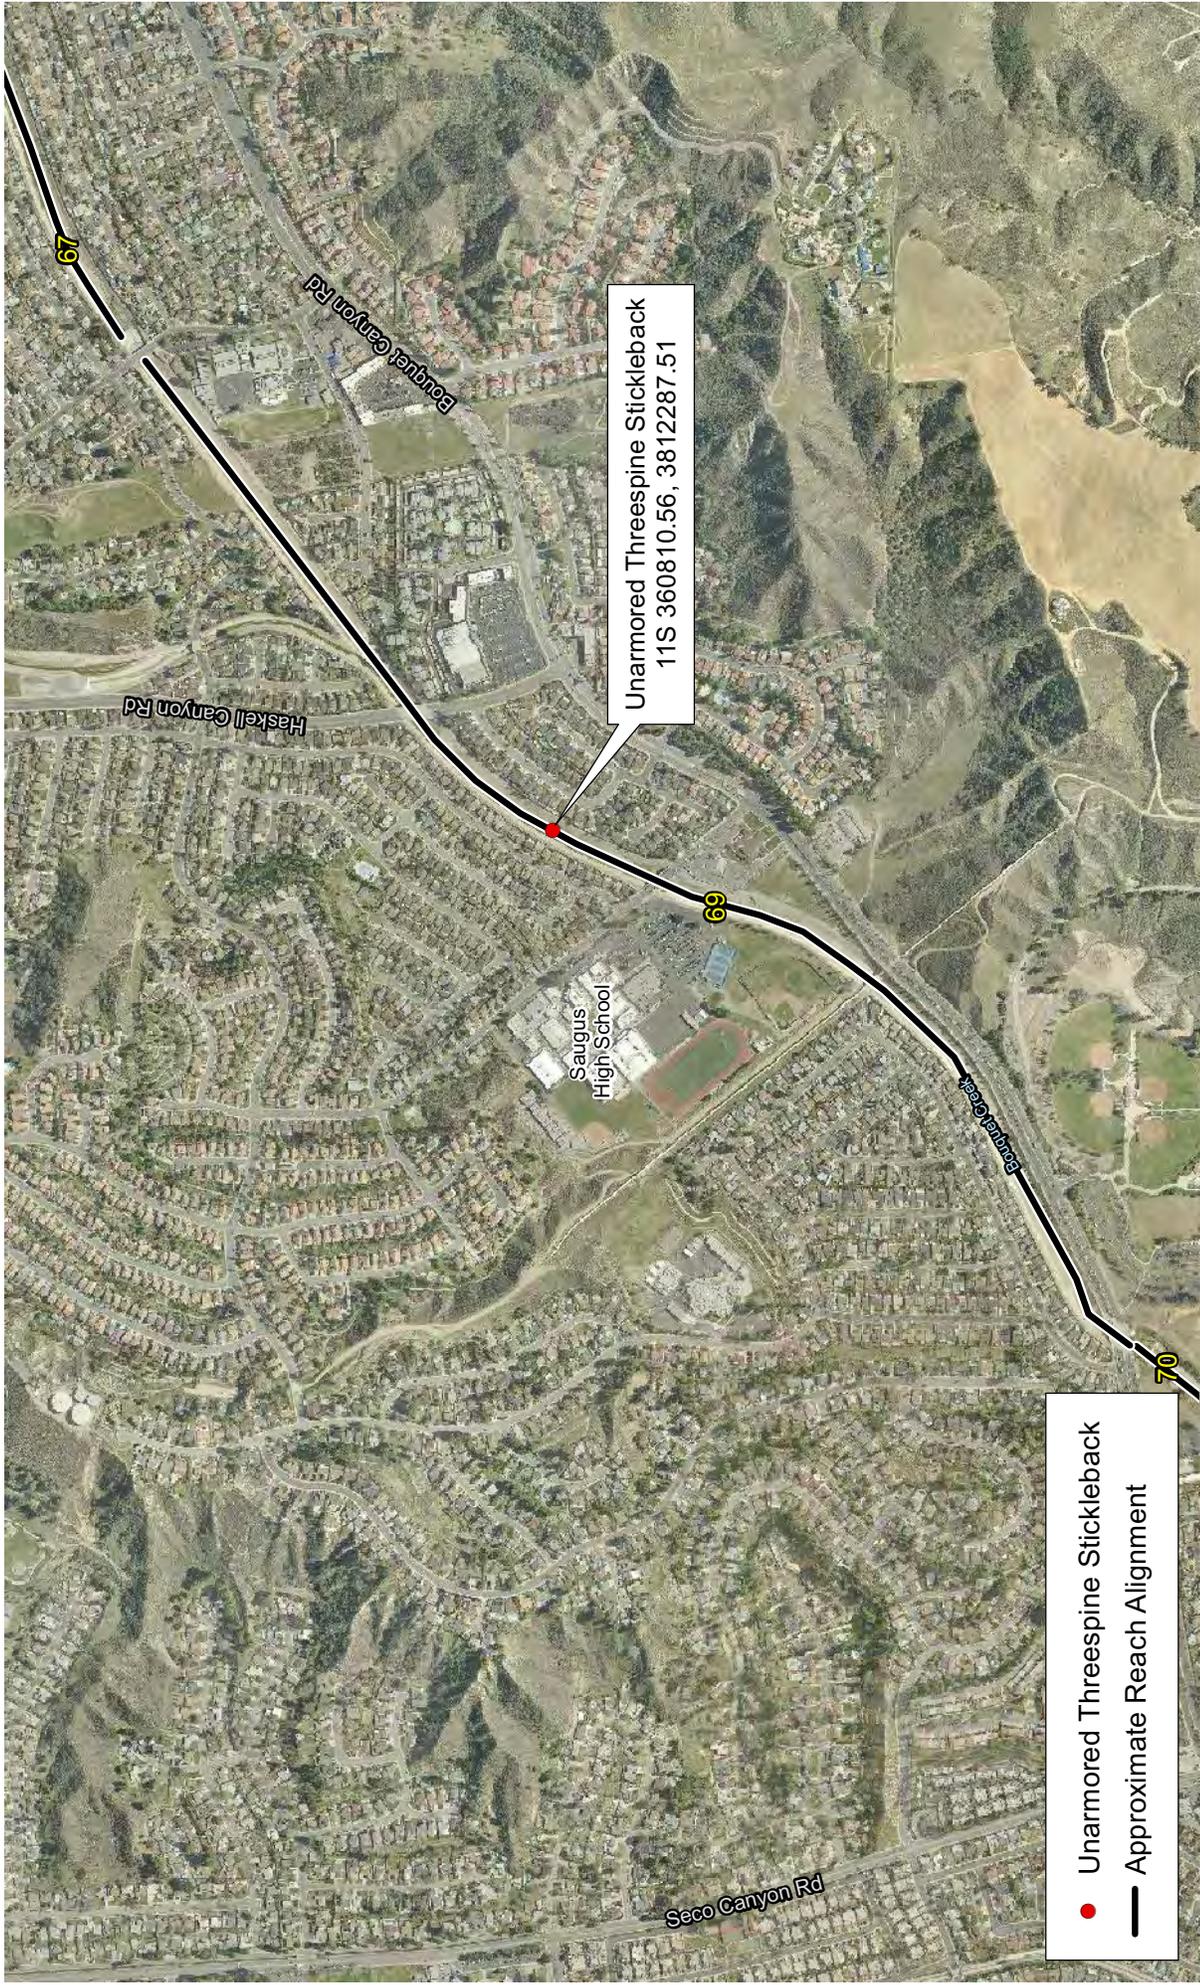
Exhibit 2

- Unarmored Threespine Stickleback
- Approximate Reach Alignment

Unarmored Threespine Stickleback
 11S 360810.56, 3812287.51

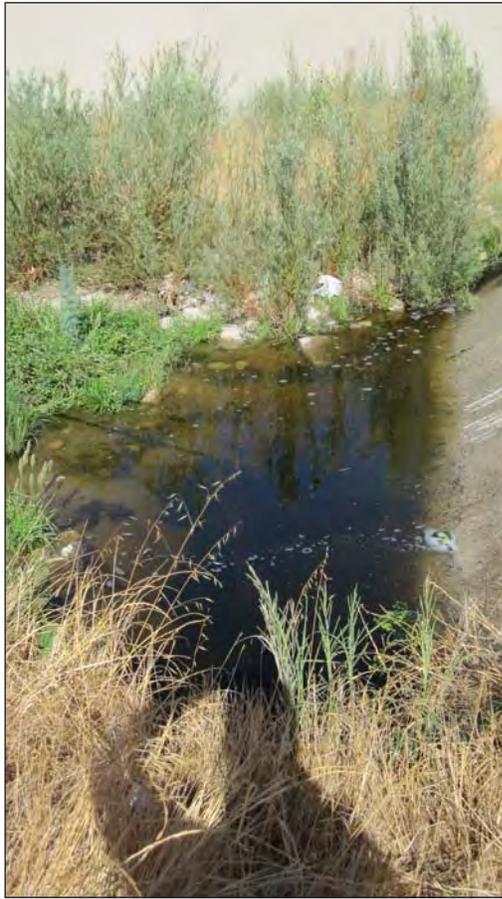
Bouquet Canyon reach 69, facing northeast. Unarmored threespine stickleback habitat.

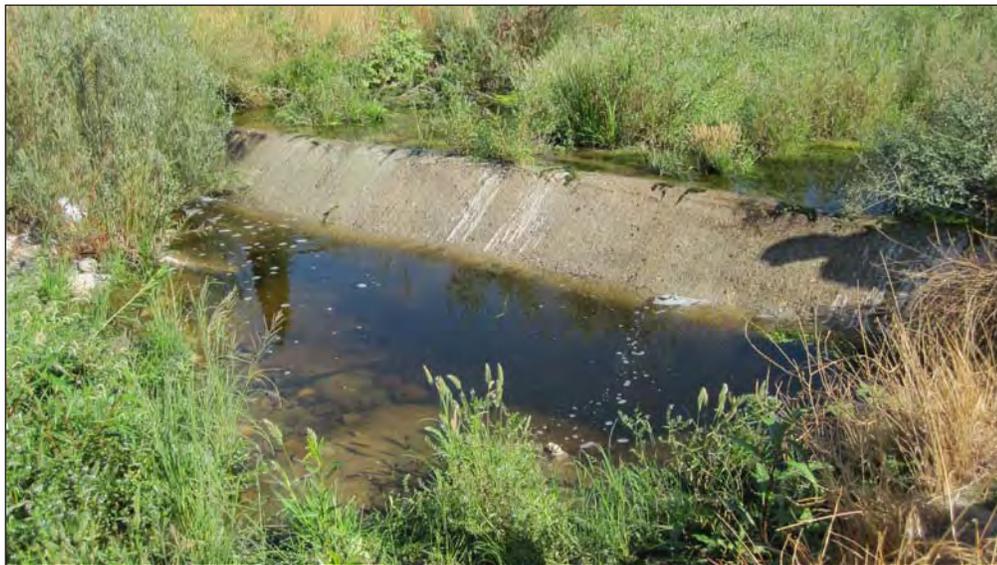
Bouquet Canyon reach 69, Facing north. Unarmored threespine stickleback (UTS) habitat.

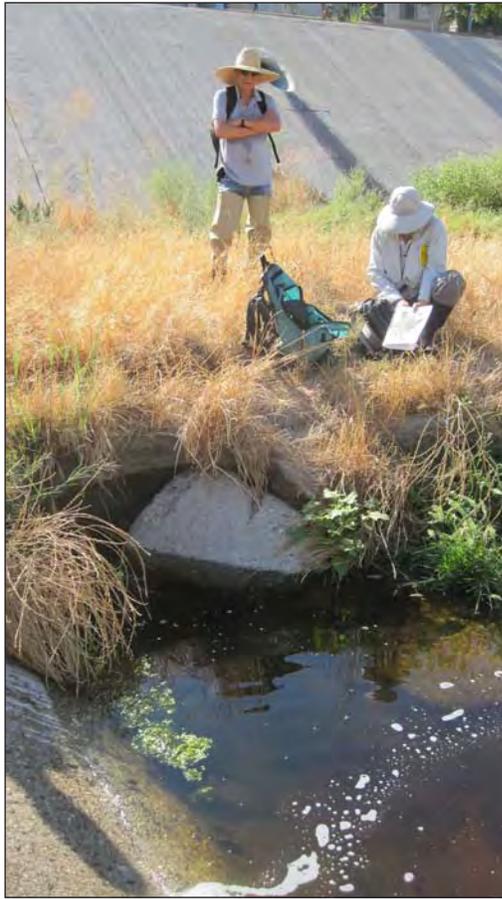
Bouquet Canyon reach 69, Facing south. Unarmored threespine stickleback surveyors at pool.

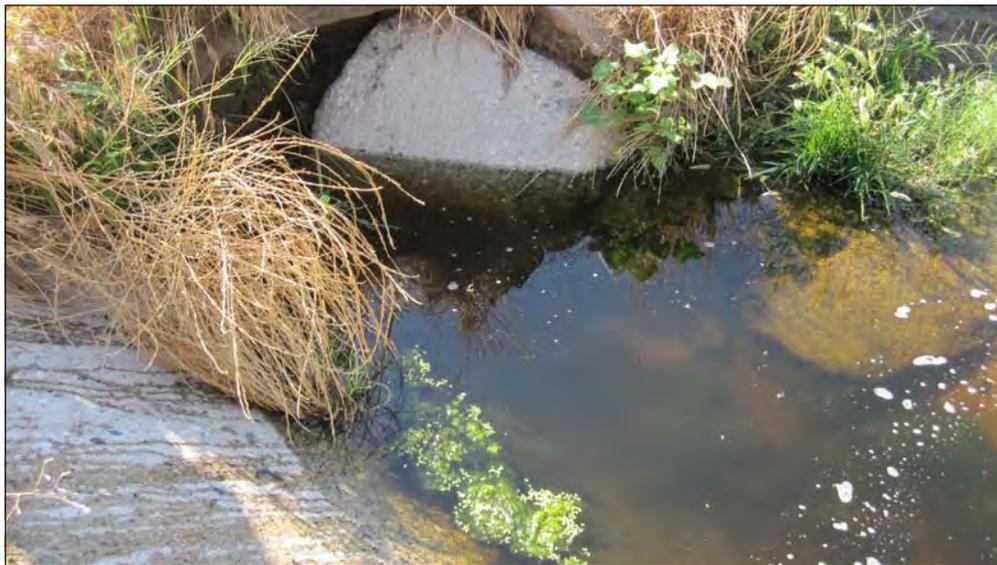
Bouquet Canyon reach 69, facing south. Unarmored threespine stickleback pool.

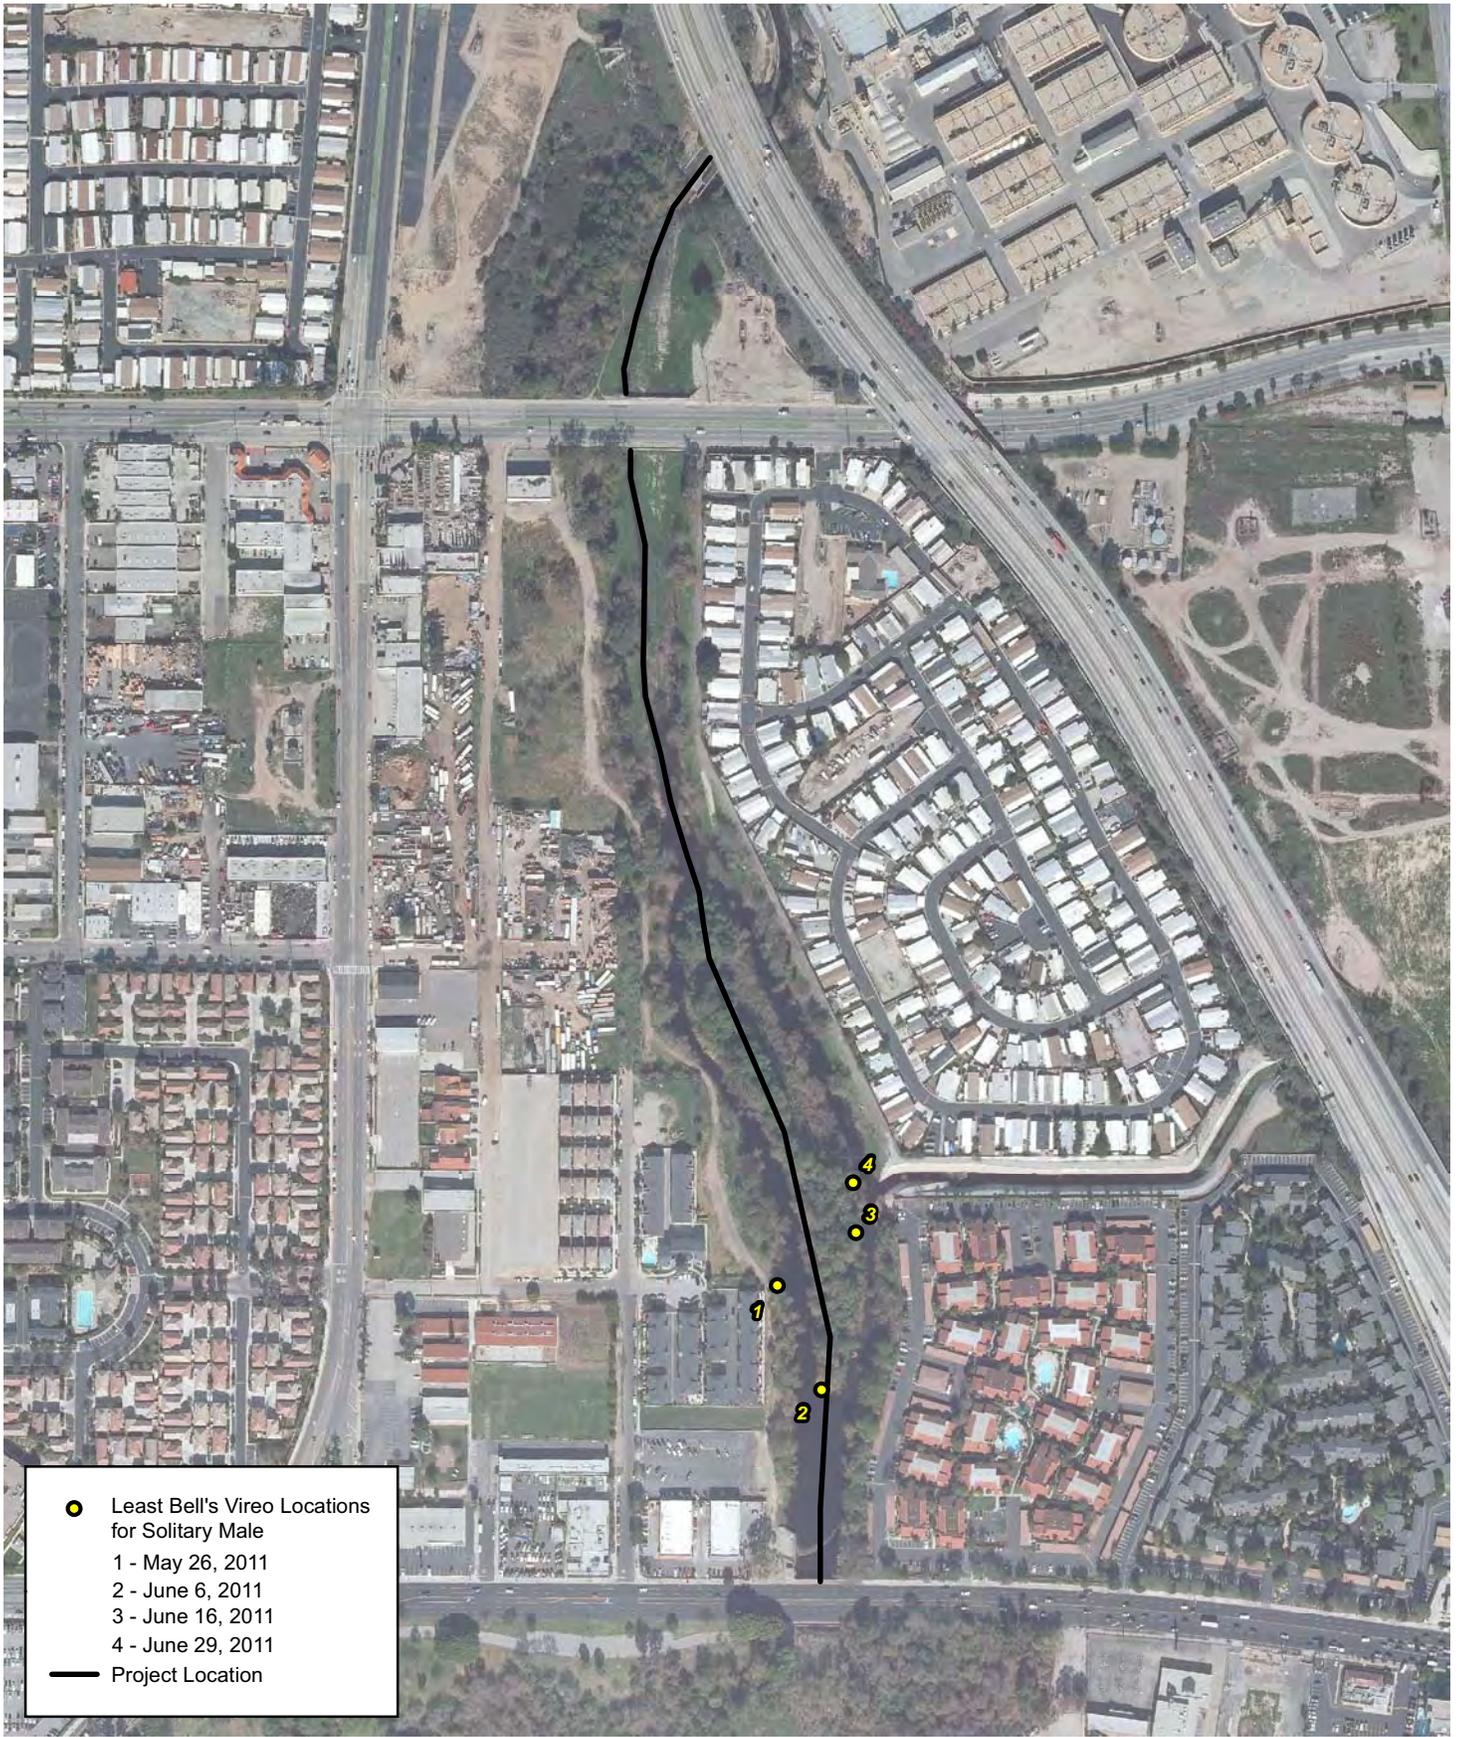
● Least Bell's Vireo Locations for Solitary Male
1 - May 26, 2011
2 - June 6, 2011
3 - June 16, 2011
4 - June 29, 2011
— Project Location
