San Francisquito Canyon Road Corridor Traffic Safety Study

Los Angeles County Public Works

February 2025

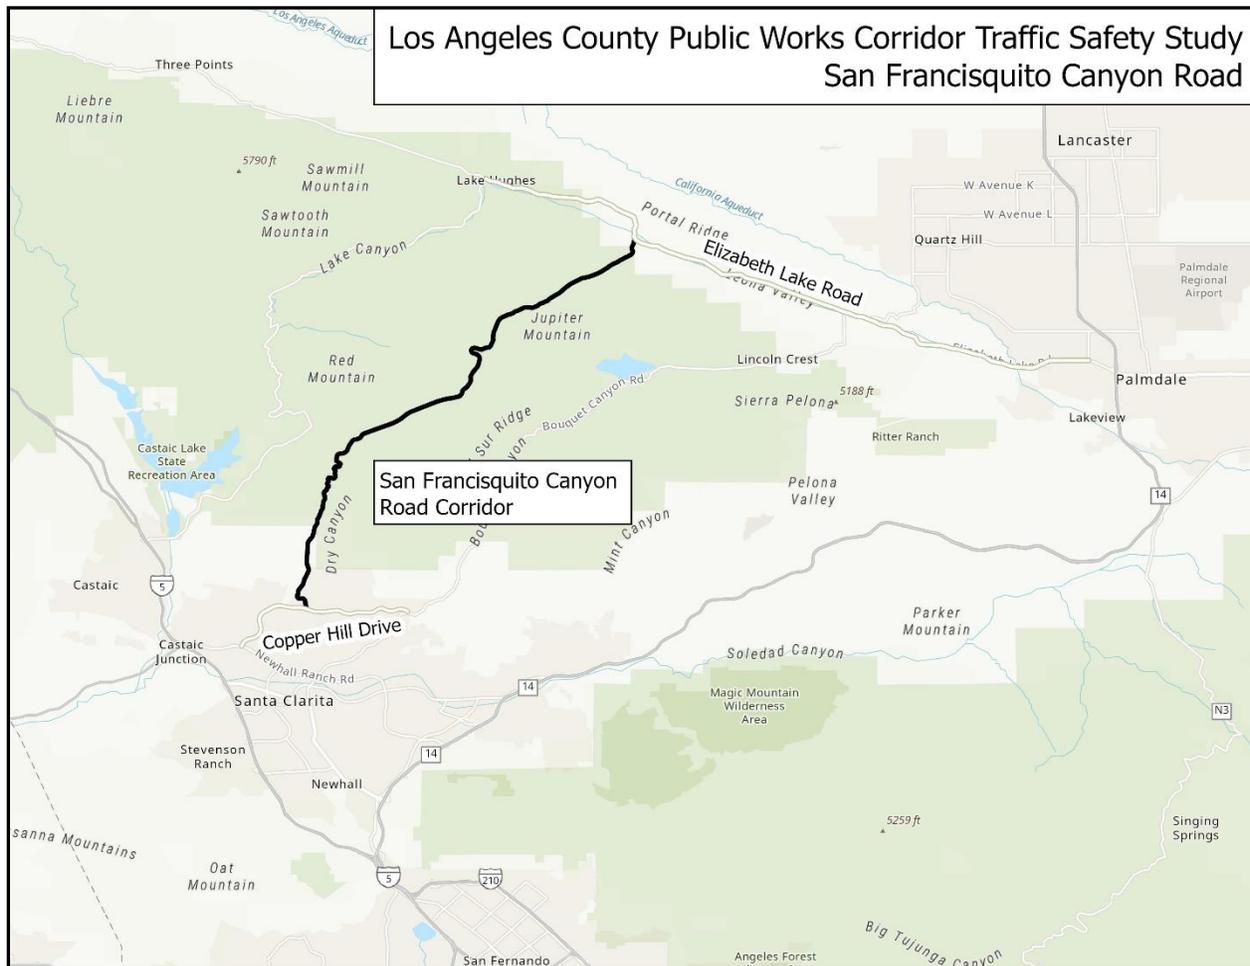
Figure 1 – Overview of San Francisquito Canyon Road from the City of Santa Clarita boundary to Elizabeth Lake Road

San Francisquito Canyon Road is 19-mile corridor bounded by Copper Hill Drive in Santa Clarita to the south and Elizabeth Lake Road in unincorporated Los Angeles County to the north. The corridor provides important connectivity to the local neighborhoods of Green Valley and for travelers between Santa Clarita and the southwestern region of the Antelope Valley. Due to a series of collisions and community concerns in recent years, a Corridor Traffic Safety Study was initiated to identify potential road safety challenges and suggest countermeasures to mitigate those safety issues. **Figure 1** illustrates the study corridor and adjacent major roads.

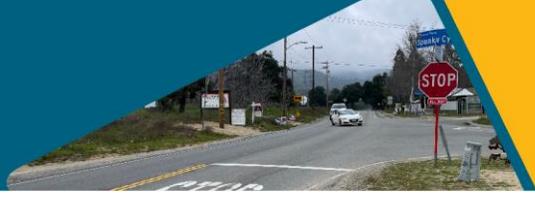
Figure 2 – Collision Diagram along Study Corridor

From 2018 to 2022, there were a total of 128 collisions, five of which resulted in fatalities and 24 resulted in severe injuries. The TIMS database does not include property damage only (PDO) collisions, so this was not included in the analysis. **Figure 2** shows an analysis of all collisions along San Francisquito Canyon Road and identifies locations with more collisions and a larger proportion of fatal/severe injuries. The figure also breaks down the collision type of all the high-severity collisions.

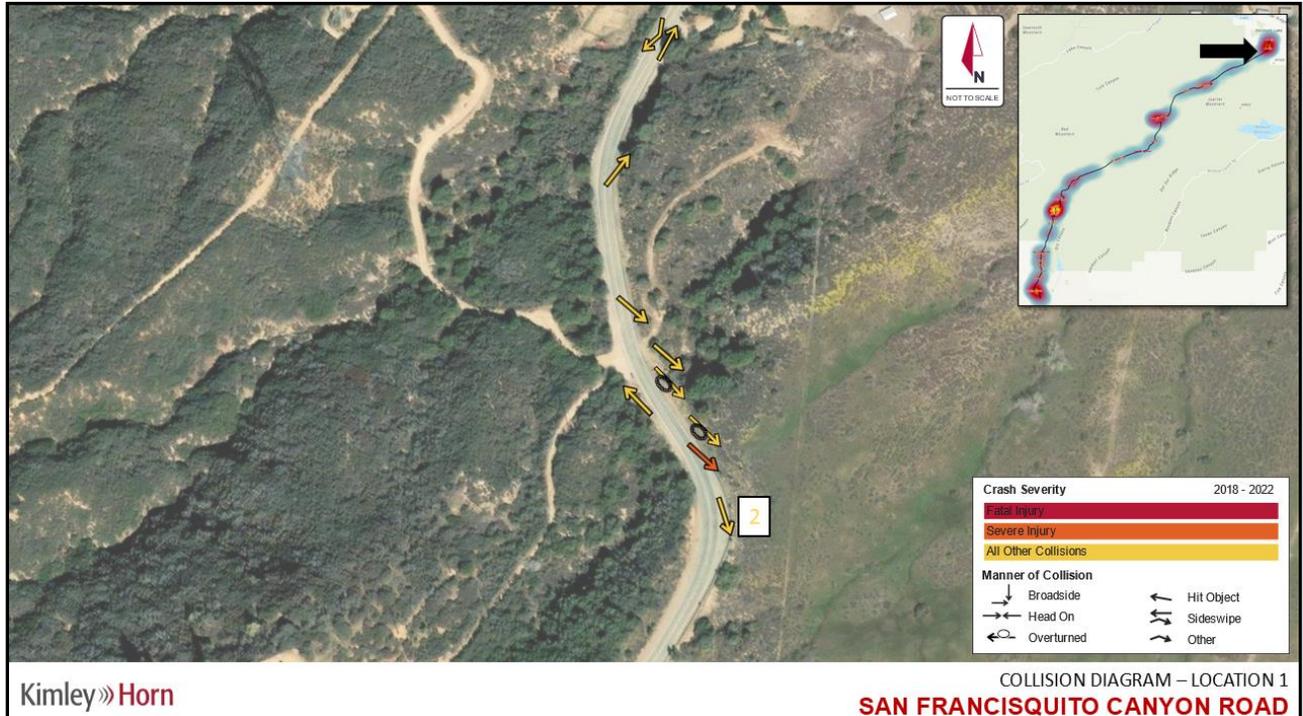
Figure 3 – Collision Diagram Location 1

Location 1 had a significant number of collisions showing drivers crossing the centerline onto the other side of the roadway and colliding with fixed objects.

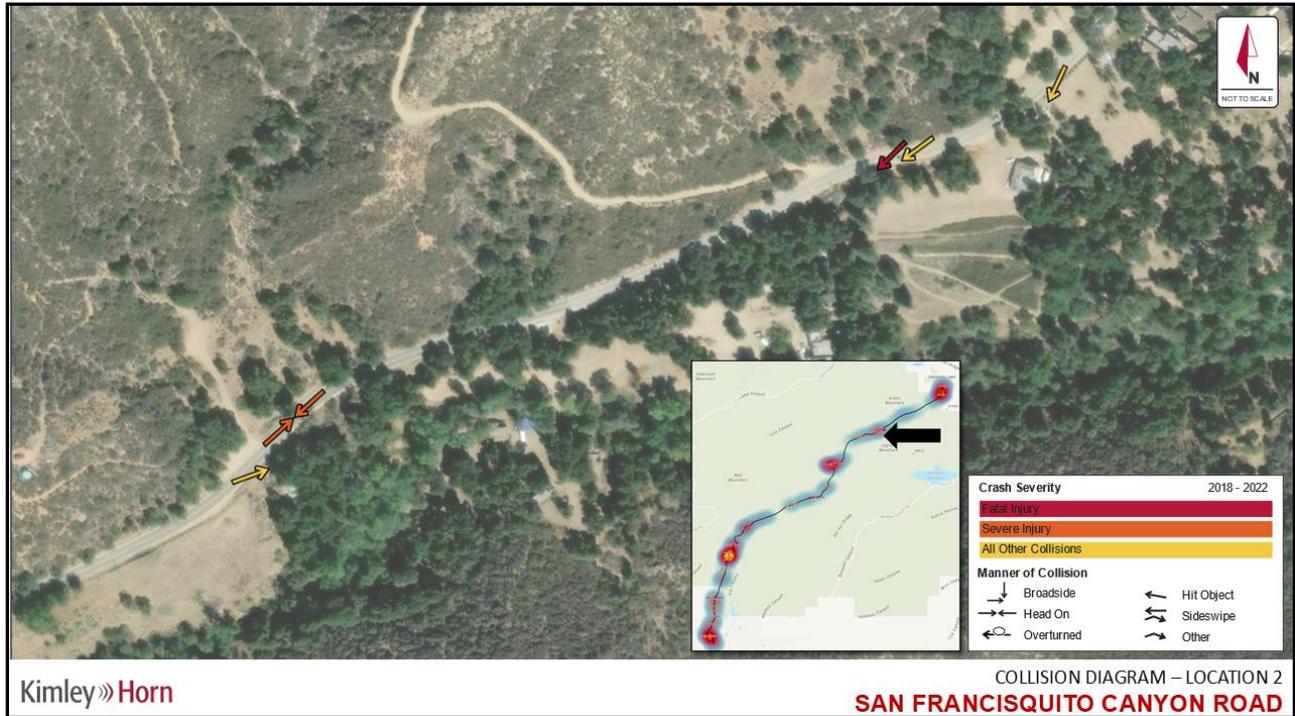
Figure 4 – Collision Diagram Location 2

Location 2 had a fatal “hit object” collision from drivers heading southbound near MM 3.53.

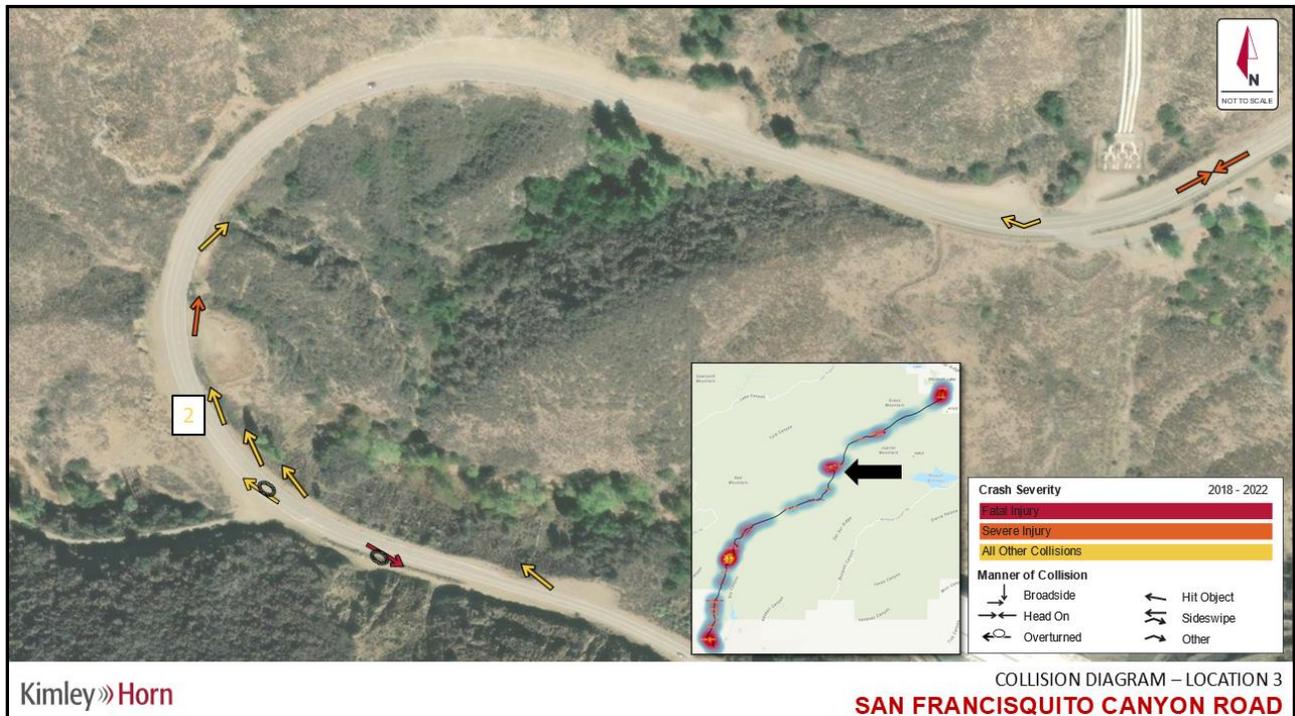
Figure 5 – Collision Diagram Location 3

Location 3 had seven “hit object” collisions in the northbound direction. This location also had an “overturned” collision resulting in a fatality.

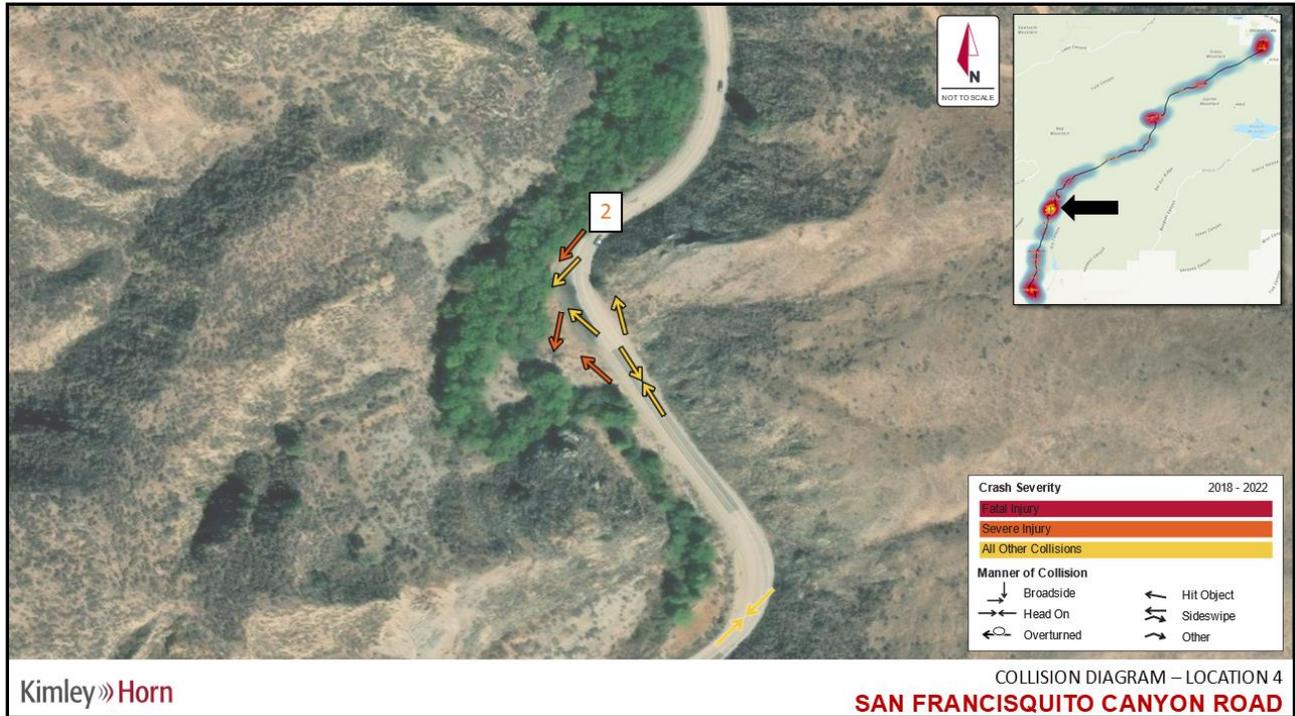
Figure 6 – Collision Diagram Location 4

Location 4 had seven “hit object” collisions near MM 14.52.

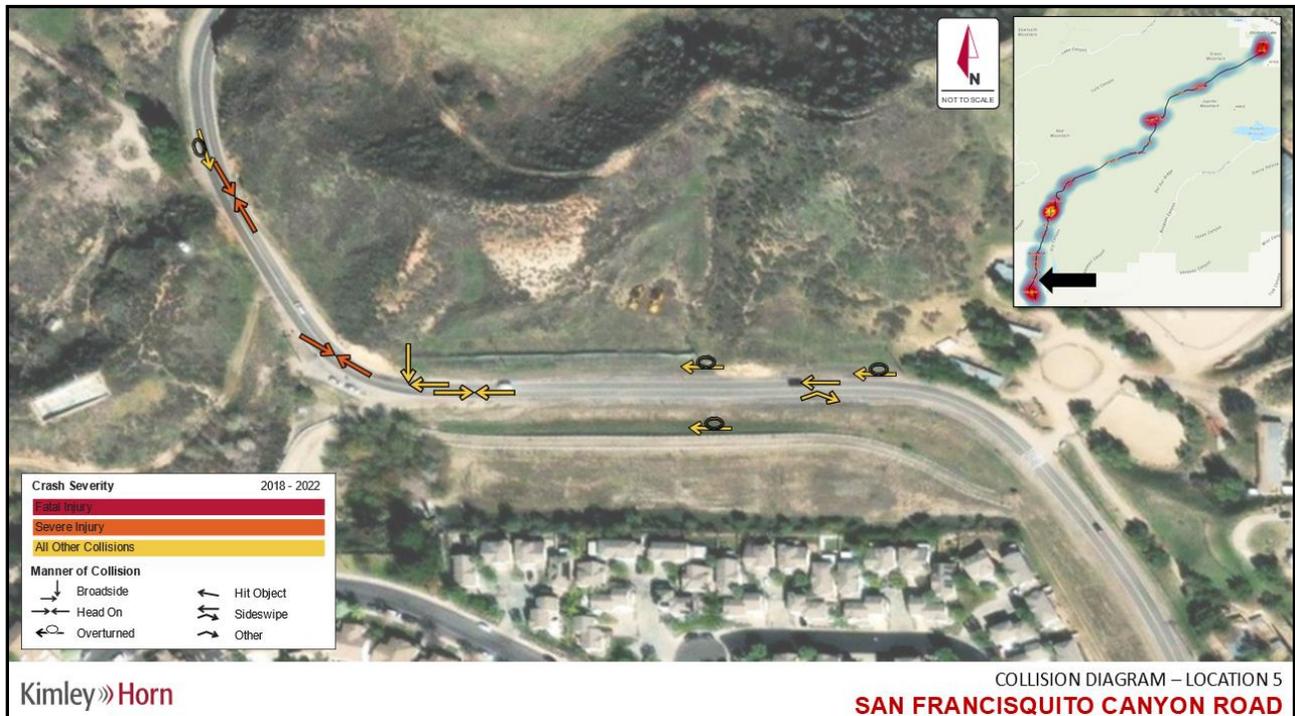
Figure 7 – Collision Diagram Location 5

Location 5 had four “overturned” and three “head-on” collisions, two of which resulted in severe injuries.

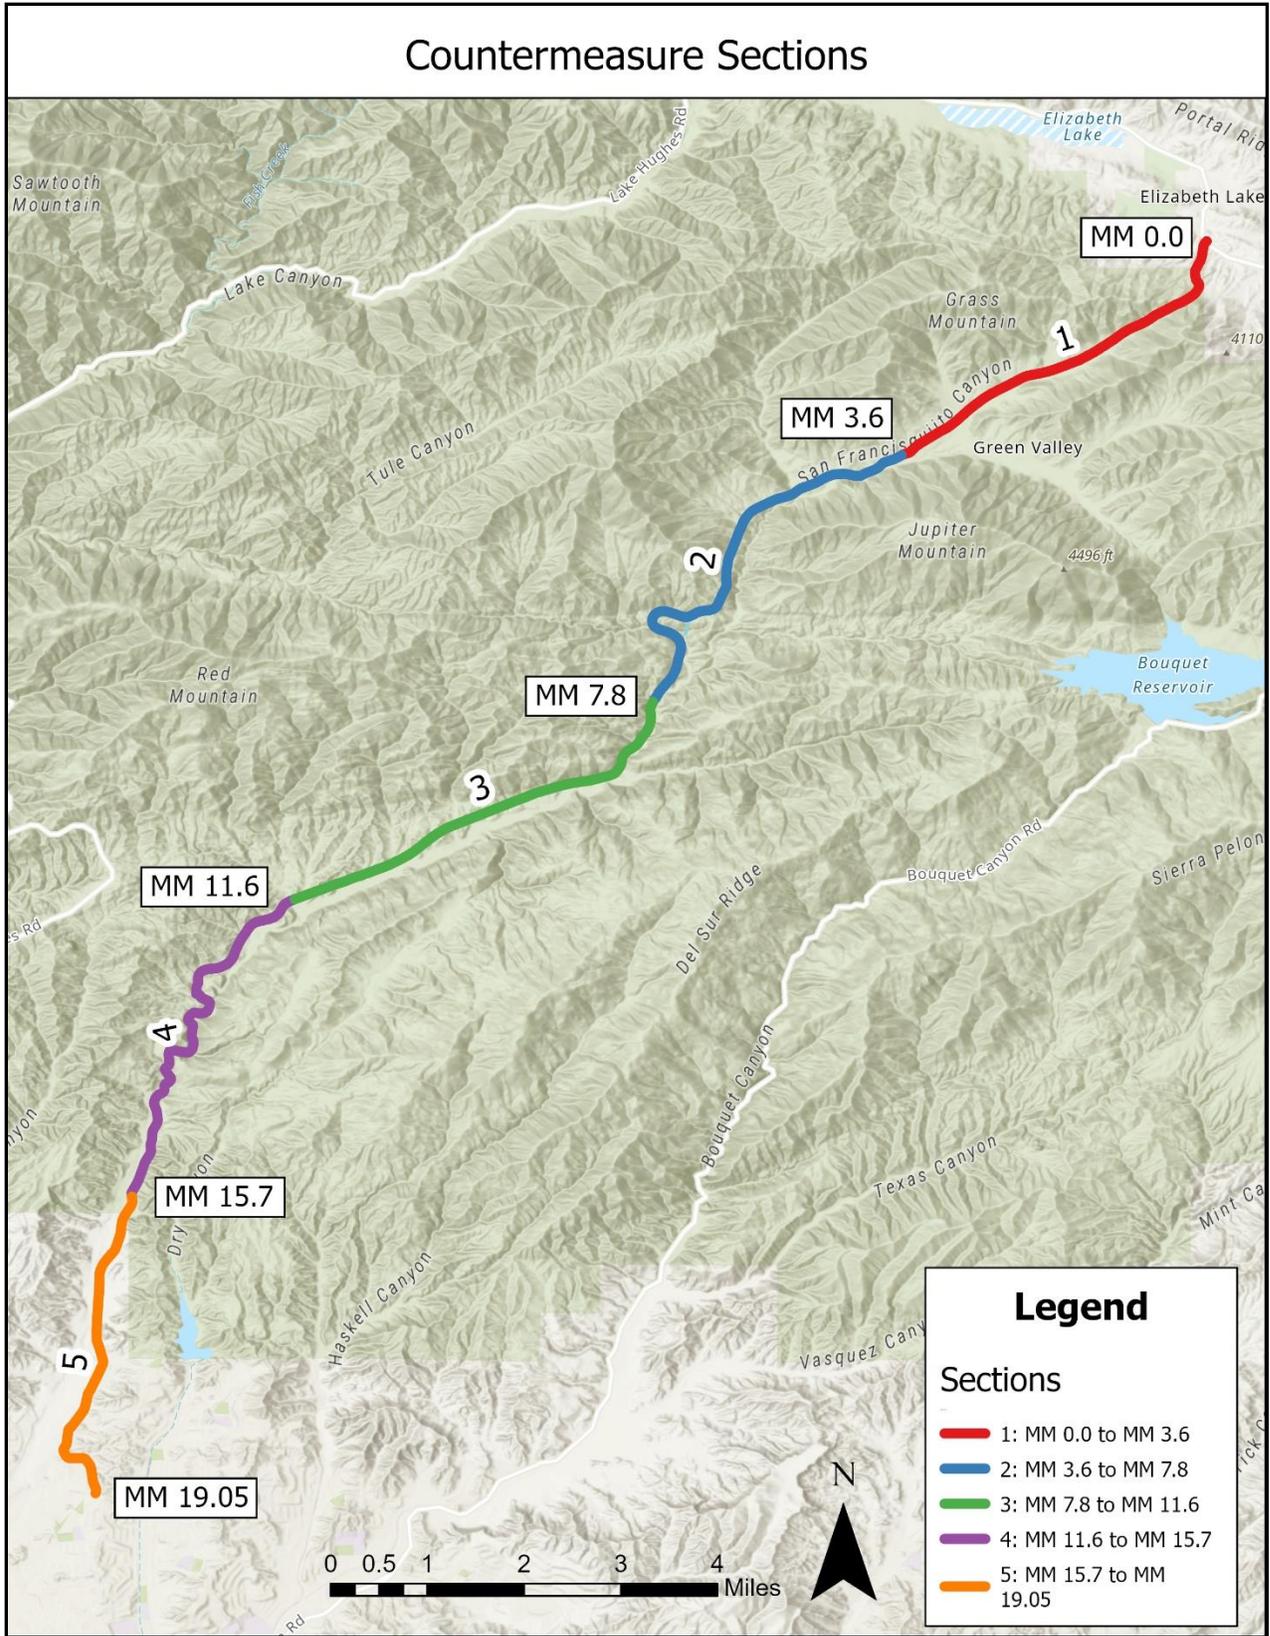
Figure 8 – Breakdown of San Francisquito Canyon Road into Five Sections

The length, diverse terrain, and design features of San Francisquito Canyon Road necessitated a breakdown of the corridor into five focus segments. The segmentation allows the County to subdivide similar improvements so they can be grouped more efficiently and allow the County to more easily apply for various types of funding. Additionally, each of these five sections have distinct attributes which have their own needs and safety improvements tailored based on the emphasis areas. The breakdown of the five sections can be seen in **Figure 8** on the following page and is discussed further in the following paragraphs.

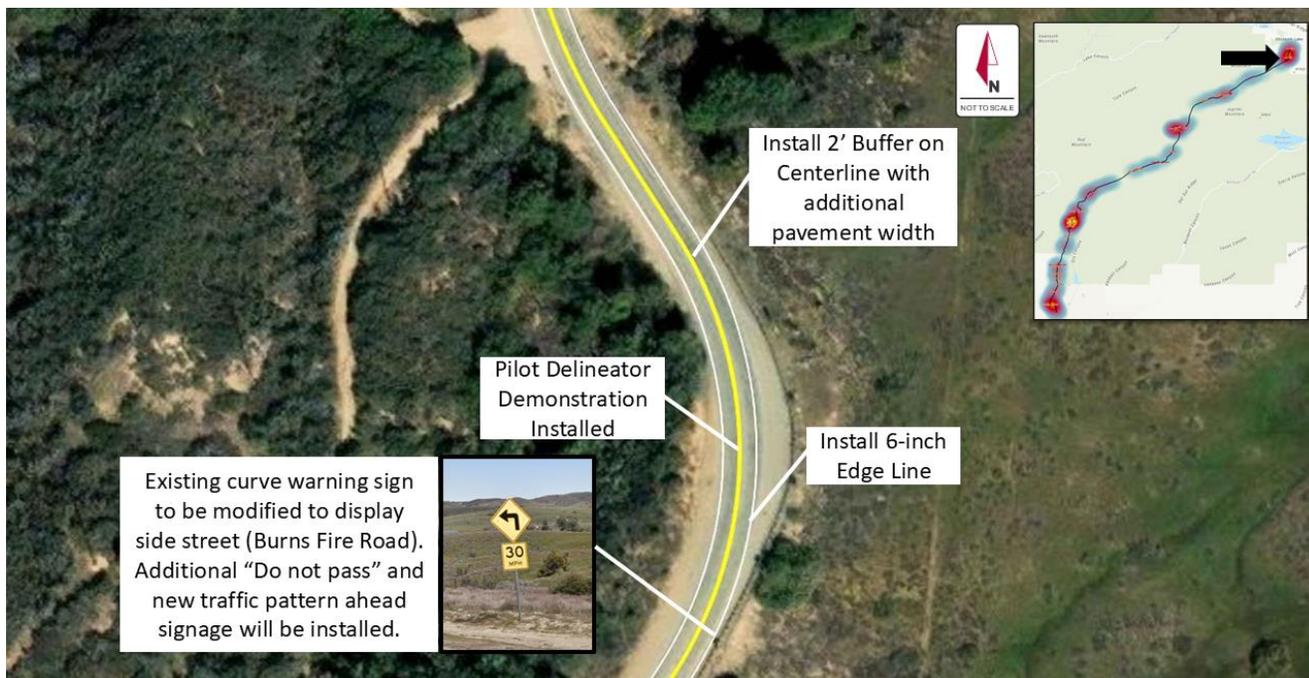
An analysis of Location A found that collisions at this location were classified as “hit object” or “overturned,” many of which occurred as drivers crossed the centerline. The collision history led to a pilot delineator installation which is being tested as a way to prevent drivers from unsafely passing along curves or other areas with a history of “head-on” collisions. The pilot delineator installation also brought additional clarity through the addition of street and warning signage.

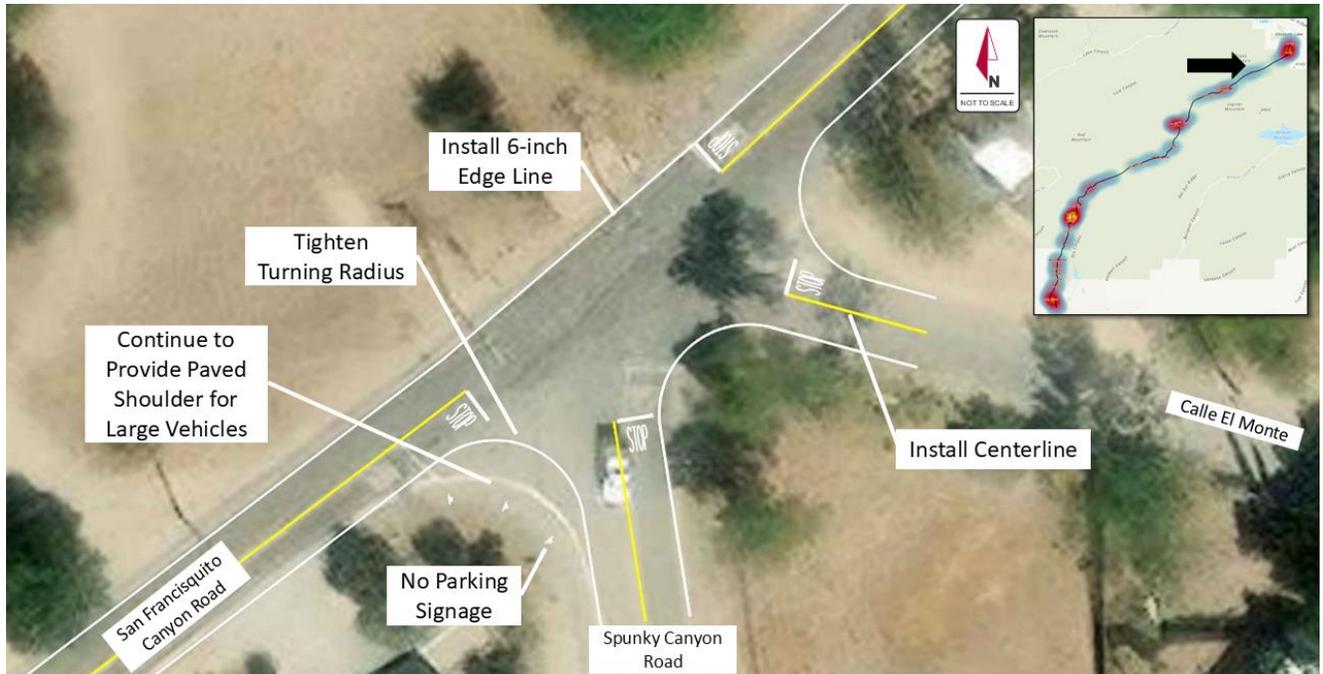
Location B involves the intersection of San Francisquito Canyon Road, Spunky Canyon Road, and Calle El Monte in Green Valley. The possibility of installing a roundabout was discussed during community outreach sessions. The idea proved to be unpopular among the community and the project team found that there would be significant issues due to the need of right-of-way acquisition. Instead, the improvements at this intersection focus on tightening the turning radius as a striping change which provides the perception to drivers to slow down prior to making any turns.

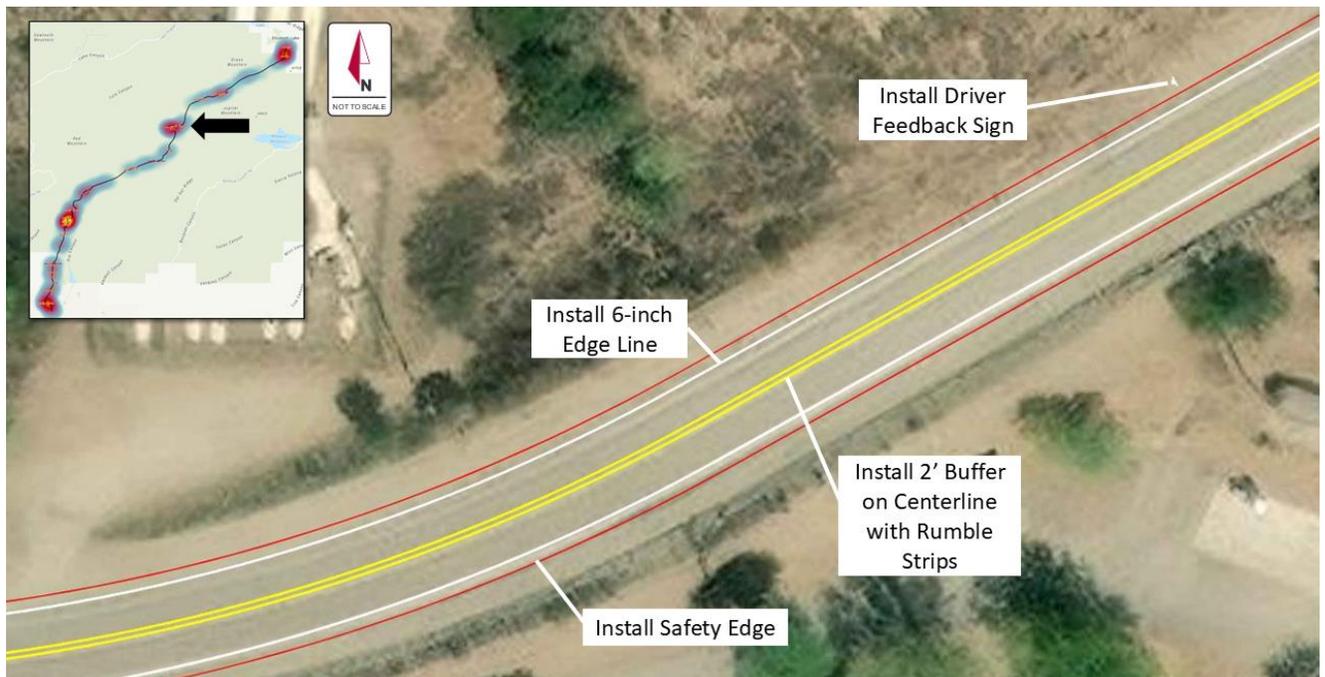
Location C's severe injury "head-on" collision north of the horseshoe curve was found to be caused due to unsafe speed. A driver speed feedback sign was proposed to reduce unsafe speeding in sensitive areas such as around curves.

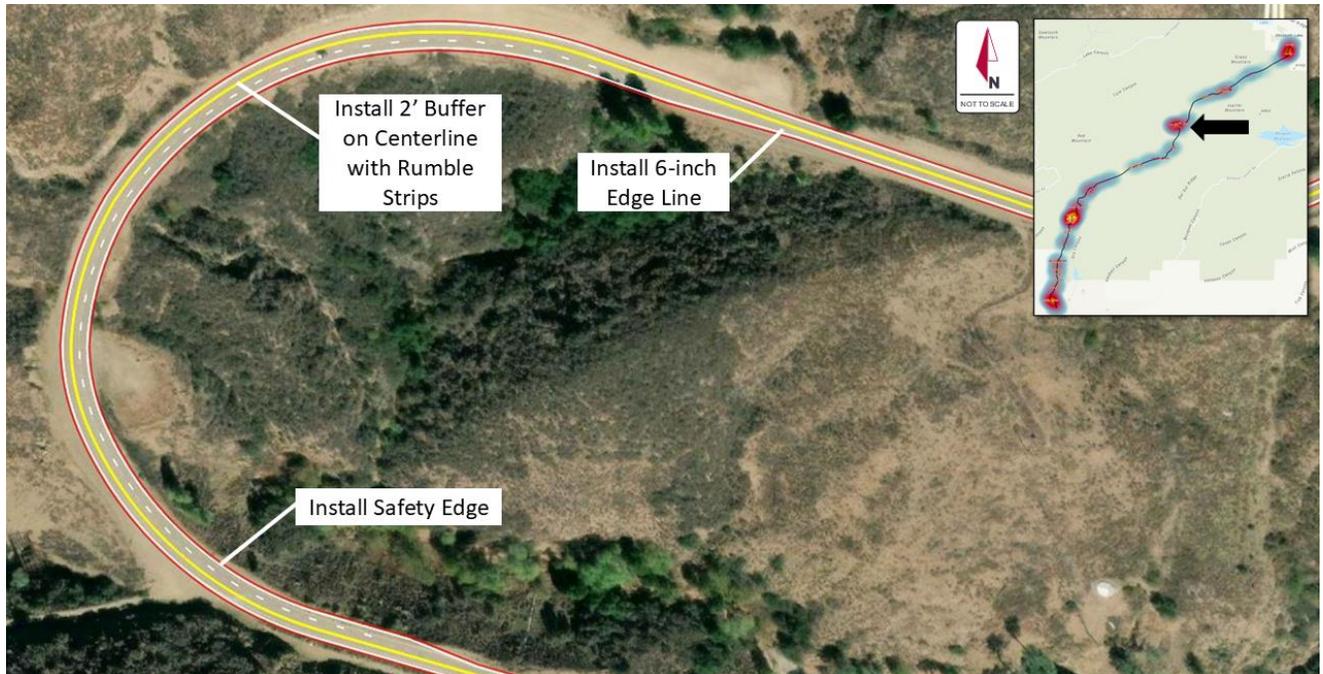
Location D has a number of run-off collisions in the northbound direction of travel off the right edge of the roadway. The corridor-wide 6-inch edge line and Safety Edge were best suited to mitigate these issues. Additionally, community feedback found that the merge of the passing lanes heading northbound were leading to several reported close calls and led to a discussion on their removal at a community outreach meeting. Further discussion on removal of the passing lane found that it was unpopular among the community as there has been an established need for additional passing lanes to prevent unsafe passing. Alternatively, extending the paved shoulder by the merge will allow drivers to not merge immediately in cases where it is unsafe and would mitigate the issue discussed. Similar to Section 1, widening the shoulder is also proposed at private driveways throughout as needed.

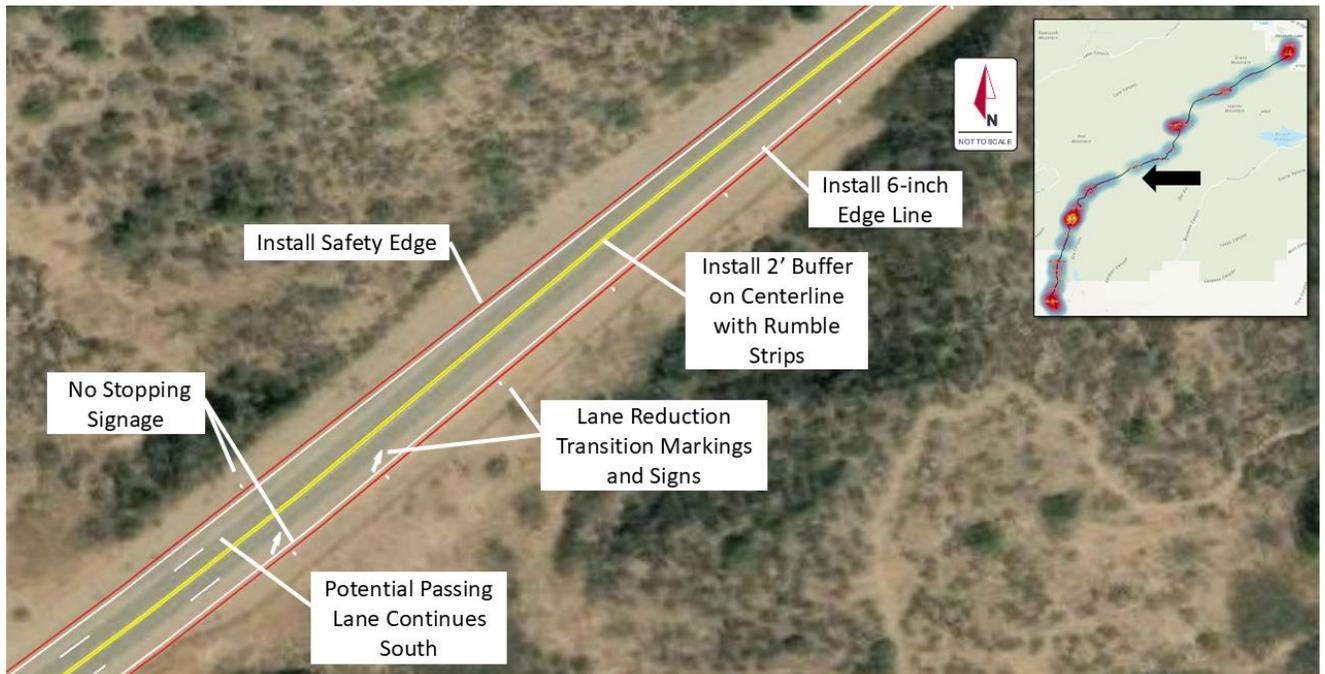
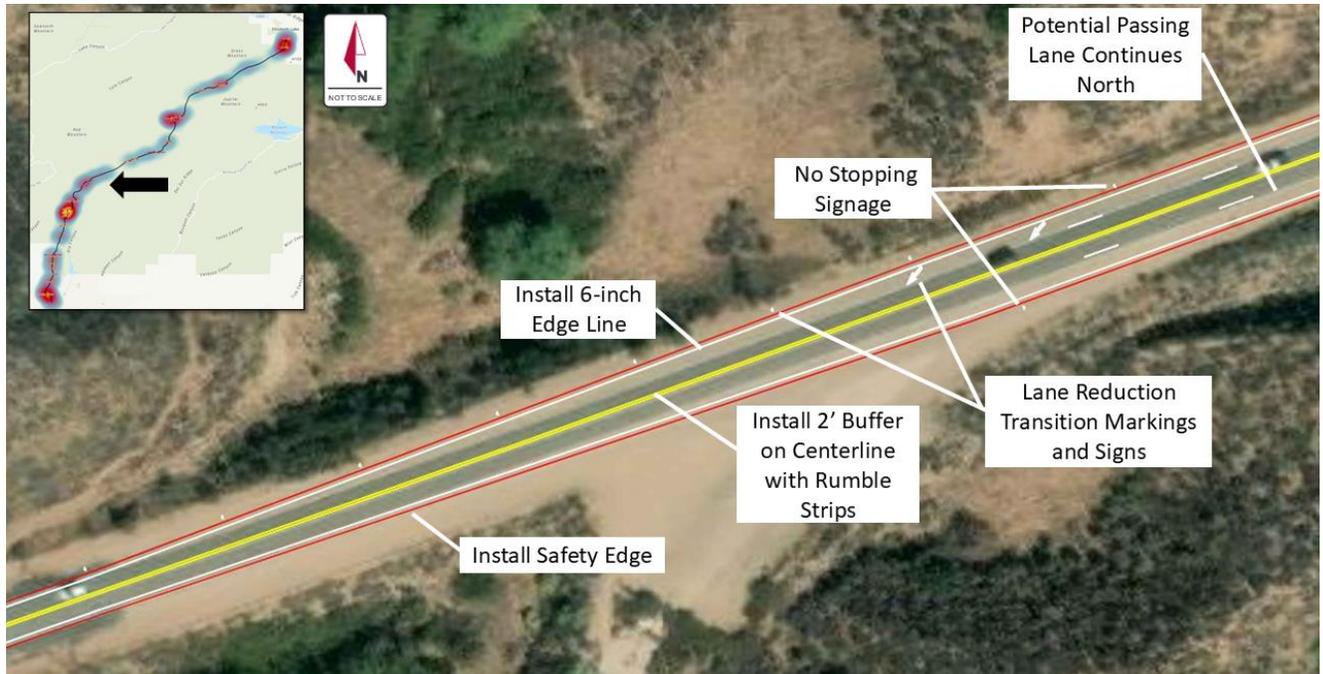
Passing Lanes are most suitable at this location due to the lack of curves in this section which has led many drivers to pass illegally and unsafely in its existing condition. The implementation of this countermeasure will allow for a safe and legal manner of passing.

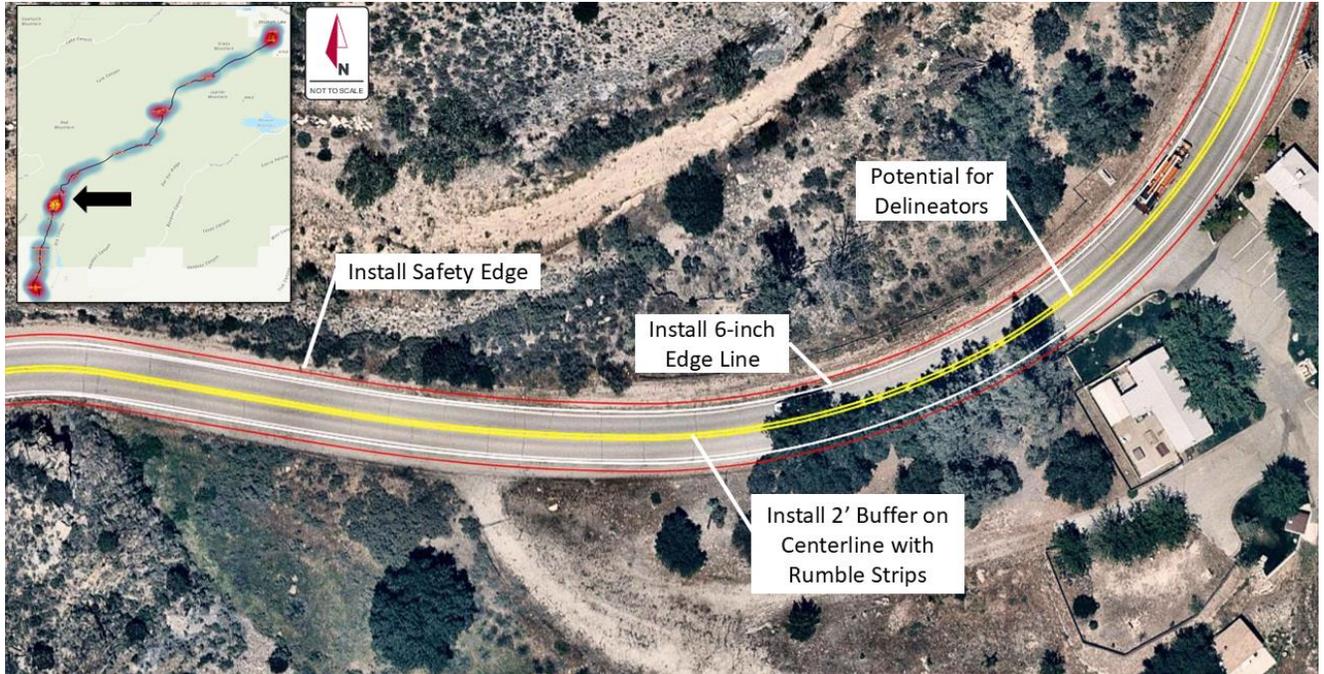
Location G was brought up by community members as an area with unsafe passing taking place. There is potential for implementing delineators along this curve to prevent drivers from performing this maneuver if the pilot program at the north end of the corridor is well received.

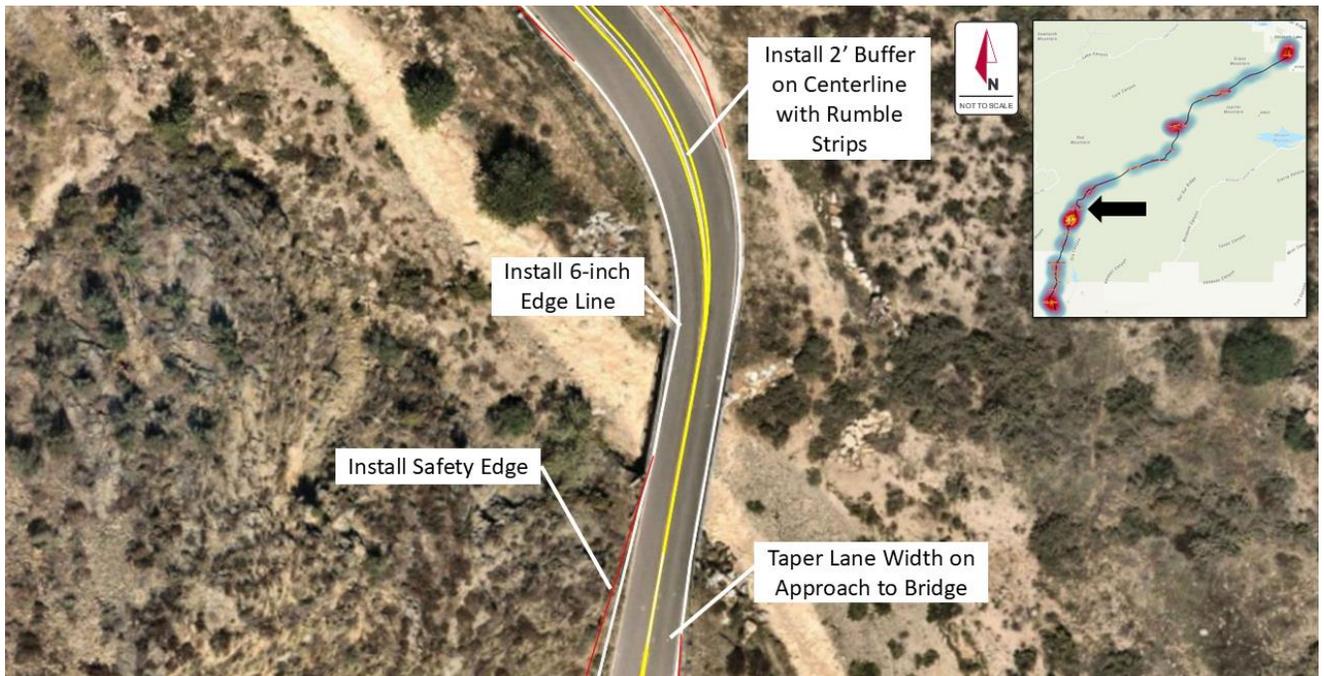
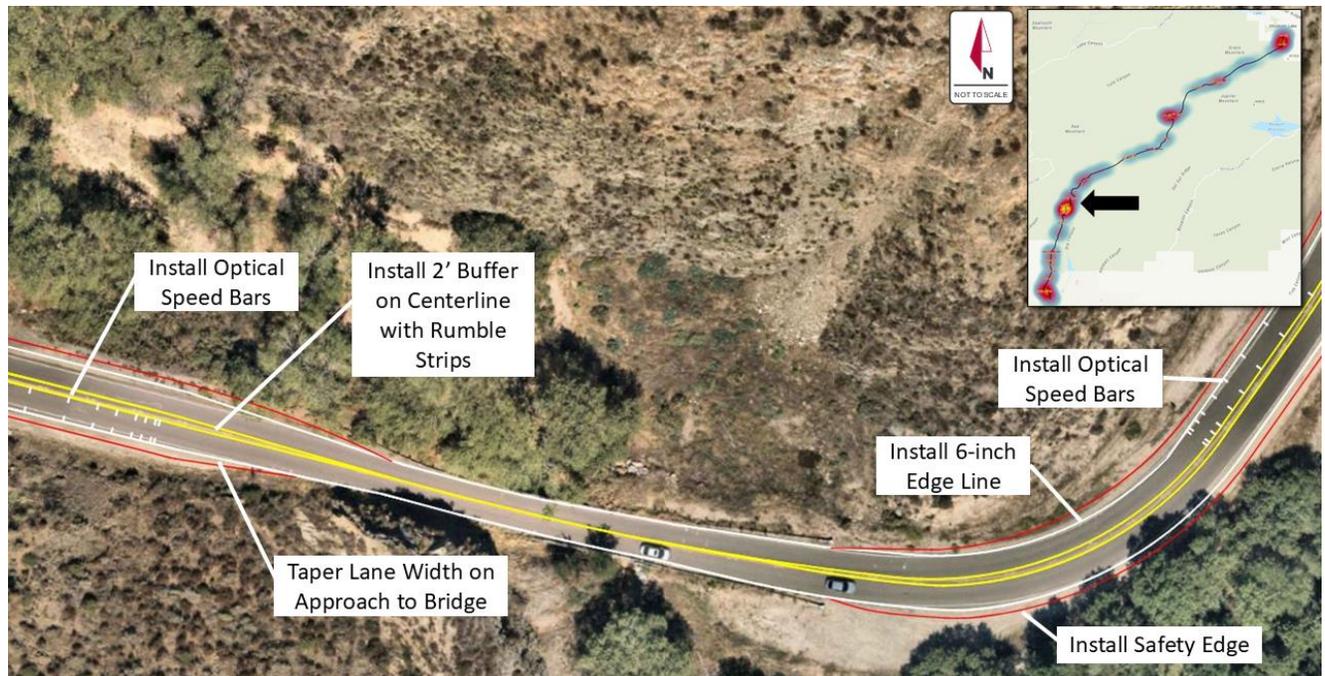
Locations H and I have similar issues with the roadway width narrowing due to a bridge. To prevent collisions at both these locations, issues with unsafe speeding should be addressed. Tapering the lane width reduces the lane width available to drivers which provides the impression that there is less room and a need to slow down. Installing optical speed bars may assist with preventing unsafe speed ahead of the curve and bridge, by giving an illusion to drivers that they are speeding up.

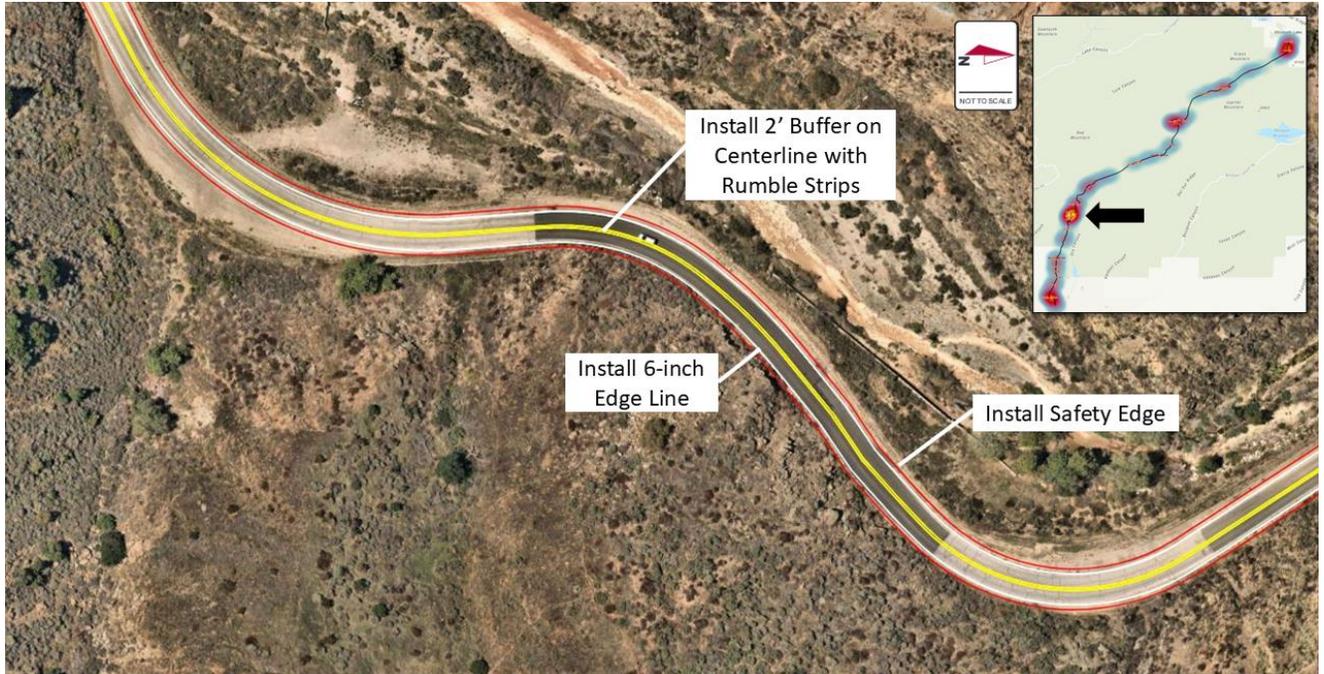
Location J is a series of sharp curves near MM 14.51. The corridor-wide proposed improvements of enhanced roadway striping (6-inch edge line), Safety Edge, and centerline buffers and centerline rumble strips would serve as the most ideal implementation at this location.

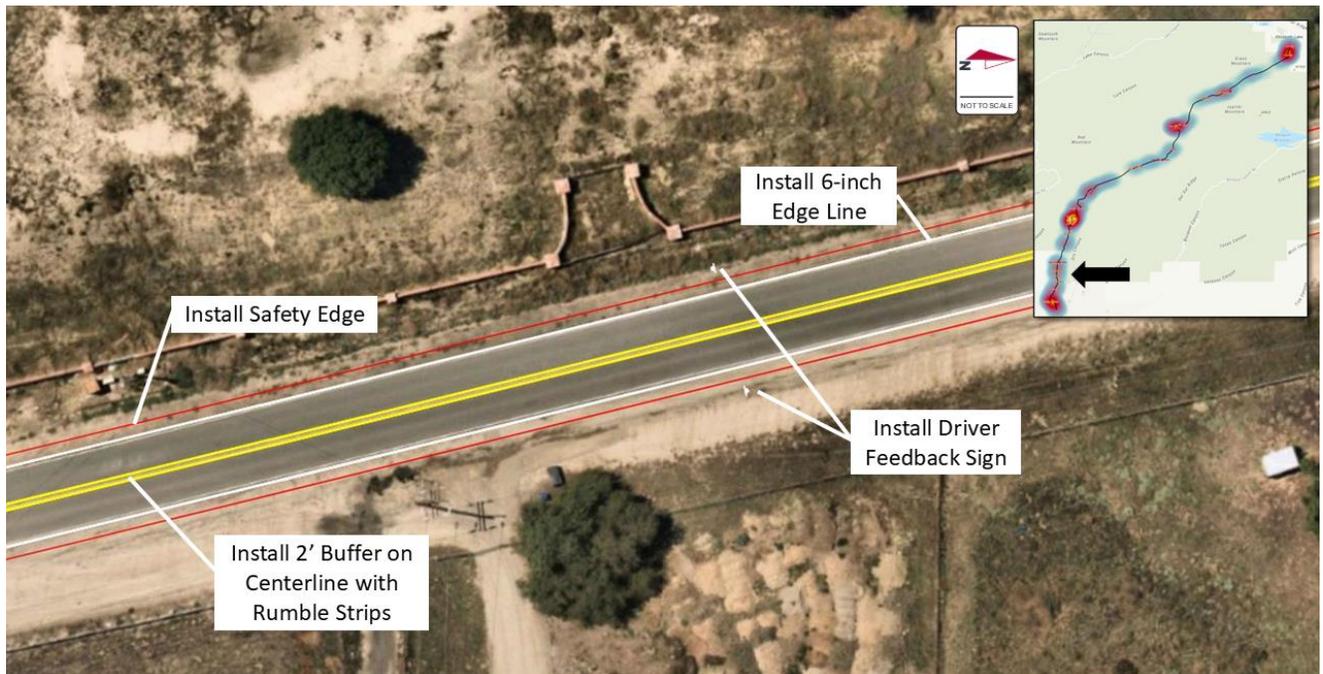
Location L proposes a driver speed feedback sign to remind drivers of their speed and to reduce unsafe speeding.

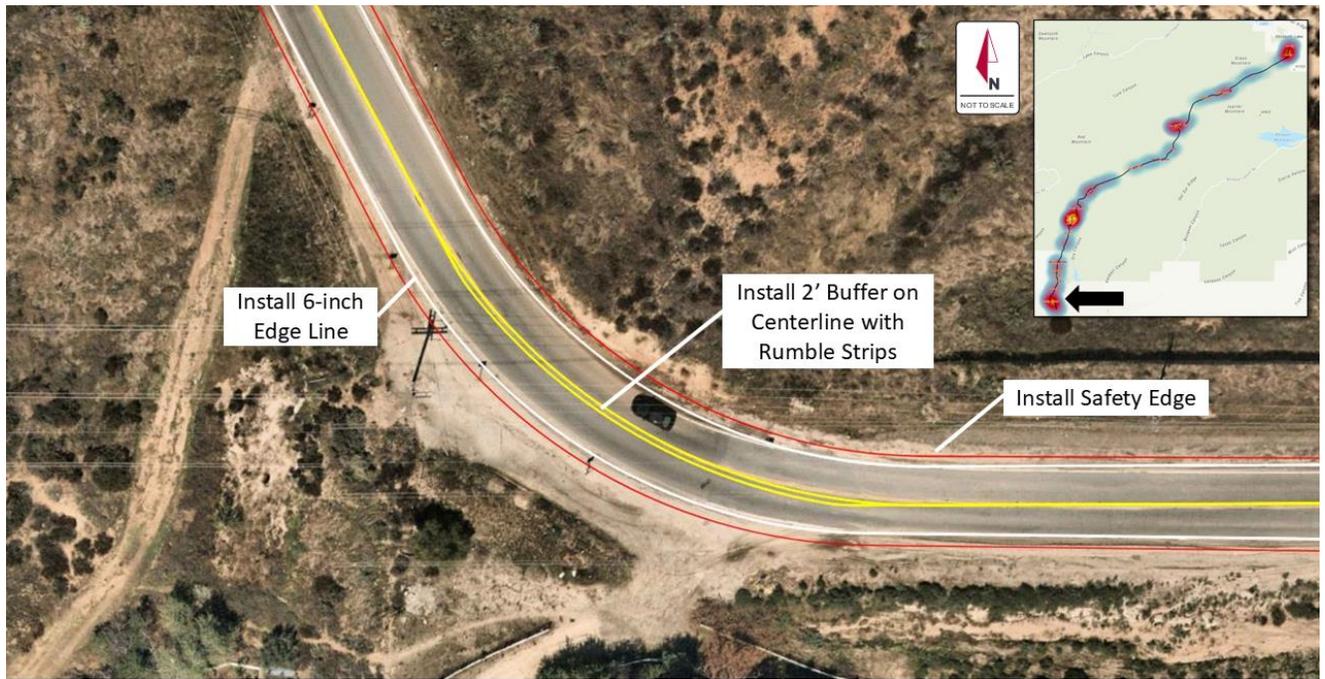
Location M has two severe injury “head-on” collisions and the corridor-wide implementation of a 2-foot buffer with rumble strips along curves is recommended to enhance safety at this location. In addition, transverse rumble strips are recommended to alert drivers of equestrian crossings utilized by the local community.

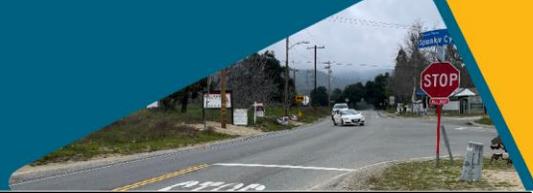
Figure 10 – Collision Diagram along Study Corridor

Figure 10 analyzes all collisions along San Francisquito Canyon Road to find locations with more collisions and a larger proportion of fatal/severe injuries. The figure also breaks down the collision type of all the high severity collisions. Most of these collision types are made up of “hit object” as discussed in **Table 4**.

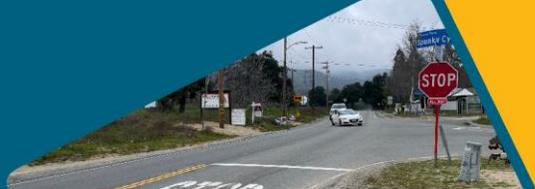
Figure 12 – Curve Radii along San Francisco Canyon Road

The curve radii along San Francisquito Canyon Road were measured for curves up to a radius 1,500 feet and are depicted in **Figure 12**. The radius affects the speed at which a driver is able to safely negotiate a curve as a smaller radius indicates a sharper turn that needs to be taken at a lower speed. The road alignment, ball bank data, and curve radii were considered together to ensure that the speed advisory signs display a safe speed needed to navigate the curves along the roadway.
