San Francisquito Canyon Road Corridor Traffic Safety Study

Los Angeles County Public Works

February 2025

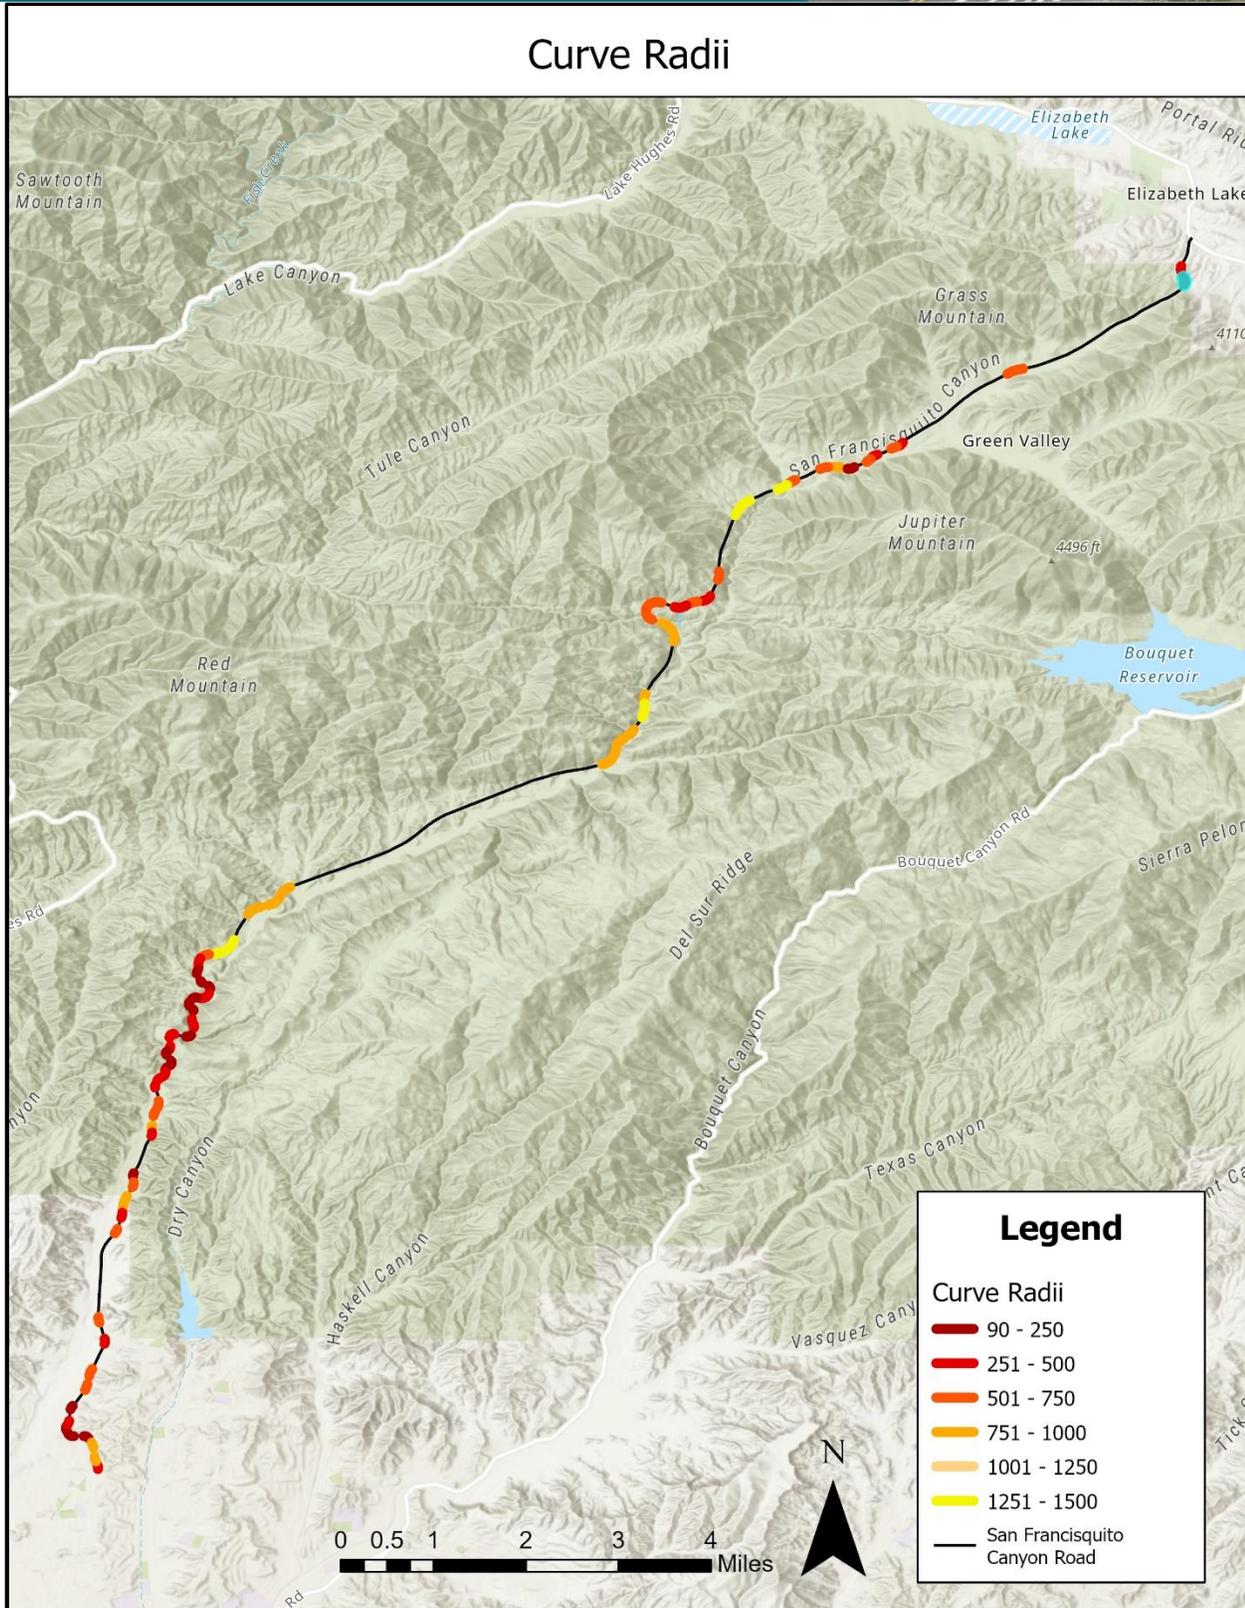
Figure 12 – Curve Radii along San Francisco Canyon Road

The curve radii along San Francisquito Canyon Road were measured for curves up to a radius 1,500 feet and are depicted in **Figure 12**. The radius affects the speed at which a driver is able to safely negotiate a curve as a smaller radius indicates a sharper turn that needs to be taken at a lower speed. The road alignment, ball bank data, and curve radii were considered together to ensure that the speed advisory signs display a safe speed needed to navigate the curves along the roadway.

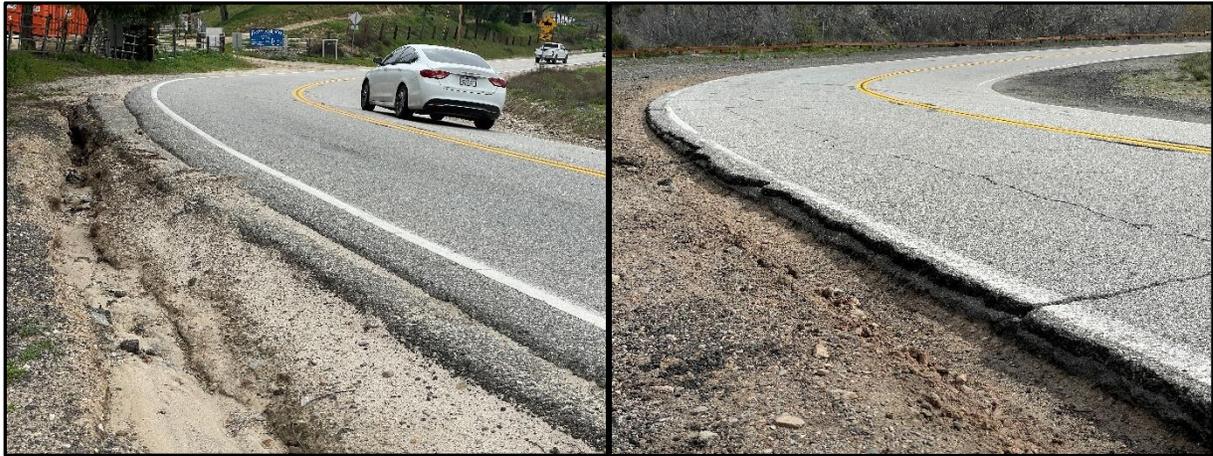
Figure 13 – Steep Erosion along Roadway

Observation #1 – Rainfall has led to erosion along the edge of the roadway.

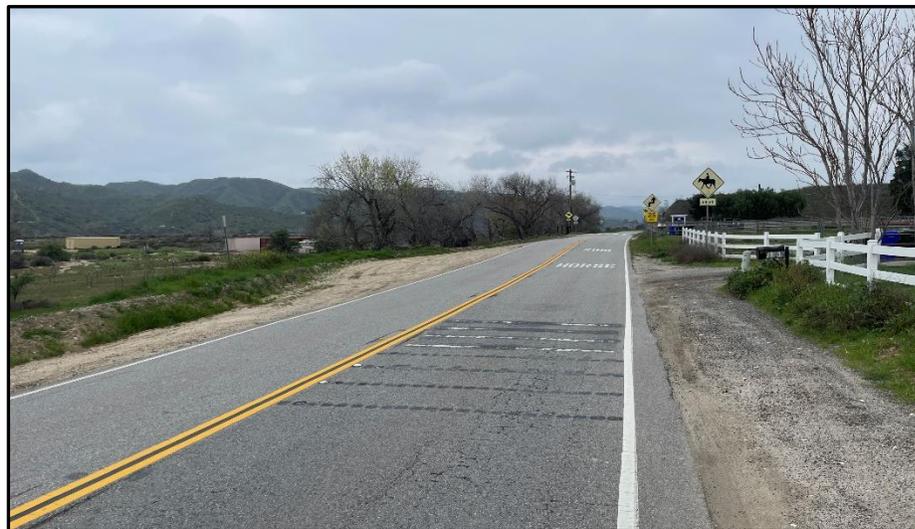
Figure 14 – Equestrian Crossings with Deteriorated Transverse Rumble Strips

Observation #2 – There are multiple equestrian crossings along the study corridor marked with signs and crosswalks. A few locations have transverse rumble strips that show signs of wear.

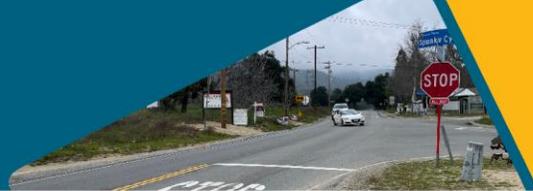
Figure 15 – Existing Centerline Rumble Strips

Observation #3 – Centerline rumble strips exist on the northern 6-mile portion of the study corridor, including through Green Valley.

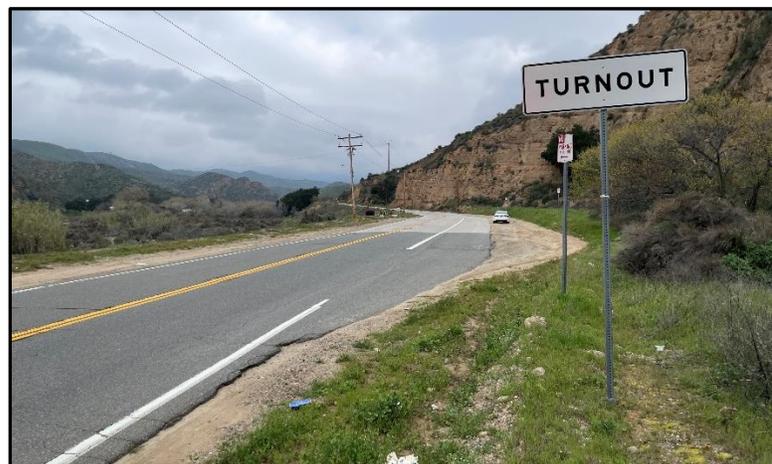
Figure 16 – 200-Foot Turnout for Northbound Drivers located by MM 15.62

Observation #4 – There are some existing turnout lanes along the route.

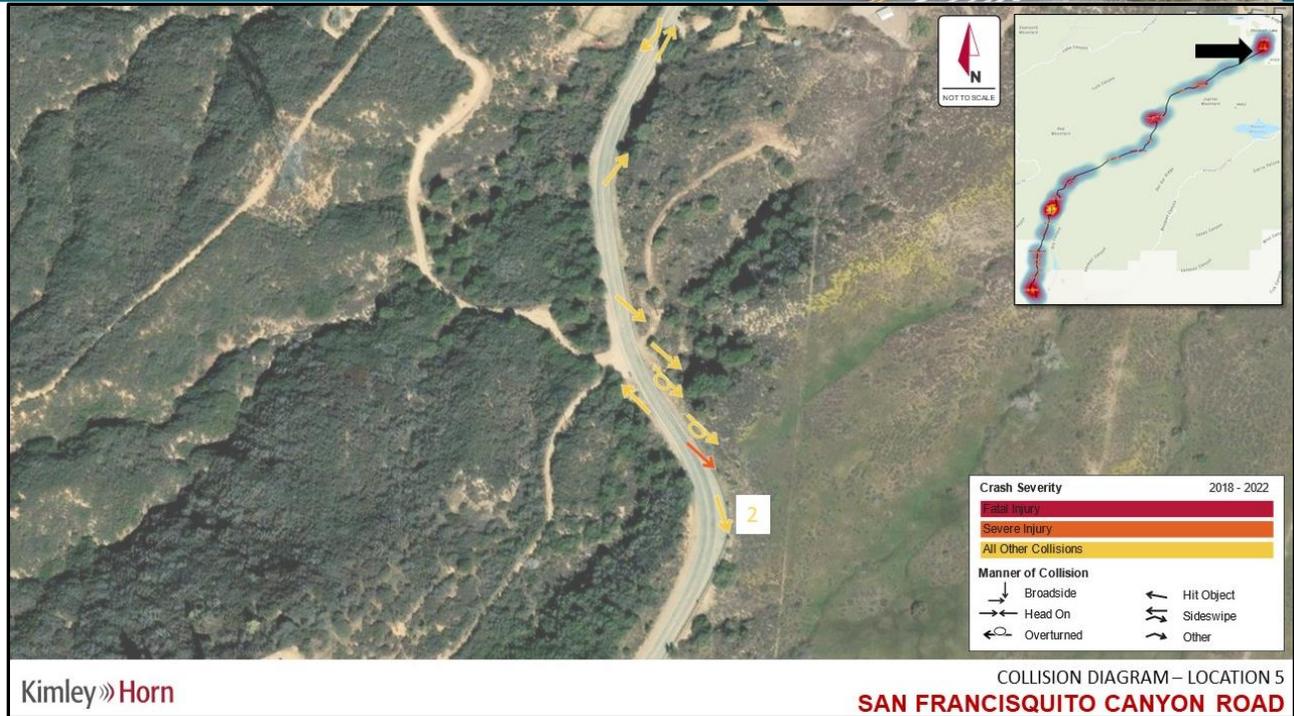
Figure 17 – Five Focus Locations

Location 1 had a four “overturned” and three “head-on” collisions, two of which resulted in severe injuries. Location 2 had seven “hit object” collisions near MM 14.52. Location 3 had seven “hit object” collisions in the northbound direction. This location also had an “overturned” collision resulting in a fatality. Location 4 had a fatal “hit object” collision from a vehicle heading southbound near MM 3.53. Location 5 had a significant number of collisions showing drivers crossing the centerline onto the other side of the roadway and colliding with fixed objects. These five locations will serve as focus locations for further analysis.

The observed data from the collision data, constituent feedback, and field visit led to several spot locations of which greater focus would result in the largest impact. **Figure 17** shows the initial five locations overlaid with collision data provided from TIMS.
