Corridor Traffic Safety Study San Francisquito Canyon Road

Community Outreach Meeting

Project Overview

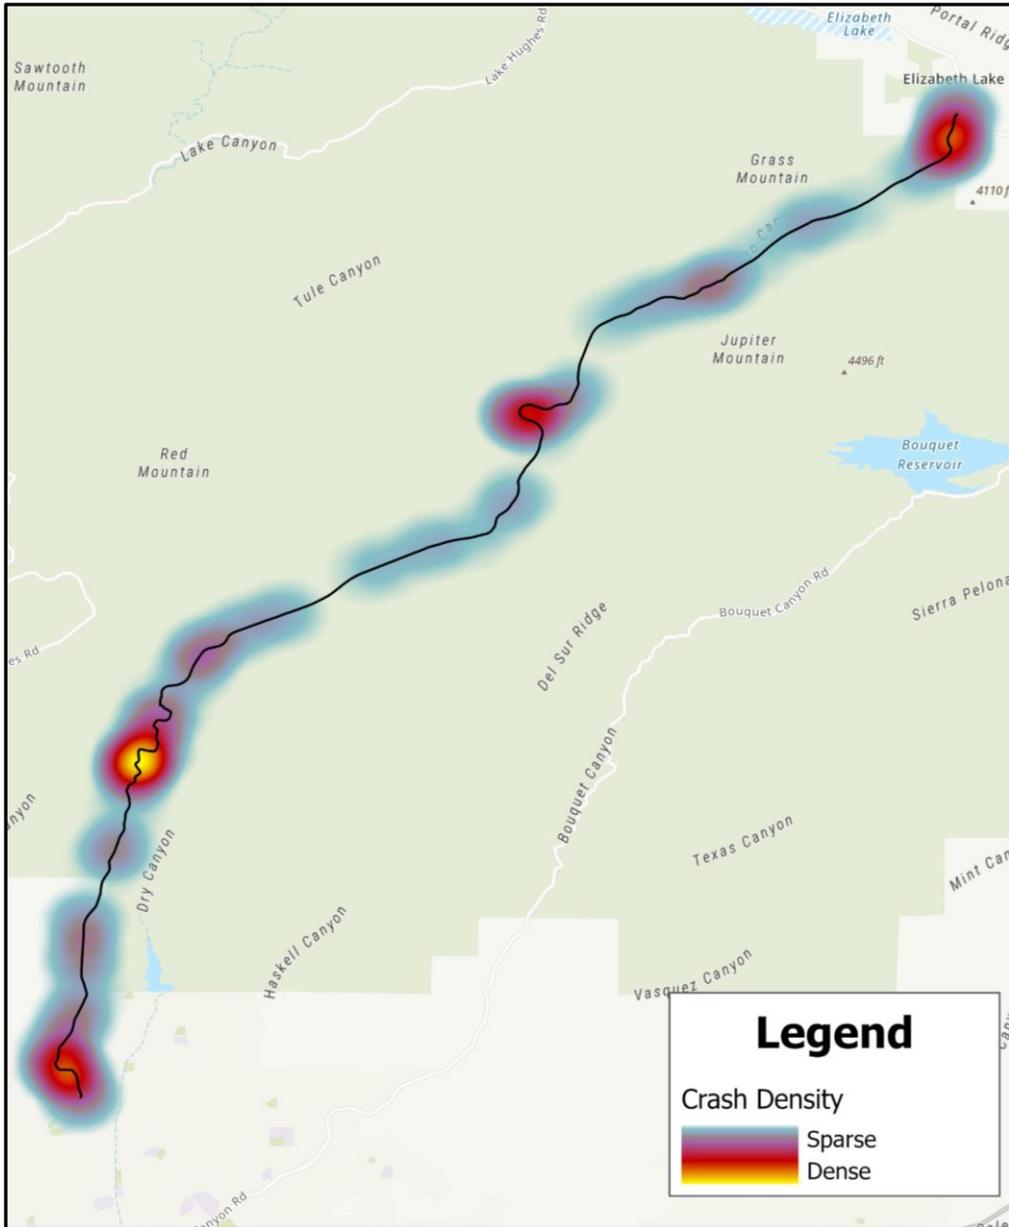
- *Crash data: January 1, 2018 – December 31, 2022
- 128 injury crashes throughout the 5-year analysis period
- Heat Map details areas with the most crashes and details where fatal/severe injury crashes occurred

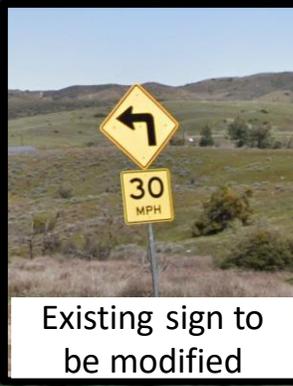
Existing sign to be modified

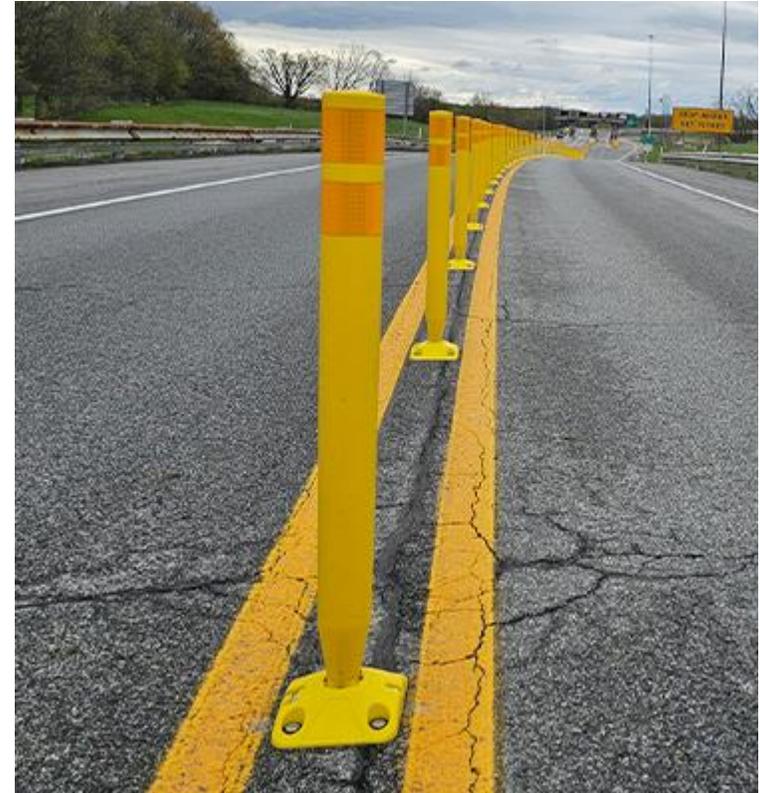
Delineators

- Retroreflective devices mounted in a series along centerline of roadway

- Prevents drivers from illegally passing along curves
- Provides additional visibility

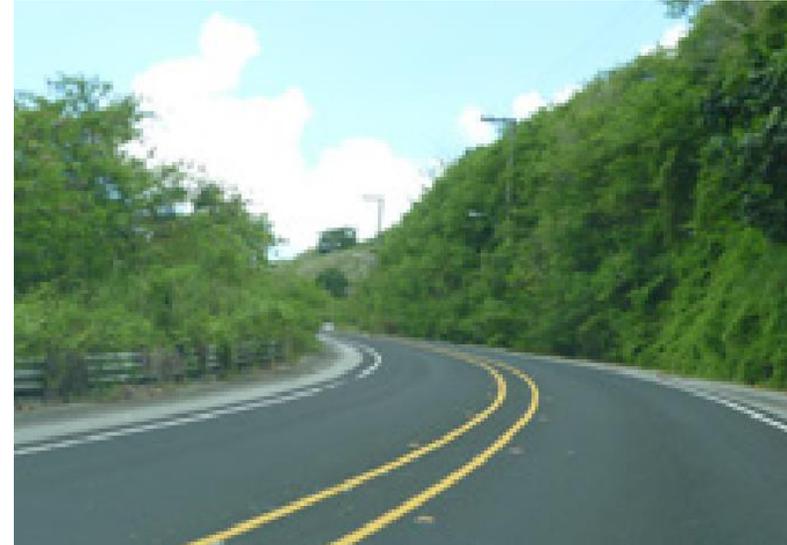
Centerline Buffer

- Provides extra space between two solid center line markings

- Further separates opposing directions of traffic

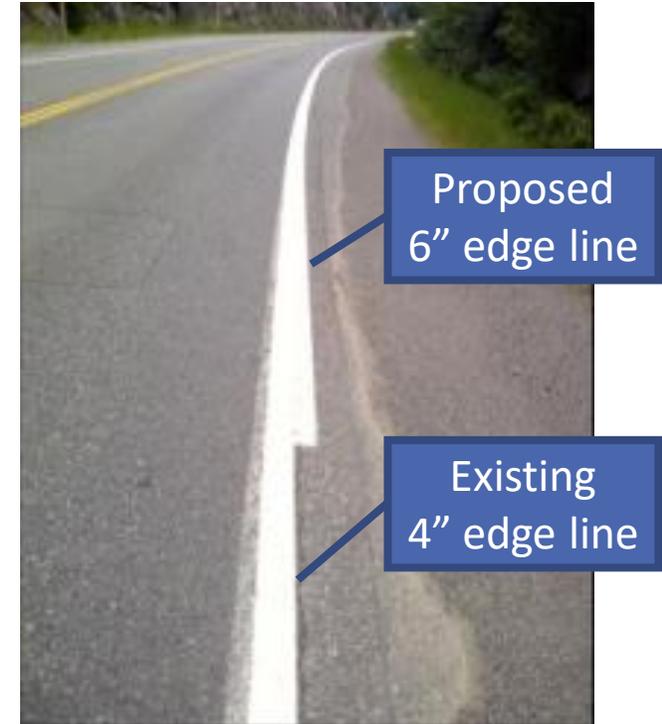
Enhanced Roadway Striping

- Delineates wider edge lines by going from 4" to 6" in thickness

- Provides additional visibility to drivers of existing edge of roadway

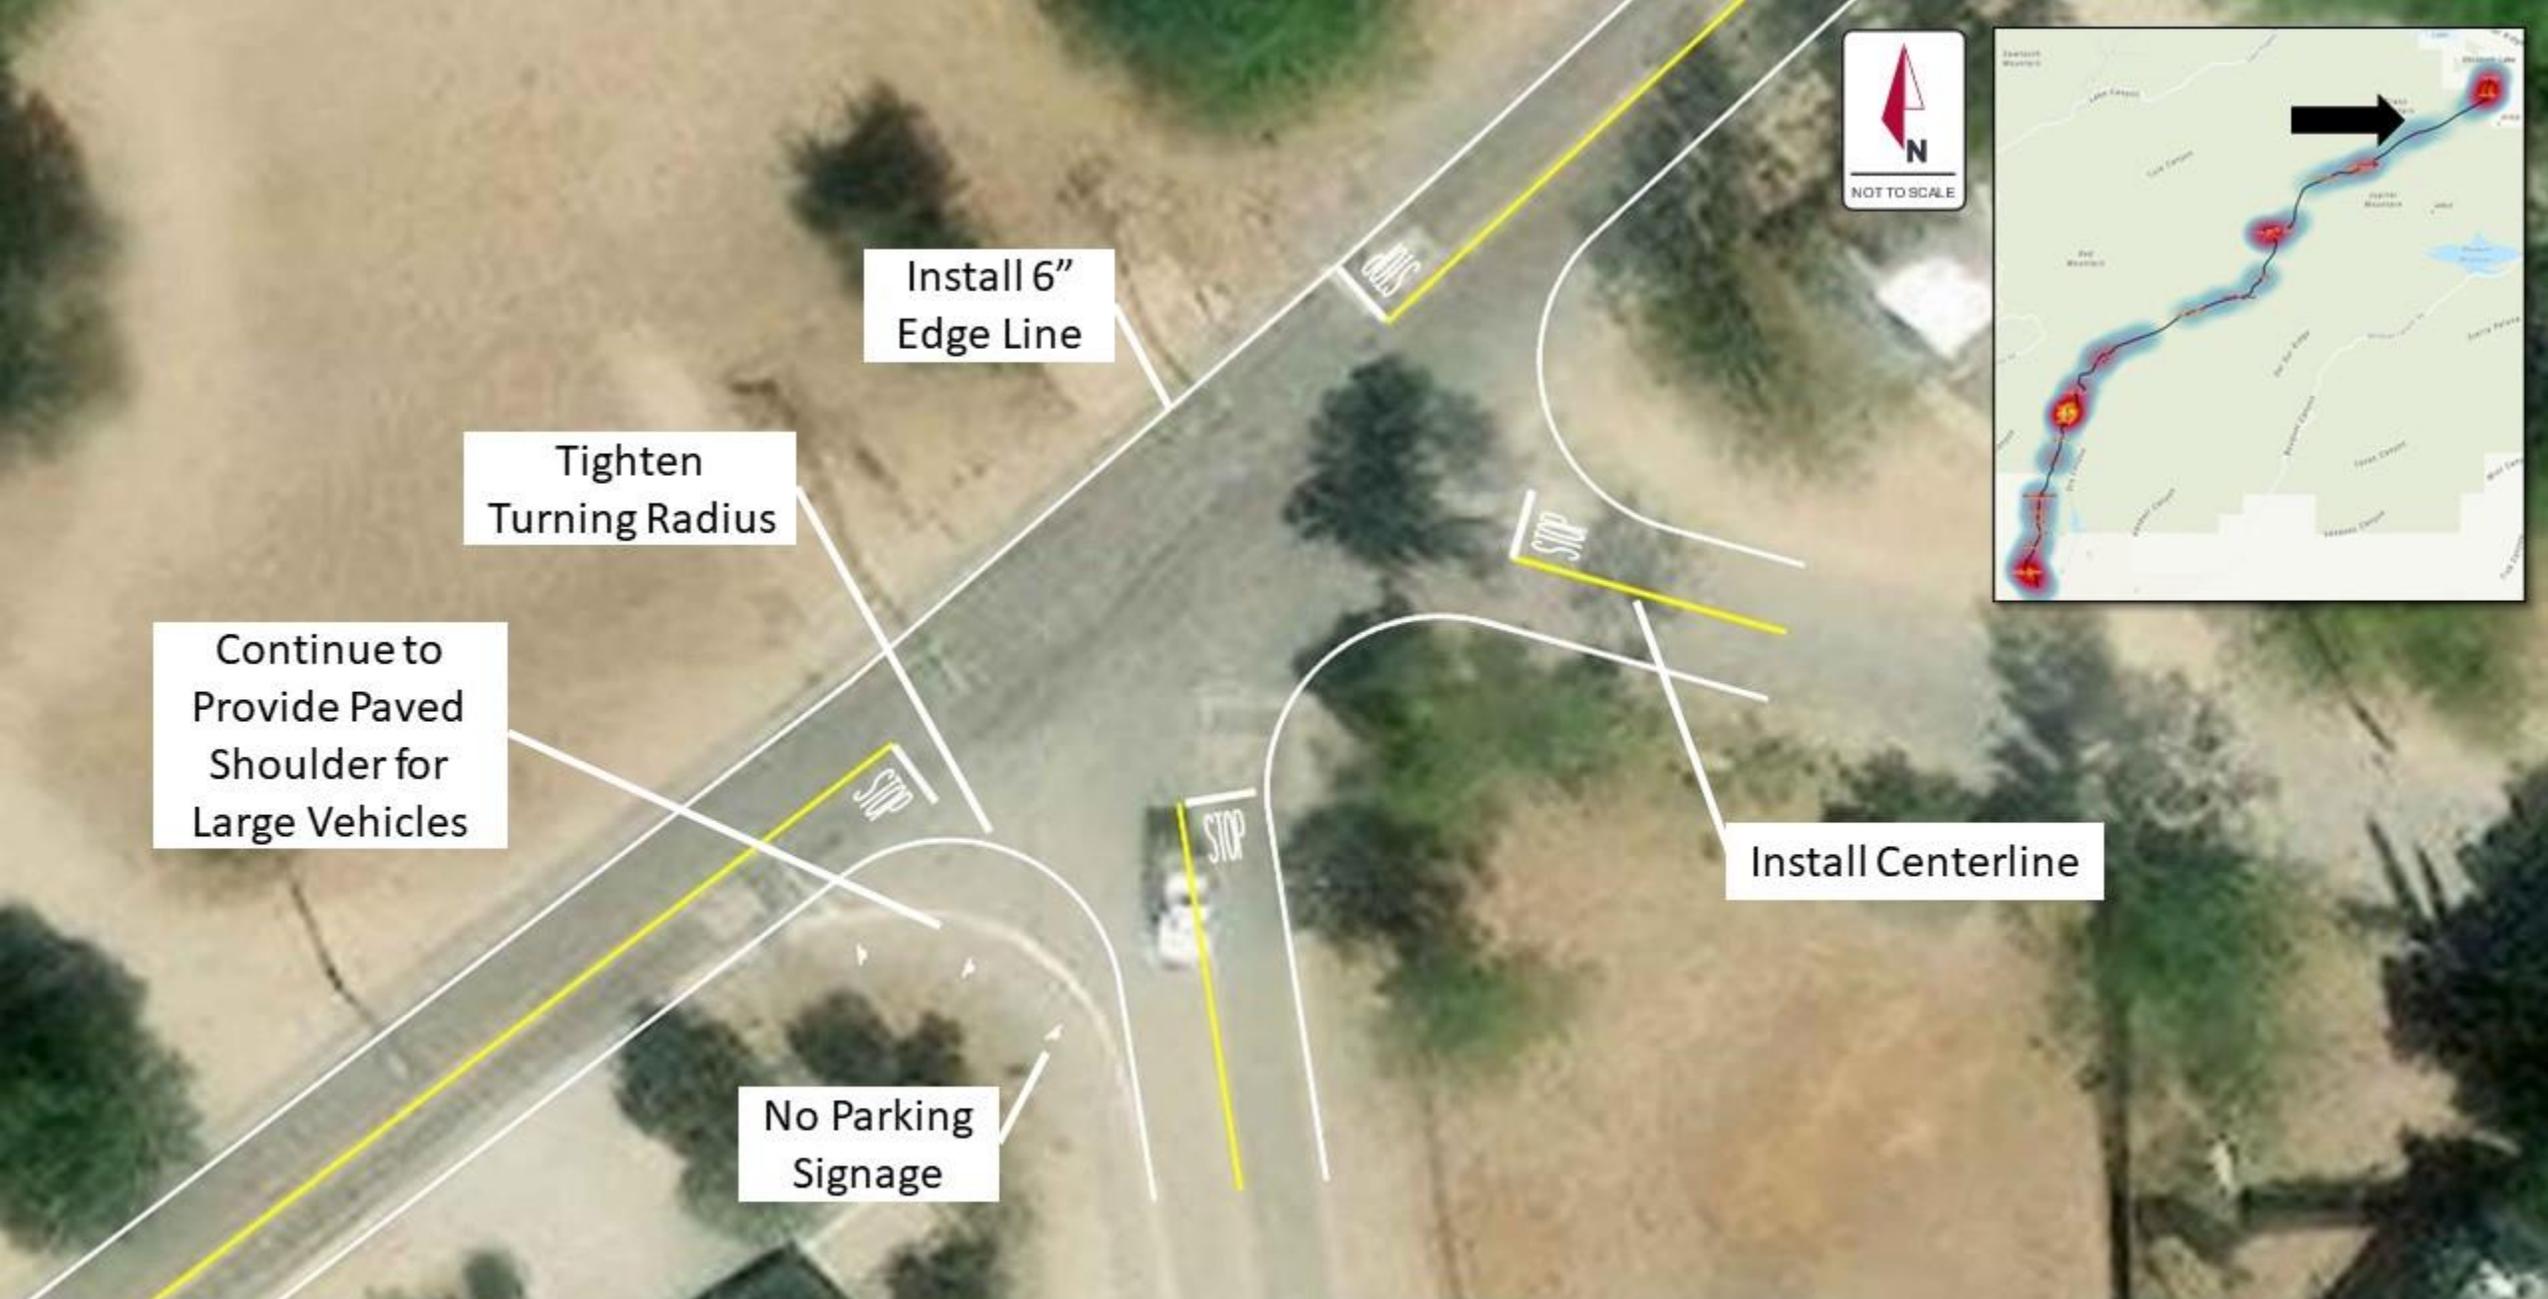
Install 6" Edge Line

Tighten Turning Radius

Continue to Provide Paved Shoulder for Large Vehicles

No Parking Signage

Install Centerline

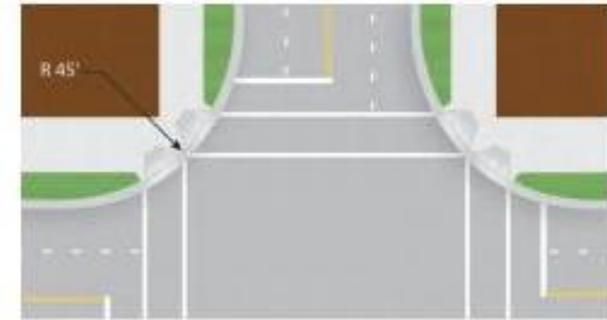
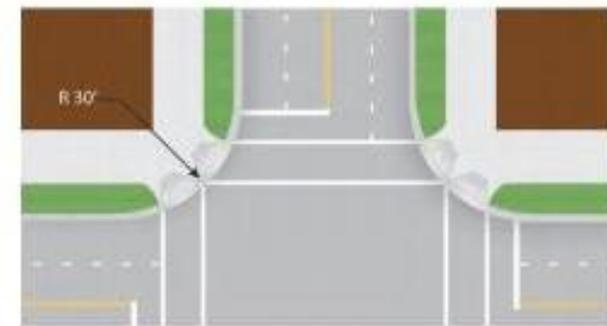
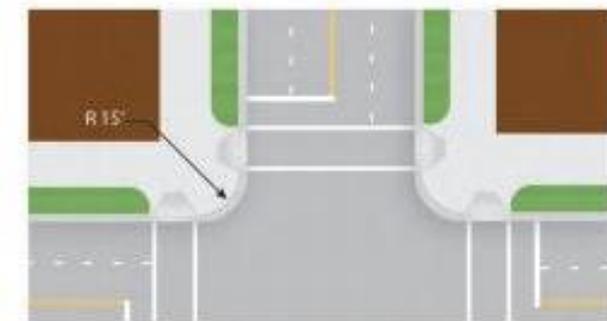
Tighten Turning Radius

- Minimizes the size of corner radius

- Reduces vehicle turning speed

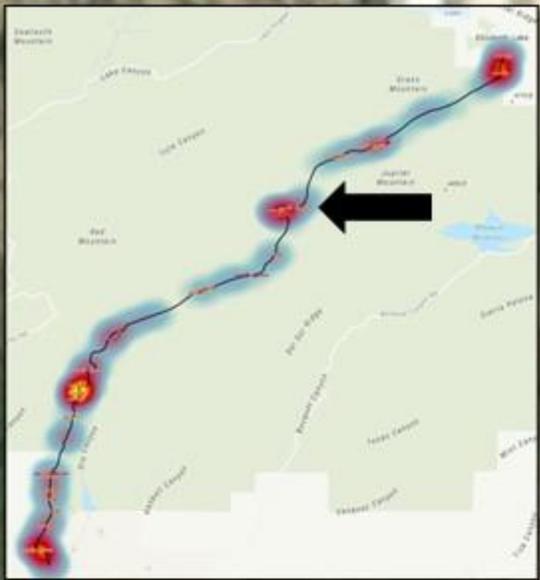
Install Driver Feedback Sign

Install 6" Edge Line

Install 2' Buffer on Centerline with Rumble Strips

Install Safety Edge

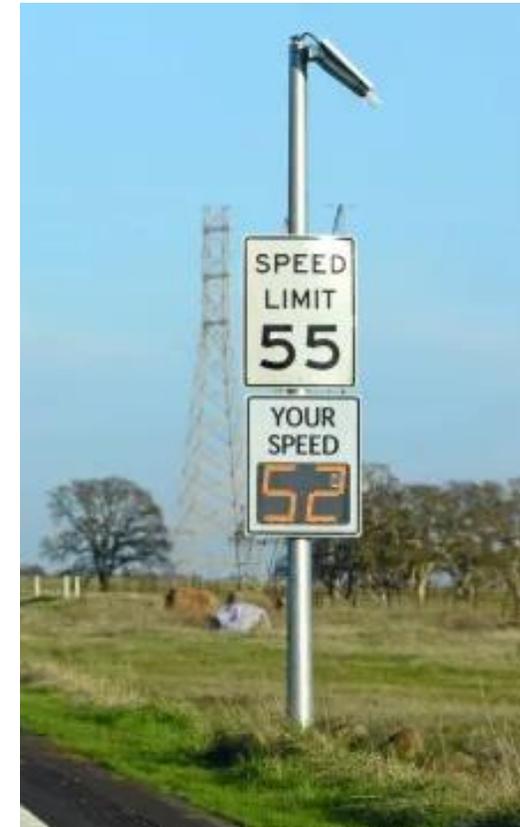
Safety Edge

What is it?

- Shapes the edge of the pavement to 30 degrees to eliminate vertical drop-off

- Provides a transition for all vehicles to return to the roadway after drifting off the paved road

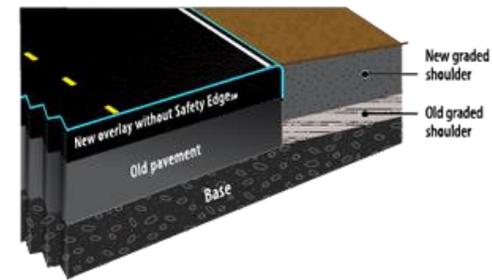
Newly constructed traditional pavement edge

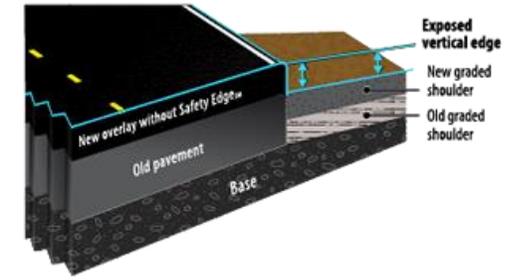
Traditional pavement edge over time

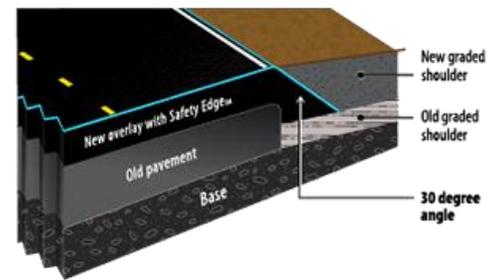
Newly constructed Safety Edge_{SM}

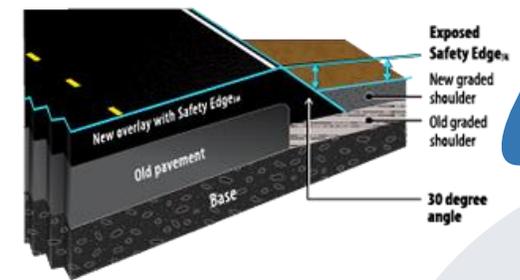
Safety Edge_{SM} over time

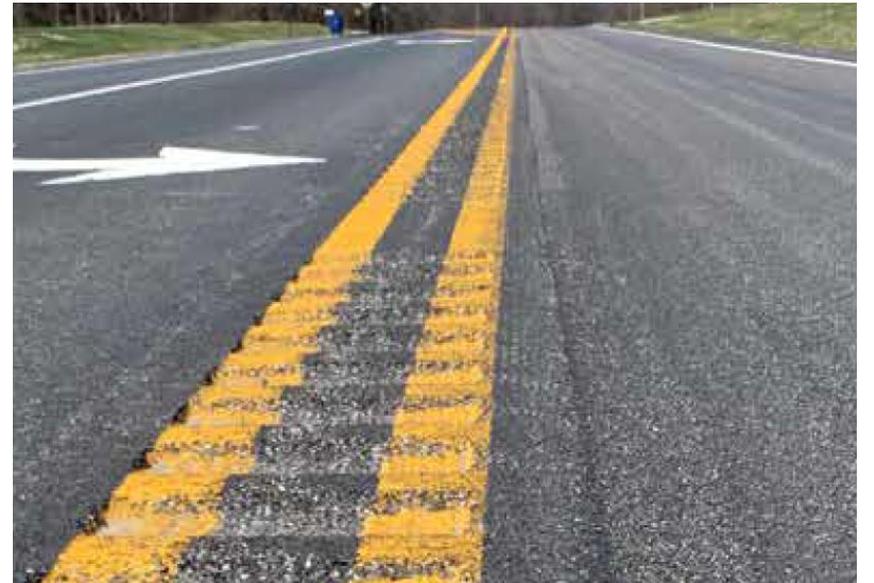
Centerline Rumble Strips

- Grooves along the centerline of roadway designed to produce noise and vibration

- Alerts drivers of roadway departure when crossing centerline

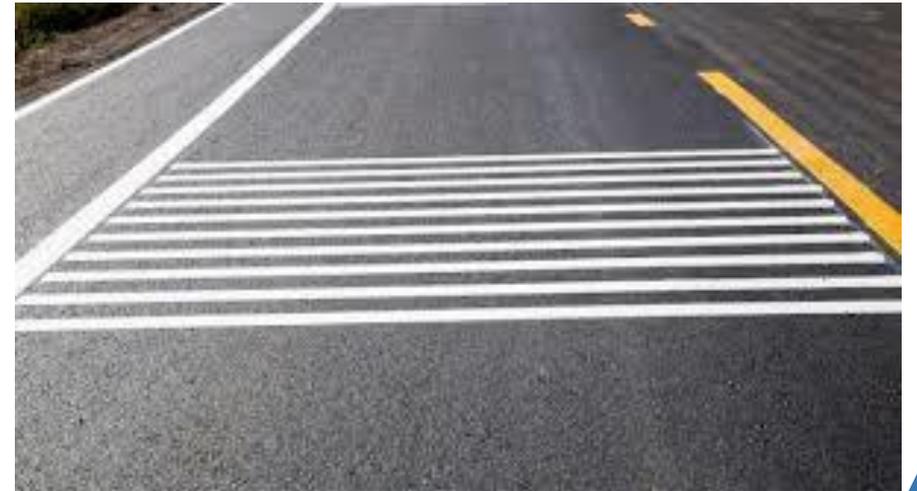
Transverse Rumble Strips

- Grooves across the roadway designed to produce noise and vibration

- Alerts drivers of a need to slow down or stop

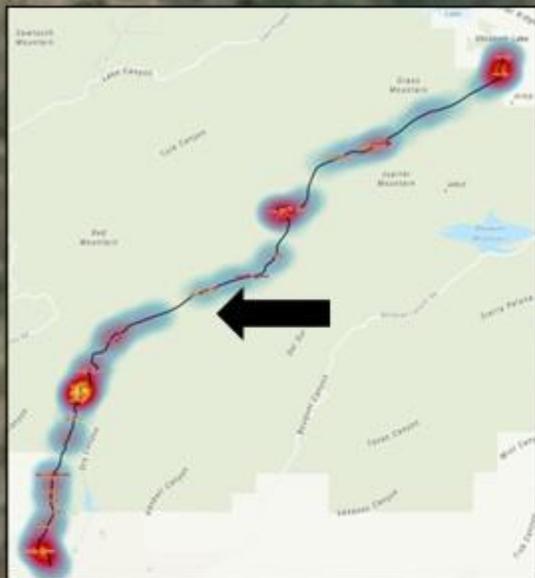
Passing Lane/Expanded Turnouts

- Provides legal and safe passage for drivers to pass, avoiding risky and unsafe passing

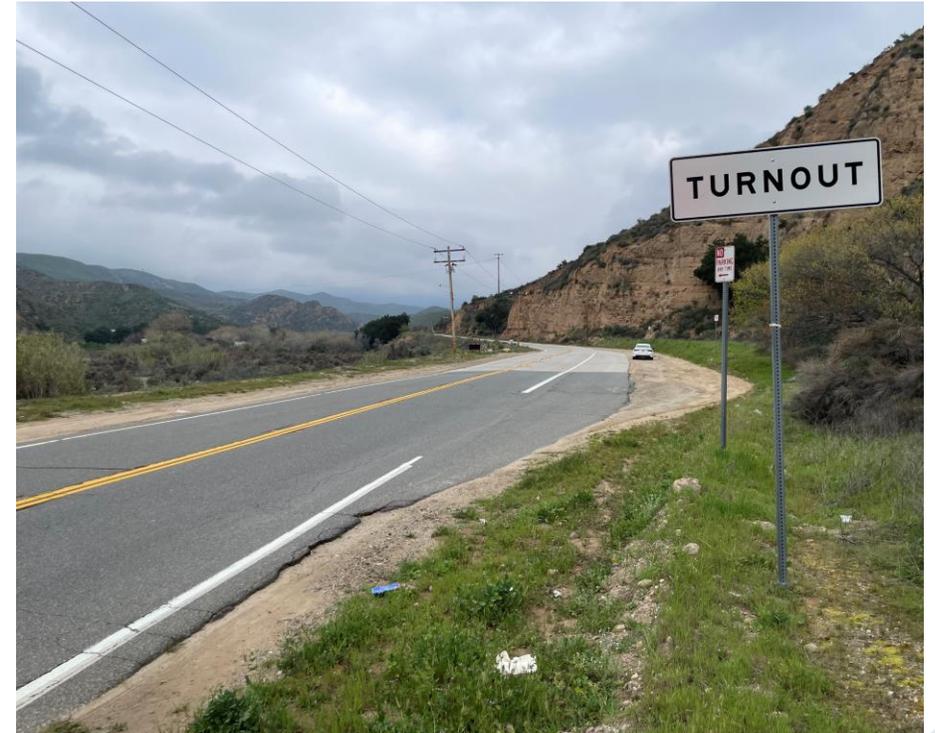
- Lane or shoulder where faster vehicles can pass slower drivers

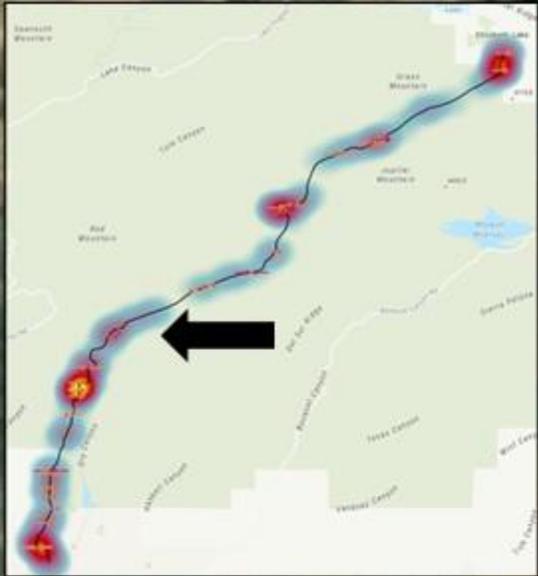
Potential Passing Lane Continues North

No Stopping Signage

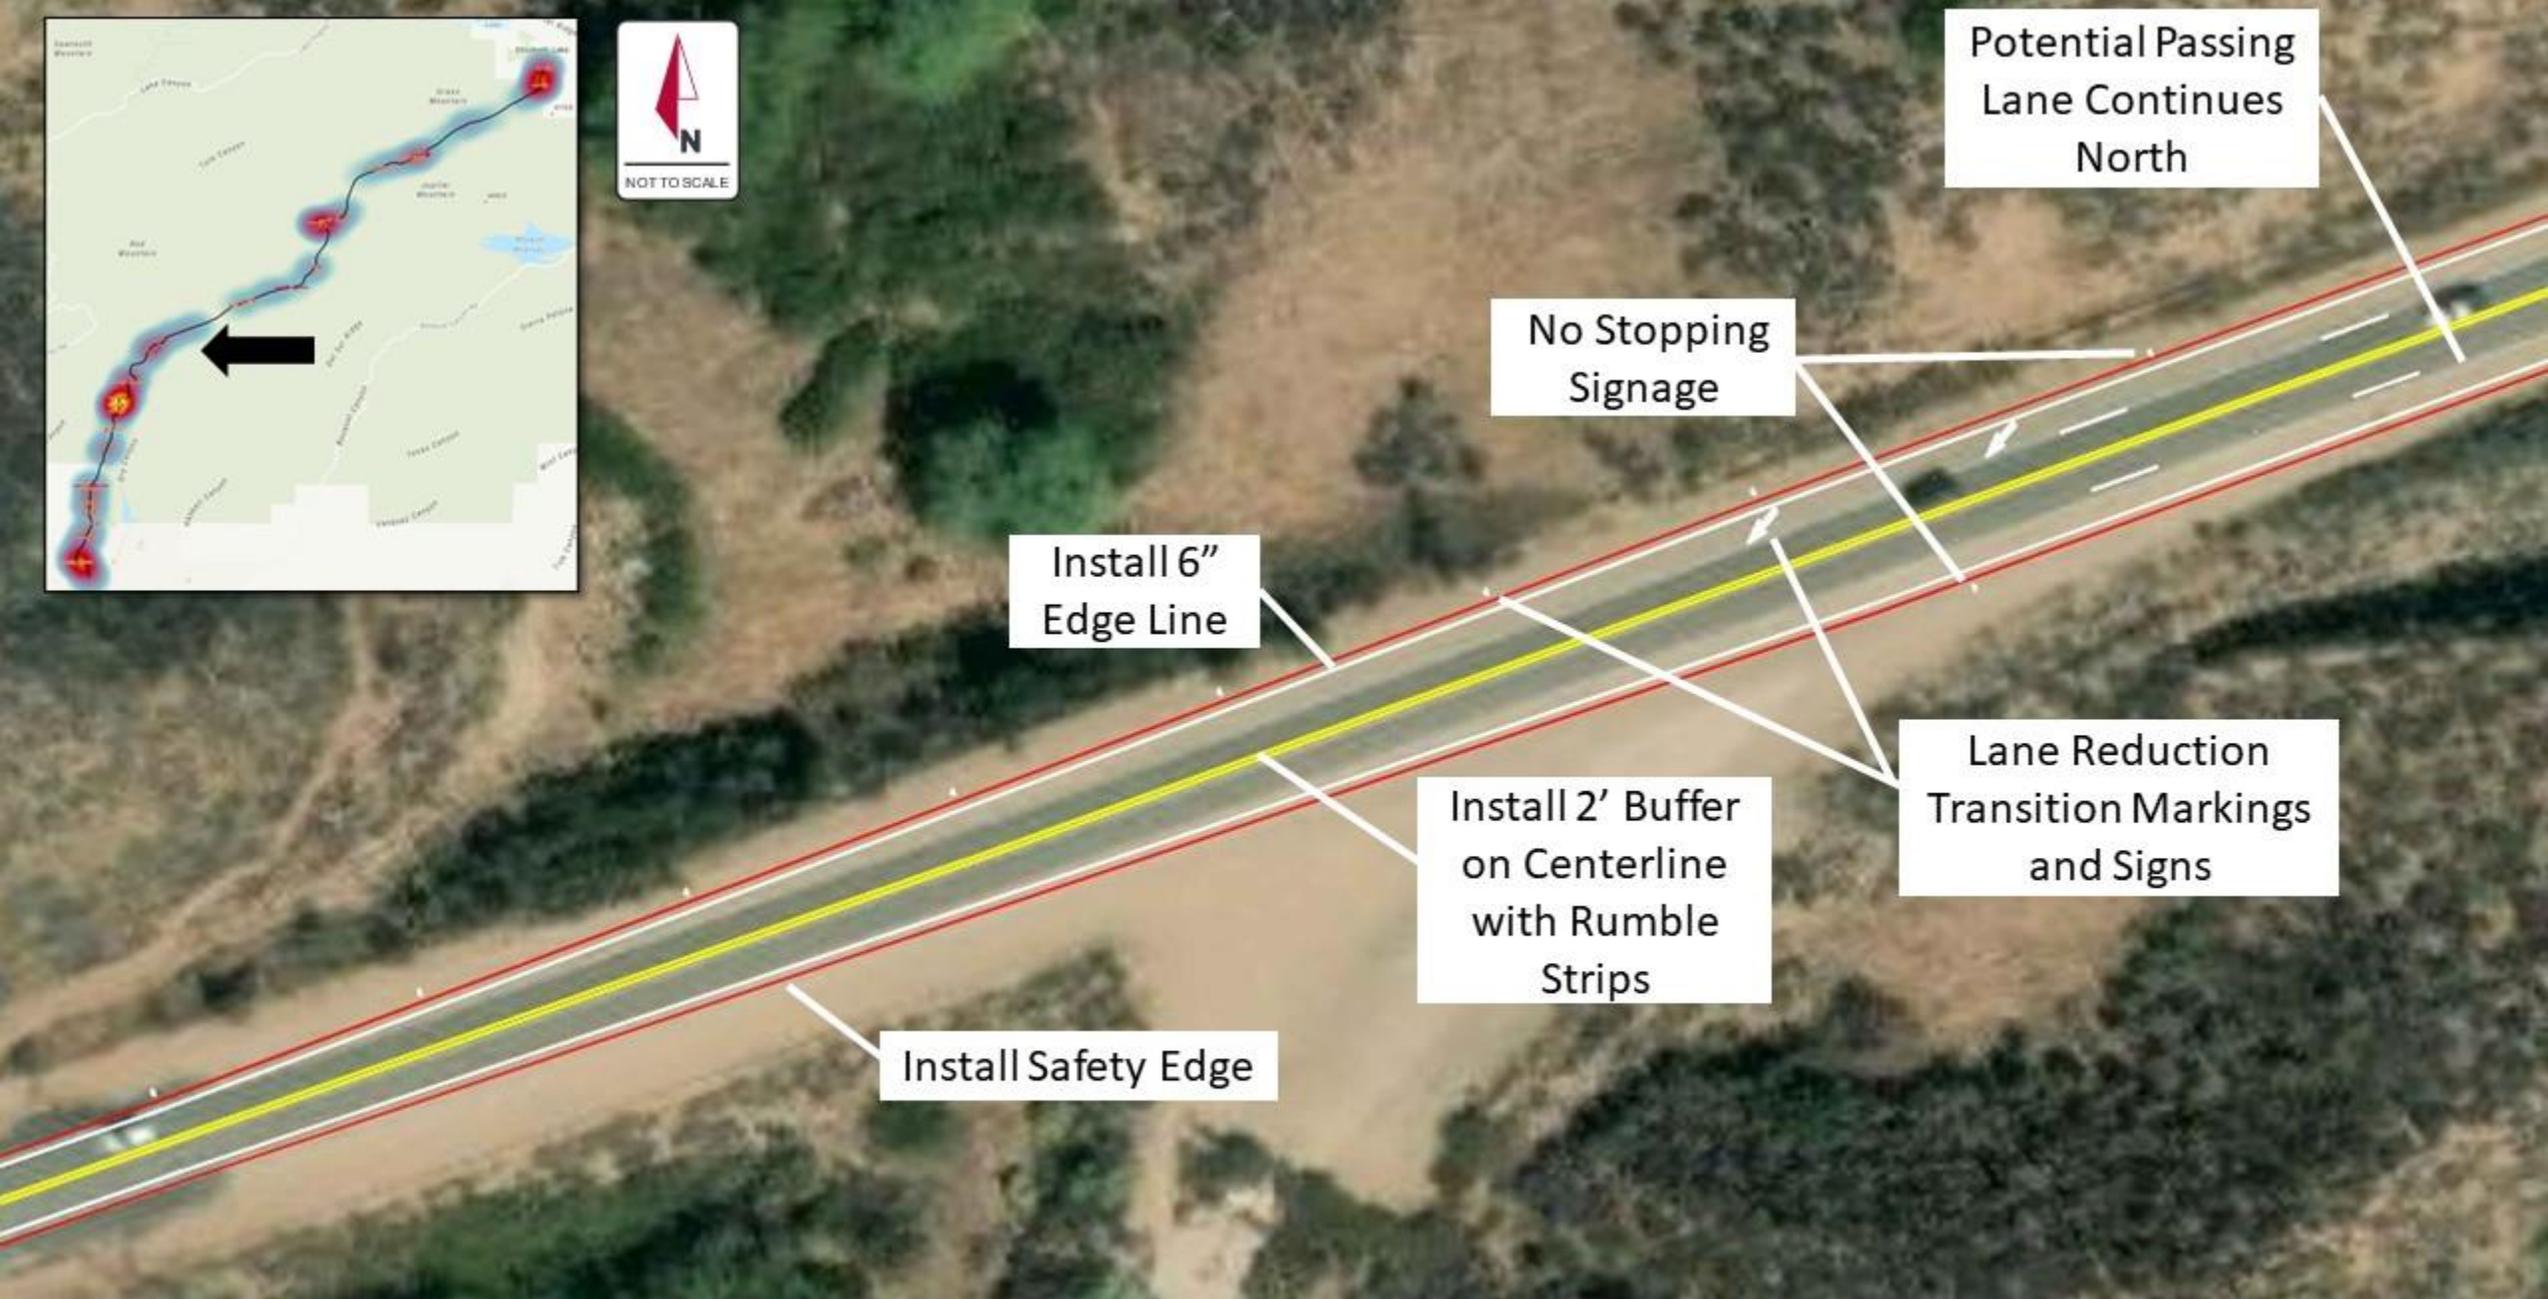
LOCATION 5 – End MP 11.8

Install 6" Edge Line

Lane Reduction Transition Markings and Signs

Install 2' Buffer on Centerline with Rumble Strips

Install Safety Edge

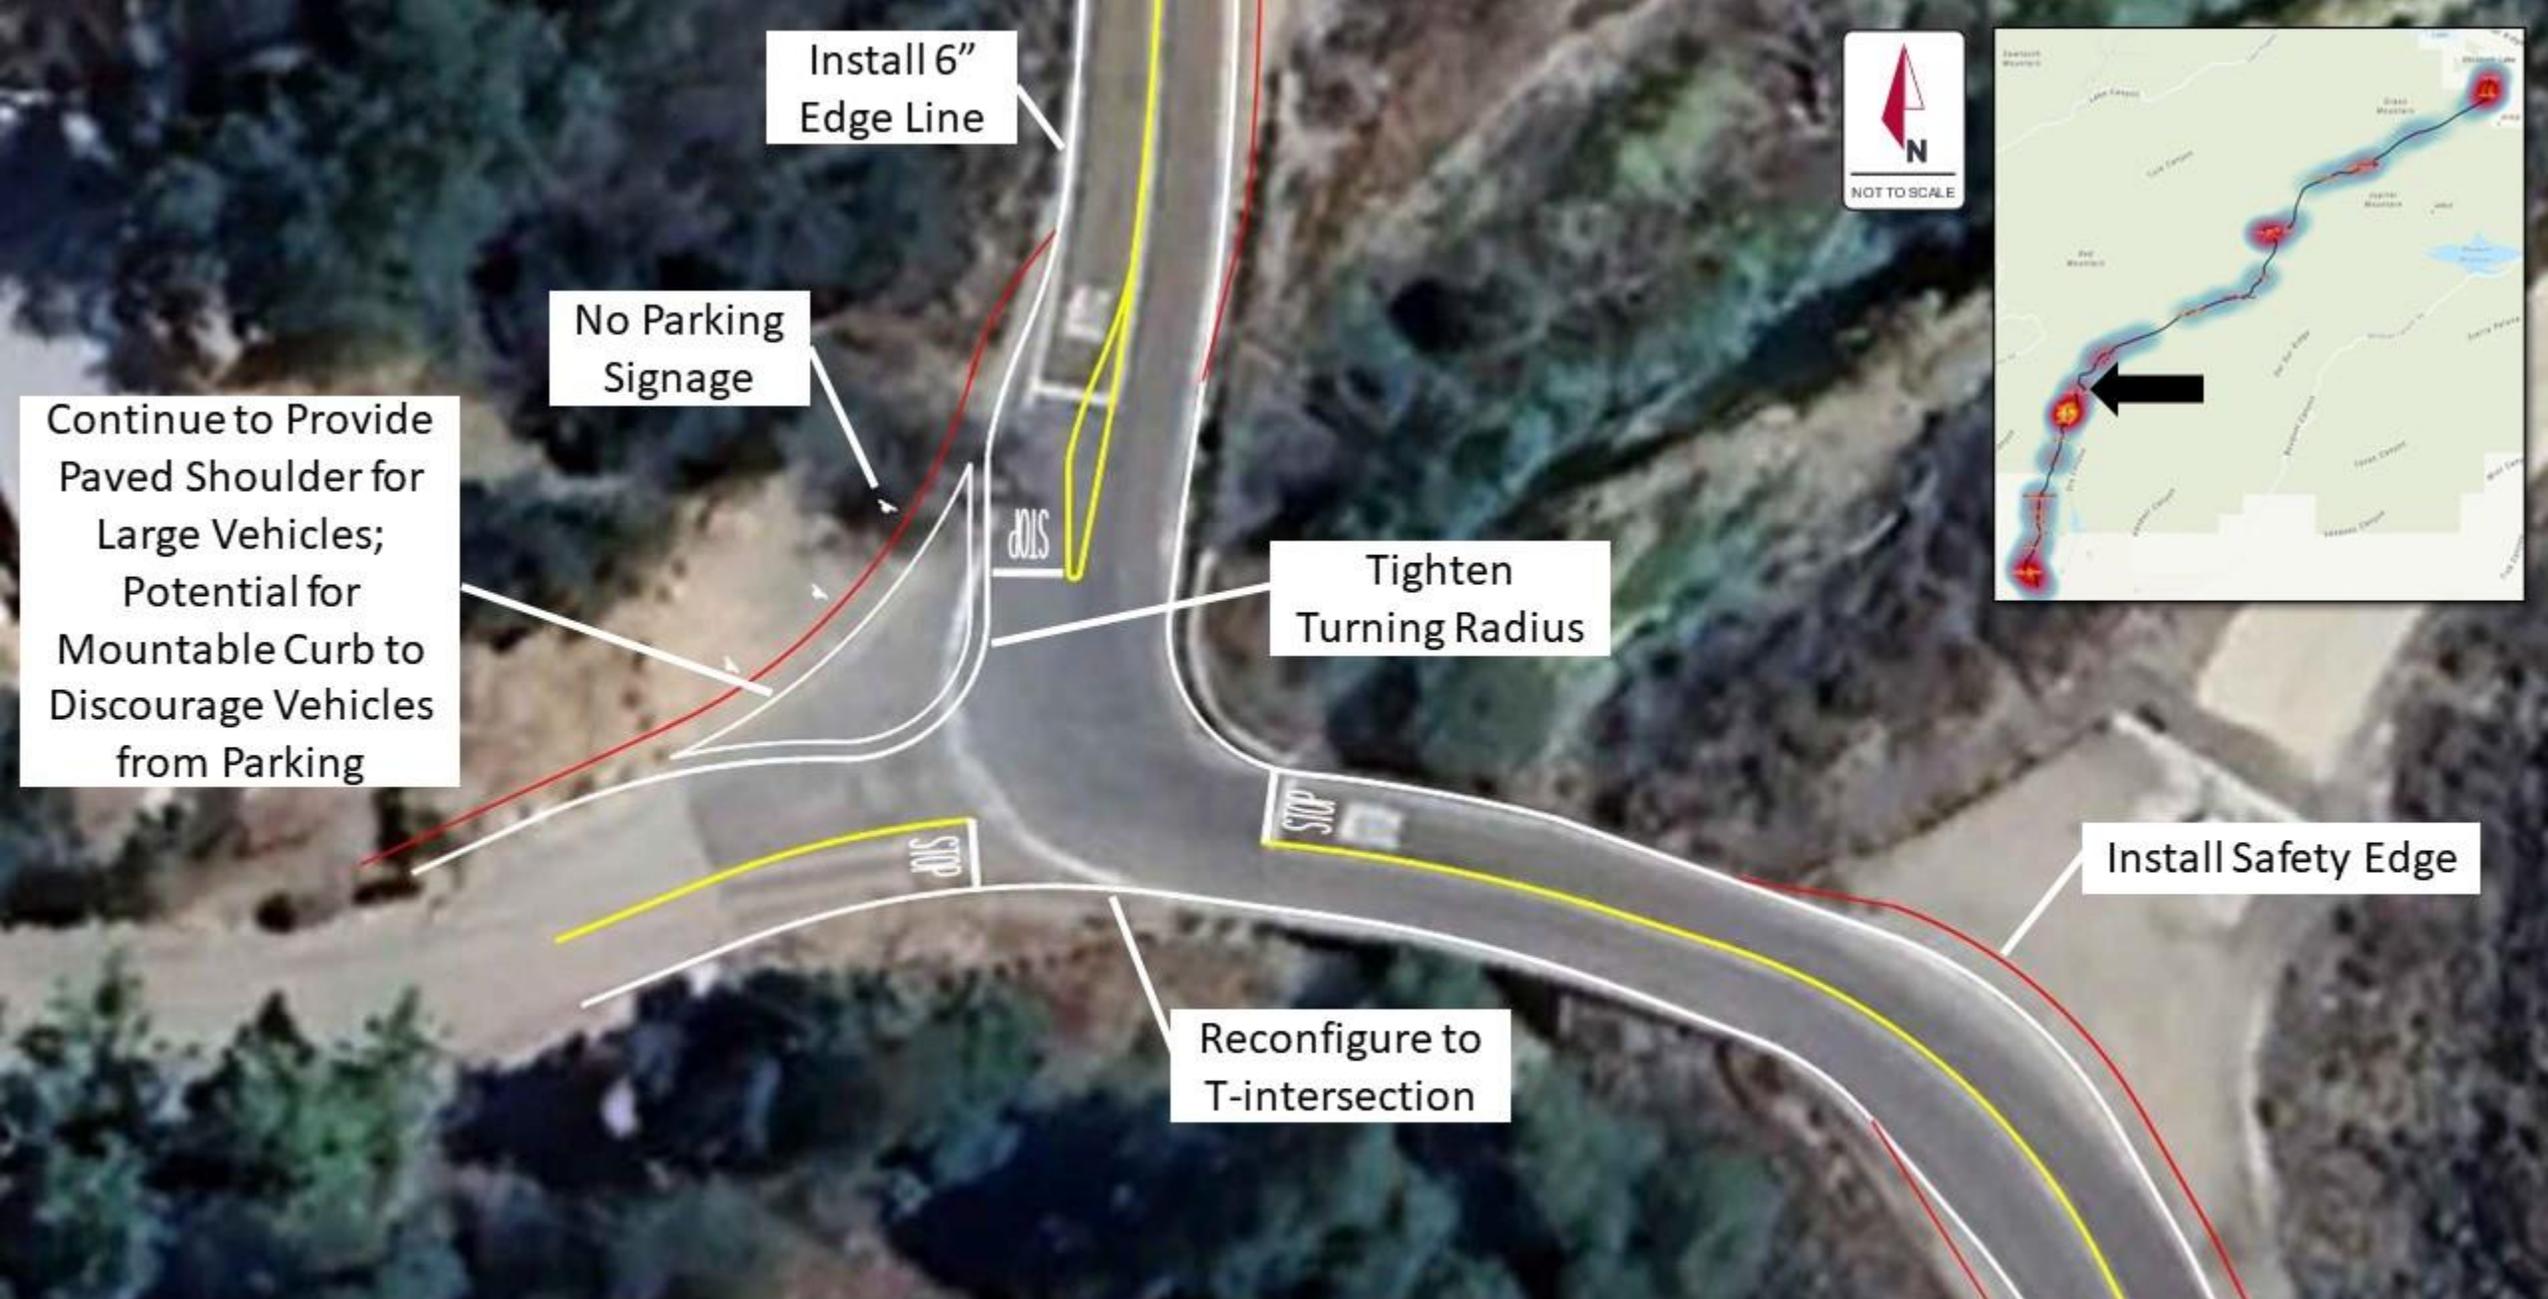
Continue to Provide Paved Shoulder for Large Vehicles; Potential for Mountable Curb to Discourage Vehicles from Parking

No Parking Signage

Install 6" Edge Line

Tighten Turning Radius

Reconfigure to T-intersection

Install Safety Edge

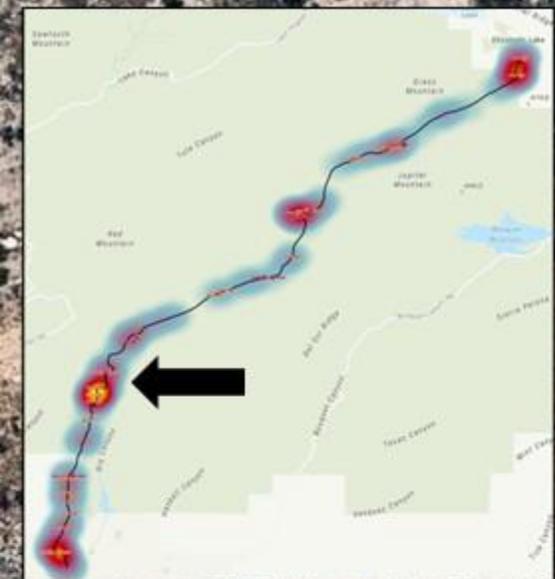
Install Safety Edge

Install 6"
Edge Line

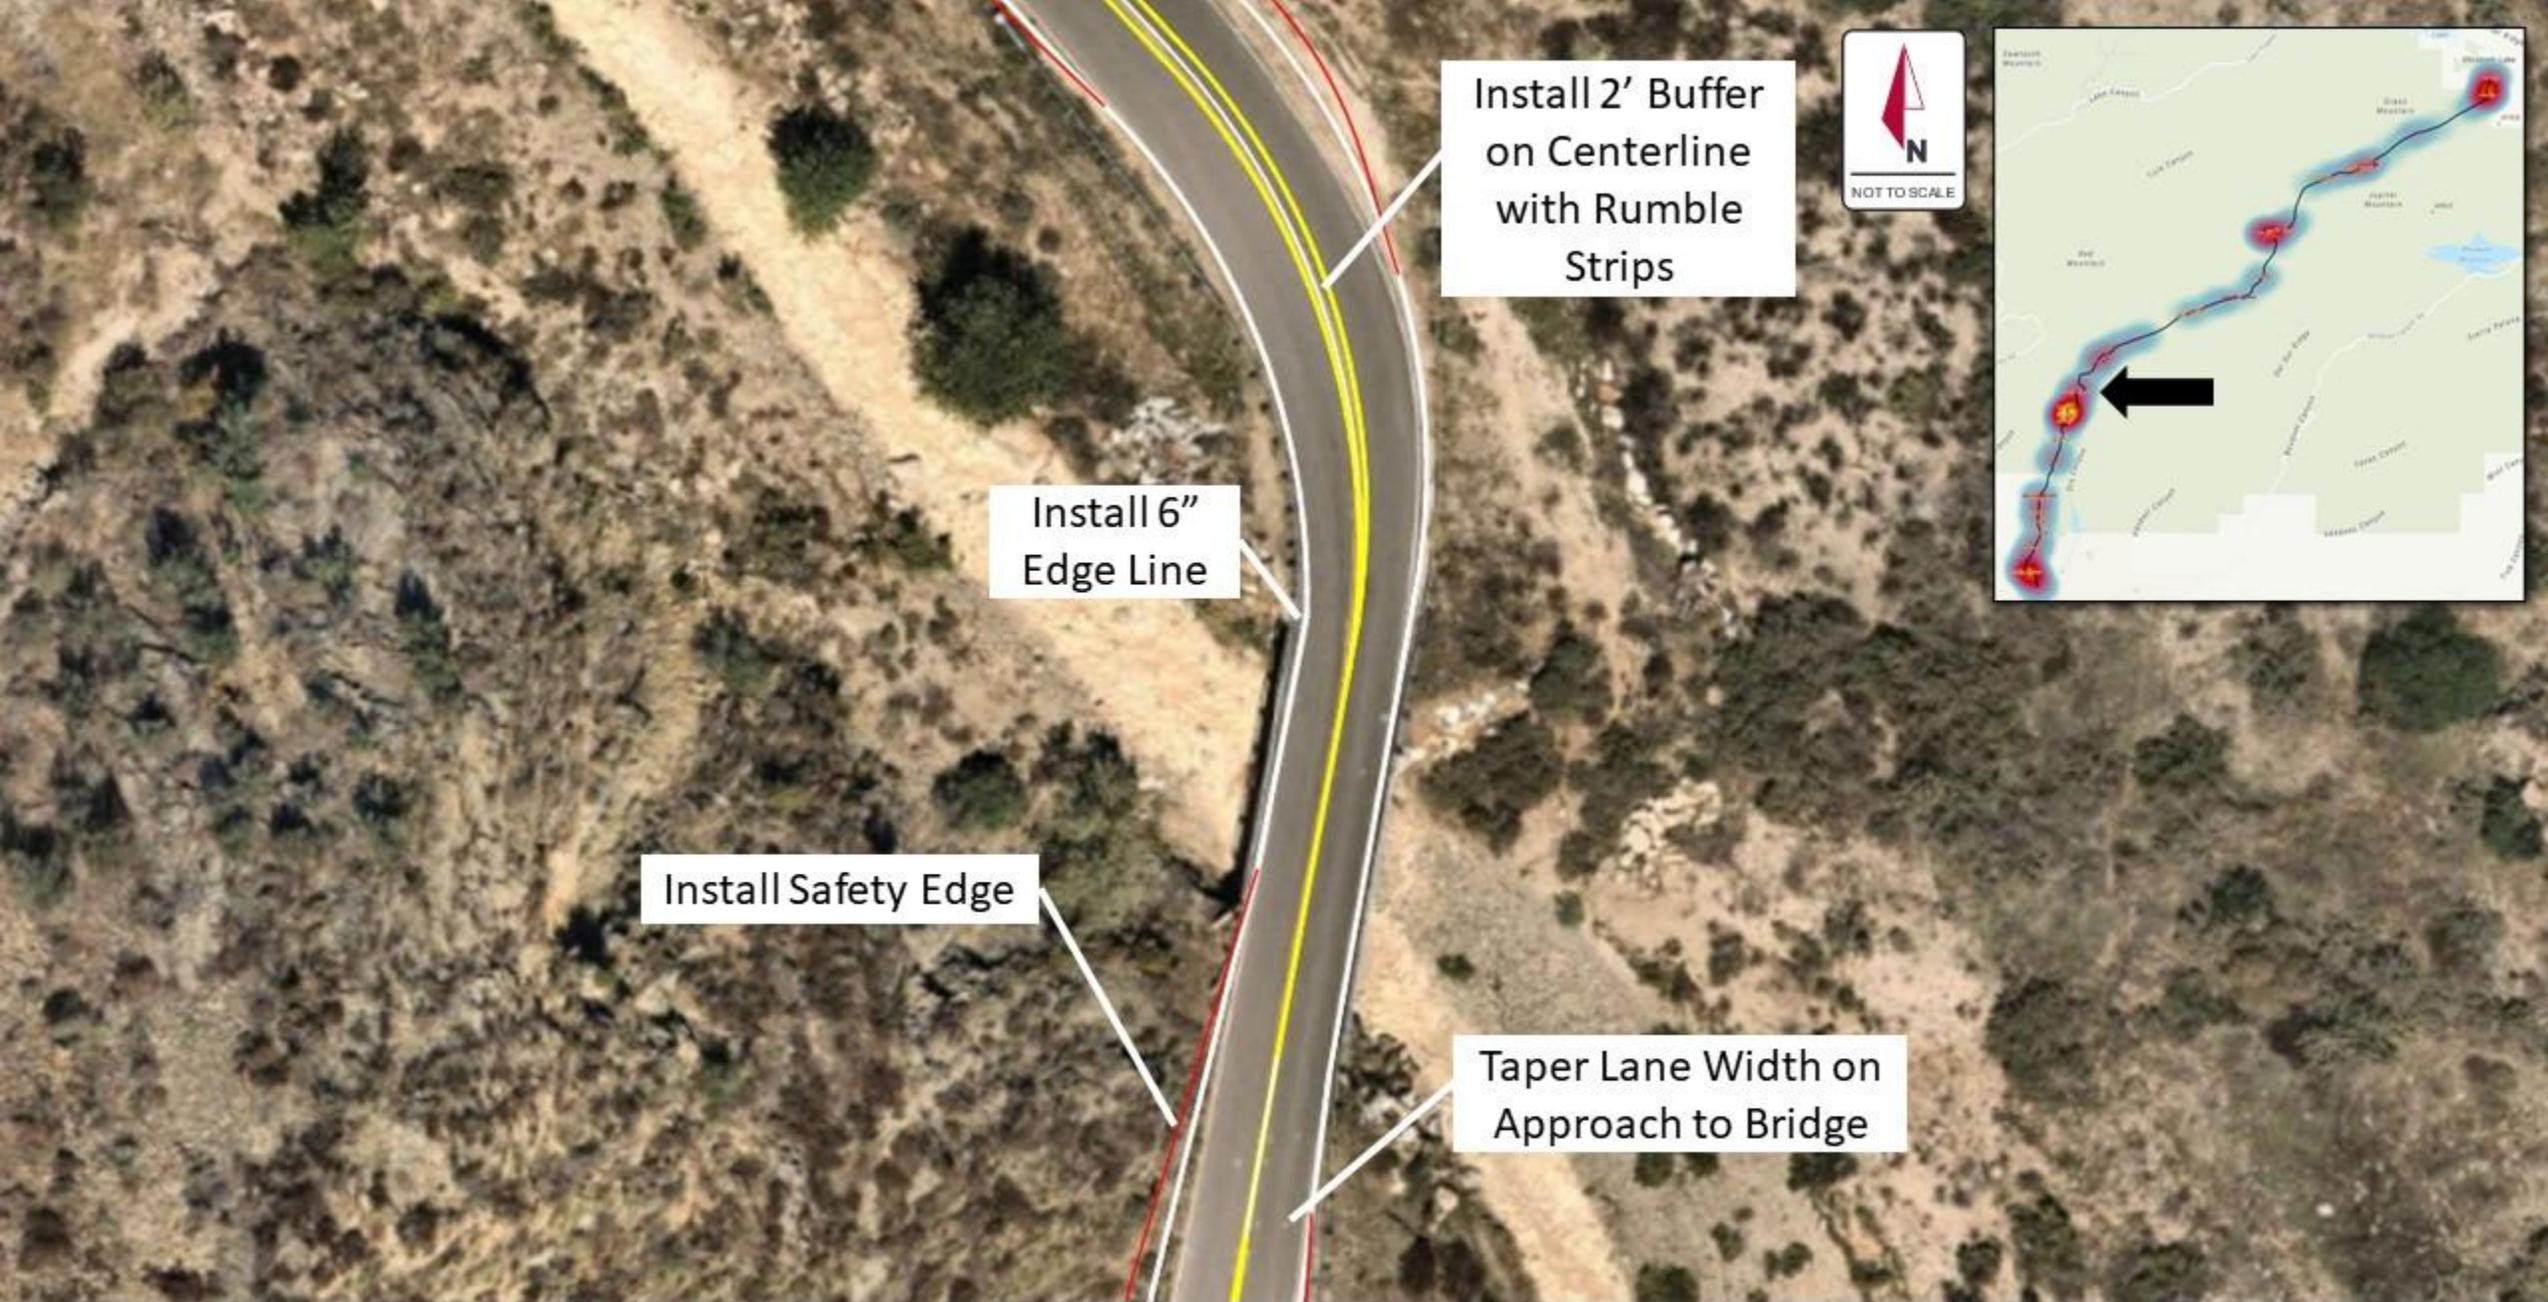
Install 2' Buffer on Centerline with Rumble Strips

Install 6" Edge Line

Install Safety Edge

Taper Lane Width on Approach to Bridge
