Corridor Traffic Safety Study San Francisquito Canyon Road

Community Outreach Meeting

Project Overview

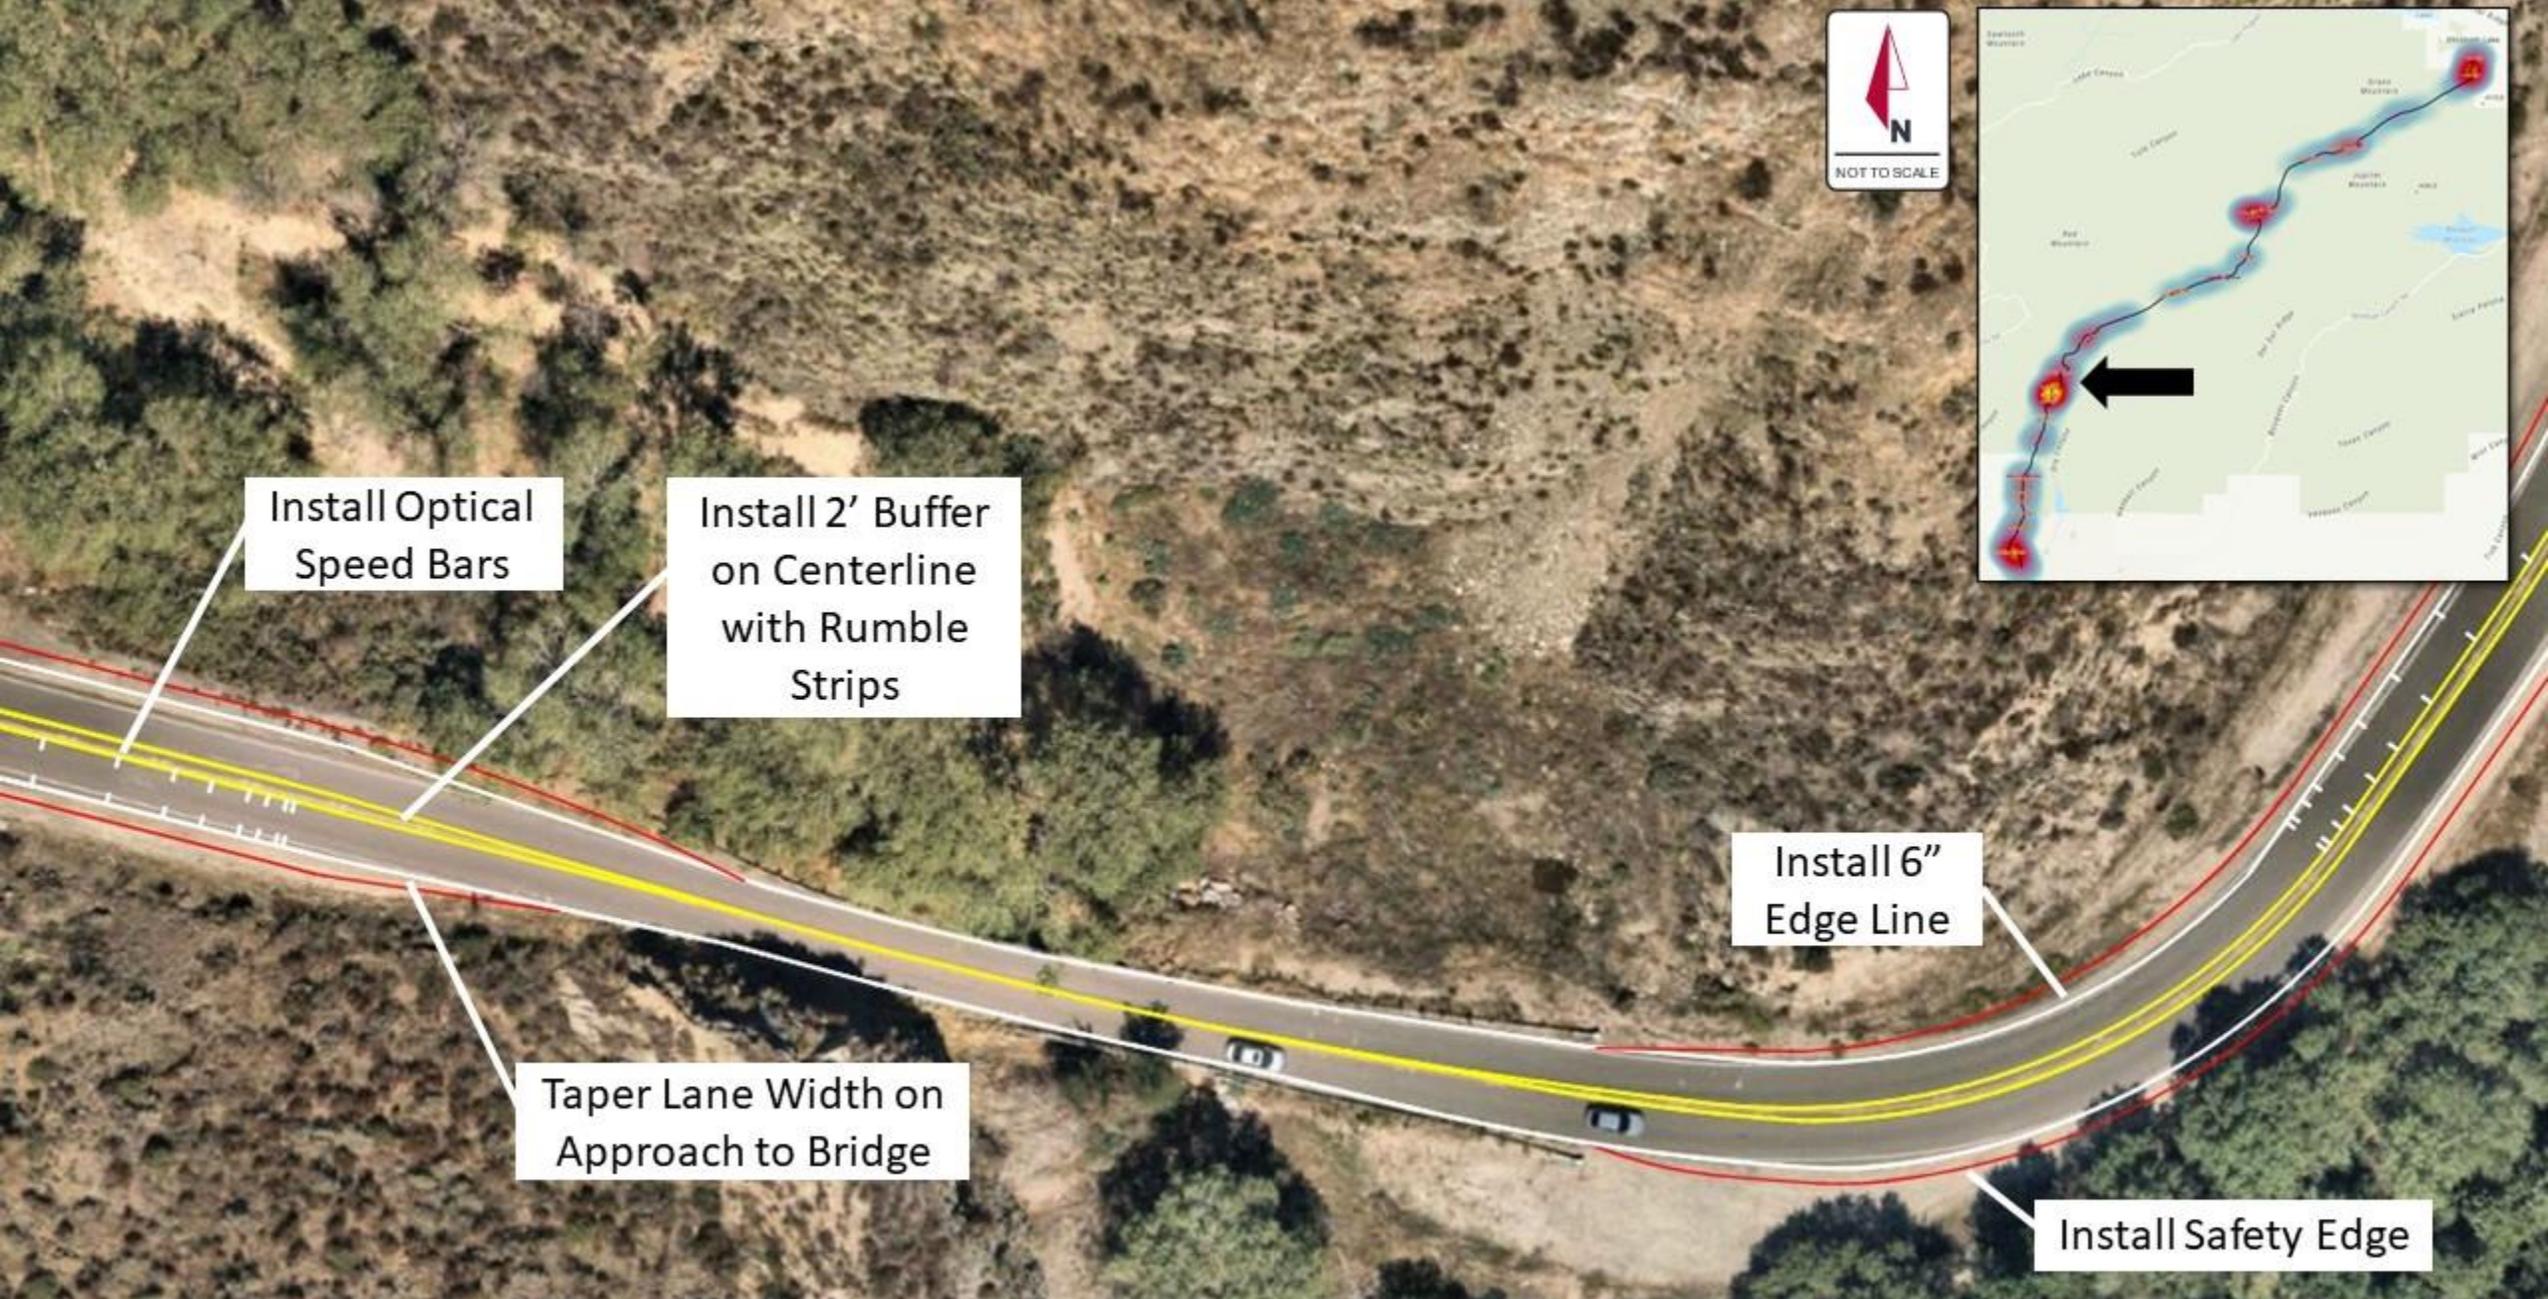
Install Optical Speed Bars

Install 2' Buffer on Centerline with Rumble Strips

Taper Lane Width on Approach to Bridge

Install 6" Edge Line

Install Safety Edge

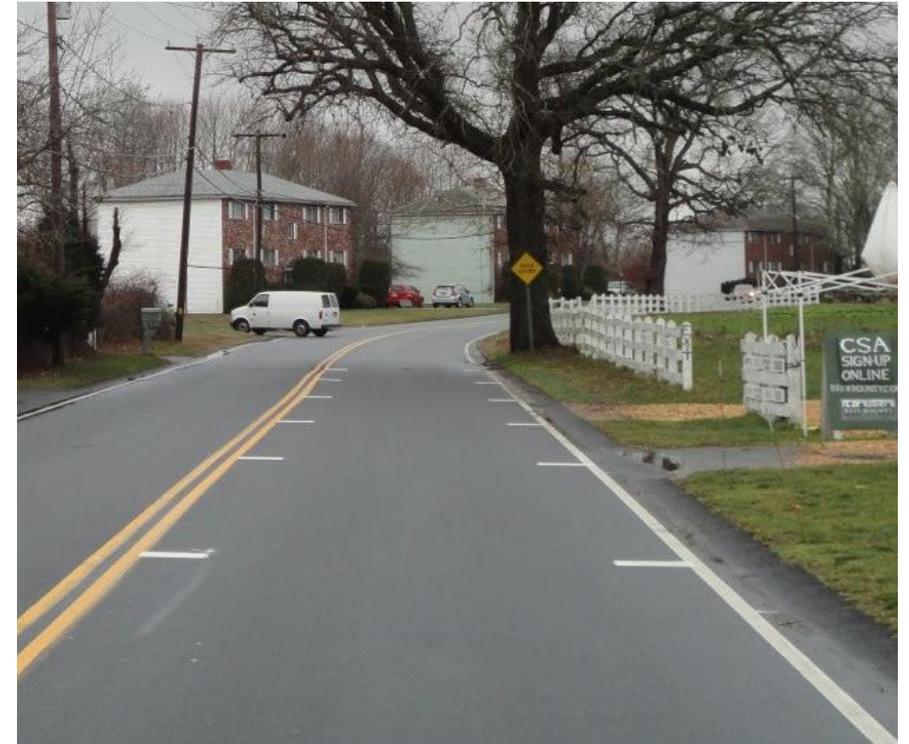
Optical Speed Bars

- Transverse pavement markings placed at decreasing spacing

- Provide the appearance to drivers that they are travelling faster than their true speed

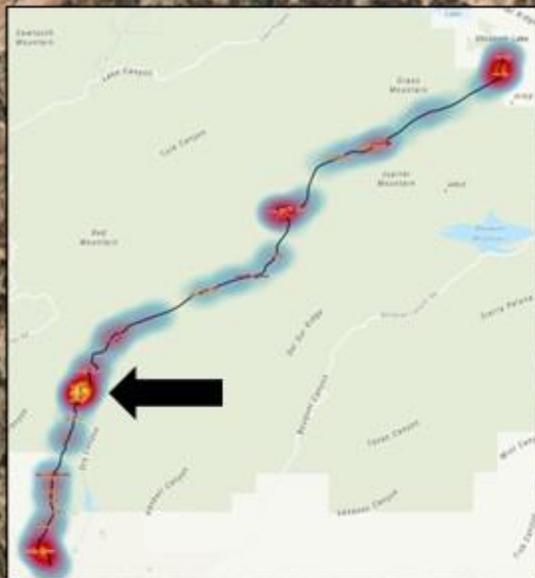
Install 2' Buffer on Centerline with Rumble Strips

Install 6" Edge Line

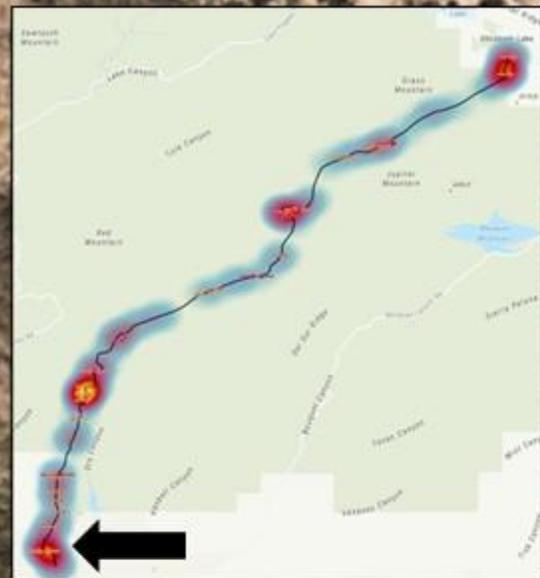
Install 6"
Edge Line

Install 2' Buffer on
Centerline with
Rumble Strips

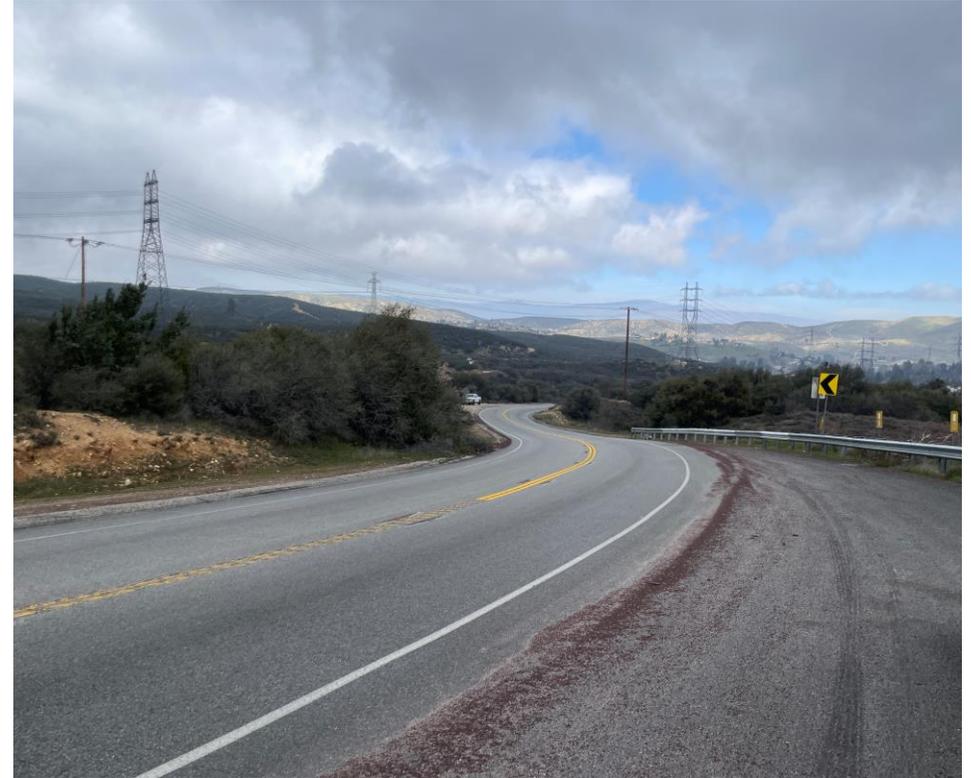
Curve where Pilot Delineator Project will be installed

- Incorporate community outreach feedback
- Finalize Corridor Traffic Safety Study
- Pilot Delineator Project
 - Curve located approximately 0.5 miles south of Elizabeth Lake Road
 - Plans are nearly complete
 - Delineators and supplemental signage to be installed by August
- Work to implement the proposed improvements
