MAP  
OF  
NORTH LINE  
OF  
RANCHO SAN PEDRO  
FROM  
FIGUEROA STREET  
TO  
WRIGHT ROAD

COUNTY SURVEYORS MAP NO. 8722  
SCALE: 1 INCH = 100 FEET

J. E. ROCKHOLD COUNTY SURVEYOR  
SURVEYED - FEBRUARY 1925

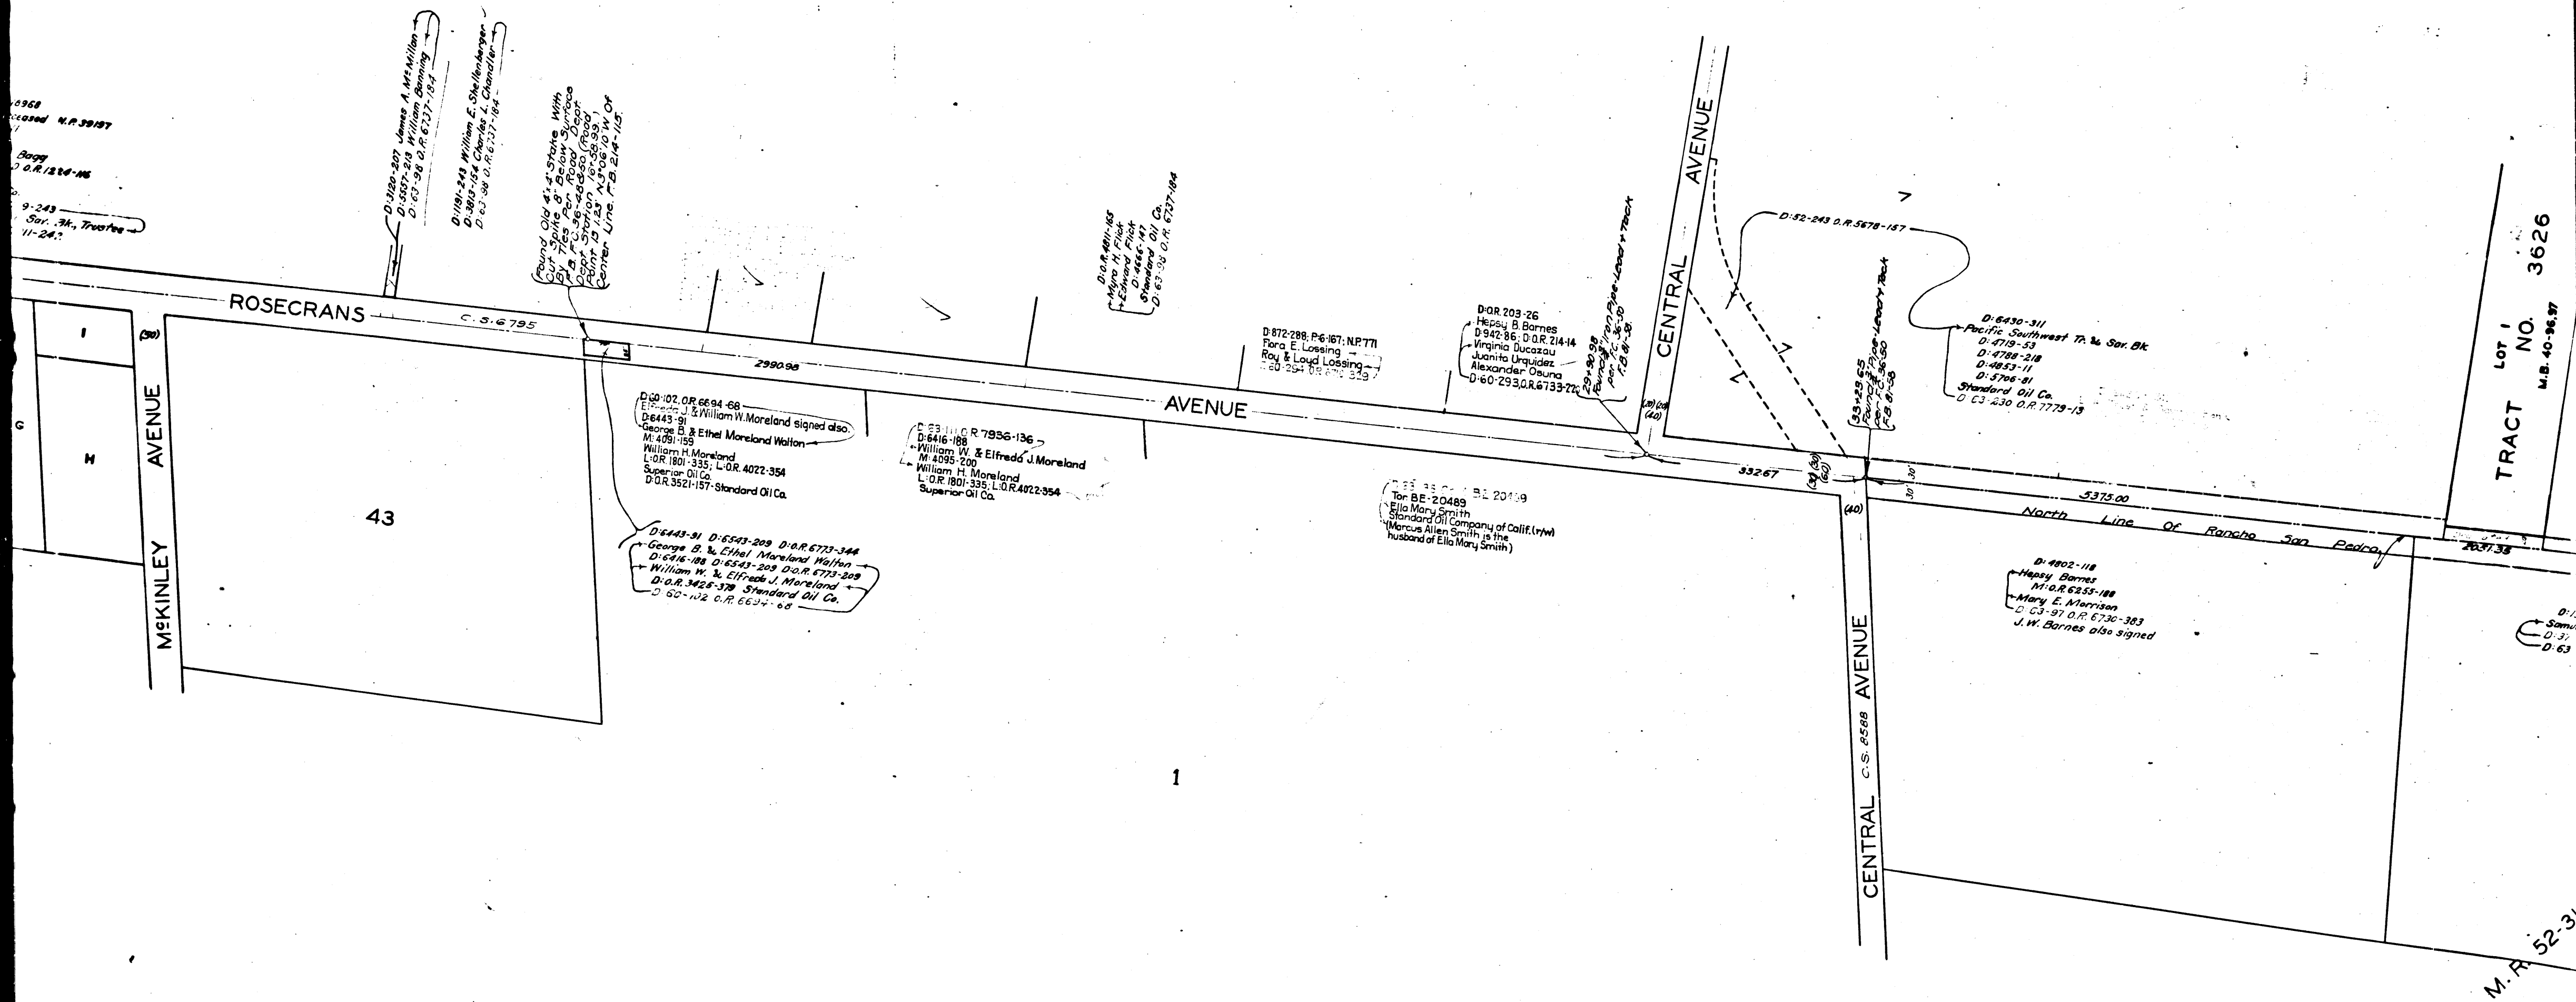
CS 8722  
A3 OF A8

Found punch mark in pavement, by ties, per Road Dept. F.B.I.R. 904-88-48, Mar 23, 1931.

gation of east line of  
Campton Avenue - Set in concrete  
with brass cap marked -  
F.B.I. 81-361

probation of east line of  
Campden Avenue - Set in and  
with brass cap marked -  
FB 81-51
