# MAP OF ELIZABETH LAKE CANYON ROAD FROM PINE CANYON ROAD TO WARM SPRINGS CANYON

COUNTY SURVEYORS MAP NO. 8826  
SHEET 3 OF 4 SHEETS  
SCALE - 1 INCH = 100 FT.

J. ROCKHOLD - COUNTY SURVEYOR  
SURVEYED - AUGUST 1925 TO SEPTEMBER 1928  
SURVEYED UNDER INSTRUCTIONS OF THE  
BOARD OF SUPERVISORS PER ORDER DATED  
JUNE 23, 1924  
BEARINGS ARE BASED ON THE BEARING OF  
PINE CANYON ROAD AS SHOWN ON C.S. 8168  
SHEET 1.

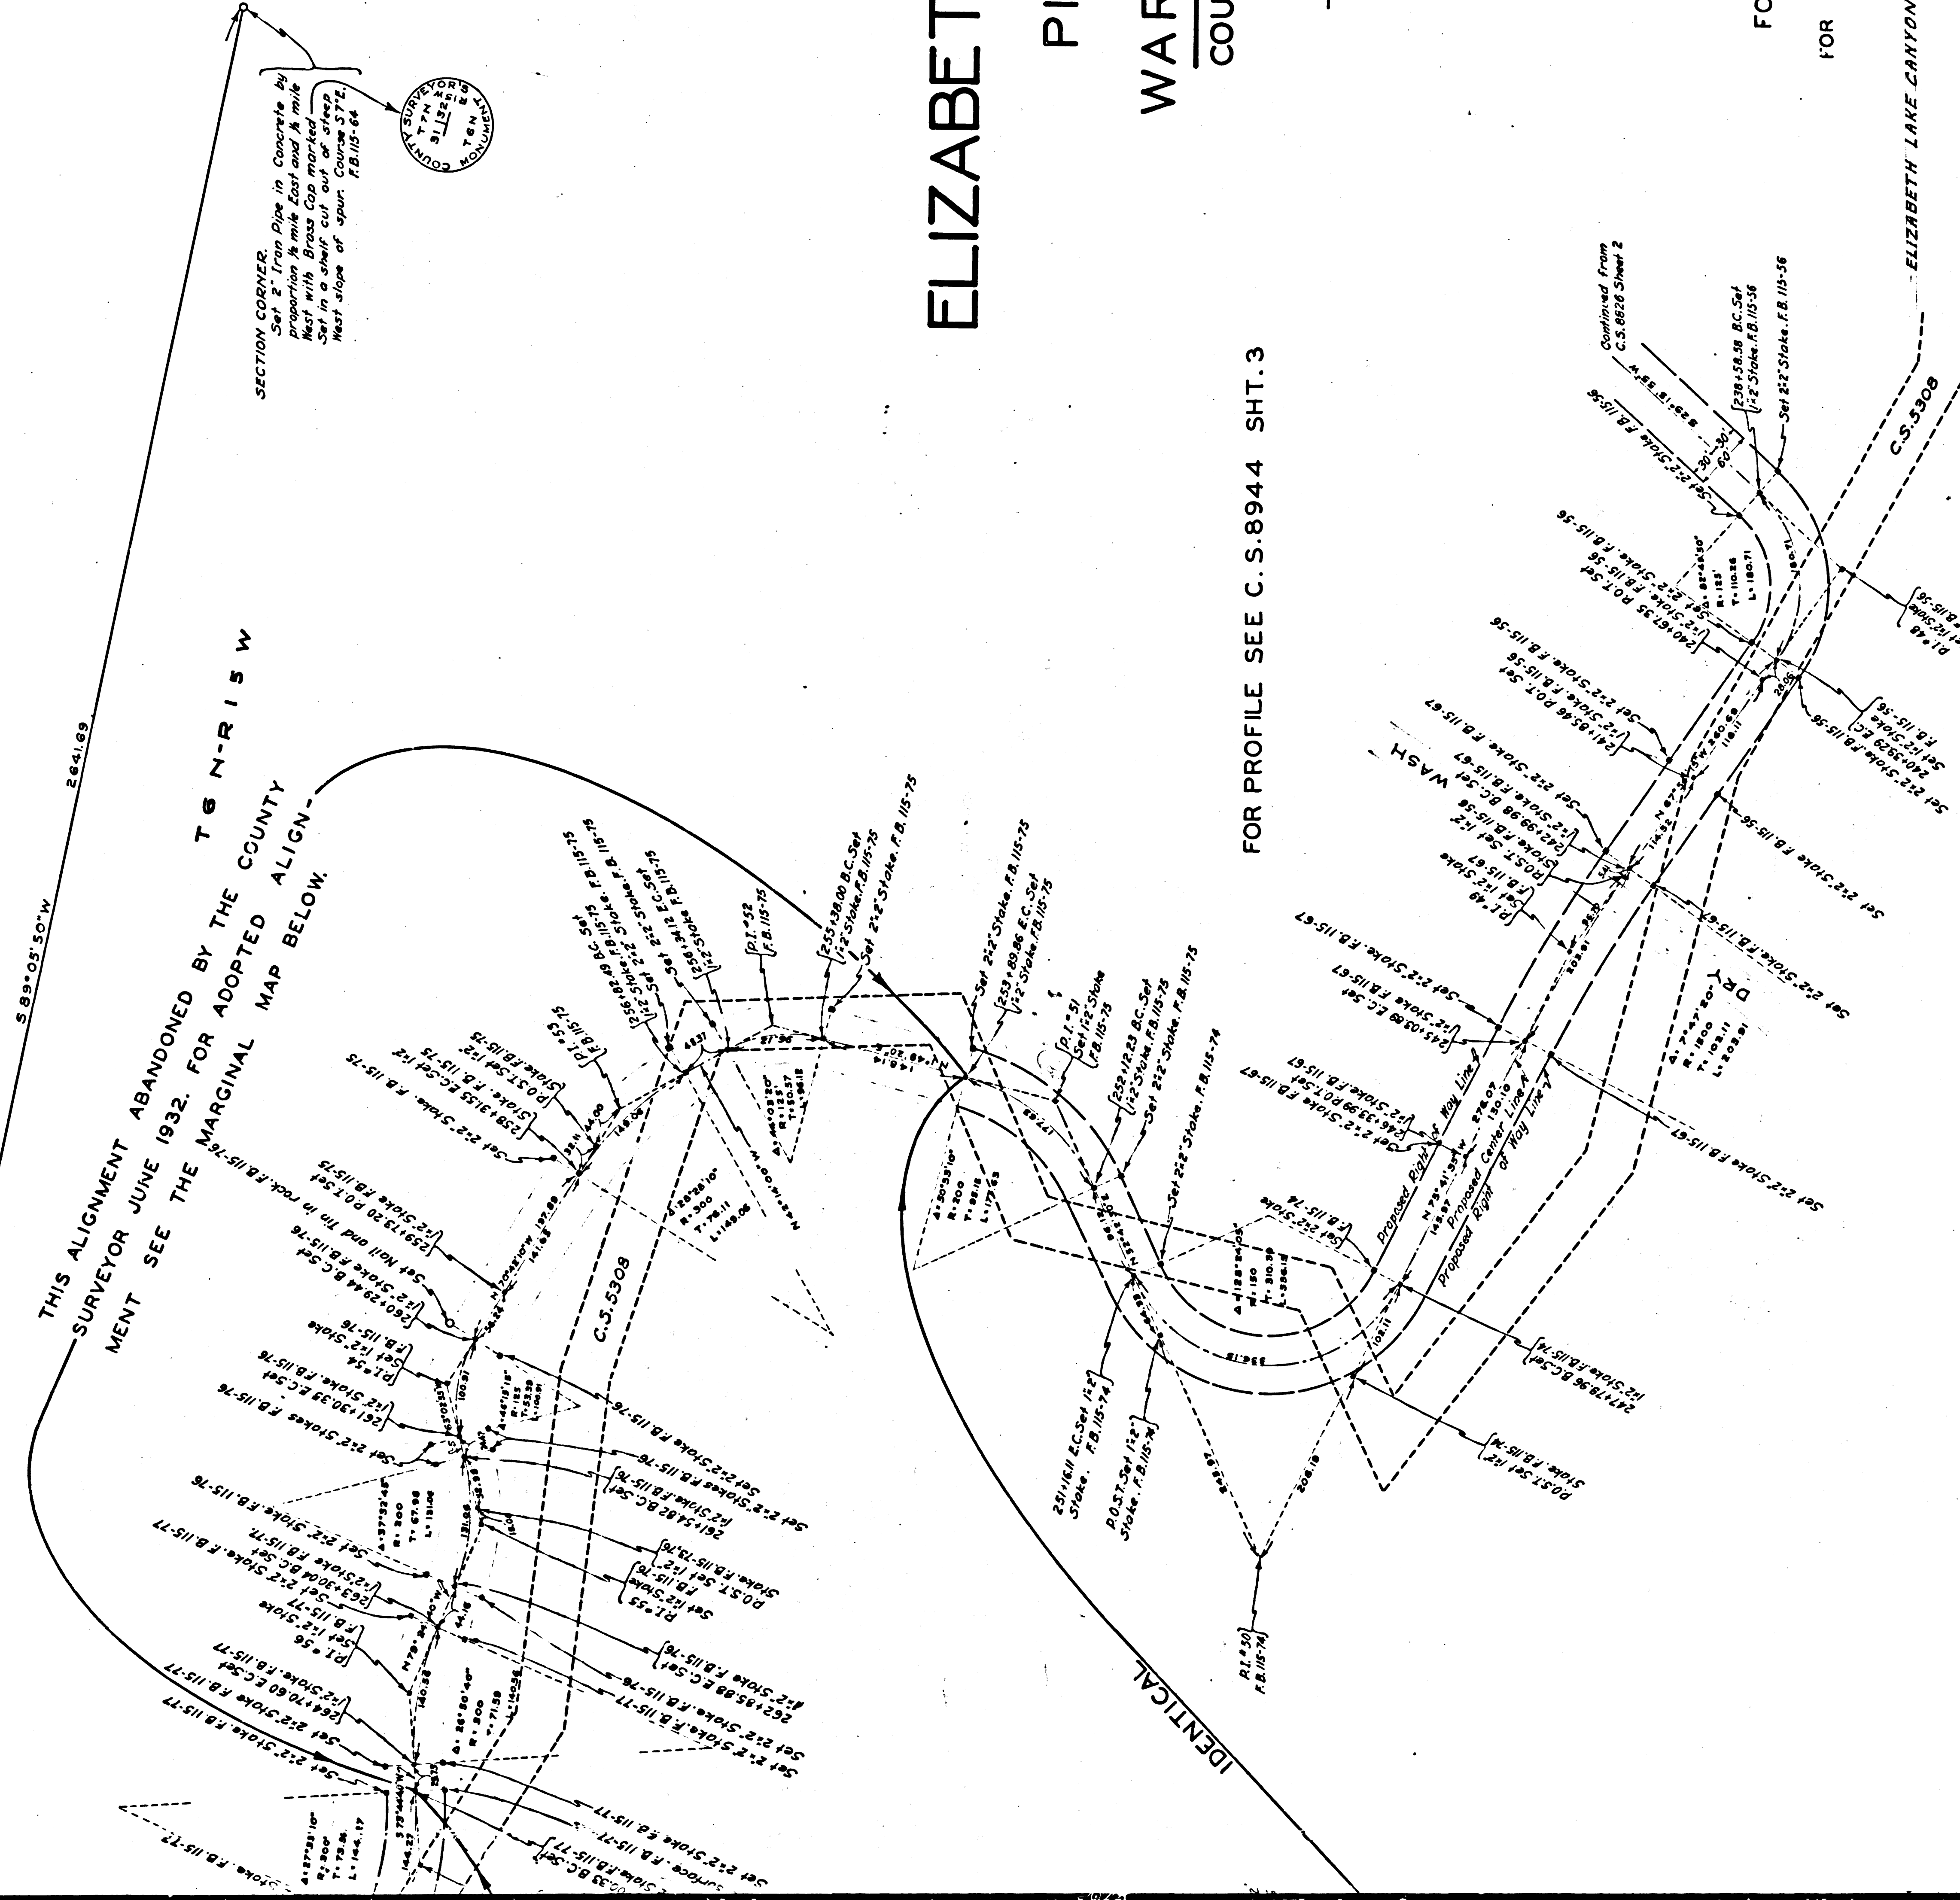
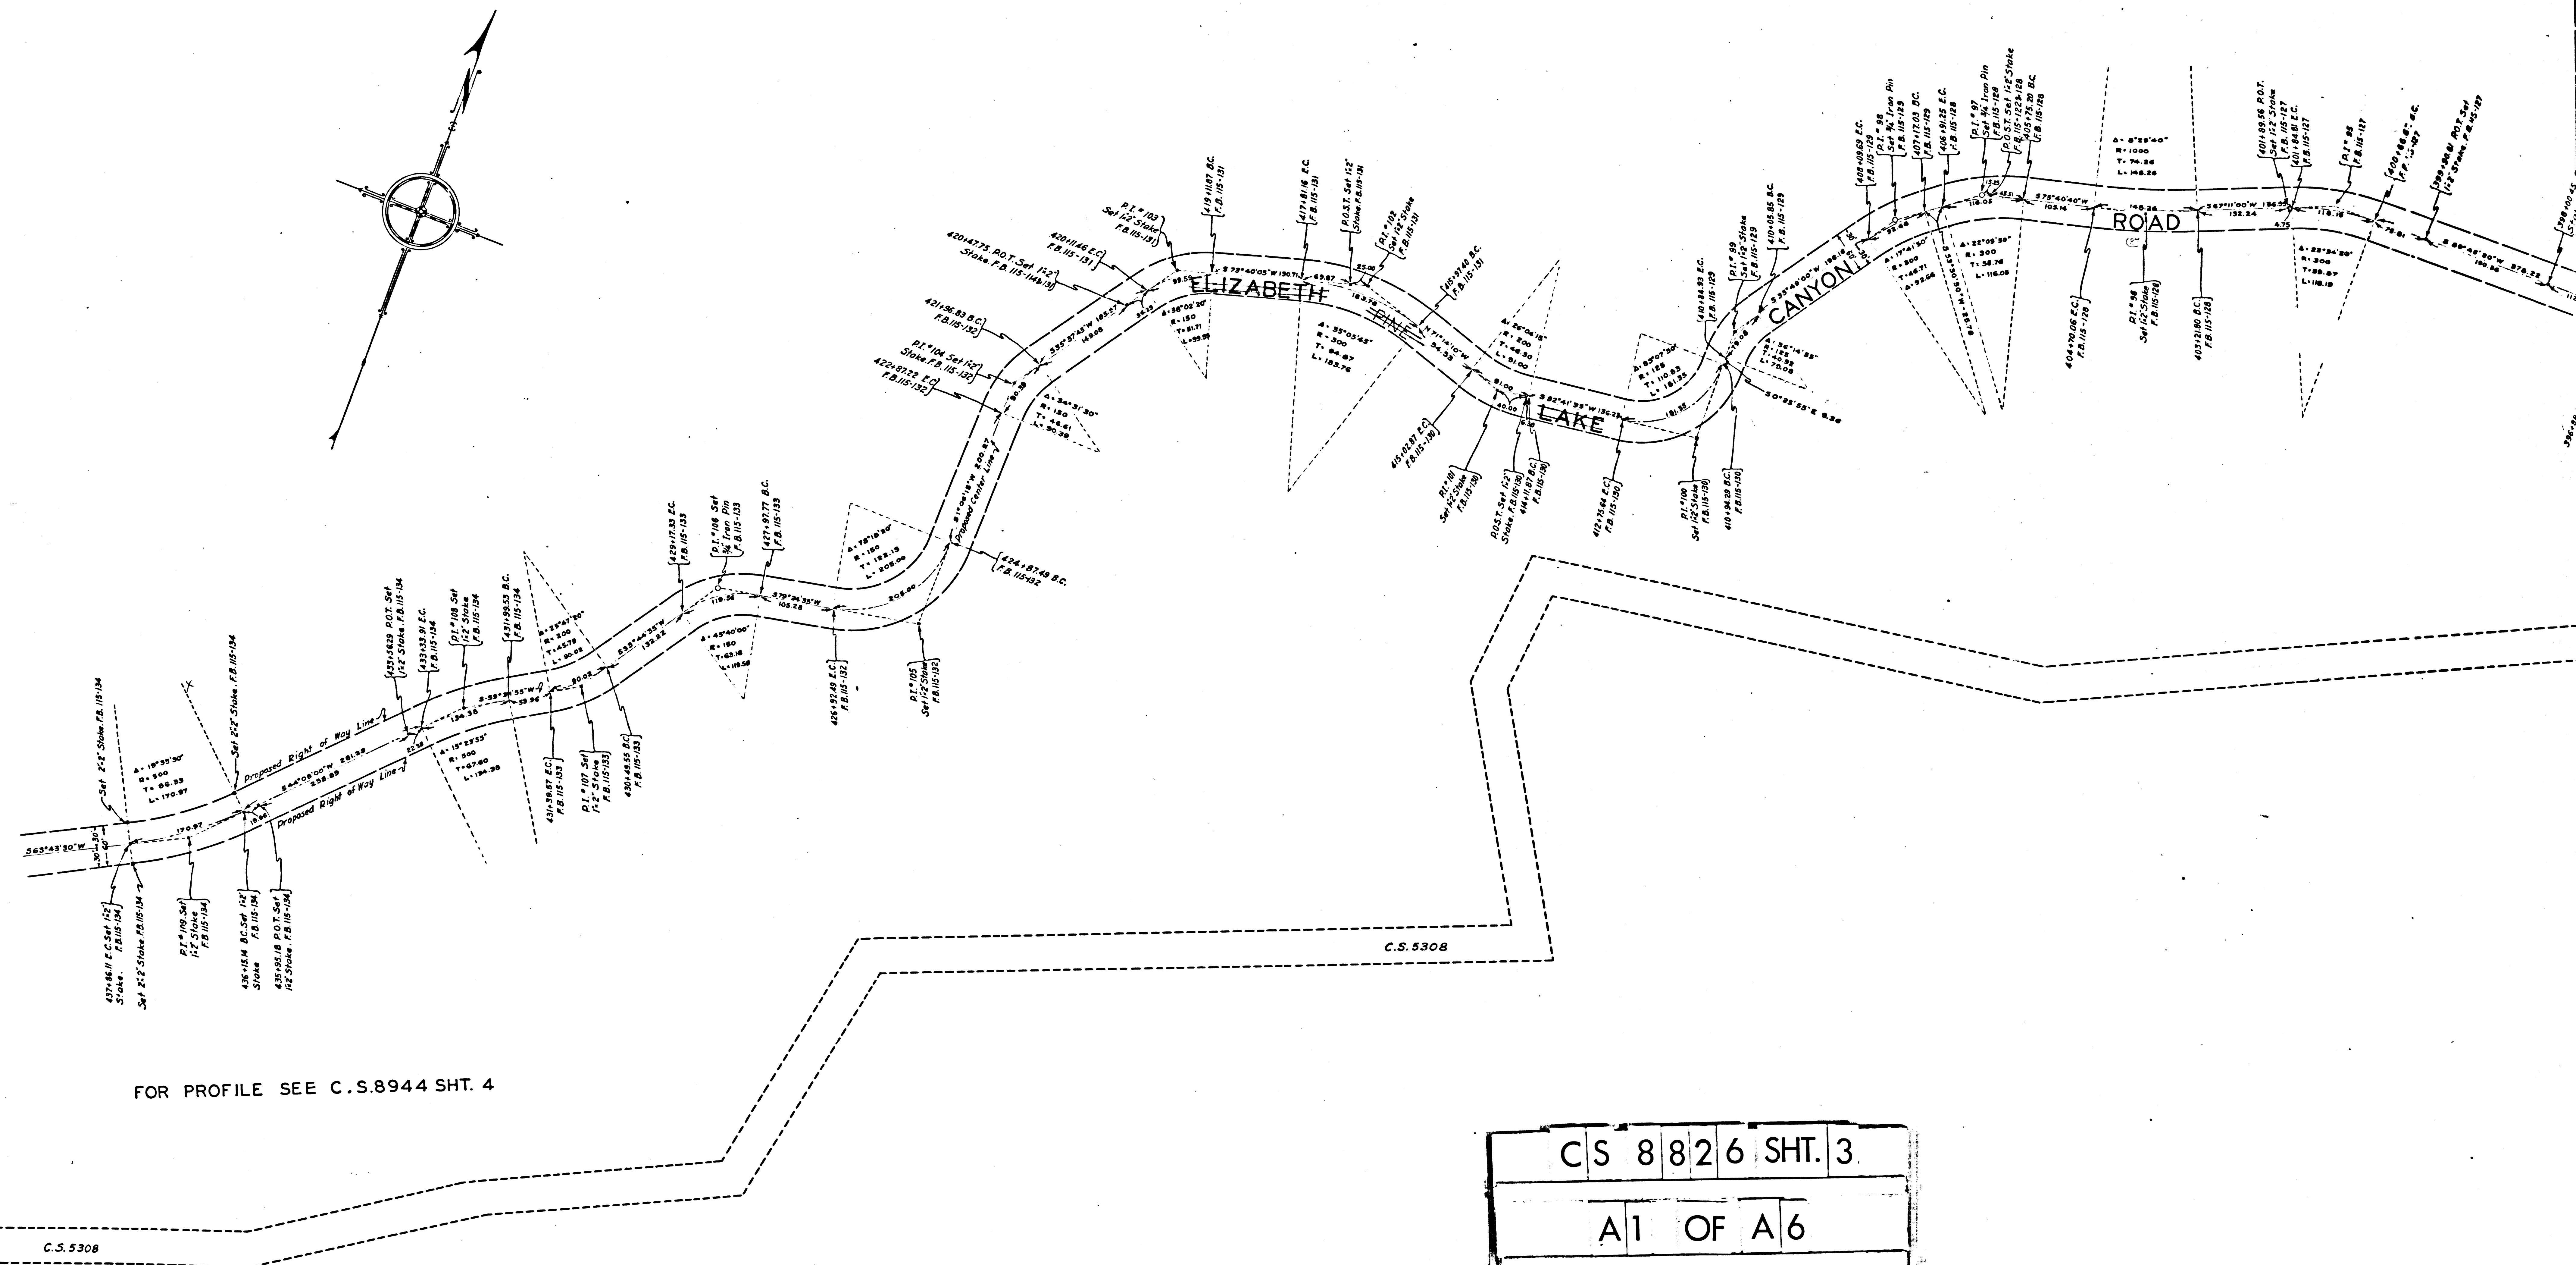
THIS ALIGNMENT ABANDONED BY THE COUNTY SURVEYOR JUNE 1932. FOR ADOPTED ALIGNMENT SEE THE MARGINAL MAP BELOW.
