TOPOGRAPHY MAP  
OF A PORTION OF  
OLIVE VIEW SANITARIUM  
IN

SEC. 22. T. 3N. R. 15W. S. 8M.

COUNTY SURVEYORS MAP NO 8956

J. E. ROCKHOLD - COUNTY SURVEYOR  
SURVEYED JULY 1927

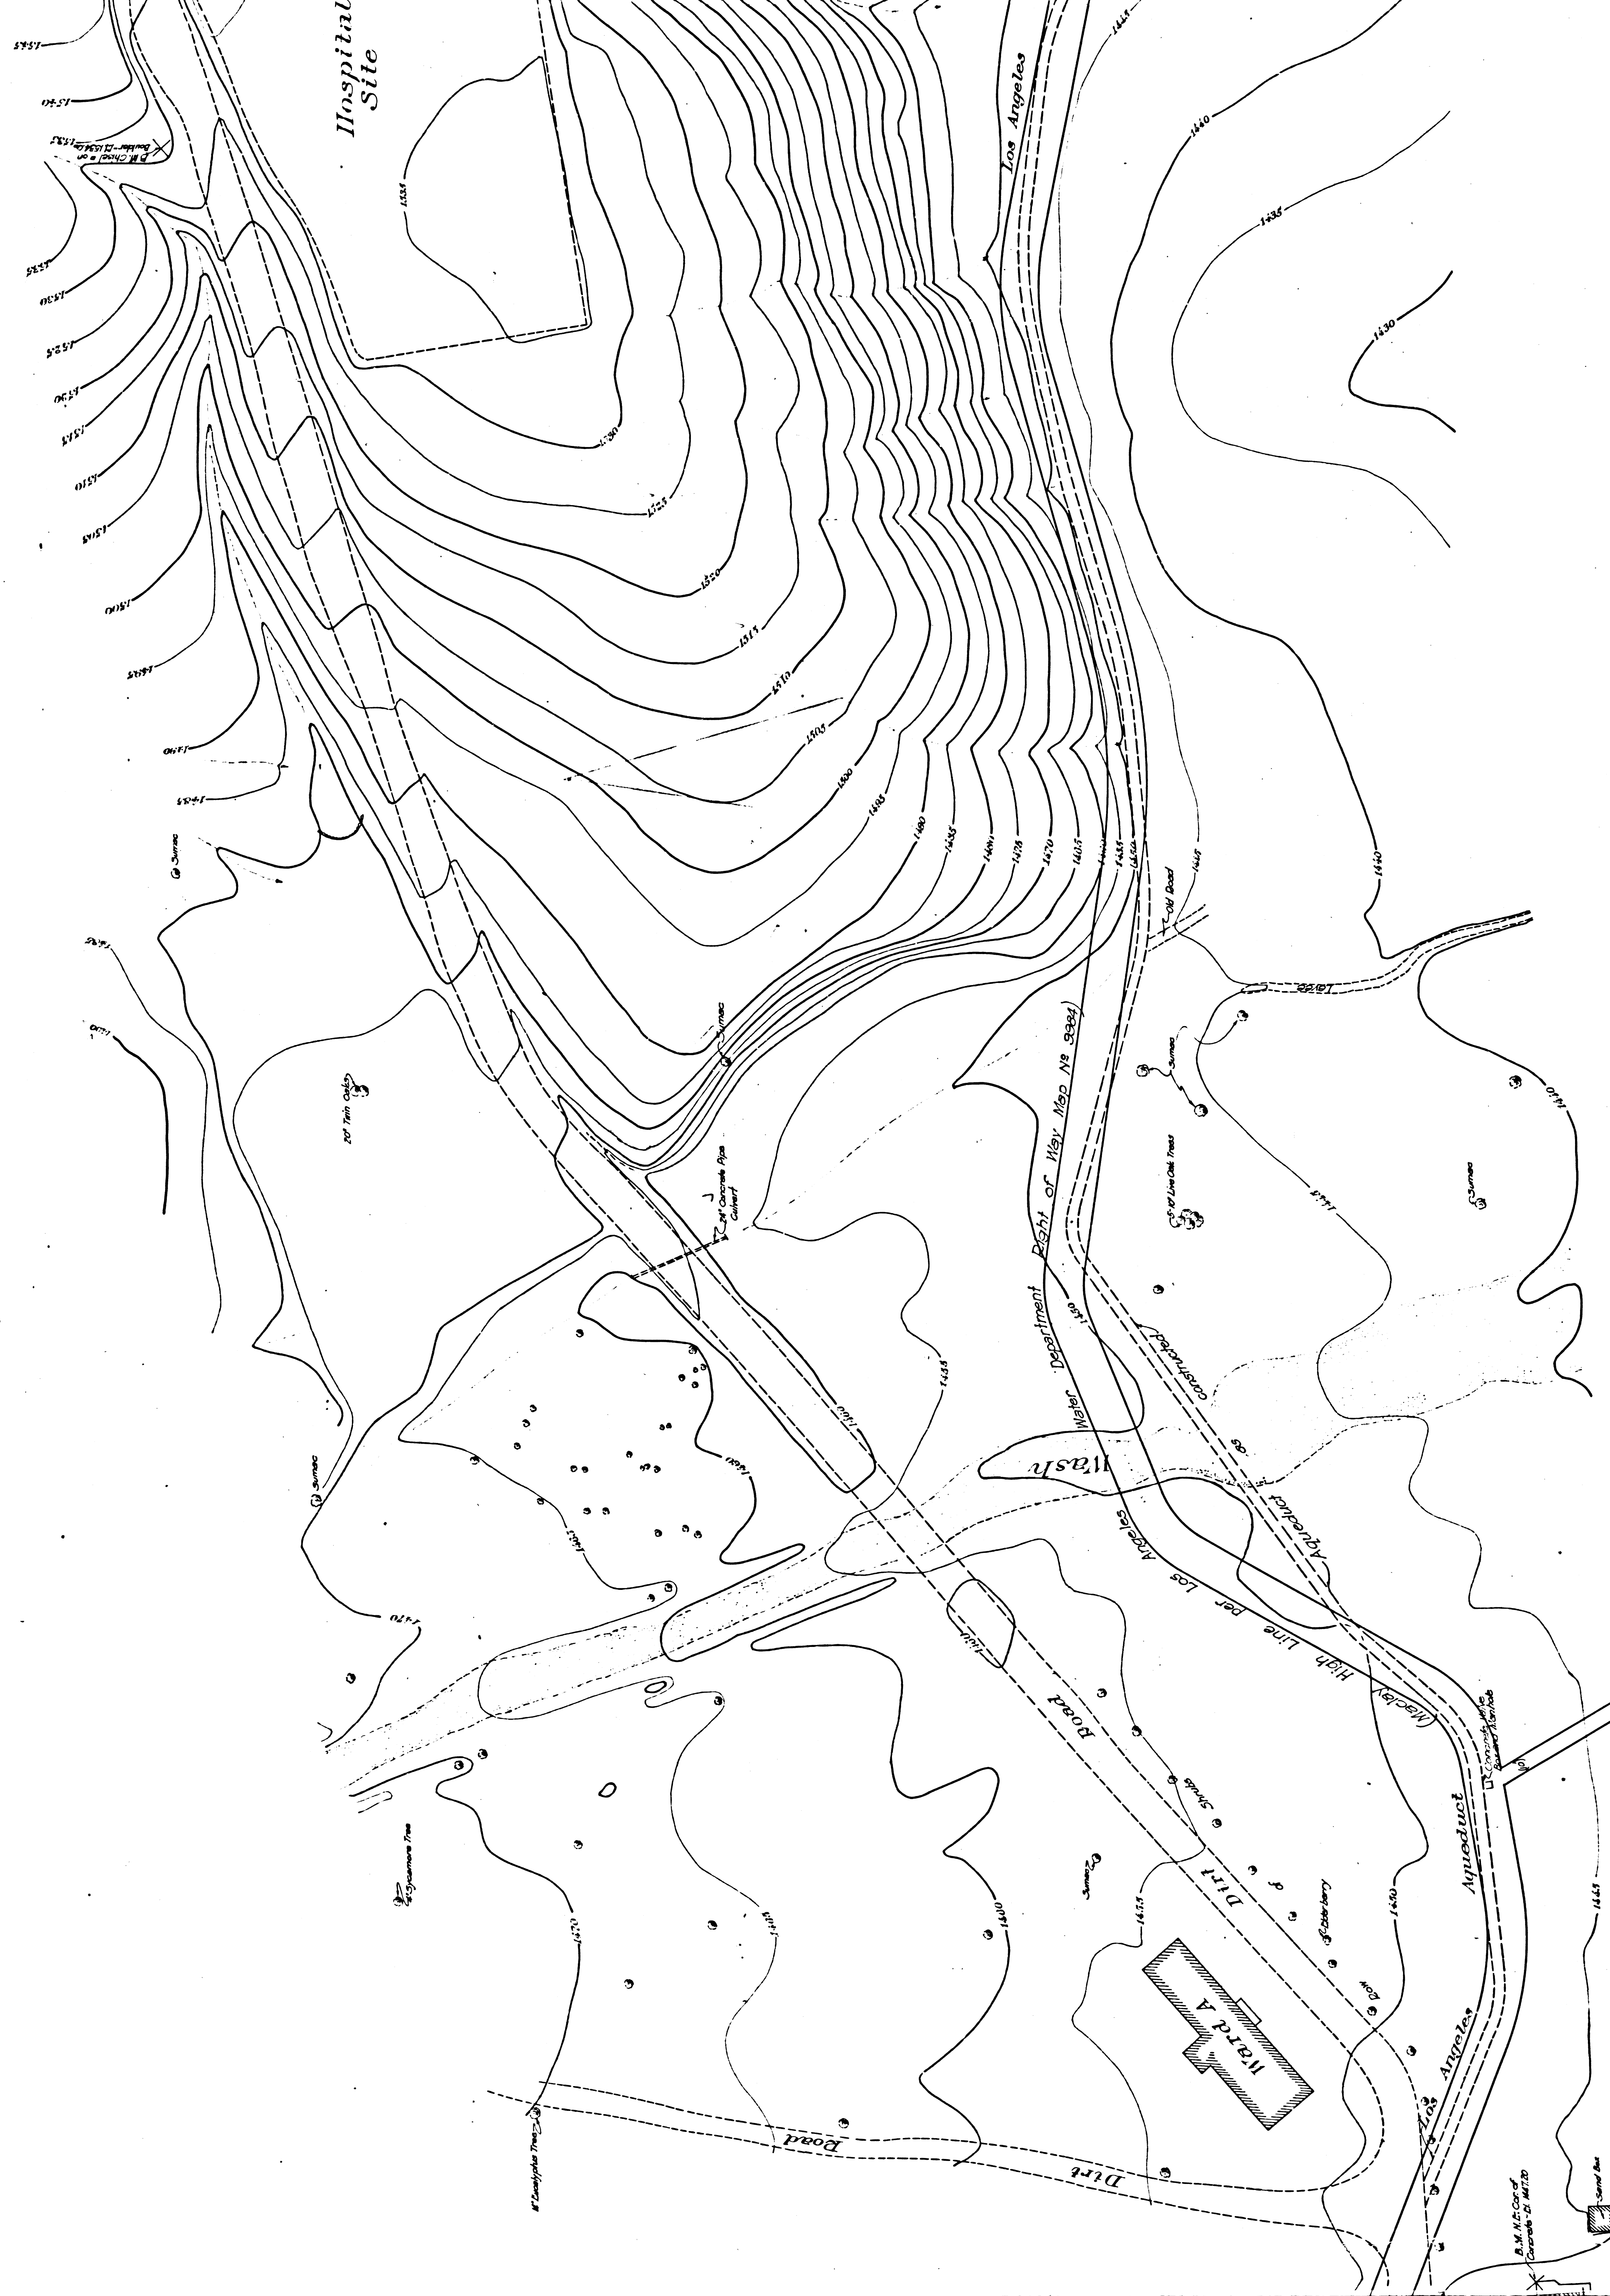
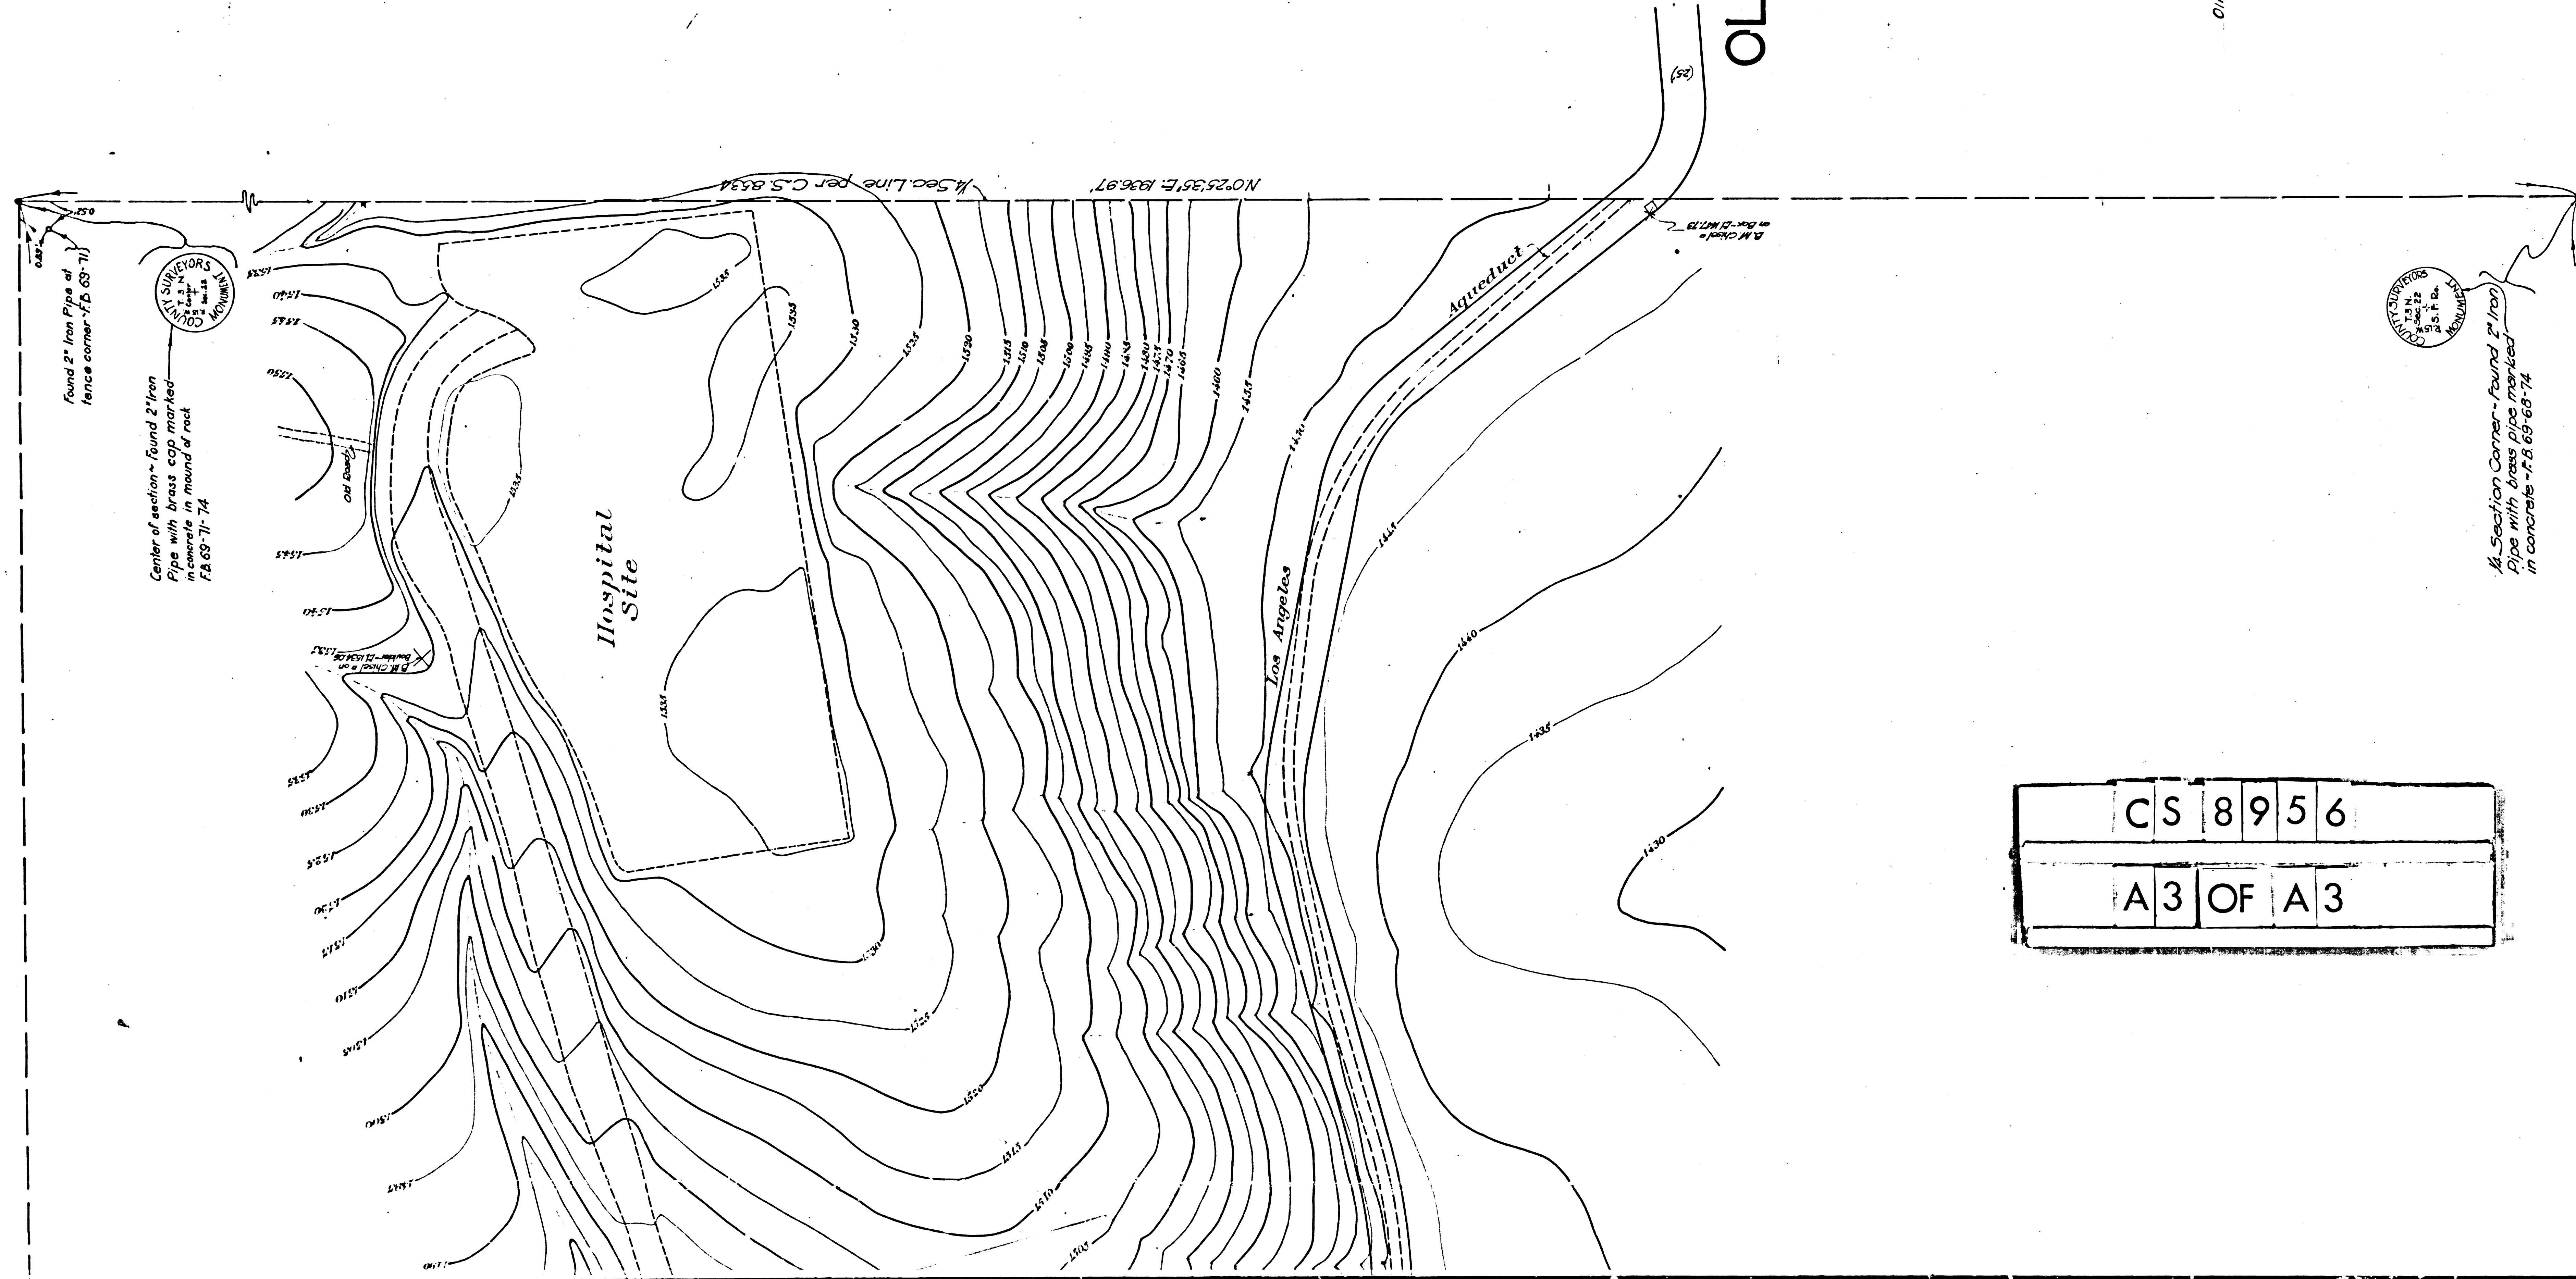
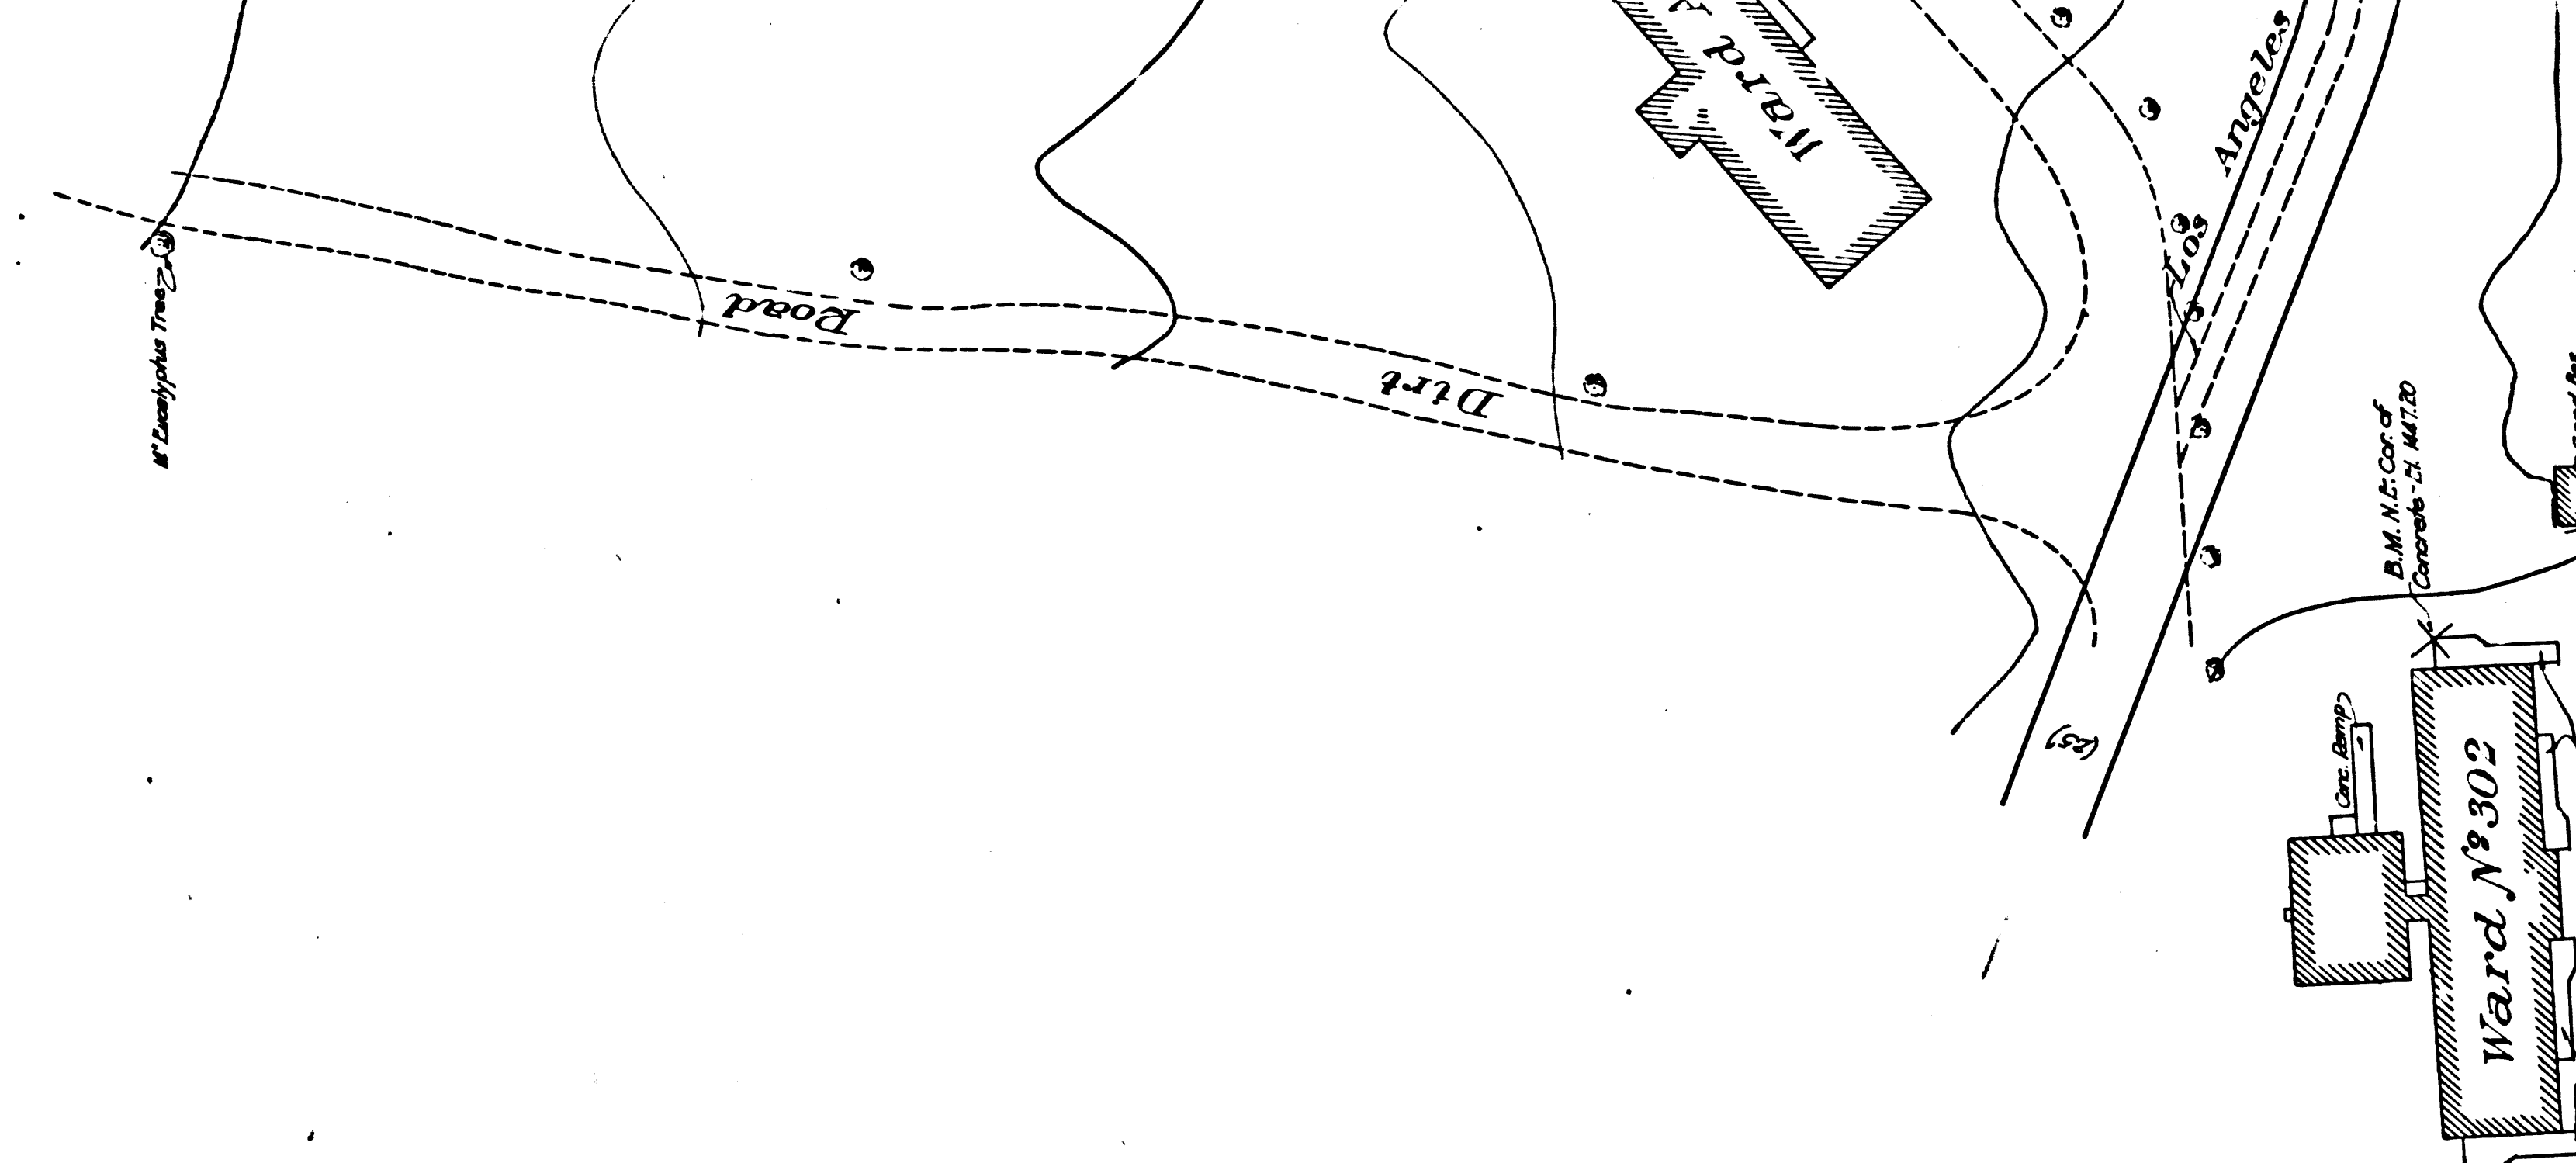
SCALE - 1 INCH = 50 FT.

BEARINGS ARE BASED ON THE BEARING OF  
THE SOUTH LINE OF SECTION 22. T. 3N. R. 15W.  
PER CS 8854

PLANE TABLE SURVEY
