**Re: Devil's Gate Reservoir Restoration Project – Phase 1 Restoration Qualitative Monitoring  
Conducted on August 27, 2025**

## 1.0 INTRODUCTION

## 2.0 QUALITATIVE MONITORING IN PHASE 1 MITIGATION AREAS

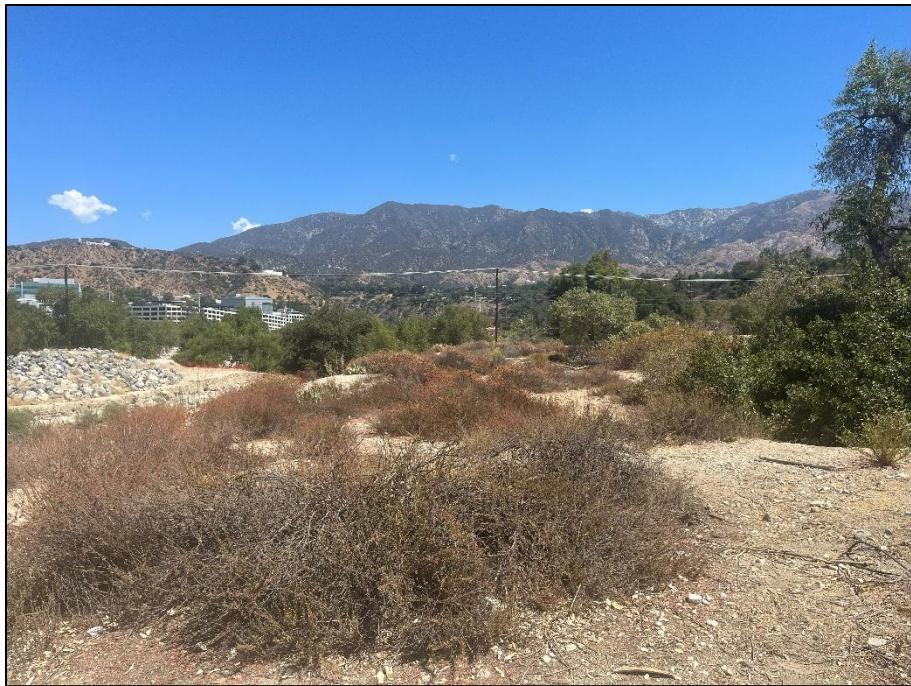
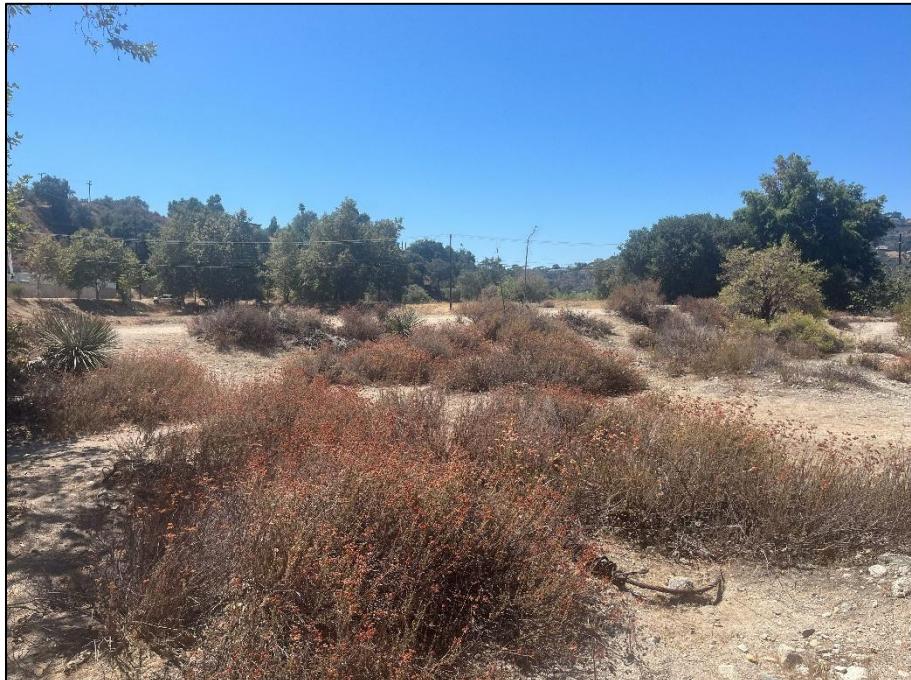
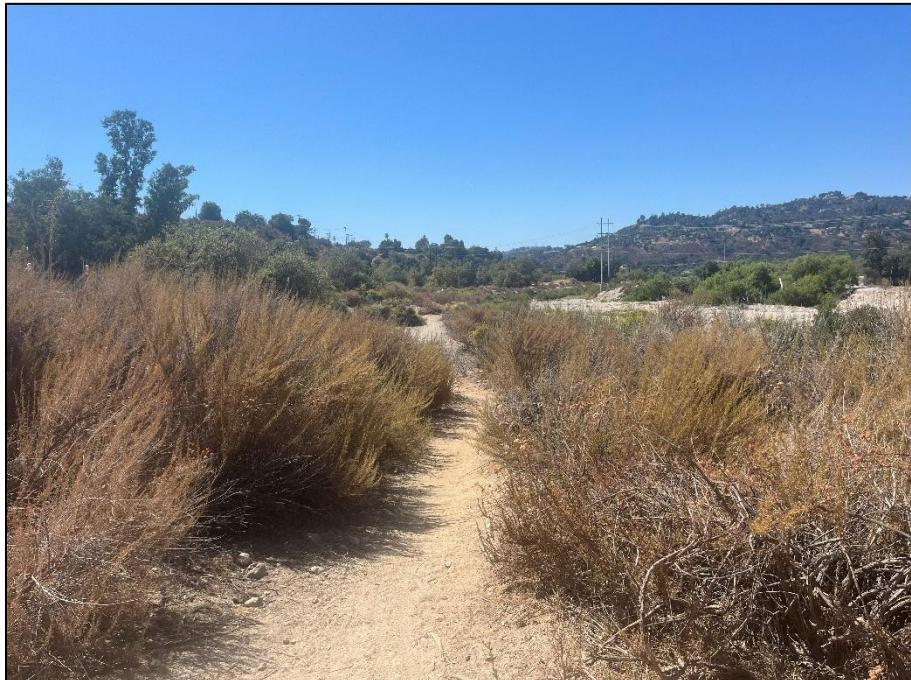
*californicum*), and chia sage (*Salvia columbariae*) were observed sprouting in the DG-1 and DG-1 WOUS mitigation areas. Native cover for the DG-1 and DG-1 WOUS mitigation areas was estimated to be approximately 60 to 65 percent with some areas having relatively dense cover and other areas being scoured and/or having minimal cover. Photos 1 through 4 in Attachment B document the status of the mitigation areas during the monitoring visit.

Nonnative weed cover in DG-1 and DG-1 WOUS was estimated to be approximately 1 percent, which is approximately 1 percent lower than the level of weed cover that was observed during the previous qualitative monitoring event. Nonnative species observed in DG-1 and DG-1 WOUS during the monitoring visit included black mustard (*Brassica nigra*) and brome grasses (*Bromus* spp.). Most nonnative weeds were just starting to germinate and had not gone to flower or seed.

Photo 1: Overview Mitigation Area DG-1

Photo 2: Overview Mitigation Area DG-1

Photo 3: Overview Mitigation Area DG-1

Photo 4: Overview Mitigation Area DG-1

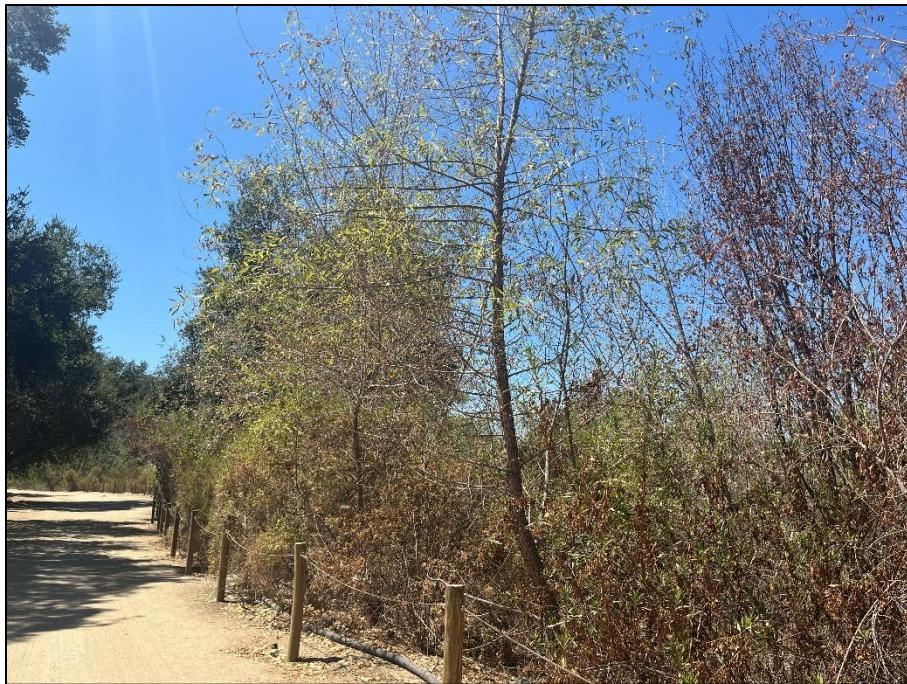
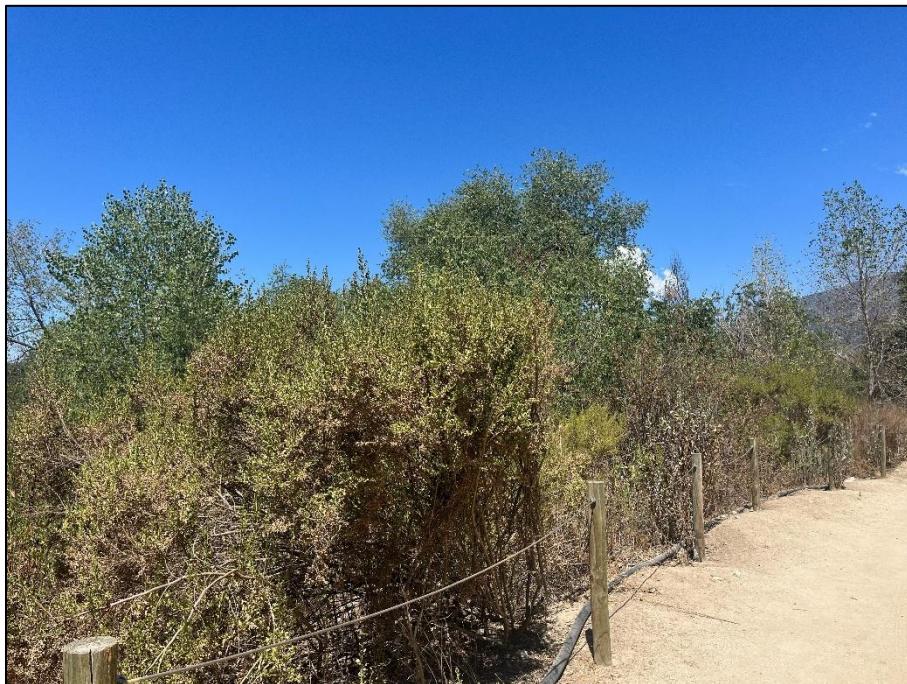
The overall health of the container plants in DG-2A was noted as being moderate. Approximately 30 percent of the container plants in DG-2A were noted as showing varied levels of stress, which is approximately 25 percent higher than the percentage of container plants that were showing stress during the previous qualitative monitoring event. Stress may be occurring as a result of 1) drought stress from recent high temperatures and below average rainfall levels, 2) competition from nonnative and invasive weeds and/or 3) recreational traffic through the mitigation areas. Additional missing or dead container plants were not observed. Photos 5 and 6 in Attachment B document the status of the mitigation area during the monitoring visit.

Native plant growth was noted throughout the DG-2A mitigation area, likely both from natural recruitment and from seeding. Native plants such as annual bursage (*Ambrosia acanthicarpa*), western ragweed (*Ambrosia psilostachya*), mugwort (*Artemisia douglasiana*), mulefat (*Baccharis salicifolia*), Canada horseweed, and telegraph weed (*Heterotheca grandiflora*) were observed sprouting in the DG-2A mitigation area. Native cover for the DG-2A mitigation area was estimated to be 75 percent.

Nonnative weed species were not observed within the DG-2A mitigation area during the monitoring visit and evidence of recent weed abatement was observed.

Photo 5: Overview Mitigation Area DG-2A

Photo 6: Overview Mitigation Area DG-2A

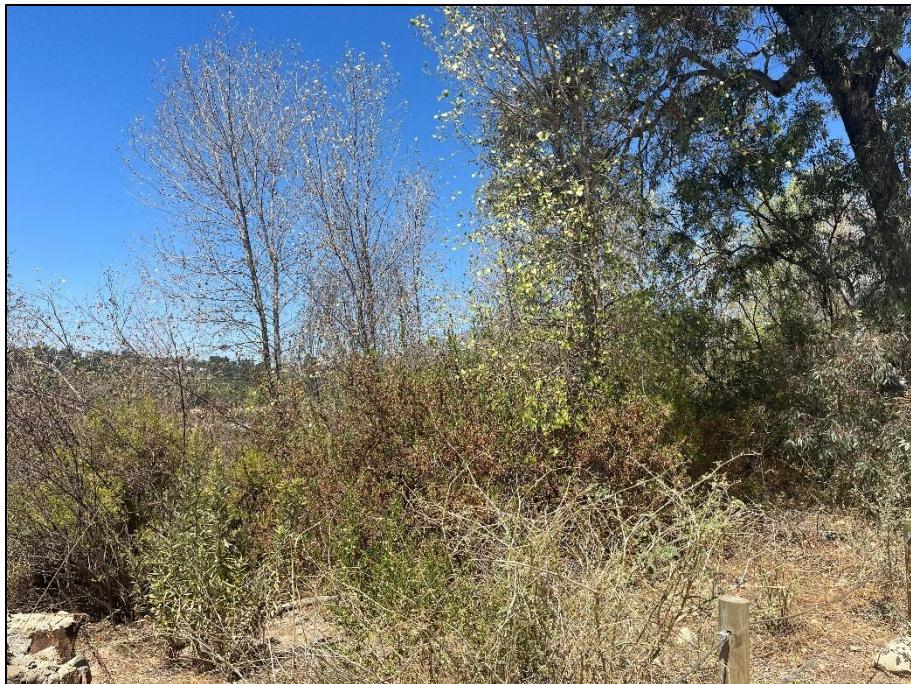
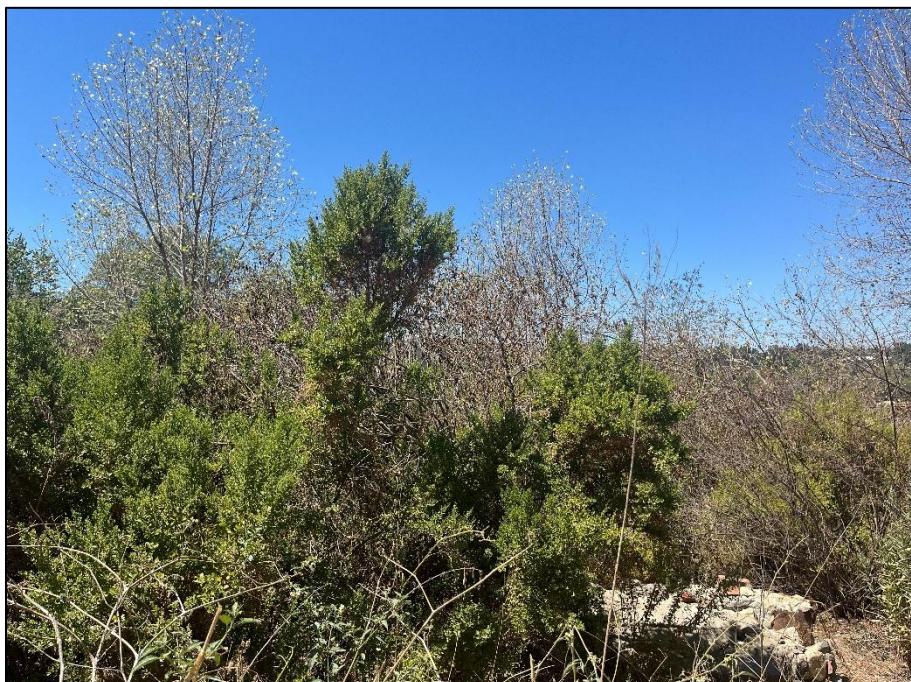
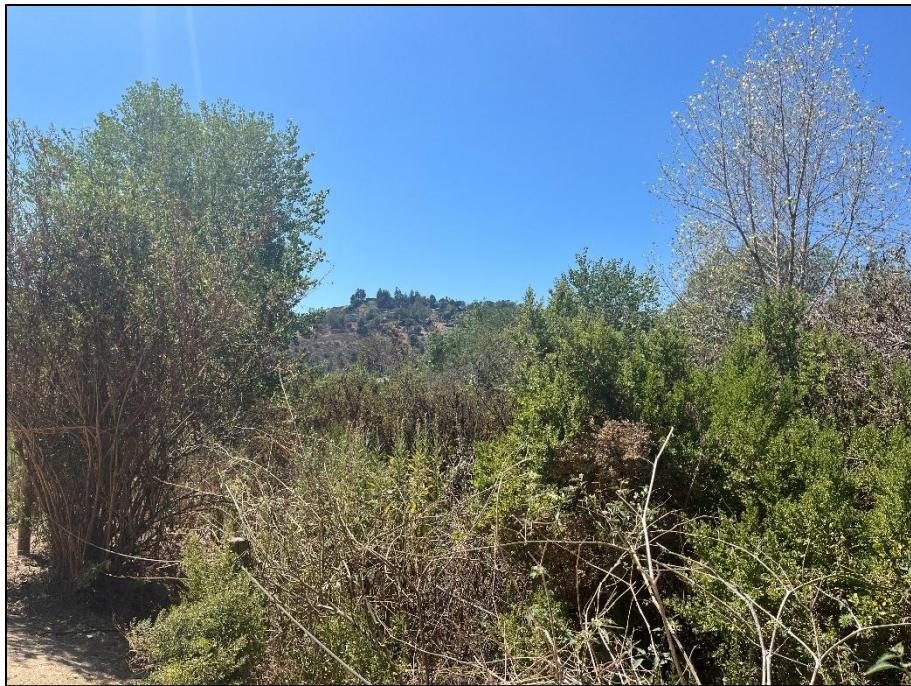
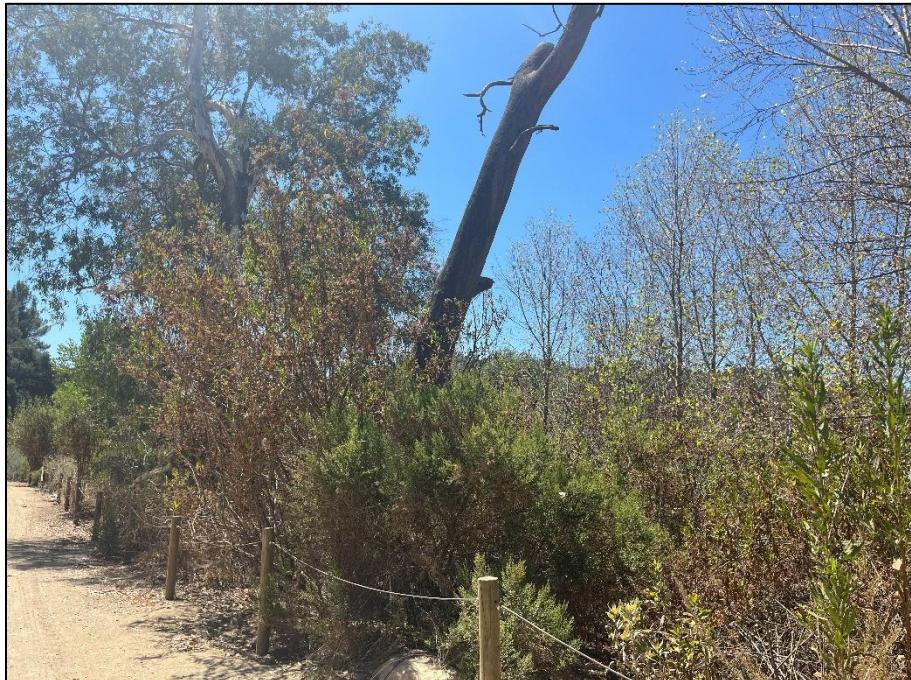
The overall health of the container plants in DG-2B was noted as being moderate. Approximately 25 percent of the container plants in DG-2B were noted as showing varied levels of stress, which is approximately 20 percent more than the percentage of container plants that were showing stress during the previous qualitative monitoring event. Stress was likely due to the same reasons as those described for DG-2A, especially drought stress. Photos 7 through 10 in Attachment B document the status of the mitigation area during the monitoring visit.

Nonnative weed cover in DG-2B was estimated at approximately 1 percent, which is approximately the same level of nonnative cover that was observed during the previous qualitative monitoring event.

Nonnative species observed in DG-2B during the monitoring visit included black mustard and poison hemlock (*Conium maculatum*). Most nonnative weeds were just starting to germinate and had not gone to flower or seed.

Photo 7: Overview Mitigation Area DG-2B

Photo 8: Overview Mitigation Area DG-2B

Photo 9: Overview Mitigation Area DG-2B

Photo 10: Overview Mitigation Area DG-2B

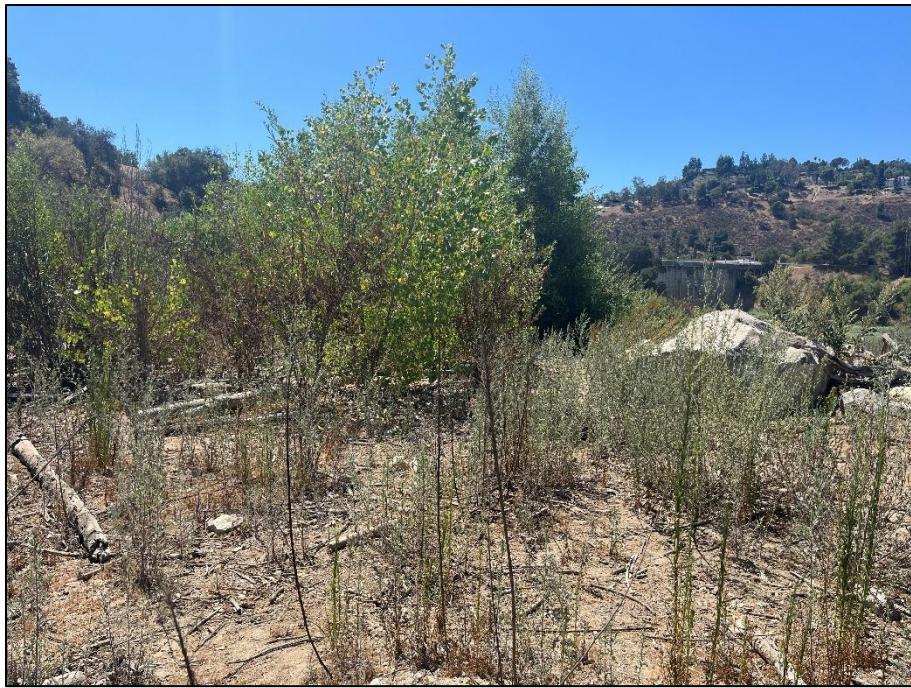
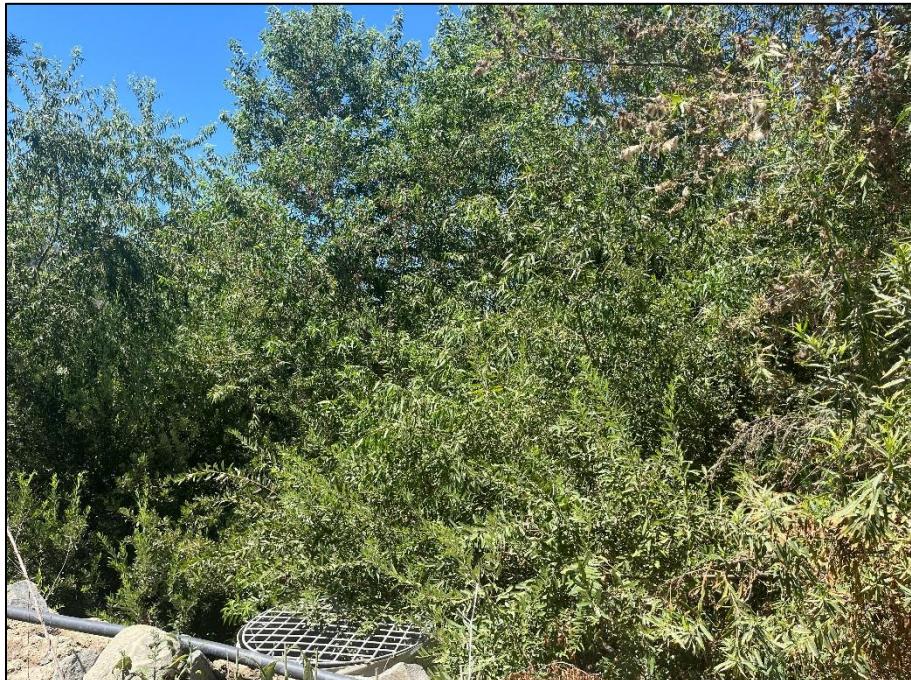
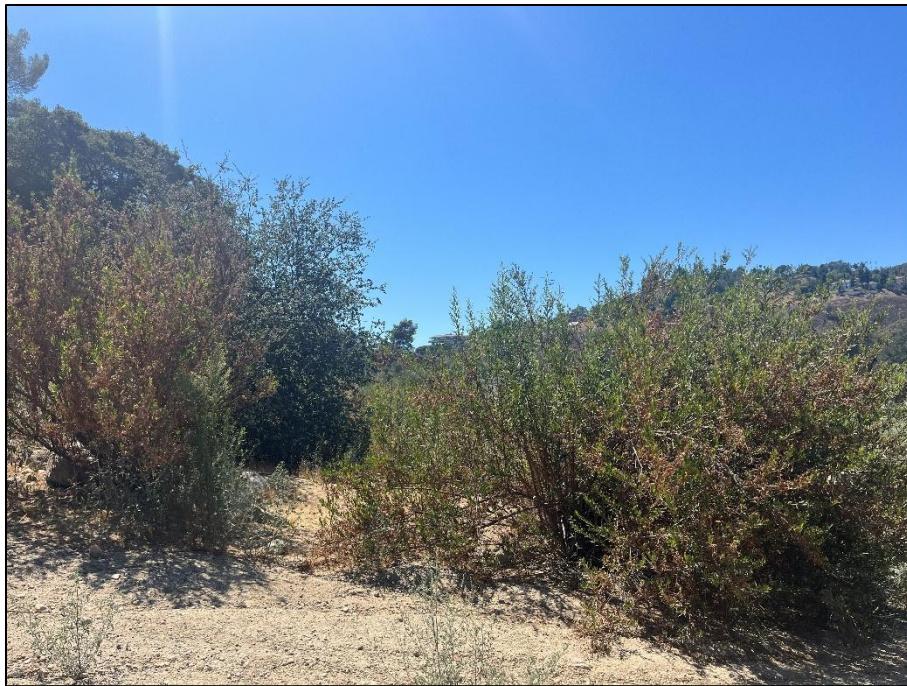
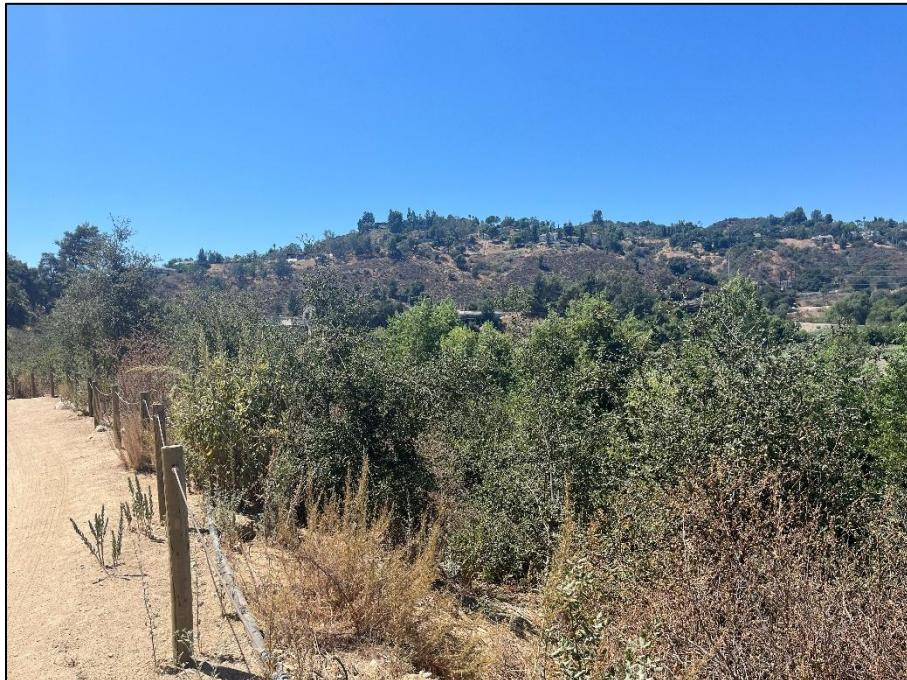
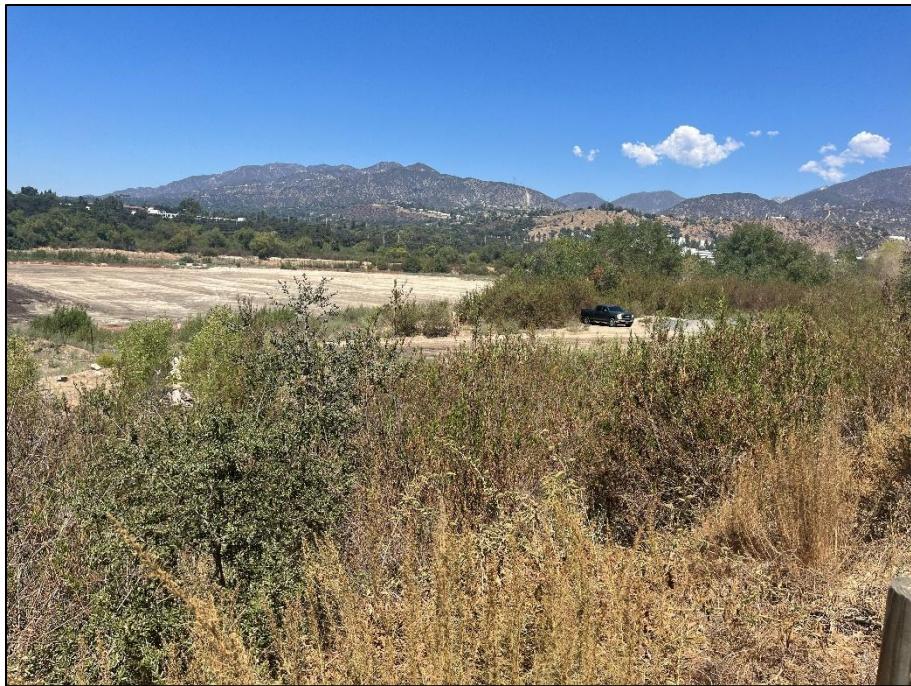
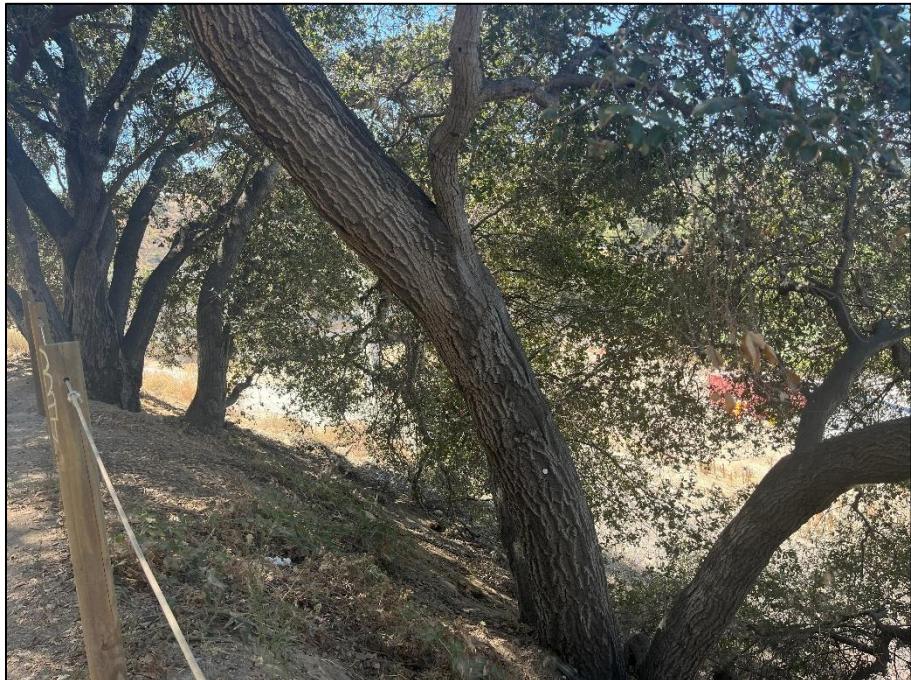
The overall health of the container plants in DG-3A was noted as being moderate to good and the willow and mulefat stakes are thriving in this mitigation area. Approximately 5 percent of the container plants in both the coast live oak woodland and mulefat thickets portions of DG-3A were noted as showing varied levels of stress, which is approximately the same percentage of container plants that were showing stress during the previous qualitative monitoring event. Some of the stress was likely due to the same reasons as those described for DG-2A. Erosion is also a problem in some areas of DG-3A along Altadena Drain and on the steep slopes in the coast live oak woodland area. During the monitoring visit, the planted coast live oak (*Quercus agrifolia*) acorns were inspected for survivorship and health. Approximately 20 germinated coast live oak acorns appear to still be present in DG-3A and are approximately five to eight feet tall. Most of the germinated acorns appear to be in good health. Previously documented branch failure on an existing coast live oak tree (Tree Tag #39) was still present; however, no new branch failure or damage was observed. The cause of the previously documented branch failure was unclear. Photos 11 through 16 in Attachment B document the status of the mitigation area during the monitoring visit.

Native plant growth was noted throughout the DG-3A mitigation area, likely both from natural recruitment and from seeding. Native plants such as annual bursage, mugwort, Canada horseweed, telegraph weed, and coast live oak (*Quercus agrifolia*) were observed sprouting in the DG-3A mitigation area. Native cover for the DG-3A mitigation area was estimated to be approximately 65 percent in the coast live oak woodland portion of the mitigation area and 75 to 80 percent in the mulefat thickets portion of the mitigation area.

Nonnative weed cover in DG-3A was estimated at approximately 1 percent, which is approximately the same level of nonnative cover that was observed during the previous qualitative monitoring event.

Photo 11: Overview Mitigation Area DG-3A Altadena Drain

Photo 12: Overview Mitigation Area DG-3A Altadena Drain

Photo 13: Overview Mitigation Area DG-3A Oak Woodland

Photo 14: Overview Mitigation Area DG-3A Oak Woodland

Photo 15: Overview Mitigation Area DG-3A Oak Woodland

Photo 16: Overview Mitigation Area DG-3A Oak Woodland

Minor erosion to planting basins was observed throughout the Phase 1 mitigation areas. The severe erosion noted in DG-3A near Altadena Drain during previous monitoring visits did not show any signs of worsening. Due to the steepness of the slope in the coast live oak woodland portion of the DG-3A mitigation area, erosion will likely continue to be somewhat of an issue in this area; however, jute nettings are currently in place on the slope and will help to lessen the severity of erosion issues. As native cover increases in this area, erosion issues should lessen. The severity of the erosion should continue to be monitored in all planted areas and if warranted, erosion Best Management Practices (BMPs) should be installed in appropriate areas. This may only require the installation of straw wattles at select sites to prevent existing rills from becoming larger. However, until more native perennial plants become established in these areas, there is the potential that intense rainfall may create additional erosion problems.

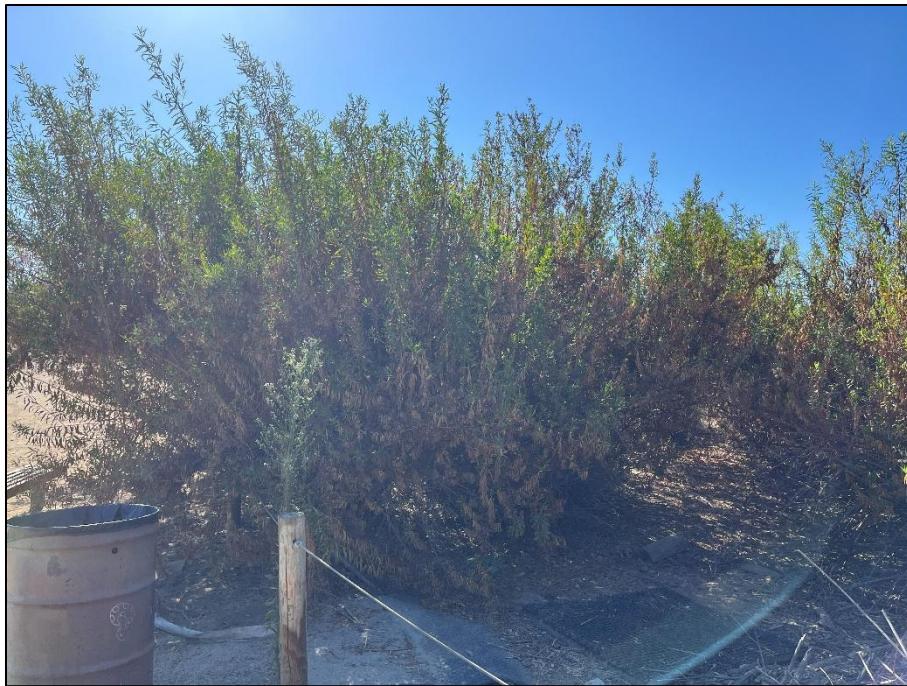
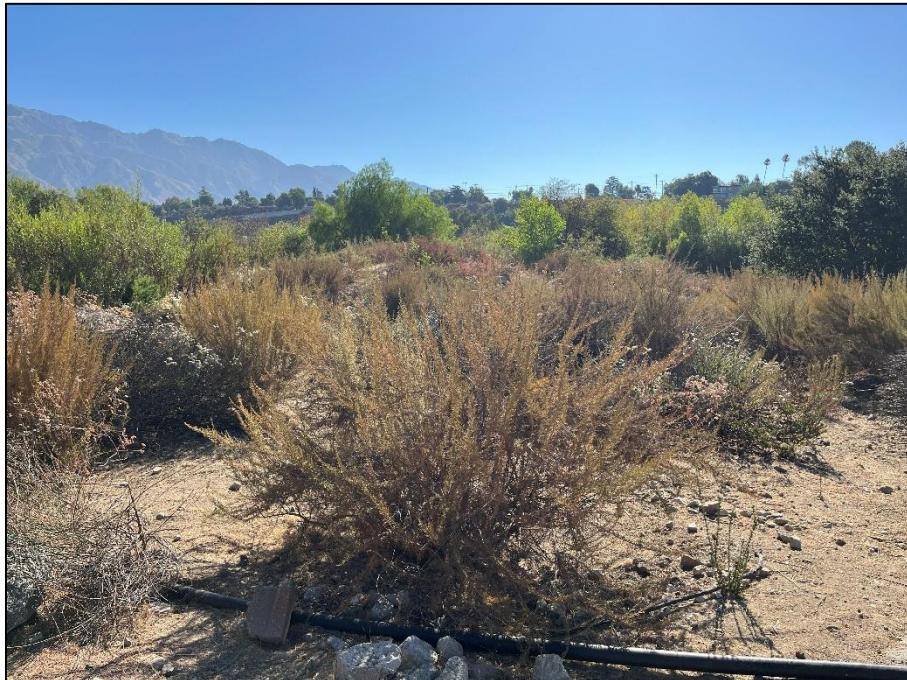
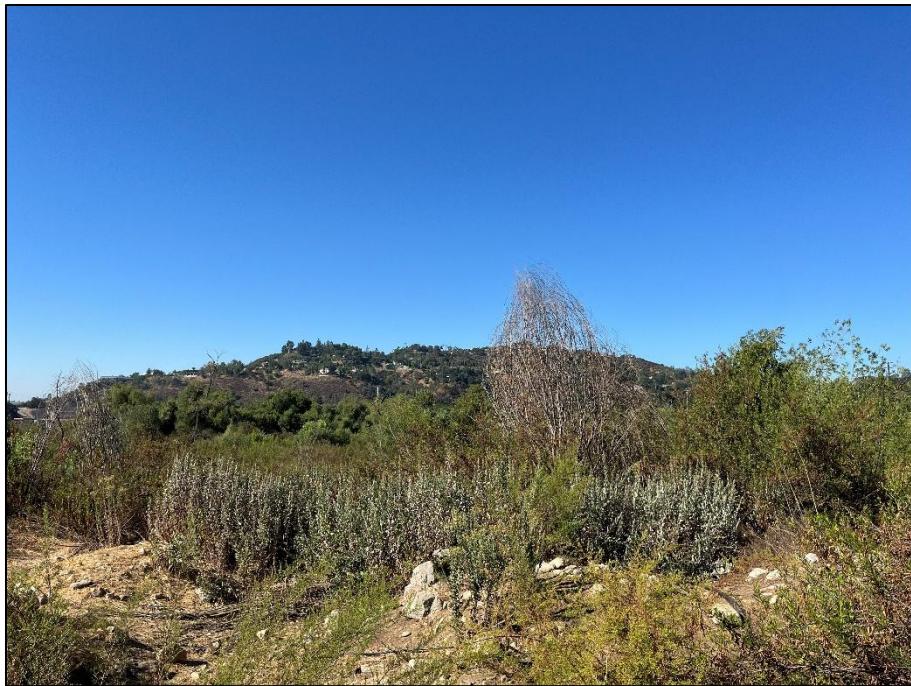
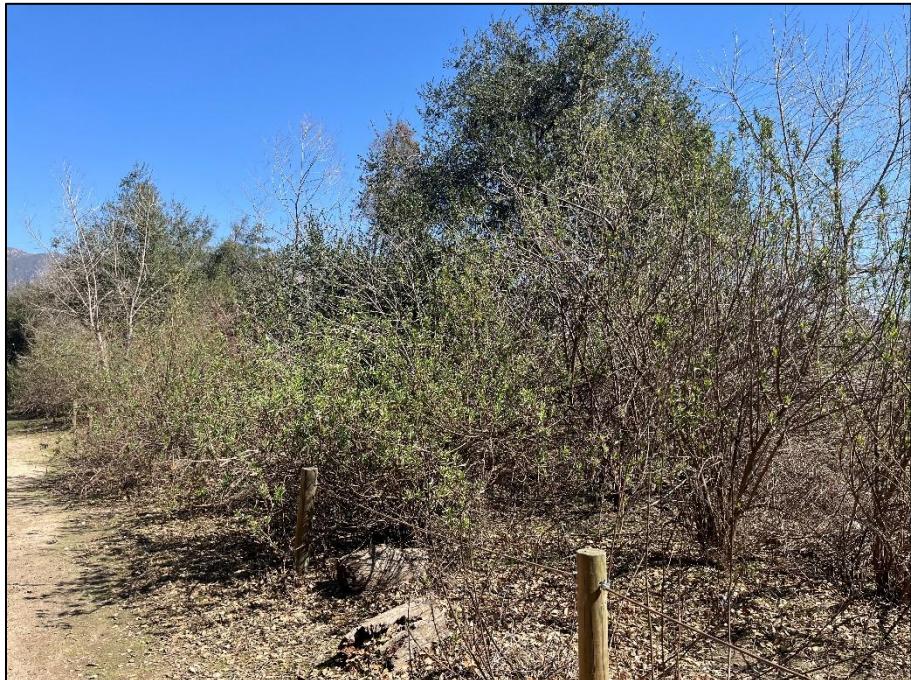
The overall health of the container plants in mitigation area DG-4 was noted as being moderate to good. Approximately 10 percent of container plants in the coastal sage scrub portions of DG-4 and approximately 25 percent of container plants in the riparian portions of DG-4 showed varied levels of stress which is approximately 5 to 20 percent higher than the percentage of plants showing stress during the previous qualitative monitoring event. The causes of stress appear to be mostly due to the same

reasons described in DG-2A, especially drought stress. Photos 17 through 20 in Attachment B document the status of the mitigation area during the monitoring visit.

Nonnative weed cover in DG-4 was estimated at approximately 1 to 5 percent, which is approximately the same as or slightly lower than the percentage of nonnative cover that was observed during the previous qualitative monitoring event. Nonnative species observed in DG-4 included tree of heaven (*Ailanthus altissima*), black mustard, poison hemlock, and perennial pepperweed (*Lepidium latifolium*). Nonnative weed cover, especially perennial pepperweed, is a significant problem in portions of the DG-4 mitigation area. Because perennial pepperweed can produce dense colonies through seed germination and underground rhizomes (rhizomatous roots), removal of this species without the use of systemic herbicide is very difficult. Most nonnative weeds were just starting to germinate and had not gone to flower or seed.

Photo 17: Overview Mitigation Area DG-4 CSS

Photo 18: Overview Mitigation Area DG-4 CSS

Photo 19: Overview Mitigation Area DG-4 Riparian

Photo 20: Overview Mitigation Area DG-4 Riparian

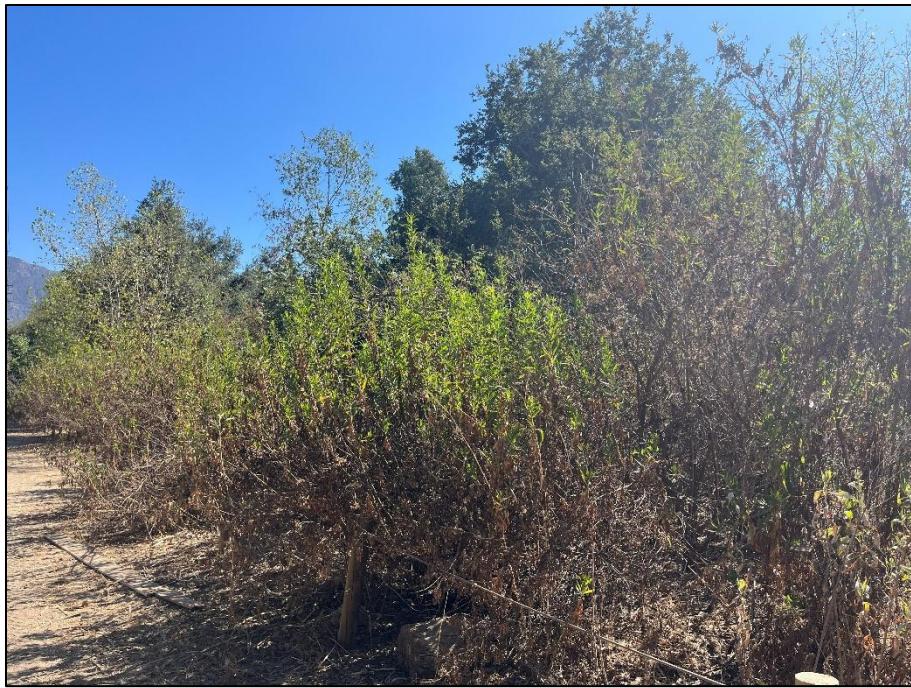
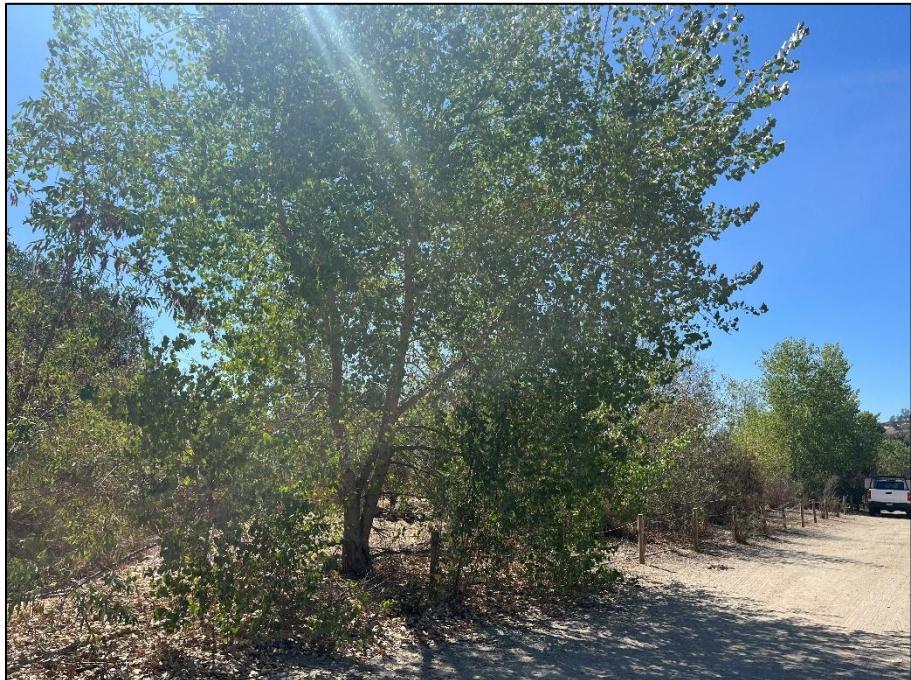
The overall health of the container plants in mitigation area DG-4B was noted as being moderate to good. Approximately less than 15 to 20 percent of container plants were showing varied levels stress which is approximately 10 to 15 percent higher than the percentage of plants that were stressed during the previous qualitative monitoring event. Stress was likely due to the same reasons as those described for DG-2A, especially drought stress. California dodder (*Cuscuta californica*), a native parasitic vine, was also observed growing on several of the container plants. A negligible number of container plants were noted as being missing or dead. Photos 21 and 22 in Attachment B document the current status of the mitigation area during the monitoring visit.

Nonnative weed cover in DG-4B was estimated to be approximately 2 percent, which is approximately 1 percent higher than the level of nonnative cover that was observed during the previous qualitative monitoring event. Nonnative species observed in DG-4B included black mustard, poison hemlock, and perennial pepperweed. Most nonnative weeds were just starting to germinate and had not gone to flower or seed.

Photo 21: Overview Mitigation Area DG-4B

Photo 22: Overview Mitigation Area DG-4B

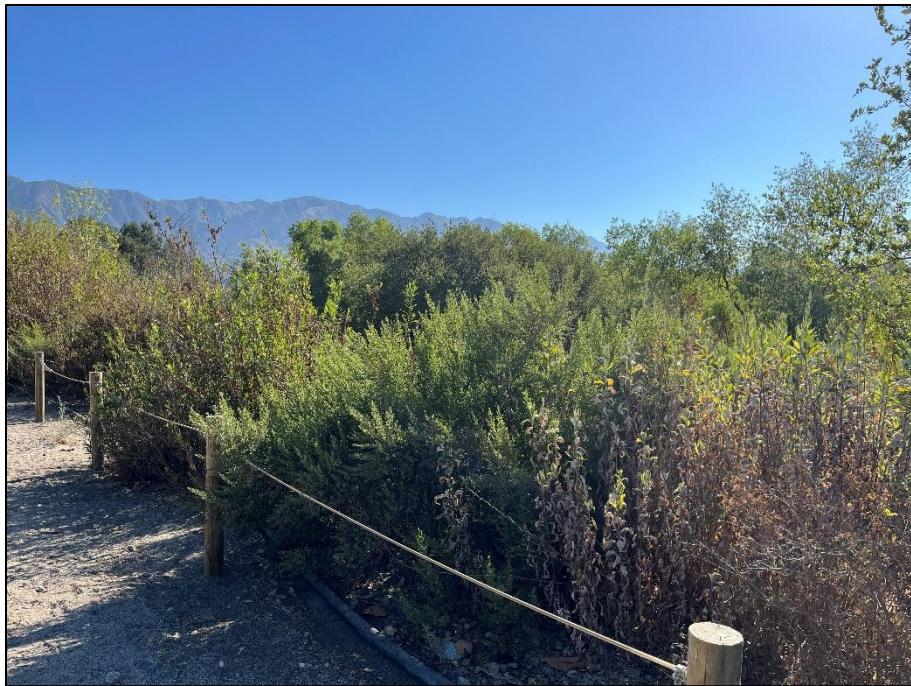
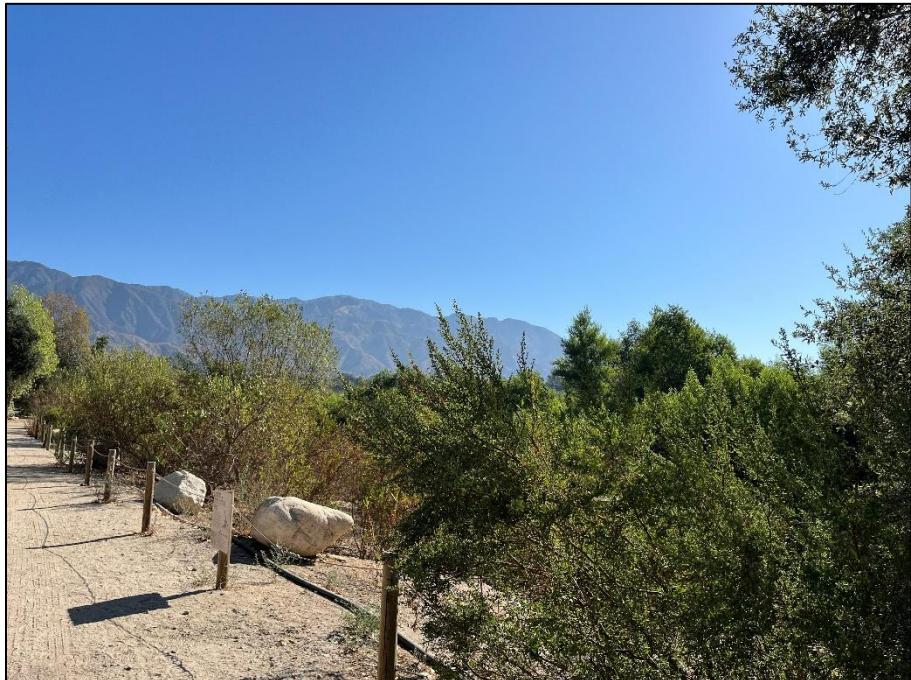
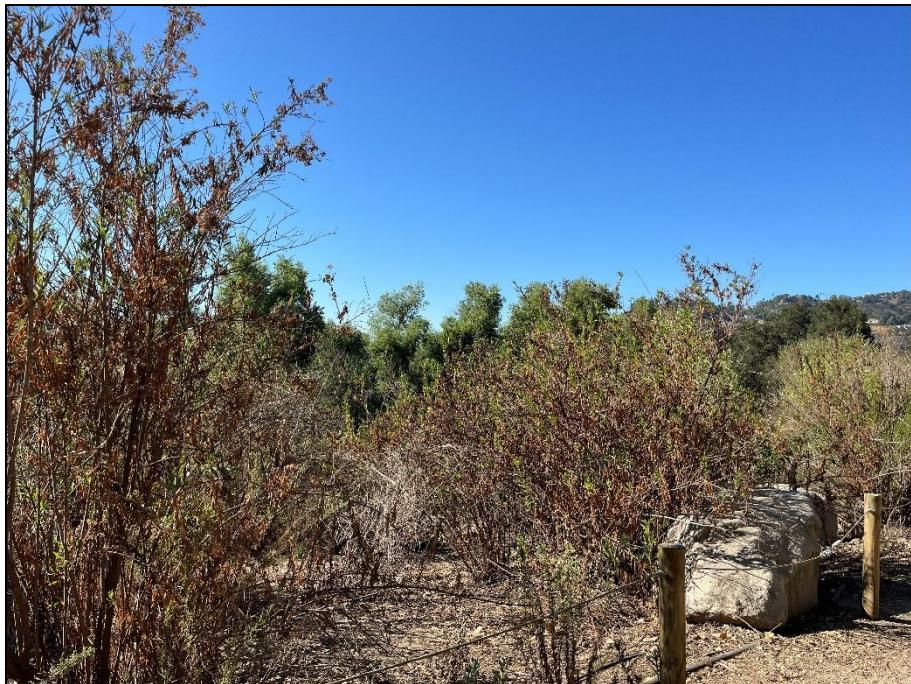
The overall health of the container plants in mitigation area DG-4C was noted as being moderate to good. Approximately 10 to 15 percent of all container plants were noted as showing minor levels of stress, which is approximately 5 to 10 percent higher than the percentage of plants that were showing stress during the previous qualitative monitoring event. Stress was likely due to the same reasons as those described for DG-2A, especially drought stress. A negligible number of container plants were noted as being missing or dead. Photos 23 through 25 in Attachment B document the status of the mitigation area during the monitoring visit.

Nonnative weed cover in DG-4C was estimated at approximately 1 percent, which is approximately 1 percent lower than the percentage of nonnative cover that was observed during the previous qualitative monitoring event. Nonnative species observed in DG-4C included black mustard and poison hemlock. Most nonnative weeds were just starting to germinate and had not gone to flower or seed.

Photo 23: Overview Mitigation Area DG-4C

Photo 24: Overview Mitigation Area DG-4C

Photo 25: Overview Mitigation Area DG-4C

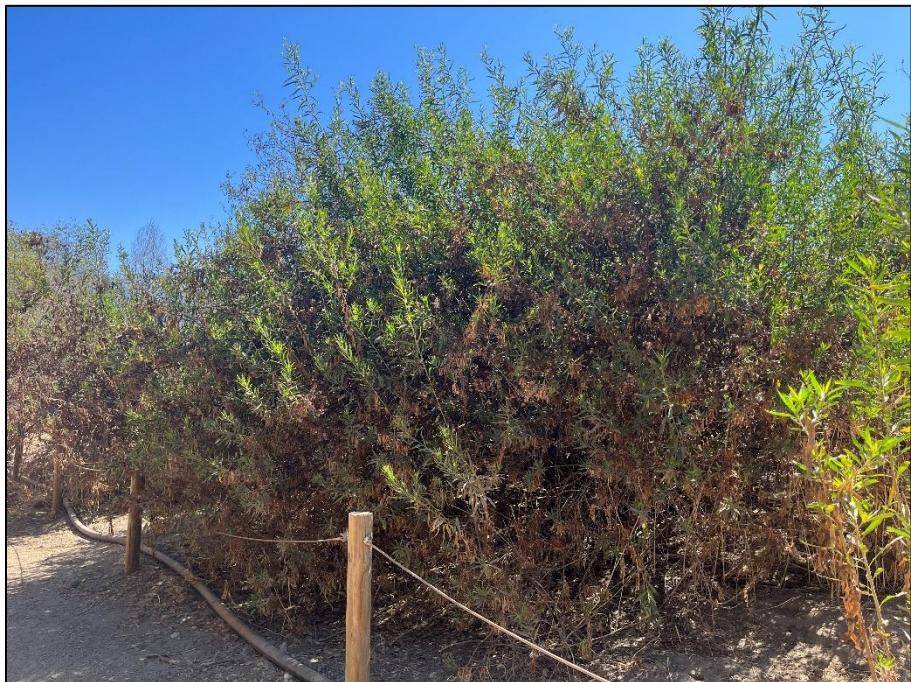
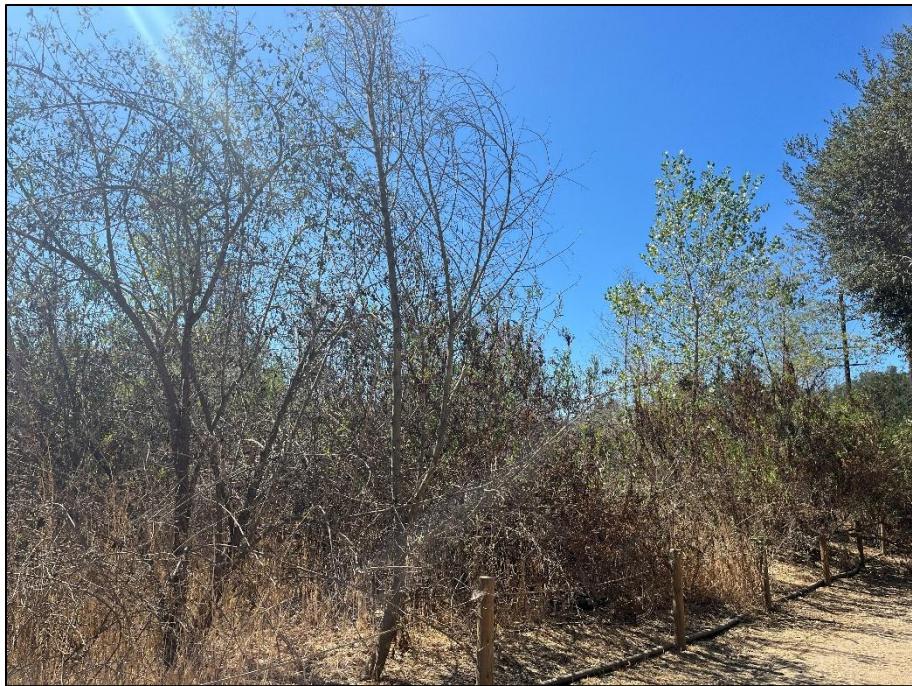
The overall health of the container plants in the DG-5 mitigation area was noted as being moderate. Approximately 50 percent of all container plants were noted as showing varied levels of stress, which is approximately 45 percent higher than the percentage of plants that were showing stress during the previous qualitative monitoring event. Stress was likely due to the same reasons as those described for DG-2A, especially drought stress. Photos 26 and 27 in Attachment B document the status of the mitigation area during the monitoring visit.

Nonnative weed cover in DG-5 was estimated at approximately 1 percent, which is approximately 1 percent lower than the percentage of nonnative weed cover that was observed during the previous qualitative monitoring event. Nonnative species observed in DG-5 included perennial pepperweed and white horehound (*Marrubium vulgare*). Most nonnative weeds were just starting to germinate and had not gone to flower or seed.

Photo 26: Overview Mitigation Area DG-5

Photo 27: Overview Mitigation Area DG-5
