August 15, 2025  
(2023-005.13)

**Re: *Devil's Gate Reservoir Restoration Project – Phase 3 Restoration Qualitative Monitoring Conducted on June 27, 2025***

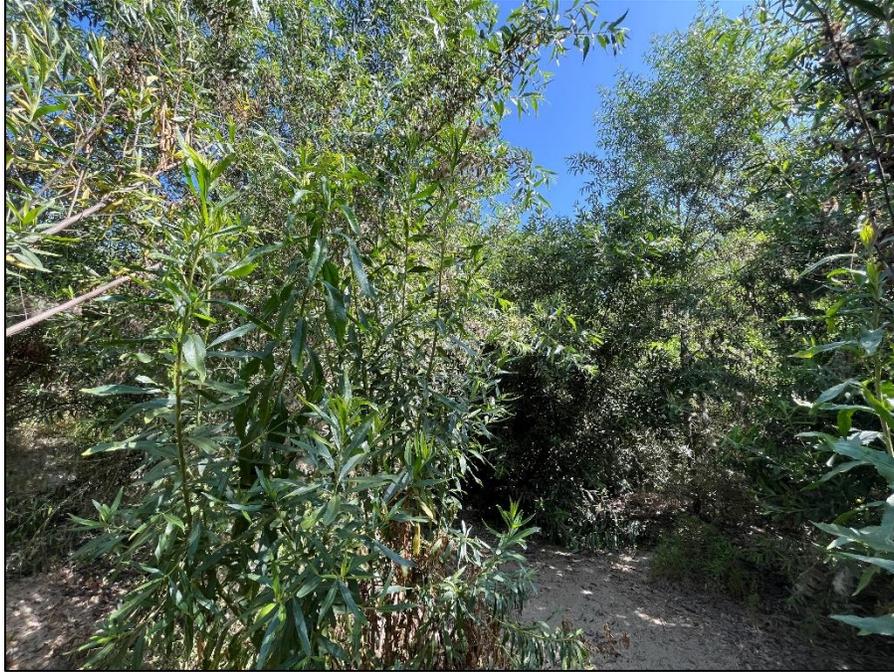
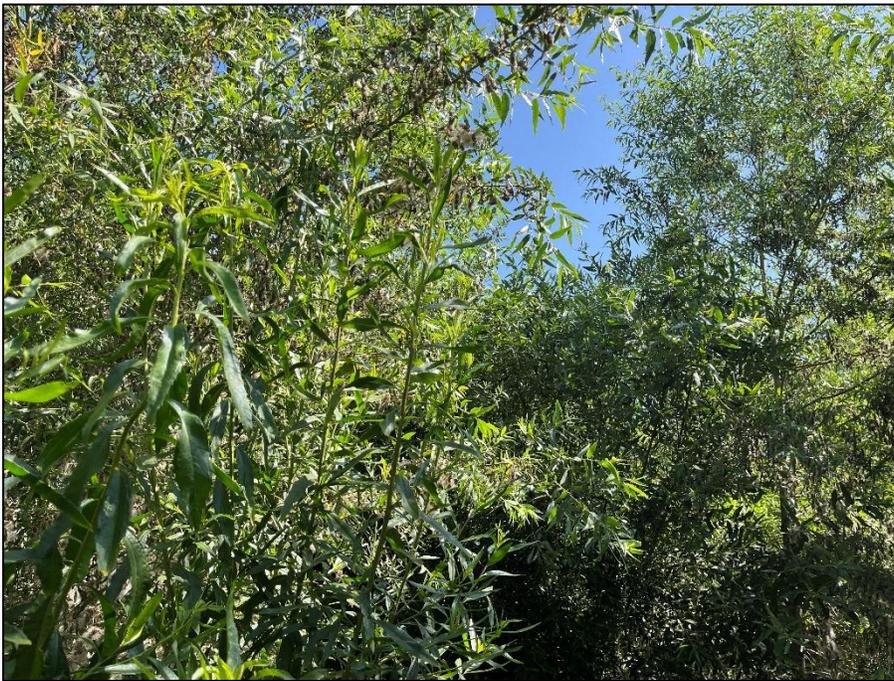
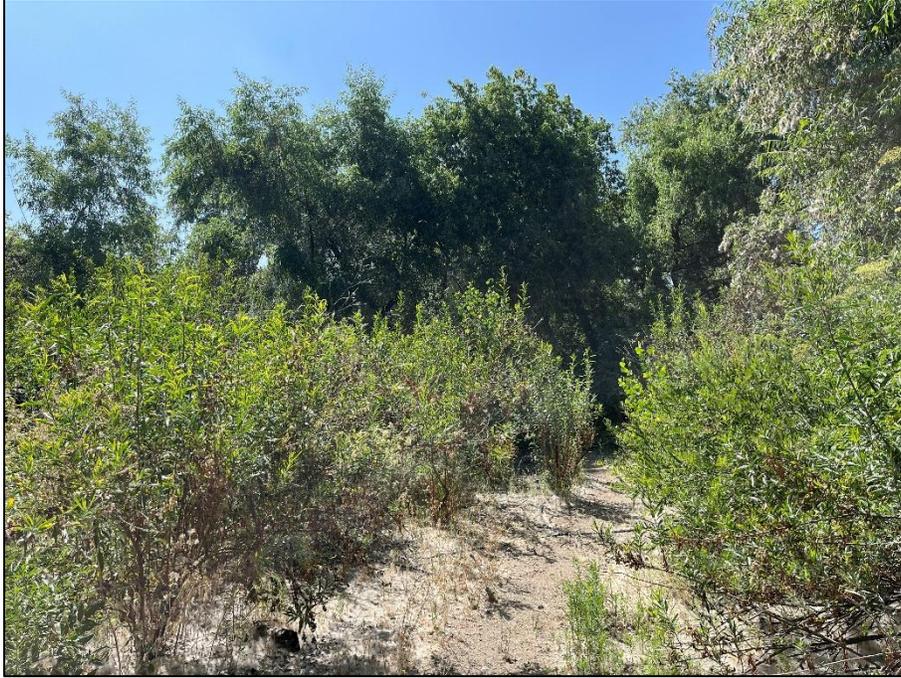
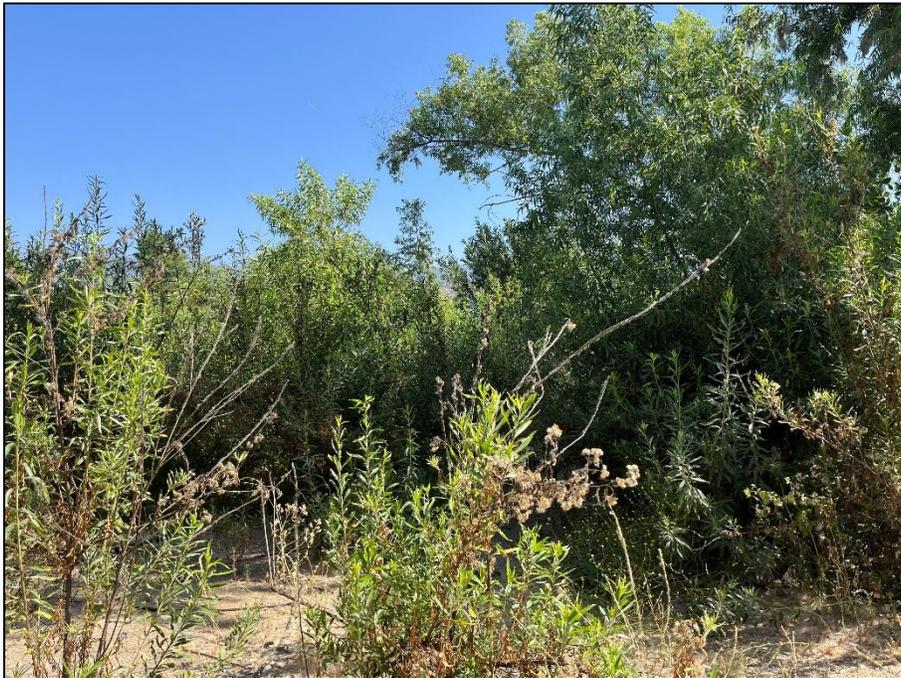
The overall health of the container plants in DG-4 WOUS and DG-4 WOUS Connections was noted as being good. Approximately less than 5 percent of the container plants and stakes in DG-4 WOUS and DG-4 WOUS Connections were noted as showing signs of stress and a negligible amount were noted as being dead or missing. This is the same percentage of plants that were showing stress during the previous monitoring visit. Stress may be occurring as a result of: 1) herbivory by rabbits or other wildlife, 2) competition from nonnative and invasive weeds, 3) misplaced emitters, or 4) recreational traffic through the mitigation areas. Photos 1 through 4 (Appendix B) document the mitigation areas during the monitoring visit.

Native plant germination from seed application and natural recruitment was noted throughout the DG-4 WOUS and DG-4 WOUS Connections mitigation areas. The native species observed sprouting in the DG-4 WOUS and DG-4 WOUS Connections mitigation areas included mulefat (*Baccharis salicifolia*), tall flatsedge (*Cyperus eragrostis*), Canada horseweed (*Erigeron canadensis*), salt heliotrope (*Heliotropium*

*curassavicum*), California rose (*Rosa californica*), California blackberry (*Rubus ursinus*), and stinging nettle (*Urtica dioica*). Native cover was estimated to be approximately 75 percent during the monitoring visit.

Nonnative weed cover in DG-4 WOUS and DG-4 WOUS Connections was estimated at approximately 15 to 20 percent, which is approximately 20 percent lower than the percentage of weed cover that was observed during the previous monitoring visit. Nonnative species observed included black mustard (*Brassica nigra*), poison hemlock (*Conium maculatum*), and perennial pepperweed (*Lepidium latifolium*). Most of the nonnative weeds observed in these mitigation areas were just starting to germinate and had not gone to flower or started to produce seed. As weed abatement continues in the mitigation areas, it is anticipated that the seed bank of nonnative and invasive weeds will decrease.

Photo 1. Overview DG-4 WOUS & WOUS Connections

Photo 2. Overview DG-4 WOUS & WOUS Connections

Photo 3. Overview DG-4 WOUS & WOUS Connections

Photo 4. Overview DG-4 WOUS & WOUS Connections

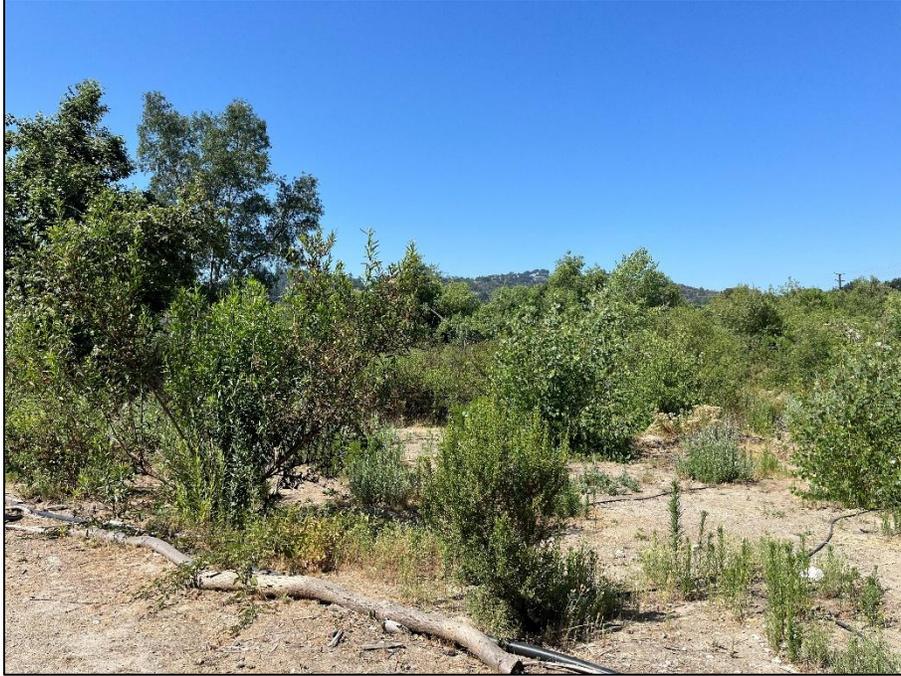
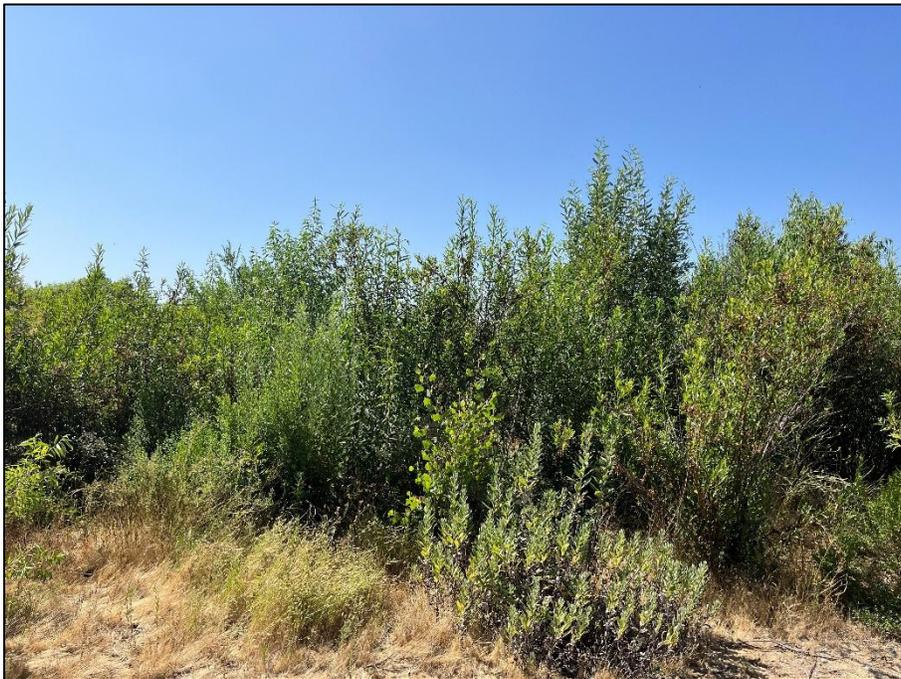
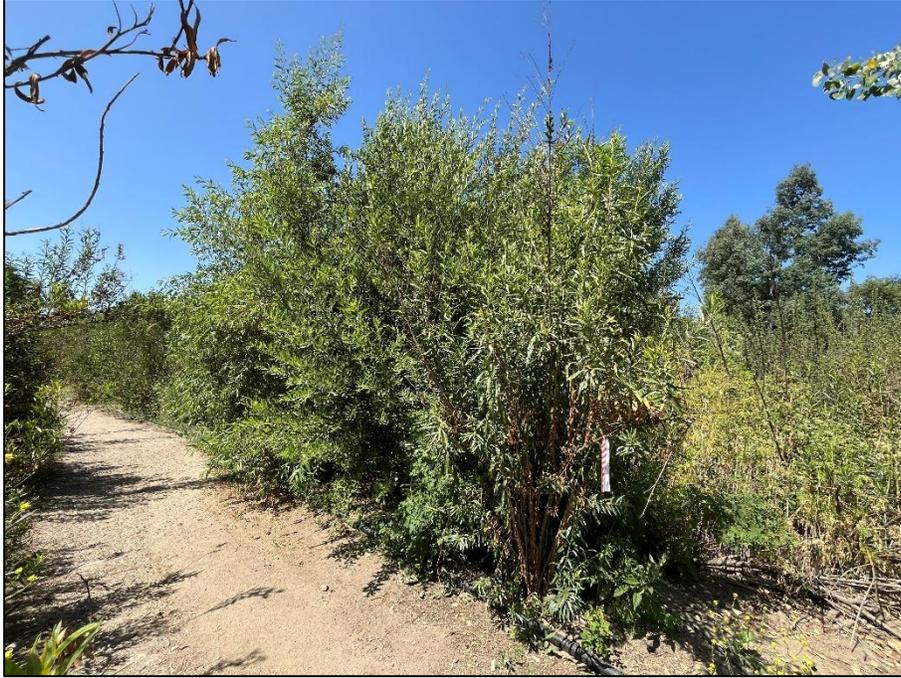
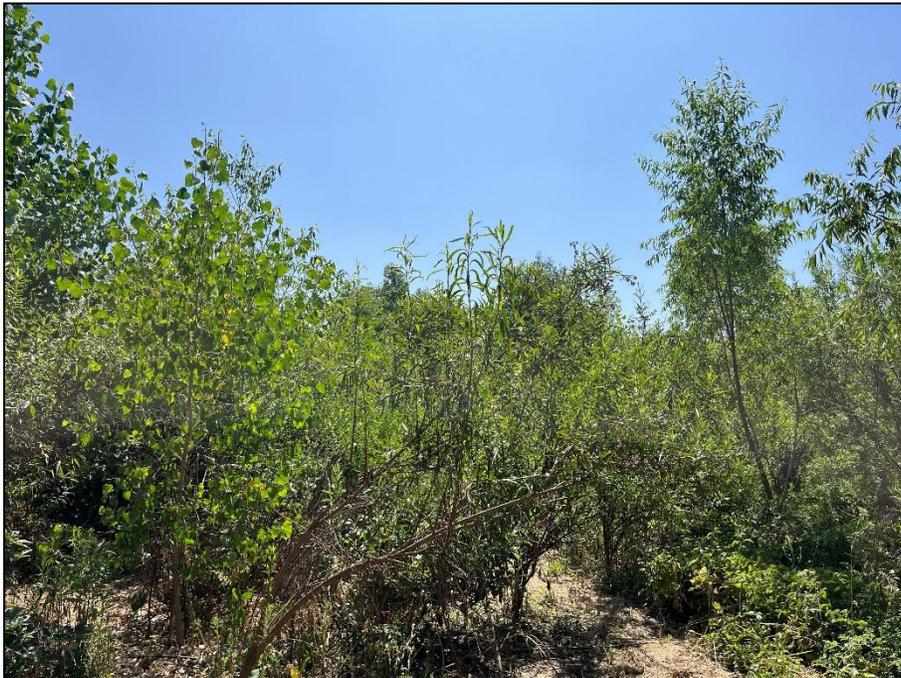
The overall health of the container plants in DG-4A was noted as being good and this mitigation area is becoming well established. Approximately less than 5 percent of the container plants and stakes in DG-4A were noted as showing signs of stress which is approximately the same percentage of plants which were showing signs of stress during the previous monitoring visit. This included the remaining container plants from the first installation and the container plants that were installed to replace the original container plants and stakes planted in the middle section of DG-4A that appeared to be dead or in a condition unlikely to recover during previous monitoring visits. Stress may be occurring due to similar reasons described for DG-4 WOUS and DG-4 WOUS Connections. Photos 5 through 8 in Appendix B document the mitigation area during the monitoring visit.

Native plant germination from seed application and natural recruitment was noted throughout the DG-4A mitigation area. Native plants such as western ragweed (*Ambrosia psilostachya*), mugwort (*Artemisia douglasiana*), tall flatsedge, Canada horseweed, California poppy (*Eschscholzia californica*), common phacelia (*Phacelia distans*), California rose, and stinging nettle were observed sprouting in the mitigation area. Native cover was estimated to be approximately 70 percent during the monitoring visit.

Nonnative weed cover in the DG-4A mitigation area ranged from approximately 5 to 20 percent during the monitoring visit, which is approximately 20 percent lower than what was observed during the previous monitoring visit. Nonnative species observed included black mustard, Italian thistle (*Carduus pycnocephalus*), red-stemmed filaree (*Erodium cicutarium*), and perennial pepperweed. Most of the nonnative weeds observed in these mitigation areas were just starting to germinate; however, some of the black mustard and perennial pepperweed were starting to go to flower and will soon produce seed. As weed abatement continues in the mitigation areas, it is anticipated that the seed bank of nonnative and invasive weeds will decrease; however, perennial pepperweed easily resprouts from rhizomatous roots that can be difficult to fully remove with hand tools.

Photo 5. Overview DG-4A

Photo 6. Overview DG-4A

Photo 7: Overview DG-4A

Photo 8: Overview DG-4A

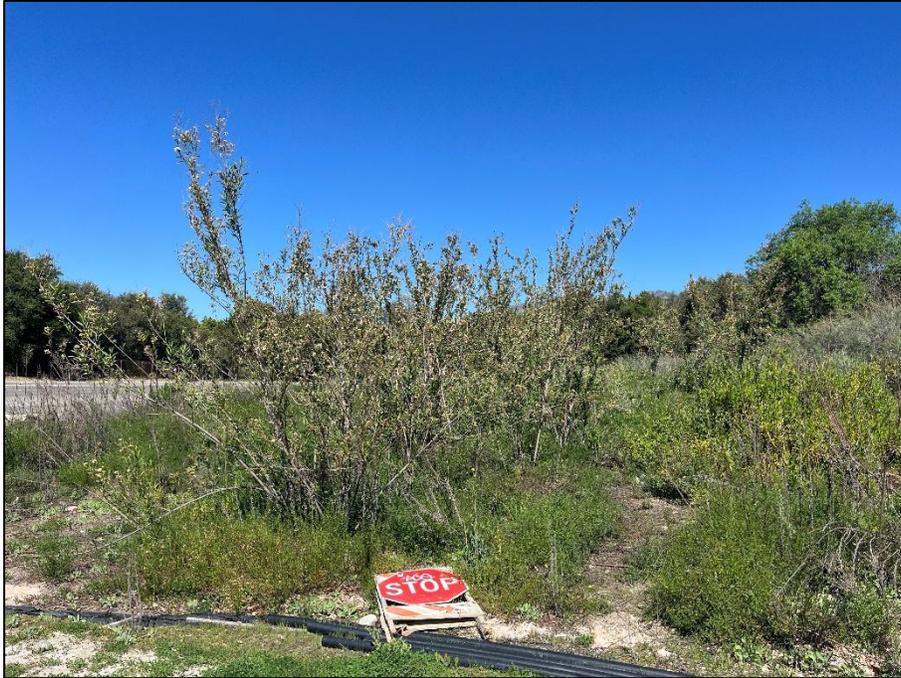
Photo 9: Overview Tire Wash

The overall health of the container plants in the Tire Wash mitigation area was noted as being good. Less than 5 percent of the container plants were noted as showing varied levels of stress, which is the same percentage of plants that were showing stress during the previous monitoring visit. This included the remaining container plants from the first installation and the replacement container plants that were

installed to replace the container plants that were either missing or appeared to be dead or in a condition unlikely to recover during previous monitoring visits. Stress may be occurring due to similar reasons described for DG-4 WOUS and DG-4 WOUS Connections. In addition, some of the container plants are being smothered by deerweed (*Acmispon glaber*), which is proliferating in this area. The irrigation system was found to be functioning properly within this mitigation area. Photo 9 in Appendix B documents the mitigation area during the monitoring visit.

Native plant germination from natural recruitment was noted throughout the Tire Wash mitigation area. Native plants such as deerweed, California sagebrush (*Artemisia californica*), tall flatsedge, telegraph weed (*Heterotheca grandiflora*), common phacelia, and ladies' tobacco (*Pseudognaphalium californica*) were observed sprouting in the mitigation area. Native cover was estimated to be approximately 90 percent during the monitoring visit.

Nonnative weed cover in the Tire Wash mitigation area was estimated at approximately 5 to 10 percent, which is approximately the same percentage of nonnative cover that was observed during the previous monitoring visit. Nonnative species observed included black mustard, red-stemmed filaree, and Spanish broom (*Spartium junceum*). Most of the nonnative weeds observed in this mitigation area were just starting to germinate and were not going to flower or producing seed. As weed abatement continues in the mitigation areas, it is anticipated that the seed bank of nonnative and invasive weeds will decrease.

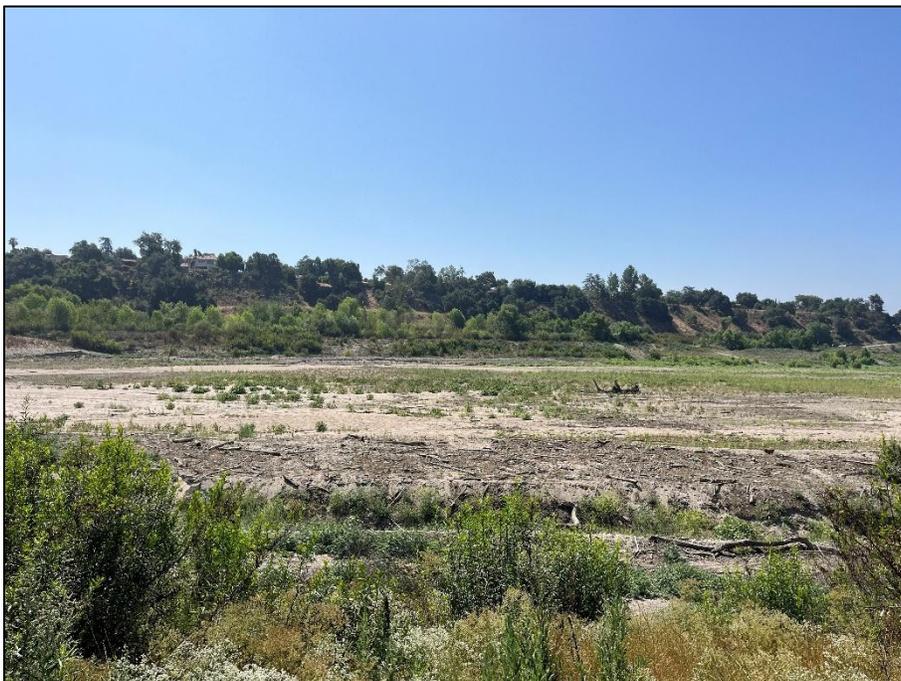
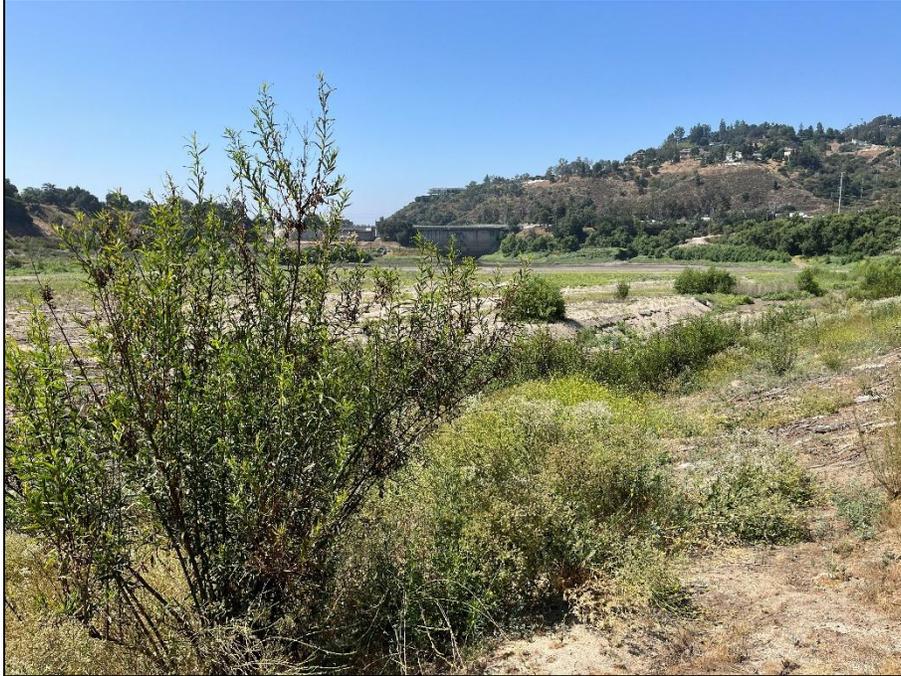
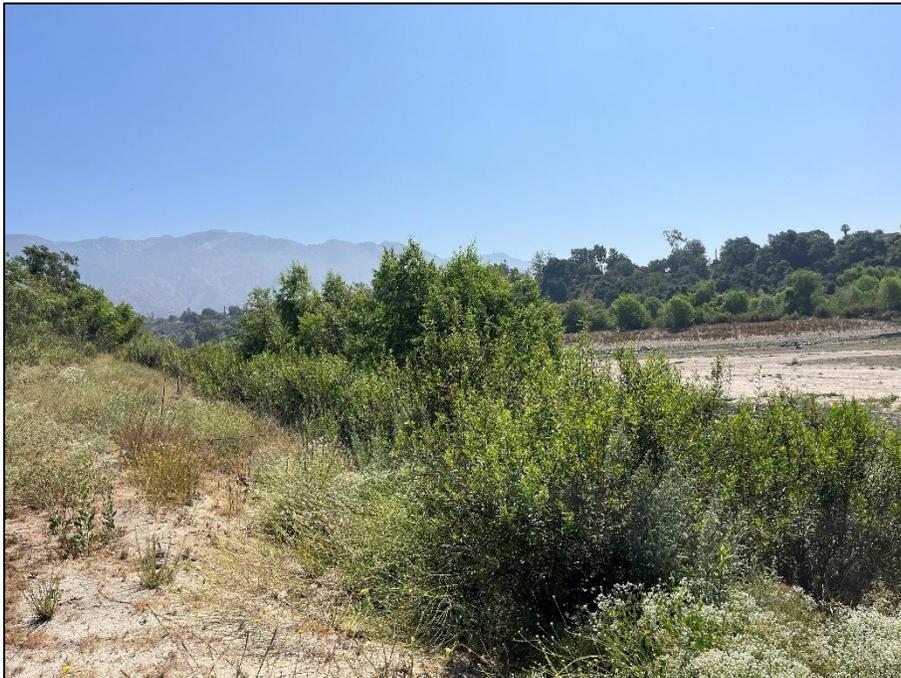
Container plants were not installed on the Side Slopes or in Flint Wash, but these areas were seeded with native plant species. Native plant growth was noted throughout the Side Slopes and Flint Wash, likely both from natural recruitment and from seeding. Minor to moderate erosion was present at the base of the Side Slopes and the hydroseeded portions of the Side Slopes where previous erosion had occurred showed minimal germination; however, the level of native cover was observed to be higher in these areas during the June monitoring visit than during previous monitoring visits and some areas appear to be stabilizing. The lower level of germination on these portions of the Side Slopes could be due to lack of soil nutrients, lack of organic matter, and/or incorrect compaction levels. Native plants such as deerweed, annual bursage (*Ambrosia acanthicarpa*), mugwort, mulefat, Canada horseweed, and black willow (*Salix gooddingii*) were observed sprouting on the Side Slopes and in Flint Wash. Overall native cover was estimated to be approximately 55 to 60 percent during the monitoring visit; however, portions of the Side Slopes that have previously had erosion issues had a lower level of cover. Photos 10 through 12 in Appendix B document the Side Slopes during the monitoring visit.

Nonnative weed cover on the Side Slopes and Flint Wash was estimated at approximately 15 percent overall, which is approximately 10 percent lower than the percentage of weed cover that was observed during the previous monitoring visit. Nonnative species observed on the Side Slopes and Flint Wash included black mustard, poison hemlock, and perennial pepperweed. Most of the nonnative weeds observed in this mitigation area were just starting to germinate; however, some were starting to flower and will soon go to seed. These areas should be weeded prior to seed production. As weed abatement continues in the mitigation areas, it is anticipated that the seed bank of nonnative and invasive weeds will

Photo 10: Overview Side Slopes

Photo 11: Overview Side Slopes

Photo 12: Overview Side Slopes

Portions of the Side Slopes which were previously noted as having significant erosion that occurred as a result of heavy rainfall during the 2023 wet season and following the tropical storm in late August 2023 were noted as having been repaired during previous monitoring visits and were included in the supplemental seeding effort which was completed in November of 2023. Some additional erosion was observed at the toe of the Side Slopes in these areas and has the potential to worsen. As more perennial plants become established on the Side Slopes, erosion should become less of an issue; however, action will need to be taken to repair the damage caused by the erosion and measures should be taken to reduce damage from erosion in the future. In addition, if the supplemental seeding effort does not produce germination on the previously eroded Side Slopes, adaptive management techniques will likely be warranted. During future monitoring events, erosion should continue to be monitored in all planted areas and if warranted, erosion Best Management Practices should be installed in appropriate areas. This may only require the installation of straw wattles at select sites to prevent existing rills from becoming larger.
