September 9, 2020

Re: *Devil's Gate Reservoir Restoration Project – Phase 1 Restoration Qualitative Monitoring Conducted on August 13, 2020*

1.0 INTRODUCTION

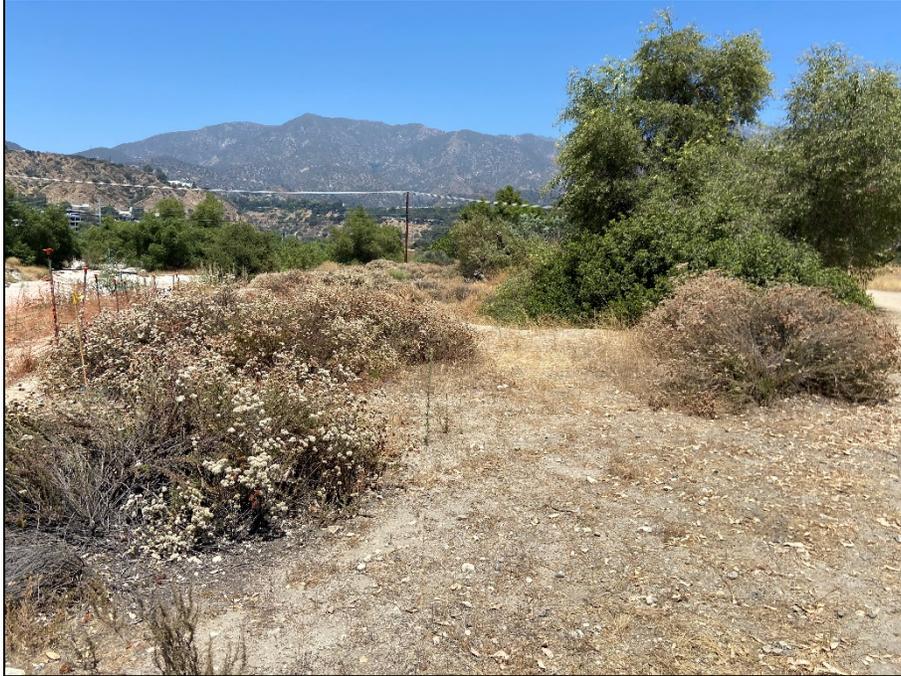
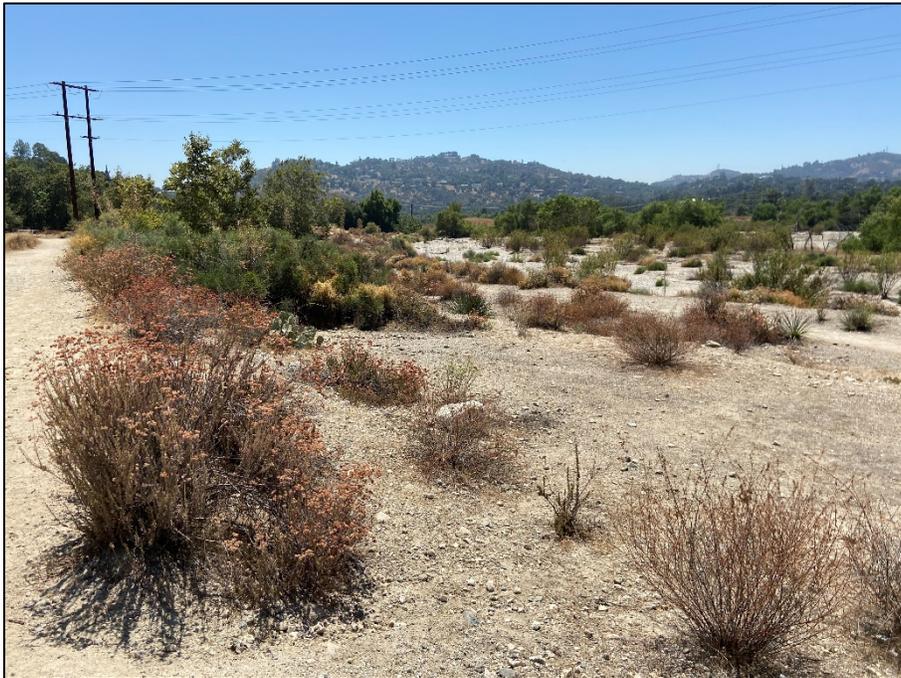
Container plants were not installed in the DG-1 or DG-1 WOUS mitigation areas, but these areas were seeded with native plant species. Native plant growth was noted throughout the DG-1 and DG-1 WOUS mitigation areas, likely both from natural recruitment and from seeding; however, germination was observed to be very minimal in the majority of these mitigation areas. Native germination was found to be higher closer to the reservoir in DG-1 where seed likely dispersed due to water flow. Portions of DG-1 WOUS were noted as being scoured during the wet season and had minimal plant growth. Native plants such as California sagebrush (*Artemisia californica*), California buckwheat (*Eriogonum fasciculatum*), grape-soda lupine (*Lupinus excubitus*), caterpillar phacelia (*Phacelia cicutaria*), California everlasting (*Pseudognaphalium californicum*), and poison oak (*Toxicodendron diversilobum*) were observed sprouting in the DG-1 and DG-1 WOUS mitigation areas. In addition, dodder (*Cuscuta sp.*) was observed growing on some of the shrubs in this mitigation area which could lead to future decline of these shrubs. Photos 1 and 2 in Attachment B document the mitigation area during the monitoring visit.

Nonnative weed cover in DG-1 and DG-1 WOUS was estimated at approximately <10 percent, which is the same level of weed cover that was observed during the first qualitative monitoring event. Nonnative species observed in DG-1 and DG-1 WOUS included black mustard (*Brassica nigra*), red brome (*Bromus madritensis ssp. rubens*), tocalote (*Centaurea melitensis*), and Indian plantain (*Plantago arenaria*).

Photo 1: Overview Mitigation Area DG-1

Photo 2: Overview Mitigation Area DG-1

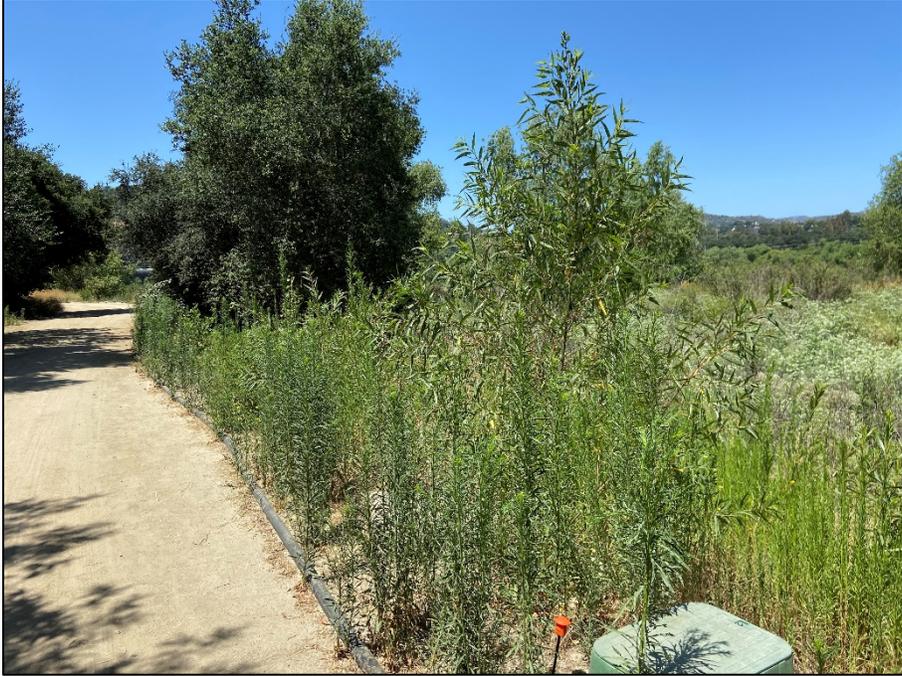
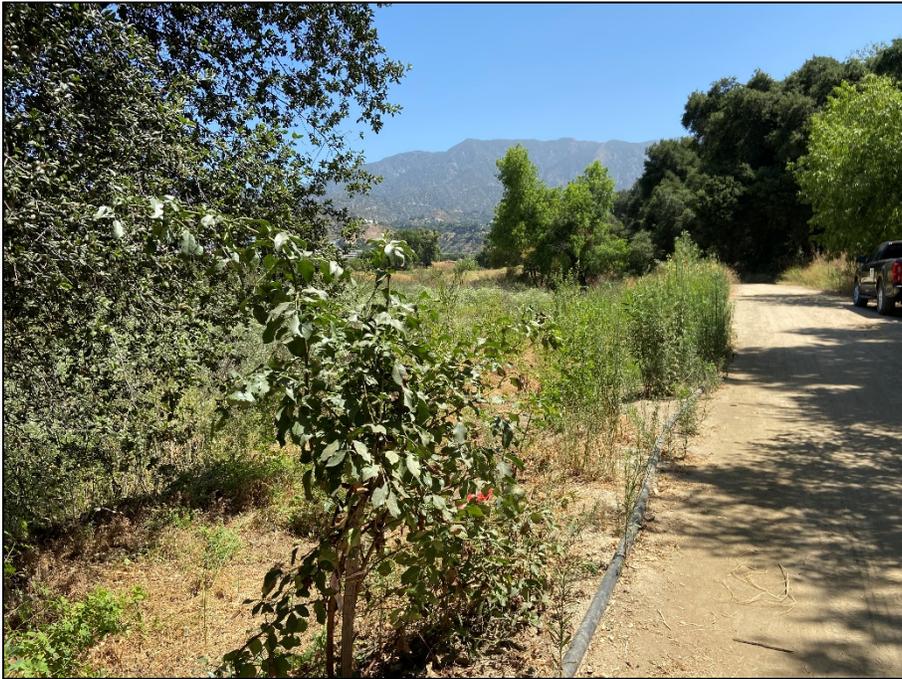
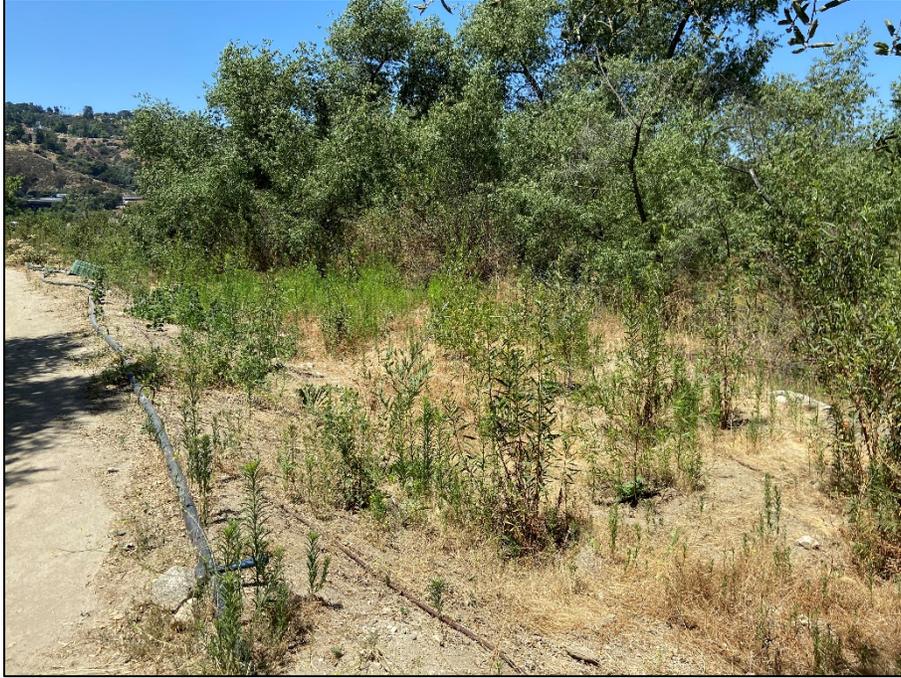
The overall health of the container plants in DG-2A was noted as being good. Approximately 10 percent of all container plants were showing varied levels of stress, which is 5 percent higher than the percentage of plants that were showing stress during the first qualitative monitoring event. Stress may be occurring as a result of 1) drought stress from recent high temperatures, 2) herbivory by rabbits or other wildlife, or 3) competition from nonnative and invasive weeds. A negligible number of container plants were noted as

being missing or dead. Formal mortality counts were taken for DG-2A during the quantitative monitoring and will be included in the annual reporting. The willow species (*Salix sp.*) and mulefat (*Baccharis salicifolia*) planted in the mitigation areas were showing signs of vigorous growth. The installation of plants in the DG-2A mitigation area appears to have been completed successfully. The current issues identified during the monitoring visit are not expected to have an effect on the continued growth of the plants in the mitigation area. Photos 3 through 5 in Attachment B document the mitigation area during the monitoring visit.

Nonnative weed cover in DG-2A was estimated at approximately <5 percent, which is the same level of weed cover that was observed during the first qualitative monitoring event. Nonnative species observed in DG-2A included black mustard, prickly lettuce (*Lactuca serriola*), perennial pepperweed (*Lepidium latifolium*) horehound (*Marrubium vulgare*), and prickly sow-thistle (*Sonchus asper*).

Photo 3: Overview Mitigation Area DG-2A

Photo 4: Overview Mitigation Area DG-2A

Photo 5: Overview Mitigation Area DG-2A

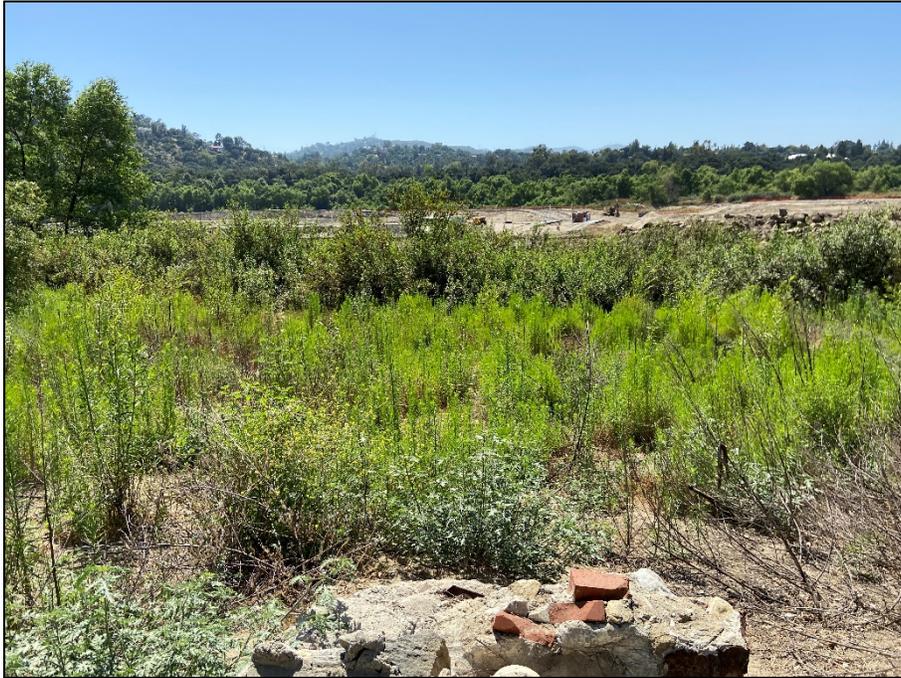
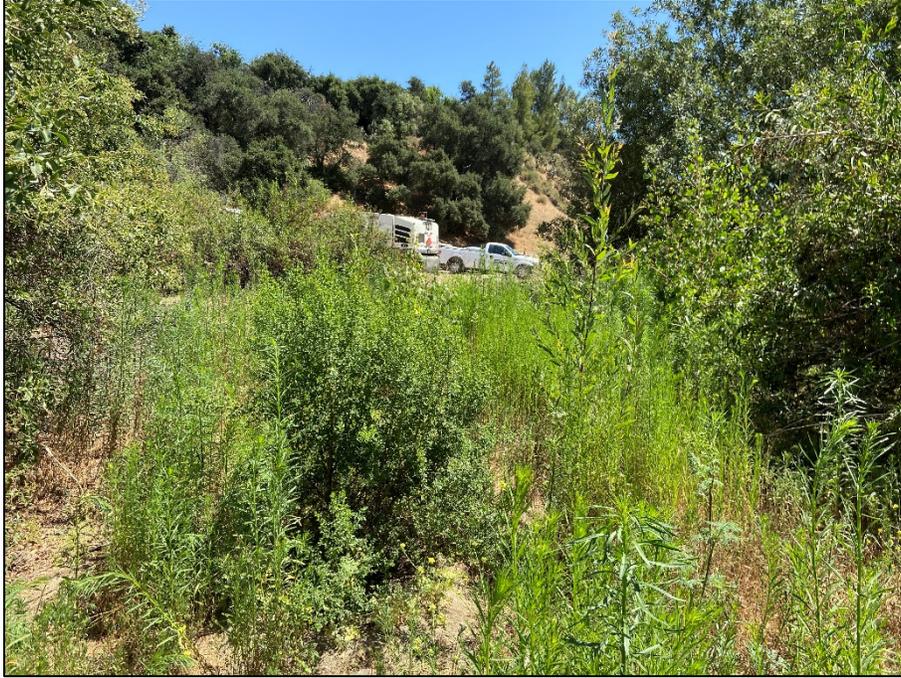
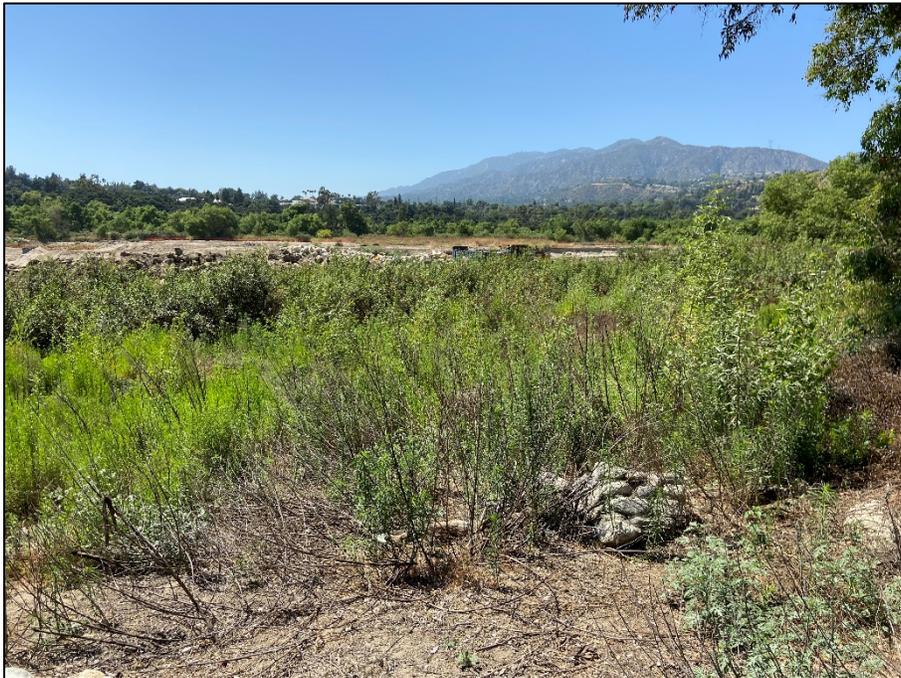
The overall health of the container plants in DG-2B was noted as being good. Approximately 15 percent of all container plants were showing varied levels of stress, which is 10 percent more than the percentage of plants that were showing stress during the first qualitative monitoring event. Stress was likely due to the same reasons as those described for DG-2A; however, recent high temperatures appeared to be the most common cause of stress. In addition, insect galls were observed on several of the willow species. Approximately 5 percent of container plants were noted as being missing or dead, which appears to be the result of the heavy flows that were documented in the first qualitative monitoring event memo. Formal mortality counts were taken for DG-2B during the quantitative monitoring and will be included in the annual reporting. Similar to DG-2A, the willow species and mulefat in the mitigation areas were exhibiting vigorous growth. The installation of the plants in the DG-2B mitigation area appears to have been successfully completed. The current issues identified during the monitoring visit are not expected to have an effect on the continued growth of plants in the mitigation area. Photos 6 through 8 in Attachment B document the mitigation area during the monitoring visit.

Native plant growth was noted throughout the DG-2B mitigation area, likely both from natural recruitment and from seeding. Native plants such as Spanish lotus (*Acmispon americanus*), annual bursage, miniature suncup, cobweb thistle, Canada horseweed, caterpillar phacelia, California bluebells, and stinging nettle (*Urtica dioica*) were observed sprouting in the DG-2B mitigation area. In addition, dodder was observed growing on some of the shrub and tree species in this mitigation area which could lead to future decline of these shrubs.

Nonnative weed cover in DG-2B was estimated at approximately <10 percent, which is approximately 5 percent more than what was observed during the first qualitative monitoring event. Nonnative species

Photo 6: Overview Mitigation Area DG-2B

Photo 7: Overview Mitigation Area DG-2B

Photo 8: Overview Mitigation Area DG-2B

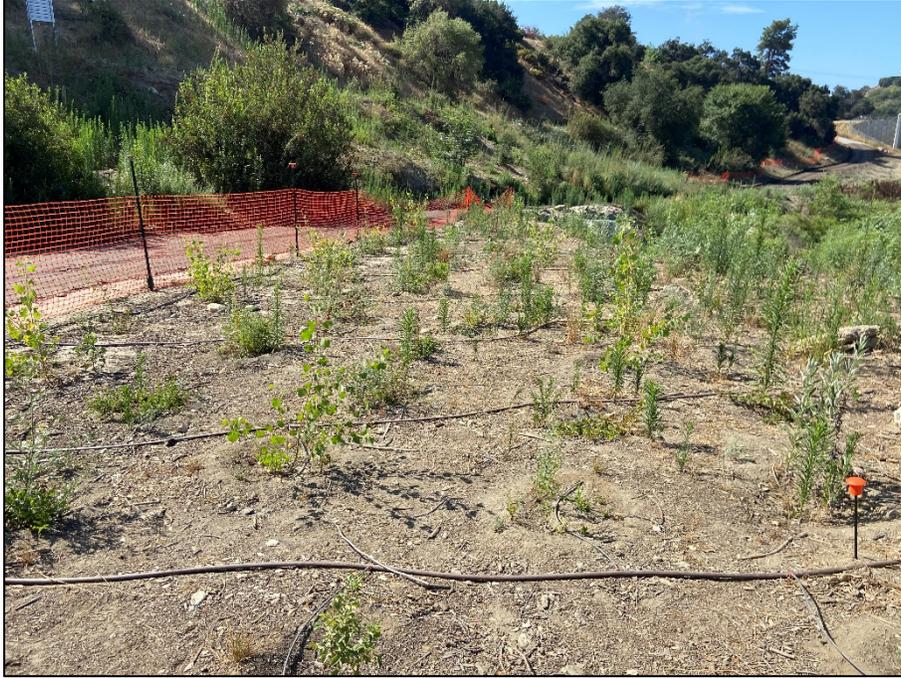
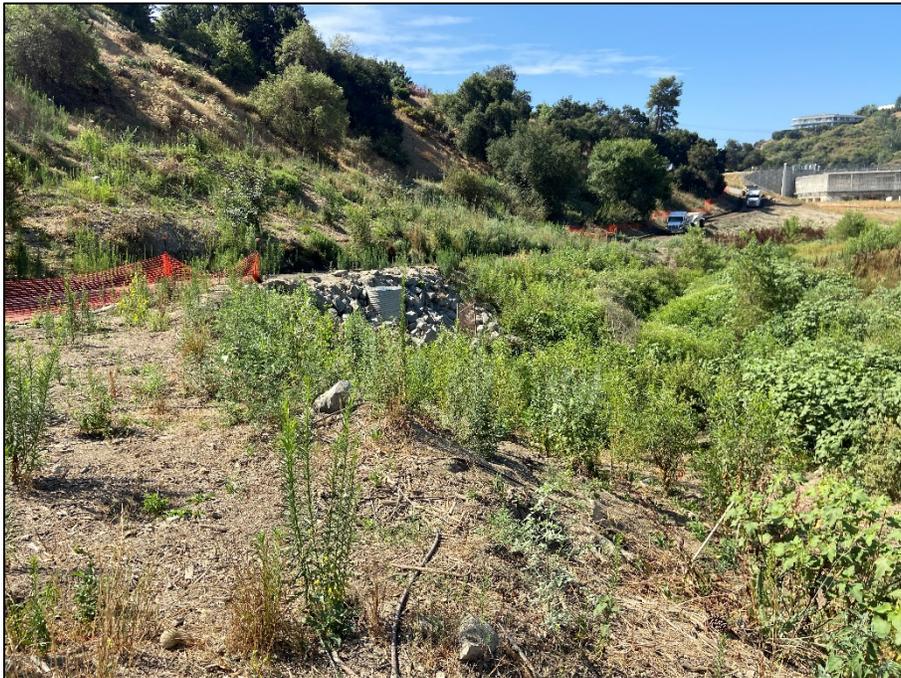
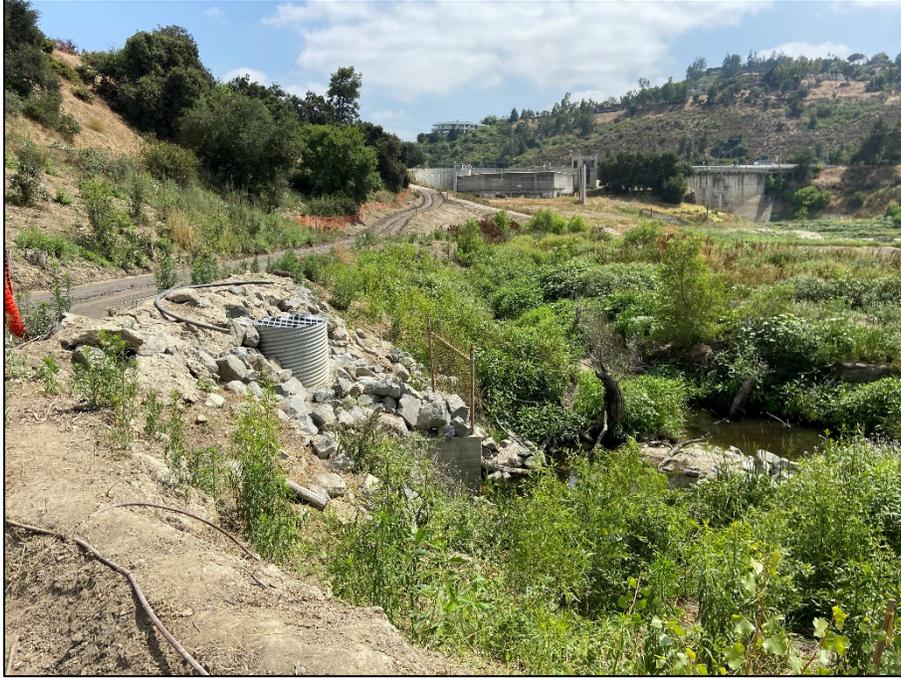
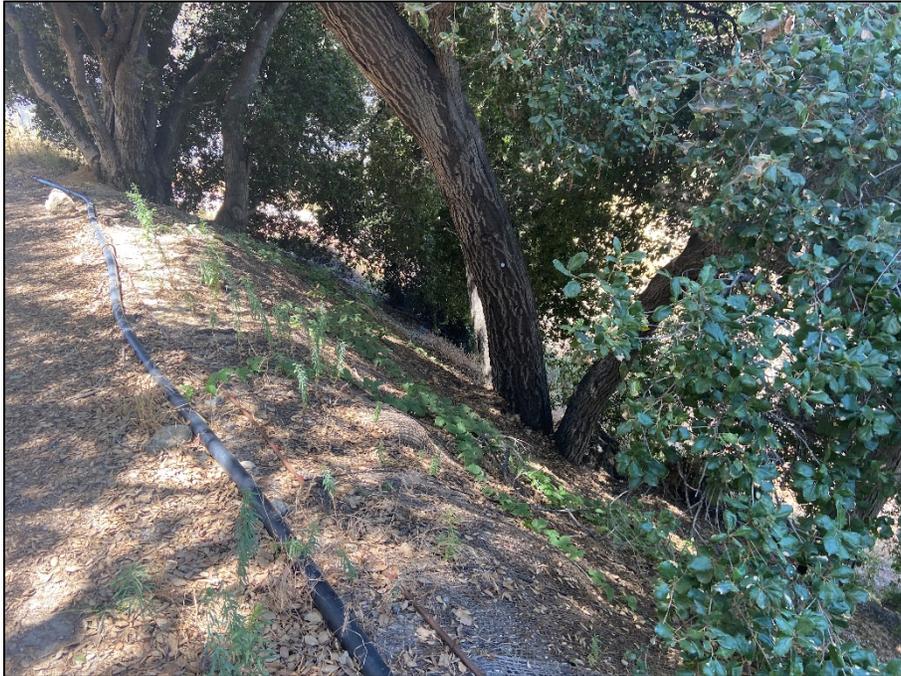
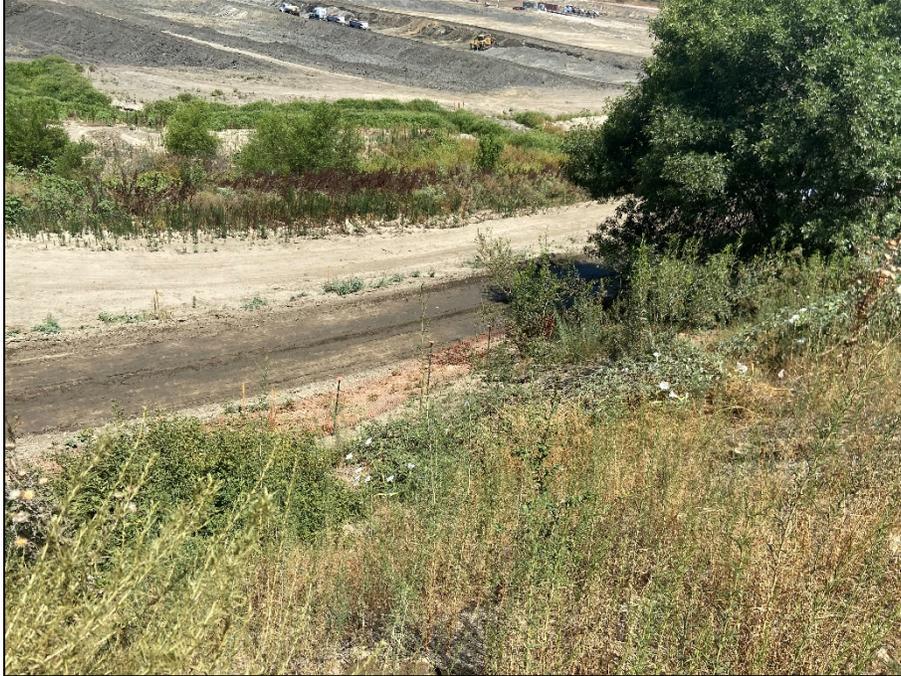
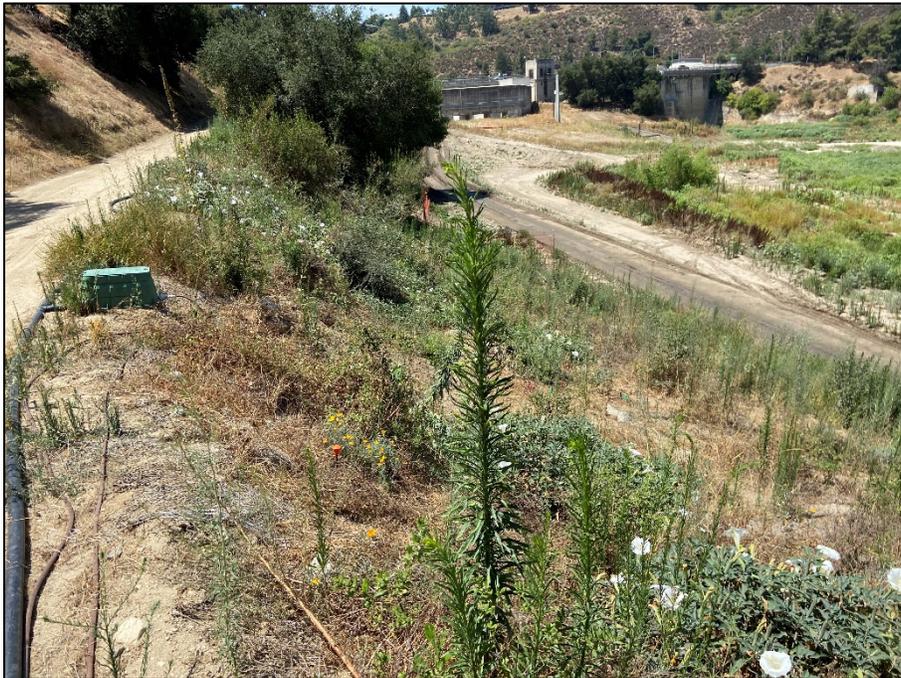
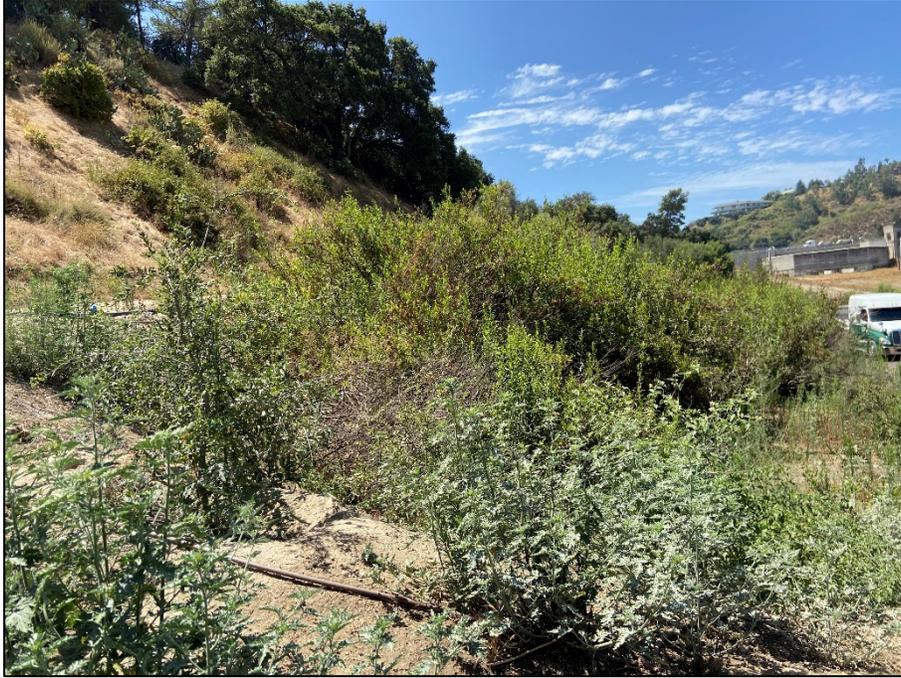
The overall health of the container plants in DG-3A was noted as being good. Approximately 20 percent of the container plants in the Coast Live Oak Woodland portions of DG-3A were noted as showing varied levels of stress, which is the same number of plants that were showing stress during the first qualitative monitoring event. Approximately 15 percent of the container plants in the Mulefat Thickets portions of DG-3A were noted as showing varied levels of stress, which is the same as the percent of container plants that were showing stress during the first qualitative monitoring event. Approximately 10 percent of container plants were noted as being dead or missing from the heavy flows that were noted during the PEP monitoring. Formal mortality counts were taken for DG-3A during the quantitative monitoring and will be included in the annual reporting. The types of stress the plants were exhibiting are the same as those described for the plants in DG-2A. However, erosion is also a problem in some areas of DG-3A. In addition, the heavy water and debris flows noted during previous monitoring visits have contributed to plant mortality and stress in this mitigation area. Similar to DG-2A, the container planted willow species and mulefat were exhibiting vigorous growth. Additionally, the recently planted willow and mulefat cuttings were observed to be sprouting vigorously. During the monitoring visit, the planted coast live oak (*Quercus agrifolia*) acorns were inspected for survivorship and health. Approximately 25 germinated coast live oak acorns appear to still be present in DG-3A. The majority of the germinated acorns appear to be in good health; however, several appeared to be showing signs of drought stress. The installation of the plants in the DG-3A mitigation area appears to have been completed successfully. The current issues noted during the monitoring are not expected to have a negative effect on the continued growth of the plants in the mitigation area. Photos 9 through 15 in Attachment B document the mitigation area during the monitoring visit.

Nonnative weed cover in DG-3A was estimated at approximately 10 to 15 percent, which is approximately 5 to 10 percent more than what was observed during the first qualitative monitoring event. Nonnative species observed in DG-3A included black mustard, lamb's quarters (*Chenopodium album*), prostrate knotweed, prickly lettuce, perennial pepperweed, sweet alyssum (*Lobularia maritima*), wild radish (*Raphanus sativus*), and black nightshade (*Solanum nigrum*). In addition, new growth was observed sprouting from the stumps of the eucalyptus trees (*Eucalyptus sp.*).

Photo 9: Overview Mitigation Area DG-3A Alta Dena Drain

Photo 10: Overview Mitigation Area DG-3A Alta Dena Drain

Photo 11: Overview Mitigation Area DG-3A Alta Dean Drain

Photo 12: Overview Mitigation Area DG-3A Oak Woodland

Photo 13: Overview Mitigation Area DG-3A Oak Woodland

Photo 14: Overview Mitigation Area DG-3A Oak Woodland

Photo 15: Overview Mitigation Area DG-3A Oak Woodland

Erosion in the Phase 1 mitigation areas was only observed in DG-3A and was minor in severity. Due to the steepness of the slope in the Coast Live Oak Woodland portion of the DG-3A mitigation area, erosion will likely continue to be somewhat of an issue in this area; however, jute nettings are currently in place on the slope and will help to lessen the severity of erosion issues. As native cover increases in this area, erosion

issues should lessen. The severity of the erosion should continue to be monitored in all planted areas and if warranted, erosion Best Management Practices (BMPs) should be installed in appropriate areas. This may only require the installation of straw wattles at select sites to prevent existing rills from becoming larger. However, until more native perennial plants become established in these areas, there is the potential that intense rainfall may create additional erosion problems.

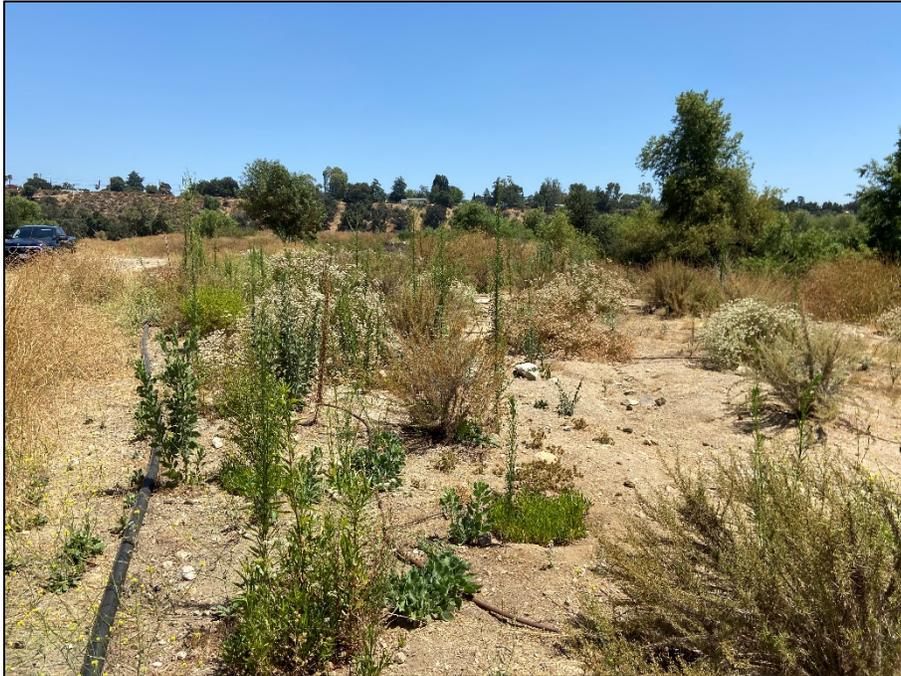
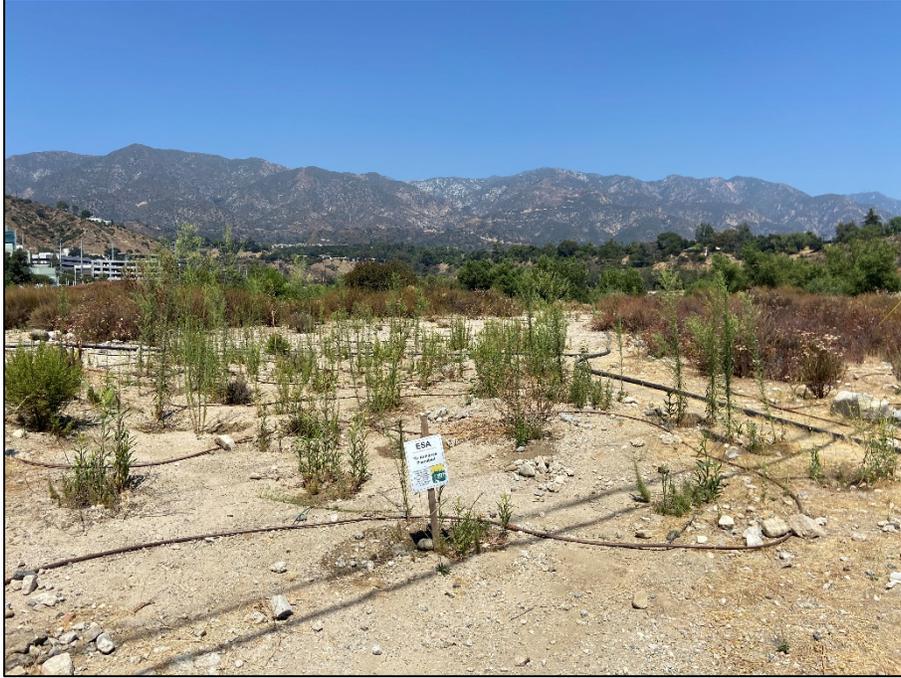
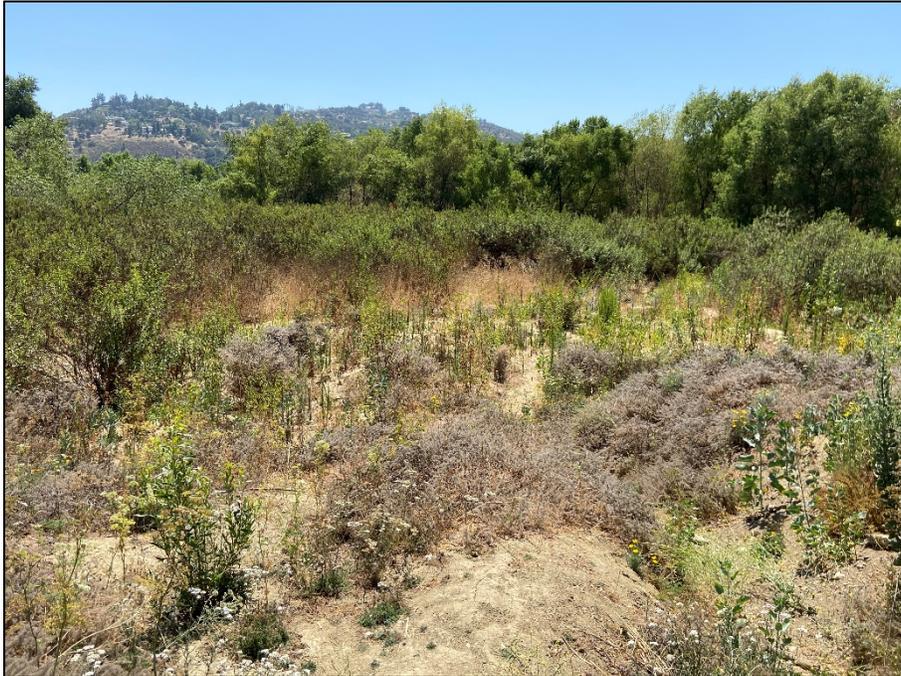
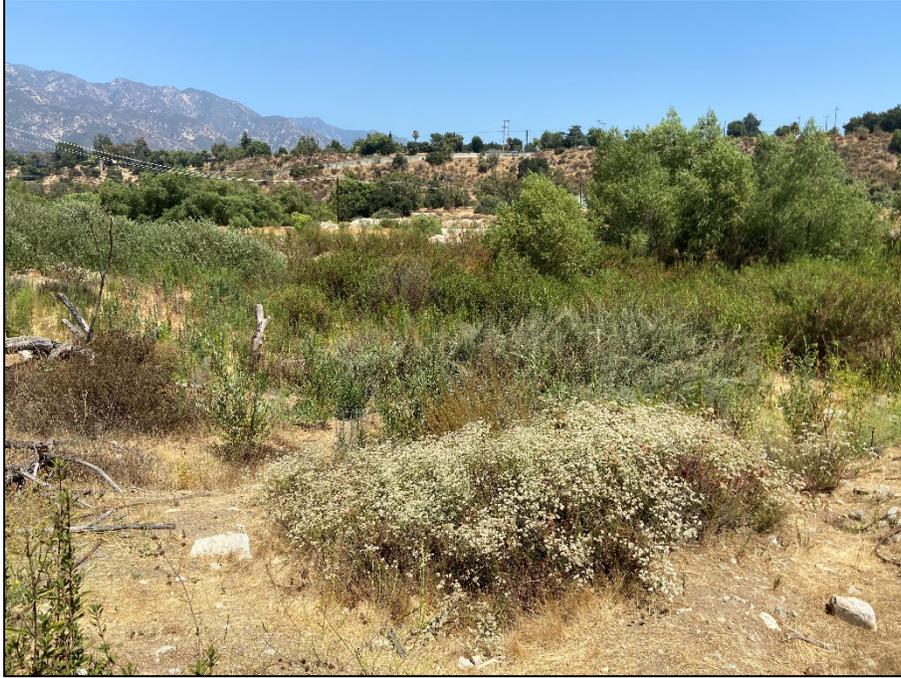
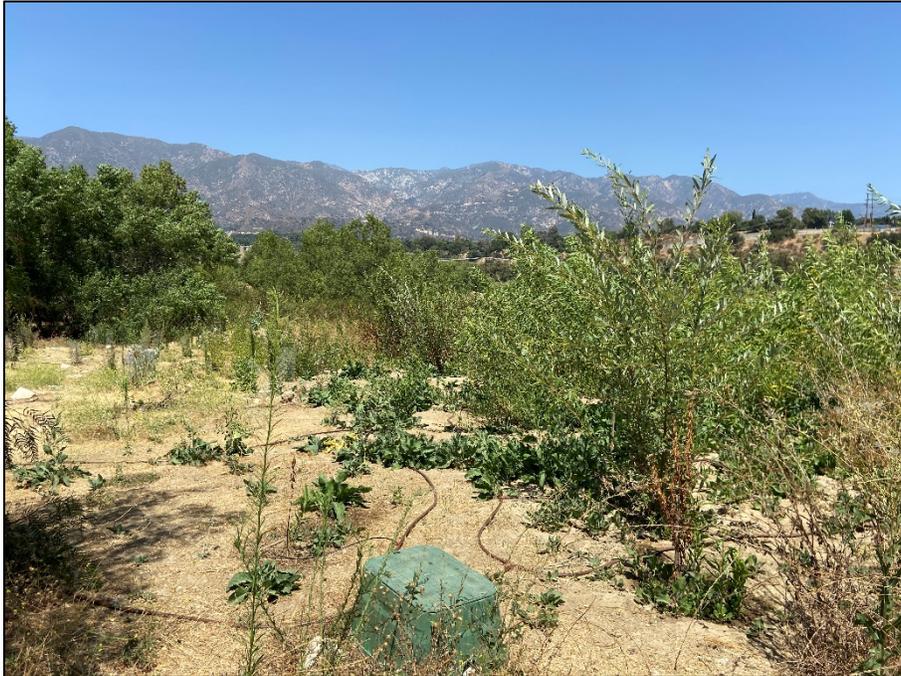
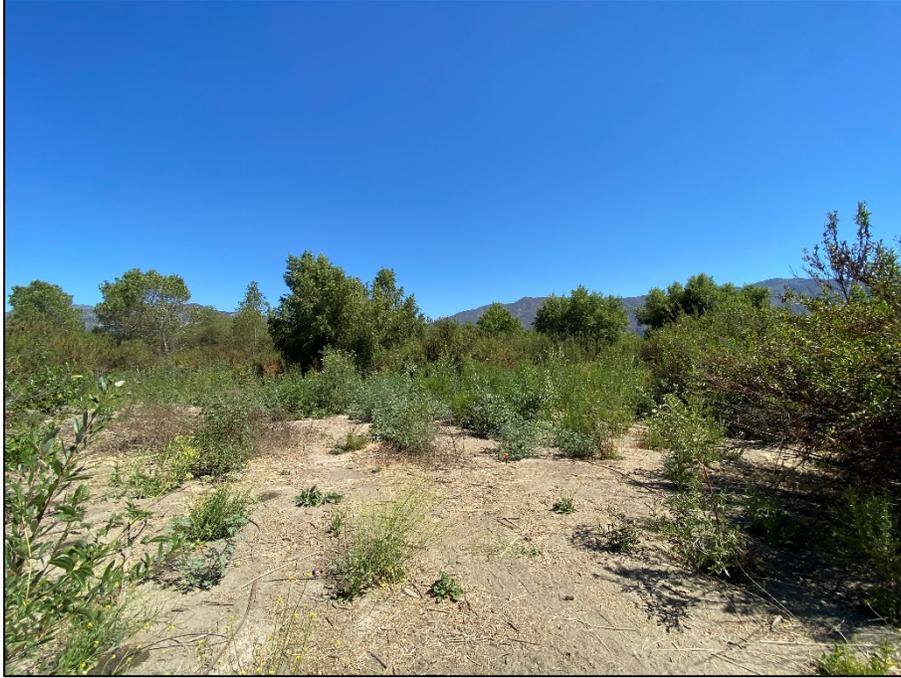
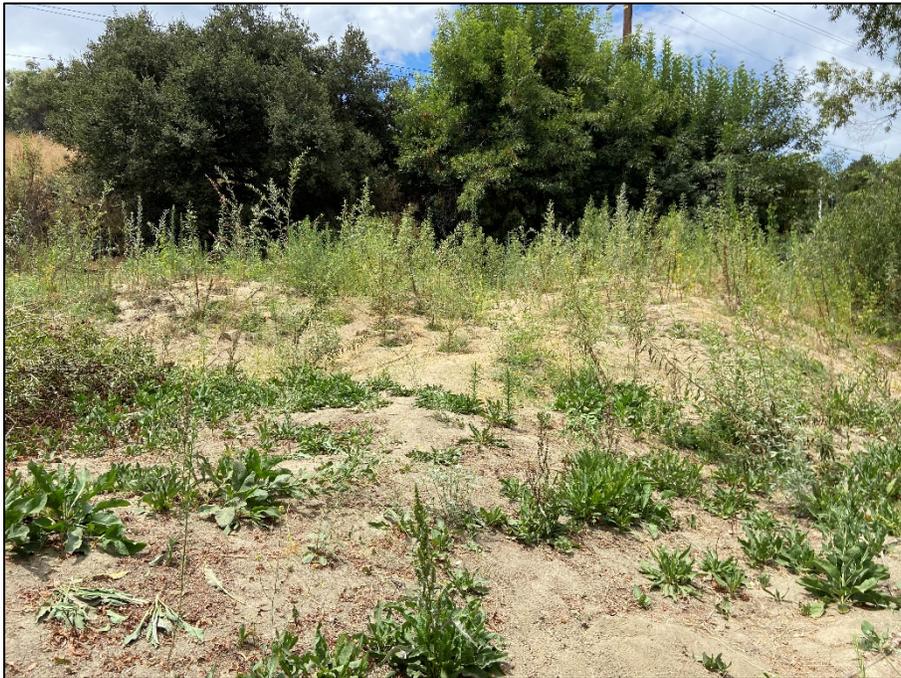
The overall health of the container plants in mitigation area DG-4 was noted as being good. Approximately 30 to 35 percent of container plants in the coastal sage scrub portions of DG-4 were showing varied levels of stress from irrigation line malfunction that appeared to be the result of both wildlife damage and vandalism. Approximately 25 percent of container plants in the riparian portions of DG-4 were showing varied levels of stress, which is approximately 10 to 15 percent more than the percentage of plants that were showing stress during the first qualitative monitoring visit. The increase appears to be mostly due to drought stress from recent high temperatures and irrigation line malfunction that appeared to be the result of both wildlife damage and vandalism. In addition, the 300-foot buffer around a least Bell's vireo (*Vireo bellii pusillus*) nest that affected middle portions of DG-4 has been removed; however, weed proliferation in this area prior to buffer removal likely contributed to plant stress and mortality. For most portions of DG-4, only a negligible number of container plants were noted as being missing or dead. However, in portions of DG-4 that are infested with perennial pepperweed, container plant mortality was found to be higher. In addition, approximately 20 percent of container plants in the southern portion of DG-4 appeared to be dead or missing. A small number of container plants also appeared to be missing in the northern and middle portions of this mitigation area due to heavy water flow. Formal mortality counts were taken for DG-4 during the quantitative monitoring and will be included in the annual reporting. The container planted willow species and mulefat were showing signs of vigorous growth. In addition, the recently planted willow and mulefat cuttings were also observed to be sprouting vigorously. The installation of plants in the DG-4 mitigation area appears to have been completed successfully and the issues noted during the monitoring are not expected to have an impact on the continued growth of the plants. Photos 16 through 22 in Attachment B document the mitigation area during the monitoring visit.

Nonnative weed cover in DG-4 was estimated at approximately 5-10 percent, which is approximately 5 percent higher than what was observed during the first qualitative monitoring event; however, portions of DG-4 where weed abatement had been delayed, due to the least Bell's vireo nest, showed significant reductions to the level nonnative weed cover following weed abatement in these areas. Nonnative species observed in DG-4 included black mustard, poison hemlock, perennial pepperweed, horehound, Indian plantain, and curly dock (*Rumex crispus*). Nonnative weed cover, especially perennial pepperweed, is a significant problem in the DG-4 mitigation area. Because perennial pepperweed can produce dense colonies through seed germination and underground rhizomes (rhizomatous roots), removal of this species without the use of systemic herbicide is very difficult.

Photo 16: Overview Mitigation Area DG-4

Photo 17: Overview Mitigation Area DG-4

Photo 18: Overview Mitigation Area DG-4

Photo 19: Overview Mitigation Area DG-4

Photo 20: Overview Mitigation Area DG-4

Photo 21: Overview Mitigation Area DG-4

Photo 22: Overview Mitigation Area DG-4

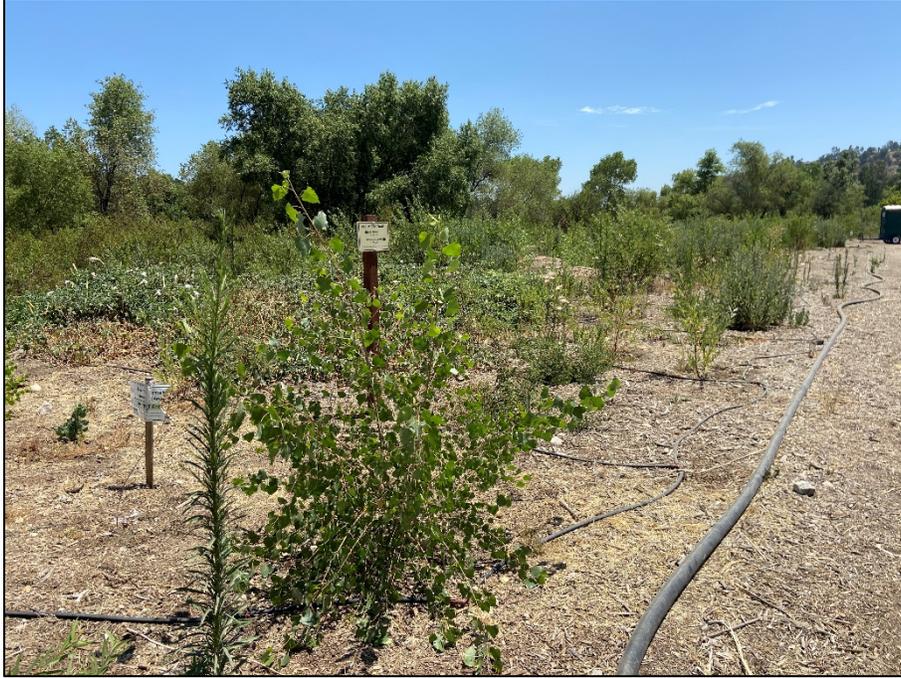
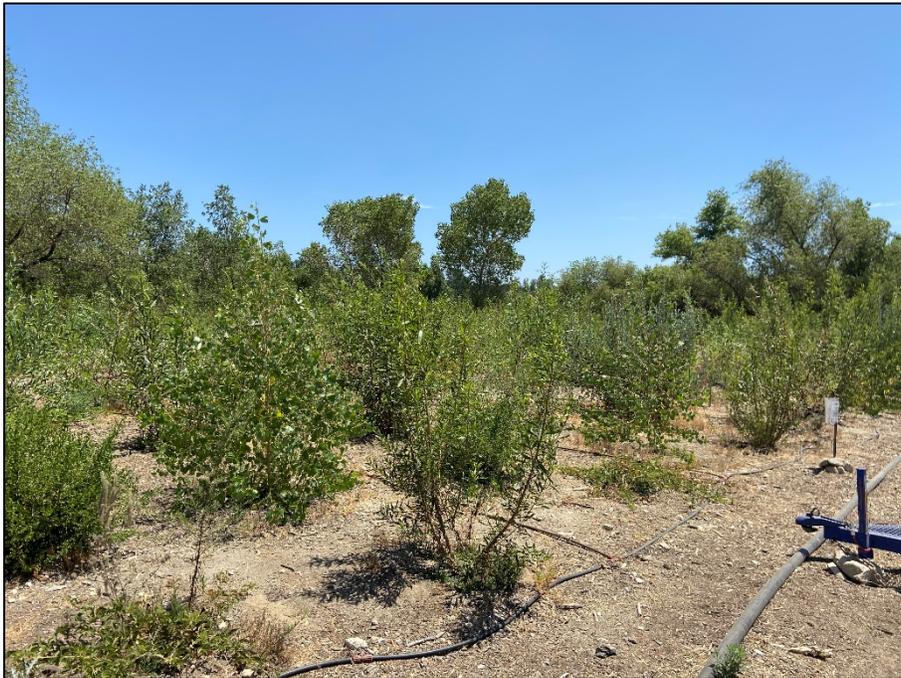
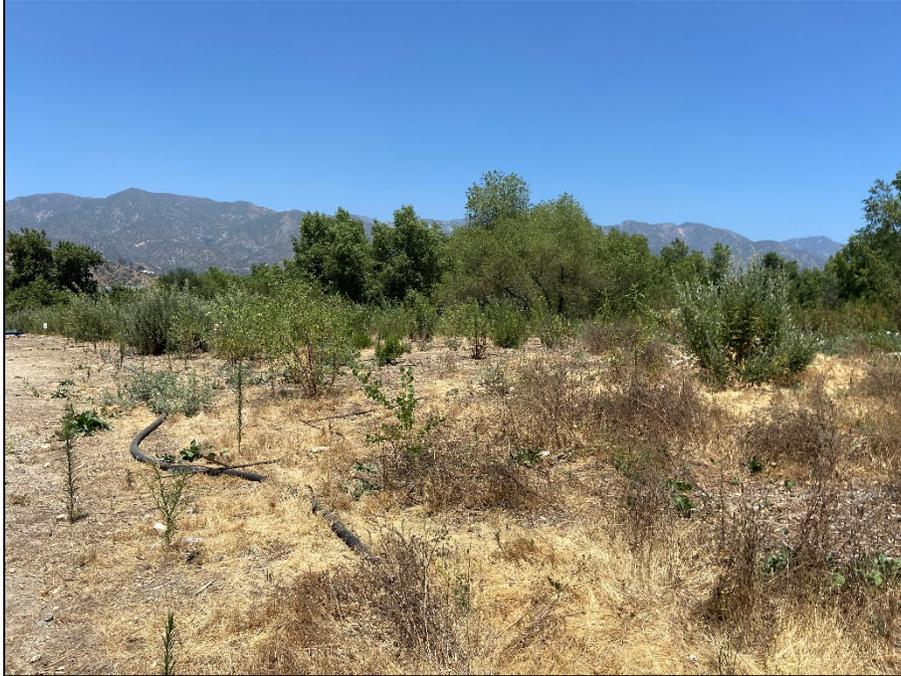
The overall health of the container plants in mitigation area DG-4B was noted as being good and this mitigation area is becoming well established. Approximately 10 percent of all container plants were noted as showing varied levels of stress, which is 5 percent higher than the percentage of plants that were showing stress during the first qualitative monitoring visit. The types of stress the plants were exhibiting are the same as those described for the plants in DG-2A. A negligible number of container plants were noted as being missing or dead. Formal mortality counts were taken for DG-4B during the quantitative monitoring and will be included in the annual reporting. Similar to DG-4, the container planted willow species and mulefat were showing signs of vigorous growth. The installation of plants in the DG-4B mitigation area appears to have been completed successfully and the issues noted during the monitoring are not expected to have an impact on the continued growth of the plants. Photos 23 through 25 in Attachment B document the mitigation area during the monitoring visit.

Nonnative weed cover in DG-4B was estimated at approximately <5 percent, which is the same percentage of nonnative cover that was observed during the first qualitative monitoring event. Nonnative species observed in DG-4B included black mustard, lamb's quarters, horehound, and perennial pepperweed.

Photo 23: Overview Mitigation Area DG-4B

Photo 24: Overview Mitigation Area DG-4B

Photo 25: Overview Mitigation Area DG-4B

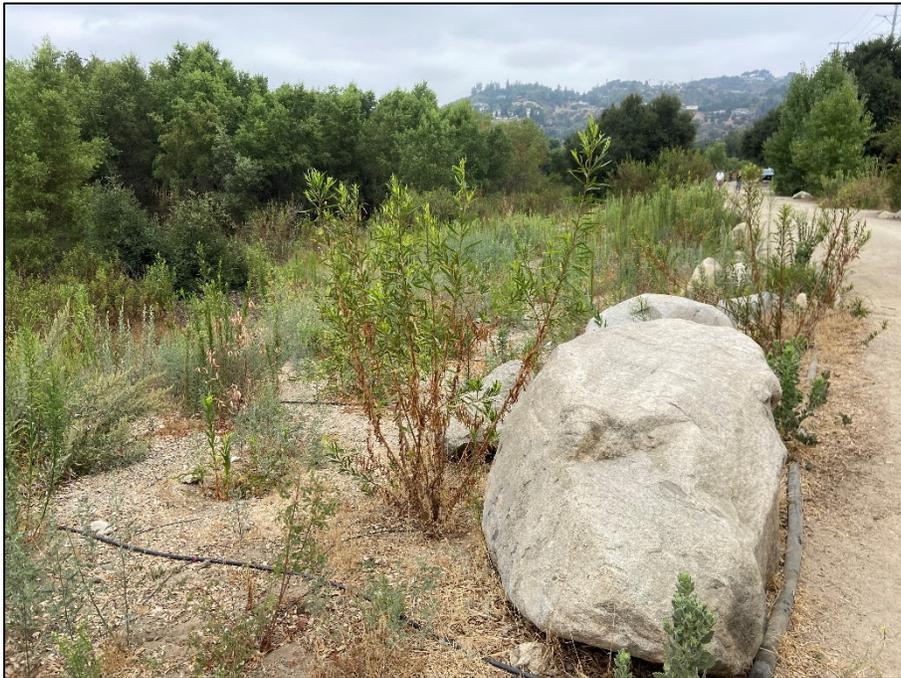
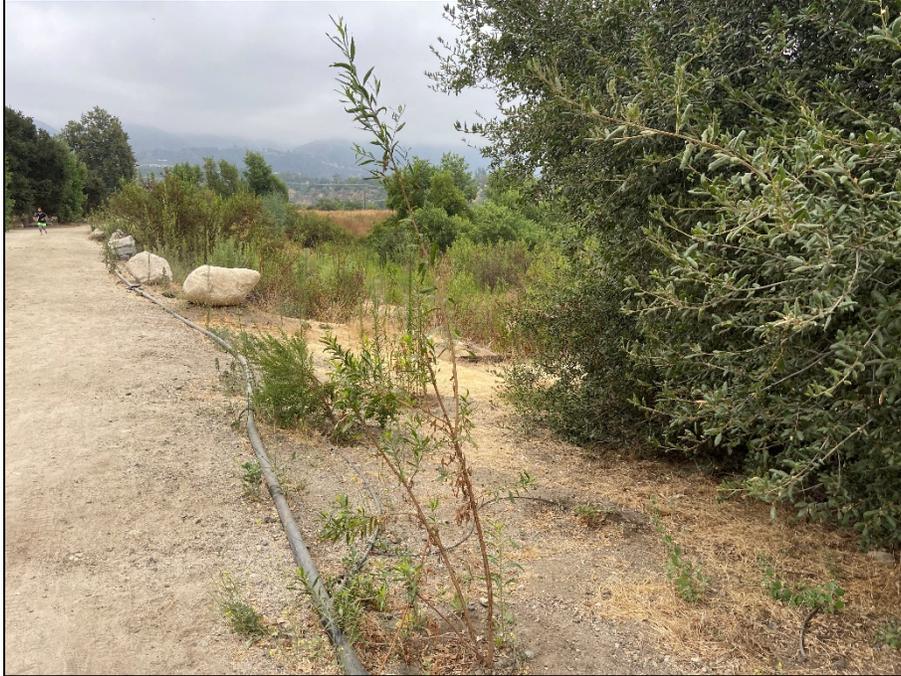
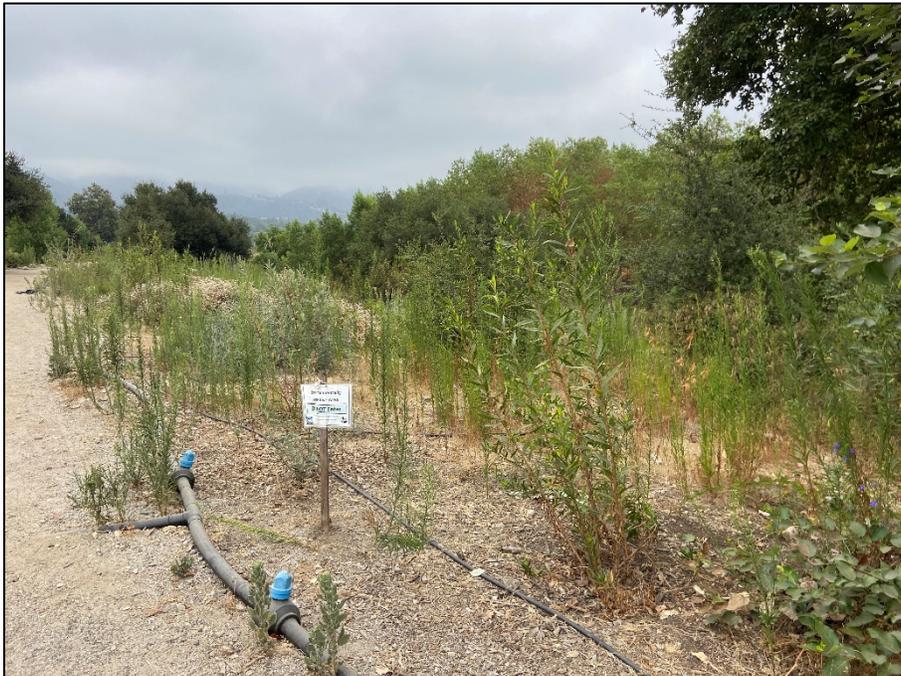
The overall health of the container plants in mitigation area DG-4C was noted as being good. Approximately 15 percent of all container plants were noted as showing varied levels of stress, which is approximately 10 percent higher than the percentage of plants that were showing stress during the first qualitative monitoring event. The types of stress the plants were exhibiting are the same as those described for the plants in DG-2A; however, recent high temperatures have likely contributed the most to the increase in stress. A negligible number of container plants were noted as being missing or dead. Formal mortality counts were taken for DG-4C during the quantitative monitoring and will be included in the annual reporting. Similar to DG-4, the container planted willow species and mulefat in the mitigation areas were showing signs of vigorous growth. The installation of plants in the DG-4C mitigation area appears to have been completed successfully and the issues noted during the monitoring are not expected to have an impact on the continued growth of the plants. Photos 26 through 28 in Attachment B document the mitigation area during the monitoring visit.

Nonnative weed cover in DG-4C was estimated at approximately <5 percent, which is the same percentage of nonnative cover that was observed during the first qualitative monitoring event. Nonnative species observed in DG-4C included black mustard and red brome.

Photo 26: Overview Mitigation Area DG-4C

Photo 27: Overview Mitigation Area DG-4C

Photo 28: Overview Mitigation Area DG-4C
