September 9, 2020

Re: *Devil's Gate Reservoir Restoration Project – Phase 1 Restoration Qualitative Monitoring Conducted on August 13, 2020*

1.0 INTRODUCTION

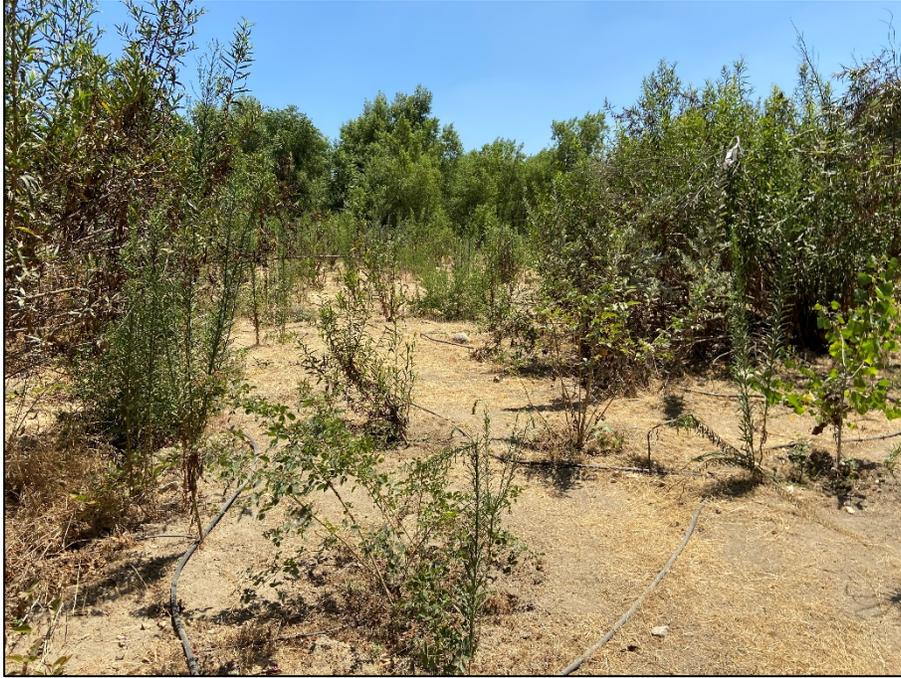
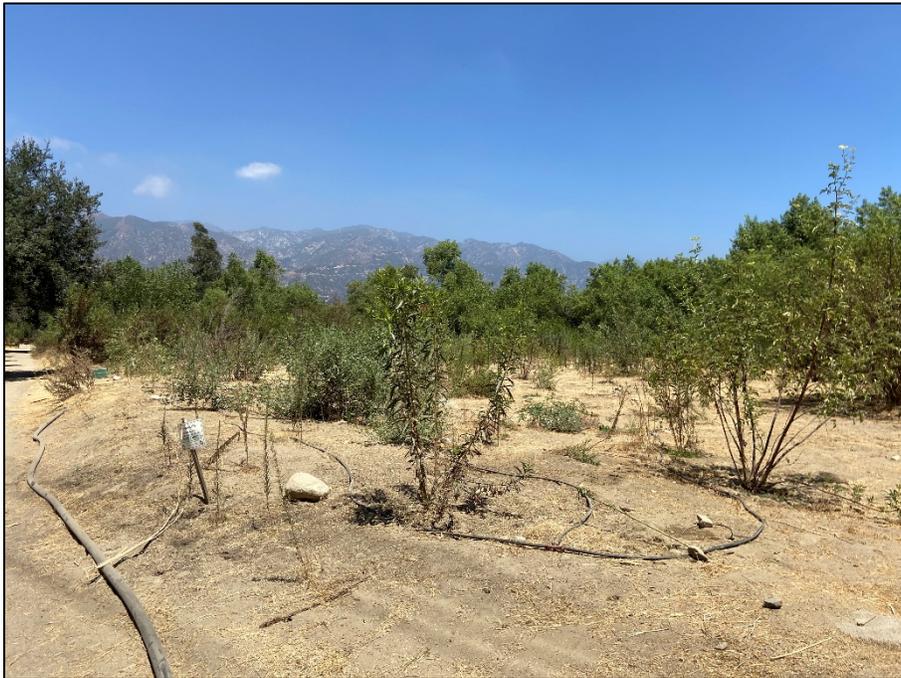
The overall health of the container plants in the DG-5 mitigation area was noted as being good. Approximately 15 to 20 percent of all container plants were noted as showing varied levels of stress, which is approximately 5 percent higher than the percentage of plants that were showing stress during the first qualitative monitoring event. The increase appears to be mostly due to drought stress from recent high temperatures. In addition, the 300-foot buffer around a least Bell's vireo nest that affected all of DG-5 has been removed; however, weed proliferation in this area prior to buffer removal likely contributed to plant stress and mortality. Gopher herbivory is also a significant problem in DG-5 and accounts for the majority of the missing container plants. Formal mortality counts were taken for DG-5 during the quantitative monitoring and will be included in the annual reporting. Similar to DG-4, the container planted willow species and mulefat were exhibiting vigorous growth. The installation of plants in the DG-5 mitigation area appears to have been completed successfully and the issues noted during the monitoring are not expected to have a negative impact on the continued growth of the plants. Photos 29 and 30 in Attachment B document the mitigation area during the monitoring visit.

Nonnative weed cover in DG-5 was estimated at approximately 30 to 35 percent, which is approximately 5 percent less than what was observed during the first qualitative monitoring event. The decrease in weed cover appears to be attributed to several species of annual nonnative grasses being dead for the season. Nonnative species observed in DG-5 included black mustard, Italian thistle (*Carduus pycnocephalus*), and dead nonnative grasses. Nonnative weed cover, especially nonnative grasses and perennial pepperweed, is a major problem in the DG-5 mitigation area.

Photo 29: Overview Mitigation Area DG-5

Photo 30: Overview Mitigation Area DG-5
