**Re: *Devil's Gate Reservoir Restoration Project – Phase 2 Restoration Plant Establishment Period Monitoring Conducted on June 17, 2021***

## **1.0 INTRODUCTION**

## 2.0 PEP MONITORING IN THE PHASE 2 MITIGATION AREAS

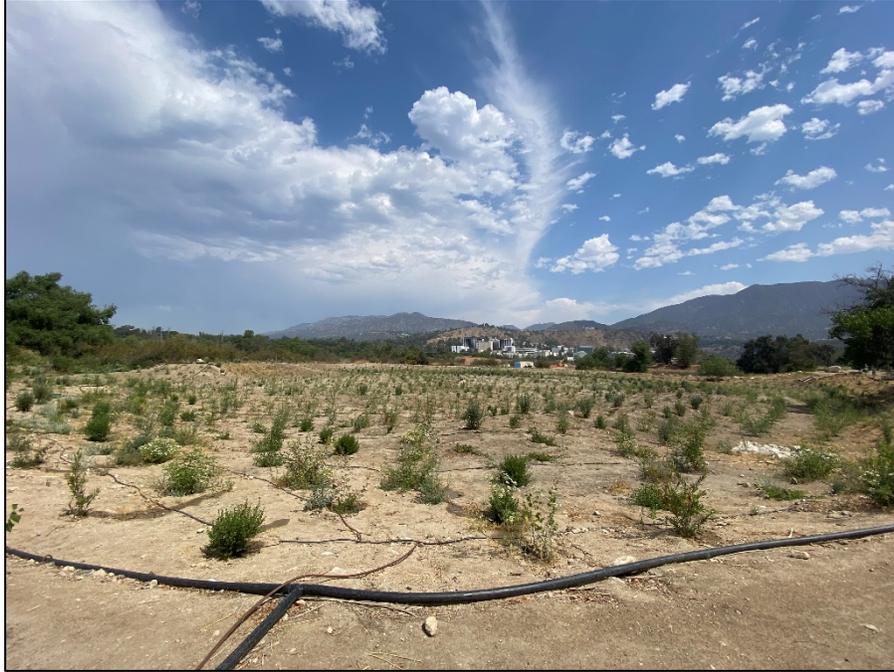
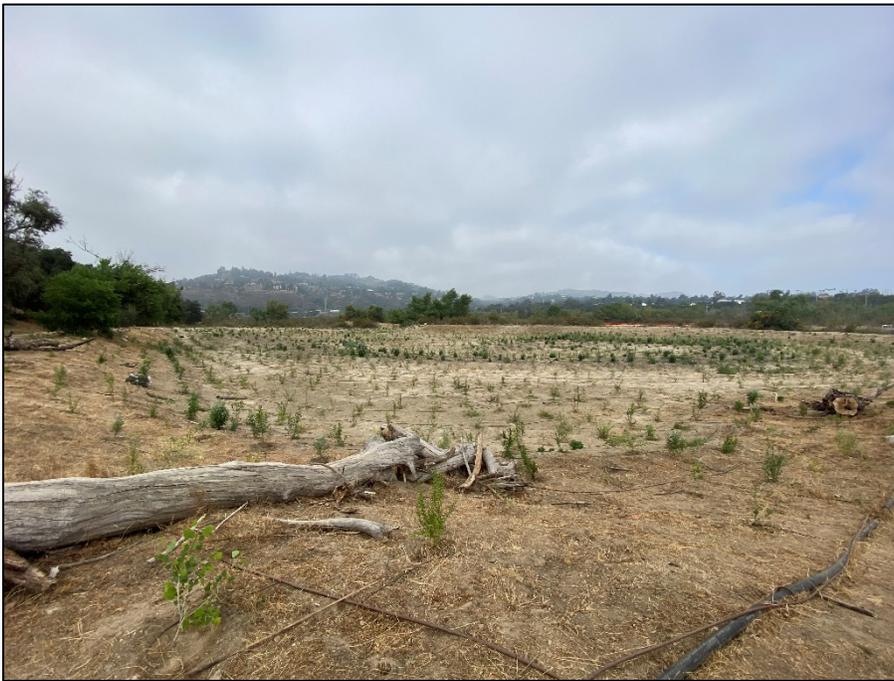
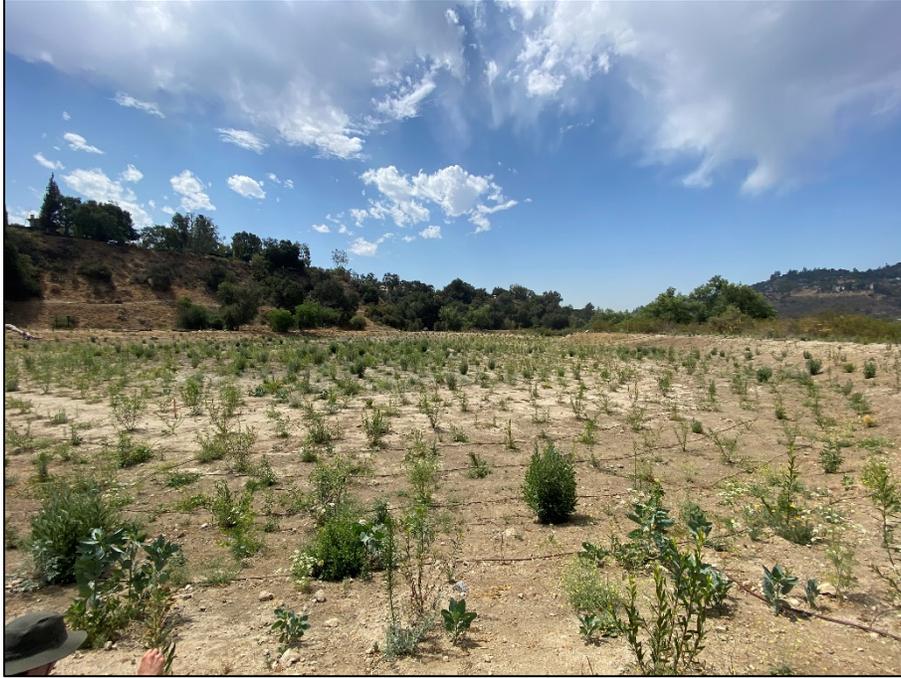
The overall health of the container plants in DG-W-1 was noted as being good. Approximately five to ten percent of the container plants in DG-W-1 were noted as showing varied levels of stress and a negligible number were noted as being dead or missing. Stress may be occurring as a result of 1) transplant shock 2) herbivory by rabbits or other wildlife, 3) competition from nonnative and invasive weeds, 4) misplaced emitters, or 5) recreational traffic through the mitigation areas. Formal mortality counts will be taken for DG-W-1 during the 2021 quantitative monitoring and will be included in the 2021 annual reporting. The willow species (*Salix sp.*) and Fremont's cottonwoods (*Populus fremontii*) in the mitigation areas were no longer showing signs of seasonal dieback. Some of the container plants were noted as lacking well defined basins and should have their basins properly constructed and/or repaired. The installation of plants in the DG-W-1 mitigation area appears to have been completed successfully. The current issues identified during the monitoring visit are not expected to have an effect on the continued growth of the plants in the mitigation area. Photos 1 through 3 in Attachment B document the mitigation area during the monitoring visit.

Minimal native plant growth was noted throughout the DG-W-1 mitigation area, but what was present is likely from both natural recruitment and from seeding. Native plants such as annual bursage (*Ambrosia acanthicarpa*), common yarrow (*Achillea millefolium*), Canada horseweed (*Erigeron canadensis*), cardinal monkey flower (*Erythranthe cardinalis*), California poppy (*Eschscholzia californica*), caterpillar phacelia (*Phacelia cicutaria*), and Parry's phacelia (*Phacelia parryi*) were observed sprouting in the DG-W-1 mitigation area. In addition, dodder (*Cuscuta sp.*) was observed growing on some of the young container plants and should be removed during maintenance activities.

Nonnative weed cover in DG-W-1 was estimated at less than five percent and weeding had recently occurred in the mitigation area. Nonnative species observed in DG-W-1 included black mustard (*Brassica nigra*), tocalote (*Centaurea melitensis*), lamb's quarters (*Chenopodium album*), poison hemlock (*Conium*

Photo 1: Overview Mitigation Area DG-W-1 (Johnson Field)

Photo 2: Overview Mitigation Area Overview Mitigation Area DG-W-1 (Johnson Field)

Photo 3: Overview Mitigation Area Overview Mitigation Area DG-W-1 (Johnson Field)

nonnatives. In particular, it is important to maintain long-term perennial pepperweed management to reduce competition and allow for native plants to germinate. In addition, dodder should be removed from container plants in the mitigation areas. Although many species of dodder are native, this parasitic plant can be harmful to younger shrubs and trees that are not yet established and can even cause mortality.

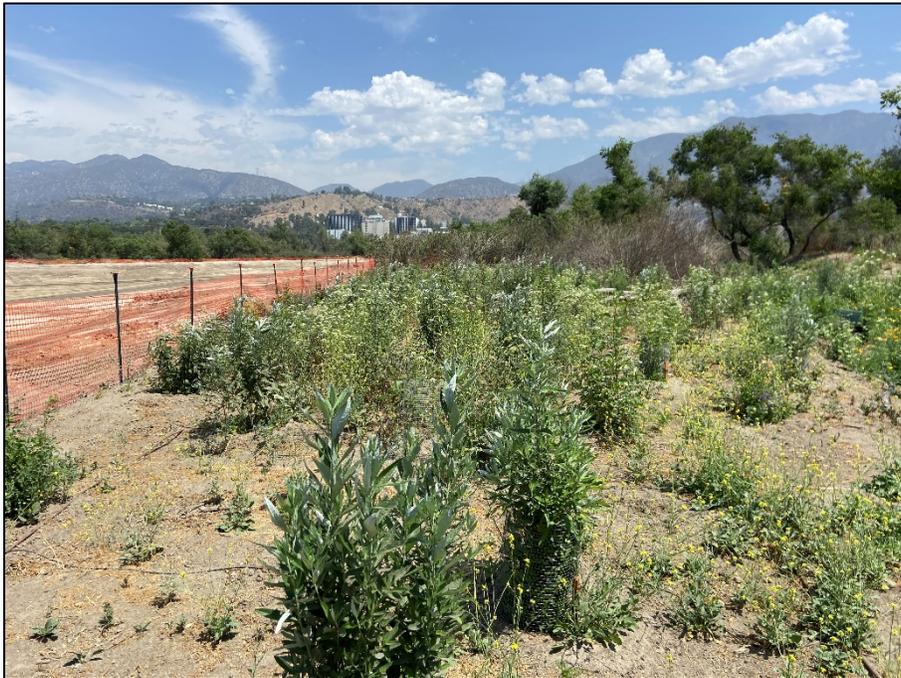
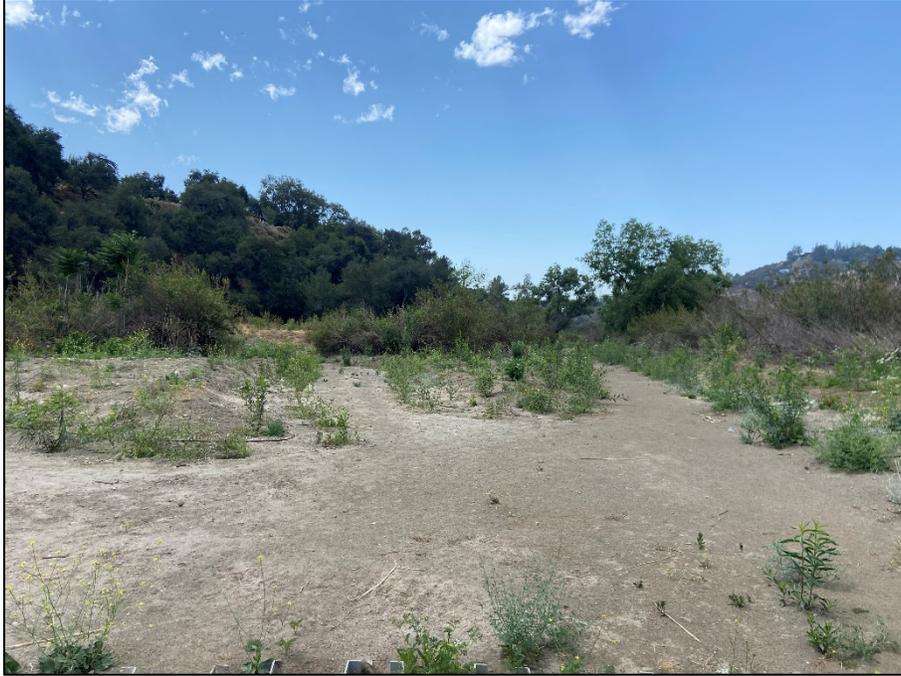
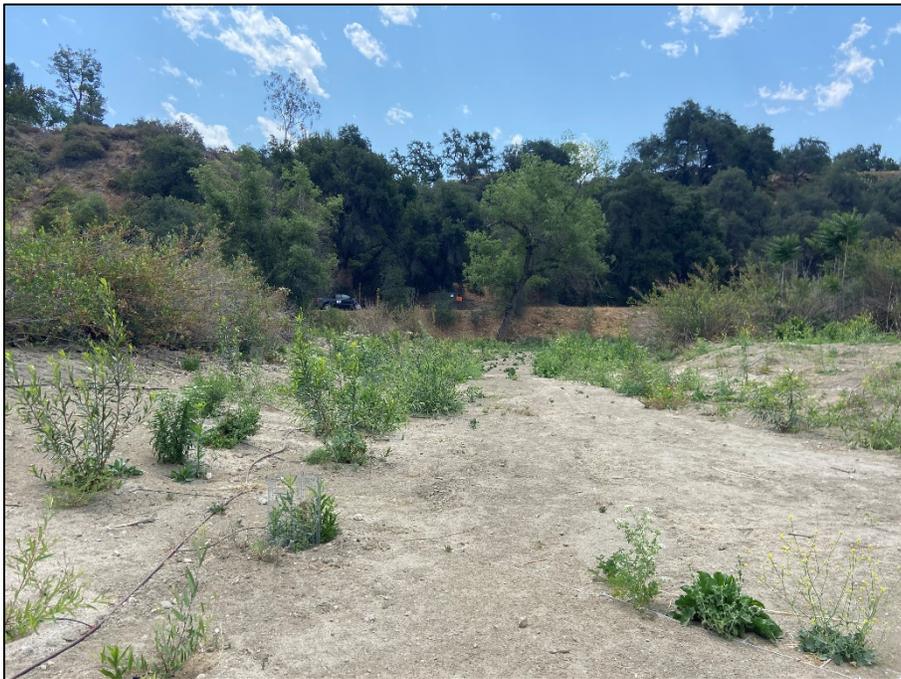
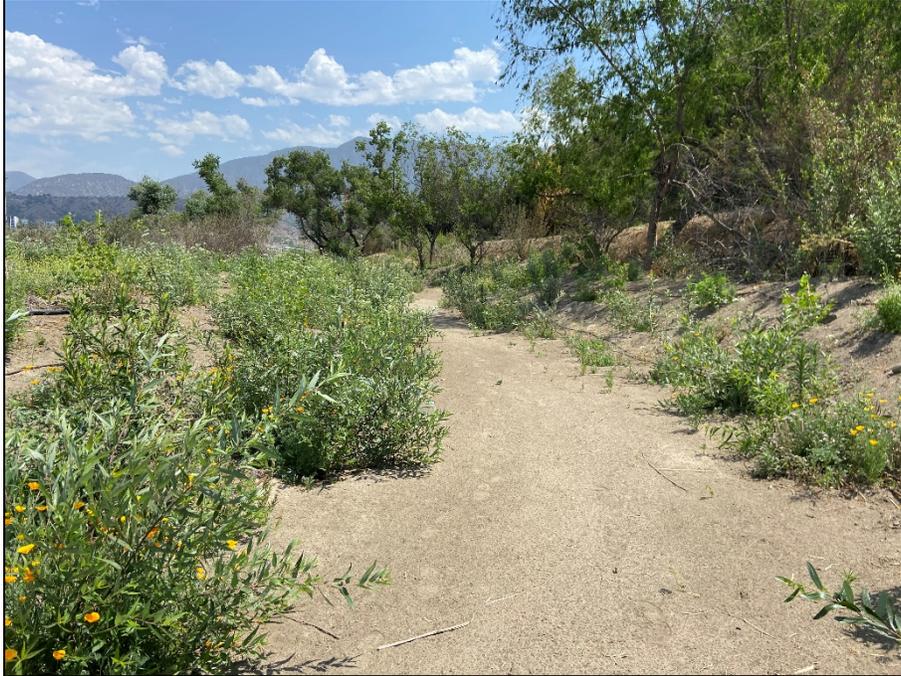
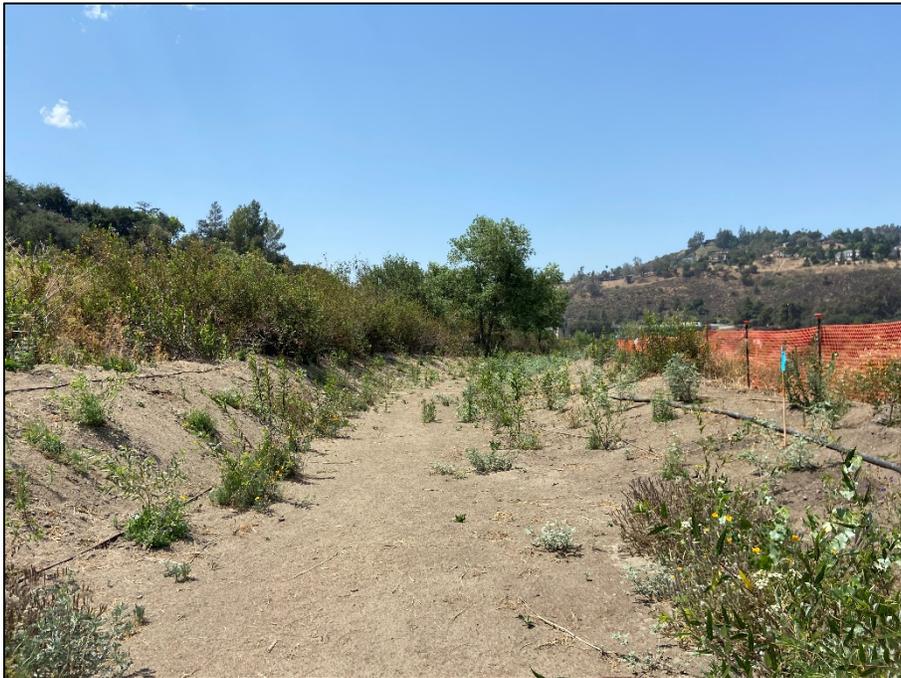
The overall health of the container plants in DG-2, DG-2 New Channels, and DG-2 WOUS was noted as being good. Approximately five to ten percent of the container plants were noted as showing varied levels of stress and a negligible number were noted as being dead or missing. Stress may be occurring due to similar reasons described for DG-W-1. Formal mortality counts will be taken for DG-2, DG-2 New Channels, and DG-2 WOUS during the 2021 quantitative monitoring and will be included in the 2021 annual reporting. Some of the container plants were noted as lacking well defined basins and should have their basins properly constructed and/or repaired. The installation of plants in the DG-2, DG-2 New Channels, and DG-2 WOUS mitigation areas appears to have been completed successfully. The current issues identified during the monitoring visit are not expected to have an effect on the continued growth of the plants in the mitigation area. Photos 4 through 8 in Attachment B document the mitigation areas during the monitoring visit.

Nonnative weed cover in DG-2, DG-2 New Channels, and DG-2 WOUS mitigation areas was estimated at approximately 25 percent with patches of dense new growth. Nonnative species observed included black mustard, poison hemlock, perennial pepperweed (*Lepidium latifolium*), and black nightshade (*Solanum nigrum*). Most of the nonnative weeds observed in this mitigation area were vegetative with only some starting to flower and go to seed.

Photo 4: Overview Mitigation Area DG-2

Photo 5: Overview Mitigation Area DG-2 & DG-2 New Channels

Photo 6: Overview Mitigation Area DG-2 & DG-2 New Channels

Photo 7: Overview Mitigation Area DG-2 WOUS

Photo 8: Overview Mitigation Area DG-2 WOUS

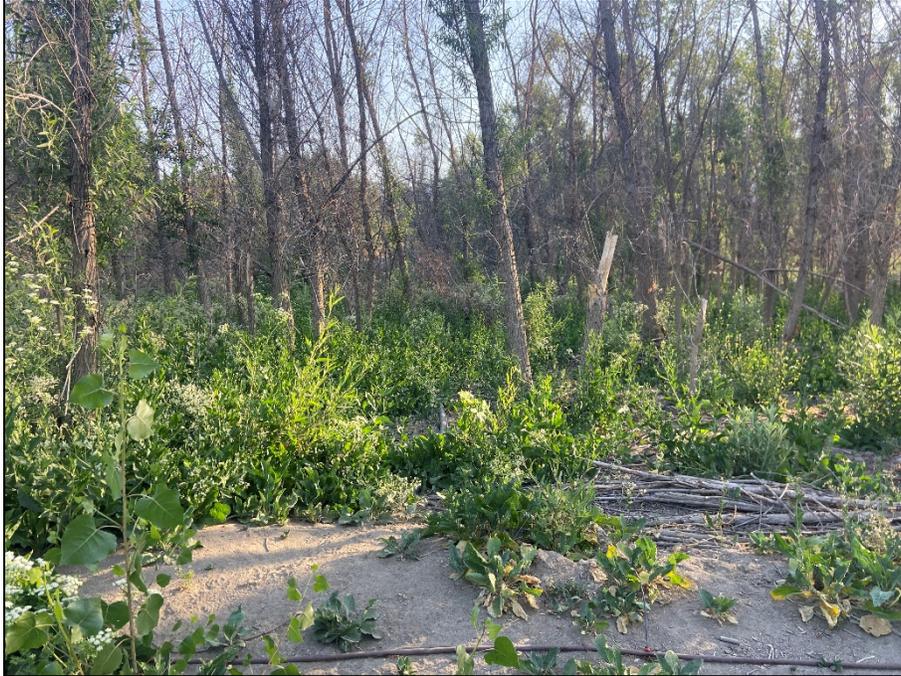
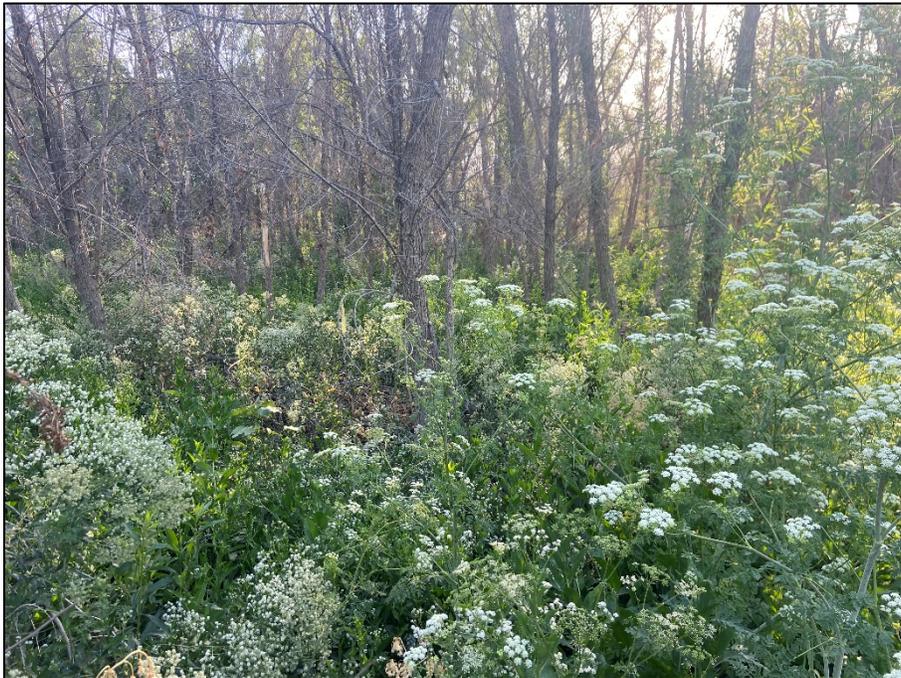
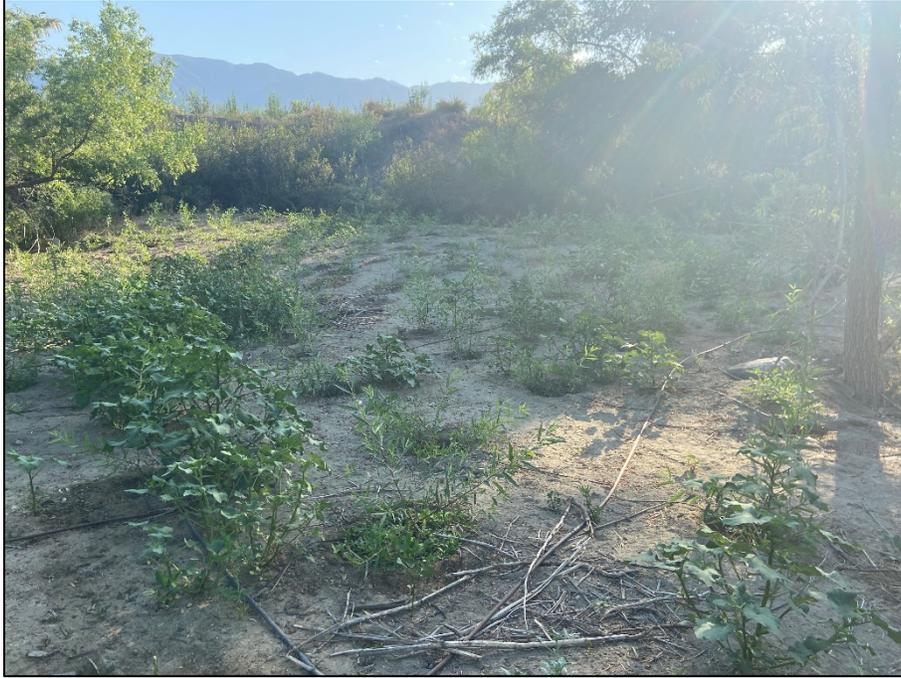
The overall health of the container plants in mitigation area DG-W-2 was noted as being fair; however, nonnative growth in this mitigation area is smothering the young container plants. Due to the high level of nonnative growth, it was difficult to determine the level of stress and the number of container plants that are dead or missing; however, it was estimated that approximately 10 to 15 percent of container plants were showing varied levels of stress. Stress may be occurring due to similar reasons described for DG-W-1; however nonnative weed growth is likely the most significant contributor to container plant stress for this mitigation area. Formal mortality counts will be taken for DG-W-2 during the 2021 quantitative monitoring and will be included in the 2021 annual reporting. Some of the container plants were noted as lacking well defined basins and should have their basins properly constructed and/or repaired. In addition, minor herbivory of young plants was observed within the DG-W-2 mitigation area and should continue to be monitored. The installation of plants in the DG-W-2 mitigation area appears to

Nonnative weed cover in DG-W-2 was estimated at approximately 60 percent. Nonnative species observed in DG-W-2 included black mustard, poison hemlock, perennial pepperweed, horehound (*Marrubium vulgare*), tree tobacco, and black nightshade. Most of the nonnative weeds in this area were starting to flower and will soon go to seed. This area should be weeded as soon as possible.

Photo 9: Overview Mitigation Area DG-W-2 (Mining Pit)

Photo 10: Overview Mitigation Area DG-W-2 (Mining Pit)

Photo 11: Overview Mitigation Area DG-W-2 (Mining Pit)

Photo 12: Overview Mitigation Area DG-W-2 (Mining Pit)

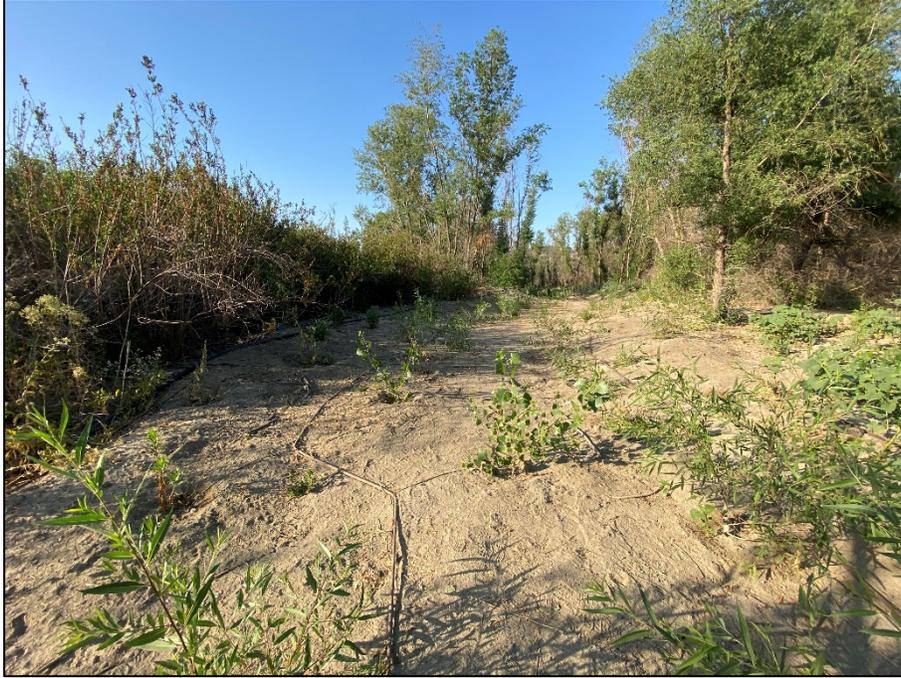
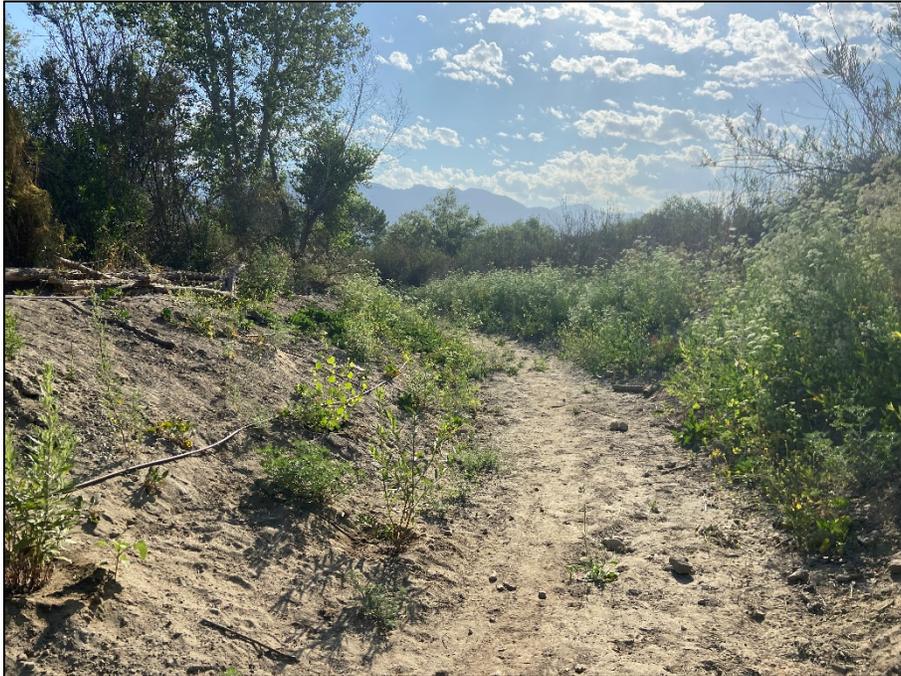
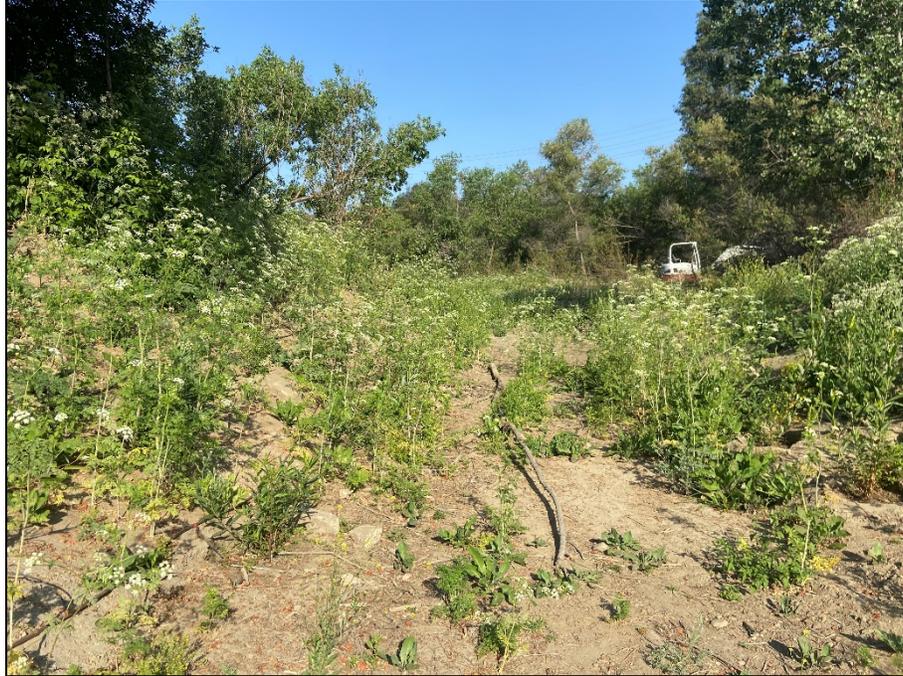
The overall health of the container plants in mitigation area DG-W-2 Outlet was noted as being good. Approximately 10 percent of the container plants were noted as showing varied levels of stress and a negligible number were noted as being dead or missing. Stress may be occurring due to similar reasons described for DG-W-1. Formal mortality counts will be taken for DG-W-2 Outlet during the 2021 quantitative monitoring and will be included in the 2021 annual reporting. Some of the container plants were noted as lacking well defined basins and should have their basins properly constructed and/or repaired. In addition, minor herbivory of young plants was observed within the DG-W-2 Outlet mitigation area and should continue to be monitored. The installation of plants in the DG-W-2 Outlet mitigation area appears to have been completed successfully and the issues noted during the monitoring are not expected to have an impact on the continued growth of the plants. Photos 13 through 15 in Attachment B document the mitigation area during the monitoring visit.

Weed abatement was observed to be actively occurring in portions of the DG-W-2 Outlet mitigation area during the PEP monitoring. Nonnative weed cover in DG-W-2 Outlet was estimated at approximately less than two percent for areas that had been recently weeded and as high as 60 percent in areas that had not yet been weeded. Nonnative species observed in DG-W-2 included pigweed amaranthus (*Amaranthus albus*), black mustard, poison hemlock, perennial pepperweed, German chamomile, tree tobacco, black nightshade, prickly sow thistle (*Sochus asper*), and tamarisk (*Tamarix ramosissima*). Most of the nonnative weeds in this mitigation area were starting to flower and will soon go to seed (excluding areas that were recently weeded). In addition, tamarisk has not been observed in the mitigation areas until now. Any occurrences of this species should be eradicated immediately to prevent the spread of this invasive species.

Photo 13: Overview Mitigation Area DG-W-2 (Mining Pit Outlet)

Photo 14: Overview Mitigation Area DG-W-2 (Mining Pit Outlet)

Photo 15: Overview Mitigation Area DG-W-2 (Mining Pit Outlet)

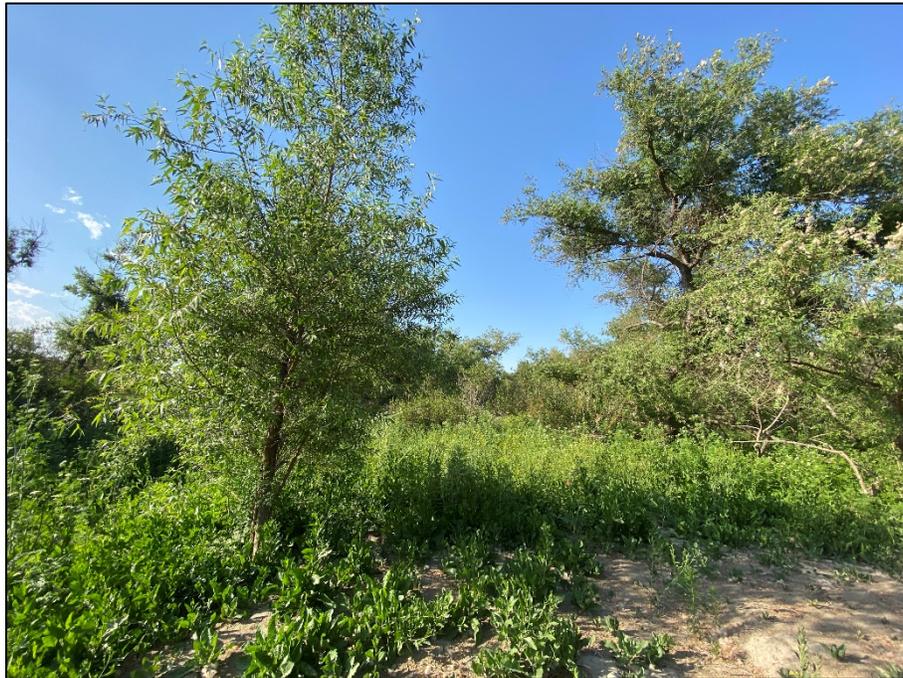
The overall health of the container plants in mitigation areas DG-4 Sheet Flow (northern) and DG-SF-1 was noted as being fair; however, nonnative growth in this mitigation area is smothering the young container plants. Due to the high level of nonnative growth, it was difficult to determine the level of stress and the number of container plants that are dead or missing; however, it was estimated that approximately 15 to 20 percent of container plants were showing varied levels of stress. Stress may be occurring due to similar reasons described for DG-W-1; however nonnative weed growth is likely the most significant contributor to container plant stress for this mitigation area. Formal mortality counts will be taken during the 2021 quantitative monitoring and will be included in the 2021 annual reporting. Some of the container plants were noted as lacking well defined basins and should have their basins properly constructed and/or repaired. In addition, minor herbivory of young plants was observed within the DG-4 Sheet Flow and DG-SF-1 areas and should continue to be monitored. The installation of plants in the DG-4 Sheet Flow and DG-SF-1 mitigation areas appears to have been completed successfully and the issues noted during the monitoring are not expected to have an impact on the continued growth of the plants. Photo 16 in Attachment B documents the mitigation area during the monitoring visit.

Nonnative weed cover in DG-4 Sheet Flow and DG-SF-1 was estimated at approximately 85 percent. Nonnative species observed in DG-4 Sheet Flow and DG-SF-1 included black mustard, poison hemlock, and perennial pepperweed. Most of the nonnative weeds in this area were starting to flower and will soon go to seed. This area should be weeded as soon as possible.

Photo 16: Overview Mitigation Area DG-4 Sheet Flow/DG-SF-1
