October 23, 2025  
2023-005.07

**Re: Devil's Gate Reservoir Restoration Project – Phase 2 Restoration Qualitative Monitoring  
Conducted on August 27, 2025**

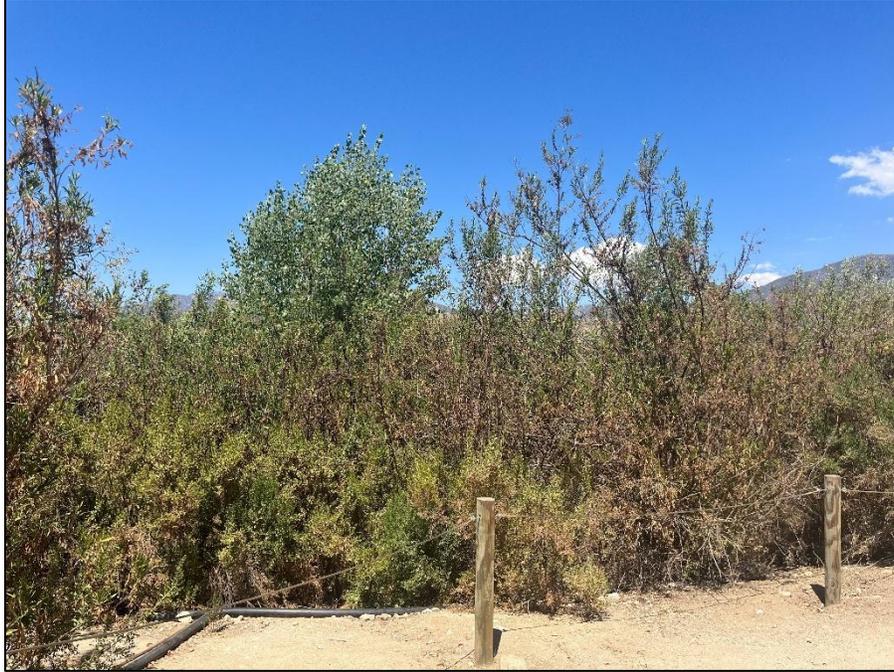
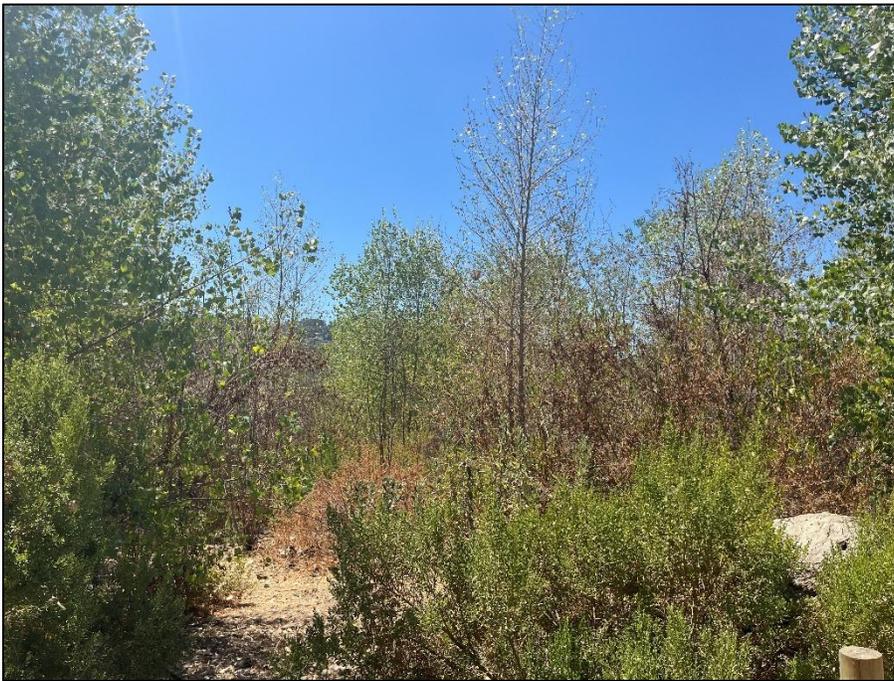
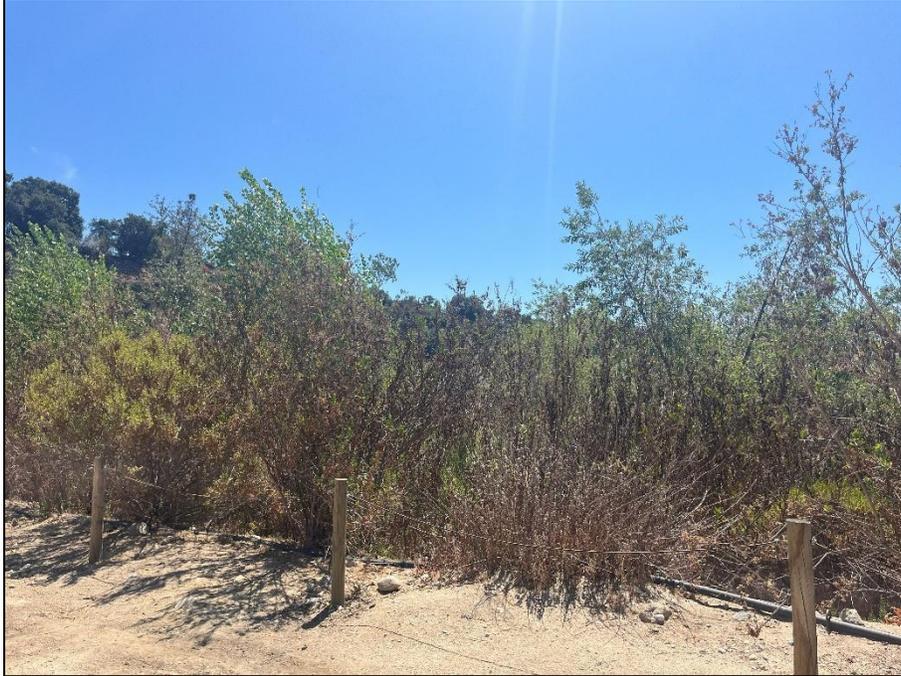
The overall health of the container plants in DG-W-1 was noted as being good. Approximately less than 5 percent of the container plants in DG-W-1 were noted as showing varied levels of stress and a negligible number were noted as dead or missing. This is approximately the same percentage of plants that were showing stress during the last monitoring event. Stress appeared to primarily be the result of drought conditions and recent high temperatures but may also be occurring because of competition from nonnative and invasive weeds or recreational traffic through the mitigation areas. Photos 1 through 3 in Attachment B document the mitigation area during the monitoring visit.

and Hooker's evening primrose (*Oenothera elata*) were observed sprouting in the DG-W-1 mitigation area. Native cover was estimated to be approximately 85 percent.

Nonnative weed cover was estimated at approximately less than 1 percent, which is approximately the same level of weed cover that was observed during the previous monitoring visit. Black mustard (*Brassica nigra*) was the only nonnative species observed in DG-W-1. Most of the nonnative weeds observed in this mitigation area were still vegetative and just beginning to germinate.

Photo 1: Overview Mitigation Area DG-W-1 (Johnson Field)

Photo 2: Overview Mitigation Area DG-W-1 (Johnson Field)

Photo 3: Overview Mitigation Area DG-W-1 (Johnson Field)

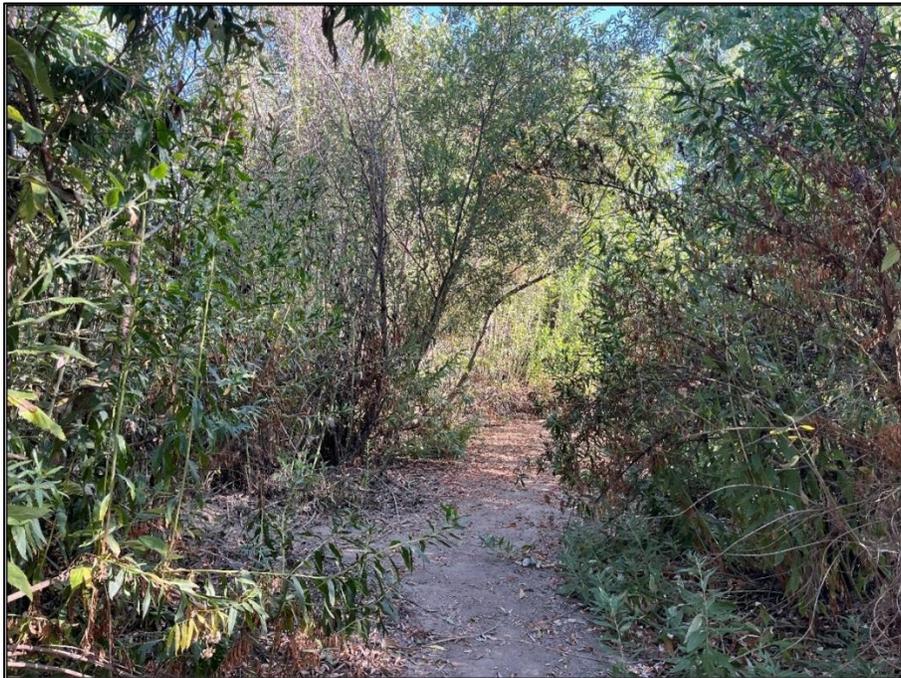
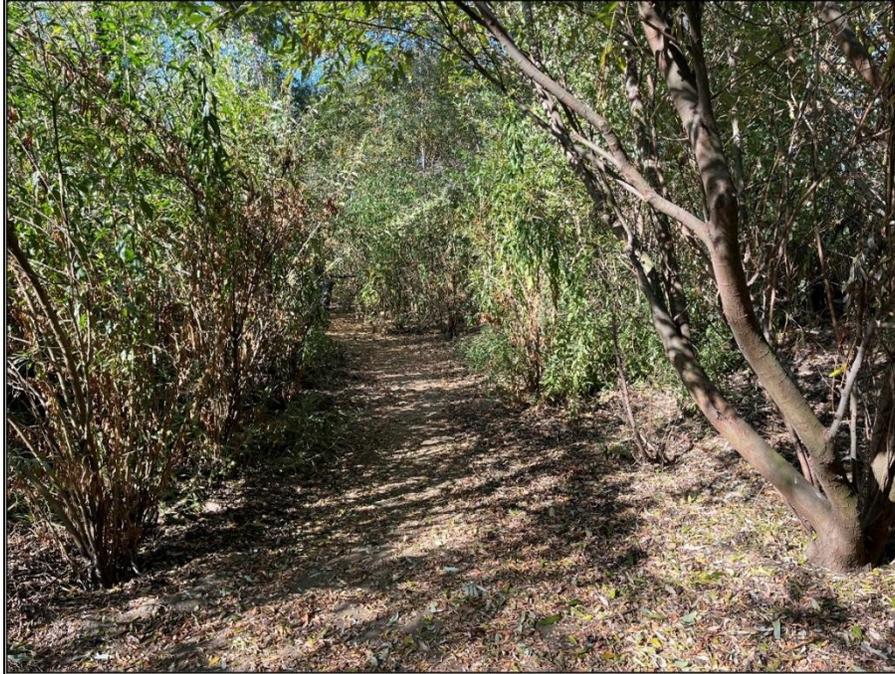
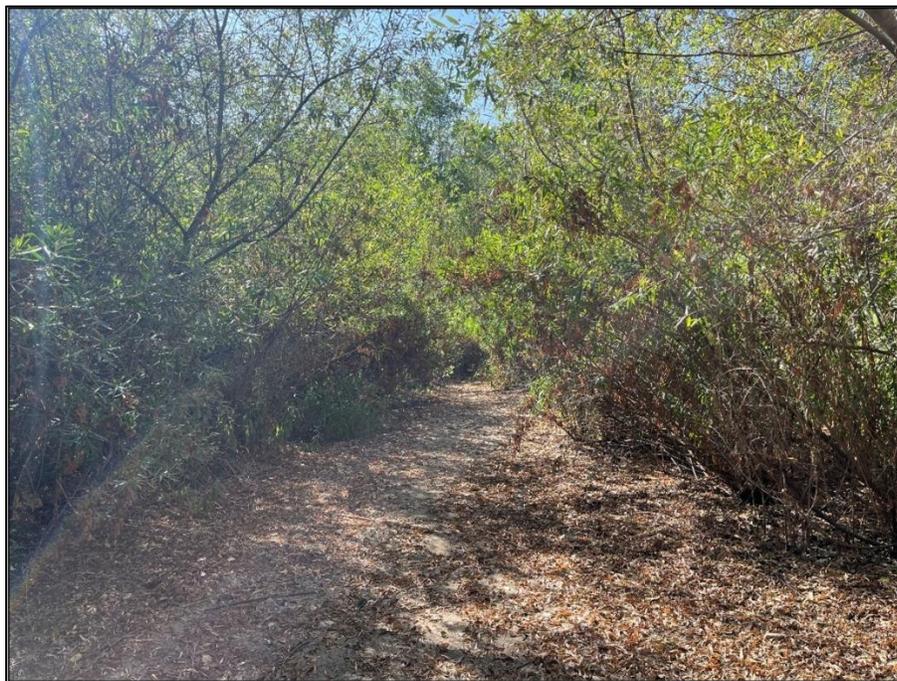
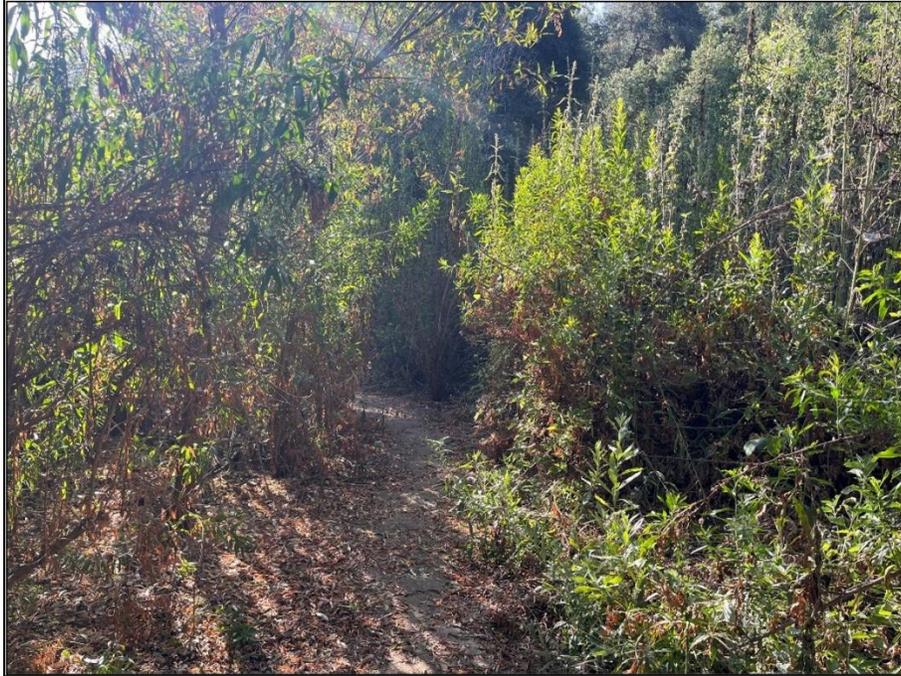
The overall health of the container plants in DG-2, DG-2 New Channels, and DG-2 WOUS was noted as being fair to good. Approximately 10 to 15 percent of the container plants were noted as showing varied levels of stress and a negligible number were noted as dead or missing. This is approximately 5 to 10 percent higher than the percentage of plants that were showing stress during the last monitoring event. Stress may be occurring due to similar reasons described for DG-W-1. During the monitoring visit, the grade control structure that was installed at the northern end of DG-2 New Channels where the channels connect to DG-W-1 was inspected for erosion. Minor erosion was observed, mostly towards the western end of the structure; however, no major erosion issues were observed, and the structure appears to be functioning properly. Photos 4 through 7 in Attachment B document the mitigation areas during the monitoring visit.

Native plant growth was noted throughout the DG-2, DG-2 New Channels, and DG-2 WOUS mitigation areas, likely from both natural recruitment and from seeding. Native plants such as mugwort, mulefat, tall flatsedge, common phacelia (*Phacelia distans*), and stinging nettle (*Urtica dioica*) were observed sprouting in the mitigation areas. Native cover was estimated to be approximately 80 percent.

Nonnative weed cover was estimated at approximately less than 1 percent, which is approximately the same percentage of nonnative cover that was observed during the last monitoring visit. Black mustard and poison hemlock (*Conium maculatum*) were the only nonnative species observed in this mitigation area. Most of the nonnative weeds observed in this mitigation area were vegetative and just starting to germinate.

Photo 4: Overview Mitigation Area DG-2 & DG-2 New Channels

Photo 5: Overview Mitigation Area DG-2 & DG-2 New Channels

Photo 6: Overview Mitigation Area DG-2 & DG-2 WOUS

Photo 7: Overview Mitigation Area DG-2 & DG-2 WOUS

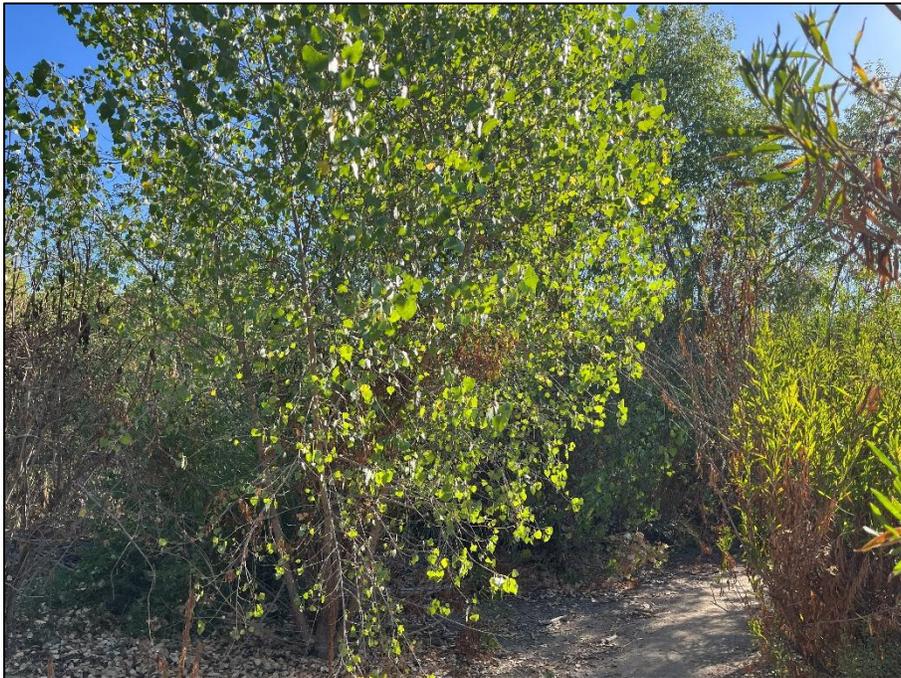
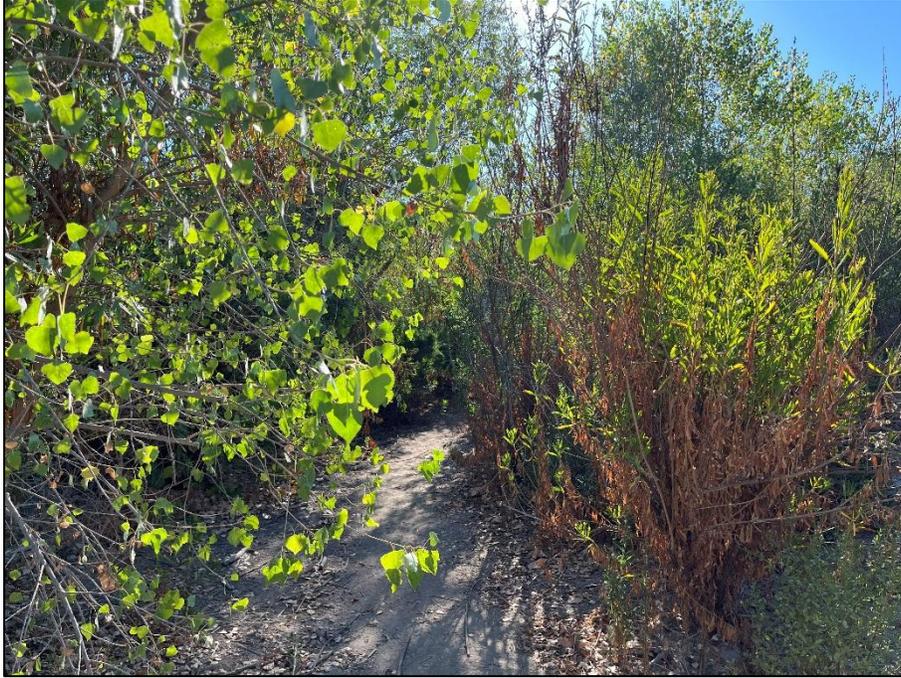
The overall health of the container plants in mitigation area DG-W-2 was noted as being fair. Approximately 25 percent of the container plants were noted as showing varied levels of stress and a negligible number were noted as dead or missing. This is approximately 20 percent higher than the percentage of plants that were showing stress during the last monitoring event. Stress may be occurring due to similar reasons described for DG-W-1. Photos 8 and 9 in Attachment B document the mitigation area during the monitoring visit.

During the monitoring visit, it was noted that many of the remaining mature black willows (*Salix gooddingii*) in this mitigation area were continuing to show signs of recovery from the invasive shot-hole borer (ISHB) infestation that was confirmed by the Los Angeles County Department of Agricultural Commissioner/Weights & Measures in December of 2021. The evidence of recovery on the willows that

were left in place includes sprouting from the base of the trees. Most of the dead and hazardous black willows in this mitigation area were removed in October of 2022. Black willows that were determined to have the potential to recover were left in place and will continue to be monitored during the qualitative monitoring visits.

Native plant growth was noted throughout the DG-W-2 mitigation area natural recruitment and seeding efforts. Native plants such as mugwort, mulefat, Canada horseweed, ladies' tobacco (*Pseudognaphalium californicum*), California rose (*Rosa californica*), stinging nettle, and rough cocklebur (*Xanthium strumarium*) were observed sprouting in the DG-W-2 mitigation area. Native cover was estimated to be approximately 70 percent.

Nonnative weed cover was estimated at approximately less than 1 percent, which is approximately 4 percent lower than the level of nonnative cover that was observed during the last monitoring event. Black mustard and poison hemlock were the only nonnative species observed in this mitigation area. Most of the nonnative weeds observed in this mitigation area were vegetative and just starting to germinate.

Photo 8: Overview Mitigation Area DG-W-2 (Mining Pit)

Photo 9: Overview Mitigation Area DG-W-2 (Mining Pit)

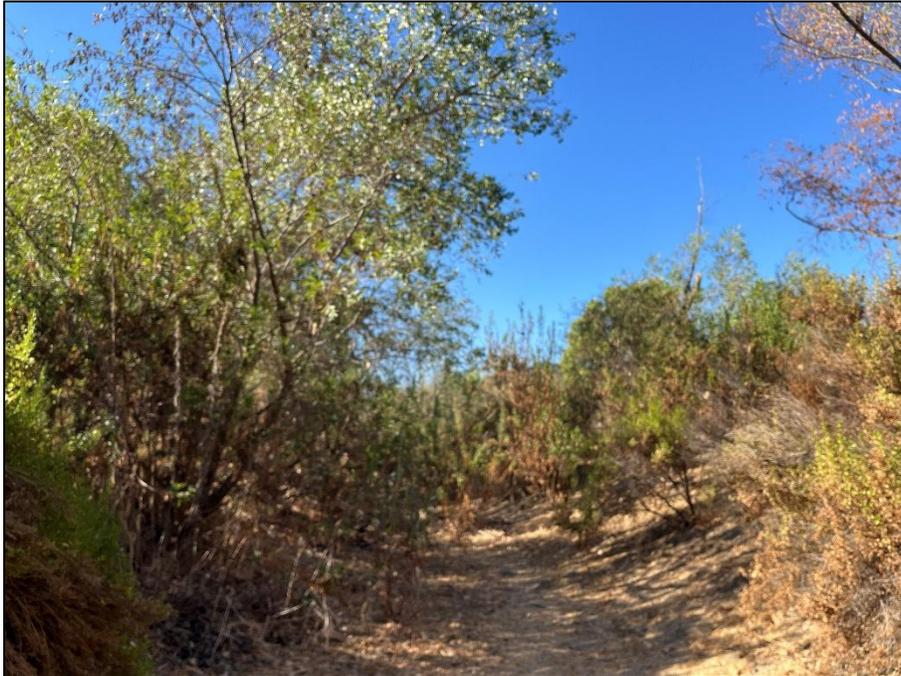
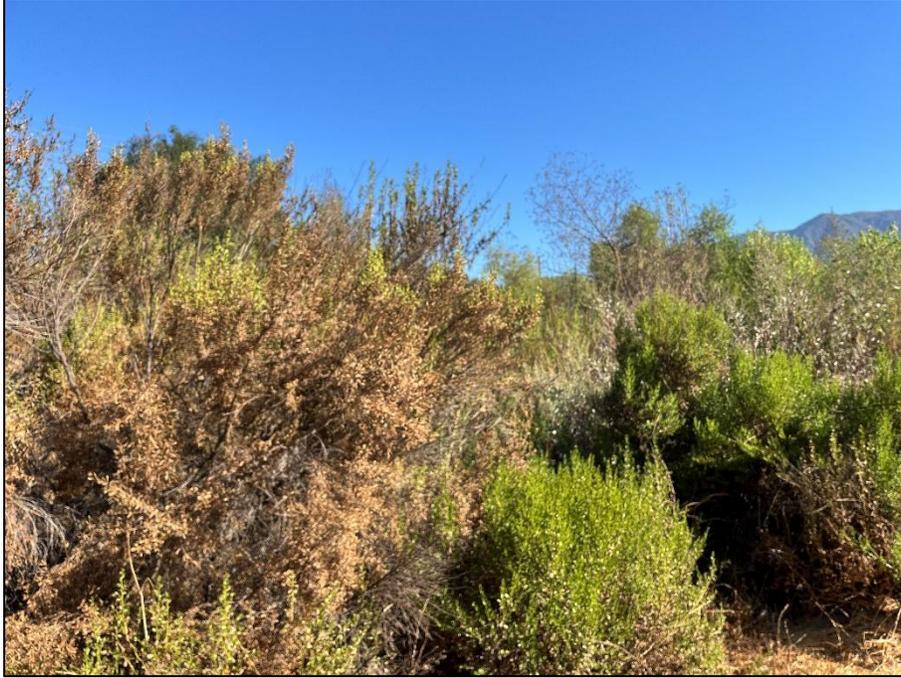
The overall health of the container plants in mitigation area DG-W-2 Outlet was noted as being fair to good. Approximately 25 percent of the container plants were noted as showing varied levels of stress and a negligible number were noted as being dead or missing. This is approximately 20 percent higher than the percentage of plants that were showing stress during the last monitoring event. Stress may be occurring due to similar reasons described for DG-W-1. Photos 10 and 11 in Attachment B document the mitigation area during the monitoring visit.

Native plant growth was noted throughout the DG-W-2 Outlet mitigation area and is likely associated with natural recruitment and seeding efforts. Native plants such as mugwort, coyote brush, and Hooker's evening primrose were observed sprouting in the DG-W-2 Outlet mitigation area. California dodder (*Cuscuta californica*) was also observed growing on some of the container plants. Native cover was estimated to be approximately 70 percent.

Nonnative weed cover was estimated to be approximately 2 percent, which is approximately 3 percent lower than the percentage of weed cover that was observed during the previous monitoring visit. Poison hemlock and perennial pepperweed (*Lepidium latifolium*) were the only nonnative species observed during the monitoring visit. Most of the nonnative weeds observed in this mitigation area were vegetative and just starting to germinate.

Photo 10: Overview Mitigation Area DG-W-2 Outlet

Photo 11: Overview Mitigation Area DG-W-2 Outlet

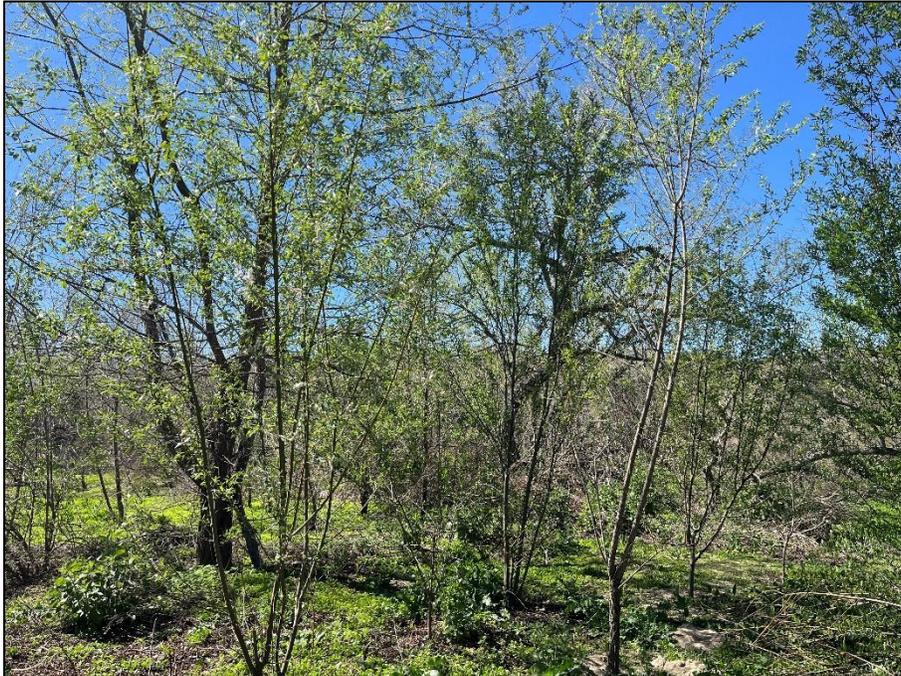
The overall health of the container plants in mitigation areas DG-4 Sheet Flow (northern) and DG-SF-1 were noted as being good. Approximately 10 percent of container plants were showing varied levels of stress, which is approximately 5 percent higher than the percentage of container plants that were showing stress during the previous monitoring event. Stress may be occurring due to similar reasons described for DG-W-1. Photo 12 in Attachment B documents the mitigation area during the monitoring visit.

Minimal native plant germination was noted throughout the DG-4 Sheet Flow and DG-SF-1 mitigation areas and what is growing is likely associated with natural recruitment and seeding efforts. Native plants such as mugwort, tall flatsedge (*Cyperus eragrostis*), and Douglas' nightshade (*Solanum douglasii*) were observed sprouting in the DG-4 Sheet Flow and DG-SF-1 mitigation areas. Native cover was estimated to be approximately 65 percent.

Nonnative weed cover in DG-4 Sheet Flow and DG-SF-1 was estimated at approximately 5 percent, which is approximately 3 percent higher than the level of weed cover that was observed during the previous monitoring visit. Nonnative species observed included black mustard and perennial pepperweed. Most of the nonnative weeds observed in this mitigation area were vegetative and just starting to germinate.

Photo 12: Overview Mitigation Area DG-SF-1
