November 17, 2025
(2023-005.13)

Re: *Devil's Gate Reservoir Restoration Project – Phase 3 Restoration Qualitative Monitoring Conducted on September 26, 2025*

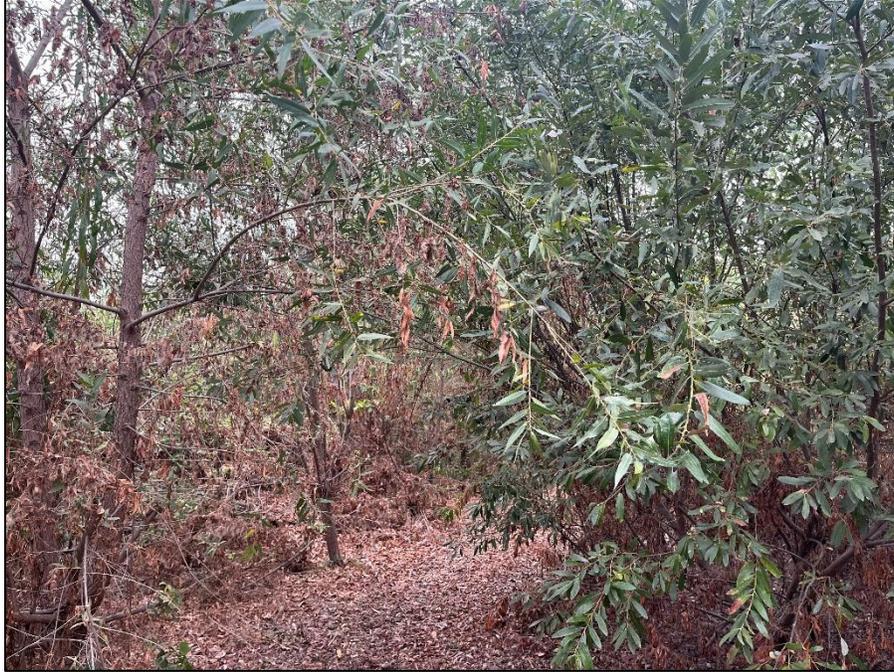
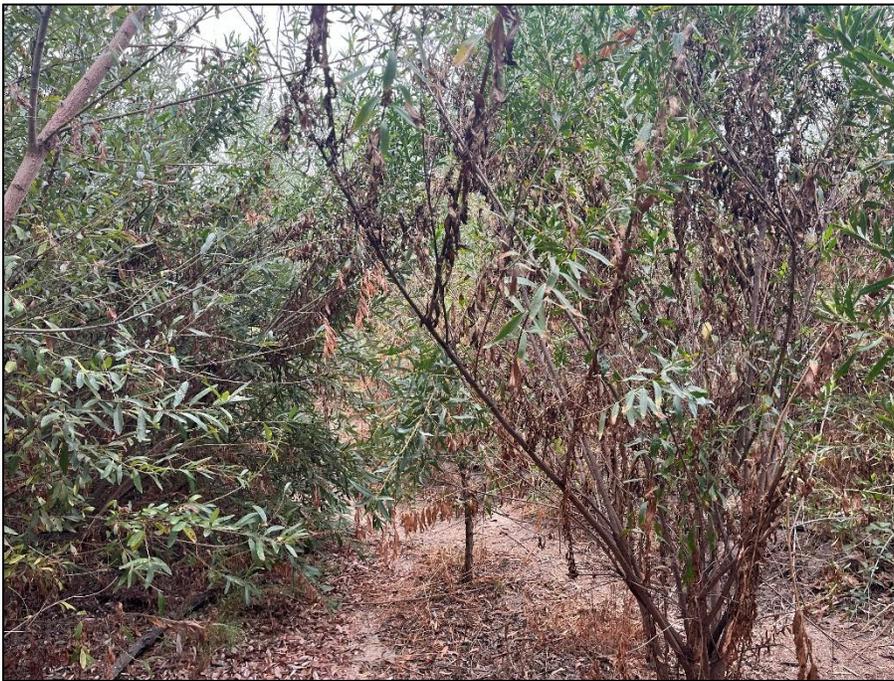
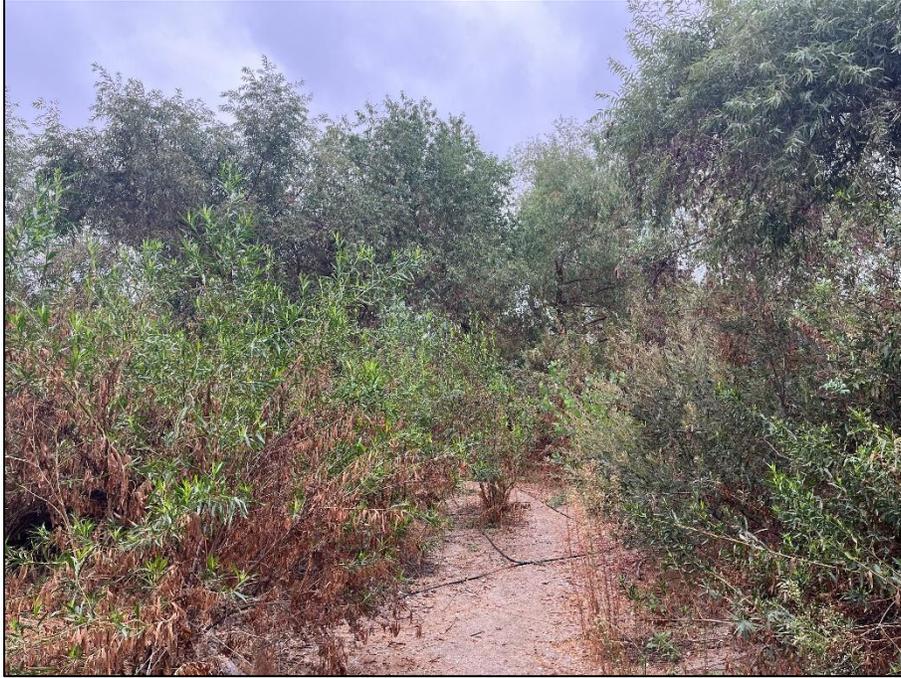
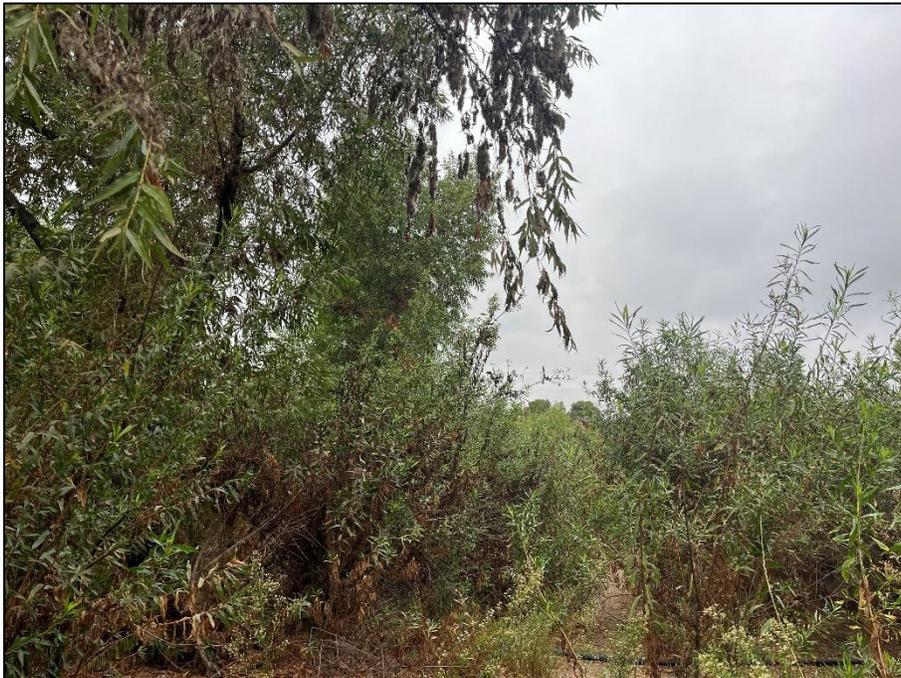
The overall health of the container plants in DG-4 WOUS and DG-4 WOUS Connections was noted as being good. Approximately less than 5 percent of the container plants and stakes in DG-4 WOUS and DG-4 WOUS Connections were noted as showing signs of stress and a negligible amount were noted as being dead or missing. This is the same percentage of plants that were showing stress during the previous monitoring visit. Stress may be occurring as a result of: 1) herbivory by rabbits or other wildlife, 2) competition from nonnative and invasive weeds, 3) misplaced emitters, 4) recreational traffic through the mitigation areas, or 5) drought stress from recent high temperatures. Photos 1 through 4 (Appendix B) document the mitigation areas during the monitoring visit.

Photo 1. Overview DG-4 WOUS & WOUS Connections

Photo 2. Overview DG-4 WOUS & WOUS Connections

Photo 3. Overview DG-4 WOUS & WOUS Connections

Photo 4. Overview DG-4 WOUS & WOUS Connections

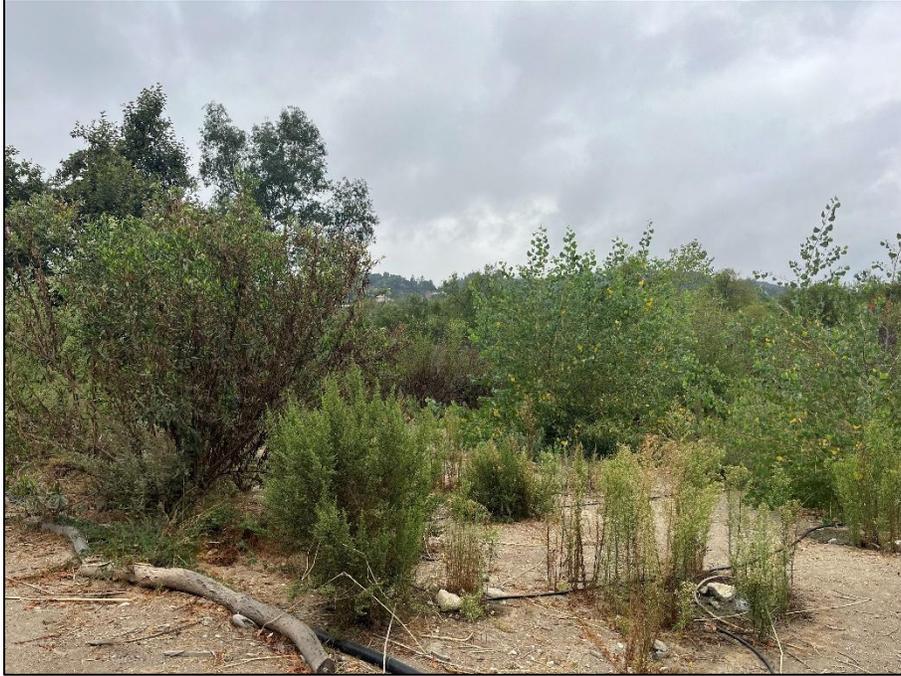
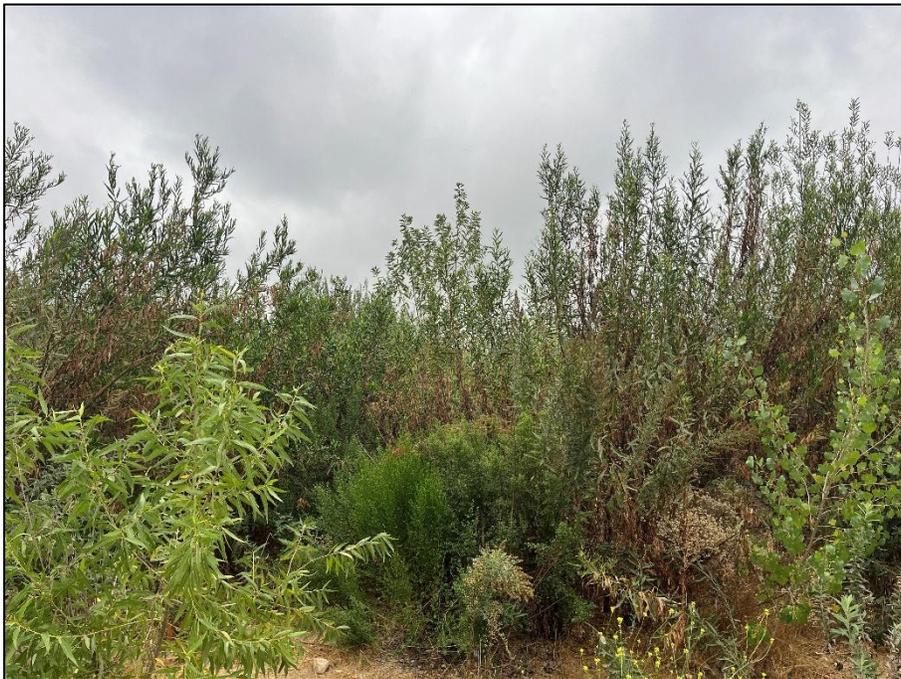
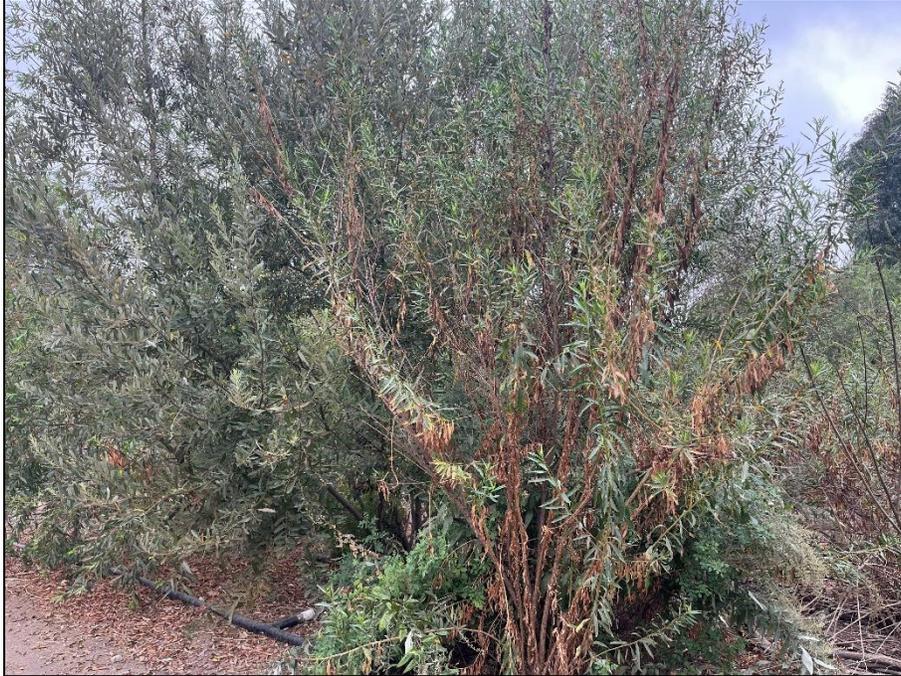
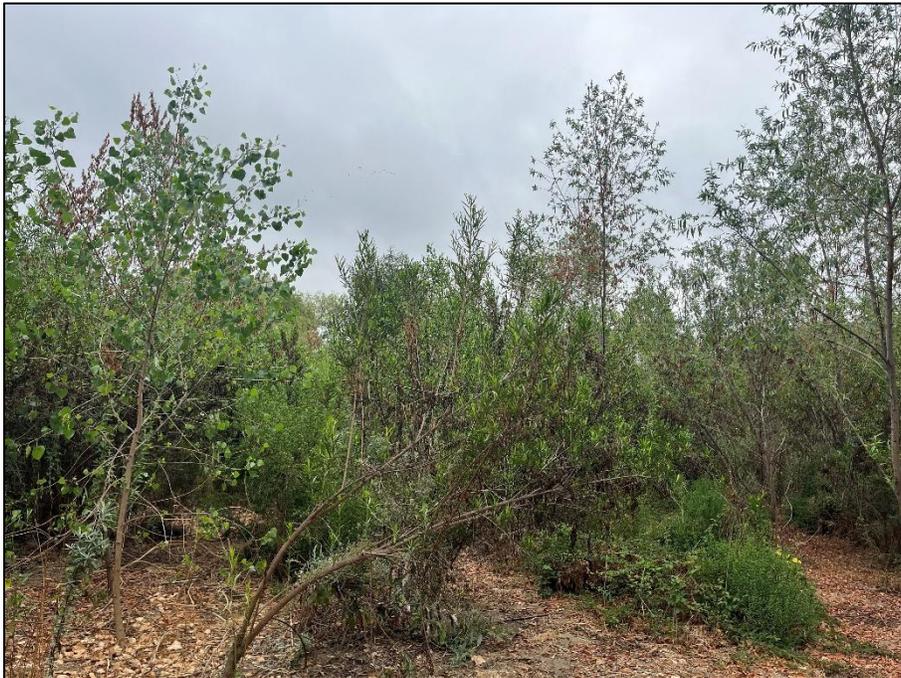
The overall health of the container plants in DG-4A was noted as being good and this mitigation area is becoming well established. Approximately less than 5 percent of the container plants and stakes in DG-4A were noted as showing signs of stress which is approximately the same percentage of plants which were showing signs of stress during the previous monitoring visit. This included the remaining container plants from the first installation and the container plants that were installed to replace the original container plants and stakes planted in the middle section of DG-4A that appeared to be dead or in a condition unlikely to recover during previous monitoring visits. Stress may be occurring due to similar reasons described for DG-4 WOUS and DG-4 WOUS Connections. Photos 5 through 8 in Appendix B document the mitigation area during the monitoring visit.

Photo 5. Overview DG-4A

Photo 6. Overview DG-4A

Photo 7: Overview DG-4A

Photo 8: Overview DG-4A

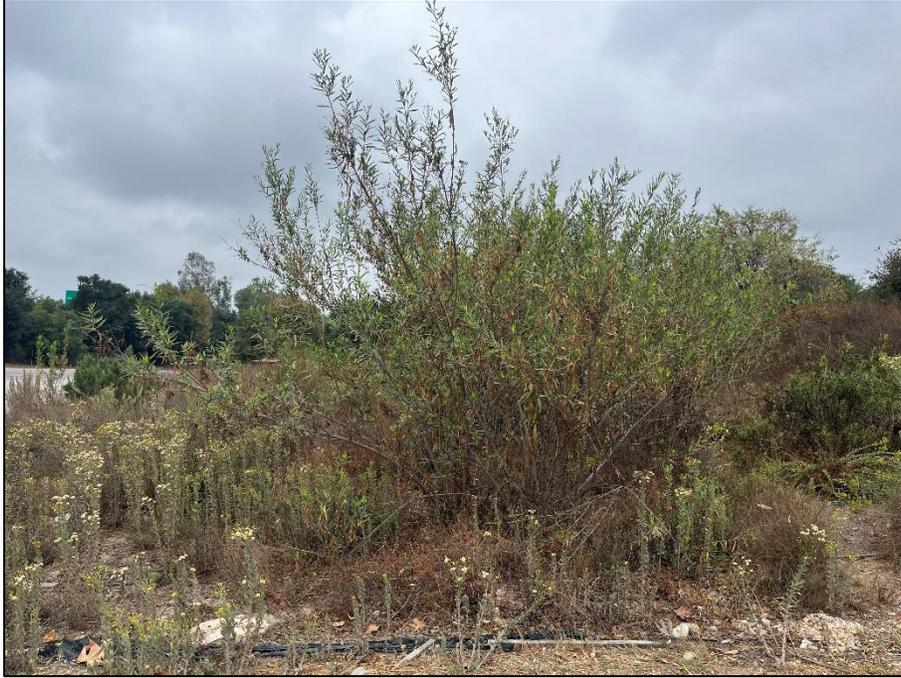
Photo 9: Overview Tire Wash

unlikely to recover during previous monitoring visits. Stress may be occurring due to similar reasons described for DG-4 WOUS and DG-4 WOUS Connections. In addition, some of the container plants are being smothered by deerweed (*Acmispon glaber*), which is proliferating in this area. The irrigation system was found to be functioning properly within this mitigation area. Photo 9 in Appendix B documents the mitigation area during the monitoring visit.

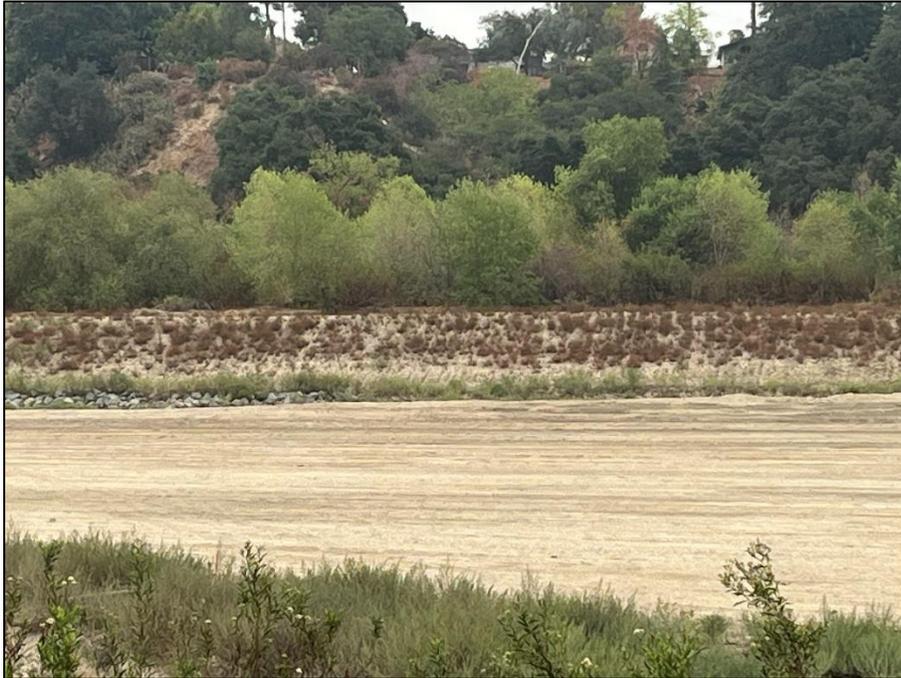
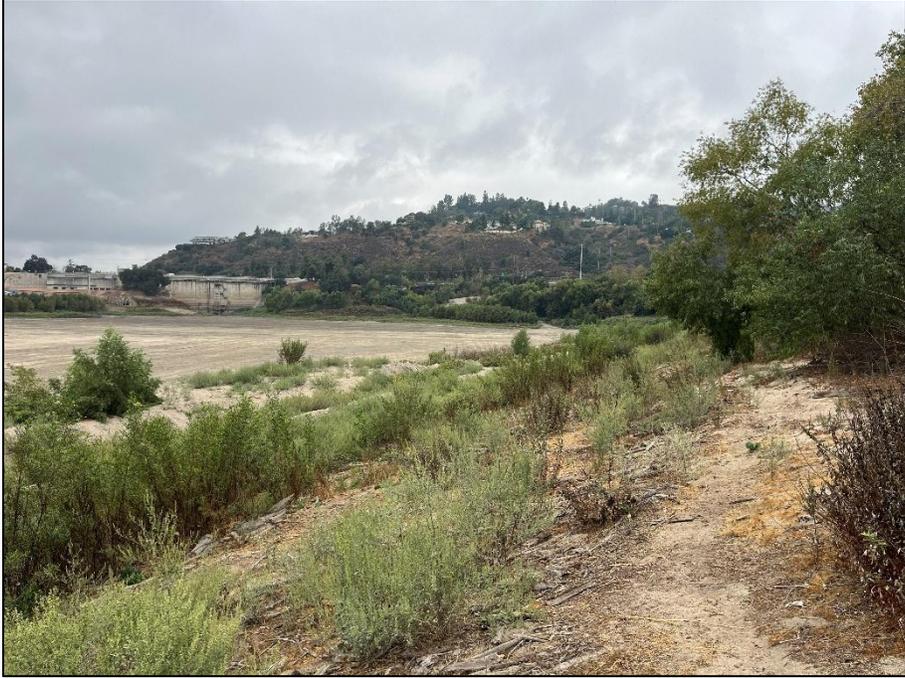
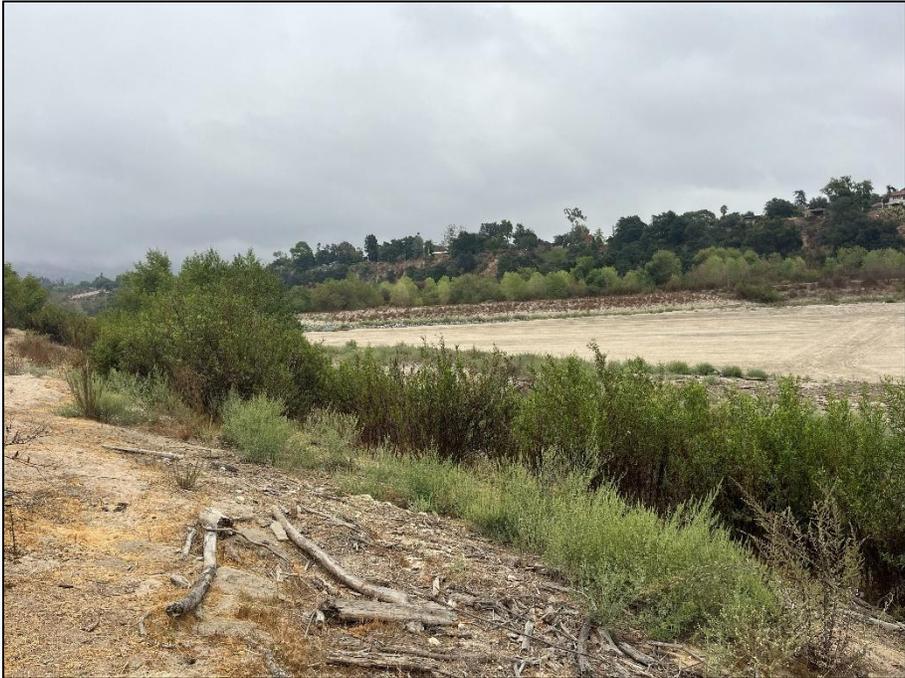
Container plants were not installed on the Side Slopes or in Flint Wash, but these areas were seeded with native plant species. Native plant growth was noted throughout the Side Slopes and Flint Wash, likely both from natural recruitment and from seeding. Minor to moderate erosion was present at the base of the Side Slopes and the hydroseeded portions of the Side Slopes where previous erosion had occurred showed minimal germination; however, the level of native cover continues to increase and some areas appear to be stabilizing. The lower level of germination on these portions of the Side Slopes could be due to lack of soil nutrients, lack of organic matter, and/or incorrect compaction levels. Native plants such as deerweed, annual bursage (*Ambrosia acanthicarpa*), mugwort, mulefat, Canada horseweed, and black willow (*Salix gooddingii*) were observed sprouting on the Side Slopes and in Flint Wash. Overall native cover was estimated to be approximately 55 to 60 percent during the monitoring visit; however, portions of the Side Slopes that have previously had erosion issues had a lower level of cover. Photos 10 through 12 in Appendix B document the Side Slopes during the monitoring visit.

Photo 10: Overview Side Slopes

Photo 11: Overview Side Slopes

Photo 12: Overview Side Slopes

Portions of the Side Slopes which were previously noted as having significant erosion that occurred as a result of heavy rainfall during the 2023 wet season and following the tropical storm in late August 2023 were noted as having been repaired during previous monitoring visits and were included in the supplemental seeding effort which was completed in November of 2023. Some additional erosion was observed at the toe of the Side Slopes in these areas and has the potential to worsen. As more perennial plants become established on the Side Slopes, erosion should become less of an issue; however, action will need to be taken to repair the damage caused by the erosion and measures should be taken to reduce damage from erosion in the future. In addition, if the supplemental seeding effort does not produce germination on the previously eroded Side Slopes, adaptive management techniques will likely be warranted. During future monitoring events, erosion should continue to be monitored in all planted areas and if warranted, erosion Best Management Practices should be installed in appropriate areas. This may only require the installation of straw wattles at select sites to prevent existing rills from becoming larger.
