January 18, 2021
2018-047.016

Re: *Devil's Gate Reservoir Restoration Project – Phase 1 Restoration Qualitative Monitoring Conducted on December 16, 2020*

1.0 INTRODUCTION

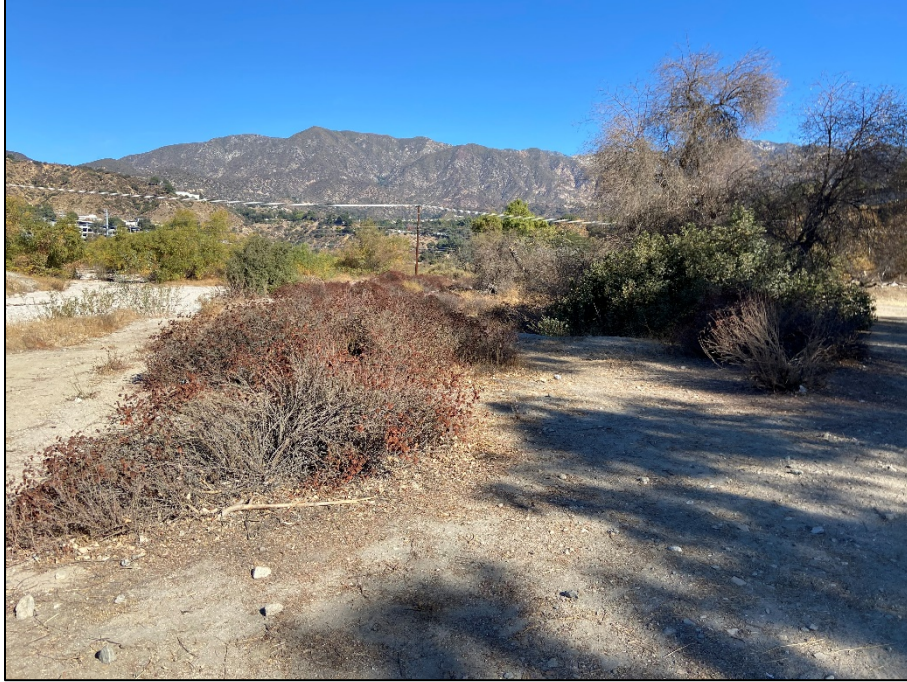
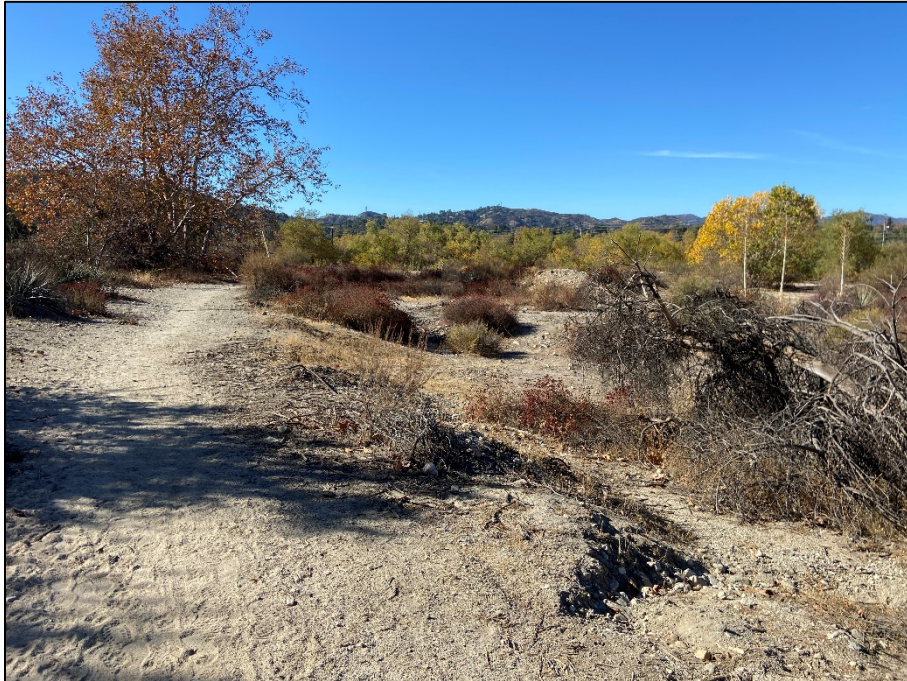
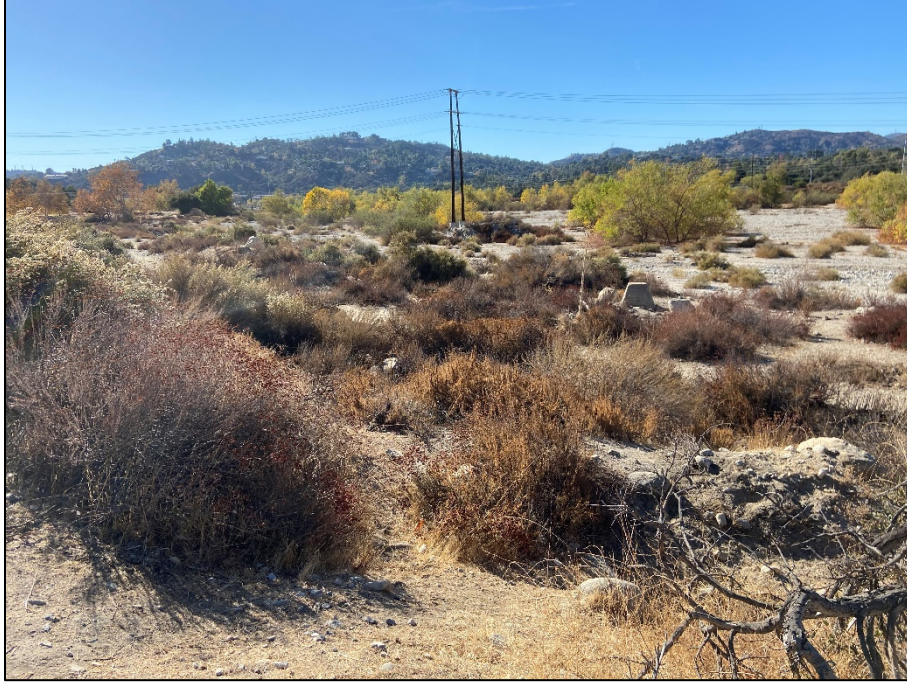
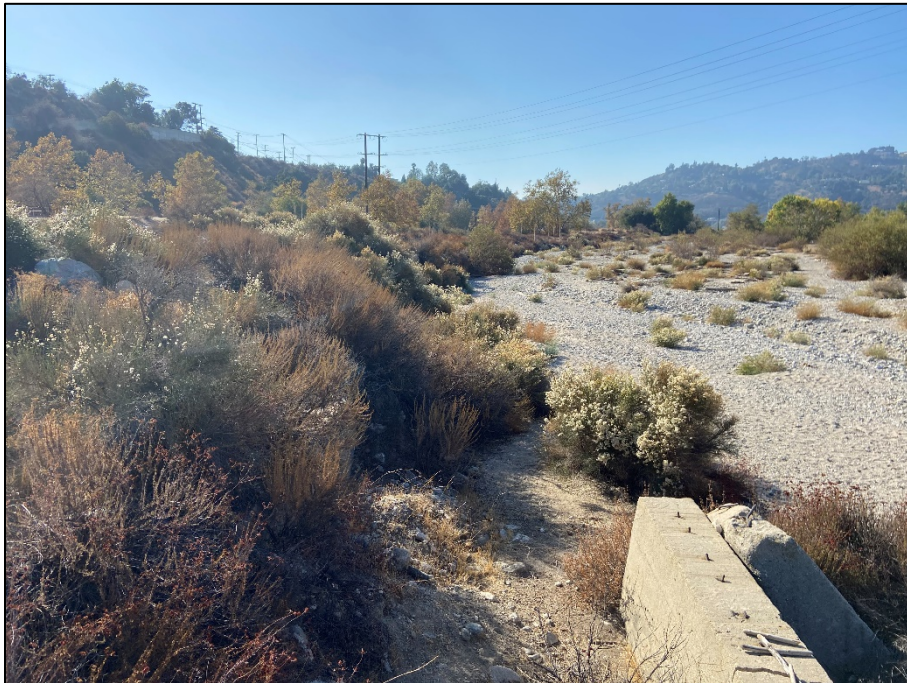
Container plants were not installed in the DG-1 or DG-1 WOUS mitigation areas, but these areas were seeded with native plant species. Native plant growth was noted throughout the DG-1 and DG-1 WOUS mitigation areas, likely both from natural recruitment and from seeding; however, germination was observed to be very minimal in the majority of these mitigation areas. Portions of DG-1 WOUS were noted as being scoured during the wet season and had minimal plant growth. Most native annuals were noted as being dead for the season. Native plants such as annual bursage (*Ambrosia acanthicarpa*), mulefat (*Baccharis salicifolia*), Canada horseweed (*Erigeron canadensis*), California buckwheat (*Eriogonum fasciculatum*), scale broom (*Lepidospartum squamatum*), and caterpillar phacelia (*Phacelia cicutaria*) were observed sprouting in the DG-1 and DG-1 WOUS mitigation areas. In addition, dodder (*Cuscuta sp.*) was observed growing on some of the shrubs in this mitigation area, which could lead to future decline of these shrubs; however, the dodder was noted as being mostly dead for the season. Photos 1 through 4 in Attachment B document the mitigation area during the monitoring visit.

Nonnative weed cover in DG-1 and DG-1 WOUS was estimated at approximately <2 percent, if the dead annual weeds are excluded, which is approximately the same level of weed cover that was observed during the previous qualitative monitoring event. Nonnative species observed in DG-1 and DG-1 WOUS included wild oat (*Avena fatua*), black mustard (*Brassica nigra*), red brome (*Bromus madritensis ssp. rubens*), tocalote (*Centaurea melitensis*), and Mediterranean grass (*Schismus barbatus*); however, most individuals were observed to be dead for the season.

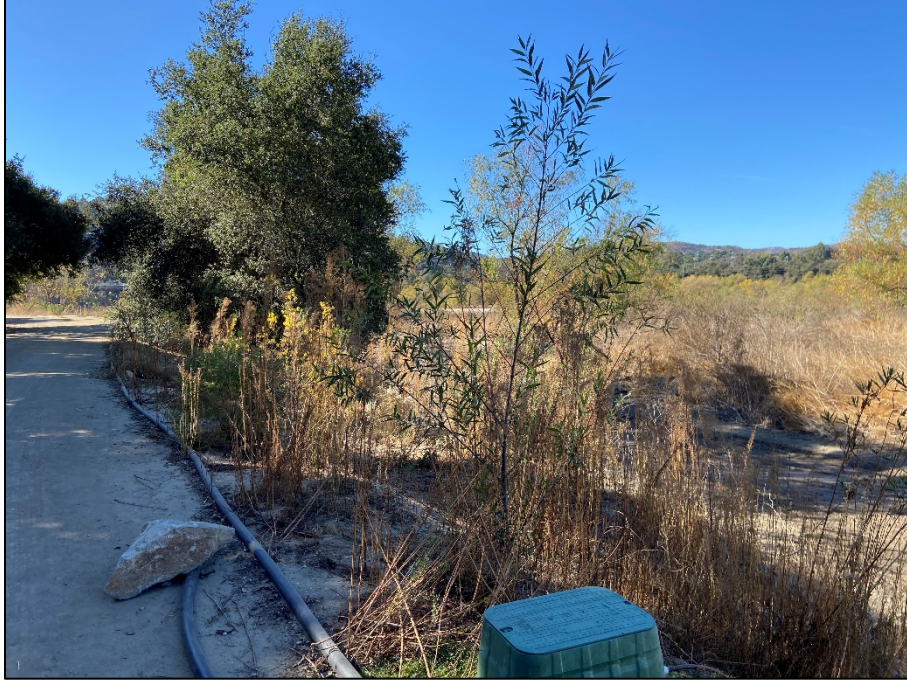
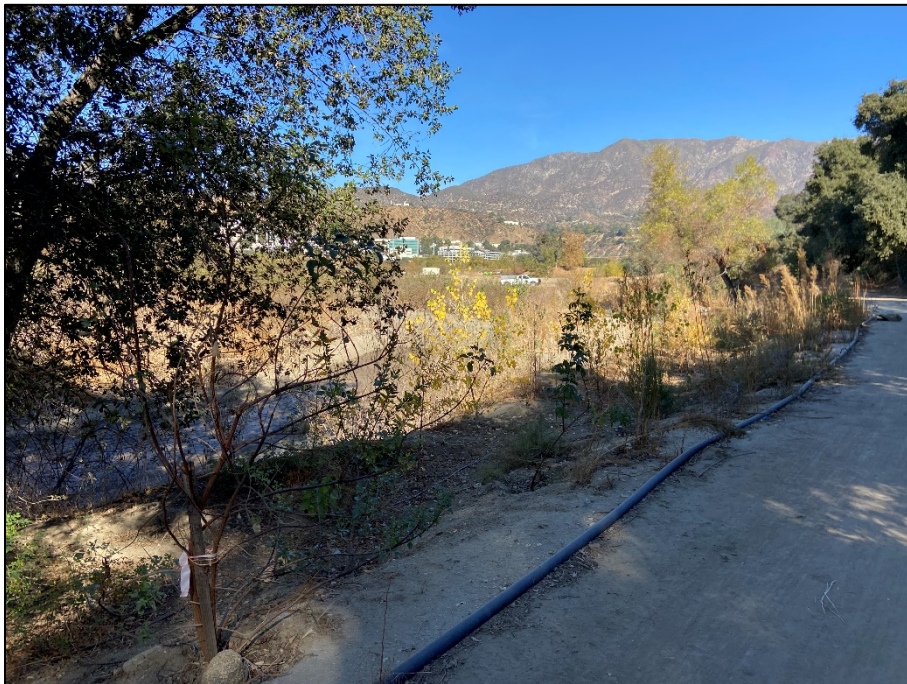
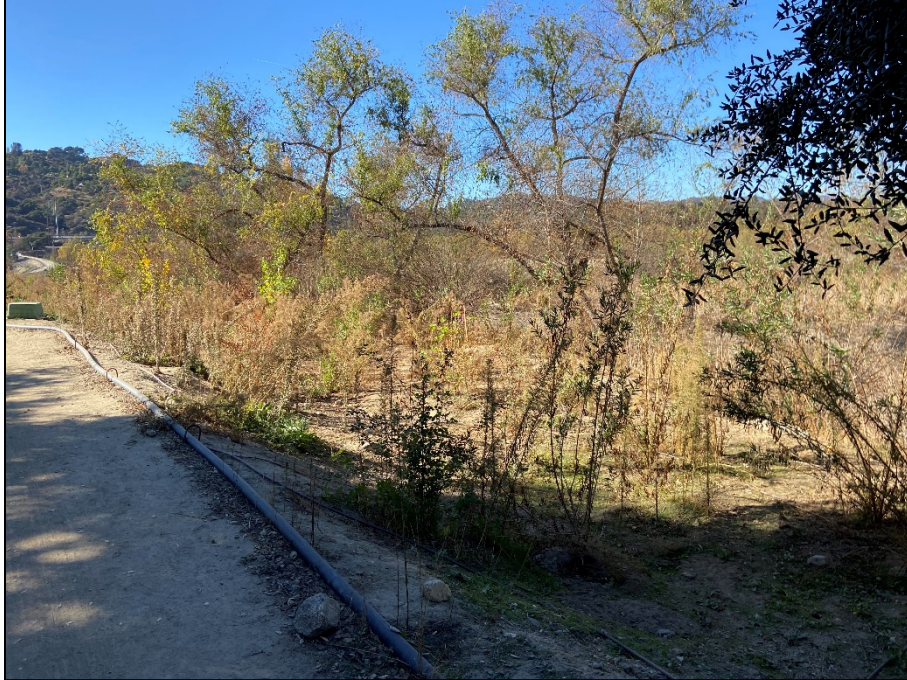
The overall health of the container plants in DG-2A was noted as being good. Only minimal stress was observed, and the majority of the remaining container plants are becoming well established. Approximately 10 percent of all container plants were showing varied levels of stress, which is the same

percentage of plants that were showing stress during the previous qualitative monitoring event. Stress may be occurring as a result of 1) herbivory by rabbits or other wildlife or 2) competition from nonnative and invasive weeds. There were no additional container plants noted as being missing or dead. Formal mortality counts were taken for DG-2A during the quantitative monitoring and will be included in the annual reporting. The willow species (*Salix sp.*) and Fremont's cottonwoods (*Populus fremontii*) in the mitigation areas were showing signs of seasonal dieback. The installation of plants in the DG-2A mitigation area appears to have been completed successfully. The current issues identified during the monitoring visit are not expected to have an effect on the continued growth of the plants in the mitigation area. Photos 5 through 7 in Attachment B document the mitigation area during the monitoring visit.

Native plant growth was noted throughout the DG-2A mitigation area, likely both from natural recruitment and from seeding. Native plants such as mugwort (*Artemisia douglasiana*), mulefat, tall flatsedge (*Cyperus eragrostis*), Canada horseweed, telegraph weed (*Heterotheca grandiflora*), and ladies' tobacco (*Pseudognaphalium californicum*) were observed sprouting in the DG-2A mitigation area.

Nonnative weed cover in DG-2A was estimated at approximately 5 to 10 percent, which is approximately 5 percent less than the level of weed cover that was observed during the previous qualitative monitoring event. Nonnative species observed in DG-2A included black mustard, poison hemlock (*Conium maculatum*), perennial pepperweed (*Lepidium latifolium*), and white horehound (*Marrubium vulgare*). While nonnative annuals were observed to be mostly dead, new germination of nonnative weeds was also observed.

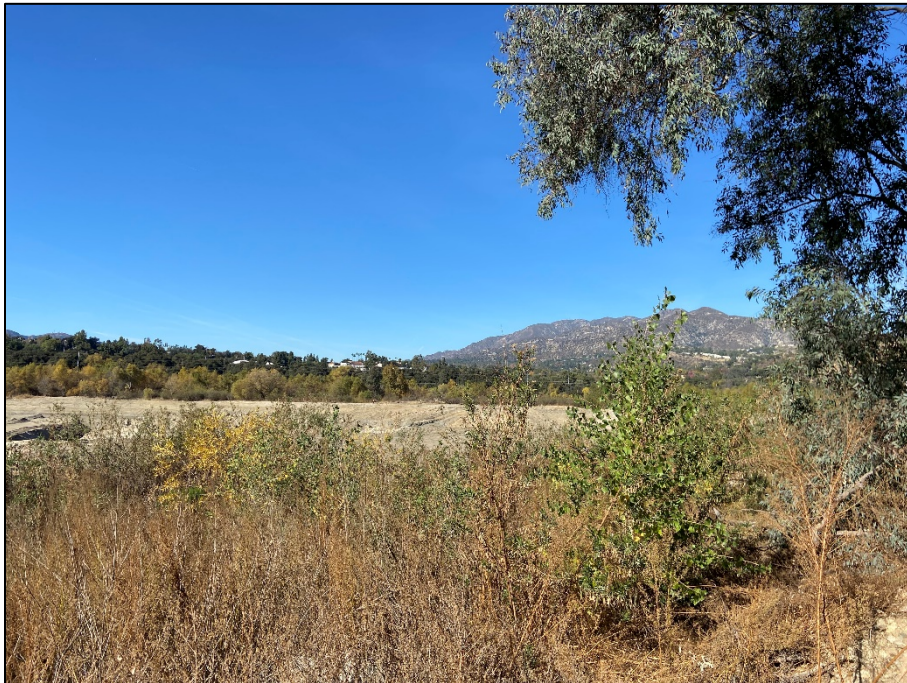
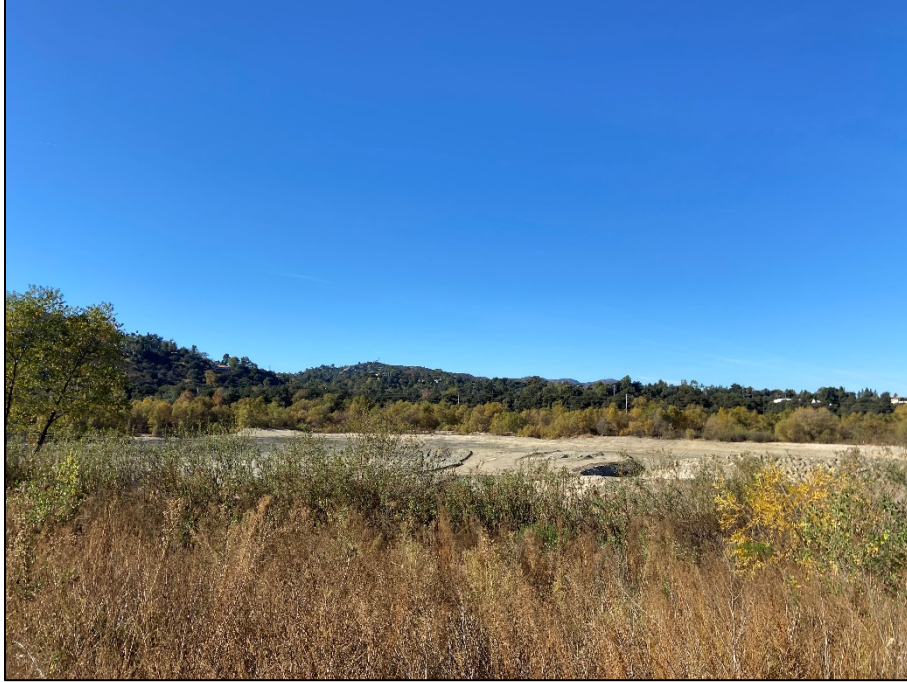
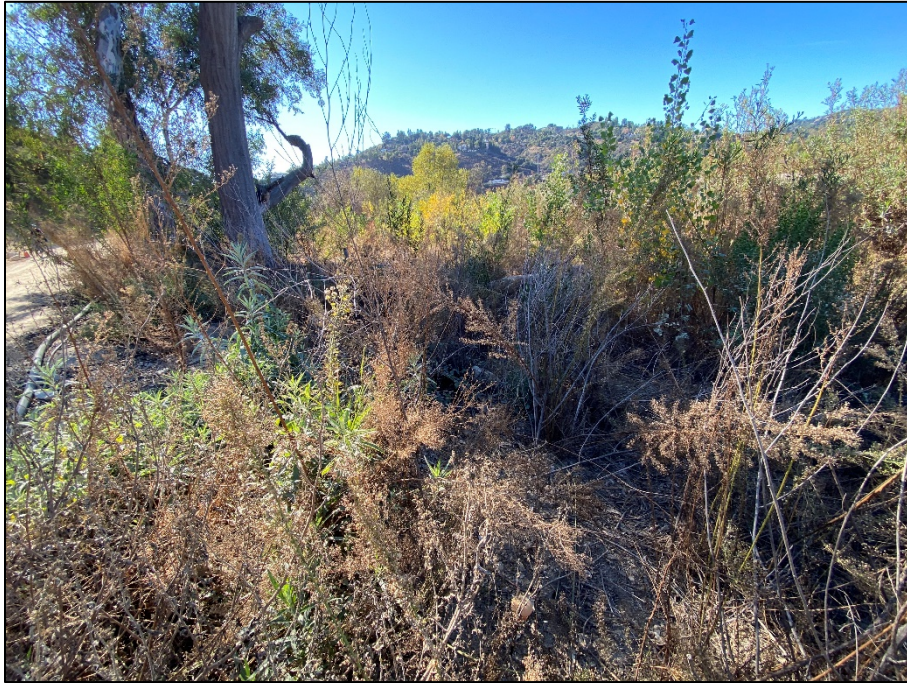
The overall health of the container plants in DG-2B was noted as being good. Approximately 10 percent of all container plants were showing varied levels of stress, which is the same percentage of plants that were showing stress during the previous qualitative monitoring event. Stress was likely due to the same reasons as those described for DG-2A. In addition, insect galls were observed on several of the willow species. Formal mortality counts were taken for DG-2B during the quantitative monitoring and will be included in the annual reporting. Similar to DG-2A, the willow species and Fremont's cottonwoods were showing signs of seasonal dieback. The installation of the plants in the DG-2B mitigation area appears to have been successfully completed. The current issues identified during the monitoring visit are not expected to have an effect on the continued growth of plants in the mitigation area. Photos 8 through 10 in Attachment B document the mitigation area during the monitoring visit.

Native plant growth was noted throughout the DG-2B mitigation area, likely both from natural recruitment and from seeding. Native plants such as annual bursage, mugwort, mulefat, Canada horseweed, telegraph weed, ladies' tobacco, and stinging nettle (*Urtica dioica*) were observed sprouting in the DG-2B mitigation area. In addition, dodder was observed growing on some of the shrub and tree species in this mitigation area which could lead to future decline of these shrubs; however, the dodder was observed to be mostly dead for the season.

Nonnative weed cover in DG-2B was estimated at approximately 5 to 10 percent, if the dead annual weeds are excluded, which is approximately 5 percent more than what was observed during the previous

qualitative monitoring event. Nonnative species observed in DG-2B included black mustard, poison hemlock, white horehound, black nightshade (*Solanum nigrum*), and perennial pepperweed; however, most black mustard individuals were observed to be dead for the season.

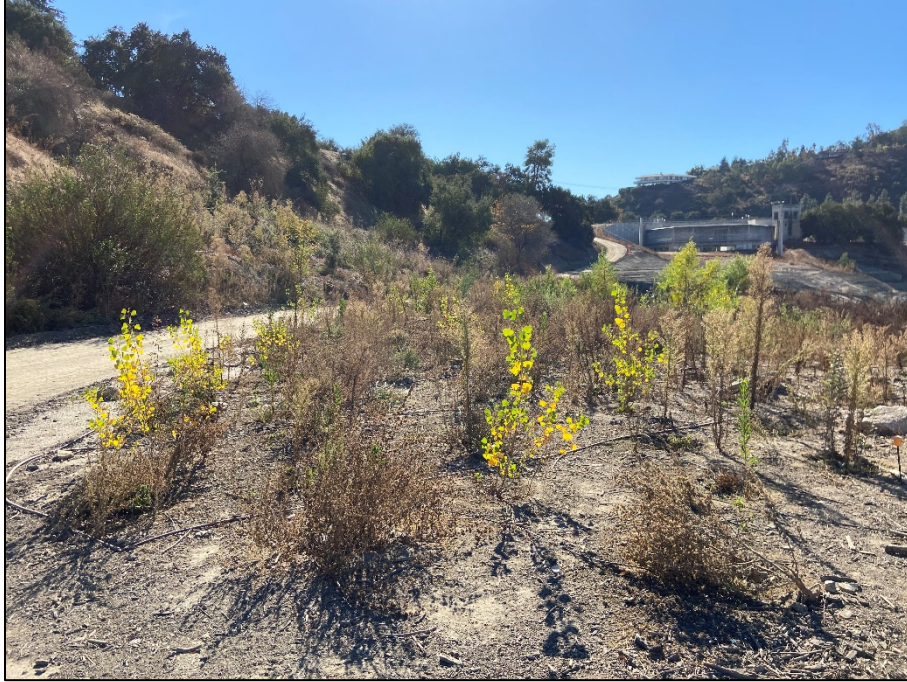
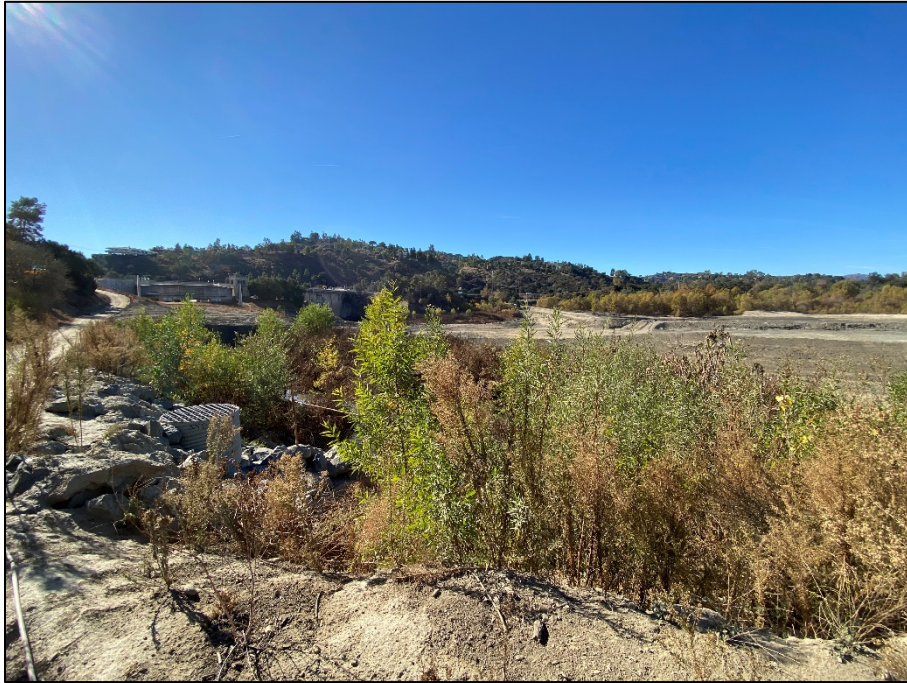
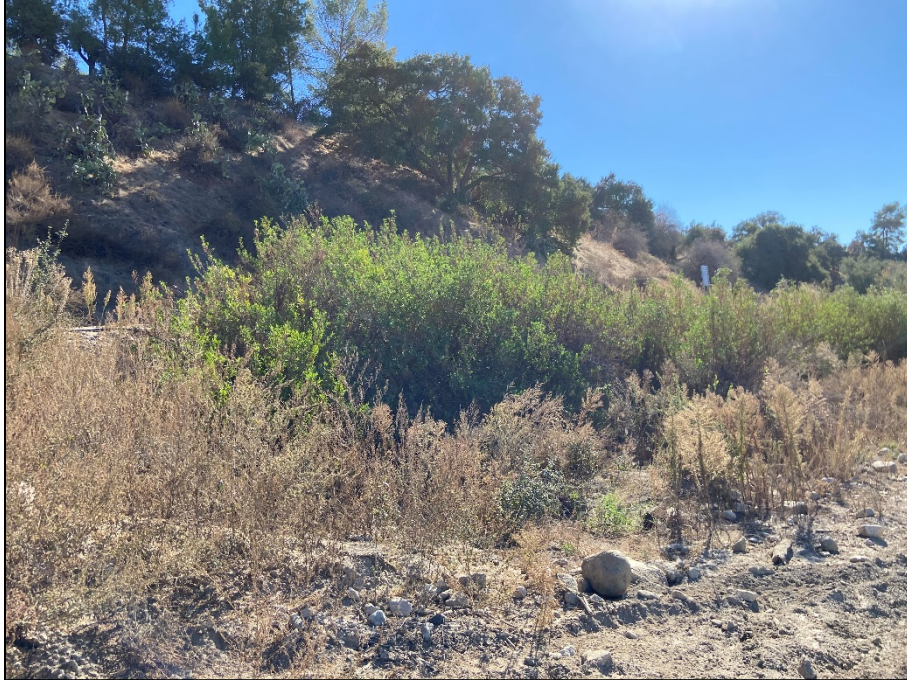
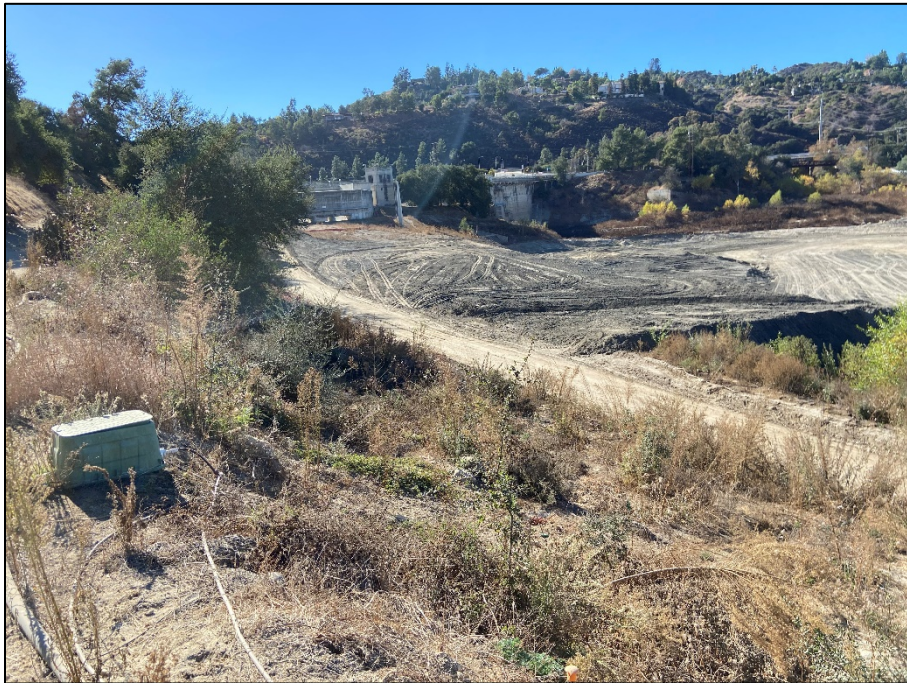
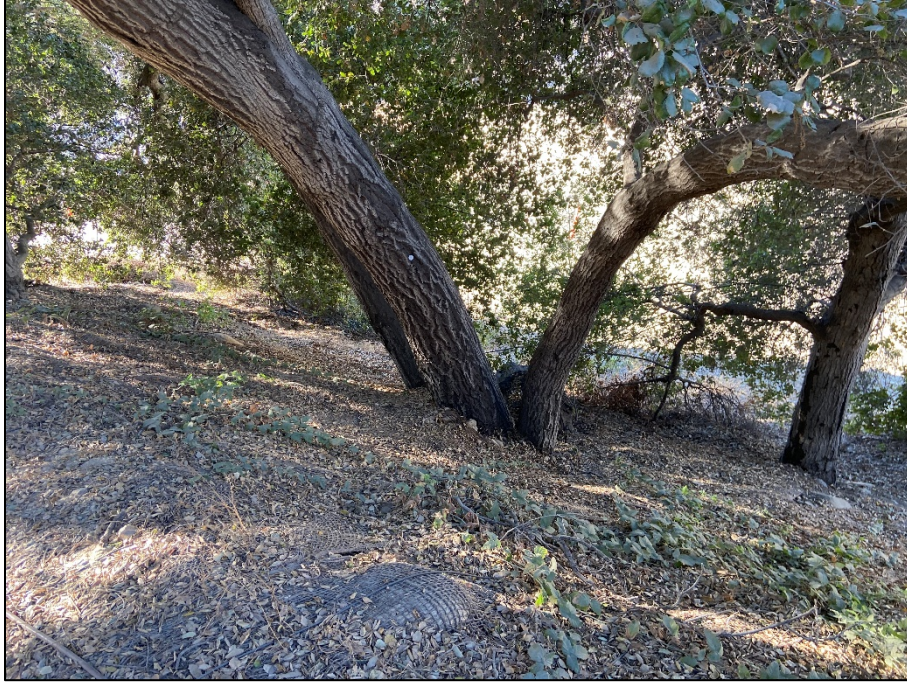
The overall health of the container plants in DG-3A was noted as being good. Approximately 15 percent of the container plants in the Coast Live Oak Woodland portions of DG-3A were noted as showing varied levels of stress, which is the same percentage of container plants that were showing stress during the previous qualitative monitoring event. Approximately 10 percent of the container plants in the Mulefat Thickets portions of DG-3A were noted as showing varied levels of stress, which is the same number of container plants that were showing stress during the previous qualitative monitoring event. Formal mortality counts were taken for DG-3A during the quantitative monitoring and will be included in the annual reporting. The types of stress the plants were exhibiting are the same as those described for the plants in DG-2A. However, erosion is also a problem in some areas of DG-3A. In addition, the heavy water and debris flows noted during previous monitoring visits have contributed to plant mortality and stress in this mitigation area. Similar to DG-2A, the container planted willow species and Fremont's cottonwoods were exhibiting seasonal dieback; however, the planted willow and mulefat cuttings were observed to be sprouting vigorously. During the monitoring visit, the planted coast live oak (*Quercus agrifolia*) acorns were inspected for survivorship and health. Approximately 20 germinated coast live oak acorns appear to still be present in DG-3A. The majority of the germinated acorns appear to be in good health; however, several appeared to be showing signs of drought stress. The installation of the plants in the DG-3A mitigation area appears to have been completed successfully. The current issues noted during the monitoring are not expected to have a negative effect on the continued growth of the plants in the mitigation area. Photos 11 through 15 in Attachment B document the mitigation area during the monitoring visit.

Native plant growth was noted throughout the DG-3A mitigation area, likely both from natural recruitment and from seeding. Native plants such as annual bursage, mugwort, mulefat, tall flatsedge, Canada horseweed, jimsonweed (*Datura wrightii*), beardless wild rye (*Elymus triticoides*), California poppy (*Eschscholzia californica*), salt heliotrope (*Heliotropium curassavicum*), telegraph weed, stinging nettle, and rough cocklebur (*Xanthium strumarium*) were observed sprouting in the DG-3A mitigation area.

Nonnative weed cover in DG-3A was estimated at approximately 5 to 10 percent, if the dead annual weeds are excluded, which is the same percent of nonnative cover that was observed during the previous qualitative monitoring event. Nonnative species observed in DG-3A included black mustard, poison hemlock, perennial pepperweed, sweet alyssum (*Lobularia maritima*), tree tobacco (*Nicotiana glauca*), wild radish (*Raphanus sativus*), and castor bean (*Ricinus communis*).

Erosion in the Phase 1 mitigation areas was only observed in DG-3A and was minor in severity. Due to the steepness of the slope in the Coast Live Oak Woodland portion of the DG-3A mitigation area, erosion will likely continue to be somewhat of an issue in this area; however, jute nettings are currently in place on the slope and will help to lessen the severity of erosion issues. As native cover increases in this area, erosion issues should lessen. The severity of the erosion should continue to be monitored in all planted areas and if warranted, erosion Best Management Practices (BMPs) should be installed in appropriate areas. This may only require the installation of straw wattles at select sites to prevent existing rills from becoming larger. However, until more native perennial plants become established in these areas, there is the potential that intense rainfall may create additional erosion problems.

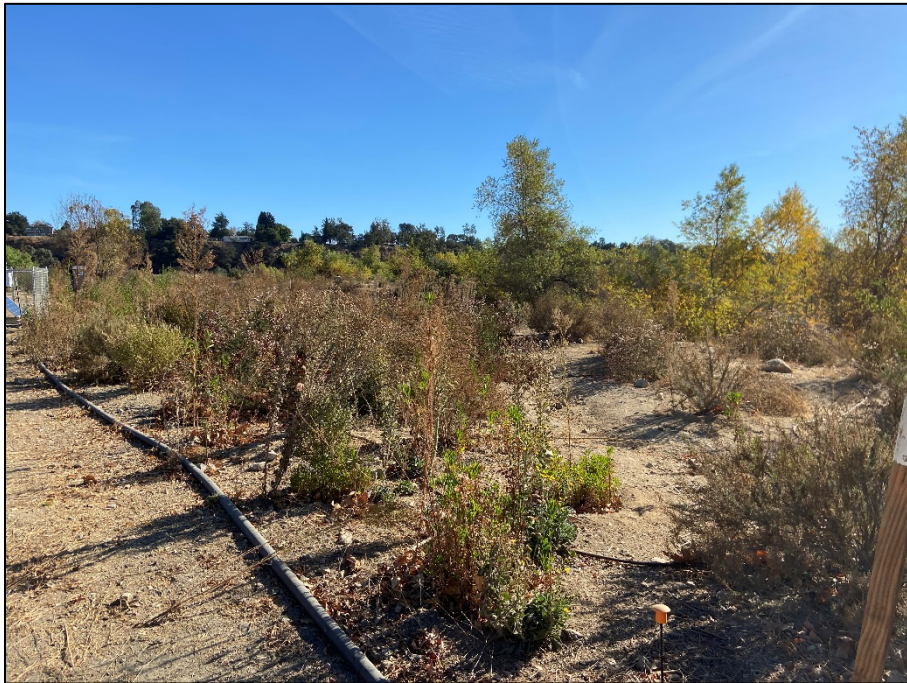
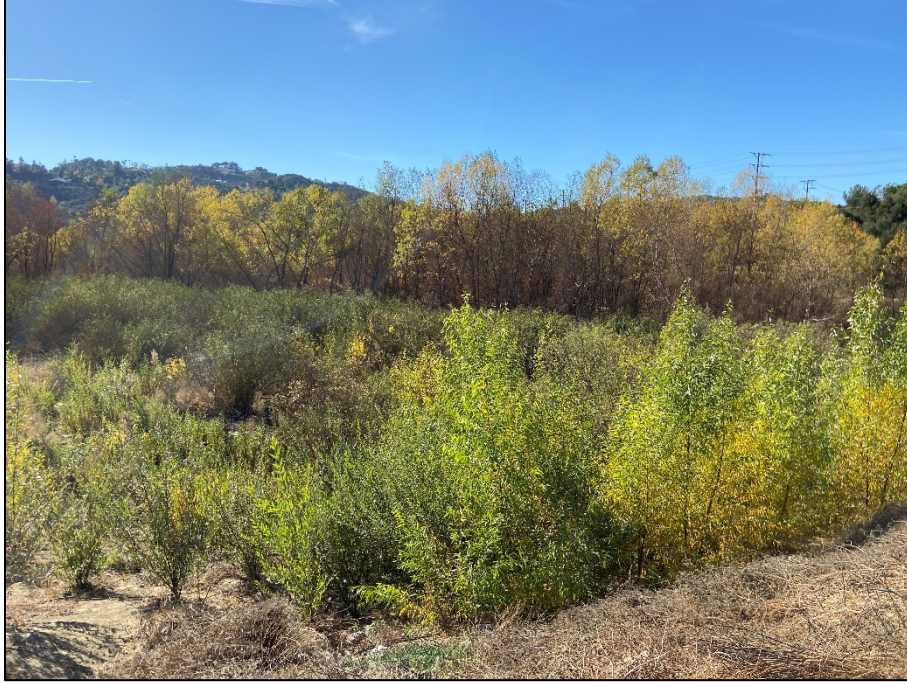
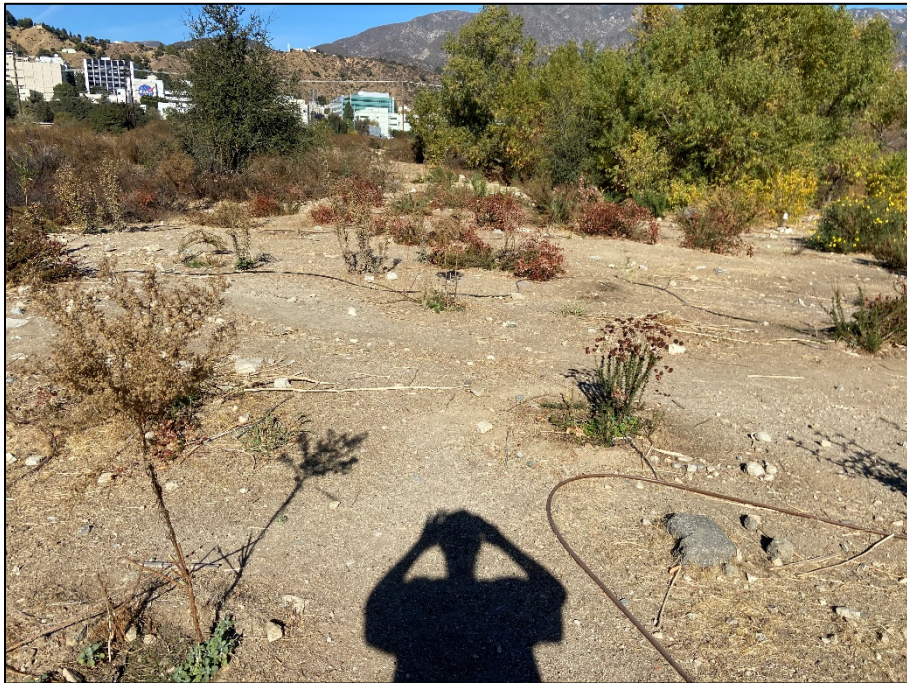
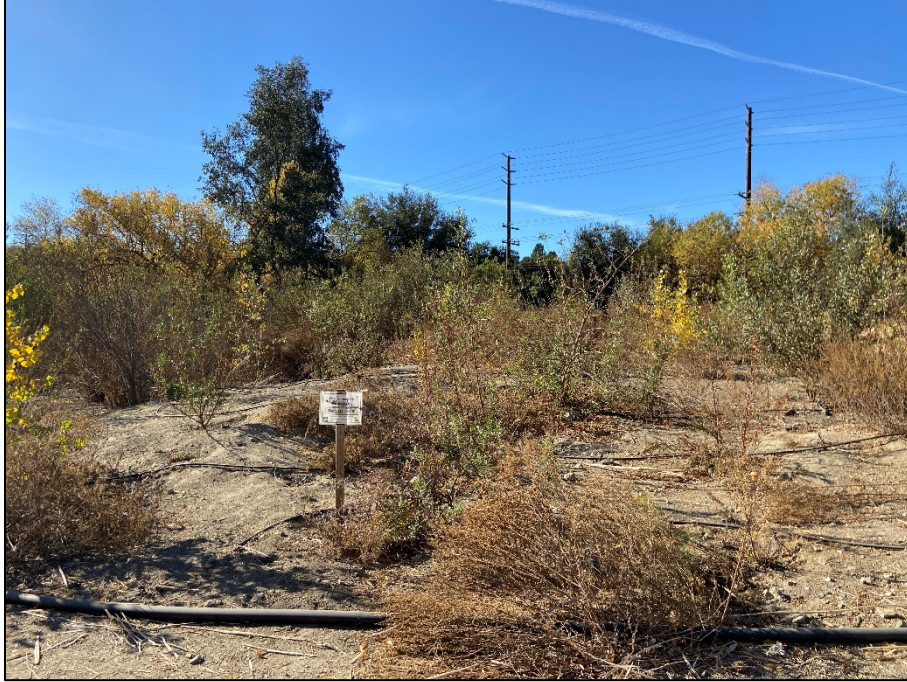
The overall health of the container plants in mitigation area DG-4 was noted as being good. Approximately 10 to 15 percent of container plants in the coastal sage scrub portions of DG-4 were showing varied levels of stress which is the same as the percentage of plants showing stress during the

previous qualitative monitoring event. Approximately 15 to 20 percent of container plants in the riparian portions of DG-4 were showing varied levels of stress, which is the same percentage of container plants that were showing stress during the previous qualitative monitoring visit. The stress appears to be mostly due to the same reasons described in DG-2A. Many plants that appeared to be stressed during previous qualitative monitoring events, due to high temperatures and drought stress, appeared to be recovering. In addition, the 300-foot buffer around a least Bell's vireo (*Vireo bellii pusillus*) nest that affected middle portions of DG-4 has been removed; however, weed proliferation in this area prior to buffer removal likely contributed to plant stress and mortality. For most portions of DG-4, only a negligible number of container plants were noted as being missing or dead. Formal mortality counts were taken for DG-4 during the quantitative monitoring and will be included in the annual reporting. The container planted willow species and Fremont's cottonwood were showing signs of seasonal dieback; however, the planted willow and mulefat cuttings were also observed to be sprouting vigorously. The installation of plants in the DG-4 mitigation area appears to have been completed successfully and the issues noted during the monitoring are not expected to have an impact on the continued growth of the plants. Photos 16 through 19 in Attachment B document the mitigation area during the monitoring visit.

Native plant growth was noted throughout the DG-4 mitigation area, likely both from natural recruitment and from seeding. Native plants such as California sagebrush (*Artemisia californica*), mugwort, mulefat, tall flatsedge, Canada horseweed, California buckwheat, California poppy, jimsonweed, salt heliotrope, telegraph weed, and stinging nettle were observed sprouting in the DG-4 mitigation area.

Nonnative weed cover in DG-4 was estimated at less than 5 percent for most areas, which is approximately 5 percent less than what was observed during the previous qualitative monitoring event; however, portions of DG-4 that are adjacent to weed infested portions of Phase 2 (i.e., DG-4A) were observed to have new germination of perennial pepperweed. Nonnative species observed in DG-4 included black mustard, poison hemlock, perennial pepperweed, and white horehound. Nonnative weed cover, especially perennial pepperweed, is a significant problem in portions of the DG-4 mitigation area. Because perennial pepperweed can produce dense colonies through seed germination and underground rhizomes (rhizomatous roots), removal of this species without the use of systemic herbicide is very difficult.

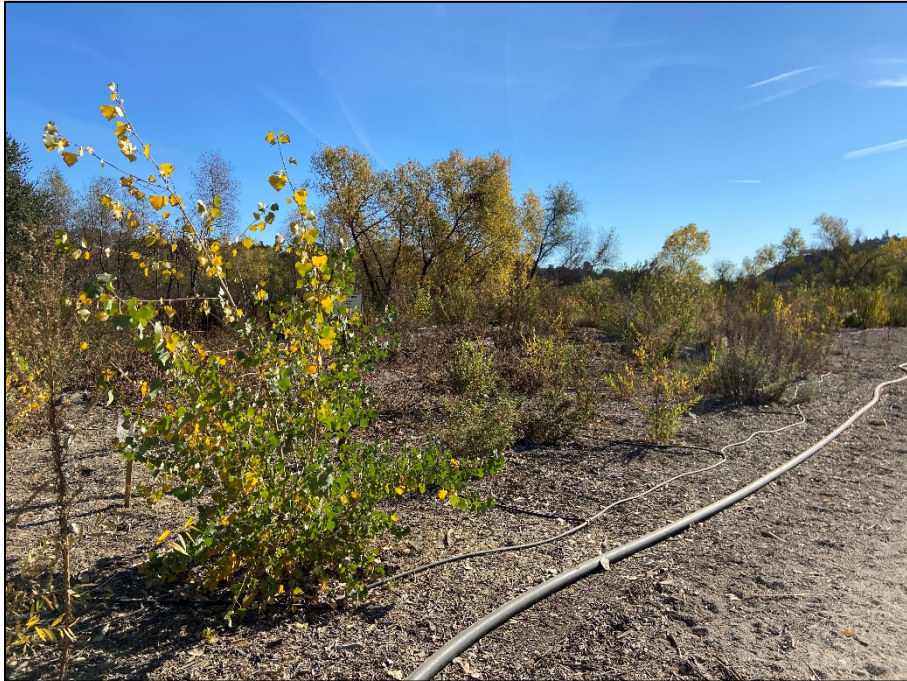
The overall health of the container plants in mitigation area DG-4B was noted as being good and this mitigation area is becoming well established. Approximately 10 percent of all container plants were noted as showing varied levels of stress, which is the same percentage of plants that were showing stress during the previous qualitative monitoring visit. The types of stress the plants were exhibiting are the same as those described for the plants in DG-2A. A negligible number of container plants were noted as being missing or dead. Formal mortality counts were taken for DG-4B during the quantitative monitoring and will be included in the annual reporting. Similar to DG-4, the container planted willow species and Fremont's cottonwoods were showing signs of seasonal dieback. The installation of plants in the DG-4B mitigation area appears to have been completed successfully and the issues noted during the monitoring are not expected to have an impact on the continued growth of the plants. Photos 20 and 21 in Attachment B document the mitigation area during the monitoring visit.

Native plant growth was noted throughout the DG-4B mitigation area, likely both from natural recruitment and from seeding. Native plants such as annual bursage, California sagebrush, mugwort, mulefat, tall flatsedge, Canada horseweed, California poppy, and stinging nettle were observed sprouting in the DG-4B mitigation area.

Nonnative weed cover in DG-4B was estimated to be less than 5 percent, which is approximately 5 percent lower than the percentage of nonnative cover that was observed during the previous qualitative monitoring event. Nonnative species observed in DG-4B included red brome, poison hemlock, and perennial pepperweed.

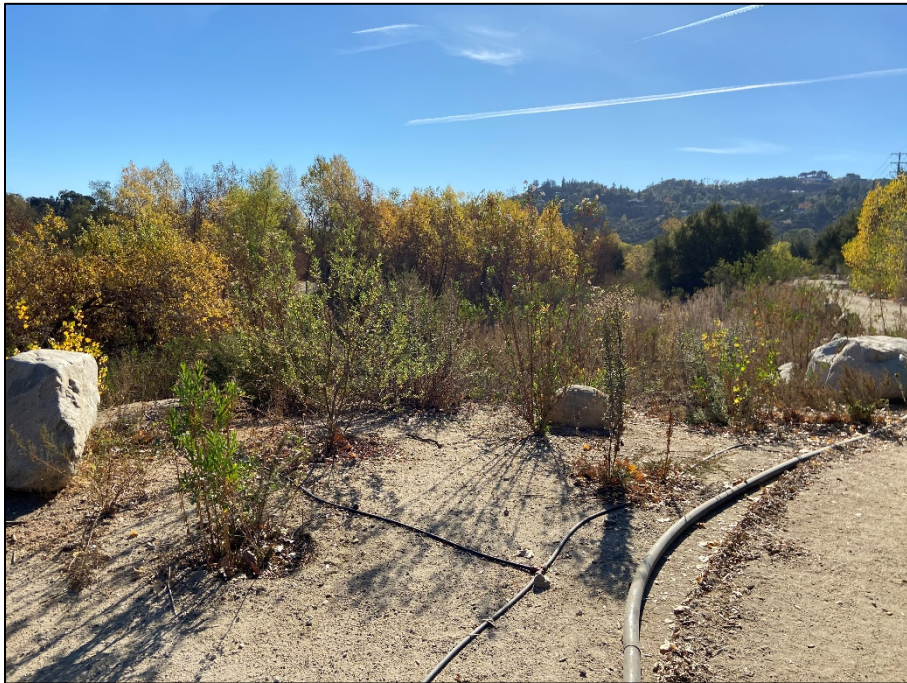
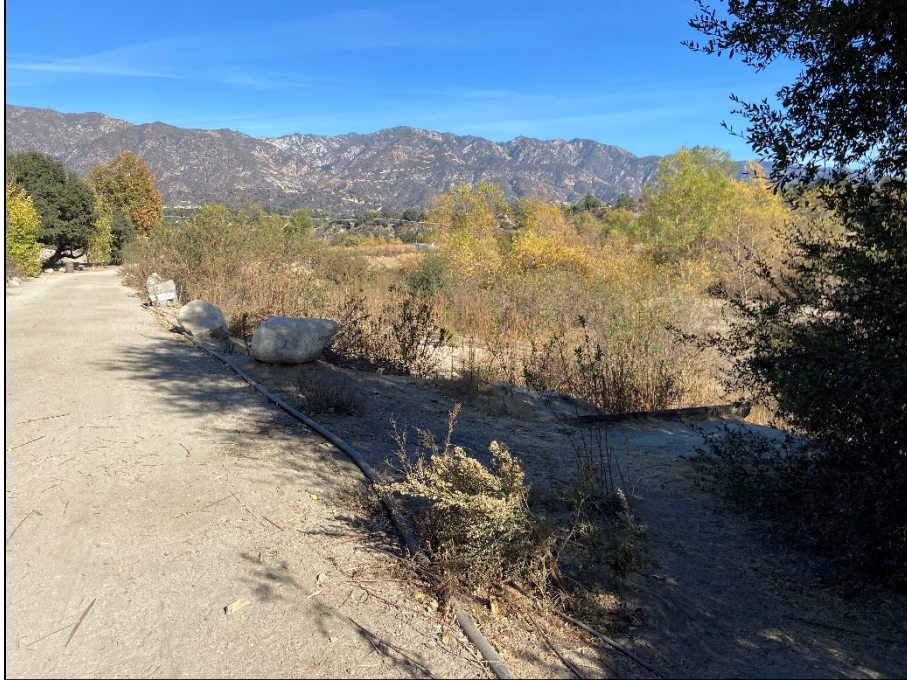
The overall health of the container plants in mitigation area DG-4C was noted as being good. Approximately 10 to 15 percent of all container plants were noted as showing varied levels of stress, which is the same percentage of plants that were showing stress during the previous qualitative monitoring event. The types of stress the plants were exhibiting are the same as those described for the plants in DG-2A. A negligible number of container plants were noted as being missing or dead. Formal mortality counts were taken for DG-4C during the quantitative monitoring and will be included in the annual reporting. Similar to DG-4, the container planted willow species and Fremont's cottonwood were showing signs of seasonal dieback. The installation of plants in the DG-4C mitigation area appears to have been completed successfully and the issues noted during the monitoring are not expected to have an impact on the continued growth of the plants. Photos 22 and 23 in Attachment B document the mitigation area during the monitoring visit.

Native plant growth was noted throughout the DG-4C mitigation area, likely both from natural recruitment and from seeding. Native plants such as annual bursage, mugwort, mulefat, Canada horseweed, California poppy, telegraph weed, and stinging nettle were observed sprouting in the DG-4C mitigation area.

Nonnative weed cover in DG-4C was estimated at approximately 5 percent, which is approximately 4 percent higher than the level of nonnative cover that was observed during the previous qualitative monitoring event. Nonnative species observed in DG-4C included black mustard, poison hemlock, perennial pepperweed, and white horehound.

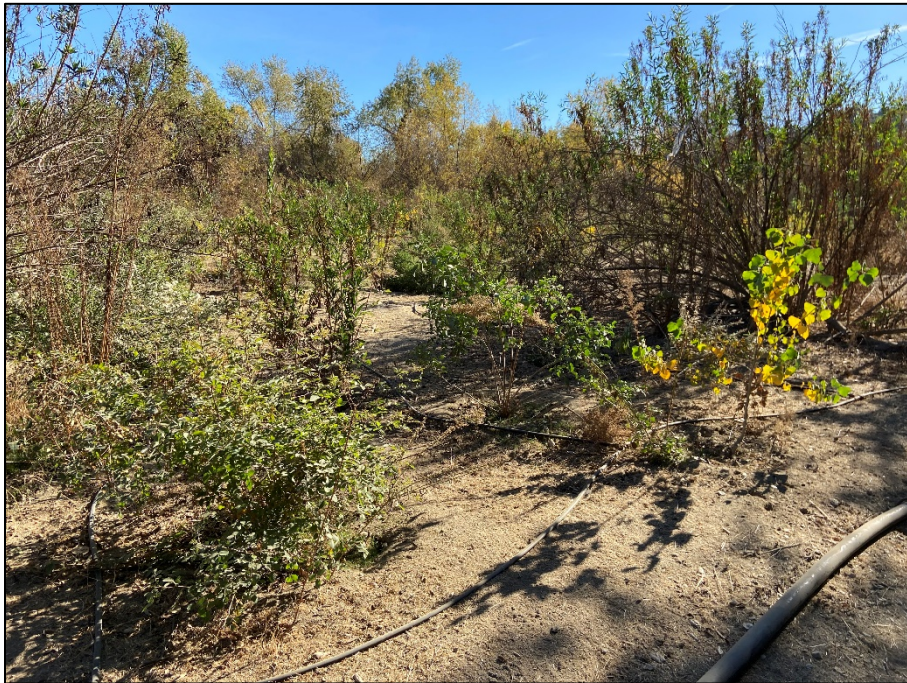
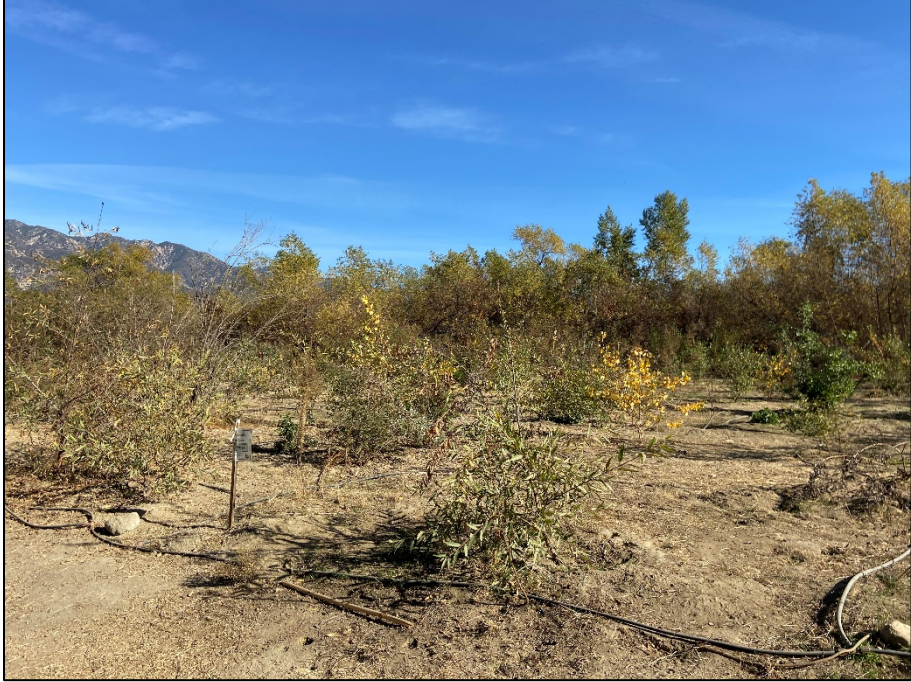
The overall health of the container plants in the DG-5 mitigation area was noted as being good. Approximately 15 to 20 percent of all container plants were noted as showing varied levels of stress, which is the same percentage of plants that were showing stress during the previous qualitative monitoring event. While the 300-foot buffer around a least Bell's vireo nest that affected all of DG-5 has been removed, weed proliferation in this area prior to buffer removal likely contributed to plant stress and mortality. Gopher herbivory is also a significant problem in DG-5 and accounts for the majority of the missing container plants. In addition, gopher activity has increased the level of basin degradation and many basins need repair. Formal mortality counts were taken for DG-5 during the quantitative monitoring and will be included in the annual reporting. Similar to DG-4, the container planted willow species and

Fremont's cottonwoods were showing signs of seasonal dieback. The installation of plants in the DG-5 mitigation area appears to have been completed successfully and the issues noted during the monitoring are not expected to have a negative impact on the continued growth of the plants. Photos 24 and 25 in Attachment B document the mitigation area during the monitoring visit.

Native plant growth was noted throughout the DG-5 mitigation area, likely both from natural recruitment and from seeding. Native plants such as annual bursage, mugwort, mulefat, Canada horseweed, California poppy, and stinging nettle were observed sprouting in the DG-5 mitigation area.

Nonnative weed cover in DG-5 was estimated at approximately 5 to 10 percent, which is the same percent of nonnative weed cover that was observed during the previous qualitative monitoring event. Nonnative species observed in DG-5 included wild oat (*Avena fatua*), black mustard, poison hemlock, common barley (*Hordeum vulgare*), and perennial pepperweed.

Rabbit herbivory of container plants was observed in the Phase 1 mitigation areas. California rose and California buckwheat appeared to be the most affected by herbivory. In addition, gopher herbivory of container plants was observed in DG-5. Minor herbivory generally will not kill the plants, but continued monitoring should be conducted during future visits to determine the level of the herbivory isn't such that plants are dying. If browsing by rabbits or other animals begins to worsen, caging around affected and/or favored container plants may be warranted. In addition, below grade gopher traps should be installed at DG-5 to remove the gophers from this area.
