Re: *Devil's Gate Reservoir Restoration Project – Phase 1 Restoration Qualitative Monitoring Conducted on November 28, 2022*

1.0 INTRODUCTION

Qualitative monitoring was conducted by Carley Lancaster on November 28, 2022. Field data collected during the monitoring event is provided as Attachment A. This report documents the seventh quarterly qualitative monitoring visit for the Phase 1 mitigation areas.

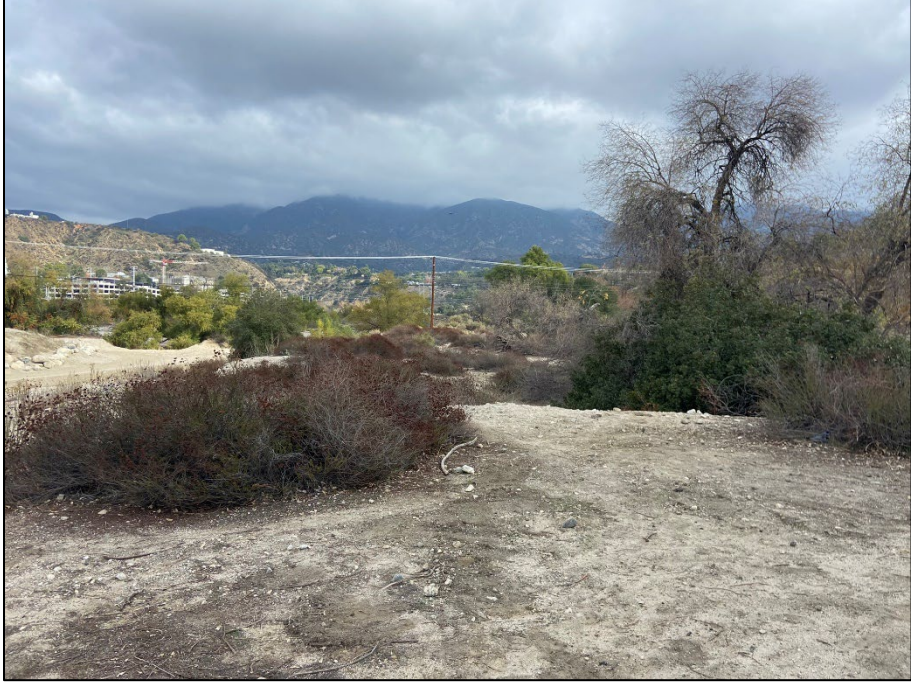
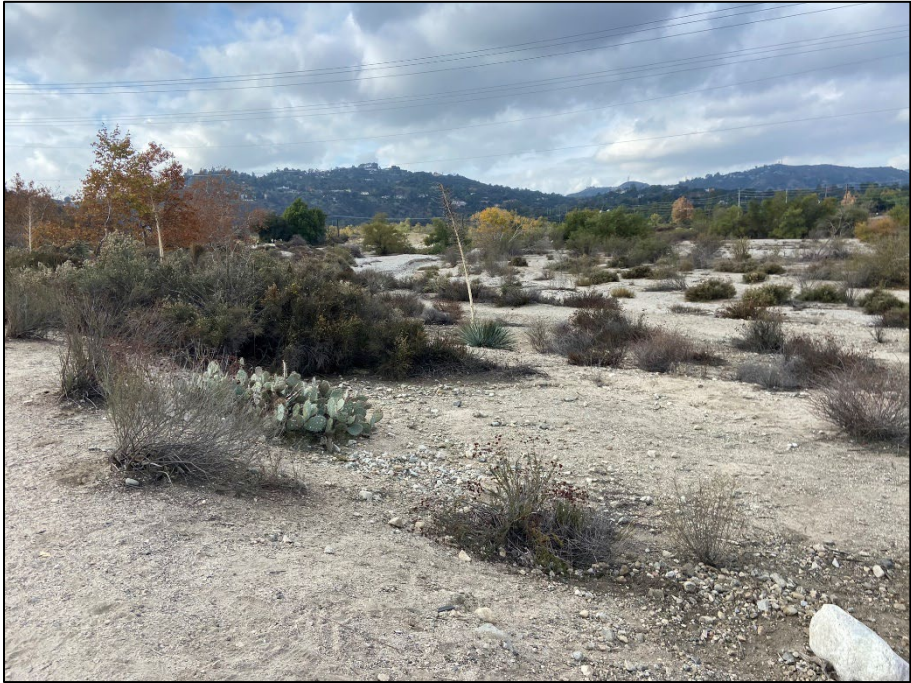
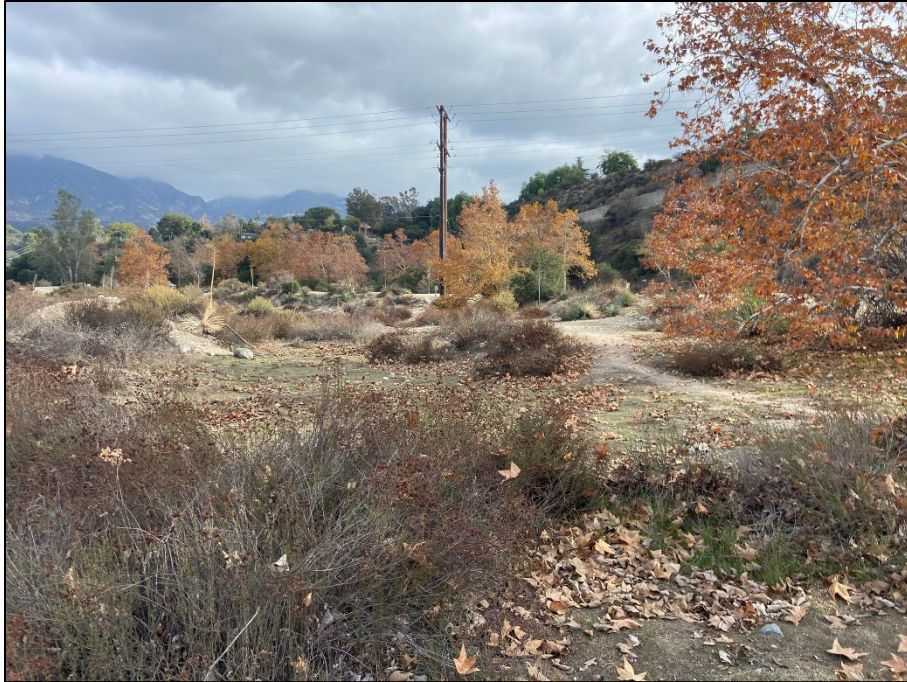
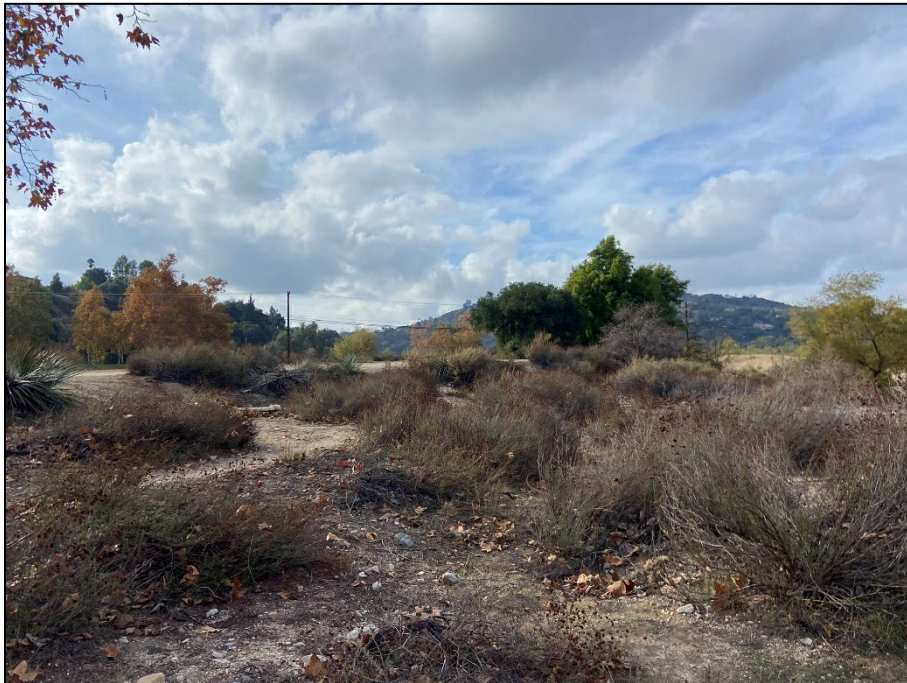
Container plants were not installed in the DG-1 or DG-1 WOUS mitigation areas, but these areas were seeded with native plant species. Native plant growth was noted throughout the DG-1 and DG-1 WOUS mitigation areas, likely both from natural recruitment and from seeding; however, germination was observed to be very minimal in most of these mitigation areas and most of the native annuals were observed to be dead for the season. Portions of DG-1 WOUS were noted as being scoured during the 2020 and 2021 wet seasons and had minimal plant growth. Native plants such as California sagebrush (*Artemisia californica*), California buckwheat (*Eriogonum fasciculatum*), and common phacelia (*Phacelia distans*) were observed sprouting in the DG-1 and DG-1 WOUS mitigation areas. Native cover for the DG-1 and DG-1 WOUS mitigation areas was estimated to be approximately 65 percent with some areas having relatively dense cover and other areas being scoured and/or having minimal cover. Photos 1 through 4 in Attachment B document the status of the mitigation areas during the monitoring visit.

Nonnative weed cover in DG-1 and DG-1 WOUS was estimated at approximately less than one percent, which is approximately one percent less than the level of weed cover that was observed during the previous qualitative monitoring event. Nonnative species observed in DG-1 and DG-1 WOUS included nonnative grasses (*Bromus* spp.). All nonnative weeds were just starting to germinate and had not gone to flower or seed. In addition, many of the annual nonnative weeds were observed to be dead for the season.

Photo 1: Overview Mitigation Area DG-1

Photo 2: Overview Mitigation Area DG-1

Photo 3: Overview Mitigation Area DG-1

Photo 4: Overview Mitigation Area DG-1

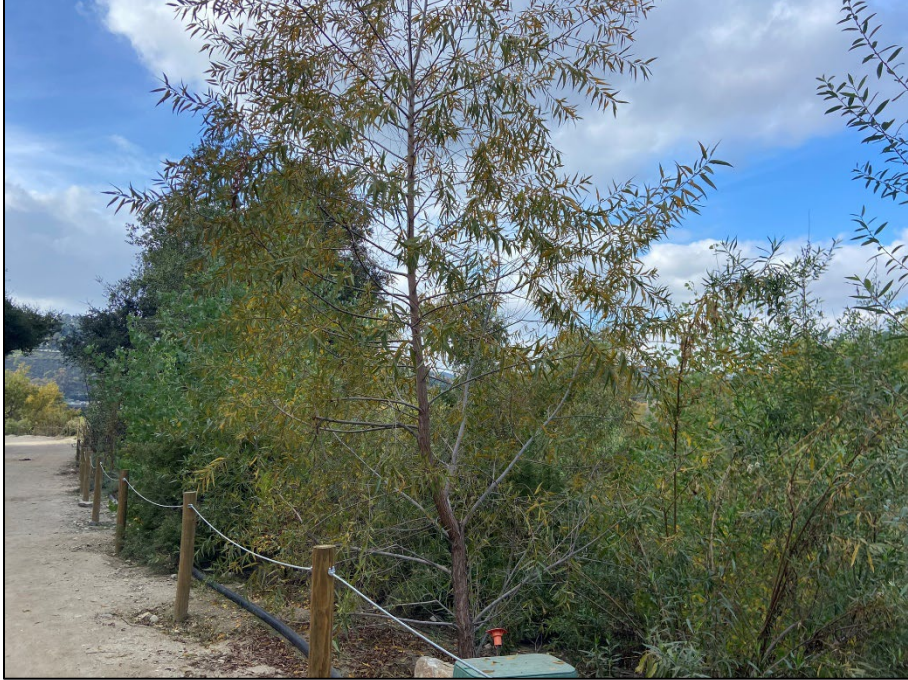
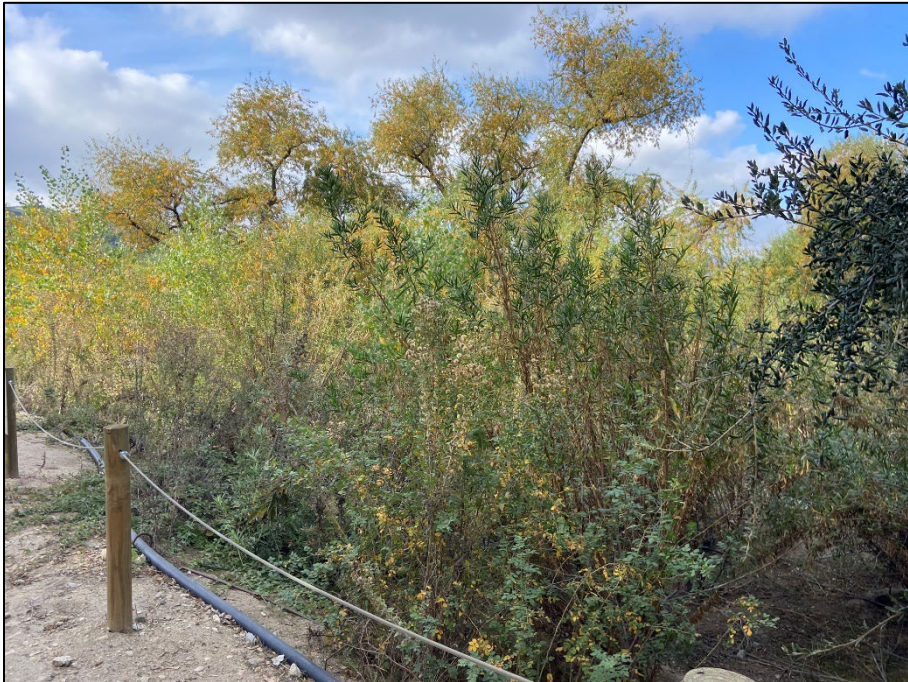
The overall health of the container plants in DG-2A was noted as being good. Approximately less than five percent of the container plants in DG-2A were noted as showing varied levels of stress, which is approximately the same as the percentage of container plants that were showing stress during the previous qualitative monitoring event. Stress may be occurring as a result of 1) herbivory by rabbits or other wildlife, 2) competition from nonnative and invasive weeds, 3) misplaced emitters, or 4) recreational

traffic through the mitigation areas. There were no additional container plants noted as being missing or dead. Formal mortality counts were taken for DG-2A during the 2020, 2021, and 2022 quantitative monitoring events. Most of the willows (*Salix* sp.) and Fremont's cottonwoods (*Populus fremontii*) were starting to show signs of seasonal dieback. Some of the willows in this mitigation area were noted as having rust fungus (*Melampsora* spp.) on some of their foliage and should be monitored for any decline in health and vigor. The installation of plants in the DG-2A mitigation area appears to have been completed successfully. The current issues identified during the monitoring visit are not expected to have an effect on the continued growth of the plants in the mitigation area. Photos 5 and 6 in Attachment B document the status of the mitigation area during the monitoring visit.

Native plant growth was noted throughout the DG-2A mitigation area, likely both from natural recruitment and from seeding. Native plants such as annual bursage (*Ambrosia acanthicarpa*), mugwort (*Artemisia douglasiana*), Canada horseweed (*Erigeron canadensis*), telegraph weed (*Heterotheca grandiflora*), Douglas' nightshade (*Solanum douglasii*), and stinging nettle (*Urtica dioica*) were observed sprouting in the DG-2A mitigation area. Native cover for the DG-2A mitigation area was estimated to be 80 percent.

Nonnative weed cover in DG-2A was estimated at approximately less than one percent, which is approximately the same as the level of weed cover that was observed during the previous qualitative monitoring event. This site appeared to have been recently weeded. Nonnative grasses were the only nonnative species observed in DG-2A during the monitoring visit. All nonnative weeds were just starting to germinate and had not gone to flower or seed. In addition, many of the annual nonnative weeds were observed to be dead for the season.

Photo 5: Overview Mitigation Area DG-2A

Photo 6: Overview Mitigation Area DG-2A

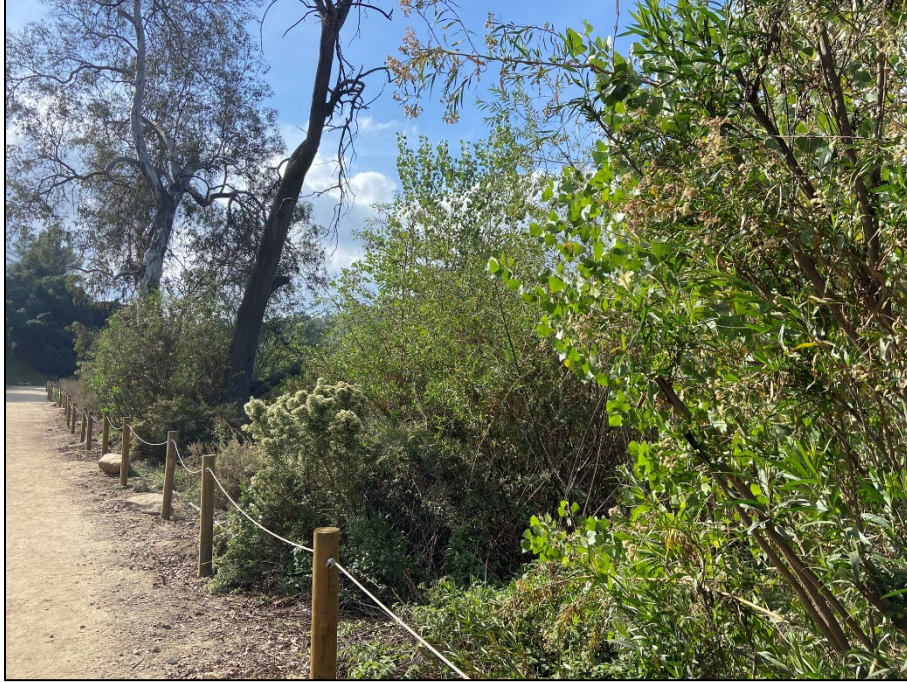
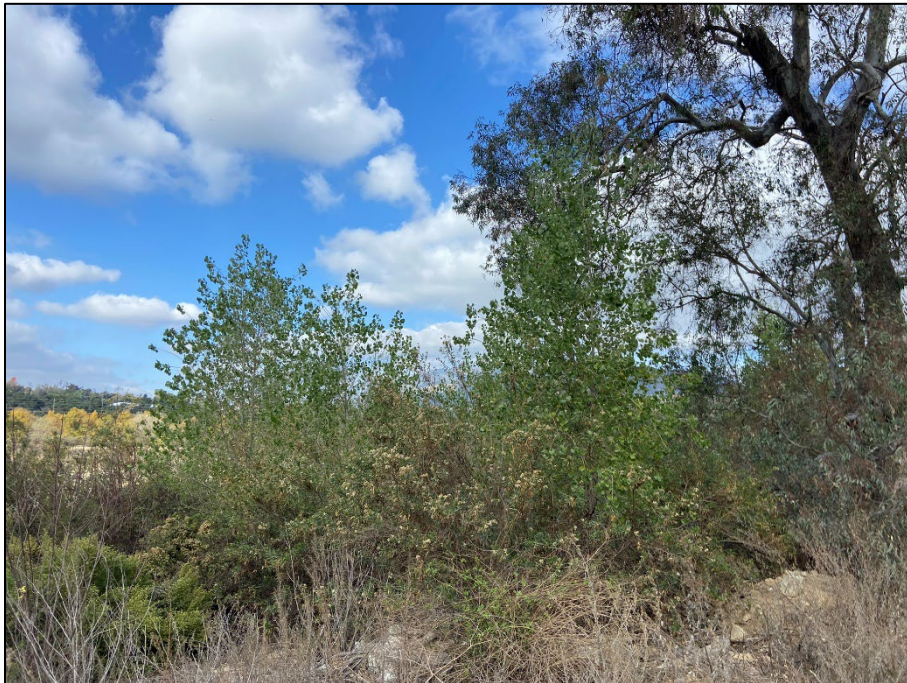
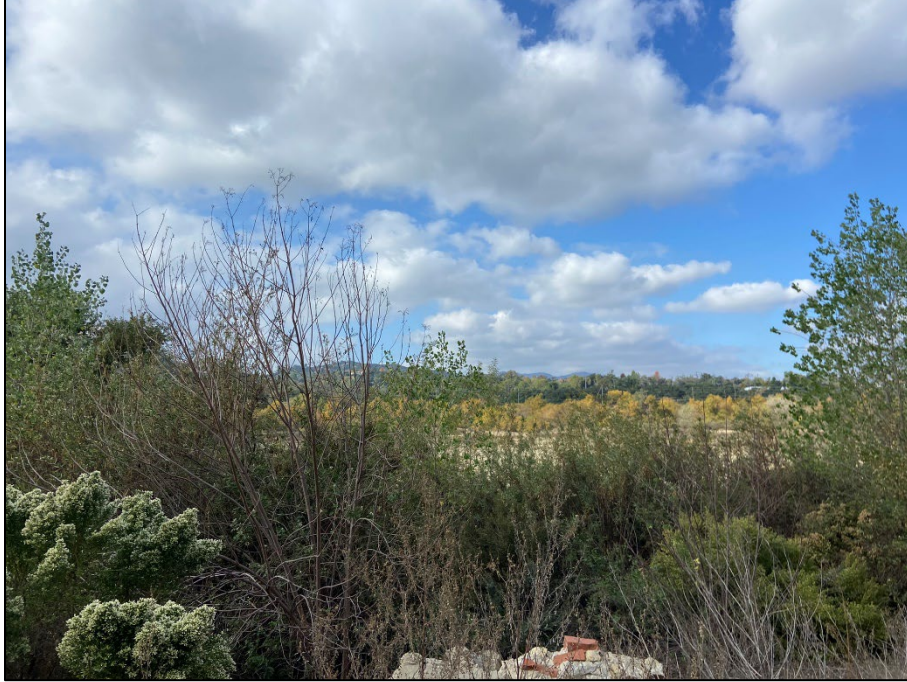
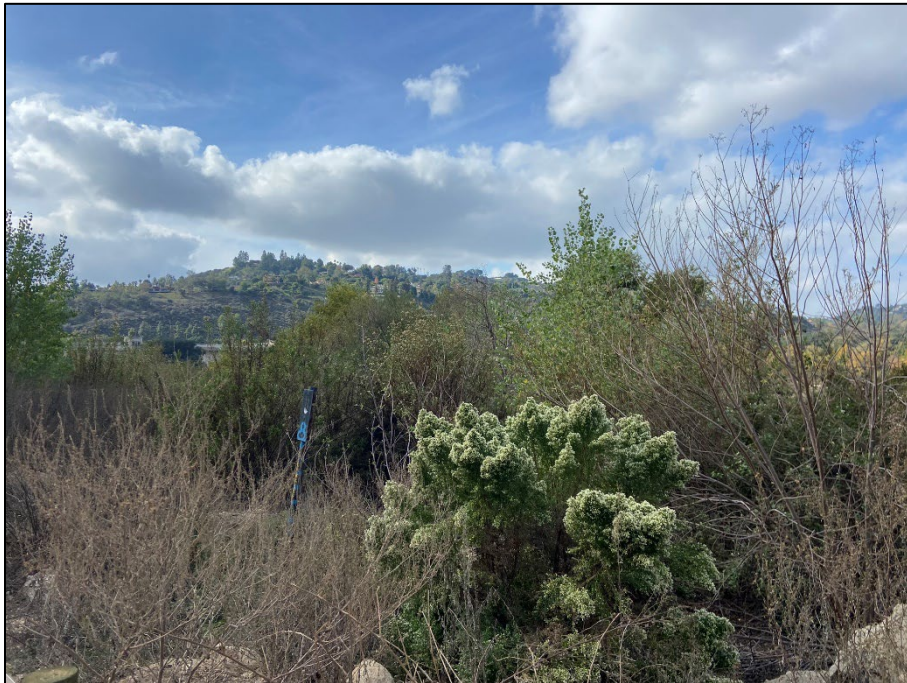
The overall health of the container plants in DG-2B was noted as being good. Approximately less than five percent of the container plants in DG-2B were noted as showing varied levels of stress, which is approximately the same percentage of container plants that were showing stress during the previous qualitative monitoring event. Stress was likely due to the same reasons as those described for DG-2A. In addition, insect galls were observed on several of the willow species. Formal mortality counts were taken for DG-2B during the 2020, 2021, and 2022 quantitative monitoring events. Similar to DG-2A, most of the willows and Fremont's cottonwoods were starting to show signs of seasonal dieback. The installation of the plants in the DG-2B mitigation area appears to have been successfully completed. The current issues identified during the monitoring visit are not expected to have an effect on the continued growth of plants in the mitigation area. Photos 7 through 10 in Attachment B document the status of the mitigation area during the monitoring visit.

Native plant growth was noted throughout the DG-2B mitigation area, likely both from natural recruitment and from seeding. Native plants such as annual bursage, mulefat (*Baccharis salicifolia*), Canada horseweed, and telegraph weed were observed sprouting in the DG-2B mitigation area. Native cover for the DG-2B mitigation area was estimated to be 80 percent.

Nonnative weed cover in DG-2B was estimated at approximately less than one percent, which is approximately the same percent that was observed during the previous qualitative monitoring event.

Nonnative grasses were the only nonnative species observed in DG-2B during the monitoring visit. All nonnative weeds were just starting to germinate and had not gone to flower or seed. In addition, many of the annual nonnative weeds were observed to be dead for the season.

Photo 7: Overview Mitigation Area DG-2B

Photo 8: Overview Mitigation Area DG-2B

Photo 9: Overview Mitigation Area DG-2B

Photo 10: Overview Mitigation Area DG-2B

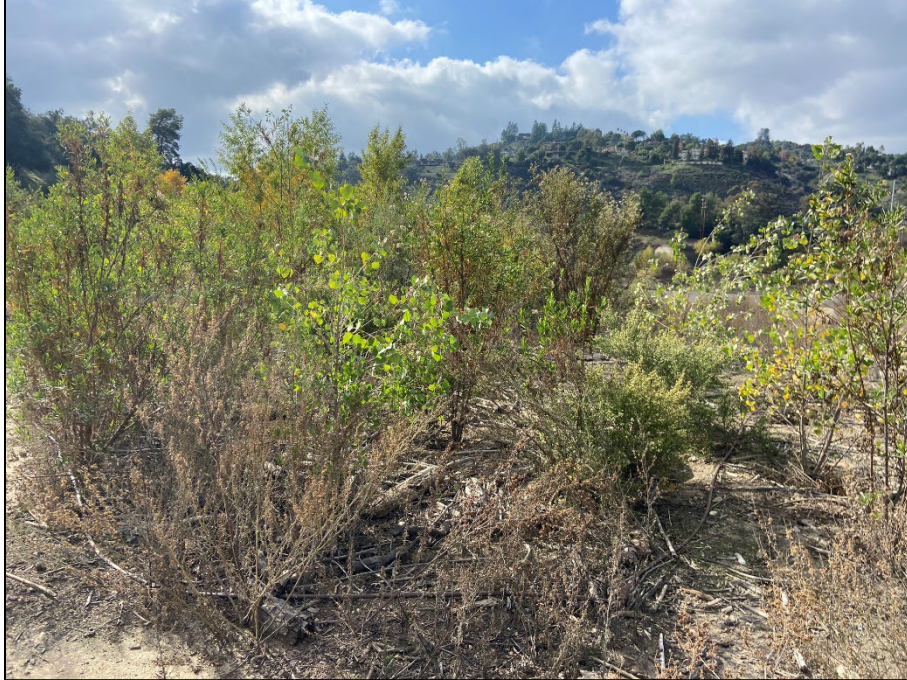
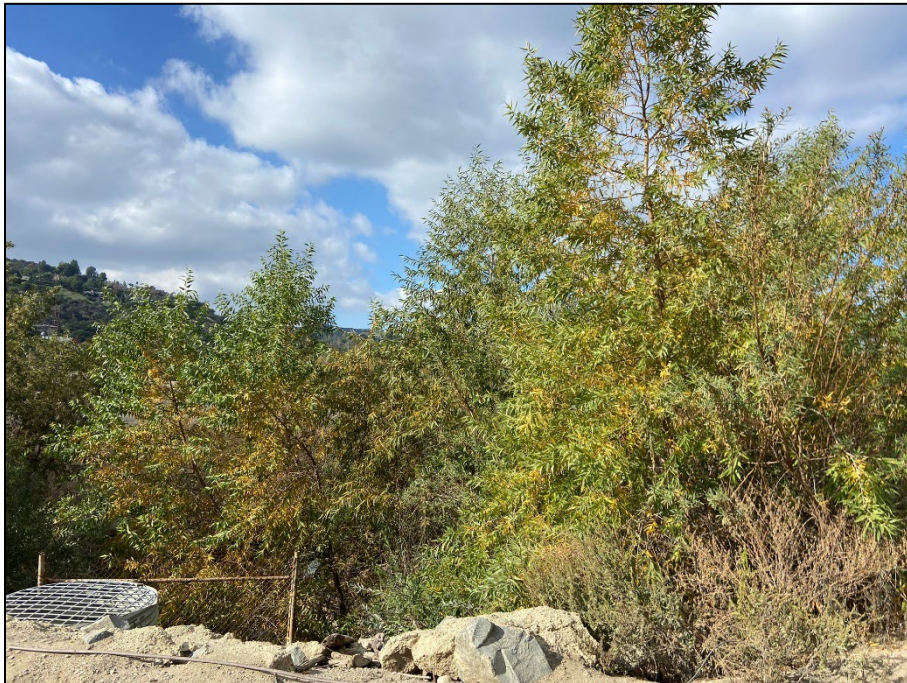
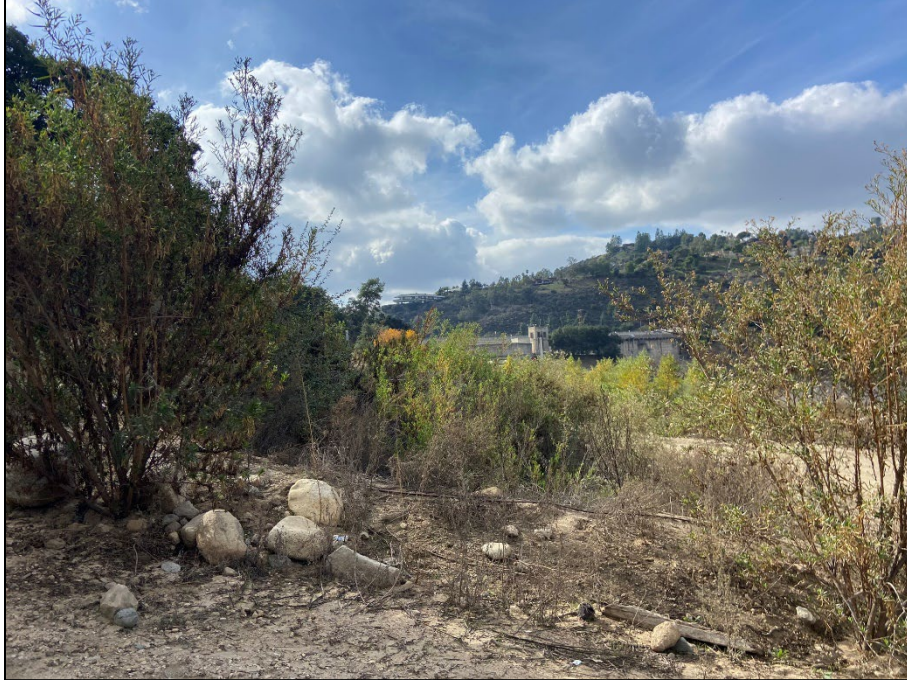
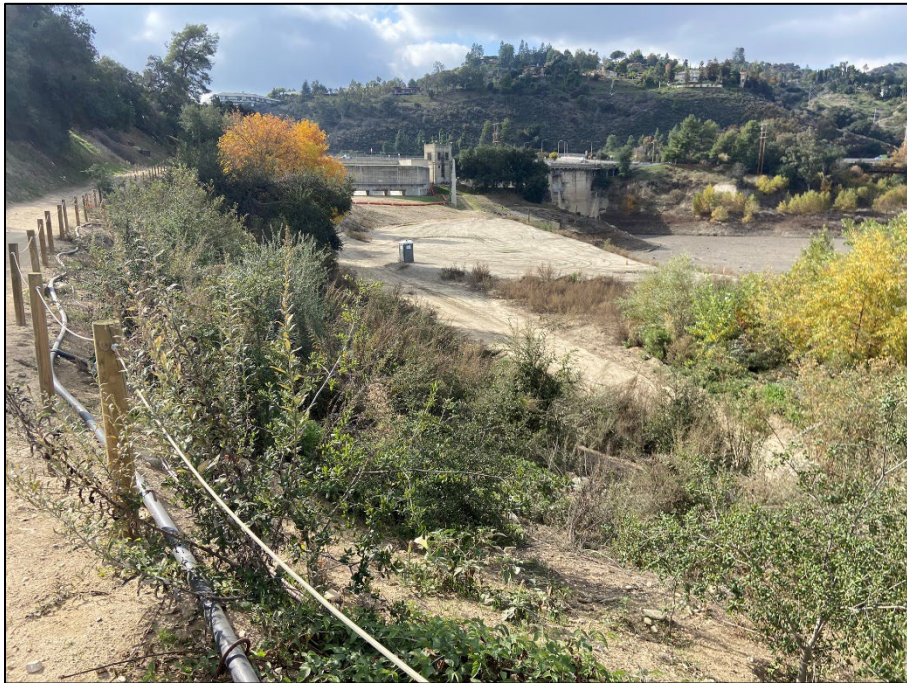
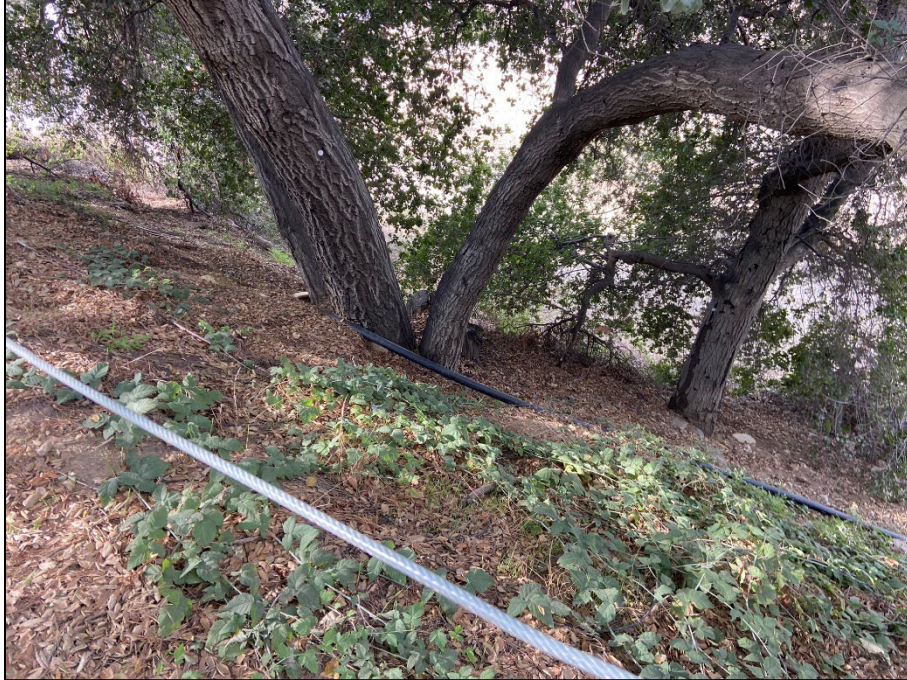
The overall health of the container plants in DG-3A was noted as being good. Approximately five percent of the container plants in the Coast Live Oak Woodland portions of DG-3A were noted as showing varied levels of stress, which is approximately the same as the percentage of container plants that were showing stress during the previous qualitative monitoring event. During the monitoring visit, the planted coast live oak acorns were inspected for survivorship and health. Approximately 20 germinated coast live oak acorns appear to still be present in DG-3A. The majority of the germinated acorns appear to be in good health. During the monitoring, it was noted that an existing coast live oak tree (Tree Tag #39) is continuing to experience branch failure for multiple branches. The cause of the branch failure was unclear.

Approximately less than five percent of the container plants in the Mulefat Thickets portions of DG-3A were noted as showing varied levels of stress, which is approximately the same percentage of container plants that were showing stress during the previous qualitative monitoring event. It should also be noted that the container plants and stakes installed near Altadena Drain were observed to be thriving. Formal mortality counts were taken for DG-3A during the 2020, 2021, and 2022 quantitative monitoring events. The types of stress the plants were exhibiting are the same as those described for the plants in DG-2A. However, erosion is also a problem in some areas of DG-3A. In addition, the Mulefat Thickets portions of DG-3A experienced approximately 18-days of inundation following heavy storm events in December of 2021. Most of the container plants appear to have fully recovered from the inundation. Some of the planting basins were observed to have varied levels of erosion and should be repaired. The willow and mulefat stakes were observed to be thriving in this mitigation area. The installation of the plants in the DG-3A mitigation area appears to have been completed successfully. The current issues noted during the monitoring are not expected to have an effect on the continued growth of the plants in the mitigation area. Photos 11 through 15 in Attachment B document the status of the mitigation area during the monitoring visit.

Native plant growth was noted throughout the DG-3A mitigation area, likely both from natural recruitment and from seeding. Native plants such as annual bursage, mugwort, mulefat, Jimson weed (*Datura wrightii*), California poppy (*Eschscholzia californica*), telegraph weed, and common phacelia were observed sprouting in the DG-3A mitigation area. Native cover for the DG-3A mitigation area was estimated to be approximately 65 percent in the coast live oak woodland portion of the mitigation area and 80 percent in the mulefat thickets portion of the mitigation area.

Nonnative weed cover in DG-3A was estimated at approximately less than one percent, which is approximately the same as the level of nonnative cover that was observed during the previous qualitative monitoring event. Nonnative species observed in DG-3A included perennial pepperweed (*Lepidium latifolium*) and nonnative grasses. All nonnative weeds were just starting to germinate and had not gone to flower or seed. In addition, most of the annual nonnative weeds were observed to be dead for the season.

Photo 11: Overview Mitigation Area DG-3A Altadena Drain

Photo 12: Overview Mitigation Area DG-3A Altadena Drain

Photo 13: Overview Mitigation Area DG-3A Oak Woodland

Photo 14: Overview Mitigation Area DG-3A Oak Woodland

Photo 15: Overview Mitigation Area DG-3A Oak Woodland

Minor erosion to planting basins was observed throughout the Phase 1 mitigation areas. The severe erosion noted in DG-3A near Altadena Drain during previous monitoring visits did not show any signs of worsening nor did the erosion to the upper slope in DG-3A. Due to the steepness of the slope in the Coast Live Oak Woodland portion of the DG-3A mitigation area, erosion will likely continue to be somewhat of an issue in this area; however, jute nettings are currently in place on the slope and will help to lessen the severity of erosion issues. As native cover increases in this area, erosion issues should lessen. The severity of the erosion should continue to be monitored in all planted areas and if warranted, erosion

Best Management Practices (BMPs) should be installed in appropriate areas. This may only require the installation of straw wattles at select sites to prevent existing rills from becoming larger. However, until more native perennial plants become established in these areas, there is the potential that intense rainfall may create additional erosion problems.

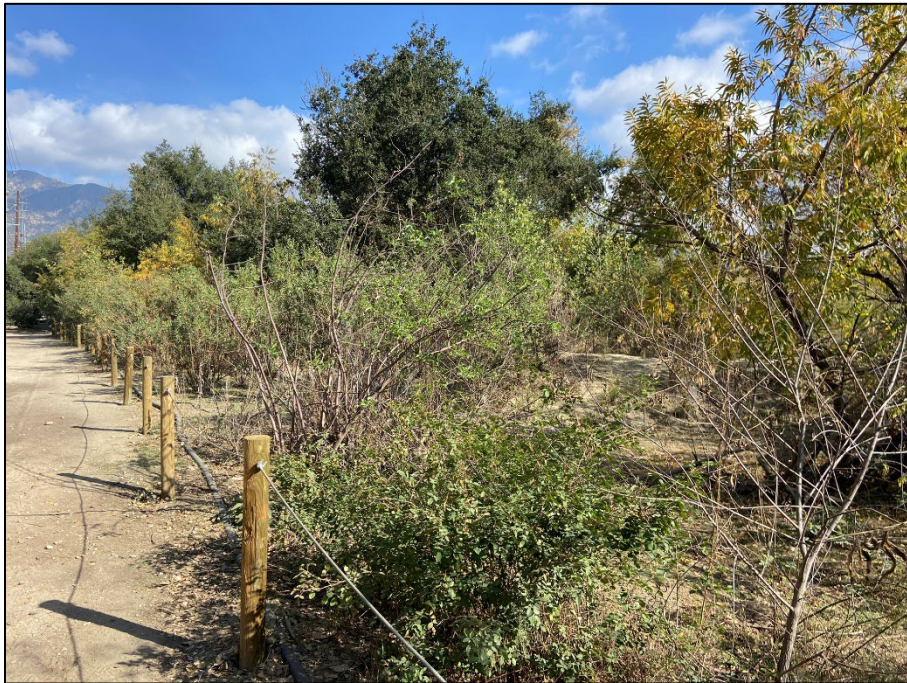
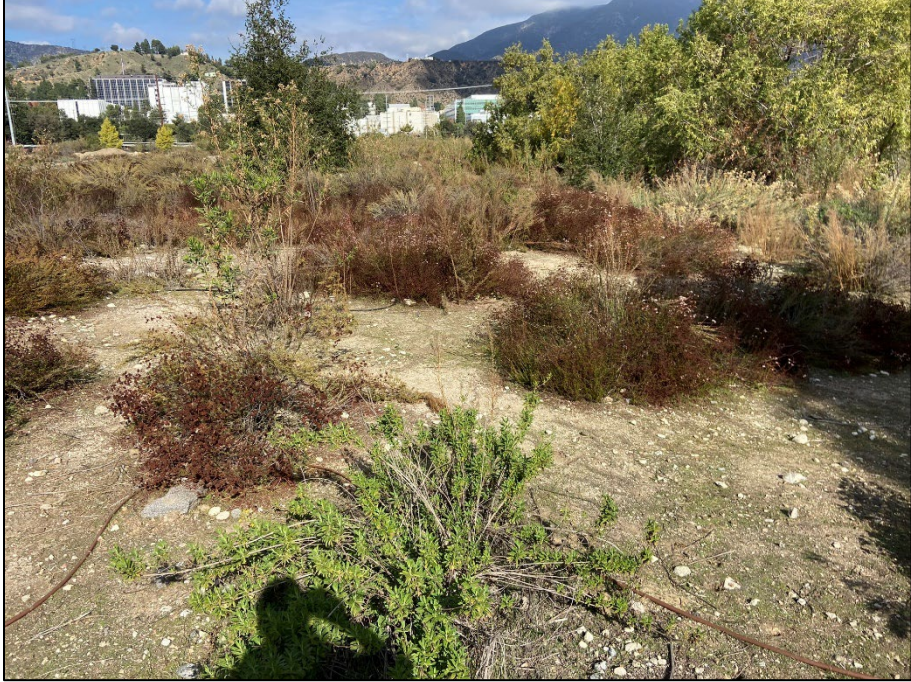
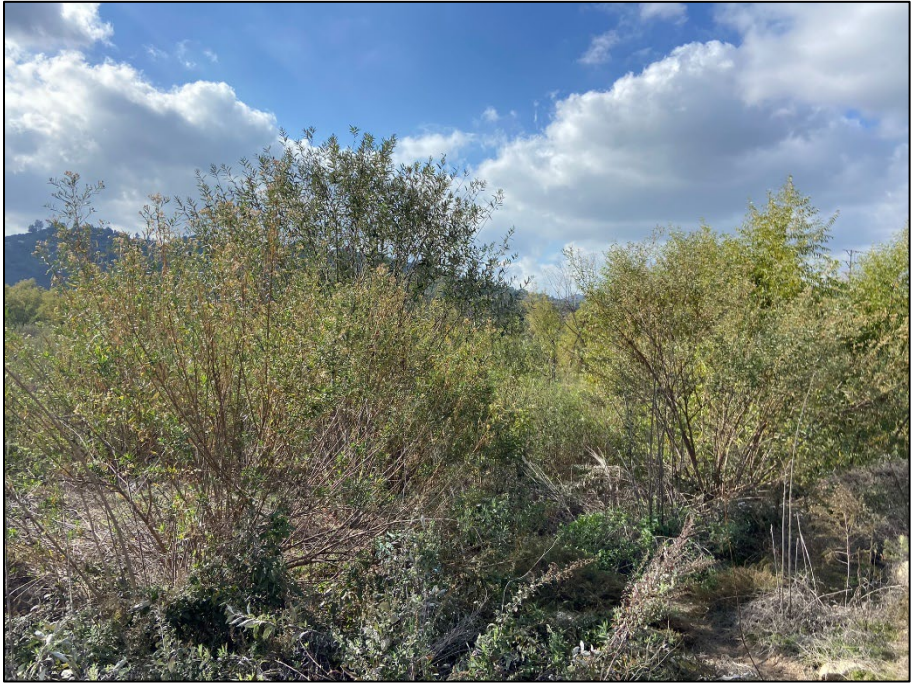
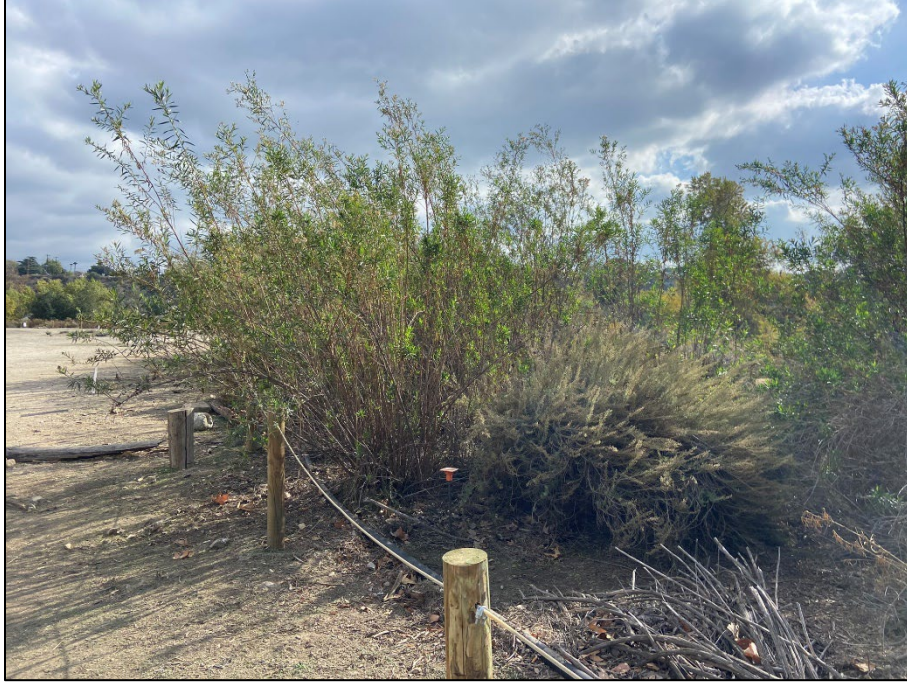
The overall health of the container plants in mitigation area DG-4 was noted as being good. Approximately five percent of container plants in the coastal sage scrub portions of DG-4 were showing varied levels of stress which is approximately five percent less than the percentage of plants showing stress during the previous qualitative monitoring event. Approximately 5 to 10 percent of container plants in most of the riparian portions of DG-4 were showing varied levels of stress, depending on the section of DG-4, which is approximately 5 to 15 percent less than the percentage of plants showing stress during the previous qualitative monitoring event. The causes of stress appear to be mostly due to the same reasons described in DG-2A. In addition, the southern portions of DG-4 experienced approximately 18-days of inundation following heavy storm events in December of 2021. Most of the container plants appear to have fully recovered from the inundation. For most portions of DG-4, only a negligible number of container plants were noted as being missing or dead. Formal mortality counts were taken for DG-4 during the 2020, 2021, and 2022 quantitative monitoring events. Similar to DG-2A, the willows and Fremont's cottonwoods were starting to show signs of seasonal dieback. Some of the planting basins were observed to have minor erosion and should be repaired. The installation of plants in the DG-4 mitigation area appears to have been completed successfully and the issues noted during the monitoring are not expected to have an impact on the continued growth of the plants. Photos 16 through 19 in Attachment B document the status of the mitigation area during the monitoring visit.

Native plant growth was noted throughout the DG-4 mitigation area, likely both from natural recruitment and from seeding. Native plants such as annual bursage, California sagebrush, mugwort, mulefat, tall flatsedge (*Cyperus eragrostis*), Canada horseweed, California buckwheat, telegraph weed, common phacelia, and stinging nettle were observed sprouting in the DG-4 mitigation area. Native cover for the DG-4 mitigation area was estimated to be approximately 75 to 85 percent in the riparian portion of the mitigation area and 65 percent in the coastal sage scrub portion.

Nonnative weed cover in DG-4 was estimated at approximately two percent, which is approximately the same as the percentage of nonnative cover that was observed during the previous qualitative monitoring event. Nonnative species observed in DG-4 included tree of heaven (*Ailanthus altissima*), black mustard (*Brassica nigra*), poison hemlock (*Conium maculatum*), perennial pepperweed, and nonnative grasses. Nonnative weed cover, especially perennial pepperweed, is a significant problem in portions of the DG-4 mitigation area. Because perennial pepperweed can produce dense colonies through seed germination and underground rhizomes (rhizomatous roots), removal of this species without the use of systemic herbicide is very difficult. Most nonnative weeds in the northern and middle sections of the mitigation area were just starting to germinate and had not gone to flower or seed; however, many of the weeds in the southern area were proliferating and had already produced seed.

Photo 16: Overview Mitigation Area DG-4

Photo 17: Overview Mitigation Area DG-4

Photo 18: Overview Mitigation Area DG-4

Photo 19: Overview Mitigation Area DG-4

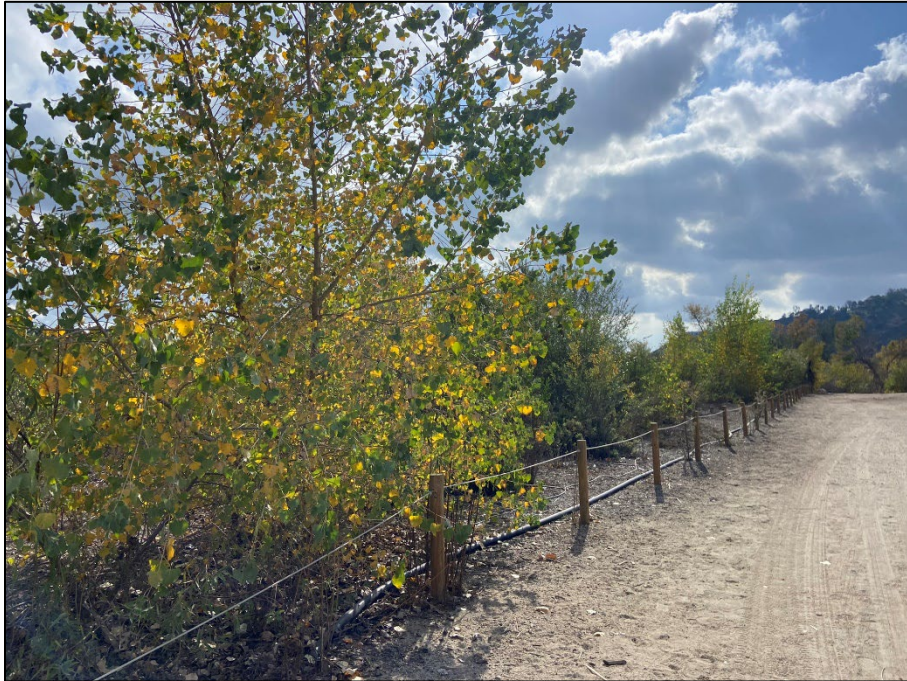
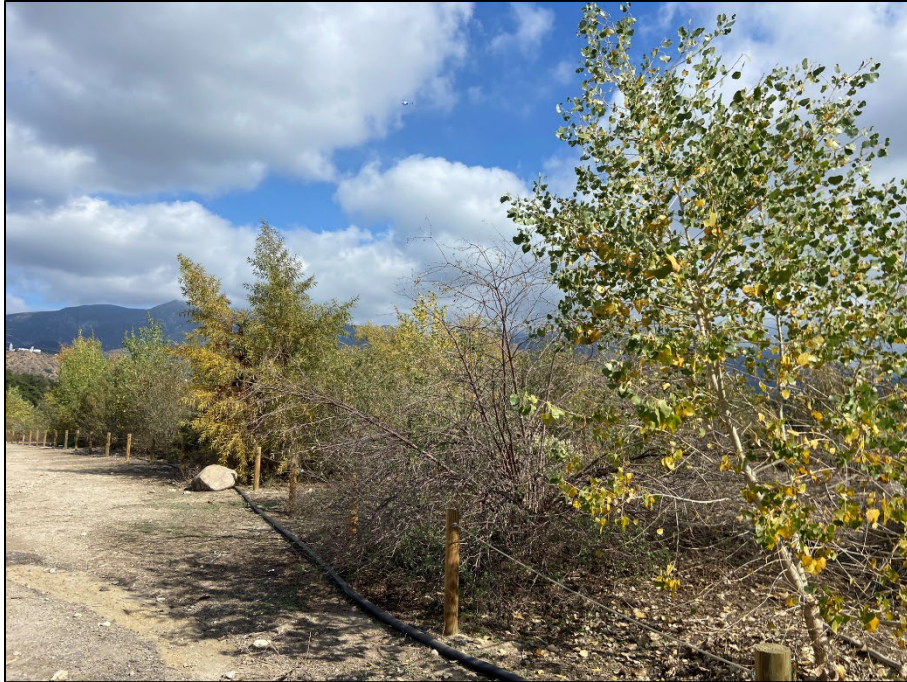
The overall health of the container plants in mitigation area DG-4B was noted as being good and this mitigation area is becoming well established. Approximately less than five percent of container plants were showing signs of drought stress which is approximately 5 to 10 percent less than the percentage of plants that were stressed during the previous qualitative monitoring event. The types of stress the plants were

exhibiting are the same as those described for the plants in DG-2A. A negligible number of container plants were noted as being missing or dead. Formal mortality counts were taken for DG-4B during the 2020, 2021, and 2022 quantitative monitoring events. Some of the planting basins were observed to have minor erosion and should be repaired. The installation of plants in the DG-4B mitigation area appears to have been completed successfully and the issues noted during the monitoring are not expected to have an impact on the continued growth of the plants. Photos 20 and 21 in Attachment B document the current status of the mitigation area during the monitoring visit.

Native plant growth was noted throughout the DG-4B mitigation area, likely both from natural recruitment and from seeding. Native plants such as mugwort, tarragon (*Artemisia dracunculus*), mulefat, and telegraph weed were observed sprouting in the DG-4B mitigation area. Native cover for the DG-4B mitigation area was estimated to be approximately 85 percent.

Nonnative weed cover in DG-4B was estimated to be approximately less than one percent, which is approximately the same as the percentage of nonnative cover that was observed during the previous qualitative monitoring event. Nonnative species observed in DG-4B included black mustard and perennial pepperweed. All nonnative weeds were just starting to germinate and had not gone to flower or seed. In addition, most of the annual nonnative weeds were observed to be dead for the season.

Photo 20: Overview Mitigation Area DG-4B

Photo 21: Overview Mitigation Area DG-4B

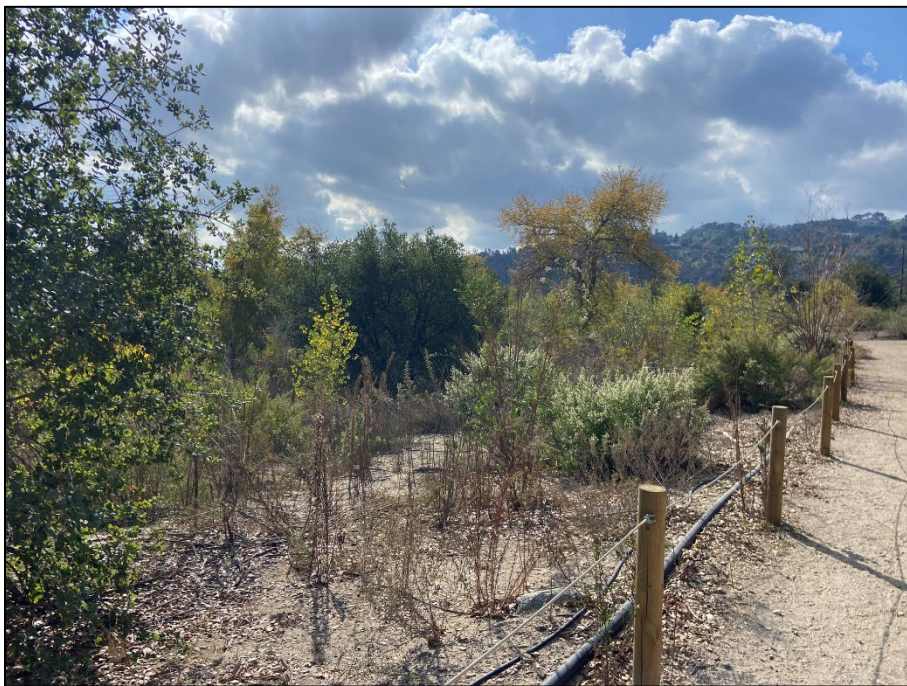
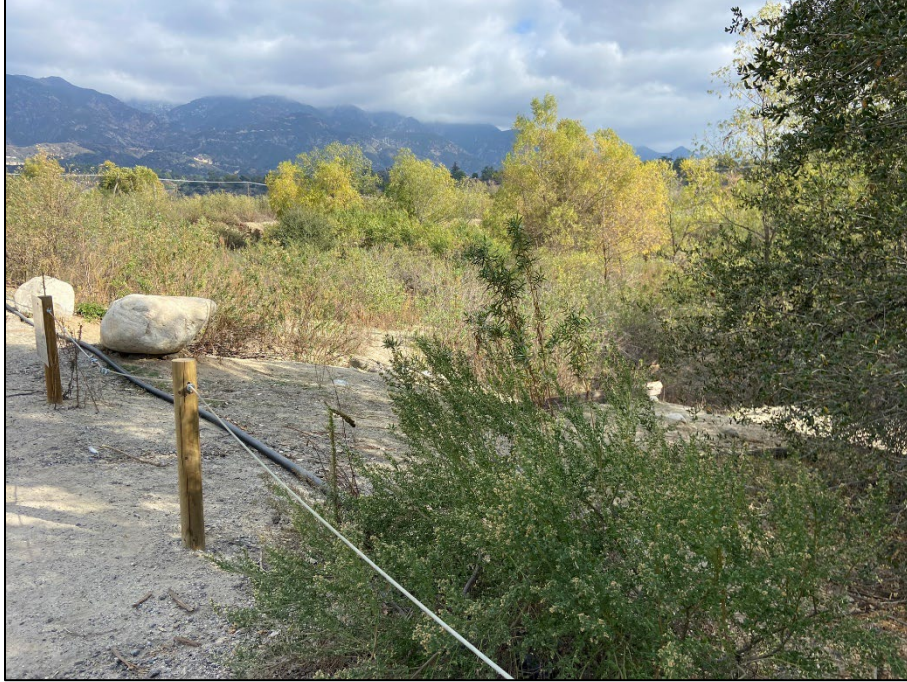
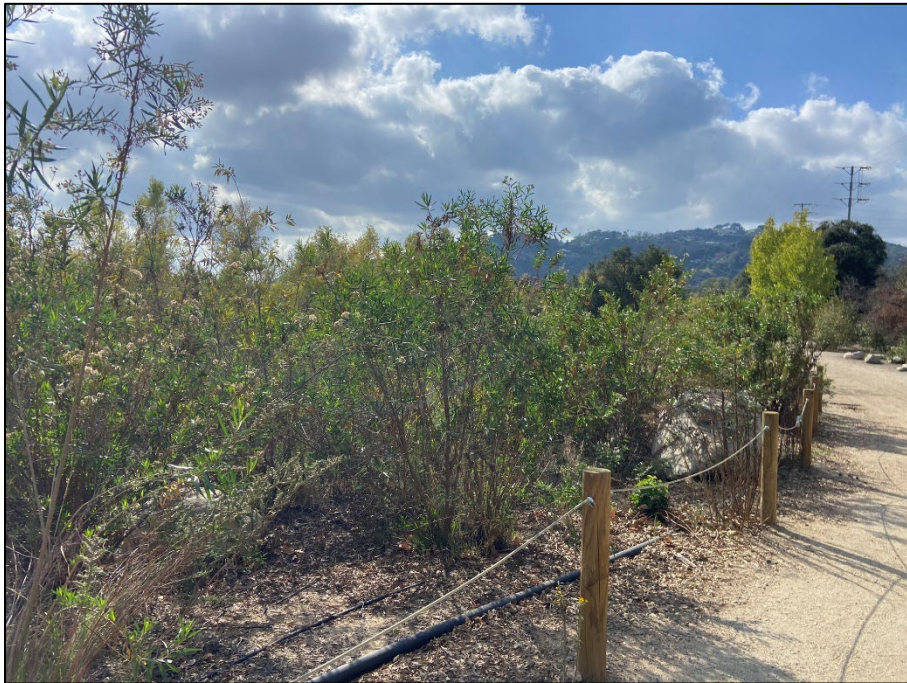
The overall health of the container plants in mitigation area DG-4C was noted as being good. Approximately 5 to 10 percent of all container plants were noted as showing minor levels of stress, which is approximately five percent less than percentage of plants that were showing stress during the previous qualitative monitoring event. The types of stress the plants were exhibiting are the same as those described for the plants in DG-2A. A negligible number of container plants were noted as being missing or dead. Formal mortality counts were taken for DG-4C during the 2020, 2021, and 2022 quantitative monitoring events. Some of the planting basins were observed to have minor erosion and should be repaired. The installation of plants in the DG-4C mitigation area appears to have been completed successfully and the issues noted during the monitoring are not expected to have an impact on the continued growth of the plants. Photos 22 to 24 in Attachment B document the status of the mitigation area during the monitoring visit.

Native plant growth was noted throughout the DG-4C mitigation area, likely both from natural recruitment and from seeding. Native plants such as annual bursage, mulefat, Canada horseweed, and telegraph weed were observed sprouting in the DG-4C mitigation area. Native cover for the DG-4C mitigation area was estimated to be approximately 75 percent.

Nonnative weed cover in DG-4C was estimated at approximately less than one percent percent, which is approximately the same percentage of nonnative cover that was observed during the previous qualitative monitoring event. Black mustard and nonnative grasses were the only nonnative species observed in DG-4C during the monitoring visit. All nonnative weeds were just starting to germinate and had not gone to flower or seed. In addition, most of the annual nonnative weeds were observed to be dead for the season.

Photo 22: Overview Mitigation Area DG-4C

Photo 23: Overview Mitigation Area DG-4C

Photo 24: Overview Mitigation Area DG-4C

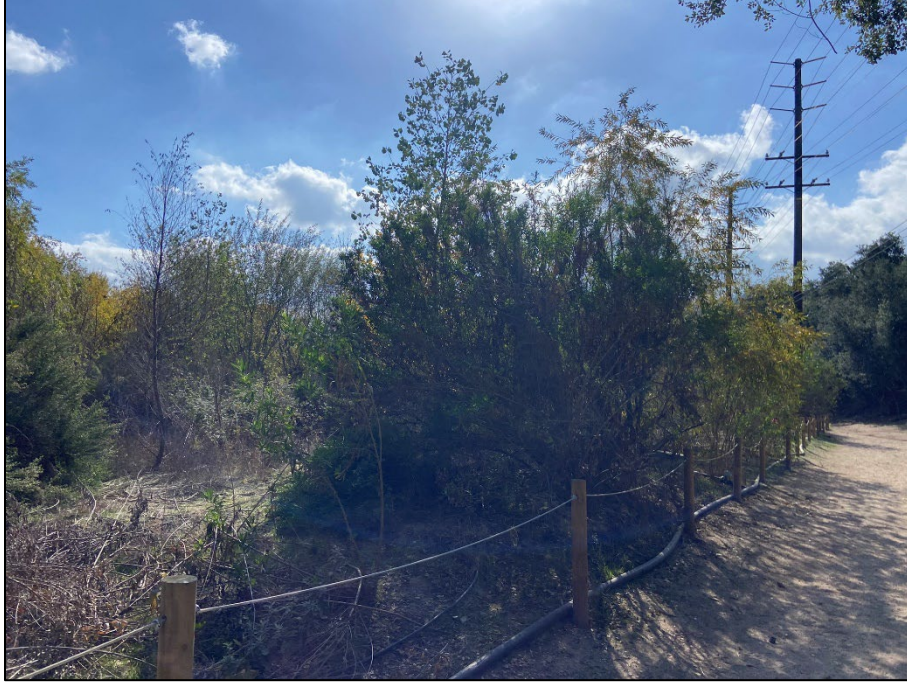
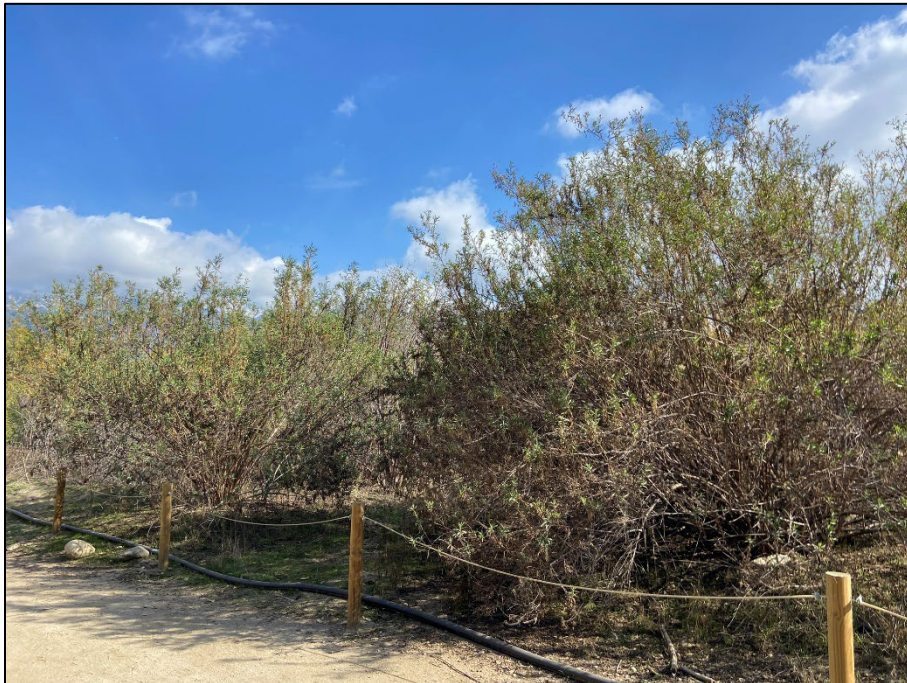
The overall health of the container plants in the DG-5 mitigation area was noted as being good. Approximately less than five percent of all container plants were noted as showing varied levels of stress, which is approximately the same as the percentage of plants that were showing stress during the previous qualitative monitoring event. Formal mortality counts were taken for DG-5 during the 2020, 2021, and 2022 quantitative monitoring events. Some of the planting basins were observed to have minor erosion and should be repaired. Similar to DG-2A, the willows and Fremont's cottonwoods were starting to show signs of seasonal dieback. The installation of plants in the DG-5 mitigation area appears to have been completed successfully and the issues noted during the monitoring are not expected to have a negative impact on the continued growth of the plants. Photos 25 and 26 in Attachment B document the status of the mitigation area during the monitoring visit.

Native plant growth was noted throughout the DG-5 mitigation area, likely both from natural recruitment and from seeding. Native plants such as annual bursage, mulefat, telegraph weed, evening primrose (*Oenothera elata*), and stinging nettle were observed sprouting in the DG-5 mitigation area. Native cover for the DG-5 mitigation area was estimated to be approximately 85 percent and the site is thriving.

Nonnative weed cover in DG-5 was estimated at approximately less than one percent, which is approximately the same percentage of nonnative weed cover that was observed during the previous qualitative monitoring event. Nonnative species observed in DG-5 included black mustard and perennial pepperweed. All nonnative weeds were just starting to germinate and had not gone to flower or seed. In addition, most of the annual nonnative weeds were observed to be dead for the season.

Photo 25: Overview Mitigation Area DG-5

Photo 26: Overview Mitigation Area DG-5
