**Year 1 Annual Monitoring Report
for the
Devil's Gate Reservoir Restoration Project
(Phase 3)
Onsite Habitat Mitigation**

Los Angeles County

May 8, 2025

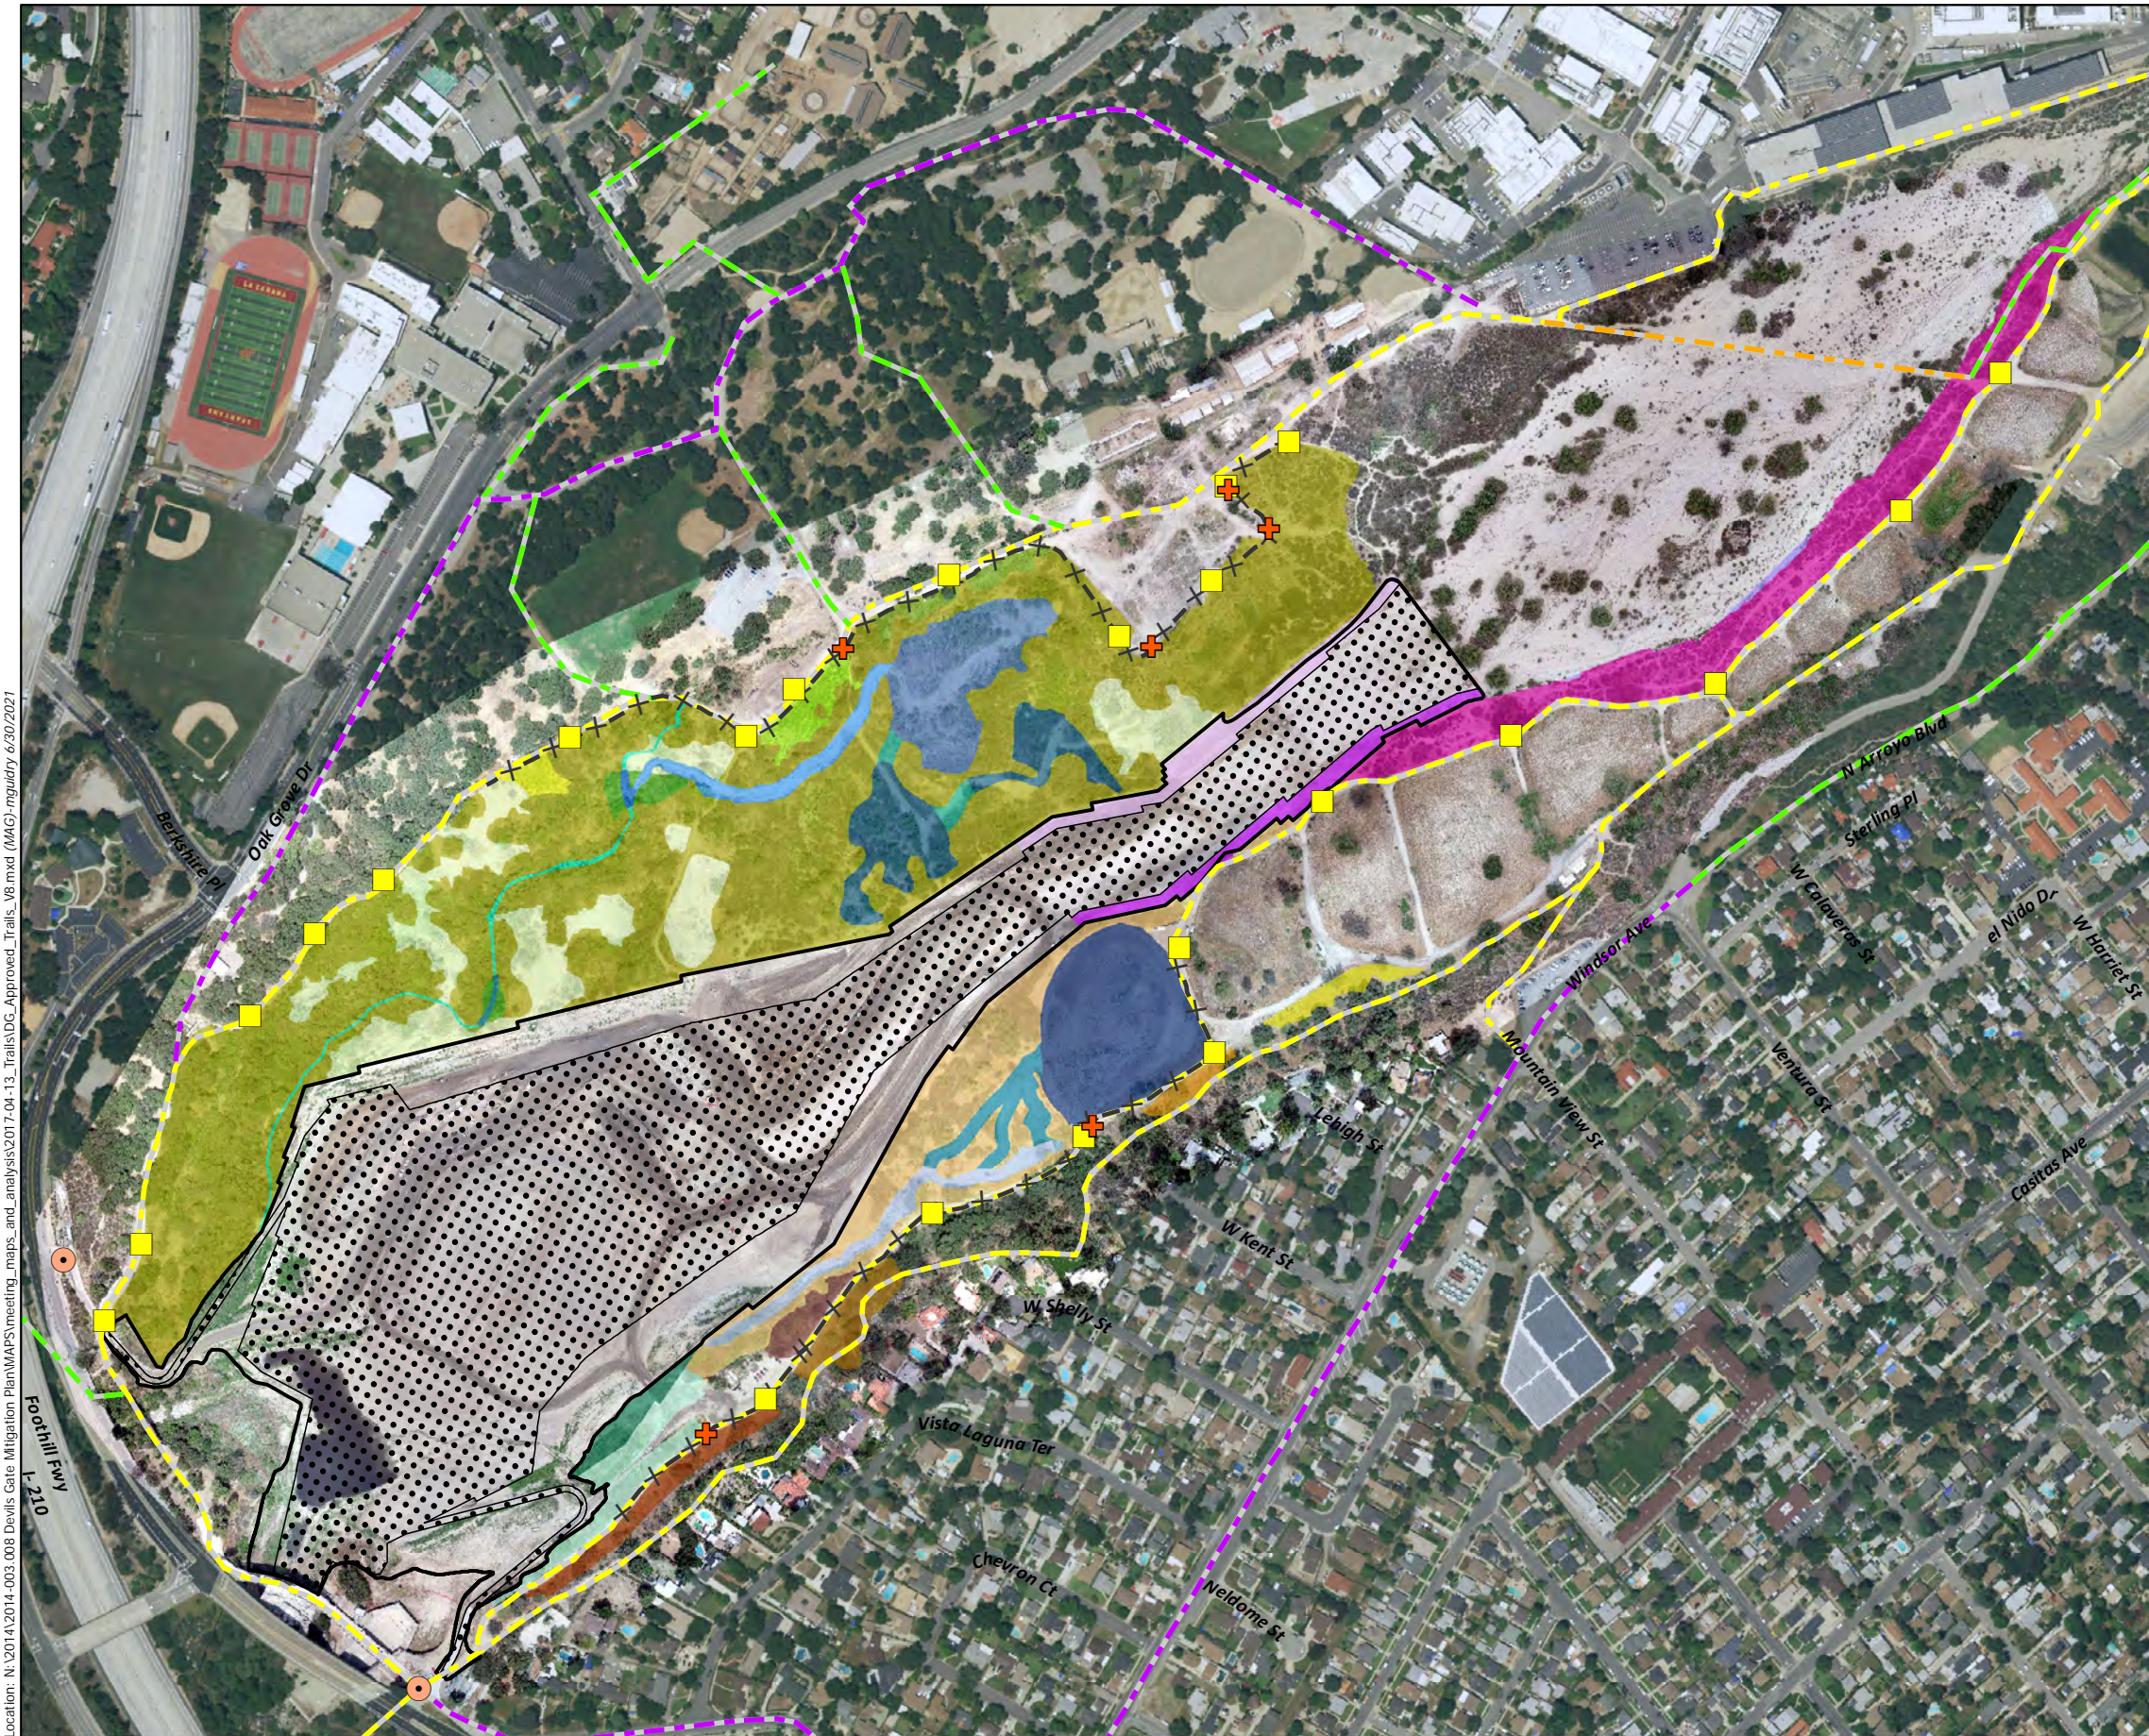
Figure 4. Site Protection Boundaries

To delineate the site and deter trespassers from entering the mitigation areas, Environmentally Sensitive Area signs were installed and in 2021 wooden post fencing connected with cables was installed along the boundaries of the mitigation areas (Figure 4). In addition, public outreach to recreational users of the area was conducted to educate the public on the restoration efforts. Lastly, stinging and thorny vegetation, including California blackberry (*Rubus ursinus*), California wild rose (*Rosa californica*), and stinging nettle (*Urtica dioica*), were planted in the mitigation areas to further deter entry.

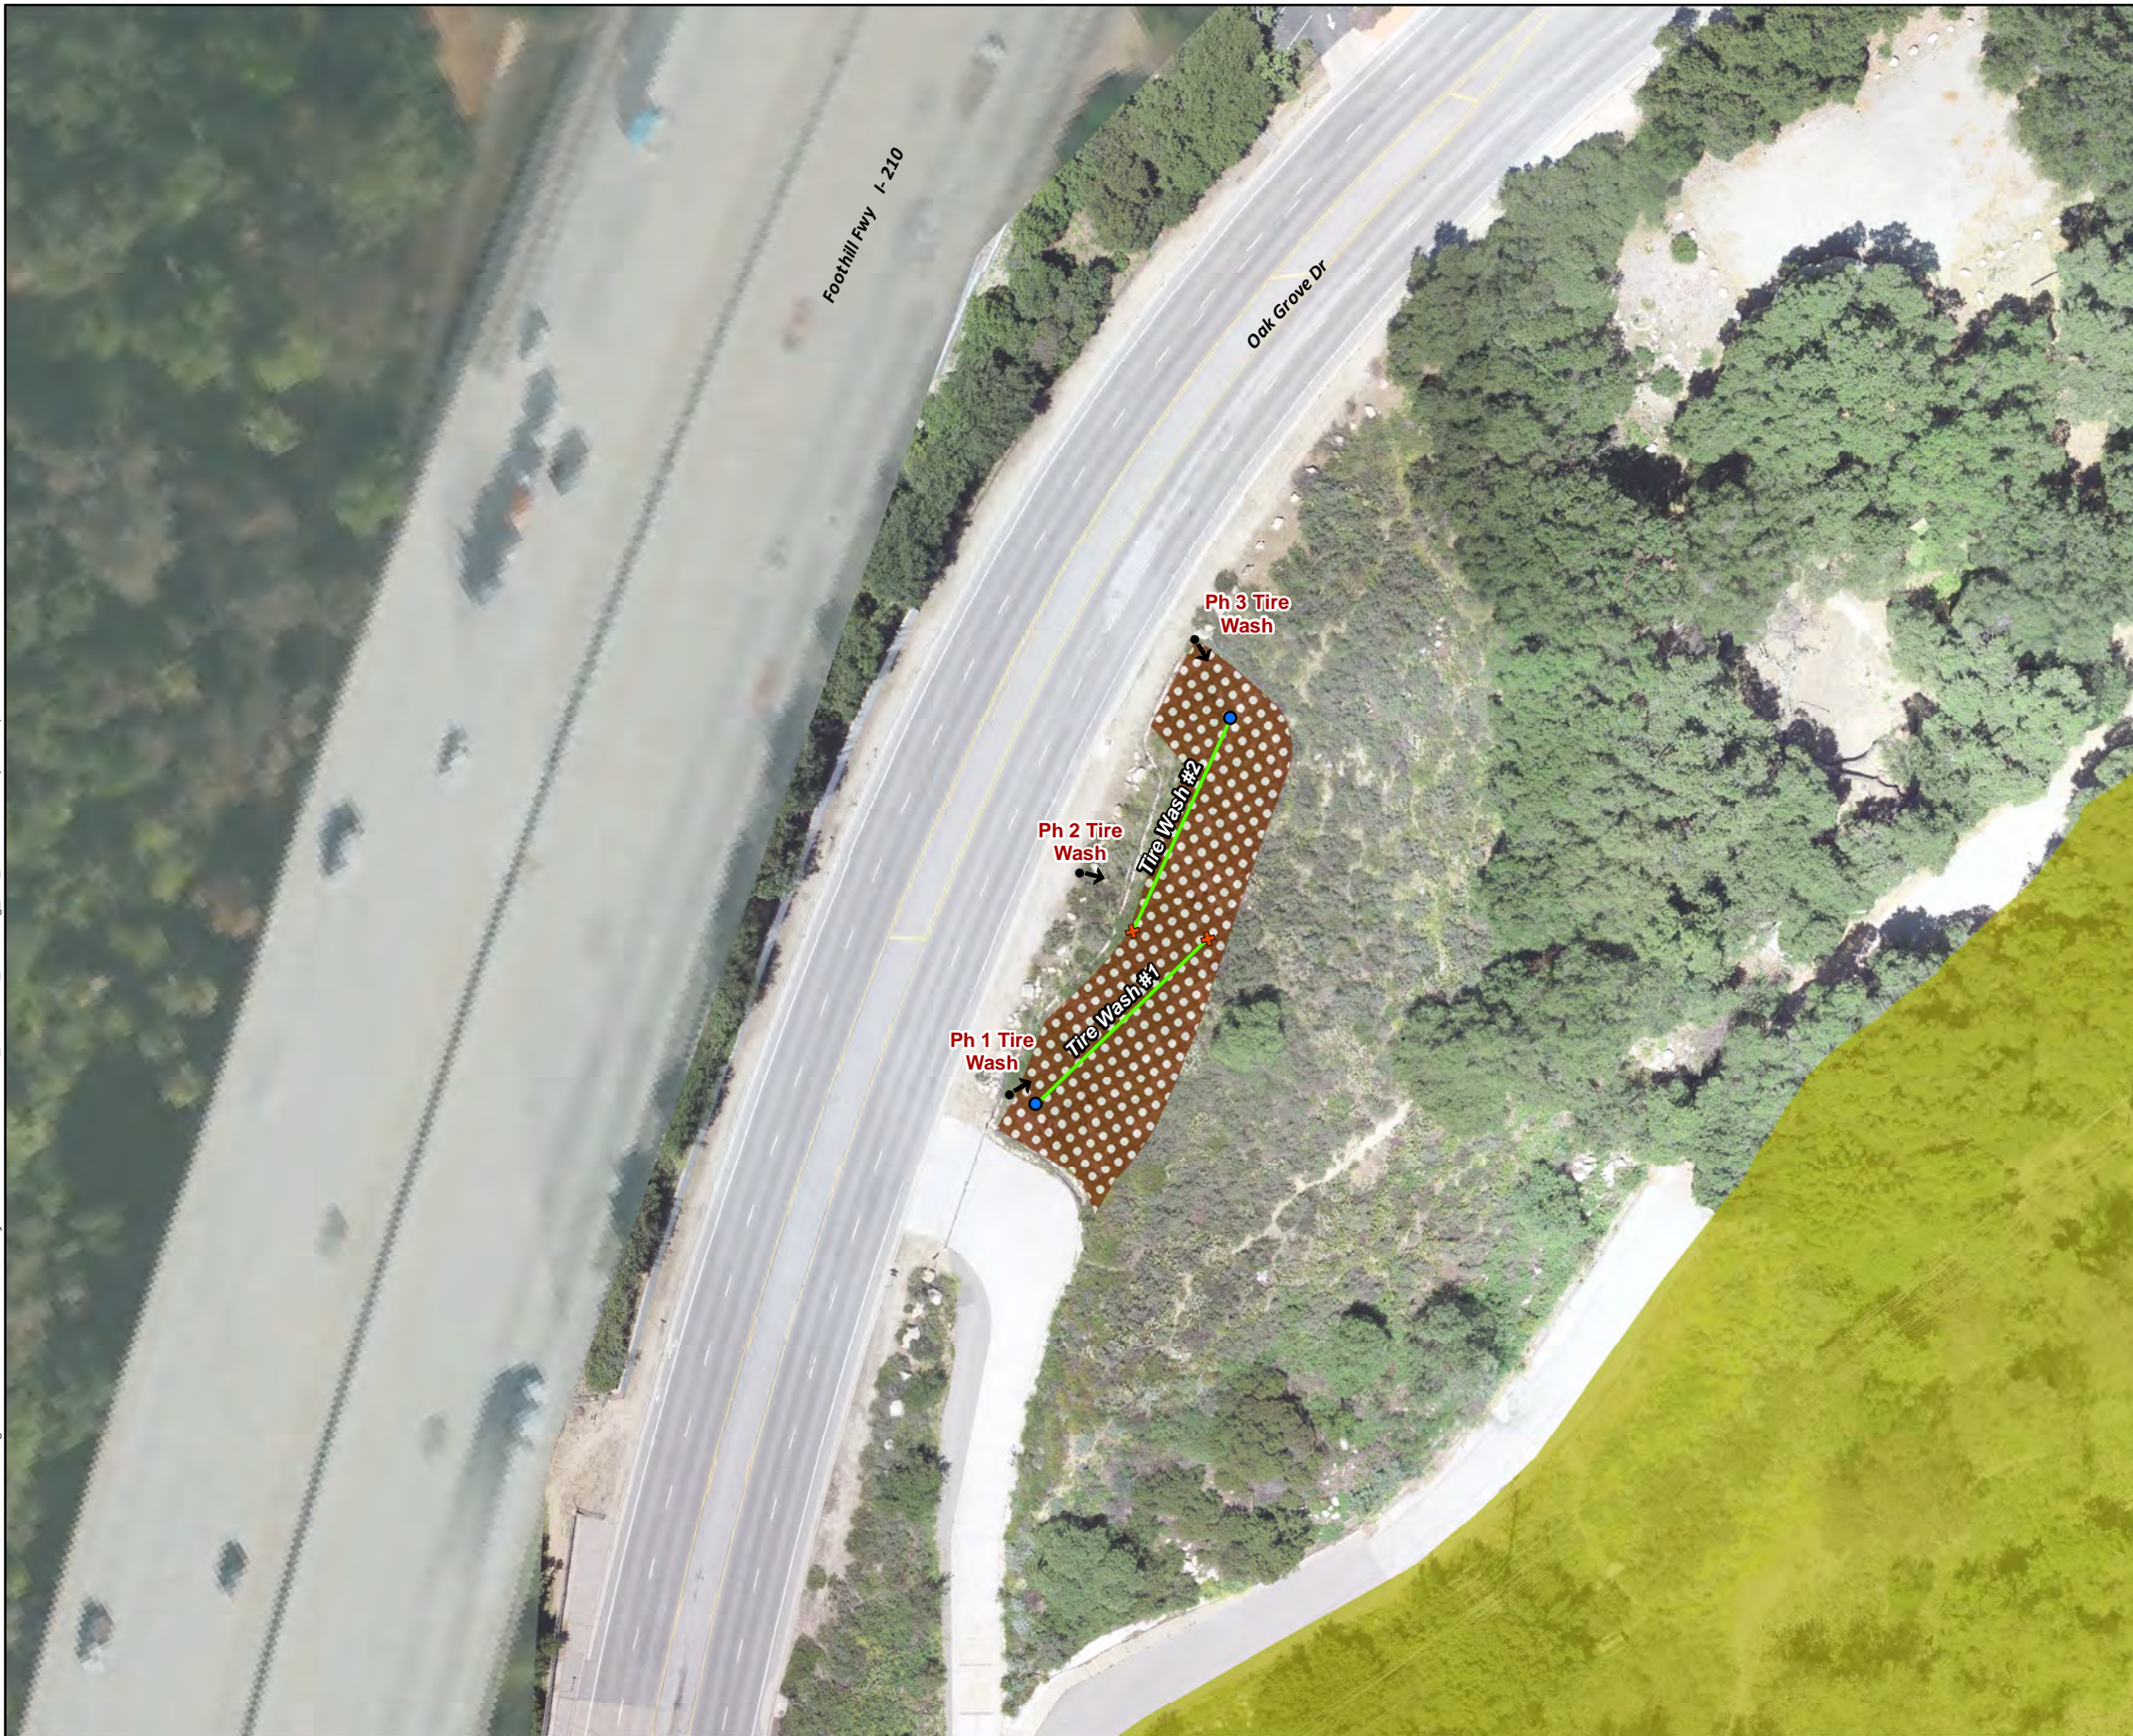
**Figure 5. Transect Locations
Onsite Habitat Mitigation Areas
Sheet 1 of 6**

Data were collected along each transect at every 0.5 meter (sampling location), starting at 0.5 meter. Each plant species that intersected the transect tape at each sampling location was recorded. A sampling dowel was used to assist in determining which plant species intersected the transect tape at each sampling location. In situations where the canopy of a plant intersected the transect tape at a sampling location, that species was also recorded; this included tree species with an overhead canopy. If only one plant species intersected the transect tape at any sampling location, that species received one tally mark. In situations where multiple plant species intersect the transect tape at a sampling location, those plant species received a fraction of a tally mark dependent on the number of species that intersected the transect tape at that sampling location.
