Geomorphic Assessment of the Santa Clara River Watershed, Synthesis of the Lower and Upper Watershed Studies

Ventura and Los Angeles Counties, California

April 2011

Prepared by
Stillwater Sciences
2855 Telegraph Avenue, Suite 400
Berkeley, CA 94705

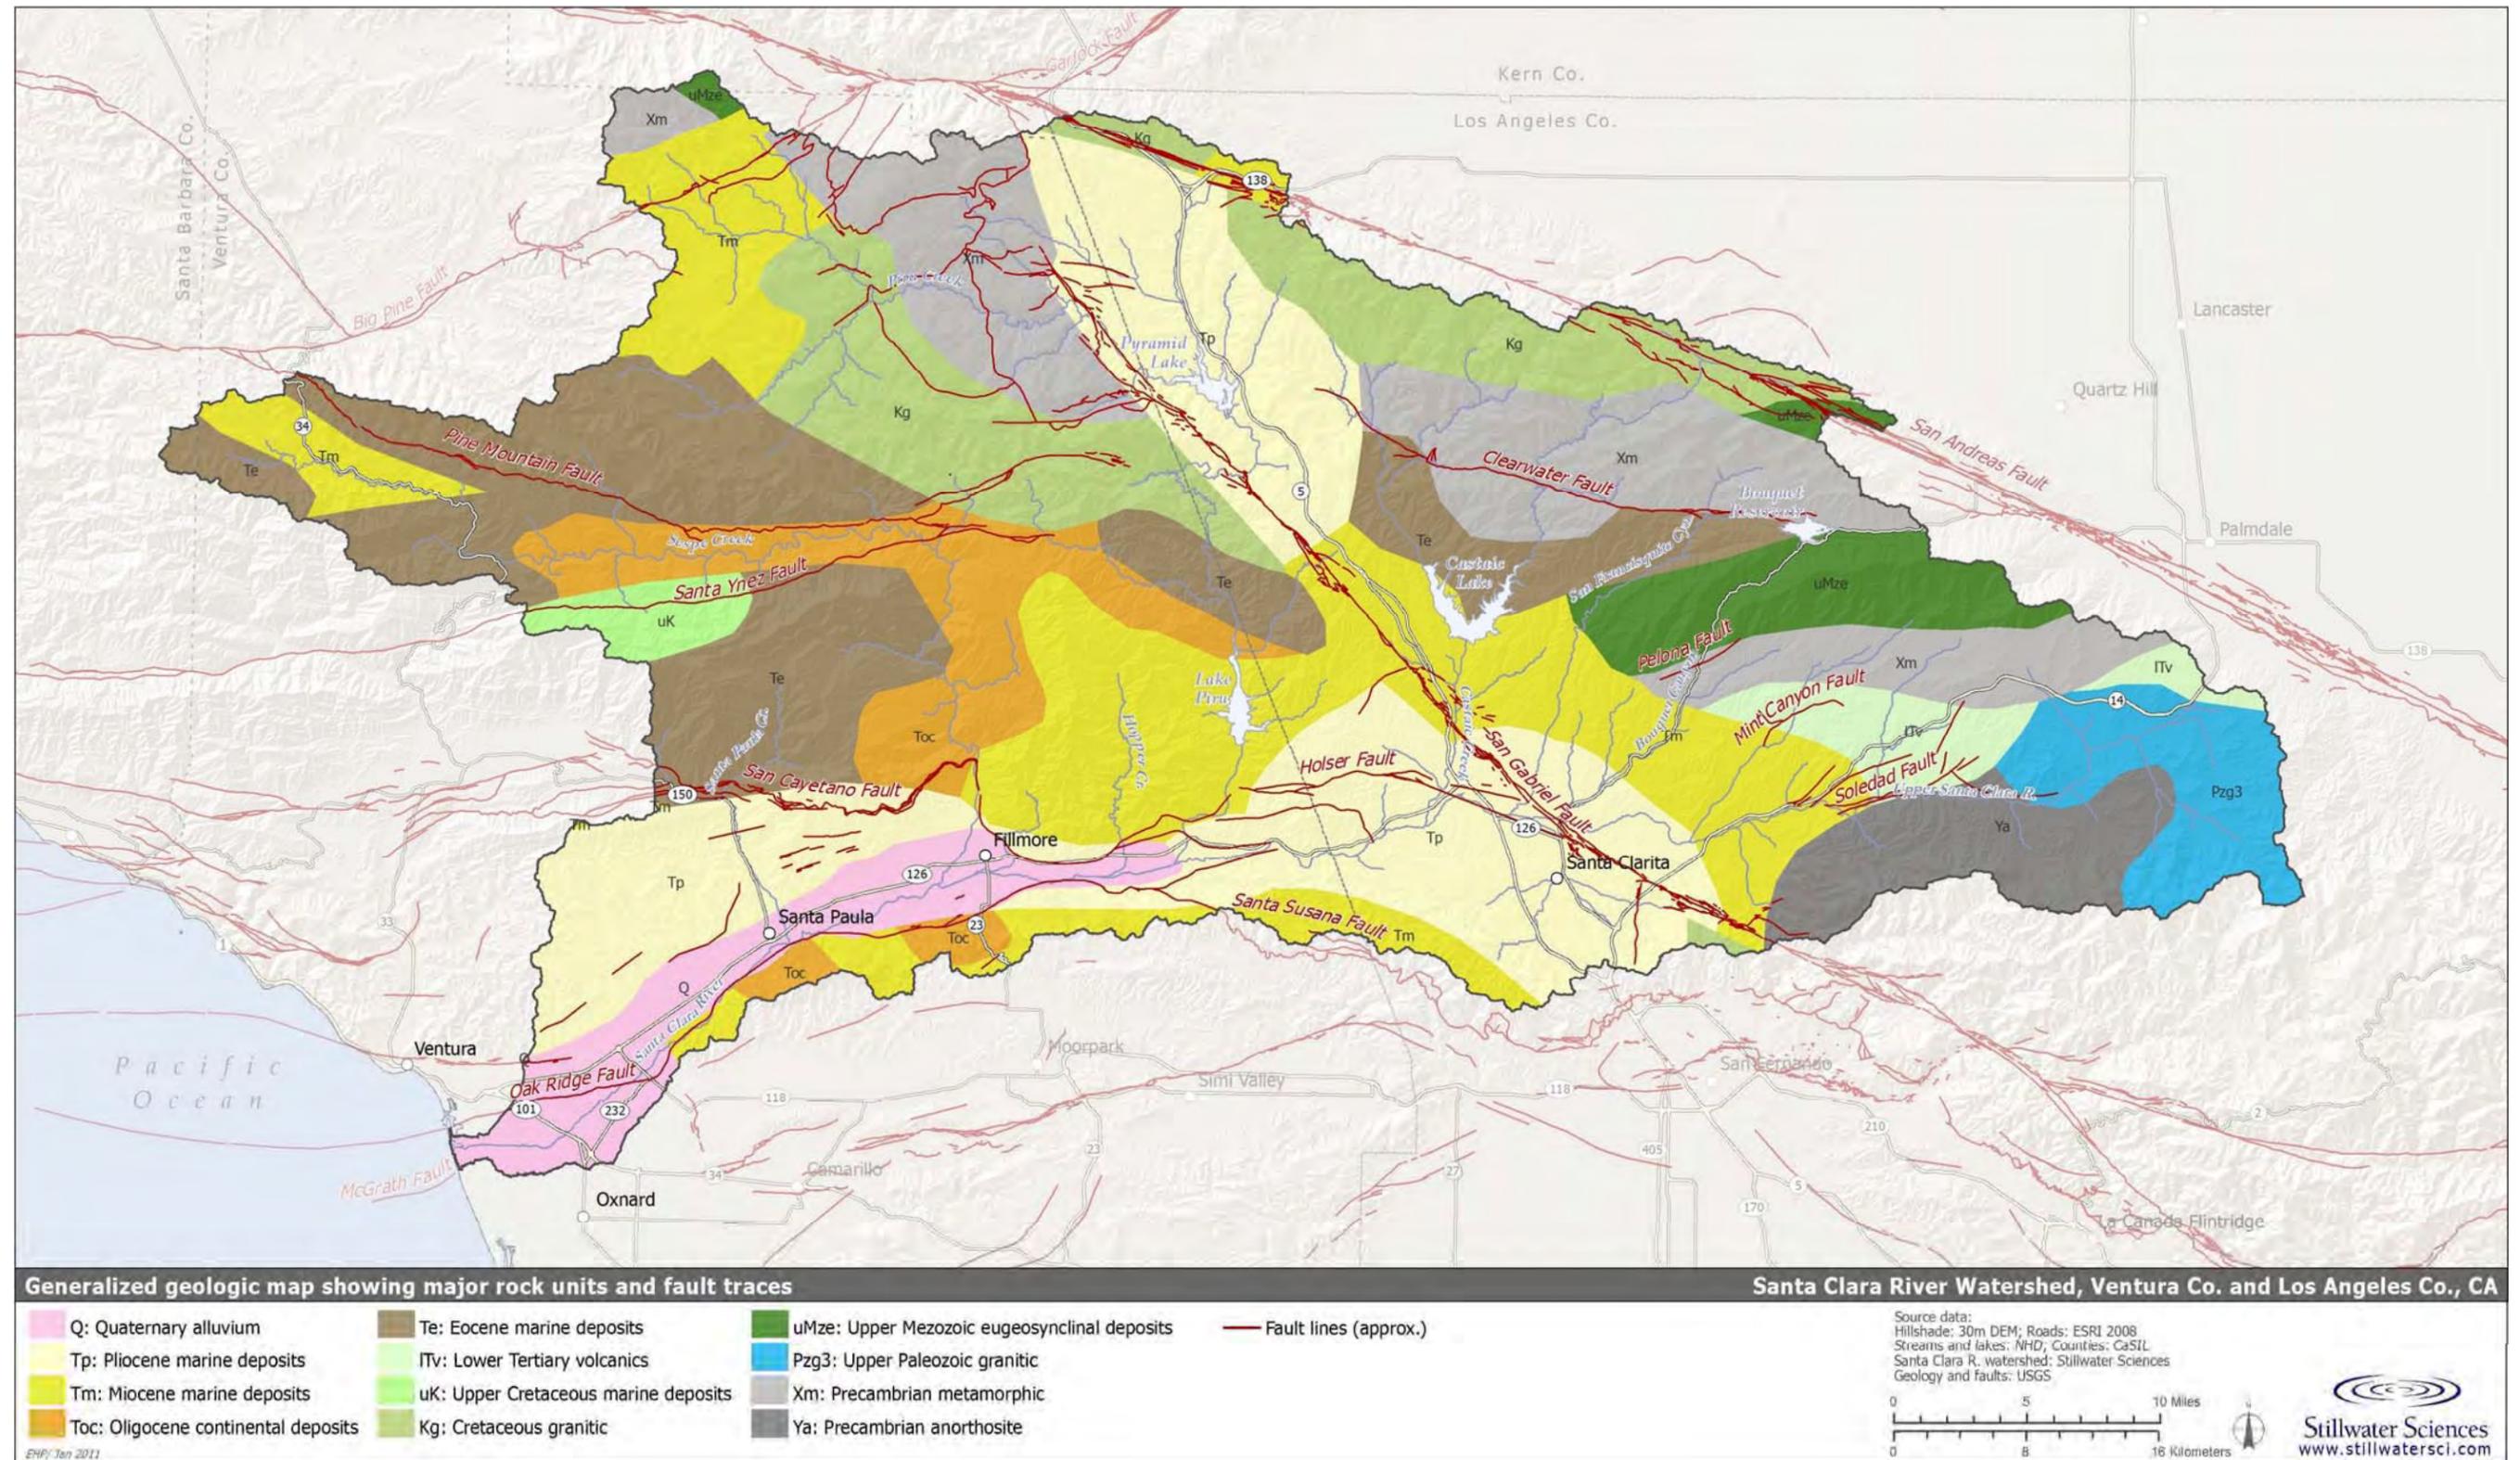
Figure 1-4. Generalized geologic map showing major rock units and fault traces in the SCR watershed.

Fractures, deformation, and faulting contribute to high bedrock erodibility throughout the SCR watershed. For example, the sedimentary bedrock units immediately bordering the Santa Clarita Basin and Santa Clara River Valley are often poorly consolidated, intensely folded, and have steeply tilted beds, making them susceptible to landsliding (e.g., Harp and Jibson 1996) and erosion by dry raveling (Scott and Williams 1978). For example, the Pico Formation siltstone has been found to have considerably high erosion rates (Stillwater Sciences 2011a; mapped here in Figure 1-4 as part of unit “Tm”). Even areas underlain by granite, gneiss, and schist (which are normally relatively resistant to erosion) have been described as being highly erodible (e.g., Scott and Williams 1978, Wells et al. 1987) due to extensive deformation and fracturing, which is especially true of the Pelona Schist bedrock unit (“ps”) that trends across much of the USCR through San Francisquito and Bouquet canyons (Spotila et al. 2002).

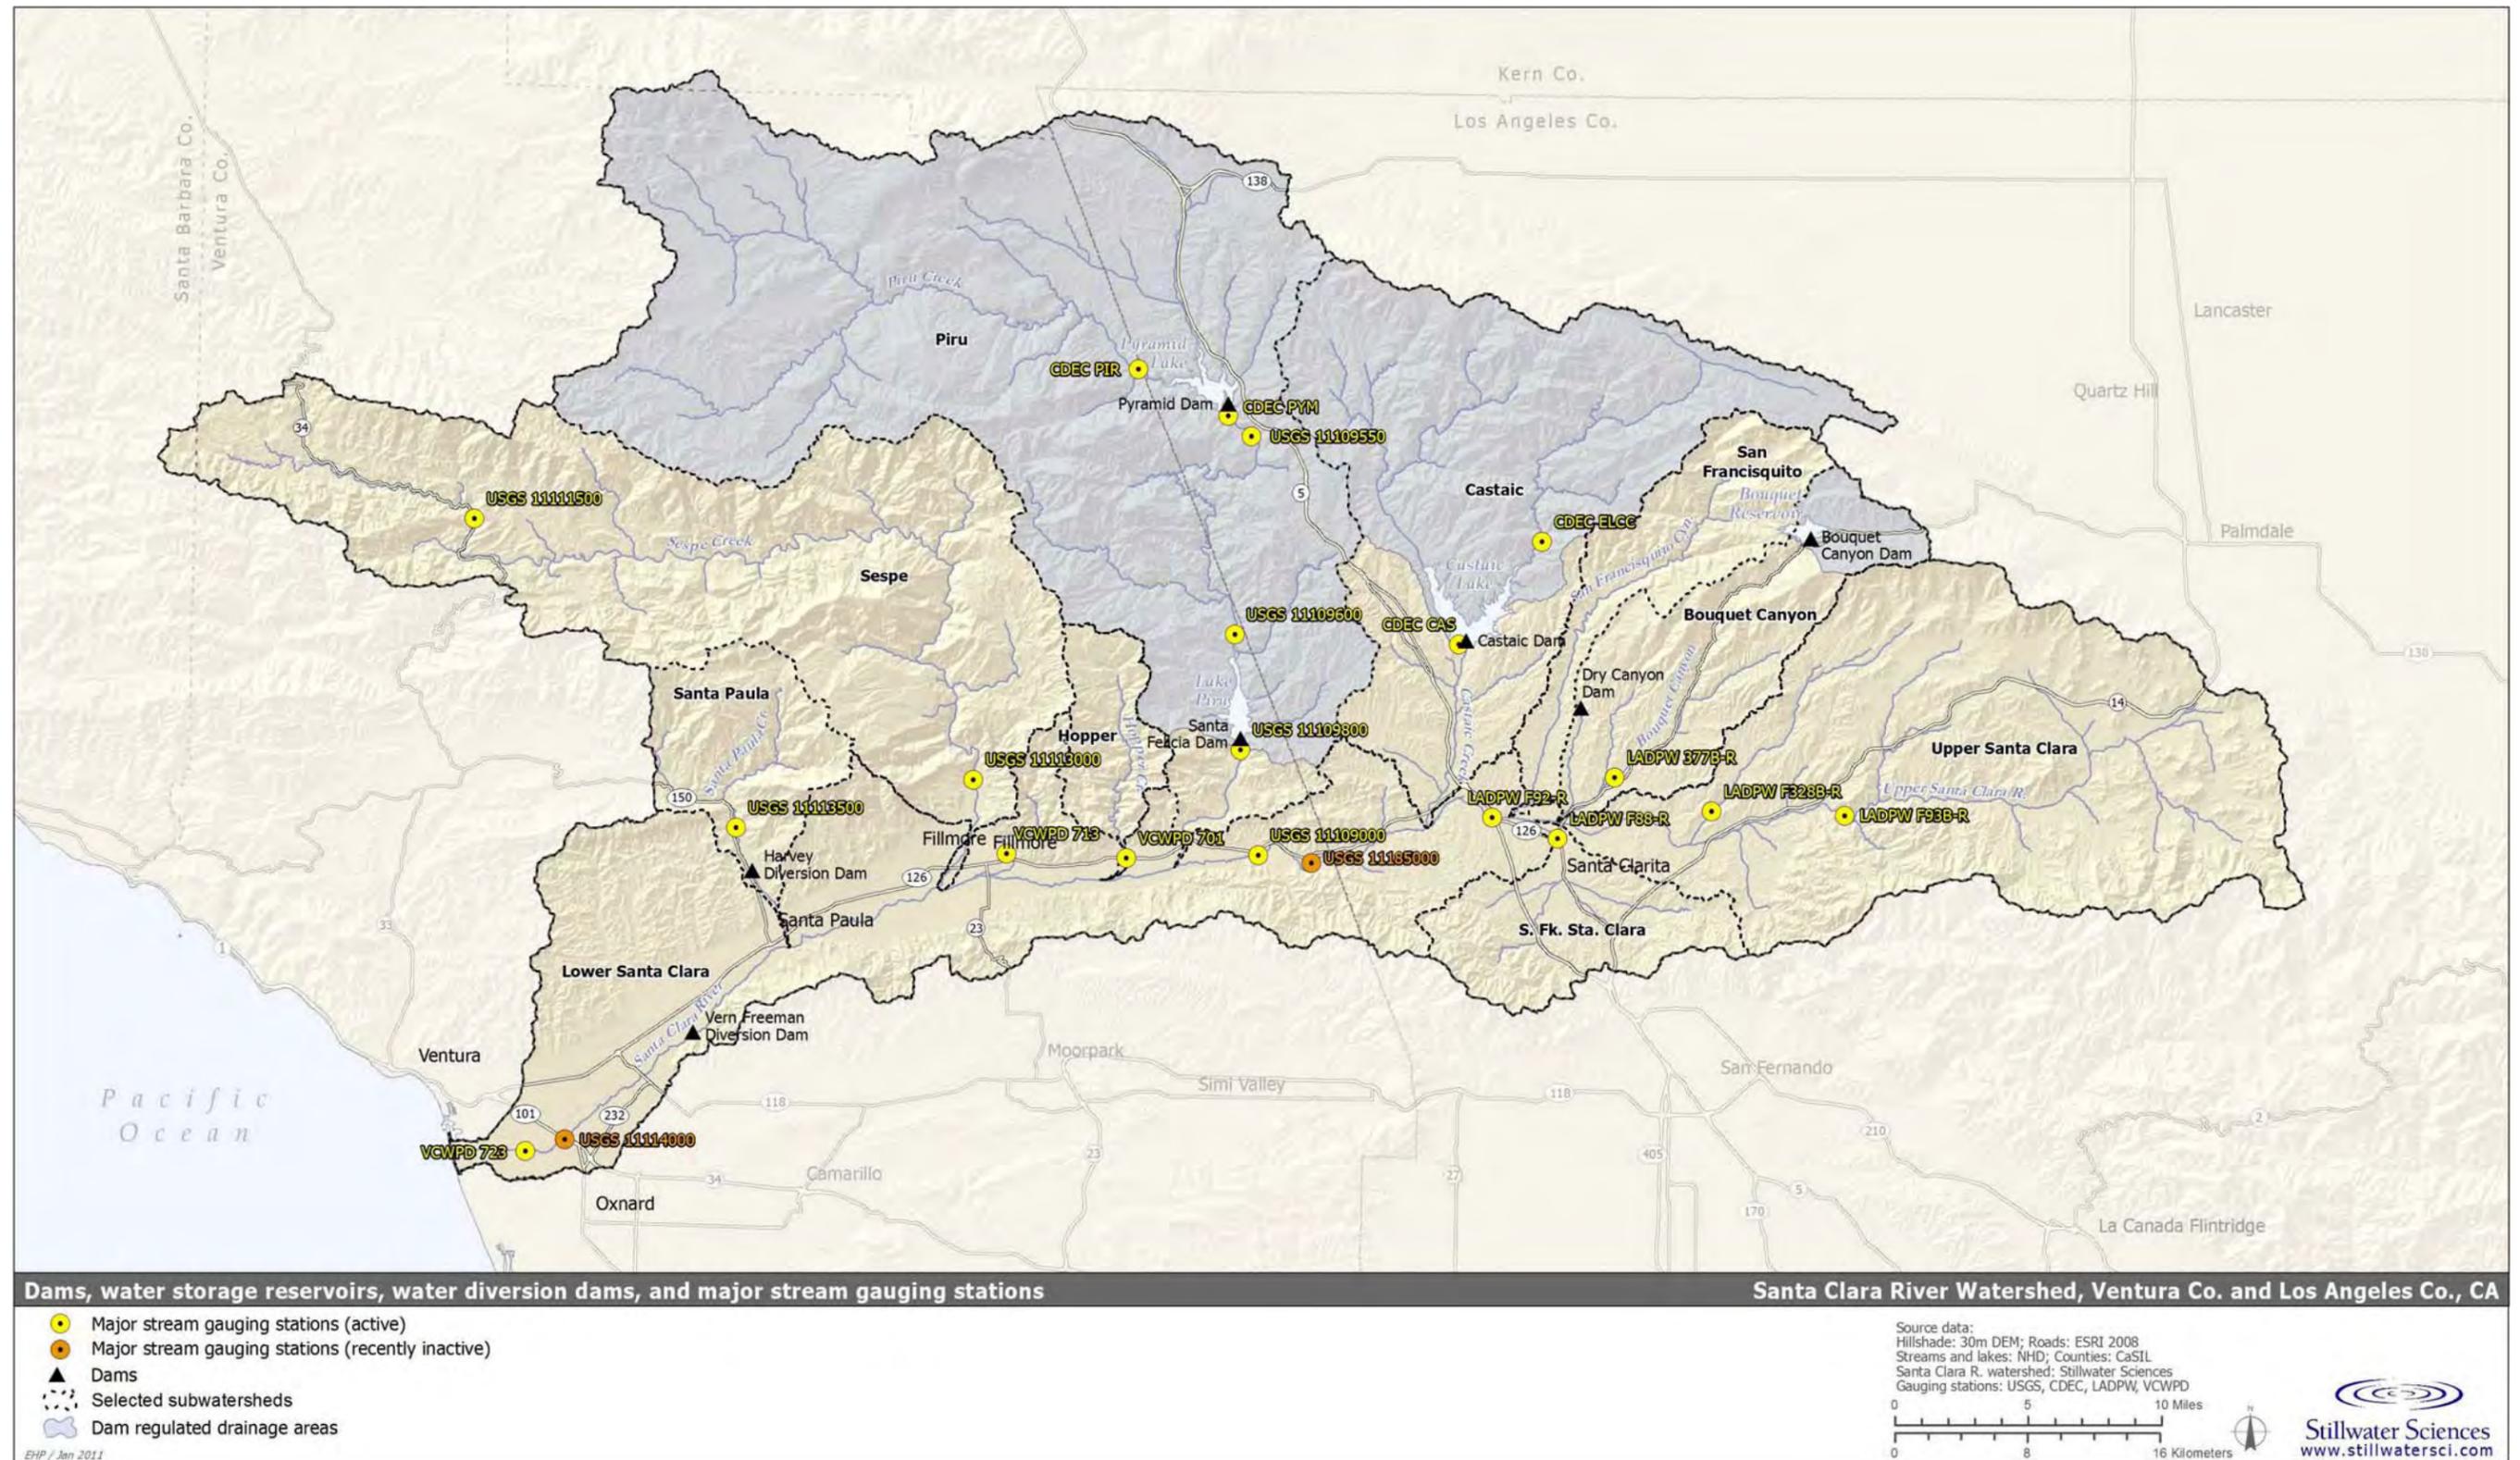
Figure 1-6. Dams, water supply reservoirs, regulated drainages, diversions, and stream gauges in the SCR watershed.

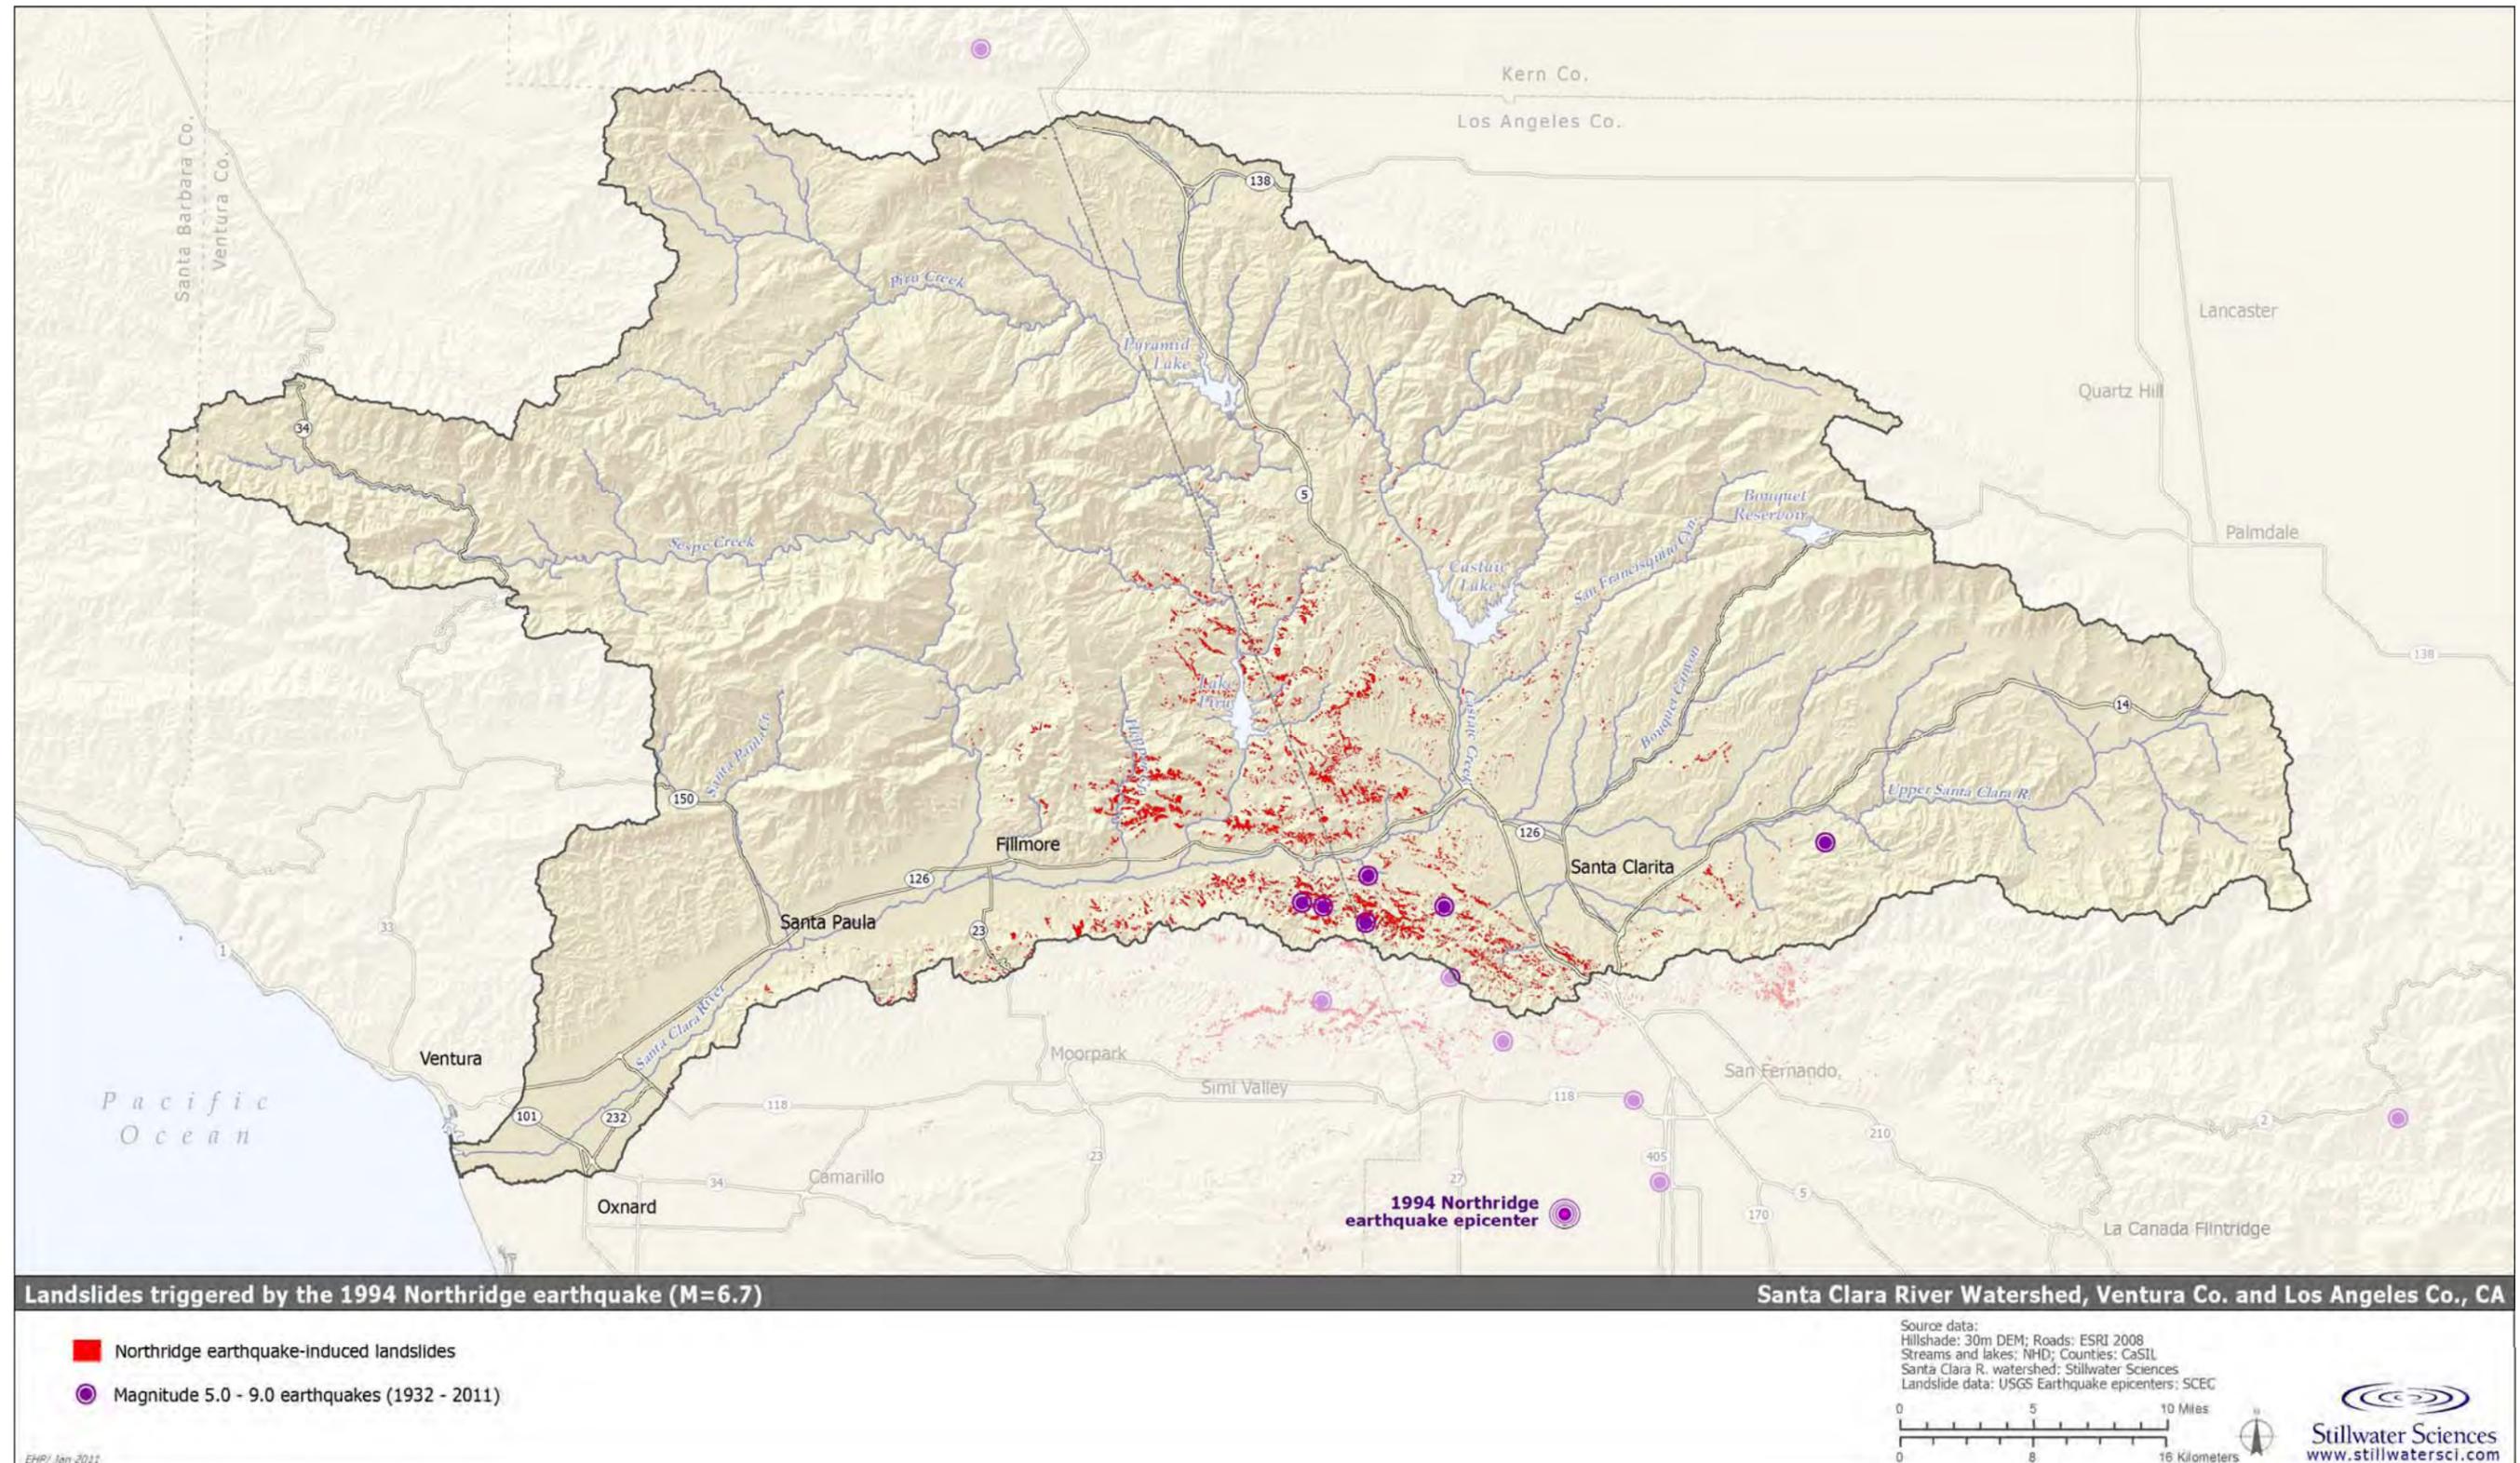
Figure 3-2. Landslides triggered by the 1994 Northridge earthquake (M=6.7). Nearly 7,400 landslides occurred in the SCR watershed. Epicenters of other earthquakes of M 5.0-9.0 recorded since 1932 are also shown.

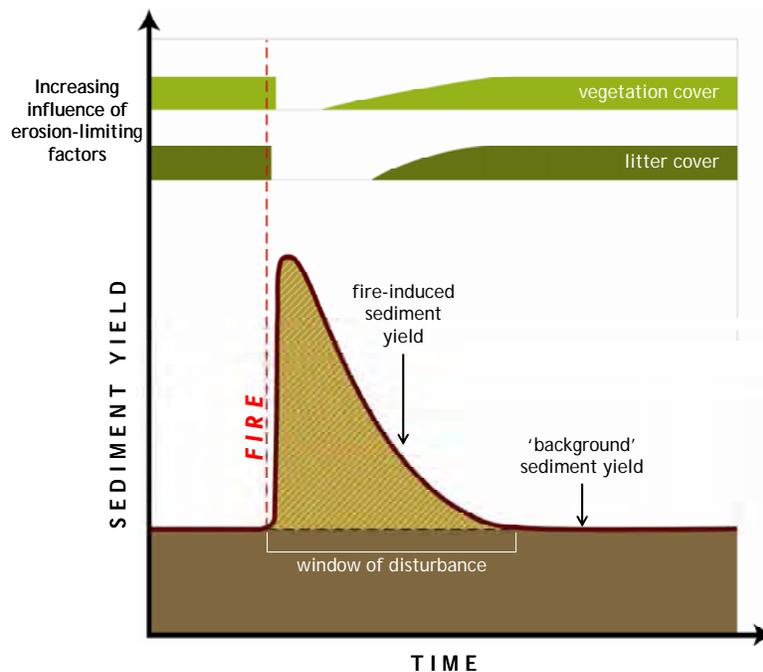
Figure 3-5. Conceptualization of sediment yield and associated vegetation and litter recovery during the fire-induced “window of disturbance” (based on Shakesby and Doerr 2006).

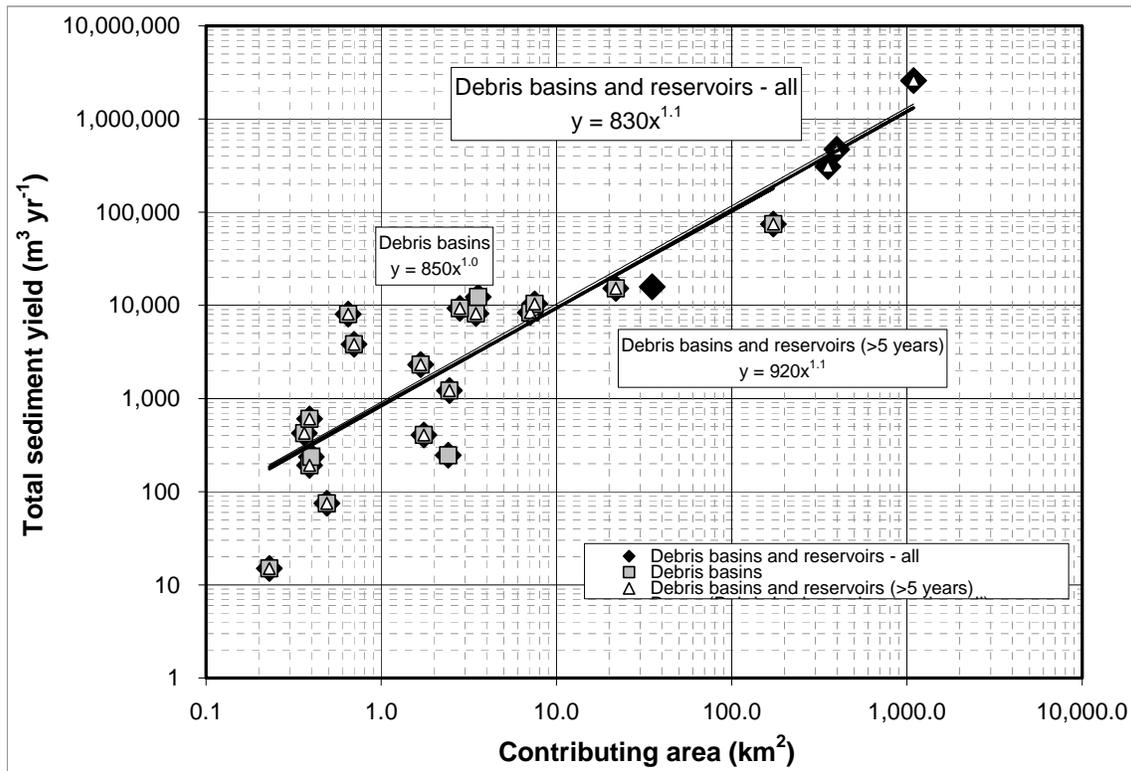
Figure 3-7. Relationship of estimated sediment yields from debris basins and reservoirs in the SCR watershed to their contributing watershed area. Original sediment yield values given volumetrically as reported in the debris basin and reservoir sedimentation data sources.

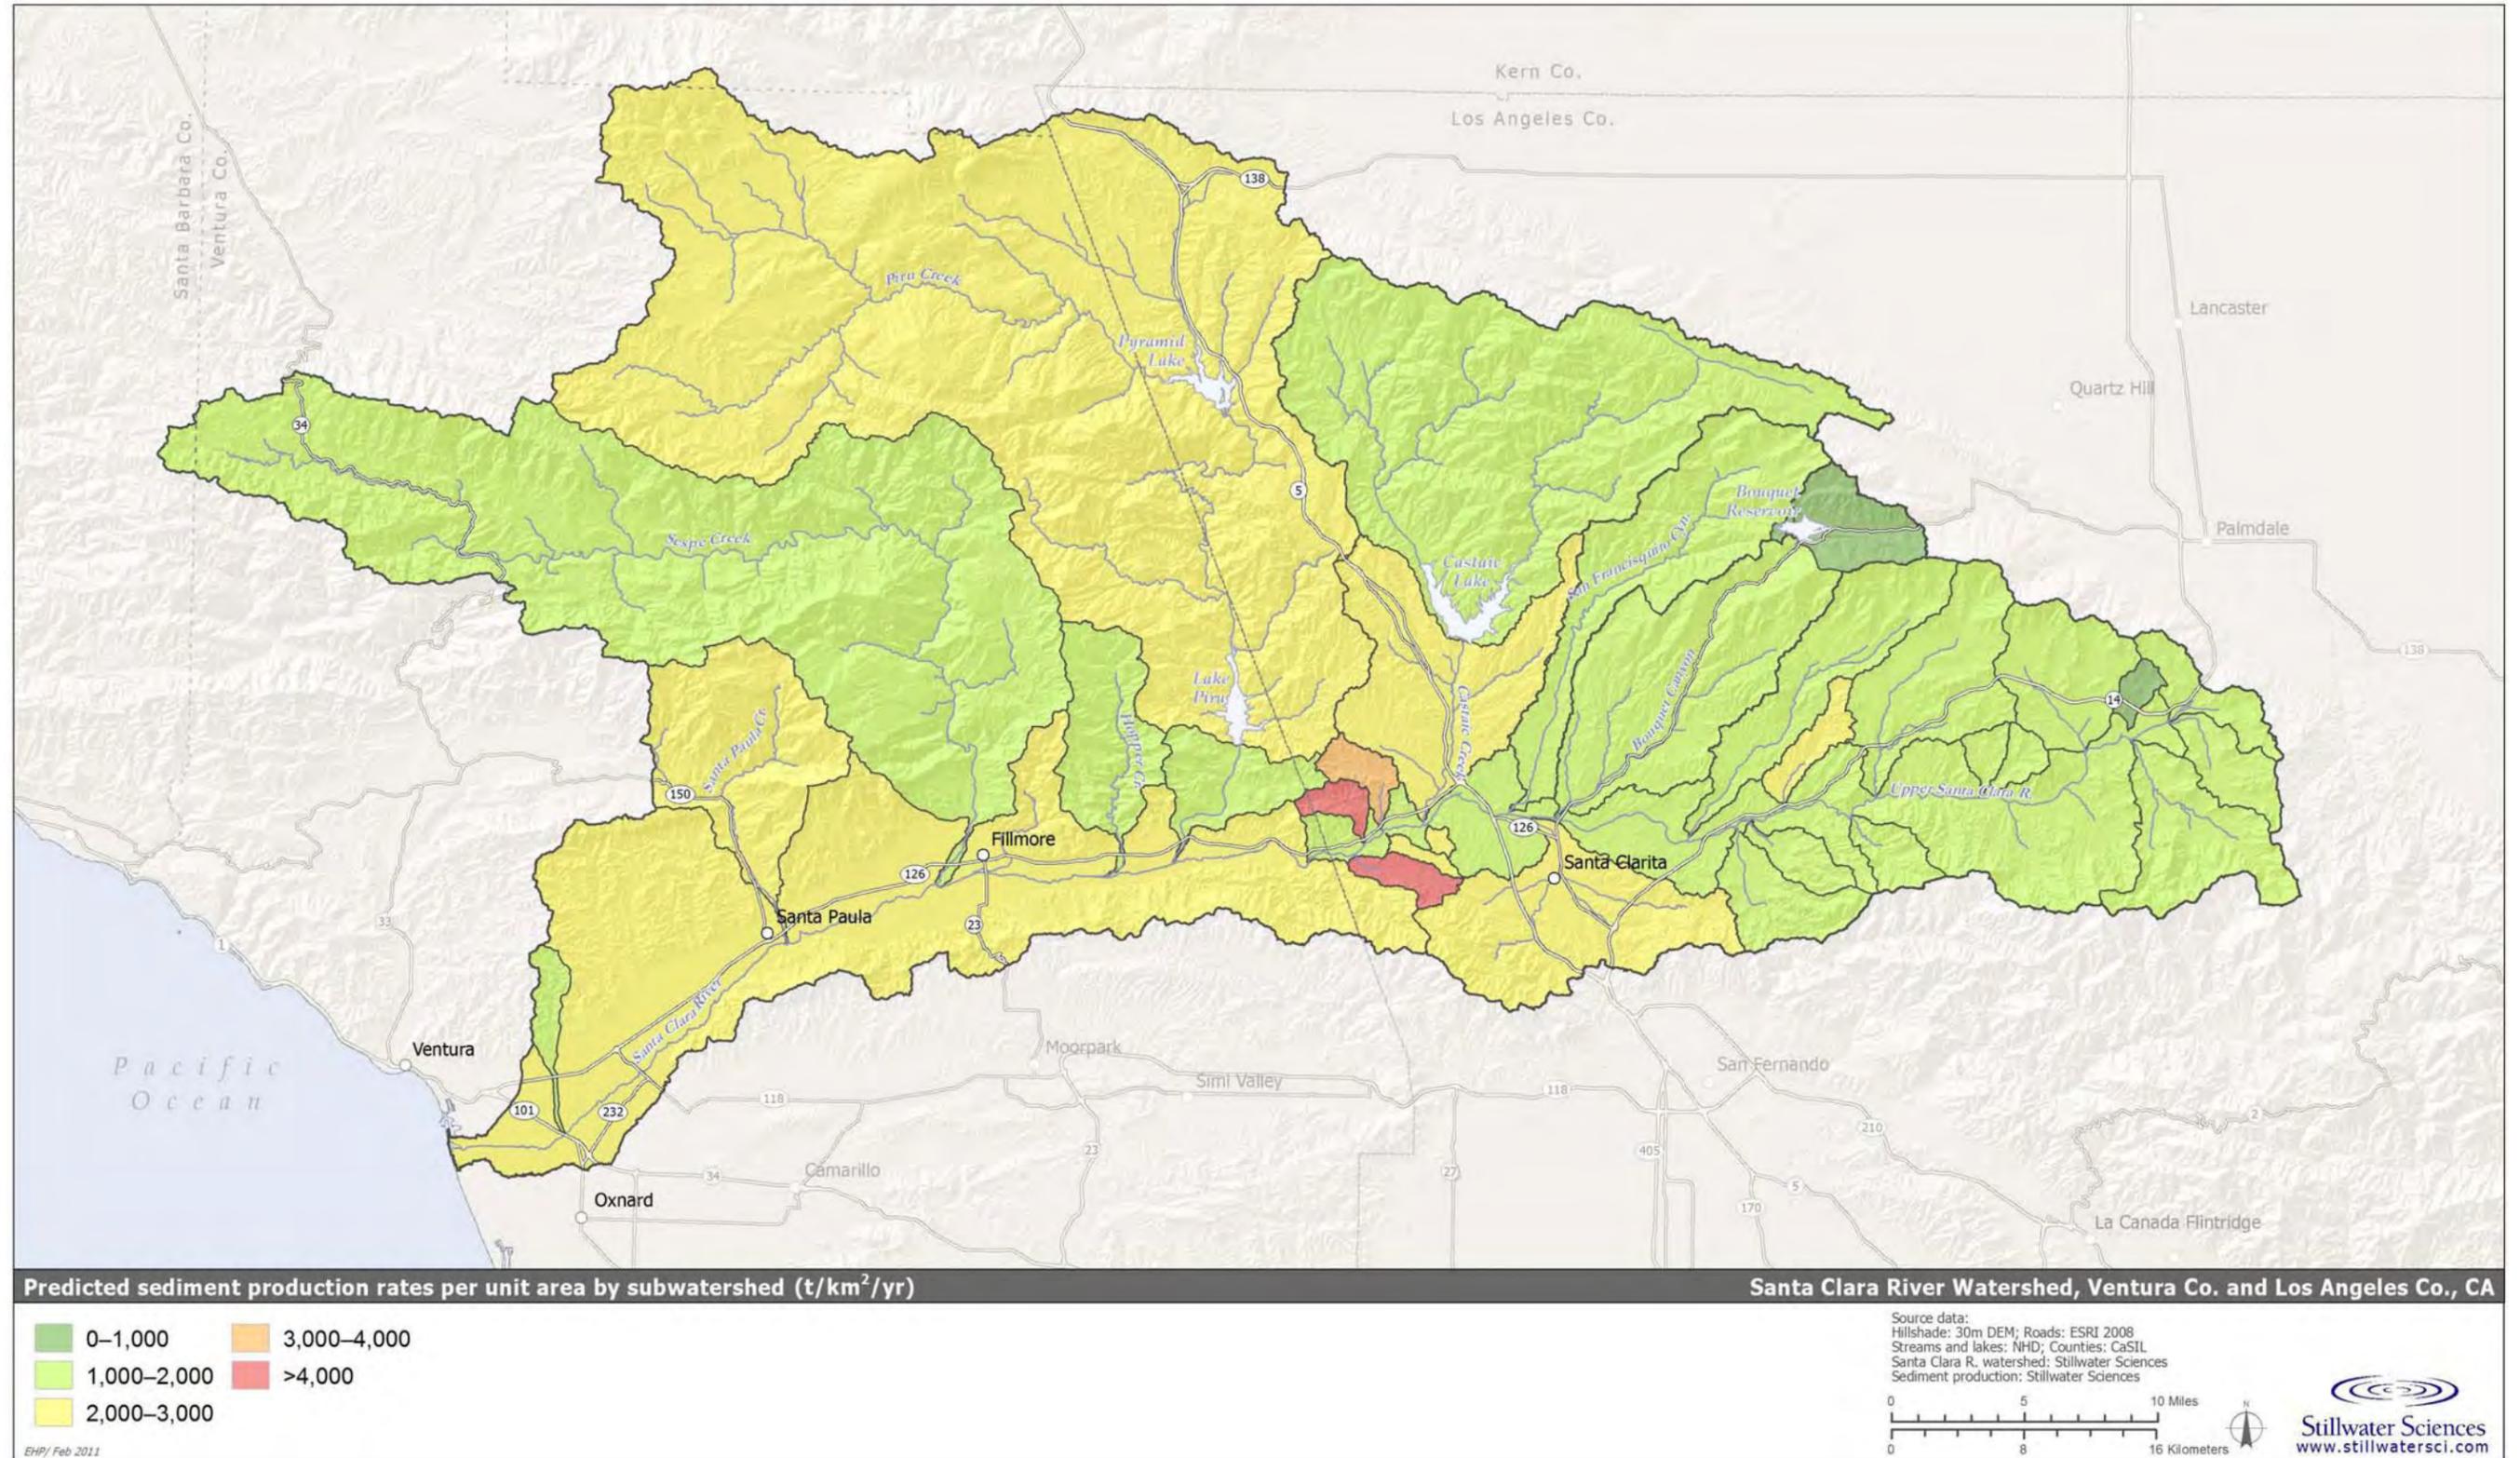
Figure 3-8. Predicted sediment-production rates per unit area by Feasibility Study subwatershed in the SCR watershed.

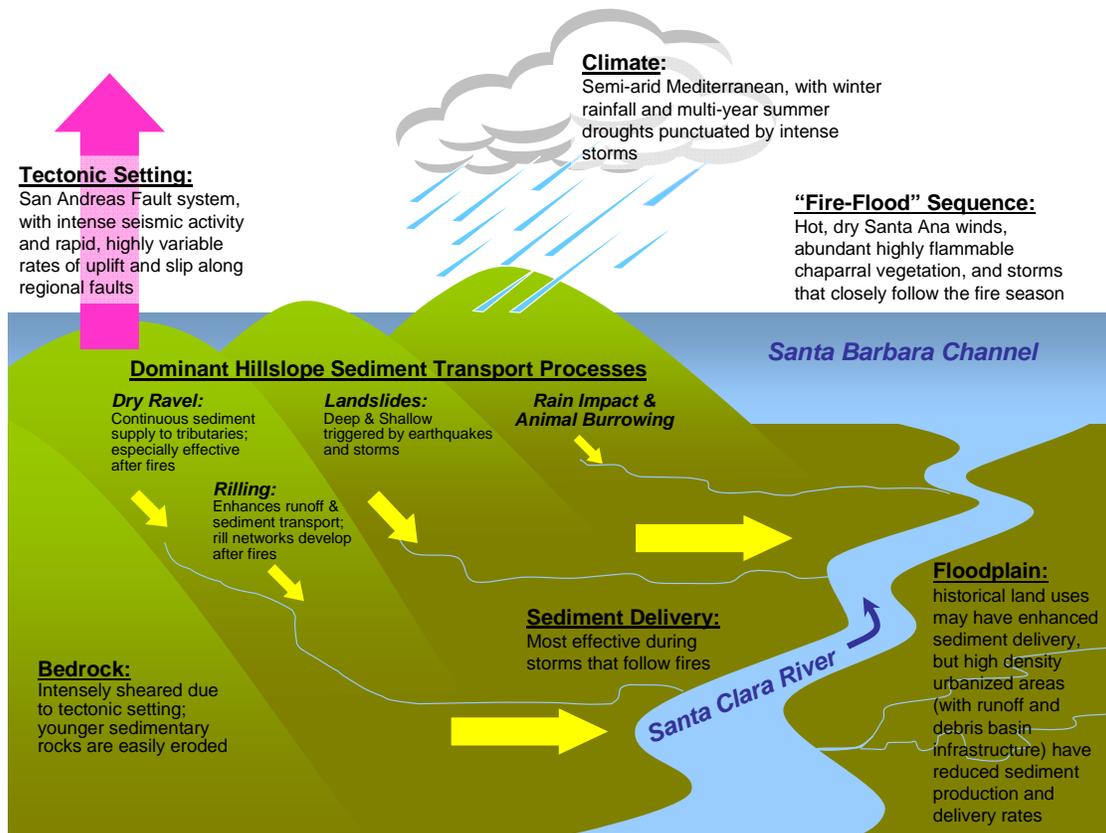
Figure 3-10. Illustration of conceptual model of hillslope processes in the SCR watershed.

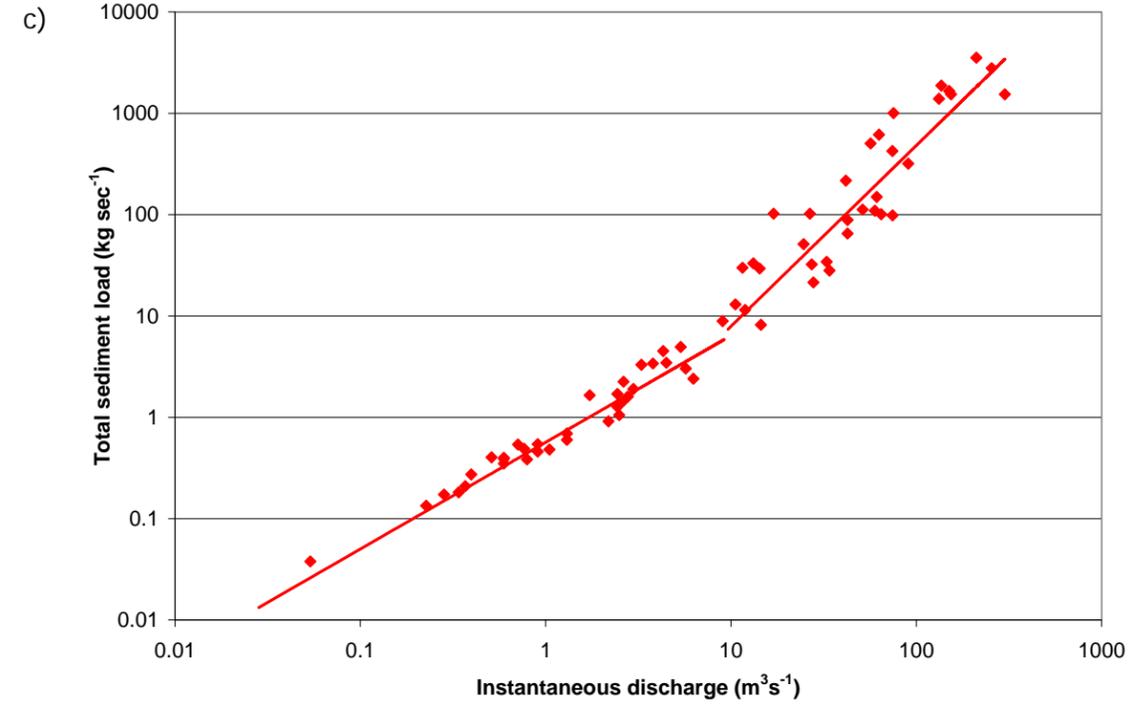
Figure 4-1c. Total sediment load (suspended load + bedload) rating curve for the USCR at the County line (USGS 11108500 and 11109000).

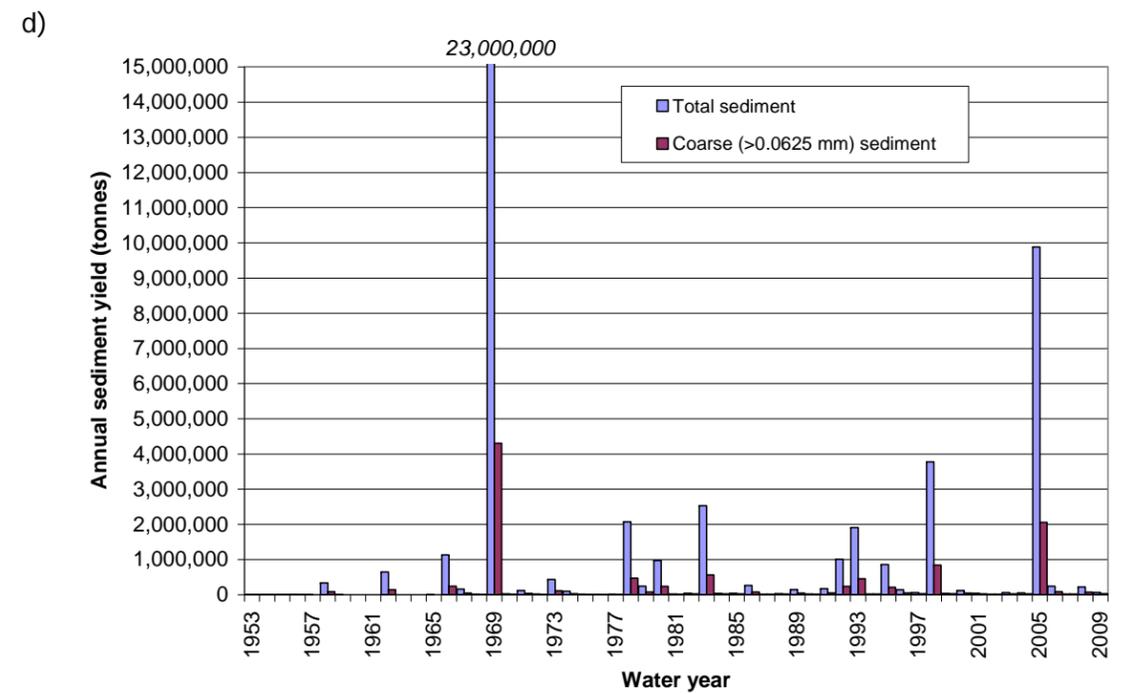
Figure 4-1d. Calculated total sediment yield (suspended load + bedload) and coarse (>0.0625 mm) sediment yield for the USCR at the County line between 1953 and 2009 (USGS 1118500 and 11109000).

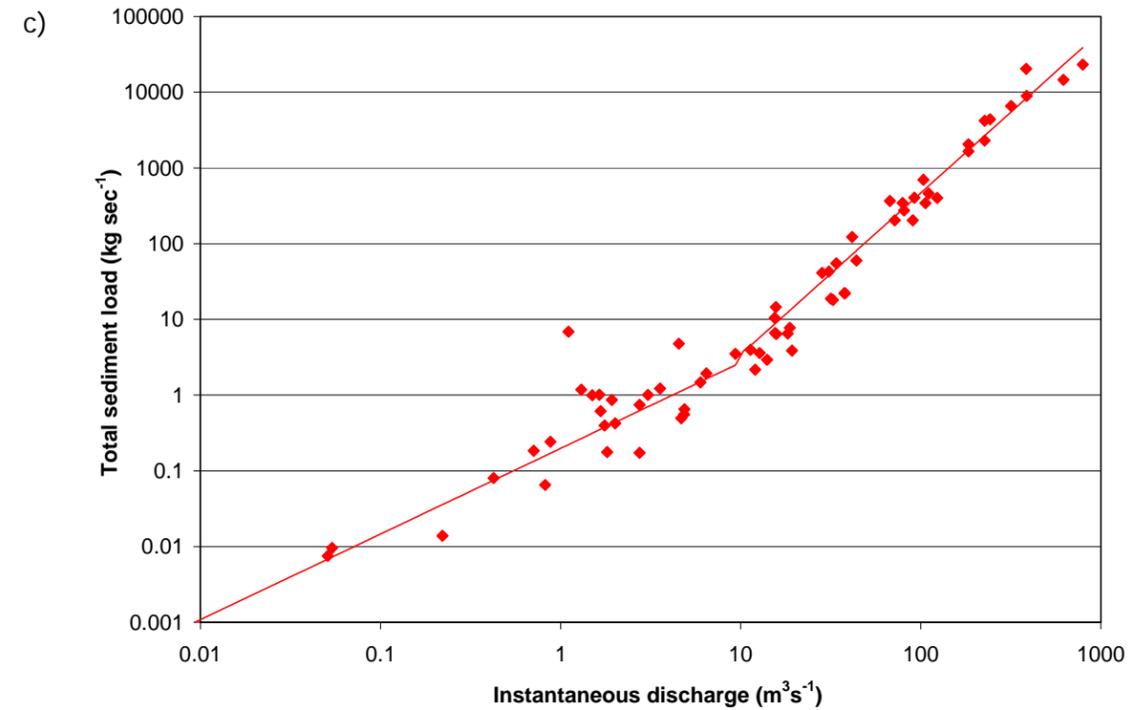
Figure 4-2c. Total sediment load (suspended load + bedload) rating curve for Sespe Creek near Fillmore (USGS 11113000).

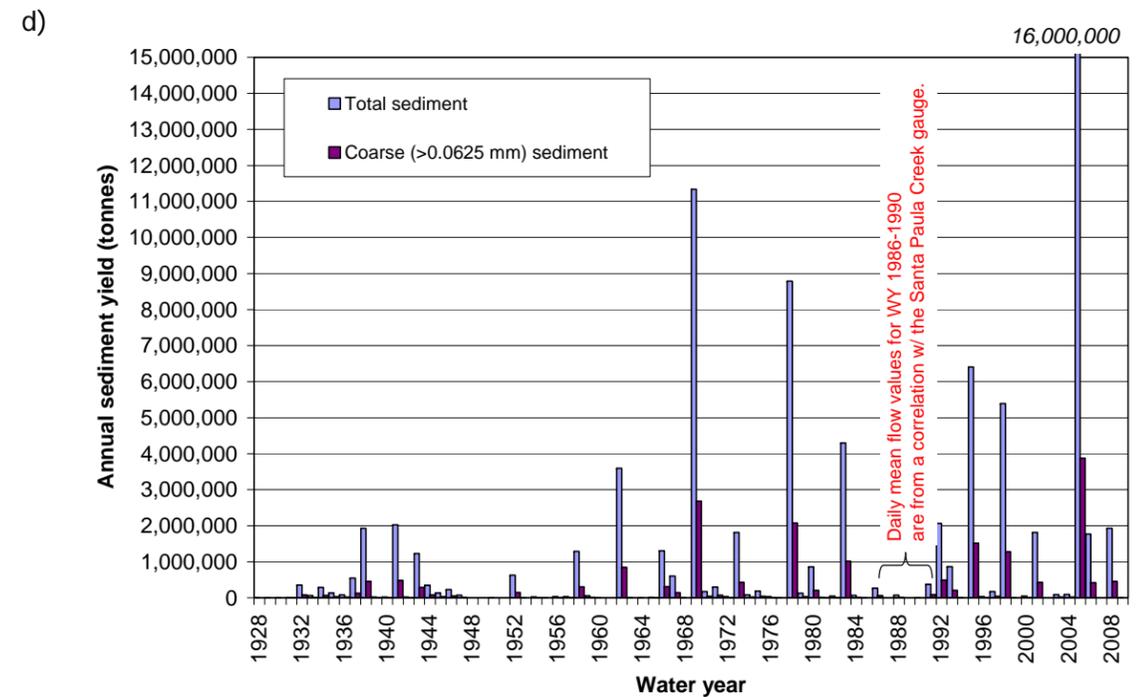
Figure 4-2d. Calculated total sediment yield (suspended load + bedload) and coarse (>0.0625 mm) sediment yield for Sespe Creek near Fillmore between 1928 and 2009 (USGS 11113000).

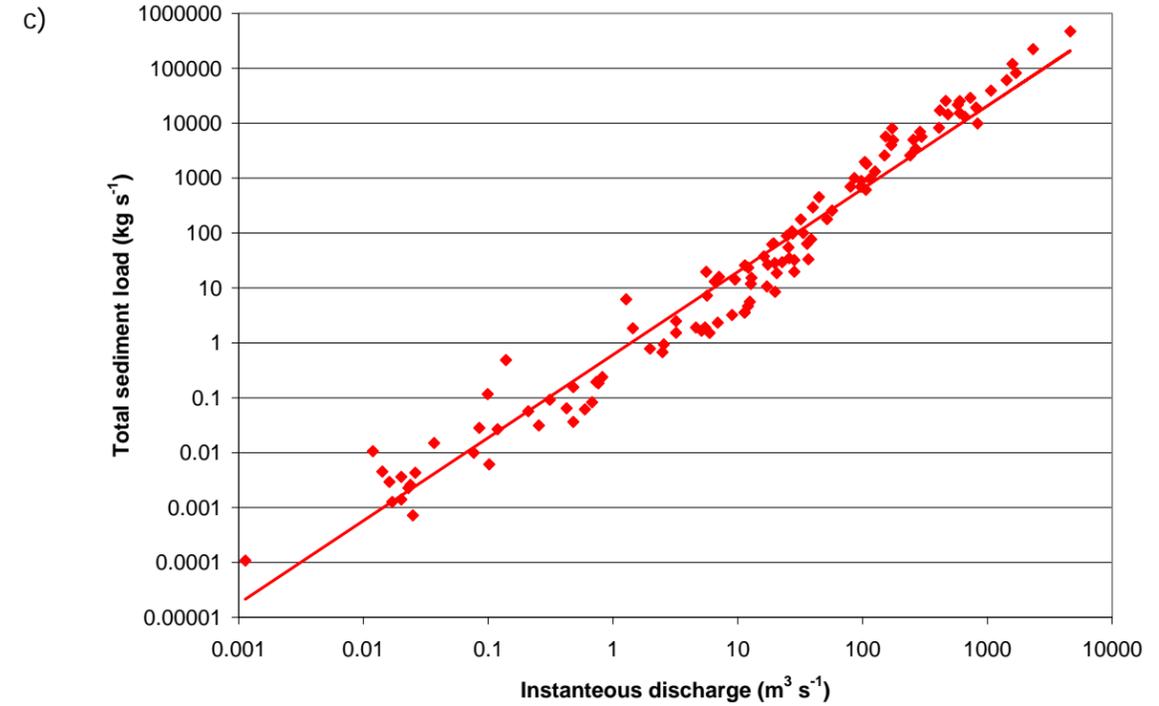
Figure 4-3c. Total sediment load (suspended load + bedload) rating curve for the LSCR at Montalvo (USGS 11114000).

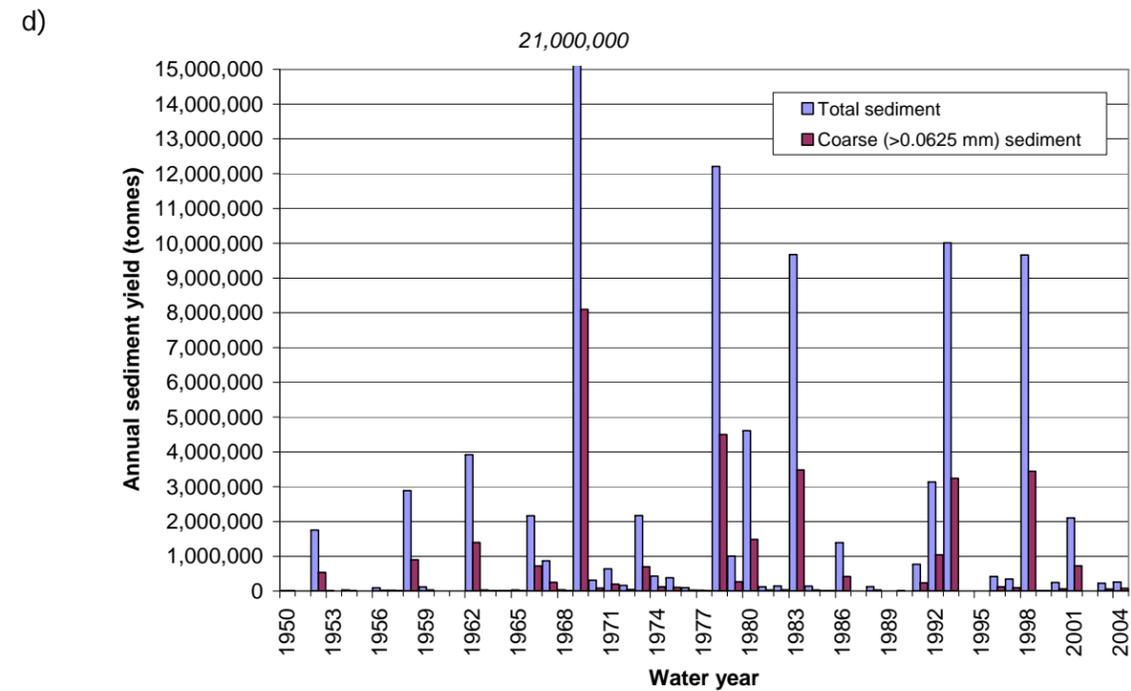
Figure 4-3d. Calculated total sediment yield (suspended load + bedload) and coarse (>0.0625 mm) sediment yield for the LSCR at Montalvo between 1950 and 2004 (USGS 11114000).
