Geomorphic Assessment of the Santa Clara River Watershed, Synthesis of the Lower and Upper Watershed Studies

Ventura and Los Angeles Counties, California

April 2011

Prepared by
Stillwater Sciences
2855 Telegraph Avenue, Suite 400
Berkeley, CA 94705

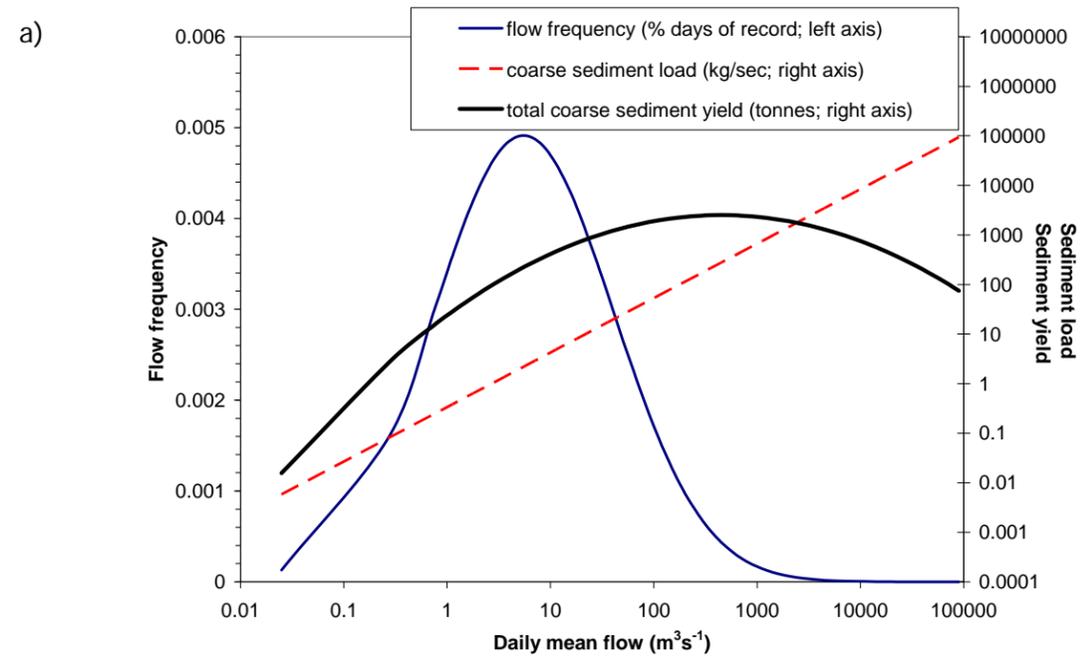
Figure 4-4a. Flow frequency (left axis, scaled to 1) and sediment load (right axis) plotted against flow, showing conceptual, dominant discharge model of an idealized alluvial river by Wolman and Miller (1960). Blue line tracks flow frequency (for mean daily flow), red line tracks sediment transport rate (in tonnes/day) and black line tracks total sediment load (in tonnes). Sediment load increases to a maximum at an intermediate flow.

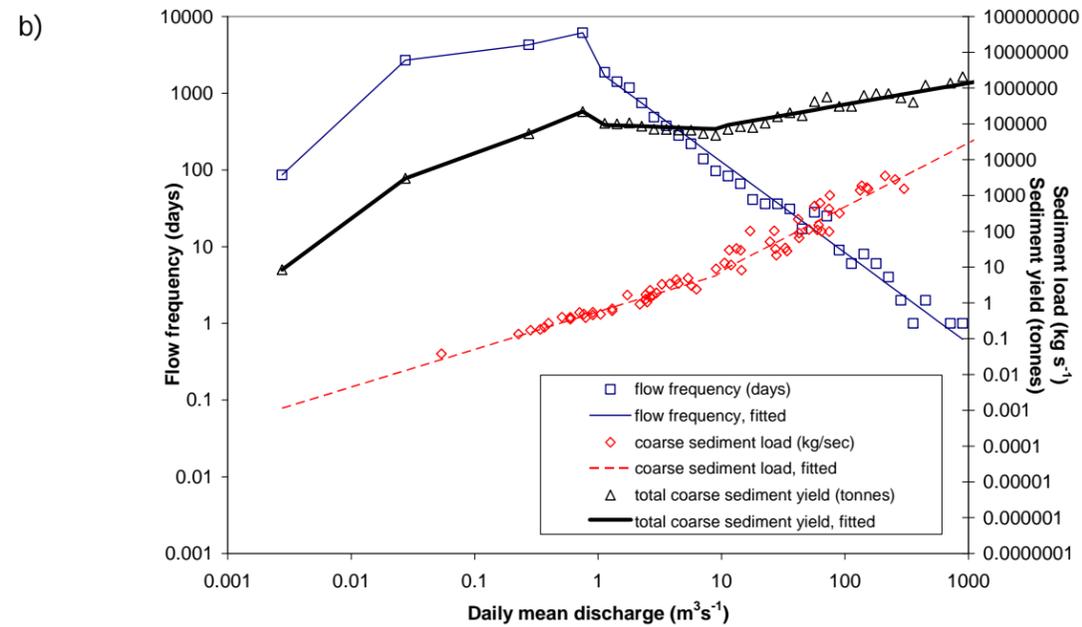
Figure 4-4b. Flow frequency and coarse (>0.0625 mm) sediment load for long-term daily mean flow record for USCR at the County line (USGS 1118500 and 11109000). Unlike classic alluvial rivers, the variation of sediment yield with flow does not exhibit a peak at “intermediate” discharges (as defined by the range of flows seen over the last century), but increases with increasing flood frequency without (heretofore observed) bounds.

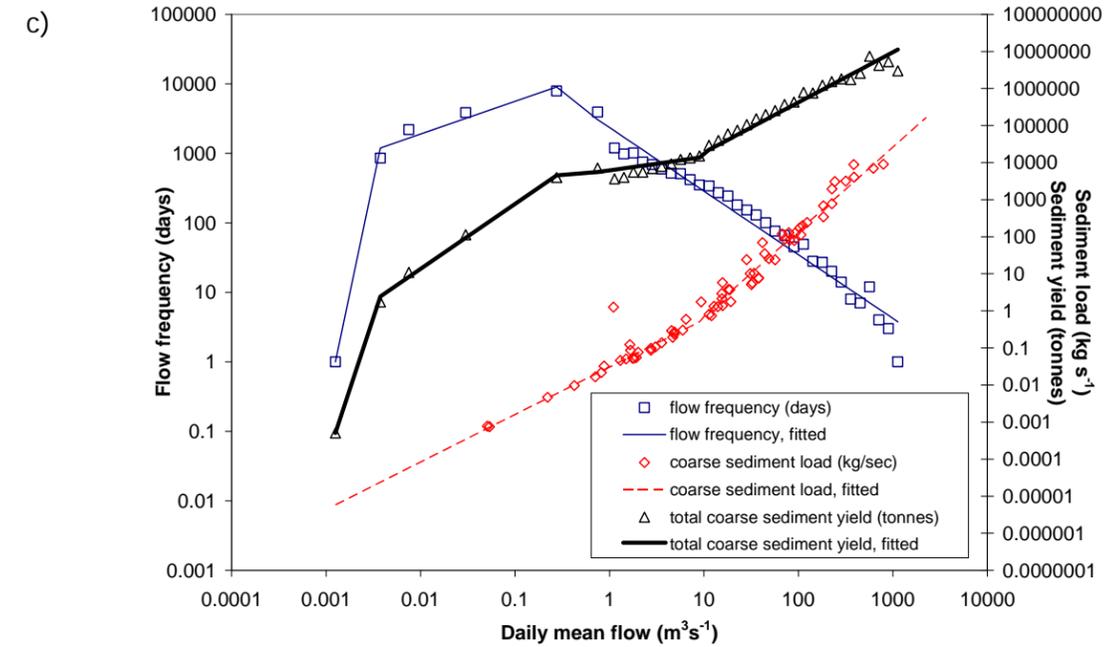
Figure 4-4c. Flow frequency and coarse (>0.0625 mm) sediment load for long-term daily mean flow record for Sespe Creek near Fillmore (USGS 11113000). Note: the daily mean flow values for WY 1986-1990 were absent for this gauge, but were derived here based on a correlation ($R^2=0.86$) with the Santa Paula Creek gauge (USGS 11113500). Unlike classic alluvial rivers, the variation of sediment yield with flow does not exhibit a peak at “intermediate” discharges (as defined by the range of flows seen over the last century).

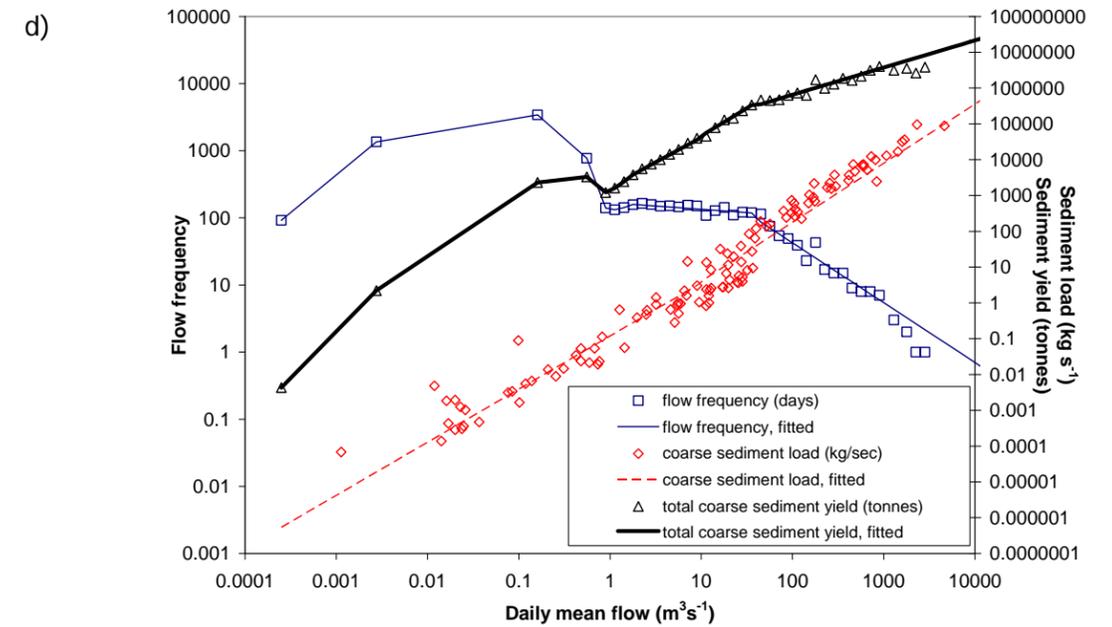
Figure 4-4d. Flow frequency and coarse (>0.0625 mm) sediment load for long-term daily mean flow record for LSCR at Montalvo (USGS 11114000). Unlike classic alluvial rivers, the variation of sediment yield with flow does not exhibit a peak at “intermediate” discharges (as defined by the range of flows seen over the last century).

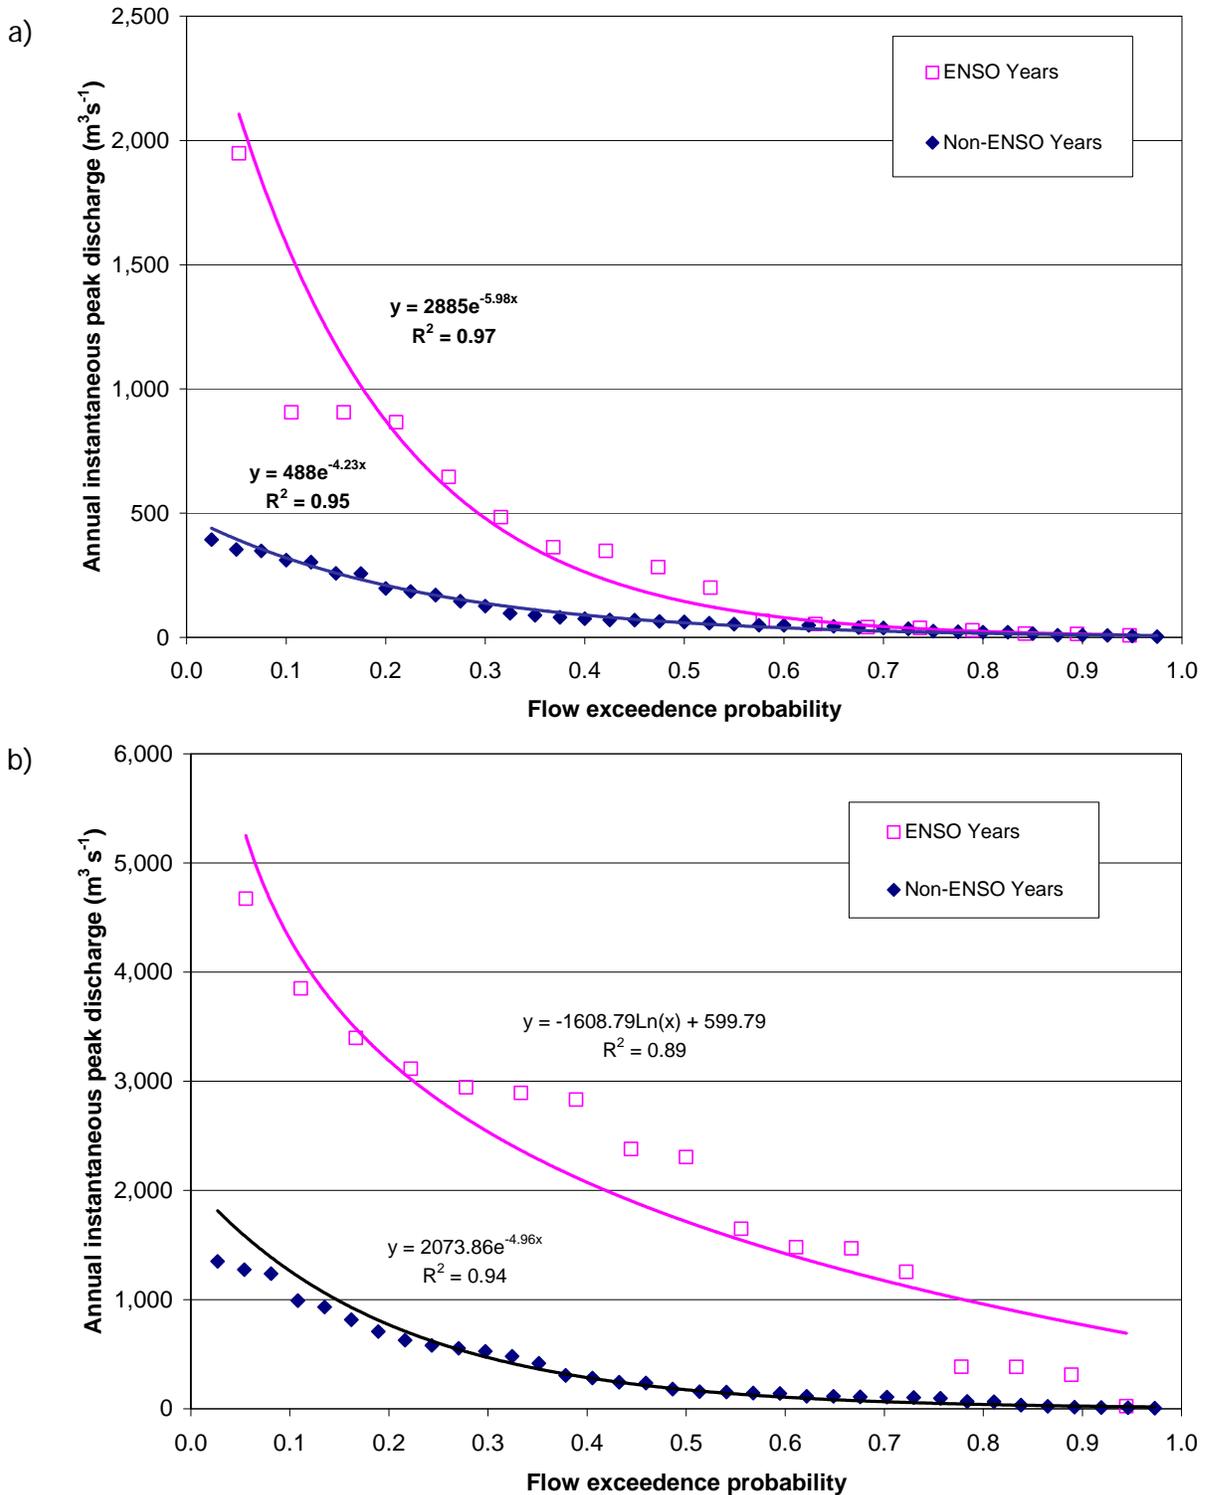
Figure 4-5. Flow exceedance for ENSO/non-ENSO years for the USCR at the County line (USGS 1118500 and 11109000) from WY 1953-2009 (a), and for the LSCR at Montalvo (USGS 11114000) from WY 1950-2005 (b). Instantaneous peak discharge from 2005 for the LSCR is from an estimated value at the Freeman Diversion Dam.

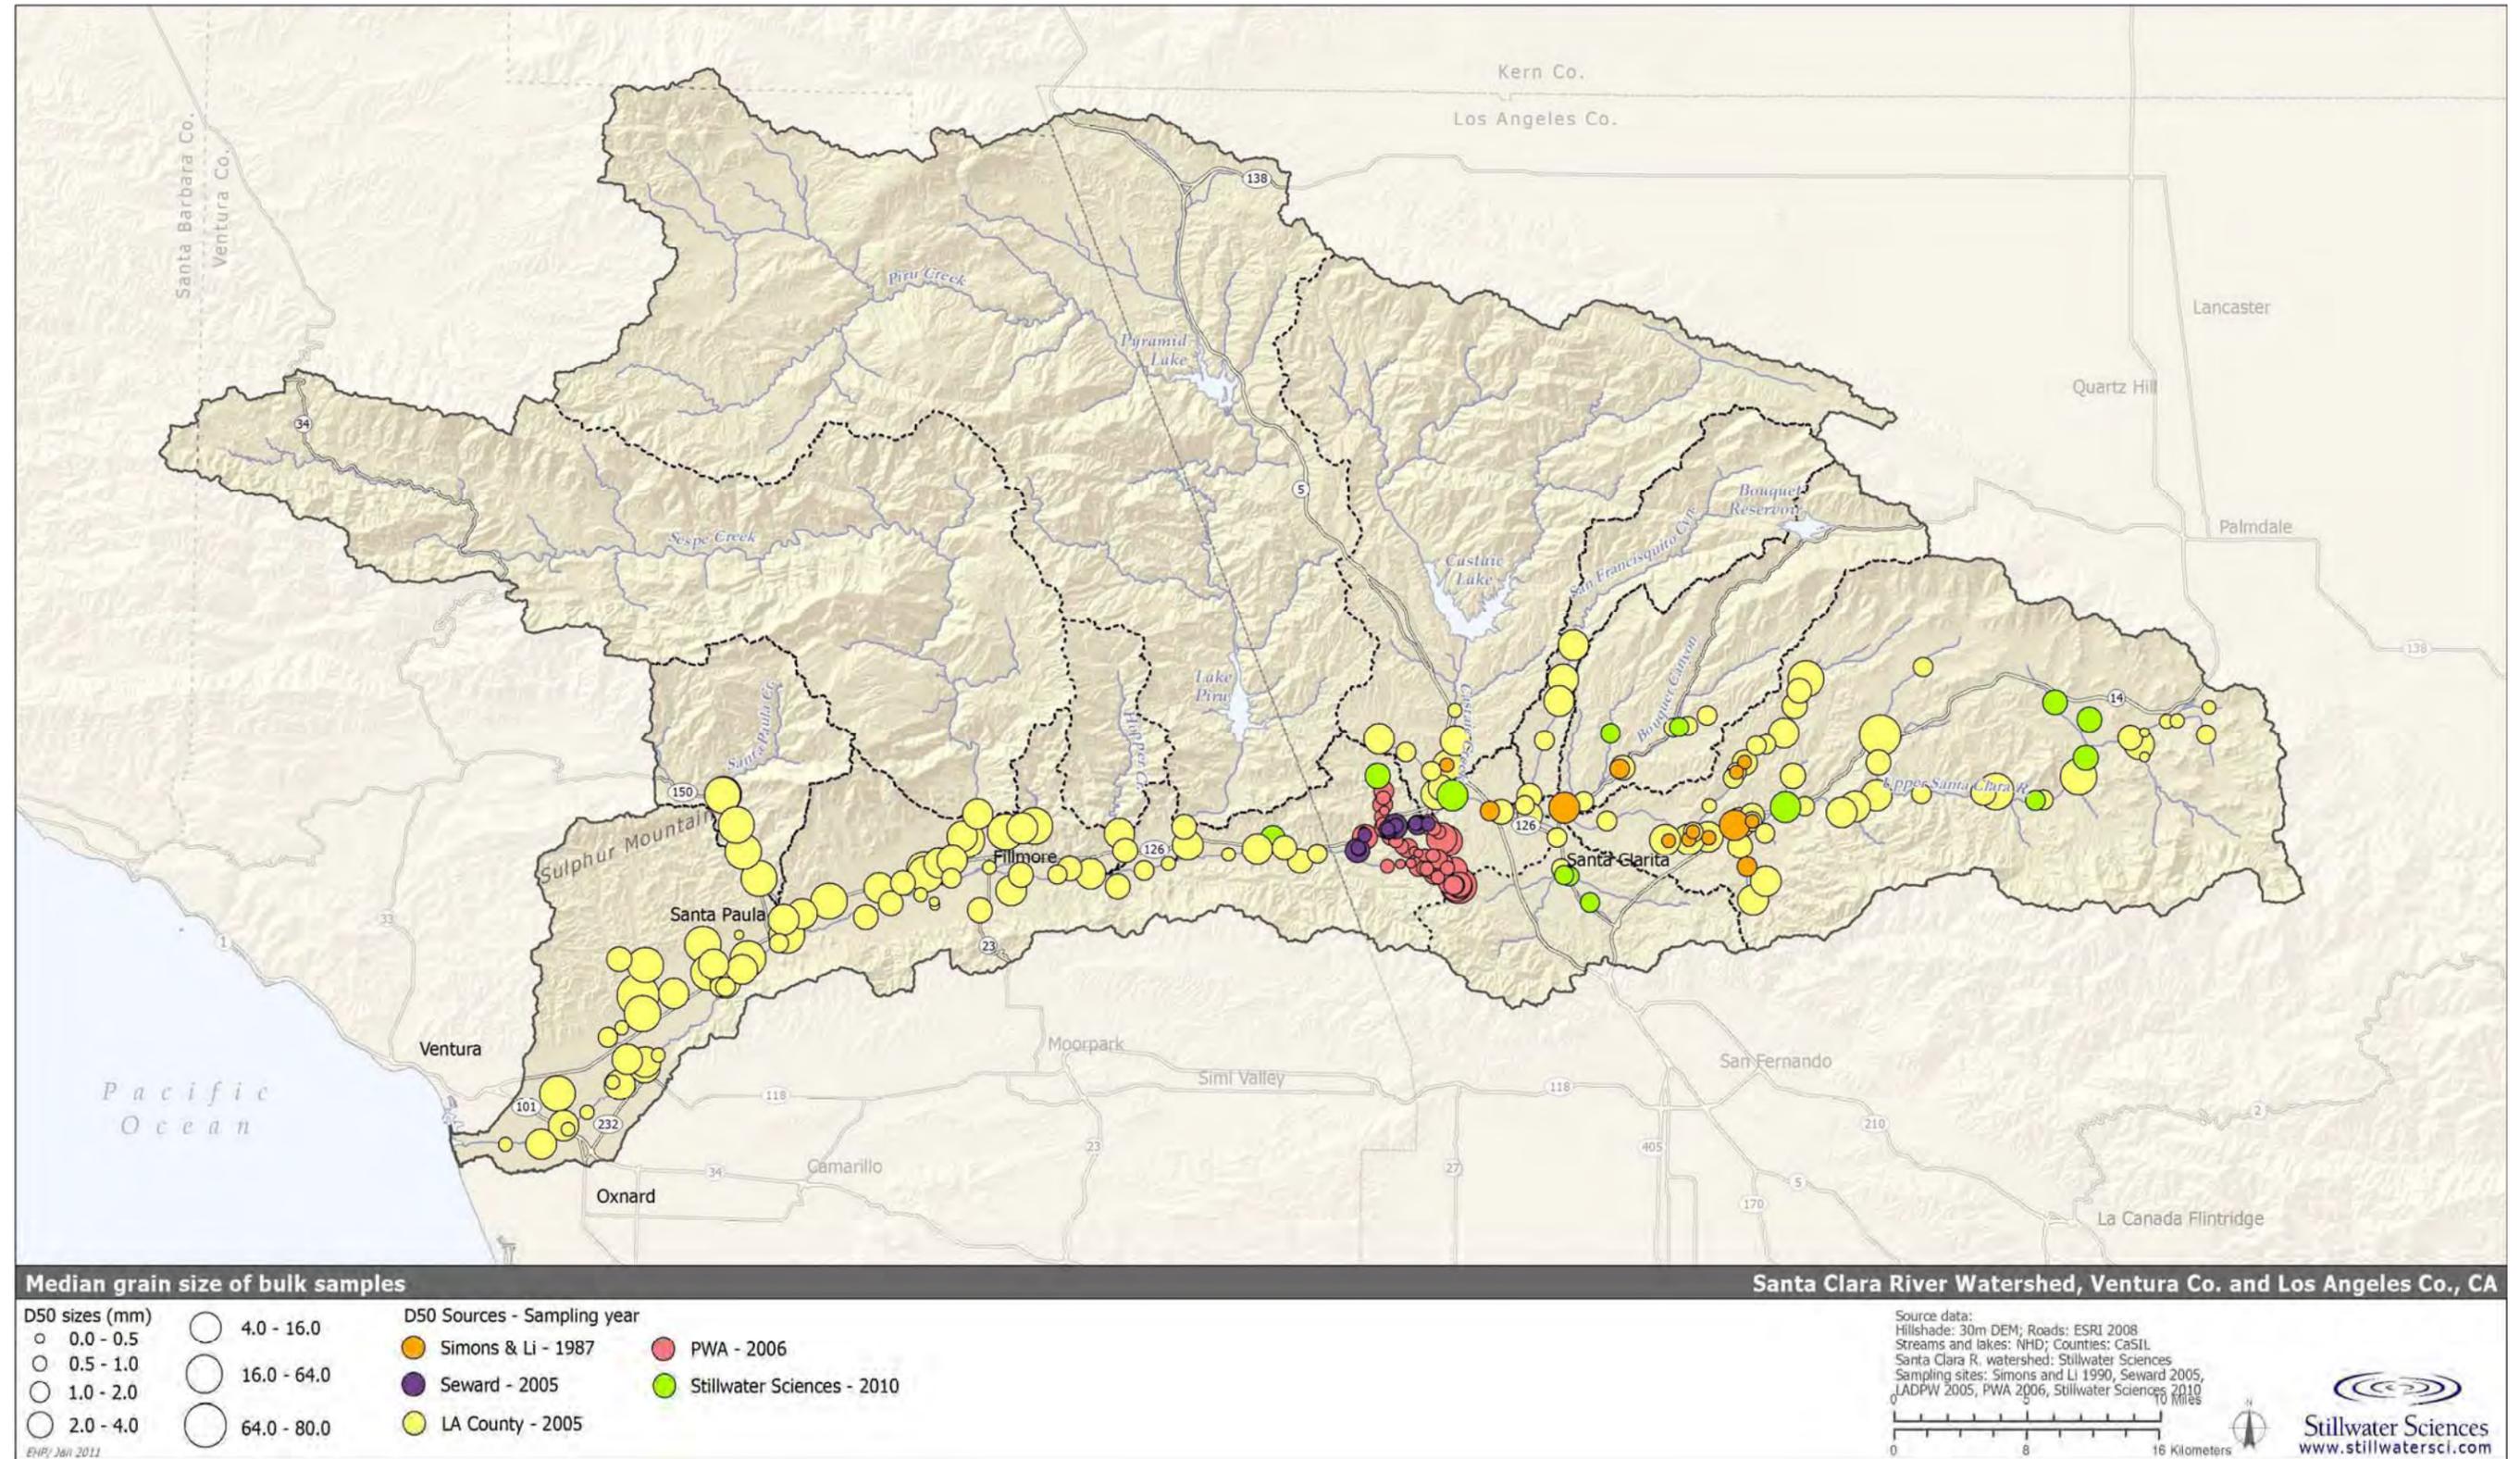
Figure 4-6. Median grain size (D_{50}) of bulk sediment samples collected throughout the SCR watershed.

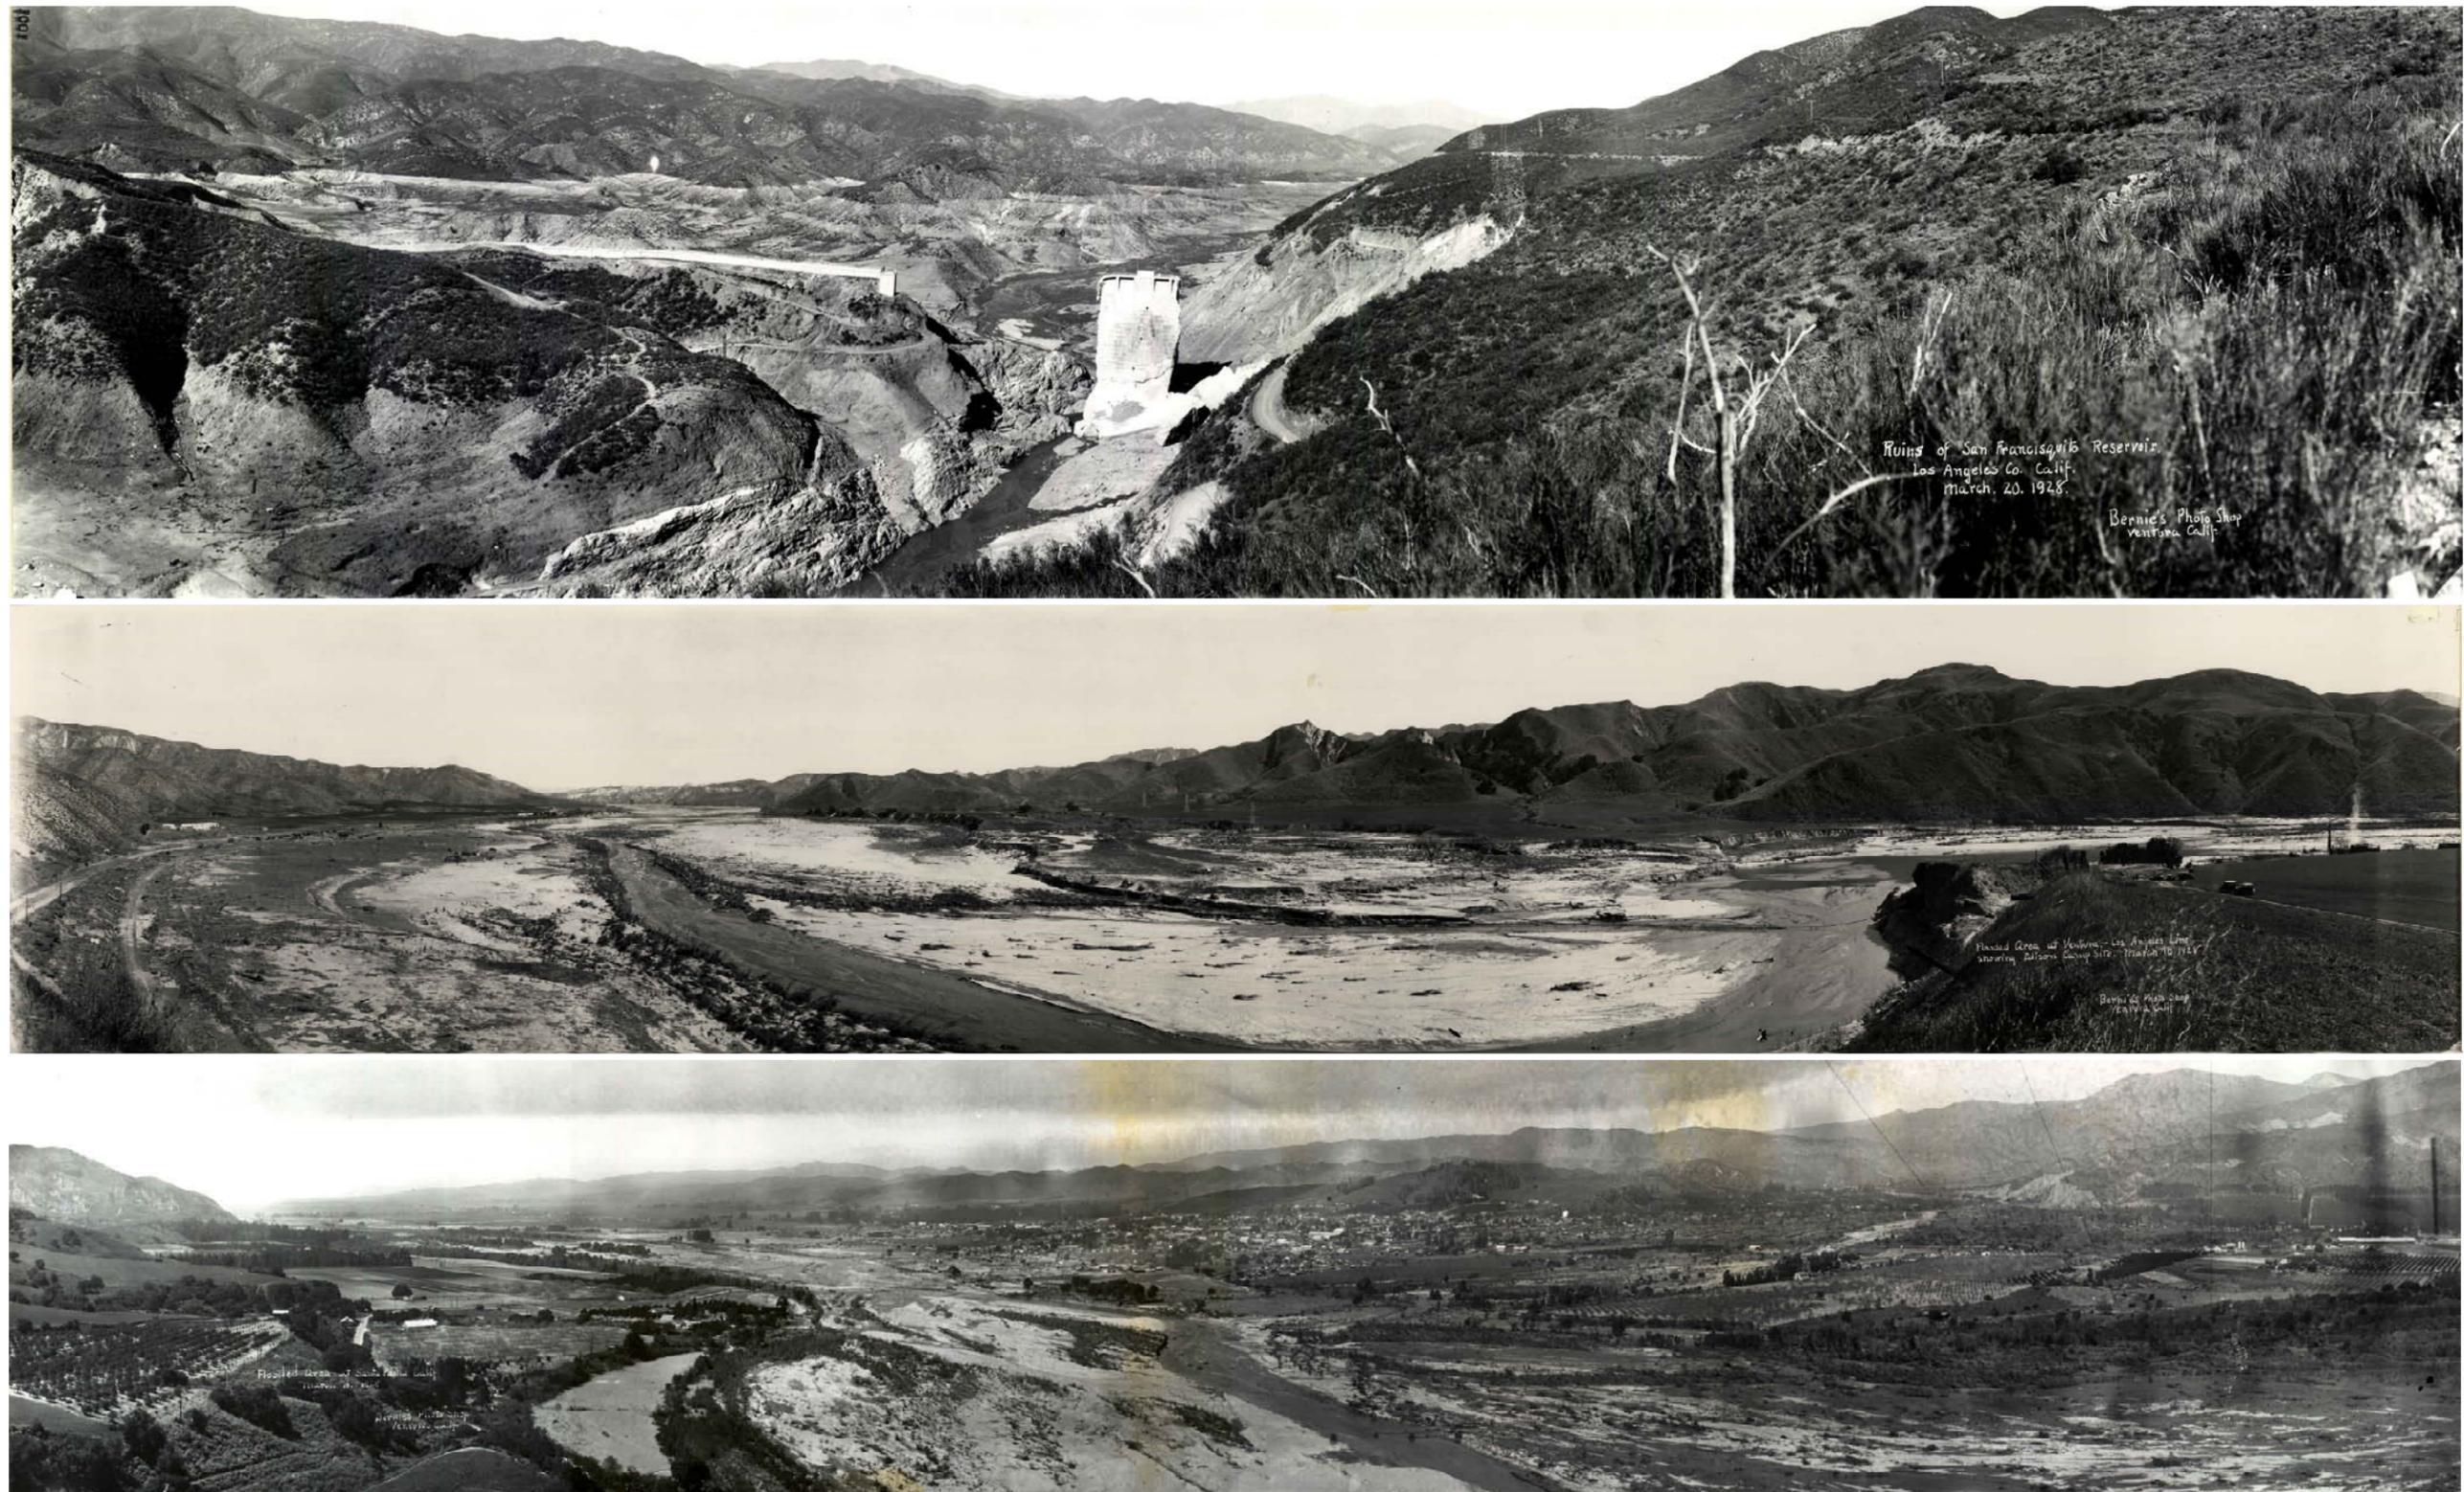
Figure 4-7. The remains of the St. Francis Dam after collapsing just before midnight on March 12, 1928, in the San Francisquito Canyon subwatershed (top). Middle, a downstream view of the mainstem Santa Clara River near the County line, five days after the dam break flood. Below, a downstream view of the mainstem SCR near Santa Paula Creek, the day after the dam break flood. Photos courtesy of the VCWPD.

Francisquito Canyon; however, the dam failed catastrophically in March 1928, resulting in one of the largest and most tragic dam failures in United States history. The long-term effects of the St. Francis Dam disaster on the morphology of the entire SCR are not fully known but are potentially significant and ongoing (see Section 4.2). Bouquet Dam was completed in 1934 to impound imported water in Bouquet Reservoir, in the relatively dry northeastern corner of the watershed. After 1955, with the completion of the 61 m (200 ft) high Santa Felicia Dam on Piru Creek (regulating 1,090 km² [421 mi²]) the watershed began to be subjected to an increasing amount of direct flow regulation and channel manipulation. Pyramid and Castaic dams, completed in 1972, retain water imported from northern California. Today, these dams intercept runoff and sediment from approximately 34% of the watershed area (see Sections 3.4 and 4.2). Further, the floodplain and channel along the Santa Clara River Valley and Santa Clarita Basin were increasingly modified, beginning in the 1950s with the dredging of pilot channels, in the 1960s with the construction of the extensive levee system from South Mountain to Highway 101 and, following the flood of 1969, construction of various additional levees, groins, and bank protection projects that continue to the present day.

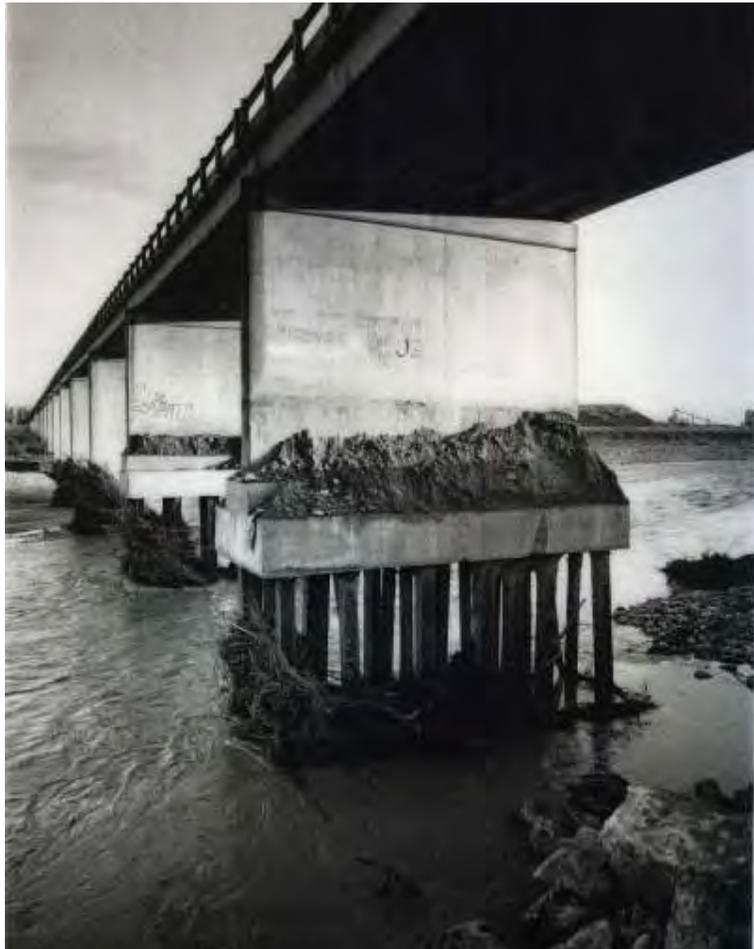
Figure 4-9. Undercutting of the Highway 118 bridge over the SCR as a result of incision following the 1969 floods. (Photo courtesy of the VCWPD.)

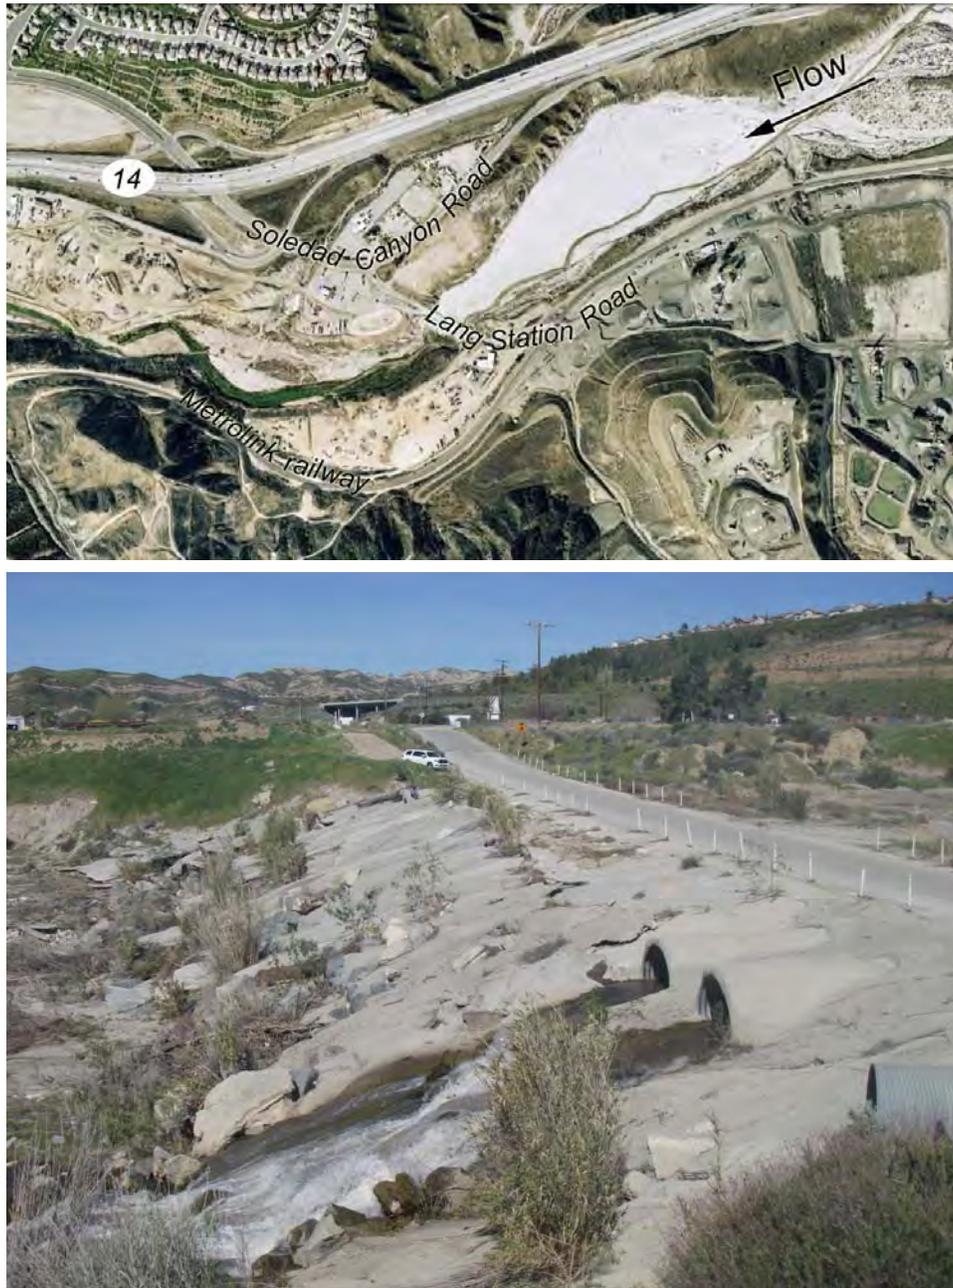
Figure 4-10. Lang Station Road and location of ongoing instream aggregate mining on the USCR near the mouth of Soledad Canyon. As visible in the NAIP 2006 aerial photograph (above), sediment is impounded on the upstream side of the 75-m (250-ft) long grade-control structure. Active floodplain and instream aggregate mining is visible downstream. The bottom photo taken during our spring 2010 field surveys shows a profile view of the 5–6 m (15–20 ft) high crossing with the river’s flow being routed through large culverts (flow direction is to the left).

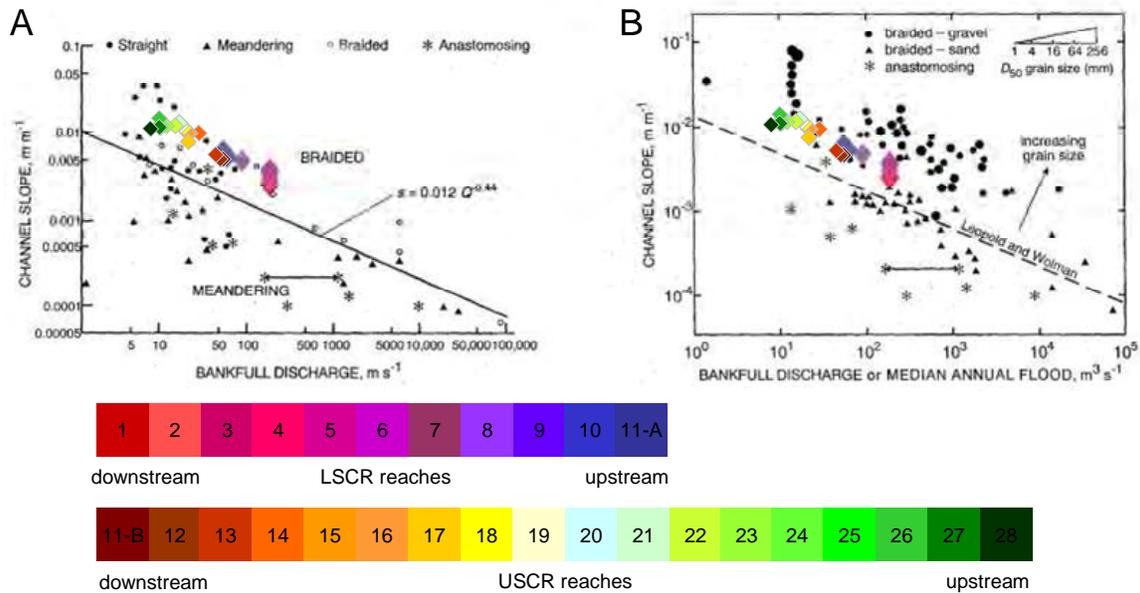
Figure 4-14. Predicted channel pattern for the SCR by reach. See text for details of data sources. Note that the pattern is classified variously as braided (A) between braided and meandering (B).

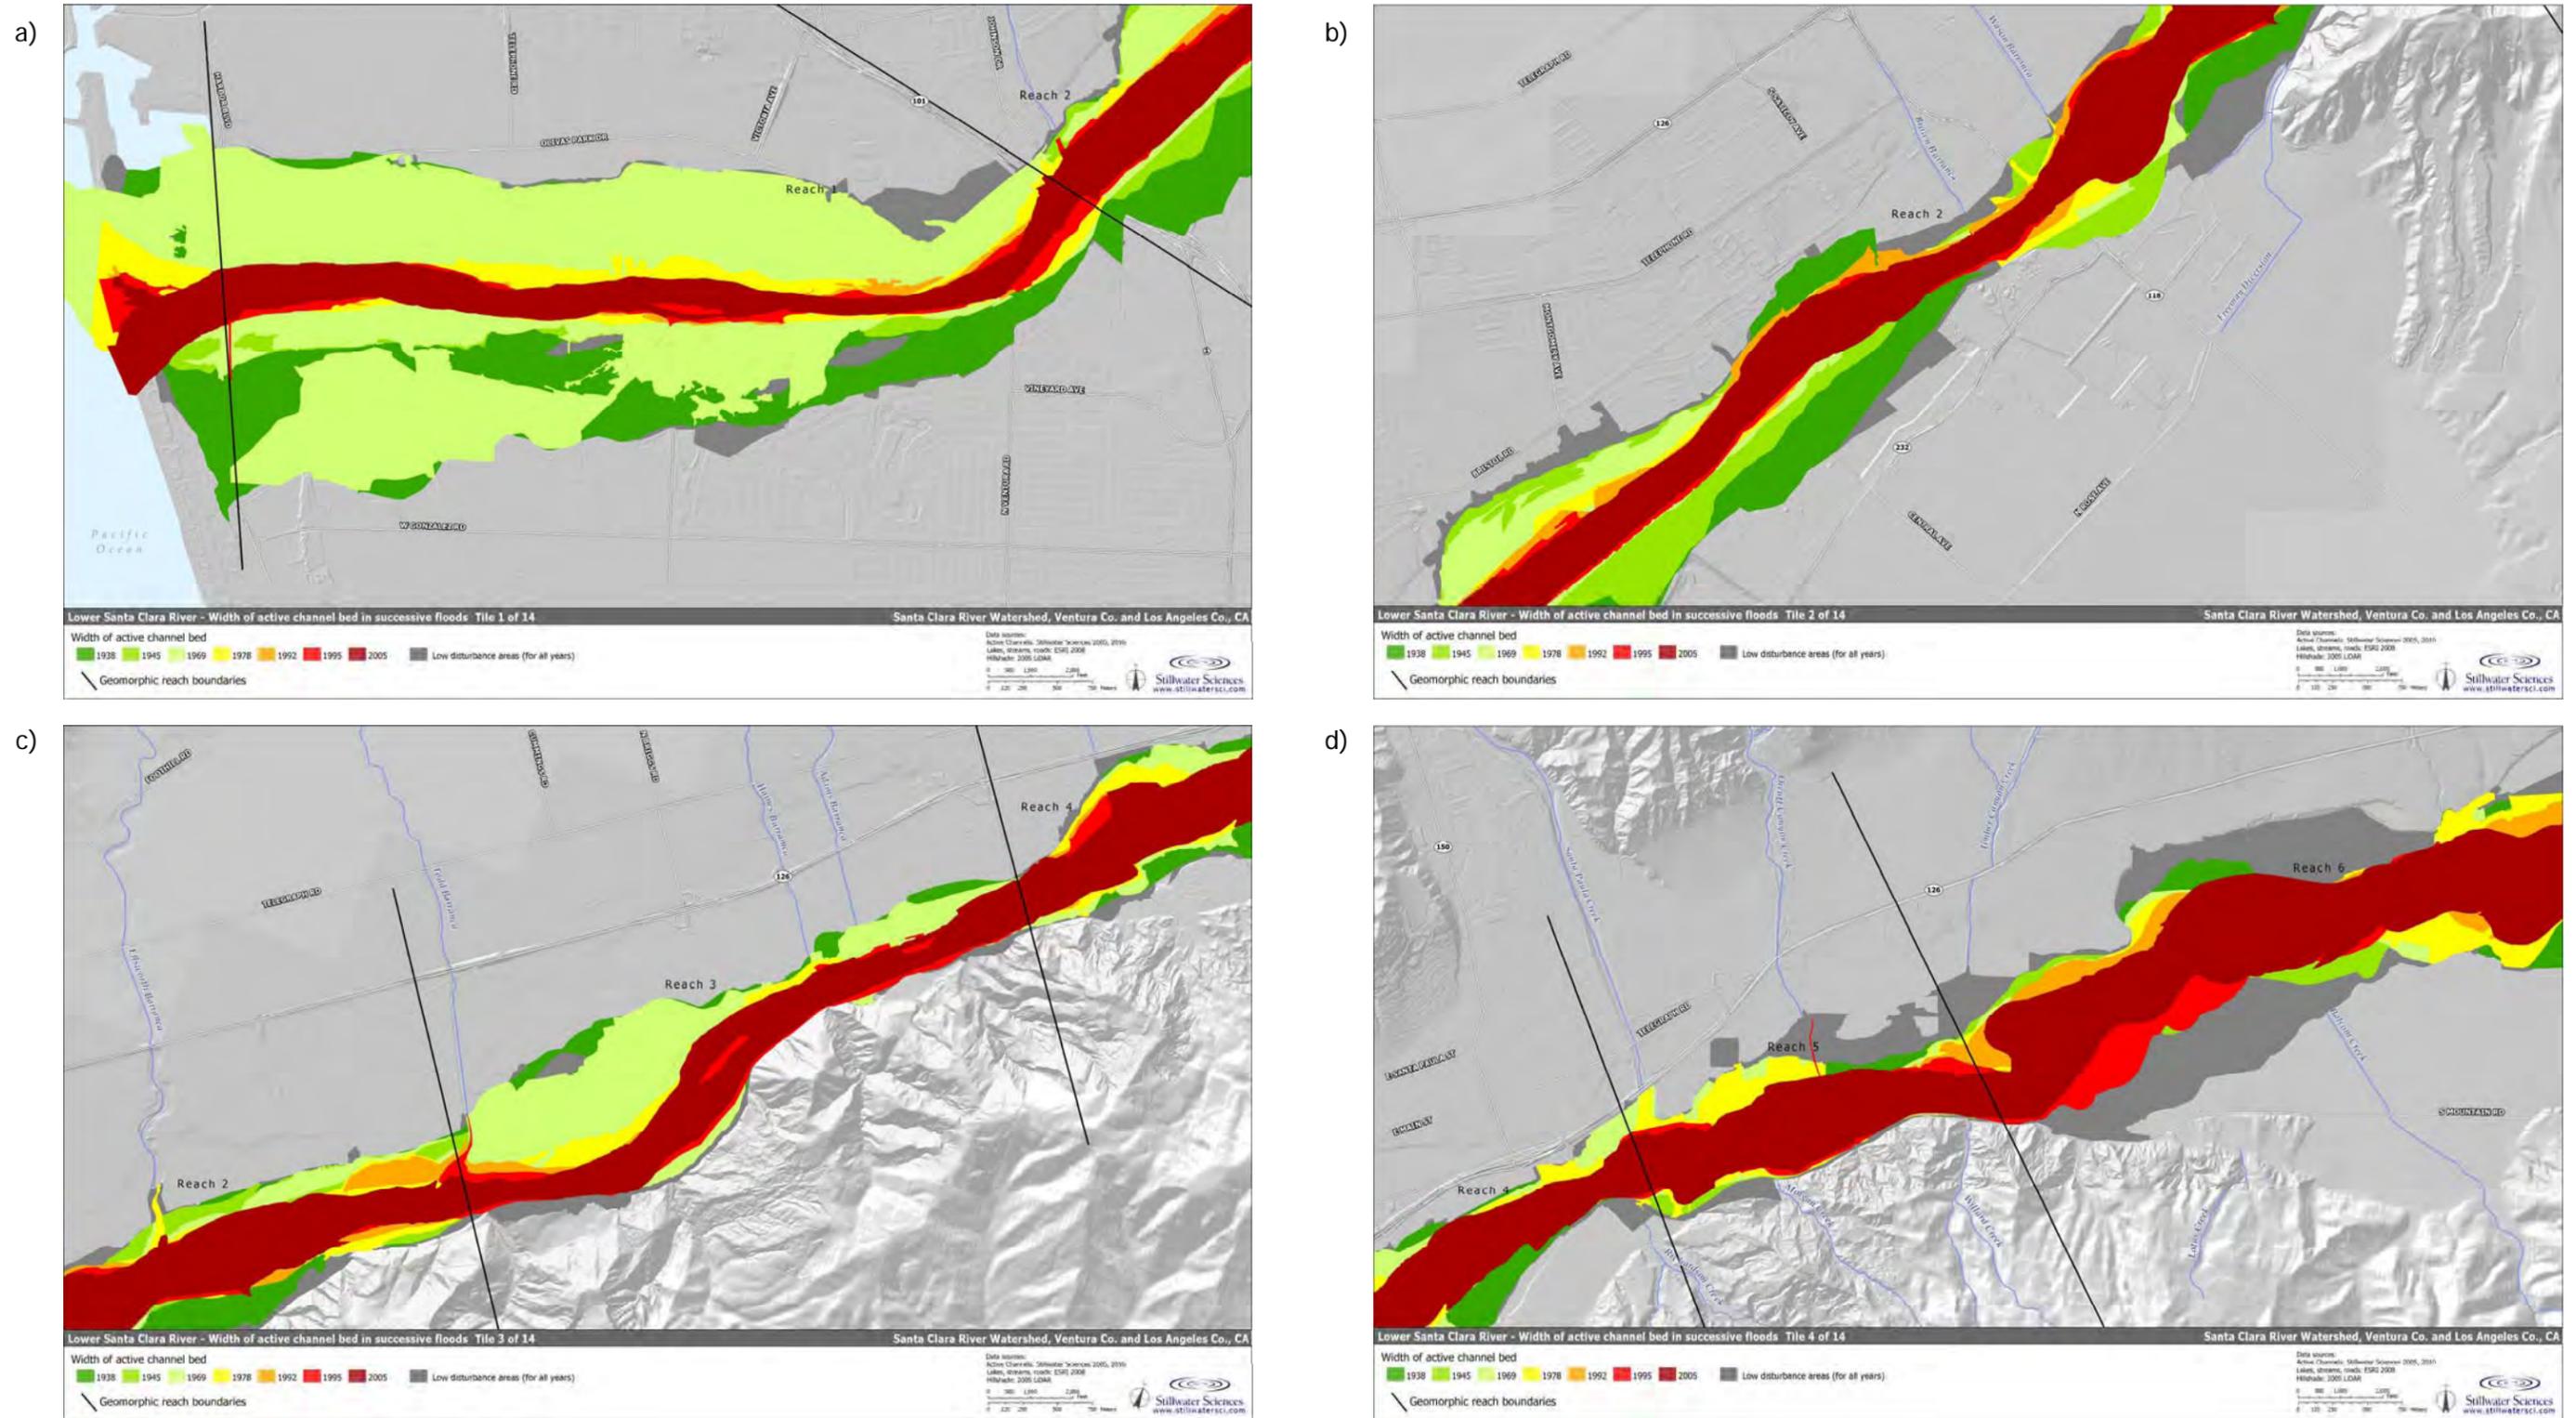
Figure 4-17 a, b, c, d. Active width of channel bed in successive floods since 1938 on the LSCR. The more recent floods are on top
