Geomorphic Assessment of the Santa Clara River Watershed, Synthesis of the Lower and Upper Watershed Studies

Ventura and Los Angeles Counties, California

April 2011

Prepared by
Stillwater Sciences
2855 Telegraph Avenue, Suite 400
Berkeley, CA 94705

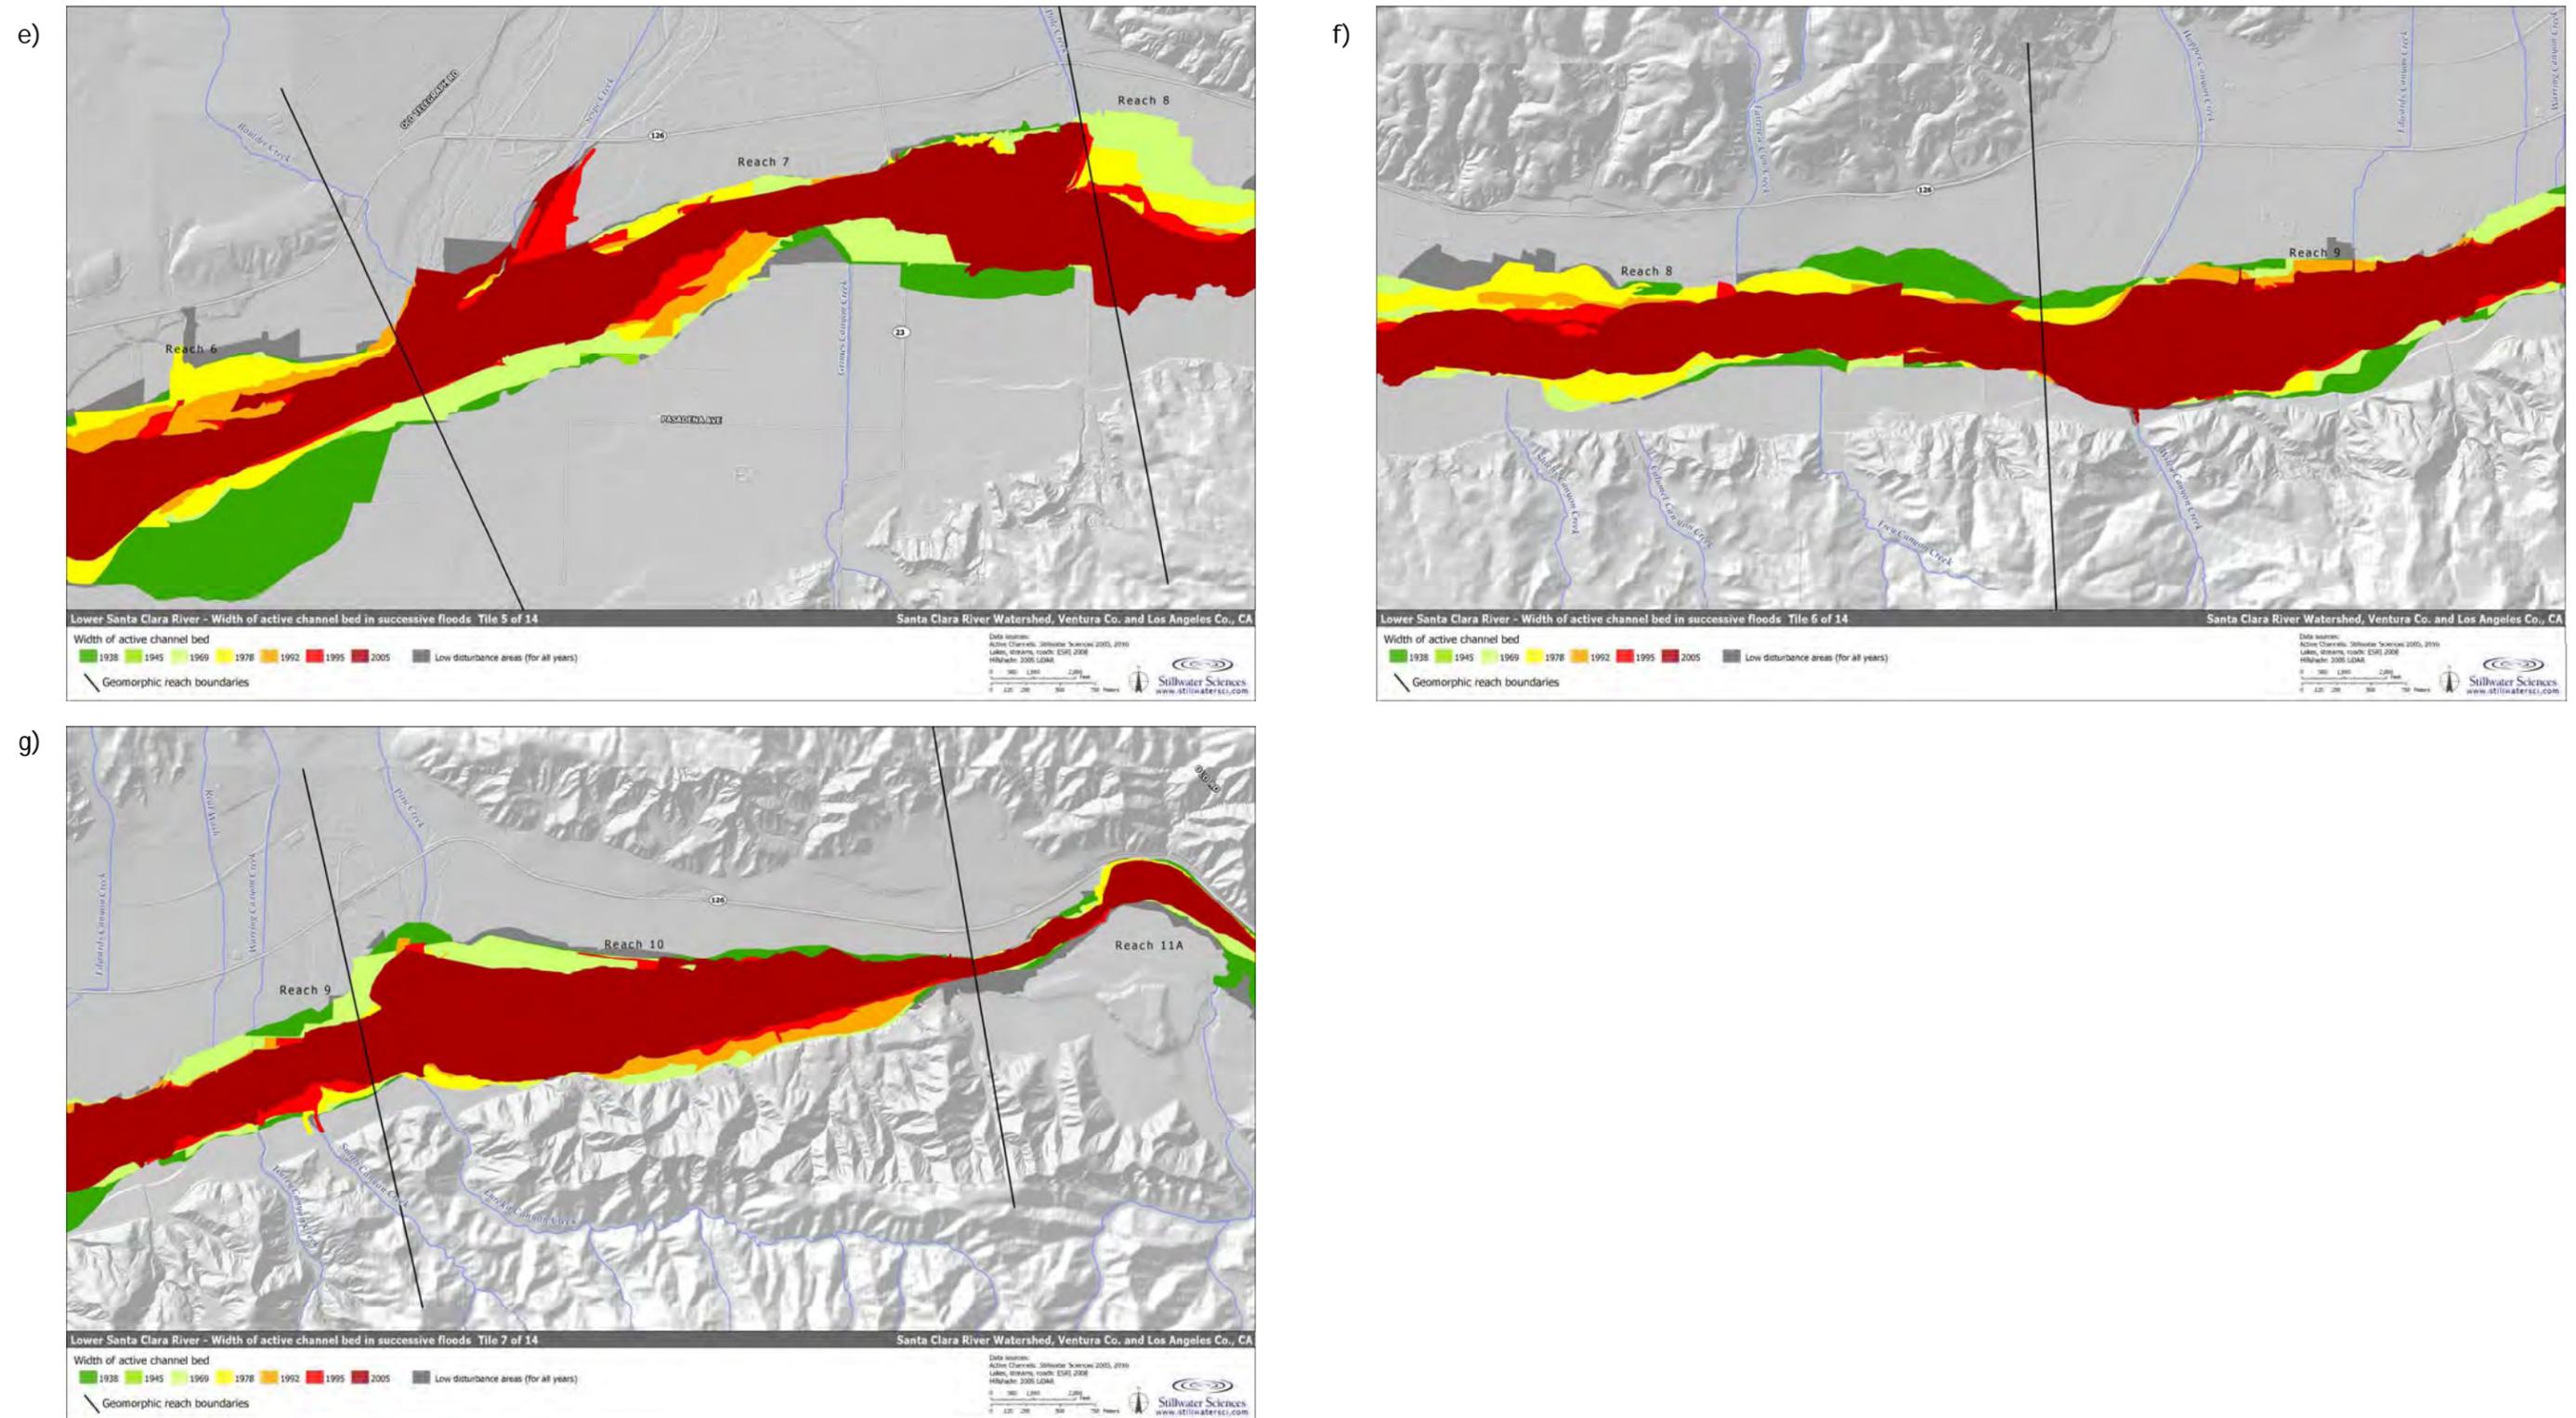
Figure 4-17 e, f, g. Active width of channel bed in successive floods since 1938 on the LSCR. The more recent floods are on top

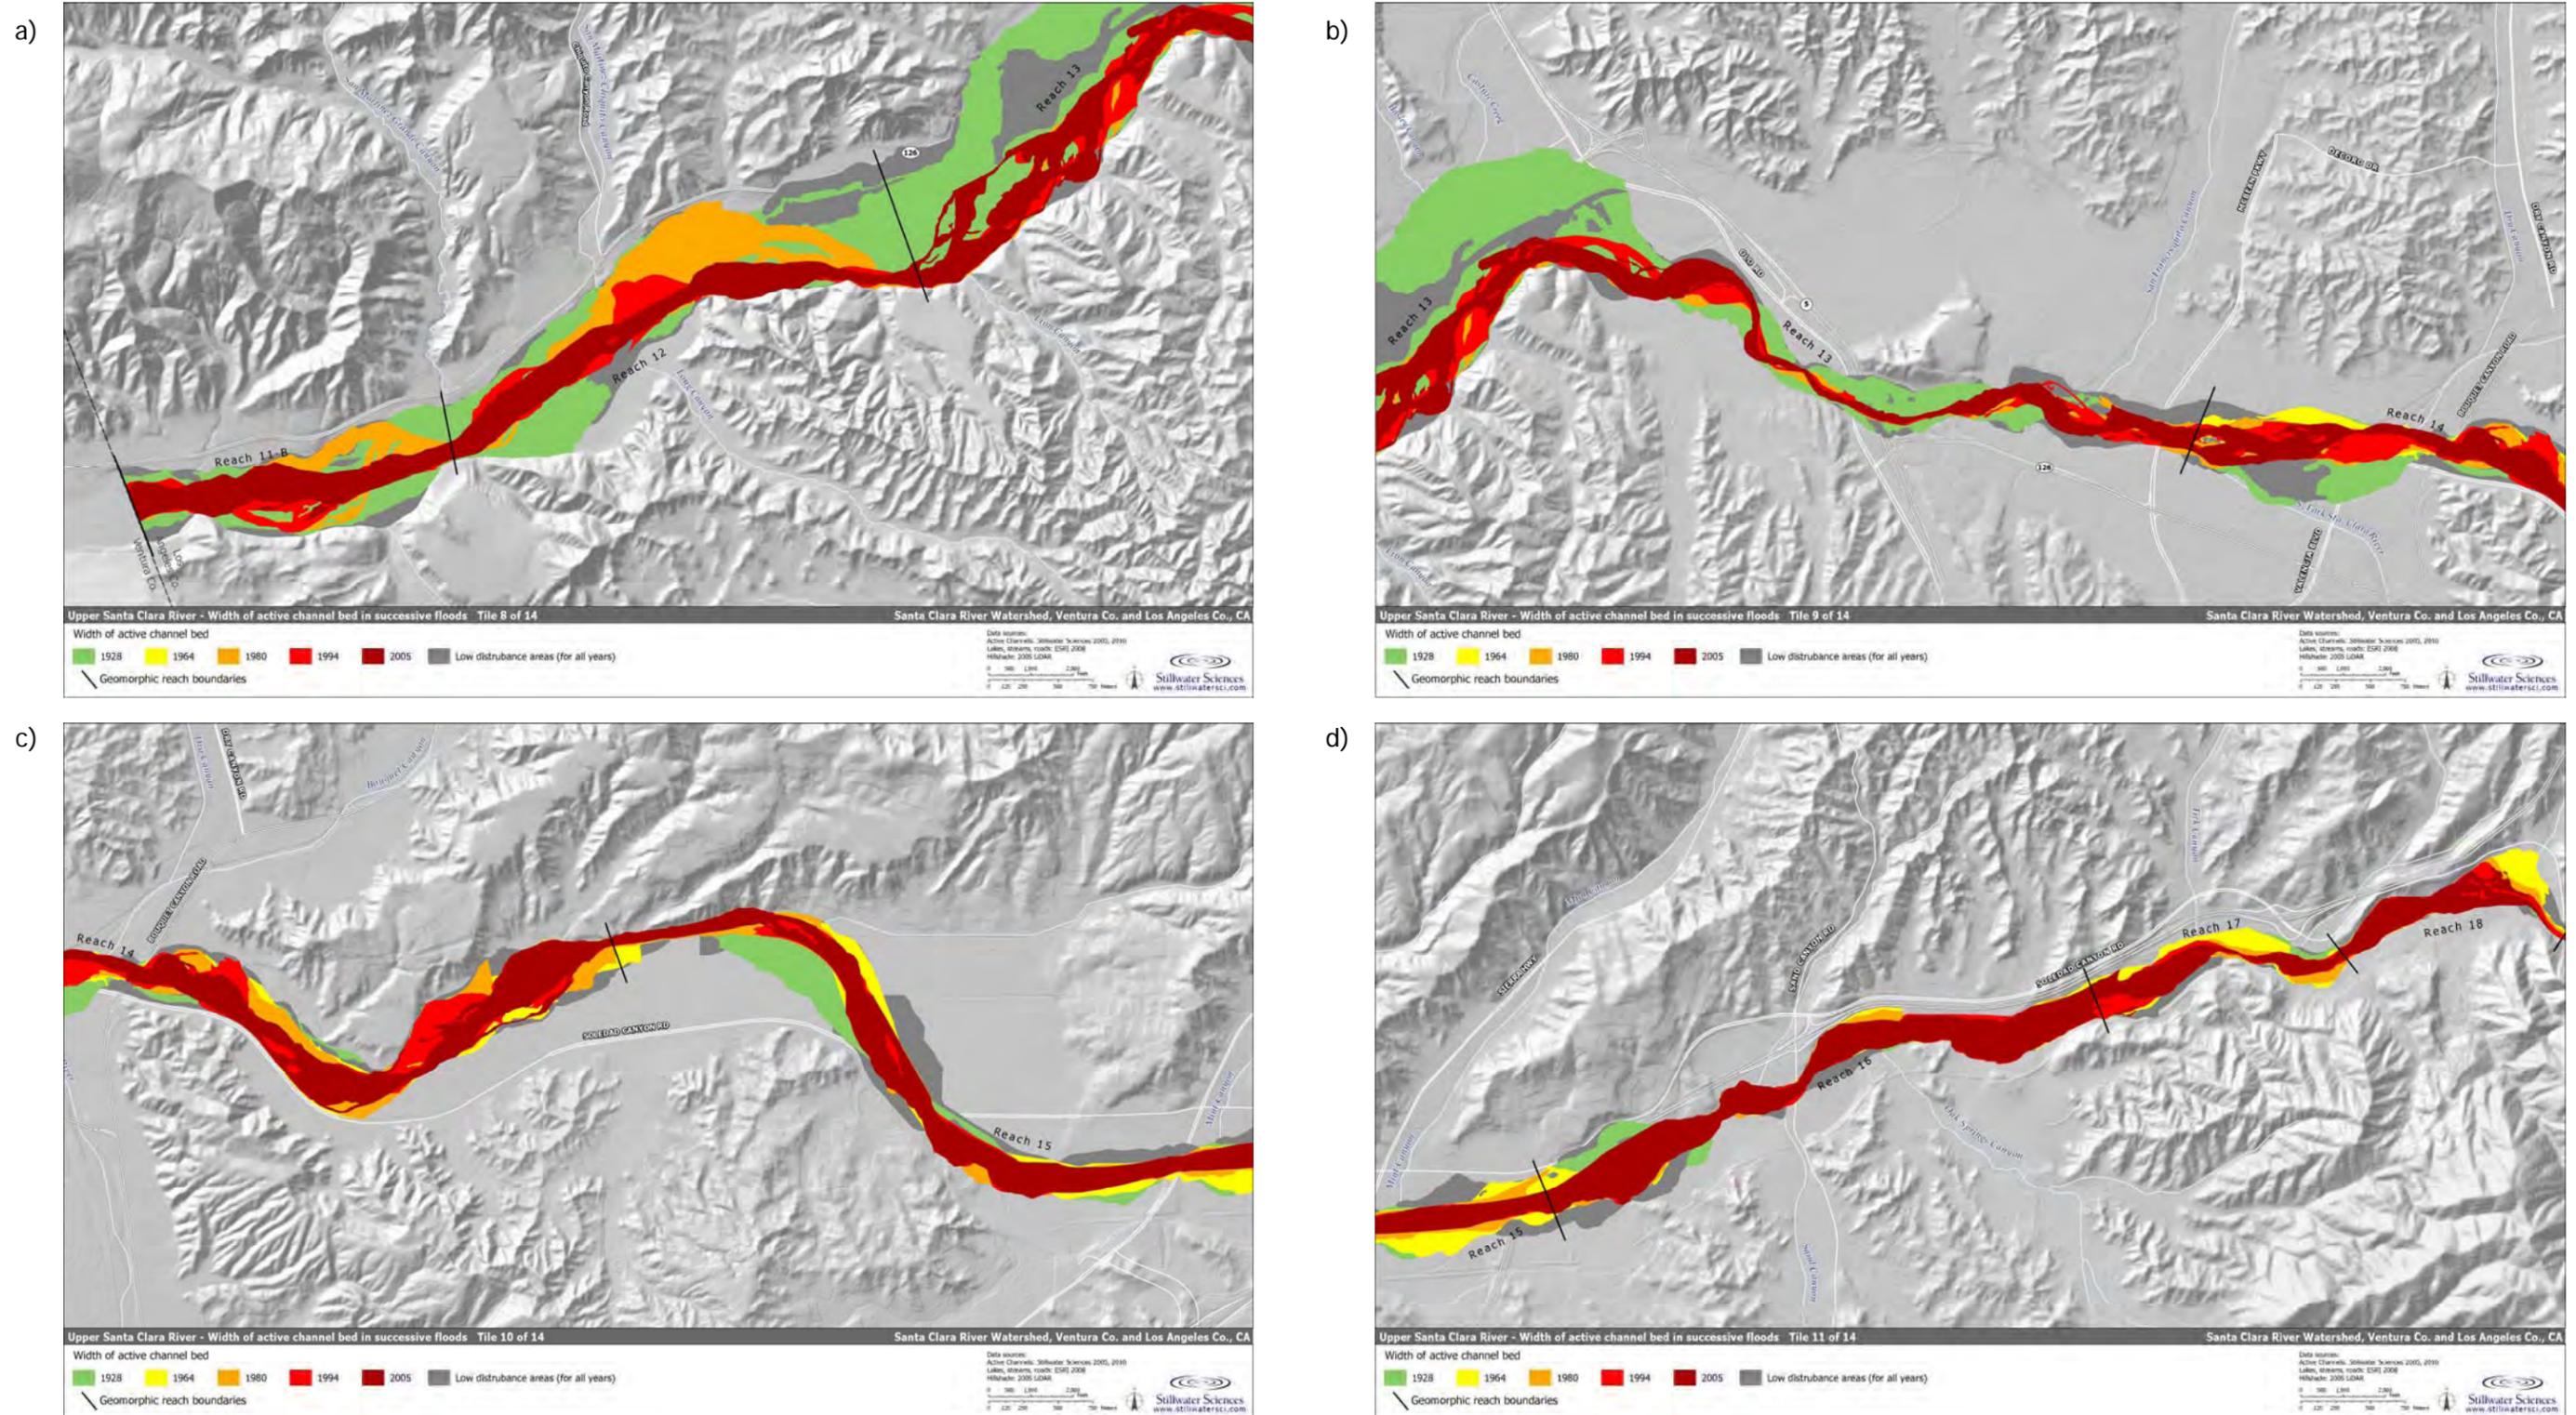
Figure 4-18 a, b, c, d. Active width of channel bed in successive floods since 1928 on the USCR. The more recent floods are on top

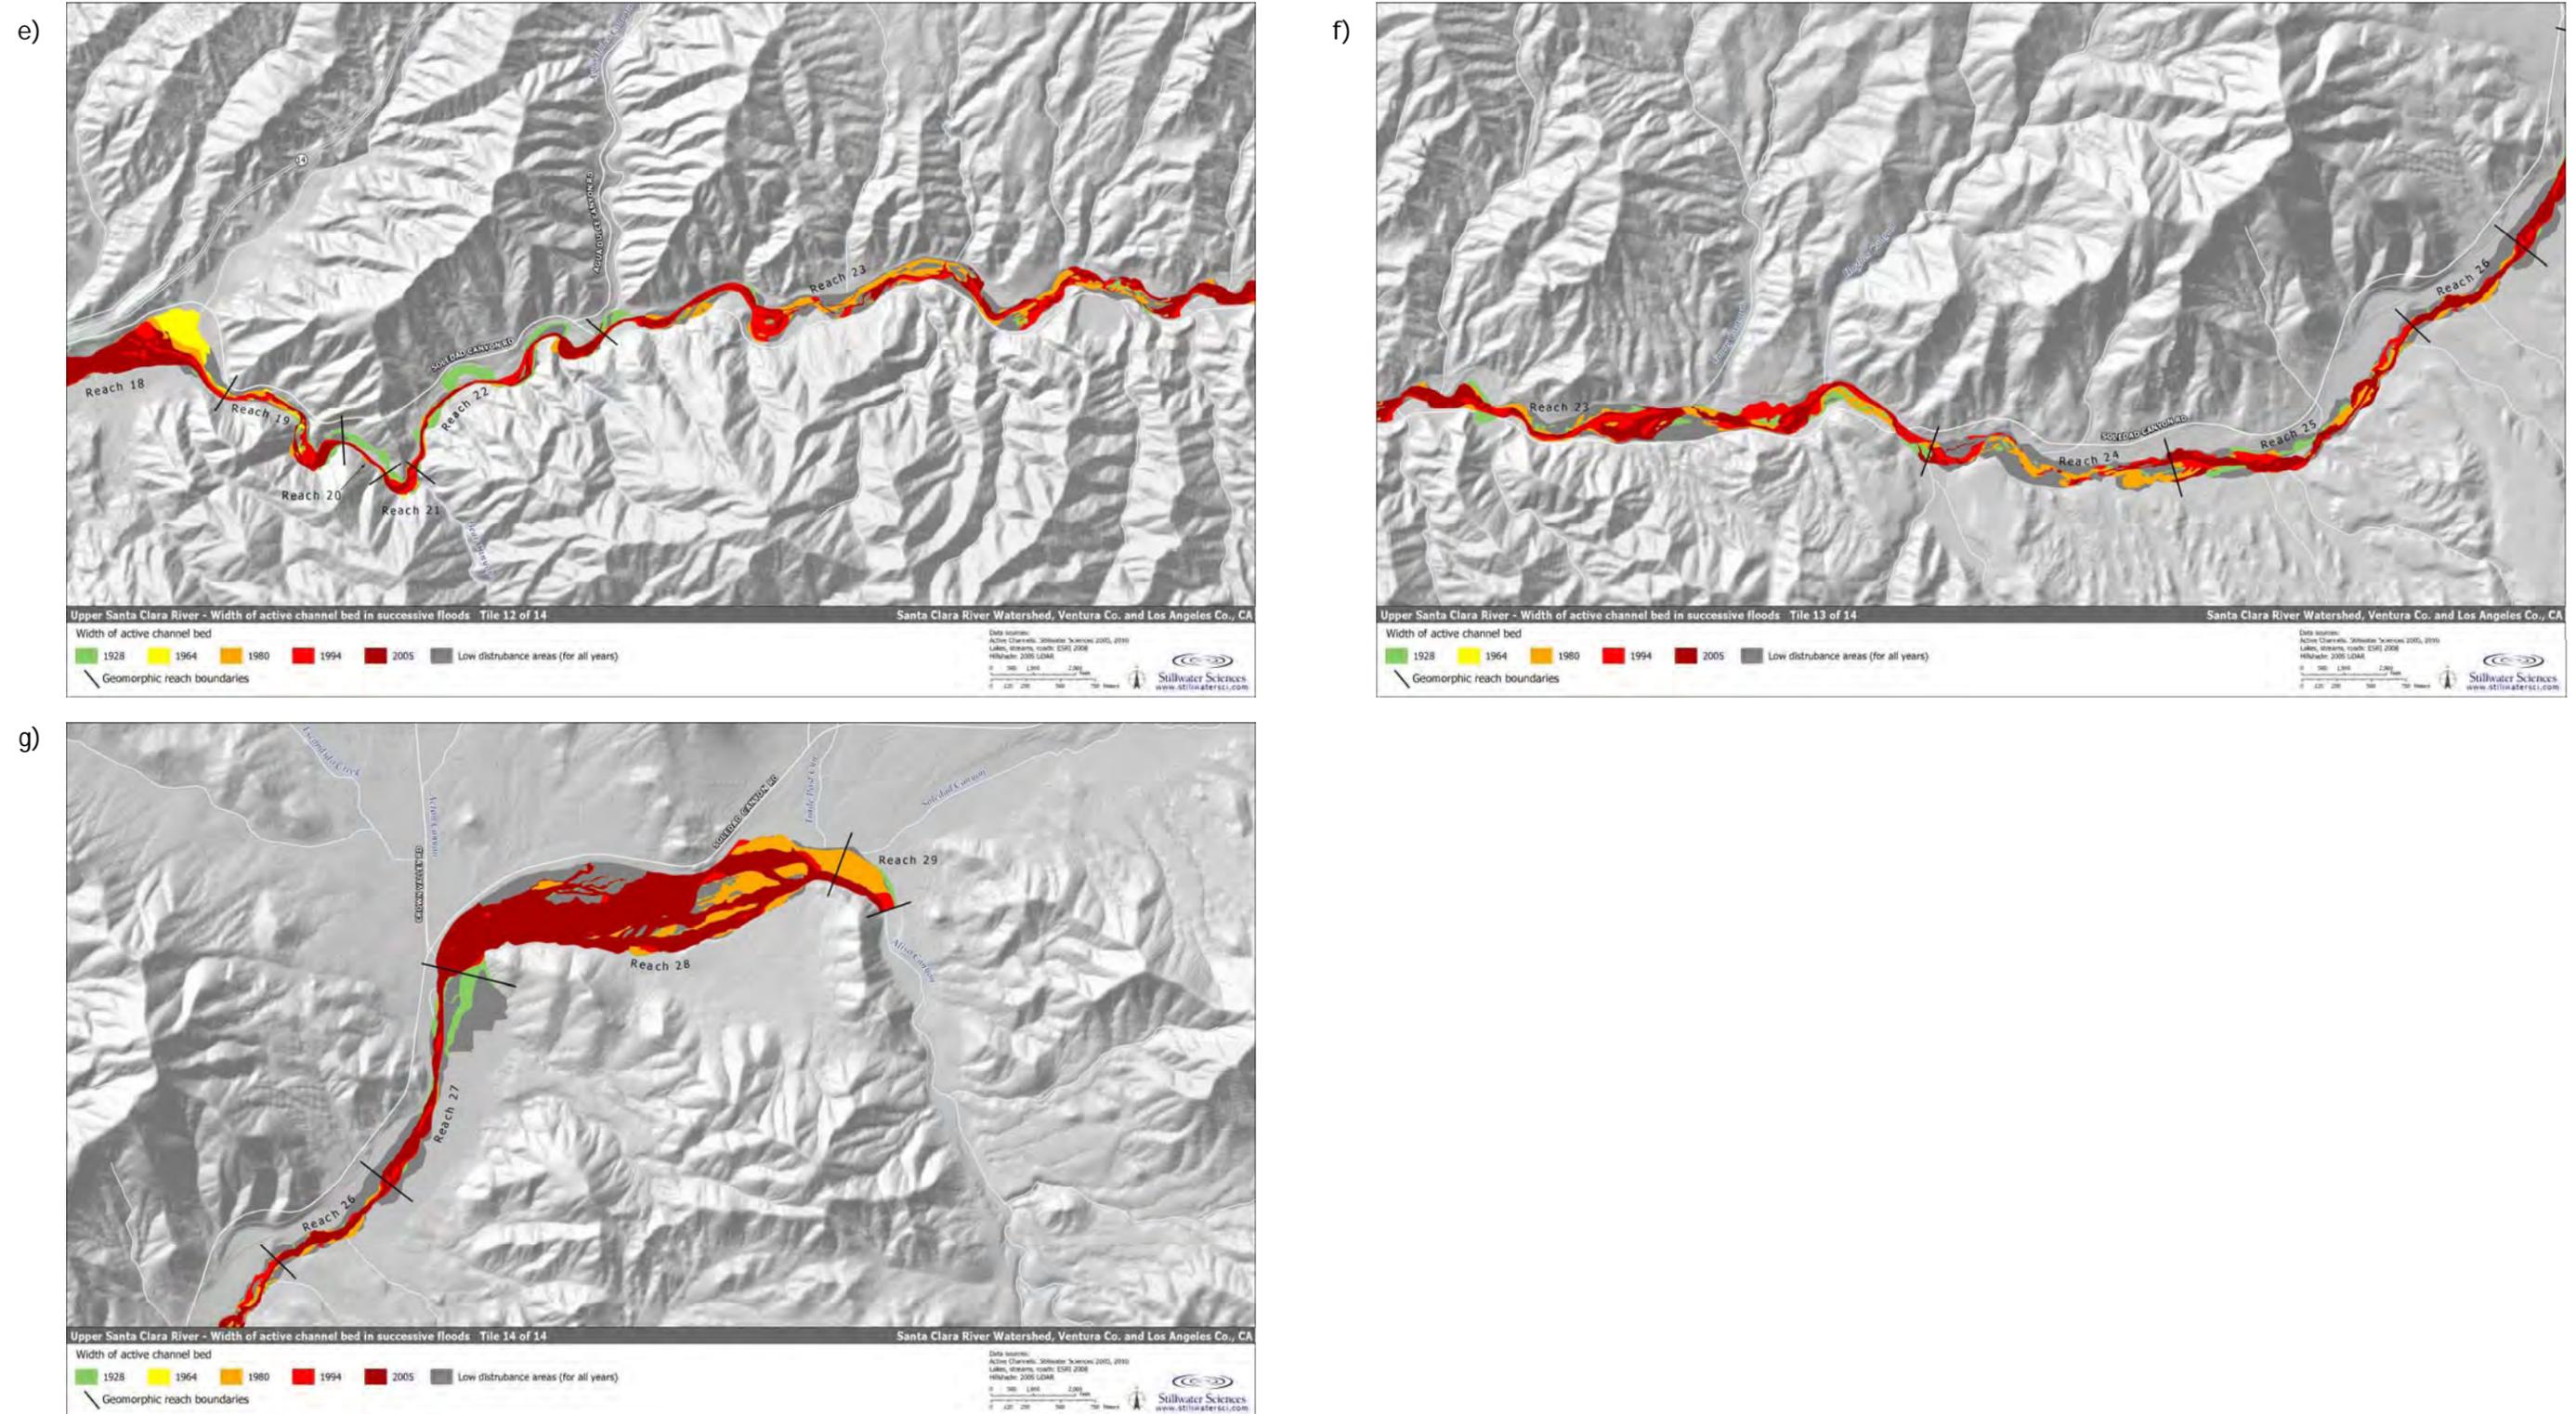
Figure 4-18 e, f, g. Active width of channel bed in successive floods since 1928 on the USCR. The more recent floods are on top

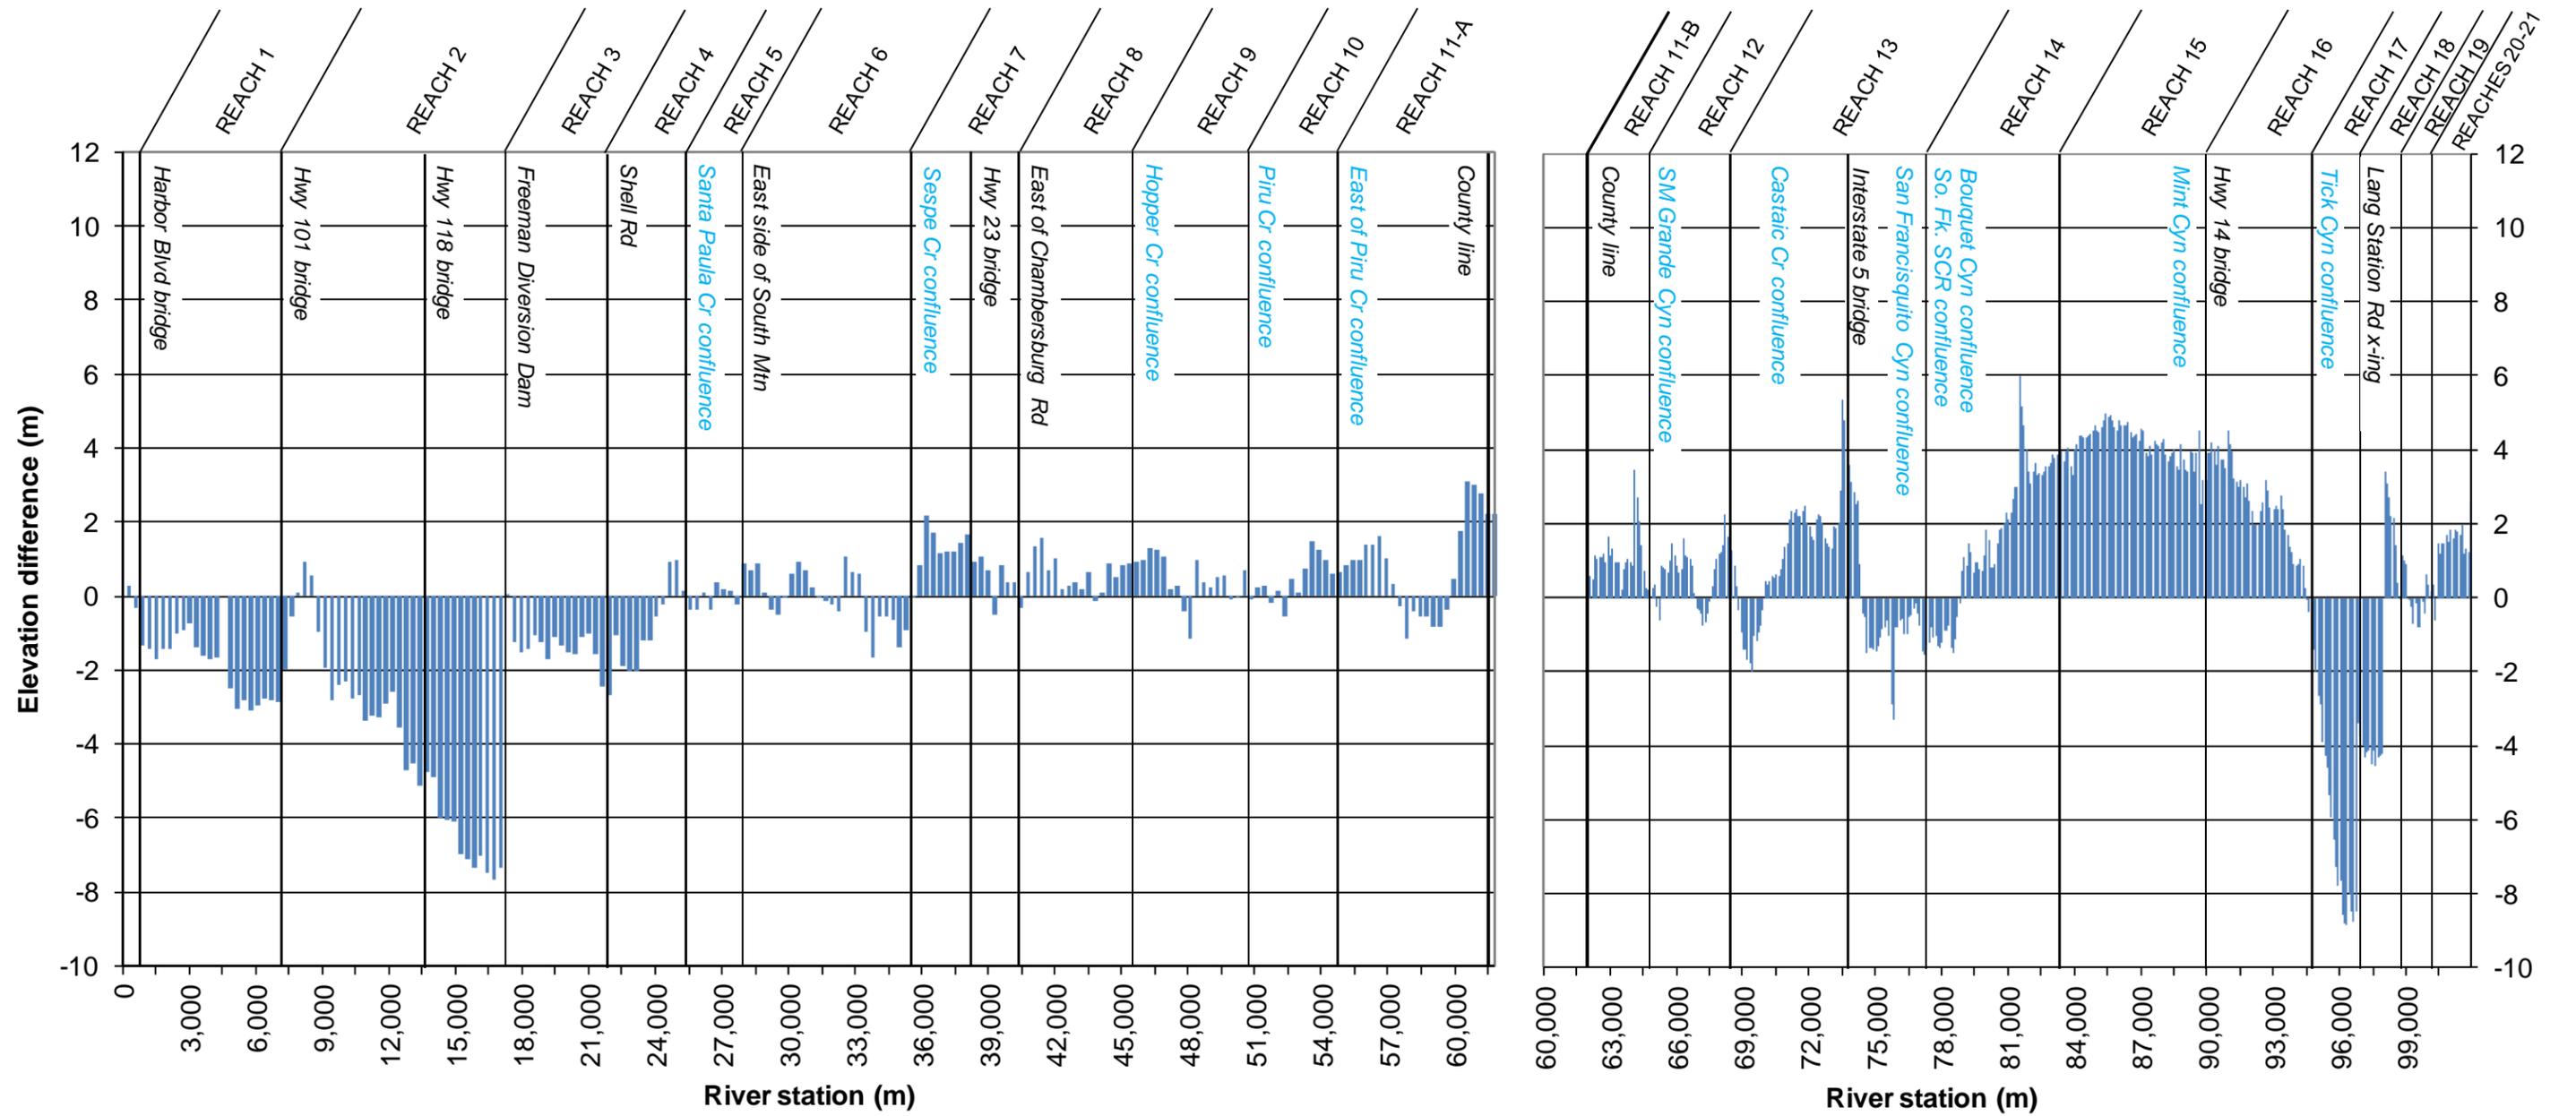
Figure 4-19. Net thalweg elevation change for the LSCR from 1949 to 2005 (left plot) and for the USCR from 1928 to 2005 (right plot).

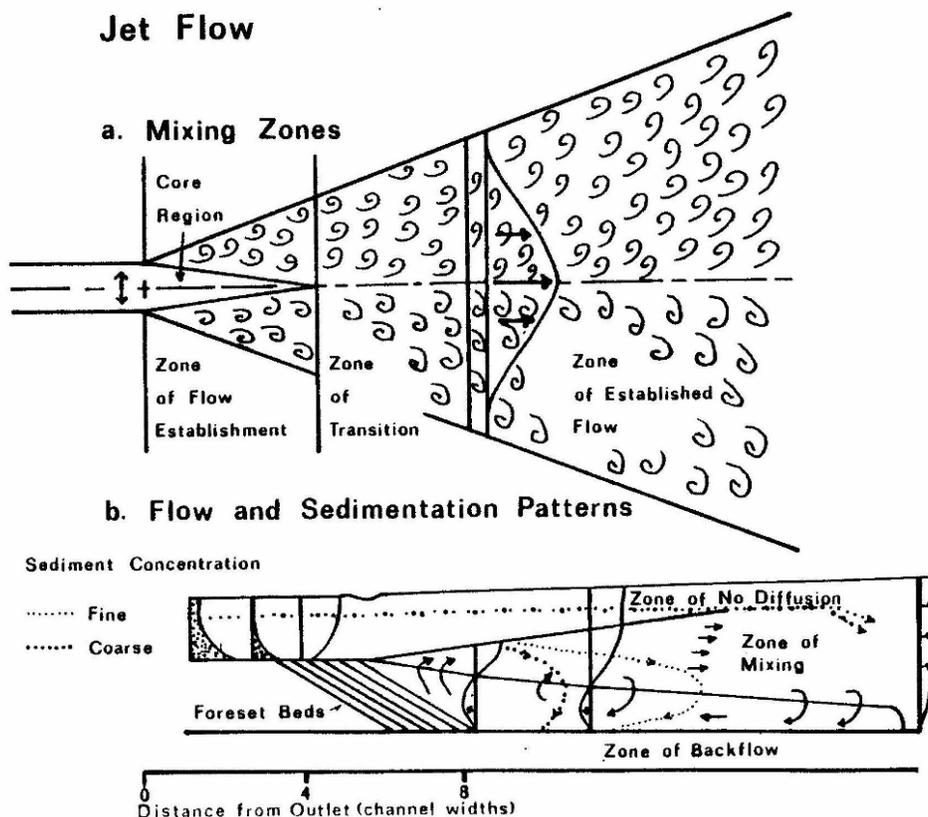
Figure 5-2. Conceptual description of sediment deposition from jet flow (O'Hirok 1985 after Bates 1953).

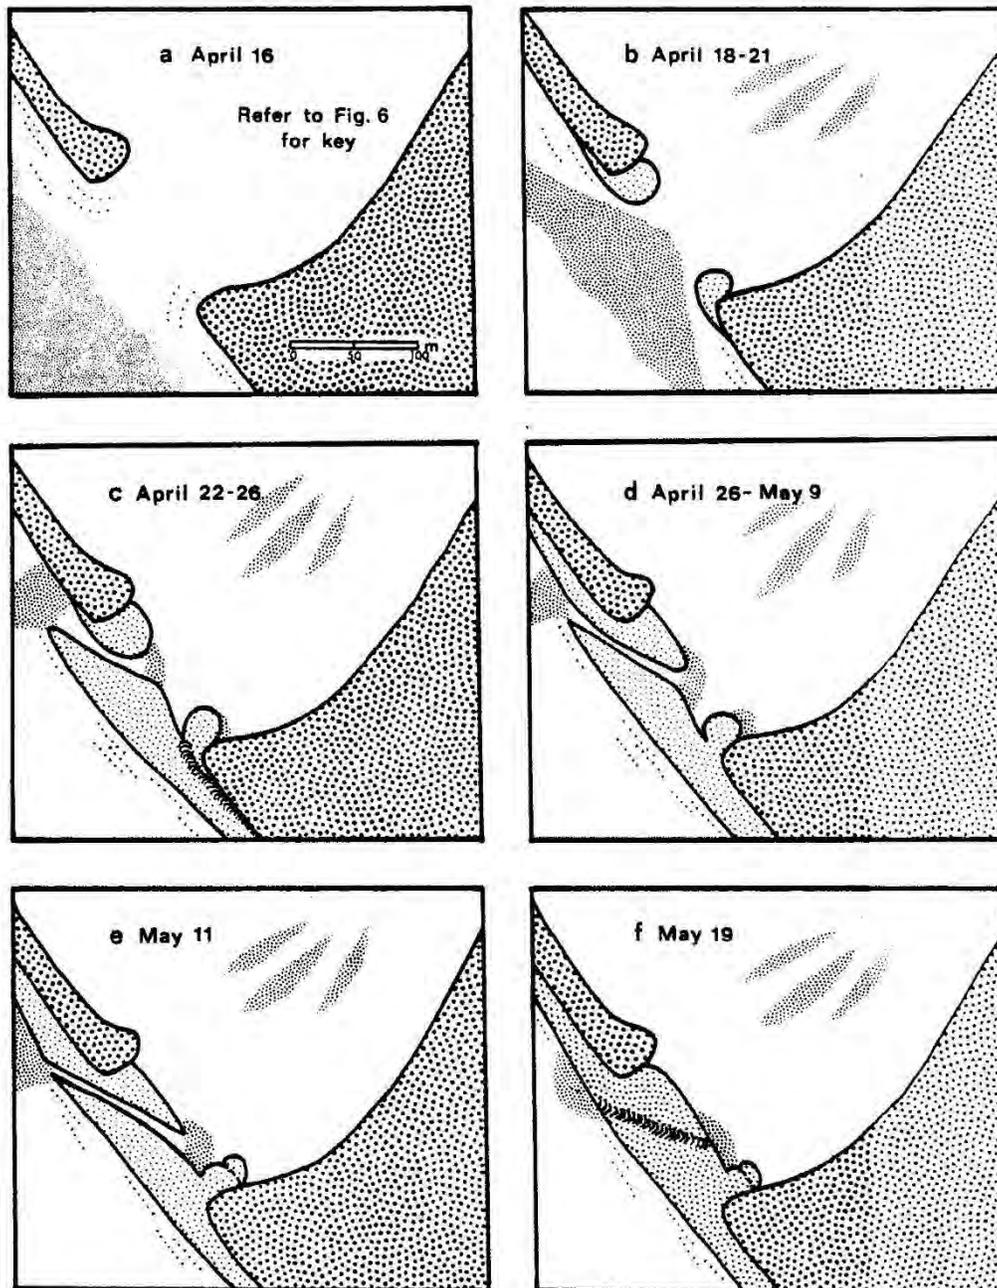
Figure 5-6. Time series of SCR mouth closure (April 16-May 19, 1982) (O’Hirok 1985).

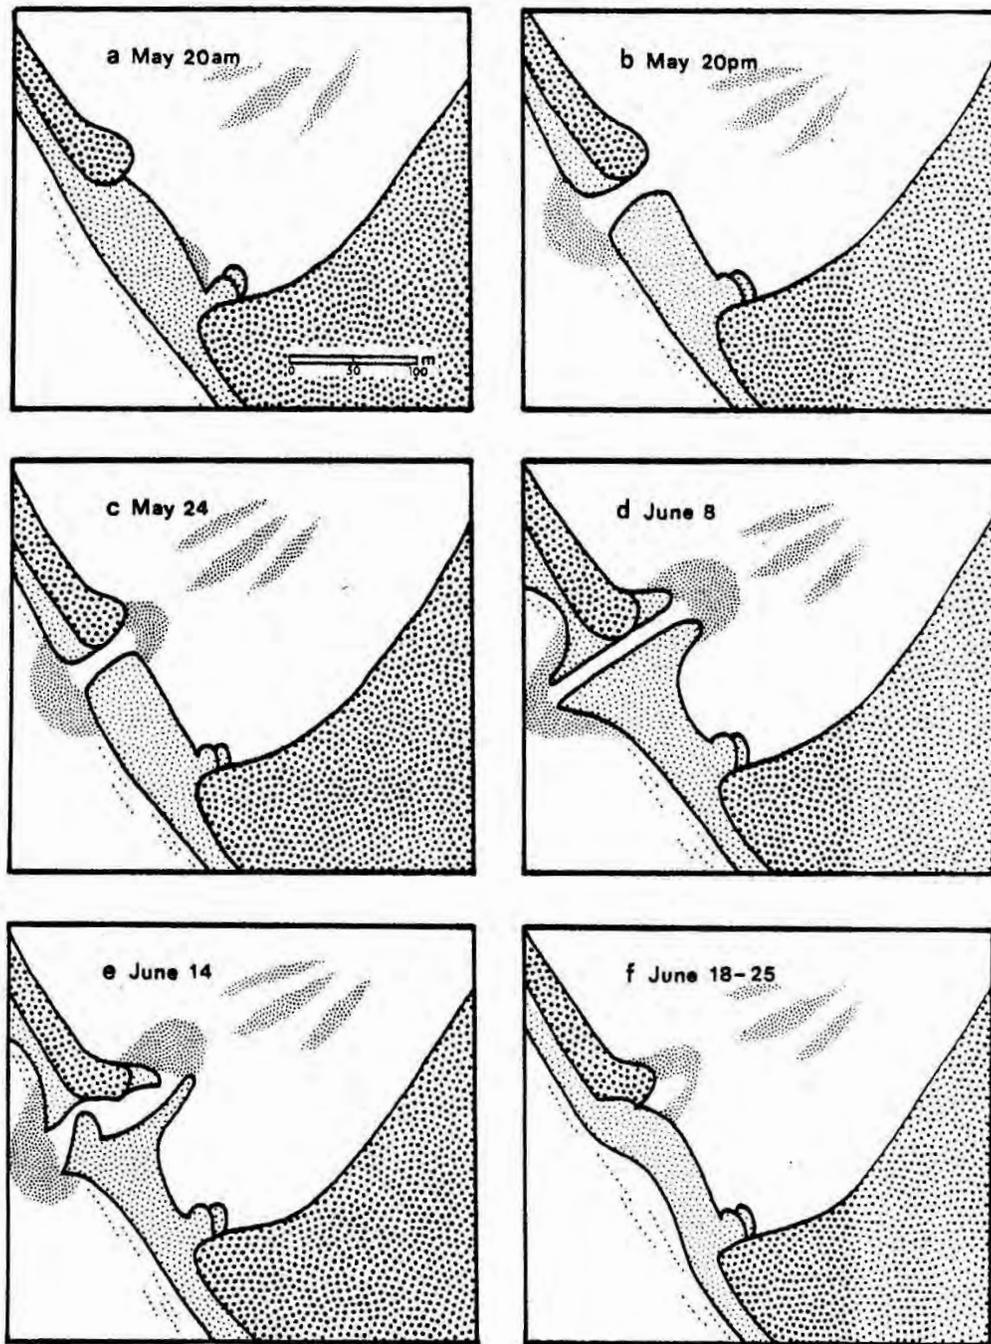
Figure 5-7. Time series of Santa Clara River mouth breach and closure (May 20-June 25, 1982) (O'Hirok, 1985).

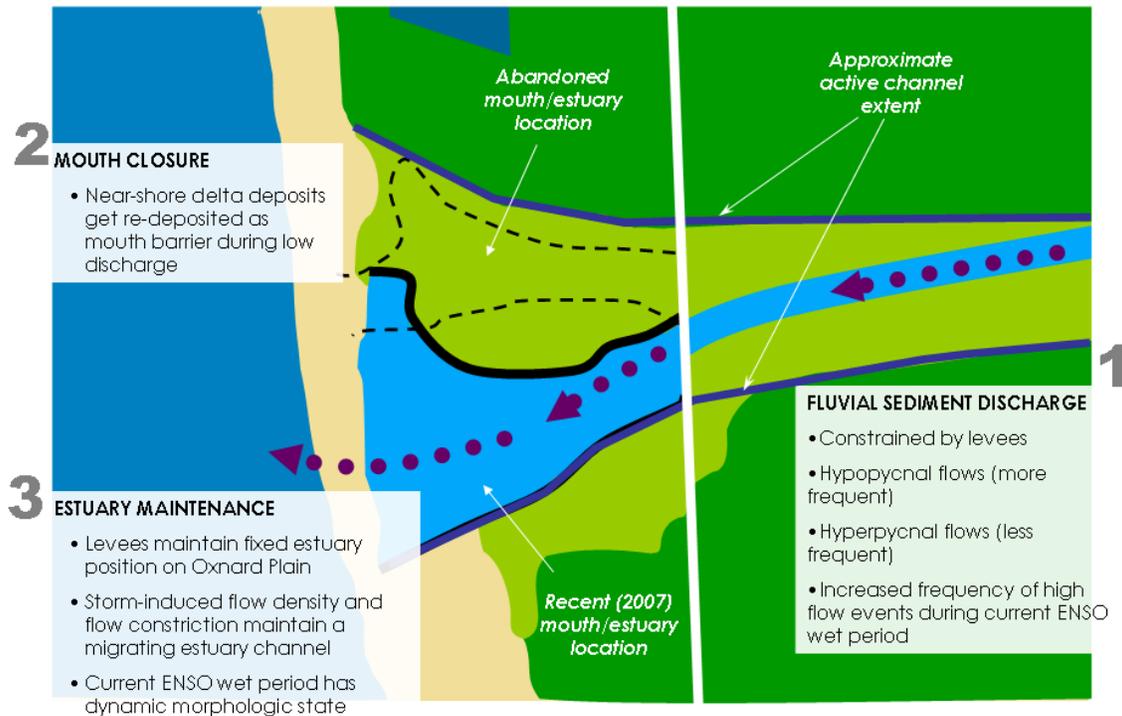
Figure 5-12. Conceptual model of the current and future maintenance of the SCR mouth/estuary complex.
