# Substrate Enhancements and Botanical Diversity for Successful Oak Habitat Creation

Richard B. Lewis III, ENV SP  
Senior Restoration Ecologist, Psomas

LOS ANGELES COUNTY  
FLOOD CONTROL DISTRICT  
SANTA ANITA  
DAM

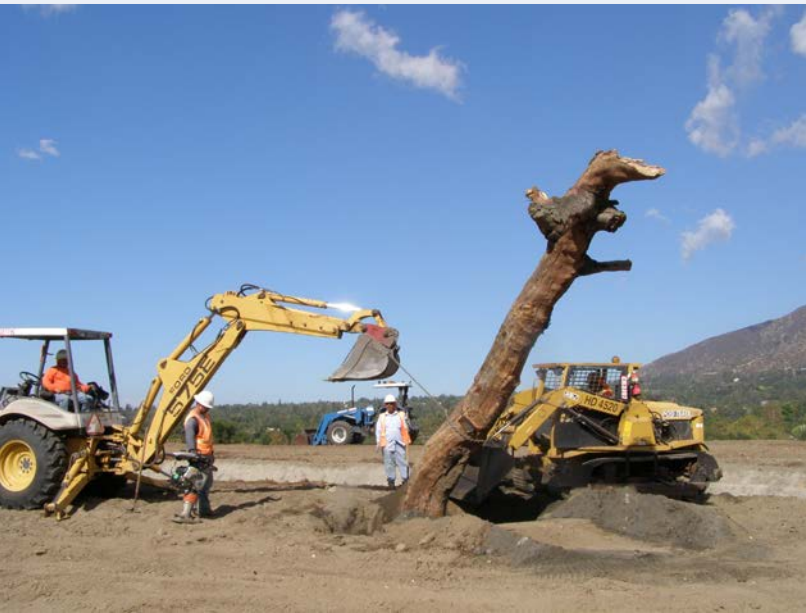
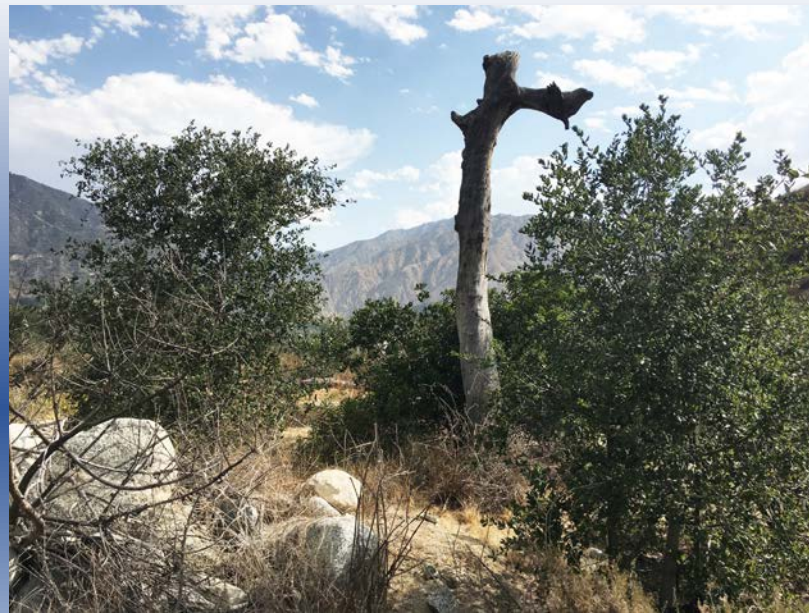
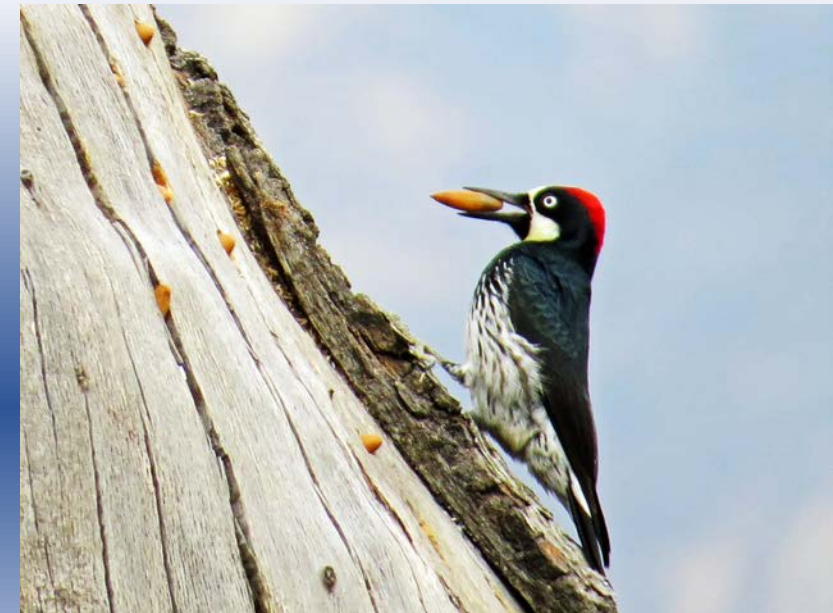
PURPOSE: FLOOD CONTROL AND WATER CONSERVATION  
TYPE: CONCRETE ARCH  
DRAINAGE AREA: 10.8 SQUARE MILES  
STORAGE CAPACITY: 1380 ACRE- FEET  
CREST HEIGHT: 225 FEET                      COMPLETED 1927

Los Angeles County Public Works  
operates Santa Anita Dam and Reservoir  
in the San Gabriel Mountains.

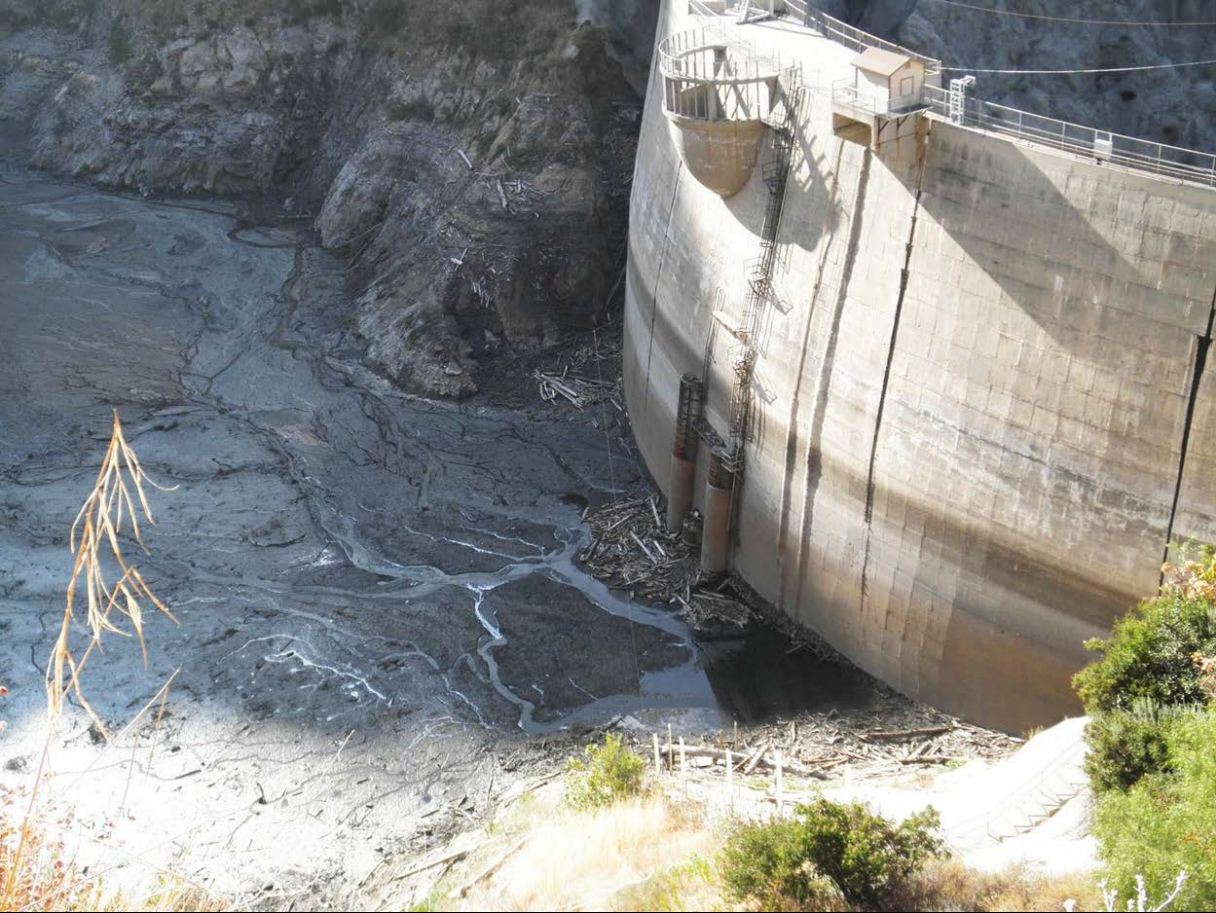
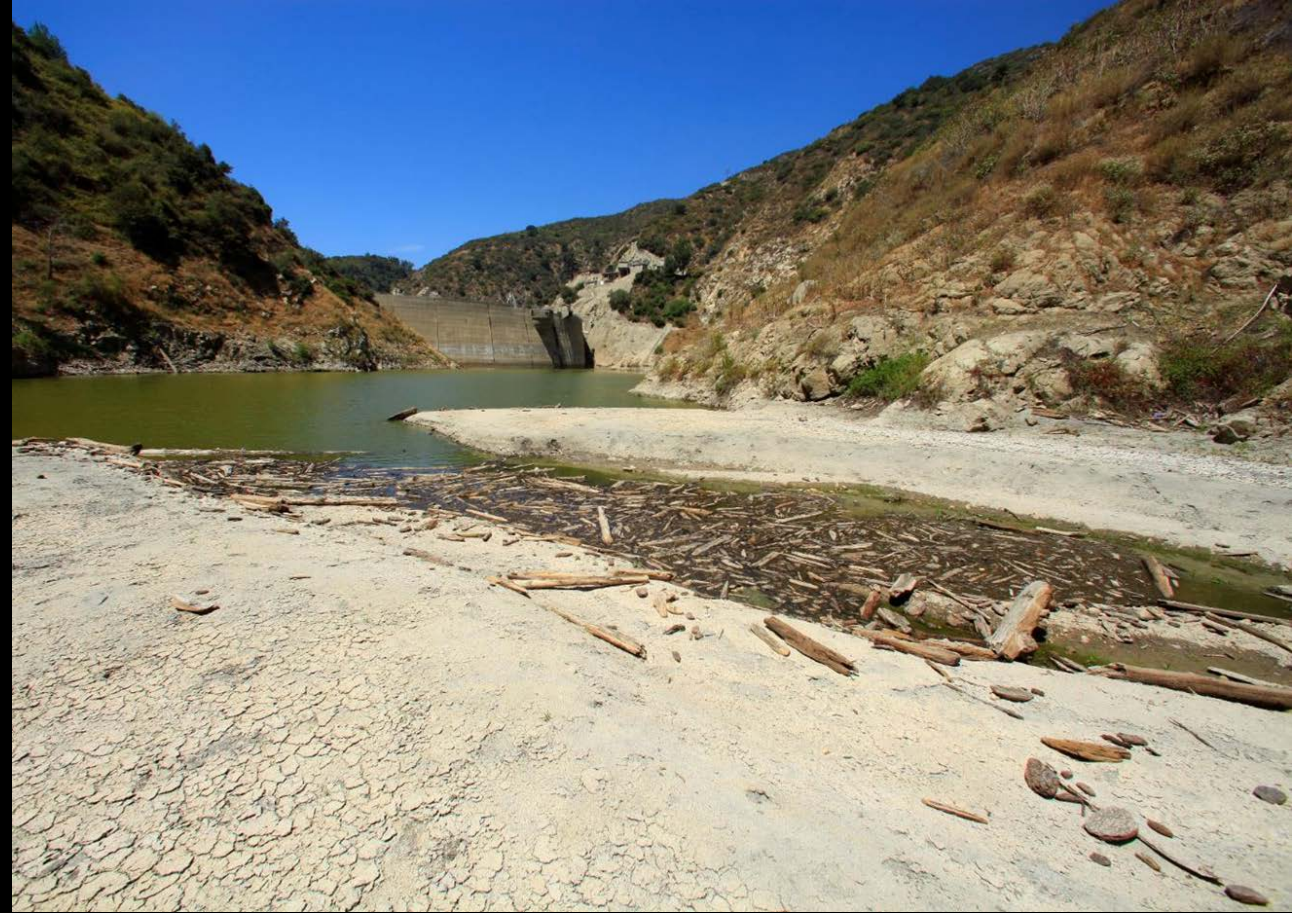
## Sediment Removal:

- Stormwater capacity
- Public safety / Water supply

Sediment is periodically removed for stormwater capacity, public safety, and to benefit water supply.

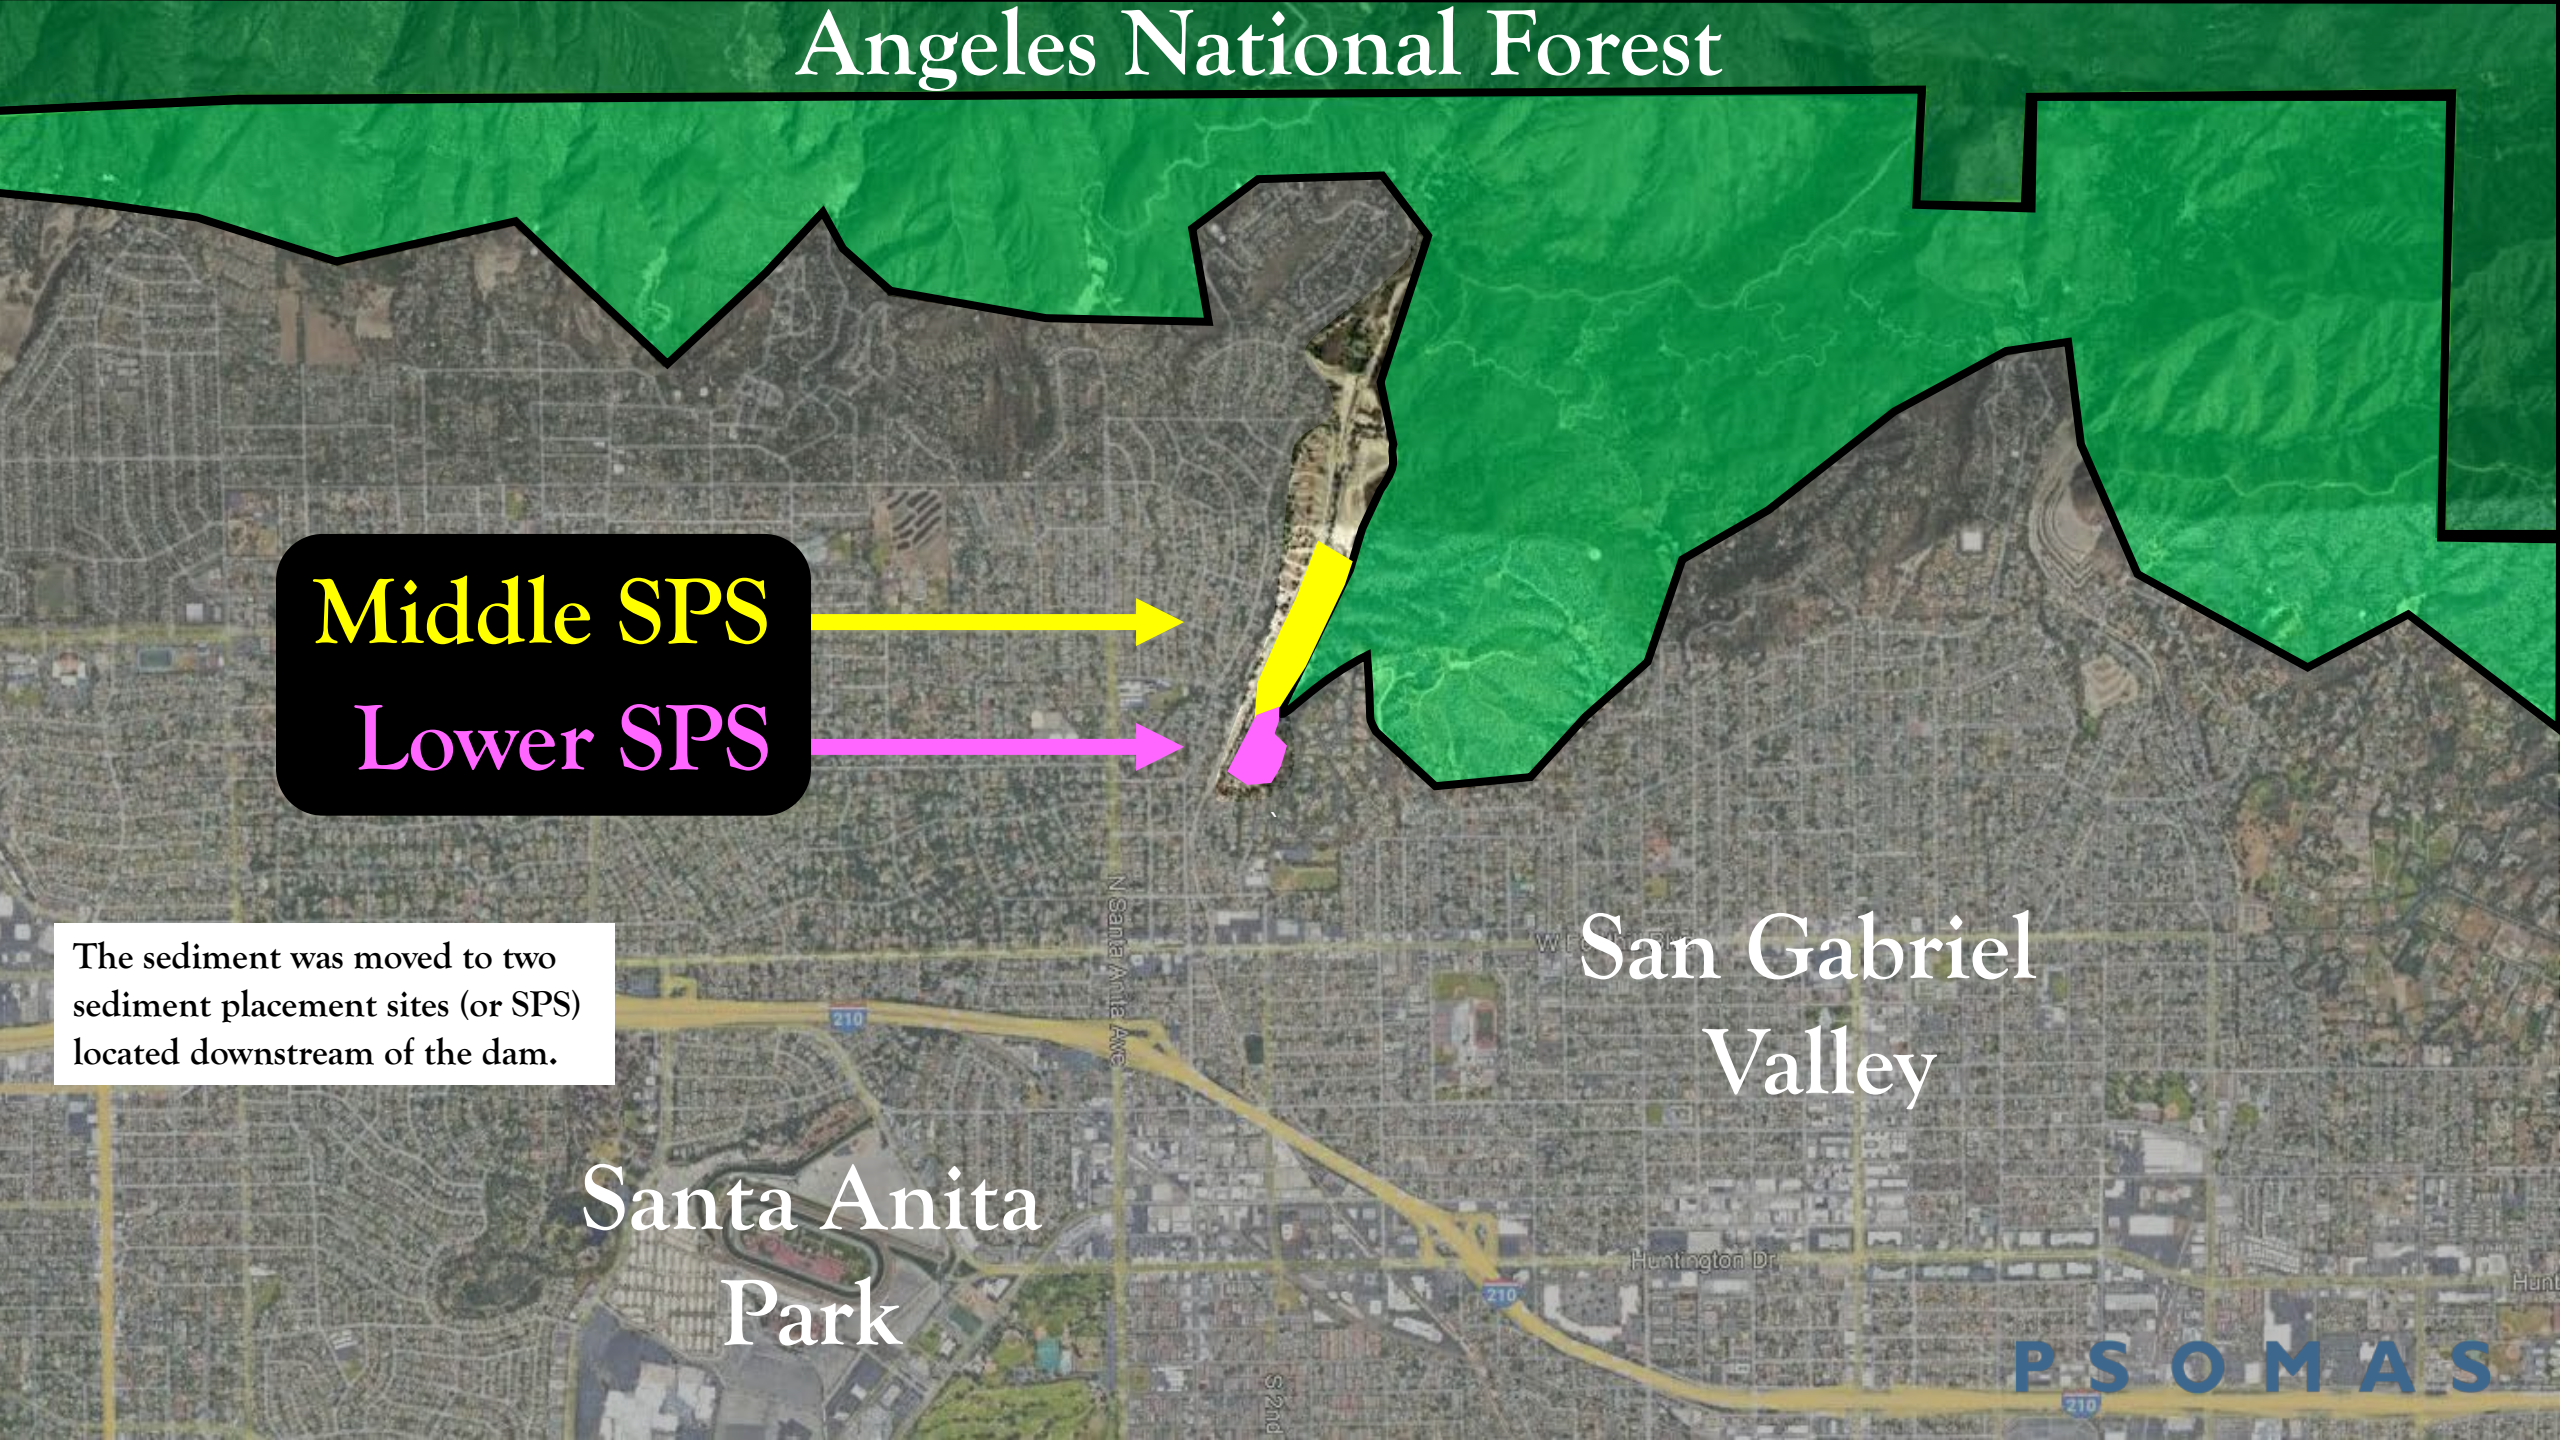
The sediment was moved to two sediment placement sites (or SPS) located downstream of the dam.

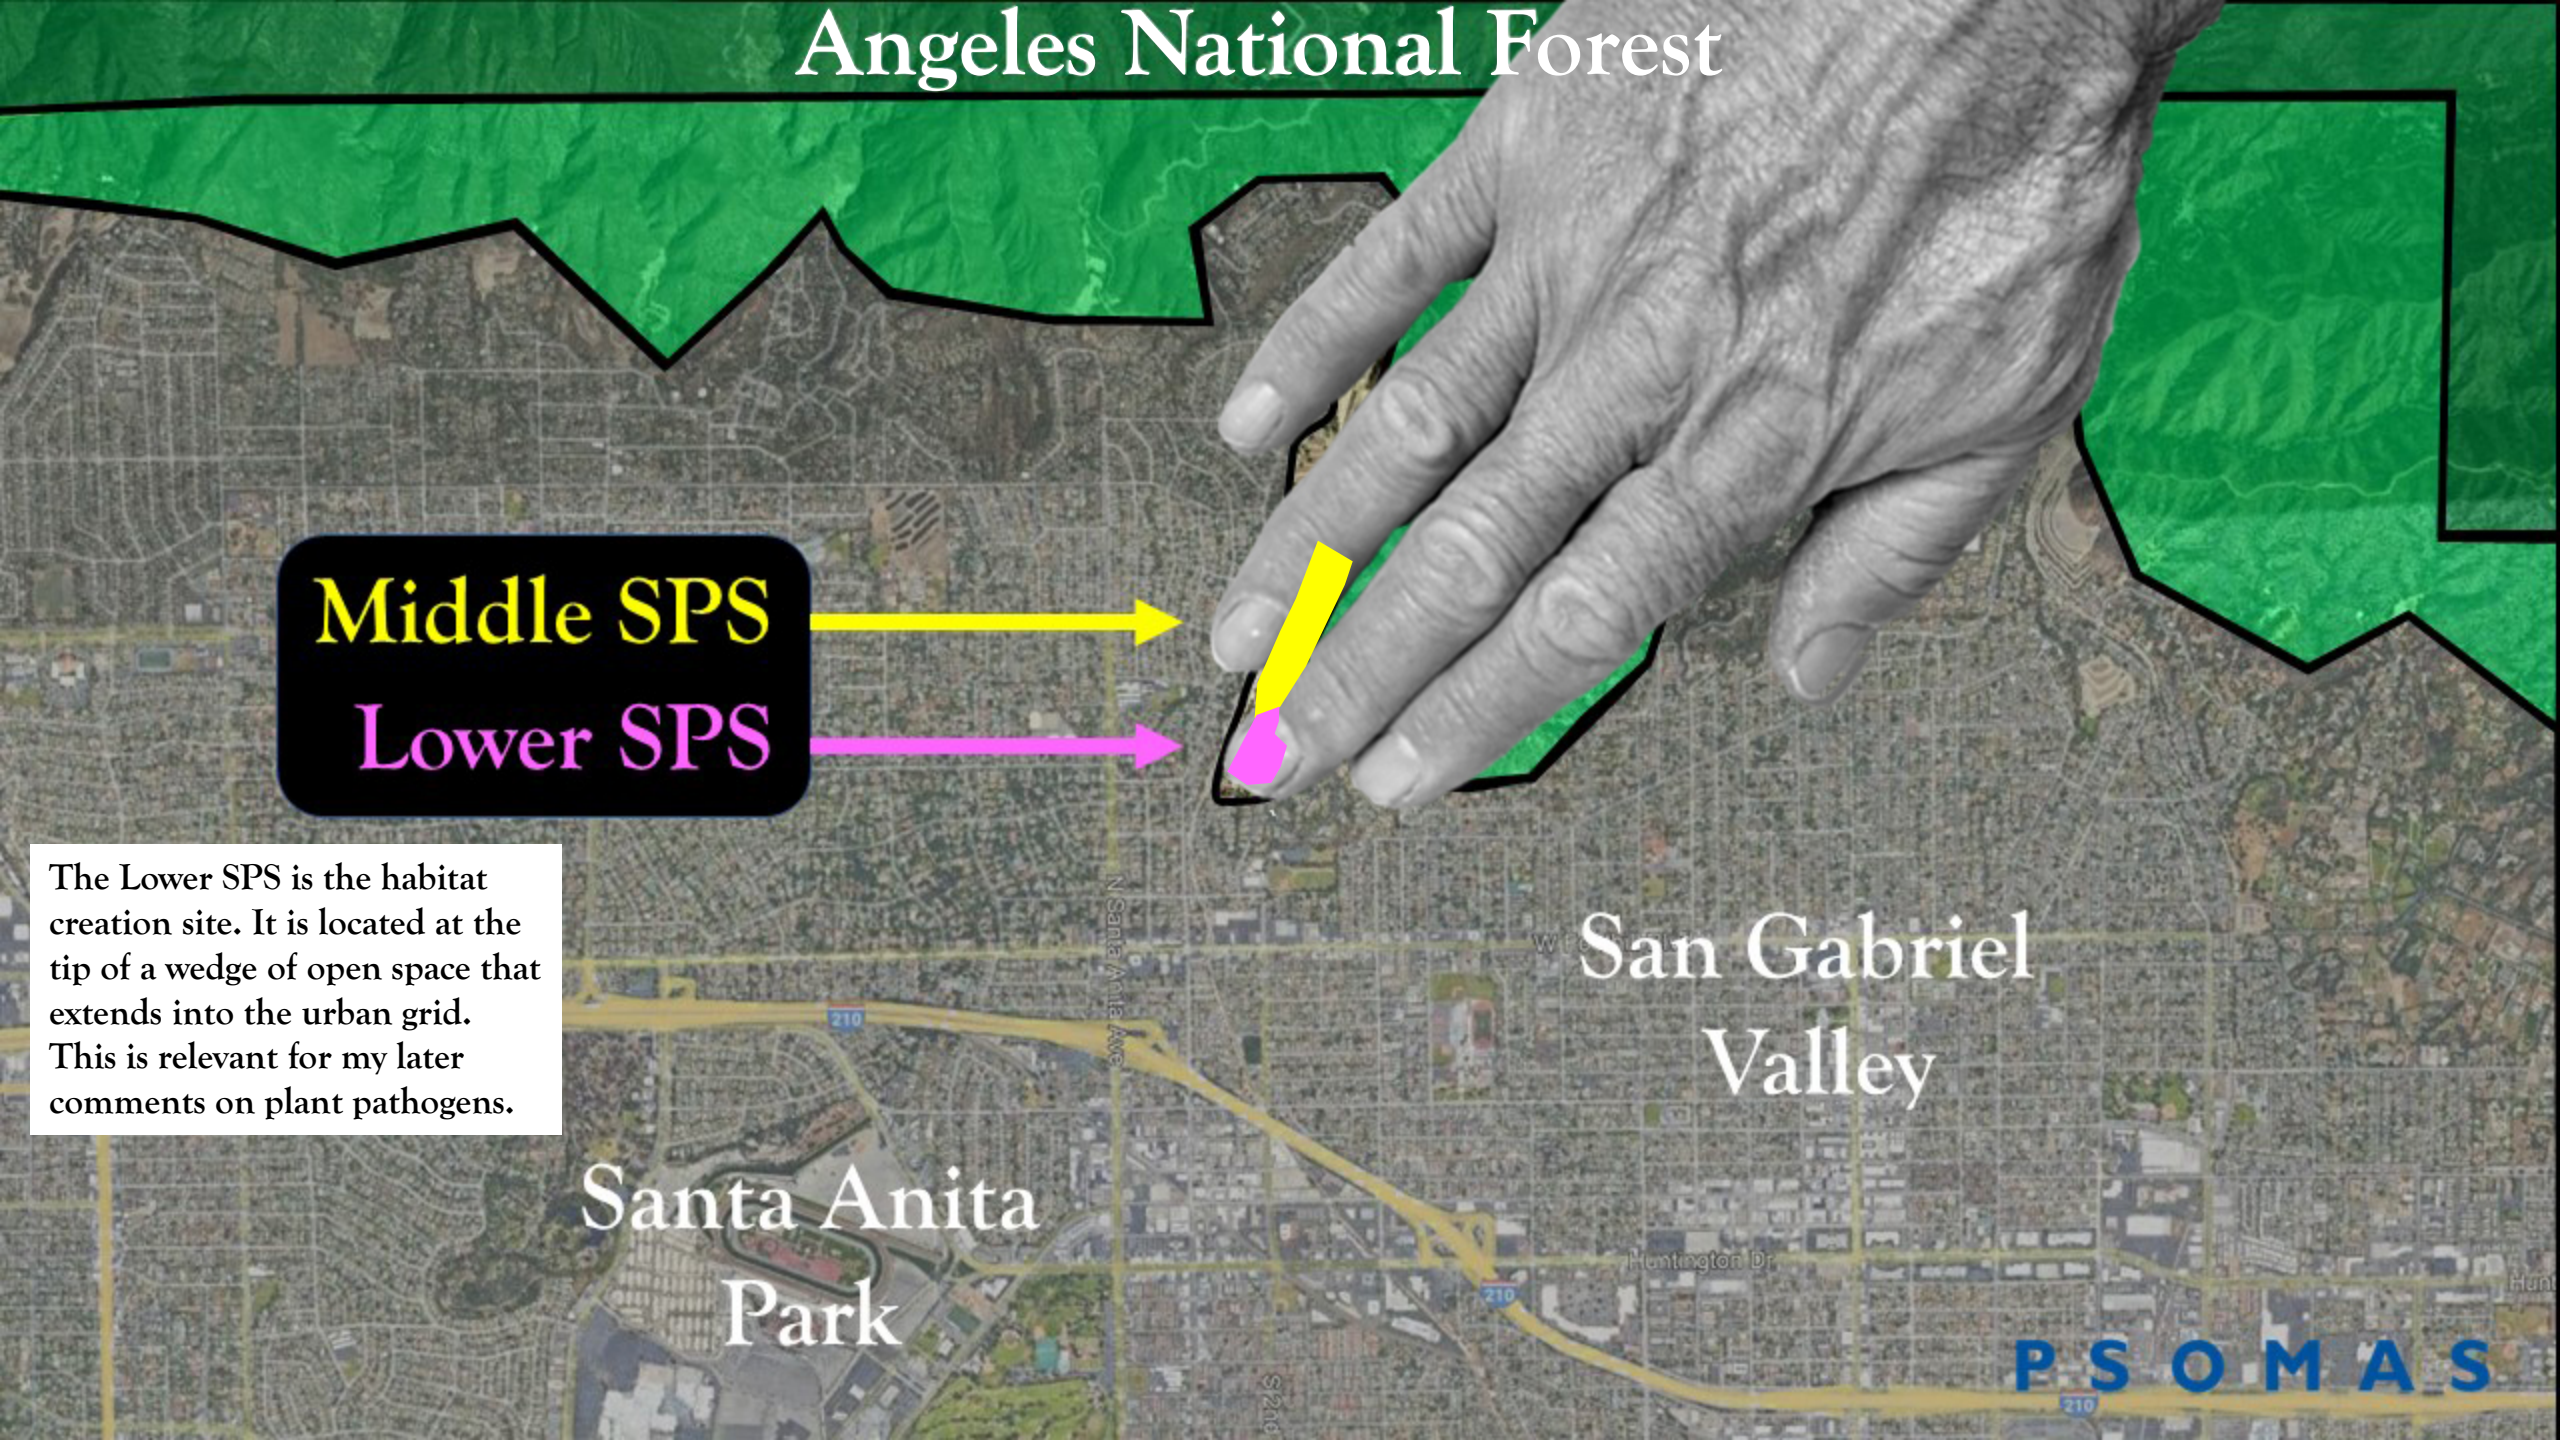
The Lower SPS is the habitat creation site. It is located at the tip of a wedge of open space that extends into the urban grid. This is relevant for my later comments on plant pathogens.

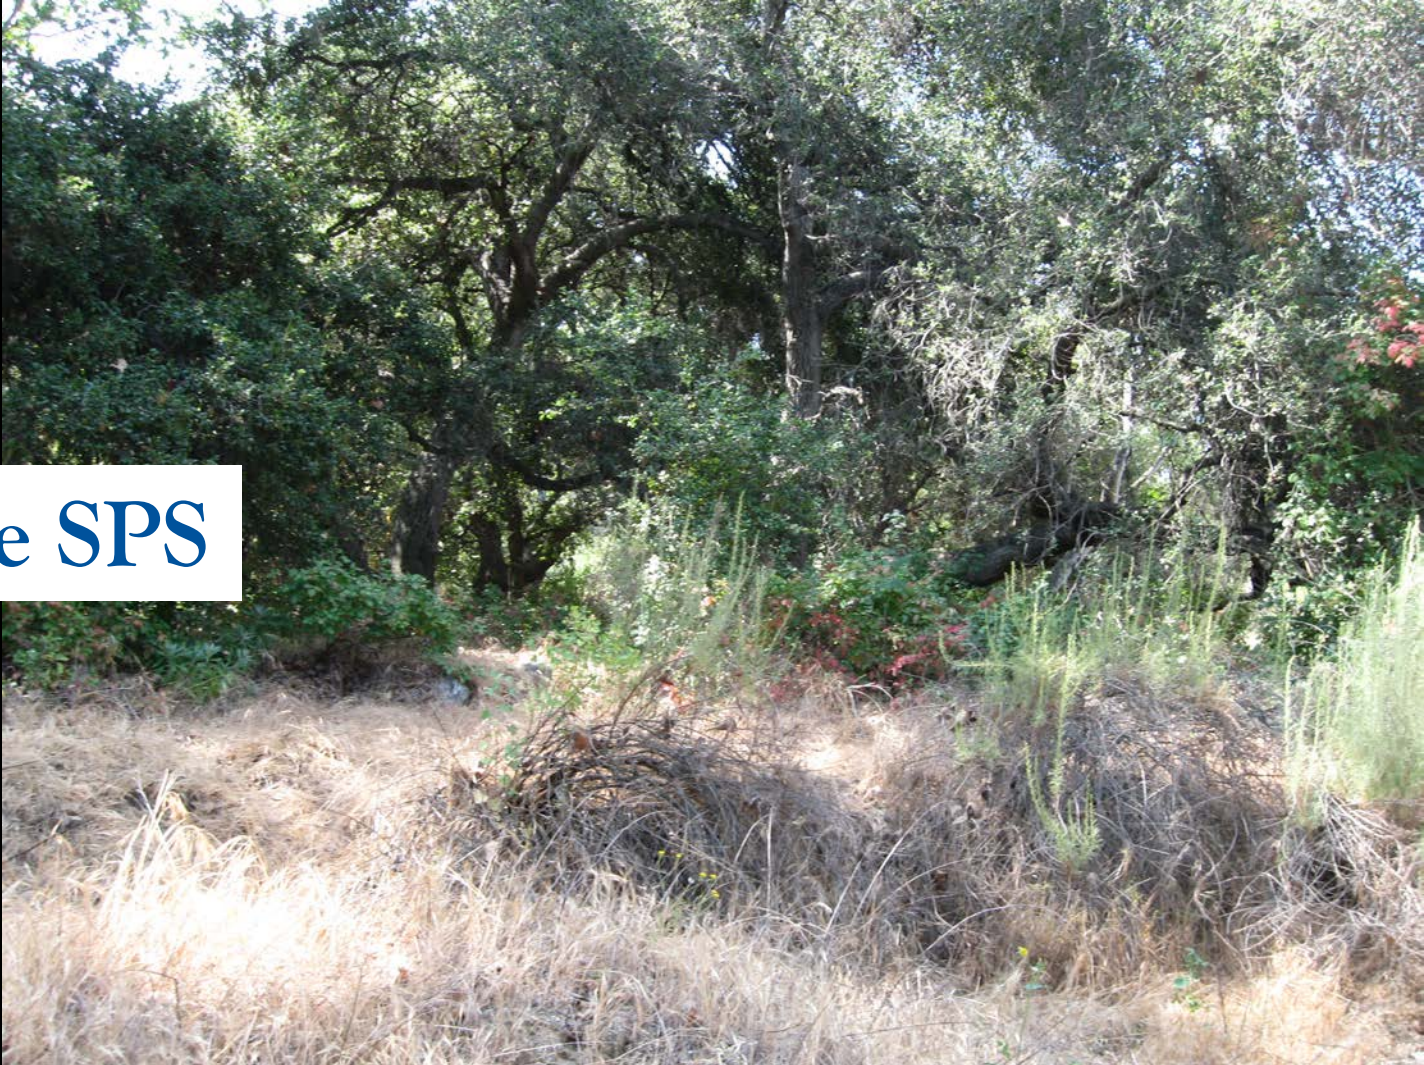
## Middle SPS

The adjacent Middle SPS was the vegetation impact site. Note the understory vegetation is badly degraded by invasive herbs, similar to other regional woodlands. Public Works retained Psomas in 2009 to prepare the habitat mitigation plan.

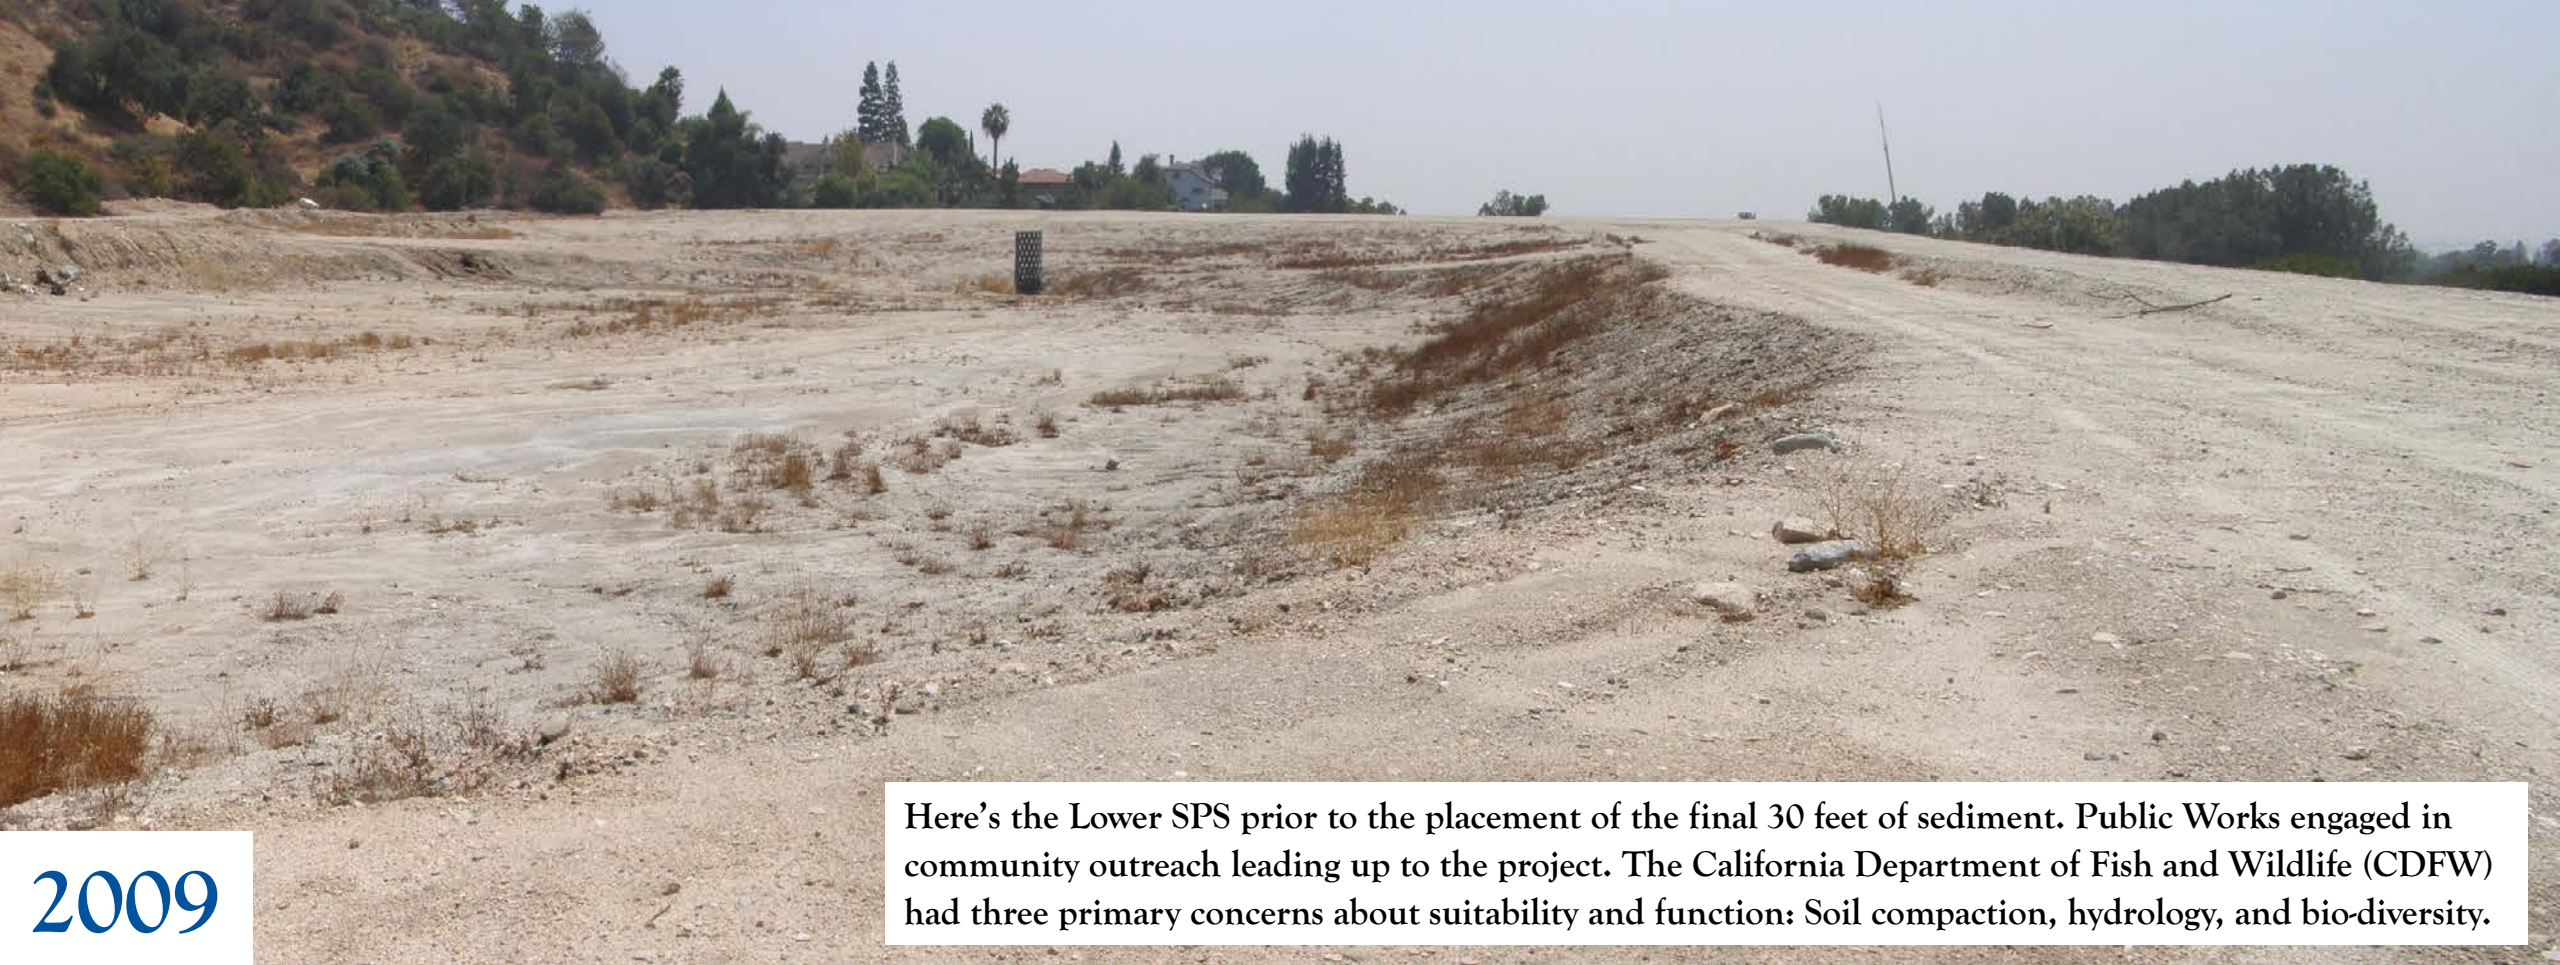
2009

Here's the Lower SPS prior to the placement of the final 30 feet of sediment. Public Works engaged in community outreach leading up to the project. The California Department of Fish and Wildlife (CDFW) had three primary concerns about suitability and function: Soil compaction, hydrology, and bio-diversity.

- Lower SPS prior to final 30' sediment placement
- Public Works' performs community outreach to constituents
- **CDFW: Soil compaction / hydrology / bio-diversity**

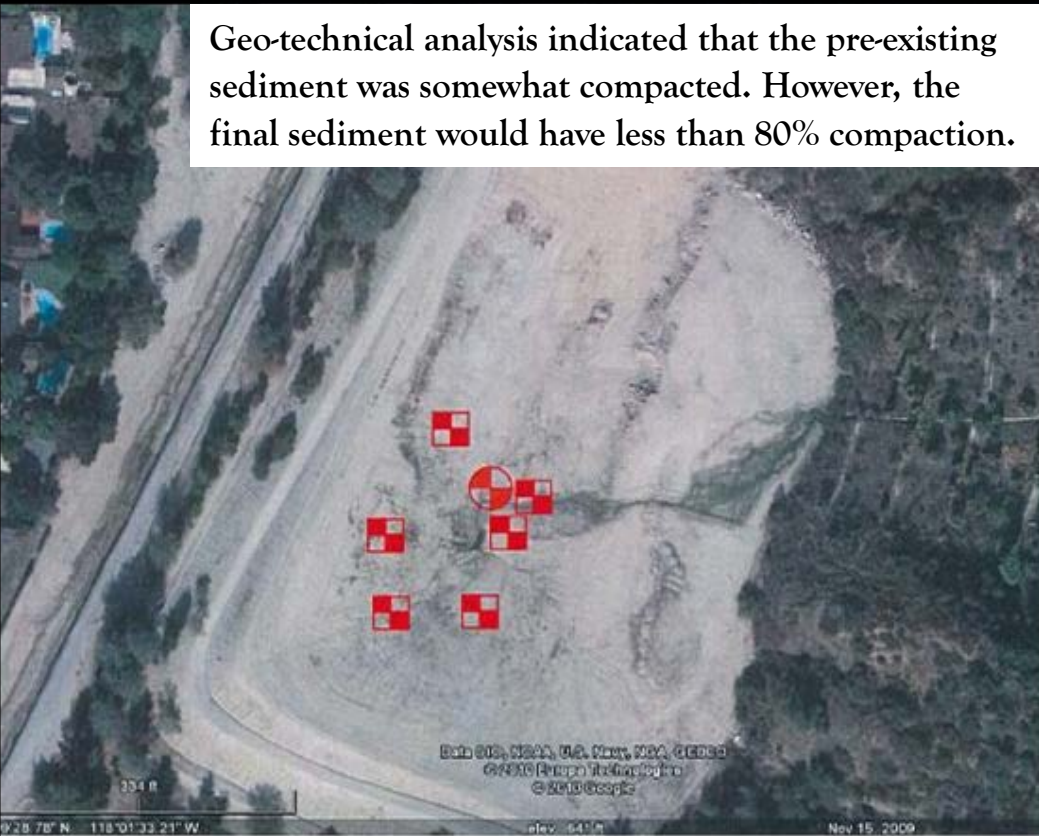
Geo-technical analysis indicated that the pre-existing sediment was somewhat compacted. However, the final sediment would have less than 80% compaction.

Boring location  
  Nuclear gage test location

- Pre-Existing 78% to 90% Compaction Gradient (0 to 53')
- 30' of New Sediment to Complete Lower SPS
- **New Sediment Compaction < 80% (Deck)**
- Slope Compaction at Least 80% for Stability

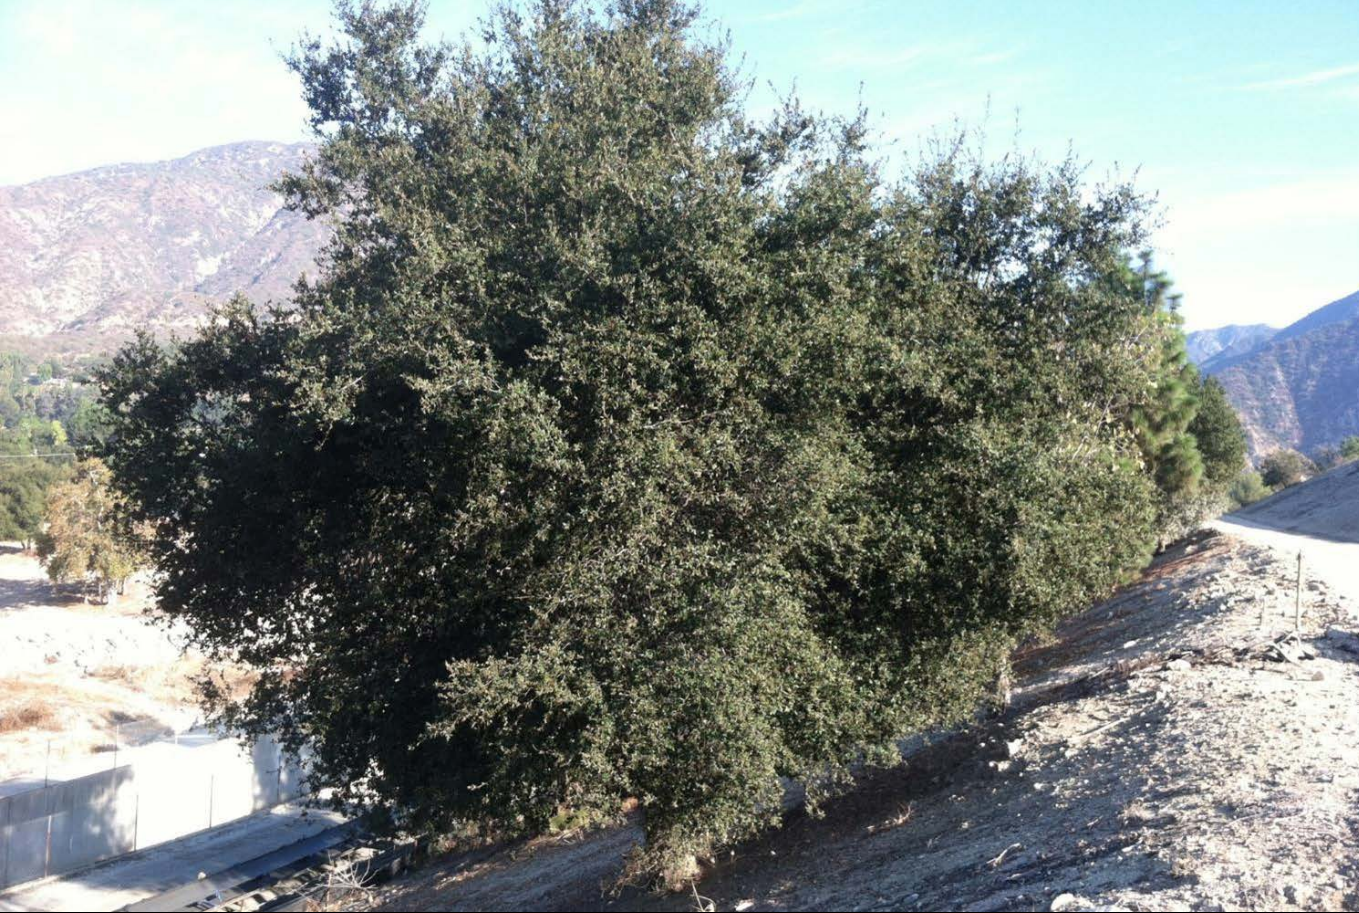
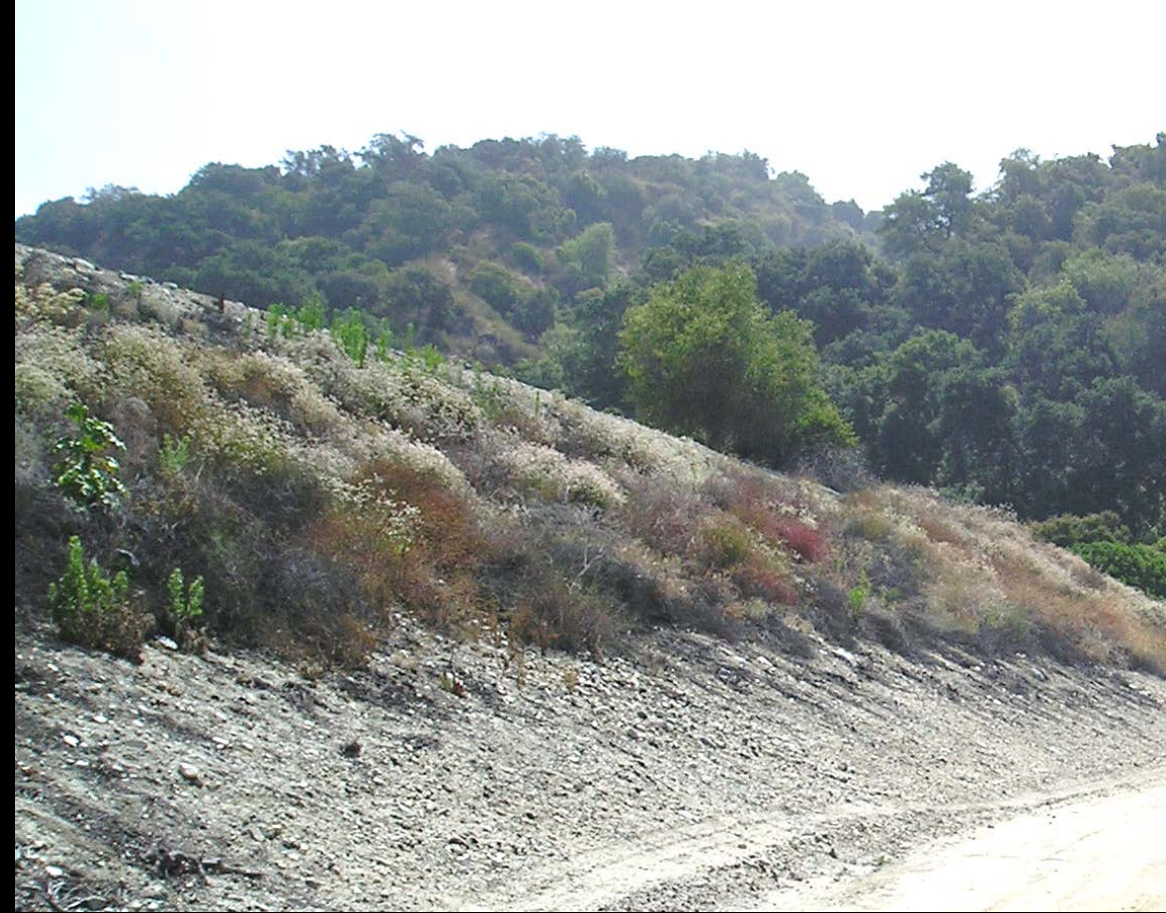
- Upper SPS: Coast live oaks and coastal sage scrub
- Non-irrigated / south- and west-facing slopes

We had observed several large coast live oaks (*Quercus agrifolia* var. *agrifolia*) and sage scrub on the nearby Upper SPS in good condition, growing in placed material from the same source (Santa Anita Reservoir).

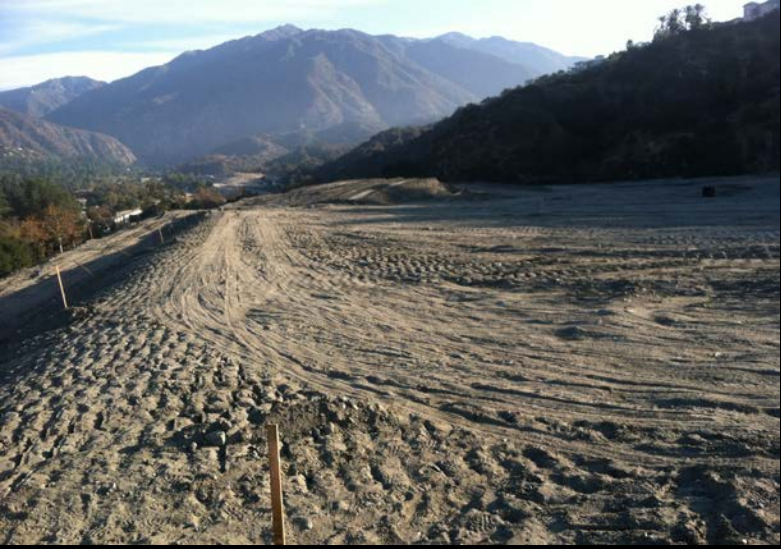
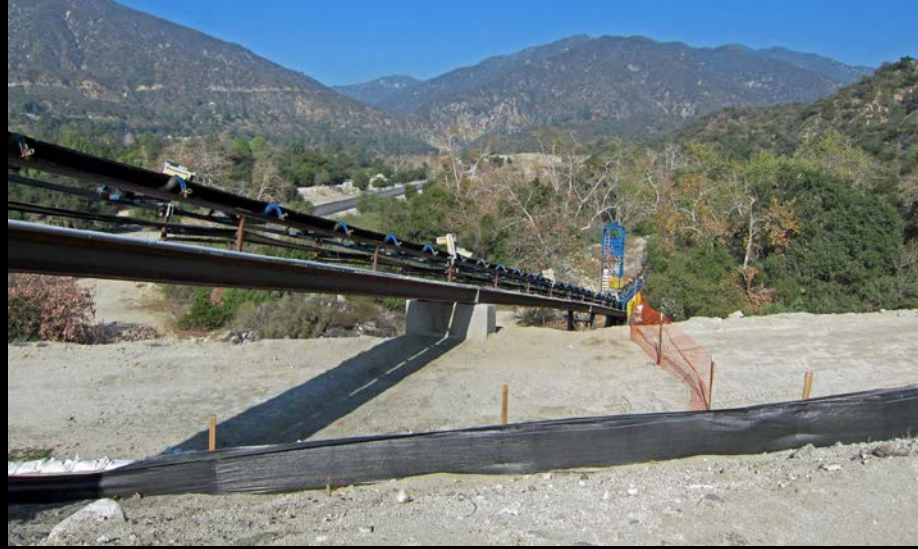
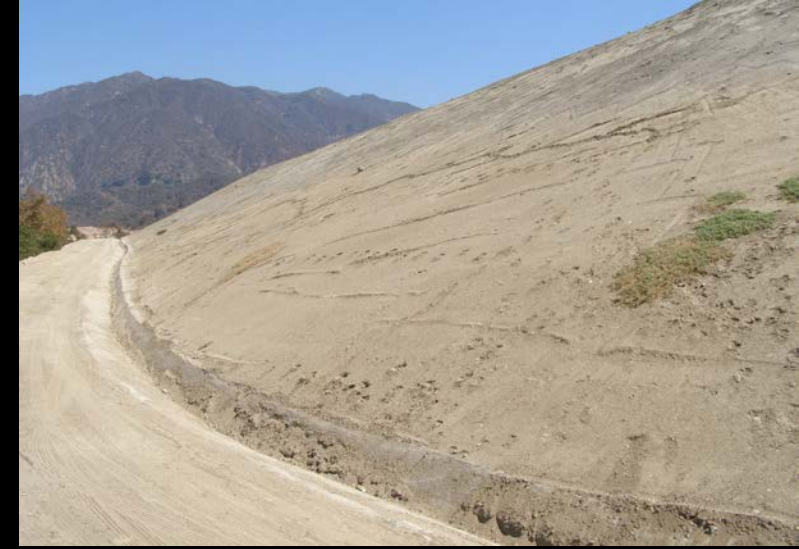
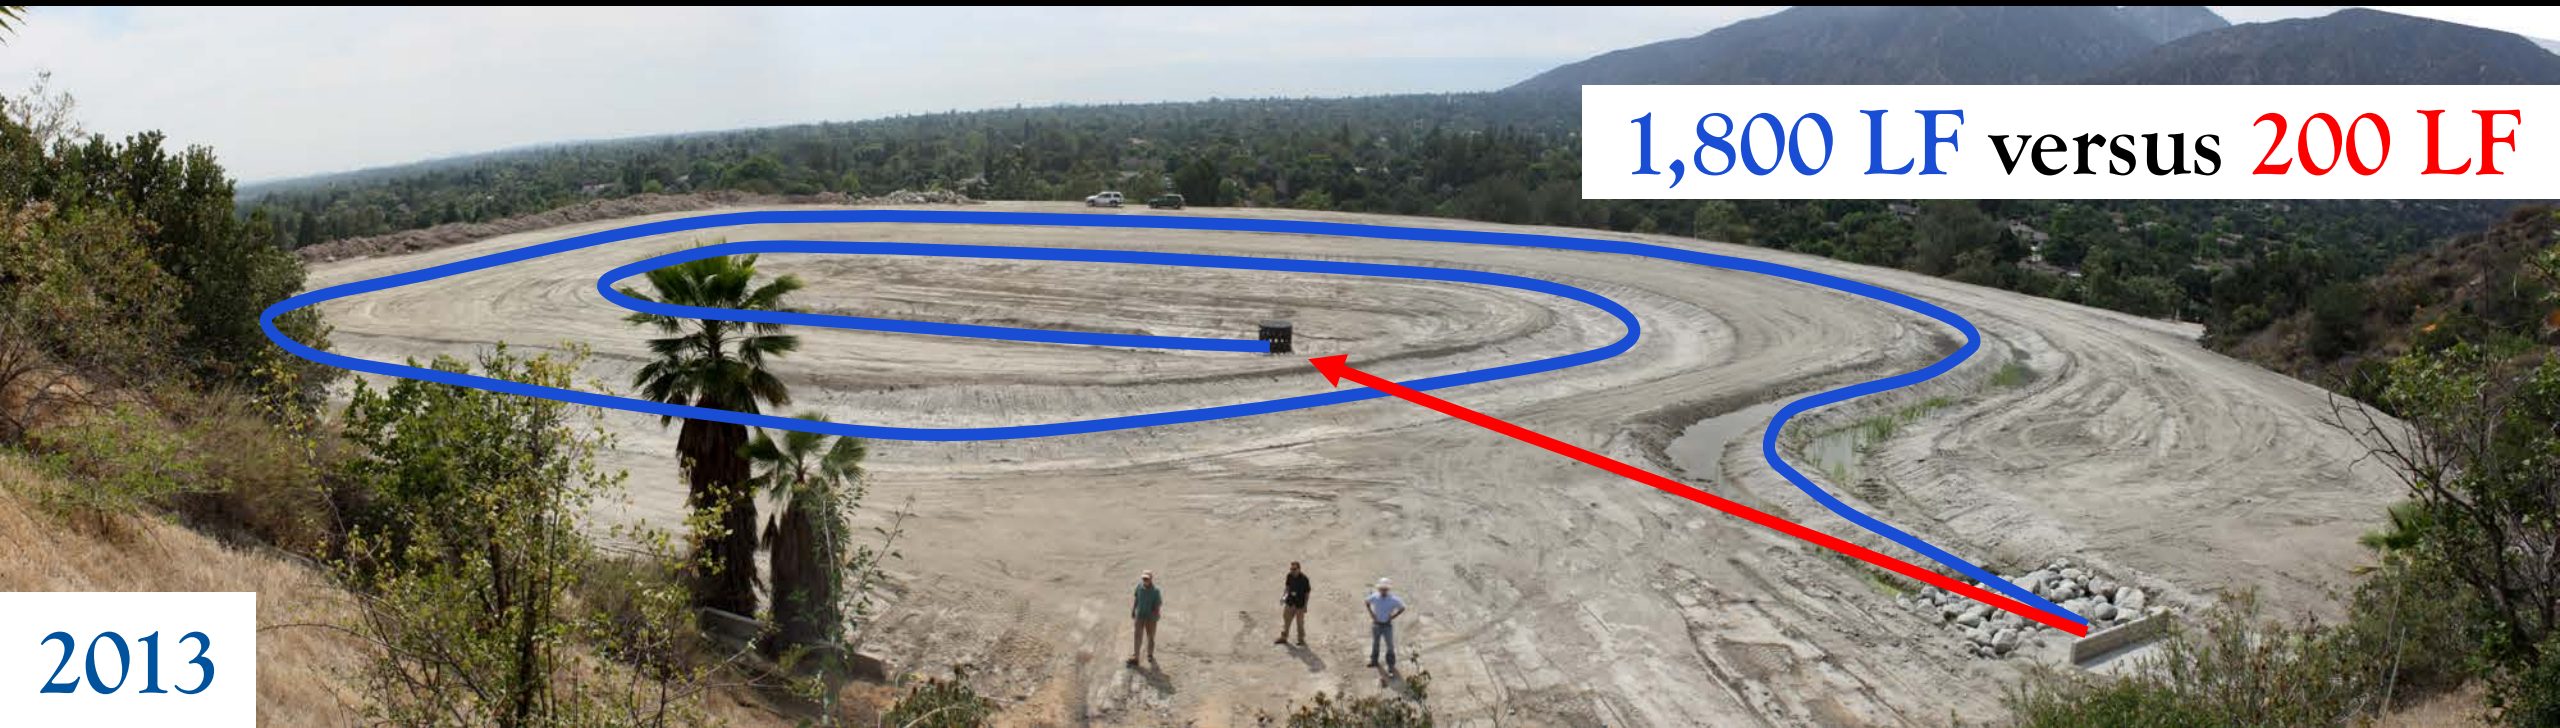
1,800 LF versus 200 LF

This resulted in 1,800 linear feet of drainage versus 200 linear feet if flows had been conveyed directly to the outlet tower.

Public Works designed spiraling drainages to disperse the substantial off-site inflows across the deck of the SPS.
