# Substrate Enhancements and Botanical Diversity for Successful Oak Habitat Creation

Richard B. Lewis III, ENV SP  
Senior Restoration Ecologist, Psomas

LOS ANGELES COUNTY  
FLOOD CONTROL DISTRICT  
SANTA ANITA  
DAM

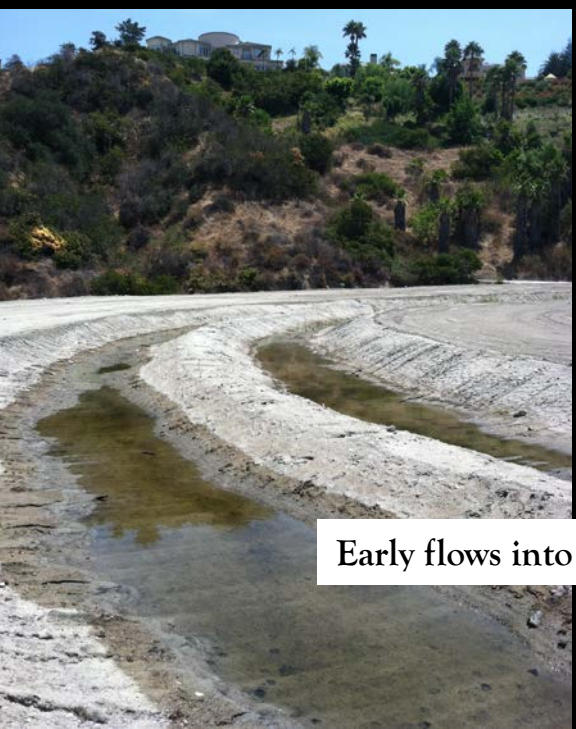
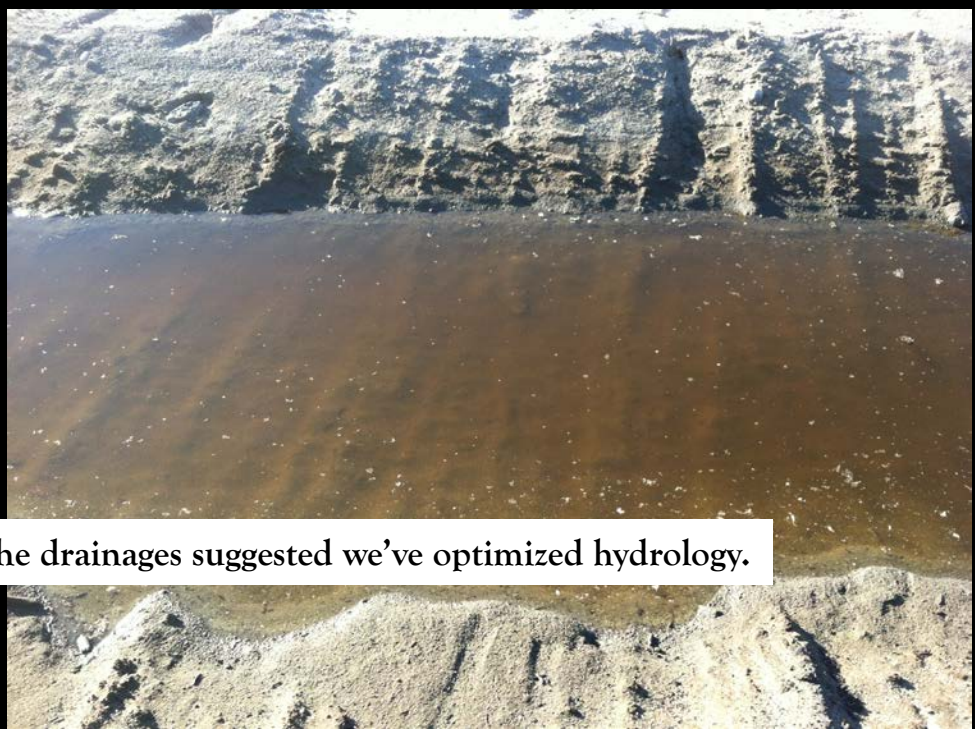
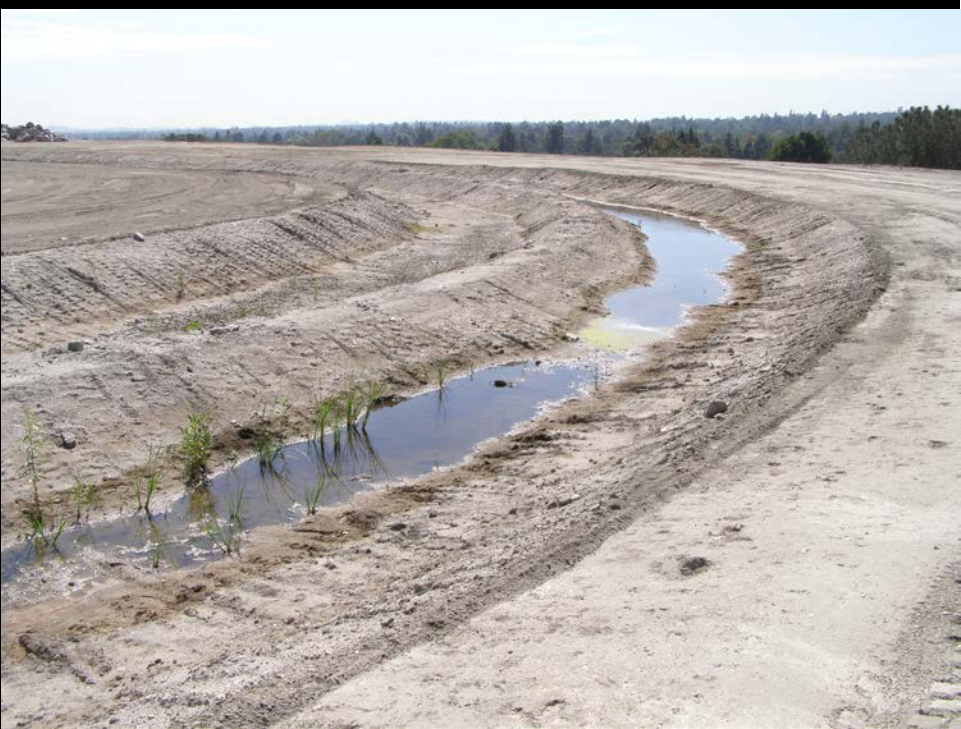
Early flows into the drainages suggested we've optimized hydrology.

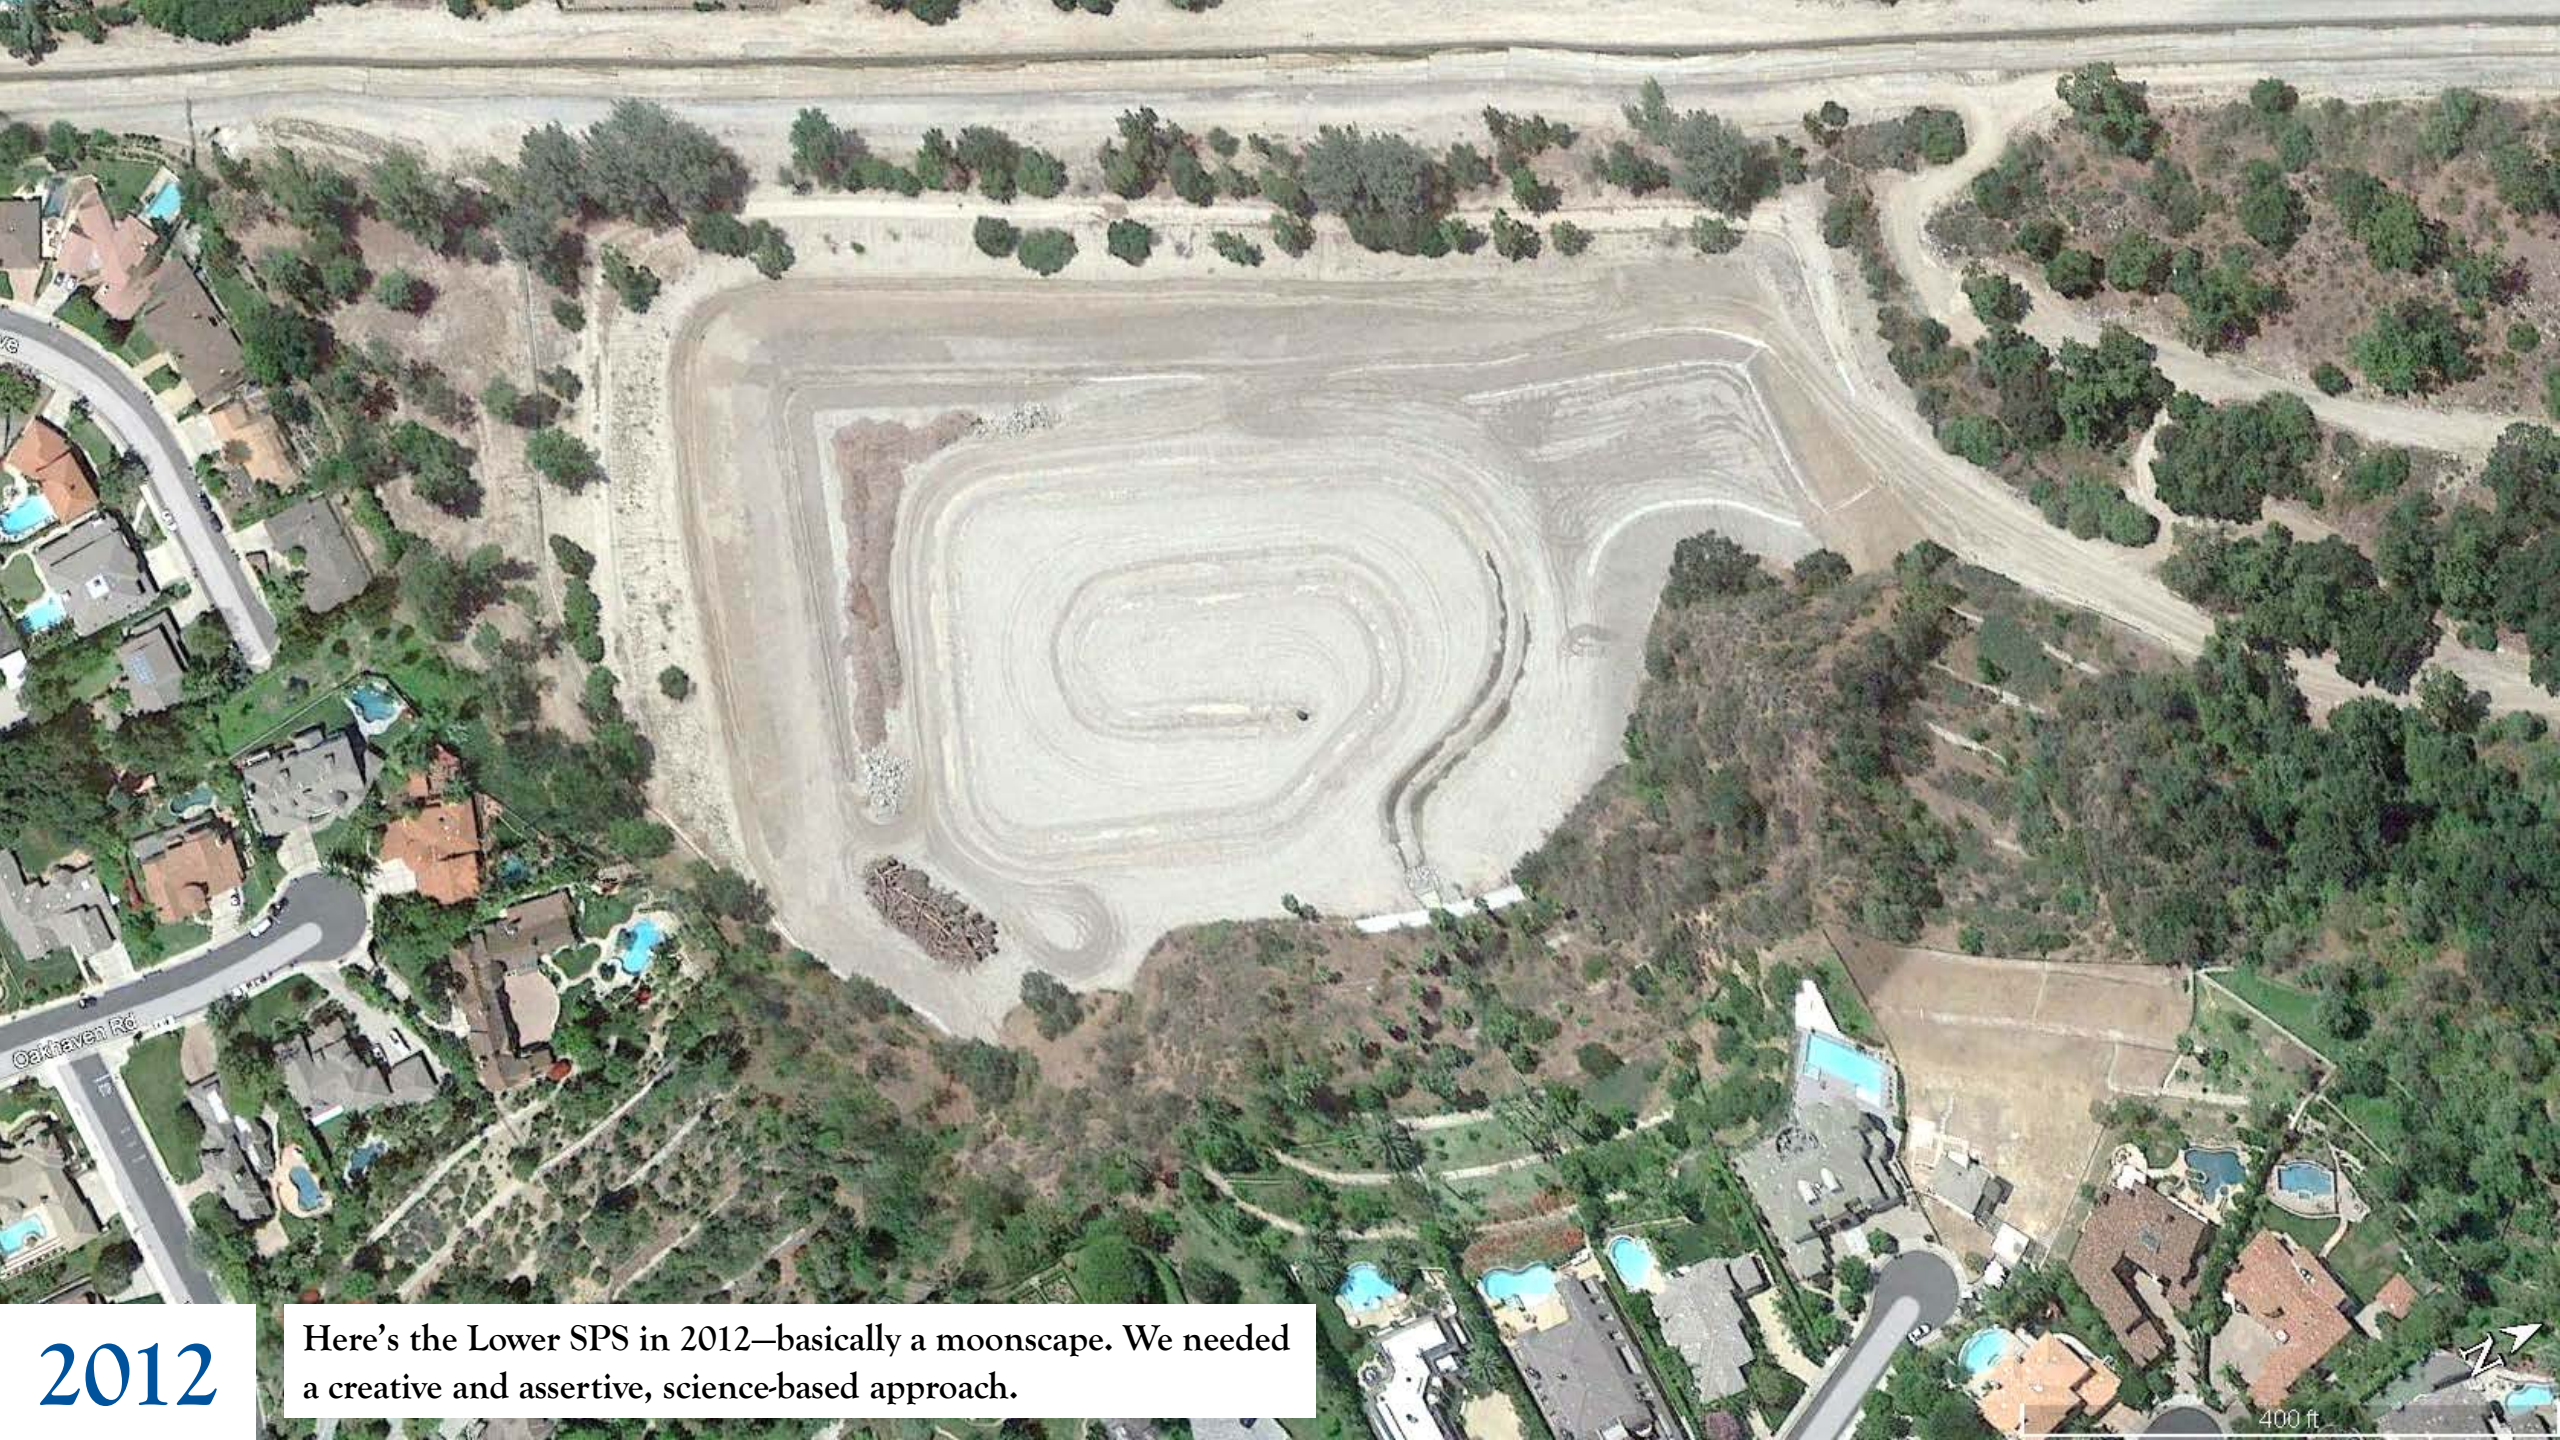
2012

Here's the Lower SPS in 2012—basically a moonscape. We needed a creative and assertive, science-based approach.

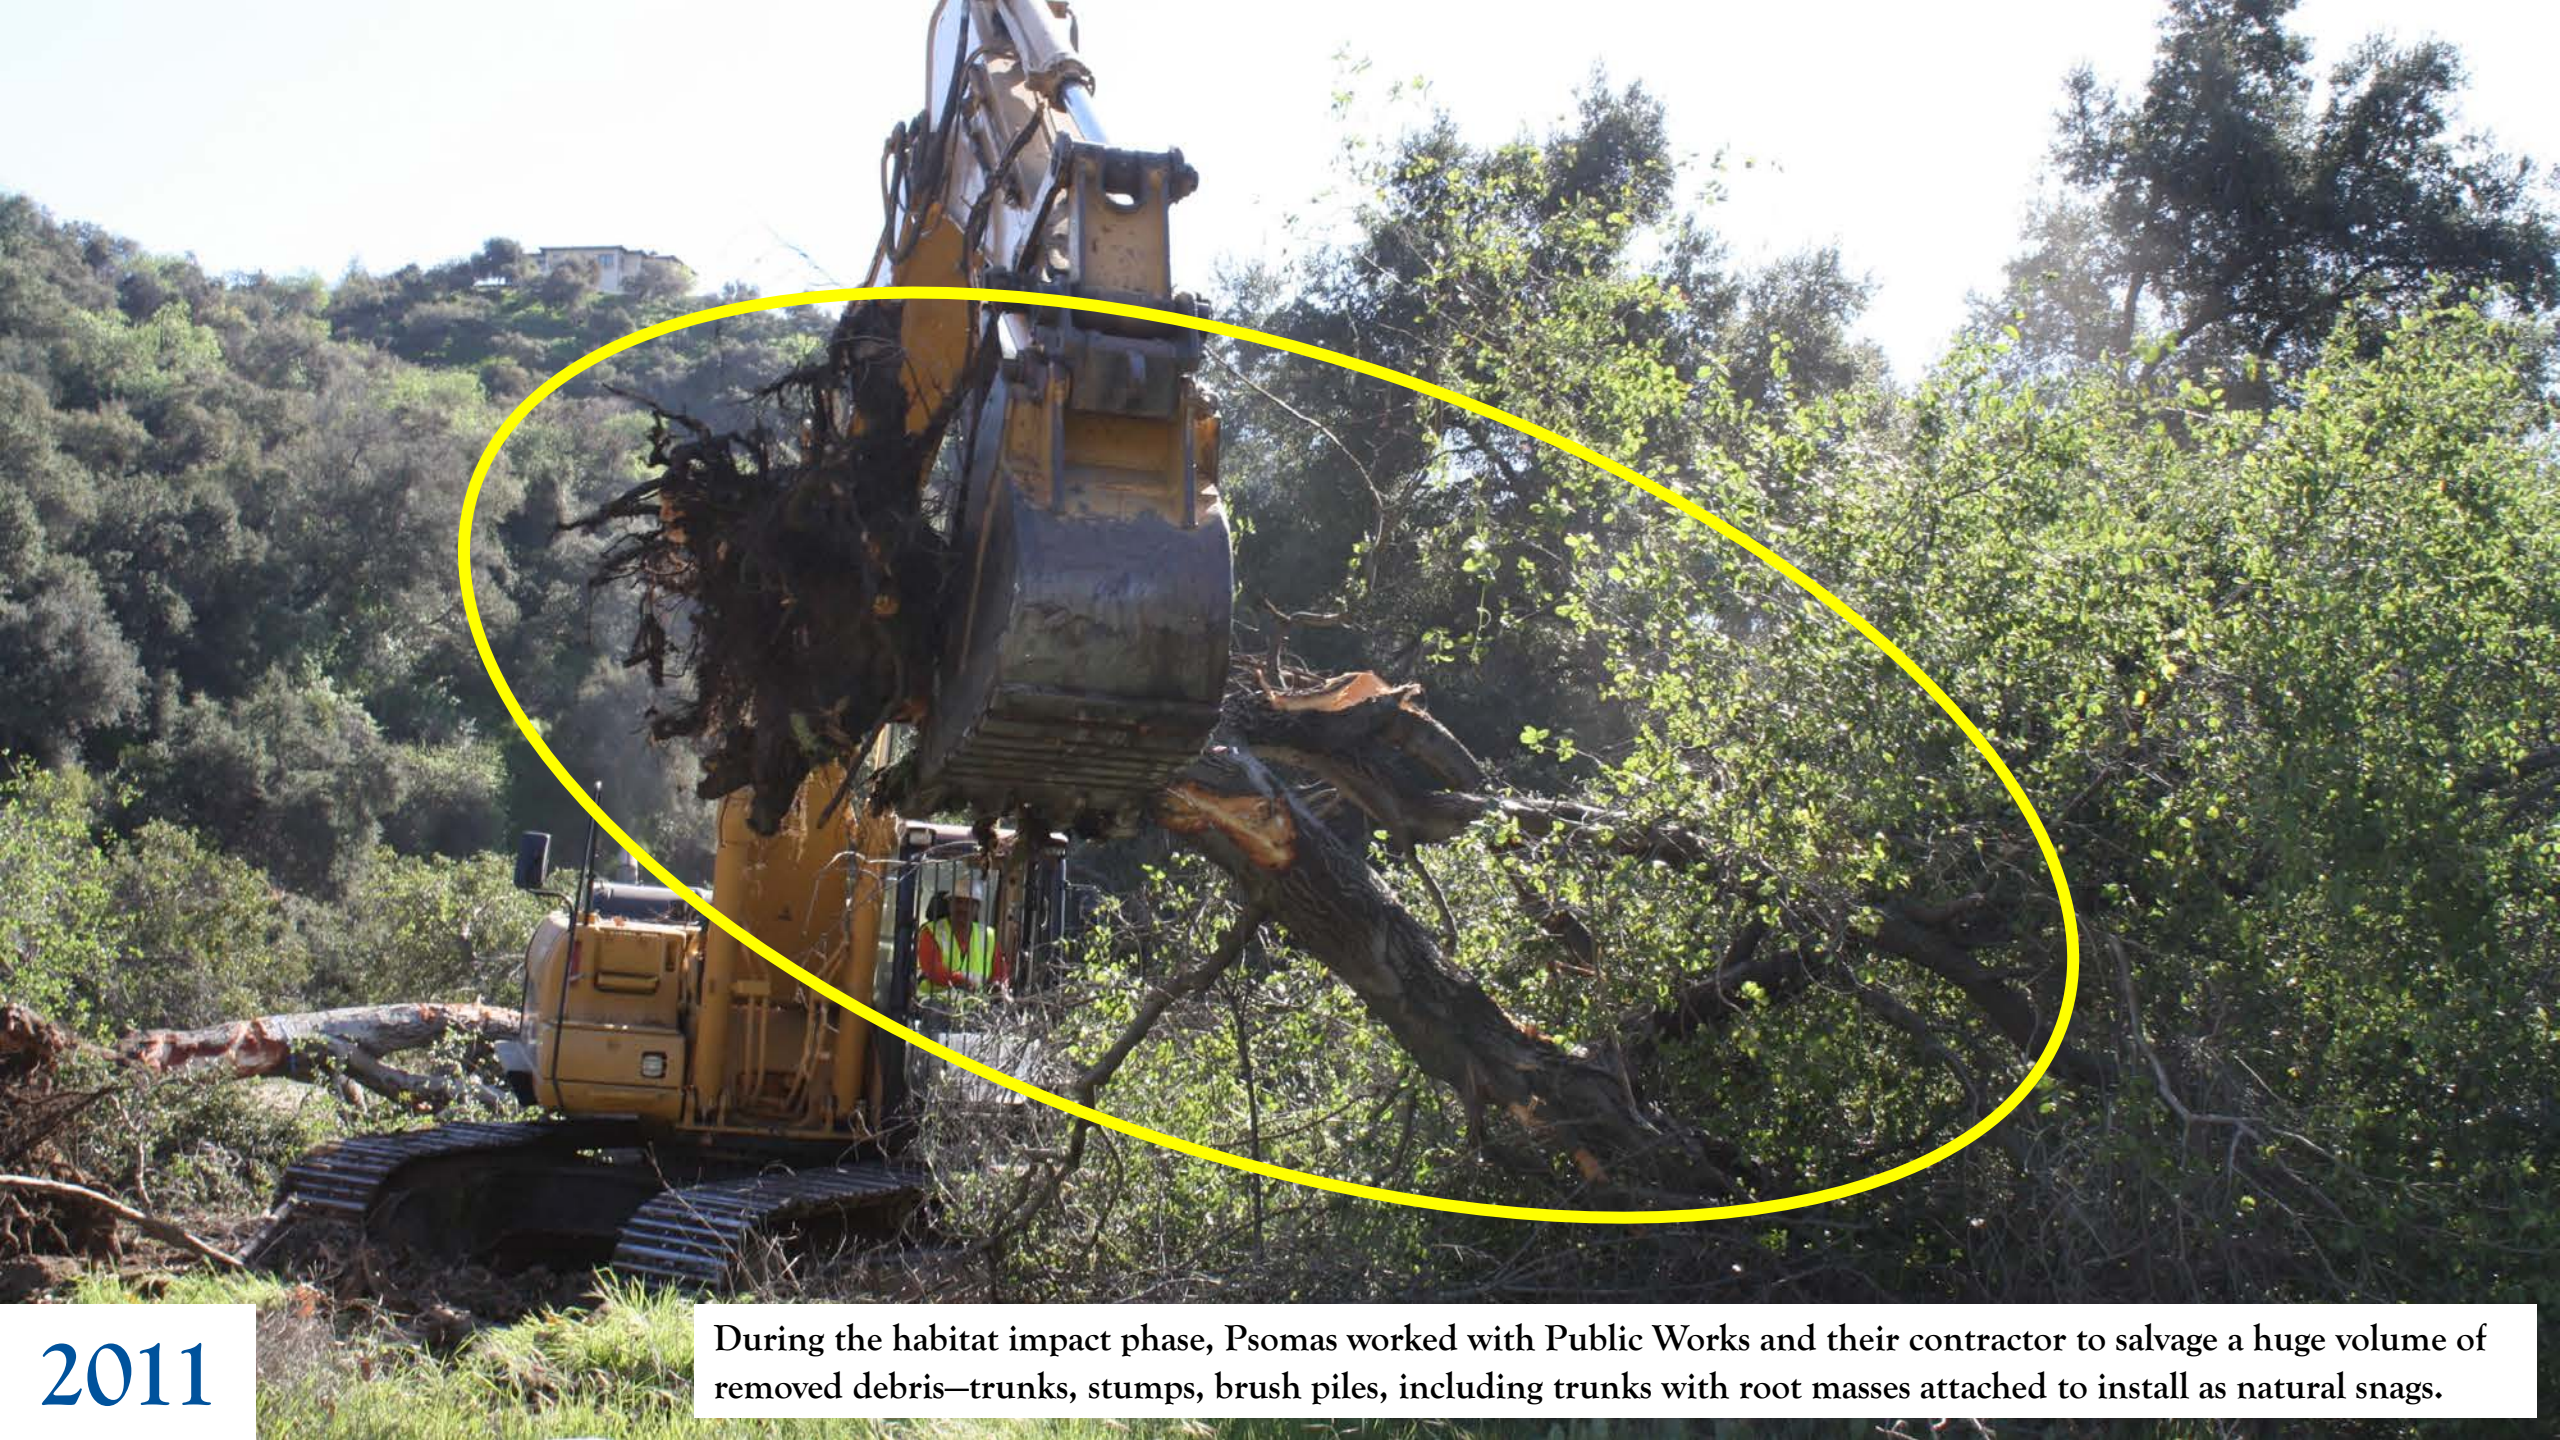
2011

During the habitat impact phase, Psomas worked with Public Works and their contractor to salvage a huge volume of removed debris—trunks, stumps, brush piles, including trunks with root masses attached to install as natural snags.

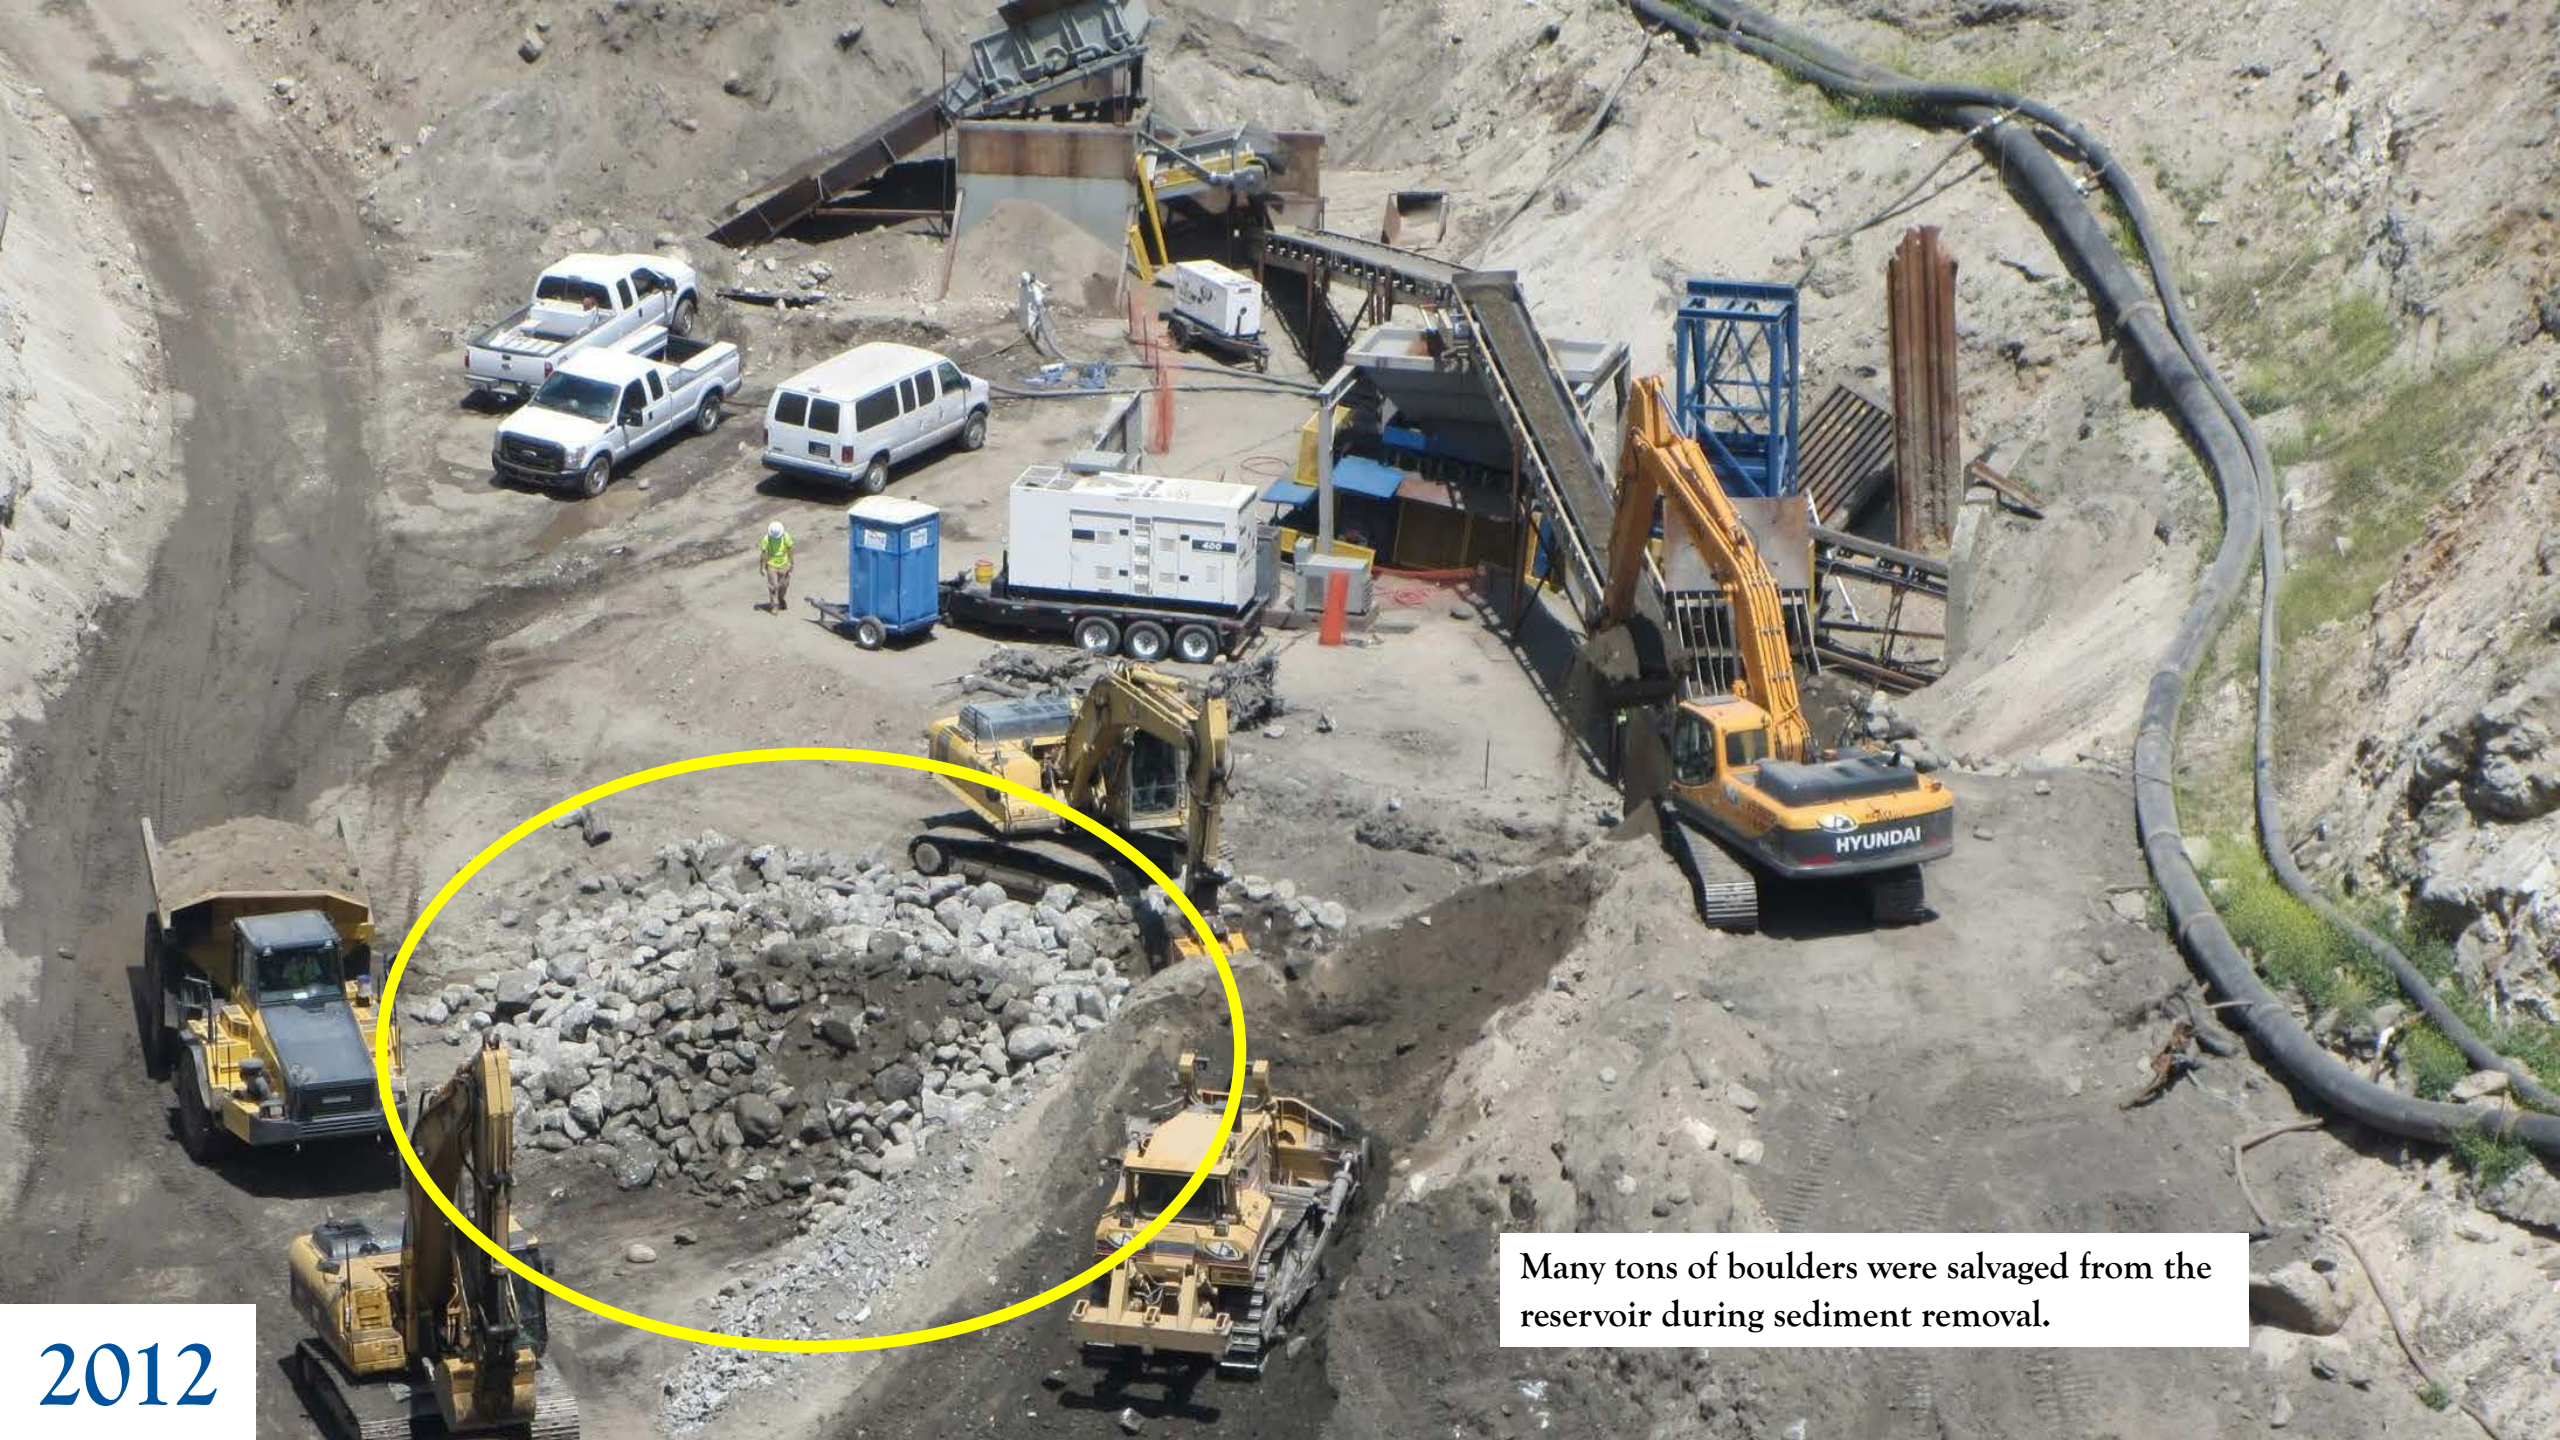
Many tons of boulders were salvaged from the reservoir during sediment removal.

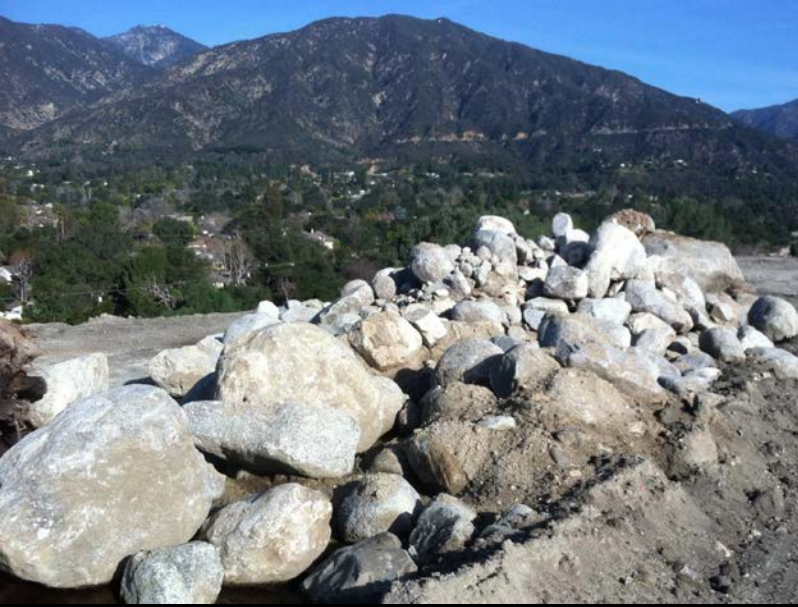
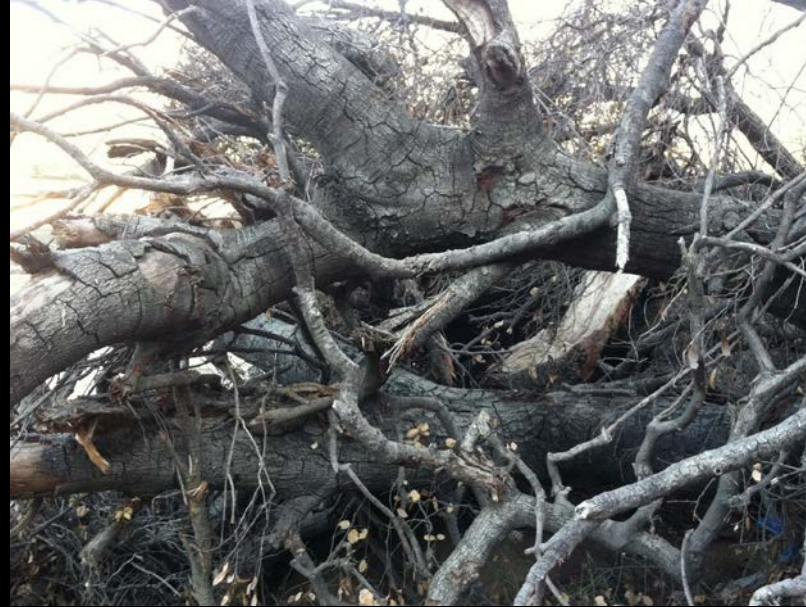
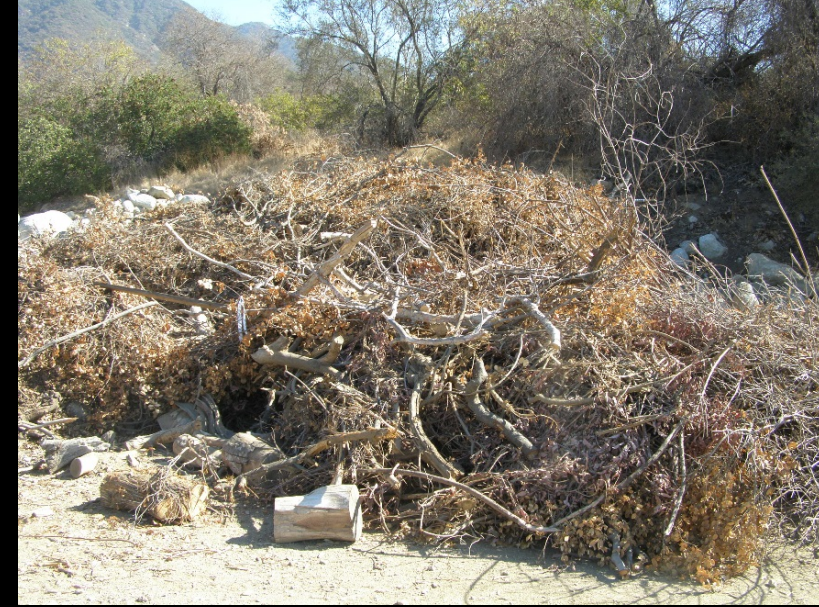
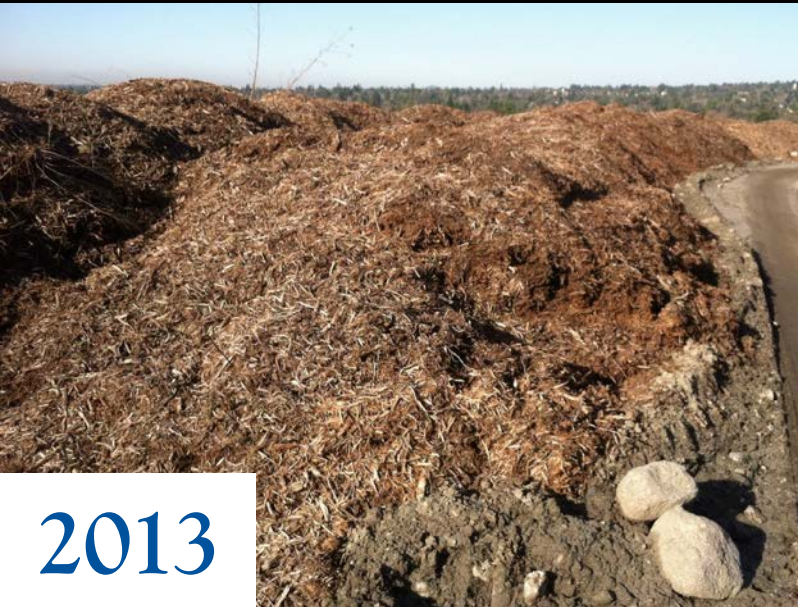
Here's some stockpiled natural materials. Whatever trunks/stems were not retained whole, were mulched for use in conditioning the placed sediment. We essentially used 'the whole animal' in terms of woody vegetation from the adjacent Middle SPS.

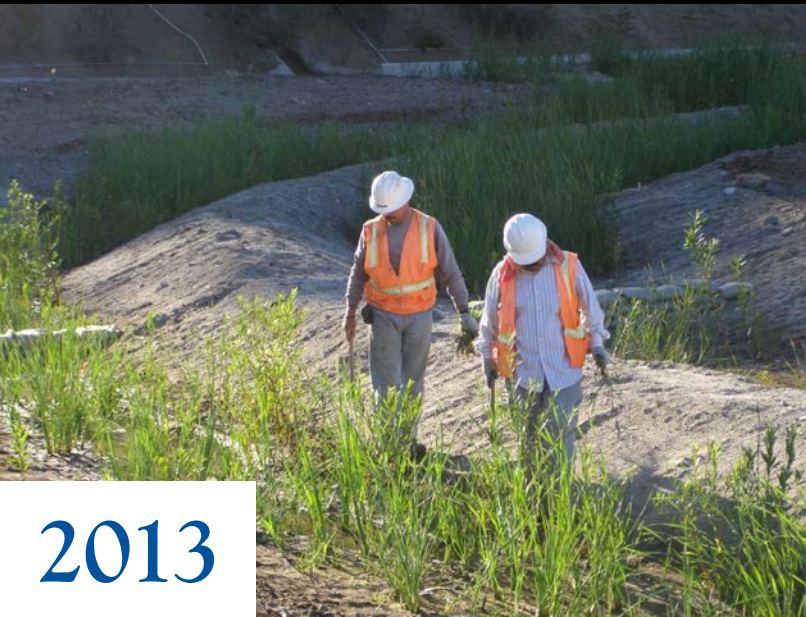
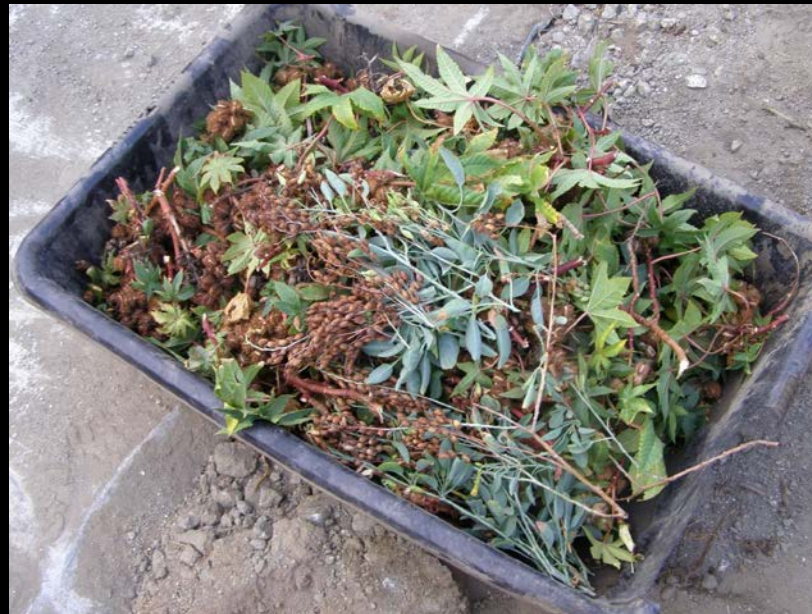
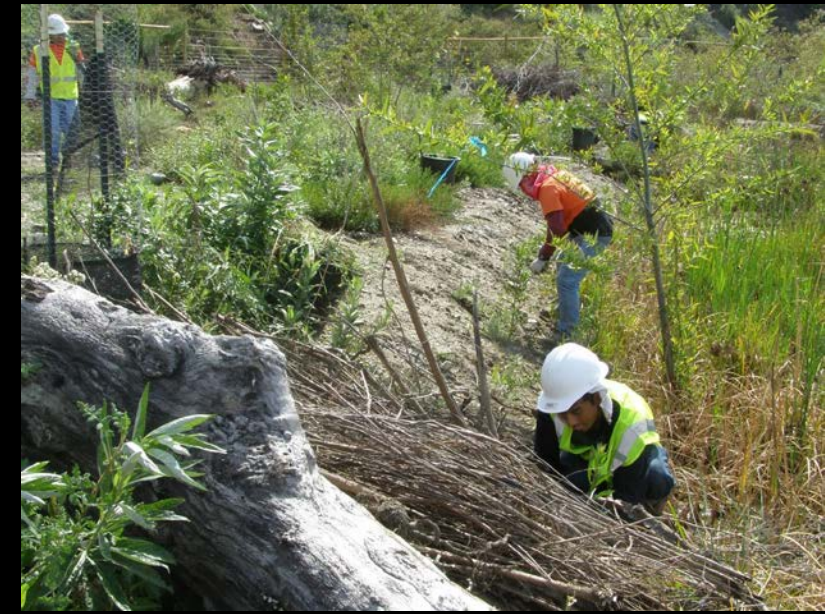
Assertive weed control was performed at all phases of this project.

- Avoid Seed Dispersal
- Avoid Adverse Impacts
- Voluntary Buffer Areas (8 Acres)

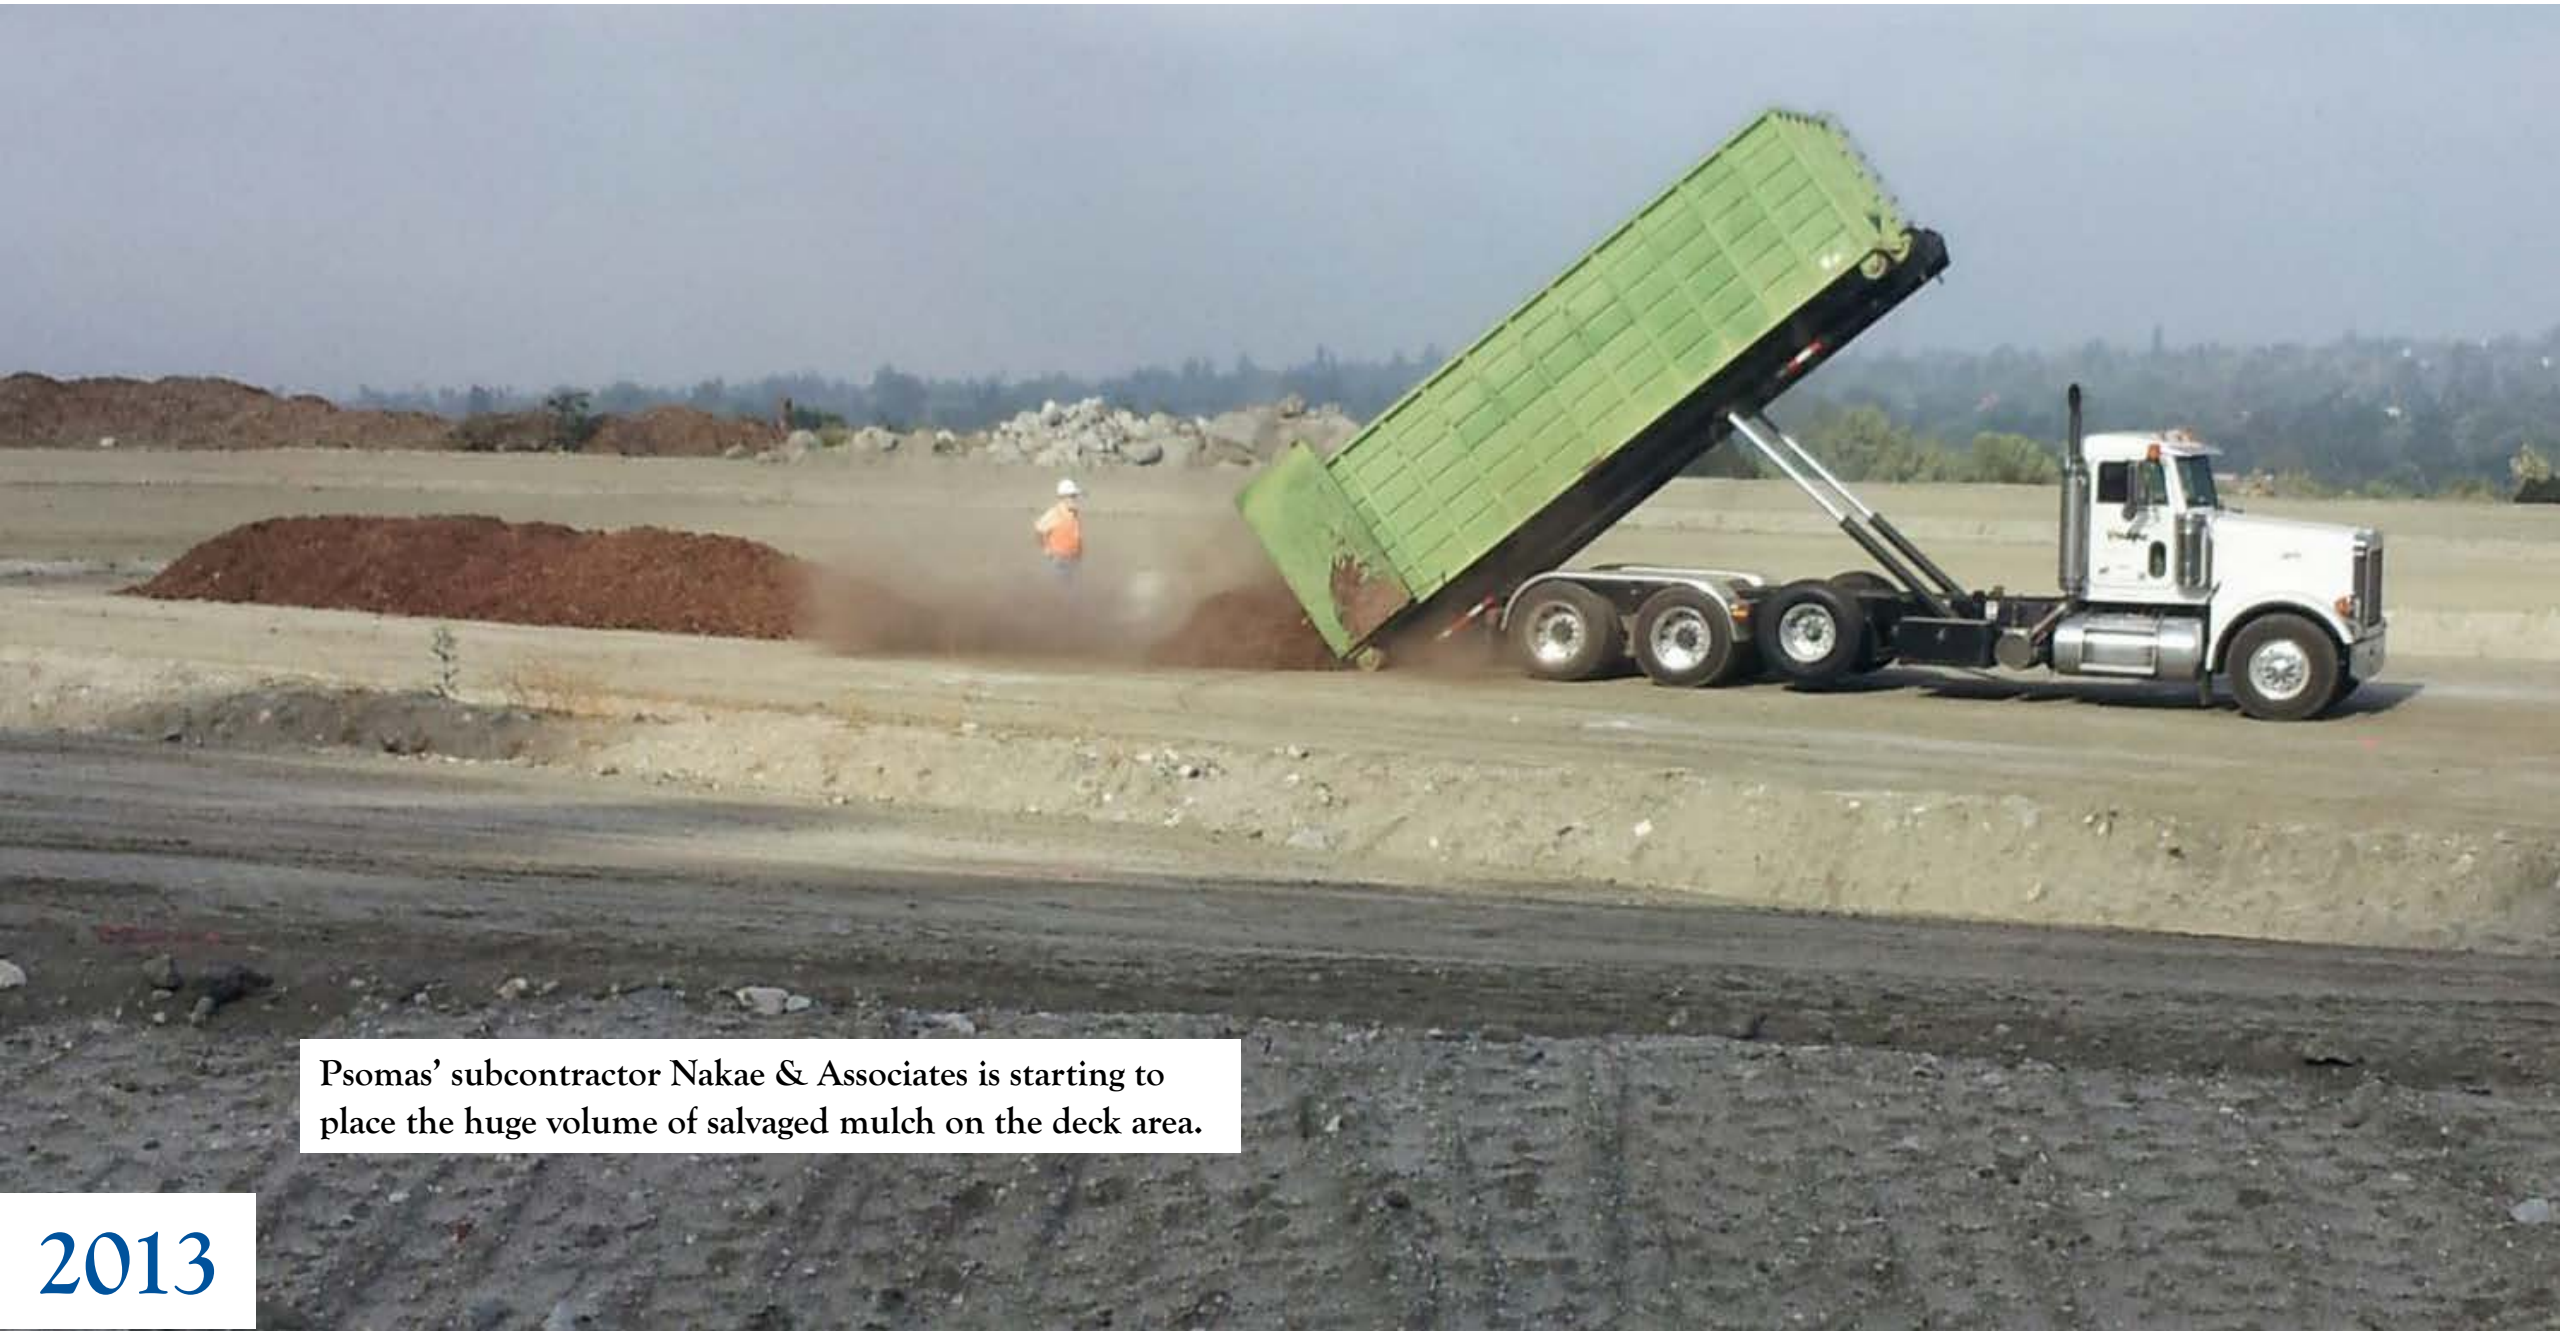
Psomas' subcontractor Nakae & Associates is starting to place the huge volume of salvaged mulch on the deck area.

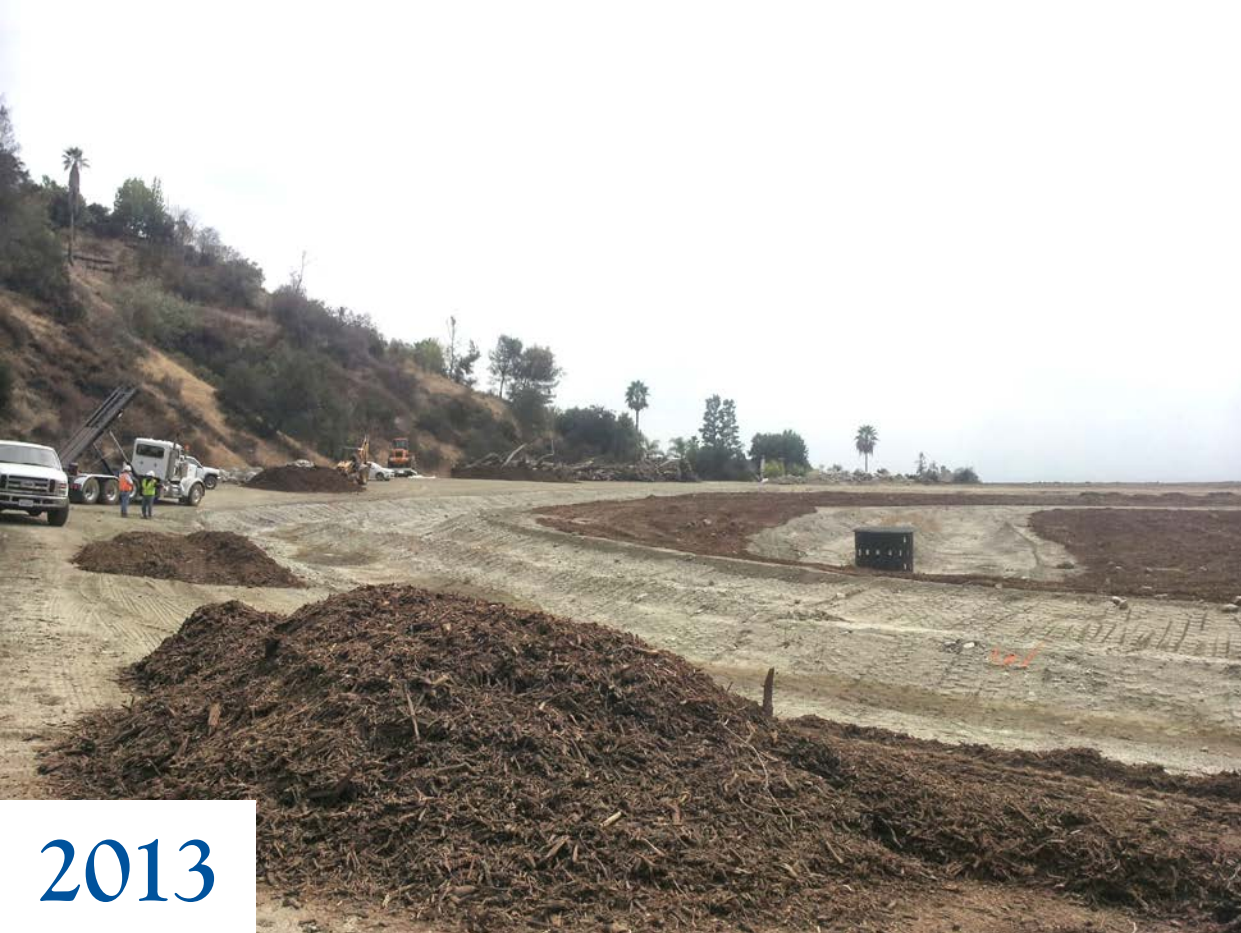
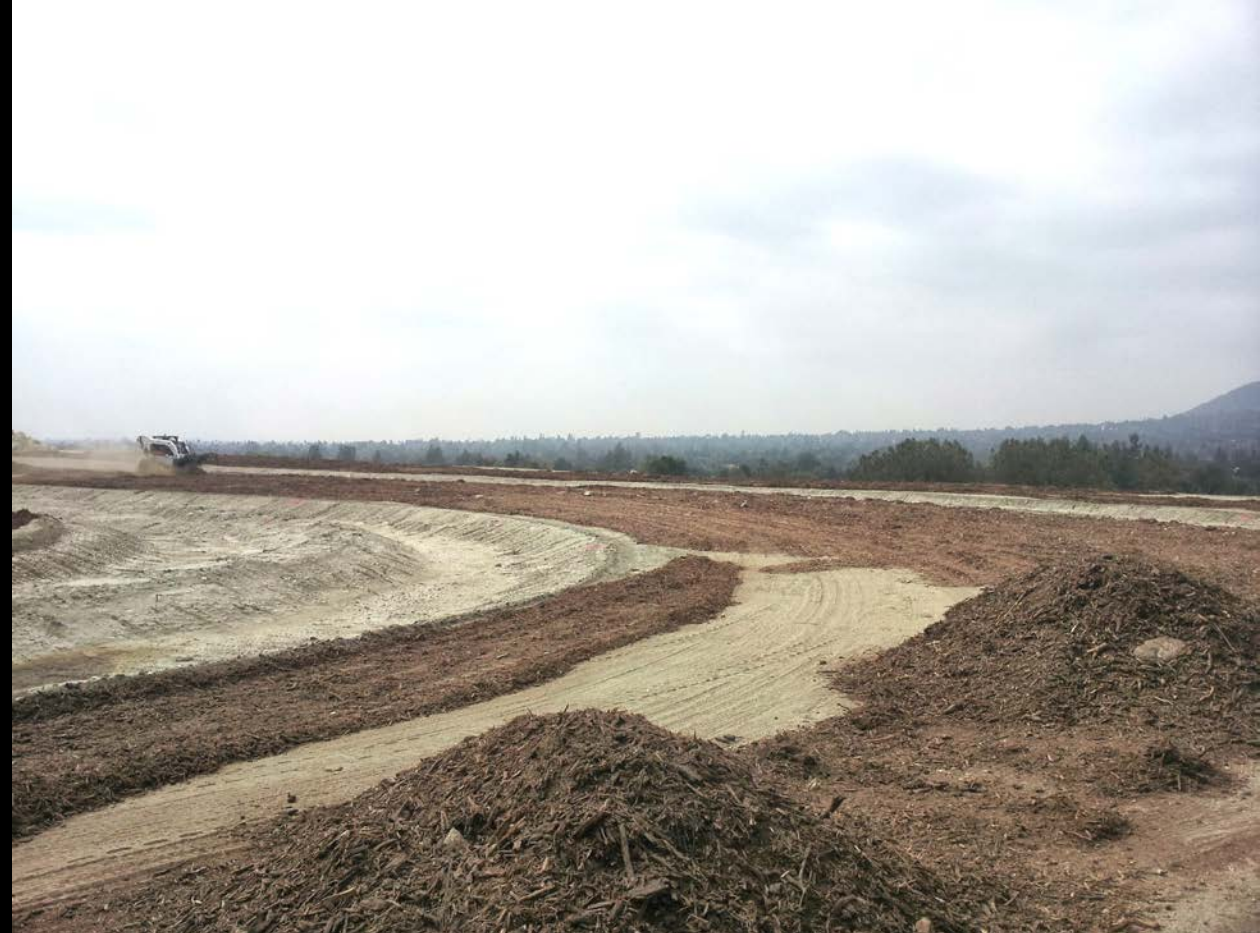
- Large volume of salvaged mulch ripped to minimum 2-foot depth
- Urea added for nitrogen balance

The mulch was ripped to a minimum depth of 2 feet using a dozer, and urea was added for nitrogen balance.
