# Substrate Enhancements and Botanical Diversity for Successful Oak Habitat Creation

Richard B. Lewis III, ENV SP  
Senior Restoration Ecologist, Psomas

LOS ANGELES COUNTY  
FLOOD CONTROL DISTRICT  
SANTA ANITA  
DAM

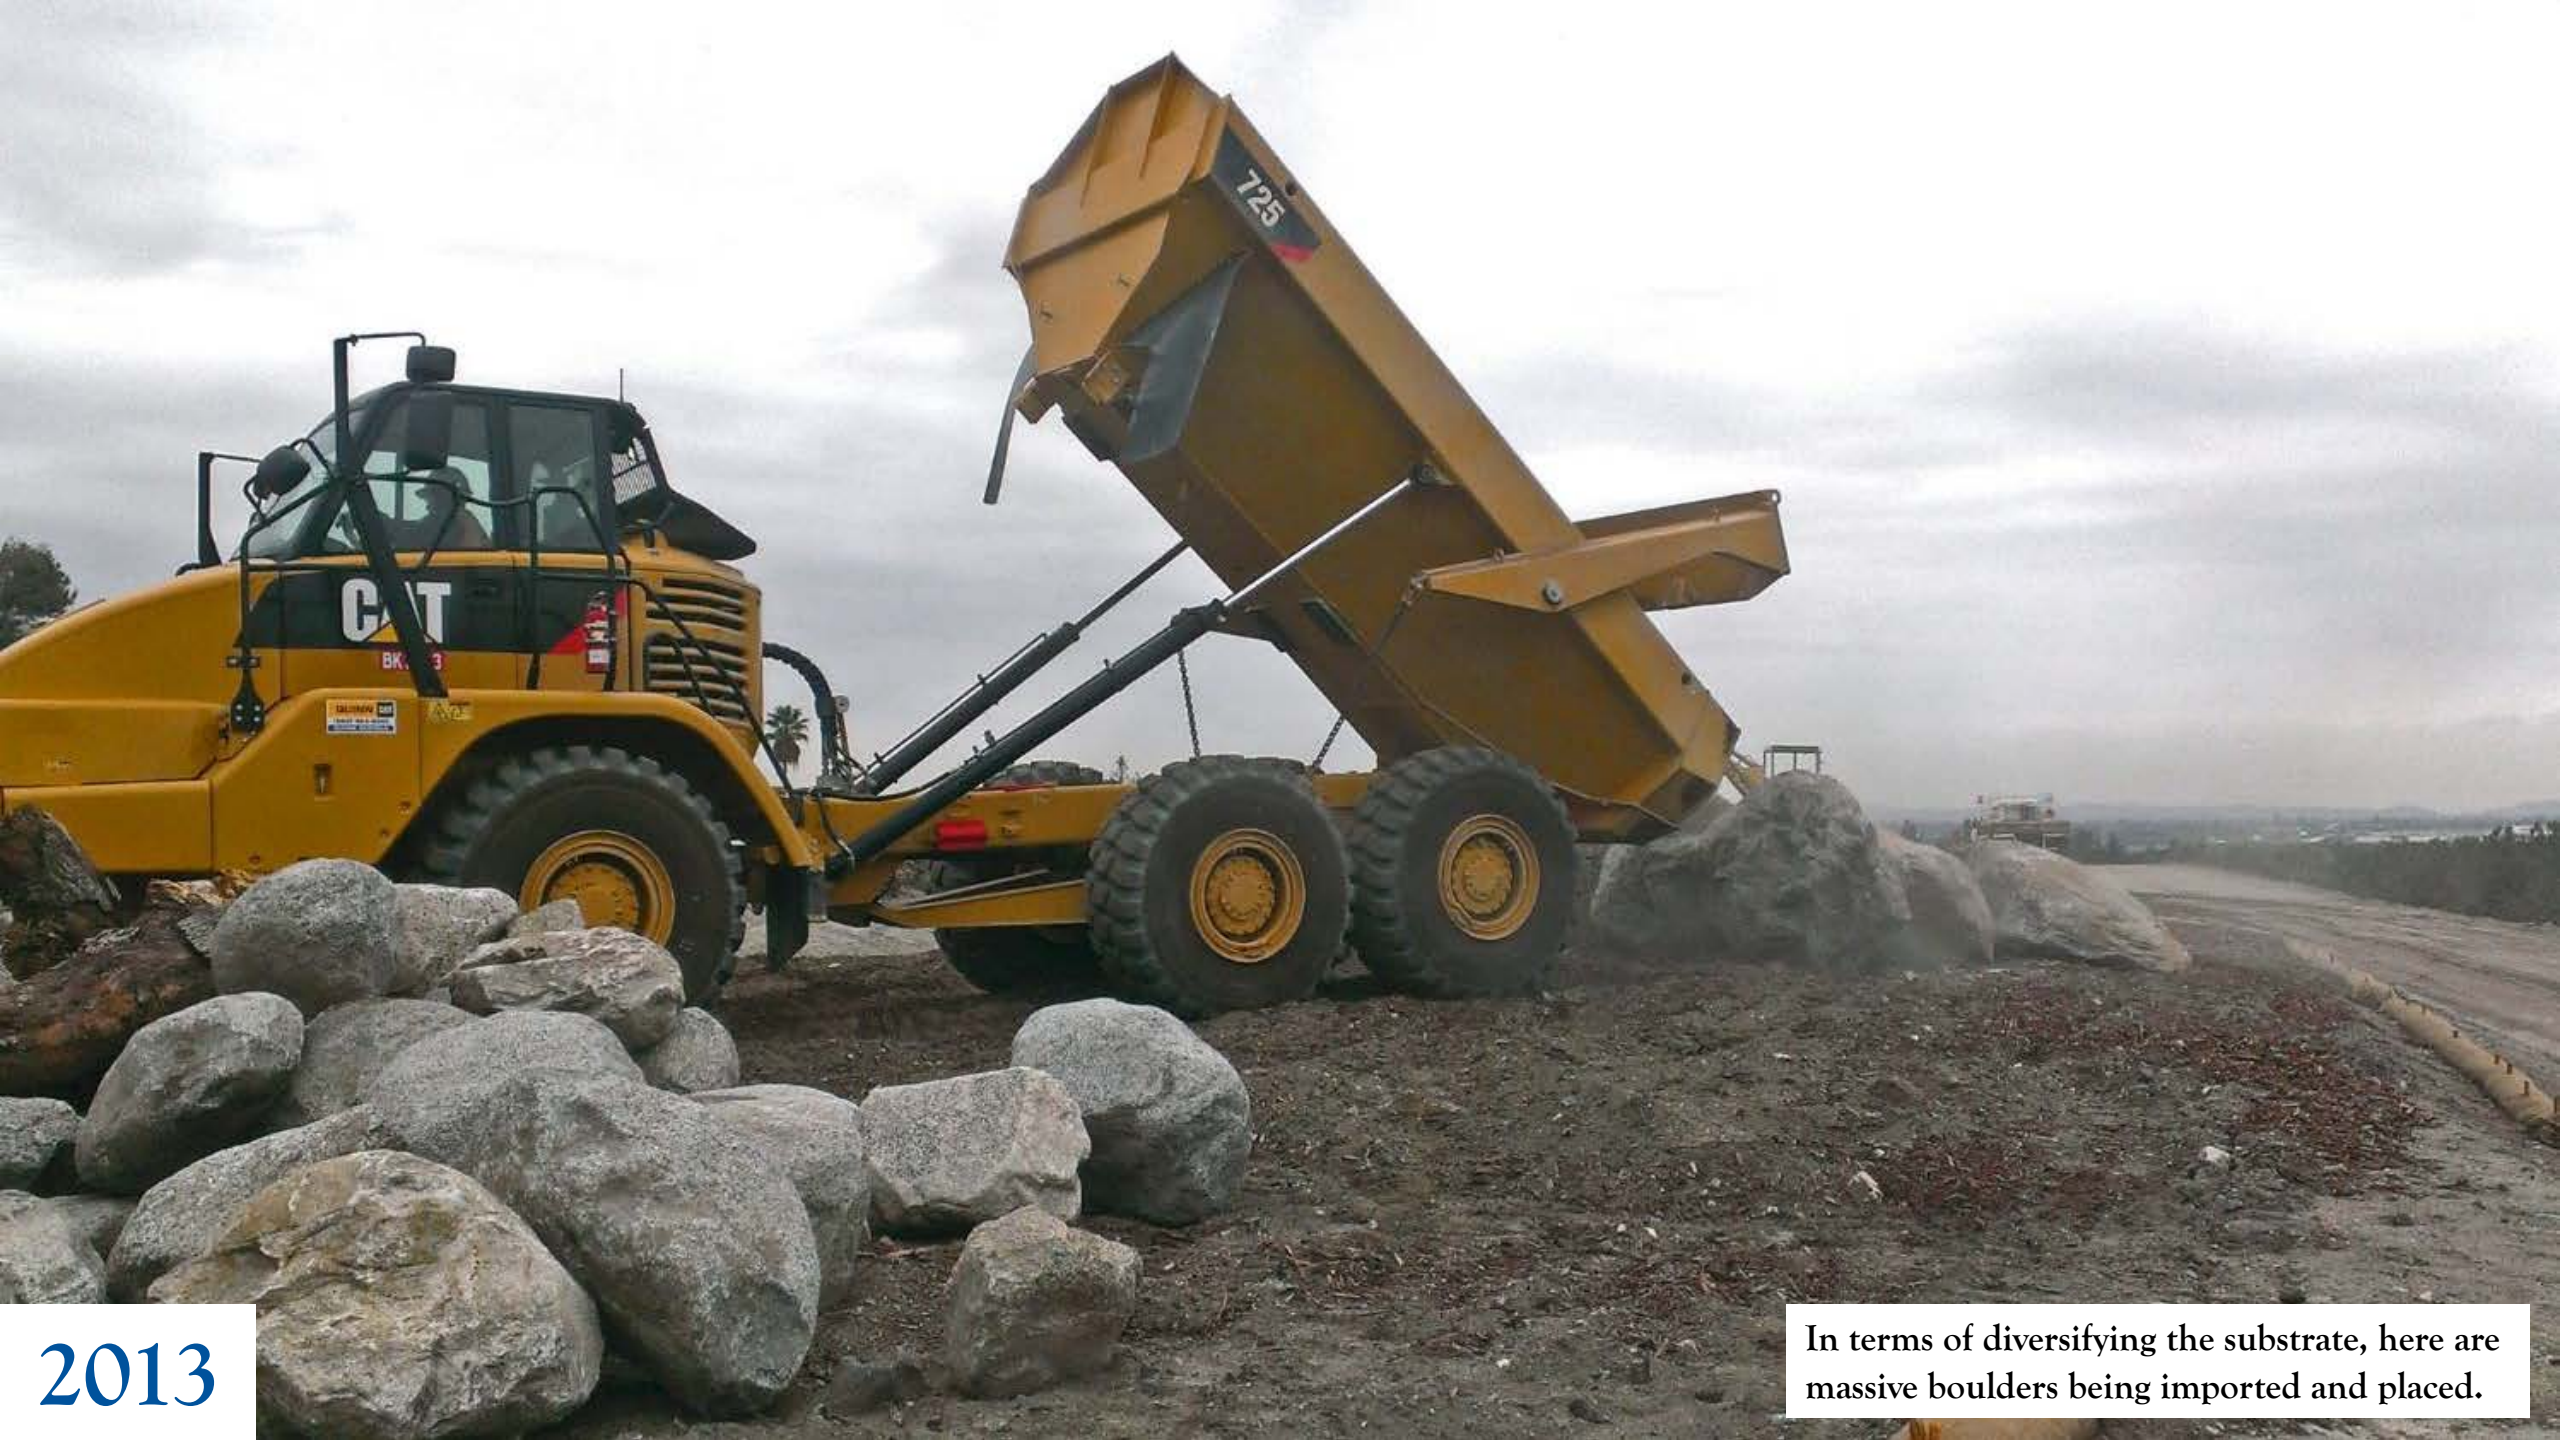
In terms of diversifying the substrate, here are massive boulders being imported and placed.

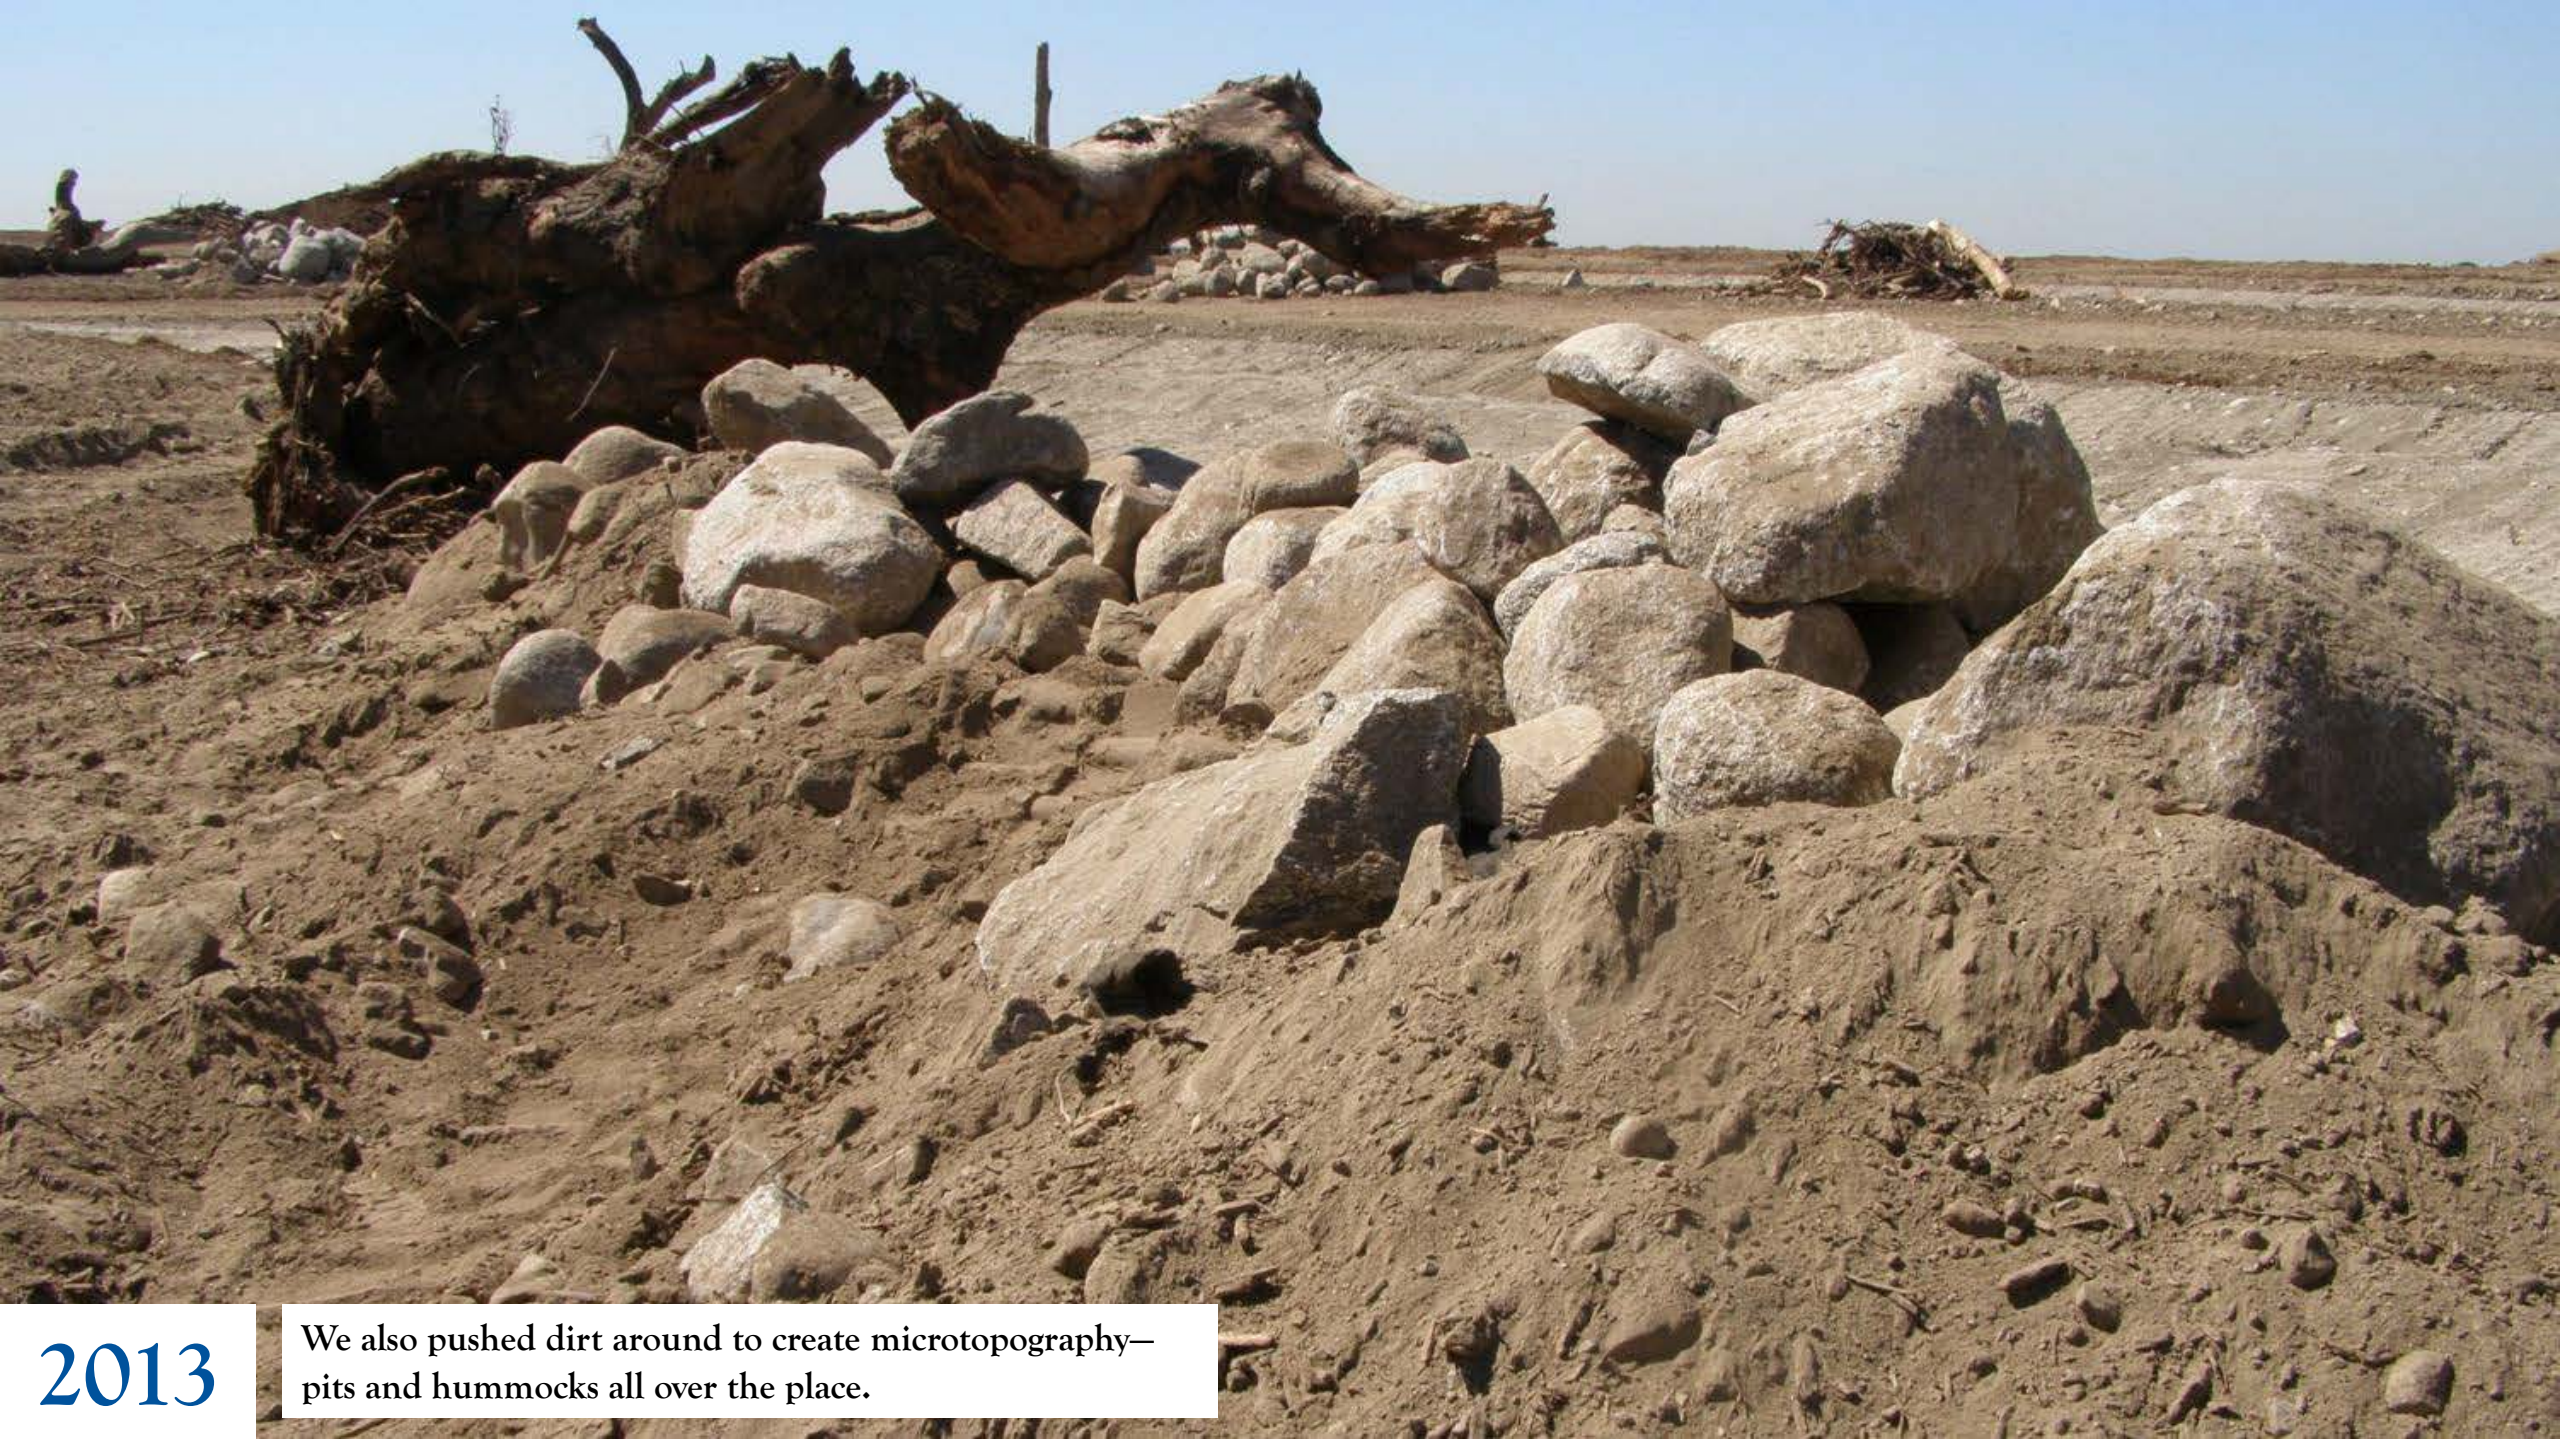
We also pushed dirt around to create microtopography—pits and hummocks all over the place.

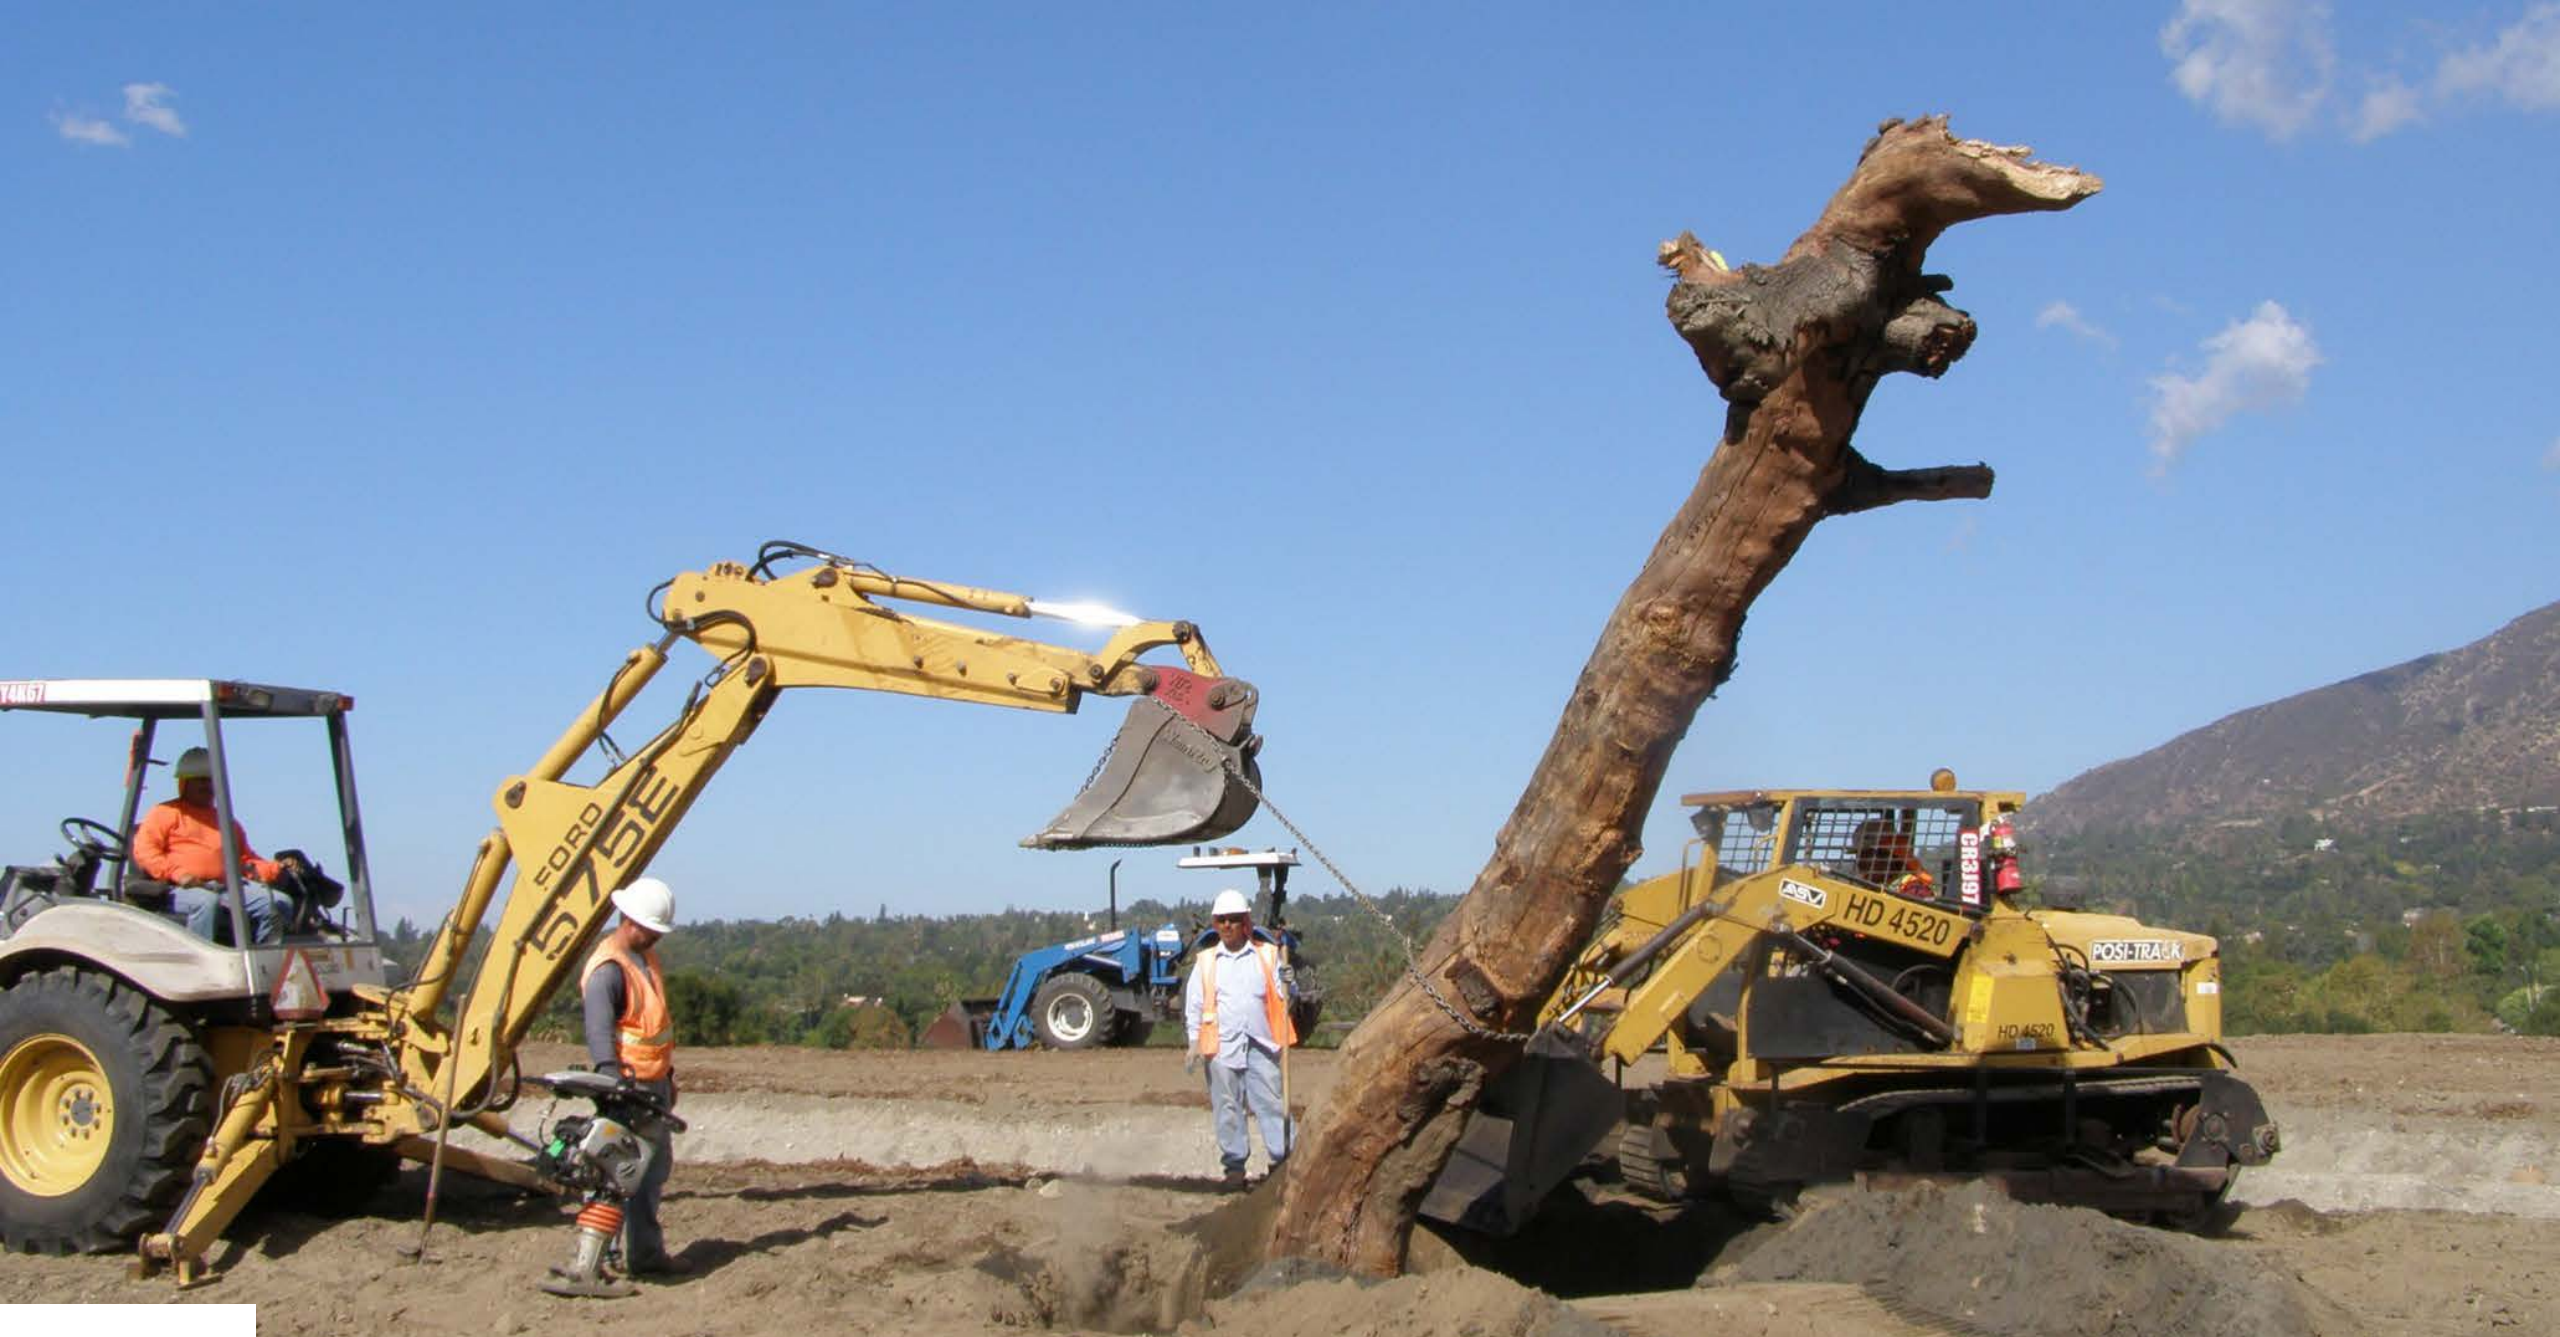
A total of 14 natural snags were erected, and you can see the scale of these. Within minutes these features were being used by raptors and songbirds.

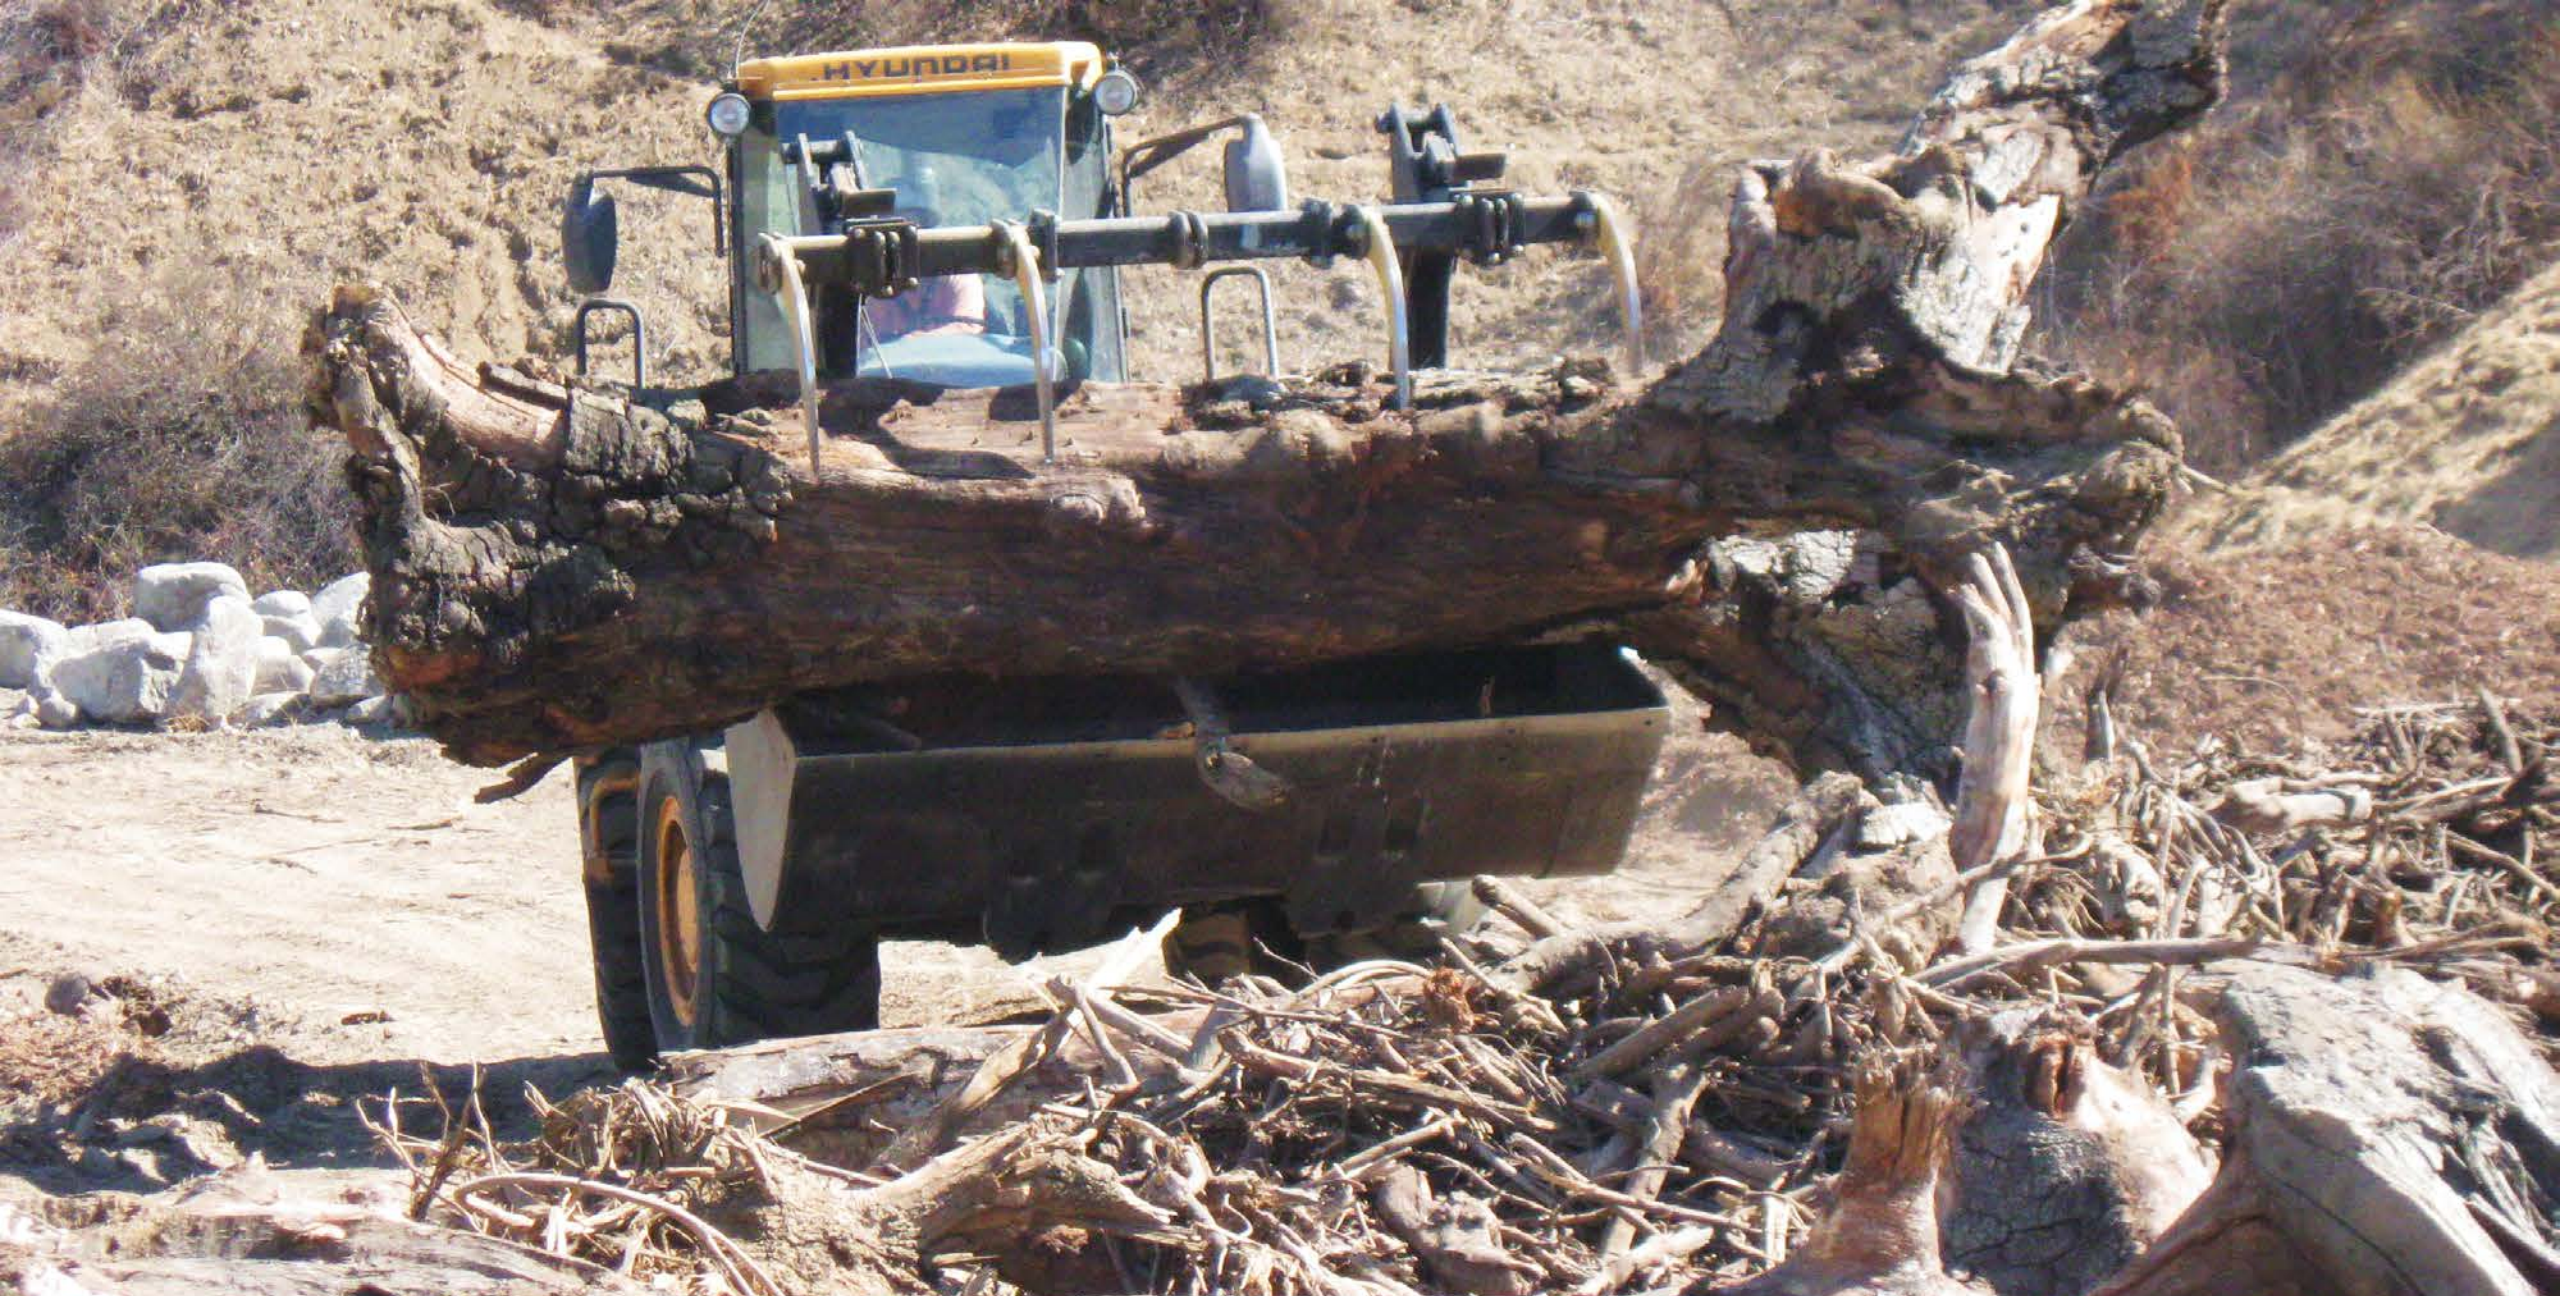
Many kinds of equipment were used for the CWD placement including these grapple attachments.

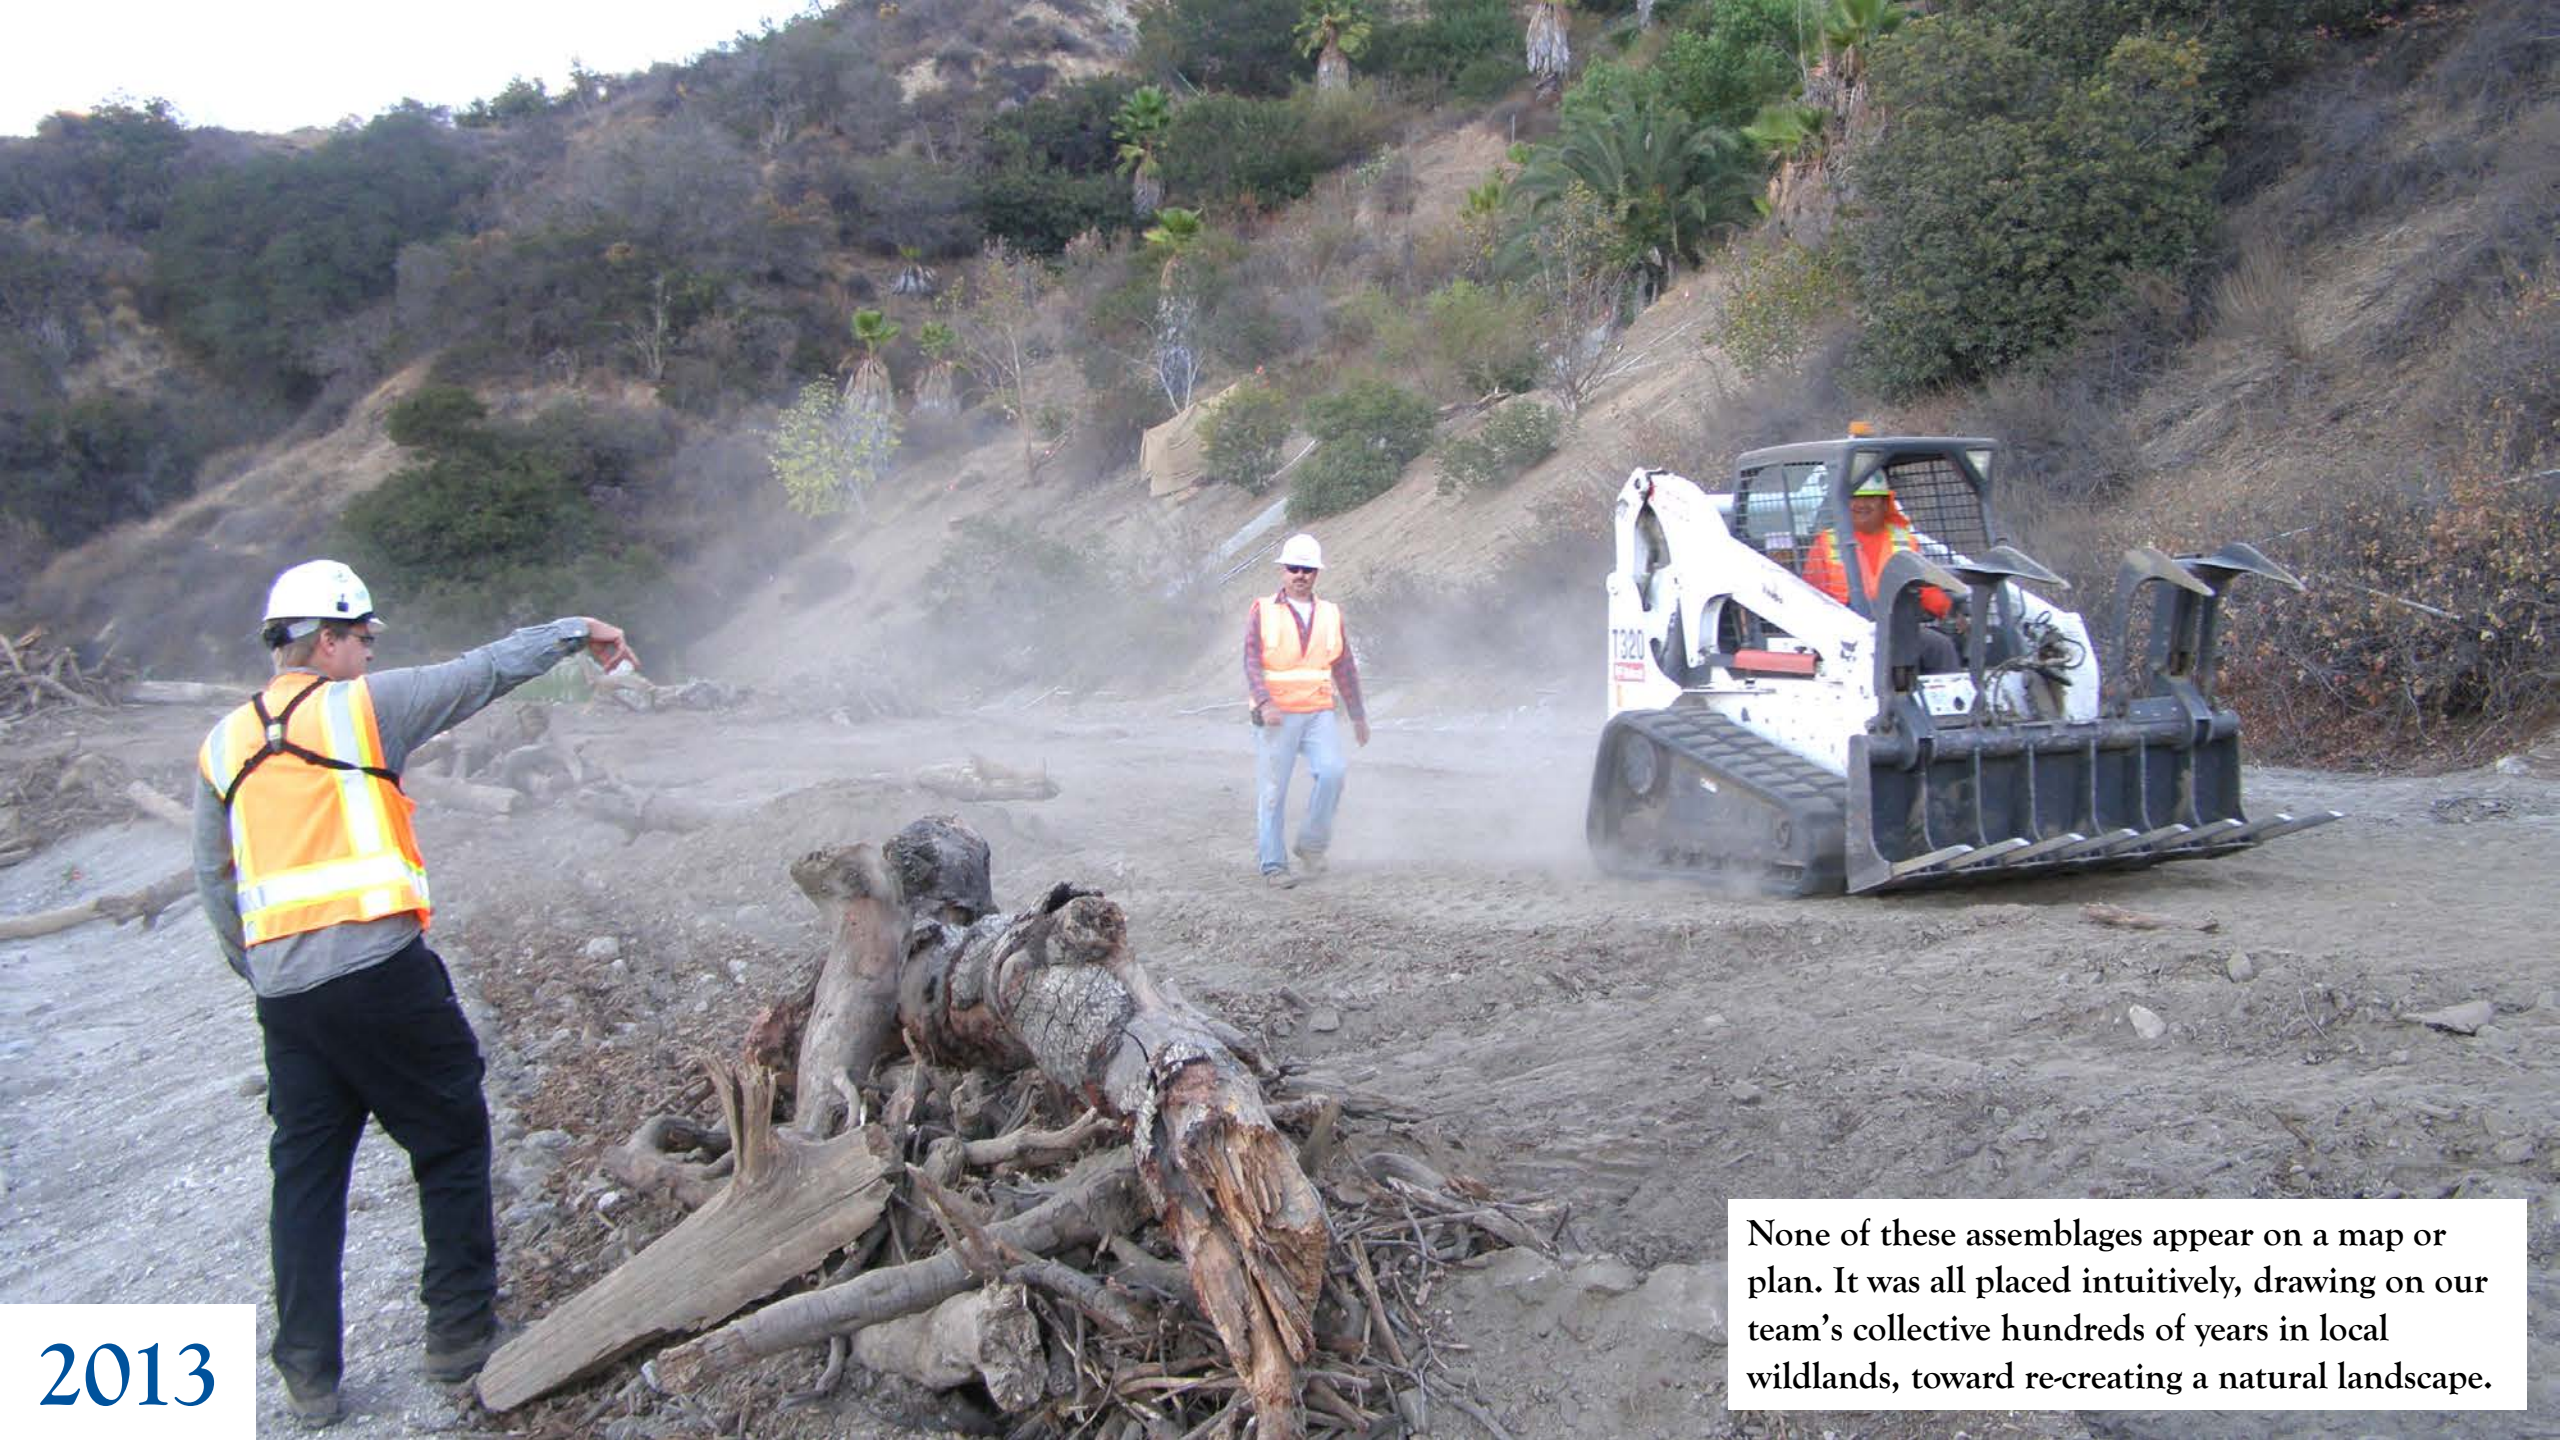
None of these assemblages appear on a map or plan. It was all placed intuitively, drawing on our team's collective hundreds of years in local wildlands, toward re-creating a natural landscape.

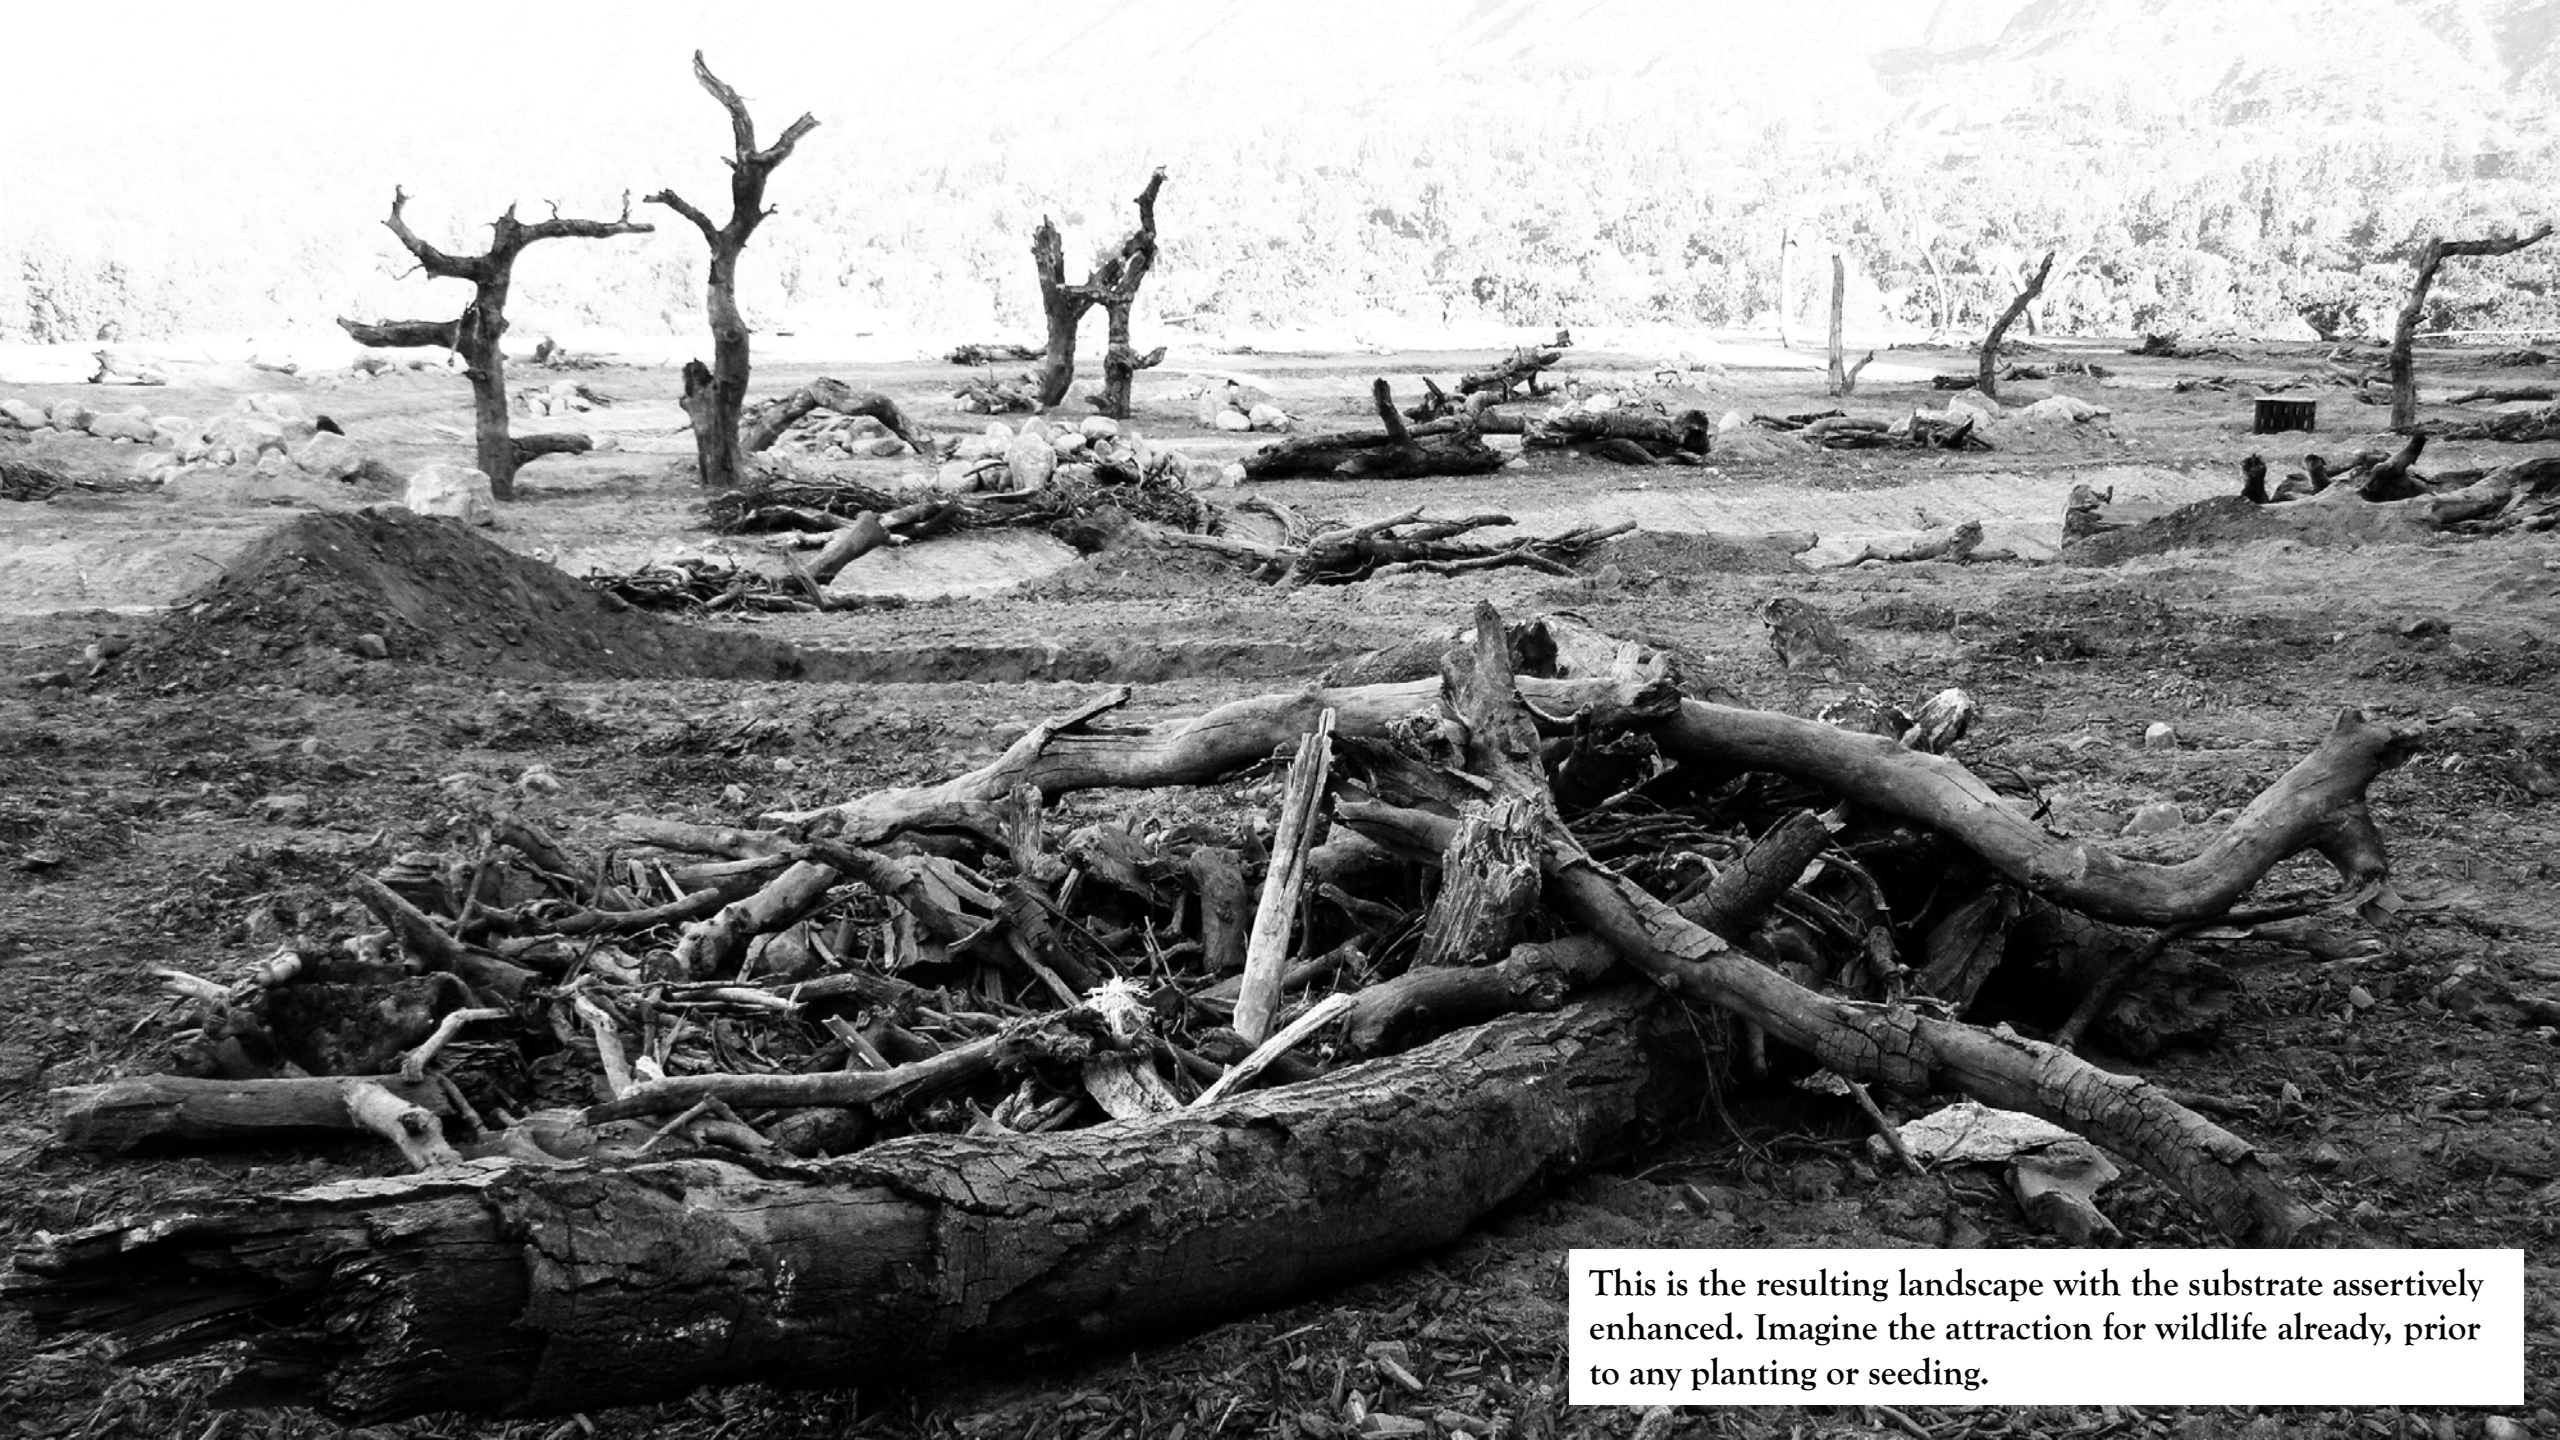
This is the resulting landscape with the substrate assertively enhanced. Imagine the attraction for wildlife already, prior to any planting or seeding.
