# Substrate Enhancements and Botanical Diversity for Successful Oak Habitat Creation

Richard B. Lewis III, ENV SP  
Senior Restoration Ecologist, Psomas

LOS ANGELES COUNTY  
FLOOD CONTROL DISTRICT  
SANTA ANITA  
DAM

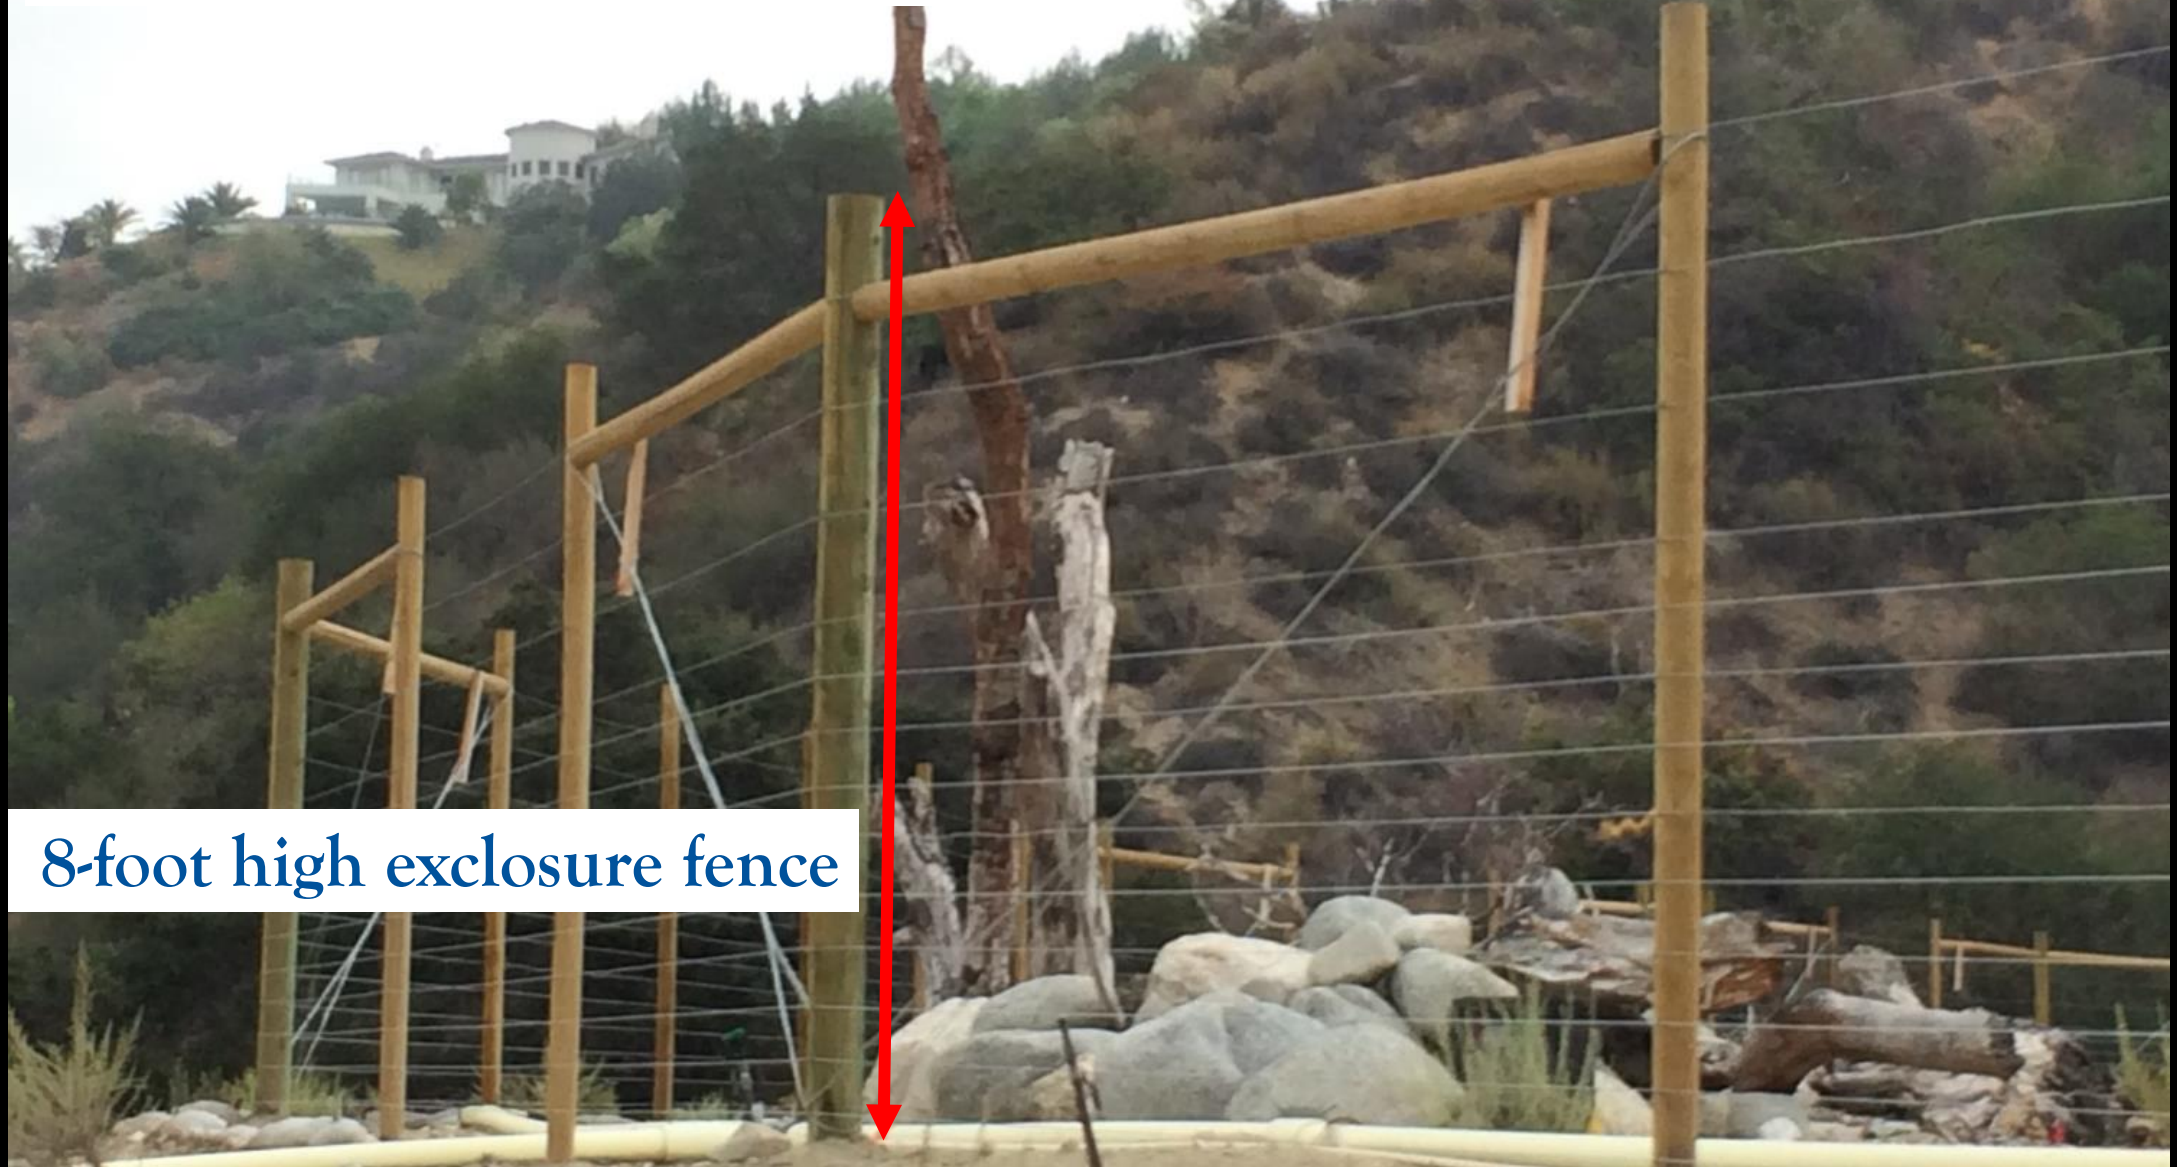
8-foot high exclosure fence

An eight-foot perimeter fence was installed (shown here mid-construction) to temporarily exclude large mammals—especially mule deer (*Odocoileus hemionus*)—to avoid excessive herbivory or trampling of the establishing vegetation, oak seedlings, etc.

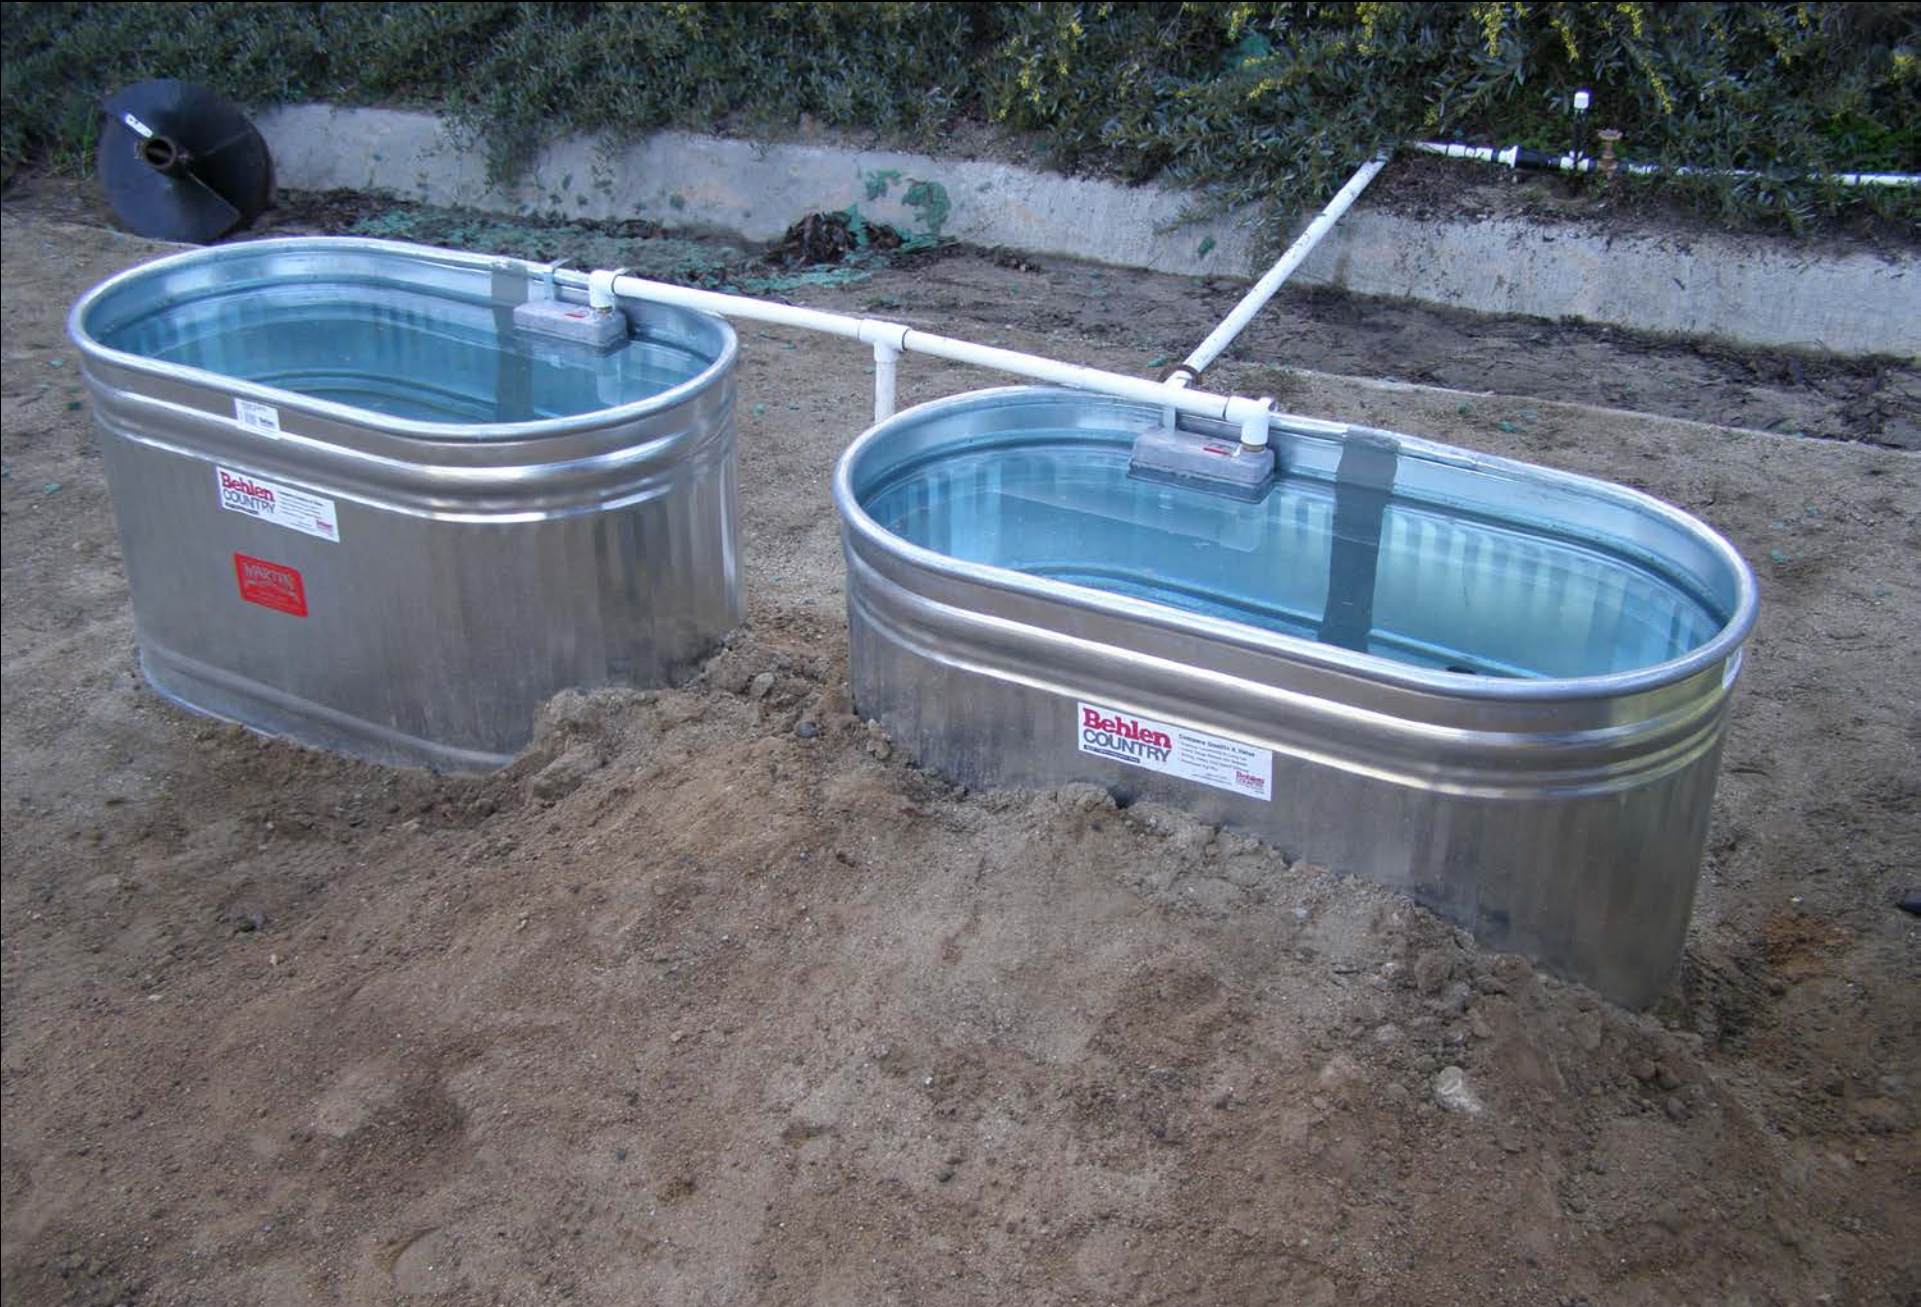
Because we temporarily fenced-off some water resources, we installed some temporary 'drinker tanks' for wildlife, and these have been heavily used.

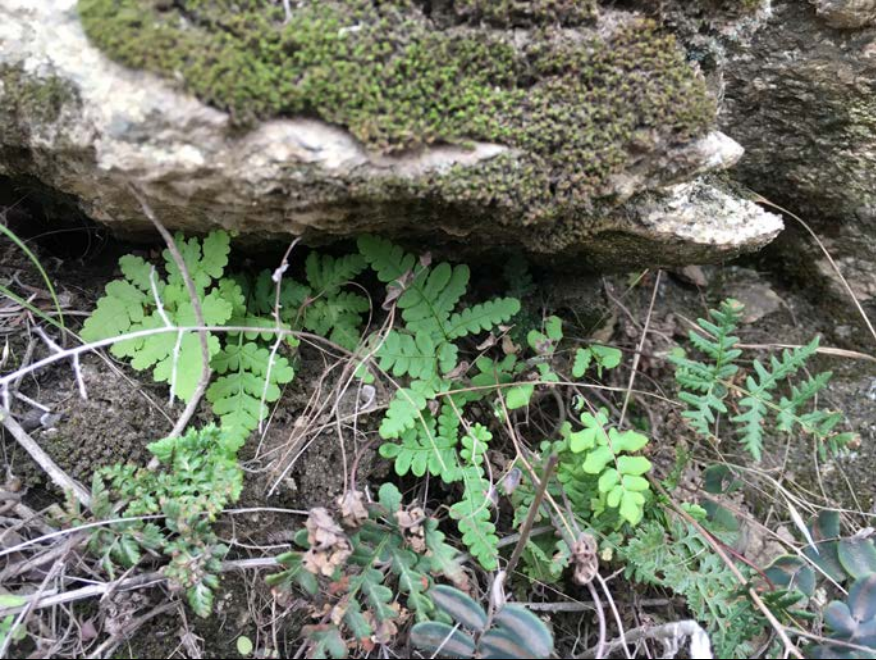
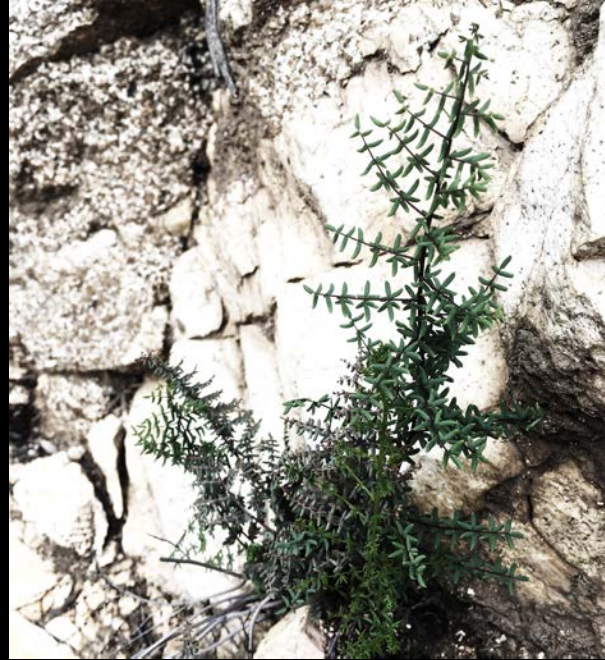
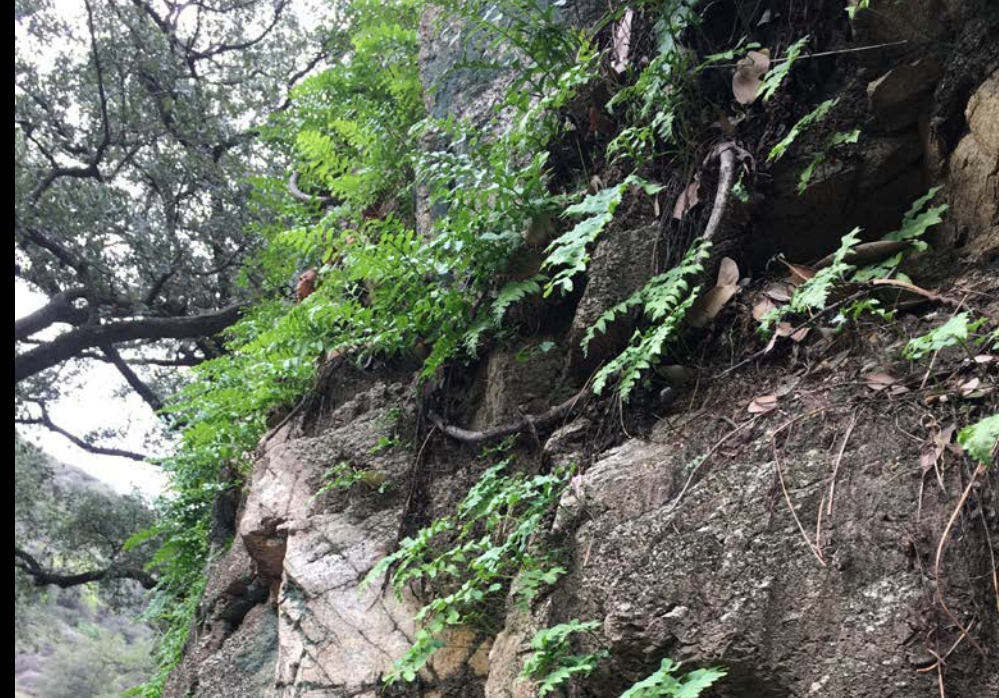
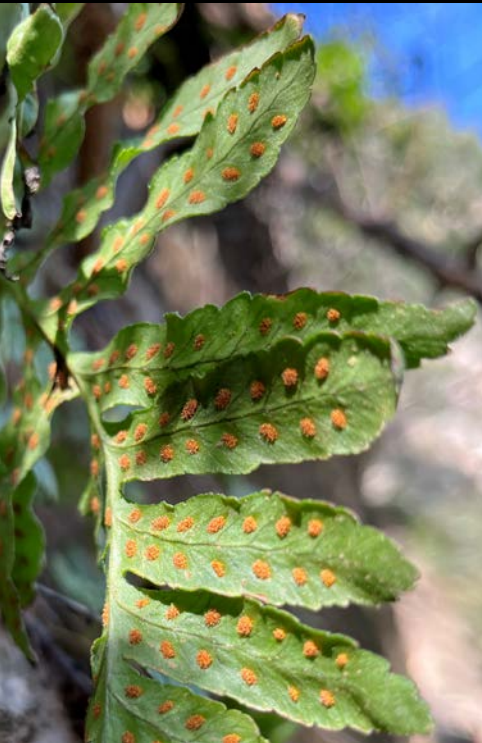
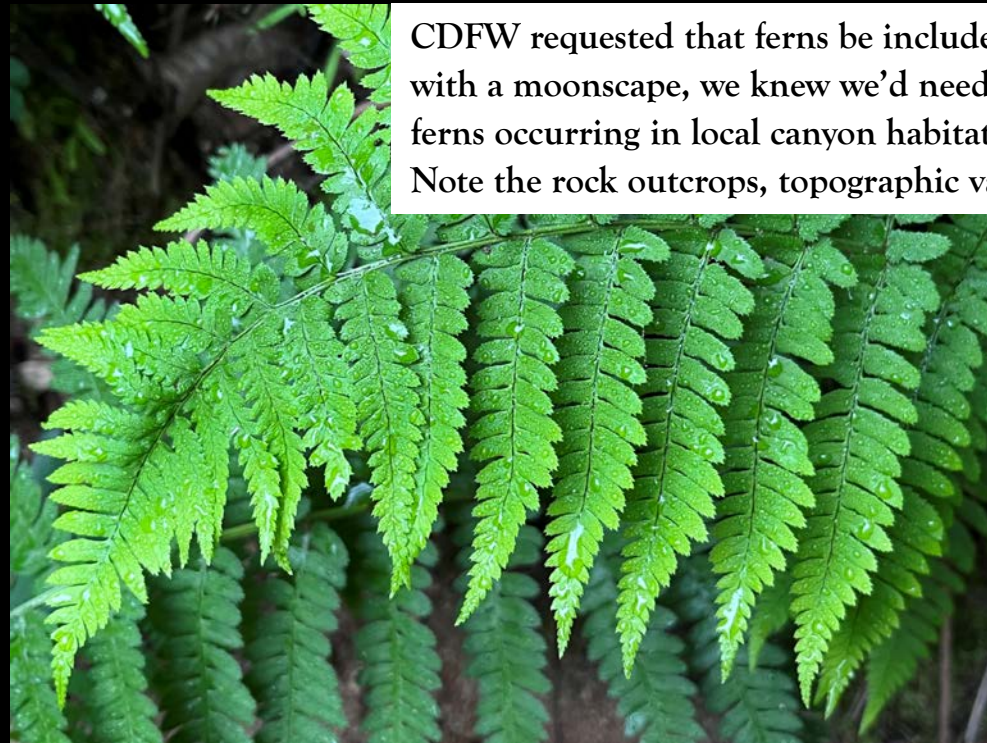
CDFW requested that ferns be included in the palette. Starting with a moonscape, we knew we'd need some similar substrate as ferns occurring in local canyon habitats, as you see in these photos. Note the rock outcrops, topographic variation, and woody debris.

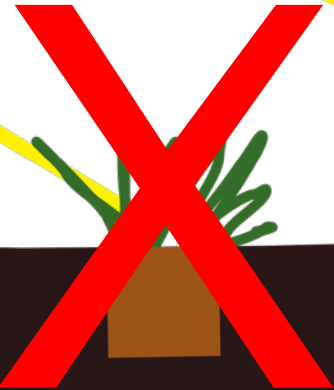
Fern Planting

Placed boulder or coarse woody debris

We did not plant our ferns with a fully concentric basin—too much exposure to sun and wind.

Instead, we dug beneath placed boulders and CWD, beneath overhang as possible, and this has worked well.

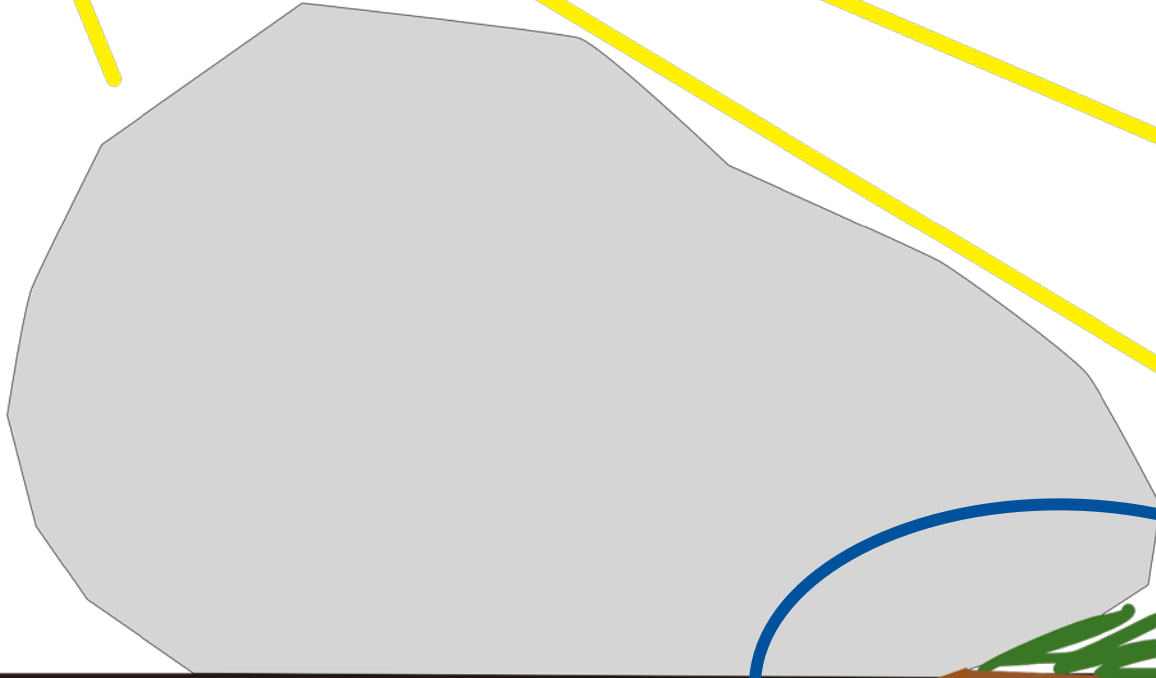
Here's a planting sequence of a native coffee fern (*Pellaea andromedifolia*), showing this method.

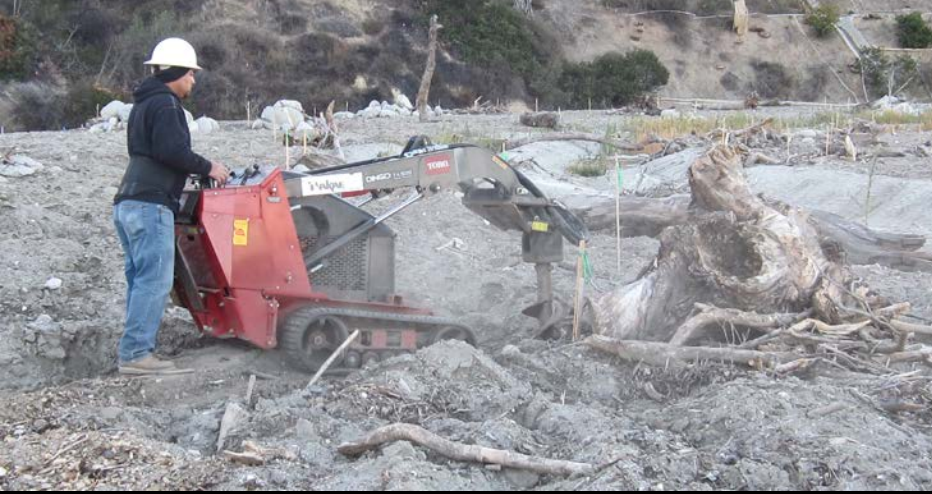
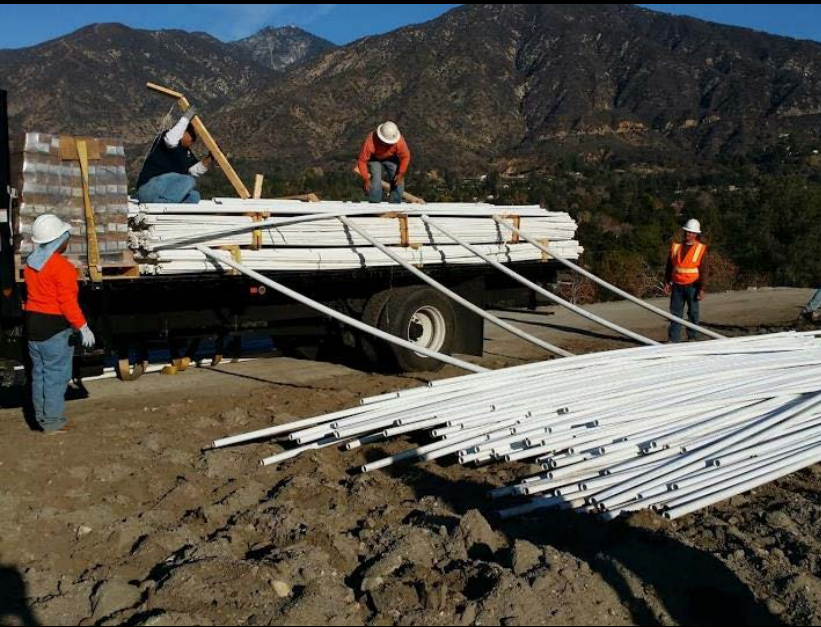
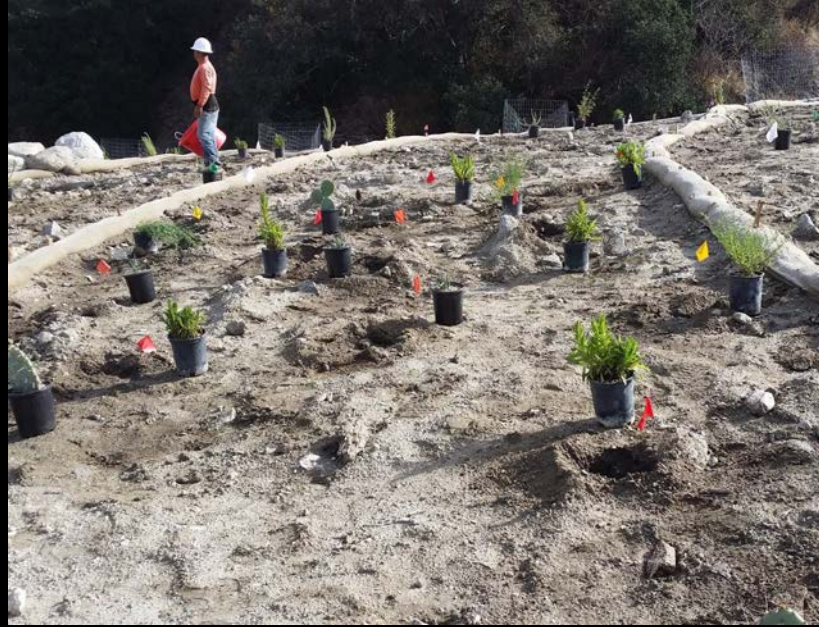
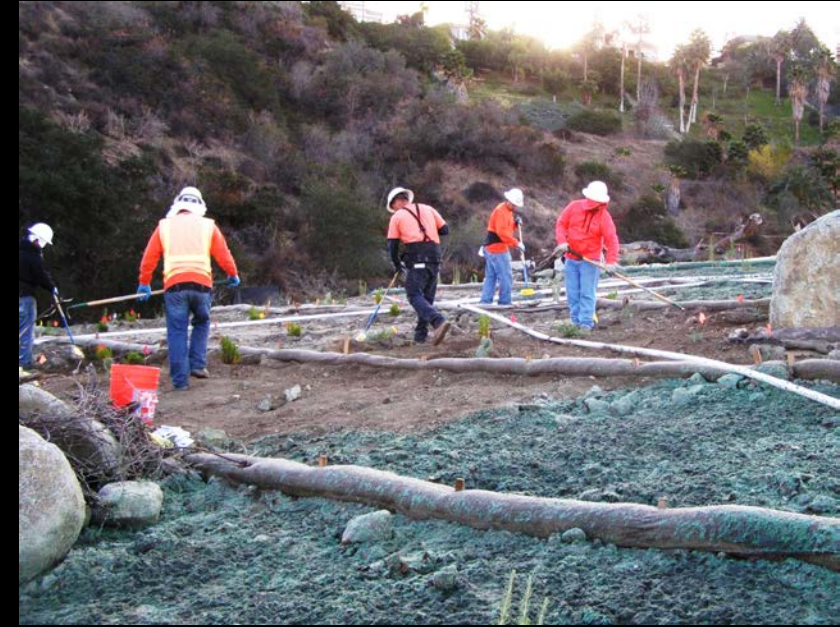
Initial Planting / Seeding

A Dingo™ was used to auger the oak planting holes. The seedlings were caged and mostly positioned adjacent to rock and CWD. This was to provide protection from sun and wind, and so the oaks roots could benefit from cooler and moist soils under these features.

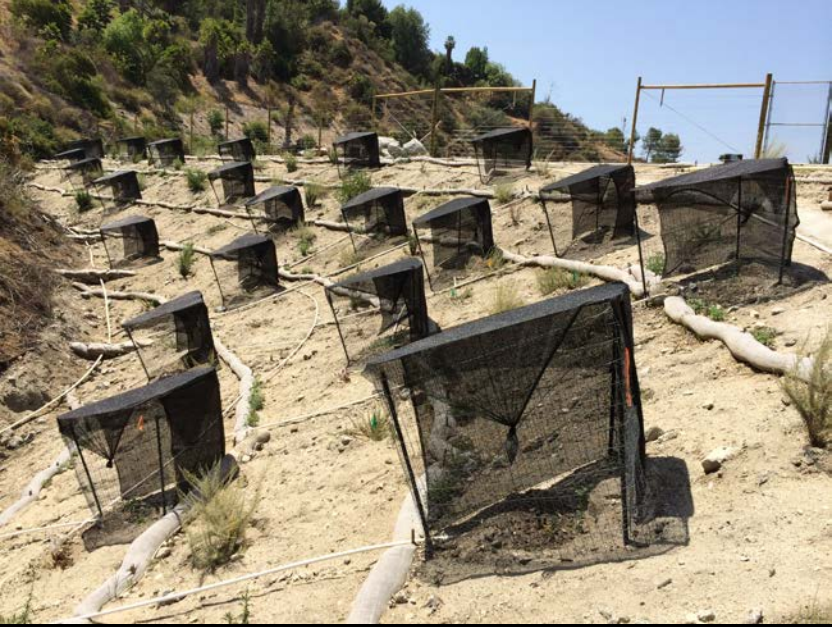
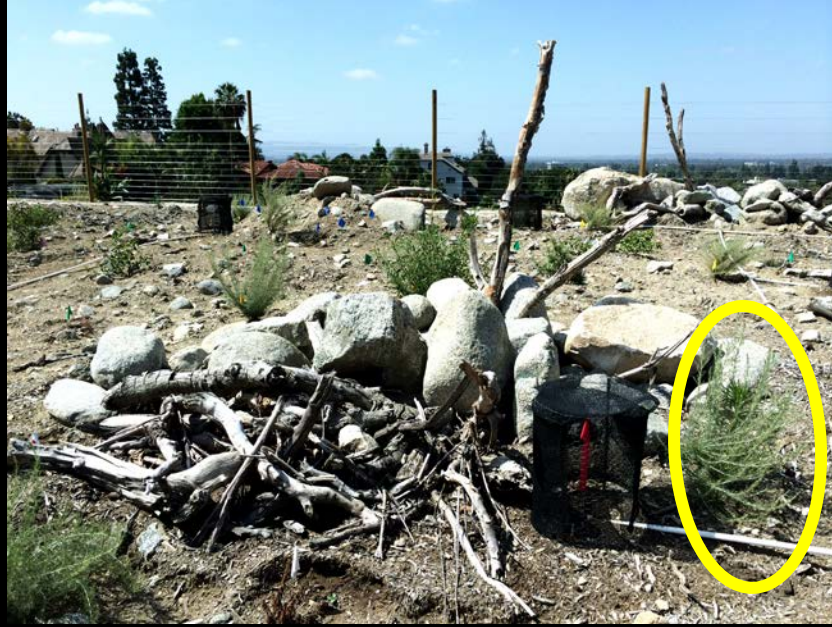
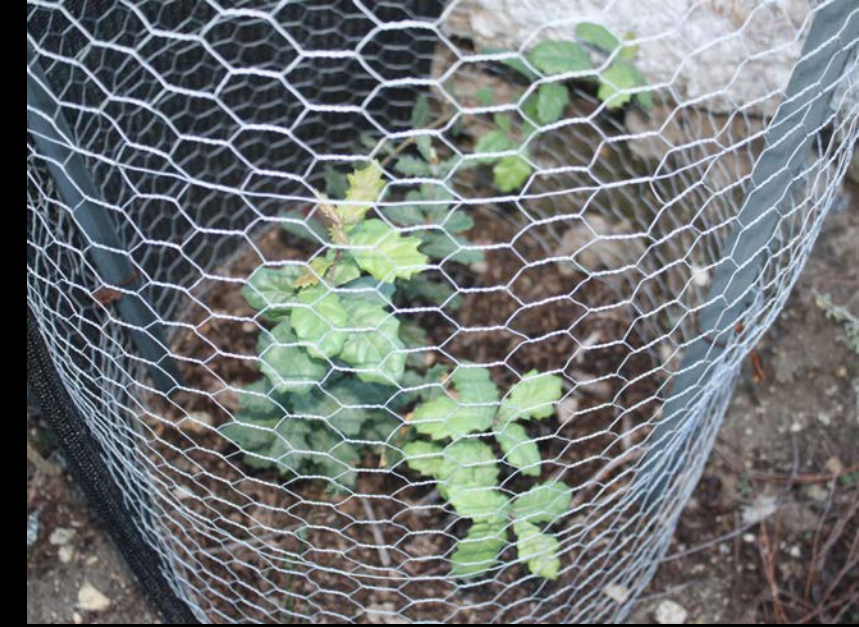
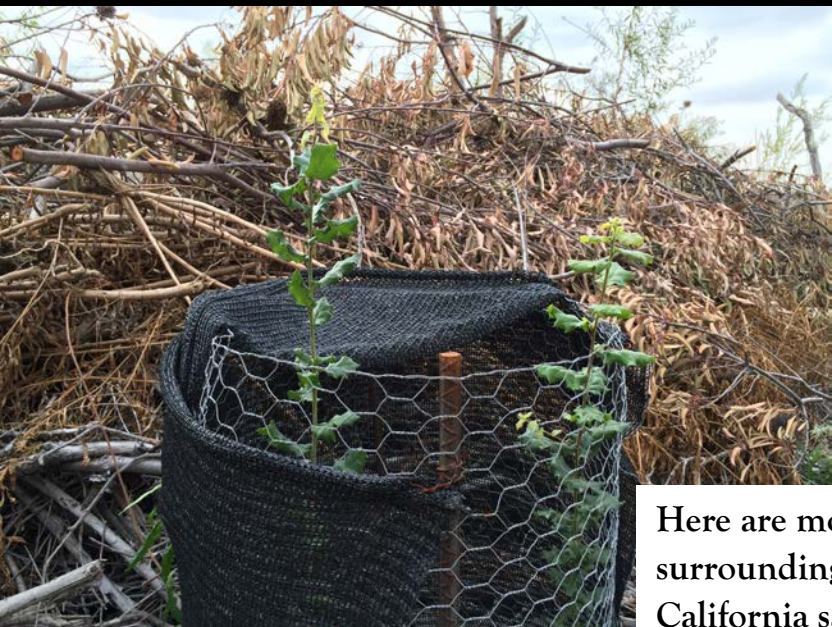
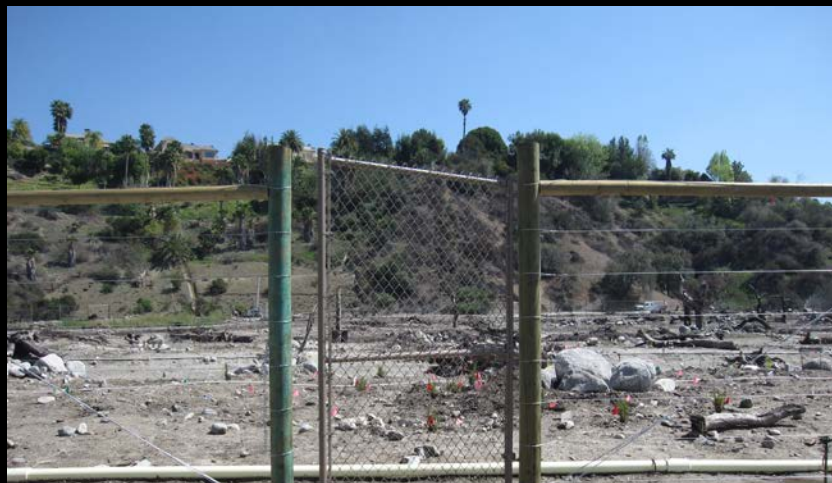
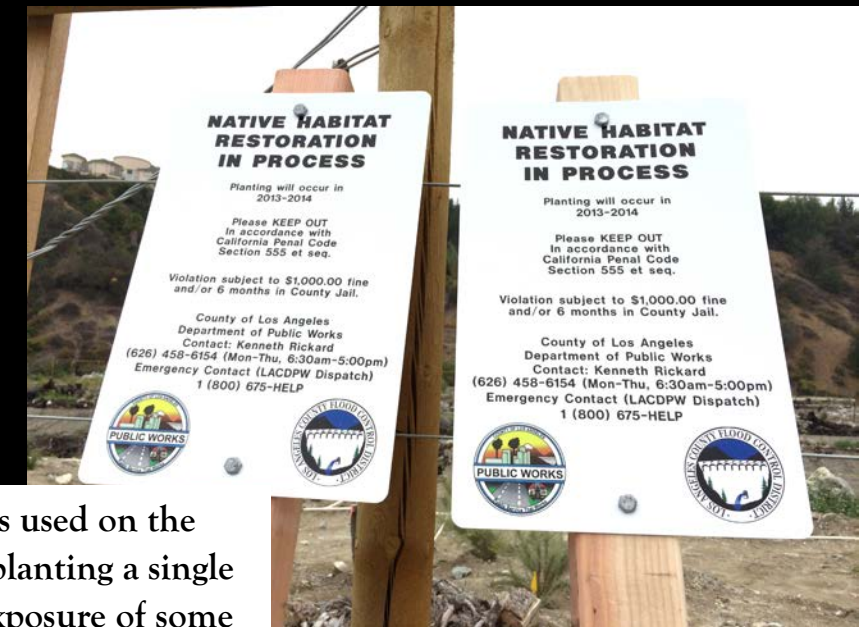
# Oak Protection

Here are more of the oak cages, including a more robust type that was used on the surrounding slopes, outside the 8-foot fence. We experimented with planting a single California sagebrush (*Artemisia californica*) plant on the southwest exposure of some oak plantings to serve as a kind of nurse plant. A combination of interpretive signs, and warning signs (shown here), were installed to deter trespassing.

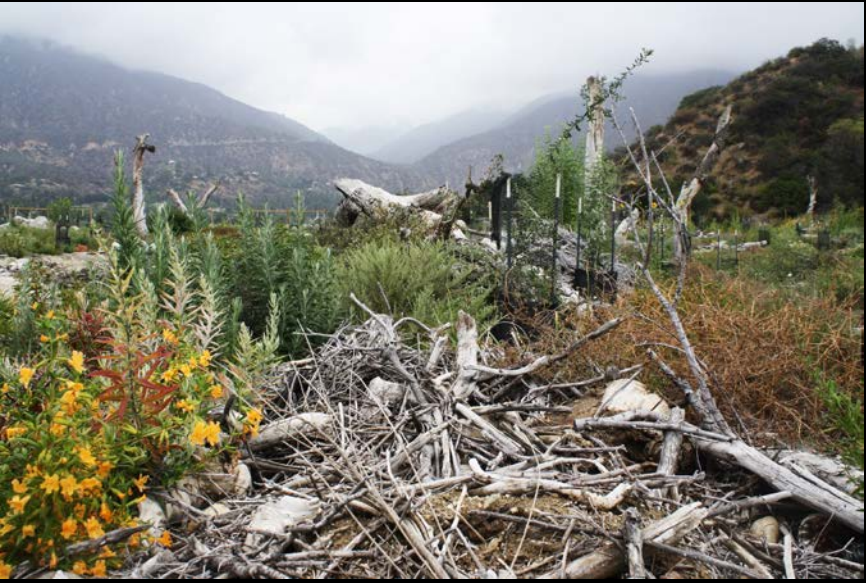
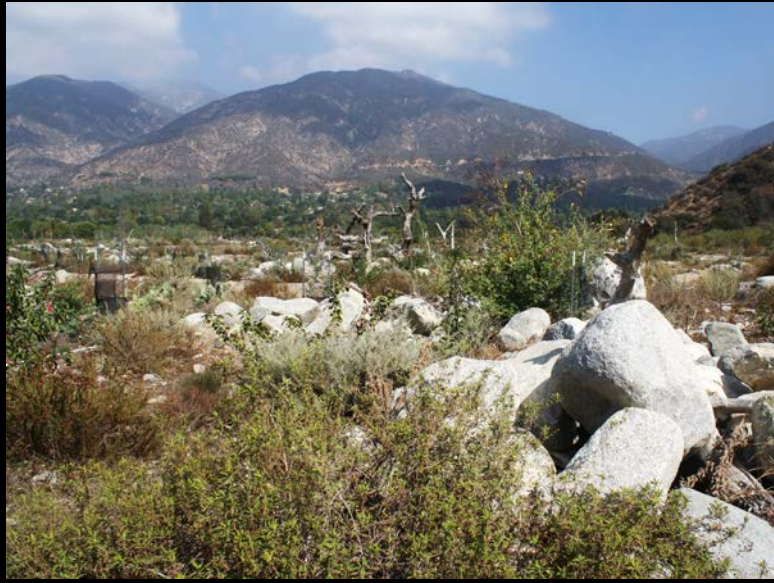
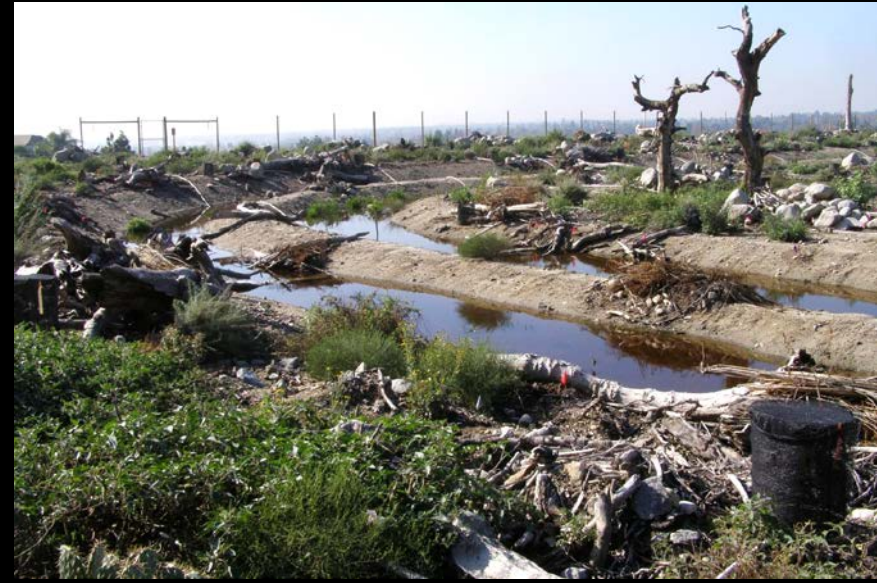
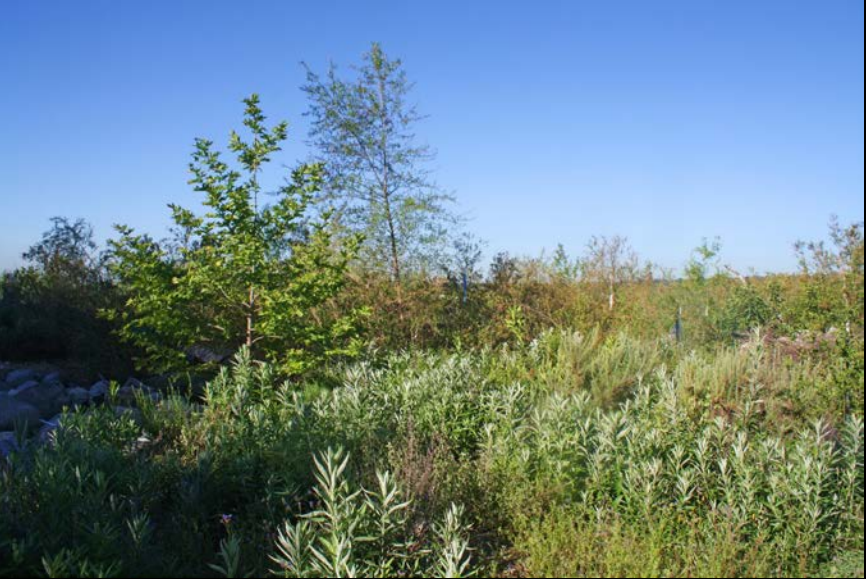
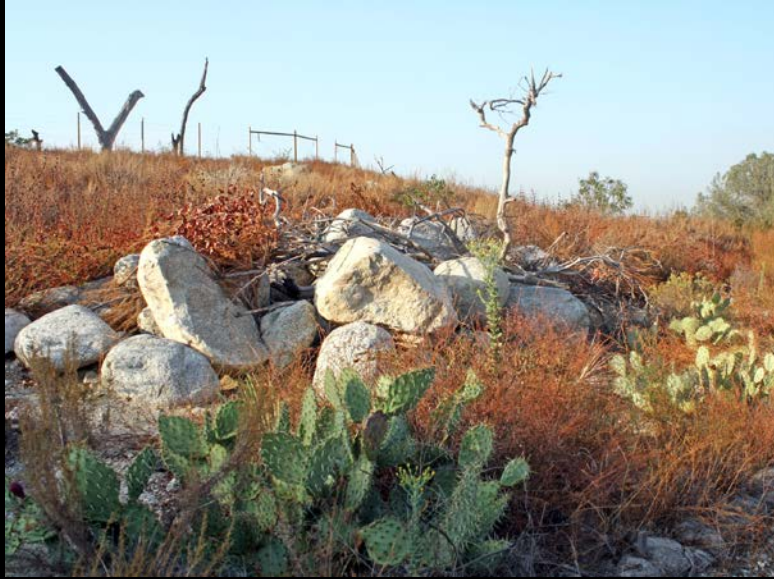
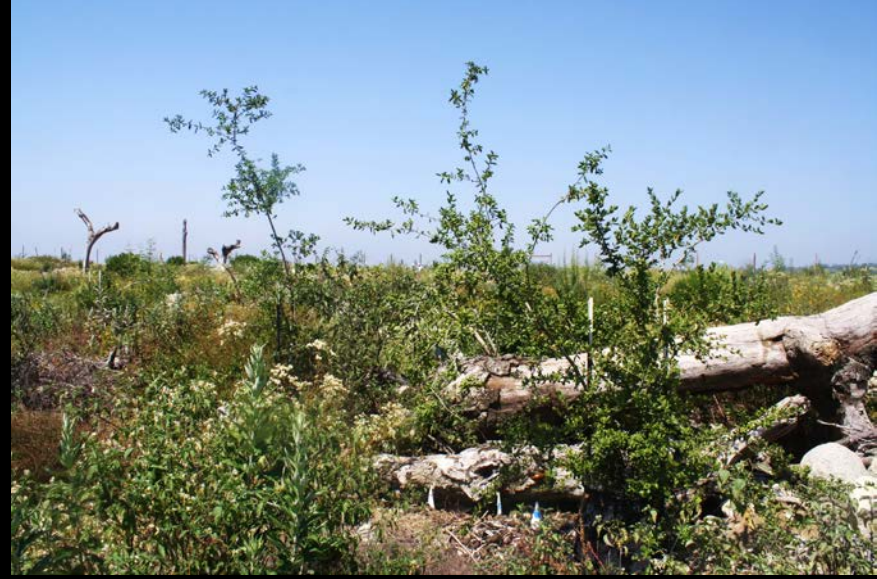
More of the interim conditions. Some oak saplings to the lower right, and some temporary ponding in the drainages (top right).

The wood and stone also support vines and vining herbs and shrubs that would have had a harder time otherwise.

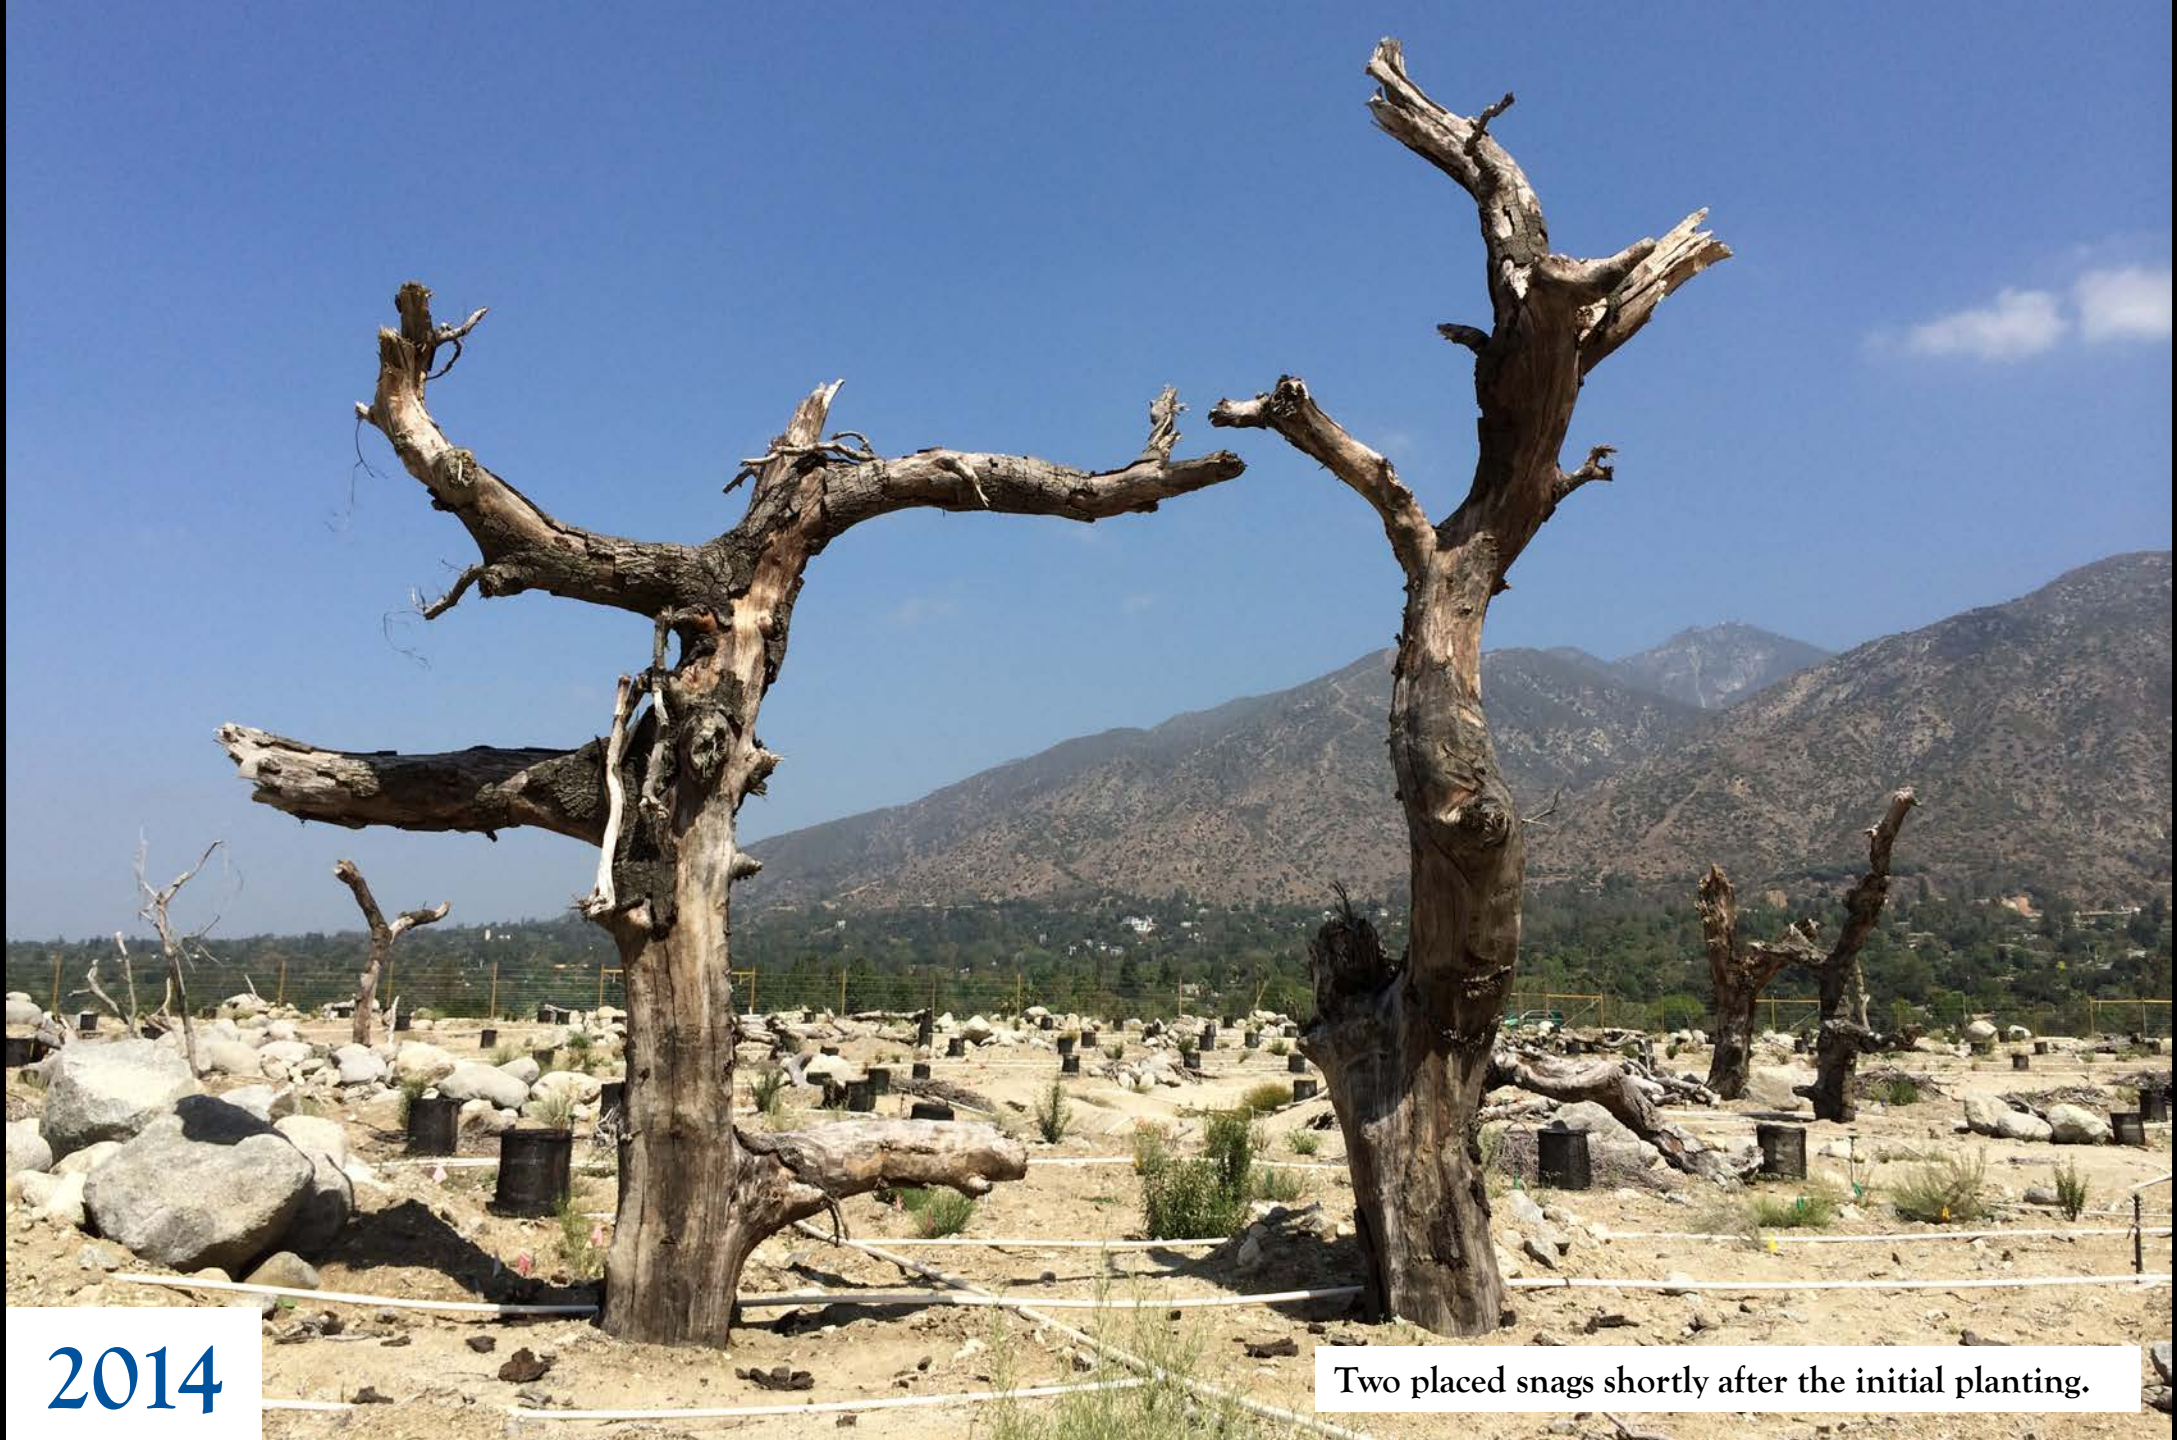
2014

Two placed snags shortly after the initial planting.

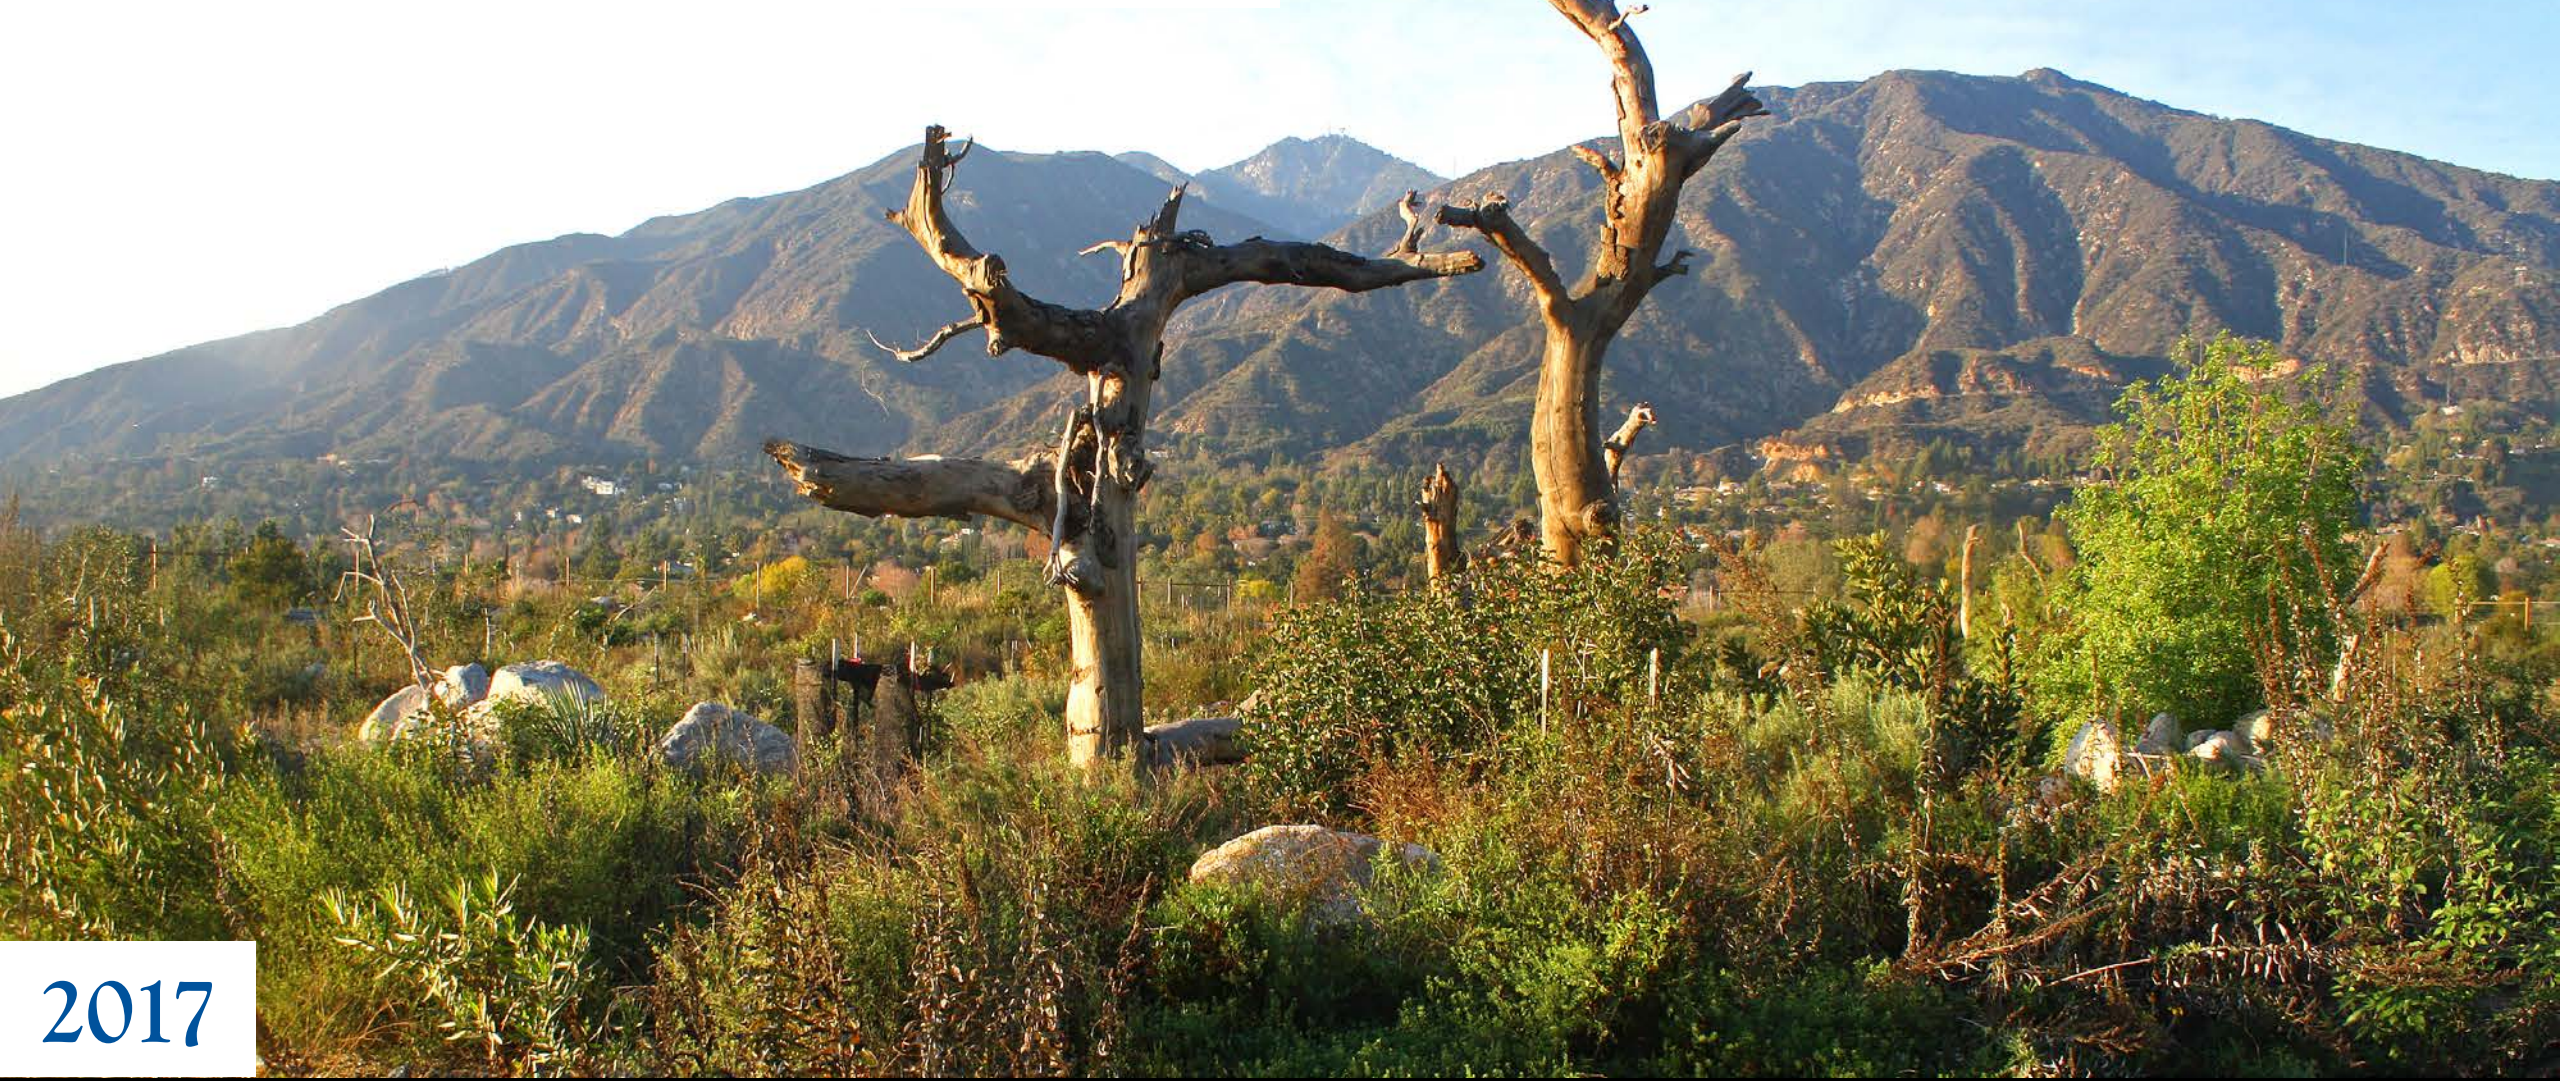
2017

And the same snags a few years later showing the diverse planted and seeded vegetation. Think of the time required for an oak to germinate, mature, begin to senesce, die-back and disarticulate, and we're pre-emptively providing habitat values that would not otherwise exist for many, many years.
