# Substrate Enhancements and Botanical Diversity for Successful Oak Habitat Creation

Richard B. Lewis III, ENV SP  
Senior Restoration Ecologist, Psomas

LOS ANGELES COUNTY  
FLOOD CONTROL DISTRICT  
SANTA ANITA  
DAM

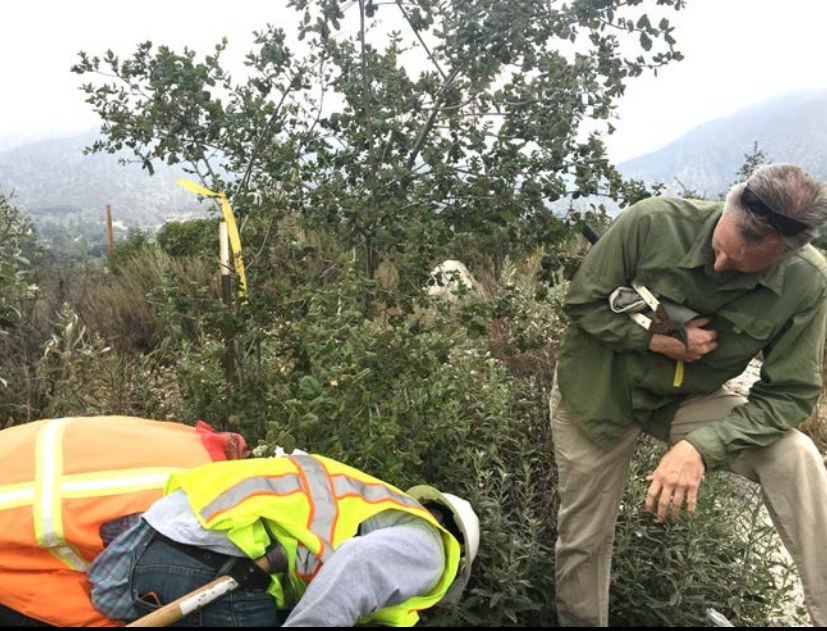
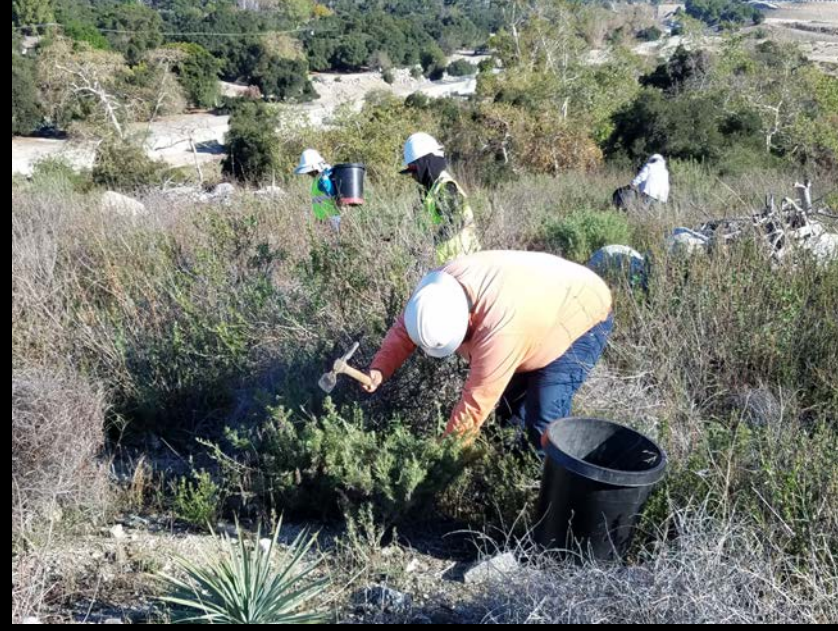
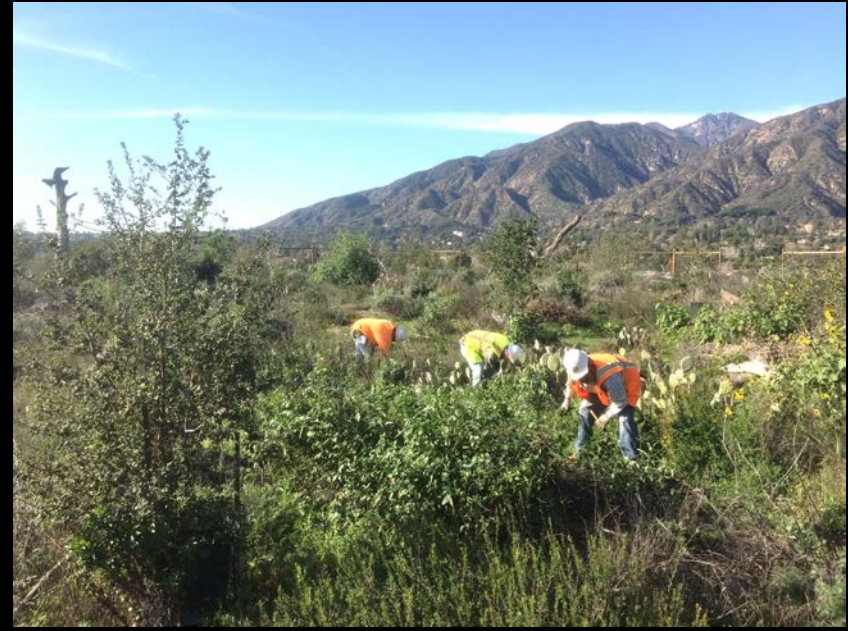
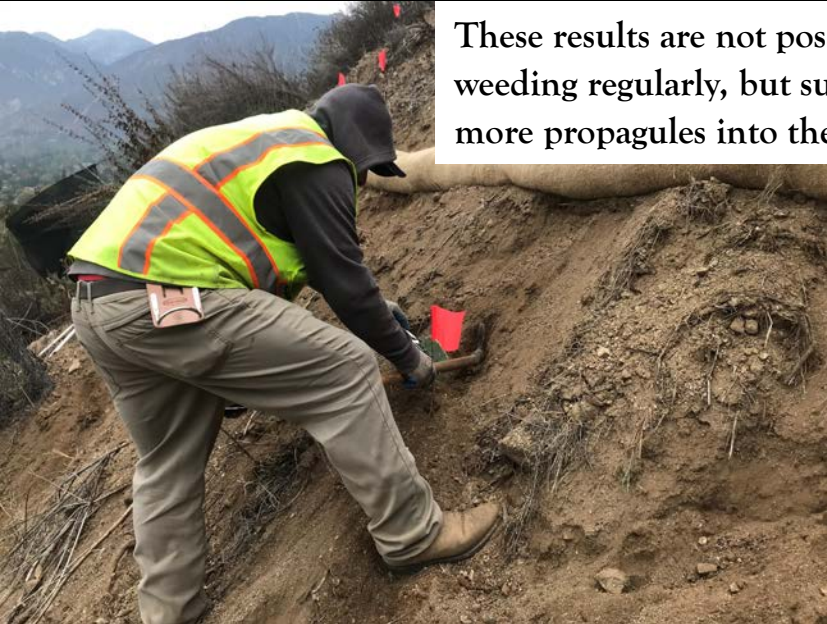
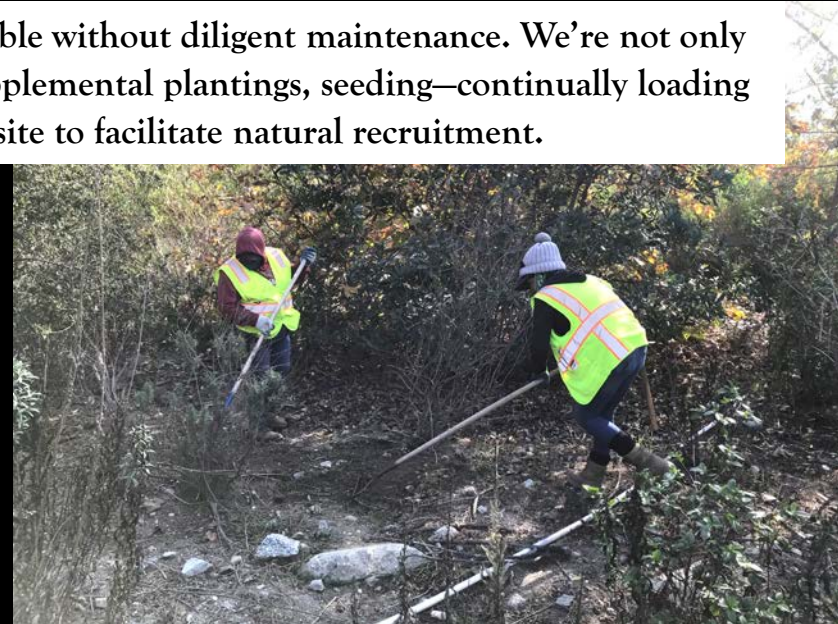
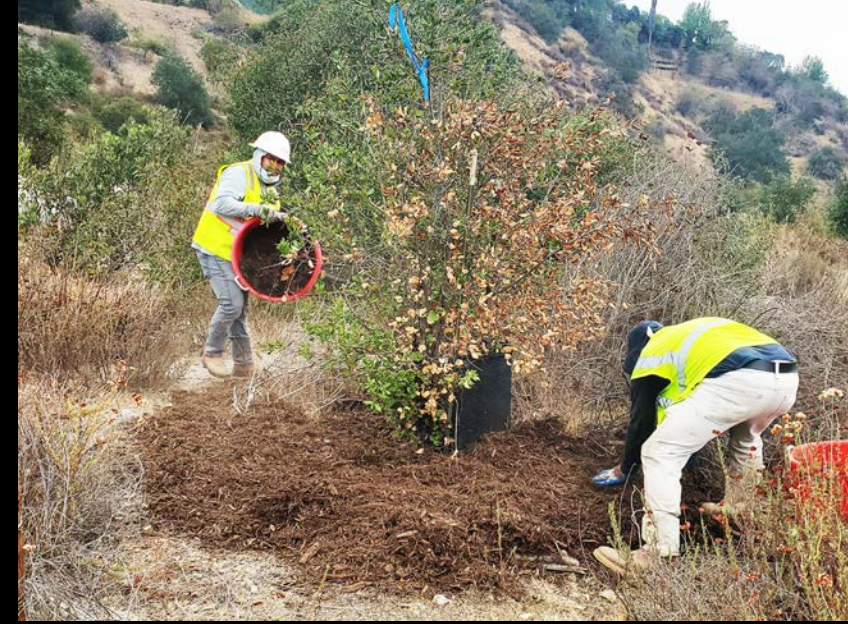
Maintenance / Enhancement

These results are not possible without diligent maintenance. We're not only weeding regularly, but supplemental plantings, seeding—continually loading more propagules into the site to facilitate natural recruitment.

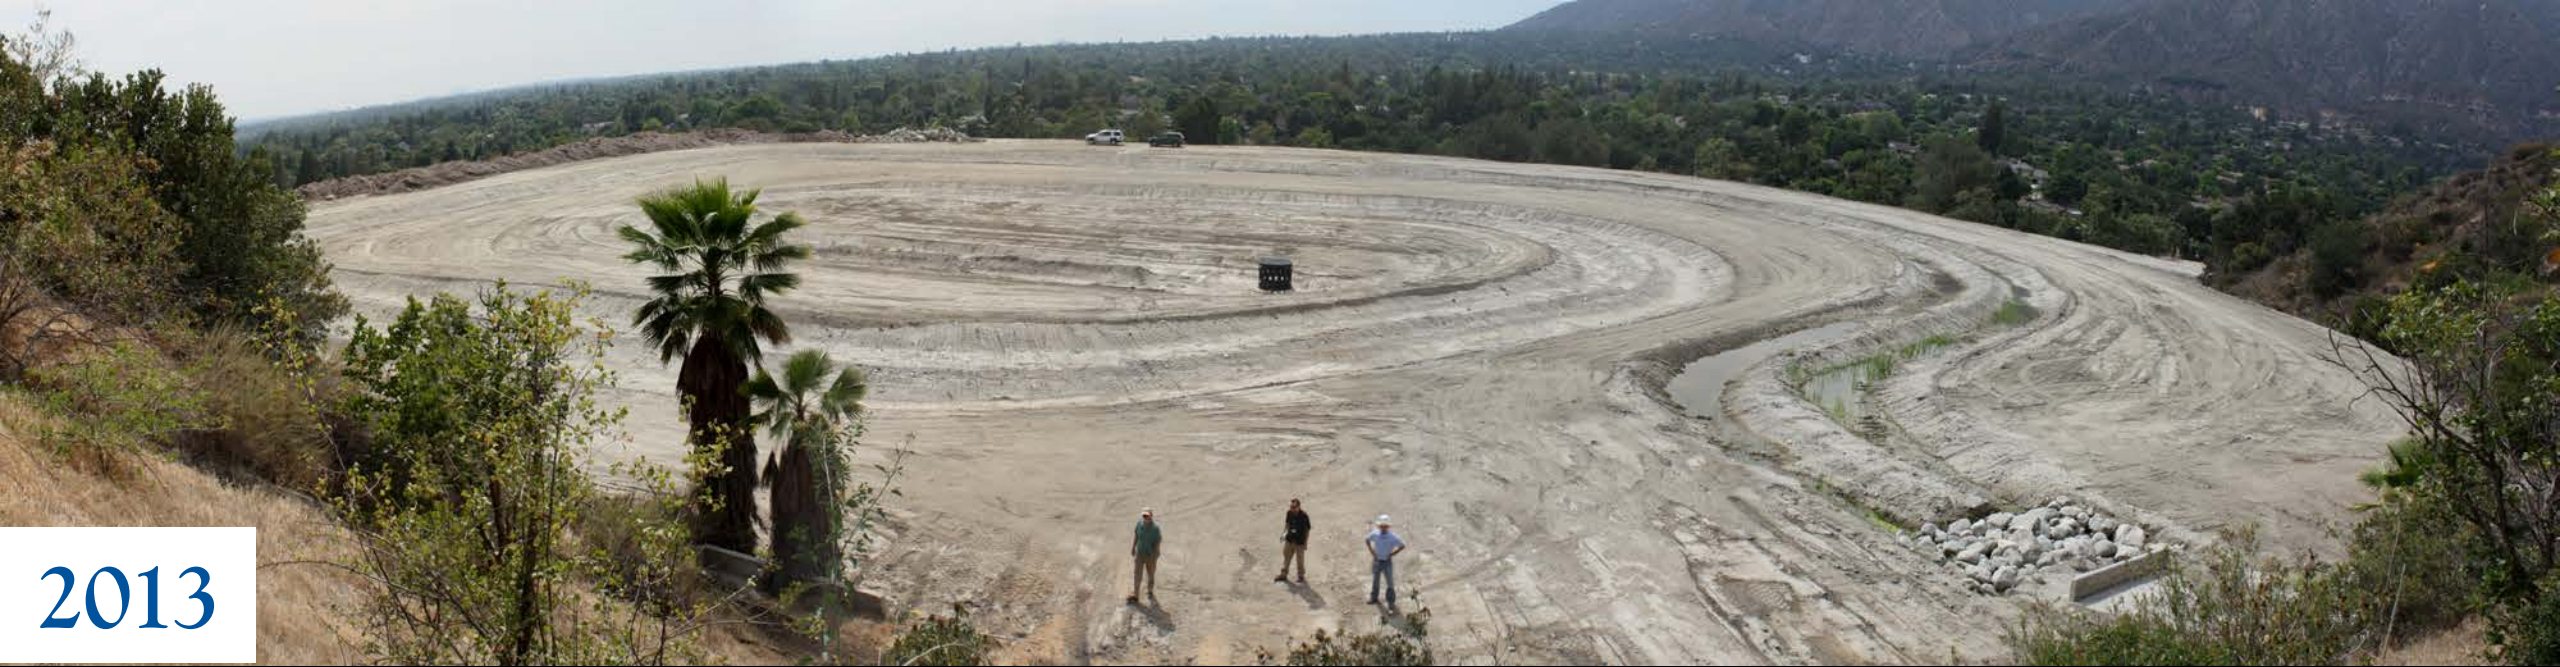
2013

These panoramas show the progress at a landscape level.

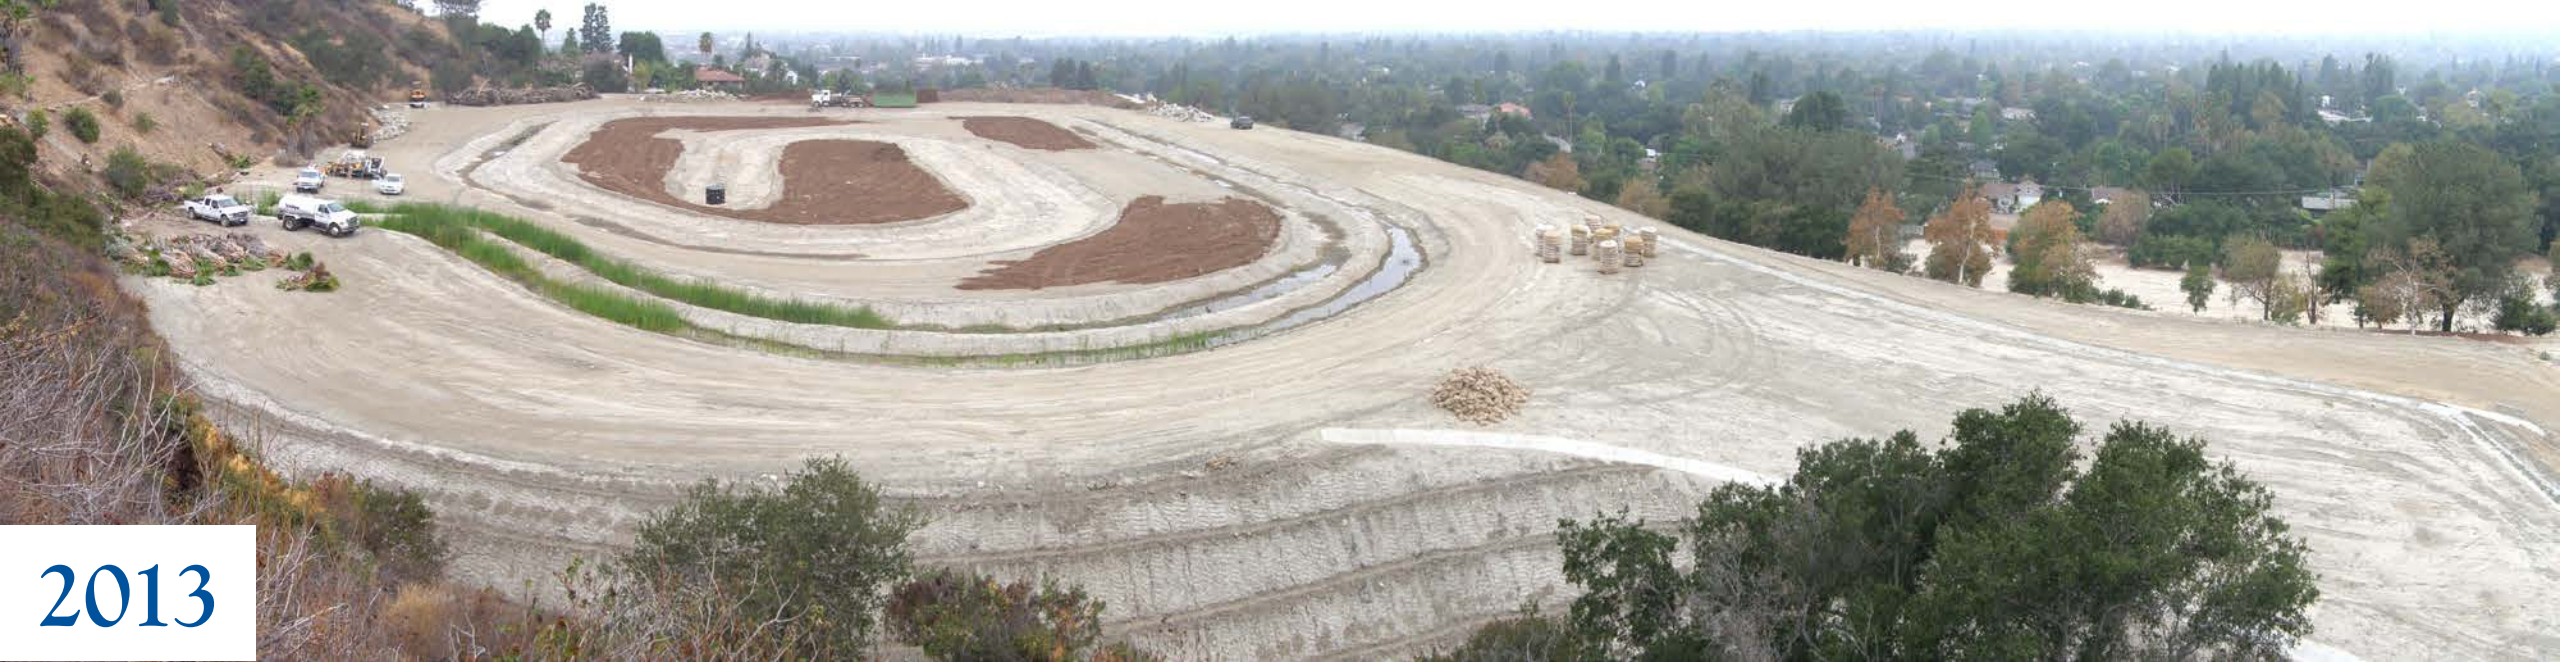
2013

These panoramas show the progress at a landscape level.

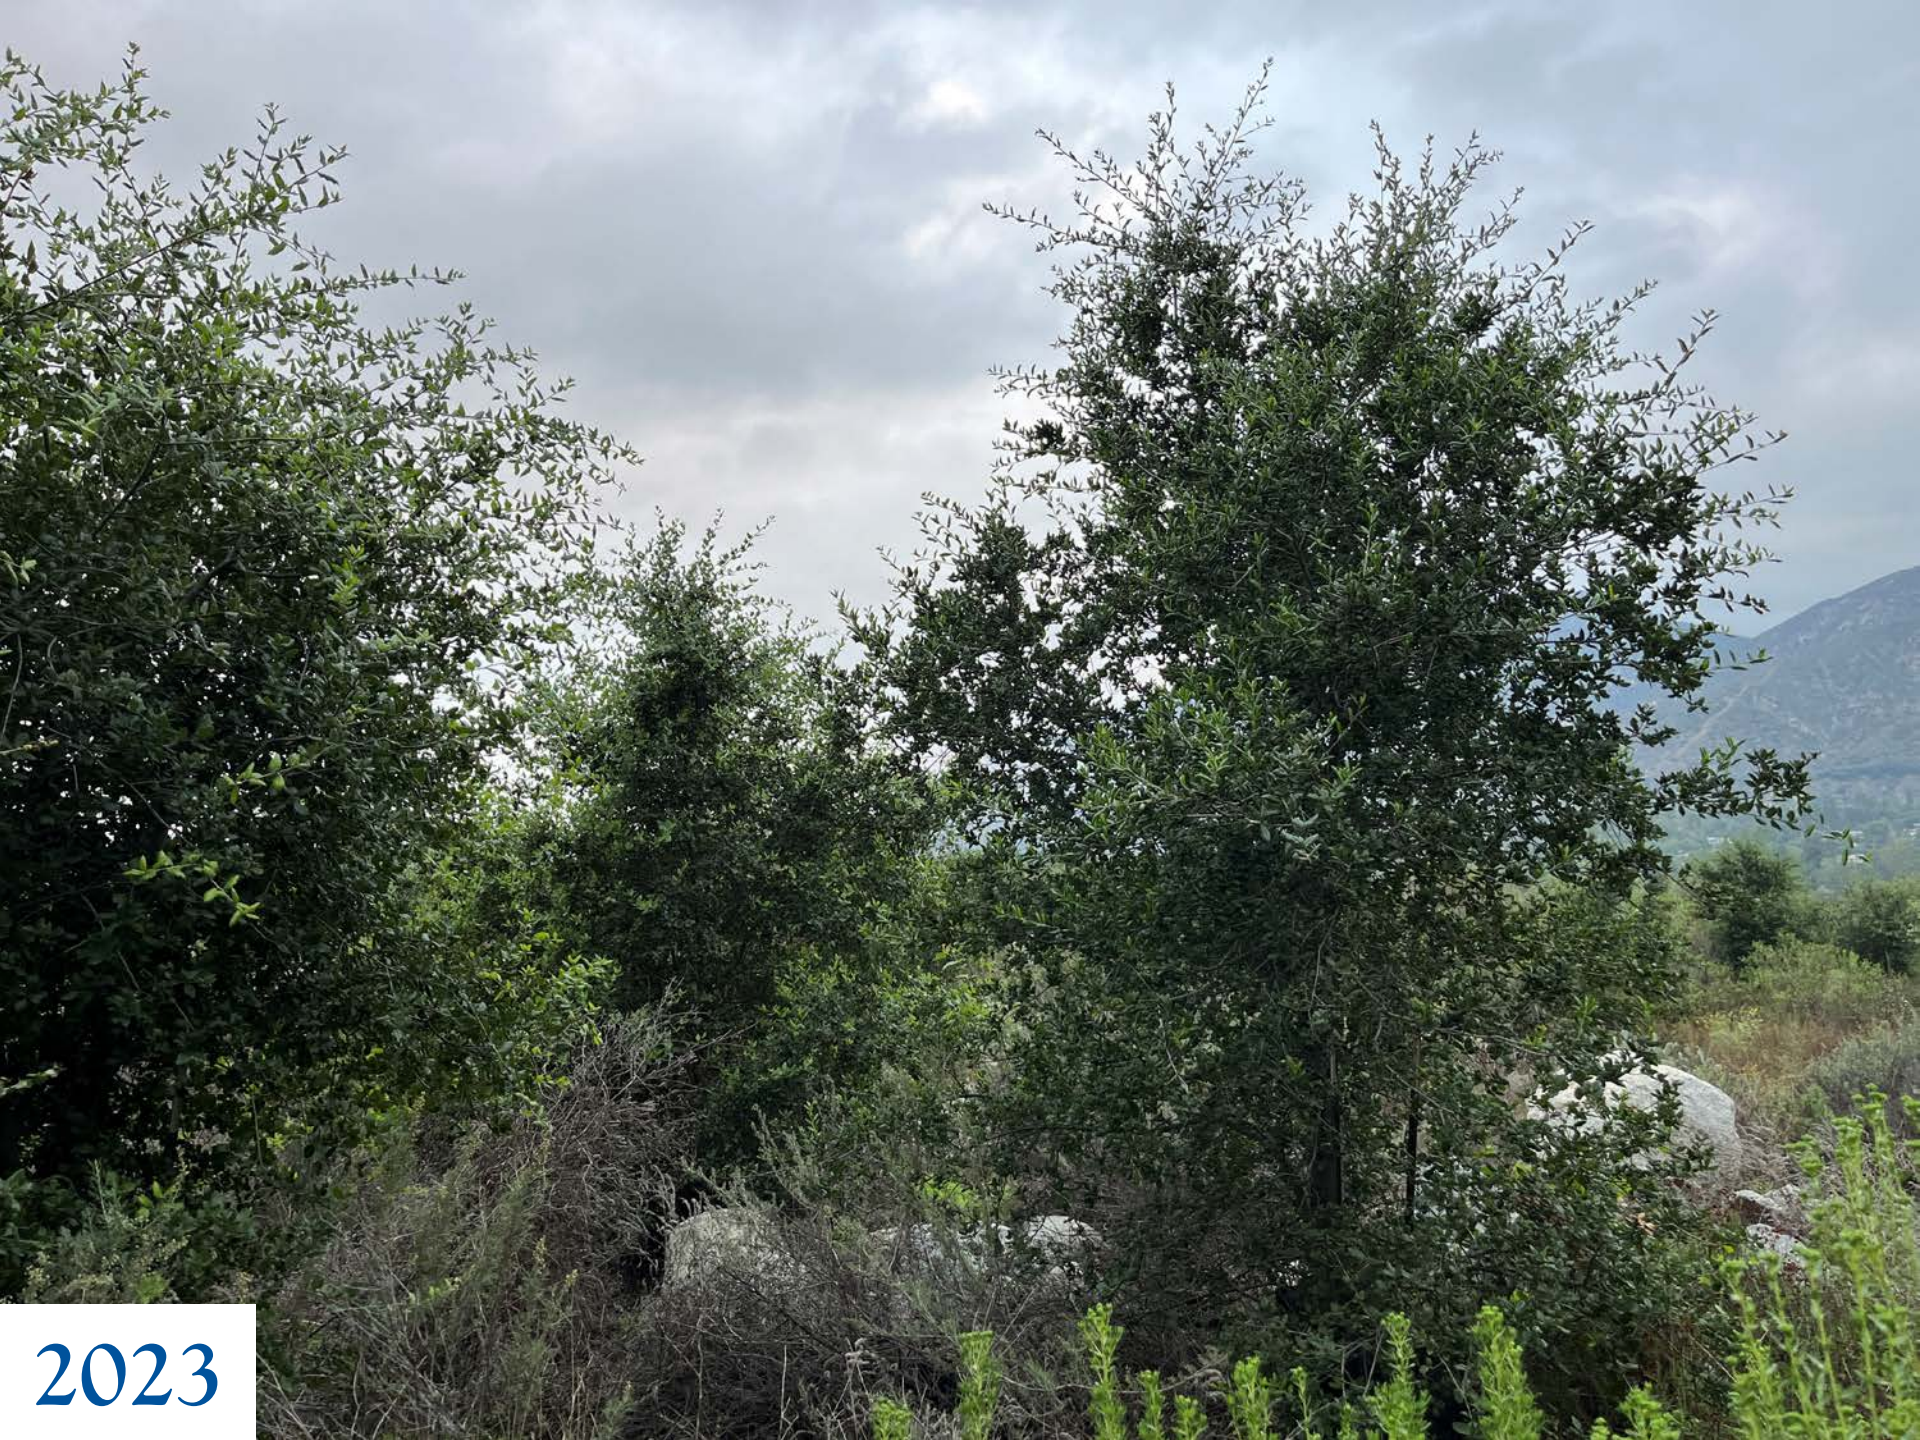
2023

Healthy, drought-resilient oaks in a mosaic of understory vegetation and natural debris.

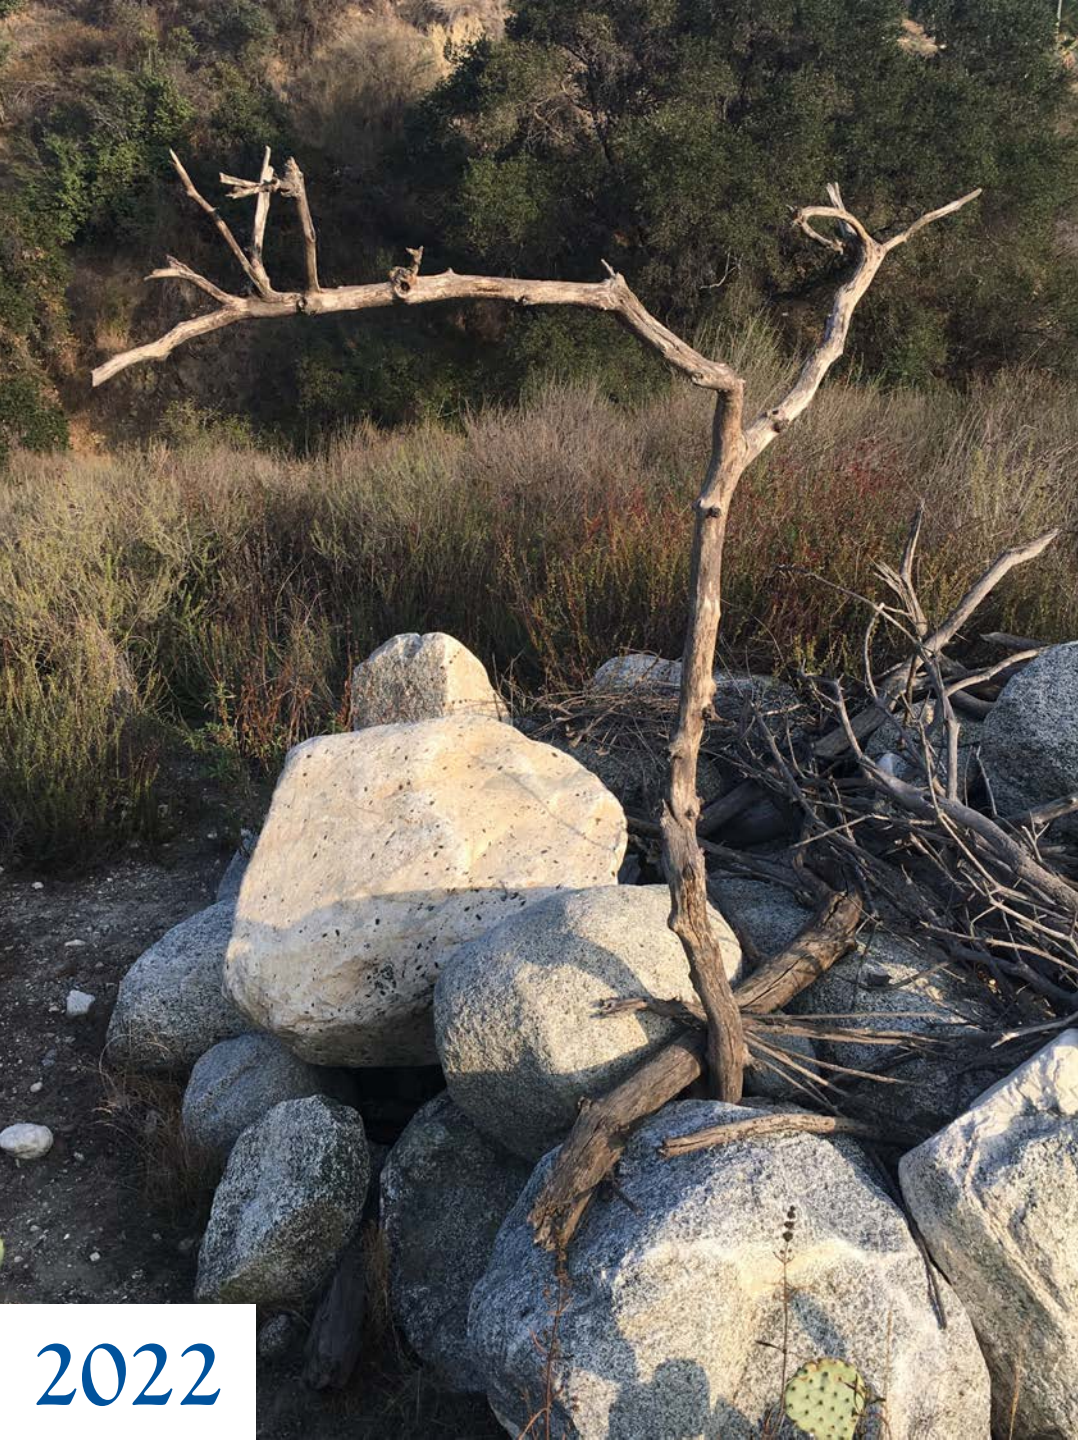
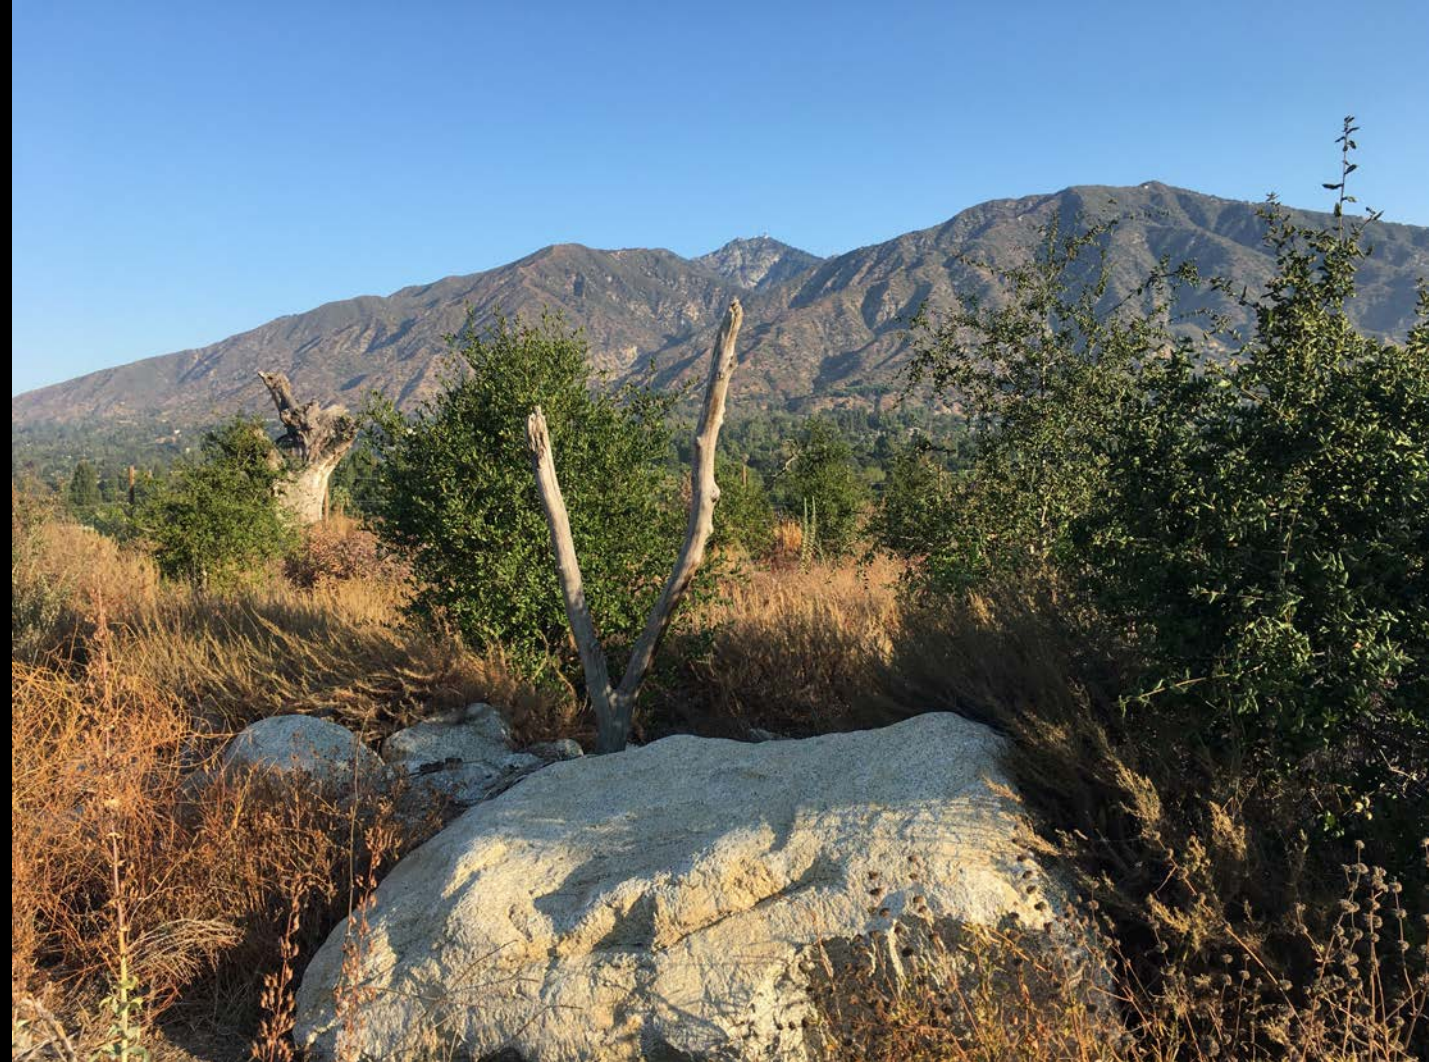
In addition to the large snags, we often place smaller branches among the assemblages, and these are heavily used by critters.

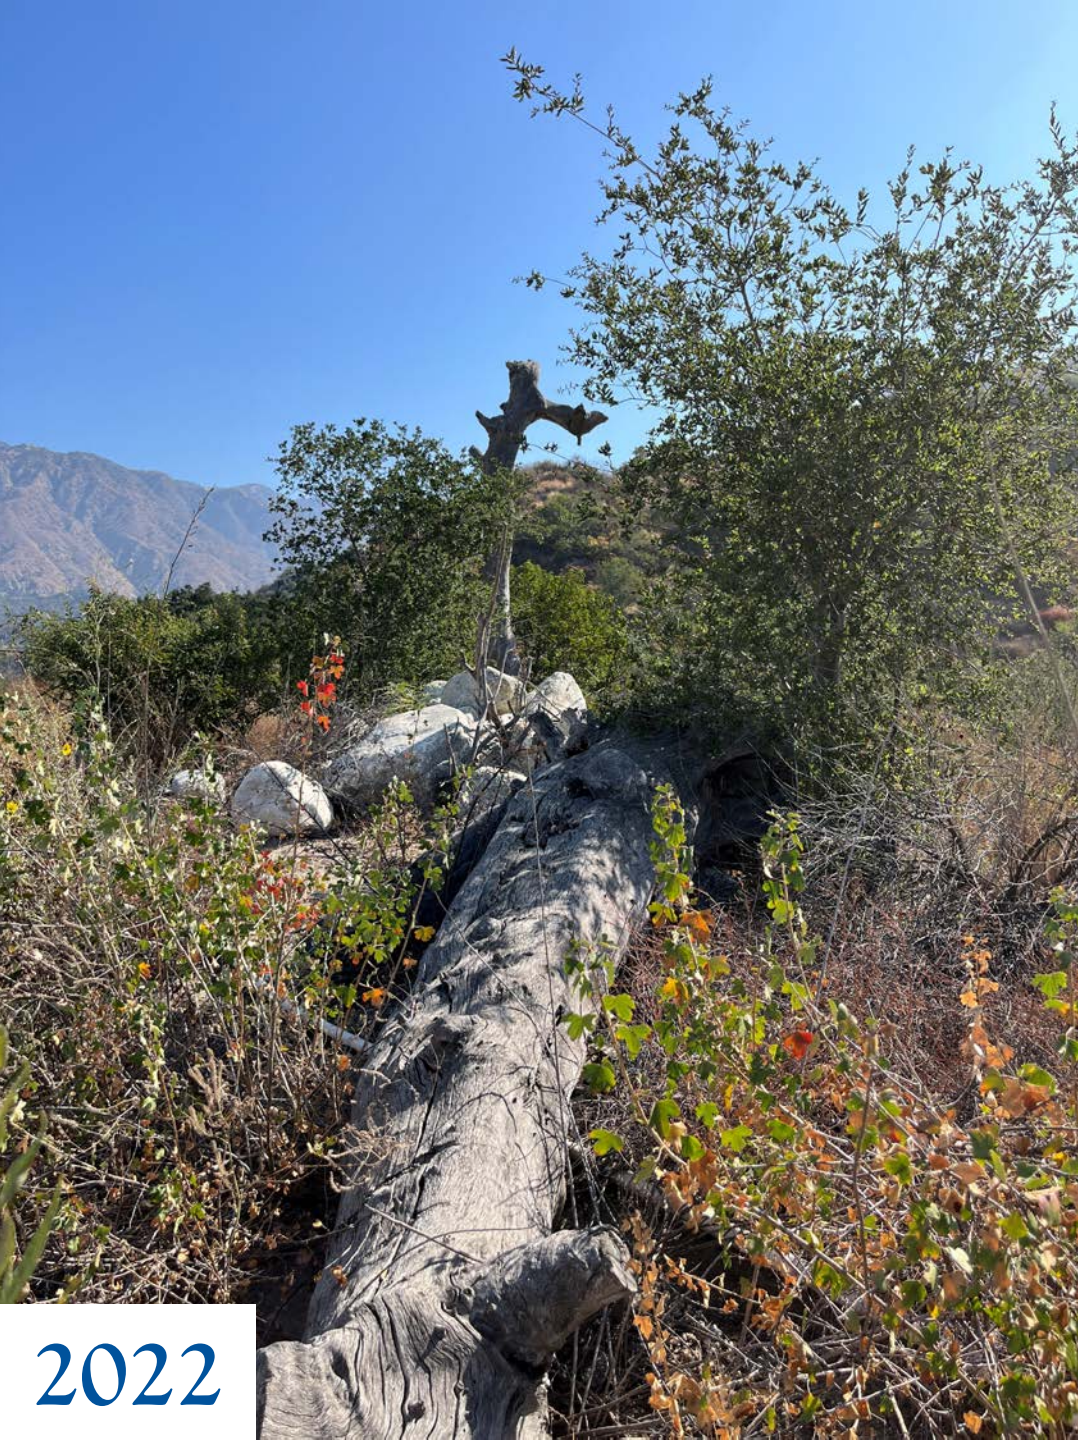
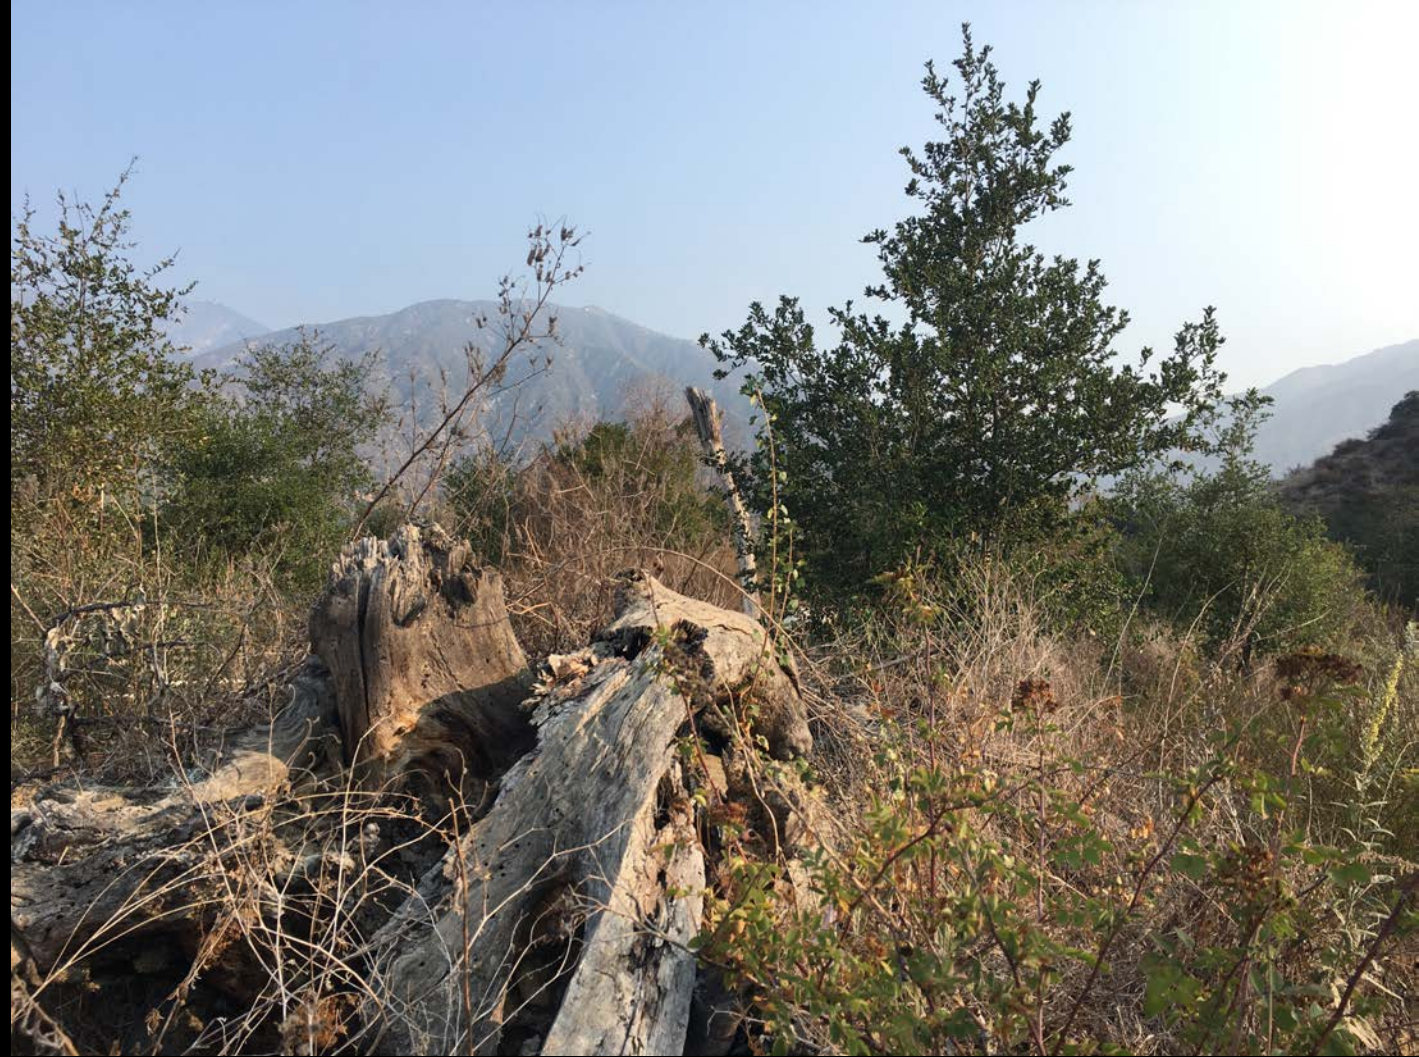
The placed CWD continues to weather and decay.

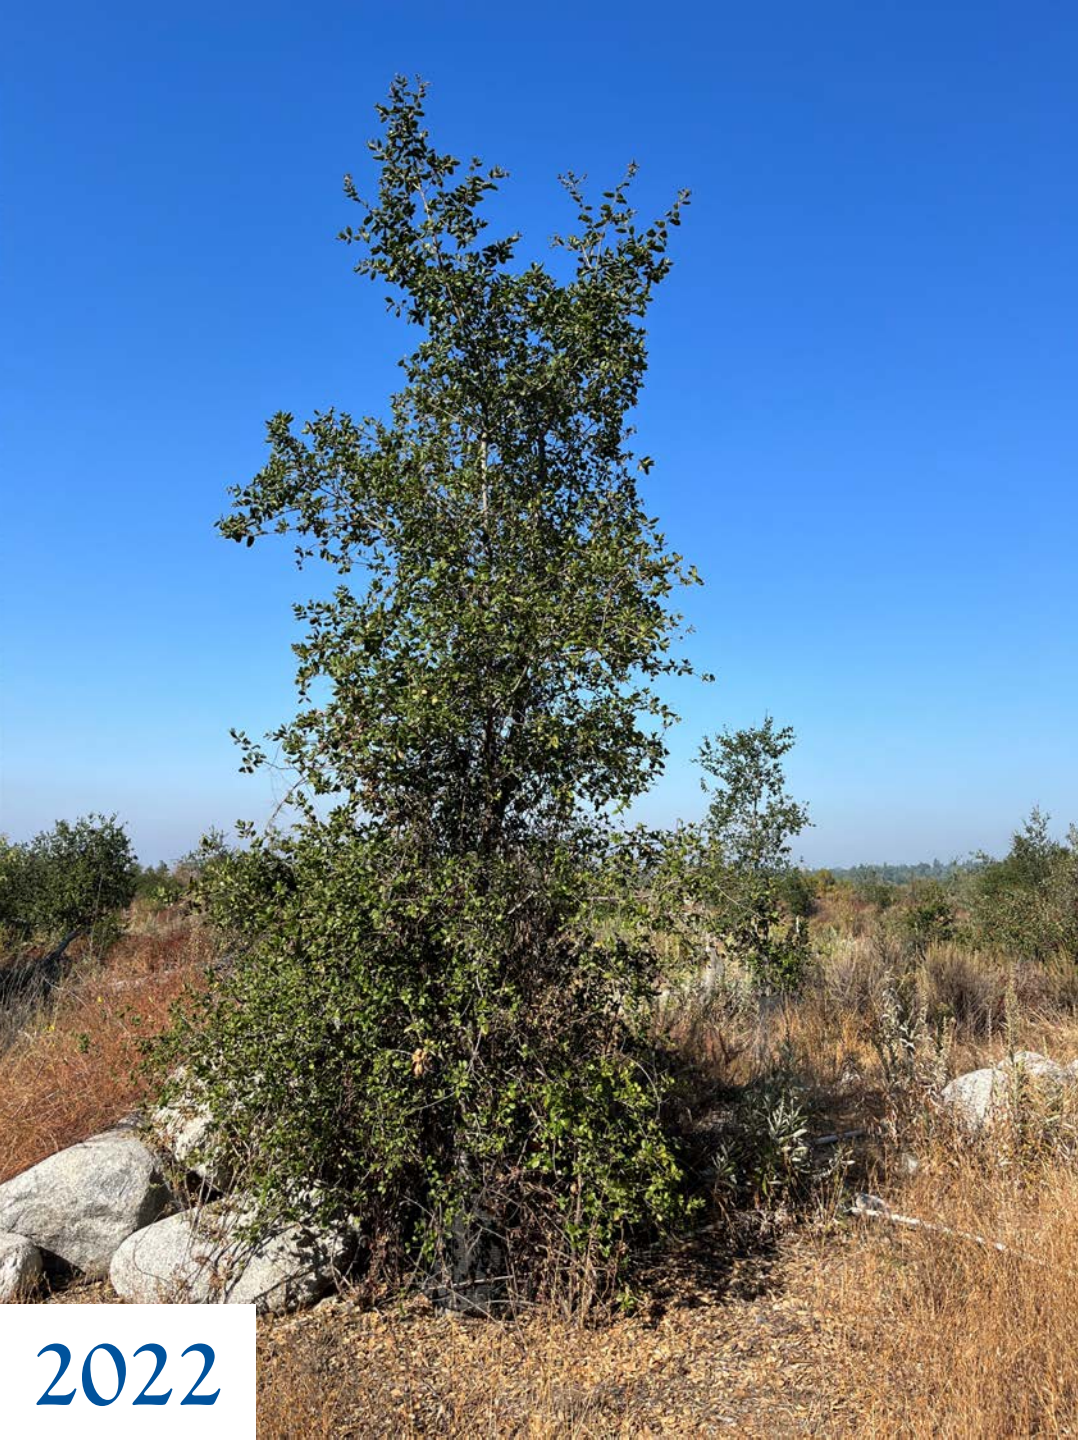
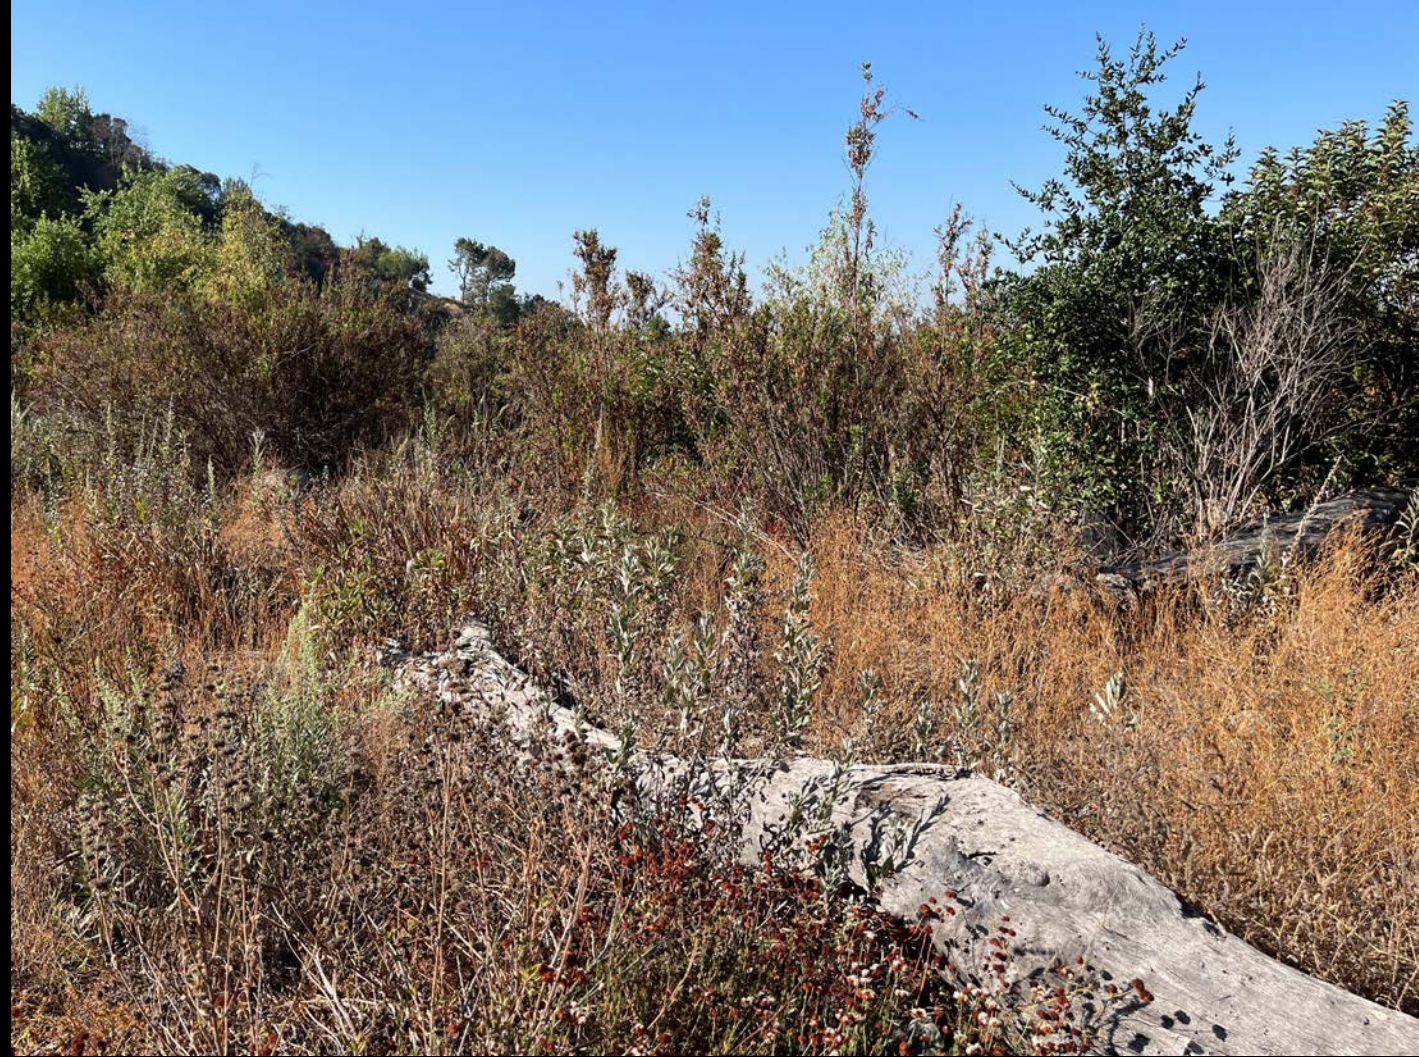
The oaks are resilient despite periods of drought. The oak habitat has not been irrigated since 2018, and the CSS areas not since 2015. We only received 3/4 of average rainfall in 2021, and 1/3 of average in 2020—really some acute drought.

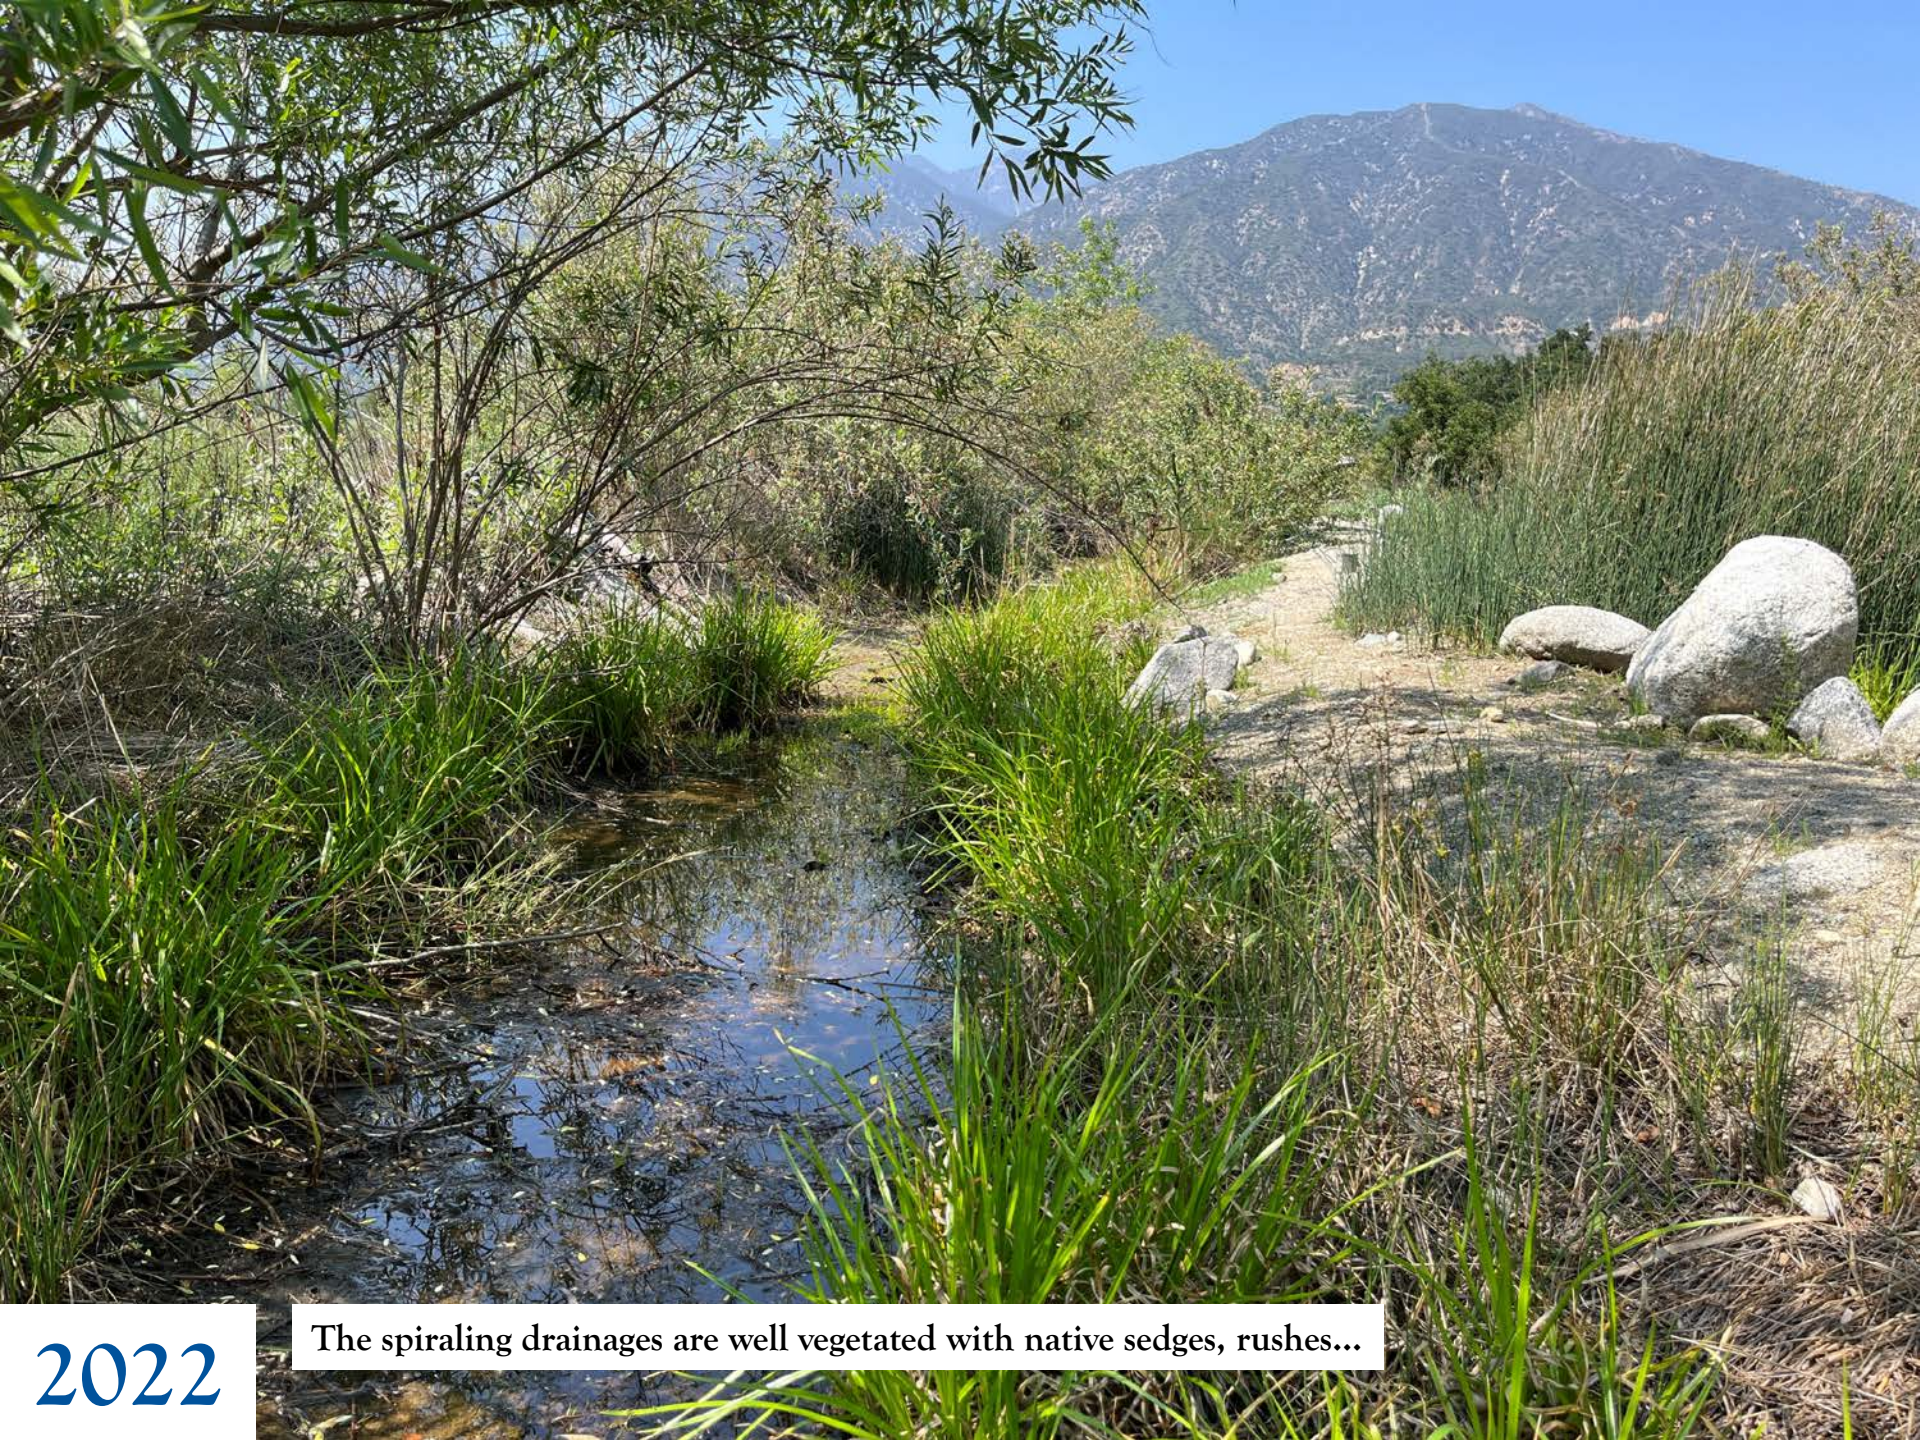
2022

The spiraling drainages are well vegetated with native sedges, rushes...
