# Substrate Enhancements and Botanical Diversity for Successful Oak Habitat Creation

Richard B. Lewis III, ENV SP  
Senior Restoration Ecologist, Psomas

LOS ANGELES COUNTY  
FLOOD CONTROL DISTRICT  
SANTA ANITA  
DAM

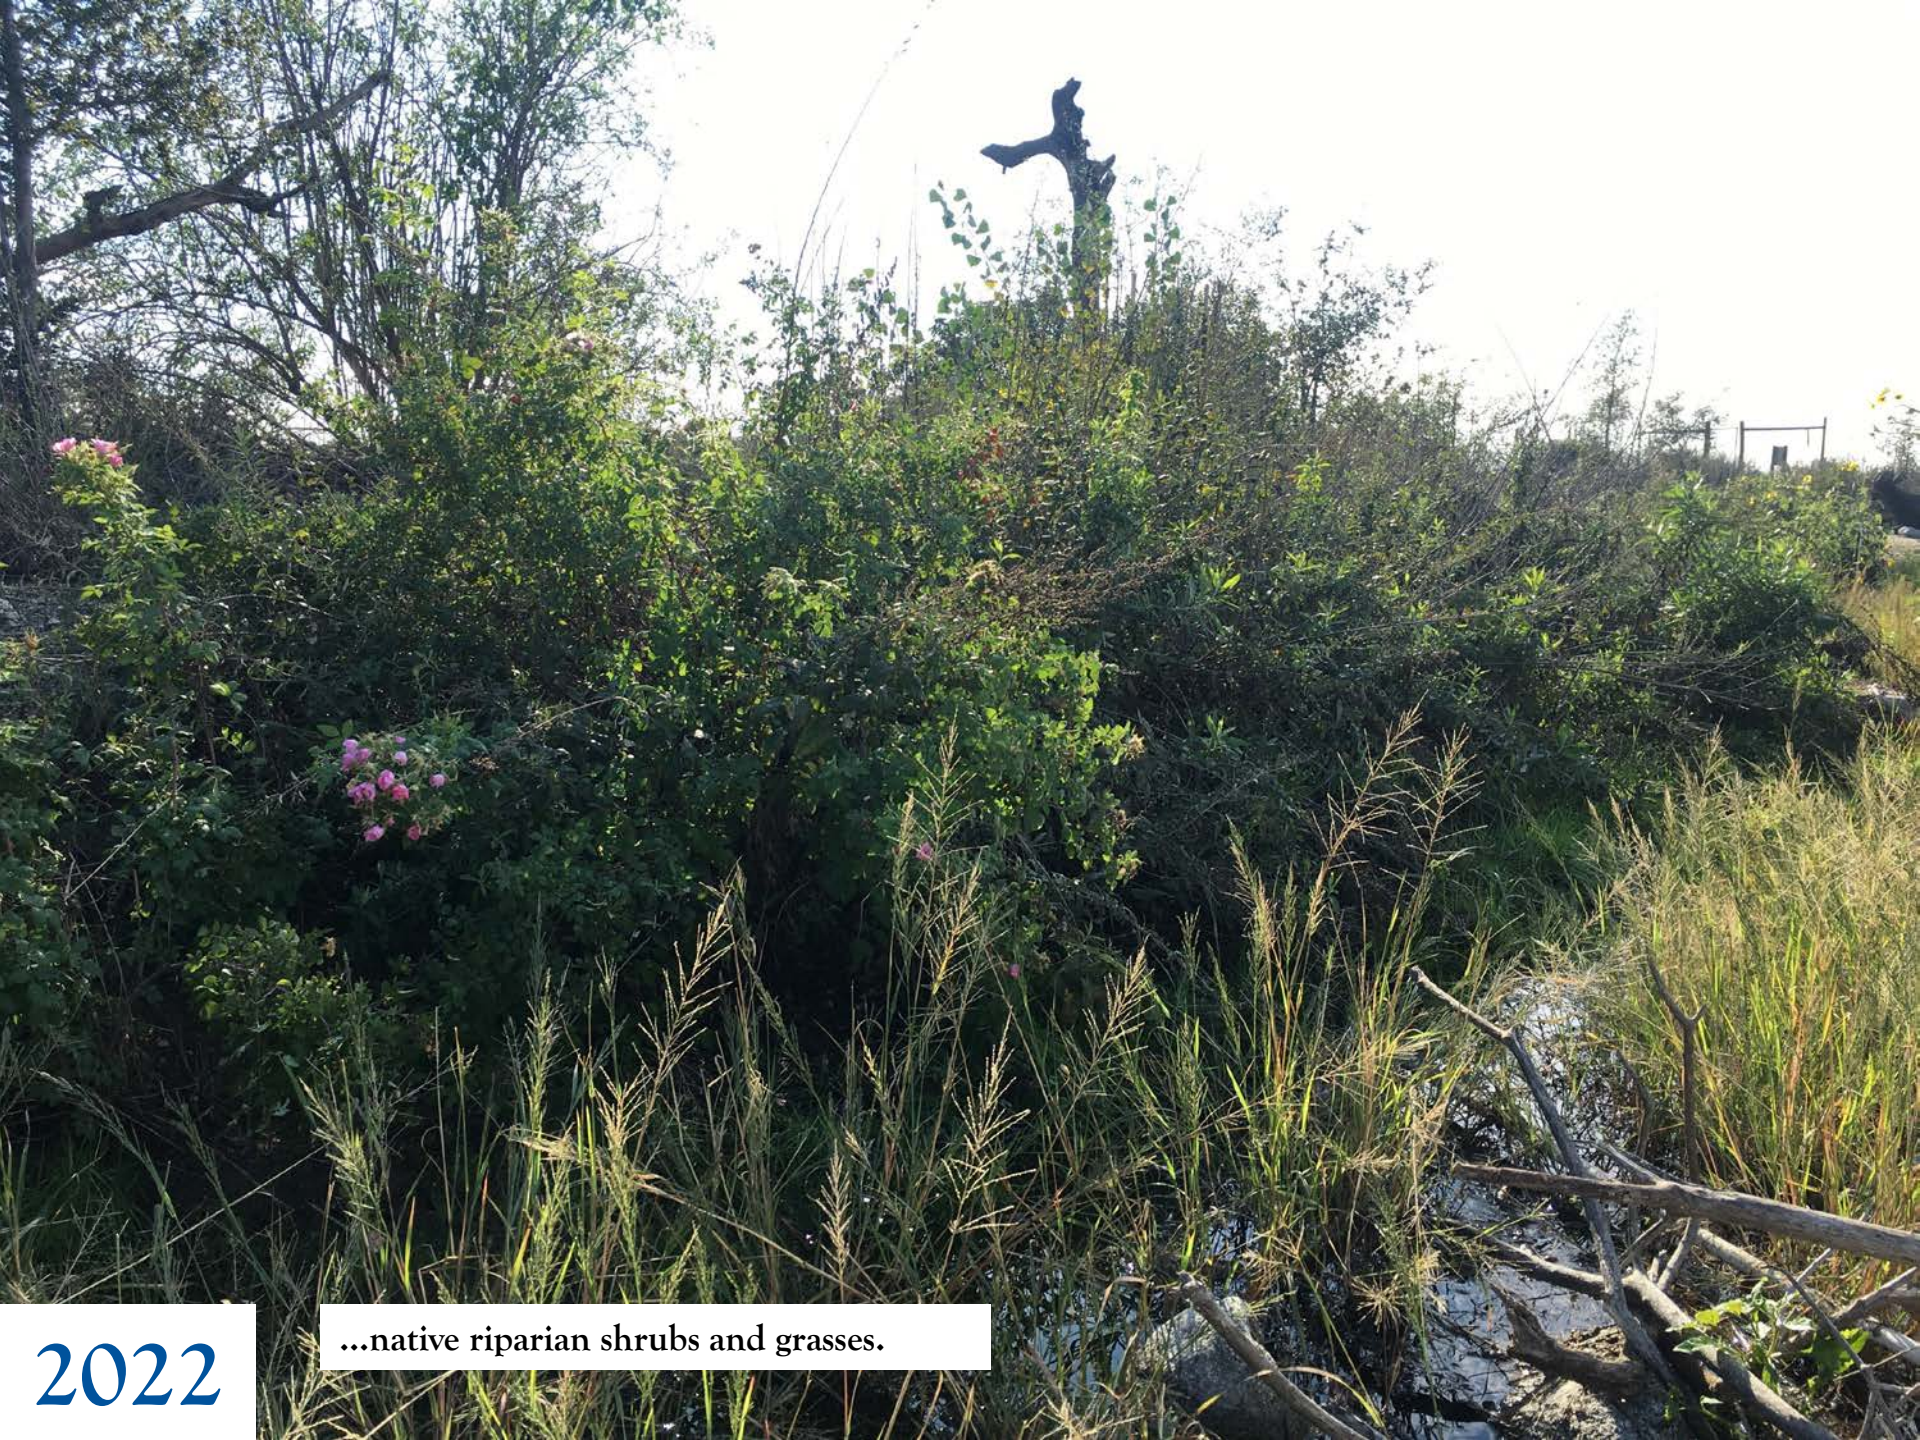
2022

...native riparian shrubs and grasses.

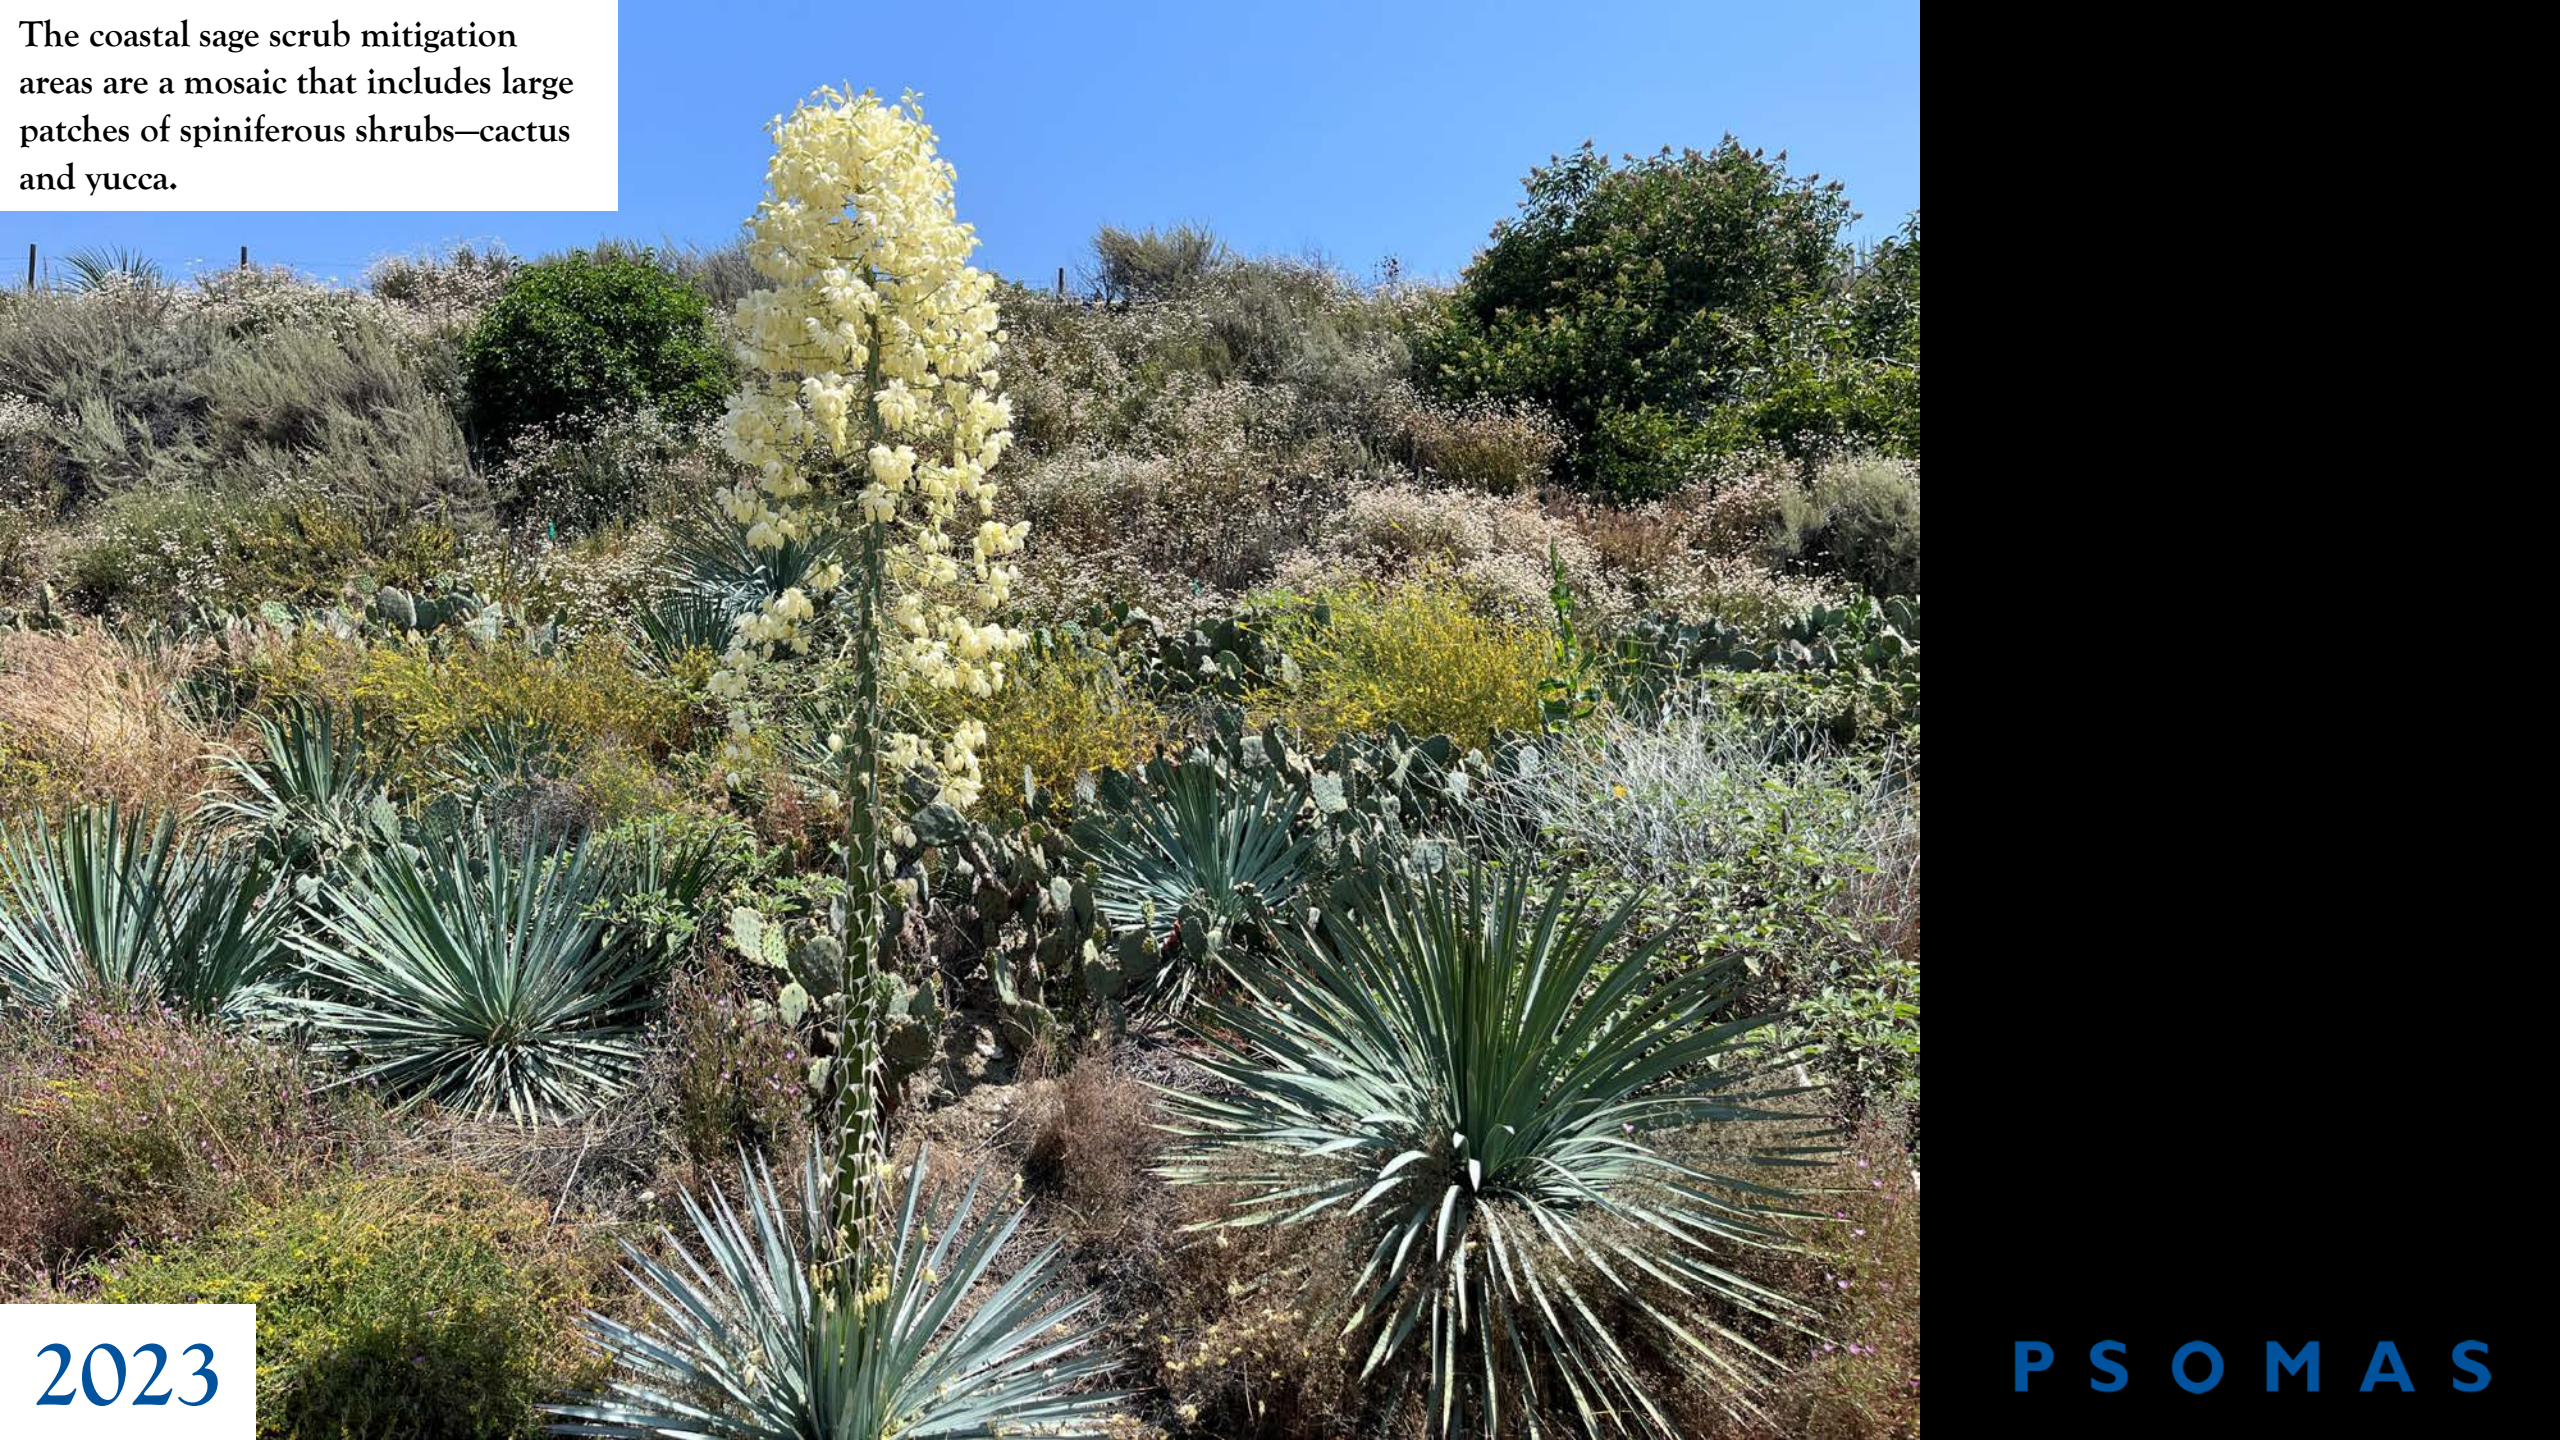
2023

The coastal sage scrub mitigation areas are a mosaic that includes large patches of spiniferous shrubs—cactus and yucca.

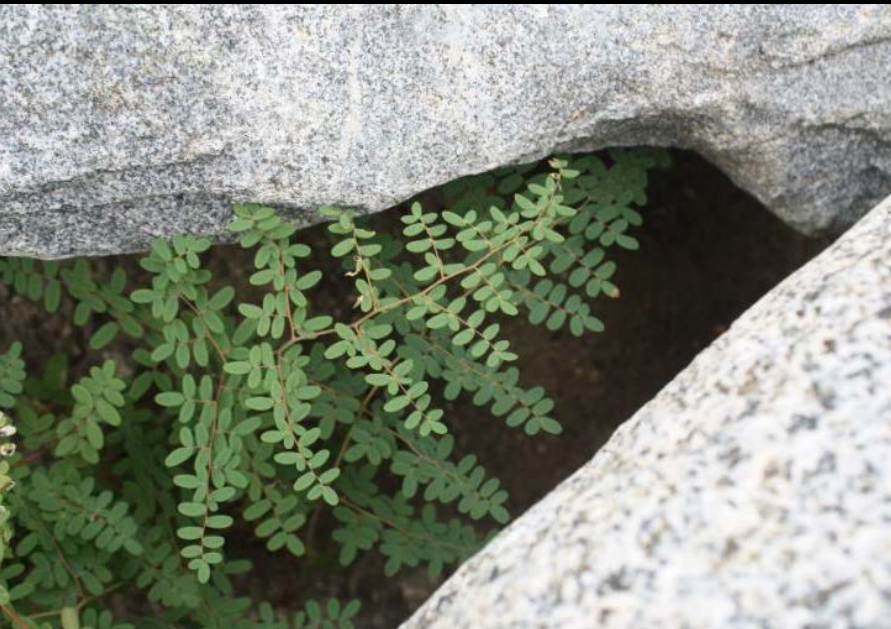
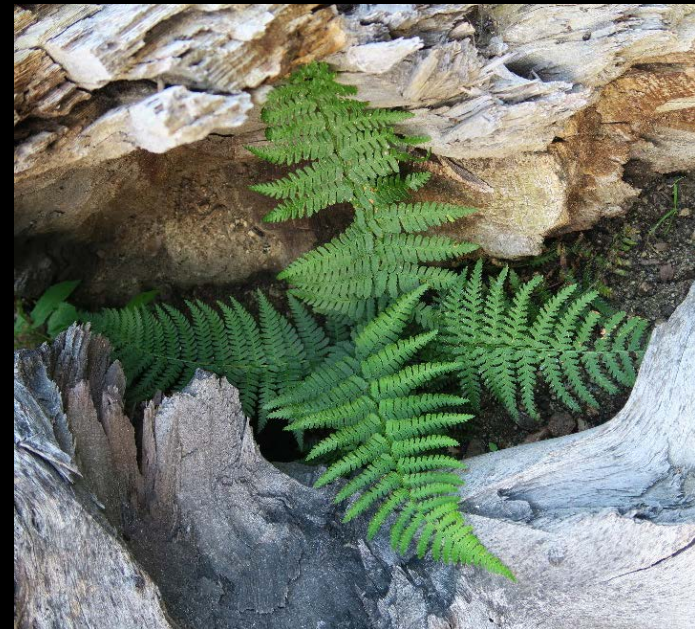
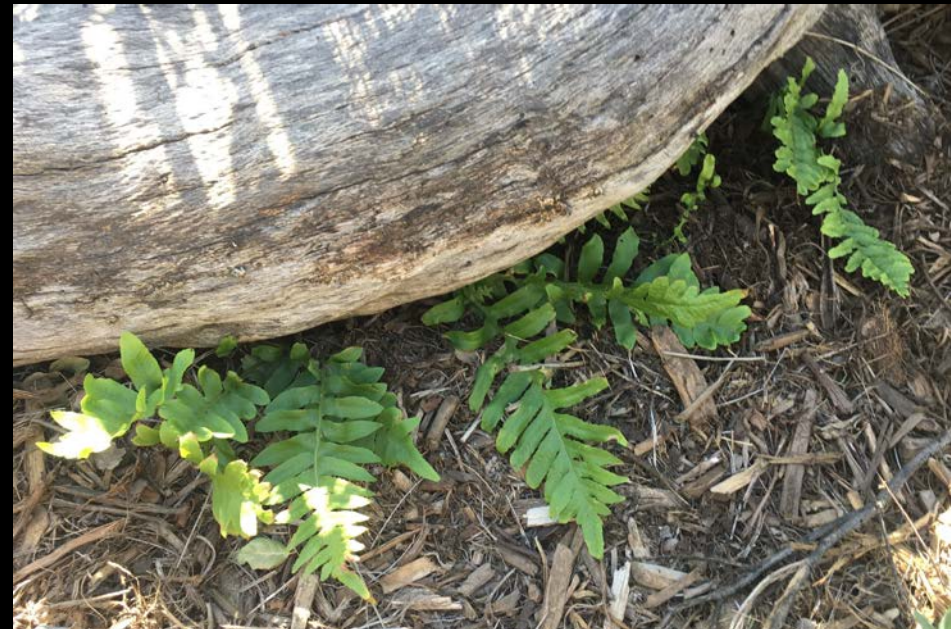
There are planted ferns hiding under just about every assemblage, and they are regenerating with observed sporangia and clonal growth.

Fern growth and *regeneration*

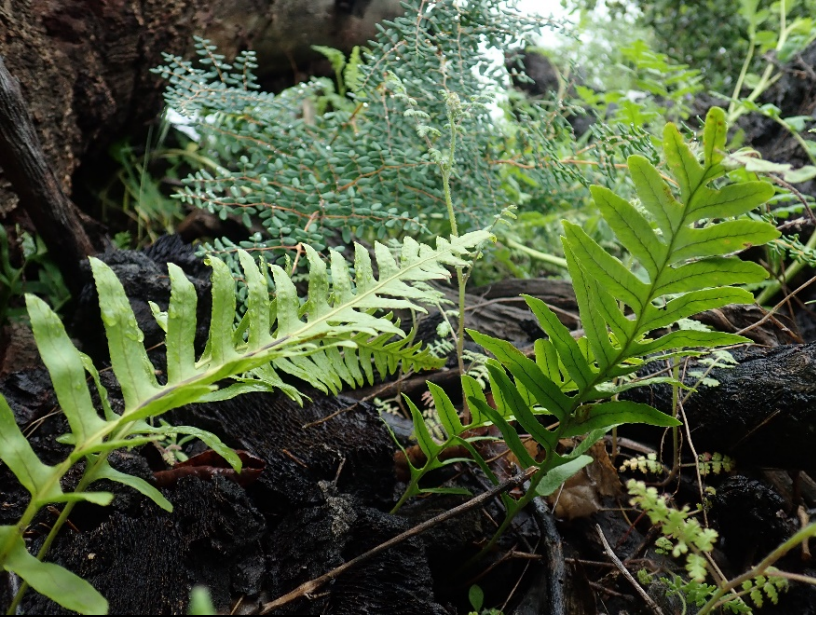
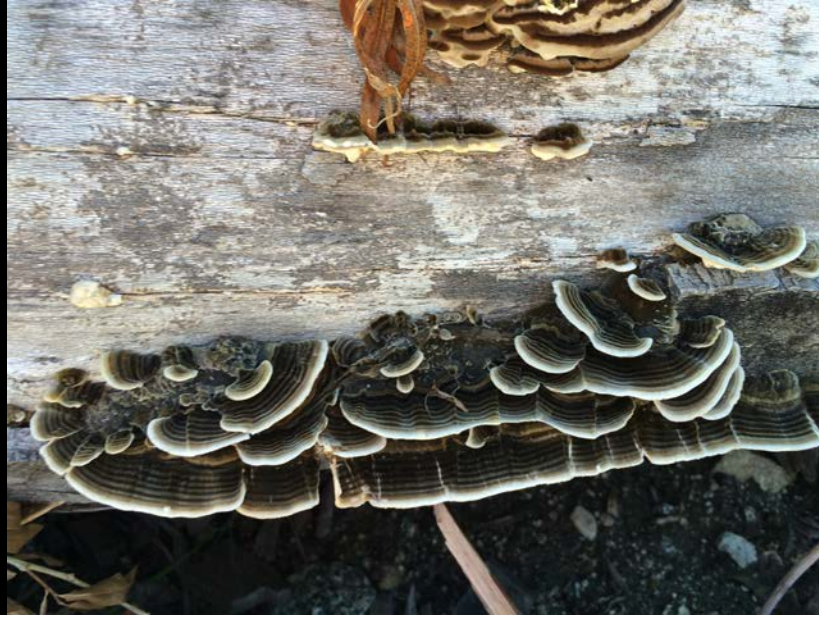
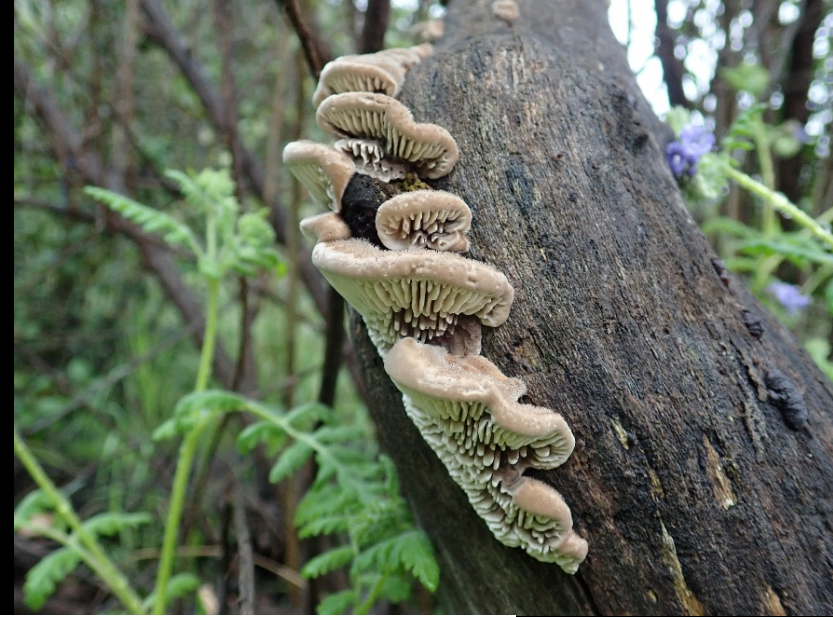
Beneficial decay processes

The placed CWD enables a beneficial decomposition food web that would have otherwise taken many years to establish.

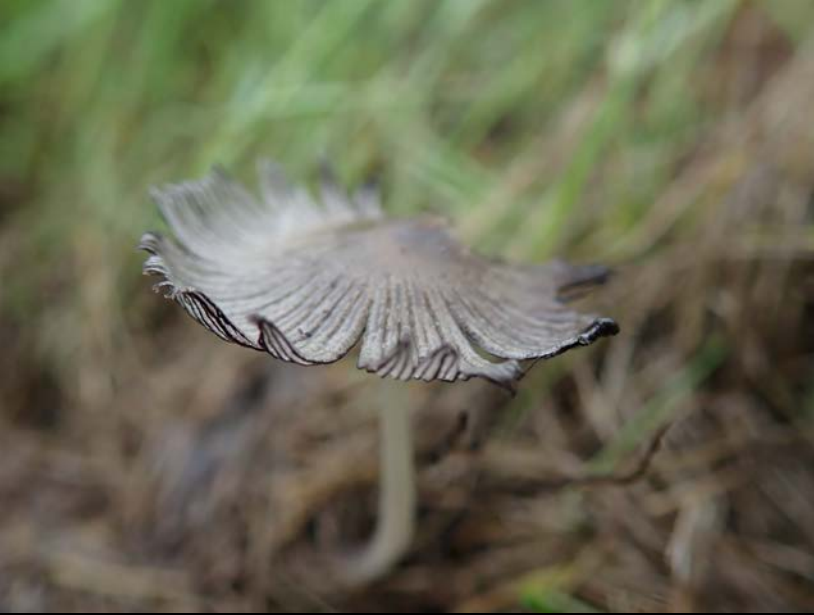
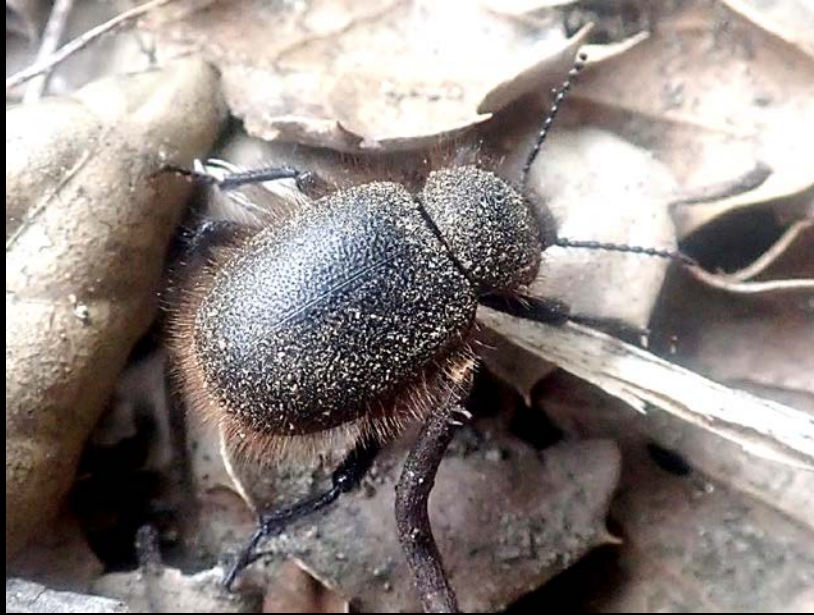
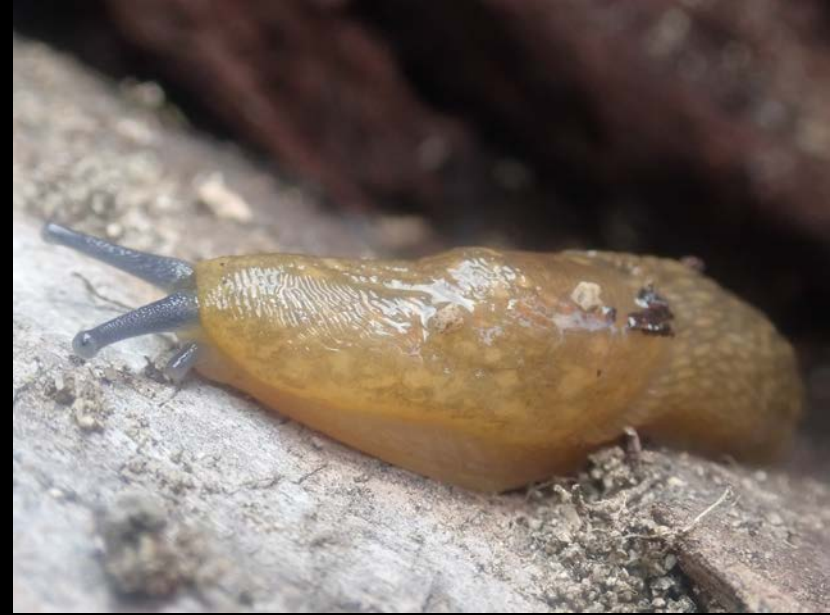
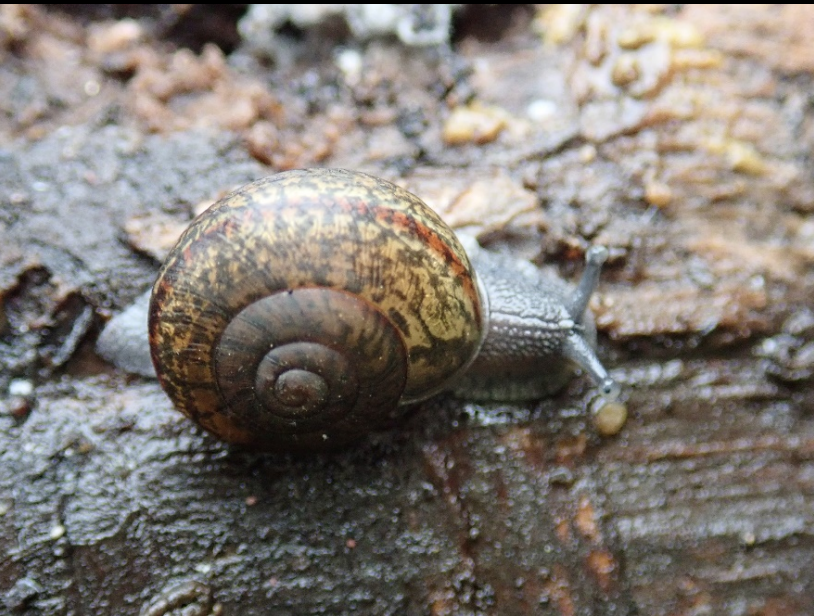
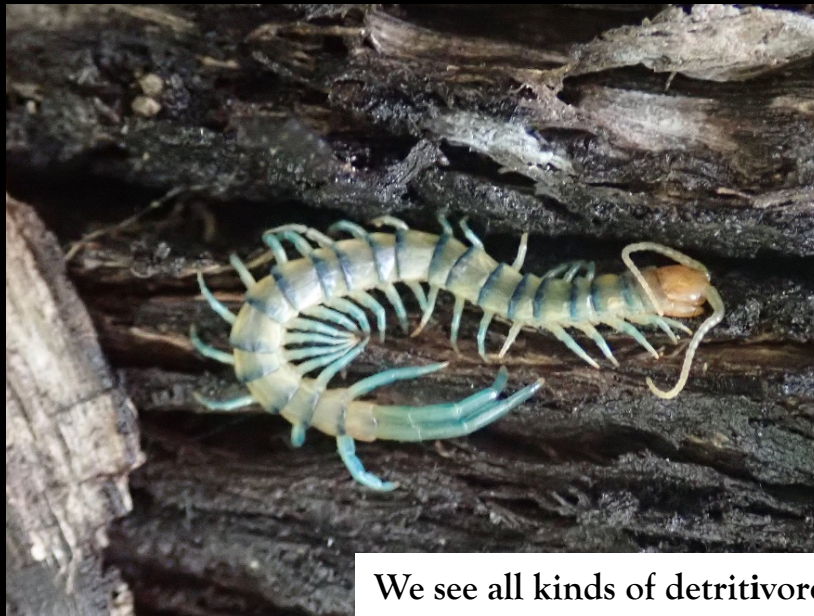
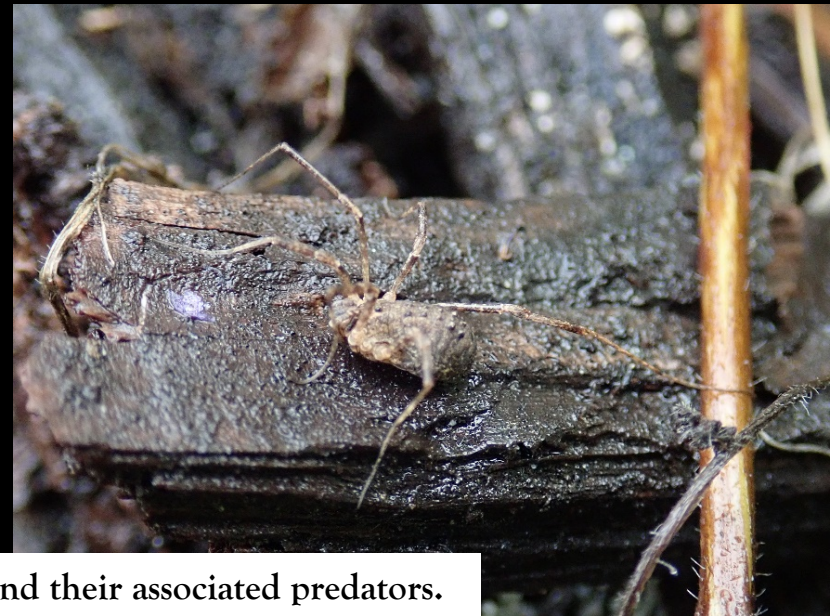
We see all kinds of detritivores and their associated predators.

The placed CWD continues to weather and decay.

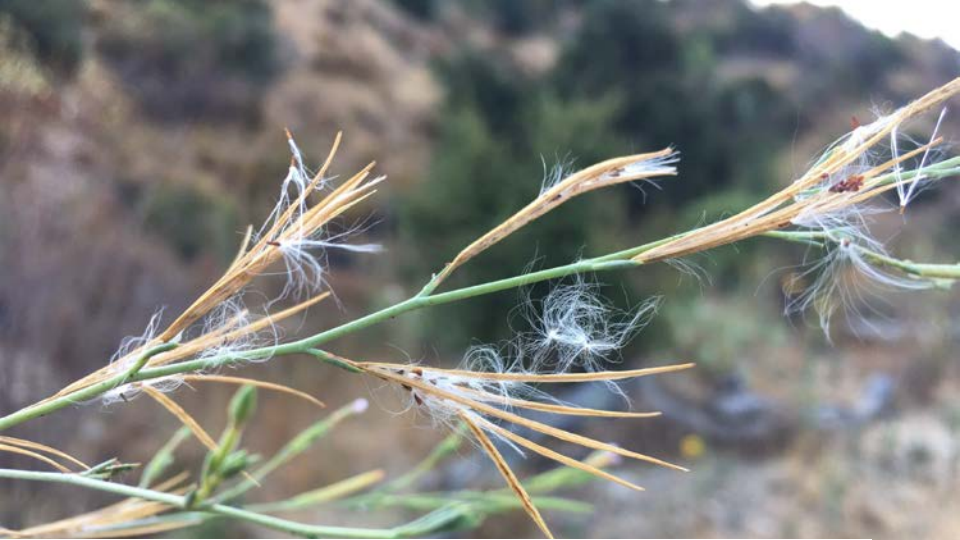
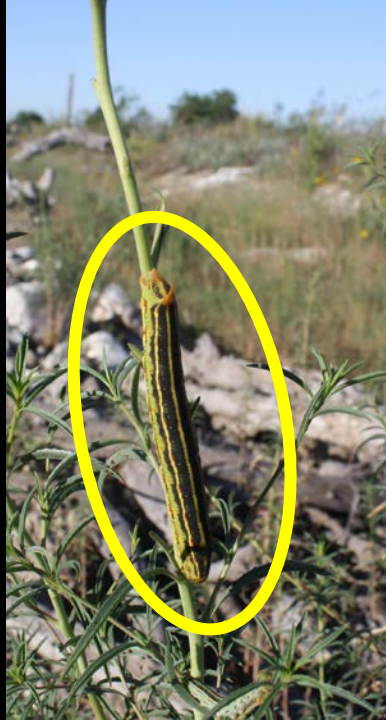
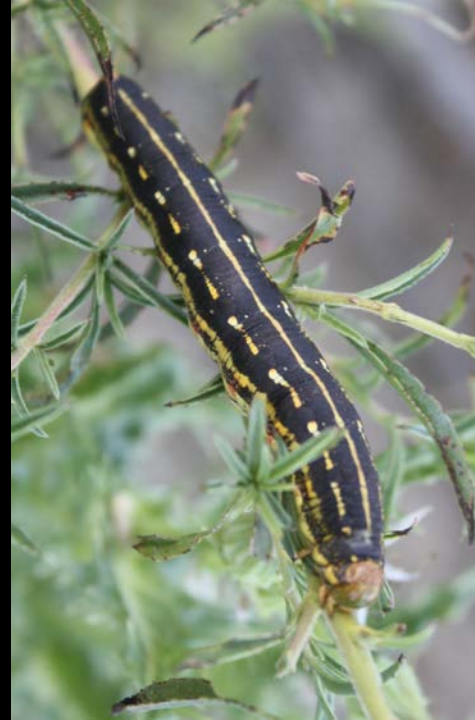
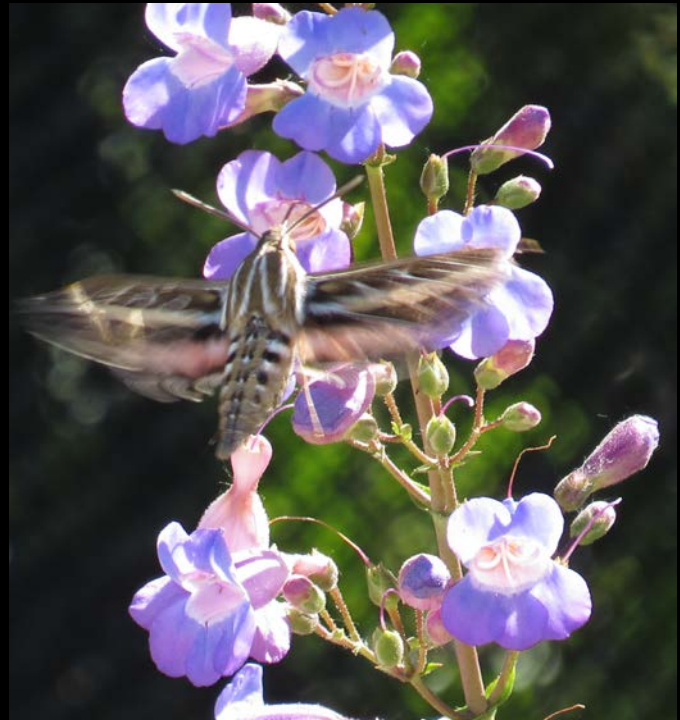
Arthropod abundance / diversity

Arthropods are abundant and diverse.

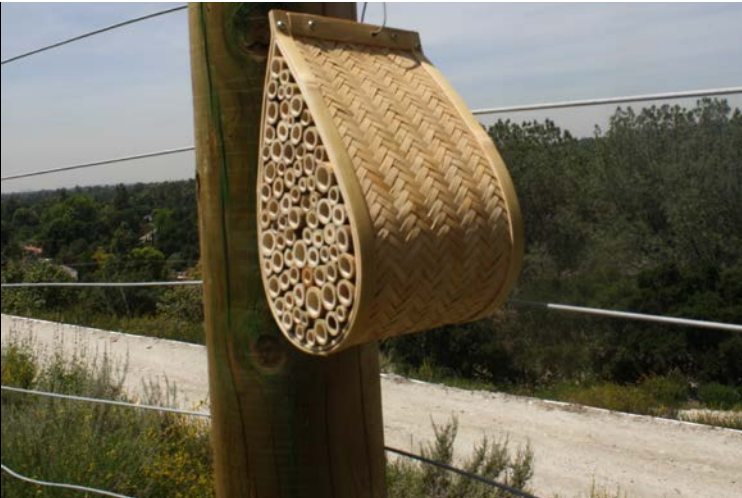
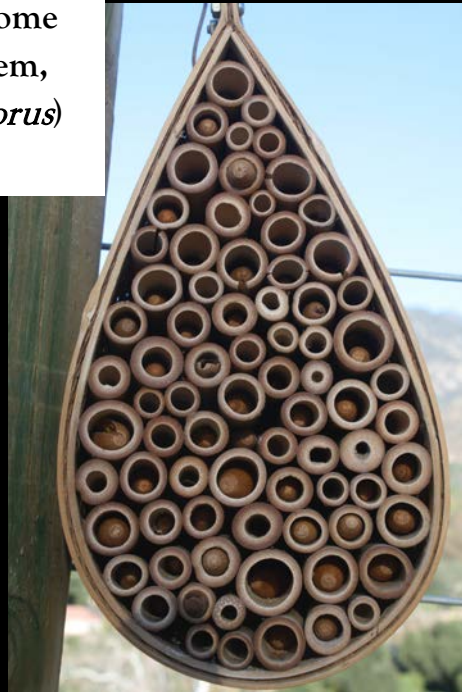
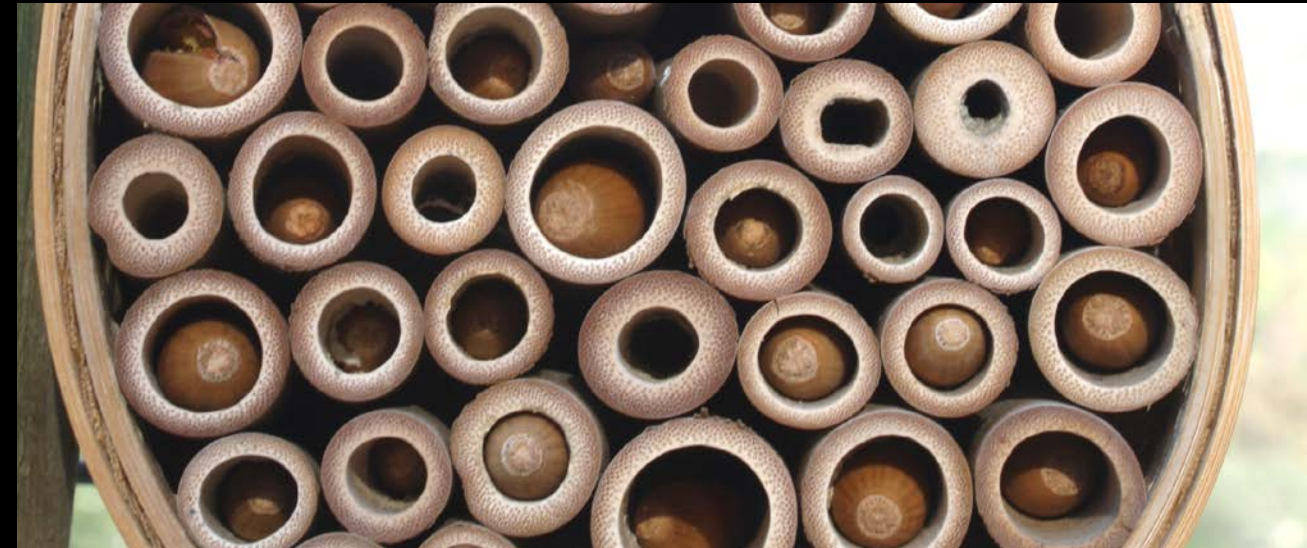
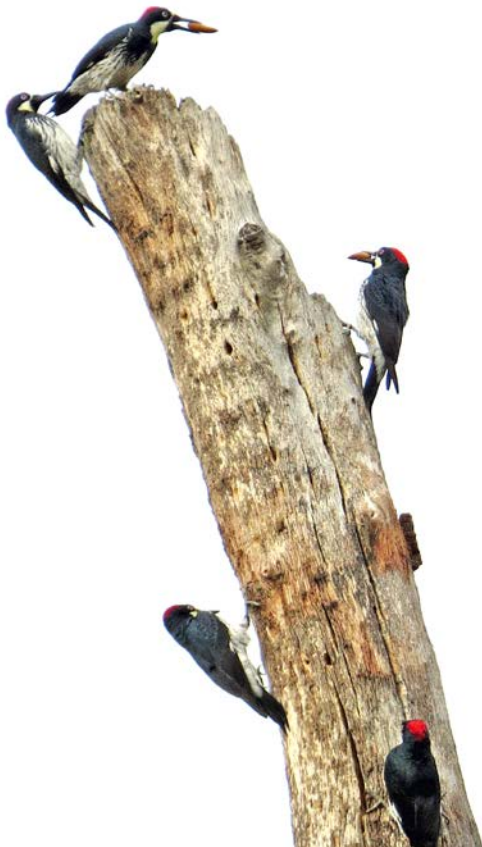
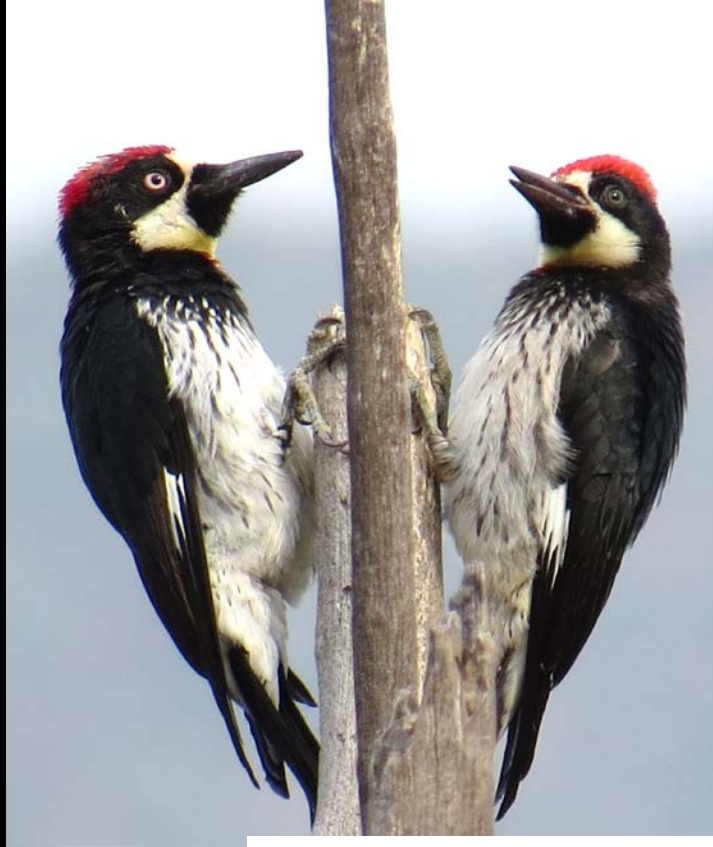
We observed an abundance of volunteer, short-fruited willowherb (*Epilobium brachycarpum*) on the site and protected it. Later, we saw hundreds of sphinx moth (*Hyles lineata*) larvae using this as their host plant, and later the adults nectaring on the site. We placed some carpenter bee houses on the site and they used them, but the acorn woodpeckers (*Melanerpes formicivorus*) had other plans...

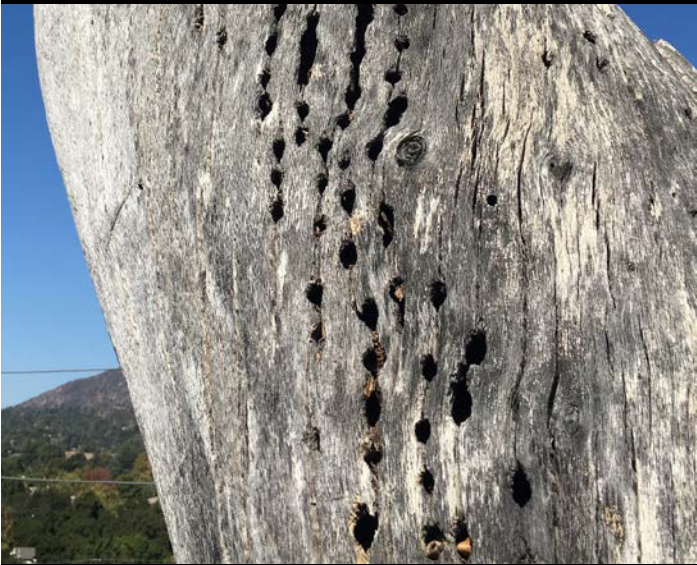
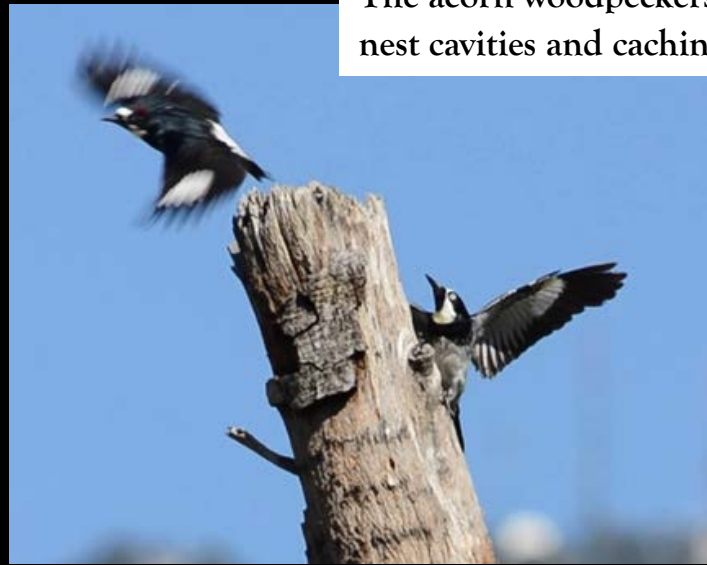
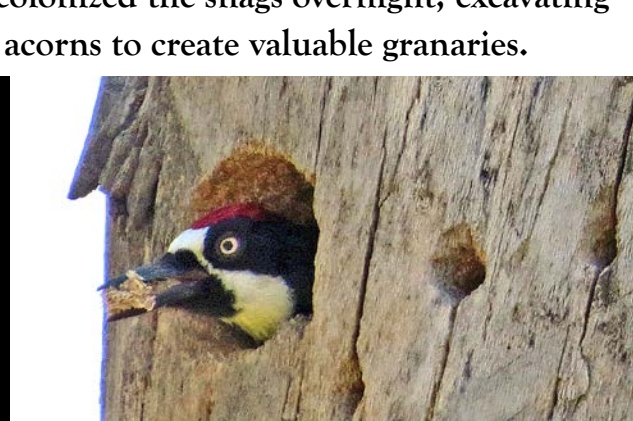
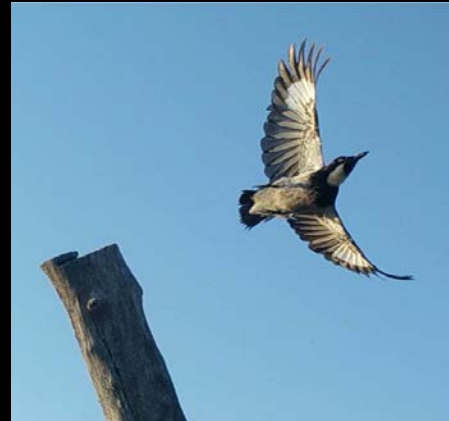
The acorn woodpeckers colonized the snags overnight, excavating nest cavities and caching acorns to create valuable granaries.

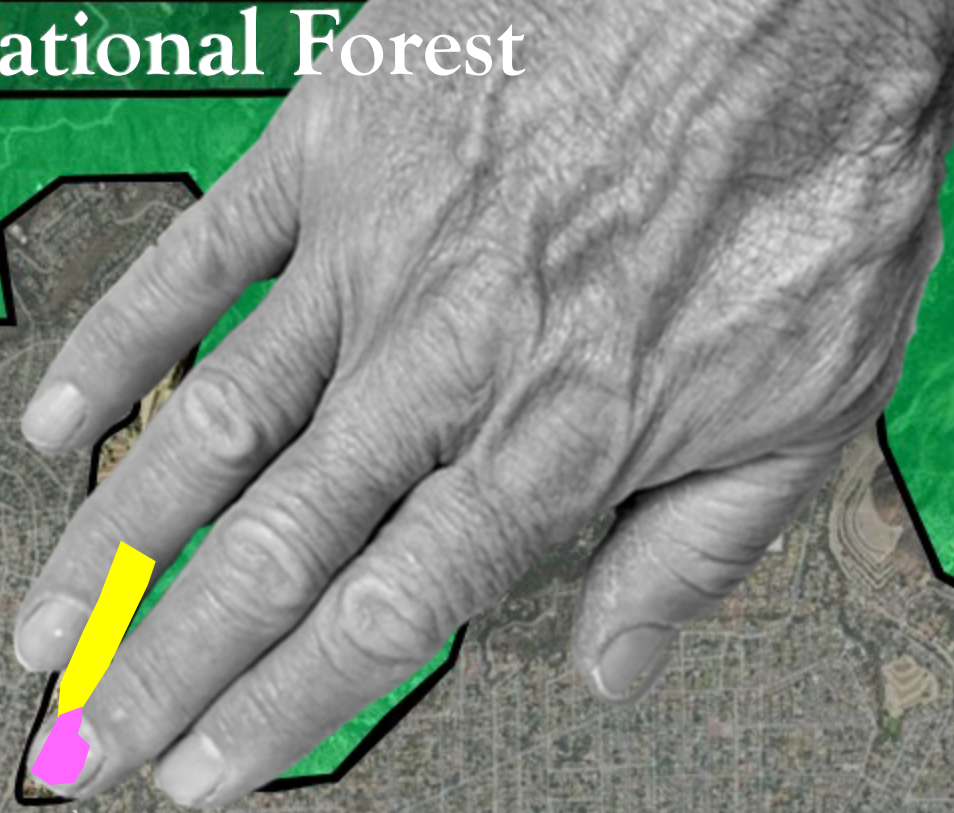
The specific location and configuration of this site, at the tip of a wedge of habitat surrounded by development, and the use of woody debris from an immediately adjacent source, make it a good candidate for experimentation without risking the contamination of sensitive natural areas.

There is always the potential of plant pathogens from adjacent urbanized areas, such as the manufactured ornamental landscape slope (red polygon) that is off-site to the east (north is oriented to the right in this image).

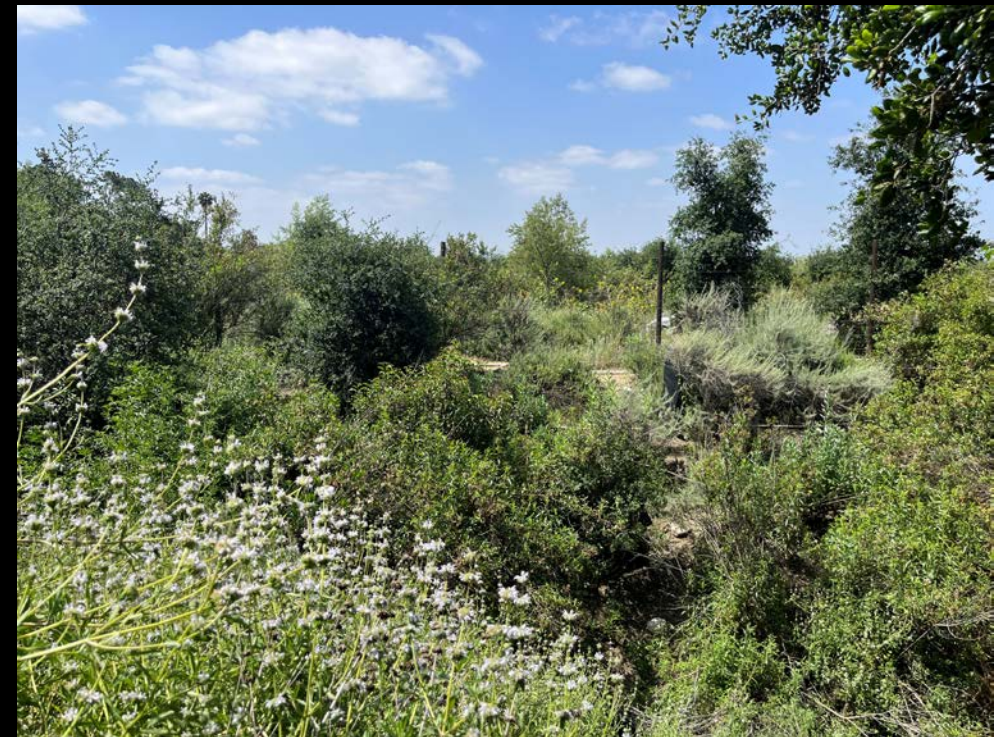
The planted Engelmann oaks were fruitful starting in 2022, and we just observed the first catkins on planted coast live oaks in 2024. Multiple bird species such as this phainopepla (*Phainopepla nitens*) have been nesting in the planted oaks. The measured oak canopy cover in 2023 exceeded 10% on this developing woodland.
