# Big Tujunga Dam Low-Effect Habitat Conservation Plan

## Big Tujunga Creek, Los Angeles County, California

December 2, 2021

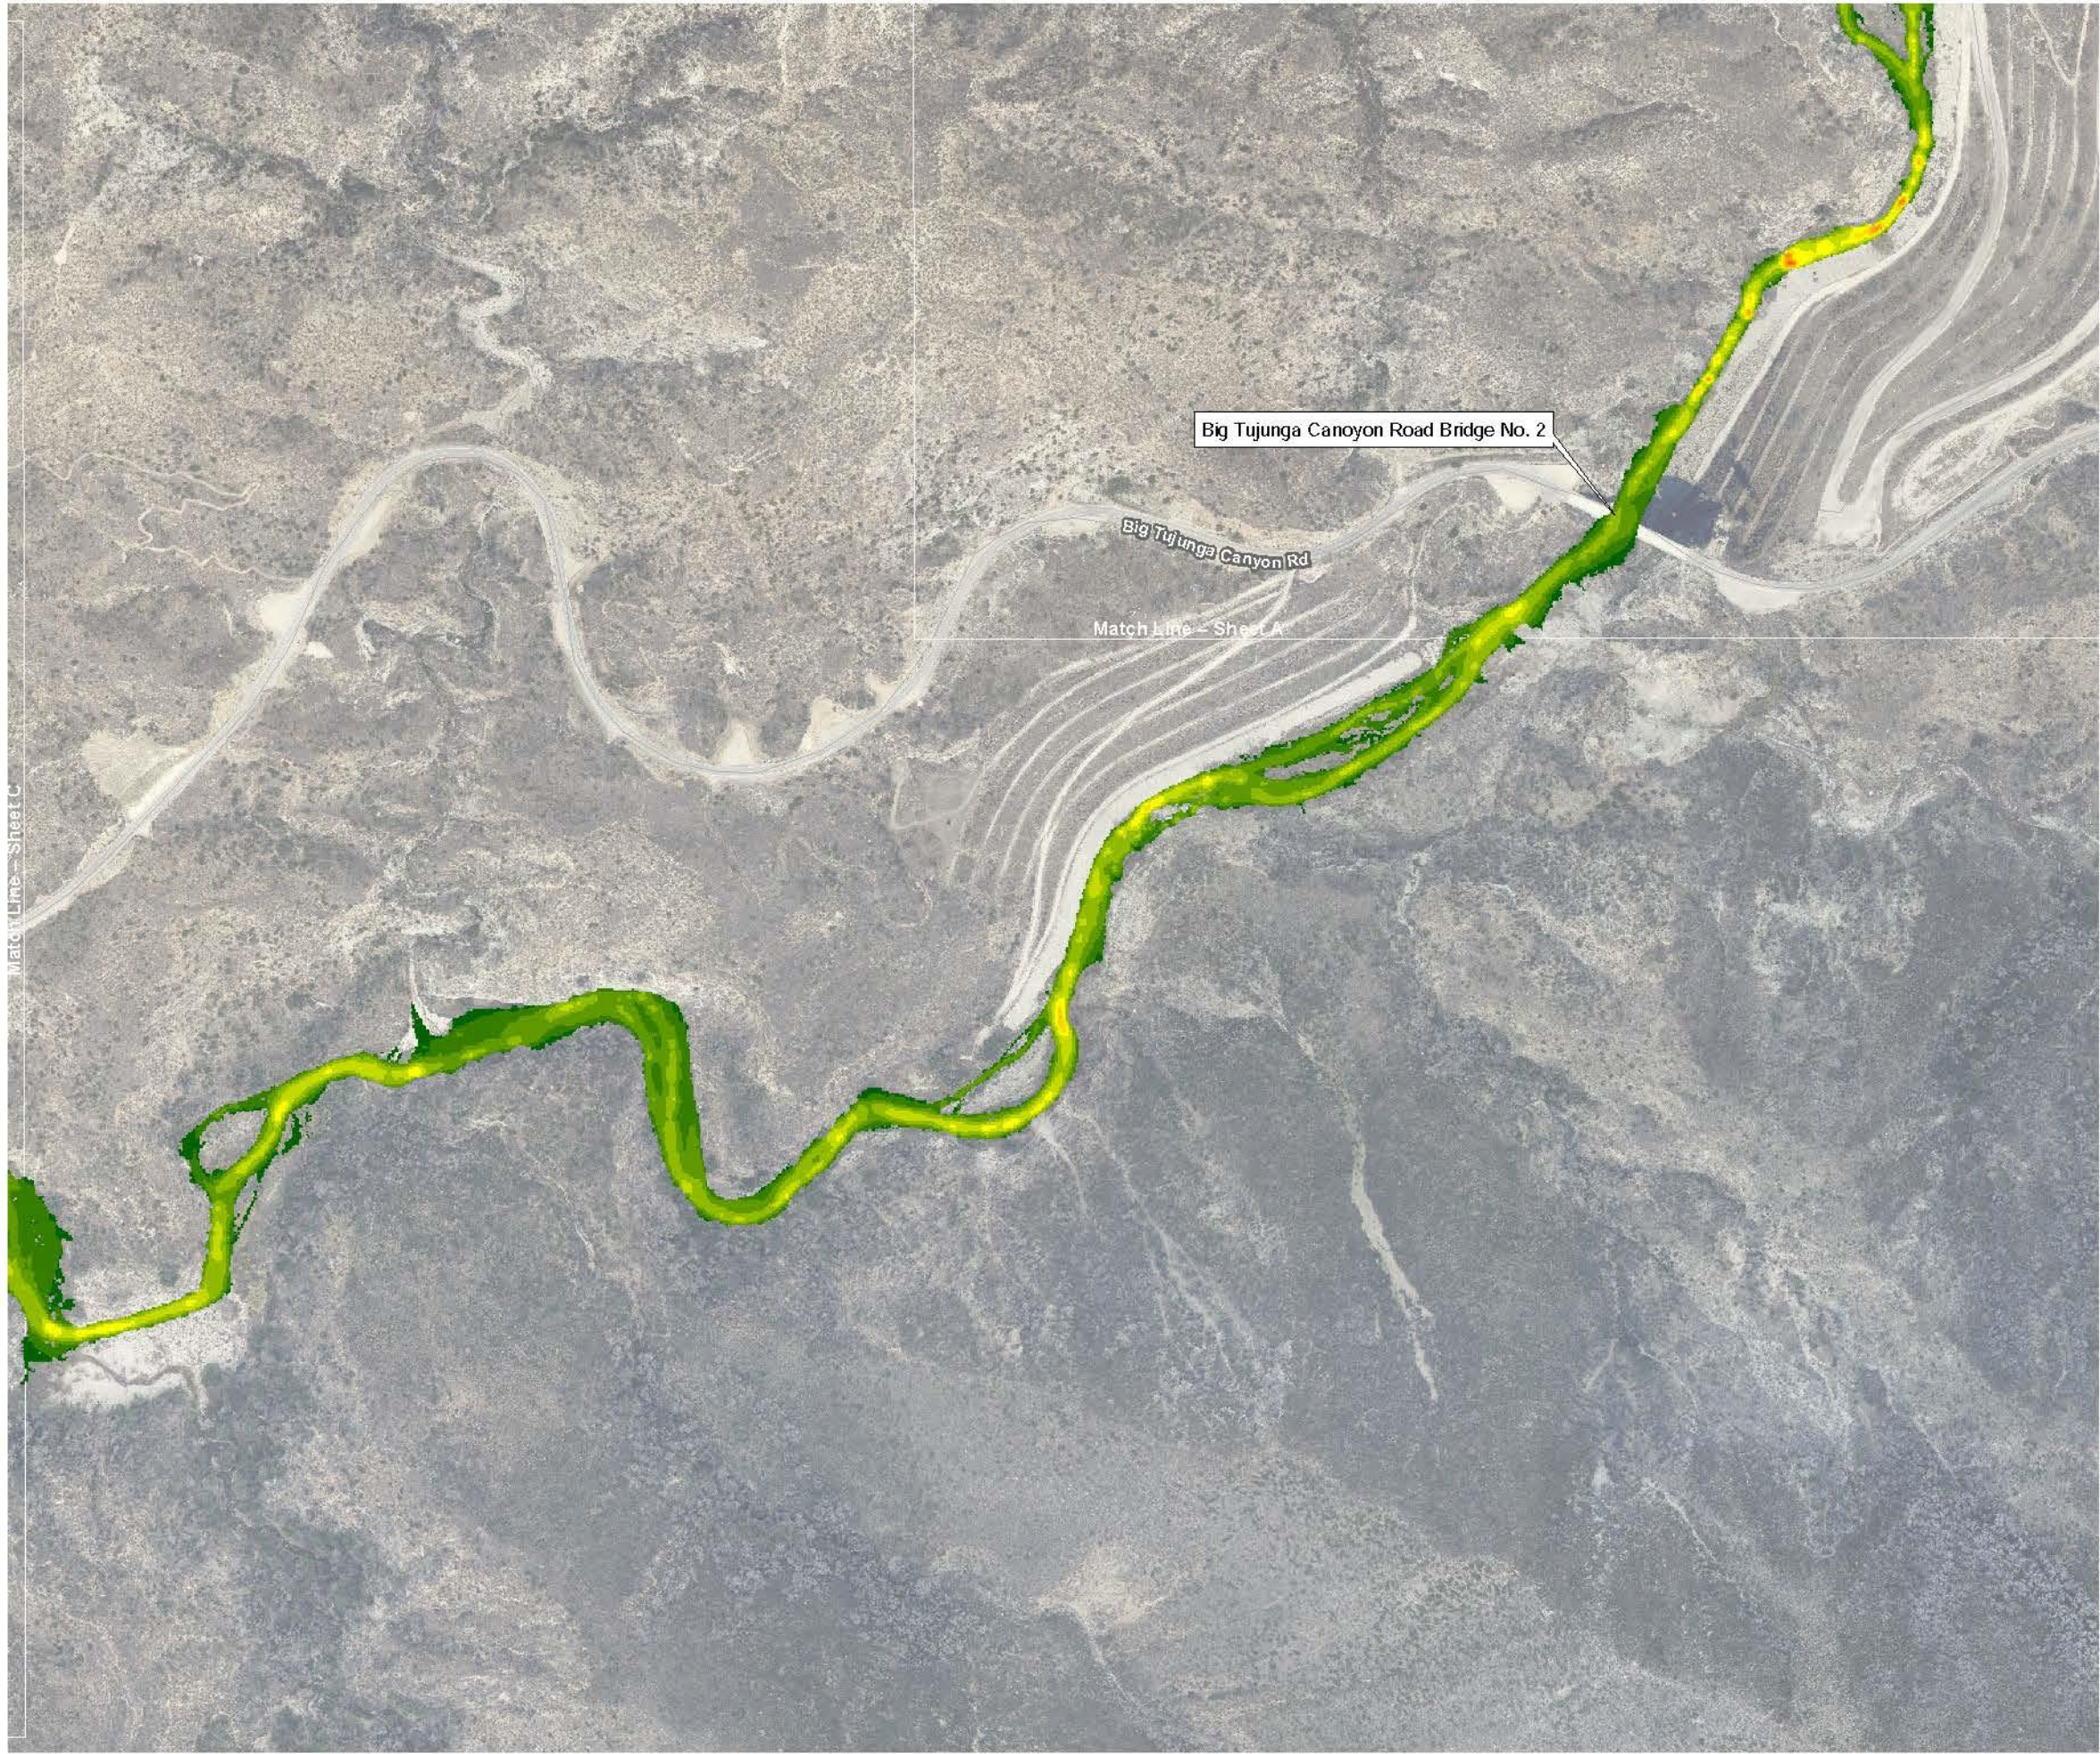
**Stream Velocity (ft/s)**

In order to move sediment and overcome the threshold of root ball strength for grasses (i.e., to remove vegetation), the stream needs to achieve velocities of 4 fps or greater. Thus, the modeled outflow of 600 cfs is expected to move a limited amount of sediment and remove a limited amount of vegetation because only a limited portion of the stream would exceed the 4-fps threshold. Dam operations release up to 500 cfs in order not to overtop Oro Vista Avenue; therefore, stream velocities would be slower than that shown on Exhibit 11 and a smaller portion of the stream (if any) would exceed the 4-fps threshold. Therefore, a spillway event may be needed for the downstream system to move a substantial amount of sediment and remove a substantial amount

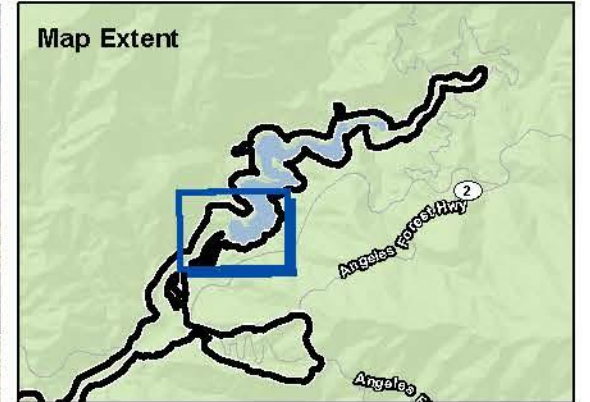
- Action Area
- Impact Areas**
- Repair/Painting of Trash Racks/Penstocks (Temporary)
- Repair, Replacement, or Installation of Leakage Points, Piezometers, or Other Instrumentation & Gages (Permanent)
