CONSOLIDATED SEWER MAINTENANCE DISTRICT CONDITION ASSESSMENT PROGRAM REPORT PROJECT Y0TV0506F

**CONDITION ASSESSMENT REPORT
COUNTY OF LOS ANGELES DEPARTMENT OF PUBLIC WORKS
CONSOLIDATED SEWER MAINTENANCE DISTRICT**

| PROJECT NAME: | Y0TV0506F | PROJECT MGR: | Fernando Villaluna |

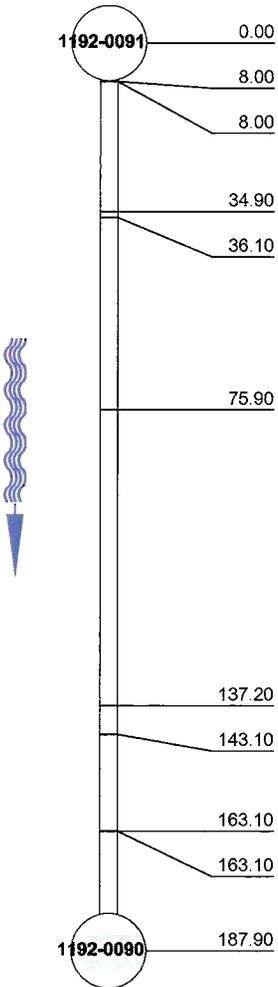
| 1:475 | position | observation | MPEG | photo | grade |
|---|---|---|---|---|---|
| | 163.10 | Fracture Multiple, from 12 to 5 o'clock, within 8 inch: YES | 00:09:25 | 595 | |
| | 163.10 | Hole Void Visible, at 12 o'clock, within 8 inch: YES | 00:09:01 | 596 | |

| Item No. | QSR | Start MH | End MH | Street | Observation: Location | Proposed Corrective Method | Length of Repair (FT) |
|---|---|---|---|--|---|--|---|
| 2 | 5141 | 1192-0091 | 1192-0090 | PARK SIENNA | Hole with soil visible and fractures: 163' | Structural integrity intact. No action needed. | - |
