CONSOLIDATED SEWER MAINTENANCE DISTRICT CONDITION ASSESSMENT PROGRAM REPORT PROJECT Y0TV0506F

**CONDITION ASSESSMENT REPORT
COUNTY OF LOS ANGELES DEPARTMENT OF PUBLIC WORKS
CONSOLIDATED SEWER MAINTENANCE DISTRICT**

PROJECT NAME:	Y0TV0506F	PROJECT MGR:	Fernando Villaluna
PROJECT DATE:	06/27/06 – 08/04/06	CONTACT NO:	(626) 300-3380
SUP. DISTRICT(s):	3	MAP PAGE(S):	1065
Report By:	Phyo Kyaw	Report Date:	11/17/08

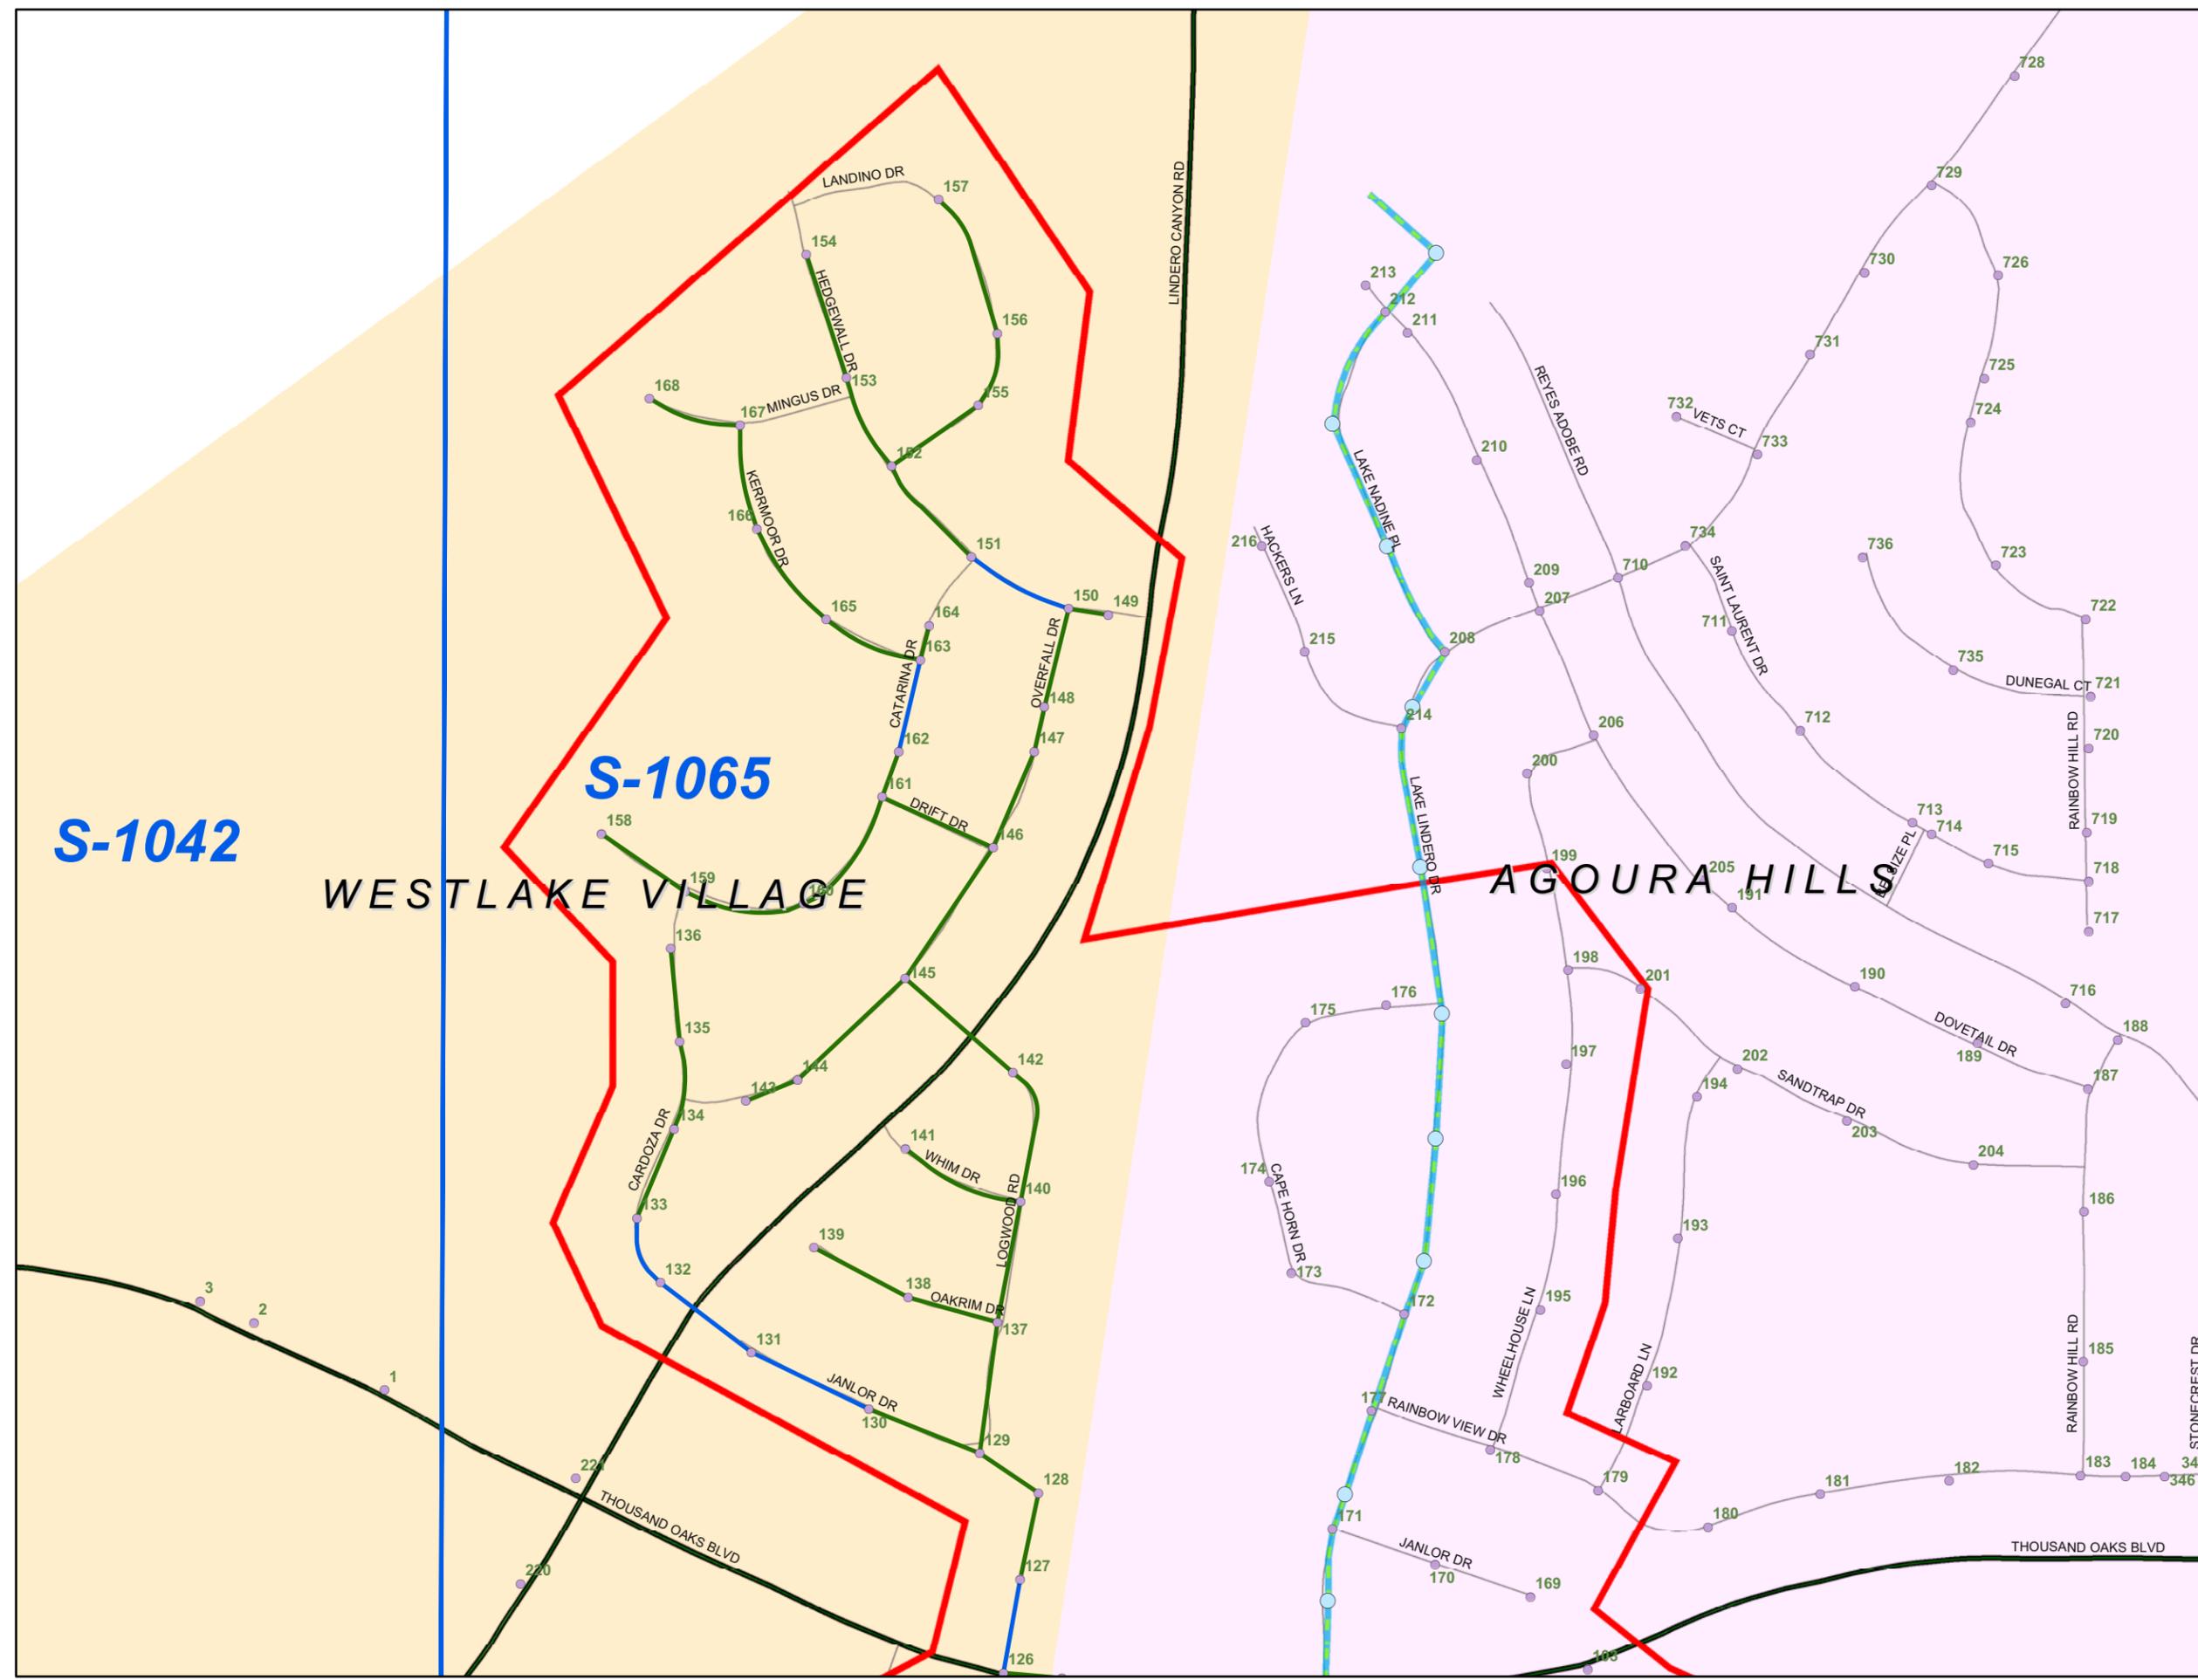
ENCLOSURE 3

Our inspection revealed that 100 percent of the inspected pipe segments within the City of Westlake Village were free of severe structural defects as indicated in the Quick Structural Rating Table shown below. A color-coded map showing the Quick Structural Rating for each pipe segment is located in Enclosure 3.
