# COUNTY OF LOS ANGELES

## DEPARTMENT OF PUBLIC WORKS

### **CONSOLIDATED SEWER MAINTENANCE DISTRICT CONDITION ASSESSMENT PROGRAM REPORT PROJECT Y0TV0607C**

**CONDITION ASSESSMENT REPORT  
COUNTY OF LOS ANGELES DEPARTMENT OF PUBLIC WORKS  
CONSOLIDATED SEWER MAINTENANCE DISTRICT**

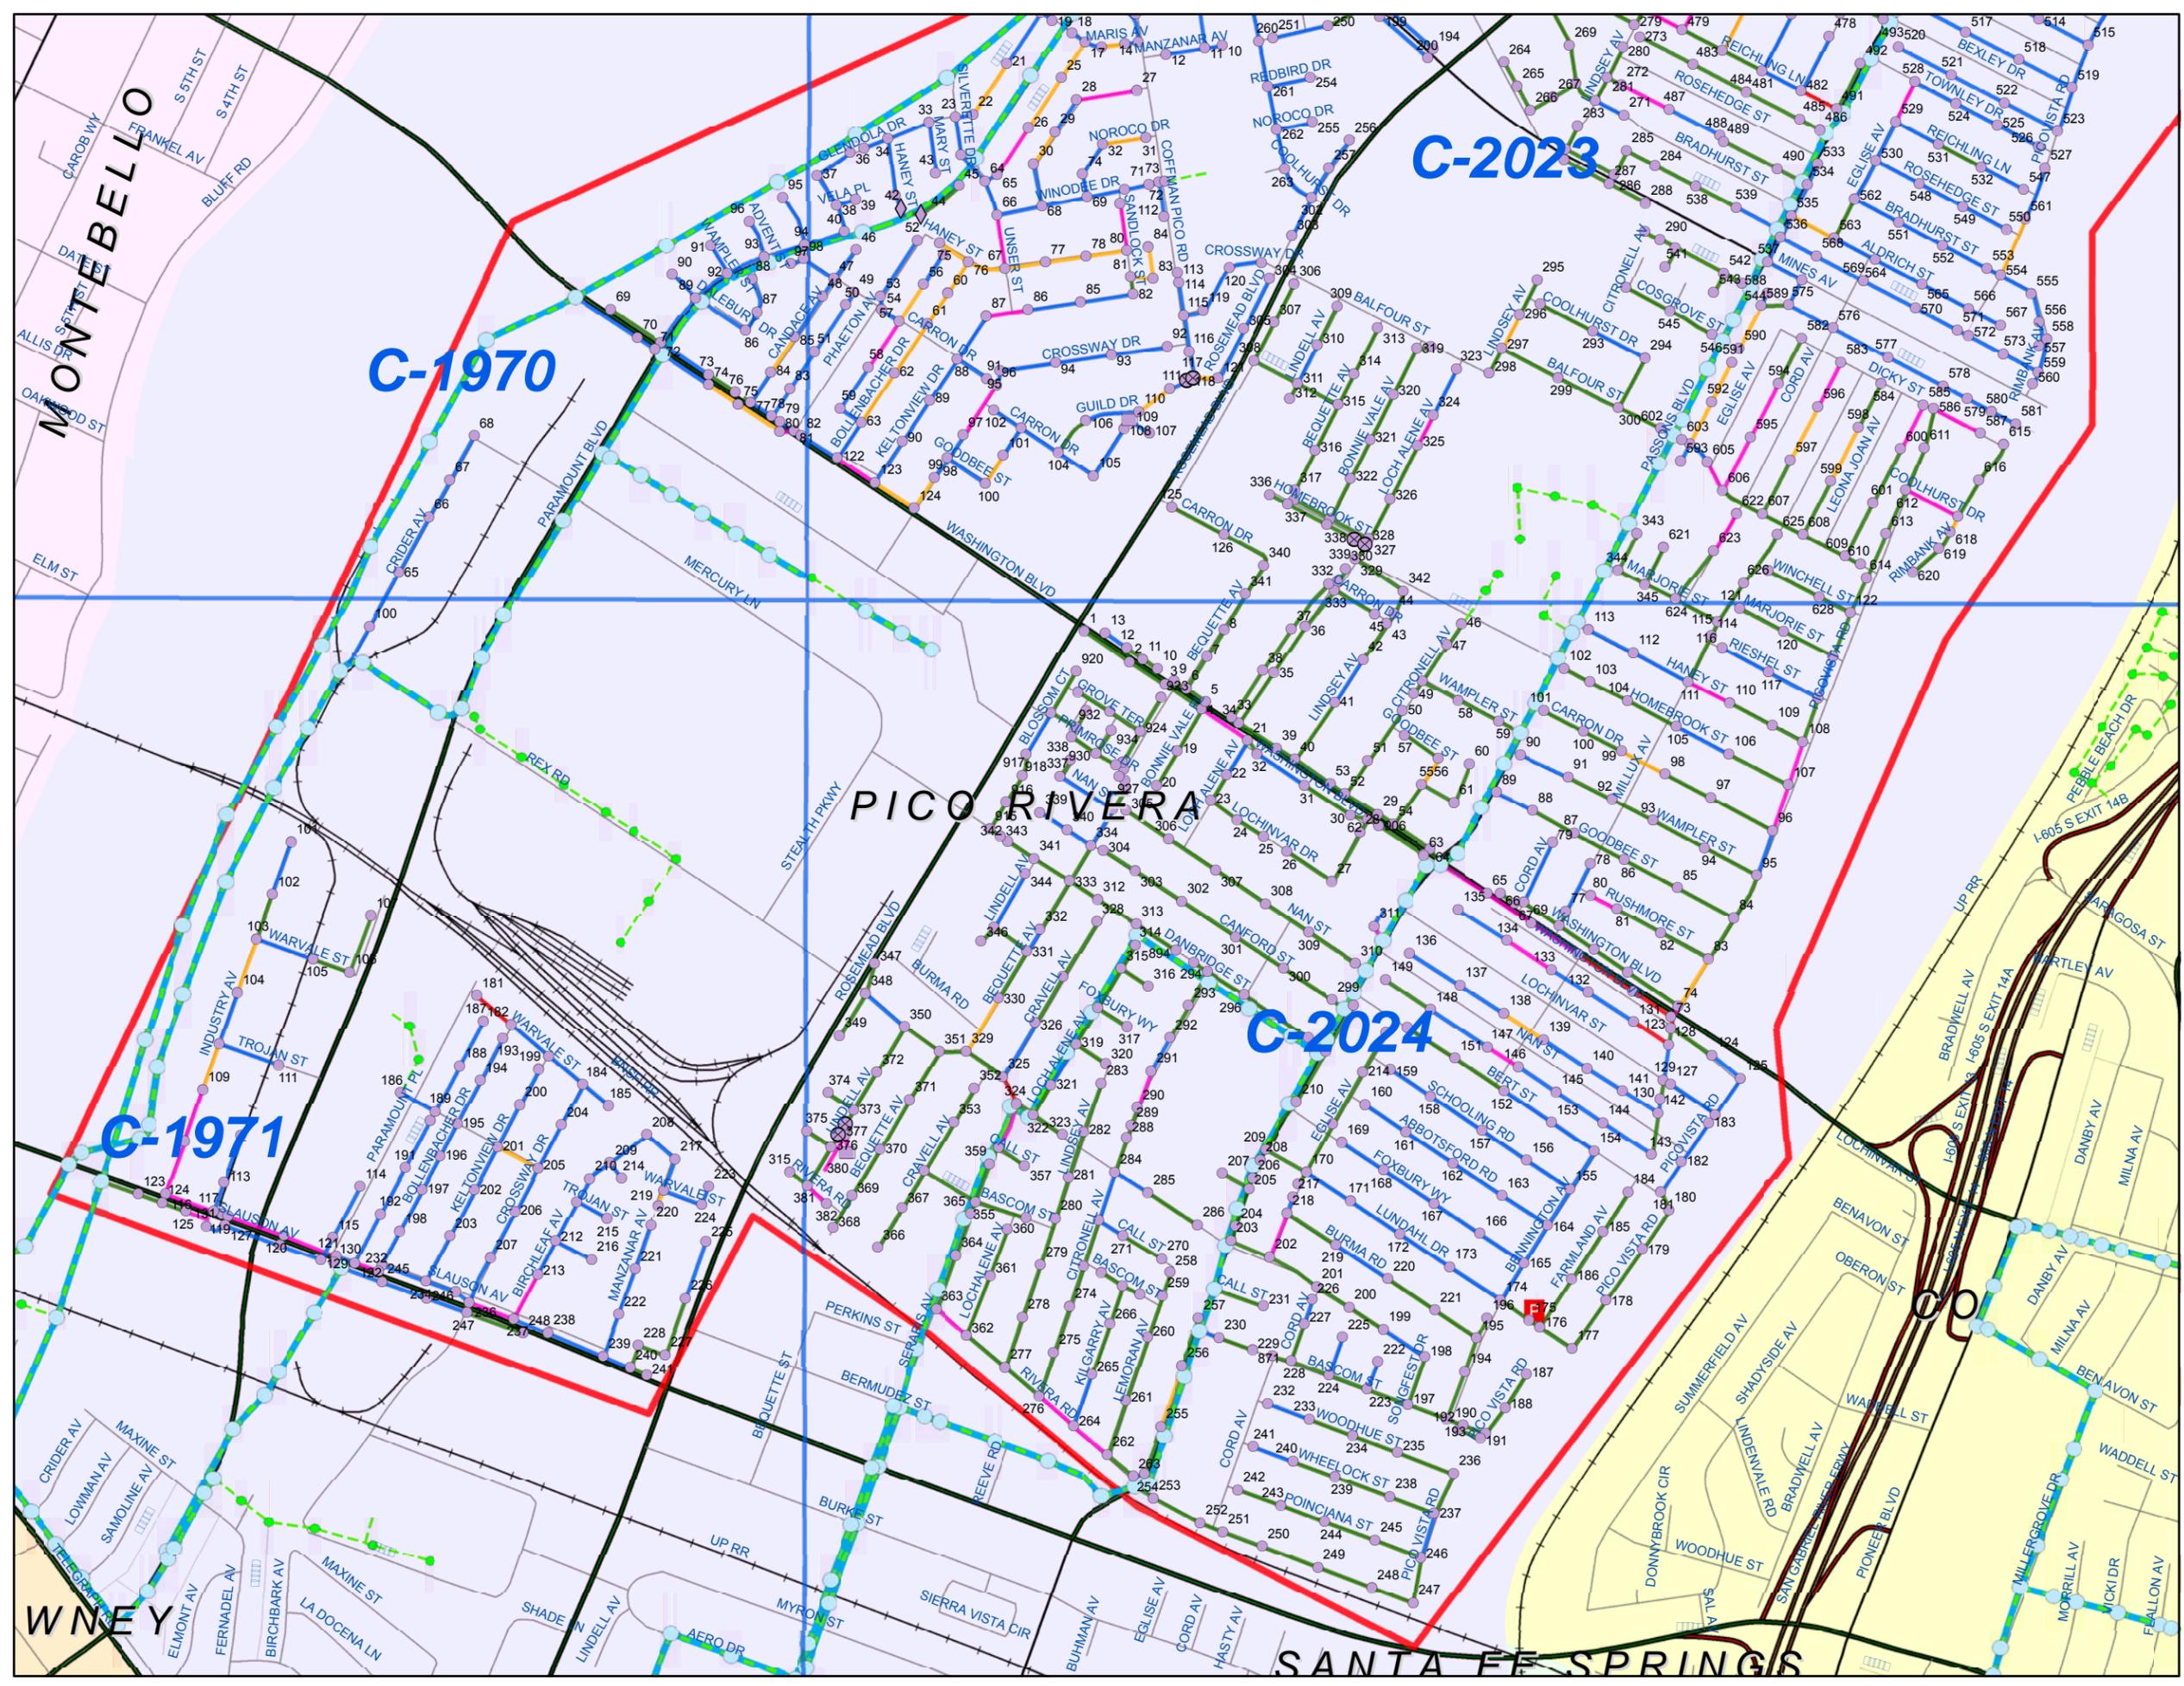
Y0TV0607C-PRV-QMR.mdx

The following line segments received a Quick Maintenance Rating of above 4000 due to the observation of Root Ball or Deposit inside the lateral connection CSMD does not maintain lateral lines: it is the responsibility of the parcel owner to maintain their respective lateral lines to facilitate the flow of wastewater from their property to the mainline. Therefore, these lines were not included on the Priority List above identified with maintenance deficiencies in need of immediate attention by CSMD.

40	412E	1971-0232	1971-0122	SLAUSON AV	High watermark	No action needed.
41	412E	1971-0120	1971-0119	SLAUSON AV	Deposits	Hydrojet (completed 4/1/09)
42	412E	2024-0264	2024-0262	RIVERA RD	Debris	Hydrojet (completed 1/21/09)
43	412B	1971-0116	1971-0110	INDUSTRY AV	Deposits	Hydrojet on a 2-month periodic (Last cleaned 5/15/09)
44	412B	2024-0147	2024-0146	EASEMENT by HASTY and BERT	Obstacle: External pipe	Emergency Project (Point Repair): Completed August 2007
45	412A	1970-0081	1970-0080	WASHINGTON BV	Deposits	Hydrojet (completed 4/2/09)
46	4122	1971-0120	1971-0121	SLAUSON AV	High watermark	No action needed.
47	4121	2024-0134	2024-0133	EASEMENT	Roots	Hydrojet (completed 6/10/09)
48	4121	2024-0080	2024-0081	RUSHMORE ST	Roots	Hydrojet (completed 1/13/09)
49	4121	2024-0311	2024-TRNK	PASSONS BV	Pipe alignment change	No action needed.
50	4121	2024-0074	2024-0073	WASHINGTON BV	Deposits	Hydrojet (completed 4/2/09)

51	4121	2023-0501	2023-0499	EASEMENT	Roots	Rodder (completed 4/4/09)
52	4121	2023-0700	2023-0699	CORD AV	Roots	Hydrojet (completed 1/14/09)
53	411B	2023-0606	2023-0595	EASEMENT by CORD and BALFOUR	Roots	Rodder (completed 1/14/09)
54	4113	2024-0218	2024-0202	EGLISE AV	Roots	Hydrojet (completed 1/14/09)
55	4100	2023-0465	2023-0479	DOWLING AV	Obstacle	Rodder (completed 1/14/09)
56	4100	2024-0380	2024-0379	LINDELL AV	Corrosion	Hydrojet (completed 1/22/09)
57	4100	2023-0587	2023-0586	DICKY ST	Roots	Hydrojet (completed 1/9/09)

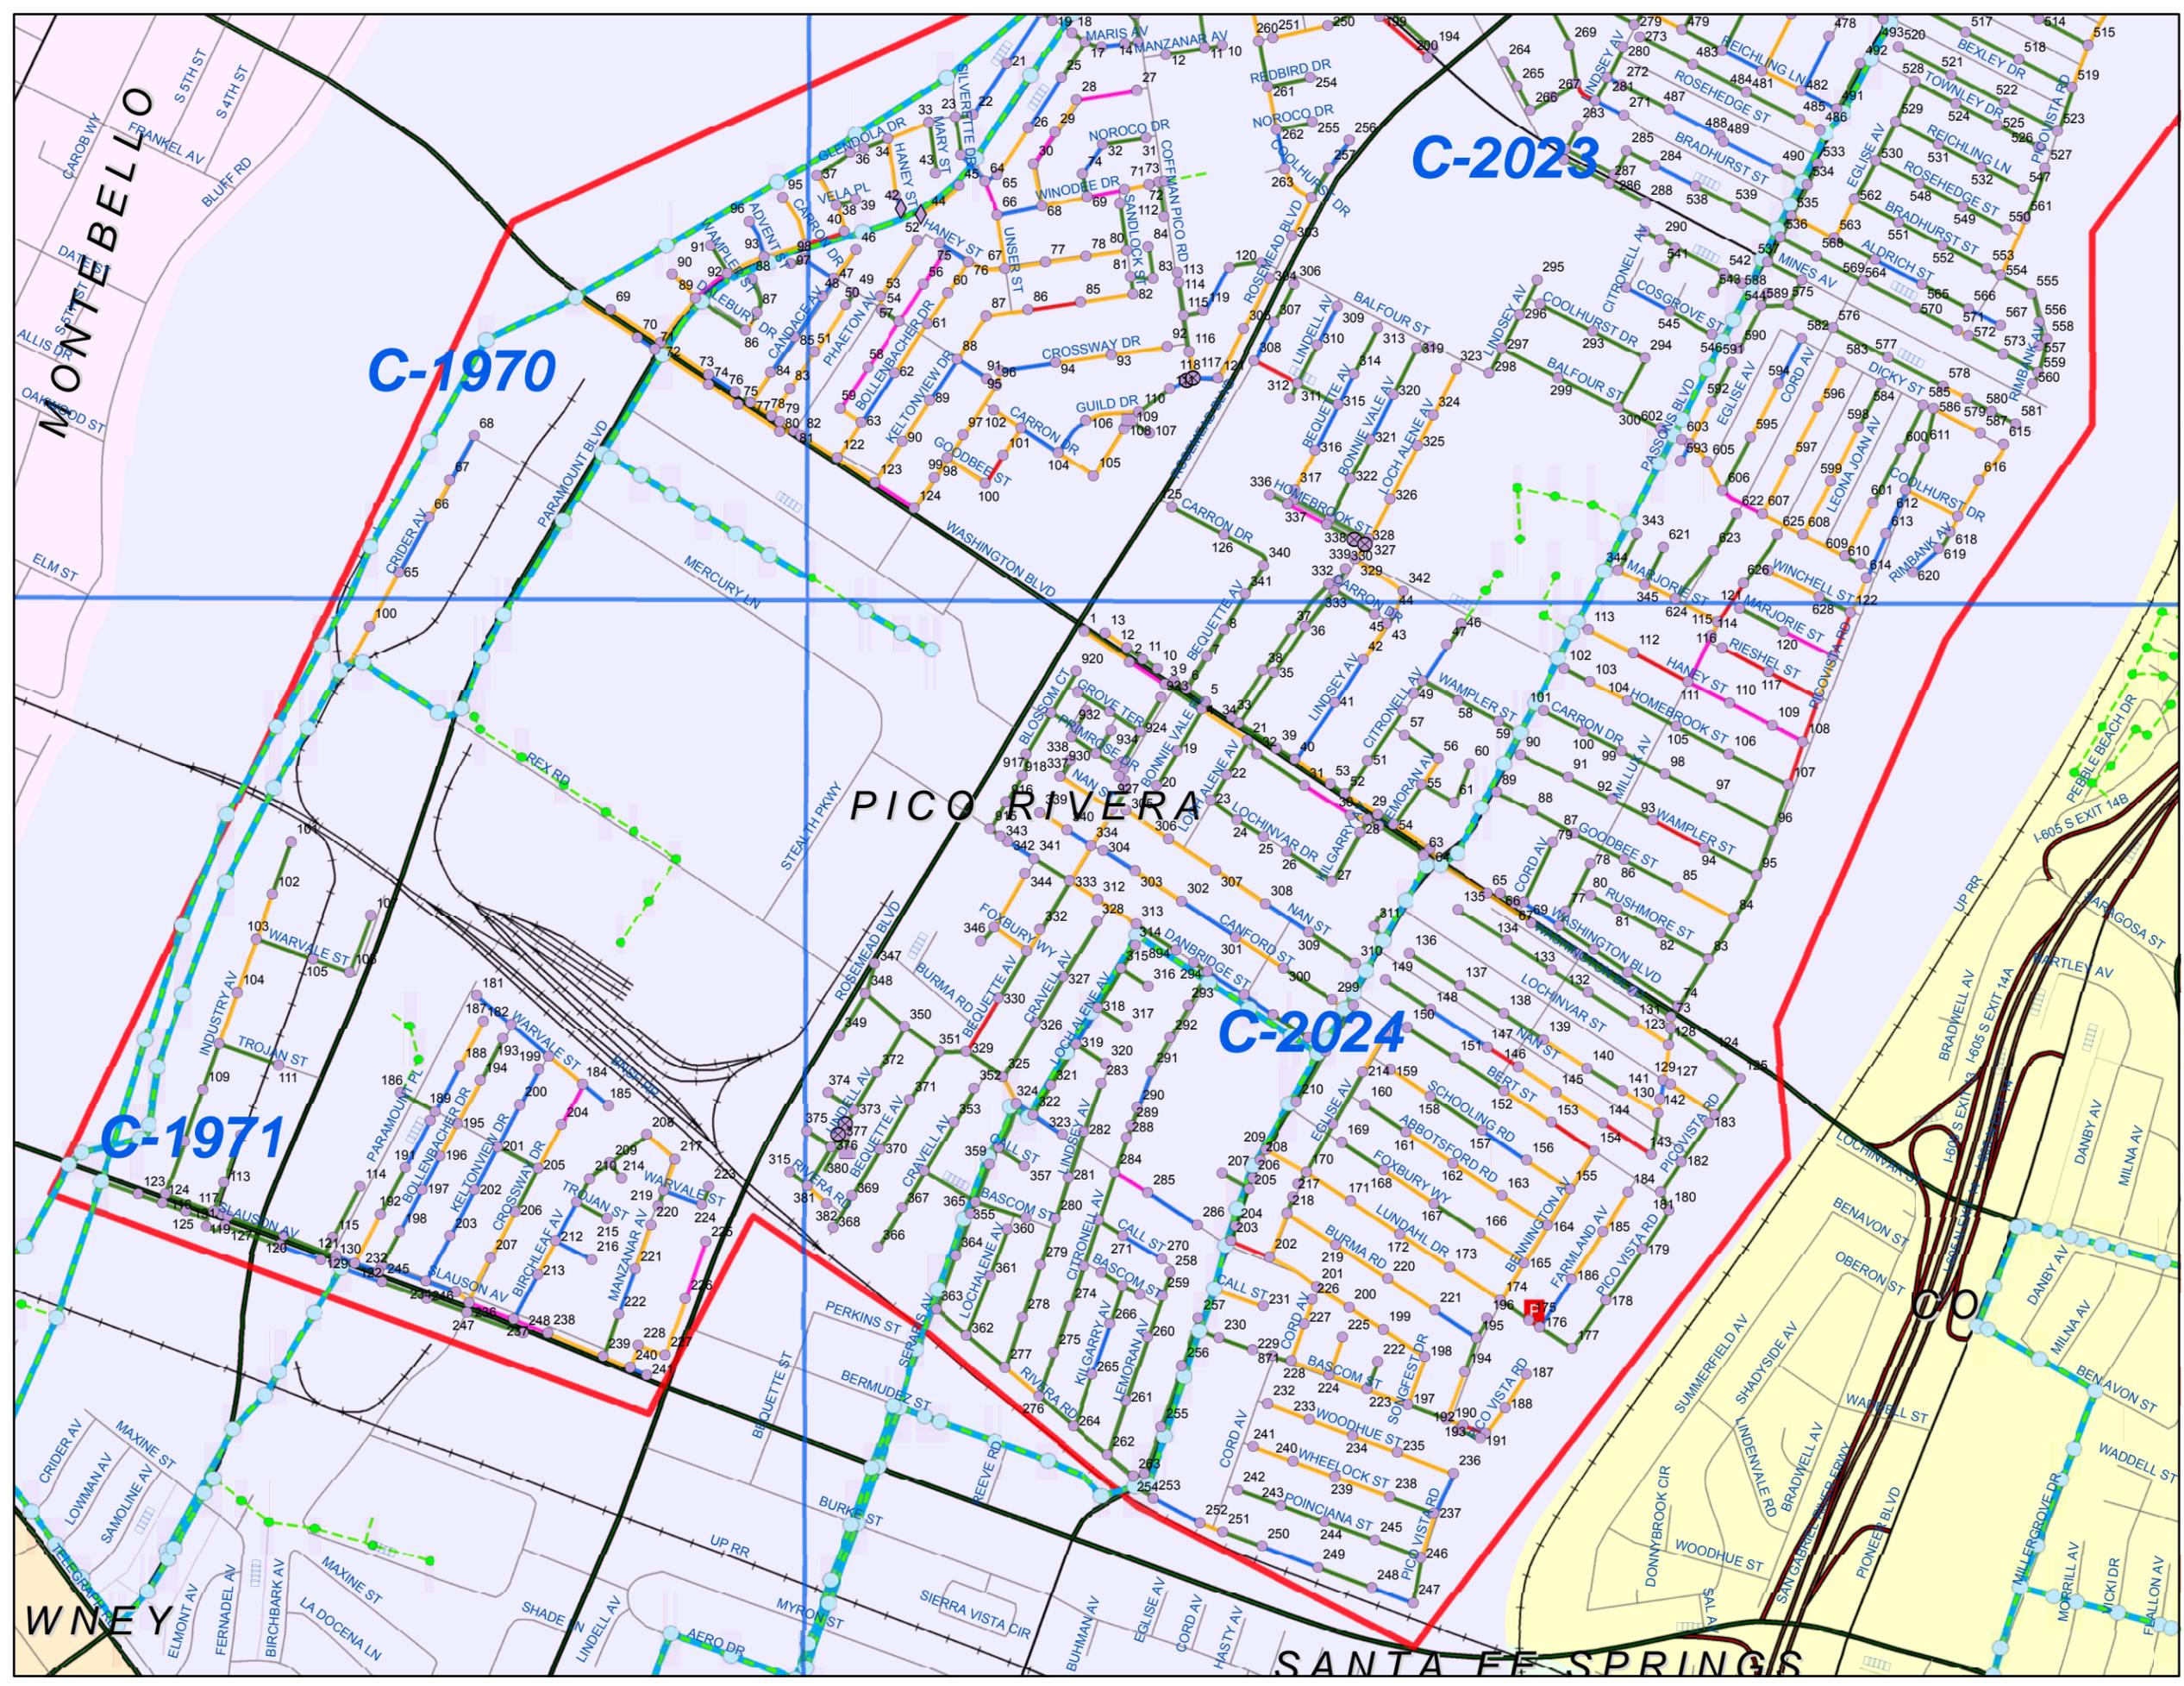
Y0TV0607C-PRV-QSR.mxd

Item No.	QSR	Start MH	End MH	Street	Observation: Location	Proposed Corrective Method	Length of Repair (FT)
1	5642	2024-0108	2024-0107	PICO VISTA RD	Broken with soil visible: 5', 112', 204'; multiple fractures and cracks	Lining: MH to MH	267
2	5241	2023-0200	2023-0199	MINES AV	Broken with soil visible: 20', 63'; multiple fractures and cracks	Lining: MH to MH	340
3	5241	2024-0112	2024-0111	HANEY ST	Broken with soil visible: 109', 224'; multiple fractures and cracks	Lining: MH to MH	330
4	5241	2024-0117	2024-0118	RIESHEL ST	Broken with soil visible: 23', 76', 131', 208'; multiple fractures and cracks	Lining: MH to MH	300
5	5232	1970-0094	2023-0040	PARAMOUNT BV	Broken with soil visible: 24'	Lining: MH to MH	225
6	5221	2023-0270	2023-0282	BRADHURST ST	Broken and hole: 118'	Lining: MH to MH	125
7	5144	2023-0240	2023-0241	ROSEMEAD BV	Broken with soil visible: 5', 37'; multiple fractures and cracks	Lining: MH to MH	235

8	5143	2023-0223	2023-0216	BRIDGEVIEW AV	Broken with soil visible: 231', 262'; multiple fractures and cracks	Lining: MH to MH	340
9	5142	2023-0085	2023-0086	KELTONVIEW DR	Broken with soil visible: 32', 187'; multiple fractures and cracks	Lining: MH to MH	275
10	5142	2024-0116	2024-0117	RIESHEL ST	Broken with soil visible: 61', 131', 214'; multiple fractures and cracks	Lining: MH to MH	295
11	5142	2024-0108	2024-0118	PICO VISTA RD	Broken with soil visible: 133', 188', 249'; multiple fractures and cracks	Lining: MH to MH	266
12	5142	2024-0146	2024-0147	EASEMENT by HASTY and BERT	Obstacle: External Pipe	Emergency Project (Point Repair): Completed August 2007	
13	5141	2023-0376	2023-0377	ROSEMEAD BV	Broken: 166'; multiple fractures and cracks	Lining: MH to MH	319
14	5141	2023-0408	2023-TRNK	DURFEE AV	Broken with soil visible: 6'; multiple fractures: 29'	Breaks located at abandoned segment. No action needed.

15	513F	2023-0101	2023-0100	BIRCHLEAF AV	Broken with soil visible: 112'; multiple fractures and cracks	Lining: MH to MH	127
16	5135	2024-0153	2024-0154	BERT ST	Broken: 39'; multiple cracks	Lining: MH to MH	326
17	5134	2024-0330	2024-0329	BEQUETTE AV	Broken with soil visible: 198'	Structural integrity in tact. No action needed.	
18	5132	2024-0144	2024-0143	EASEMENT by PICO VISTA and NAN	Broken with soil visible: 85'; fractures and cracks	Lining: MH to MH	325
19	5131	2023-0441	2023-0458	ALLEY by ROSEMEAD and HAVENWOOD	Broken with soil visible: 293'	Lining: MH to MH	297
20	5121	2023-0399	2023-0400	LAYMAN ST	Broken: 178' (inside lateral); fracture; deposits	Structural integrity in tact. No action needed.	
21	5121	2023-0626	2024-0115	MILLUX AV	No visual broken at 172' as inspection indicates.	Structural integrity in tact. No action needed.	
22	5121	2024-0202	2024-0203	REX RD	Broken: 101';	Structural integrity in tact. No action needed.

23	5113	2024-0122	2024-0119	PICO VISTA RD	Broken: 197'	Structural integrity in tact. No action needed.	
24	5112	2023-0132	2023-0133	SPEED WY	Hole: 119'	Structural integrity in tact. No action needed.	
25	5111	2023-0131	2023-0132	LEXINGTON RD	Hole: 154'	Structural integrity in tact. No action needed.	
26	5111	2023-0308	2023-0311	ALLEY between ROSEMEAD and LINDELL	Broken: 271'	Lining: MH to MH	283
27	5100	2023-0405	2023-0406	DELAND AV	Broken: 226' (inside lateral)	Structural integrity in tact. No action needed.	
28	5100	2024-0176	2024-0175	LUNDAHL DR	Broken and hole with soil visible: 15'	Line not in use. No action needed.

29	5100	2024-0093	2024-0094	WAMPLER ST	Broken: 128'	Point Repair by SMD Central Yard: Completed December 2008	
30	5100	2024-0189	2024-0190	BASCOM ST	Broken: 11'	Lining: MH to MH	103
31	433J	2024-0114	2024-0111	MILLUX AV	Multiple Fractures: 21', 86', 135', 252', 290'	Lining: MH to MH	360
32	4337	1971-0238	1971-0237	SLAUSON AV	Fracture: 175', 188'; multiple cracks	Lining: MH to MH	200
33	4334	2023-0058	2023-0059	ALLEY by WASHINGTON and PHAETON	Broken: 227'; multiple fractures and cracks	Lining: MH to MH	312
34	4334	2023-0243	2023-0244	MANZANAR AV	Fracture: 1', 75'; multiple cracks	Lining: MH to MH	257
35	423L	2023-0224	2023-0223	BRIDGEVIEW AV	Multiple fractures and cracks	Lining: MH to MH	341
36	423I	1971-0225	1971-0226	ROSEMEAD BV	Fracture: 176'; multiple cracks	Lining: MH to MH	242
37	423H	2023-0238	2023-0239	ROSEMEAD BV	Multiple Fractures: 102'	Lining: MH to MH	244
38	423G	2024-0109	2024-0108	HANEY ST	Fracture: 57', 127'; multiple cracks	Lining: MH to MH	267

39	4237	2023-0057	2023-0058	ALLEY by CARRON and PHAETON	Fracture: 98'; multiple cracks	Lining: MH to MH	300
40	4235	2024-0110	2024-0109	HANEY ST	Fracture: 72', 167'; multiple cracks	Lining: MH to MH	250
41	4233	1970-0089	1970-0092	PARAMOUNT BV	Fracture: 119'; multiple cracks	Lining: MH to MH	228
42	413K	2023-0228	2023-0227	MARIS AV	Fracture: 93', 120', 237', 254', 281'; multiple cracks	Lining: MH to MH	325
43	413K	2023-0225	2023-0224	BRIDGEVIEW AV	Fracture: 72'; multiple cracks	Lining: MH to MH	342
44	413H	2023-0239	2023-0240	ROSEMEAD BV	Fracture: 53'; multiple cracks	Lining: MH to MH	240
45	413H	2023-0247	2023-0218	MANZANAR AV	Fracture: 7', 104'; multiple cracks	Lining: MH to MH	253
46	413G	2023-0218	2023-0217	DUNLAP CROSSING RD	Fracture: 217'; multiple cracks	Lining: MH to MH	222
47	413F	2023-0246	2023-0247	MANZANAR AV	Fracture: 60'; multiple cracks	Lining: MH to MH	183
48	413E	2023-0229	2023-0228	MARIS AV	Fracture: 8', 330'	Structural integrity in tact. No action needed.

49	413D	2024-0031	2024-0030	WASHINGTON BV	Fracture: 85', 331'; multiple cracks	Lining: MH to MH	349
50	413B	2024-0110	2024-0111	HANEY ST	Fracture: 50'	Structural integrity in tact. No action needed.	
51	413A	2023-0056	2023-0057	ALLEY by CARRON and PHAETON	Fracture: 28', 174'; multiple cracks	Lining: MH to MH	220
52	413A	2023-0607	2023-0606	BALFOUR ST	Fracture: 208'; multiple cracks	Lining: MH to MH	270
53	4137	2023-0055	2023-0056	ALLEY by HANEY and PHAETON	Fracture: 166'; multiple cracks	Lining: MH to MH	206
54	4136	1971-0237	1971-0236	SLAUSON AV	Hole: 18'; cracks	Lining: MH to MH	350
55	4136	2023-0233	2023-0234	MANZANAR AV	Fracture: 180', 195'; multiple cracks	Structural integrity in tact. No action needed.	
56	4135	2023-0064	2023-0066	UNSER ST	Fracture: 94'; multiple cracks	Lining: MH to MH	217
57	4135	2023-0377	2023-0235	ROSEMEAD BV	Fracture: 270'	Structural integrity in tact. No action needed.

58	4134	2023-0174	2023-0175	LOS TOROS AV	Fracture: 82'	Structural integrity in tact. No action needed.	
59	4133	2023-0029	2023-0030	REDBIRD DR	Fracture: 137'; multiple cracks	Lining: MH to MH	220
60	4133	2023-0124	2023-0123	WASHINGTON BV	Fracture: 221'	Lining: MH to MH	270
61	4132	2023-0070	2023-0069	WINODEE DR	Fracture: 4', 171'	Lining: MH to MH	202
62	4132	1970-0078	1970-0079	WASHINGTON BV	Fracture: 3'	Lining: MH to MH	109
63	4131	2023-0359	2023-0371	ROSEMEAD BV	Fracture: 140'	Lining: MH to MH	181
64	4131	2023-0186	2023-0233	MANZANAR AV	Fracture: 84'	Structural integrity in tact. No action needed.	
65	412A	2023-0028	2023-0027	REDBIRD DR	Fracture: 208'	Lining: MH to MH	346
66	4127	1971-0184	1971-0204	CROSSWAY DR	Fracture: 146'	Structural integrity in tact. No action needed.	
67	4123	2024-0285	2024-0284	REX RD	Hole: 289' (inside lateral)	Structural integrity in tact. No action needed.

68	4121	2023-0337	2023-0338	Homebrook St	Broken: 13'	Broken at joint with band visible. Structural integrity intact. No action needed.	
69	4112	2023-0351	2023-0352	Acacia Av	Fracture: 46'	Structural integrity in tact. No action needed.	
70	4100	2023-0159	2023-0160	Dulin Av	Fracture: 288'	Structural integrity in tact. No action needed.	
71	4100	2024-0120	2024-0119	Marjorie St	Fracture: 280'	Structural integrity in tact. No action needed.	
72	4100	2024-0002	2024-0003	Washington Bv	Fracture: 26'	Structural integrity in tact. No action needed.

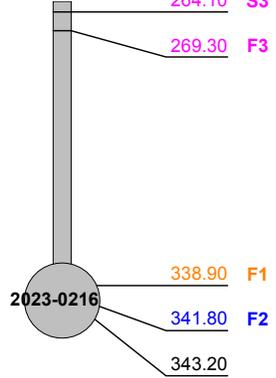
1:627	position	observation	MPEG	photo	grade
	<u>264.10</u> <b>S3</b>	Fracture Multiple, from 07 to 05 o'clock, within 8 inch: YES, start	00:16:44	8532	S 4
	<u>269.30</u> <b>F3</b>	Fracture Multiple, from 07 to 05 o'clock, within 8 inch: YES, end	00:17:13	8533	S 4
	<u>338.90</u> <b>F1</b>	Crack Multiple, from 07 to 05 o'clock, within 8 inch: YES, end	00:19:54	8534	S 3
	<u>341.80</u> <b>F2</b>	Deposits Attached Grease, 1 of cross sectional area, from 05 to 07 o'clock, within 8 inch: YES, end	00:20:15	8535	M 2
	<u>343.20</u>	Downstream Manhole, Survey Ends	00:21:13

QSR	QMR	SPR	MPR	OPR	SPRI	MPRI	OPRI
5143	2M00	212	138	350	2.99	2	2.5

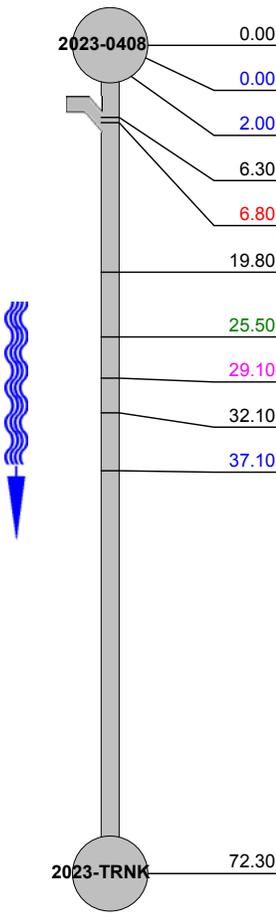
Remark: **Two Pipes tie into one at MH**

1:200	position	observation	MPEG	photo	grade
	0.00	Downstream Manhole, Survey Begins	00:00:53		
	0.00	Water Level, 1 # of cross sectional area	00:01:07		M 2
	2.00	Deposits Attached Grease, 1 # of cross sectional area, from 05 to 07 o'clock, within 8 inch: YES	00:01:12	9031	M 2
	6.30	Tap Factory Made Active, at 02 o'clock, 8", within 8 inch: YES, Remark: from MH 0408	00:07:37	9032	
	6.80	Broken, from 04 to 08 o'clock, within 8 inch: YES	00:02:01	9033	S 5
	19.80	Roots Fine Joint, at 03 o'clock, within 8 inch: YES	00:03:42	9034	
	25.50	Alignment Right, 5 #	00:10:49		M 1
	29.10	Fracture Multiple, from 12 to 12 o'clock, within 8 inch: YES	00:04:54	9035	S 4
	32.10	Cleanout Mainline, Remark: CO on sidewalk	00:06:29		
	37.10	Obstacles Rocks, 2 # of cross sectional area, at 06 o'clock	00:12:03	9036	M 2
	72.30	Upstream Manhole, Survey Ends	00:13:27	9037

QSR	QMR	SPR	MPR	OPR	SPRI	MPRI	OPRI
5141	2311	9	7	16	4.5	1.75	2.67

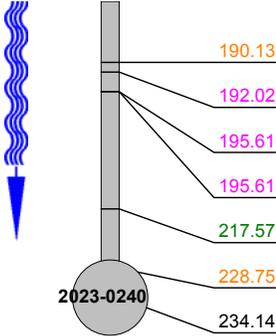
1:429	position	observation	MPEG	photo	grade
	<u>190.13</u>	Crack Multiple, from 07 to 04 o'clock, within 8 inch: YES	00:11:46	11416	S 3
	<u>192.02</u>	Fracture Multiple, from 12 to 12 o'clock, within 8 inch: YES	00:12:11	11417	S 4
	<u>195.61</u>	Fracture Multiple, from 03 to 09 o'clock, within 8 inch: YES	00:12:29	11418	S 4
	<u>195.61</u>	Broken, from 09 to 10 o'clock, within 8 inch: YES	00:12:32	11419, b	S 4
	<u>217.57</u>	Crack Circumferential, from 02 to 04 o'clock, within 8 inch: YES	00:13:32	11421	S 1
	<u>228.75</u>	Crack Multiple, from 07 to 03 o'clock, within 8 inch: YES	00:14:03	11422	S 3
	<u>234.14</u>	Downstream Manhole, Survey Ends	00:14:33

QSR	QMR	SPR	MPR	OPR	SPRI	MPRI	OPRI
4632	2100	53	2	55	2.41	2	2.39

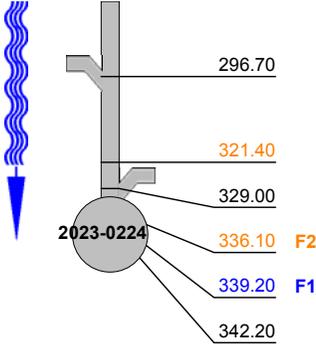
1:660	position	observation	MPEG	photo	grade
	296.70	Tap Factory Made Active, at 02 o'clock, 6", within 8 inch: YES	00:19:51	8652	
	321.40	Fracture Longitudinal, at 09 o'clock, within 8 inch: YES	00:21:19	8653	S 3
	329.00	Tap Factory Made Active, at 10 o'clock, 6", within 8 inch: YES	00:22:00	8654	
	336.10 <b>F2</b>	Crack Multiple, from 07 to 05 o'clock, within 8 inch: YES, end	00:22:29	8655	S 3
	339.20 <b>F1</b>	Deposits Attached Grease, 1 % of cross sectional area, from 05 to 07 o'clock, within 8 inch: YES, end	00:22:54	8656	M 2
	342.20	Downstream Manhole, Survey Ends	00:23:38

QSR	QMR	SPR	MPR	OPR	SPRI	MPRI	OPRI
413K	2M00	199	136	335	2.93	2	2.46

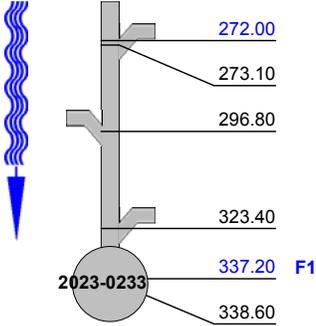
1:627	position	observation	MPEG	photo	grade
	272.00	Crack Longitudinal, at 08 o'clock, within 8 inch: YES	00:18:12	8247	S 2
	273.10	Tap Factory Made Active, at 10 o'clock, 6", within 8 inch: YES	00:18:32	8248	
	296.80	Tap Factory Made Active, at 02 o'clock, 6", within 8 inch: YES	00:19:35	8249	
	323.40	Tap Factory Made Active, at 10 o'clock, 6", within 8 inch: YES	00:20:43	8250	
	337.20 F1	Deposits Attached Grease, 1 # of cross sectional area, from 05 to 07 o'clock, within 8 inch: YES, end	00:21:30	8251	M 2
	338.60	Downstream Manhole, Survey Ends	00:22:18

QSR	QMR	SPR	MPR	OPR	SPRI	MPRI	OPRI
4131	2M00	27	136	163	2.25	2	2.04
