**CONSOLIDATED SEWER MAINTENANCE DISTRICT
CONDITION ASSESSMENT PROGRAM REPORT
PROJECT Y0TV0607A**

**CONDITION ASSESSMENT REPORT
COUNTY OF LOS ANGELES DEPARTMENT OF PUBLIC WORKS
CONSOLIDATED SEWER MAINTENANCE DISTRICT**

PROJECT NAME:	Y0TV0607A	PROJECT MGR:	Kari Eskridge
PROJECT DATE:	01/15/07-03/26/07	CONTACT NO:	(626) 300-3390
SUP. DISTRICT(s):	2	MAP PAGE(S):	1593, 1646, 1647 & 1701
Report By:	Phyo Kyaw	Report Date:	12/14/09

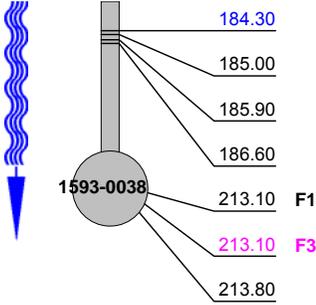
1:429	position	observation	MPEG	photo	grade
	184.30	Joint Offset Large, within 8 inch: NO	00:24:17	7902	S 2
	185.00	Tap Break-in Active, at 12 o'clock, 6", within 8 inch: NO	00:24:56	7903	
	185.90	Joint Offset Medium, within 8 inch: NO	00:25:18	7904	S 1
	186.60	Joint Offset Medium, within 8 inch: NO	00:25:49	7905	S 1
	213.10 F1	Roots Fine Joint, from 7 to 5 o'clock, within 8 inch: YES, End	00:27:45	7906	
	213.10 F3	Fracture Multiple, from 7 to 5 o'clock, within 8 inch: YES, End	00:28:03	7907	S 4
	213.80	Manhole, within 8 inch: NO, Remarks: 1593-0038	00:28:55	7908

QSR	QMR	SPR	MPR	OPR	SPRI	MPRI	OPRI
4833	2300	48	6	54	2.82	2	2.7

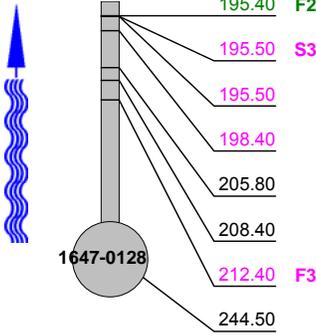
1:462	position	observation	MPEG	photo	grade
	195.40 F2	Crack Multiple, from 7 to 5 o'clock, within 8 inch: YES, End	00:23:27	5803	S 3
	195.50 S3	Fracture Multiple, from 7 to 5 o'clock, within 8 inch: YES, Start	00:24:01	5804	S 4
	195.50	Deformed, 10 □, within 8 inch: NO	00:24:22	5805	S 4
	198.40	Broken, from 4 to 6 o'clock, within 8 inch: YES	00:25:21	5806	S 4
	205.80	Tap Factory Active, at 3 o'clock, 6", within 8 inch: NO	00:26:16	5807	
	208.40	Tap Factory Active, at 9 o'clock, 6", within 8 inch: NO	00:26:50	5808	
	212.40 F3	Fracture Multiple, from 7 to 5 o'clock, within 8 inch: YES, End	00:27:10	5809	S 4
	244.50	Manhole, within 8 inch: NO, Remarks: 1647-0128	00:28:39	5810

QSR	QMR	SPR	MPR	OPR	SPRI	MPRI	OPRI
4536	2211	45	5	50	3	1.67	2.78

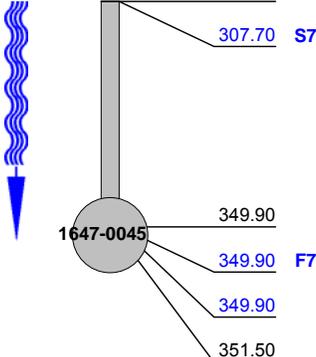
1:429	position	observation	MPEG	photo	grade
	307.70 F5	Roots Fine Joint, from 8 to 4 o'clock, within 8 inch: YES, End	00:32:09	4532	
	307.70 S7	Water Level Sag, 20 □, within 8 inch: NO, Remarks: FLOW BEING HELD BY INCOMI, Start	00:33:02	4533	M 2
	349.90	Crack Circumferential, from 7 to 6 o'clock, within 8 inch: NO	00:34:38	4534	S 1
	349.90 F7	Water Level Sag, 20 □, within 8 inch: NO, Remarks: FLOW BEING HELD BY INCOMI, End	00:35:05	4535	M 2
	349.90	Water Level, 10 □, within 8 inch: NO	00:35:22	4536	M 2
	351.50	Manhole, within 8 inch: NO, Remarks: 1647-0045	00:36:08	4537

QSR	QMR	SPR	MPR	OPR	SPRI	MPRI	OPRI
4336	312C	44	39	83	2.44	2.05	2.24

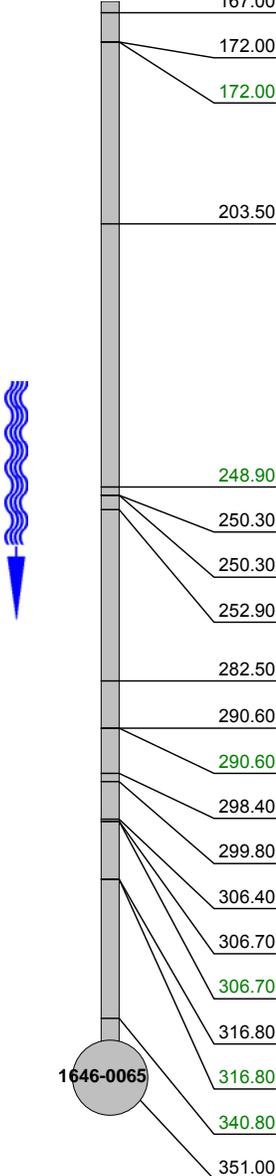
316.80	Roots Fine Joint, from 7 to 3 o'clock, within 8 inch: YES	00:29:07	5750	
	316.80	Crack Multiple, from 7 to 5 o'clock, within 8 inch: YES	00:29:31	5751	S 3

340.80	Crack Multiple, from 7 to 5 o'clock, within 8 inch: YES	00:31:35	5752	S 3
	351.00	Manhole, within 8 inch: NO, Remarks: 1646-0065	00:32:31	5753

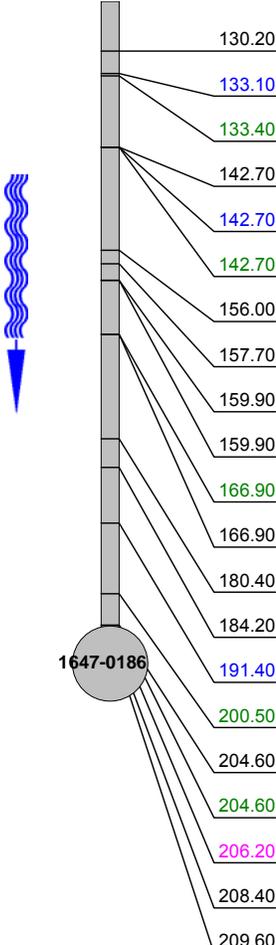
204.60	Crack Multiple, from 8 to 10 o'clock, within 8 inch: NO	00:27:49	3902	S 3
	206.20	Fracture Multiple, from 1 to 8 o'clock, within 8 inch: YES	00:28:38	3903	S 4

208.40	Crack Circumferential, from 7 to 6 o'clock, within 8 inch: NO	00:29:20	3904	S 1
	209.60	Manhole, within 8 inch: NO, Remarks: 1647-0186	00:29:55	3905

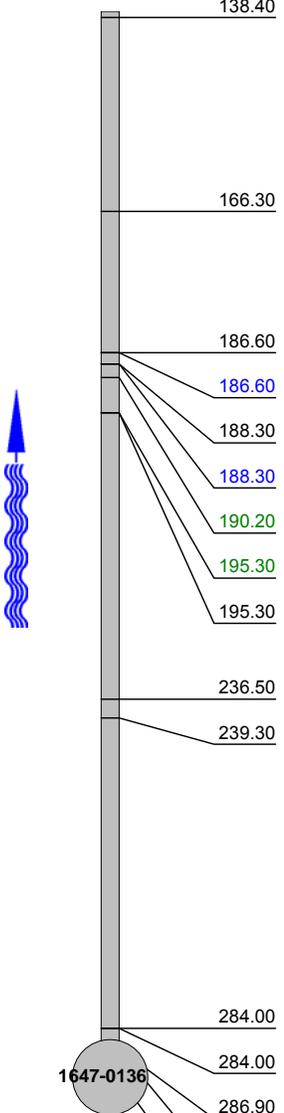
284.00	Tap Factory Active, at 9 o'clock, 6", within 8 inch: NO	00:26:32	5617	
	286.90	Tap Factory Active, at 3 o'clock, 6", within 8 inch: NO	00:27:11	5618

286.90	Roots Fine Lateral, at 3 o'clock, within 8 inch: NO	00:27:25	5619	M 1
	291.00	Manhole, within 8 inch: NO, Remarks: buried, 1647-0136	00:28:22	5620

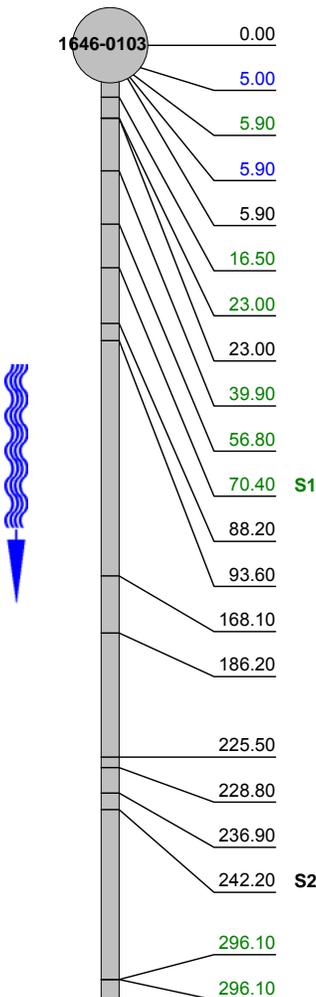
242.20 S2	Roots Fine Joint, from 12 to 1 o'clock, within 8 inch: YES, Start	00:18:21	5287	
	296.10	Fracture Longitudinal, at 5 o'clock, within 8 inch: YES	00:21:54	5288	S 3

296.10	Fracture Longitudinal, at 8 o'clock, within 8 inch: YES	00:22:11	5289	S 3

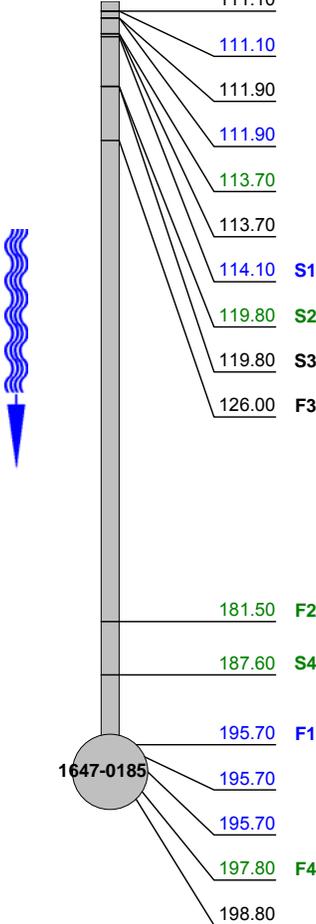
195.70 F1	Water Level Sag, 20 □, within 8 inch: NO, End	00:23:23	4261	M 2
	195.70	Water Level, 10 □, within 8 inch: NO	00:23:37	4262	M 2
	195.70	Fracture Circumferential, from 3 to 9 o'clock, within 8 inch: YES	00:24:18	4263	S 2

197.80 F4	Crack Multiple, from 7 to 5 o'clock, within 8 inch: YES, End	00:24:46	4264	S 3
	198.80	Manhole, within 8 inch: NO, Remarks: 1647-0185	00:25:17	4265

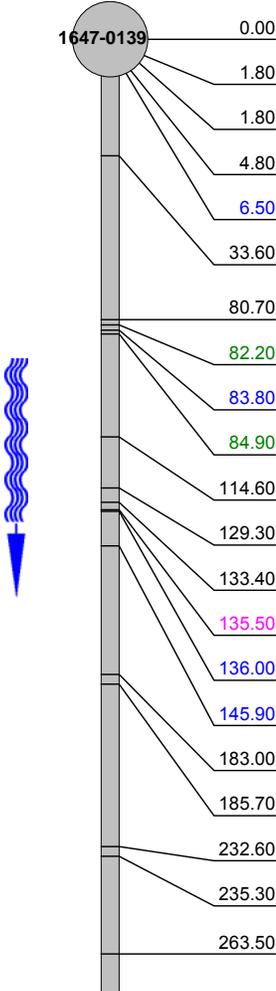
185.70	Tap Factory Active, at 3 o'clock, 6", within 8 inch: NO	00:13:08	6359	
	232.60	Tap Factory Active, at 9 o'clock, 6", within 8 inch: NO	00:14:24	6360

235.30	Tap Factory Active, at 3 o'clock, 6", within 8 inch: NO	00:14:51	6361	
	263.50	Roots Fine Joint, from 8 to 10 o'clock, within 8 inch: YES	00:15:42	6362
