**CONSOLIDATED SEWER MAINTENANCE DISTRICT
CONDITION ASSESSMENT PROGRAM REPORT
PROJECT Y0TV0910A**

**CONDITION ASSESSMENT REPORT
COUNTY OF LOS ANGELES DEPARTMENT OF PUBLIC WORKS
CONSOLIDATED SEWER MAINTENANCE DISTRICT**

PROJECT NAME:	Y0TV0910A	PROJECT MGR:	Eric Liu
PROJECT DATE:	07/10/09	CONTACT NO:	(626) 300-3369
SUP. DISTRICT(s):	5	MAP PAGE(S):	1025,1066,1091&1092
Report By:	Hanna Kebede	Report Date:	08/13/2012

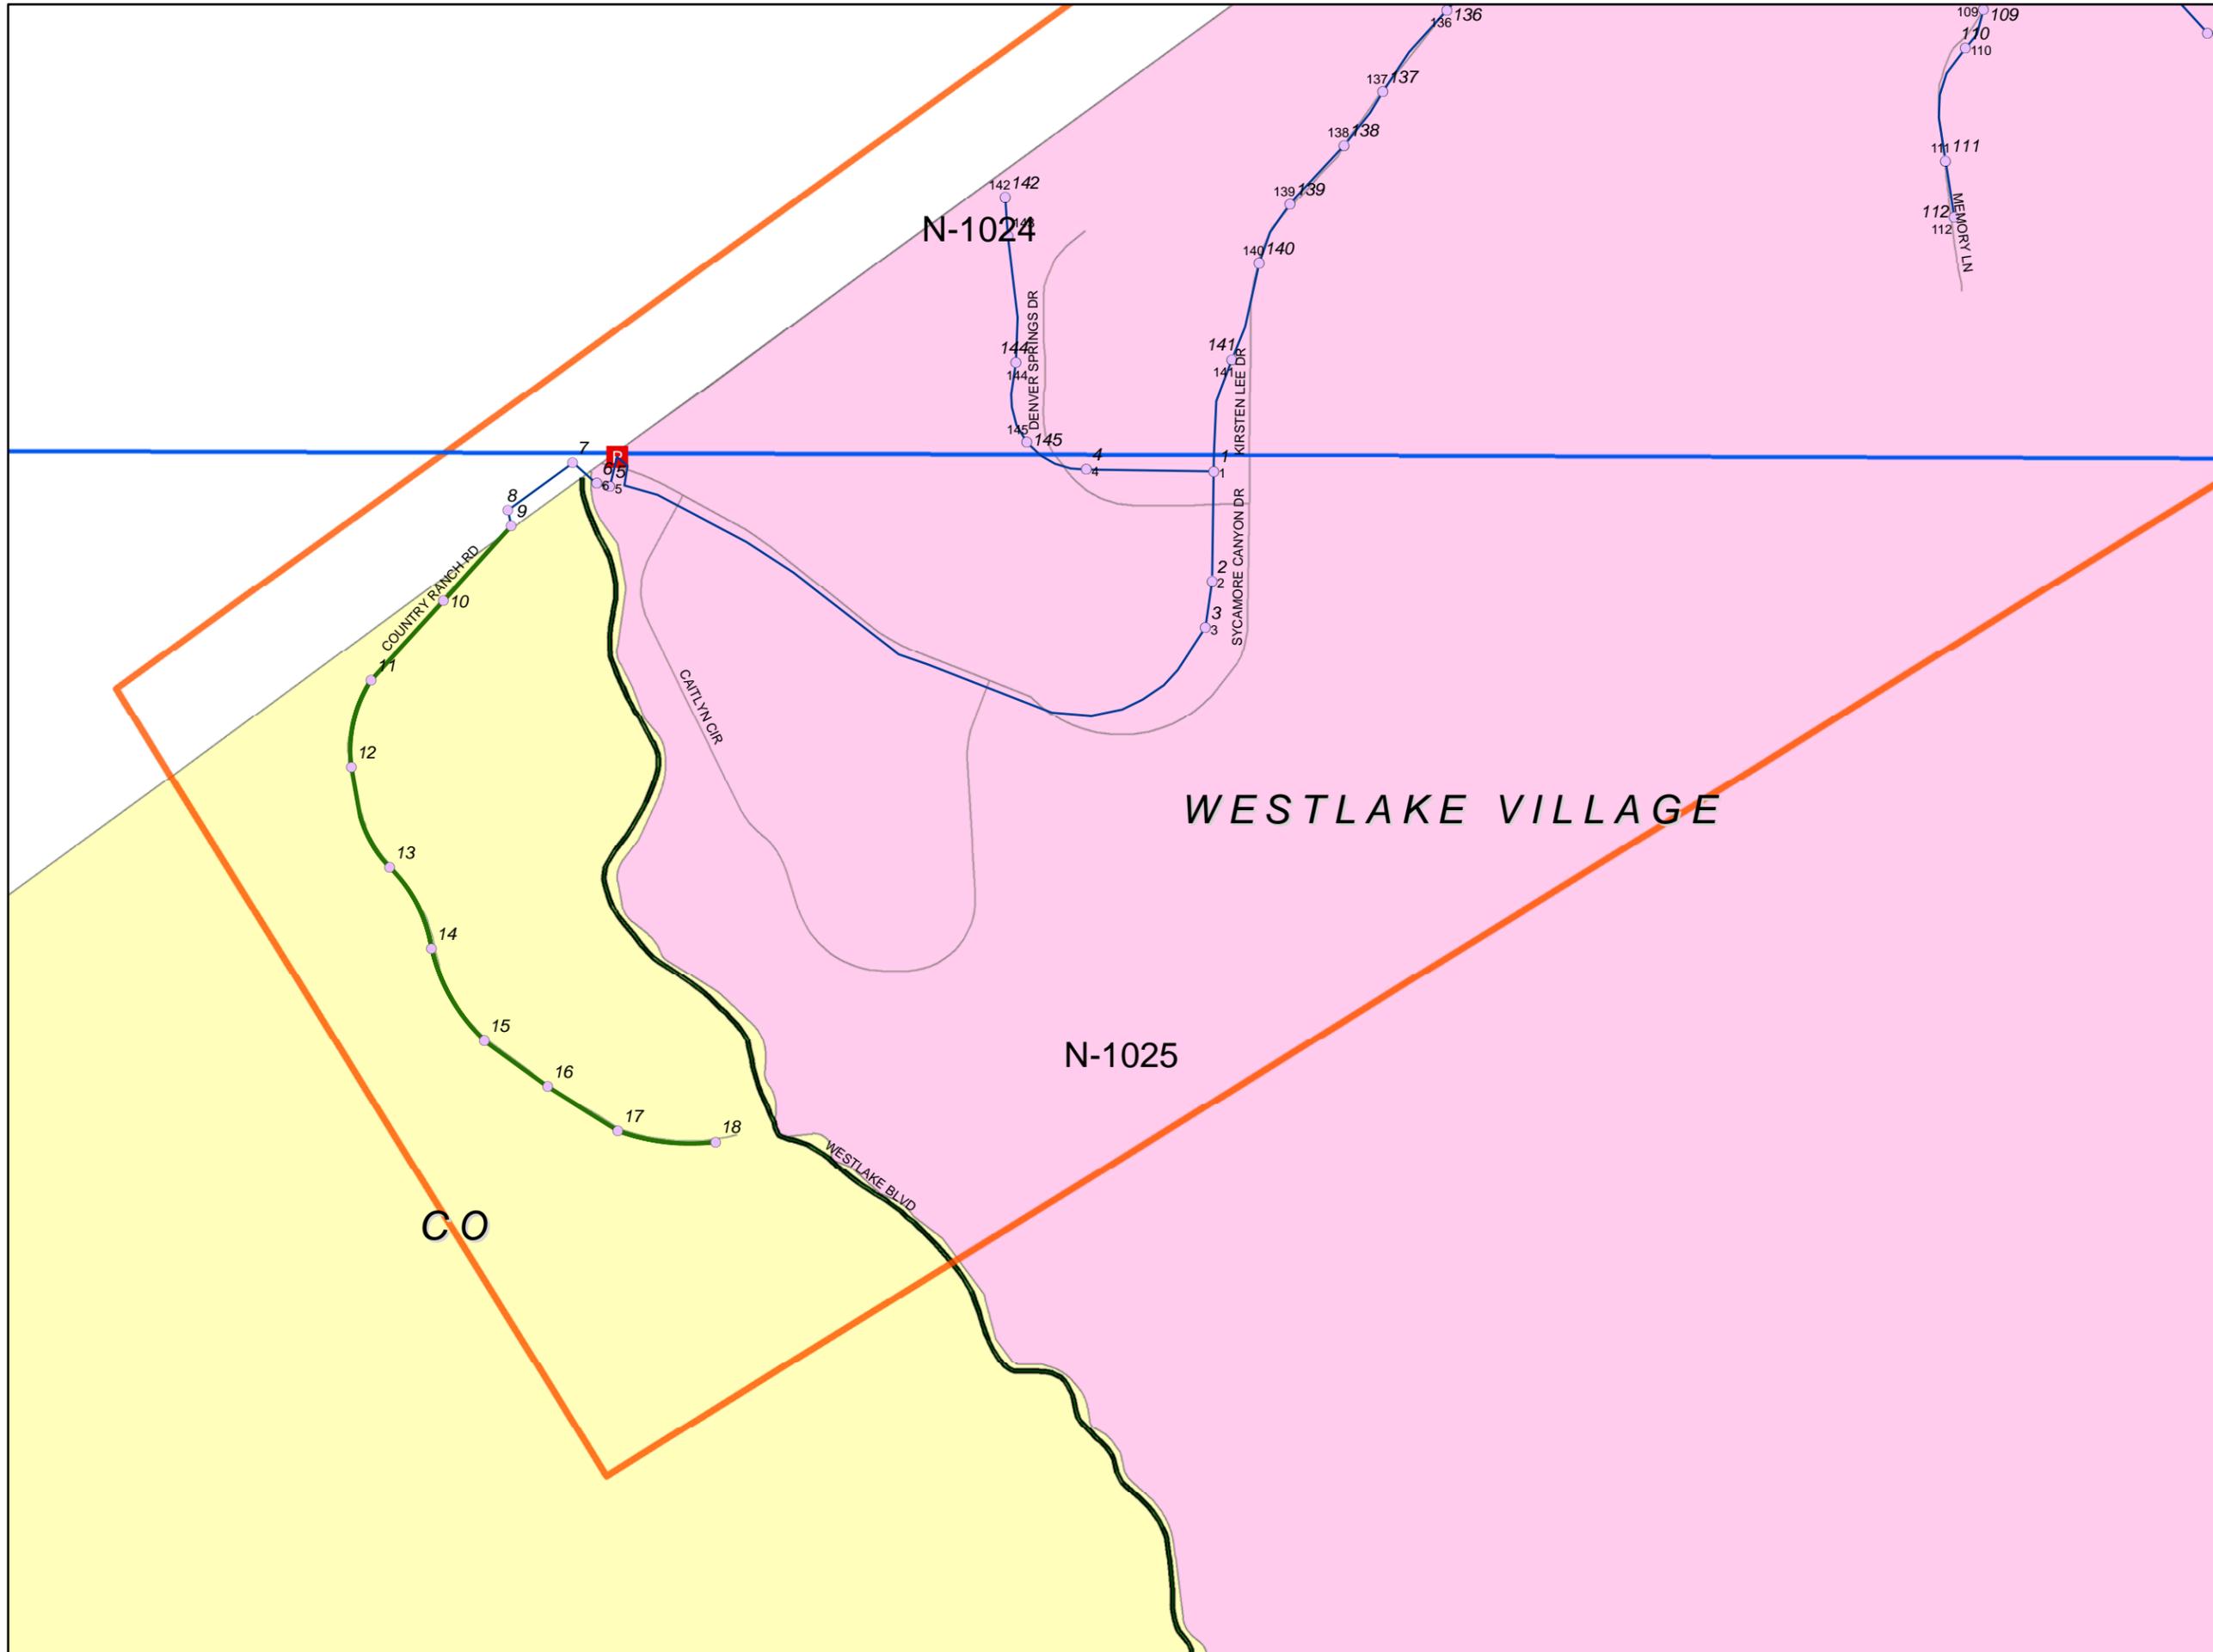
QUICK STRUCTURAL RATING (QSR)

Our inspection revealed that approximately 100 percent of the inspected pipe segments within the Unincorporated County of Los Angeles were free of severe structural defects. A color-coded map showing the Quick Structural Rating for each pipe segment is located in Enclosure 3.
