# Devil's Gate Reservoir Restoration Project Fourth Quarter Compliance Report Activities Occurring Between October 2022 and December 2022

March 2023

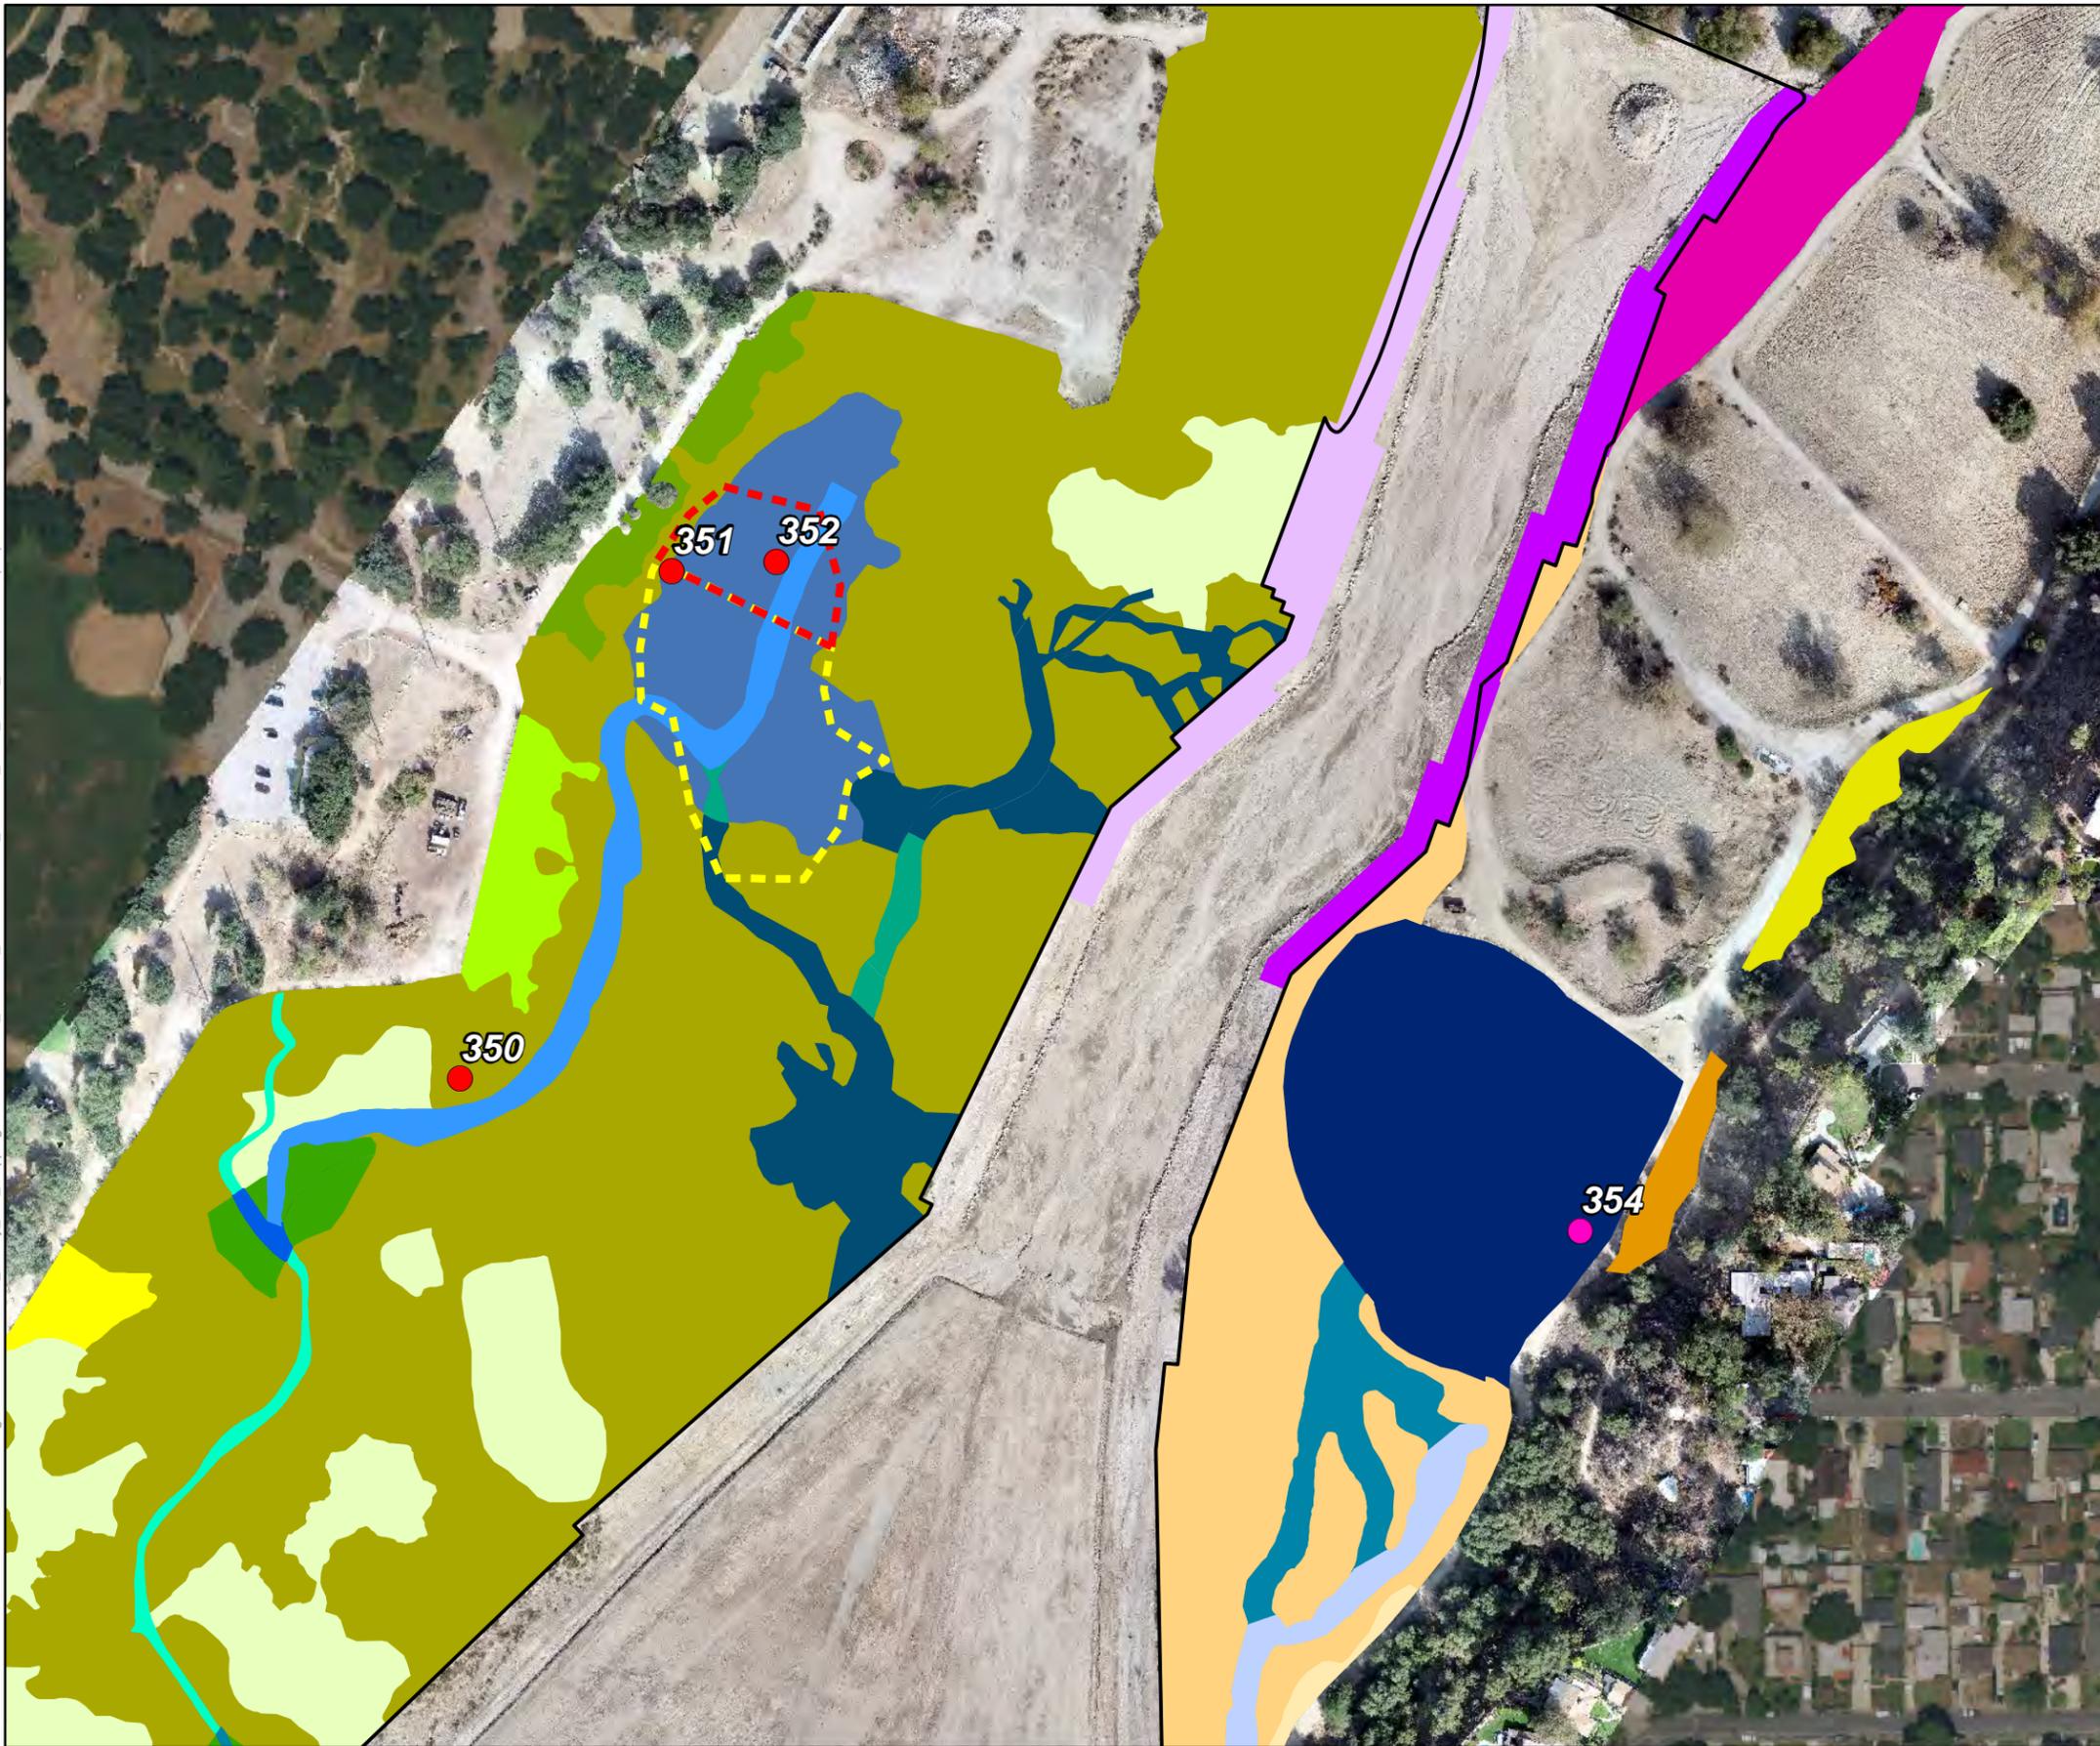
A total of 163 ISHB infested trees were removed from the mitigation areas in DG-4, DG-4 WOUS, and DG-W-2 (Mining Pit) including five amplifier trees and 158 trees with low to moderate infestation that were dead or in a condition unlikely to recover. One amplifier tree located within DG-W-1 (Johnson Field) was trimmed of infested branches. The number of removed trees differed significantly from the number identified during the survey conducted by ACWM in the summer of 2021 due to the fact that many of the black willows in the Black Willow Forest had fallen over on their own between the time of the survey conducted by ACWM and when removal took place. Trees and limbs that had fallen over on their own prior to the removal effort were generally left in place for wildlife habitat at the direction of ACWM due to the fact that these trees and limbs were determined to have a low potential of still being infested. In addition, safety concerns prevented trimming unstable trees in the Black Willow Forest. Lastly, 20 trees that were determined to provide suitable bat habitat during the pre-construction bat survey were avoided during removal activities.

ECORP will continue to monitor the remaining trees in the mitigation areas for any signs of additional infestation or dieback. In addition, ECORP will monitor the tarped woodchips on a regular basis during the six-month solarization period to address any damages to the tarp that may need to be repaired. ECORP will continue to work with the ACWM to collaborate on adaptive management techniques and any additional removal that may be required in the future. If necessary, ECORP will work with the ACWM to coordinate deploying ISHB traps within the restoration areas to confirm presence or absence. If issues with ISHB infestation continue, host trees may need to be excluded from the planting palette for future phases of restoration.

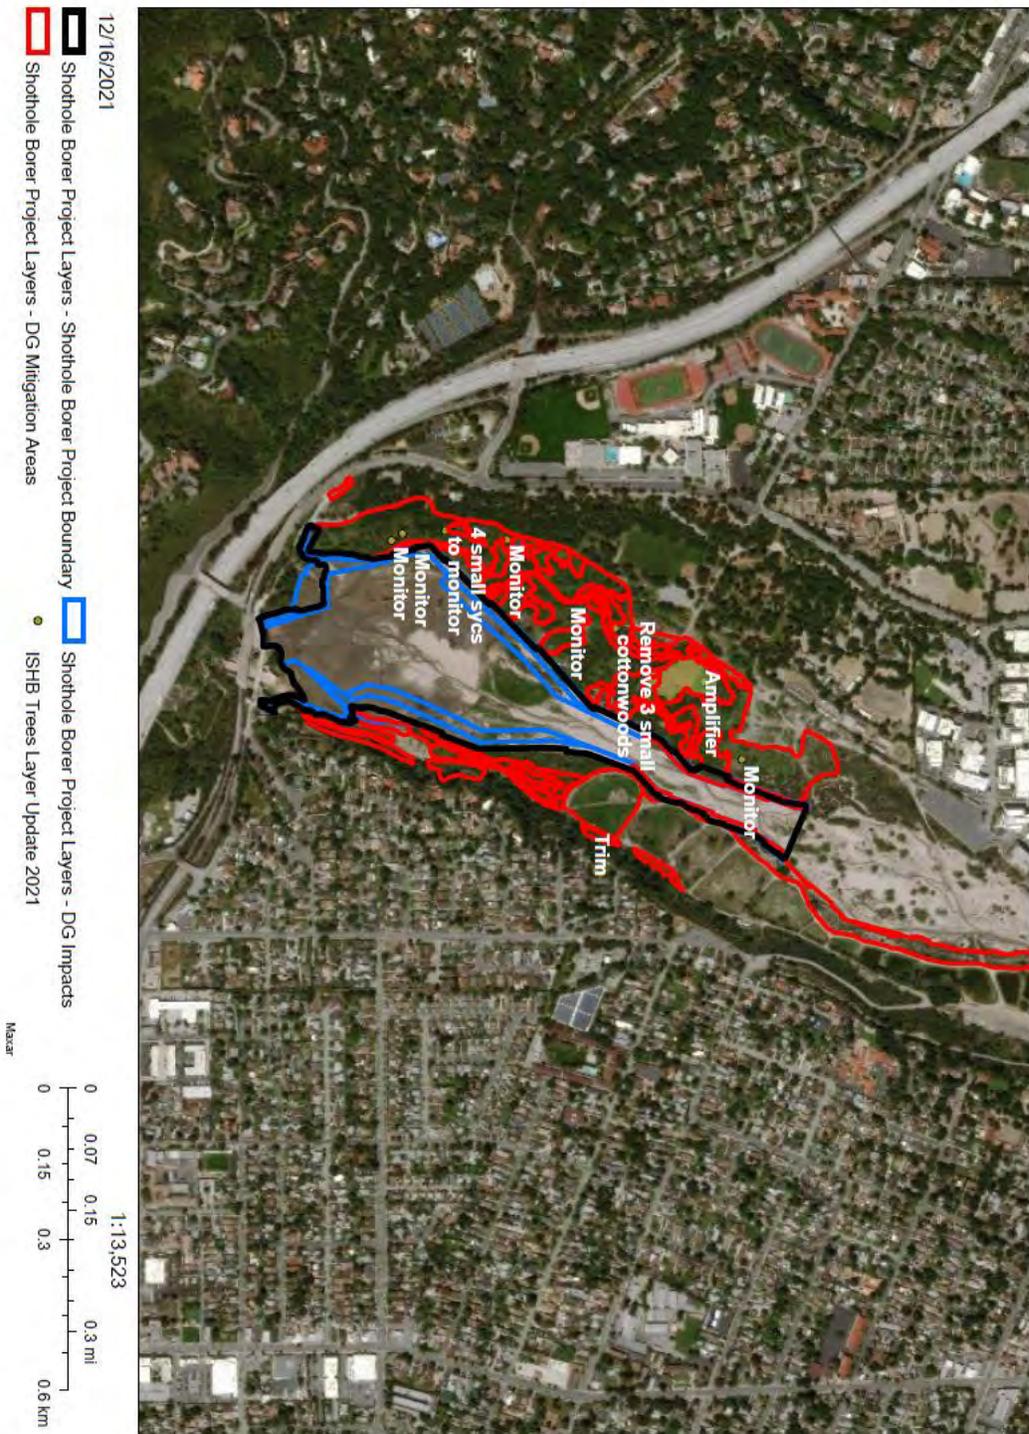
Map 1. Devil's Gate Restoration Project Overview Map with Project Boundaries. Note the green area marked with an Amplifier tree is the Black Willow Forest 1.

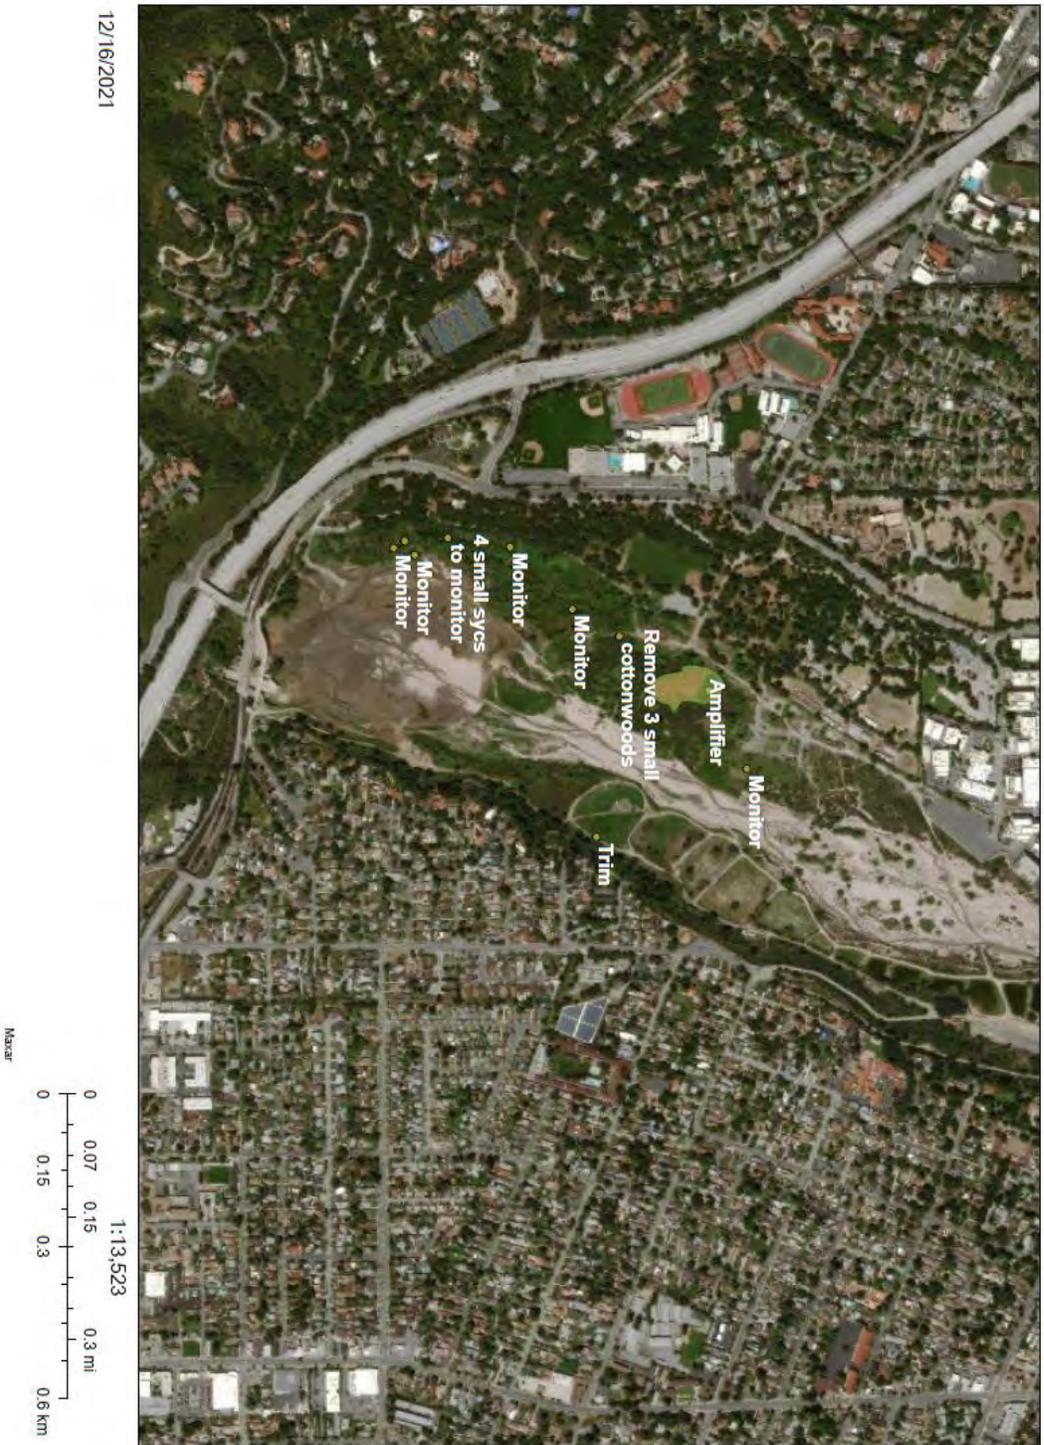
Map 2. Devil's Gate Restoration Project Overview Map without Project Boundaries. Note that there is an unseen Amplifier near the marked one in the light/dark green area.

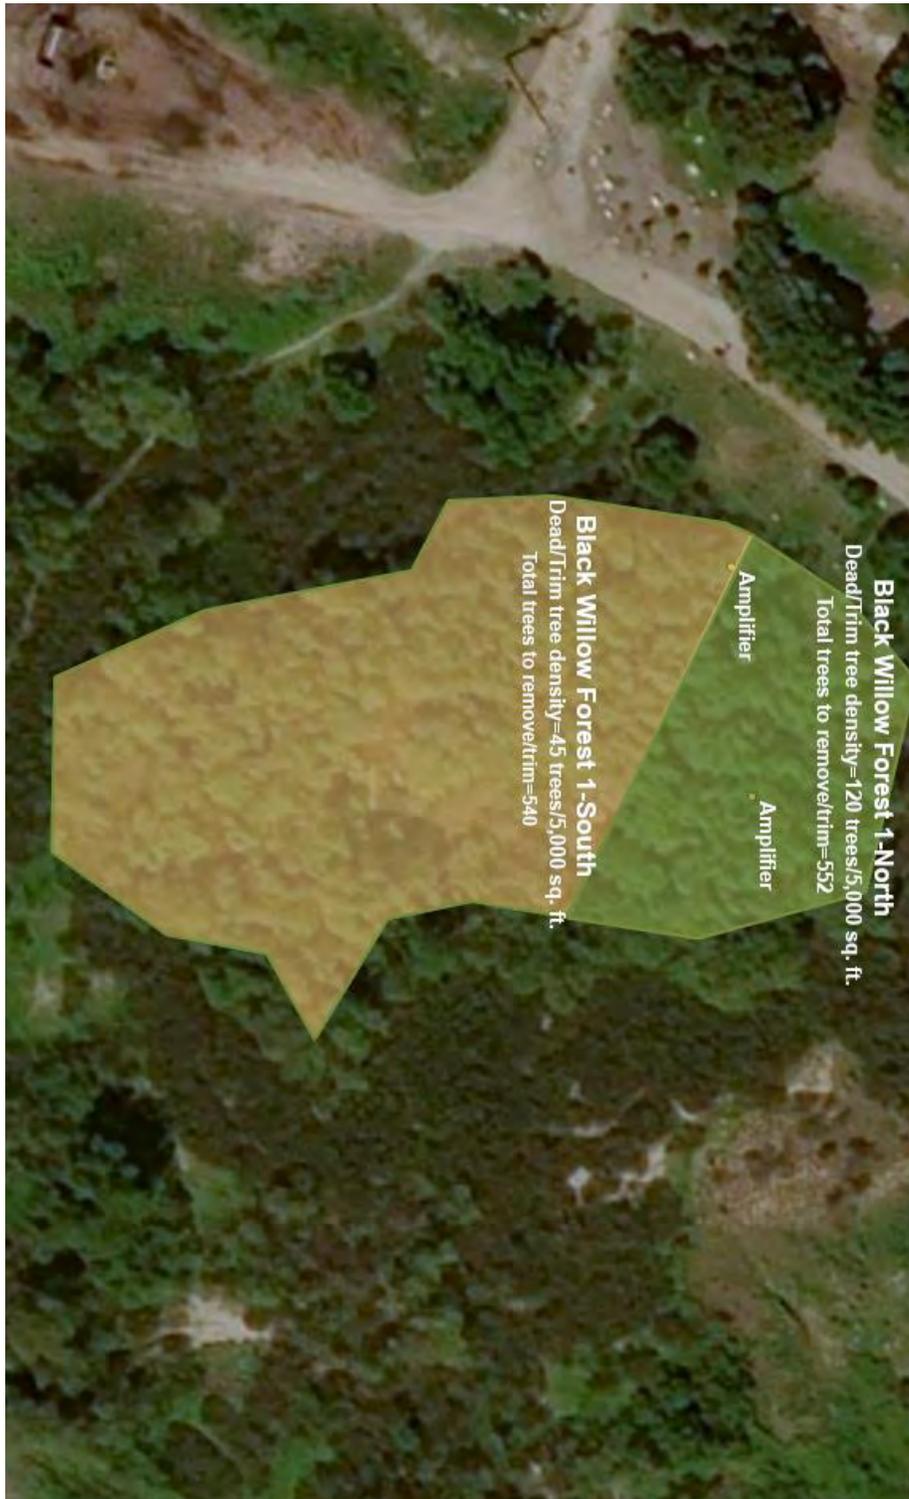
Dead trees located roughly in the area named DG-W-2 (named Black Willow Forest 1 for the purpose of this report) were also inspected. The number of trees to remove or be trimmed in this area was determined by marking the parameter of forest area by GPS, then determining the dead or trim tree density in a 5,000 sq. ft. area within it. The forest dead/trim tree density was observed to be spatially different, so this was delineated, and the forest area was divided into two sections, North and South (See Map 3). The southern section consisted of 60,399 sq. ft. with a density of 45 dead/trim trees per 5,000 sq. ft. area. The northern section consisted of 23,145 sq. ft. with a density of 120 dead/trim trees per 5,000 sq. ft. area.

Map 3. Overview of Black Willow Forest 1. North and South sections delineated according to dead/trim tree density. Note location of two amplifier trees within area.

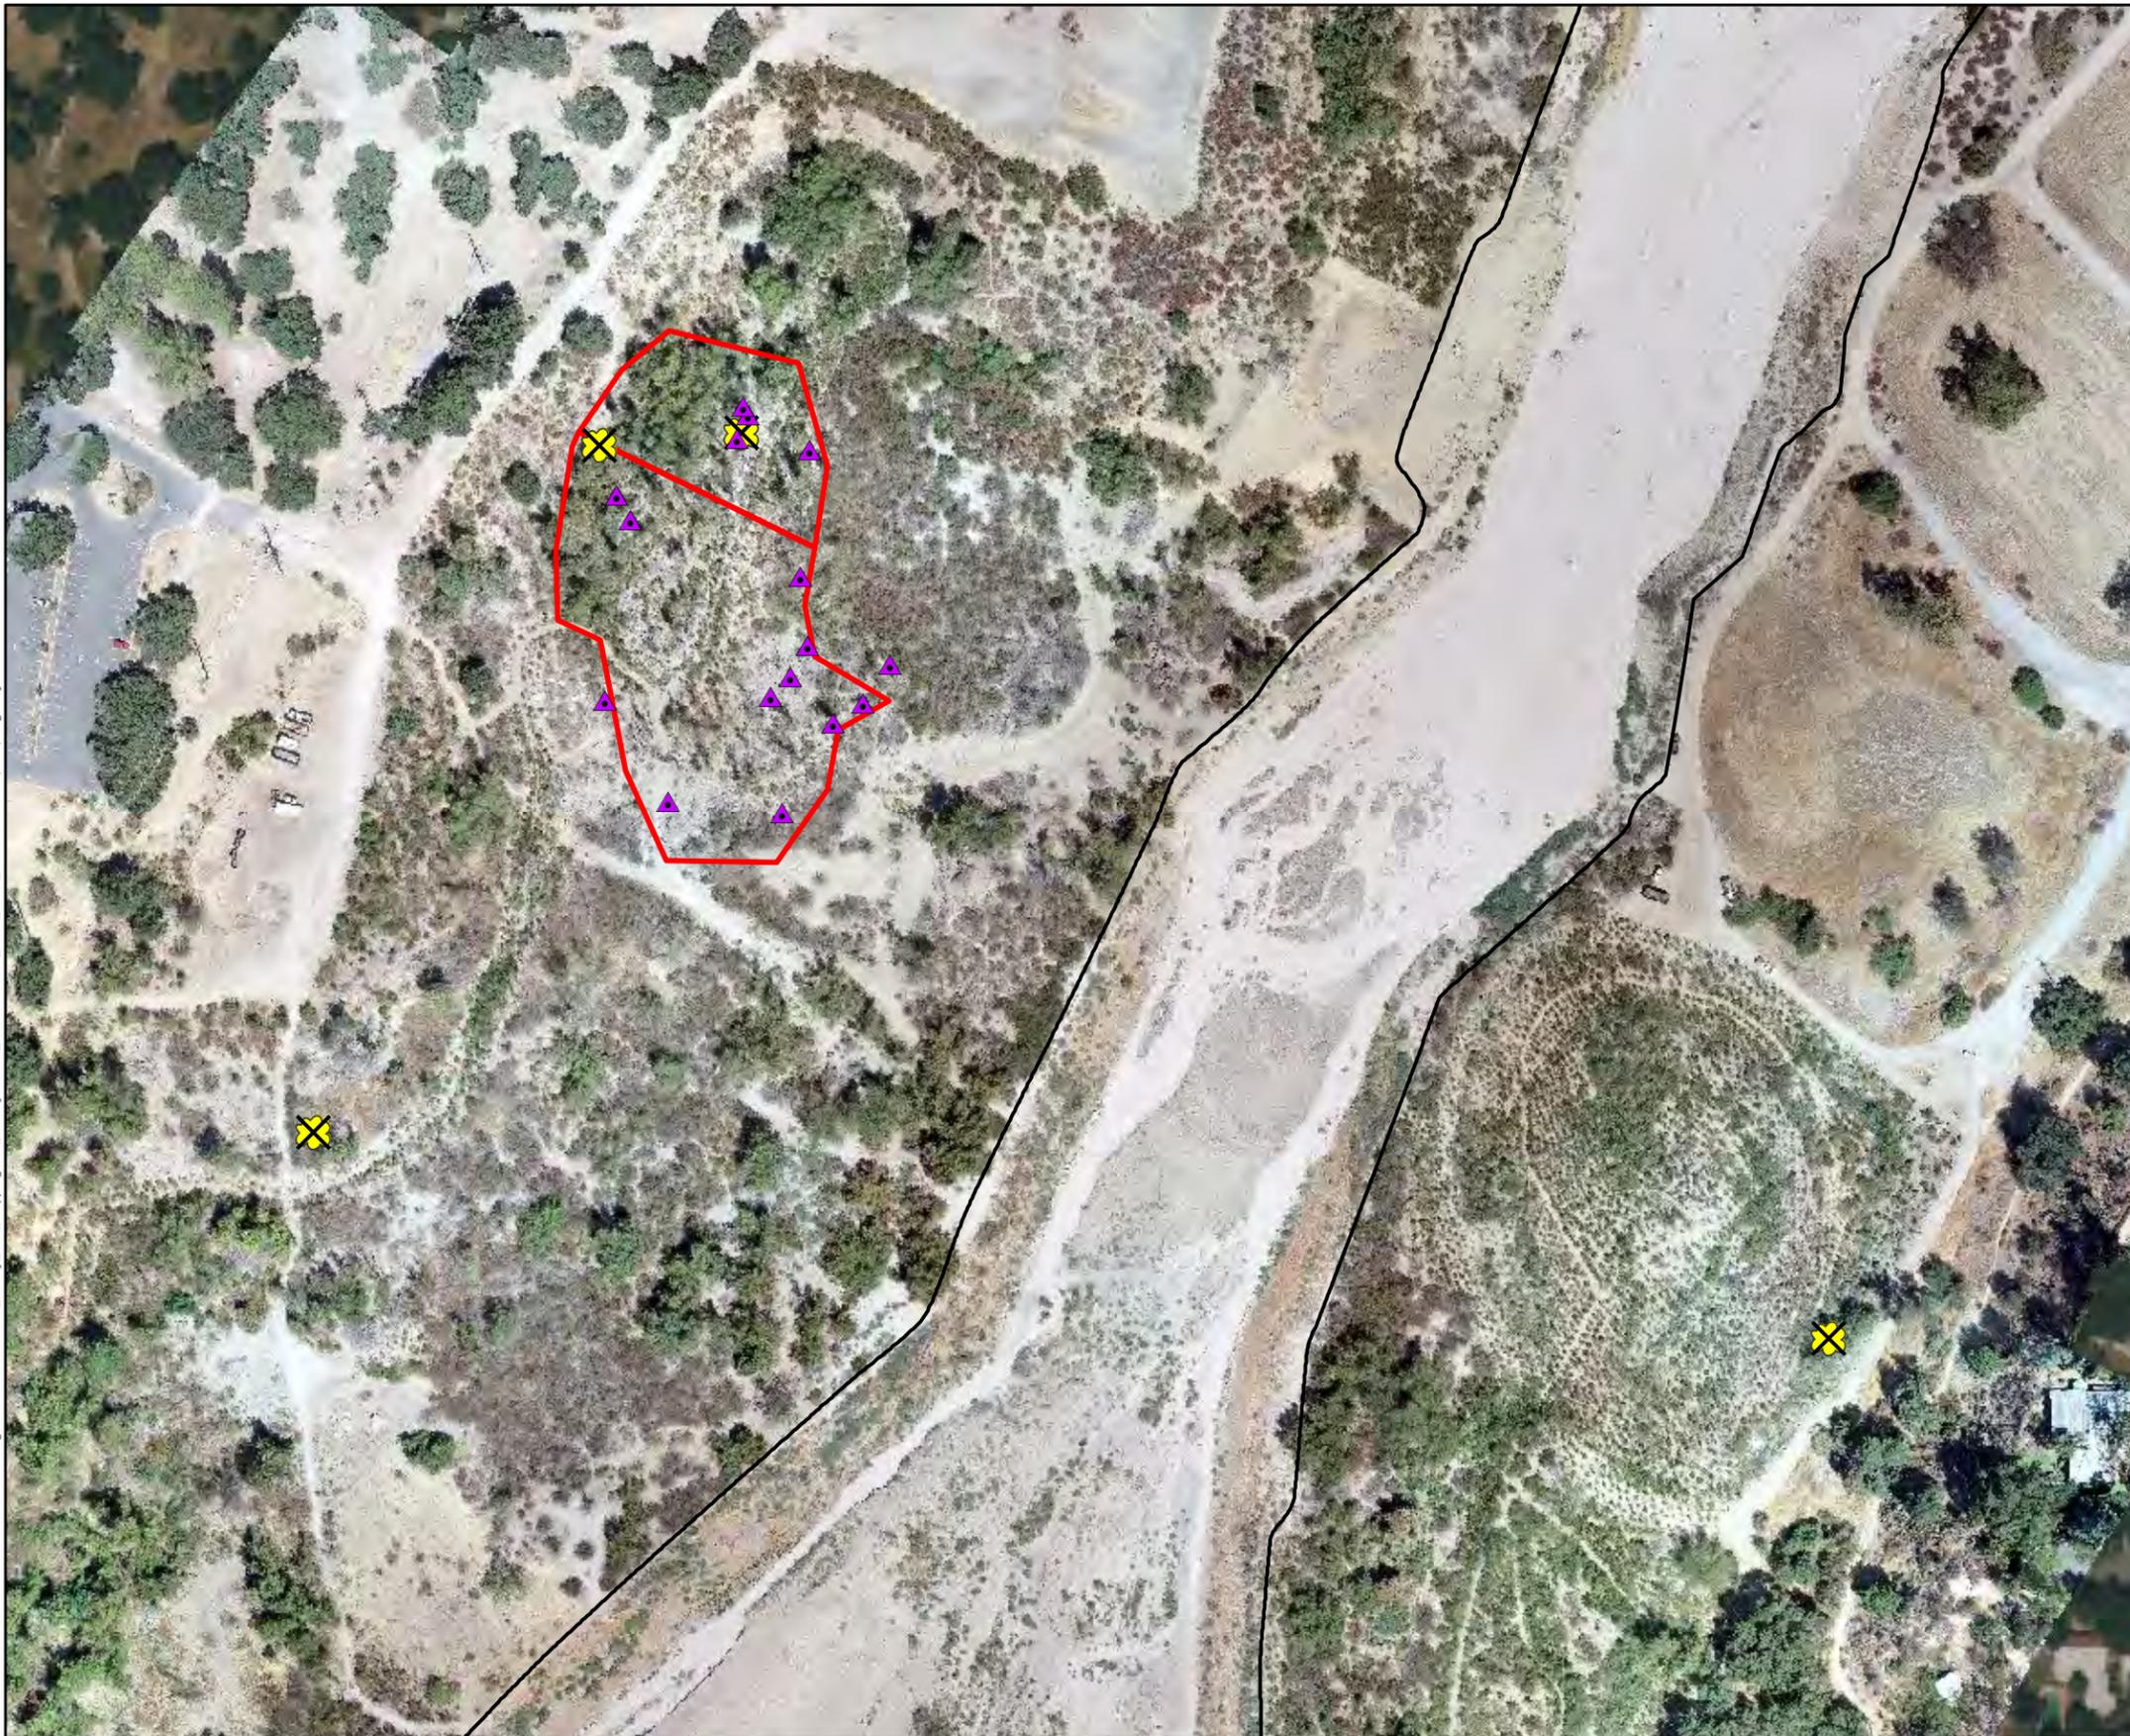
**Figure 3.**  
**Bat Habitat Assessment Results**

The habitat assessment was conducted on October 5, 2022, by ECORP bat biologist Lauren Simpson assisted by ECORP biologist Corrina Tapia. During the assessment, a total of 21 individual trees scheduled for trimming or removal due to ISHB infestation were identified as suitable roosting habitat due to the presence of exfoliating bark, crevices, and/or woodpecker cavities (Figure 3). Of those trees, only one was considered an amplifier tree. This tree was scheduled for trimming but not removal. Representative photographs of the suitable roosting trees are included in Appendix A.

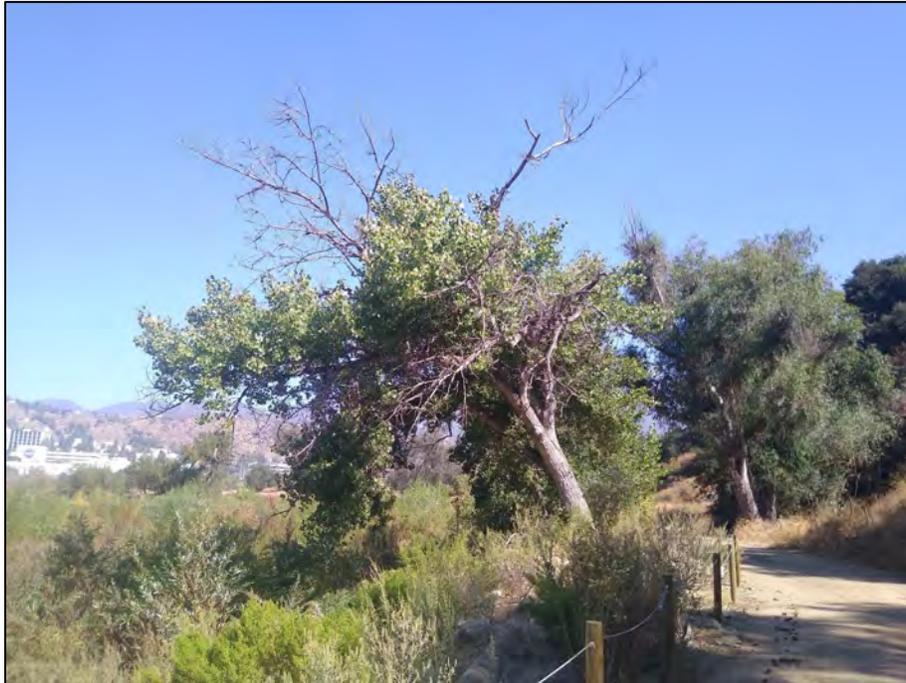
The emergence survey was conducted in October outside of the bat maternity season. No bats were observed emerging from the tree scheduled for trimming during the survey.

Photo 1. View of amplifier tree scheduled for trimming where emergence survey was conducted.

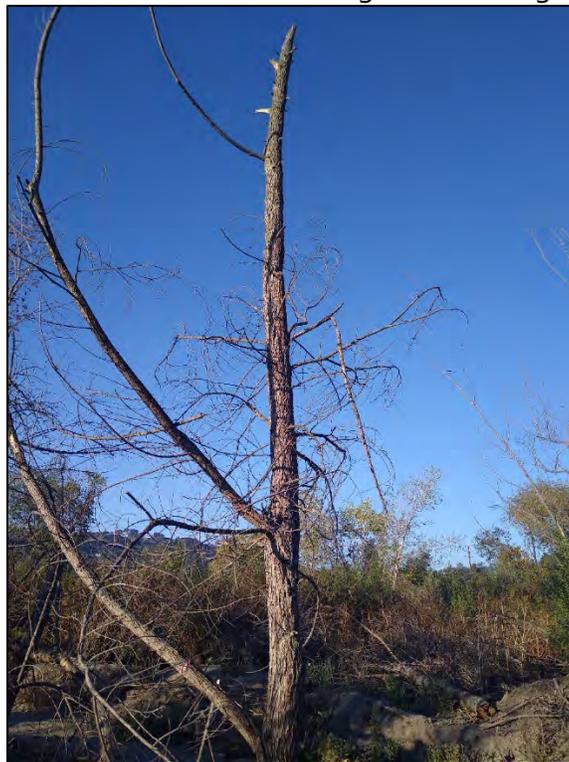
No sign or evidence of use of trees by roosting bats were observed during the survey. However, a total of 21 suitable bat-roosting trees were identified. The majority of the trees identified as potential habitat provided only limited suitable habitat for roosting in the form of sections of exfoliating bark and/or woodpecker cavities. These types of tree features can provide suitable roosting habitat for solitary or small groups of roosting bats but are not of sufficient size to support colonial roosting. Of these 21 trees, 20 were able to be avoided during ISHB infested tree trimming and removal activities. One tree, a Fremont cottonwood (*Populus fremontii*) tree that was classified as an amplifier tree on the east side of the Project site could not be avoided. An emergence survey was conducted at this tree and no bats were observed emerging during the survey.

Photo 2. Representative photograph of bat habitat tree in black willow forest.

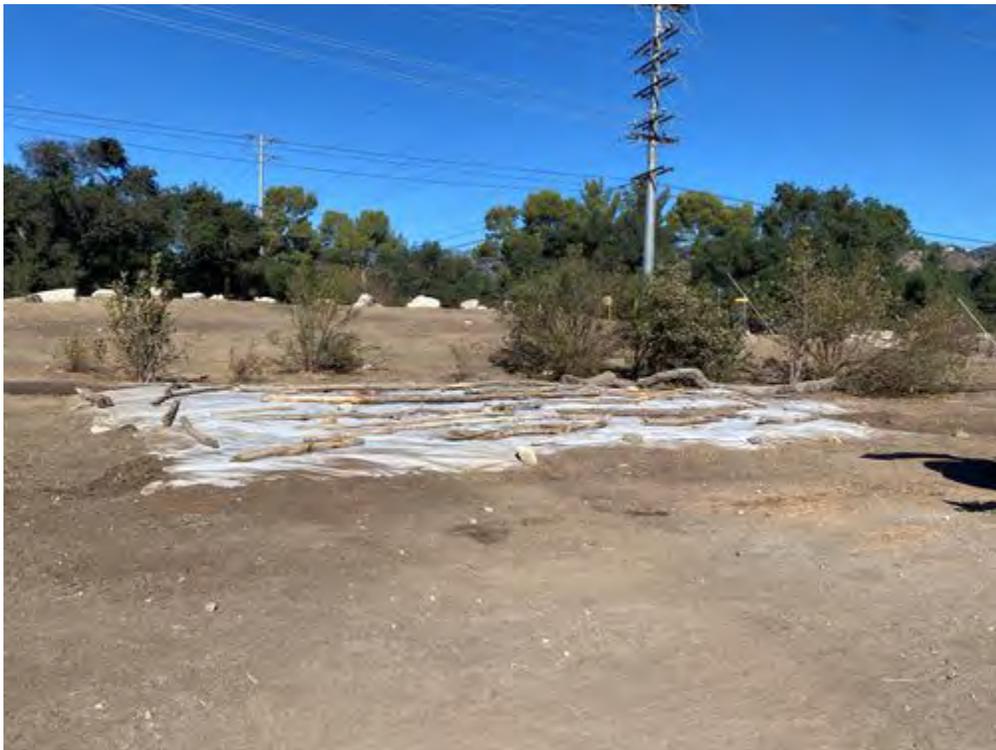
**Secured\_tarp\_facingW.jpg**  
-118.17517944444445 34.19256932222222

Logs were placed on top of the tarp to avoid spread of chipped trees and vandalism. The tarps will remain in place for a period of at least six months in an effort to kill any remaining ISHB beetles and larvae and will be removed only after confirmation is received from ACWM.
