Devil's Gate Monitoring Log

Devil's Gate Reservoir Restoration Project - 2018-047.00

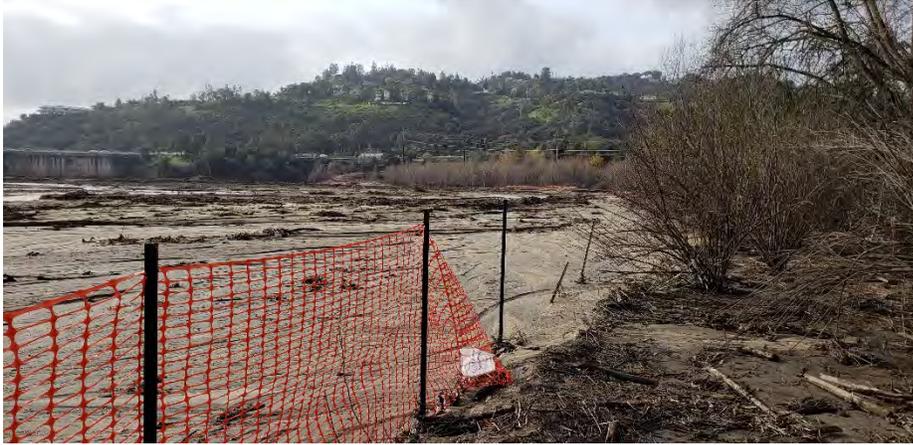
Log Entry #4 Photo A

0958 Observed construction fencing down on western side. Appears to be caused by the rainfall over the last 3-4 days.

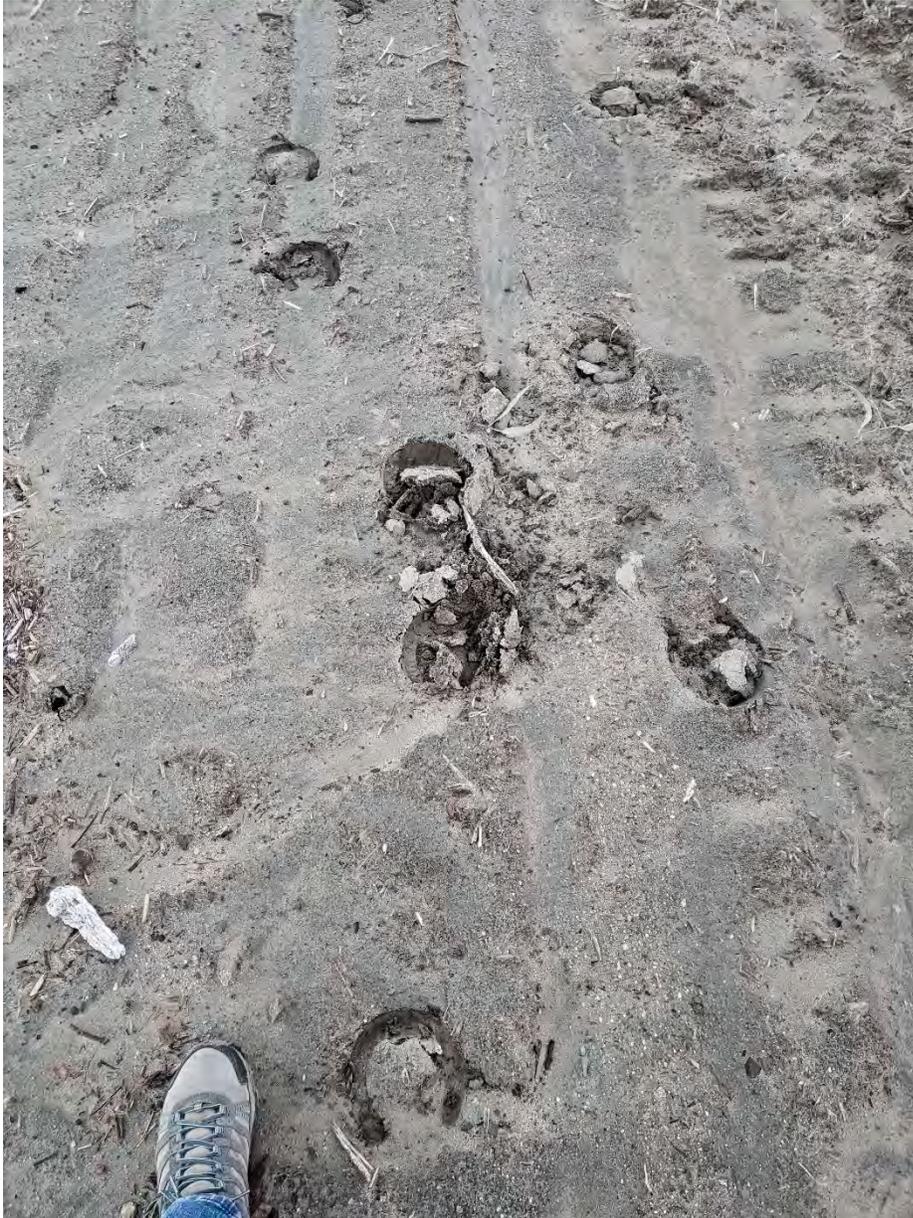
Log Entry #2 Photo A

Observed horse tracks in construction site

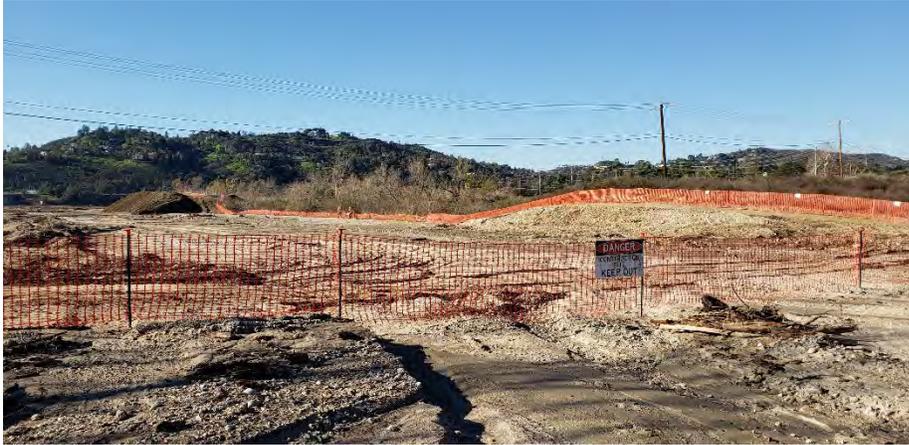
Log Entry #8 Photo A

0918 Griffith had repaired many breaks in fence and continues repairs.

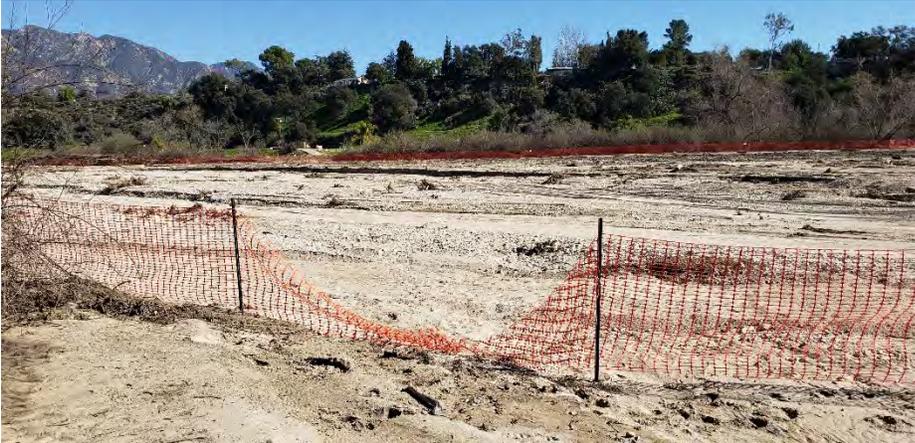
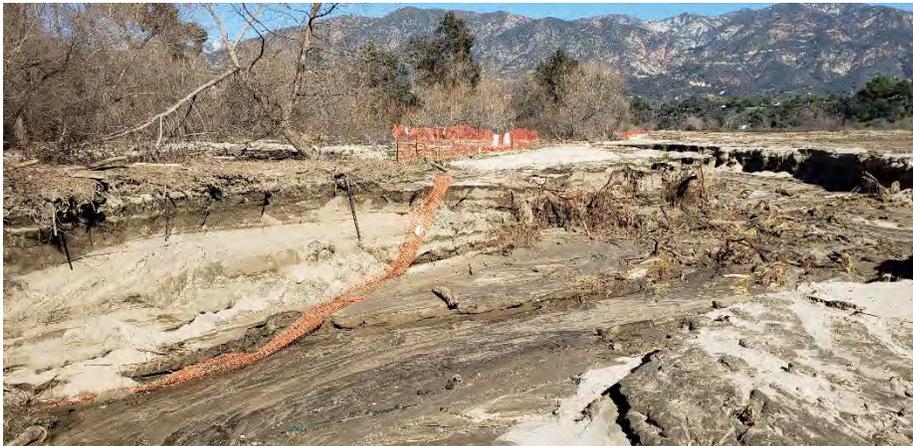
Multiple areas of downed fence, particularly on western boundary. A major section along the southwestern boundary is missing/washed out and is in need of replacement. Appears to be in same state as site check on Wednesday.

Fence is need of repair/replacement.

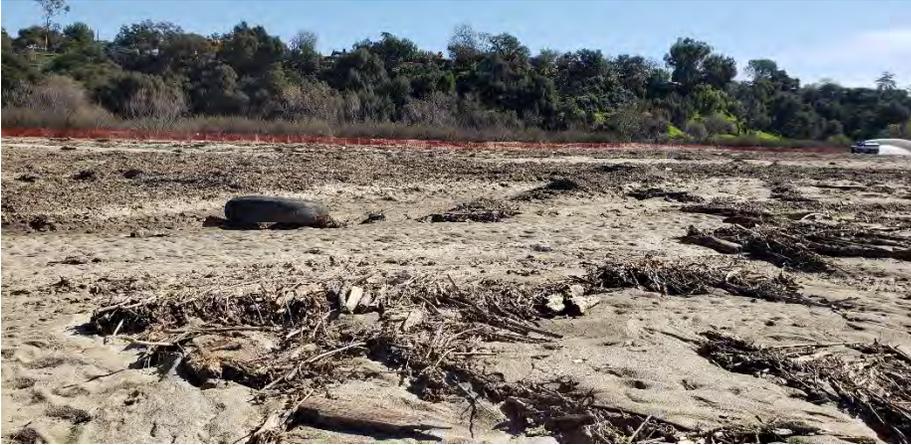
Log Entry #2 Photo A

Debris (natural and human trash) washed into site from high flows and storm from the previous week. Even tire, metal poles, woody debris...

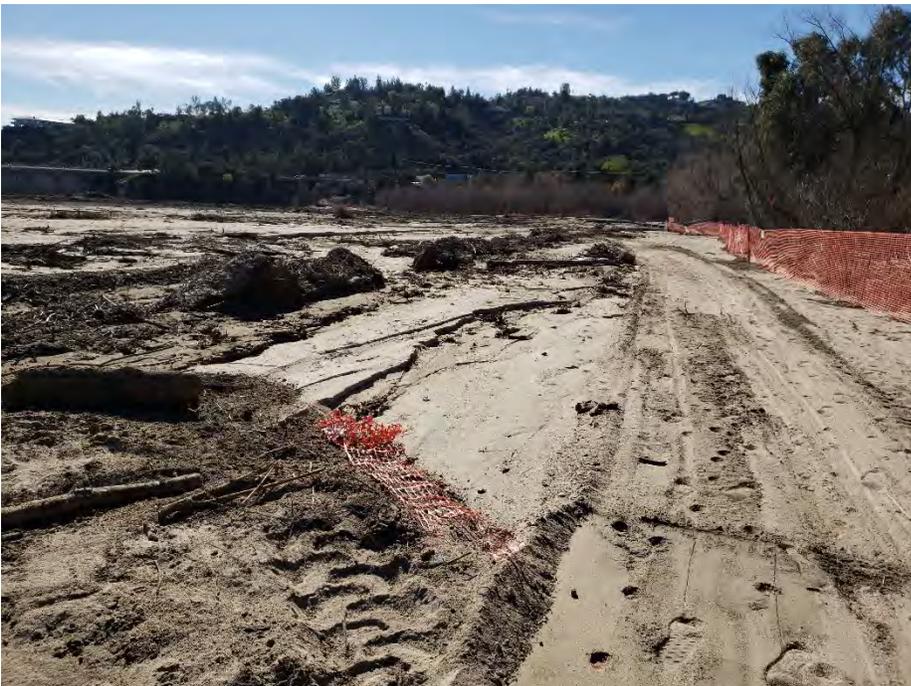
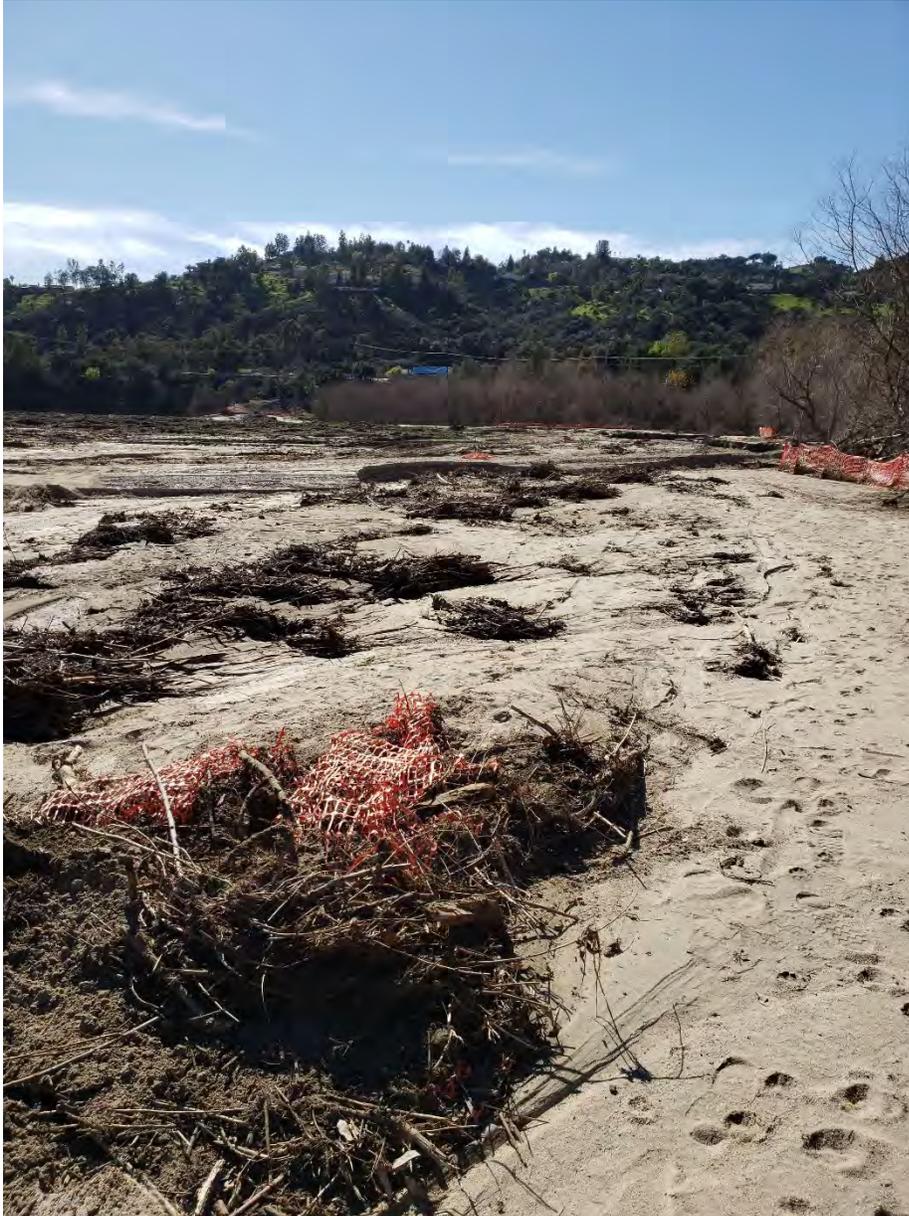
Fence remnants littering site.

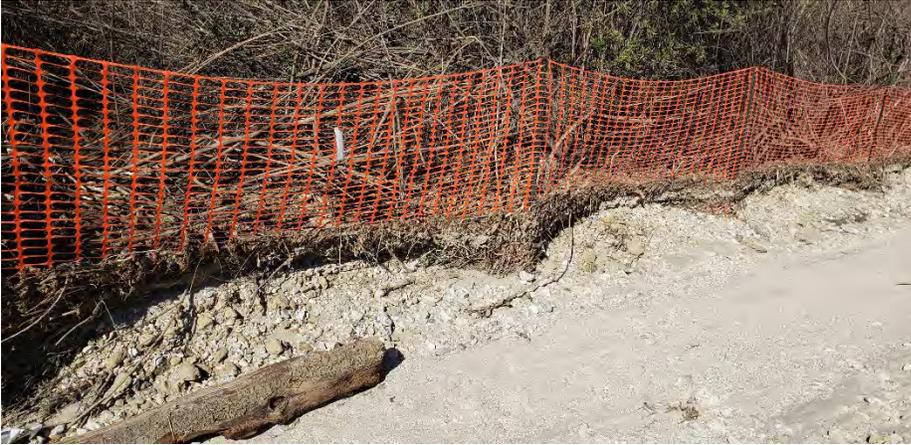
Log Entry #4 Photo A

certain areas of the fence are so clogged with debris it may prevent wildlife from moving freely through it.
