CONSOLIDATED SEWER MAINTENANCE DISTRICT CONDITION ASSESSMENT PROGRAM REPORT PROJECT Y0TV0506E

CCTV PROJECT
Y0TV0506E

Supervisorial District 1
Cities of Industry
La Puente &
County Unincorporated

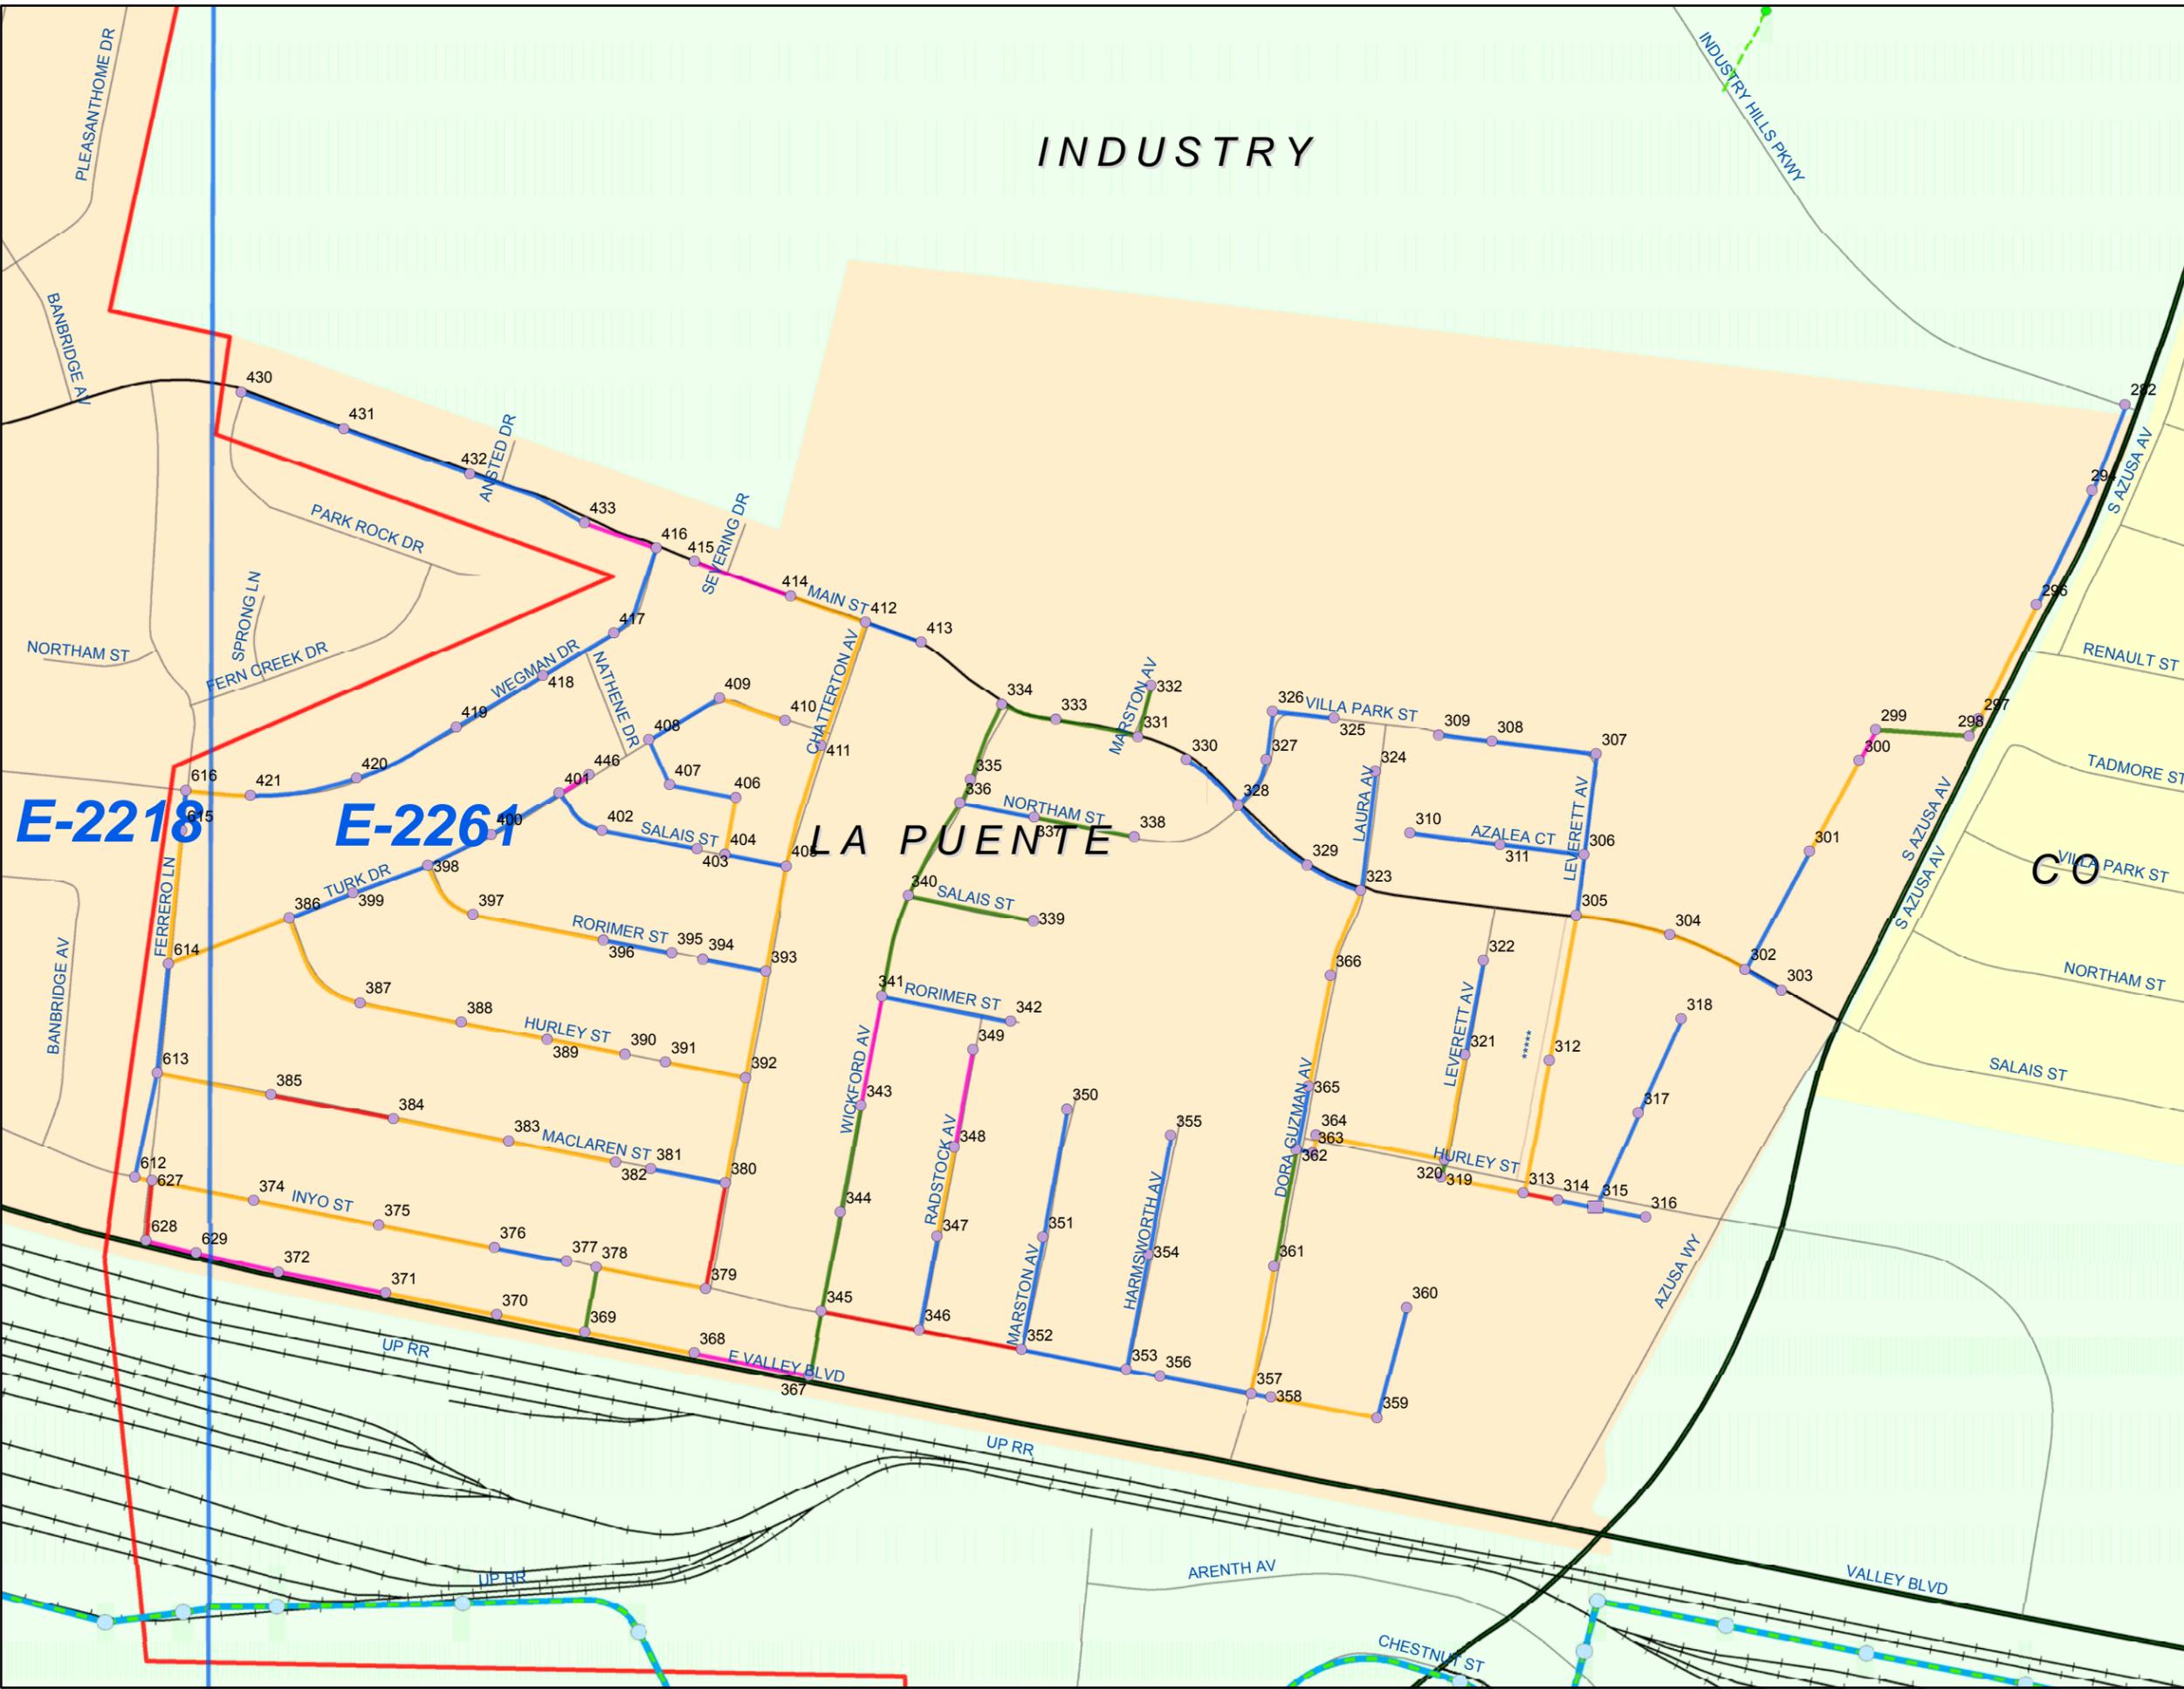
QUICK MAINTENANCE RATING (QMR)

Supervisory District 1
City of La Puente

The following line segments received a Quick Maintenance Rating of above 4000 due to the observation of Root Ball or Deposit inside the lateral connection. CSMD does not maintain lateral lines: it is the responsibility of the parcel owner to maintain their respective lateral lines to facilitate the flow of wastewater from their property to the mainline. Therefore, these lines were not included on the Priority List above identified with maintenance deficiencies in need of immediate attention by CSMD. CSMD has sent Notices of Root Intrusion from Lateral to the respective property owners.

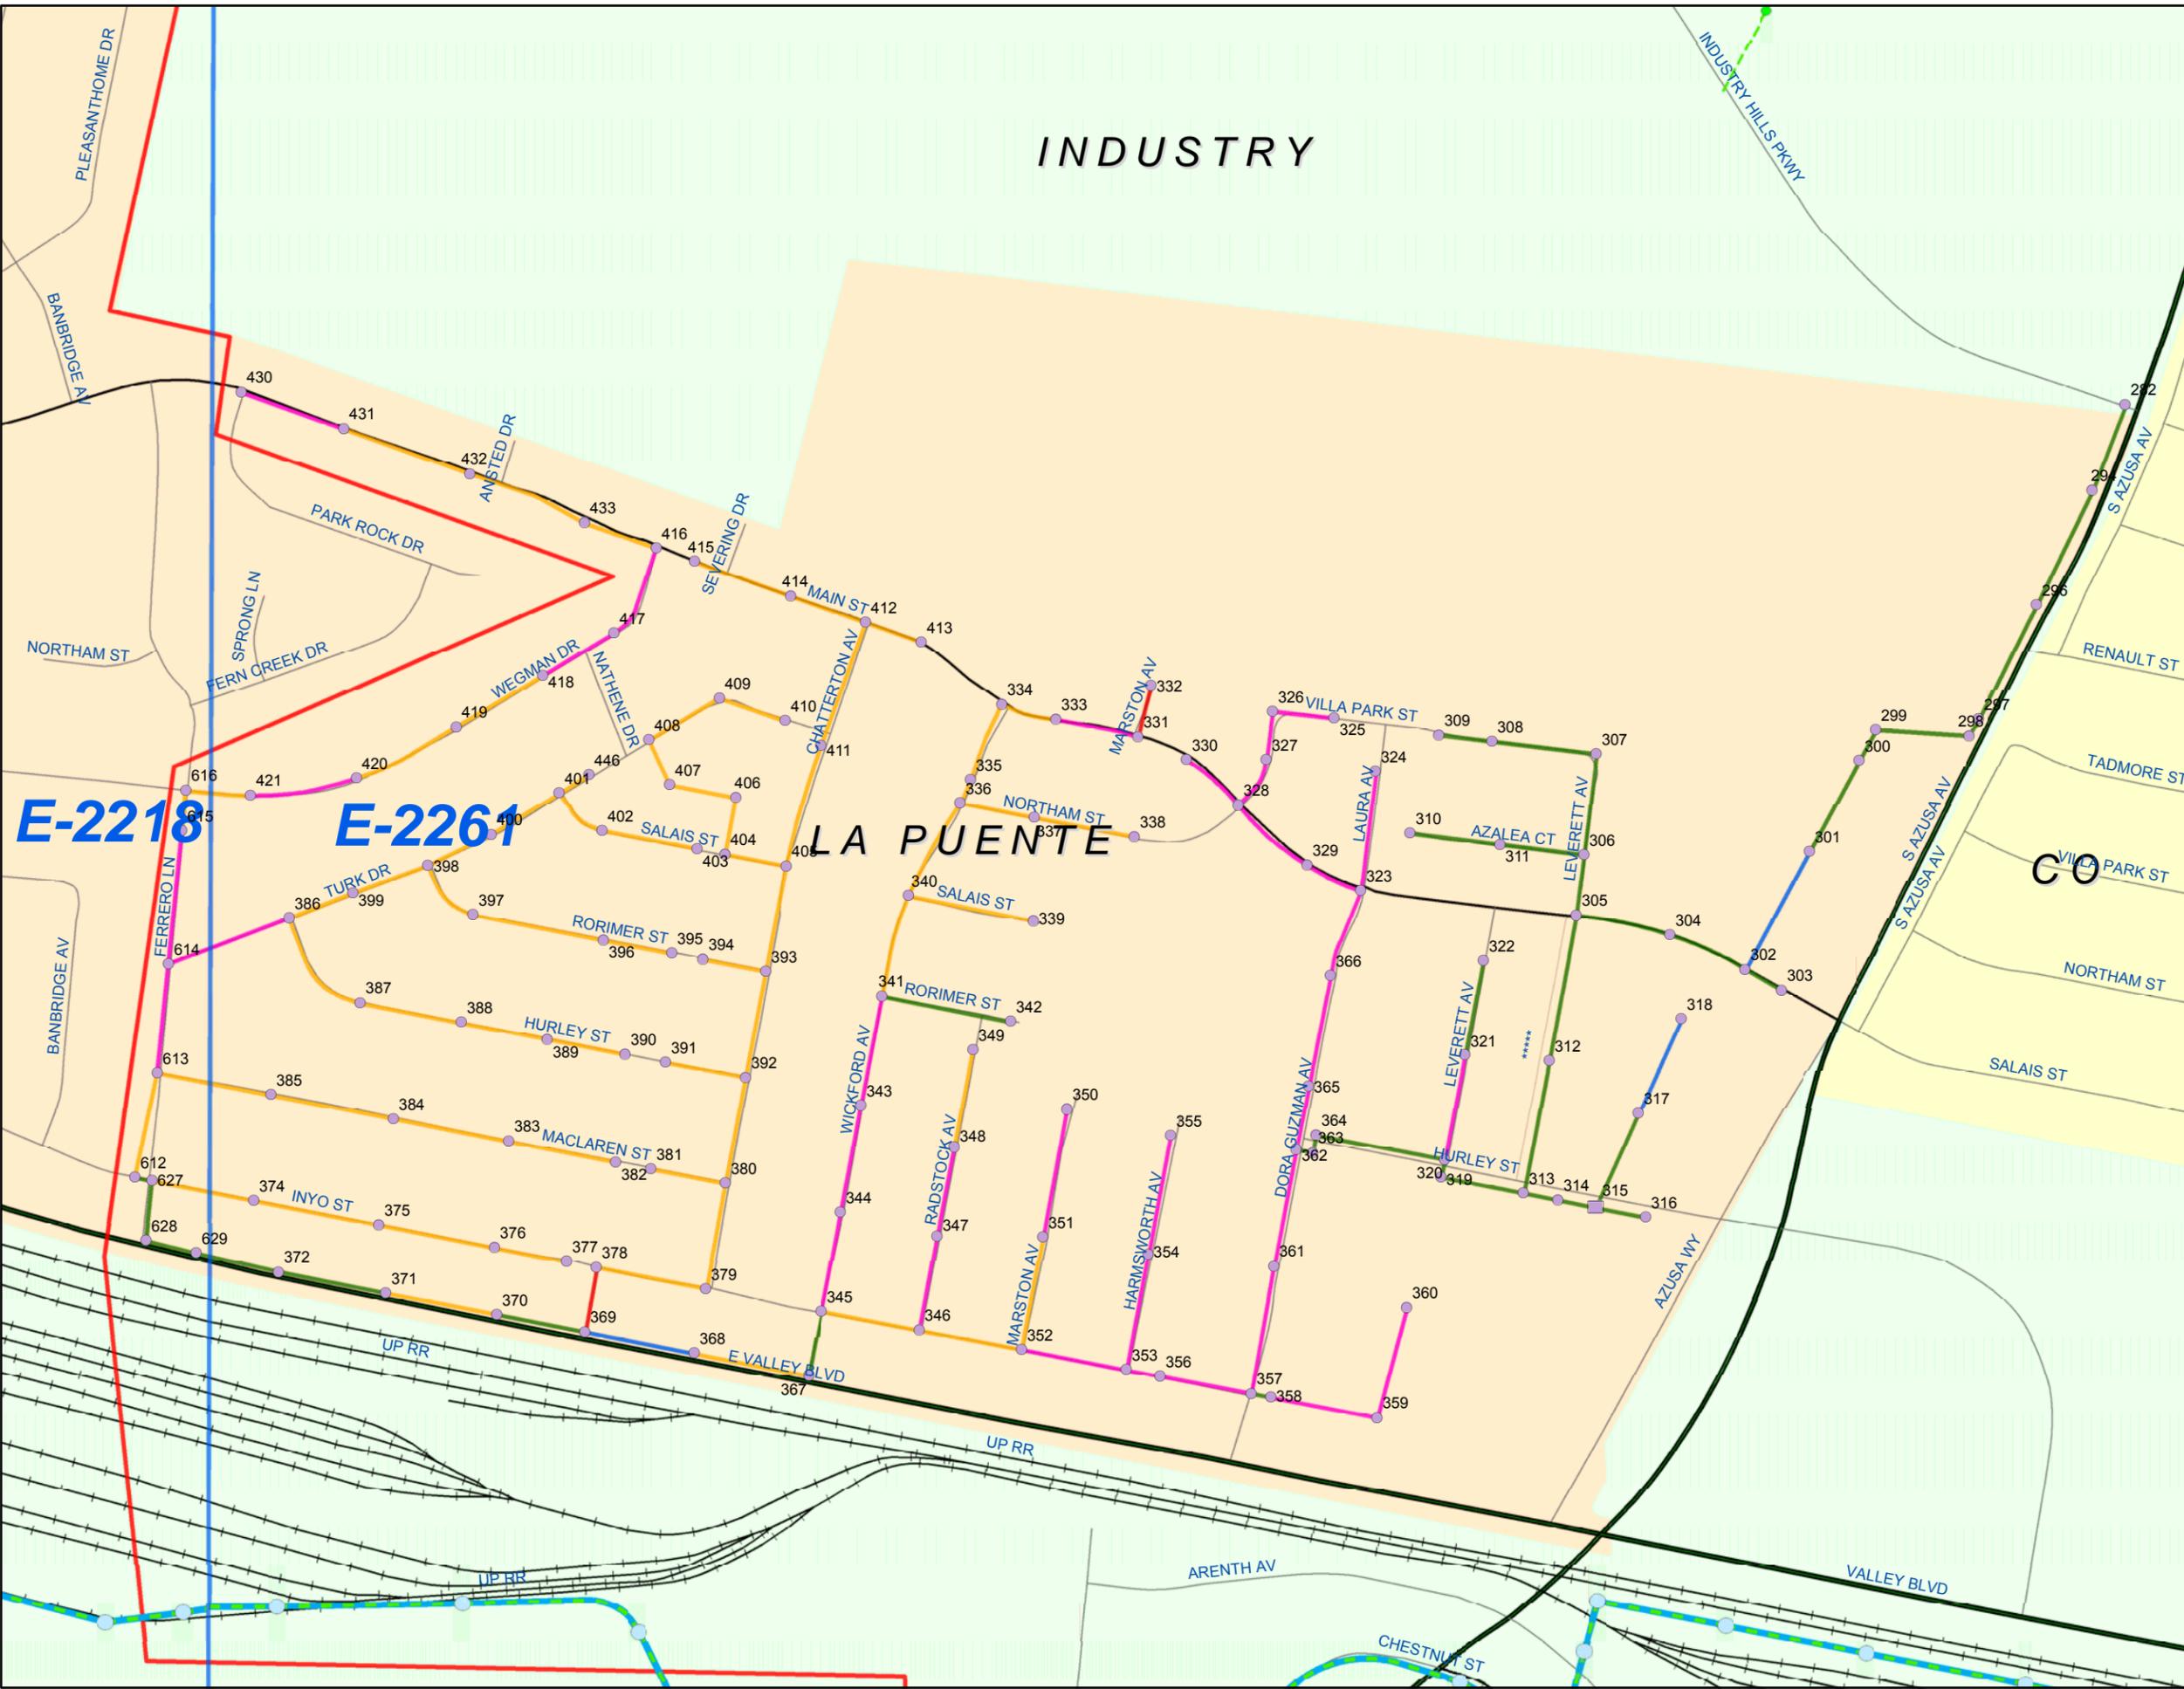
QUICK STRUCTURAL RATING (QSR)

Supervisory District 1
City of La Puente

ITEM NO.	QSR	START MH	END MH	STREET	OBSERVATION: LOCATION	PROPOSED CORRECTIVE ACTION	LENGTH OF REPAIR (FT)
1	5143	2261-0378	2261-0369	Inyo St	Broken: 135'; fractures	Lining: MH to MH	148
2	5133	2261-0332	2261-0331	Marston Av	Hole with soil visible: 91'	Structural integrity intact. No action needed.	-
3	4A00	2261-0362	2261-0361	Dora Guzman Av	Fractures and cracks (multiple locations)	Structural integrity intact. No action needed.	-
4	4831	2261-0366	2261-0365	Dora Guzman Av	Fractures and cracks (multiple locations)	Structural integrity intact. No action needed.	-
5	4726	2261-0350	2261-0351	Marston Av	Fractures and cracks (multiple locations)	Structural integrity intact. No action needed.	-
6	4721	2261-0328	2261-0329	Main St	Fractures and cracks (multiple locations)	Structural integrity intact. No action needed.	-
7	4721	2261-0354	2261-0353	Harmsworth Av	Fractures and cracks (multiple locations)	Structural integrity intact. No action needed.	-

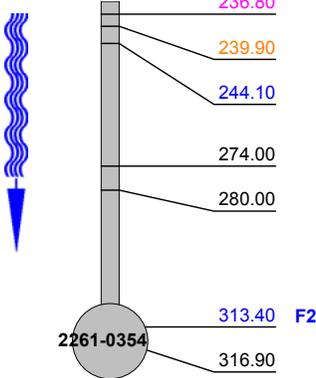
1:561	position	observation	MPEG	photo	grade
	<u>236.80</u>	Fracture Multiple, from 7 to 5 o'clock, within 8 inch: YES	00:19:33	698	S 4
	<u>239.90</u>	Fracture Longitudinal, at 9 o'clock, within 8 inch: YES	00:20:17	699	S 3
	<u>244.10</u>	Deposits Attached Other, from 8 to 4 o'clock, 5", within 8 inch: NO	00:20:49	700	M 2
	<u>274.00</u>	Tap Factory Active, at 3 o'clock, 4", within 8 inch: NO	00:21:52	701	
	<u>280.00</u>	Tap Factory Active, at 9 o'clock, 4", within 8 inch: NO	00:22:33	702	
	<u>313.40</u> F2	Deposits Attached Grease, from 4 to 8 o'clock, 5", within 8 inch: NO, End	00:23:42	703	M 2
	<u>316.90</u>	Manhole, within 8 inch: NO, Remarks: 0354-2261	00:24:36	704

QSR	QMR	SPR	MPR	OPR	SPRI	MPRI	OPRI
4631	2611	27	13	40	3.86	1.86	2.86

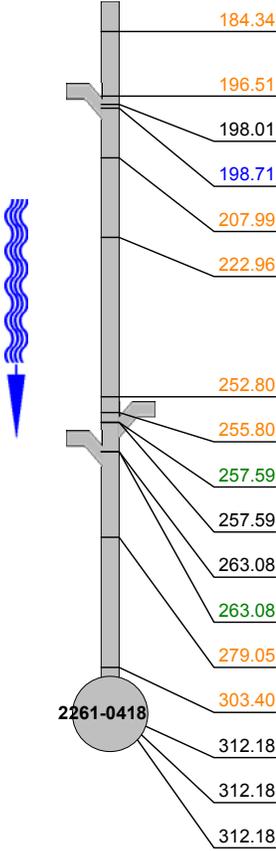
279.05	Crack Multiple, from 02 to 10 o'clock, within 8 inch: YES	00:14:46	4313a	S 3
	303.40	Crack Multiple, from 07 to 05 o'clock, within 8 inch: YES	00:15:31		S 3

312.18	General Observation, Remark: Materials found- VCP	00:16:27		
	312.18	General Observation, Remark: End of Segment	00:16:38		
	312.18	Manhole	00:16:58

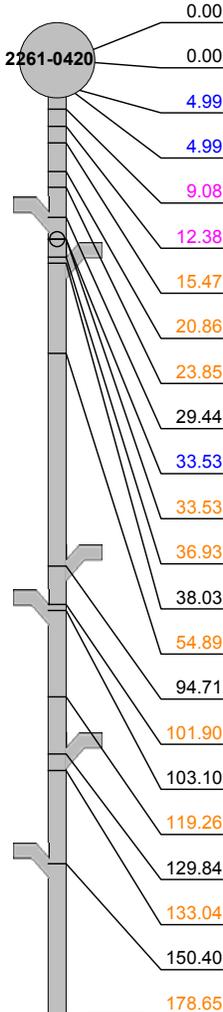
129.84	Tap Factory Made Active, at 10 o'clock, 6", within 8 inch: YES	00:09:08		
	133.04	Crack Multiple, from 07 to 09 o'clock, within 8 inch: YES	00:09:23		S 3

150.40	Tap Factory Made Active, at 02 o'clock, 6", within 8 inch: YES	00:09:52		
	178.65	Crack Multiple, from 10 to 03 o'clock, within 8 inch: YES	00:10:38		S 3

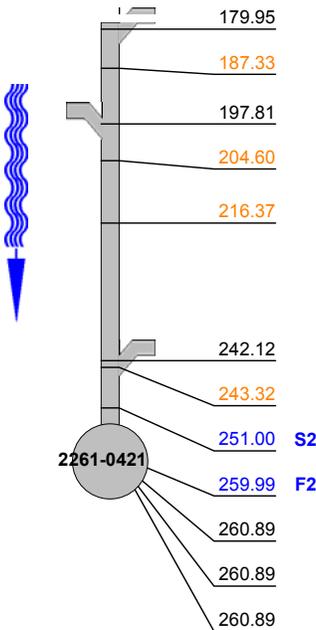
259.99 F2	Deposits Settled Gravel, 2 sq of cross sectional area, at 06 o'clock, within 8 inch: YES, end	00:14:28		M 2
	260.89	General Observation, Remark: Materials found- VCP	00:14:41

260.89	General Observation, Remark: End of Segment	00:14:47		
	260.89	Manhole	00:15:02

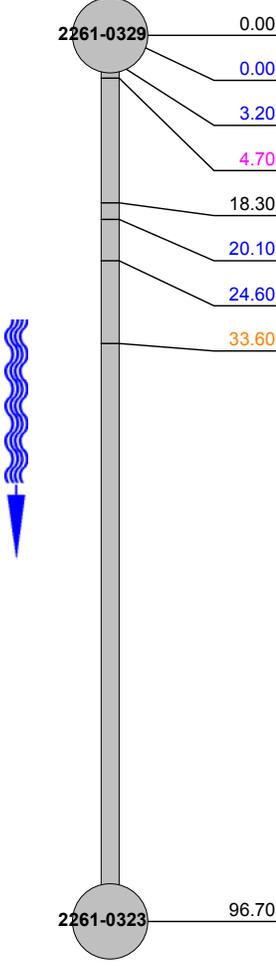
1:250	position	observation	MPEG	photo	grade
	0.00	Manhole, within 8 inch: NO, Remarks: 0329-2261	00:00:49	3841	
	0.00	Water Level, 10 ☐, within 8 inch: NO	00:01:09	3842	M 2
	3.20	Deposits Ingressed Fine, from 8 to 4 o'clock, 5 ☐, within 8 inch: NO, Remarks: SILT	00:01:34	3843	M 2
	4.70	Fracture Multiple, from 7 to 5 o'clock, within 8 inch: YES	00:02:09	3844	S 4
	18.30	Tap Factory Active, at 9 o'clock, 4", within 8 inch: NO	00:02:56	3845	
	20.10	Deposits Attached Grease, from 4 to 8 o'clock, 5 ☐, within 8 inch: NO	00:03:21	3846	M 2
	24.60	Deposits Attached Other, from 8 to 4 o'clock, 5 ☐, within 8 inch: NO	00:03:49	3847	M 2
	33.60	Crack Multiple, from 3 to 5 o'clock, within 8 inch: YES	00:04:25	3848	S 3
	96.70	Manhole, within 8 inch: NO, Remarks: 0323-2261	00:06:39	3849

QSR	QMR	SPR	MPR	OPR	SPRI	MPRI	OPRI
4131	2400	7	8	15	3.5	2	2.5
