COUNTY OF LOS ANGELES

DEPARTMENT OF PUBLIC WORKS

CONSOLIDATED SEWER MAINTENANCE DISTRICT CONDITION ASSESSMENT PROGRAM REPORT PROJECT NOS. Y0TV1314B1 AND Y0TV1314B2

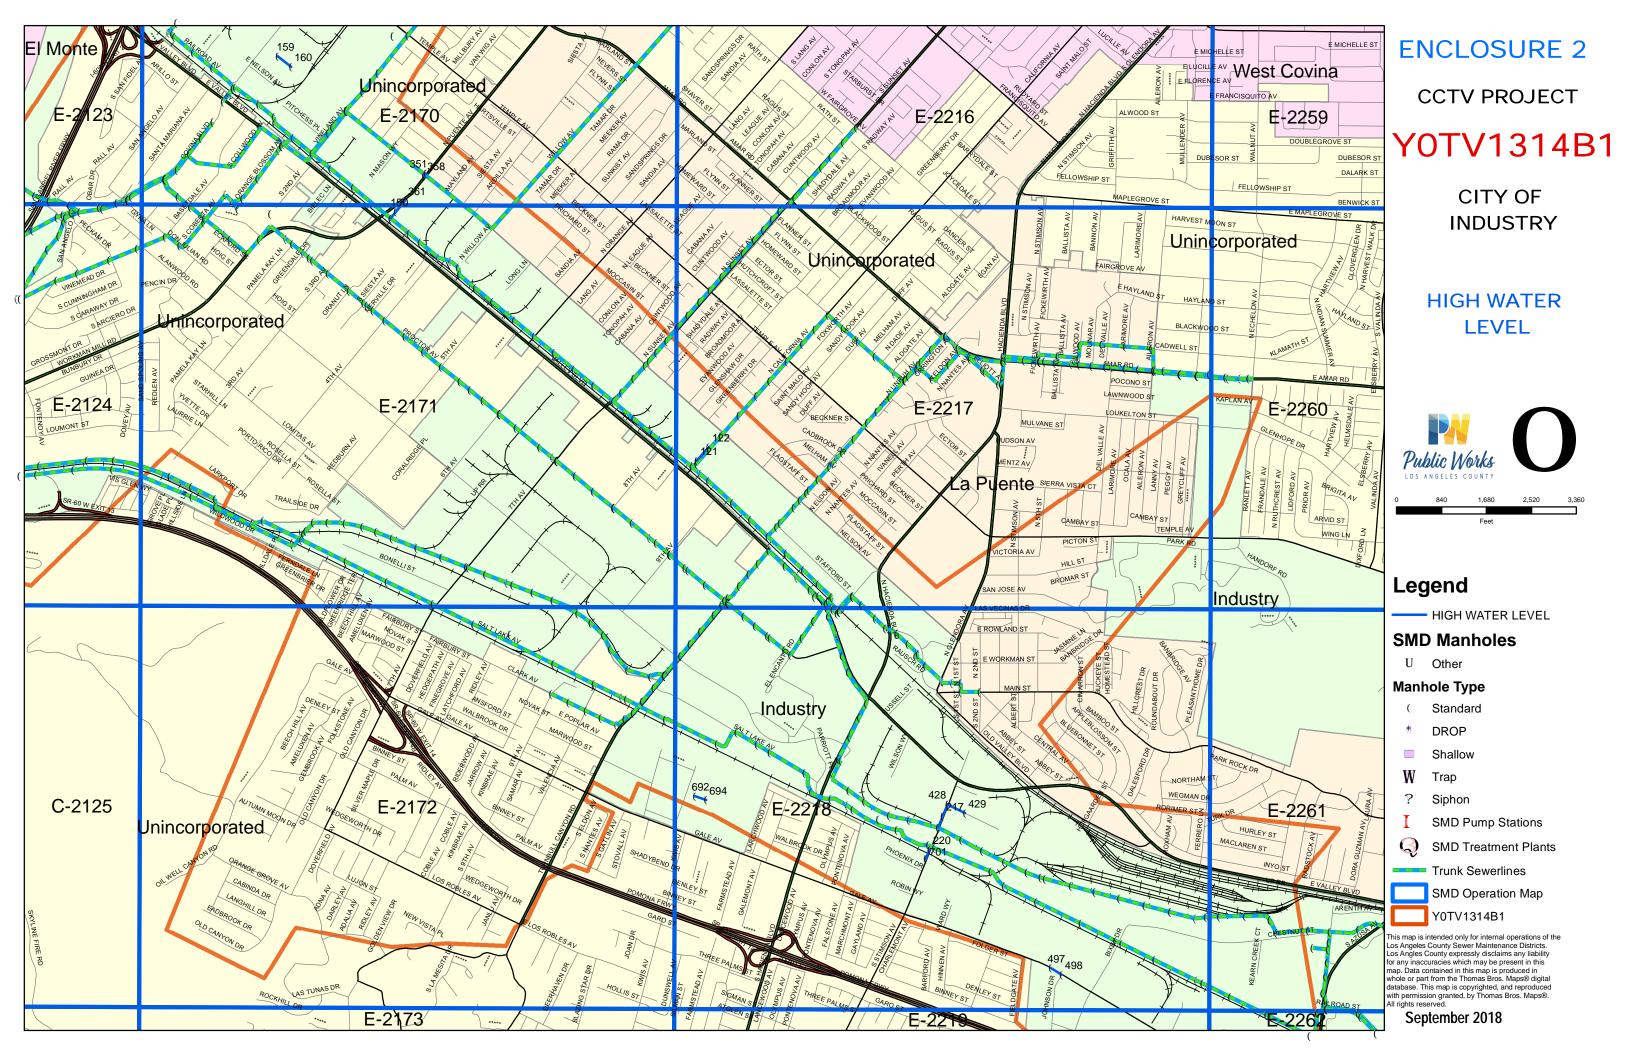
ENCLOSURE 2 HIGH WATER LEVELS CITY OF INDUSTRY (YOTV1314B1)

ITEM NO.	QMR	START MH	END MH	STREET	OBSERVATION: LOCATION	САРАСПУ	CORRECTIVE ACTION
1	4131	2170-0160	2170-0159	NELSON AV	Water Mark 70%	YES	No action needed
2	4121	2218-0498	2218-0497	GALE AV	Water Mark 70%	YES	No action needed
3	4112	2217-0122	2217-0121	CALIFORNIA AV	Water Mark 55%	YES	No action needed
4	4112	2170-0351	2170-0358	PUENTE AV	Water Mark 55%	YES	No action needed
5	4111	2218-0429	2218-0428	STEPHENS ST	Water Mark 50%	YES	No action needed
6	4111	2218-0428	2218-0217	STIMSON AV	Water Mark 50%	NO	No action needed
7	4111	2218-0217	2218-TRNK	STIMSON AV	Water Mark 50%	NO	No action needed
8	4111	2218-0701	2218-0220	STIMSON AV	Water Mark 55%	YES	No action needed
9	4111	2171-0150	2171-TRNK	PUENTE AV	Water Mark 55%	YES	No action needed
10	QSR	2218-0694	2218-0692	GALE AVE EASEMENT	Sag	NO	Hydrojet
11	QSR	2170-0361	2171-0150	PUENTE AV	Sag	NO	Hydrojet

All sewer pipes where the Water Level, Water Mark, and miscellaneous remarks of camera underwater or sags in the line are at or above 50 percent capacity have been listed and analyzed on the High Water Level Table in Enclosure 2. The nature of these high water level conditions is also summarized on this table.

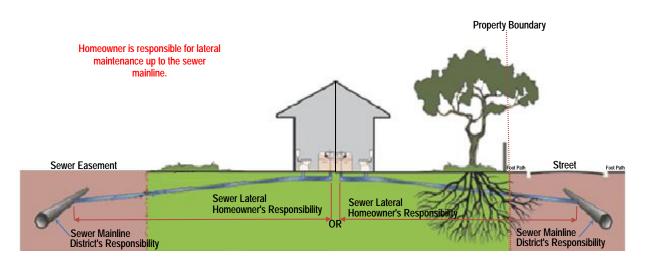
SEWER LATERALS - AREAS OF RESPONSIBILITY

The sewer system within the District is comprised of a series of underground pipes. Many are publicly owned; however, the sewer laterals are entirely owned by the private property owner they serve. The laterals extend from the building to the mainline within the street (or within an easement at the rear of your home). The laterals are typically four inches in diameter while the District's mainline is typically at least eight inches in diameter. The private property owner is responsible for the entire length of the lateral, which includes the portion that may be located within the public right of way (under the asphalt and street landscaping).
