CONSOLIDATED SEWER MAINTENANCE DISTRICT CONDITION ASSESSMENT PROGRAM REPORT PROJECT Y0TV0607A

This letter is to inform you that as part of the Sewer Condition Assessment Program, the County of Los Angeles Department of Public Works Consolidated Sewer Maintenance District has completed the closed-circuit television (CCTV) inspection of 176,600 feet or 100 percent of the City of Lawndale's sewer system.

The enclosed report outlines the structural and maintenance ratings of your system based on the Pipeline Assessment and Certification Program's (PACP) rating methodology. Included in the report are the following:

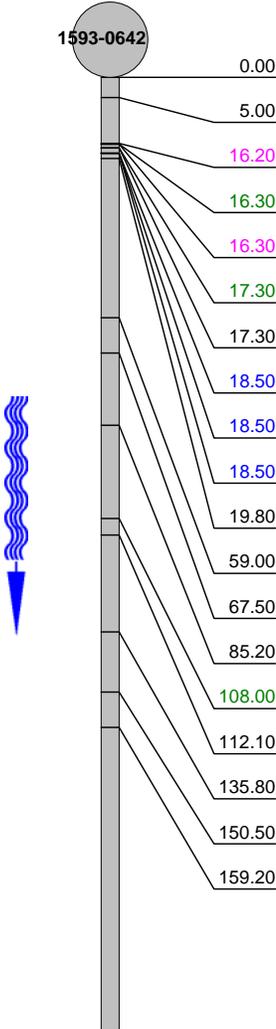
112.10	TFC	Tap Factory Capped, at 9 o'clock, 6", within 8 inch: NO		00:21:09	7736
	135.80	TFA	Tap Factory Active, at 3 o'clock, 6", within 8 inch: NO		00:22:23	7737

150.50	TFC	Tap Factory Capped, at 3 o'clock, 6", within 8 inch: NO		00:23:23	7738
	159.20	TFC	Tap Factory Capped, at 9 o'clock, 6", within 8 inch: NO		00:24:16	7739

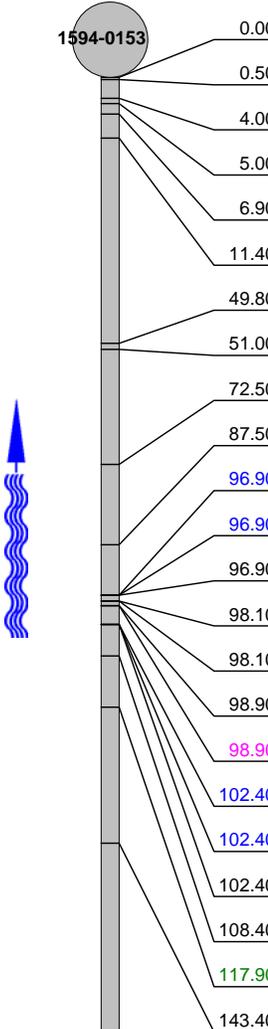
0.00	AMH	Manhole, within 8 inch: NO, Remarks: 1594-0153		00:00:42	8088
	0.50	CC	Crack Circumferential, from 7 to 6 o'clock, within 8 inch: NO	S 1	00:02:38	8089

4.00	RFJ	Roots Fine Joint, from 7 to 5 o'clock, within 8 inch: YES	M 1	00:03:26	8090
	5.00	MWL	Water Level, 5 %, within 8 inch: NO		00:04:30	8091
	6.90	RFJ	Roots Fine Joint, from 7 to 5 o'clock, within 8 inch: YES	M 1	00:05:00	8092

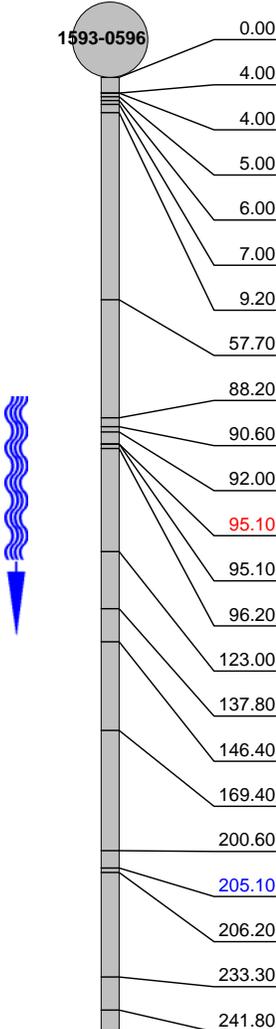
0.00	AMH	Manhole, within 8 inch: NO, Remarks: 1593-0596		00:00:28	3448
	4.00	CC	Crack Circumferential, from 7 to 2 o'clock, within 8 inch: YES	S 1	00:01:27	3449

4.00	RFJ	Roots Fine Joint, from 4 to 8 o'clock, within 8 inch: YES	M 1	00:01:45	3450
	5.00	TFA	Tap Factory Active, at 9 o'clock, 6", within 8 inch: NO		00:02:31	3451

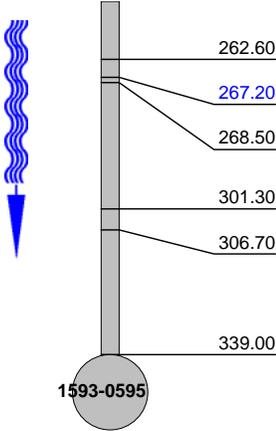
Date: 02/07/2007	P.O.#: Y0TV0607A	Weather: 1 Dry	Surveyed By: MARTIN GARCIA	section number: 630	PSR: 73046
Total Pipe Length: 318.00	Survey Customer: LAW	System Owner: LAW	Clean Date: 02/05/2007	Pre-Cleaned: J Jetting	Map Grid #: 1593

1:594	position	code	observation	grade	MPEG	photo
	262.60	TFA	Tap Factory Active, at 3 o'clock, 6", within 8 inch: NO		00:17:33	3471
	267.20	CL	Crack Longitudinal, at 9 o'clock, within 8 inch: YES	S 2	00:18:12	3472
	268.50	TFA	Tap Factory Active, at 10 o'clock, 6", within 8 inch: NO		00:18:45	3473
	301.30	TFA	Tap Factory Active, at 10 o'clock, 6", within 8 inch: NO		00:20:01	3474
	306.70	TFA	Tap Factory Active, at 3 o'clock, 6", within 8 inch: NO		00:20:32	3475
	339.00	AMH	Manhole, within 8 inch: NO, Remarks: 1593-0595		00:21:54	3476

QSR	QMR	SPR	MPR	OPR	SPRI	MPRI	OPRI
5122	1200	13	2	15	1.86	1	1.67

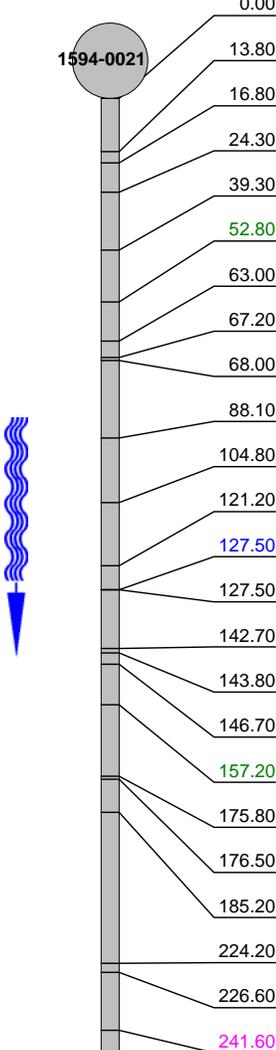
185.20	TFA	Tap Factory Active, at 9 o'clock, 6", within 8 inch: NO		00:14:36	4560
	224.20	TFA	Tap Factory Active, at 3 o'clock, 6", within 8 inch: NO		00:16:38	4561

226.60	TFA	Tap Factory Active, at 9 o'clock, 6", within 8 inch: NO		00:17:09	4562
	241.60	FM	Fracture Multiple, from 3 to 9 o'clock, within 8 inch: YES	S 4	00:25:47	4563

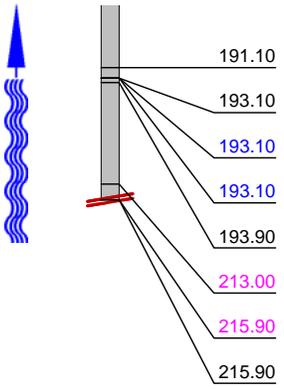
1:429	position	code	observation	grade	MPEG	photo
	<u>191.10</u>	TFA	Tap Factory Active, at 2 o'clock, 6", within 8 inch: NO		00:16:58	4925
	<u>193.10</u>	JOM	Joint Offset Medium, within 8 inch: NO	S 1	00:17:39	4926
	<u>193.10</u>	CL	Crack Longitudinal, at 9 o'clock, within 8 inch: YES	S 2	00:18:08	4927
	<u>193.10</u>	CL	Crack Longitudinal, at 2 o'clock, within 8 inch: YES	S 2	00:18:36	4928
	<u>193.90</u>	TFA	Tap Factory Active, at 12 o'clock, 6", within 8 inch: NO		00:19:12	4929
	<u>213.00</u>	FM	Fracture Multiple, from 5 to 12 o'clock, within 8 inch: YES	S 4	00:20:38	4930
	<u>215.90</u>	FM	Fracture Multiple, from 5 to 11 o'clock, within 8 inch: YES	S 4	00:21:51	4931
	<u>215.90</u>	MSA	Abandoned Survey, within 8 inch: NO, Remarks: Due To Fracture Multiple		00:22:50	4932

QSR	QMR	SPR	MPR	OPR	SPRI	MPRI	OPRI
4232	4132	21	13	34	2.33	2.17	2.27
