**CONSOLIDATED SEWER MAINTENANCE DISTRICT  
CONDITION ASSESSMENT PROGRAM REPORT  
PROJECT Y0TV0708B**

This memo is to inform you that as part of the Sewer Condition Assessment Program, the County of Los Angeles Department of Public Works Consolidated Sewer Maintenance District has completed the closed-circuit television (CCTV) inspection of 253,931 feet or approximately 14.7 percent of the sewer system within Unincorporated County Supervisorial Districts 1 and 4.

The Sewer Condition Assessment Program utilizes the Pipeline Assessment and Certification Program (PACP). The attached report outlines the structural and maintenance ratings of your system based on PACP's rating methodology. Included in the report are the following:

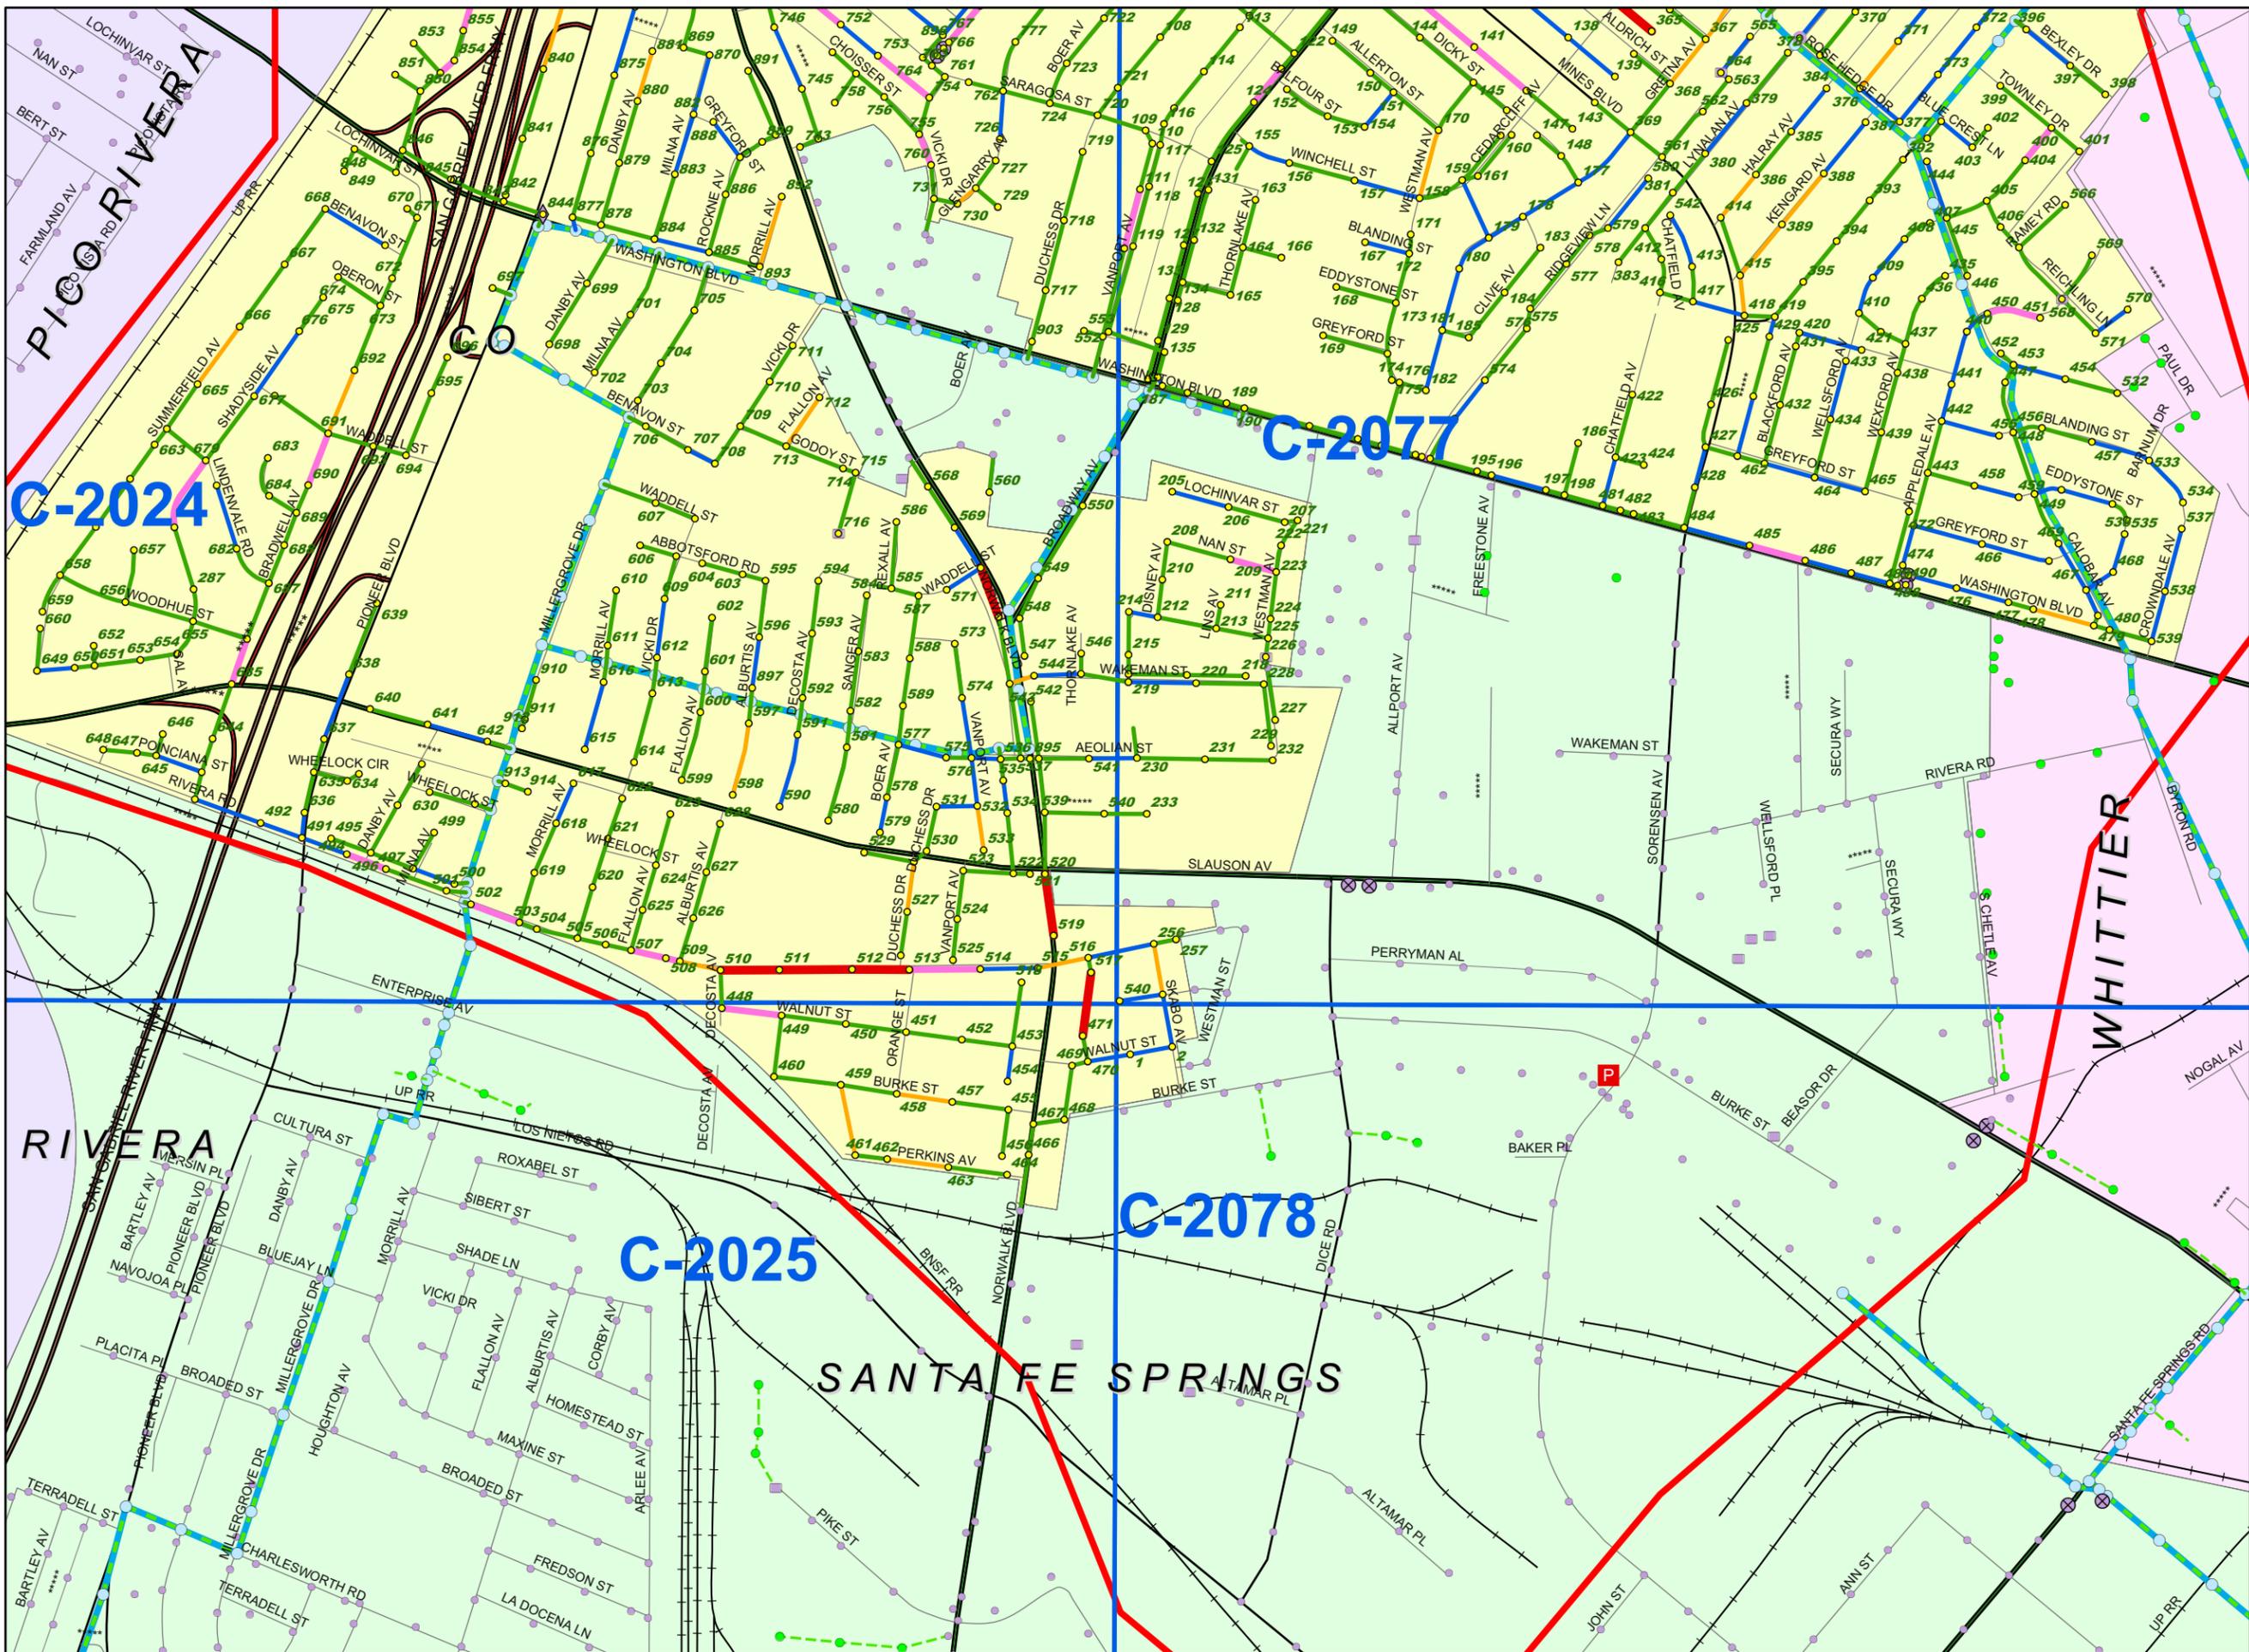
# QUICK MAINTENANCE RATING (QMR)

# ENCLOSURE 2

## CCTV PROJECT

Supervisory District 4  
County Unincorporated

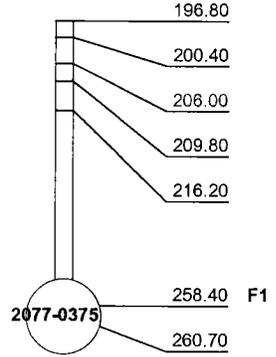
1:496	position	observation	MPEG	photo	grade
	196.80	Crack Circumferential, from 8 to 4 o'clock, within 8 inch: YES	00:18:22	2480	
	200.40	Water Level, 15 %, within 8 inch: NO	00:18:46	2481	
	206.00	Broken, from 10 to 2 o'clock, within 8 inch: YES	00:19:45	2482	S 5
	209.80	Water Level, 10 %, within 8 inch: NO	00:20:03	2483	
	216.20	Tap Factory Capped, at 9 o'clock, 6", within 8 inch: NO	00:20:27	2484	
	258.40 F1	Crack Circumferential, from 7 to 5 o'clock, within 8 inch: YES, End	00:22:10	2485	
	260.70	Manhole, within 8 inch: NO, Remarks: 2077-0375	00:22:31	2486

QSR	QMR	SPR	MPR	OPR	SPRI	MPRI	OPRI
5143	0000	17	0	17	4.25	0	4.25

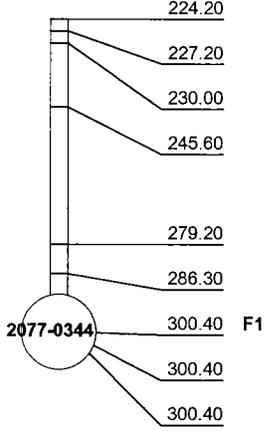
Date: <b>11/19/2007</b>	P.O.#: <b>YOTV0708B</b>	Weather: <b>Dry</b>	Surveyed By: <b>Martin Garcia</b>	section number: <b>1065</b>	PSR: <b>119286</b>
Total Pipe Length: <b>312.00</b>	Survey Customer: <b>LACDPW</b>	System Owner:	Clean Date: <b>11/16/2007</b>	Pre-Cleaned: <b>Jetting</b>	Map Grid #:

1:558	position	observation	MPEG	photo	grade
	<u>224.20</u>	Broken Soil Visible, from 8 to 10 o'clock, within 8 inch: YES	00:19:03	2266, b	
	<u>227.20</u>	Fracture Circumferential, from 7 to 5 o'clock, within 8 inch: YES	00:19:45	2268	
	<u>230.00</u>	Fracture Circumferential, from 7 to 5 o'clock, within 8 inch: YES	00:20:10	2269, b	
	<u>245.60</u>	General Observation, within 8 inch: NO, Remarks: CHIPPED PIPE	00:22:05	2271	
	<u>279.20</u>	Broken Soil Visible, from 7 to 11 o'clock, within 8 inch: YES	00:23:43	2272, b	
	<u>286.30</u>	Tap Factory Active, at 3 o'clock, 6", within 8 inch: NO	00:24:38	2274	
	<u>300.40</u> F1	Crack Circumferential, from 7 to 5 o'clock, within 8 inch: YES, End	00:25:27	2275	
	<u>300.40</u>	Vermin Cockroach, within 8 inch: NO	00:25:46	2276	
	<u>300.40</u>	Manhole, within 8 inch: NO, Remarks: 2077-0344	00:26:03	2277
