**CONSOLIDATED SEWER MAINTENANCE DISTRICT
CONDITION ASSESSMENT PROGRAM REPORT
PROJECT Y0TV0708G**

This memo is to inform you that as part of the Sewer Condition Assessment Program, the County of Los Angeles Department of Public Works Consolidated Sewer Maintenance District (District) has completed the closed-circuit television (CCTV) inspection of 359,110 feet or approximately 17 percent of the sewer system within Unincorporated County maintained by the District's South Yard

The attached report outlines the structural and maintenance ratings of your system based on the Pipeline Assessment and Certification Program's rating methodology. Included in the report are the following:

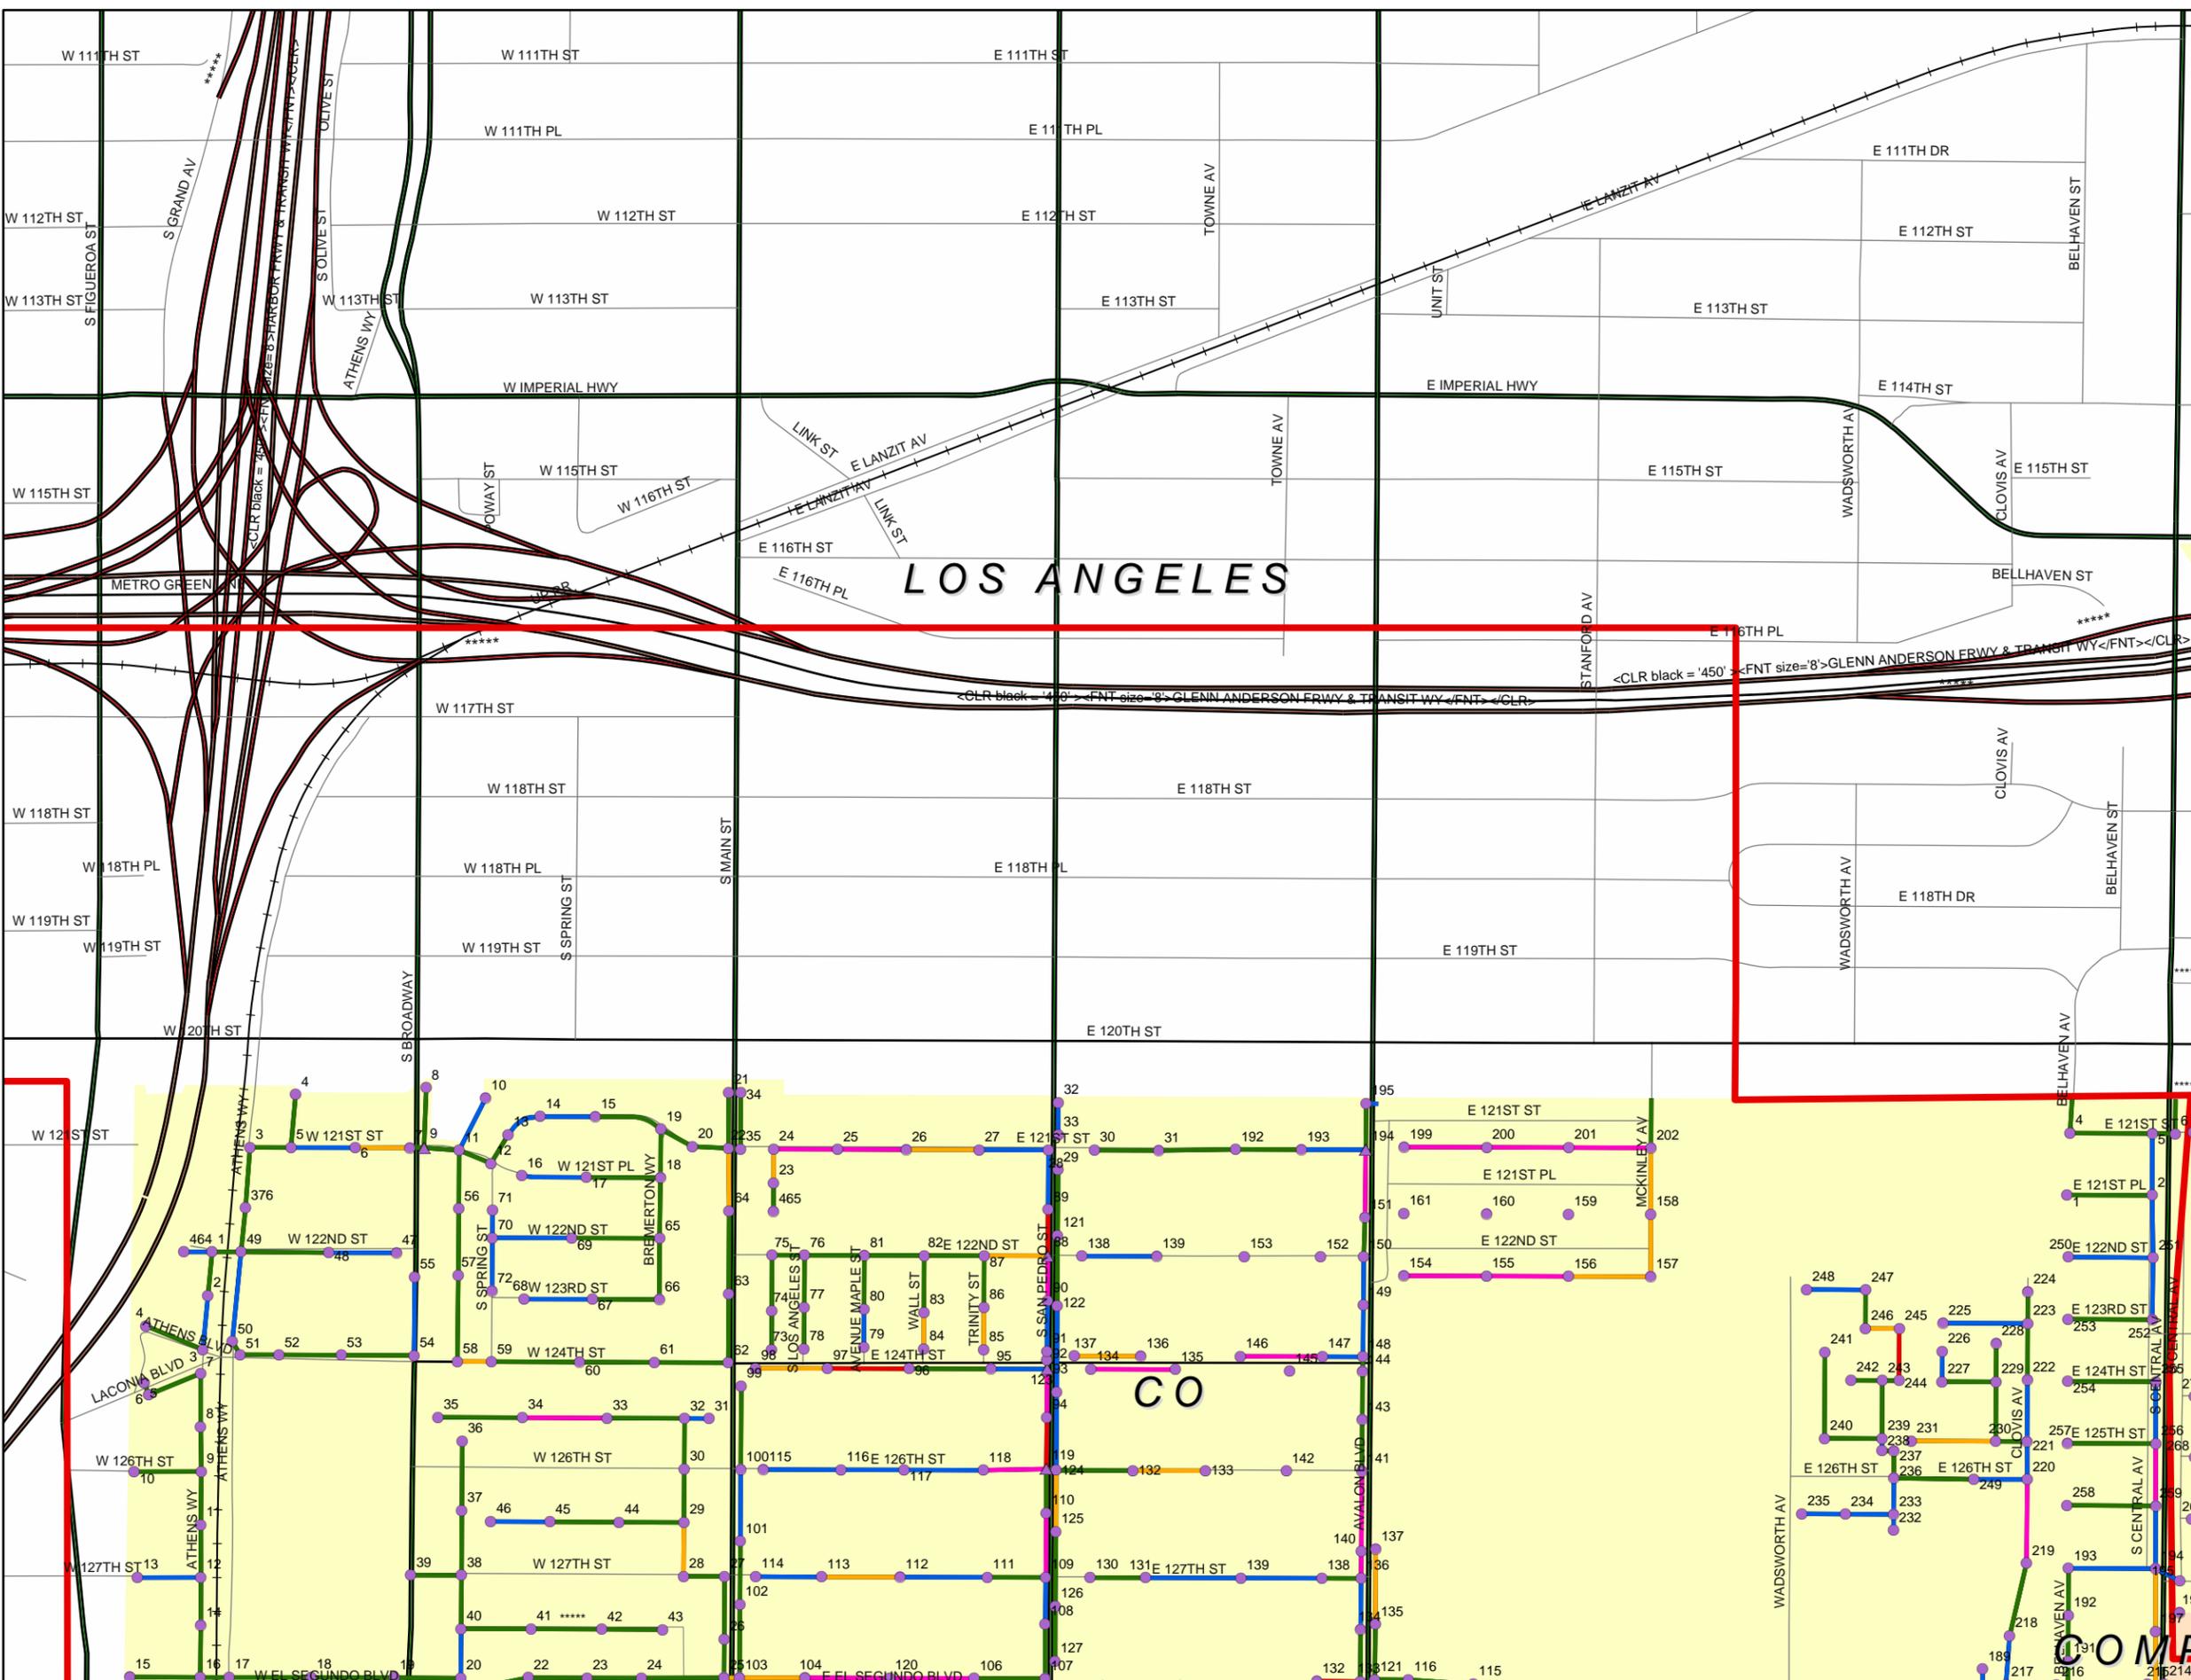
Supervisorial District 5
Unincorporated County

QUICK MAINTENANCE RATING (QMR)

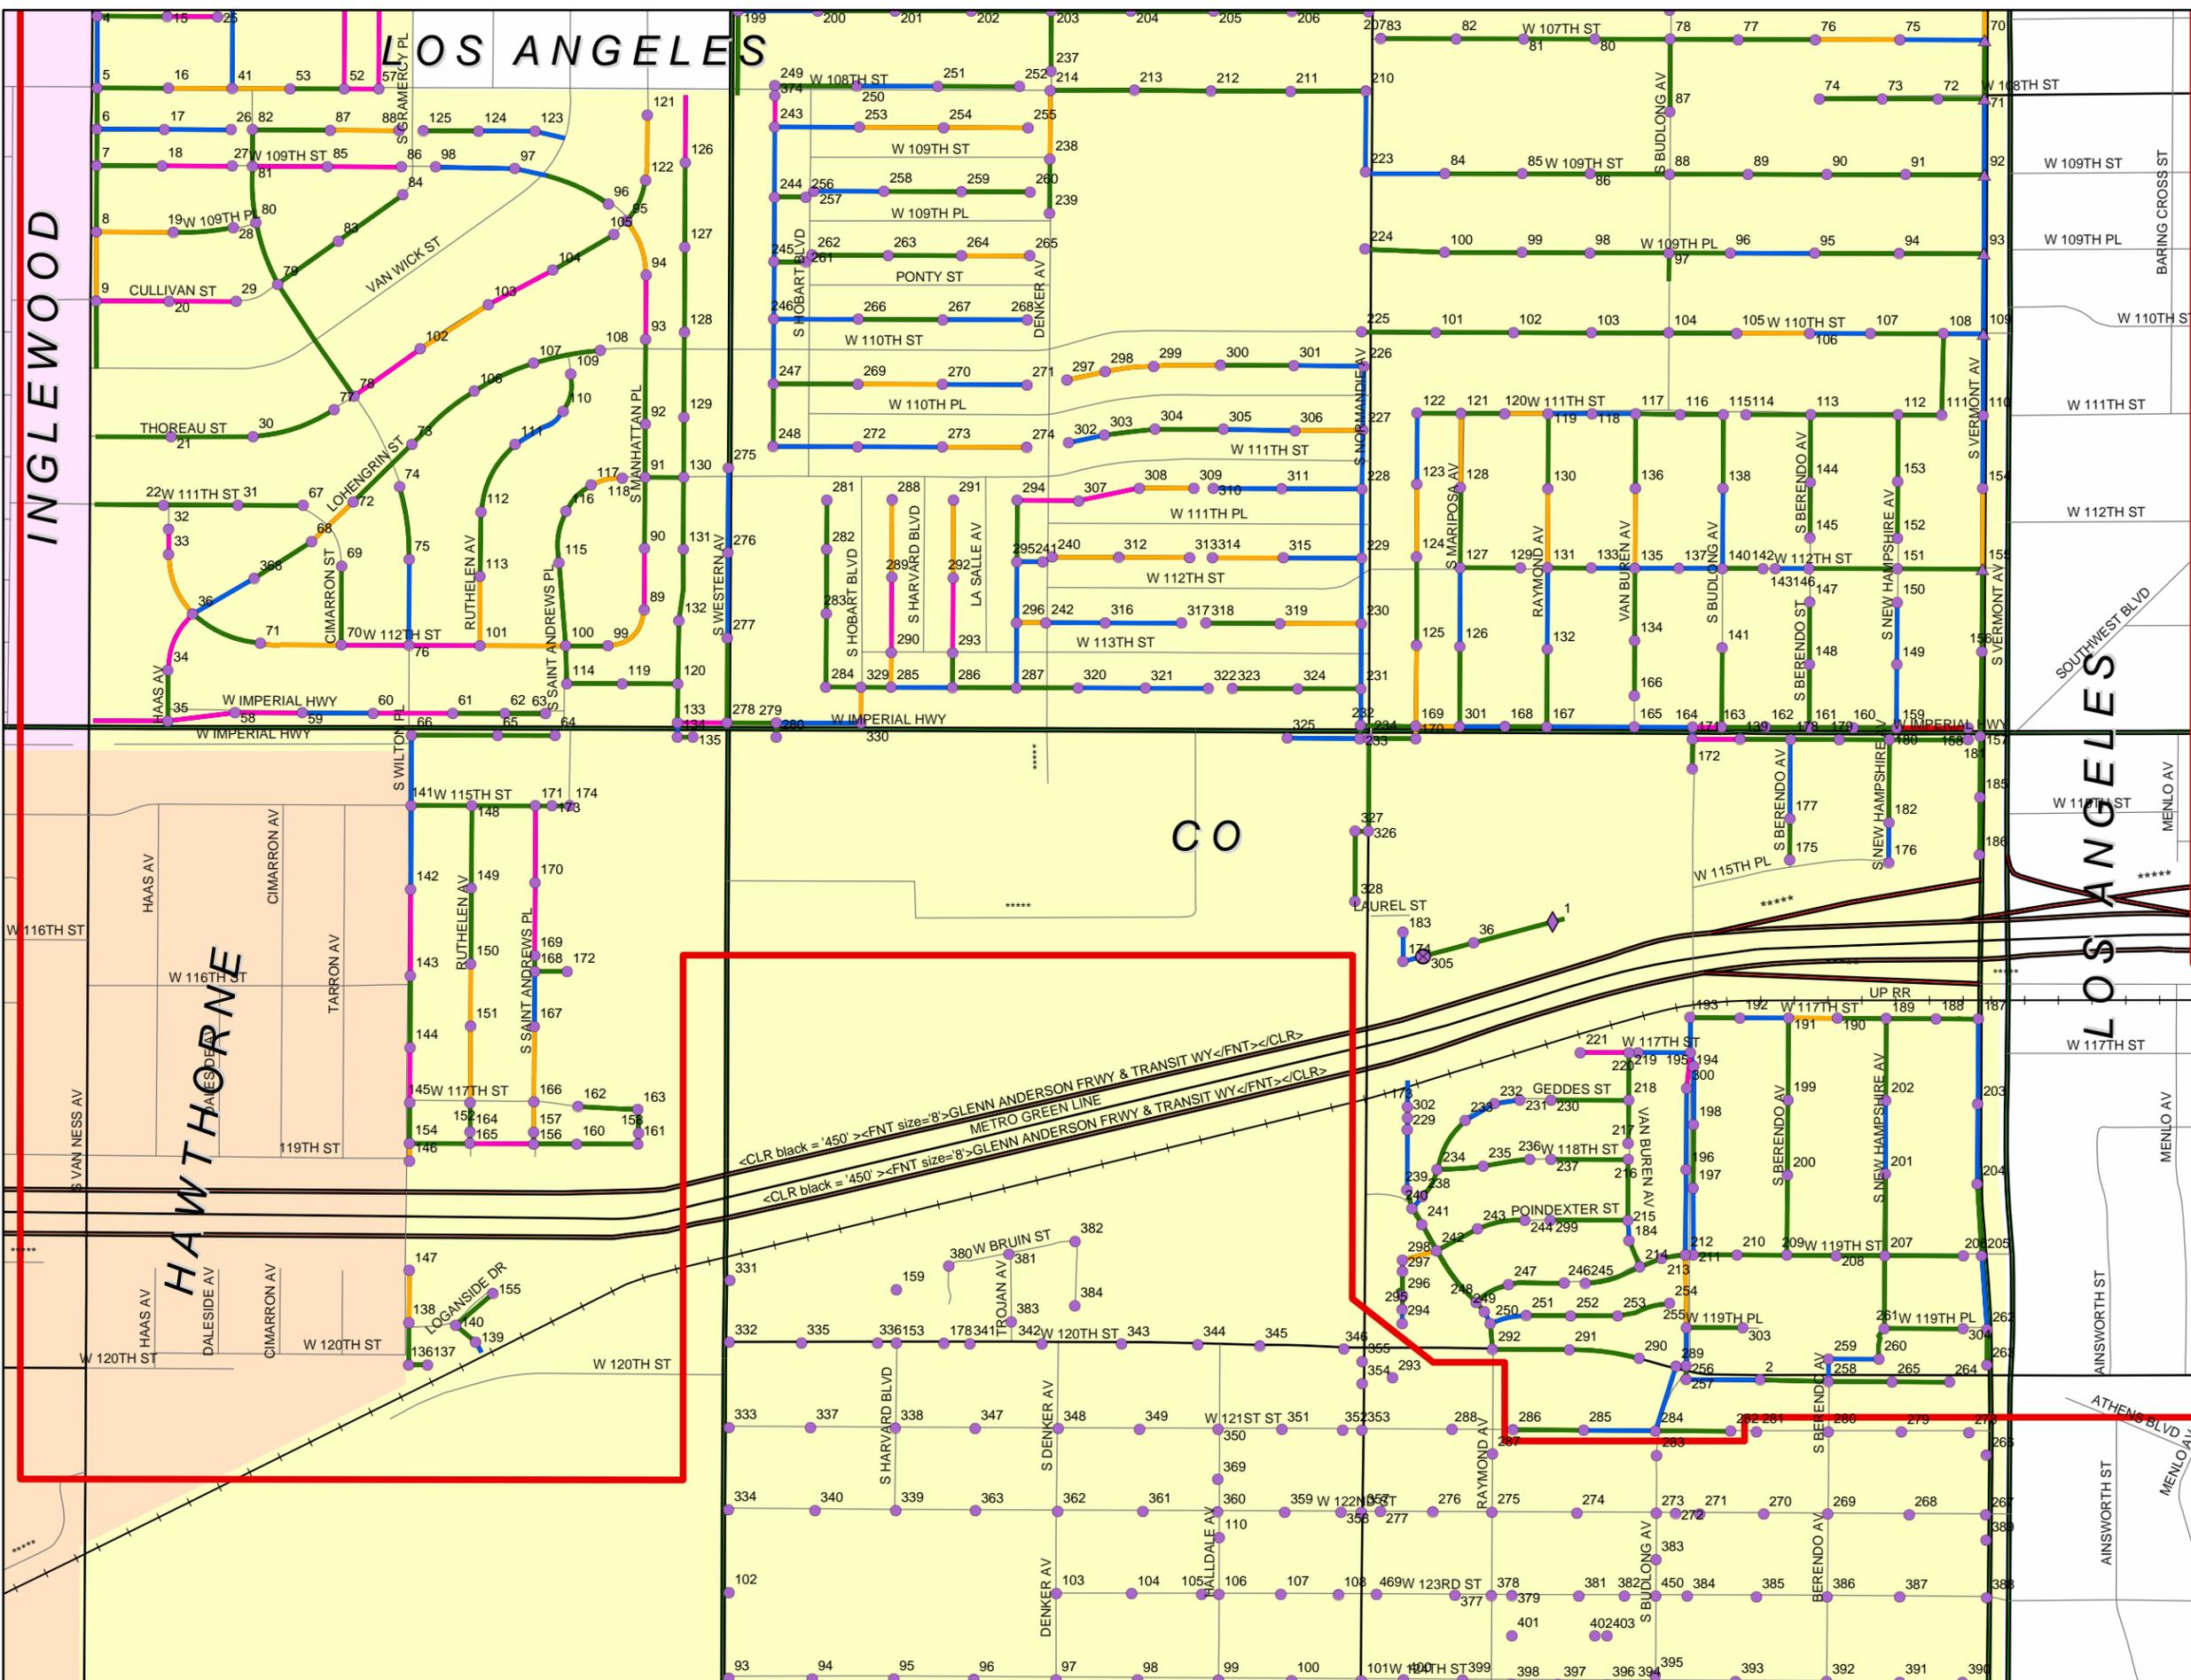
Supervisorial District 5
Unincorporated County

QUICK MAINTENANCE RATING (QMR)

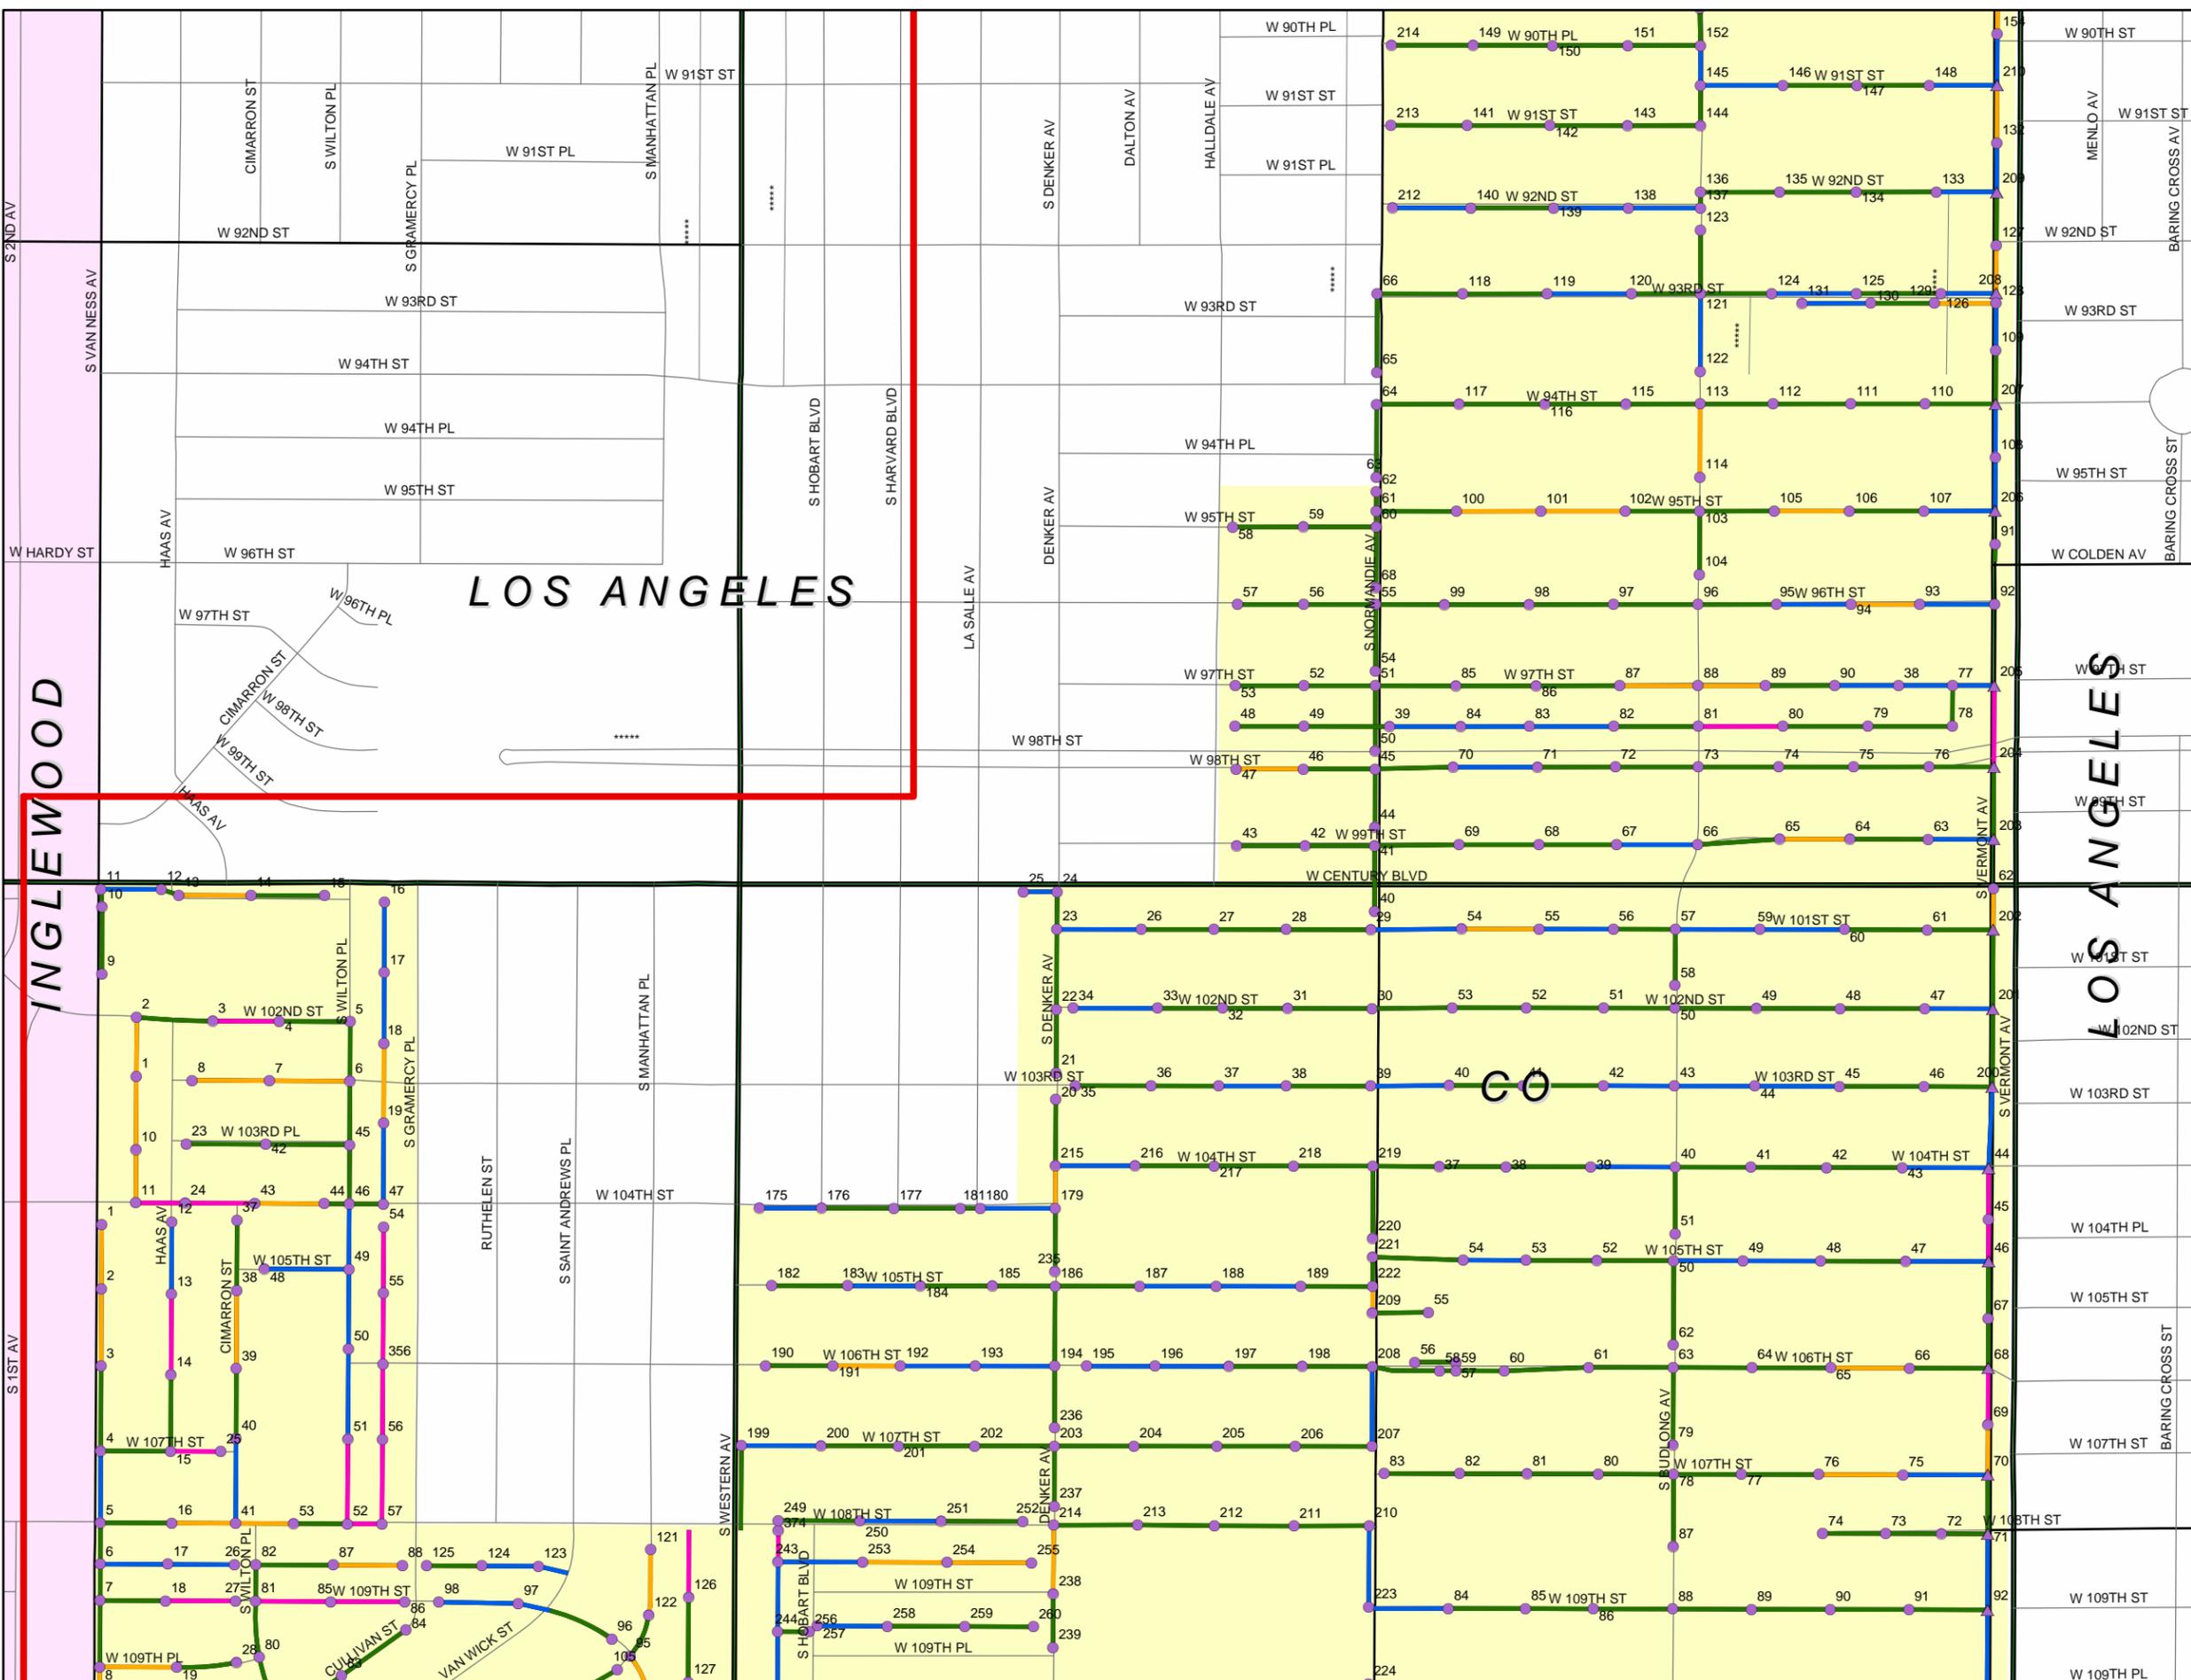
Supervisorial District 5
Unincorporated County

QUICK MAINTENANCE RATING (QMR)

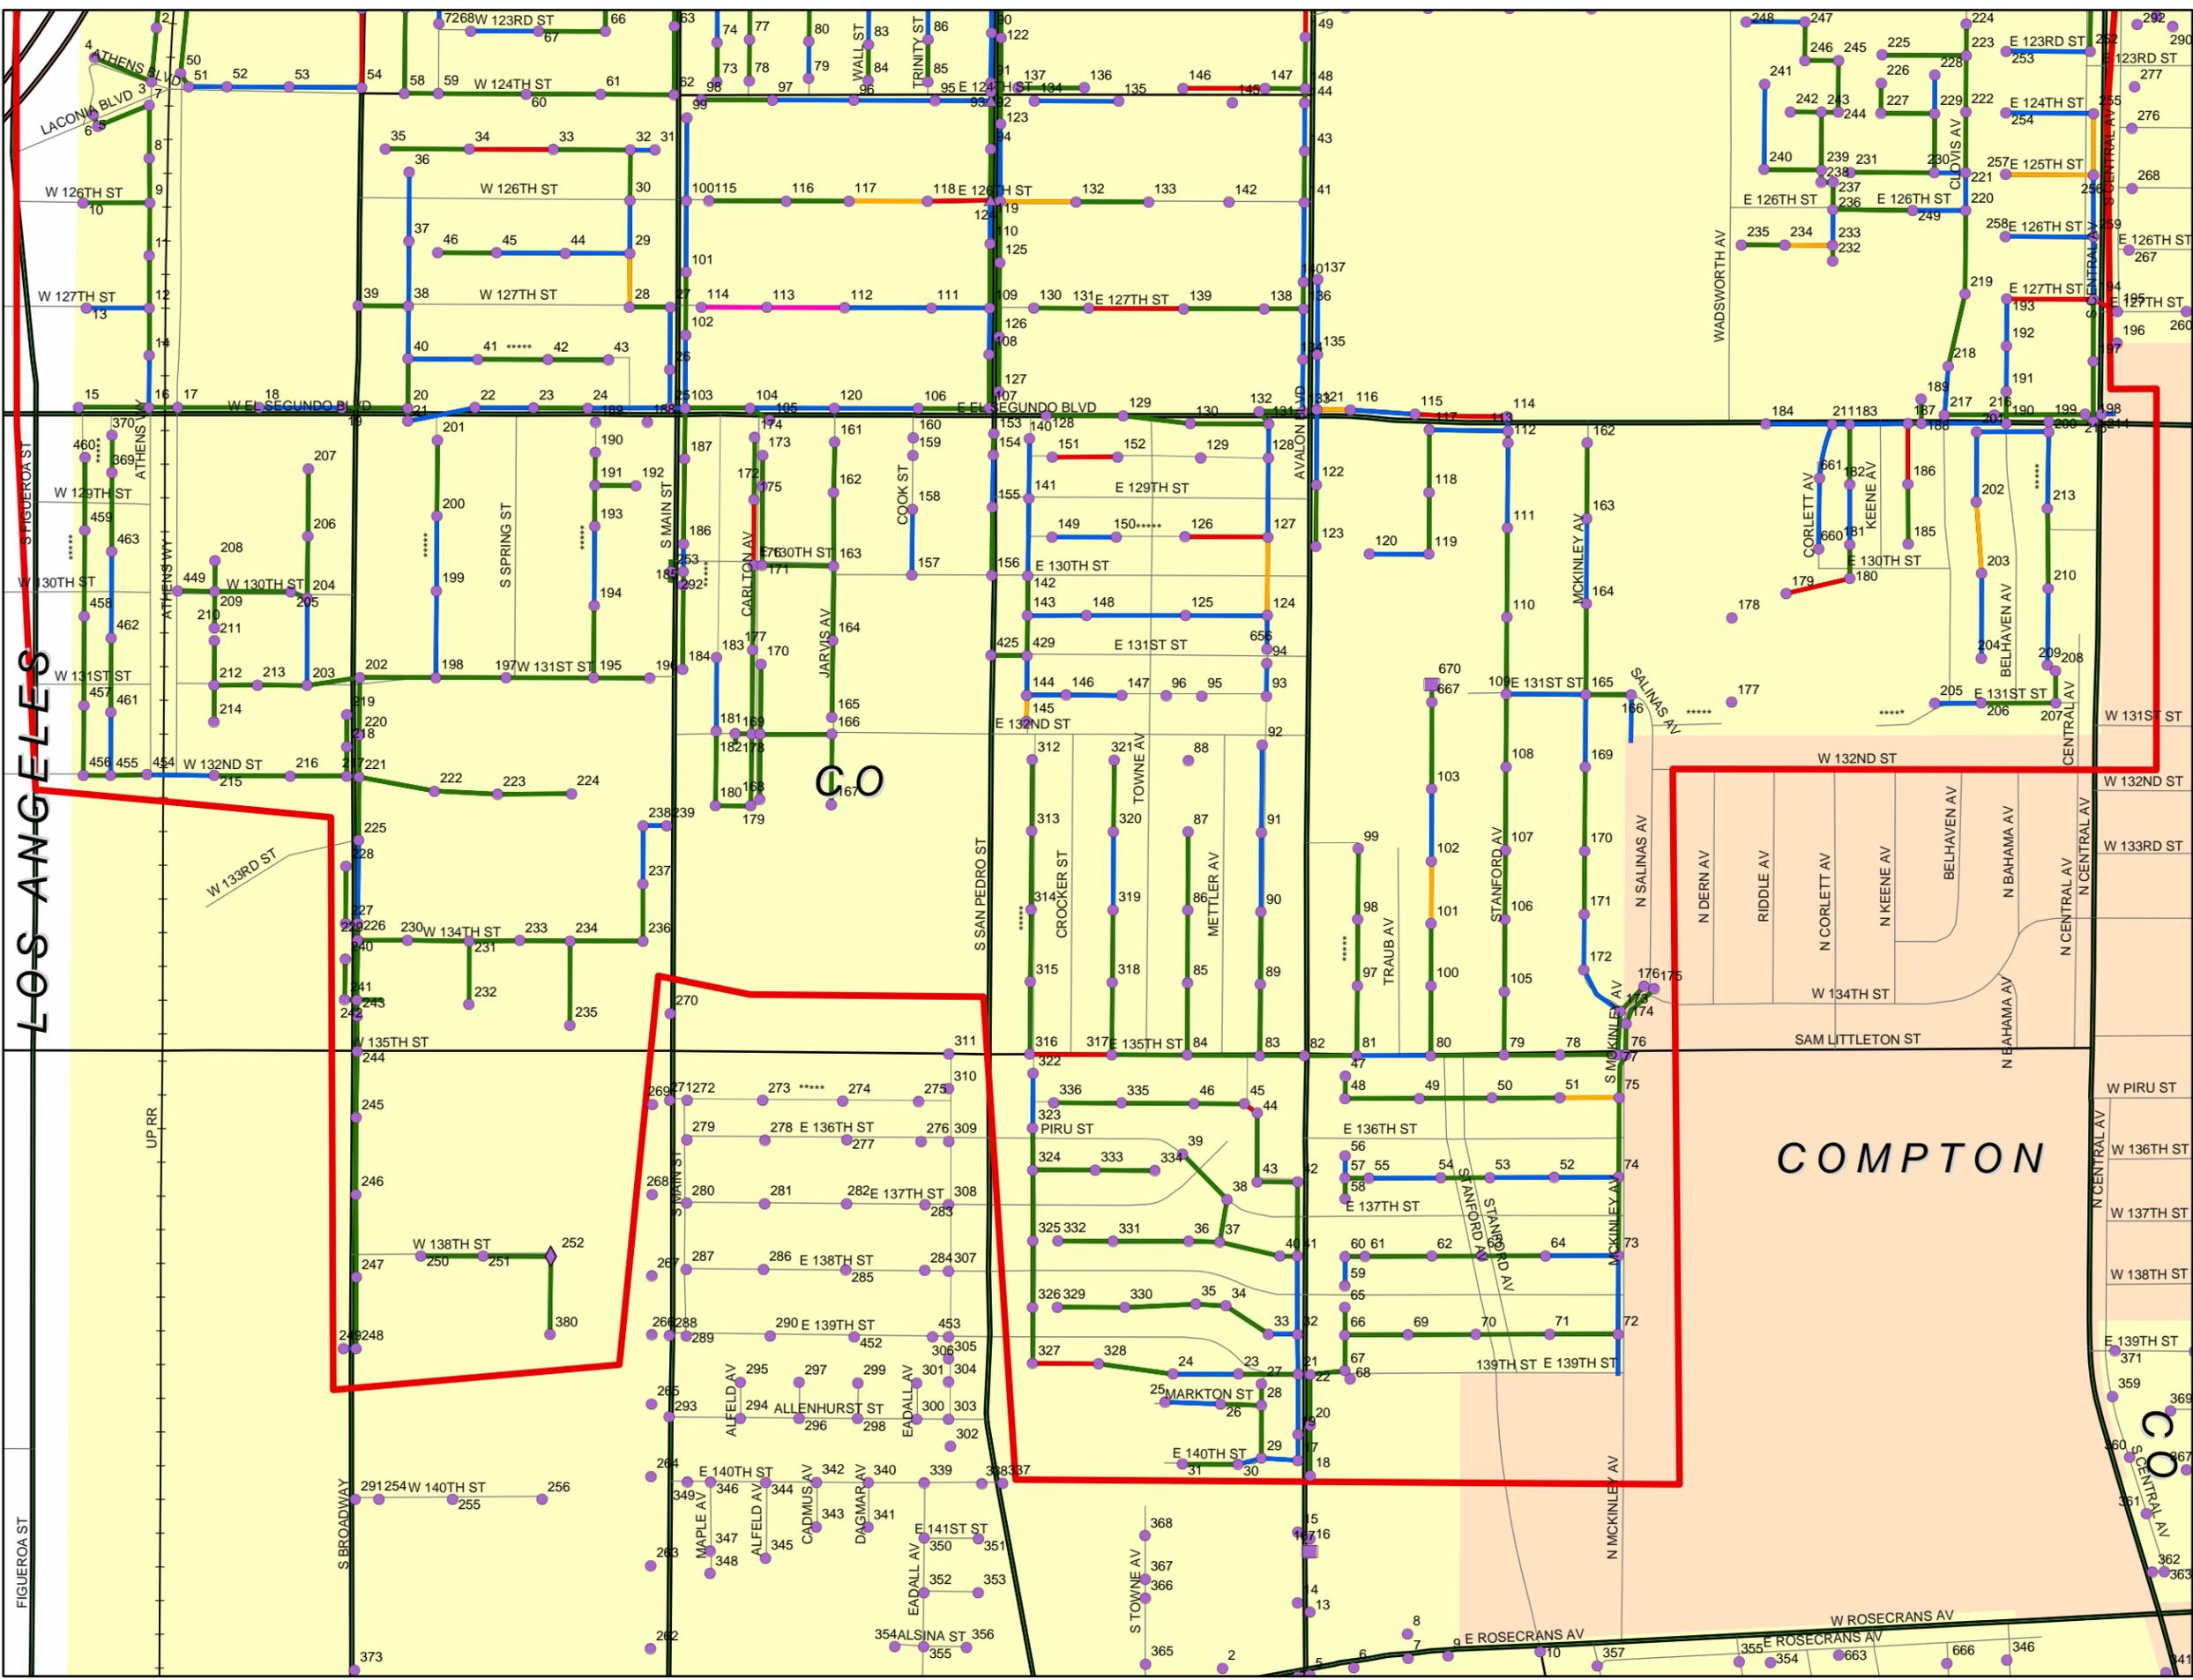
Supervisorial District 5
Unincorporated County

QUICK STRUCTURAL RATING (QSR)

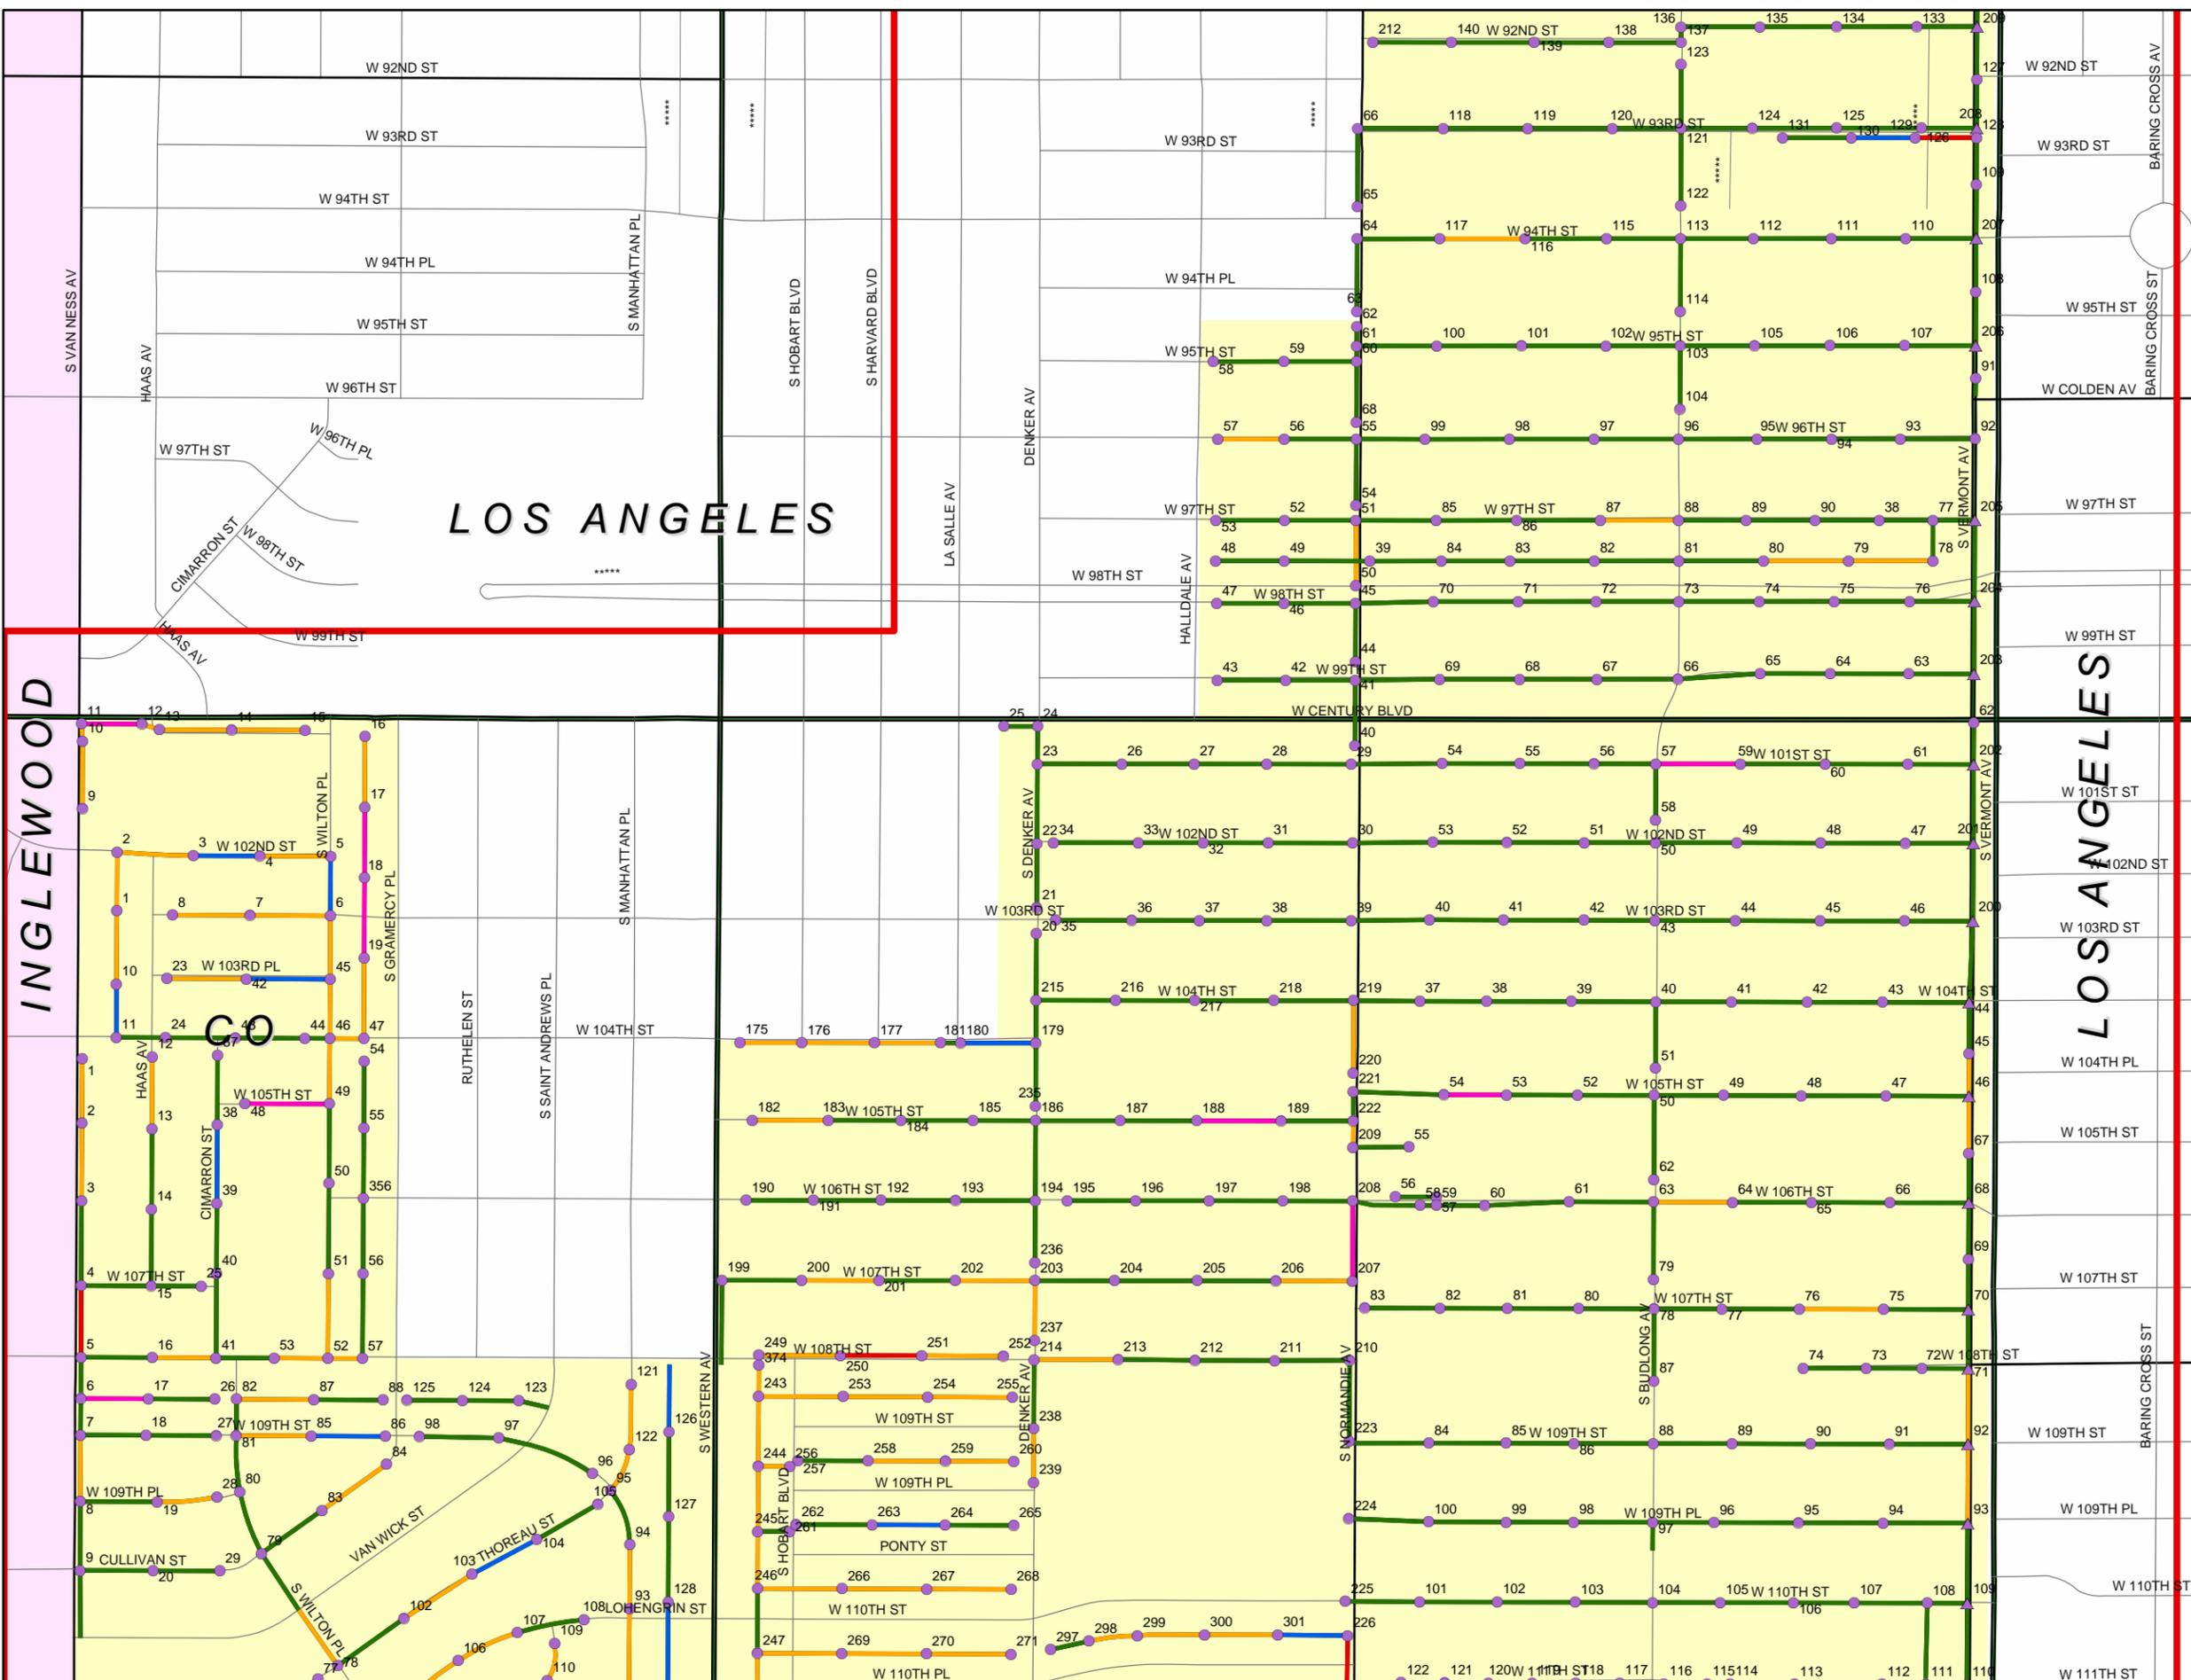
Supervisorial District 5
Unincorporated County

QUICK STRUCTURAL RATING (QSR)

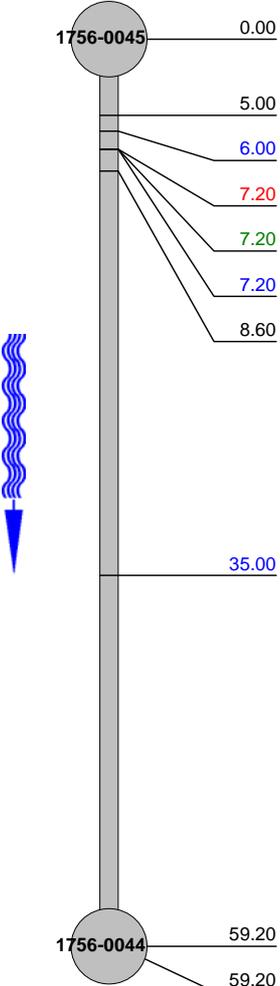
1:150	position	observation	MPEG	photo	grade

0.00	Manhole, within 8 inch: NO, Remarks: 1756-0045	00:00:29	6622	
	5.00	Tap Break-in Active, at 9 o'clock, 6", within 8 inch: NO	00:00:58	6623	
	6.00	Water Level, 10 %, within 8 inch: NO	00:01:15	6624	M 2
	7.20	Hole Soil Visible, from 11 to 1 o'clock, within 8 inch: YES	00:01:57	6625, b	S 5
	7.20	Crack Circumferential, from 8 to 4 o'clock, within 8 inch: YES	00:02:13	6627	S 1
	7.20	Deposits Attached Grease, from 8 to 9 o'clock, 5 %, within 8 inch: YES	00:02:27	6628	M 2
	8.60	Tap Break-in Active, at 9 o'clock, 6", within 8 inch: NO	00:02:44	6629	
	35.00	Water Level, 15 %, within 8 inch: NO	00:03:41	6630	M 2
	59.20	General Observation, within 8 inch: NO, Remarks: PIPE MATERIAL VITRIFIED C	00:04:44	6631	
	59.20	Manhole, within 8 inch: NO, Remarks: 1756-0044	00:04:52	6632

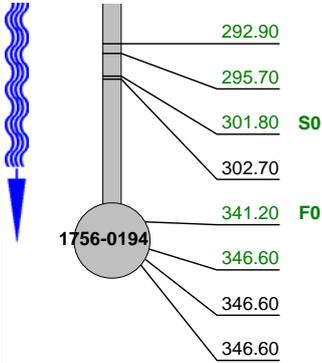
1:627	position	observation	MPEG	photo	grade
	292.90	Crack Circumferential, from 7 to 5 o'clock, within 8 inch: YES	00:18:57	11718, b	S 1
	295.70	Crack Circumferential, from 4 to 9 o'clock, within 8 inch: YES	00:19:27	11720, b	S 1
	301.80 SO	Crack Circumferential, from 7 to 5 o'clock, within 8 inch: YES, Start	00:20:05	11722, b	S 1
	302.70	Tap Factory Active, at 3 o'clock, 6", within 8 inch: NO	00:20:32	11726	
	341.20 FO	Crack Circumferential, from 7 to 5 o'clock, within 8 inch: YES, End	00:22:31	11727	S 1
	346.60	Vermin Cockroach, within 8 inch: NO	00:22:50	11728	M 1
	346.60	General Observation, within 8 inch: NO, Remarks: PIPE MATERIAL VITRIFIED C	00:23:18	11729	
	346.60	Manhole, within 8 inch: NO, Remarks: 1756-0194	00:23:27	11730

QSR	QMR	SPR	MPR	OPR	SPRI	MPRI	OPRI
5121	2112	20	4	24	1.33	1.33	1.33

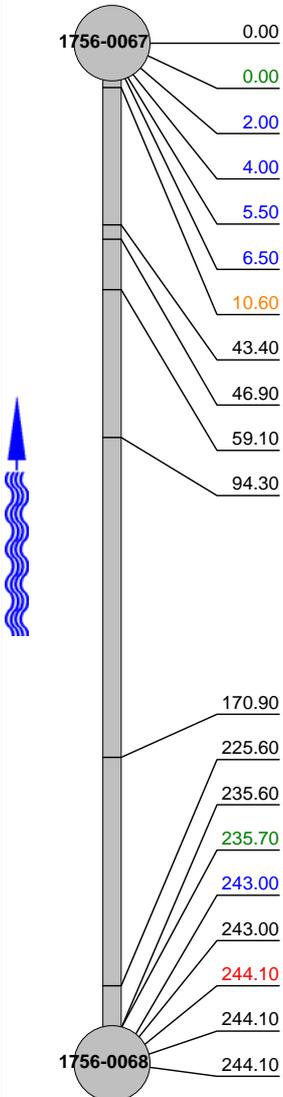
244.10	Broken, from 3 to 9 o'clock, within 8 inch: NO	00:14:00	12446	S 5
	244.10	End of Pipe, within 8 inch: NO, Remarks: 1756-0068 PIPE CAPPED OFF	00:14:54	12447

QSR	QMR	SPR	MPR	OPR	SPRI	MPRI	OPRI
5124	3121	14	6	20	2.33	2	2.22

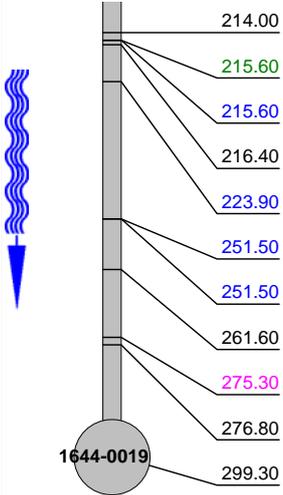
1:462	position	observation	MPEG	photo	grade
	<u>214.00</u>	Tap Factory Active, at 2 o'clock, 6", within 8 inch: NO	00:16:36	149	
	<u>215.60</u>	Crack Circumferential, from 7 to 10 o'clock, within 8 inch: YES	00:17:08	150, b	S 1
	<u>215.60</u>	Crack Longitudinal, at 8 o'clock, within 8 inch: YES	00:17:22	152, b	S 2
	<u>216.40</u>	Tap Factory Active, at 10 o'clock, 6", within 8 inch: NO	00:18:05	154	
	<u>223.90</u>	Crack Longitudinal, at 8 o'clock, within 8 inch: YES	00:18:35	155, b	S 2
	<u>251.50</u>	Crack Longitudinal, at 3 o'clock, within 8 inch: YES	00:19:53	157, b	S 2
	<u>251.50</u>	Crack Longitudinal, at 9 o'clock, within 8 inch: YES	00:20:13	159, b	S 2
	<u>261.60</u>	Tap Factory Active, at 2 o'clock, 6", within 8 inch: NO	00:20:56	161	
	<u>275.30</u>	Fracture Multiple, from 7 to 5 o'clock, within 8 inch: YES	00:22:05	162, b	S 4
	<u>276.80</u>	Tap Factory Active, at 10 o'clock, 6", within 8 inch: NO	00:22:33	164

QSR	QMR	SPR	MPR	OPR	SPRI	MPRI	OPRI
4131	3121	34	5	39	2	2.5	2.05

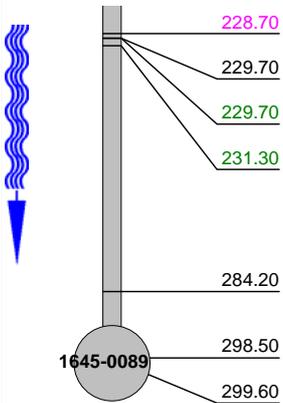
1:495	position	observation	MPEG	photo	grade
	<u>228.70</u>	Fracture Multiple, from 7 to 5 o'clock, within 8 inch: YES	00:19:58	2210, b	S 4
	<u>229.70</u>	Tap Factory Active, at 9 o'clock, 6", within 8 inch: NO	00:20:26	2212	
	<u>229.70</u>	Roots Fine Lateral, at 9 o'clock, within 8 inch: NO	00:20:39	2213, b	M 1
	<u>231.30</u>	Crack Circumferential, from 12 to 3 o'clock, within 8 inch: YES	00:21:22	2215, b	S 1
	<u>284.20</u>	Tap Factory Active, at 9 o'clock, 6", within 8 inch: NO	00:23:08	2217	
	<u>298.50</u>	Tap Factory Active, at 9 o'clock, 6", within 8 inch: NO	00:23:52	2218	
	<u>299.60</u>	Manhole, within 8 inch: NO, Remarks: 1645-0089	00:24:33	2219

QSR	QMR	SPR	MPR	OPR	SPRI	MPRI	OPRI
4233	4121	22	9	31	2.44	1.8	2.21
