Year 1 Annual Monitoring Report

Devil's Gate Reservoir Restoration Project (Phase 1) Onsite Habitat Mitigation

December 18, 2020

ECORP Consulting, Inc.
ENVIRONMENTAL CONSULTANTS

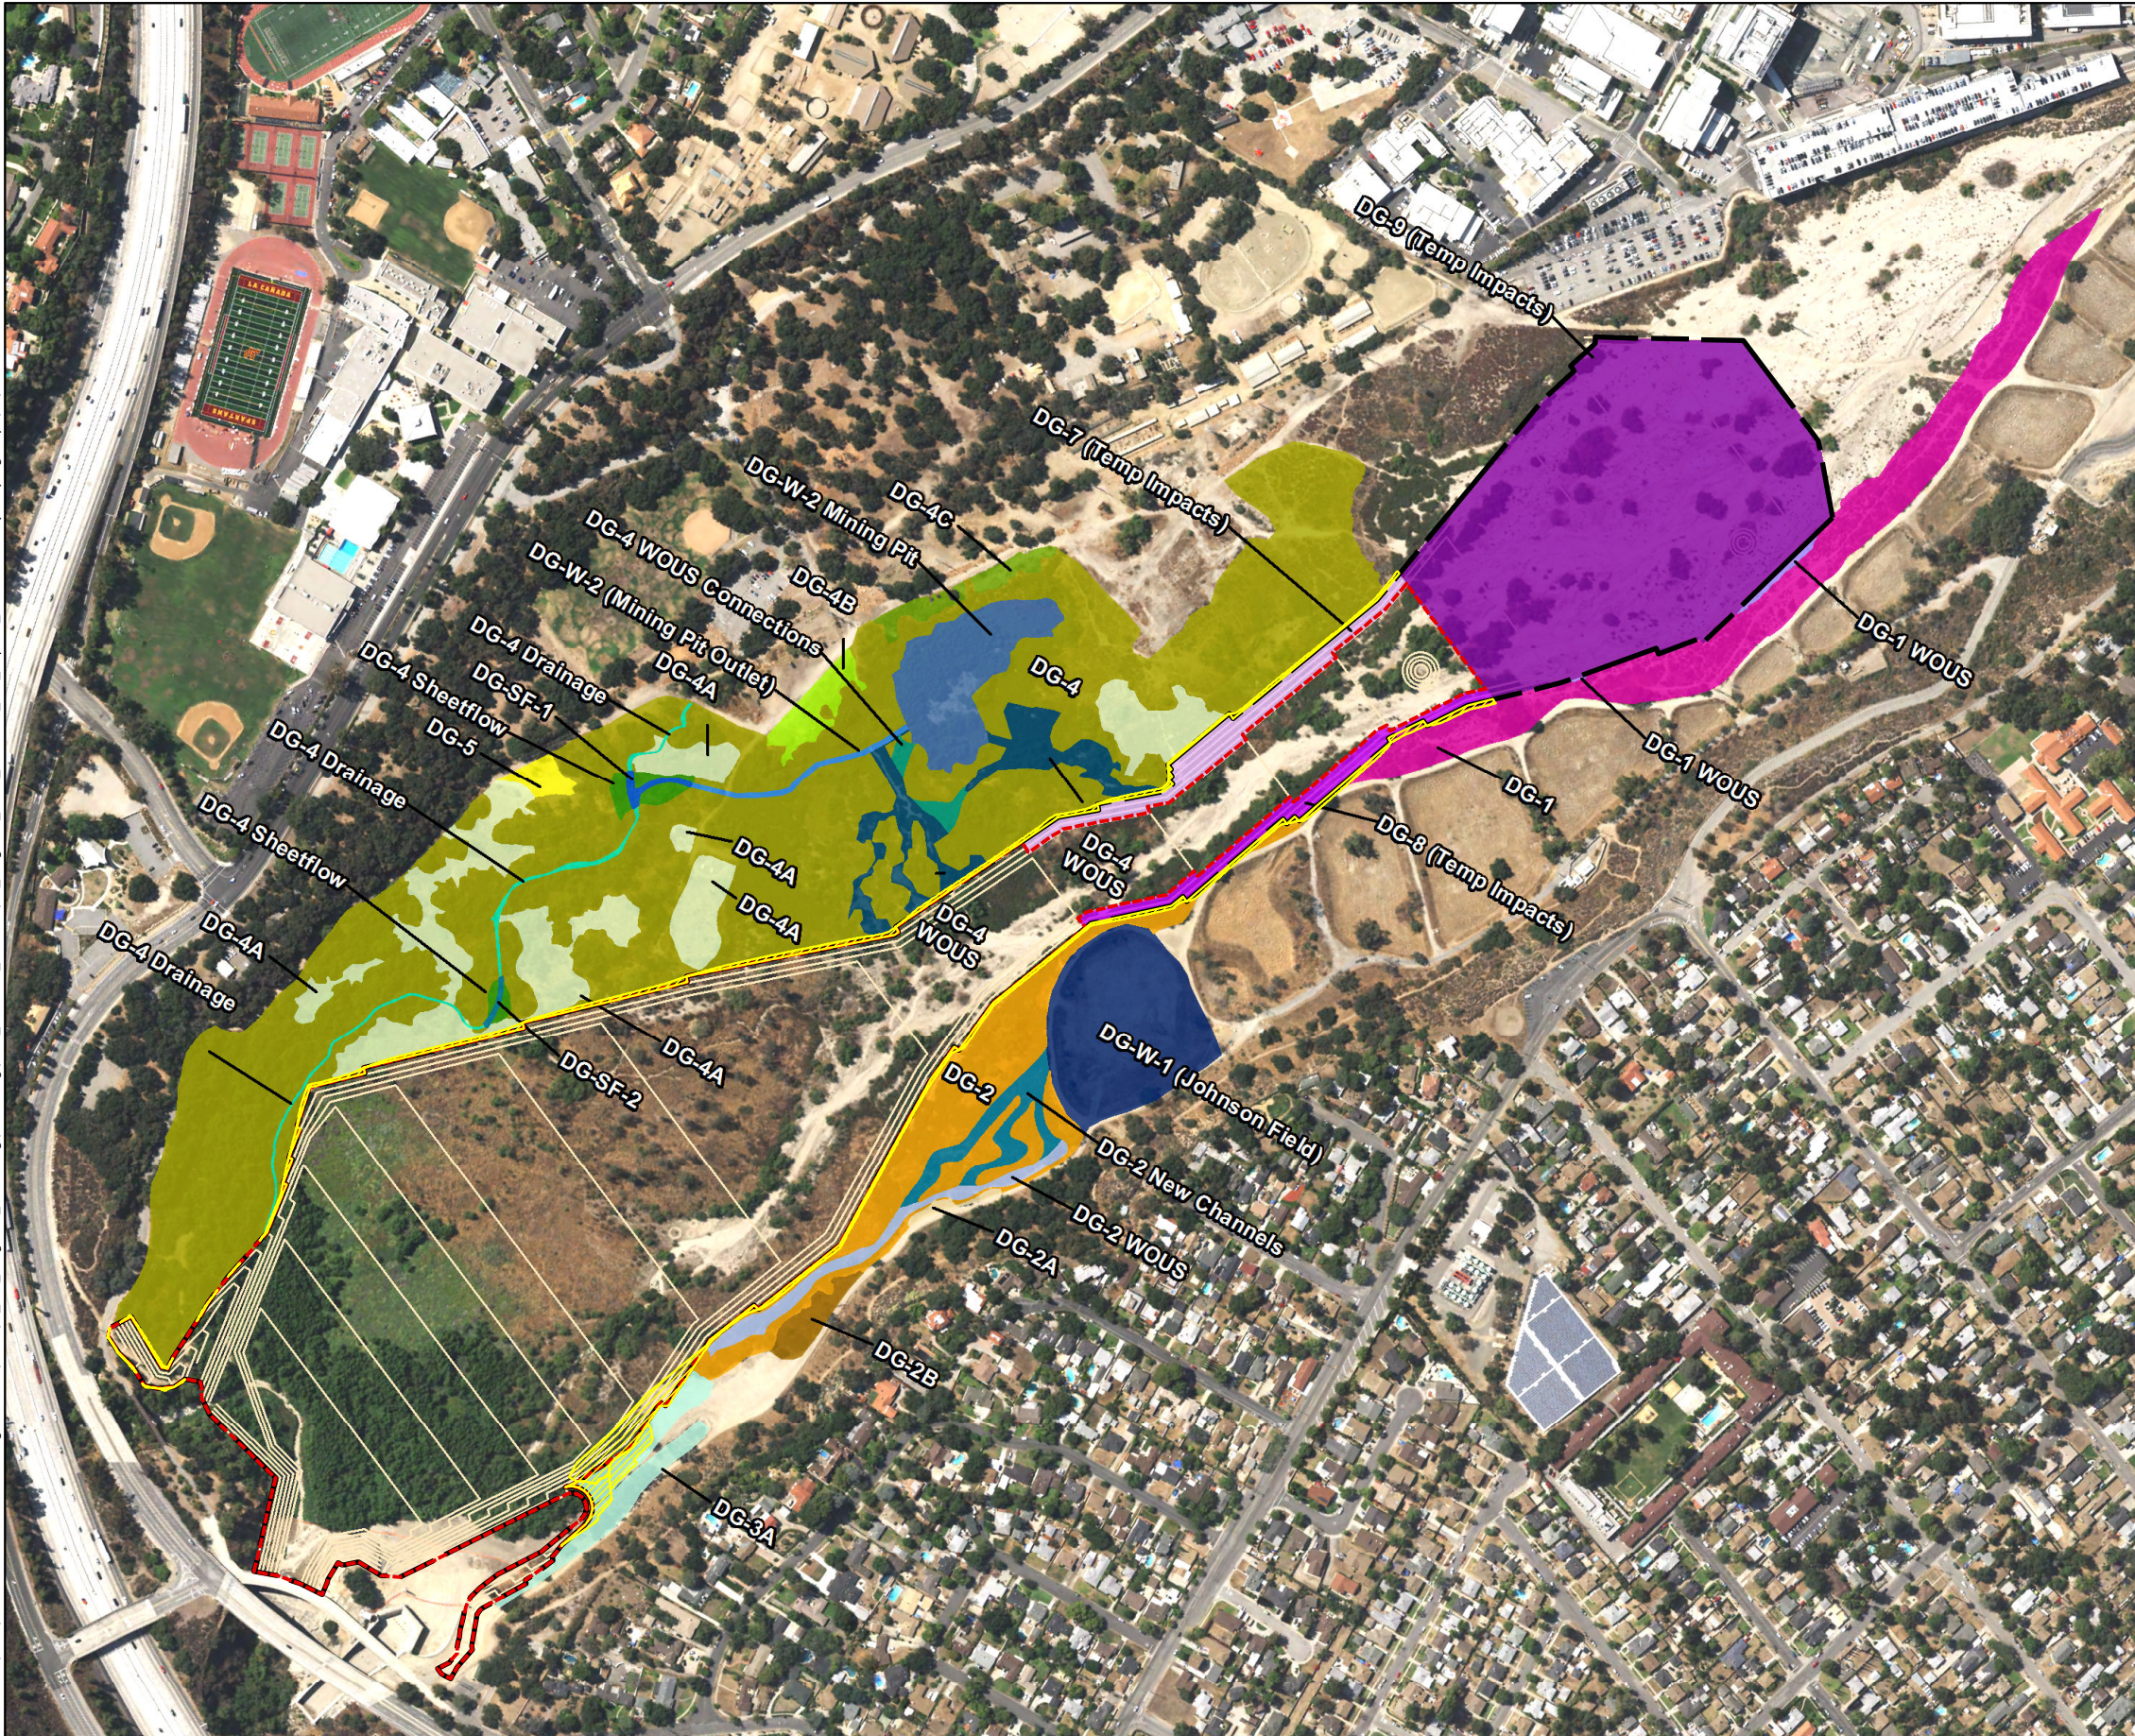
Figure 3
Devil's Gate Mitigation Areas

- Initial Sediment Removal Footprint ¹
- Permanent Maintenance Footprint ¹
- Temporary Impact Area
- Sediment Removal Excavation Contours ¹

- DG-1
- DG-1 WOUS
- DG-2
- DG-2 New Channels
- DG-2 WOUS
- DG-2A
- DG-2B
- DG-3A
- DG-4
- DG-4 Drainage
- DG-4 Sheetflow
- DG-4 WOUS
- DG-4 WOUS Connections
- DG-4A
- DG-4B
- DG-4C
- DG-5
- DG-7 (Temp Impacts)
- DG-8 (Temp Impacts)
- DG-9 (Temp Impacts)
- DG-SF-1
- DG-SF-2
- DG-W-1 (Johnson Field)
- DG-W-2 (Mining Pit)
- DG-W-2 (Mining Pit Outlet)

The Phase 1 onsite habitat mitigation areas (hereafter referred to as mitigation areas) are located to the east and west of the Devil's Gate Reservoir (Reservoir) just outside of the PMA for the Project (Figure 3). Mitigation areas DG-1, DG-1 WOUS, DG-2A, DG-2B, and DG-3A are located on the east side of the Reservoir and mitigation areas DG-4, DG-4B, DG-4C, and DG-5 are located on the west side of the Reservoir. The mitigation areas are encompassed by the Hahamongna Watershed Park, which is heavily used for recreational activities, such as hiking, bird watching, horseback riding, and disc golf.

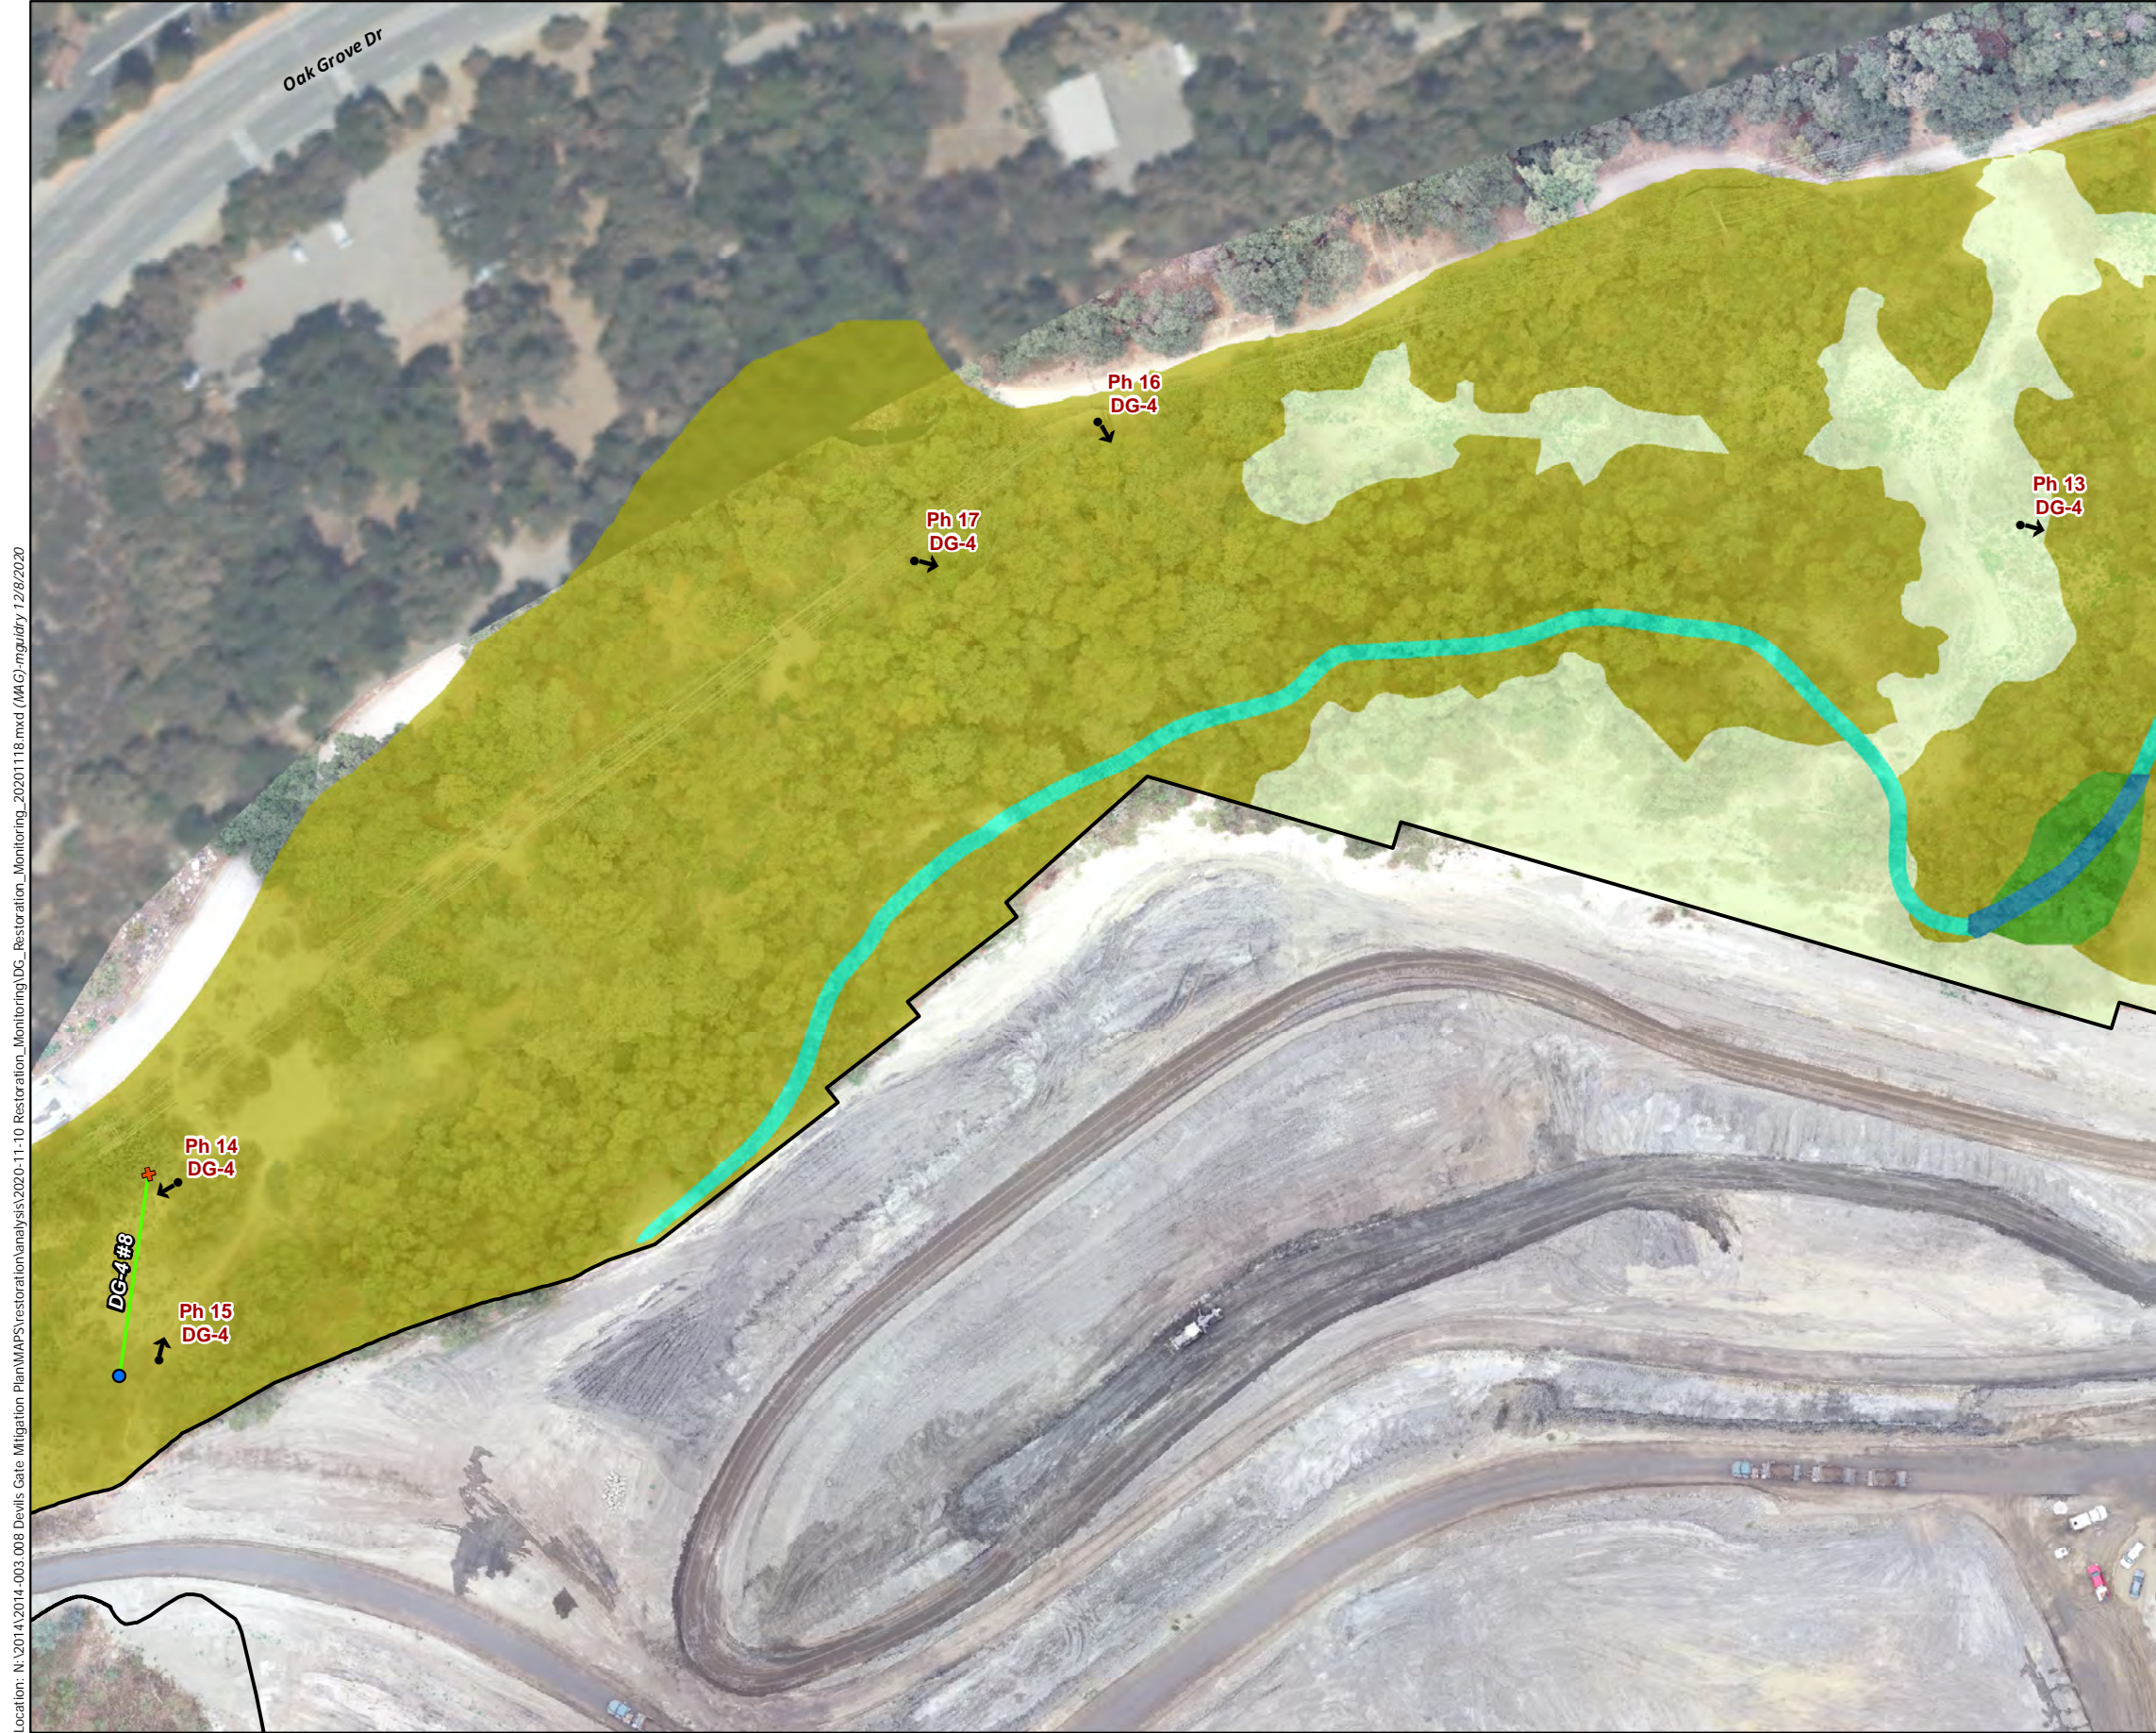
Figure 4a. Restoration Transects
Page 1 of 8

- DG-4
- DG-4 Drainage
- DG-4 Sheetflow
- DG-4A
- DG-SF-2

Data was collected along each transect at every 0.5 m (sampling location), starting at 0.5 m. Each plant species that intersected the transect tape at each sampling location was recorded. A sampling dowel was used to assist in determining which plant species intersected the transect tape at each sampling location. In situations where the canopy of a plant intersected the transect tape at a sampling location, that species

Bare ground, rock, and litter were also recorded along each transect in areas that had no plant overlap. Species occurrence along each transect line was totaled and divided by the number of sampling points and multiplied by 100 to derive the percent cover (total cover) along each transect. Species richness was determined for each mitigation area and reference site by documenting all of the native species that occurred within a belt transect. The belt transects extended one-meter to the left and right of each of the 25 transects within the mitigation areas, and the 7 transects within the reference sites.

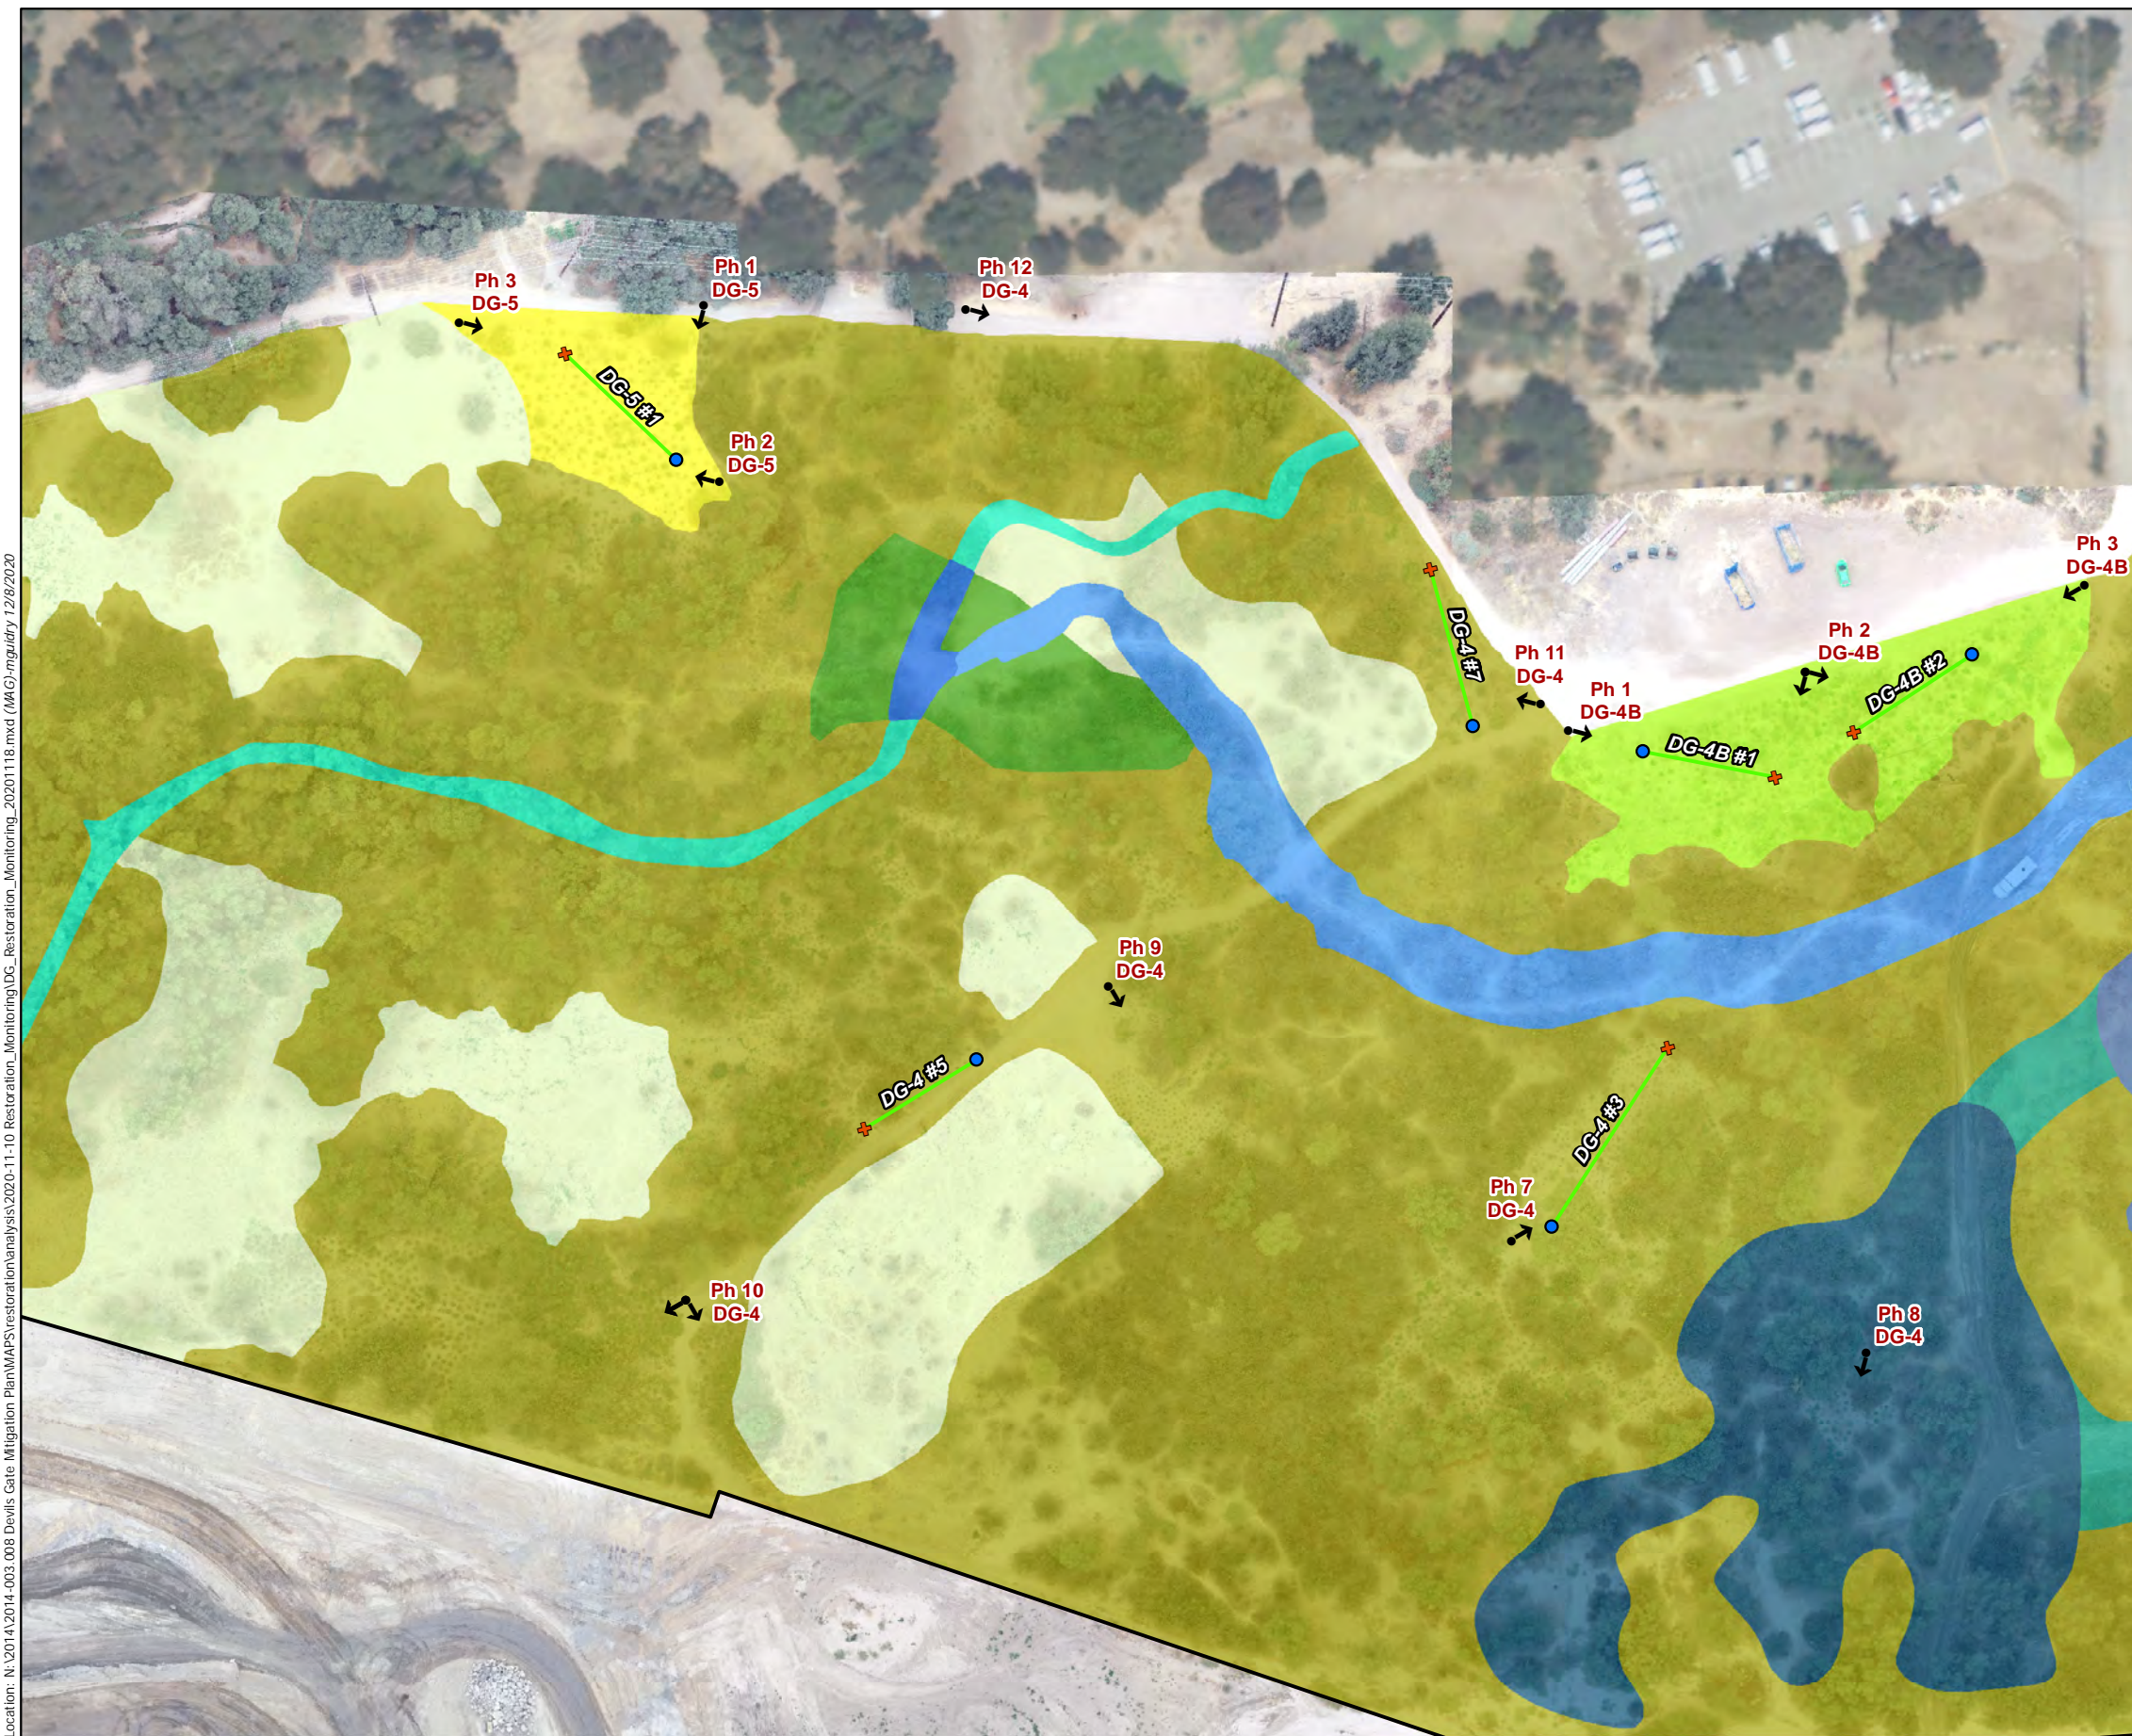
Figure 4b. Restoration Transects
Page 2 of 8

- DG-4
- DG-4 Drainage
- DG-4 Sheetflow
- DG-4 WOUS
- DG-4 WOUS Connections
- DG-4A
- DG-4B
- DG-5
- DG-SF-1
- DG-W-2 (Mining Pit)
- DG-W-2 (Mining Pit Outlet)

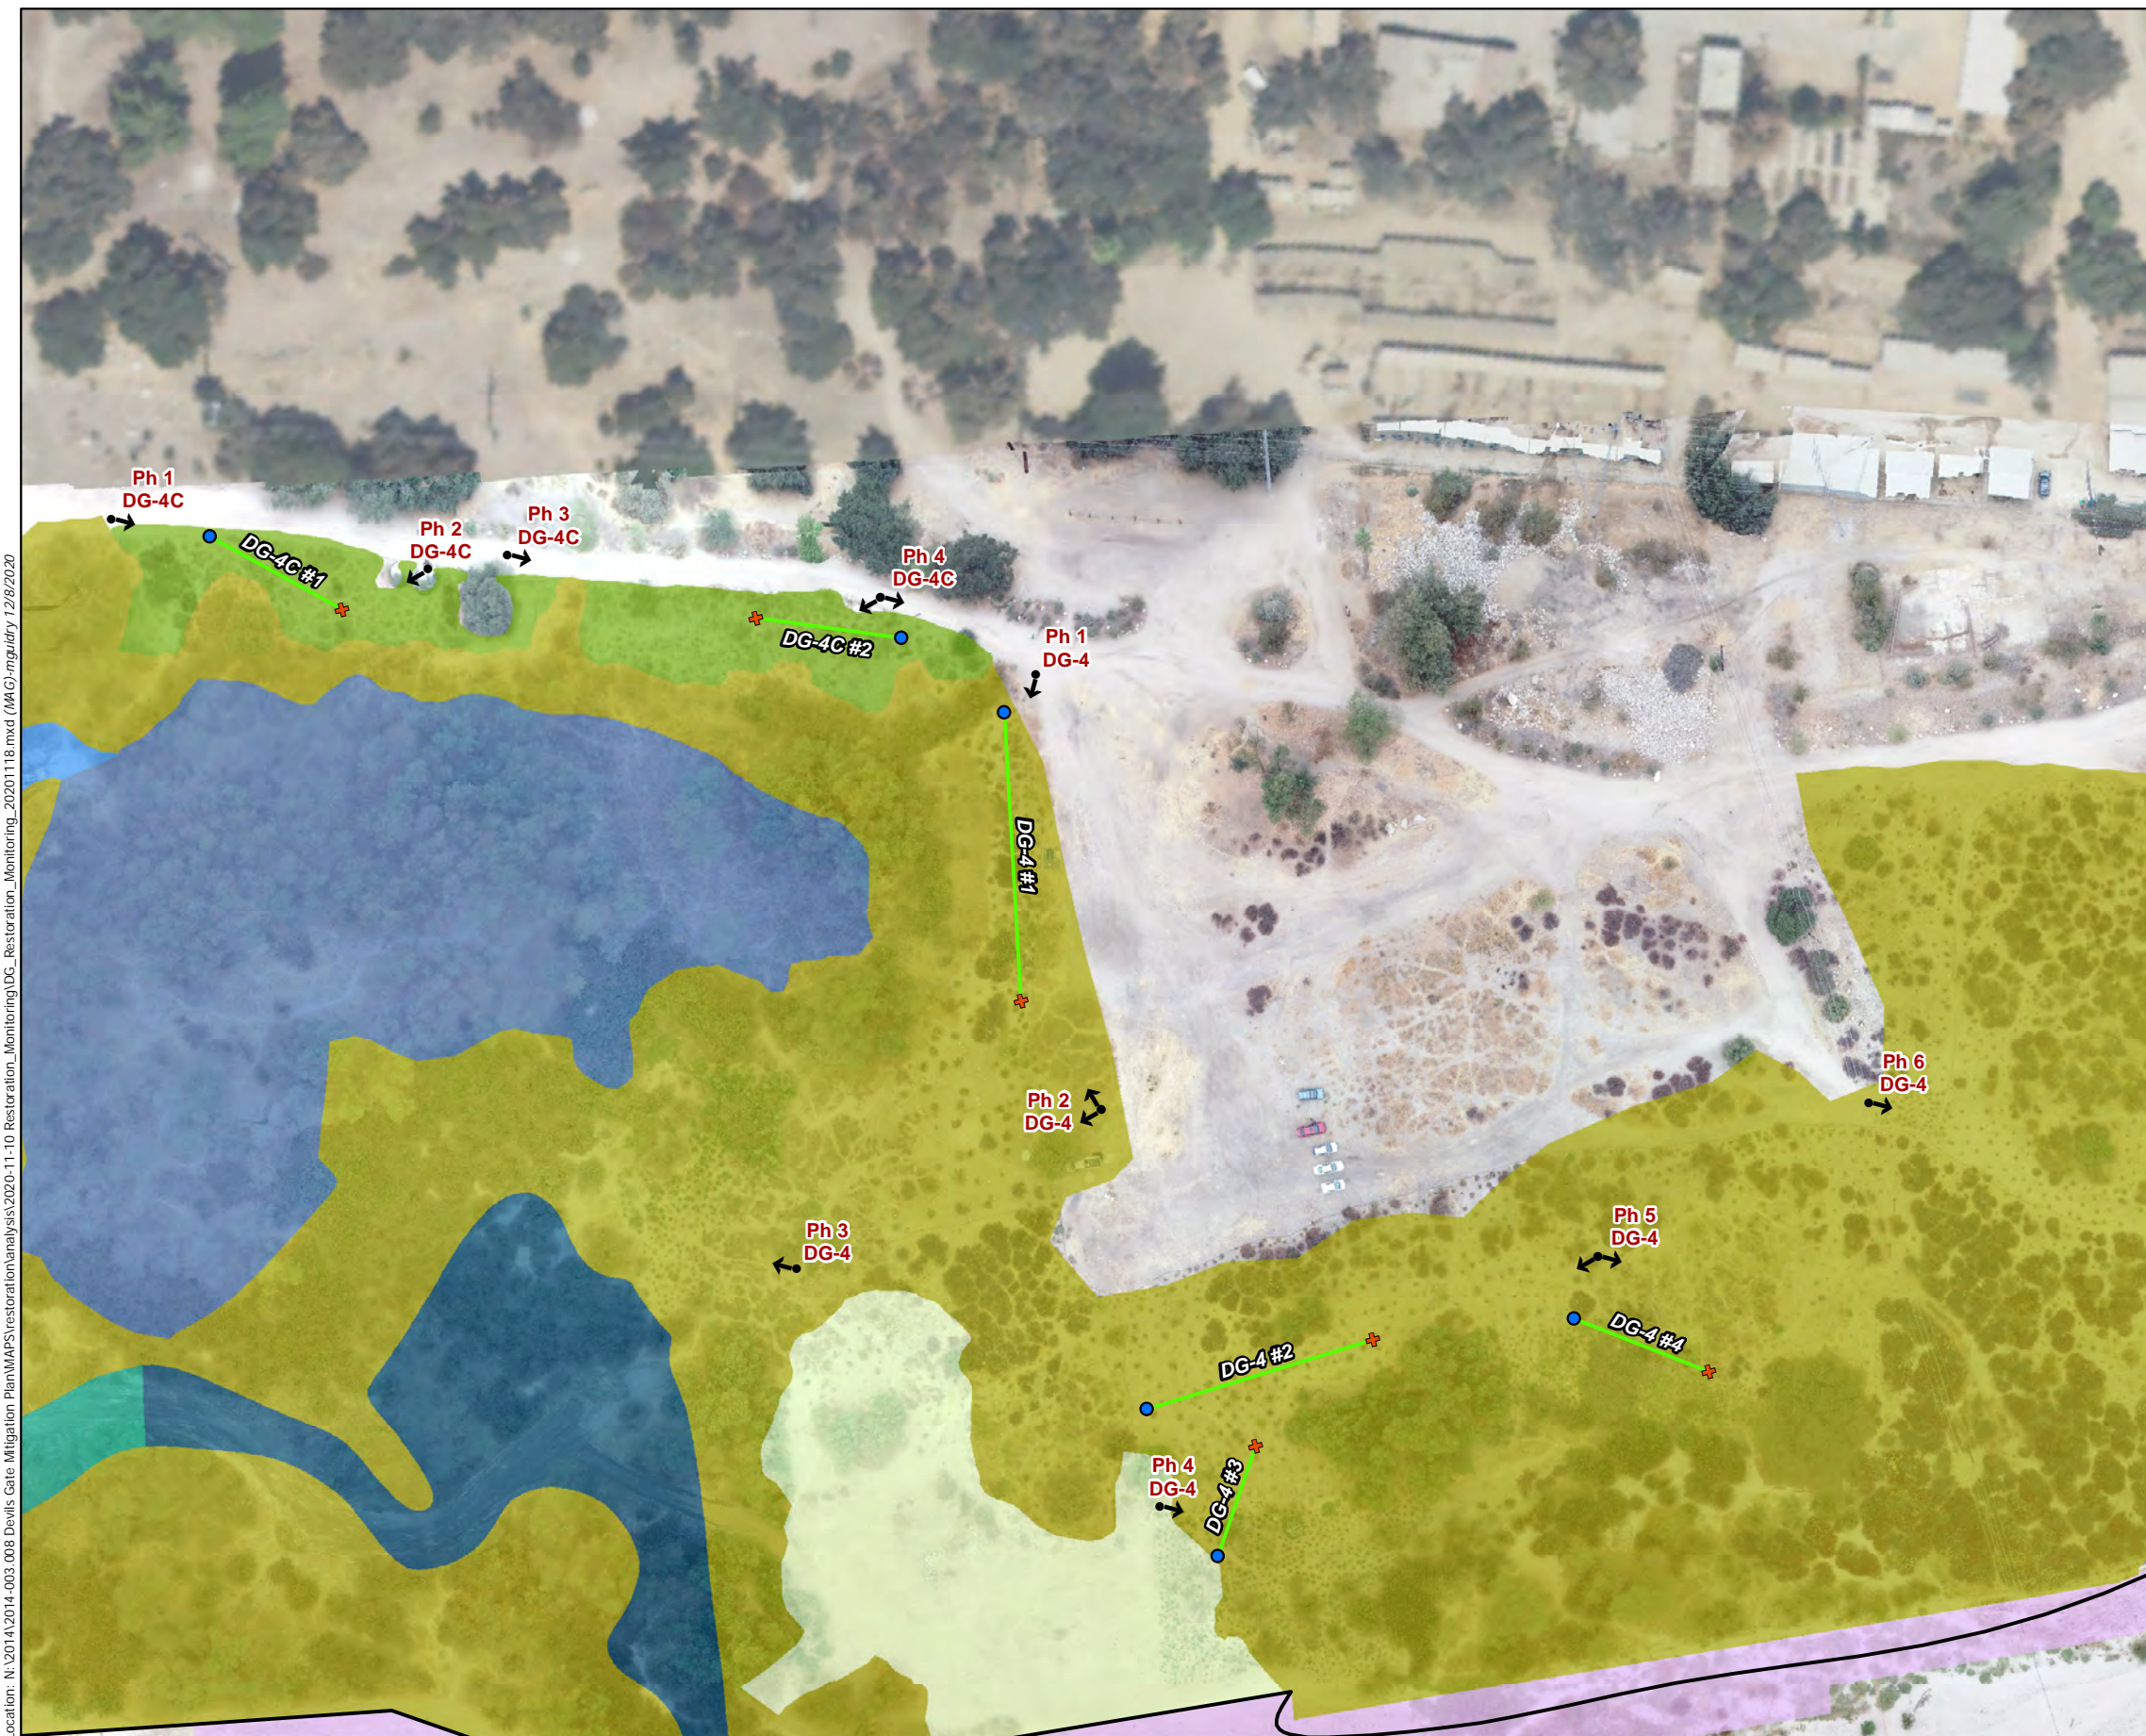
Figure 4c. Restoration Transects
Page 3 of 8

- DG-4
- DG-4 WOUS
- DG-4 WOUS Connections
- DG-4A
- DG-4C
- DG-7 (Temp Impacts)
- DG-W-2 (Mining Pit)
- DG-W-2 (Mining Pit Outlet)

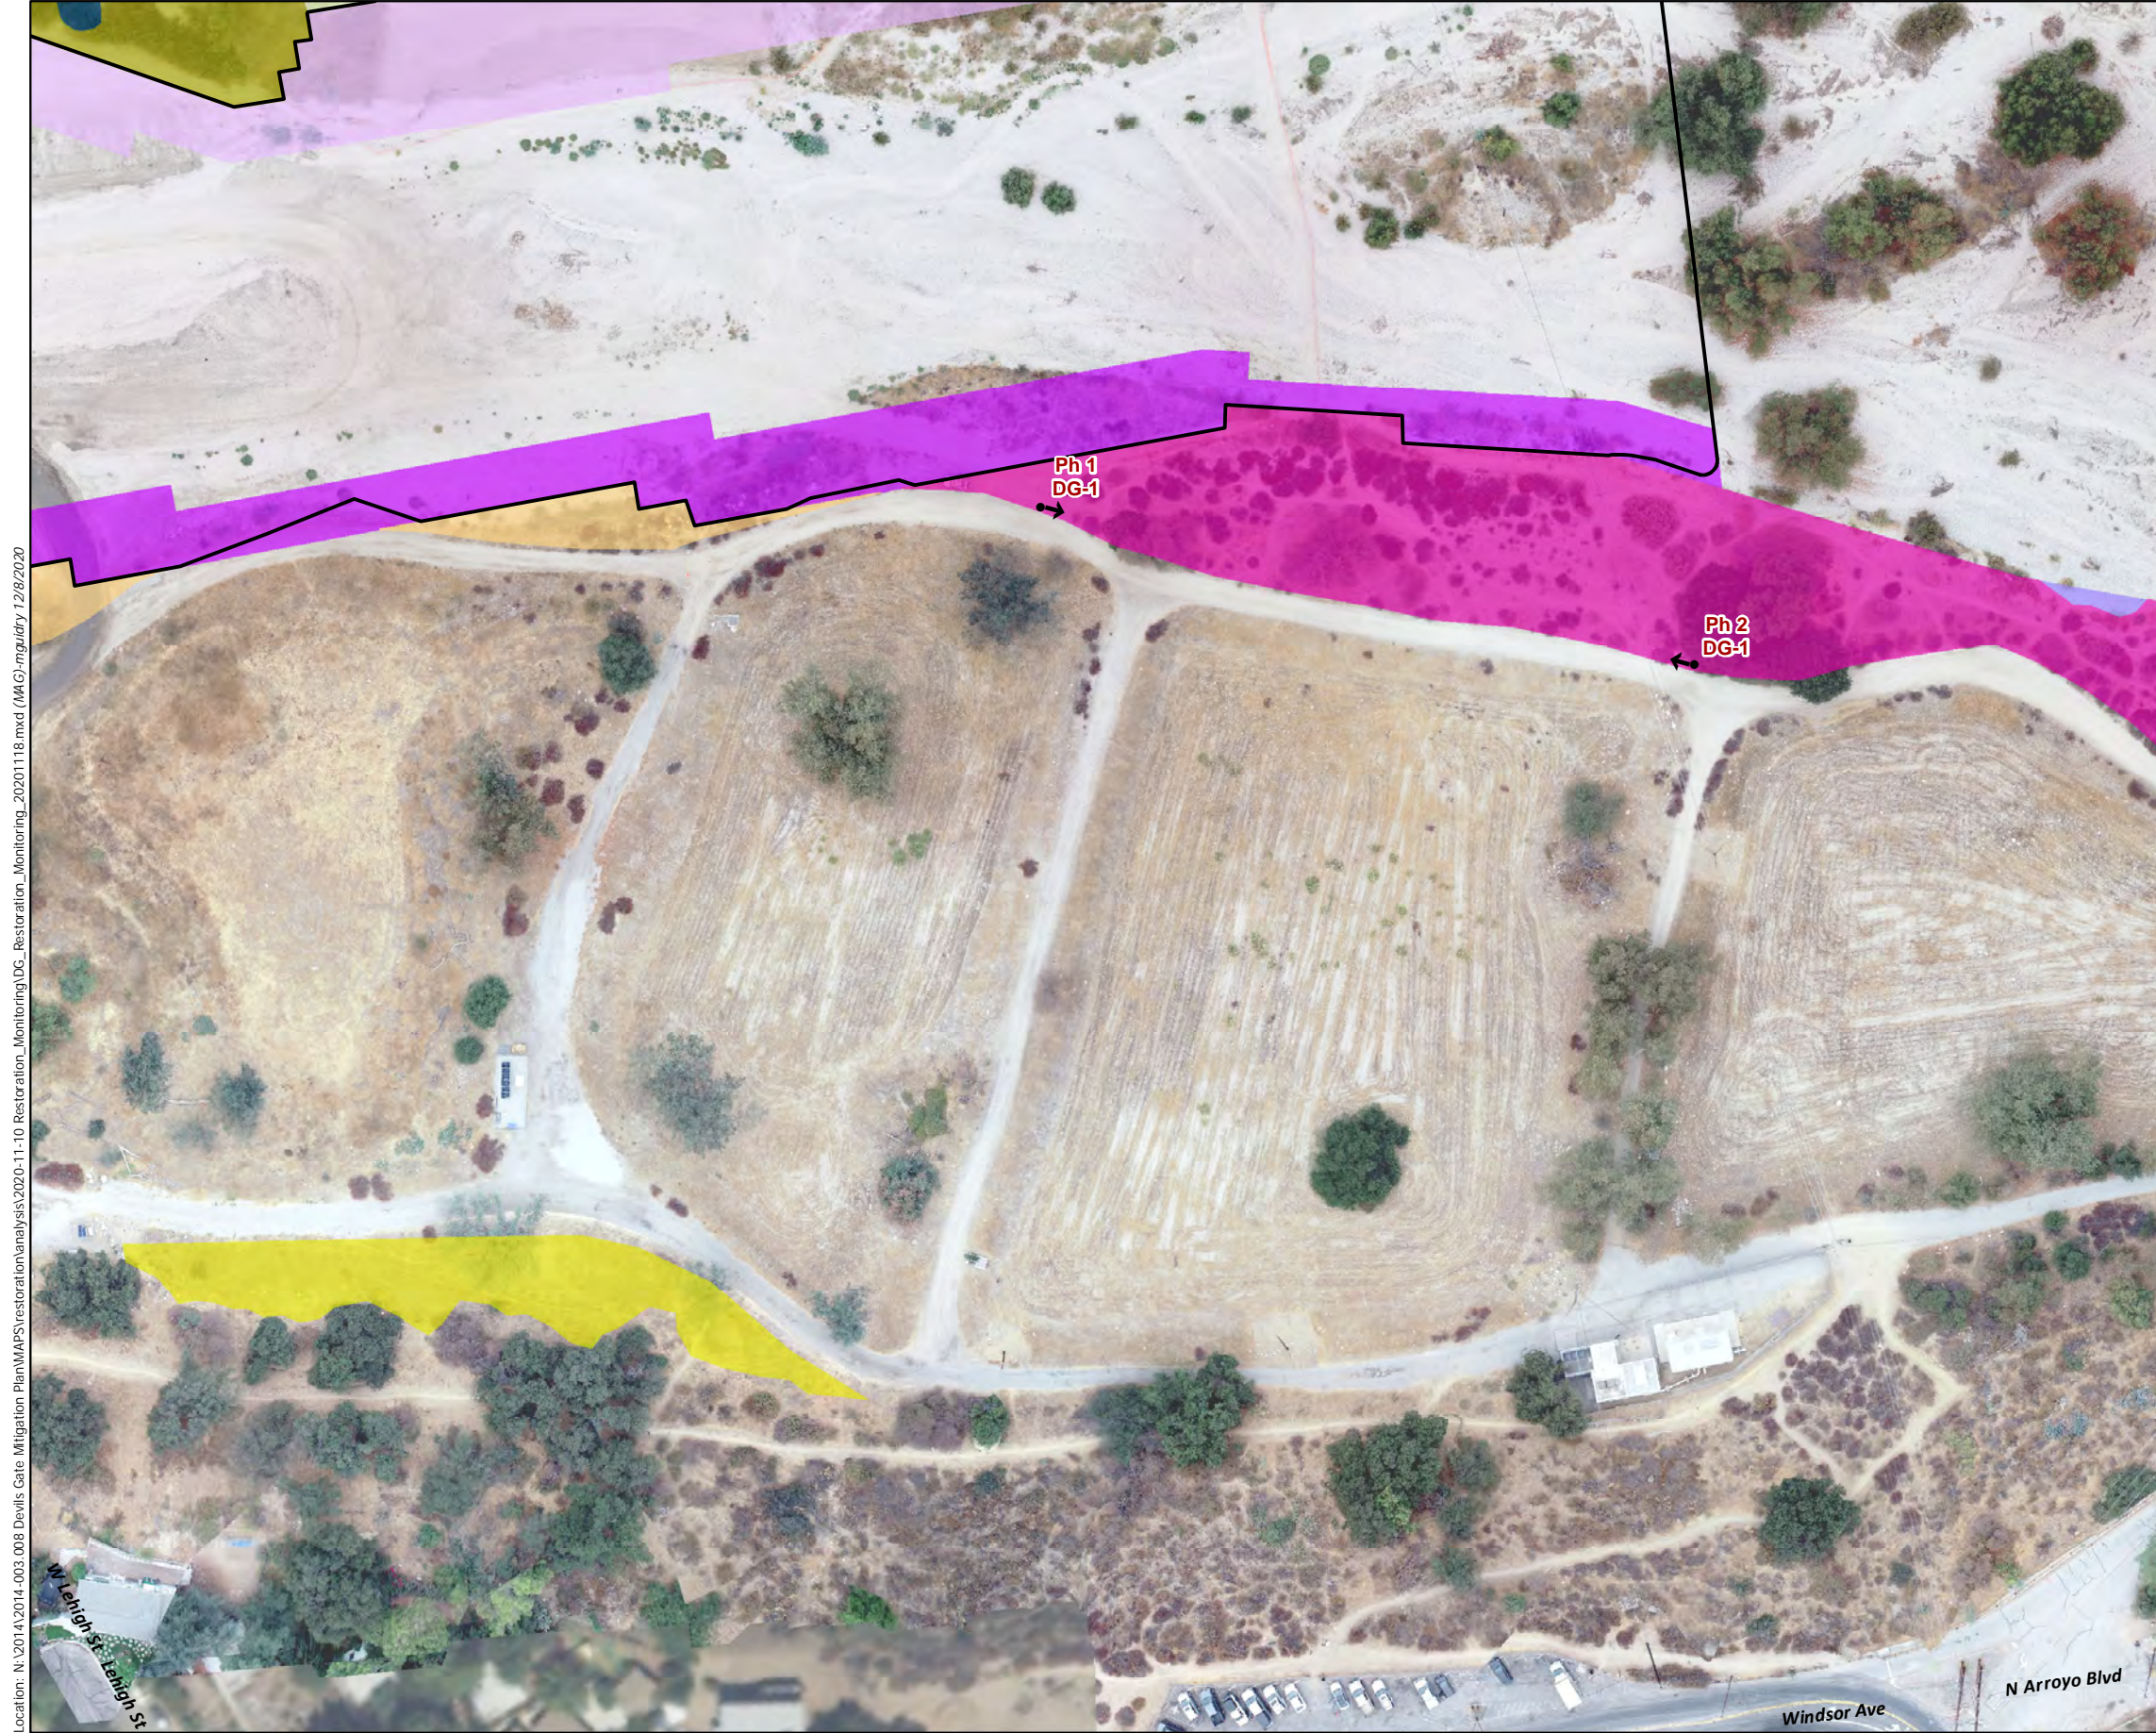
Figure 4d. Restoration Transects
Page 4 of 8

- DG-1
- DG-1 WOUS
- DG-2
- DG-4
- DG-4 WOUS
- DG-4A
- DG-7 (Temp Impacts)
- DG-8 (Temp Impacts)
- DG-East Trail 4

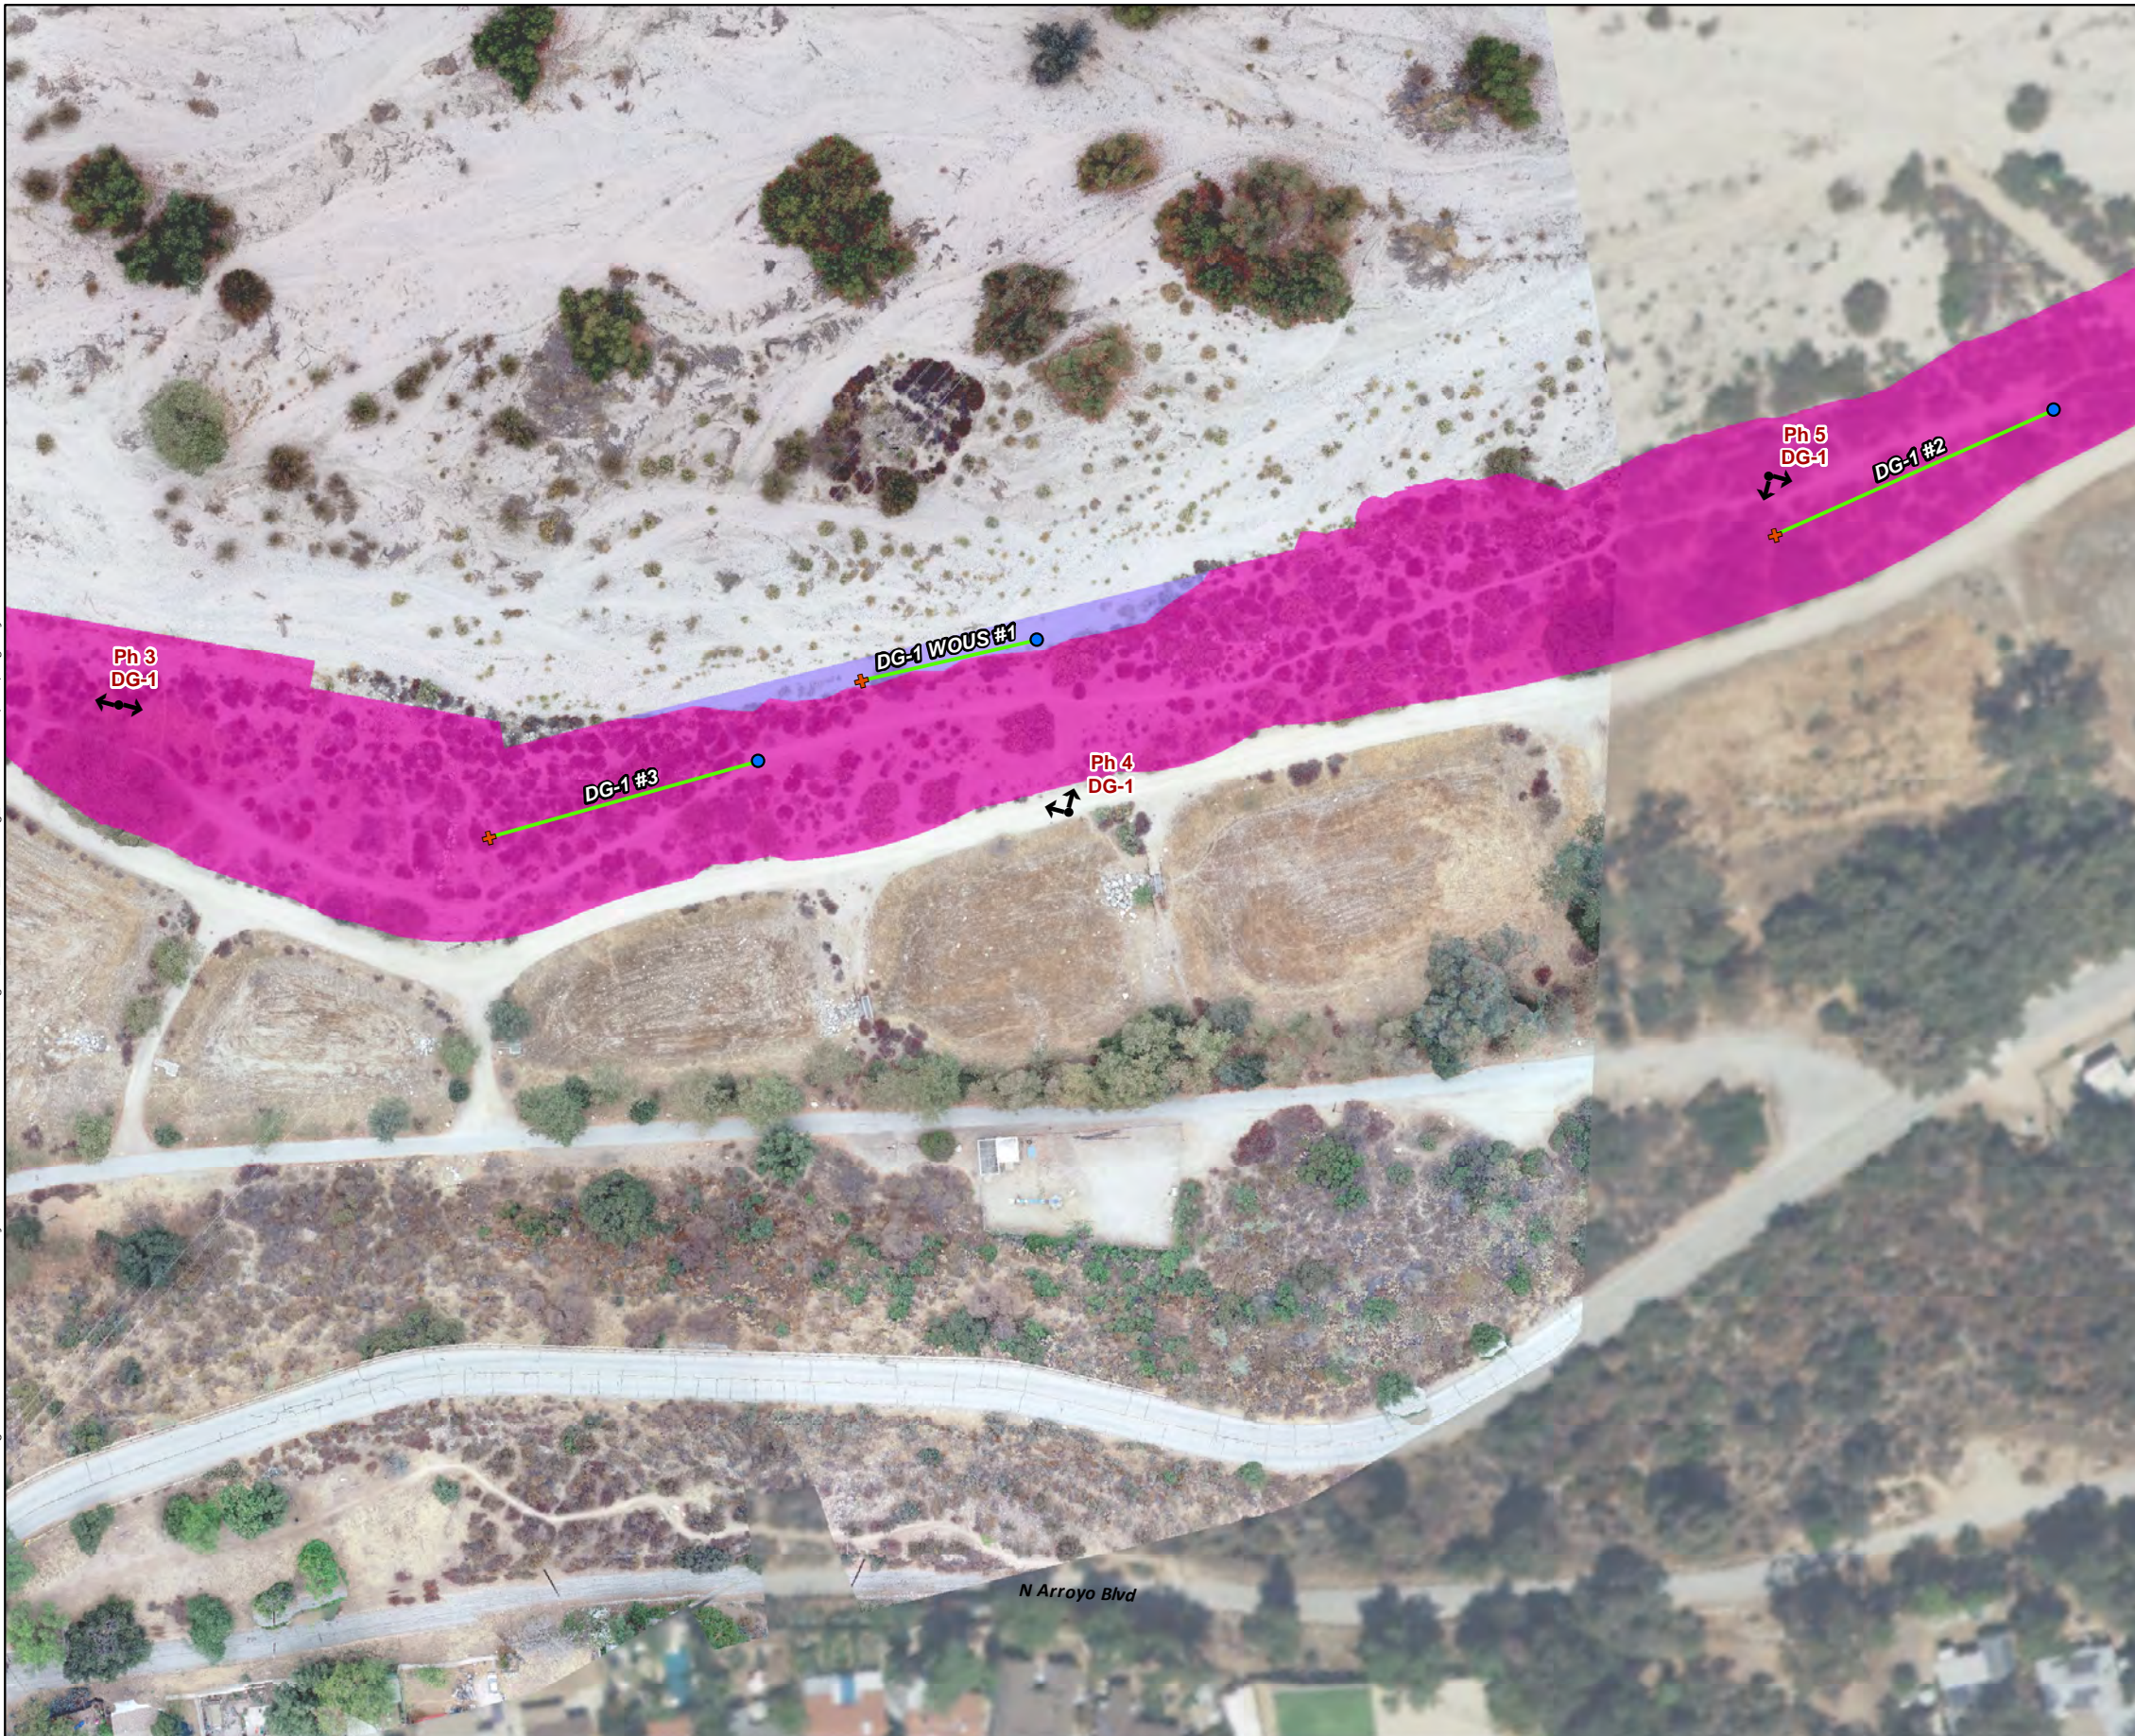
Figure 4e. Restoration Transects
Page 5 of 8

- DG-1
- DG-1 WOUS
