Year 1 Annual Monitoring Report

Devil's Gate Reservoir Restoration Project (Phase 1) Onsite Habitat Mitigation

December 18, 2020

ECORP Consulting, Inc.
ENVIRONMENTAL CONSULTANTS

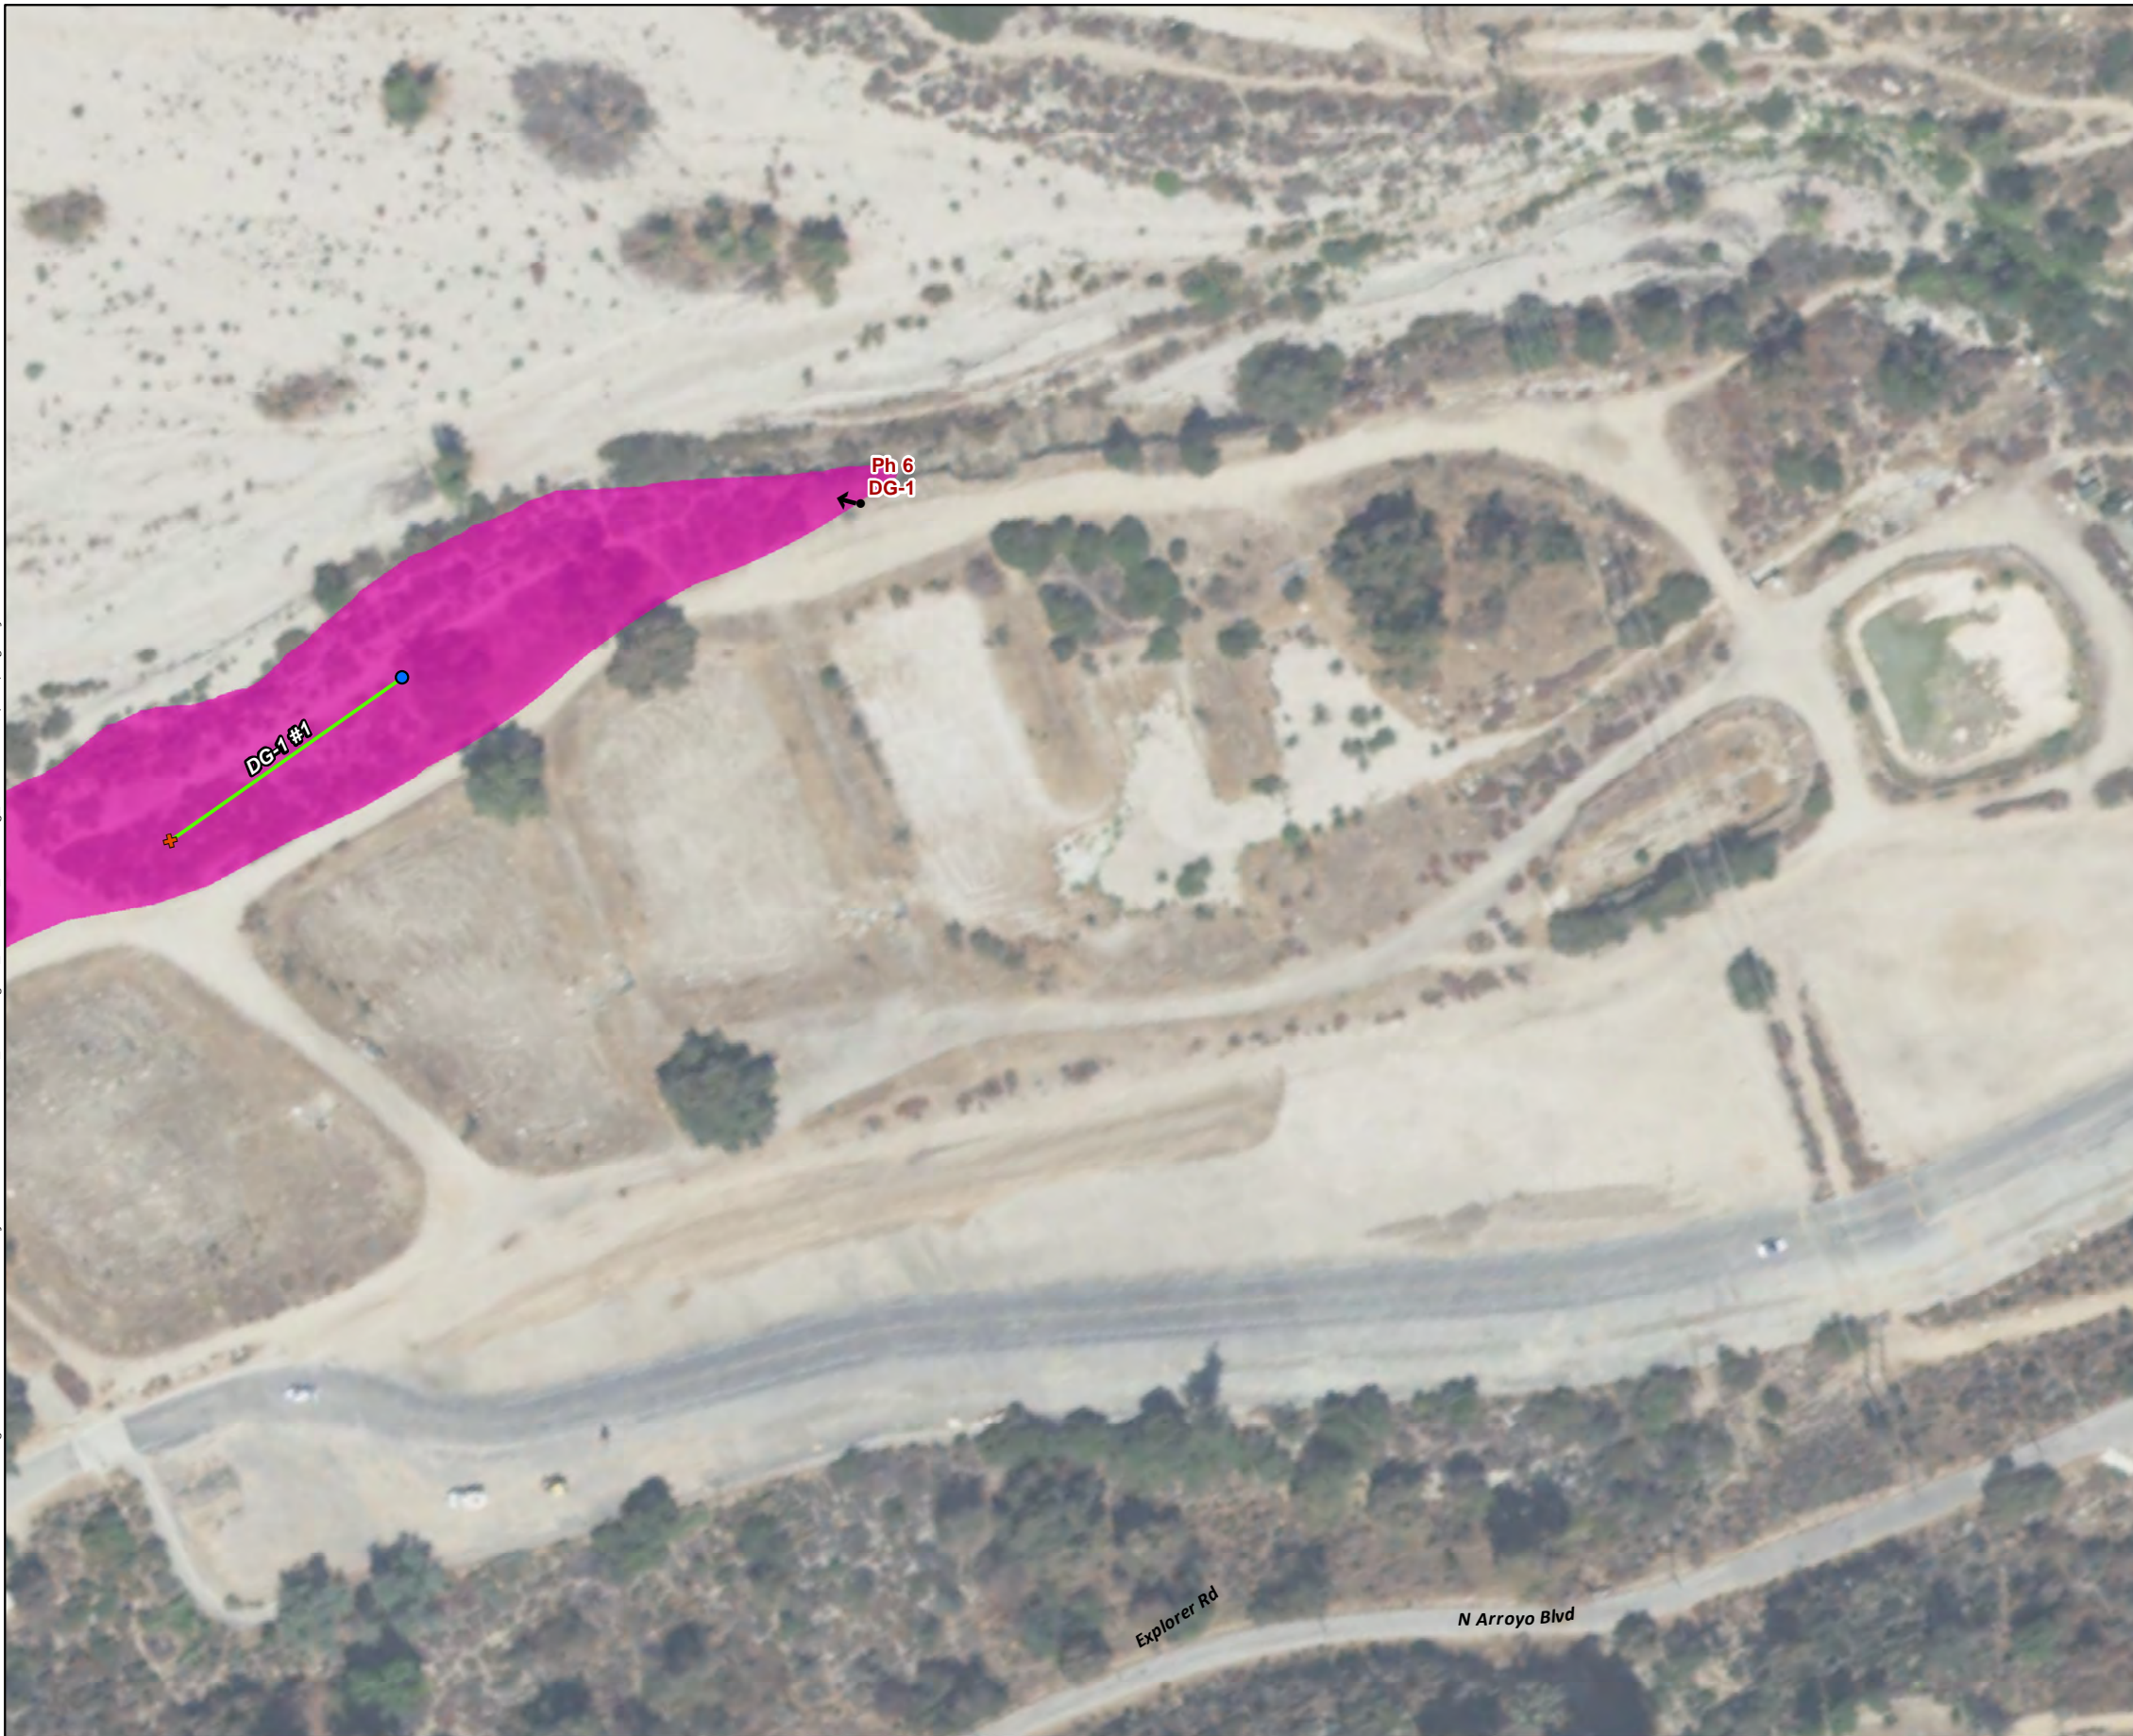
Figure 4f. Restoration Transects
Page 6 of 8

- DG-1

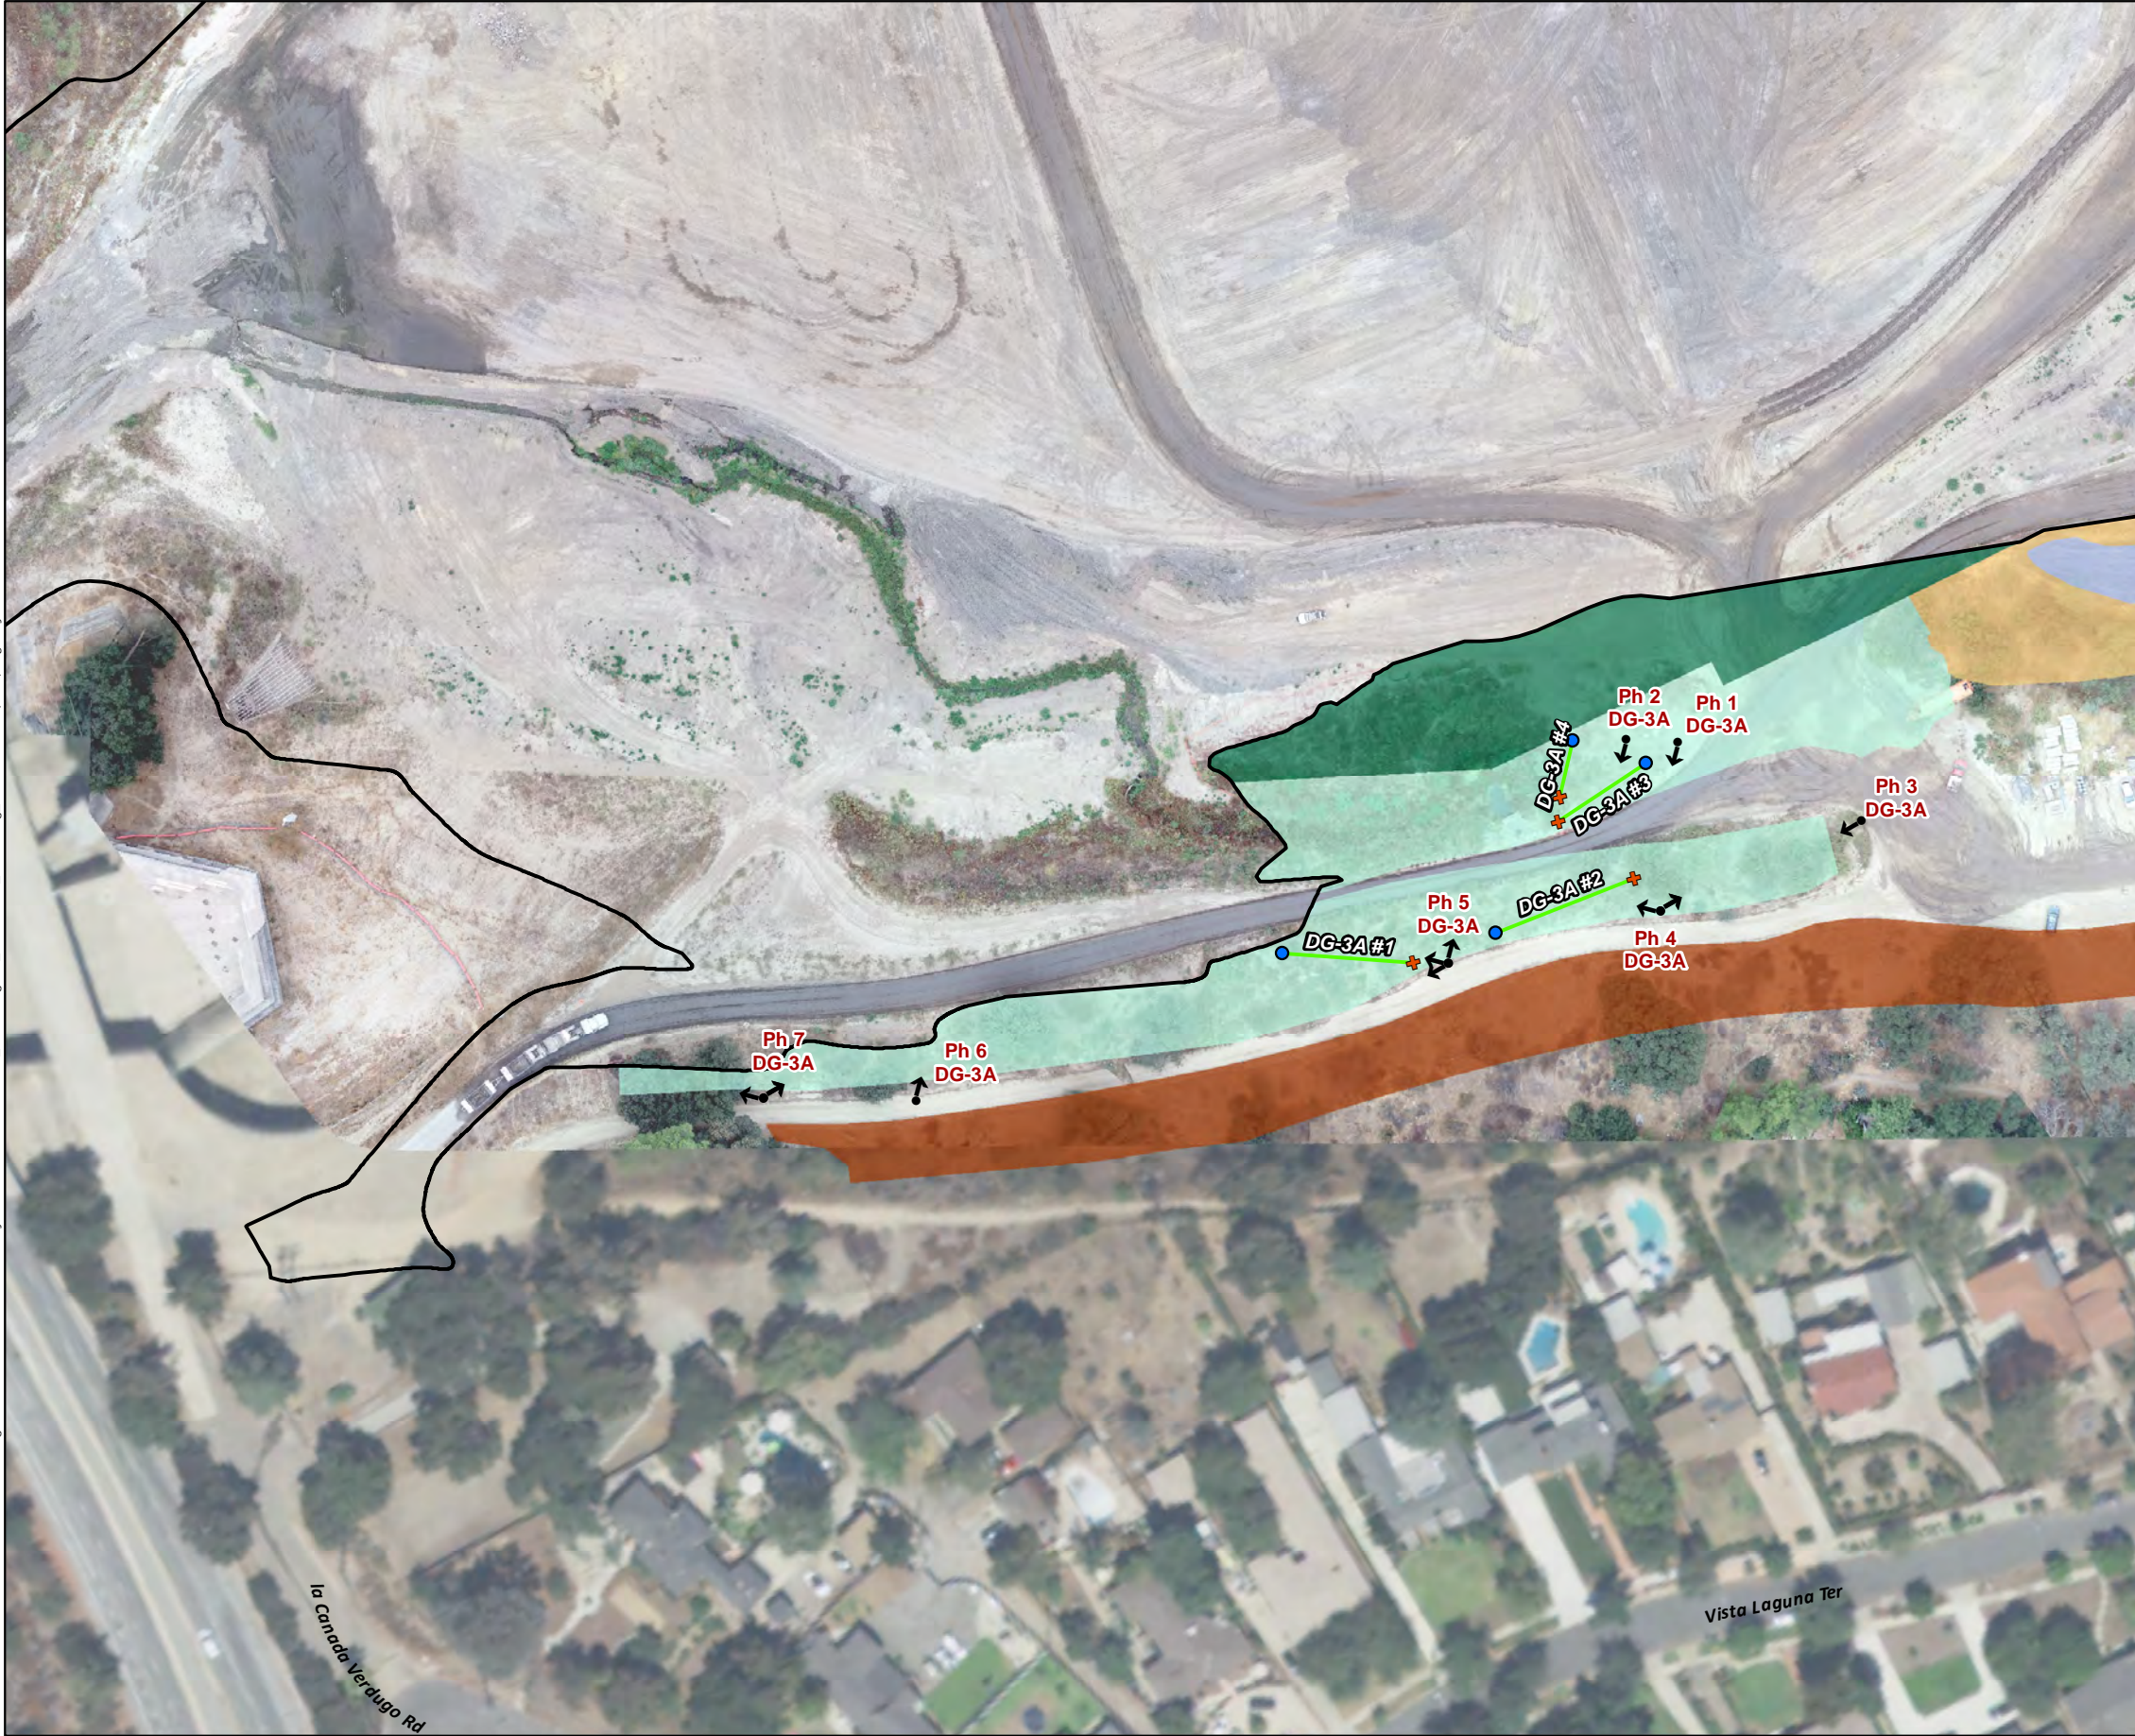
Figure 4g. Restoration Transects
Page 7 of 8

- DG-2
- DG-2 WOUS
- DG-3A
- DG-3B
- DG-East Trail 1

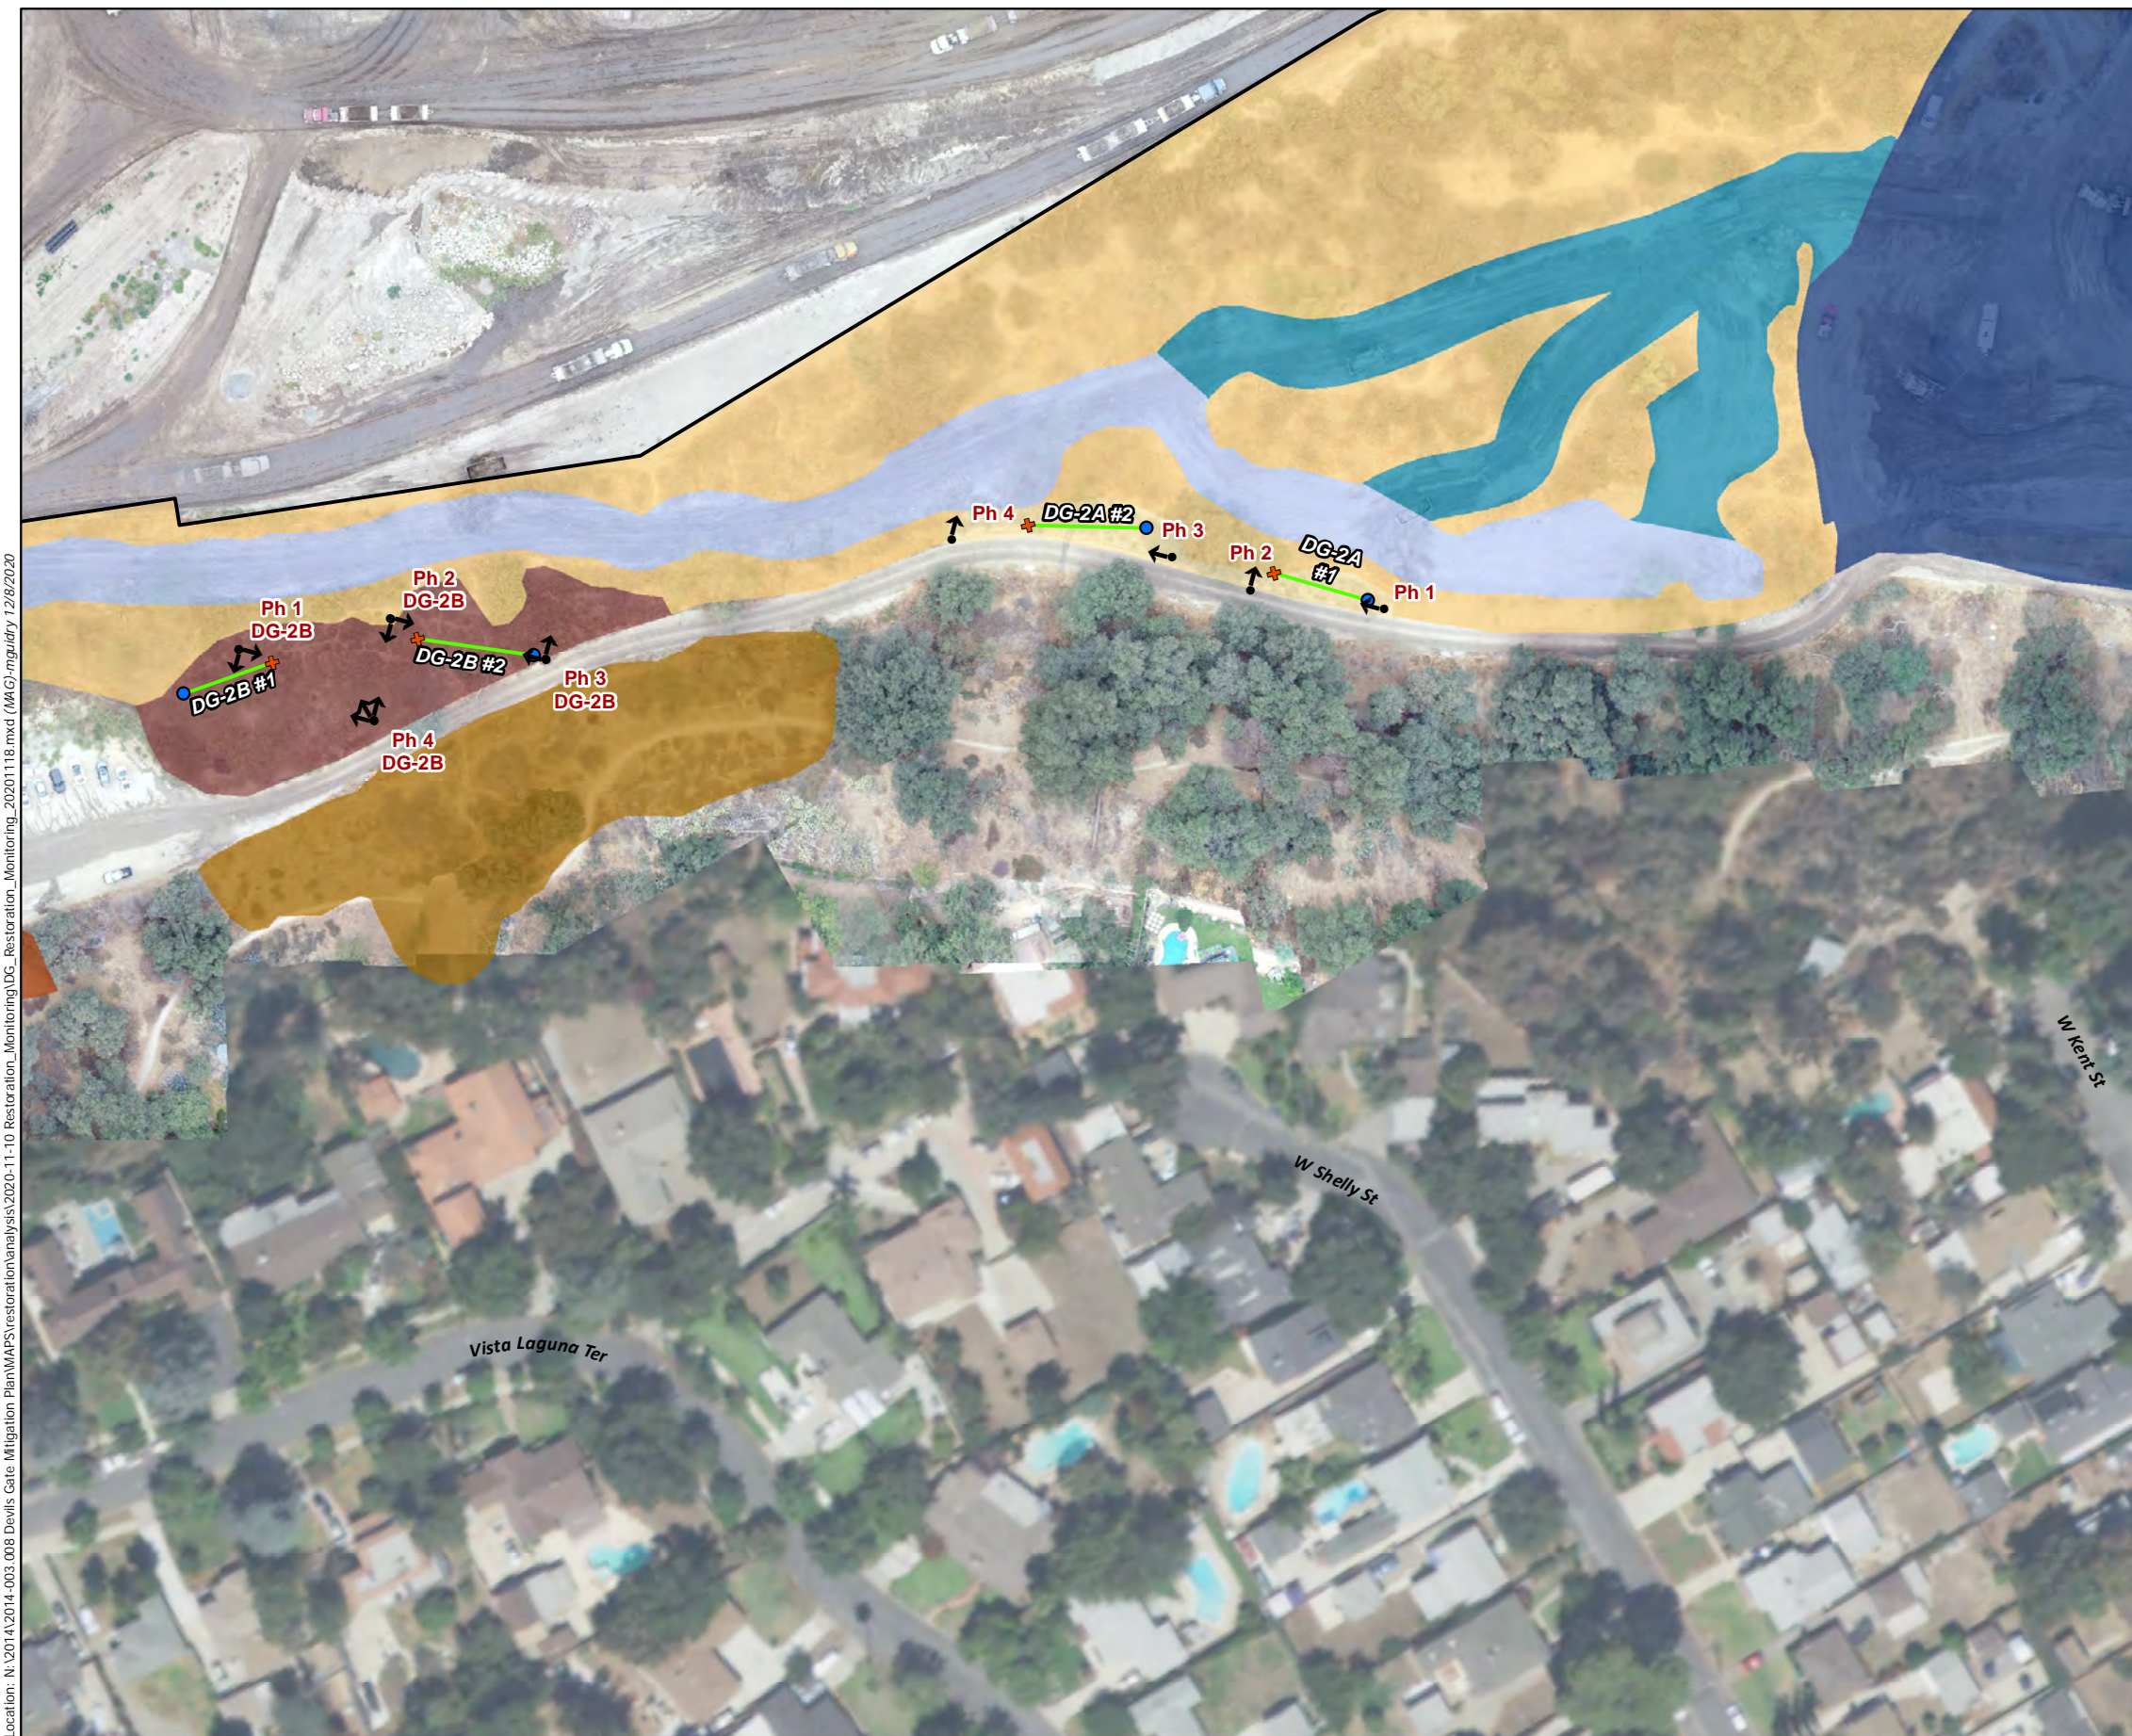
Figure 4h. Restoration Transects
Page 8 of 8

- DG-2
- DG-2 New Channels
- DG-2 WOUS
- DG-2A
- DG-2B
- DG-East Trail 1
- DG-East Trail 2
- DG-East Trail 3
- DG-W-1 (Johnson Field)

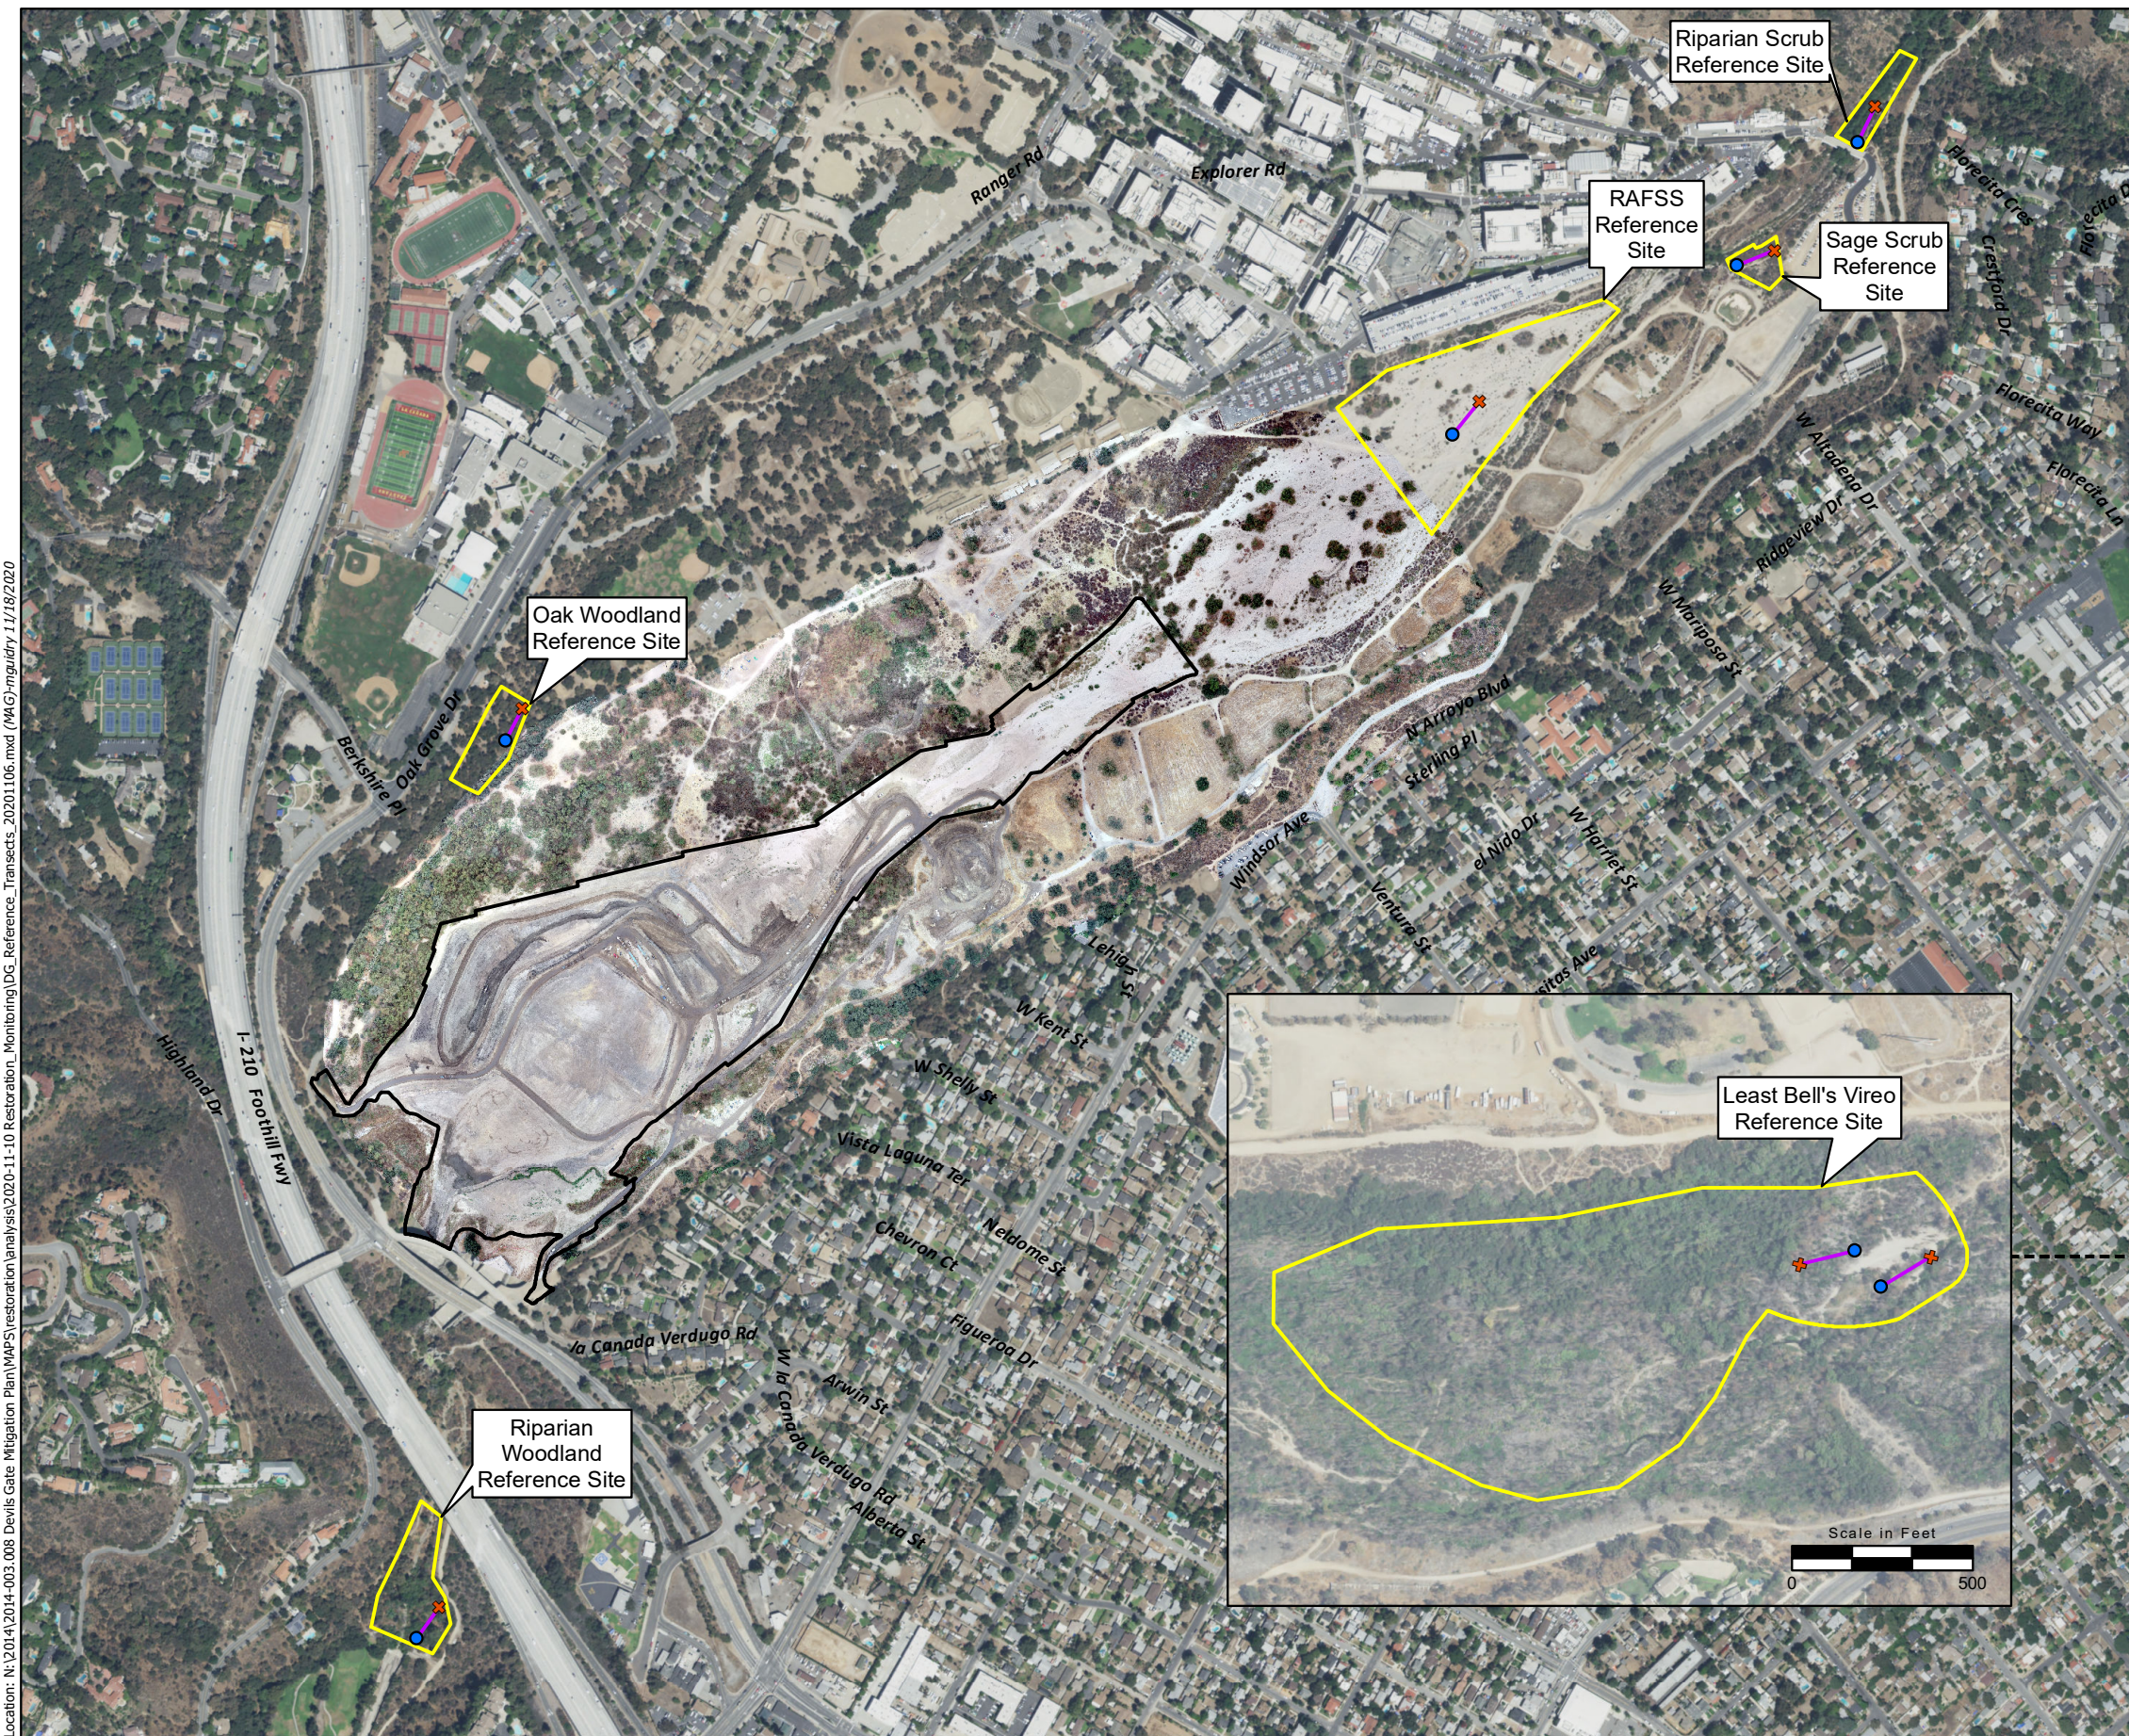
Figure 5
Habitat Mitigation Reference Sites
and Transects

- Final Design Boundary ¹
- Reference Site
- Reference Transect
- Transect Start
- Transect End

Bare ground, rock, and litter were also recorded along each transect in areas that had no plant overlap. Species occurrence along each transect line was totaled and divided by the number of sampling points and multiplied by 100 to derive the percent cover (total cover) along each transect. Species richness was determined for each mitigation area and reference site by documenting all of the native species that occurred within a belt transect. The belt transects extended one-meter to the left and right of each of the 25 transects within the mitigation areas, and the 7 transects within the reference sites.

Table 6 shows the native species richness for the reference sites. Native species richness was found to be 10 for the RAFSS reference site, 5 for the CSS reference site, 3 for the oak woodland reference site, 20 for the riparian reference site, and 22 in the LBVI reference sites.
