A 1 OF A 3

MAP OF  
**PALM STREET**  
FROM  
**CENTER STREET**  
TO  
**ARTESIA & BUENA PARK ROAD**  
COUNTY SURVEYORS MAP NO. 8853  
SCALE: 1 INCH = 100 FEET  
J. E. ROCKHOLD COUNTY SURVEYOR  
SURVEYED AUGUST 1926

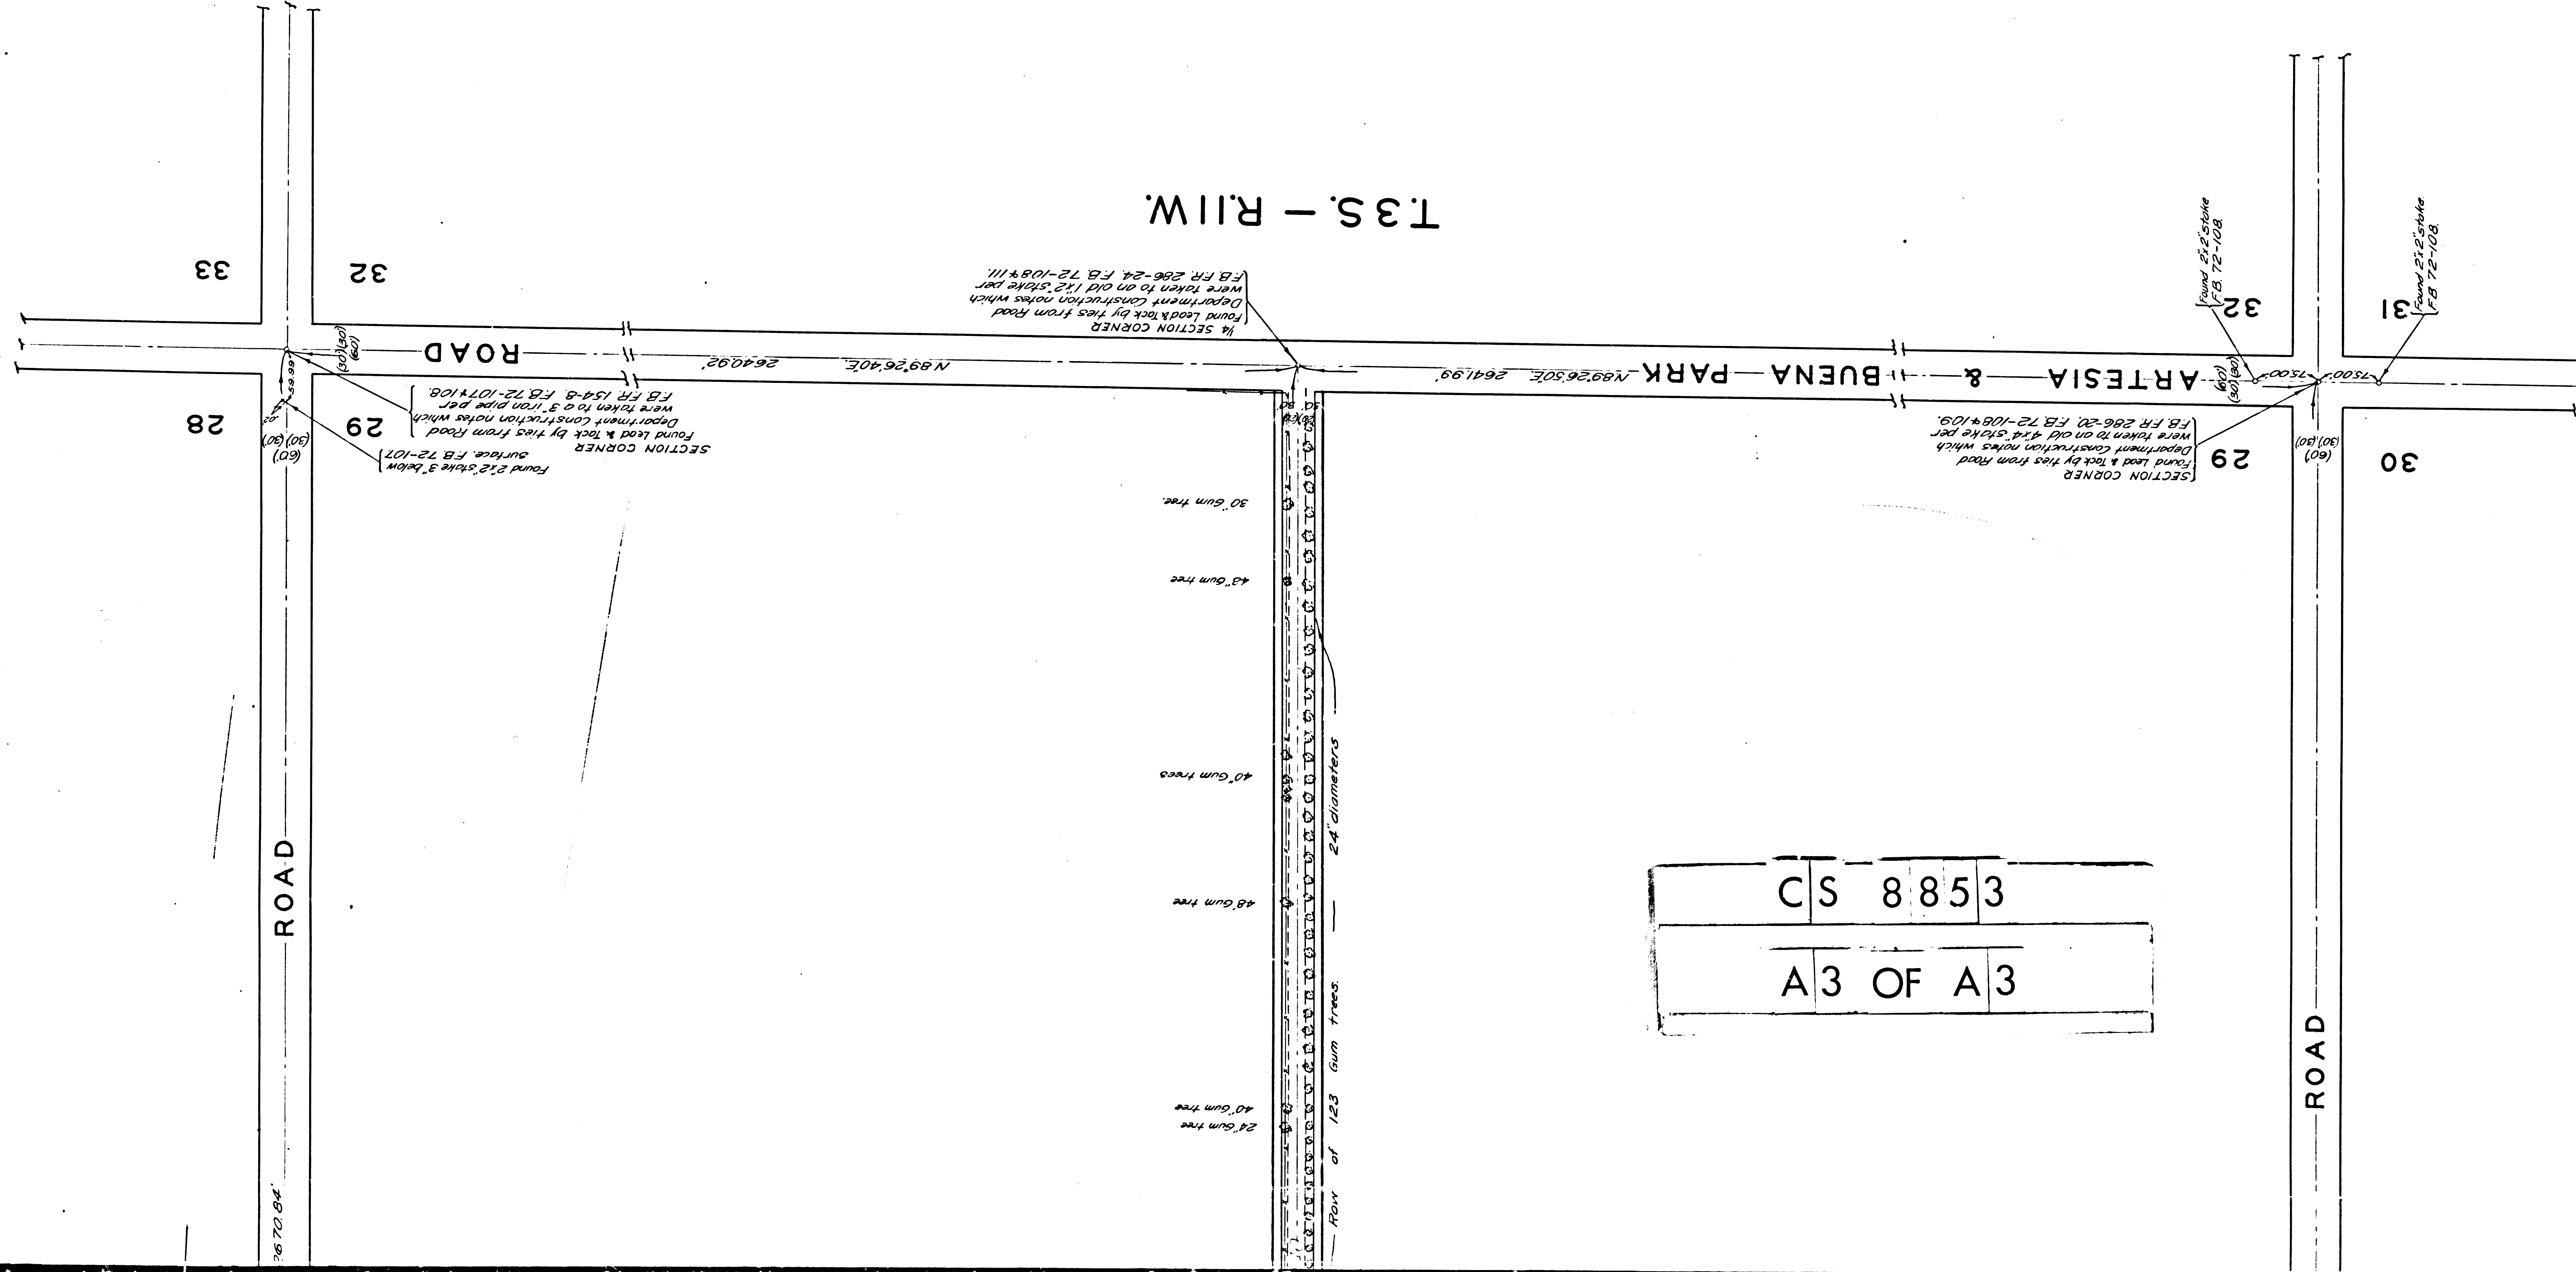
1/4 SECTION CORNER  
Found old rotten redwood 4x4  
stake, with spike, washer and  
ring & below the surface.  
Replaced 4x4 redwood stake by 2" iron pipe  
Set in concrete one foot below  
the surface with brass cap marked  
F.B. 72-109  
COR. 30+29  
MONUMENT

CENTER SECTION 29  
Set 2" iron pipe in concrete  
with brass cap marked  
below the surface by  
intersection. F.B. 72-111  
COR. 29+28  
MONUMENT

1/4 SECTION CORNER  
Set 2" iron pipe in concrete  
with brass cap marked  
1' below the surface by  
proportion between center  
Street and Arroyo-Buena  
Porte Road. F.B. 72-107  
COR. 29+28  
MONUMENT
