**Year 5 Annual Monitoring Report
for the
Devil's Gate Reservoir Restoration Project
(Phase 2)
Onsite Habitat Mitigation**

Los Angeles County

Los Angeles County Public Works

**ECORP Consulting, Inc.**
ENVIRONMENTAL CONSULTANTS
111 Academy Way, Suite 210,
Irvine, California 92617

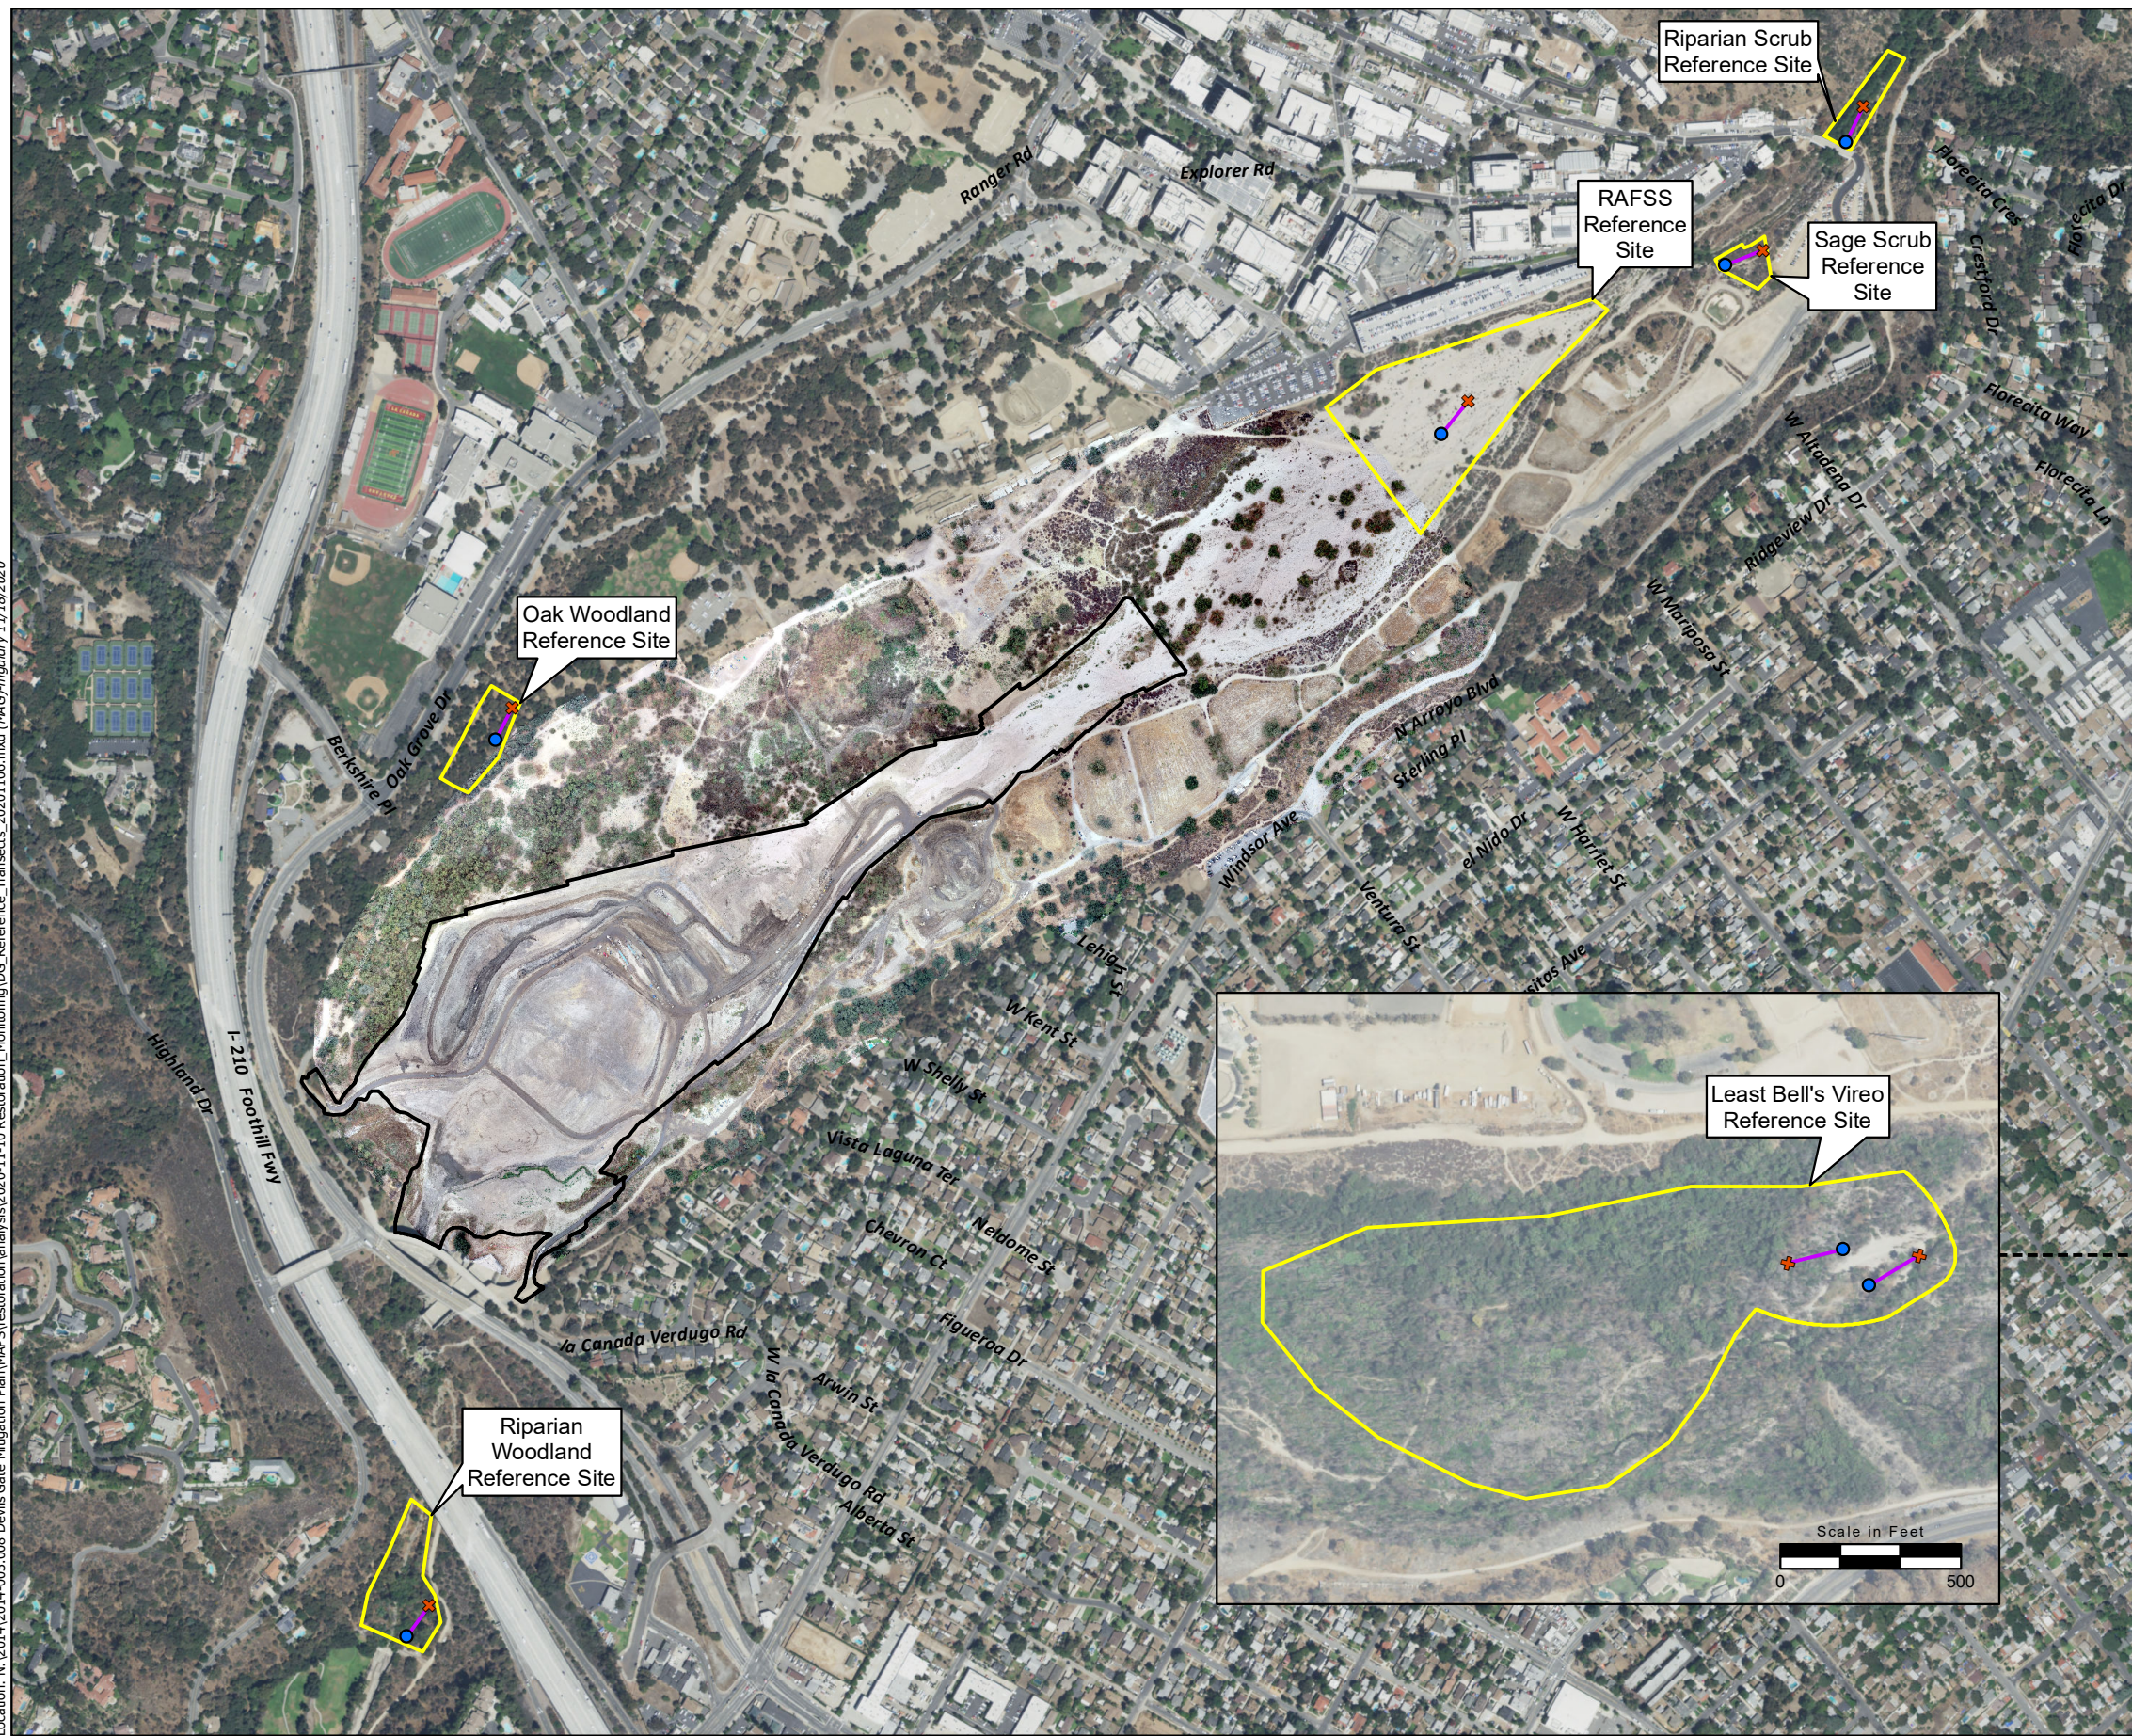
Figure 6.
Transect Locations Reference Sites

Data for the reference sites were not collected during Year 5 for Phase 2 and the data from Year 1 for Phase 1 will be used for comparison. Reference sites were established during Year 1 for the Phase 1 mitigation areas for riparian scrub, riparian woodland, and LBVI habitats. Reference sites were relatively undisturbed and had vegetation composition similar to the goal vegetation communities for the mitigation areas. The reference site for the LBVI habitat was selected in an undisturbed riparian habitat with mature riparian trees and a well-established understory. In addition, the reference site for LBVI habitat was selected in occupied habitat where the species has been known to be present for the past several years.
