**REPORT ON 2016-17 INSPECTION OF
LACDPW SCRDS FACILITIES**

**CONTRACT:STORMWATER CAPTURE RUBBER DAM
MAINTENANCE SERVICES (2014-IT001)**

AUGUST 20, 2018

RUBBER DAM INSPECTION REPORT

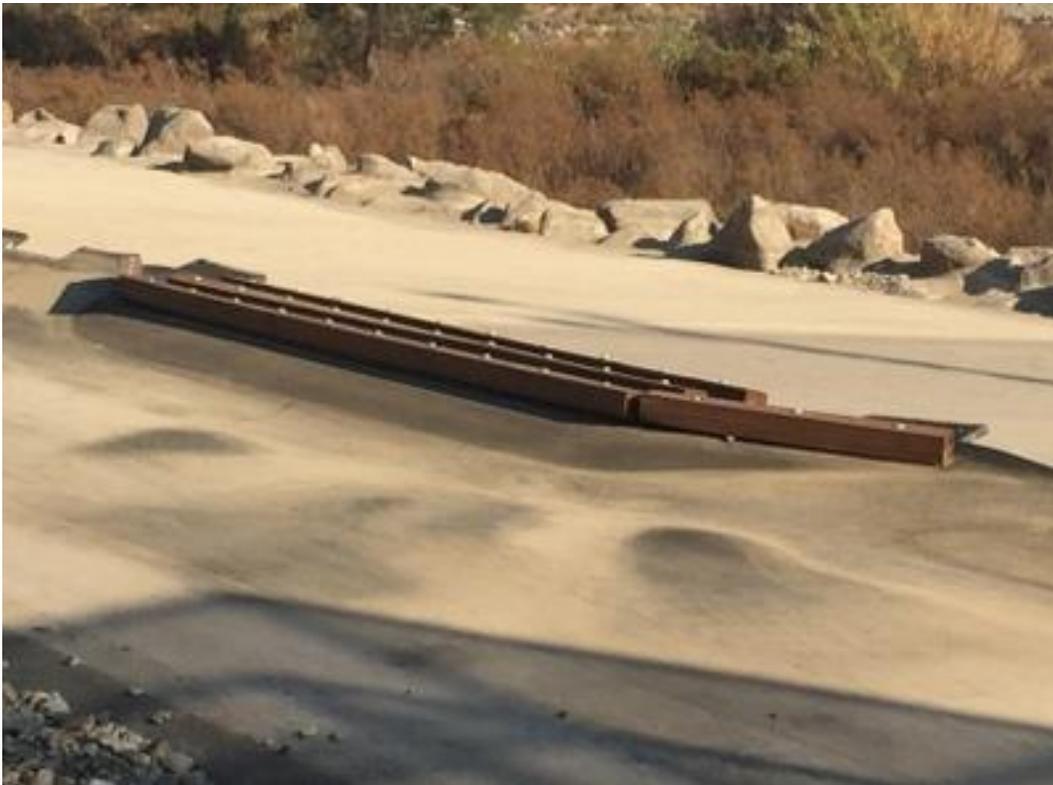
PHOTO 15 REPAIRED AREA RIGHT ABUTMENT

1) Overall condition of Rubber Dam, Mechanical and Electrical equipment at site:
 Rubber Body - Class D Repair at right abutment needs removal and replacement.
 Mechanical Equipment - Motor Valve lacks proportional feedback as included at Valley 2 & 3.
 Electrical Equipment - UPS needs replacement, Building alarm not working.
 Radio, Antenna & Antenna Mast - No significant damage observed

- 1) Remove and replace Class D repair at right abutment.
- 2) Replace UPS and tie in to PLC Programming & Alarms.
- 3) Repair and test building alarm.
- 4) Re-wire and test slide gate panels.

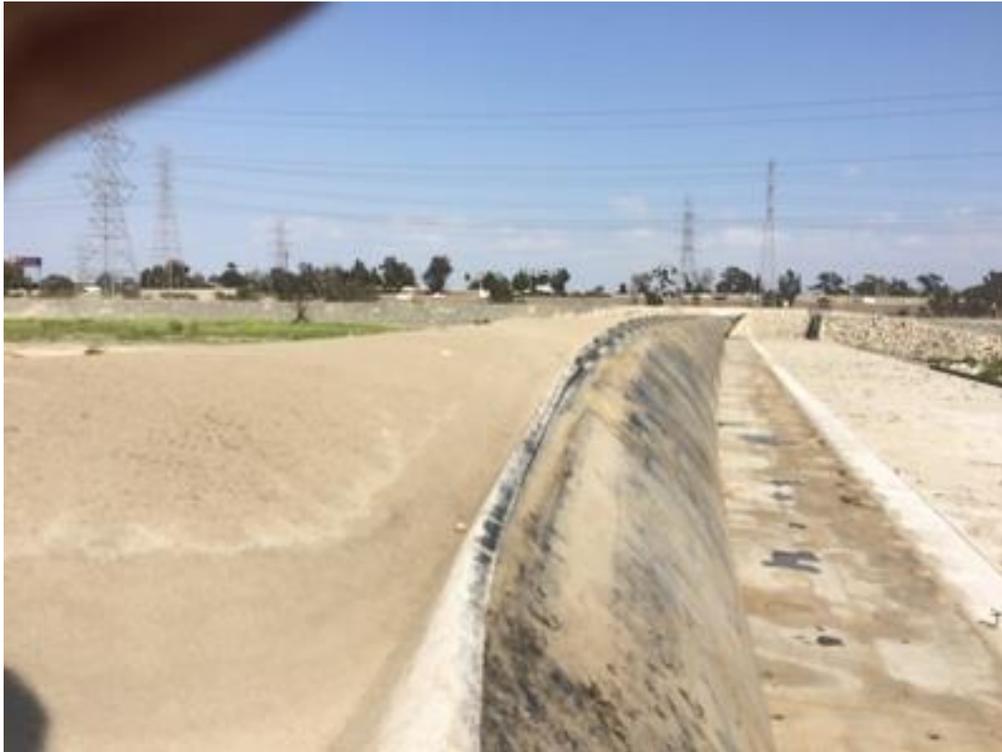
PHOTO 5 INFLATED RUBBER DAM UNDER FIN RIGHT ABUTMENT

- 1) UPS needs replacement.
- 2) Indication of beginnings of bubbles under fin.
- 3) Fin unusually high increasing chances of fin bubbles & de-lamination.
- 4) Slide gate not operational.

- 1) Repair building alarm.
- 2) Replace UPS and tie in to PLC Programming & Alarms.
- 3) Monitor under fin bubbles.
- 4) Cut fin to normal height.
- 5) Investigate cause of slide gate failure to operate.

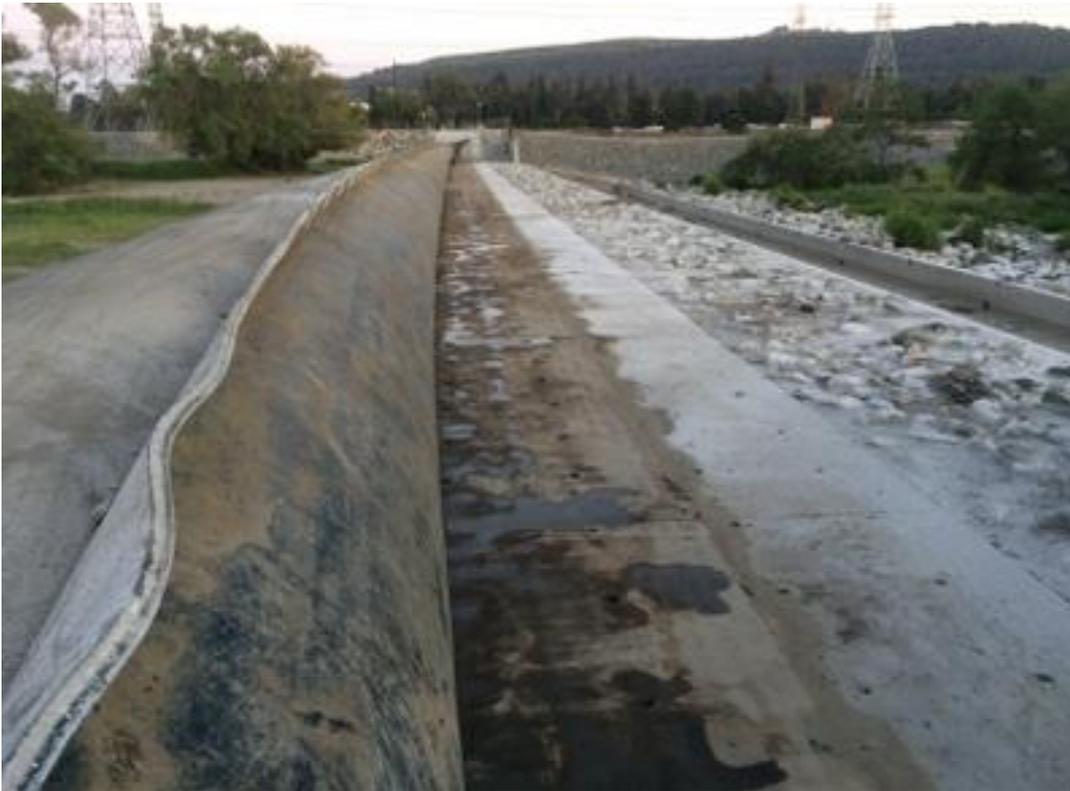
PHOTO 5 INFLATED RUBBER DAM UNDER FIN RIGHT ABUTMENT

- 1) UPS needs replacement.
- 2) Fin unusually high increasing chances of fin bubbles & de-lamination.

- 1) Replace UPS and tie in to PLC Programming & Alarms.
- 2) Cut fin to normal height.
- 3) Fix building alarm.

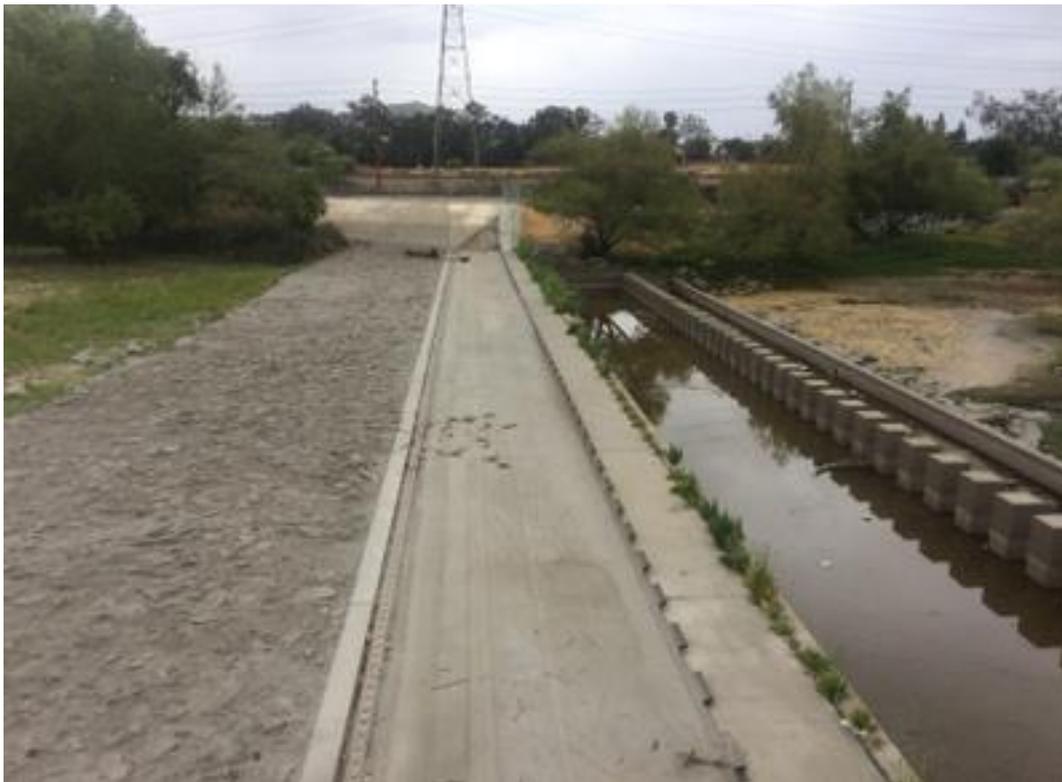
PHOTO 2 DEFLATED RUBBER DAM DOWNSTREAM VIEW

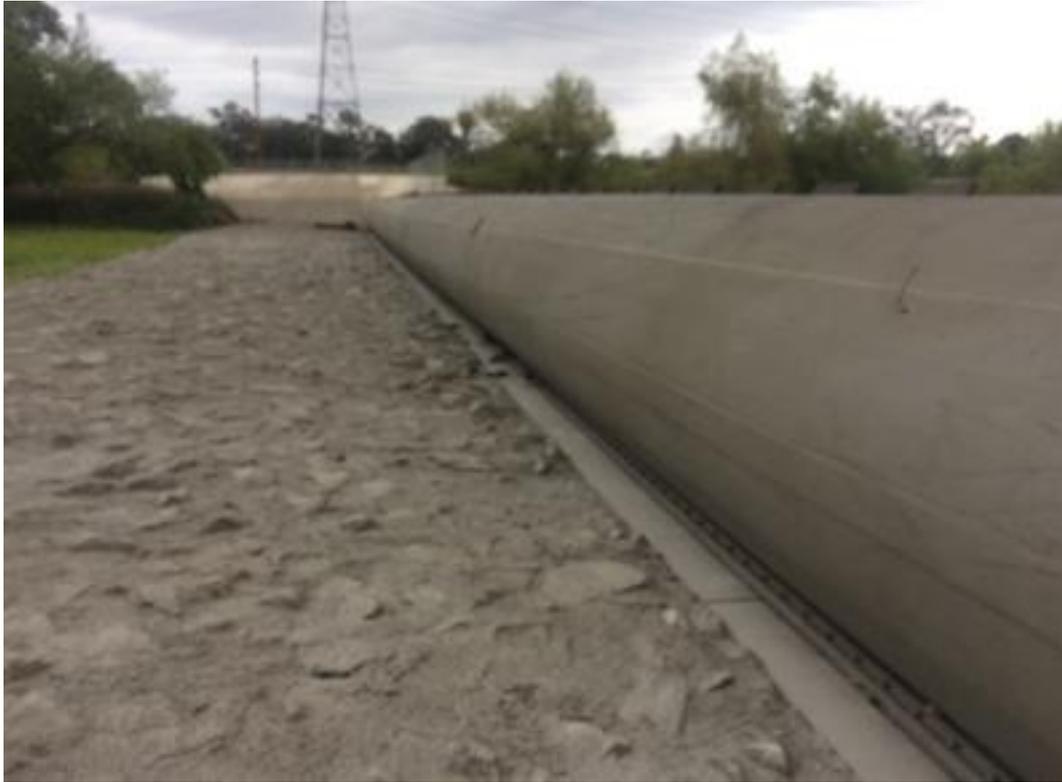
PHOTO 3

INFLATED RUBBER DAM UPSTREAM VIEW

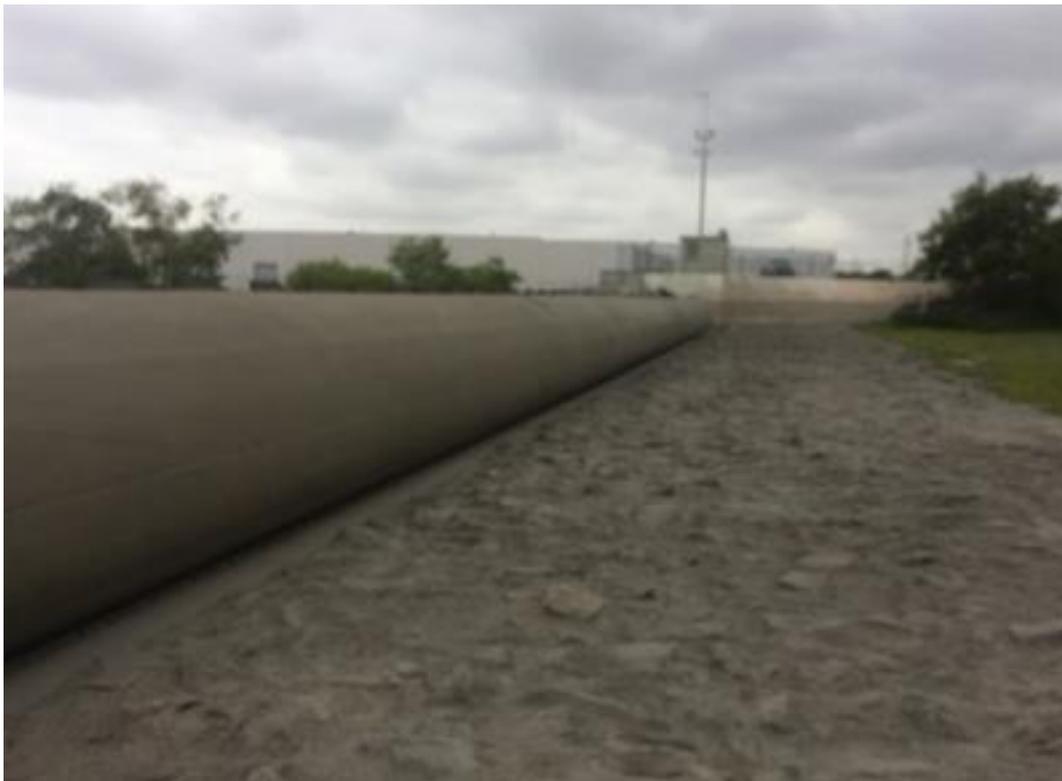
PHOTO 4

INFLATED RUBBER DAM DOWNSTREAM VIEW

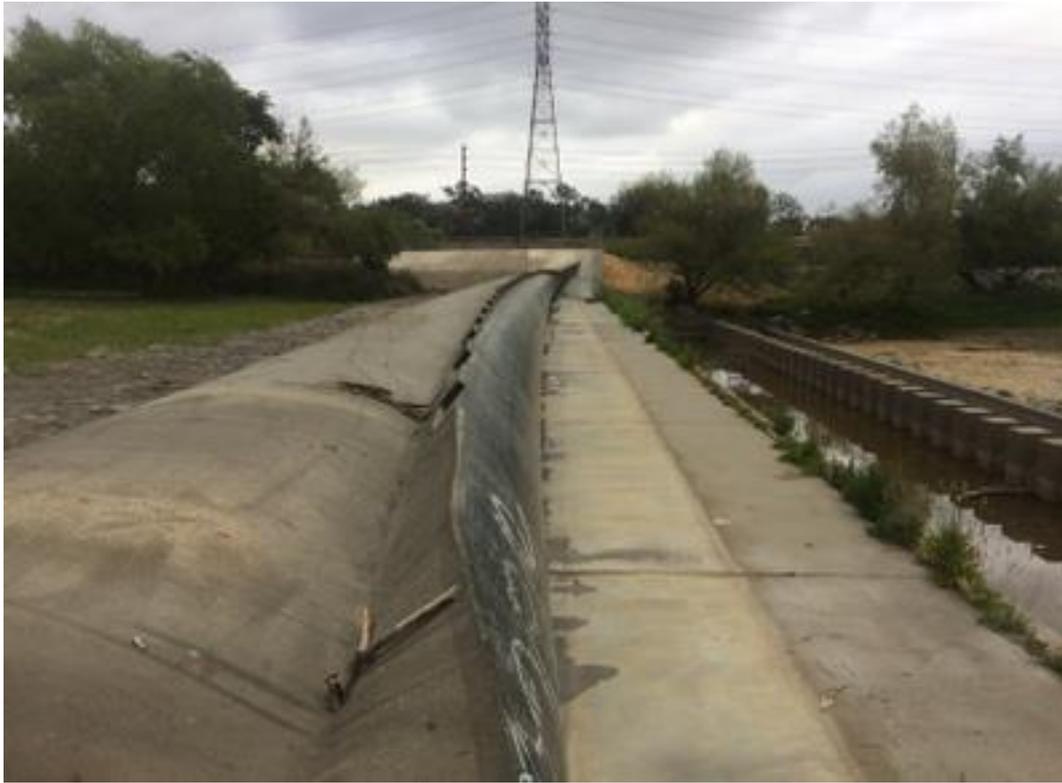
PHOTO 5 INFLATED RUBBER DAM UNDER FIN RIGHT ABUTMENT

- 1) No change noted to cover rubber separation at fin area.
- 2) UPS needs replacement.
- 3) Motor valve needed replacement & was replaced June 2018.
- 4) Antenna mounted at 10' above building roof is too low and causes network problems.

- 1) Develop method for monitoring of separation at lower edge of fin.
- 2) Replace UPS and tie in to PLC Programming & Alarms.
- 3) Move radio antenna to top of pole at right abutment.

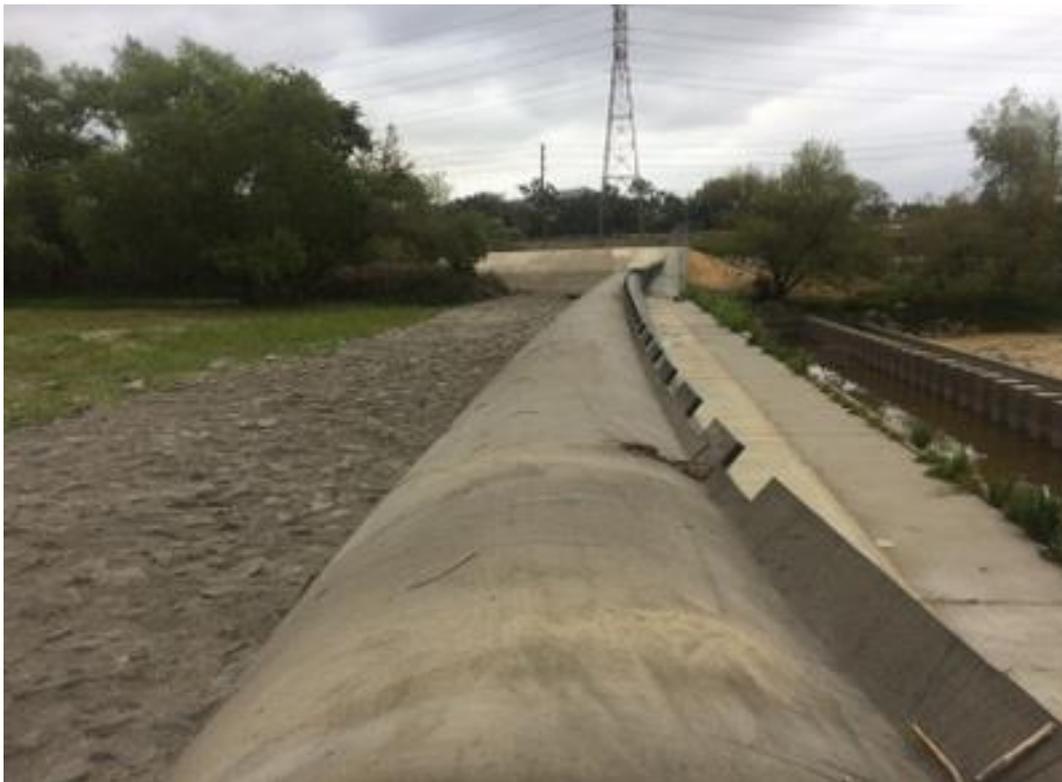
PHOTO 6 INFLATED RUBBER DAM TOP VIEW RIGHT ABUTMENT

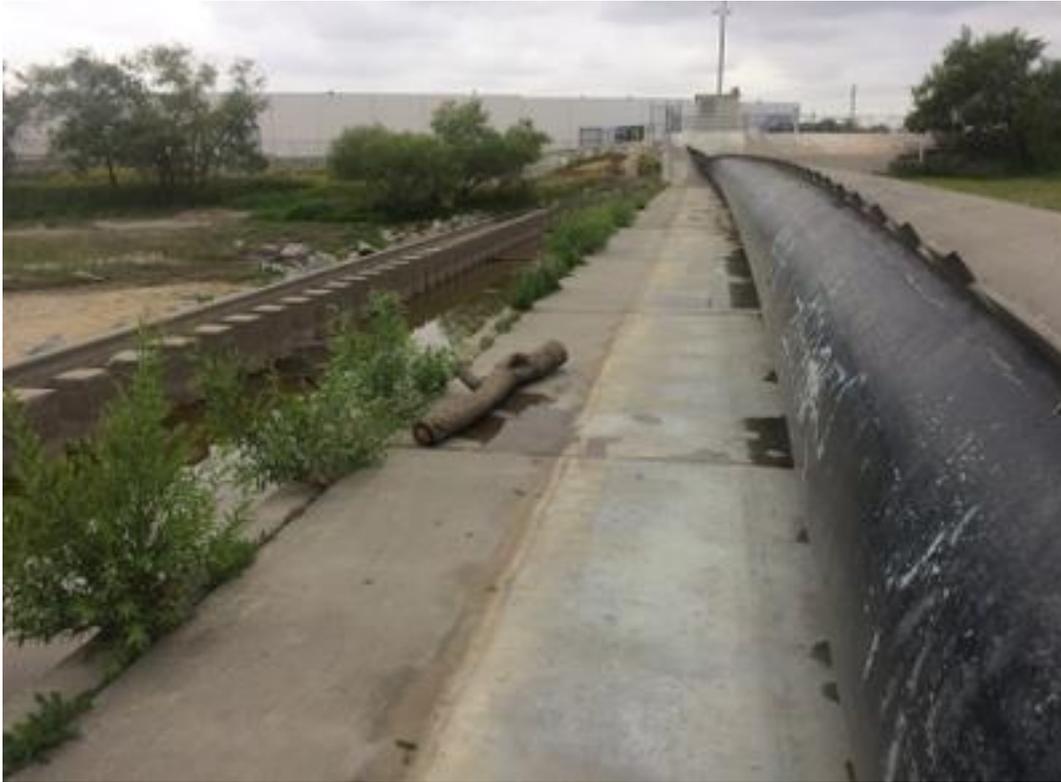
PHOTO 7

INFLATED RUBBER DAM UNDER FIN LEFT ABUTMENT

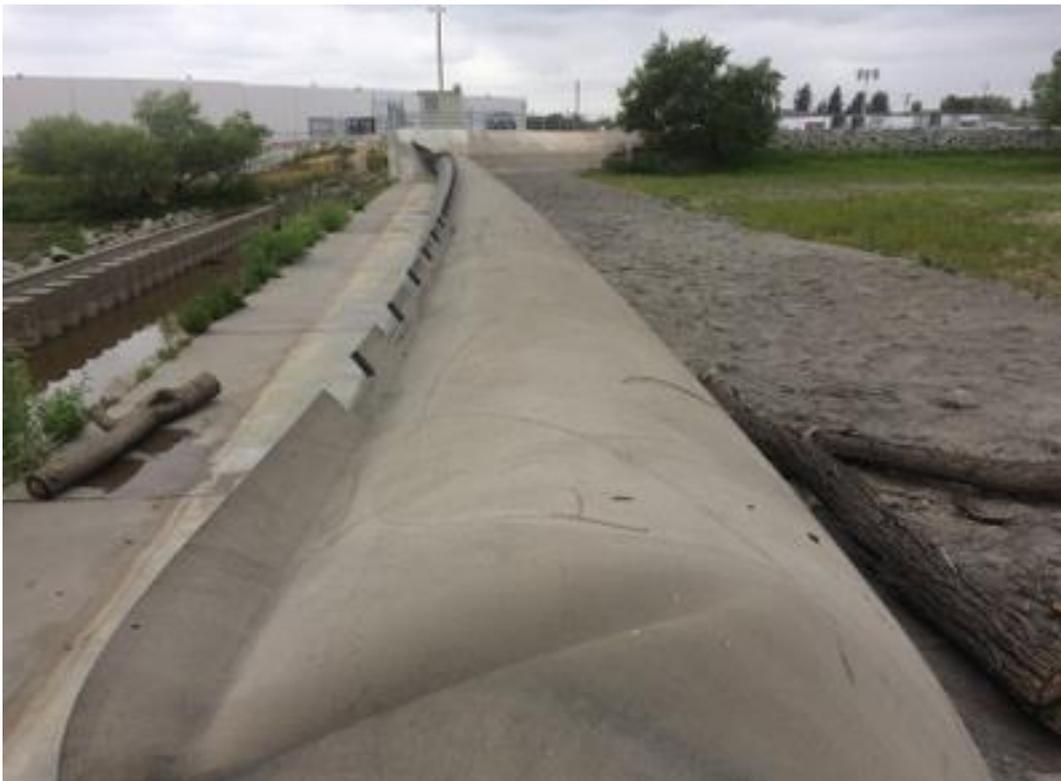
PHOTO 8

INFLATED RUBBER DAM TOP VIEW LEFT ABUTMENT

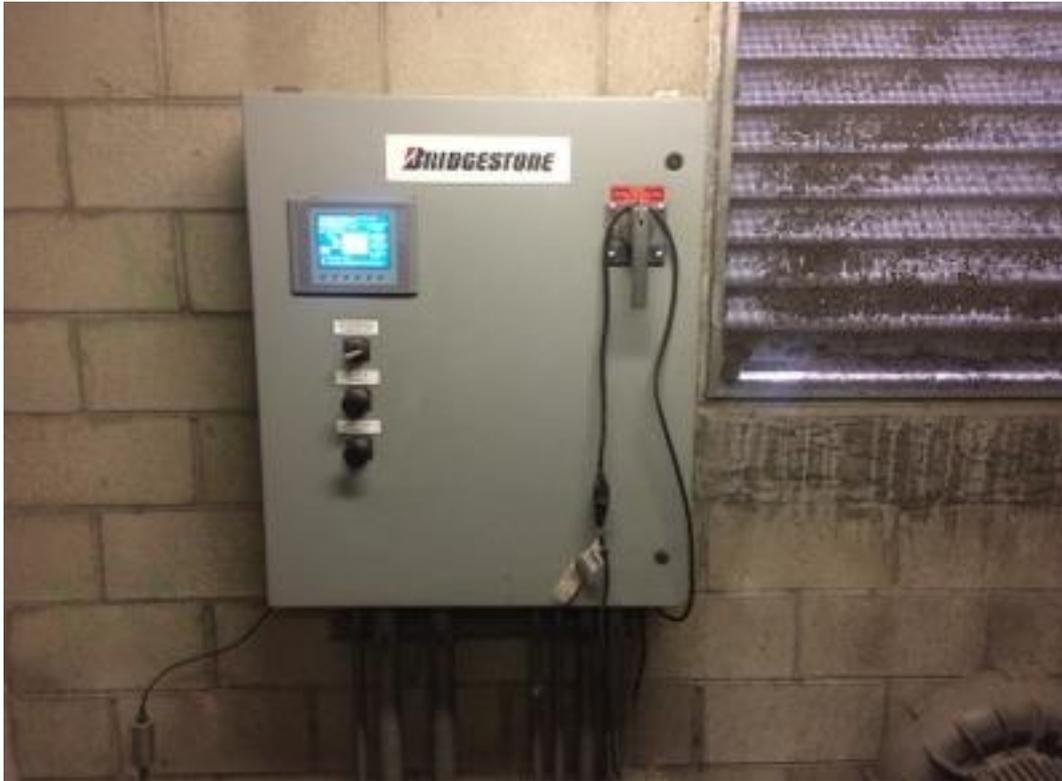
PHOTO 9 CONTROL PANEL EXTERIOR VIEW

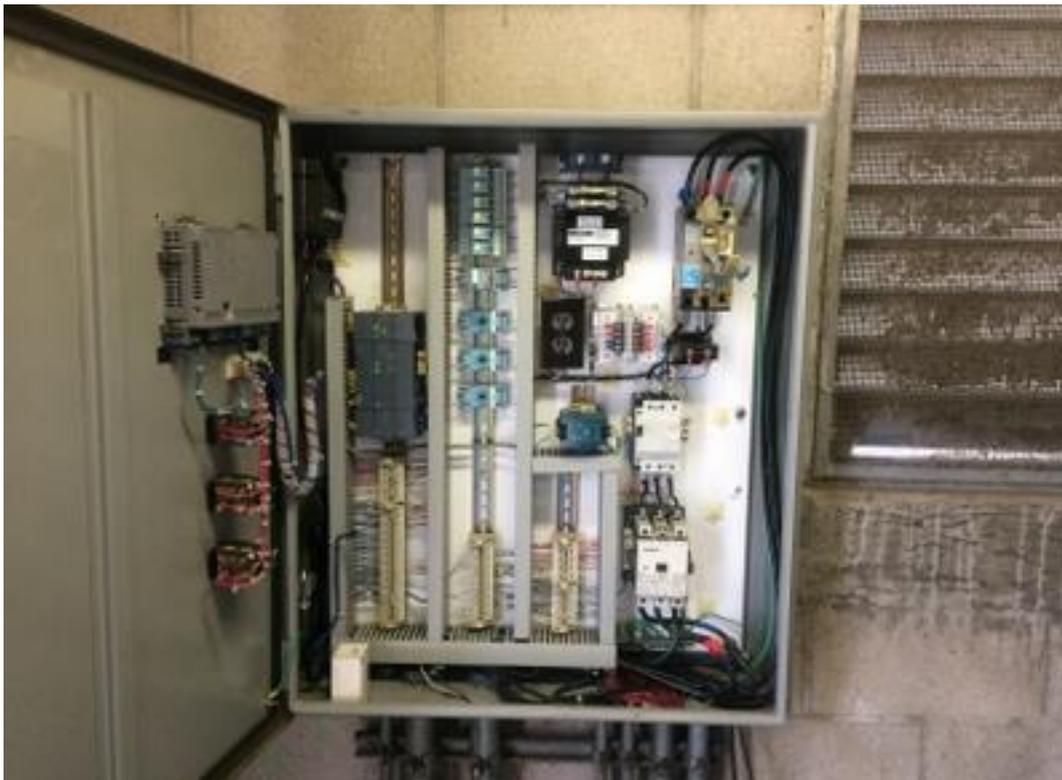
PHOTO 10 CONTROL PANEL INTERIOR VIEW

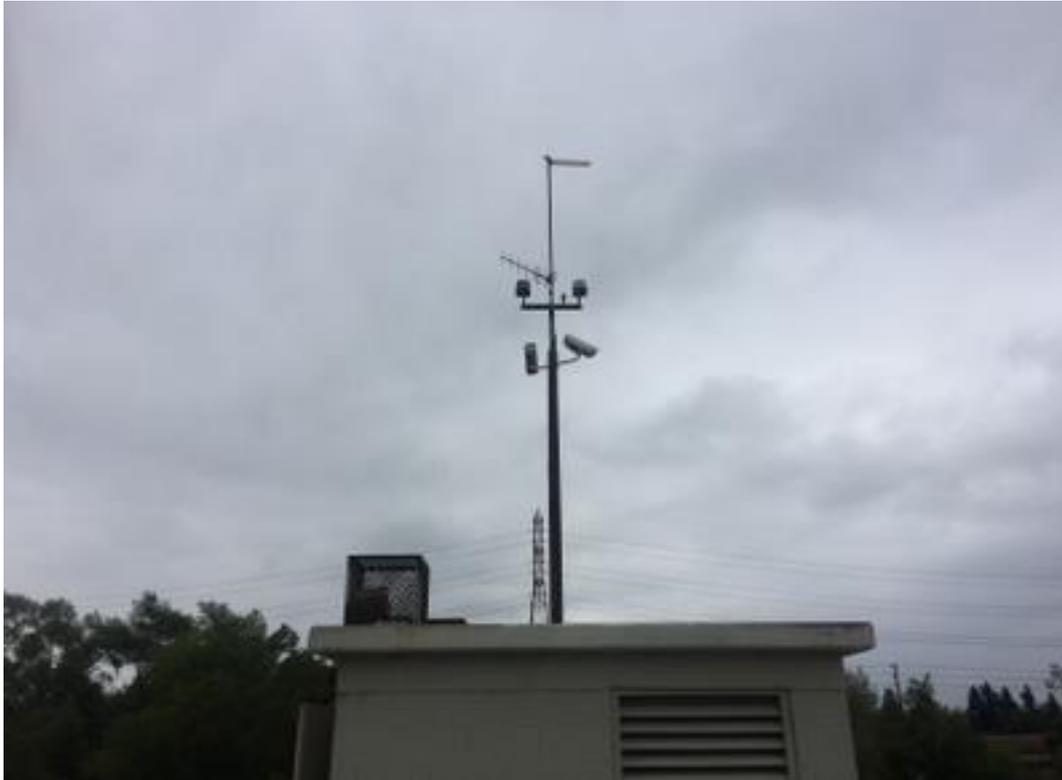
PHOTO 11

ANTENNA MAST

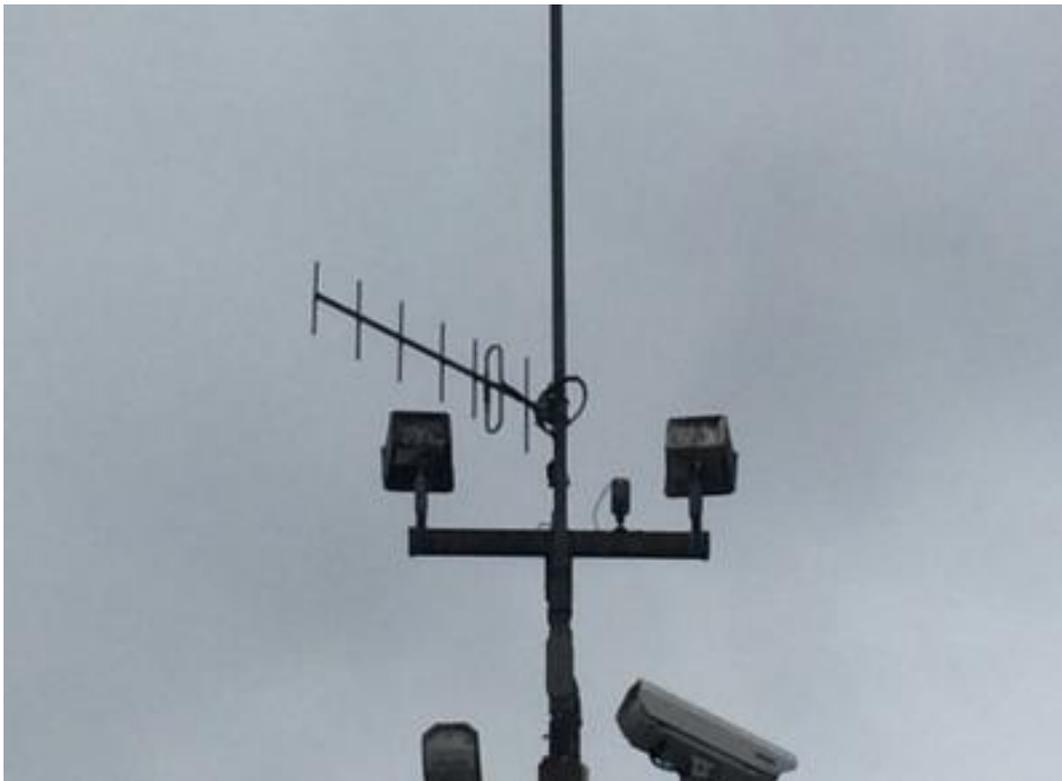
PHOTO 12

ANTENNA DETAIL

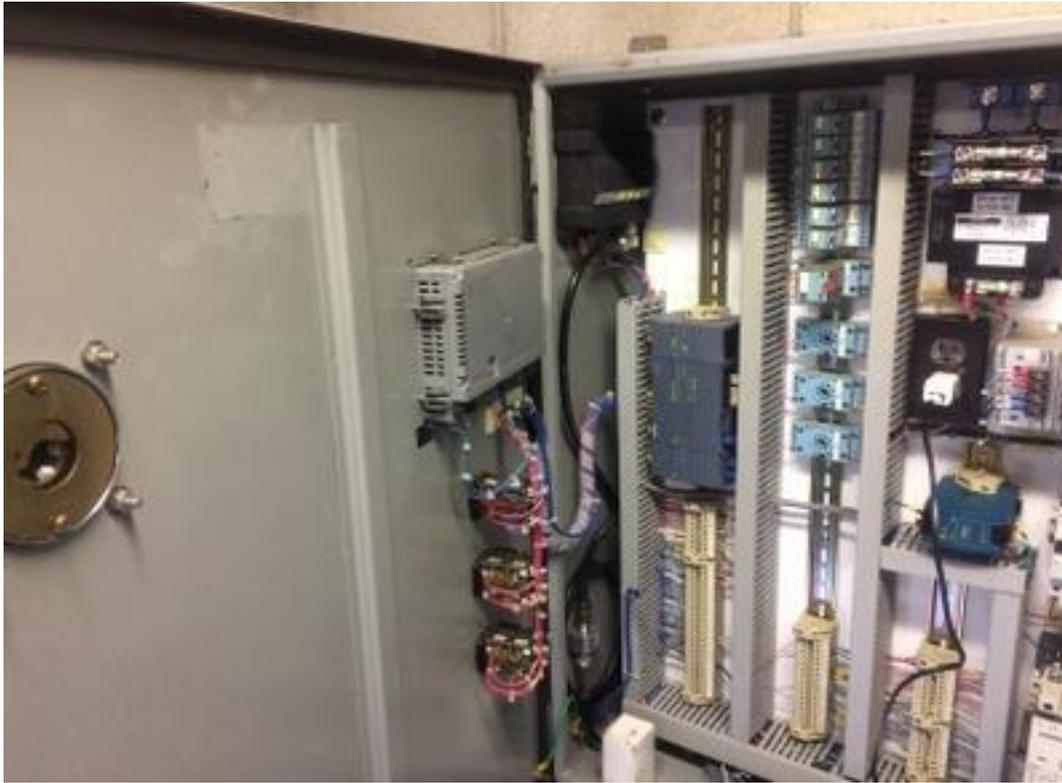
PHOTO 13 RADIO EQUIPMENT

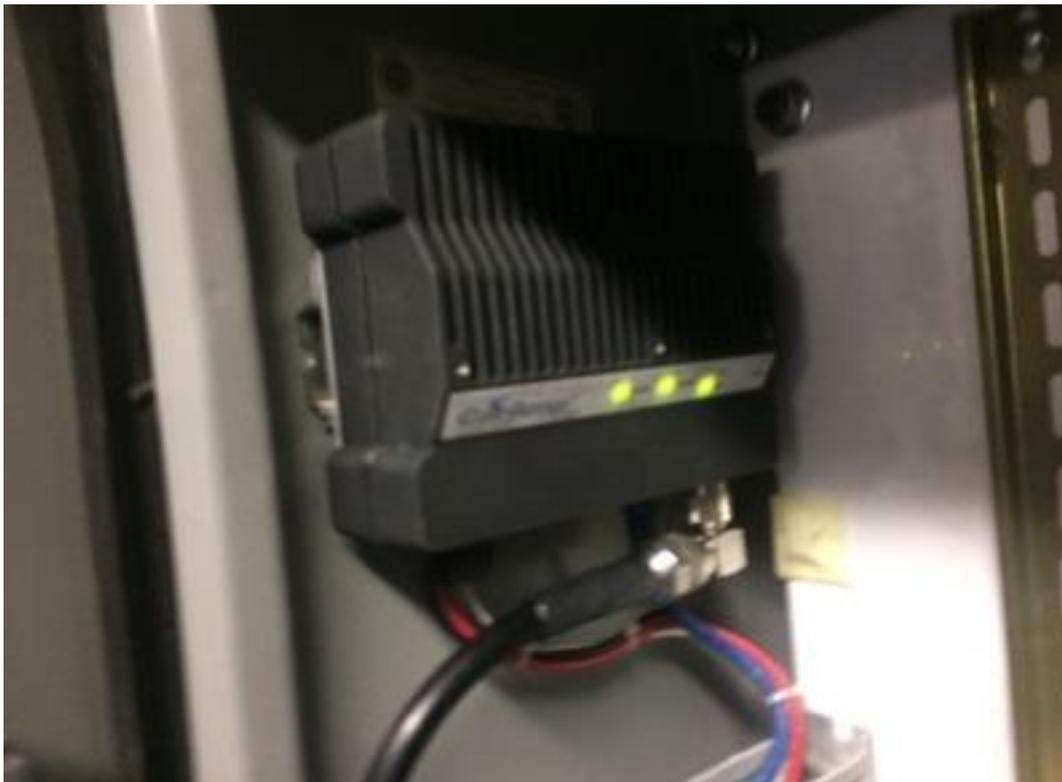
PHOTO 14 RADIO EQUIPMENT DETAIL

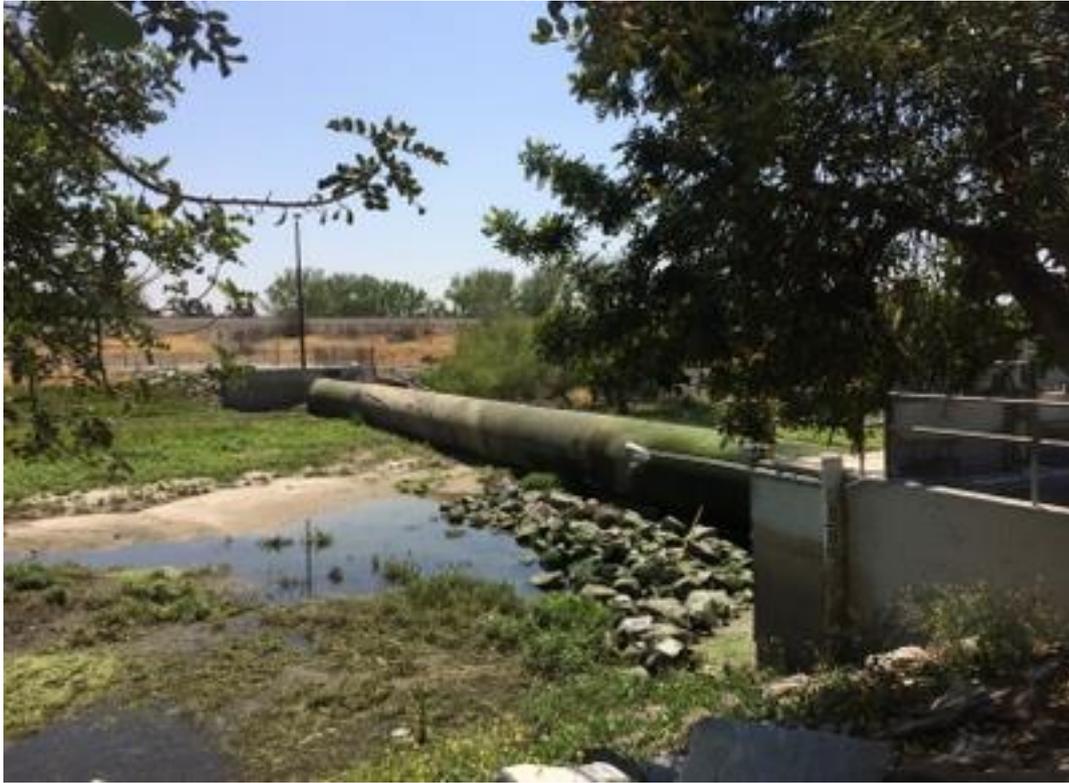
PHOTO 1 INFLATED RUBBER DAM UPSTREAM VIEW

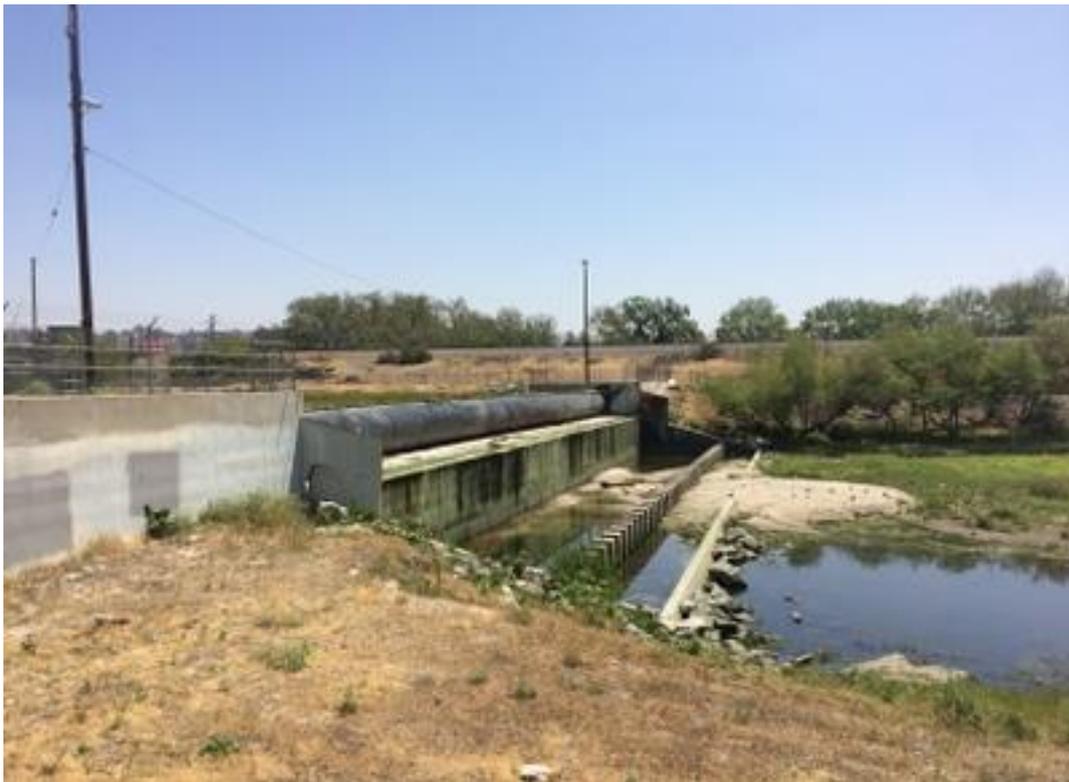
PHOTO 2 INFLATED RUBBER DAM DOWNSTREAM VIEW

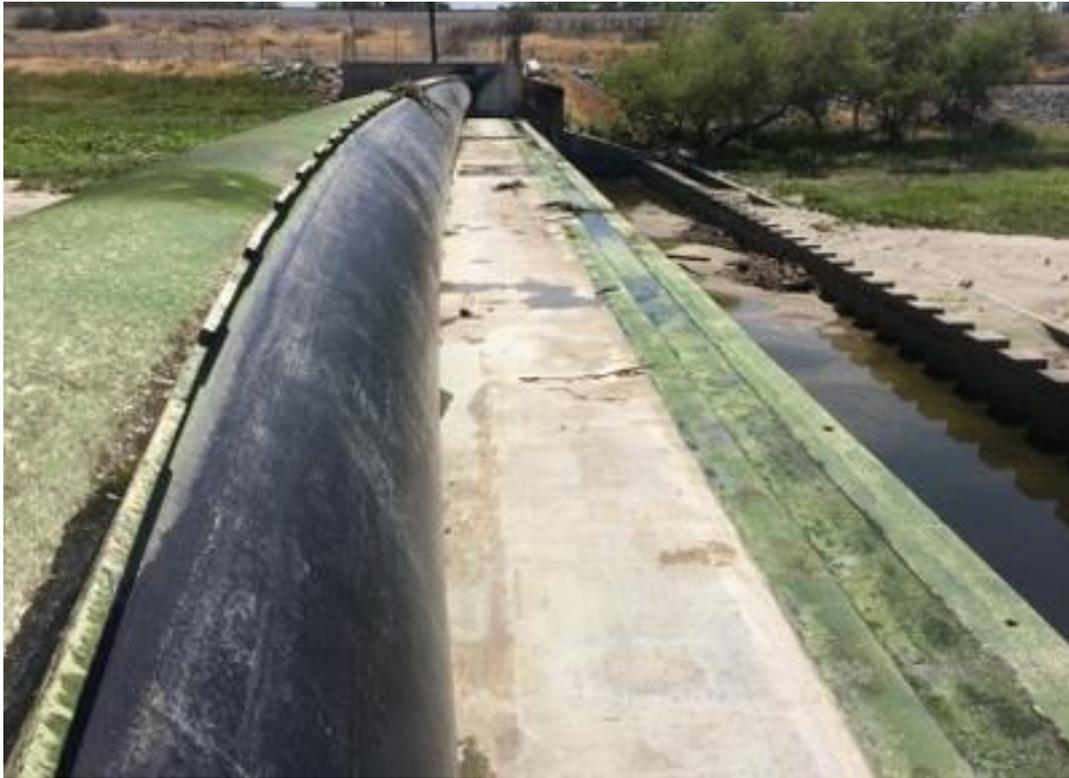
PHOTO 3 INFLATED RUBBER DAM UNDER FIN RIGHT ABUTMENT

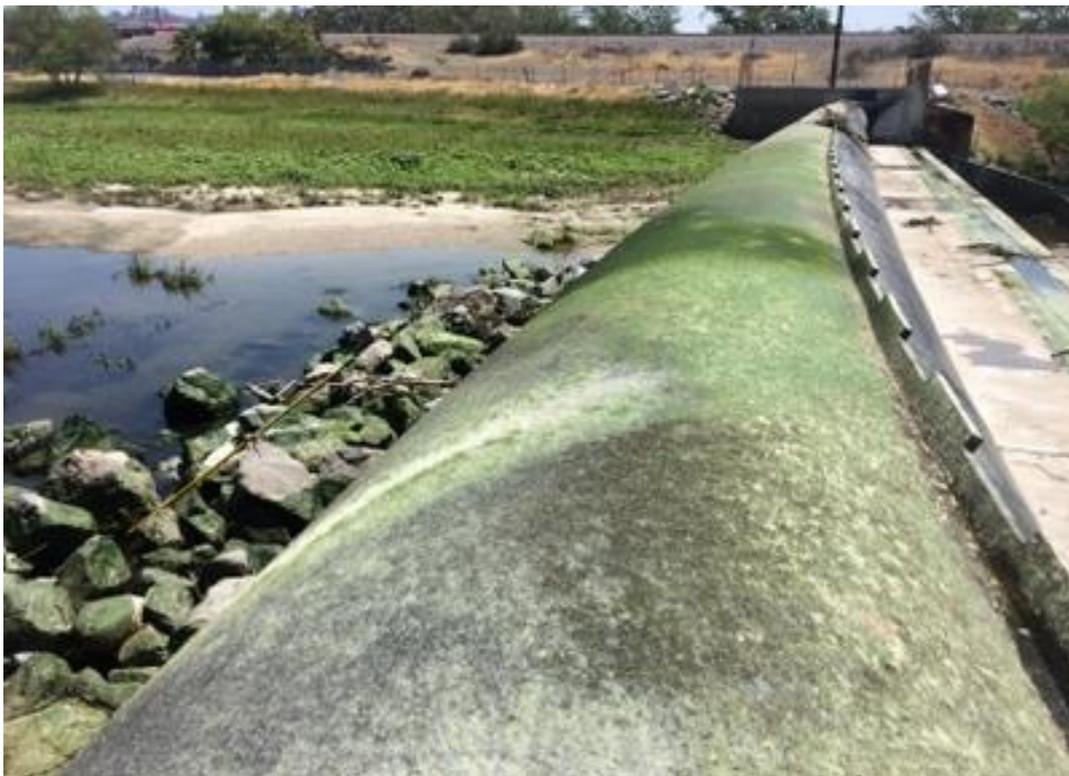
PHOTO 4 INFLATED RUBBER DAM TOP VIEW RIGHT ABUTMENT

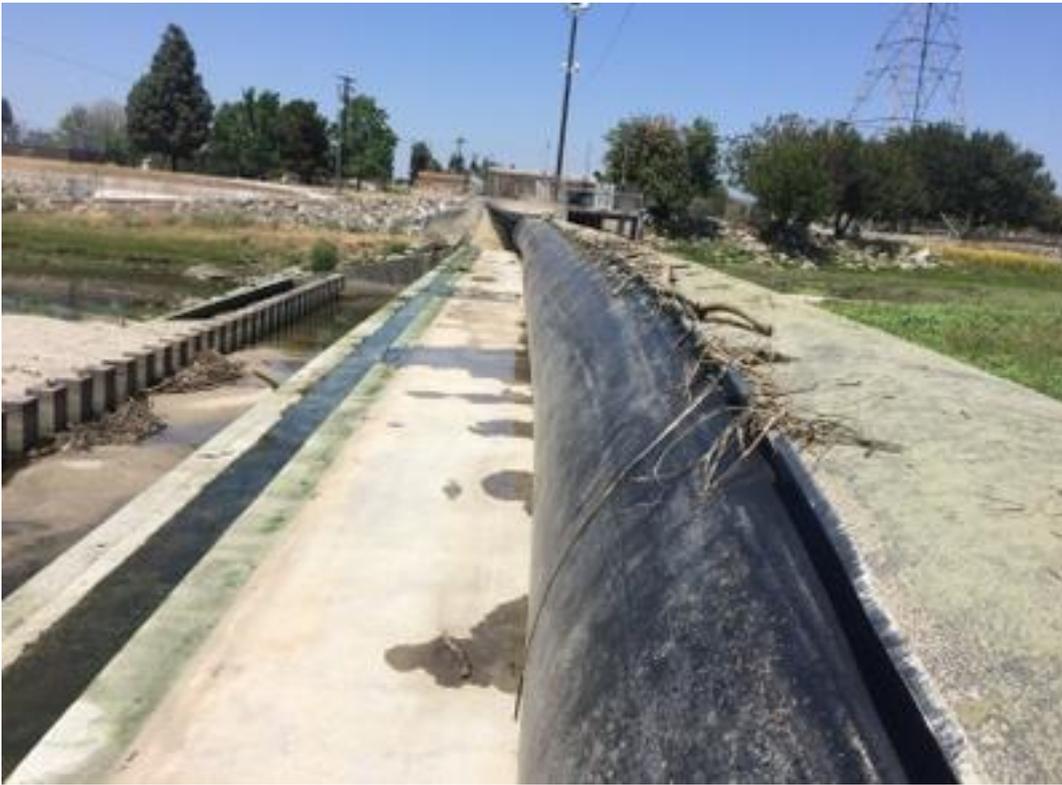
PHOTO 5 INFLATED RUBBER DAM UNDER FIN LEFT ABUTMENT DETAIL

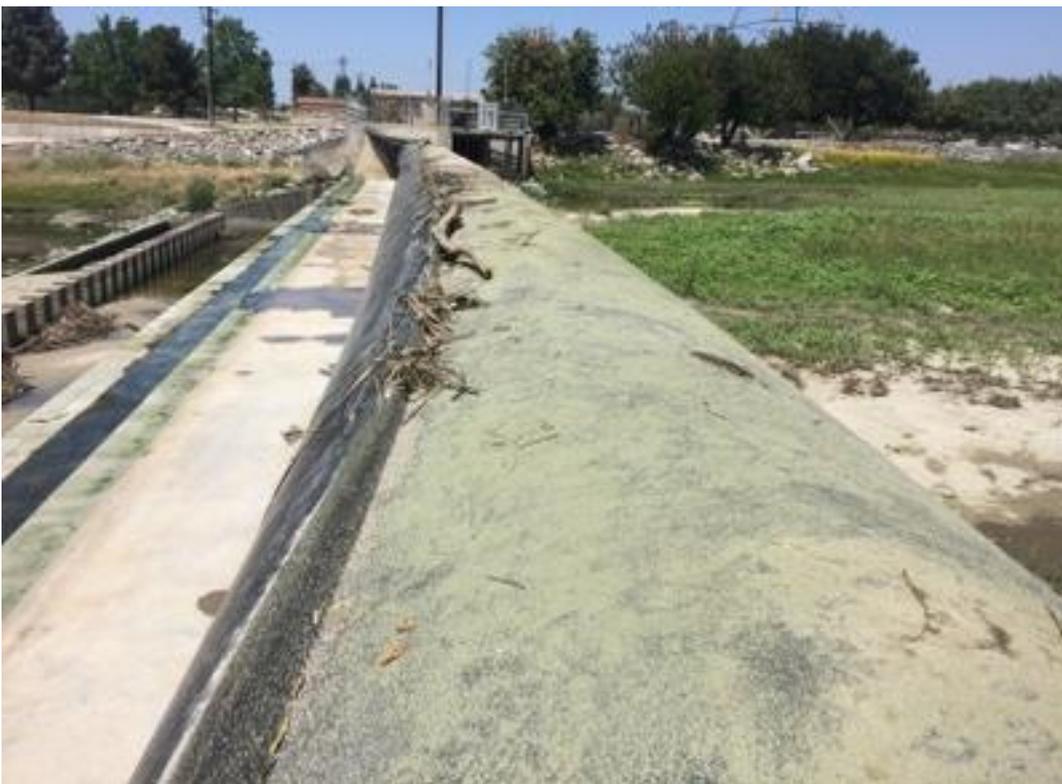
PHOTO 6 INFLATED RUBBER TOP VIEW LEFT ABUTMENT

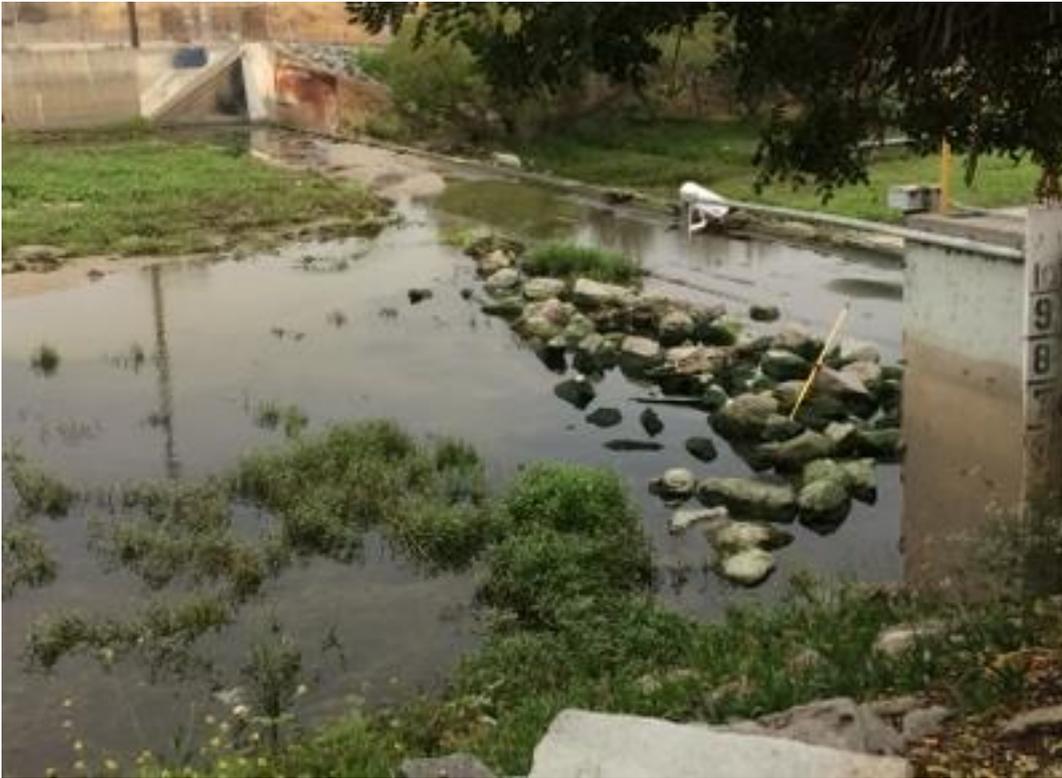
PHOTO 7

DEFLATED RUBBER DAM UPSTREAM VIEW

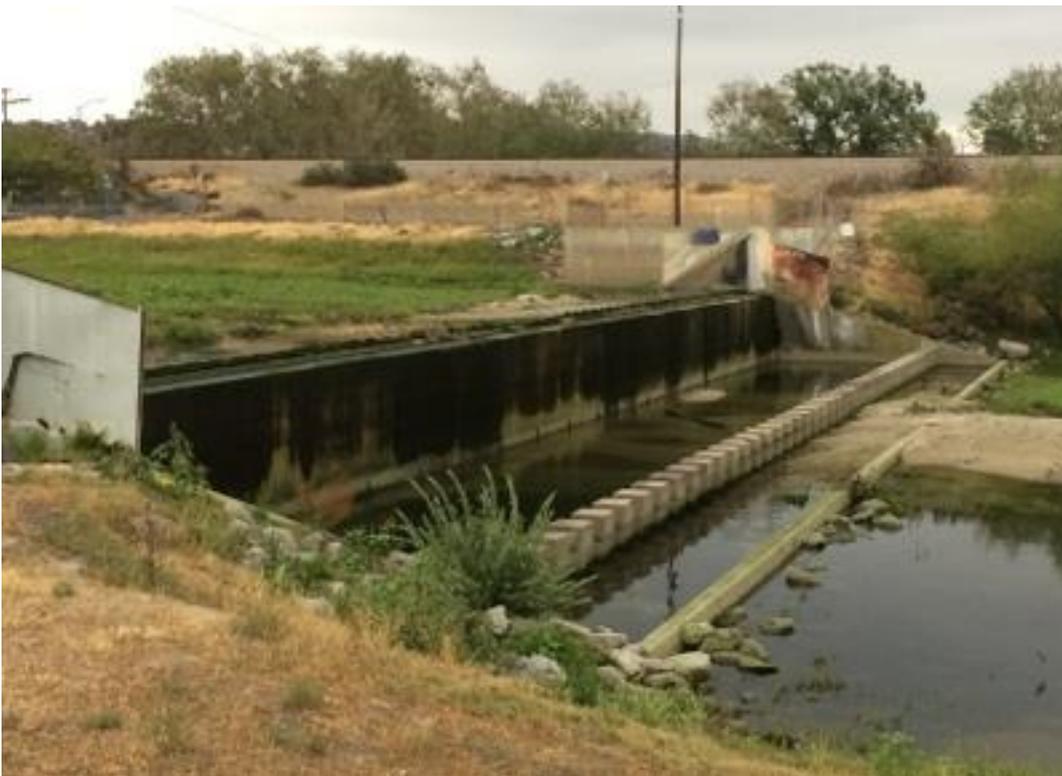
PHOTO 8

DEFLATED RUBBER DAM DOWNSTREAM VIEW

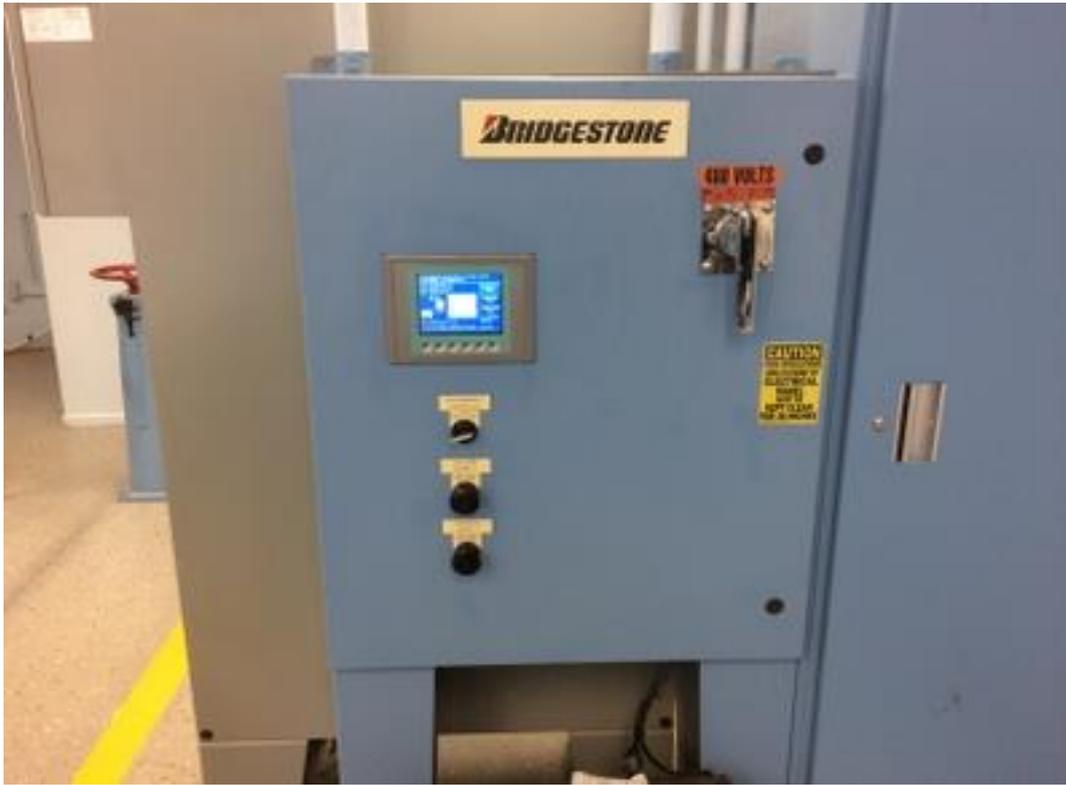
PHOTO 9 CONTROL PANEL EXTERIOR VIEW

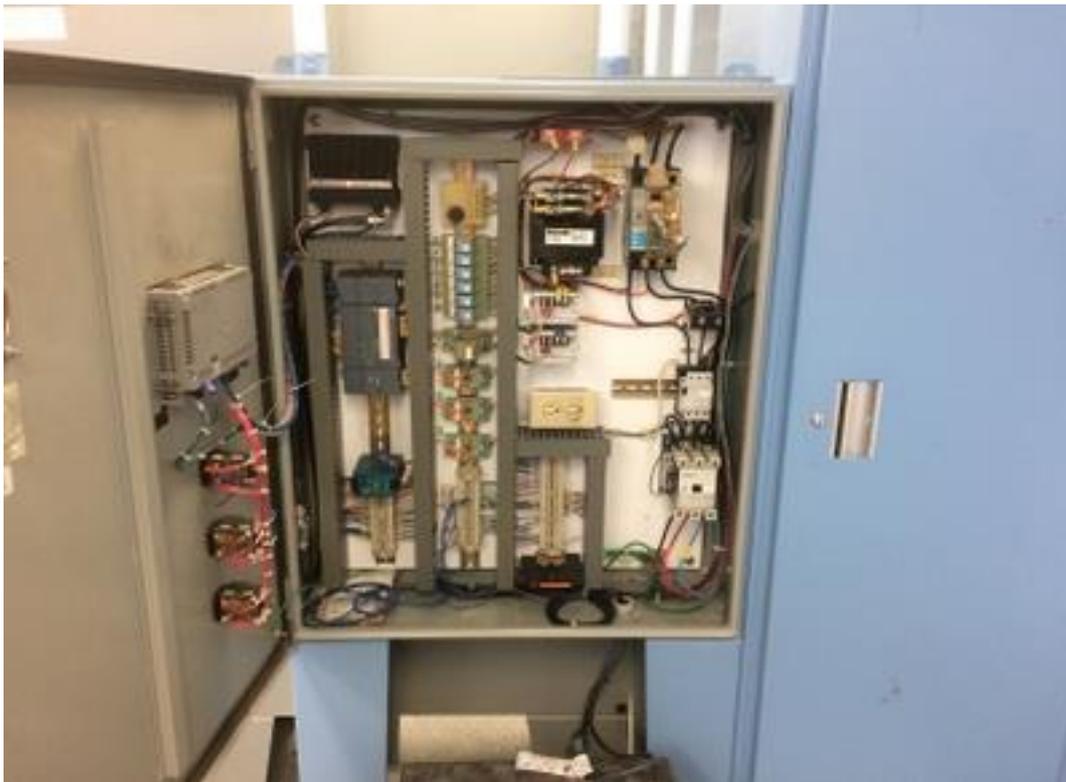
PHOTO 10 CONTROL PANEL INTERIOR VIEW

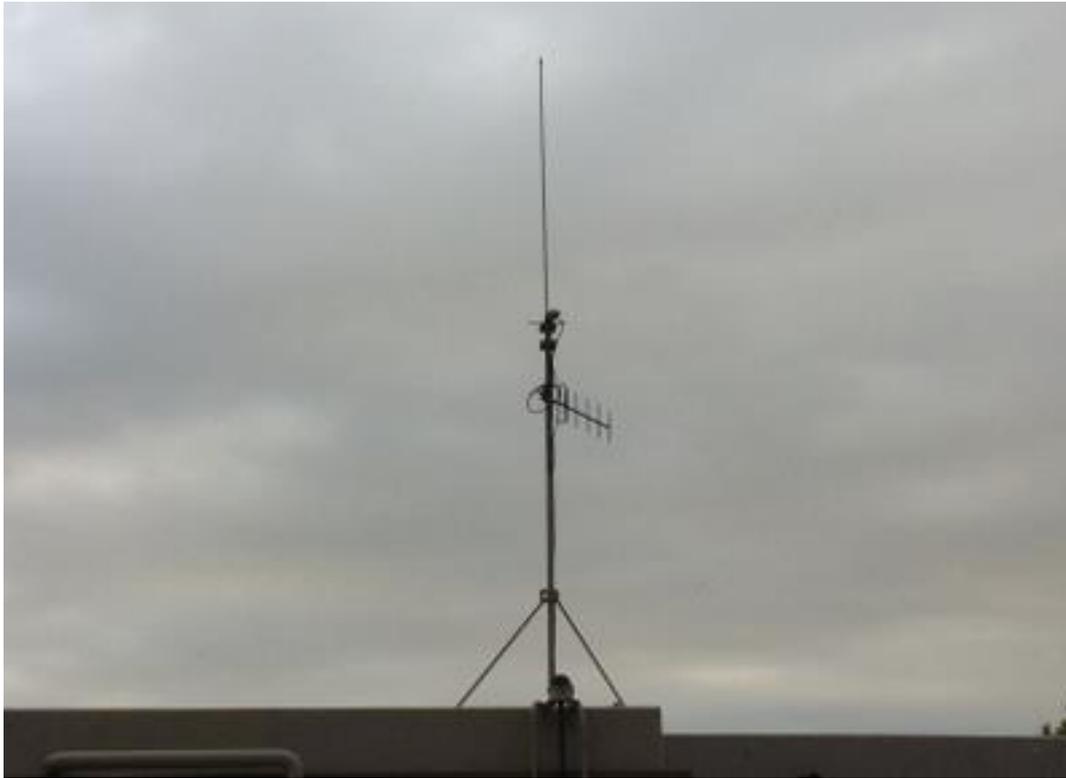
PHOTO 11

ANTENNA MAST
